**Geotechnical Evaluation and Drainage Planning
in Arctic Bay, Nunavut**

Arctic Bay, NU

Final Report
REV-02

Prepared by:
Nunami Stantec Limited

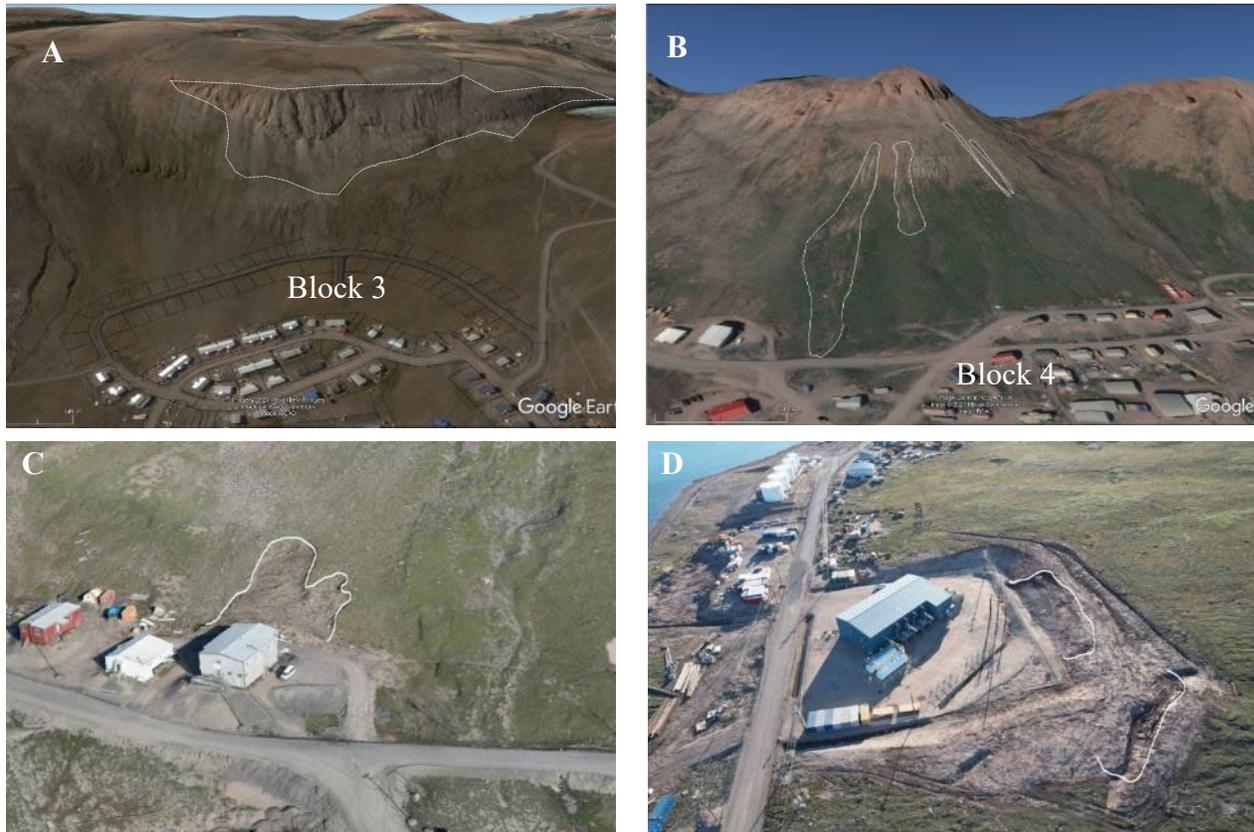
developed portion of the community, however, the uppermost portion of Block 3 (Figure 3-6) was found to be located within 150 m of slopes segments presenting rockfall hazards. Other shallow landslide deposits are visible above from Block 4.

Figure 3-6 (A) Rockfall and (B) Active Layer Detachments upslope from the Community; (C) landslide behind the Taqqut Inns North hotel and (D), unstable terrain behind the power plant

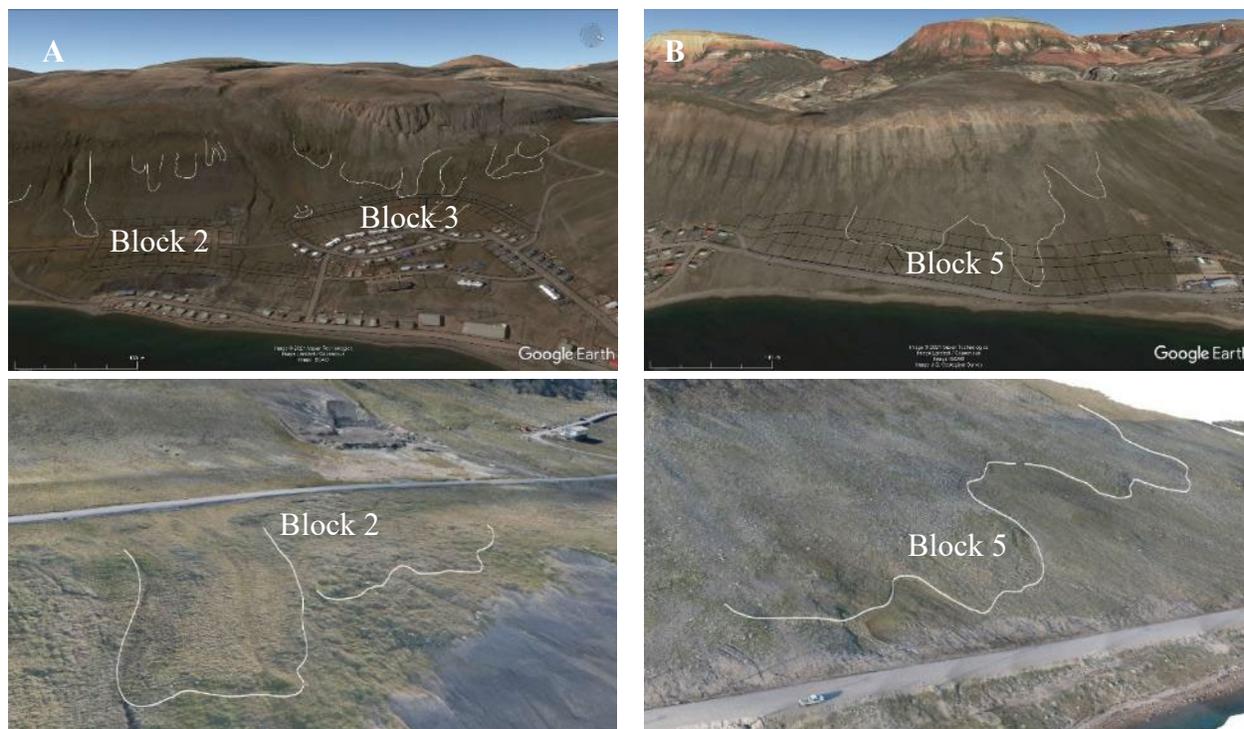
Field observations made in 2022 confirmed the widespread occurrence of solifluction and frost creep within hamlet, both along undisturbed slope segments and areas where development took place.

Figure 3-7 Solifluction Lobes Upslope from Blocks 2 and 3 (a), and Block 5 (b)

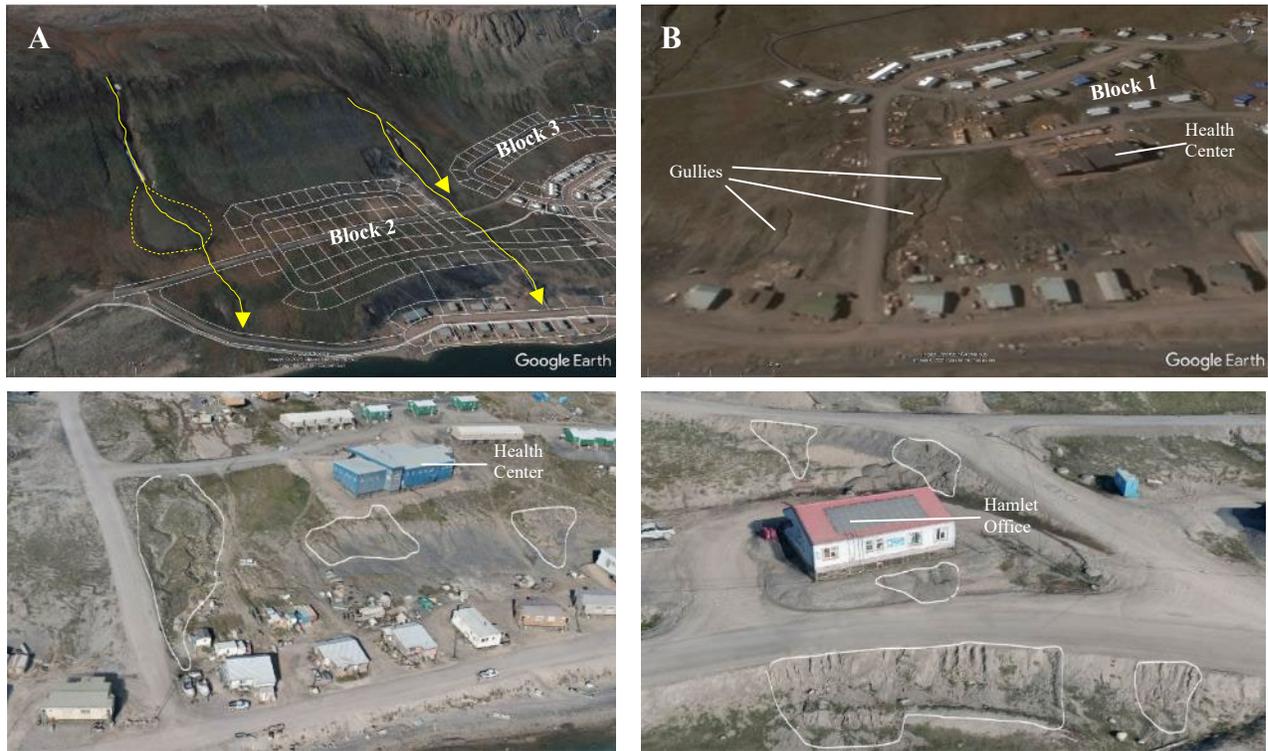
Figure 3-8 Example of areas impacted by seepage, erosion and gullyng

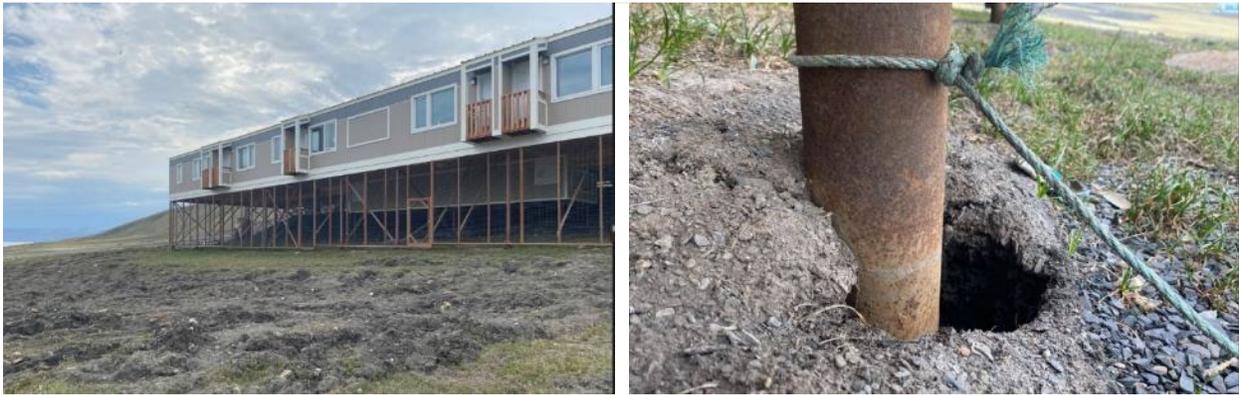
Signs of ground movement were observed around the perimeter of the building, at the contact between the piles and the ground surface, (a void is visible on the downslope side of the pile displayed on Figure 4-1 below).

Figure 4-1 Near-surface ground movement observed at recently installed foundation piles (5-plex, Block 3)

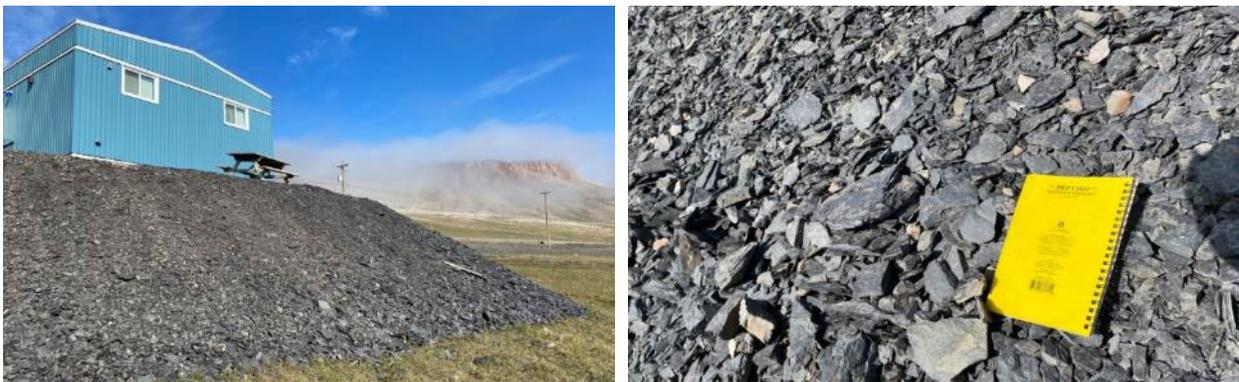
Figure 4-2 Fragmented shale rock used to build pad in newly constructed area of Block 3

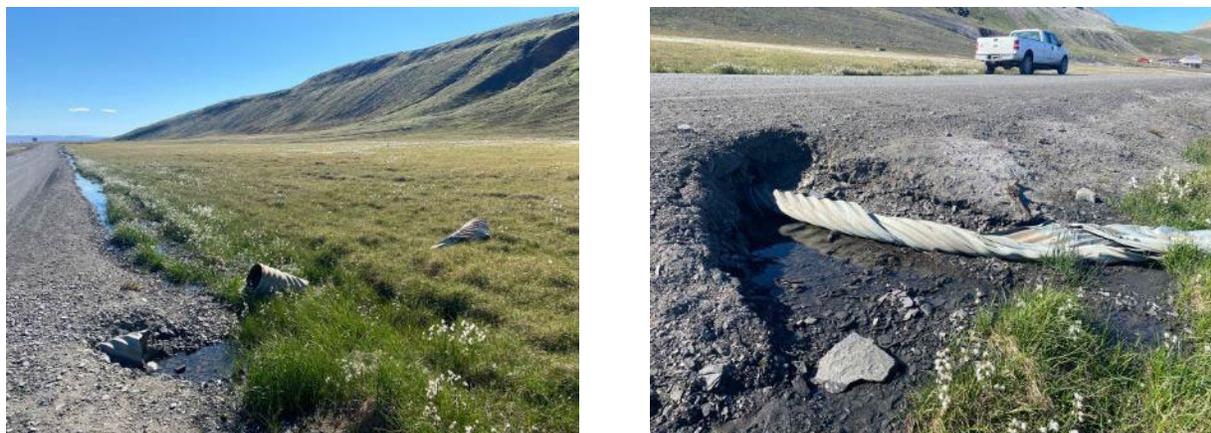
Major integrity issues were observed at culvert AB_56 and culvert AB_159, where AB_56 is showing a buried inlet and both AB_56 and culvert AB_159 showing badly torn outlets. It was also observed that the road was narrow, and that the embankment was low with reference to the surrounding terrain. Soils on the upper side of the road were often waterlogged, suggesting inefficient drainage across the recently built roadway. The outlets of both culverts being ripped and badly torn is likely related to the snow plowing activity (i.e., the grader or snow blade hitting the end of the culverts). An assumption related to the low-lying embankment and buried inlet is that the roadbed appears to have progressively sunk into the soft organic-rich soils, progressively pushing culvert downward, causing infill and blockage. The presence of longitudinal cracks on the shoulder of the road suggests differential settlement underneath the roadsides.

Figure 5-2 IDPA #1: Culvert issues and springtime flooding over Road R6. Example from culvert AB_159

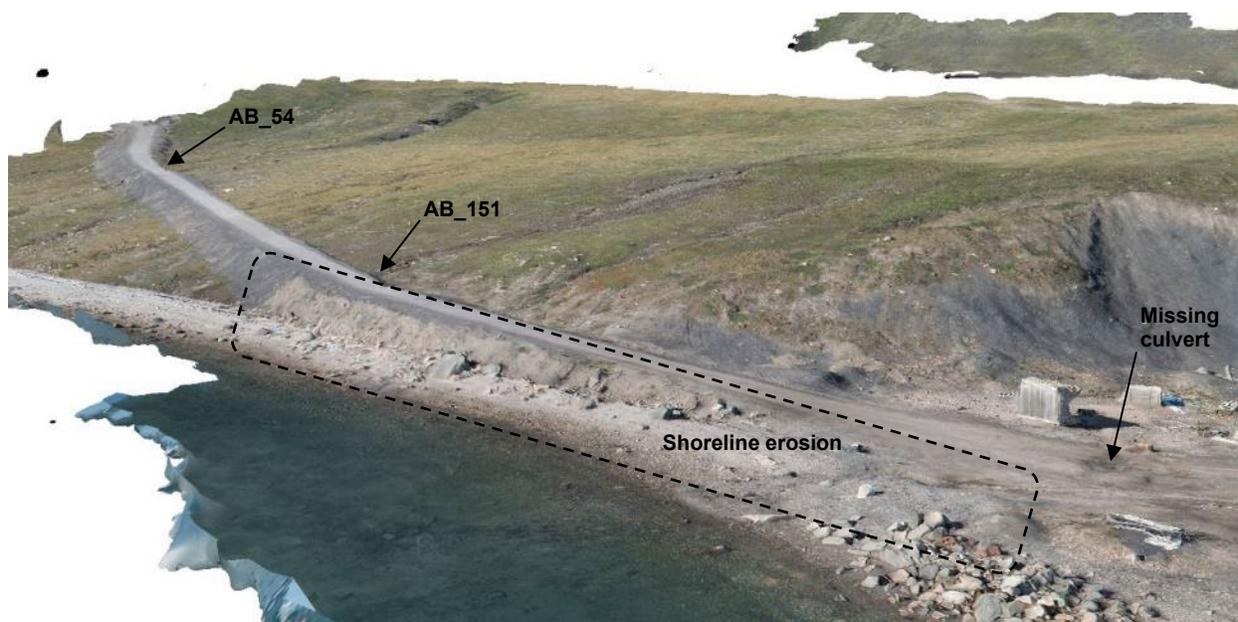
Figure 5-4 IDPA #2

Both these culverts are located along a section of road that is steep (up to 18 %), narrow (under 5 m) and showing oversteep embankment side-slopes (in places, up to 70 %). A culvert was also observed to be missing at the base of the slope. This area is known to be impacted by flooding and shoreline erosion.

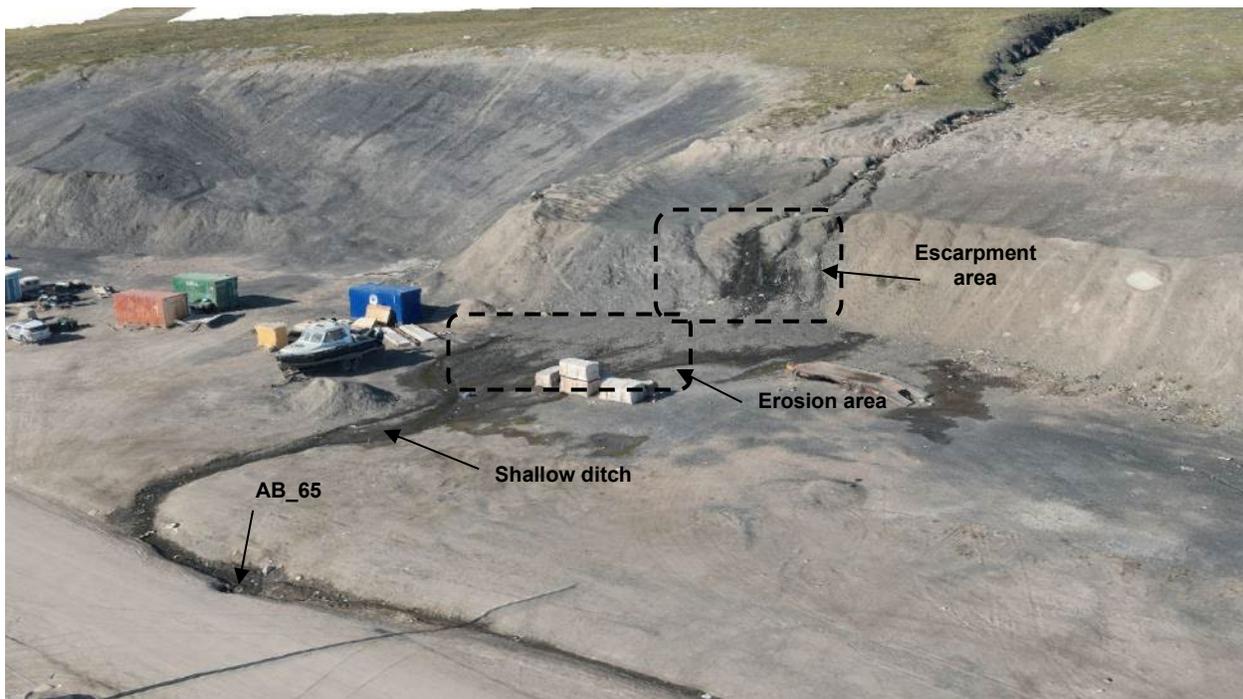
The main issues along this drainage channel include the overflow or cascading waters coming down the short (6 to 8 m) bedrock escarpment as well as the erosion caused along the channel (Figure 5-5). During meetings and discussions with hamlet officials, concerns were expressed regarding the recurrent erosion of fill material within the staging area (especially in the gully channel at the base of the escarpment), and more specifically, the overall hazards presented by the feature to local kids playing in the area.

Figure 5-5 IDPA #3. Overview

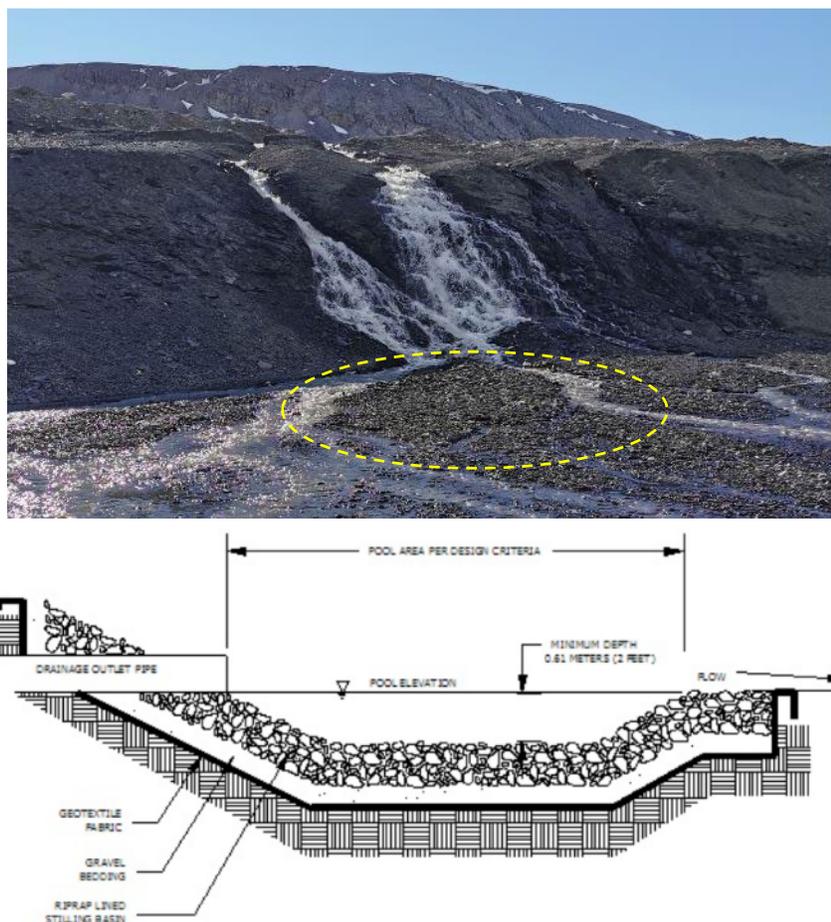
Figure 5-6 IDPA #3. Proposed plunge pool area and schematic example³

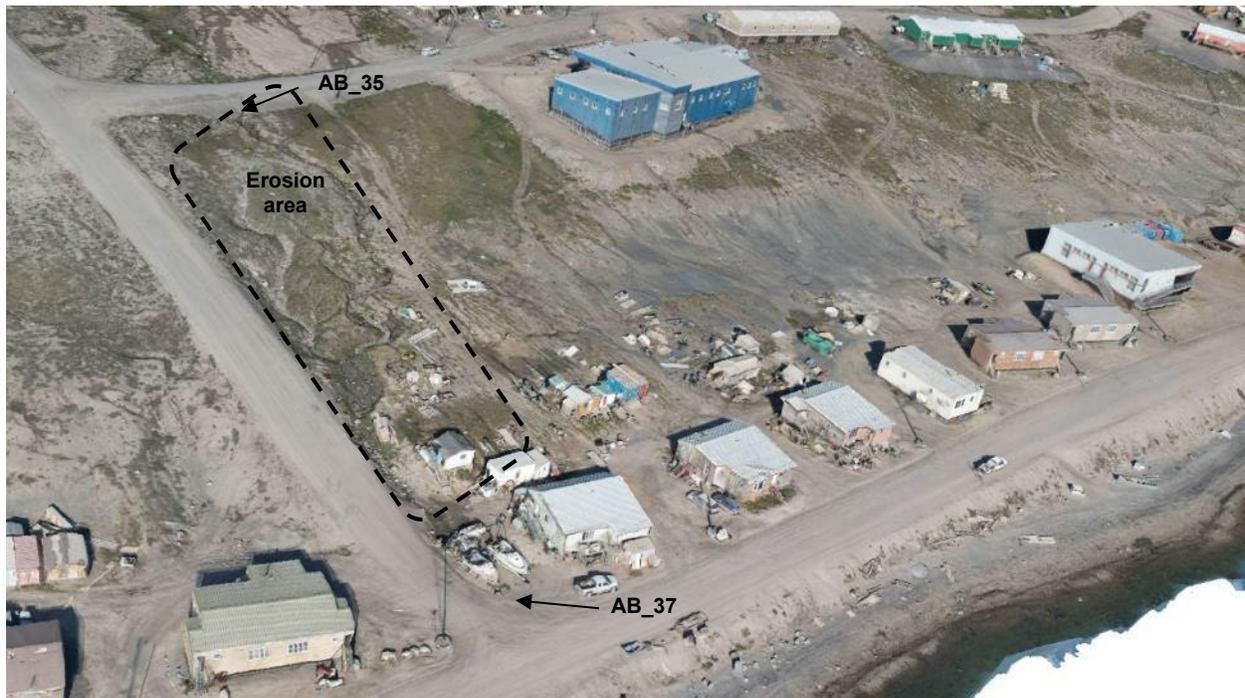
Figure 5-7 IDPA #4

At the approach of Road R55, culvert AB-37 was observed to be partially infilled, apparently caused by the sedimentation of materials eroded upslope along the channel.

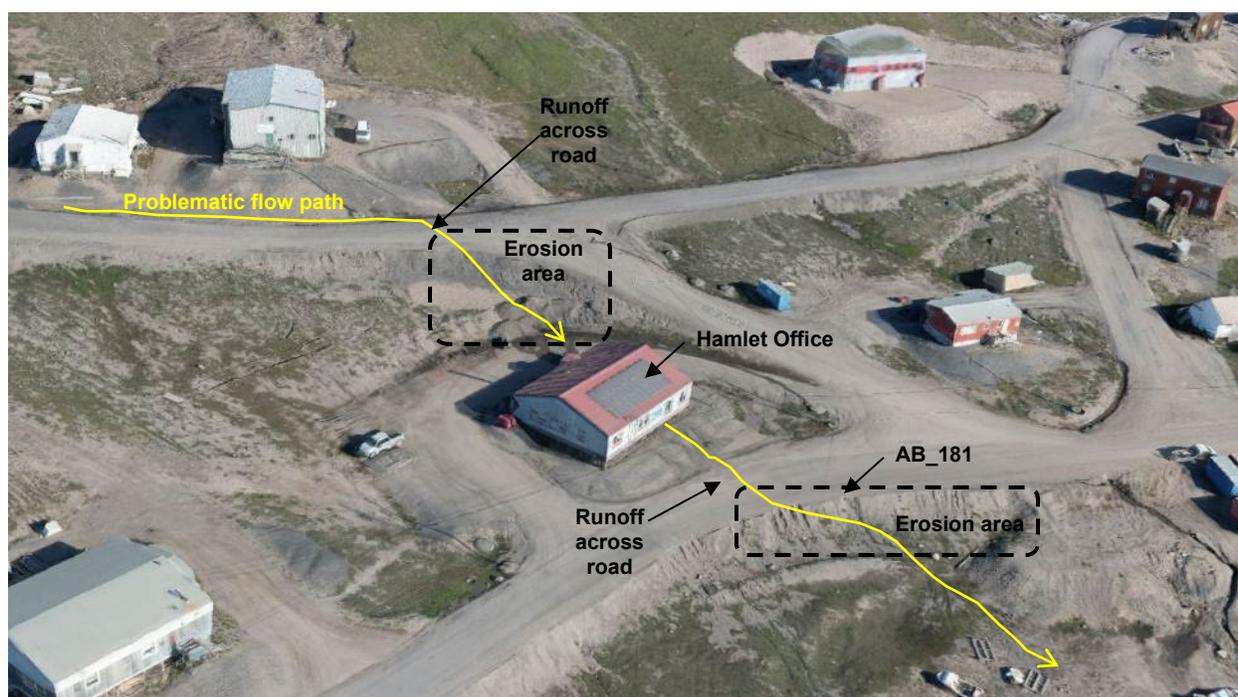
From the Tangmaarvik Hotel (Road R66) to the shoreline area downslope from the Hamlet Office (Road R3), the flow of surface water is conveyed through poorly defined ditches, often overflowing across road surfaces. Around the Hamlet office, runoff water was observed to have caused shallow rills and erosion, especially alongside the road embankments, but also across the parking area and underneath the Hamlet Office building itself. Downslope from the office, the water again overflows on top of the road, causing significant erosion of the road embankment. Culvert AB_181, downslope from the Hamlet Office, was observed to be inefficient, mainly due to its small diameter (200 mm).

Figure 5-8 IDPA #5. Observed drainage issues

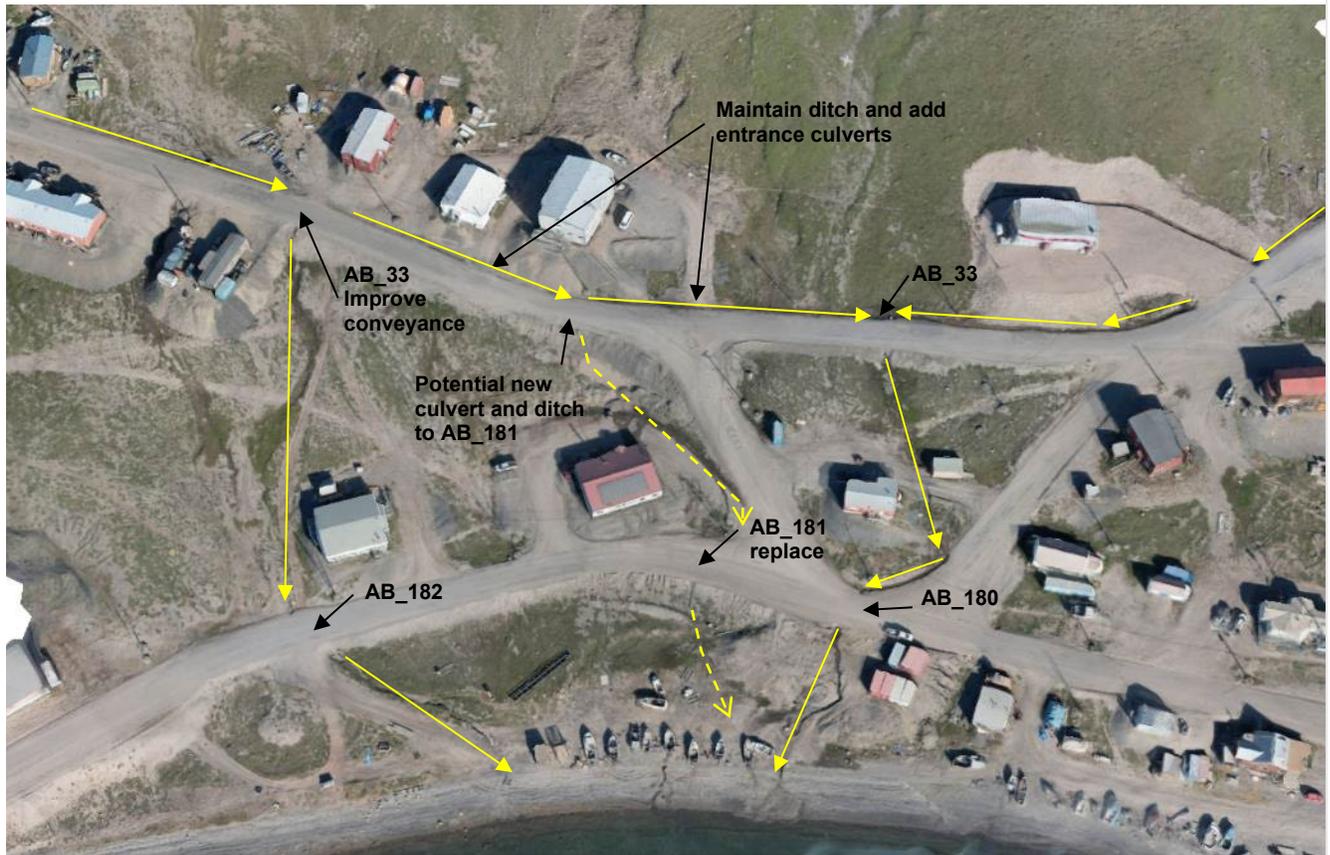
Figure 5-9 IDPA #5. Recommended actions

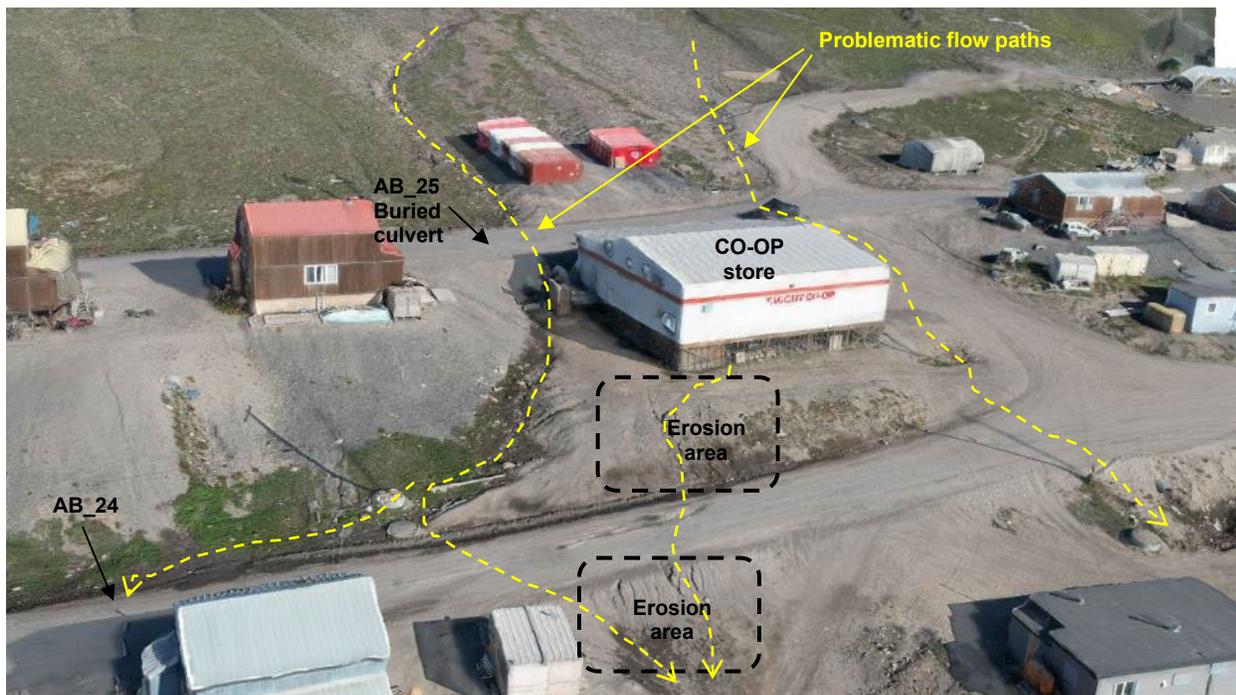
Figure 5-10 IDPA #6

Additional drainage issues were observed along this drainage path further down from the CO-OP store, including erosion along the drainage channel and culvert conveyance issues due to culvert infill and blockage.

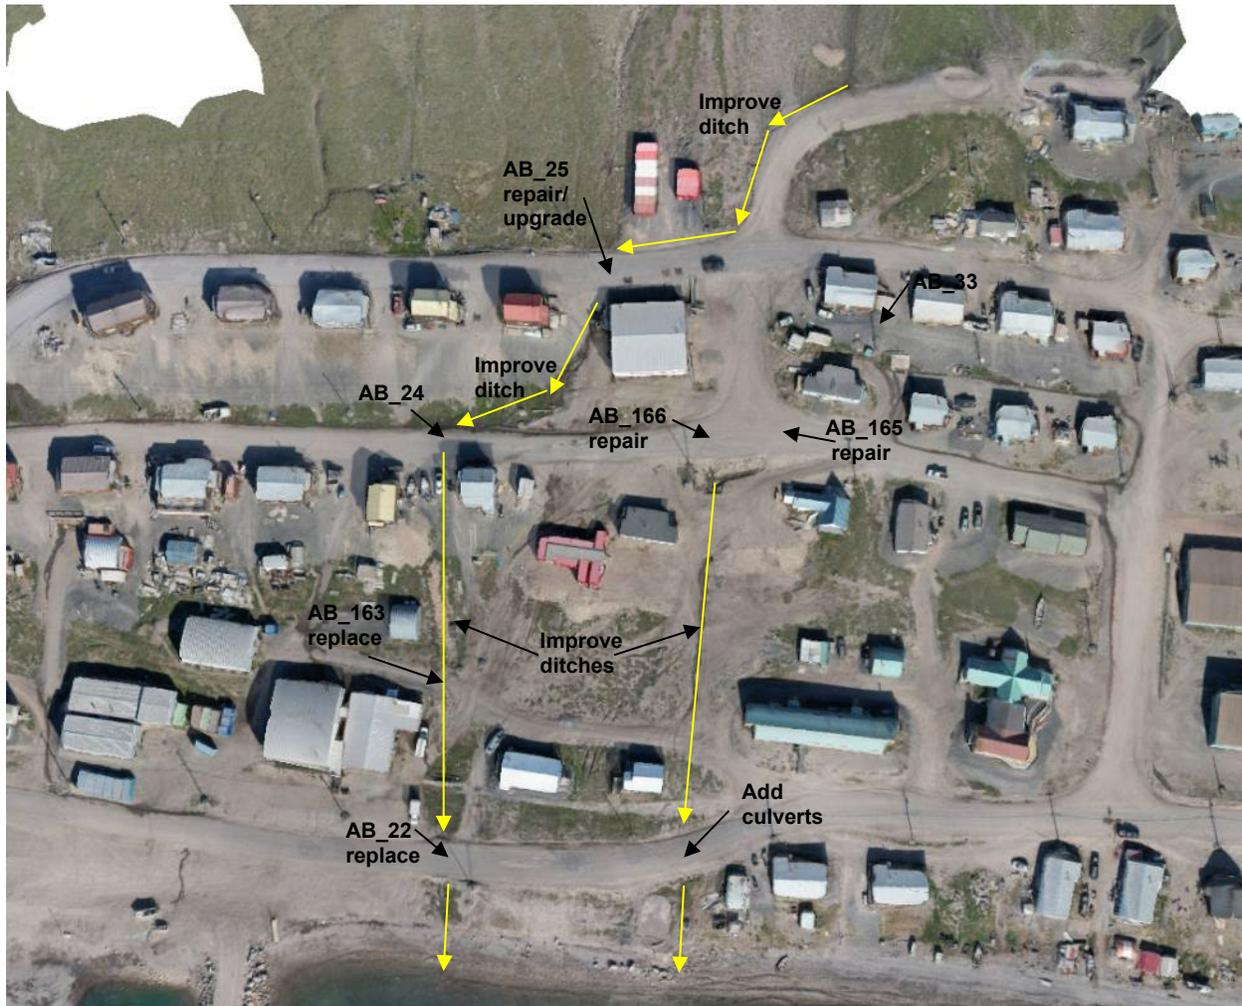
Figure 5-11 IDPA #5. Corrective actions
