# **Geotechnical Evaluation and Drainage Planning in Baker Lake, Nunavut**

*Final Report Rev-00*

**The Municipality of Baker Lake, Nunavut**

**Nunami Stantec Limited**

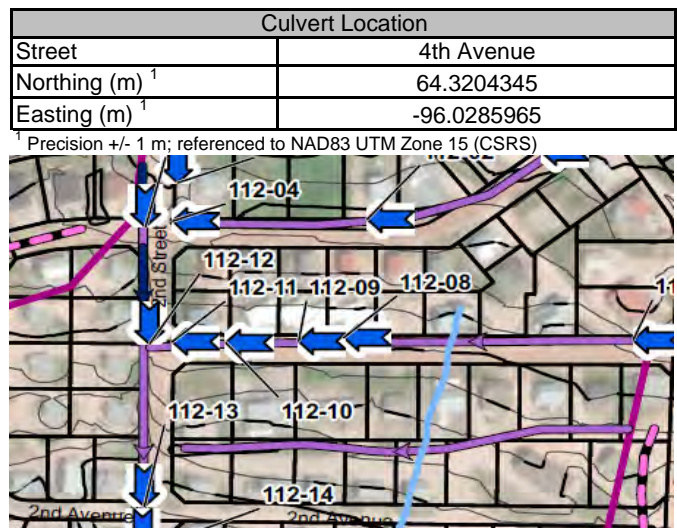
Culvert Information		
Culvert ID		112-10
Type		Entrance
Shape		Round
Material		Csp
Diameter or Dimensions (mm)		500
Marker Post Present		N
End Crushing	Upstream	Y
	Downstream	Y
Infill Depth (mm)	Upstream	400
	Downstream	250
Other		Both ends crushed and infilled
Comments

Culvert Condition Ratings (MTO 2013)				
Barrel Material (0-4)	Shape (0-4)	Capacity (0-2)	Erosion and Scour (0-2)	US/DS Channel (0-2)
0	3	2	0	2

Recommended Action(s):	Replace	Priority:	High
------------------------	---------	-----------	------

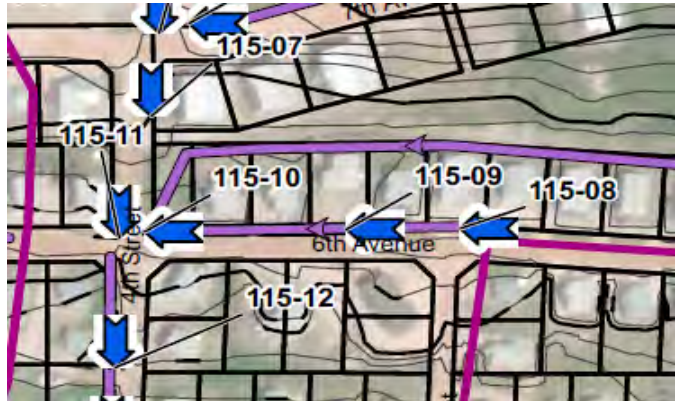
Culvert Condition Ratings (MTO 2013)				
Barrel Material (0-4)	Shape (0-4)	Capacity (0-2)	Erosion and Scour (0-2)	US/DS Channel (0-2)
0	2	2	1	1

Recommended Action(s):	Replace	Priority:	High
------------------------	---------	-----------	------

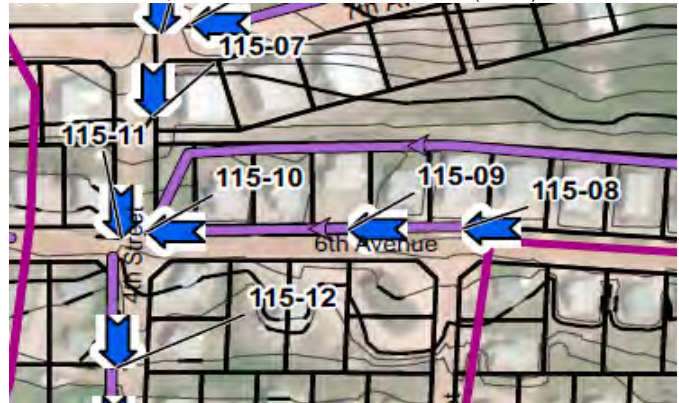
Culvert Condition Ratings (MTO 2013)				
Barrel Material (0-4)	Shape (0-4)	Capacity (0-2)	Erosion and Scour (0-2)	US/DS Channel (0-2)
0	2	2	1	1

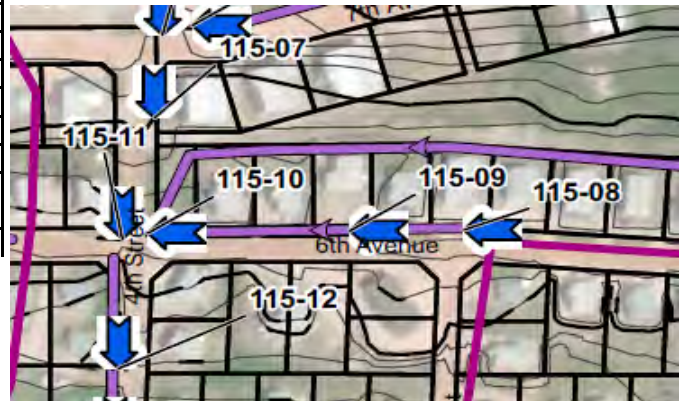
Culvert Condition Ratings (MTO 2013)				
Barrel Material (0-4)	Shape (0-4)	Capacity (0-2)	Erosion and Scour (0-2)	US/DS Channel (0-2)
0	2	2	1	1

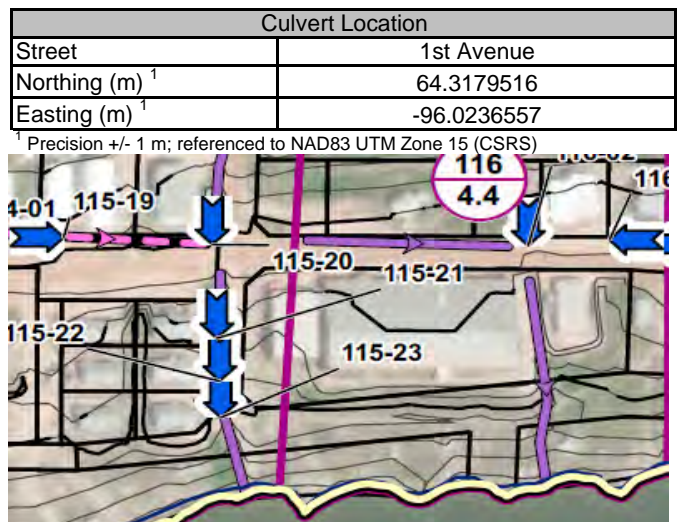
Culvert Information		
Culvert ID		115-20
Type		Cross
Shape		Round
Material		Csp
Diameter or Dimensions (mm)		600
Marker Post Present		N
End	Upstream	N
	Downstream	Y
Infill Depth (mm)	Upstream	0
	Downstream	0
Other		None
Comments

Culvert Condition Ratings (MTO 2013)				
Barrel Material (0-4)	Shape (0-4)	Capacity (0-2)	Erosion and Scour (0-2)	US/DS Channel (0-2)
0	2	0	1	0

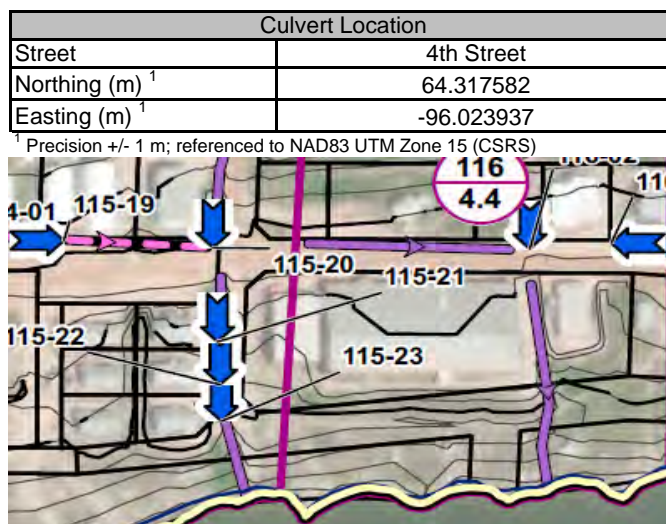
Culvert Information		
Culvert ID		115-21
Type		Entrance
Shape		Round
Material		Csp
Diameter or Dimensions (mm)		600
Marker Post Present		N
End	Upstream	Y
	Downstream	Y
Infill Depth (mm)	Upstream	0
	Downstream	0
Other		None
Comments

Culvert Condition Ratings (MTO 2013)				
Barrel Material (0-4)	Shape (0-4)	Capacity (0-2)	Erosion and Scour (0-2)	US/DS Channel (0-2)
0	3	0	1	0

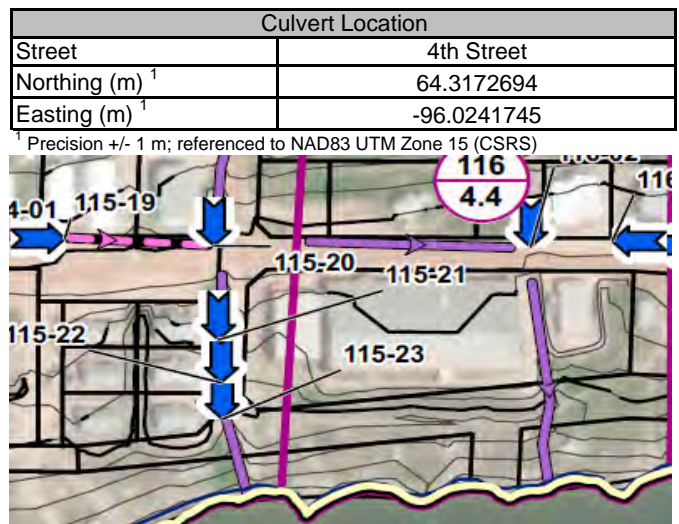
Culvert Information		
Culvert ID		115-23
Type		Entrance
Shape		Round
Material		Csp
Diameter or Dimensions (mm)		600
Marker Post Present		N
End	Upstream	Y
	Downstream	Y
Infill Depth (mm)	Upstream	0
	Downstream	0
Other		Downstream end crushed
Comments

Culvert Condition Ratings (MTO 2013)				
Barrel Material (0-4)	Shape (0-4)	Capacity (0-2)	Erosion and Scour (0-2)	US/DS Channel (0-2)
0	2	0	0	1
