**Geotechnical Investigations  
and Drainage Planning in  
Clyde River, Nunavut**

Clyde River, NU

Final Report  
REV-02

Nunami Stantec Limited

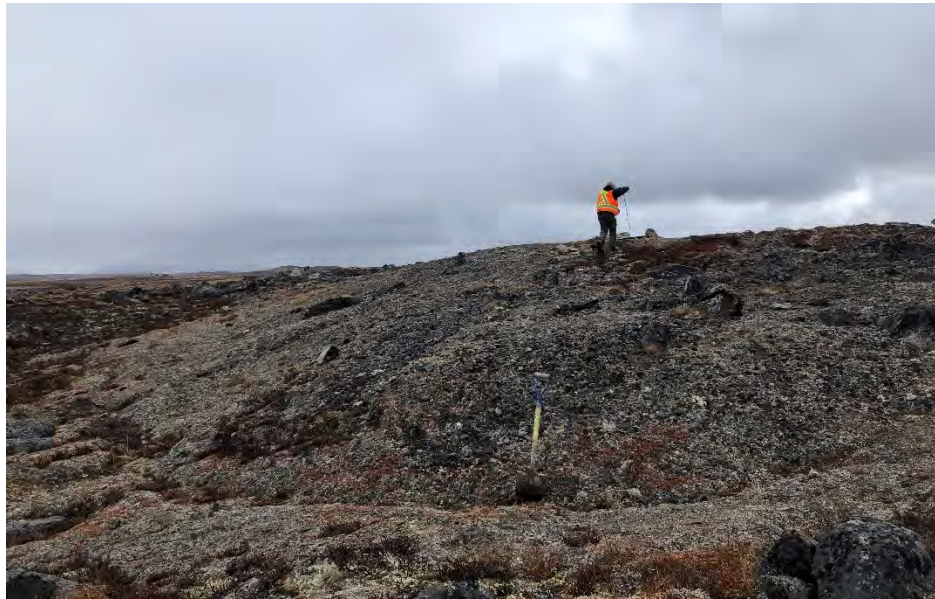
Figure 3-2 Example of solifluction lobe in Block 2 (Lot 21)

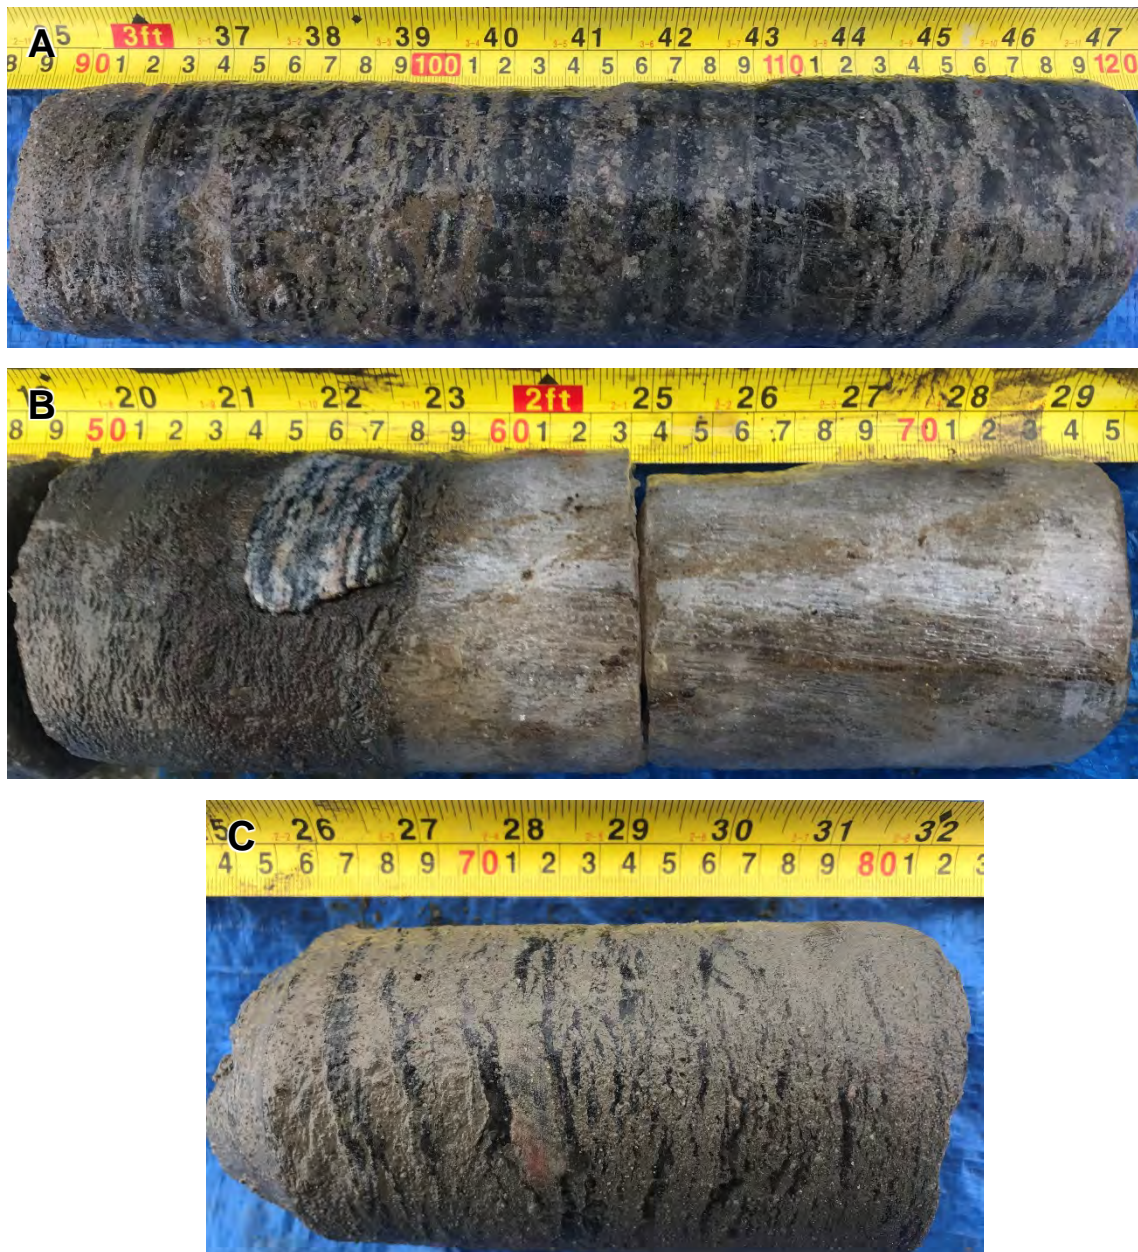
Figure 4-3 Examples of ice-rich permafrost core samples.

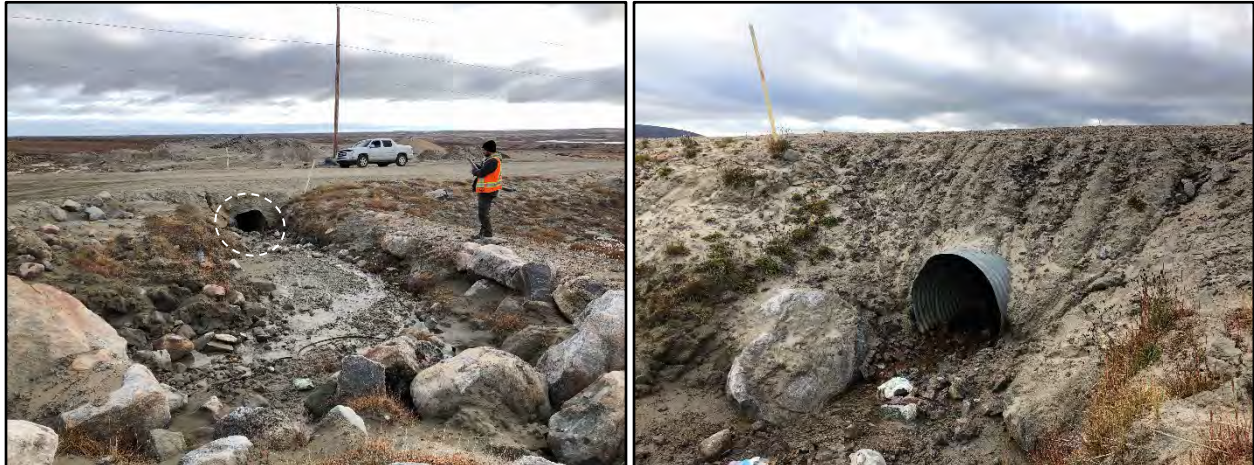
- Culverts located across access road to existing borrow pit.
- Drainage from the borrow pit area (north of Block 2) toward the southeast (Block 4 area).
- Erosion observed alongside embankment surrounding C-02.
- **Upgrade and maintenance recommended.**

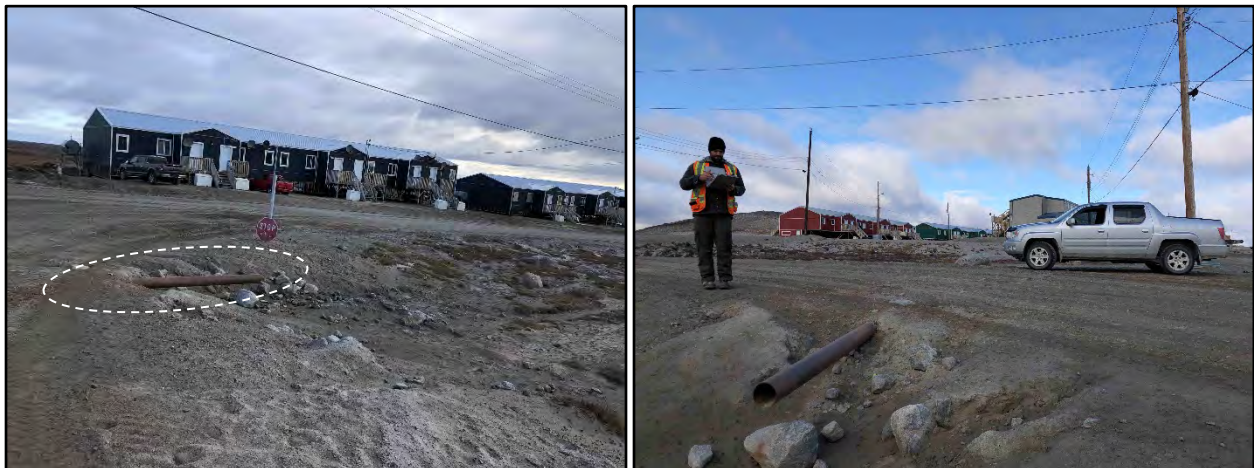
- Culvert located across road R34.
- Drainage from lots surrounding road R33 toward Bloc 2, Lot 20.
- Undersized culvert (~130 mm), the west extremity was observed to be buried within roadbed.
- **Culvert should be replaced and repositioned. A swale or shallow ditch would promote faster drainage alongside road R34 in the area.**

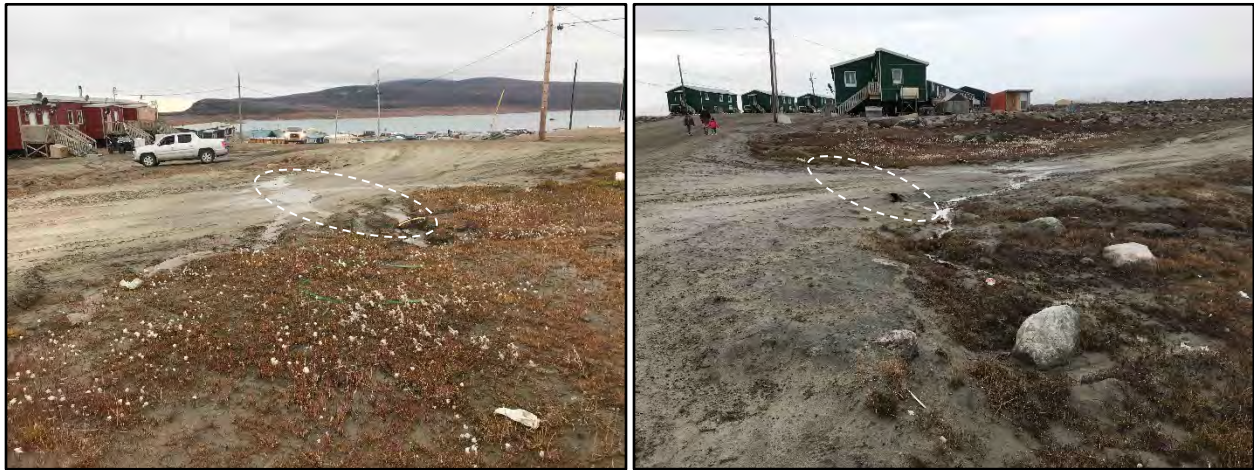
- Culvert located across access road to Housing Corporation yard.
- Drainage of upstream area toward shallow ditch (draining water eastwardly)
- Undersized culvert (~250 mm), the west end was observed to be buried. The east end was observed to be damaged (likely from grading/snowplowing activities).
- Surface water flow observed over the access road. Likely related to buried culvert inlet.
- **Culvert needs replacement. Swales or ditches would promote faster drainage alongside road R27 and R20.**

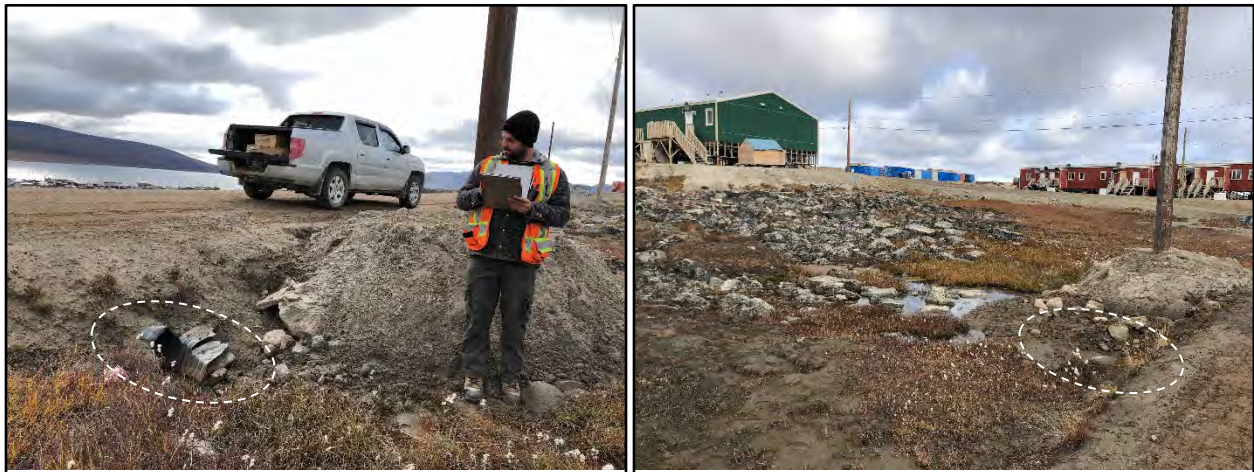
- Culvert located across road R20.
- Drainage from upstream lots toward the small stream flowing to the sealift district.
- Poorly defined flow path leading to localized water ponding.
- Partial culvert inlet Blockage by silt and sand (~5 %).
- Damaged culvert inlet.
- **Culvert need maintenance or upgrade.**

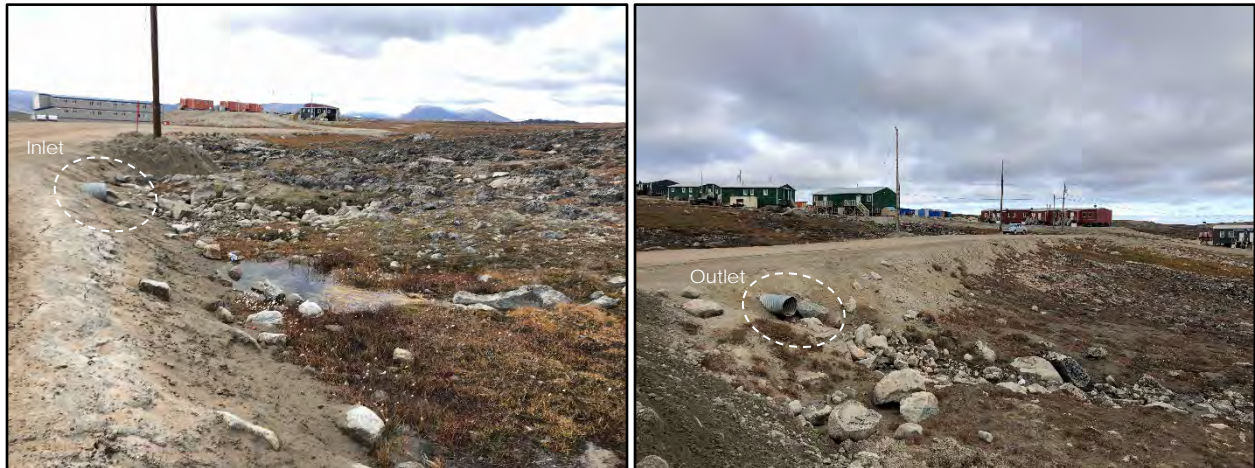
- Culvert located across road R20 (immediately south from Block 2).
- Drainage from Block 2 (Lot 20) toward the stream flowing to the sealift district.
- Poorly defined flow path upstream from culvert.
- Ponding observed around culvert inlet.
- Culvert outlet perched above ground surface (~30 cm). Risk for localized erosion.
- Tension cracks observed alongside embankment.
- **Culvert placement could be optimized to facilitate water flow and limit potential ponding.**

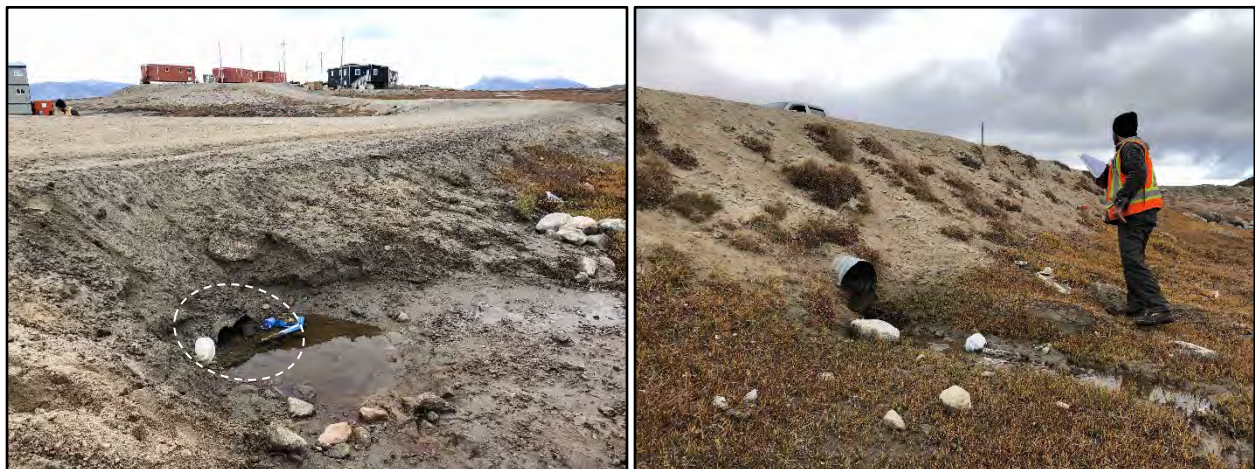
- Culvert located across road R20.
- Drainage from Block 2, (Lot 20) toward the stream flowing to the sealift district.
- Poorly defined flow path upstream from culvert.
- Ponding observed around culvert inlet.
- Partial culvert inlet blockage (~80 %).
- Tension cracks observed alongside embankment (upslope embankment).
- **Culvert need maintenance or upgrade to facilitate water flow and limit potential ponding.**

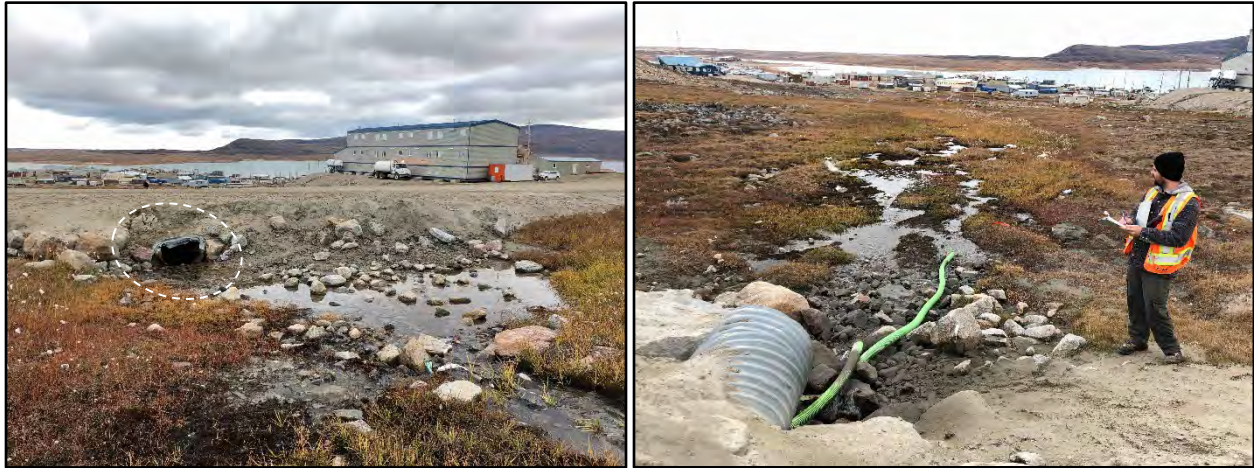
- Culvert located across road R20.
- Drainage from sub-basins west of Block 2, toward the stream flowing to the sealift district.
- Crushed culvert inlet and minor erosion noted alongside upslope road embankment.
- Ponding observed around culvert inlet.
- **Culvert need maintenance or replacement. A larger culvert would allow for a more efficient drainage in period of snowmelt or following heavy rainfall events.**
- **Rip-rap required at culvert outlet to minimize potential erosion.**

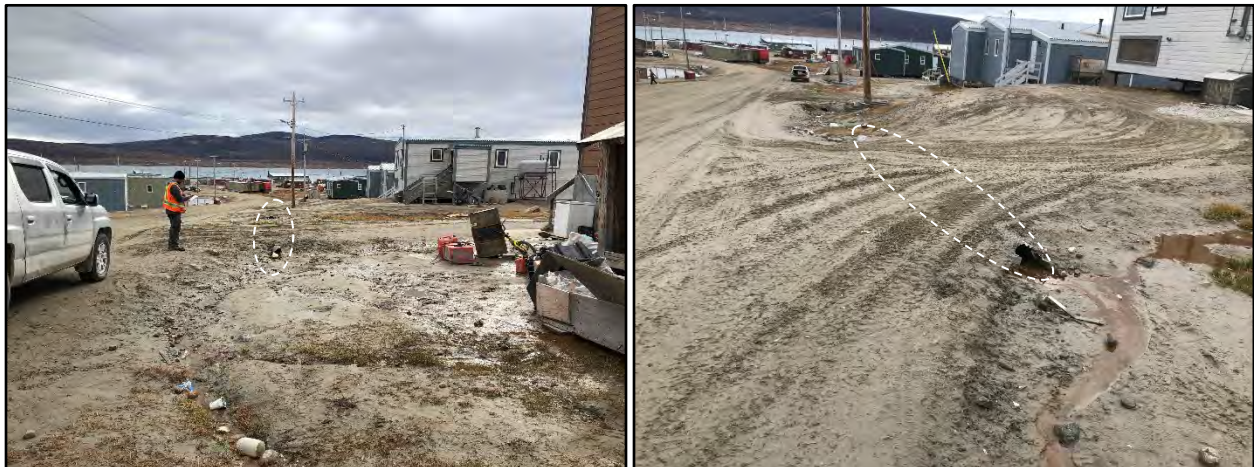
- Series of small diameter culverts (~150 mm) located across driveways along road R5.
- Waterlogged soils and standing water observed in low-lying areas characterized by thin fill (<40 cm) or no fill.
- Localized erosion and sedimentation observed along the road, with some culverts showing partial blockage by sand and silt (e.g., C-17 and C-18).
- Several of the culverts were observed to be crushed, deformed and/or perched.
- **Several culverts need maintenance or replacement. A ditch along the west side of road R5 would allow for more efficient drainage and would limit potential erosion.**

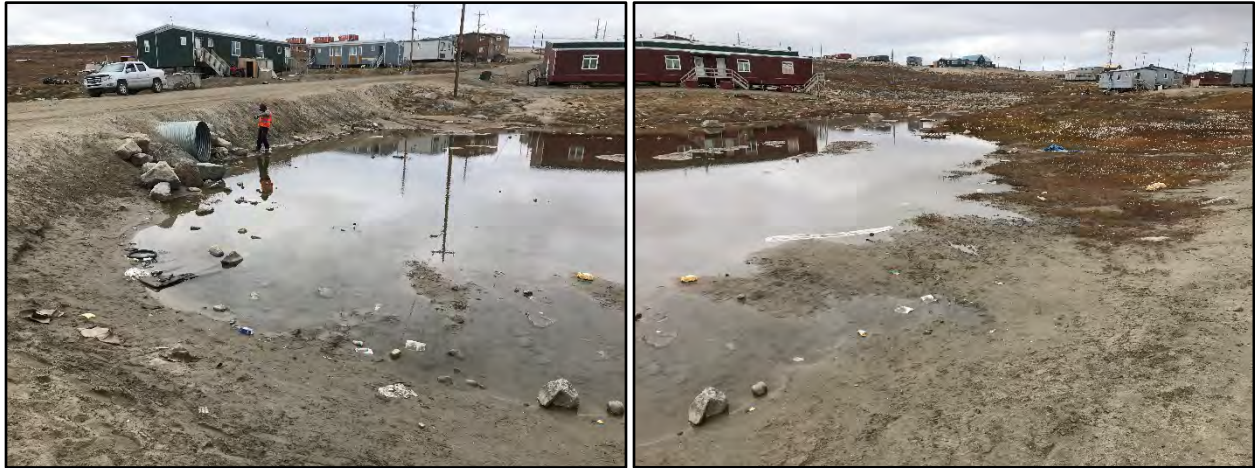
- Recently upgraded culvert located across road R5.
- Drainage of the stream flowing westerly toward the sealift district.
- Good overall condition however the culvert was observed to be slightly perched above the ground surface, allowing for ponding upstream from the culvert.
- Possibility that some localized subsidence occurred in the area (thermal degradation).
- **Lowering the culvert would allow for more efficient drainage.**

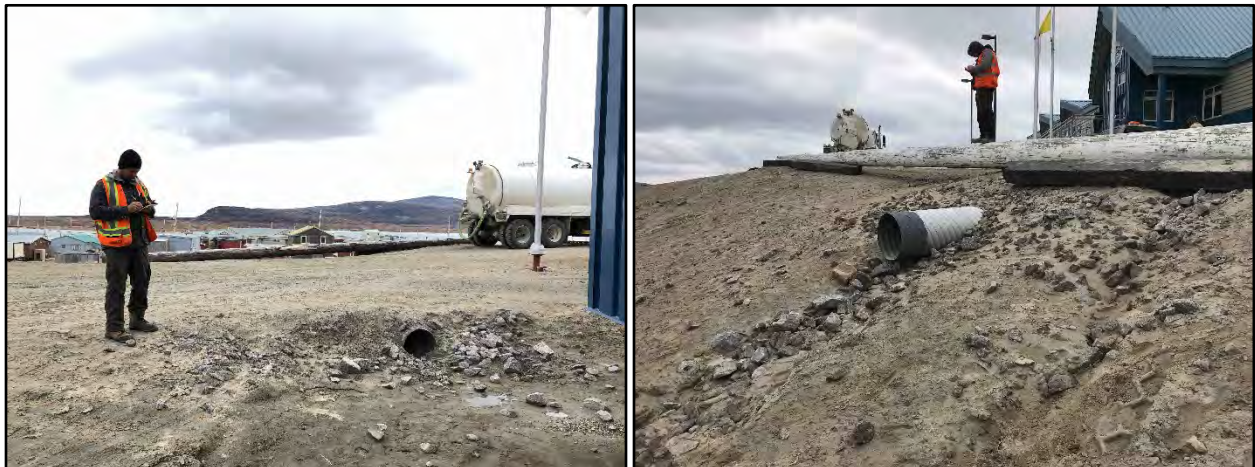
- Culvert located in front of the Municipal Center (east corner).
- Drainage of the pad hosting the Municipal Center, toward the residential lots downslope.
- Good overall condition.
- Minor sedimentation observed within the culvert.
- **Annual maintenance should include cleaning the inlet of loose sand and silt. Some Rip rap should be placed at the outlet to protect then steep embankment from erosion.**

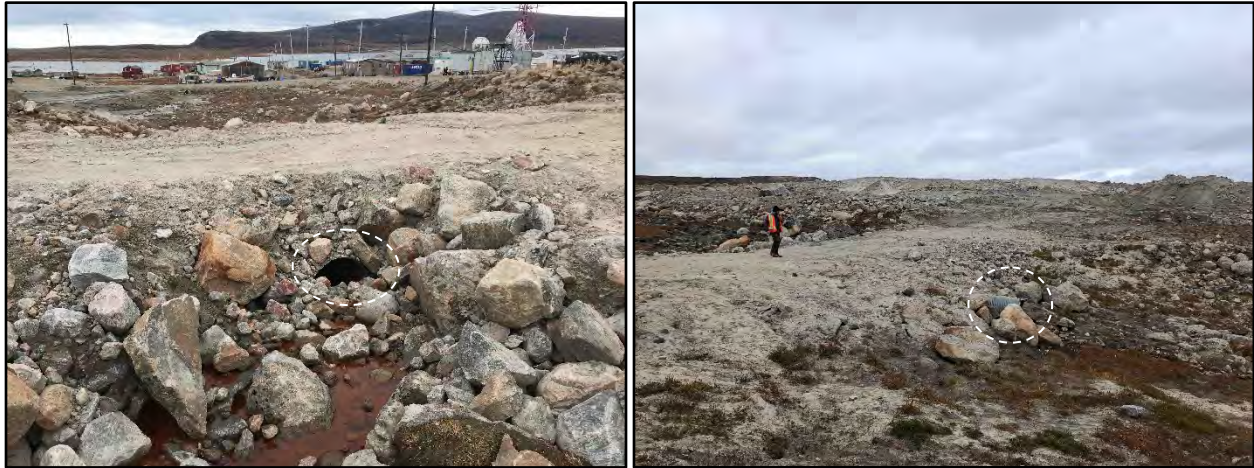
- Culvert located across access road to inactive borrow pit.
- Downslope drainage from Blocks 3 and 4 through a major flow path toward Patricia Bay.
- Culvert inlet partially blocked with gravel and cobbles.
- Culvert outlet perched.
- Good overall condition
- **Annual maintenance should include cleaning erodible material and obstructions from the inlet area.**

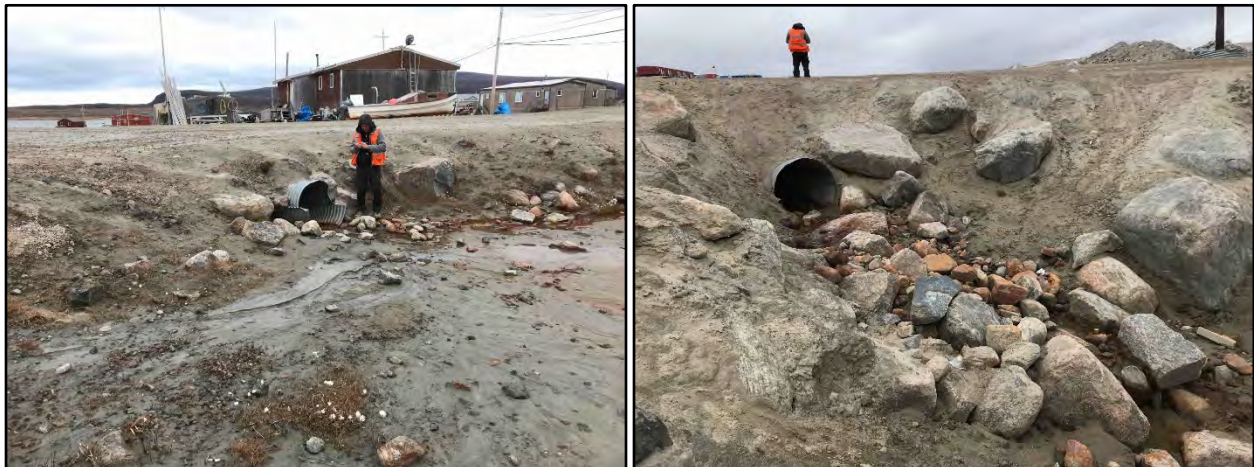
- Culvert located across access road to the community arena.
- Drainage from Blocks 3 and 4 through a major flow path toward Patricia Bay.
- Good overall condition.
- Minor sand and silt sedimentation immediately upstream from the culvert.
- **Annual maintenance should include clearing material within the culvert.**
- **Attention should be given to limit erosion of fine-grained soils in the area (former borrow pit immediately north of the arena).**

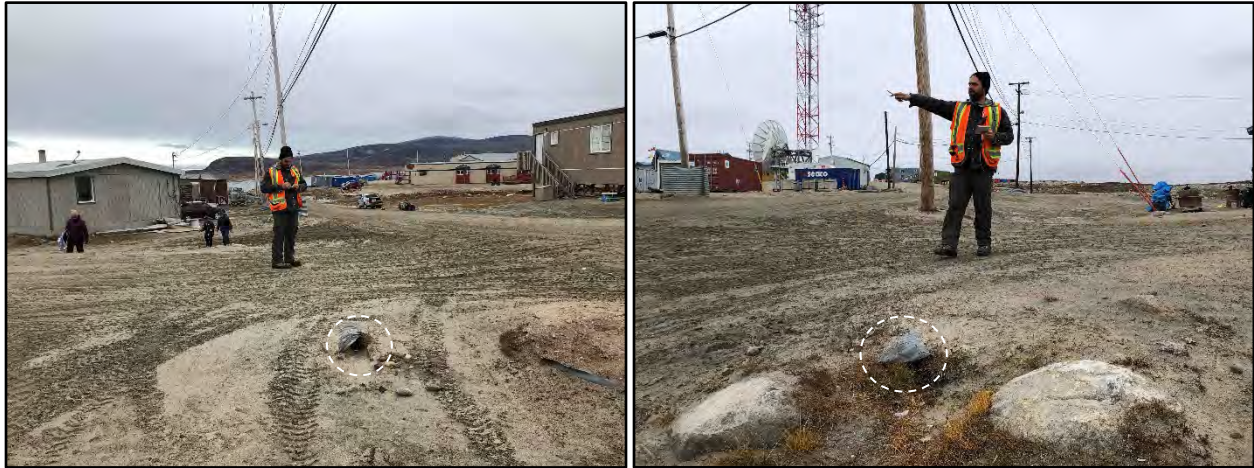
- Small culvert (~150 mm) located across residential driveway along road R8.
- No swale or ditch confining drainage towards the culvert.
- Partial culvert blockage by sand and silt (>50 %).
- Damage culvert inlet and outlet (likely from grading/snowplowing activities).
- **Culvert requires maintenance or replacement.**
- **Proper ditches or swales required alongside road R8.**

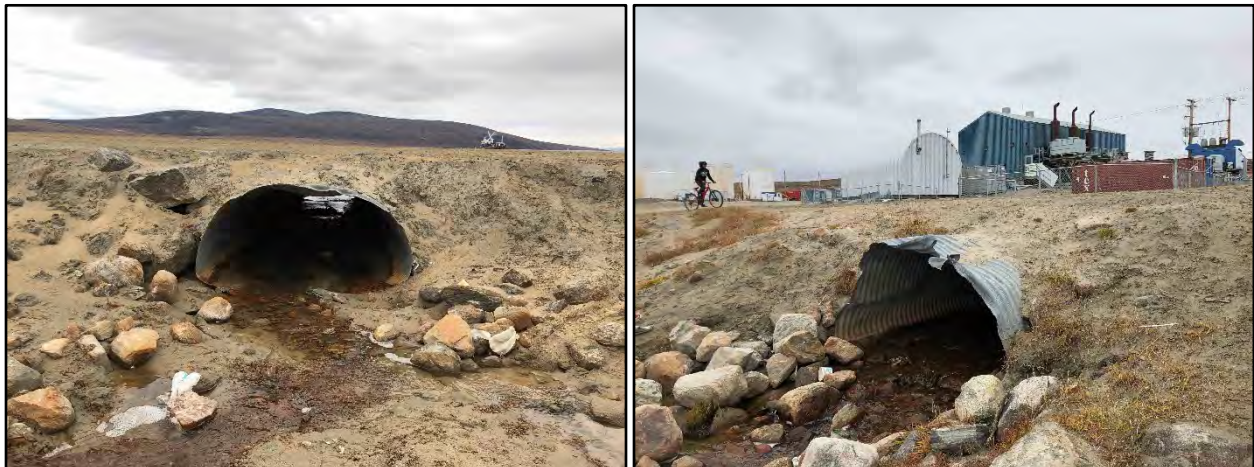
- Culvert located across access road leading to the power plant.
- Drainage of a major flow path toward the shoreline area.
- Some sand and gravel accumulation within the culvert. Material observed not to impact water flow.
- Culvert observed to be deformed. Structural integrity of the culvert likely impacted.
- Limited fill cover present above the crest of the culvert (~20 cm).
- **Overall stability of the culvert should be monitored. Replacement might be required.**

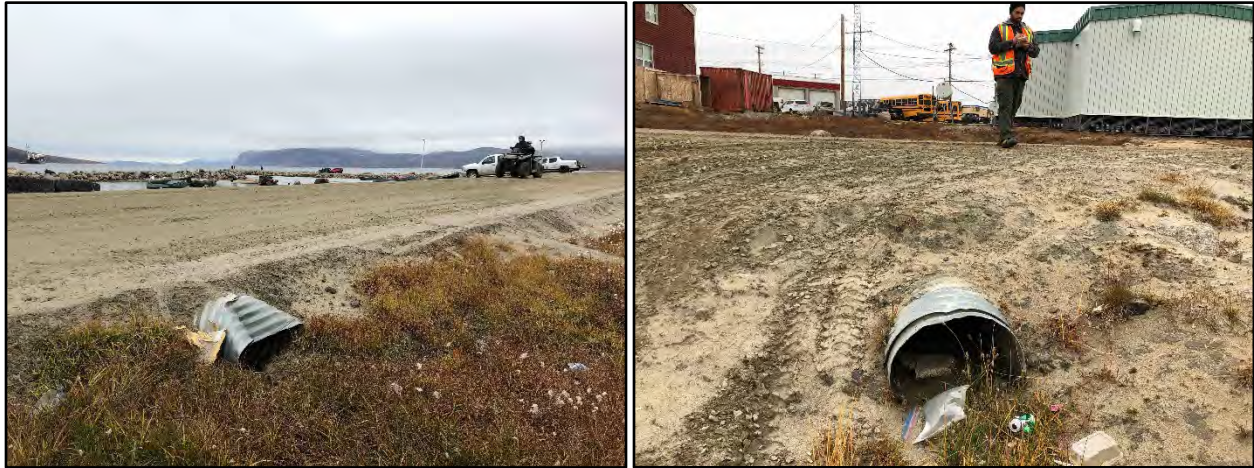
- Culvert located across road R3.
- Drainage from a small flow path toward Patricia Bay. The flow path was observed to be poorly defined upstream from the culvert.
- Culvert inlet observed to be deformed.
- Sedimentation observed within the culvert (<20% blockage).
- **Deformed culvert inlet should be fixed. Annual maintenance should include clearing material within the culvert.**

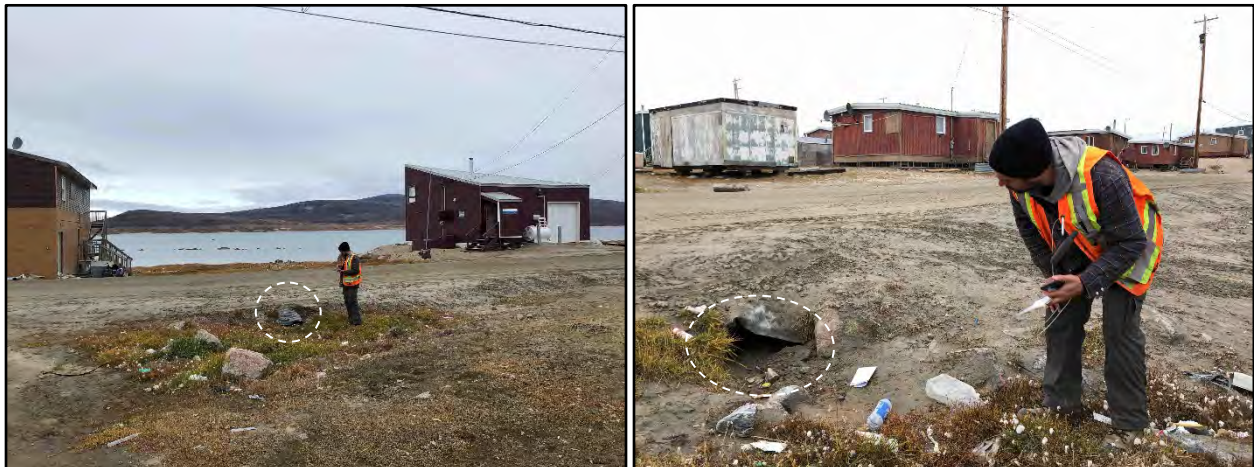
- Culvert located across road R3.
- Drainage from a small flow path toward Patricia Bay. The flow path was observed to be poorly defined upstream from the culvert.
- Culvert observed to be deformed.
- Sedimentation observed within the culvert (<20% blockage).
- **Deformed culvert inlet should be fixed. Annual maintenance should include clearing material within the culvert.**

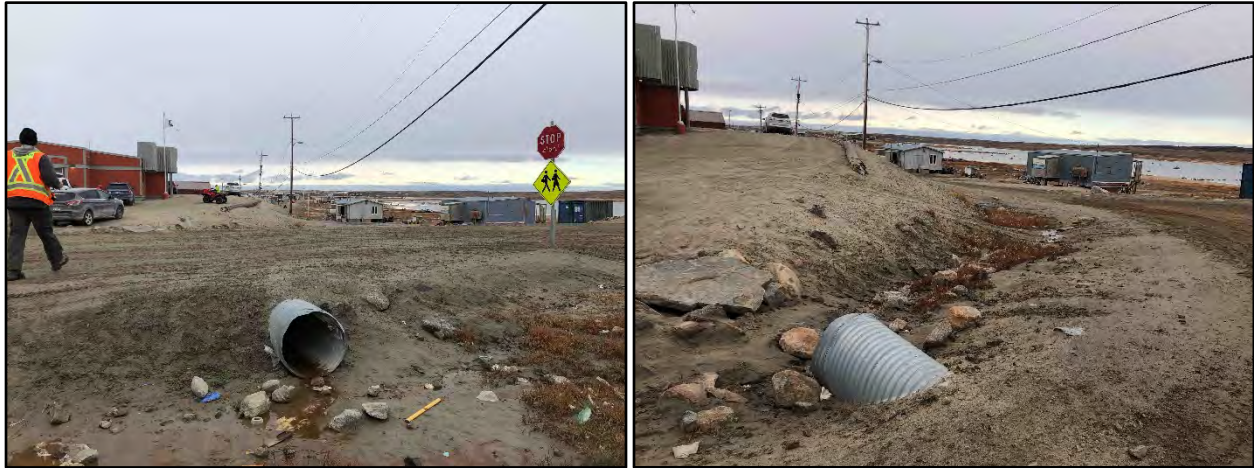
- Culvert located across road R10.
- Drainage from flow path adjacent to Quluaq school toward ditchline alongside road R10.
- Good overall condition.
- Slightly raised culvert inlet allows for ponding alongside the Quluaq school parking lot.
- **Improved ditch conditions would improve drainage between culverts C-27 and C-29.** Ditch upgraded should consist in adding fill on either side of the ditch rather than excavating below natural grade.

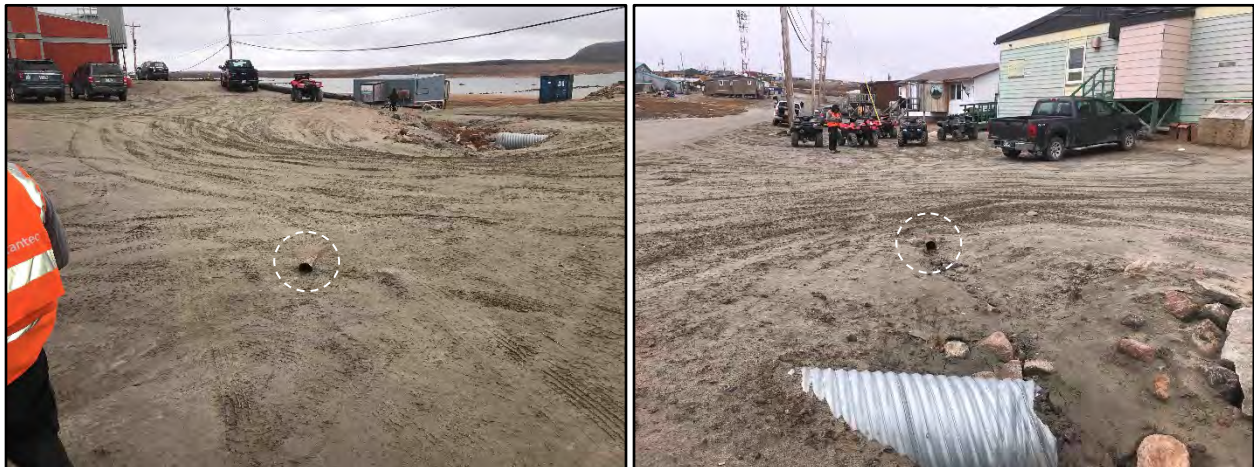
- Small culvert (< 150 mm) located across Family Resource Center driveway.
- Drainage alongside road R8 toward road R10.
- Poorly confined flow path feeding the culvert. No swale or ditch observed.
- Sedimentation observed within the culvert (<20% blockage).
- **Ditch required to facilitate drainage alongside road R8 to R10. Existing undersized culvert should be replaced. Extra culverts should be installed wherever cross-ditch access are required.**

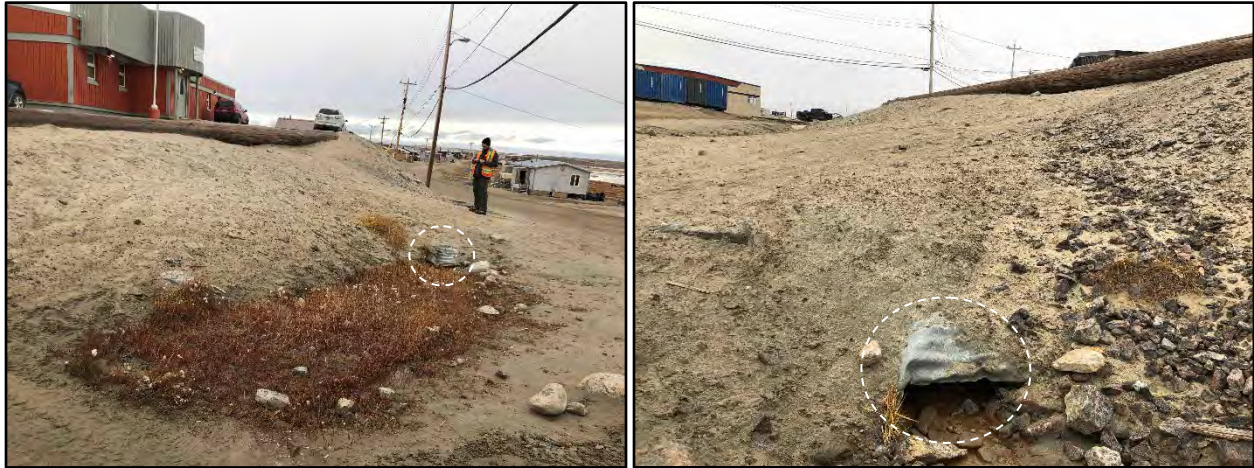
- Culvert located adjacent to the Health Care Center (alongside road R10).
- Drainage from culvert C-27 toward major flow path to Patricia Bay.
- Missing ditch and unconfined flow upstream from culvert.
- Sedimentation observed within the culvert (<20% blockage).
- Damage culvert inlet and outlet (likely from grading/snowplowing activities).
- **Ditch required to facilitate drainage alongside road R10. The culvert needs to be fixed or replaced so to allow for improved drainage.**

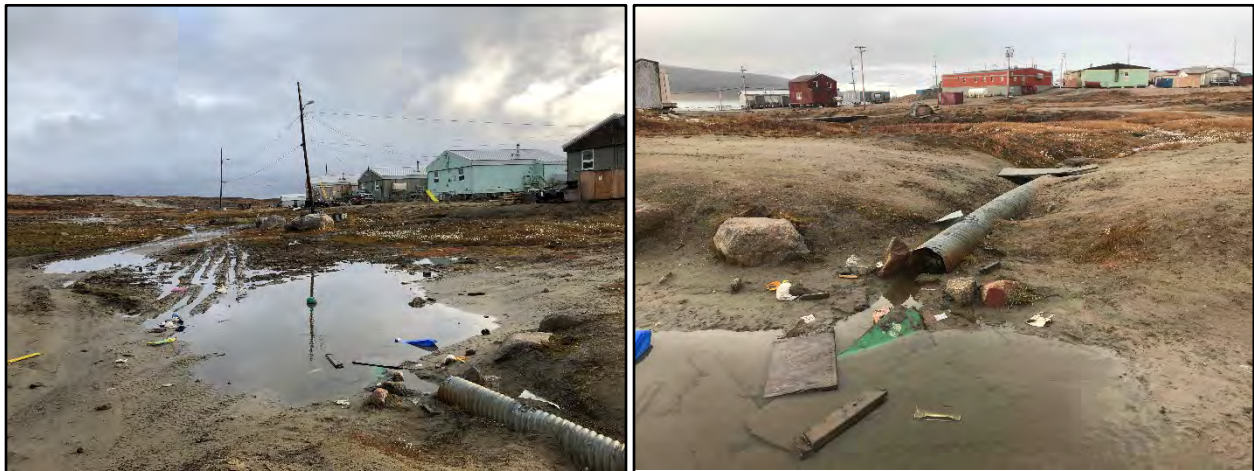
- Culvert located across the access road connecting the arena to the eastern community district.
- Drainage from the northeast toward a major flow path to Patricia Bay.
- Poorly confined flow path feeding the culvert. Water ponding observed.
- Culvert fully exposed, with surface water flowing on either side of the culvert.
- Sedimentation observed within the culvert (~10% blockage).
- Undersized culvert (300 mm) for the potential discharge during melting season.
- **Road access should either be fixed or decommissioned. Culvert needs replacement.**

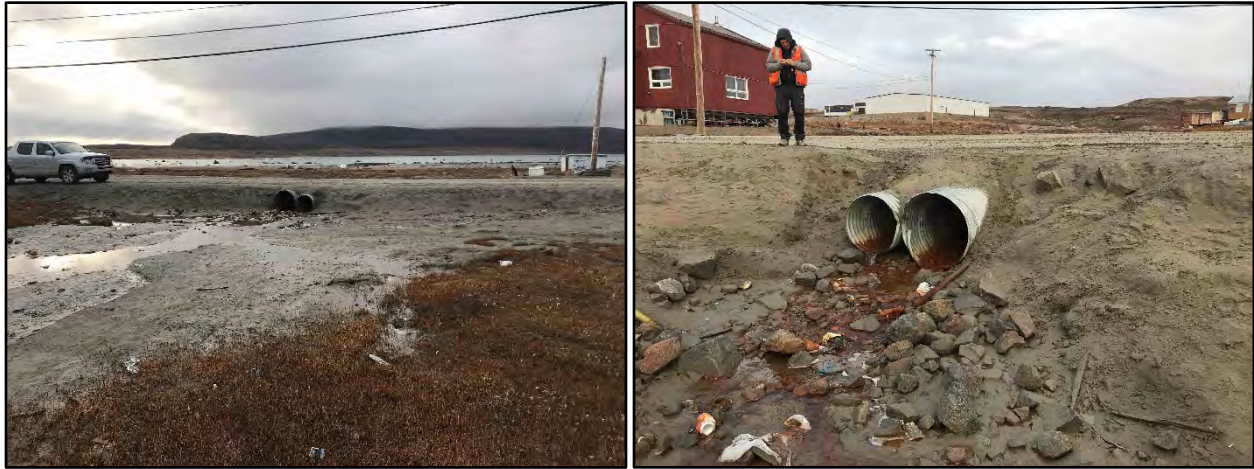
- Two culverts side by side located across road R13.
- Drainage of major flow path to Patricia Bay.
- Good overall condition.
- **Adding riprap material below the culvert outlet would minimize potential future erosion.**

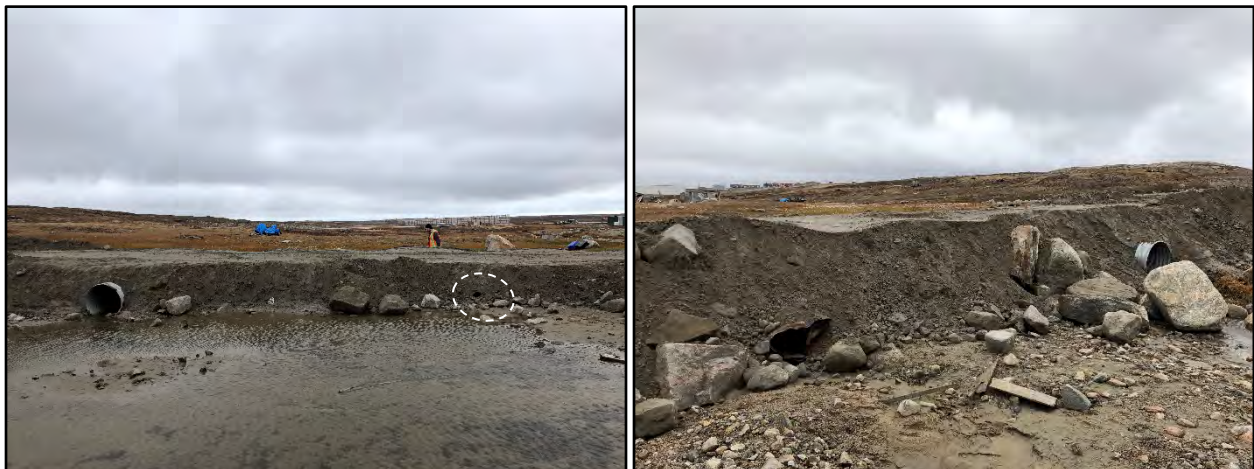
- Two culverts located across a new access road leading to a borrow pit.
- Drainage of major flow path toward the discharge area located east of the community.
- Poorly defined flow path upstream from the culvert.
- The position of the newly installed culvert is not optimal, which allows for water ponding upstream from the access road. The older culvert is partially crushed, with its inlet and outlet observed to be partially blocked by debris.
- **Road upgrade required. Replacement of damage culvert recommended.**

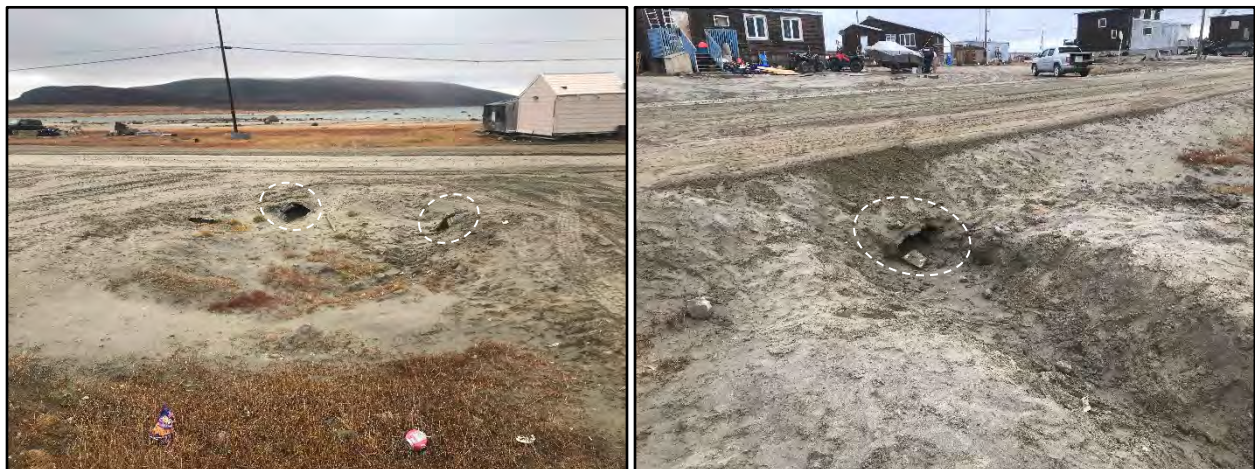
- Group of three culverts located across residential driveways and road R14.
- Drainage of runoff water from poorly drained backyard area towards Patricia Bay.
- Poorly defined ditches or swales feeding the culverts.
- Sedimentation observed within the culverts (~30% blockage).
- Damage culvert inlet and outlet (likely from grading/snowplowing activities).
- **Culvert maintenance or replacement required. A ditch should run alongside road R14, with culverts placed at driveway locations.**

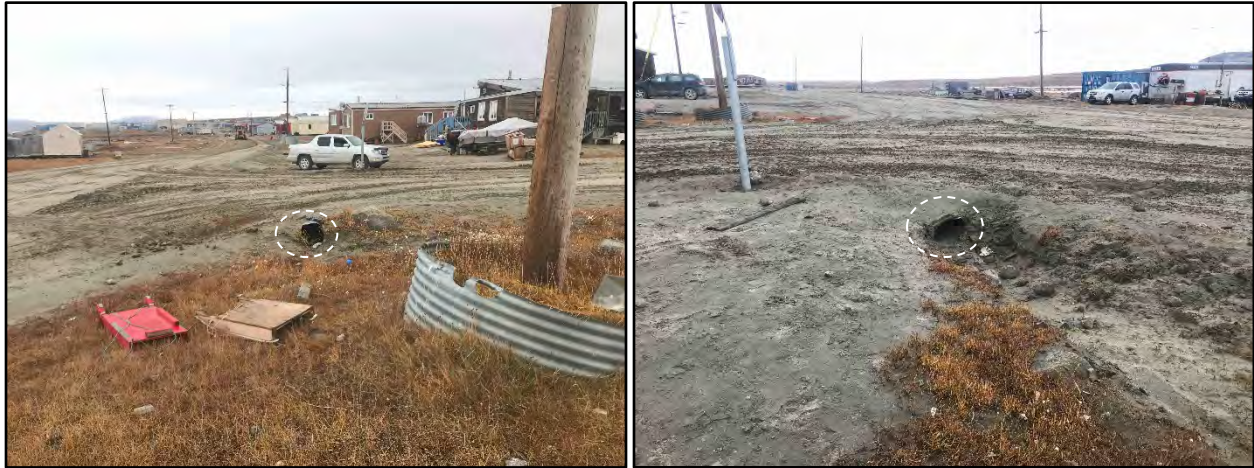
- Culvert located at the intersection of road R14 to road R16.
- Drainage of runoff water from poorly drained backyard area towards Patricia Bay.
- Poorly defined flow path upstream and downstream from the culvert.
- Sedimentation observed within the culvert (~20% blockage).
- **Culvert maintenance required. A ditch should run alongside the two roads, with culverts placed at driveway locations.**

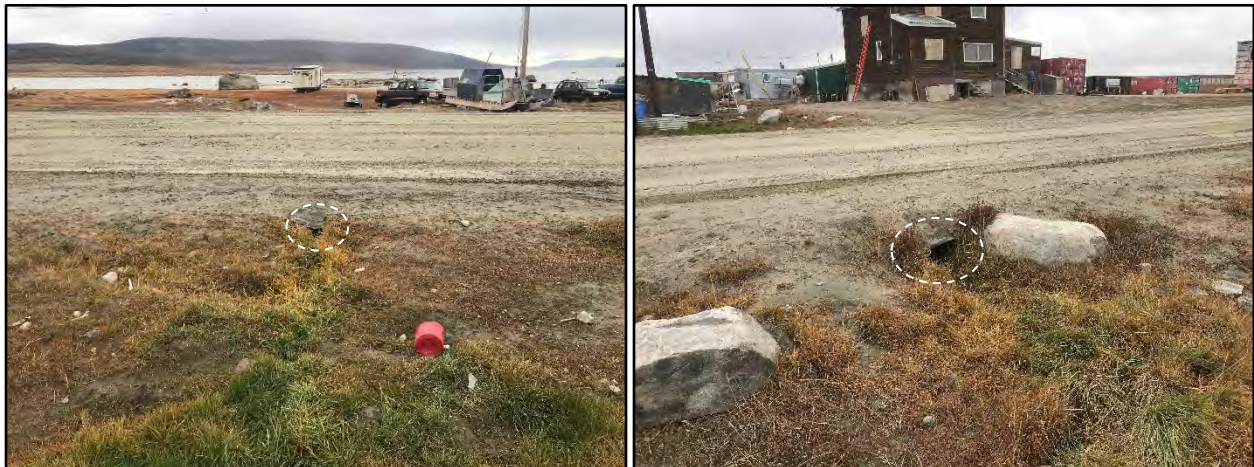
- Culvert located across road R14.
- Drainage of runoff water from poorly drained backyard area towards Patricia Bay.
- Poorly defined flow path upstream from the culvert. No ditch or swale observed.
- Sedimentation observed within the culvert (~50% blockage).
- Partially crushed culvert.
- **The flow path leading to the culvert could be improved by adding fill and directing flow into a ditch. Maintenance is required on the culvert to improve water flow.**

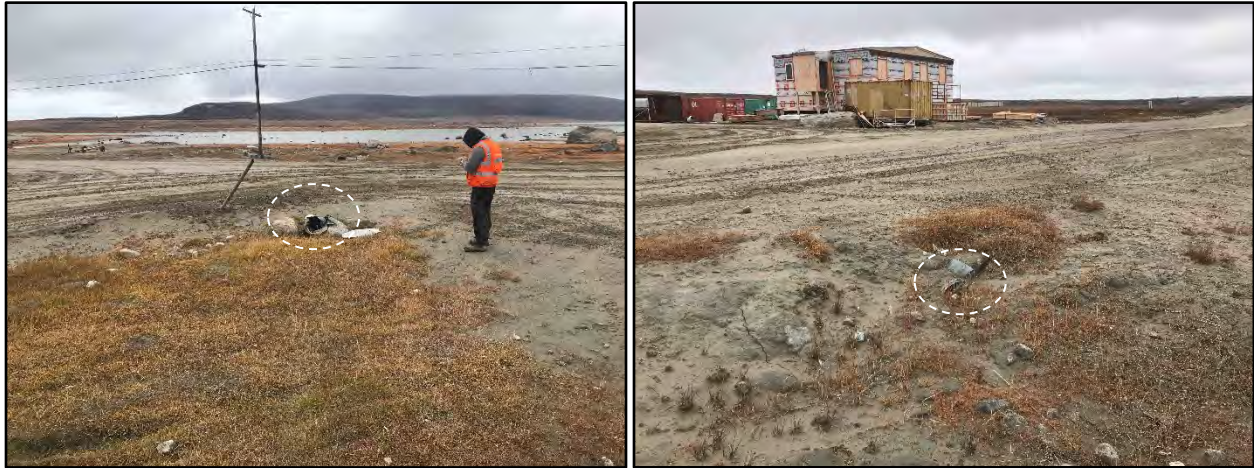
- Culvert located across road R14.
- Drainage of standing water in low lying area alongside road R14.
- Poorly defined flow path upstream from the culvert. No ditch or swale observed.
- Perched culvert inlet. Damage culvert outlet (likely from grading/snowplowing activities).
- **Adding fill alongside the road would help recontouring the area and form a shallow swale, allowing the water to better drain towards the culvert. Maintenance required on culvert.**

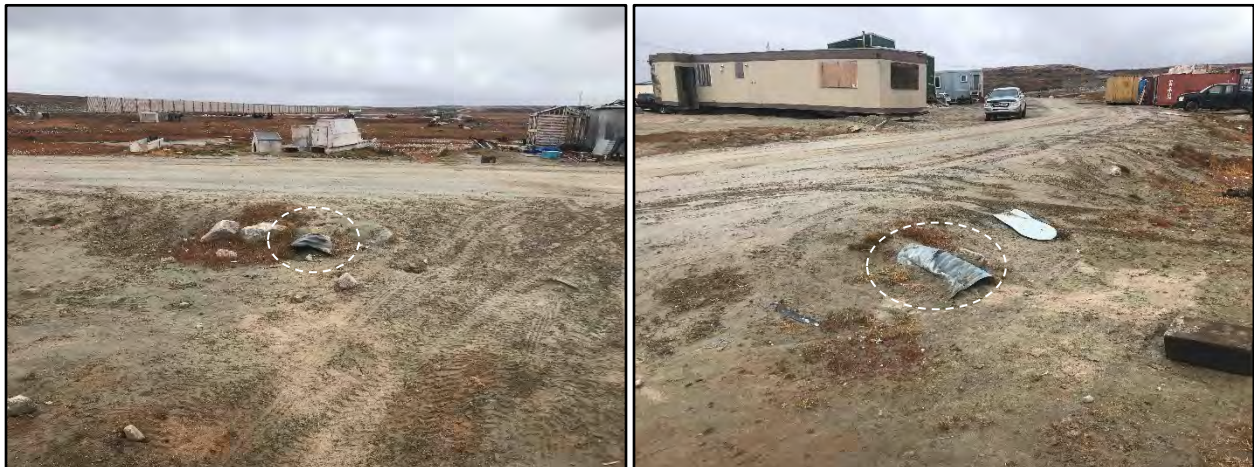
- Culvert located across road R17.
- Drainage of side road flow path toward major flow path to Patricia Bay.
- Crushed culvert inlet and outlet with partial culvert blockage by sand and silt.
- **Culvert maintenance or replacement required. A ditch should run alongside road R17, with culverts placed at driveway locations.**

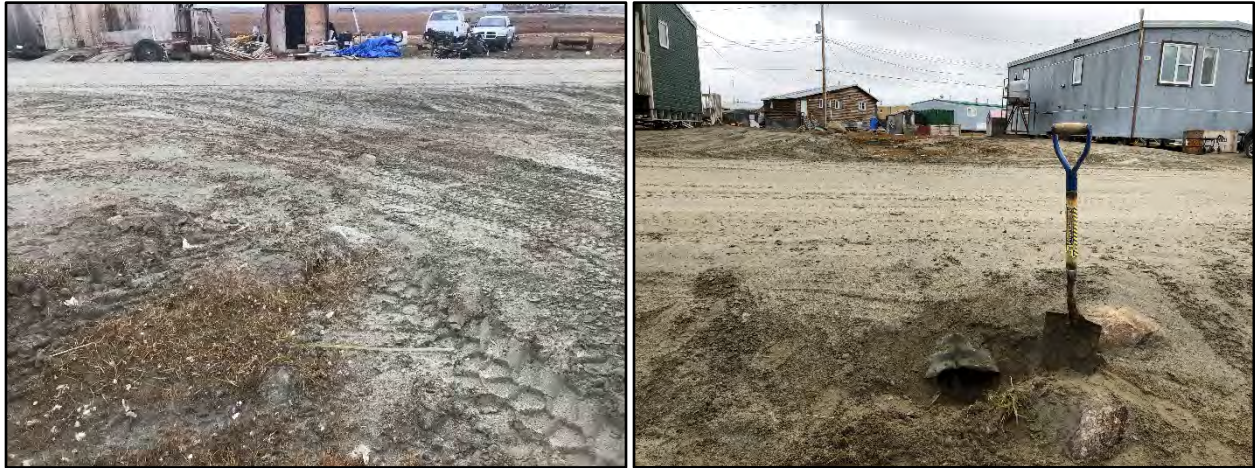
- Culvert located across road R17.
- Drainage of low-lying terrain alongside road toward major flow path to Patricia Bay.
- Poorly defined flow path upstream from culvert.
- Crushed and buried culvert inlet and outlet.
- **Culvert maintenance or replacement required. A ditch should run alongside road R17, with culverts placed at driveway locations.**

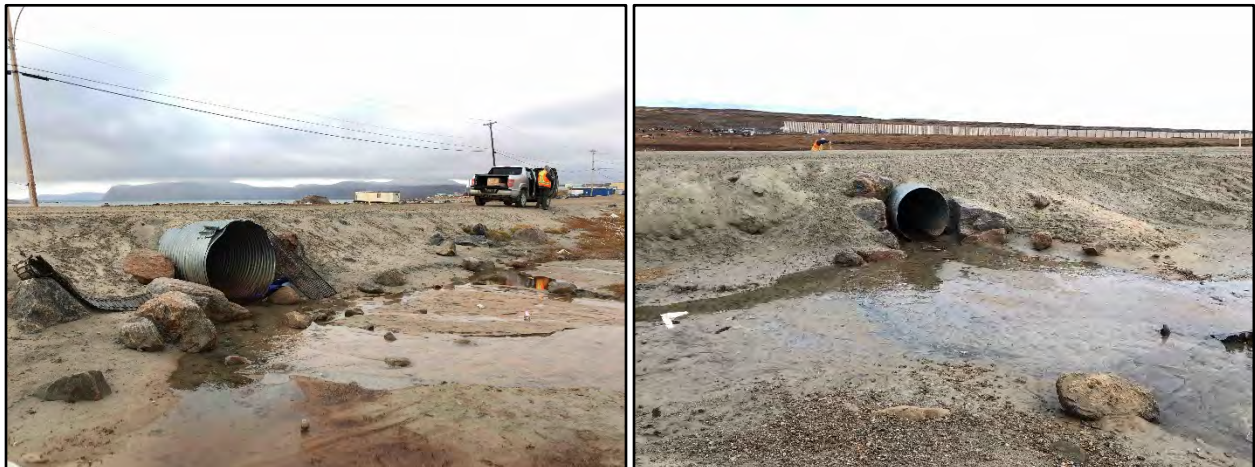
- Culvert located across road R35 to the airport.
- Drainage of major flow path toward Patricia Bay.
- Good overall condition.
- **Annual maintenance recommended.**
