**Geotechnical Investigations  
and Drainage Planning in  
Clyde River, Nunavut**

Clyde River, NU

Final Report  
REV-02

Nunami Stantec Limited

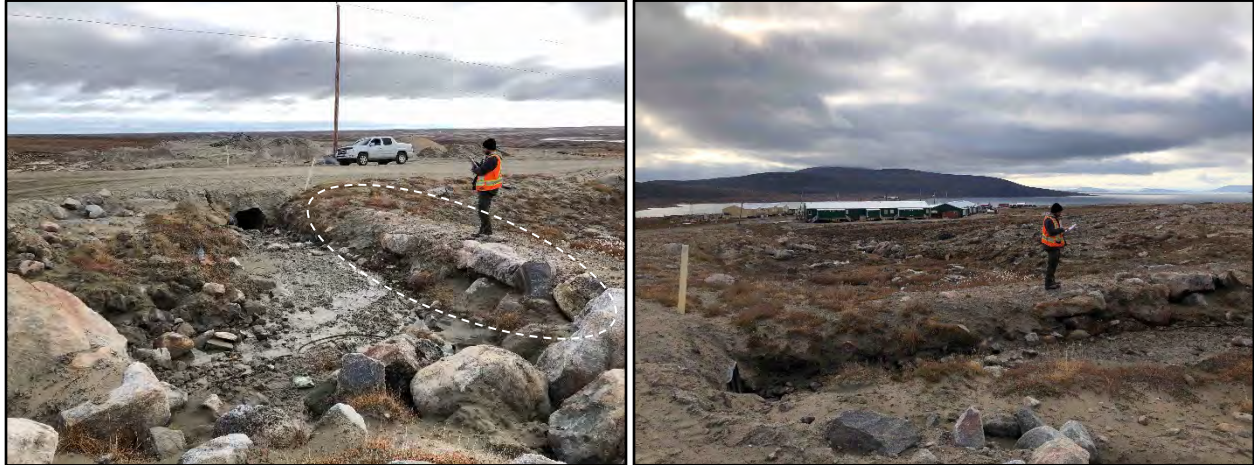
- Berm located adjacent to access road to existing borrow pit
- Berm allows to redirect surface water flow from culvert C-01 towards culvert C-02.
- Some seepage observed through the berm.
- **Material should be added to the berm consolidate the berm and limit potential seepage.**

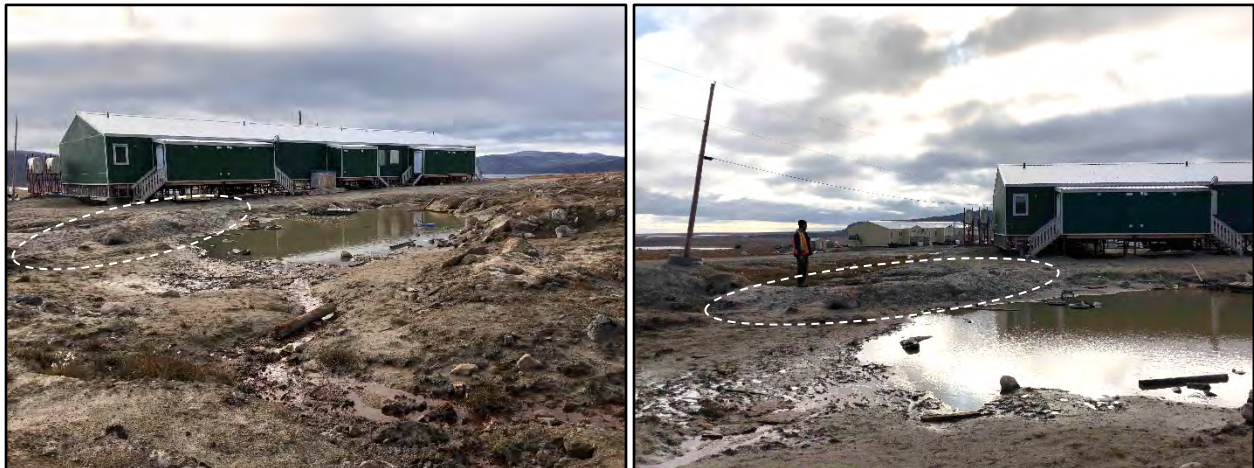
- Small berm located north of the northern district.
- Berm allows to redirect surface water flow behind the residential units rather than alongside road R27 where no ditch is present.
- Disturbed topography and poor drainage conditions leading to localized ponding.
- **Adding fill and recontouring the poorly drained area would allow for more effective drainage. If required, adding material along the berm would limit potential seepage towards road R27.**

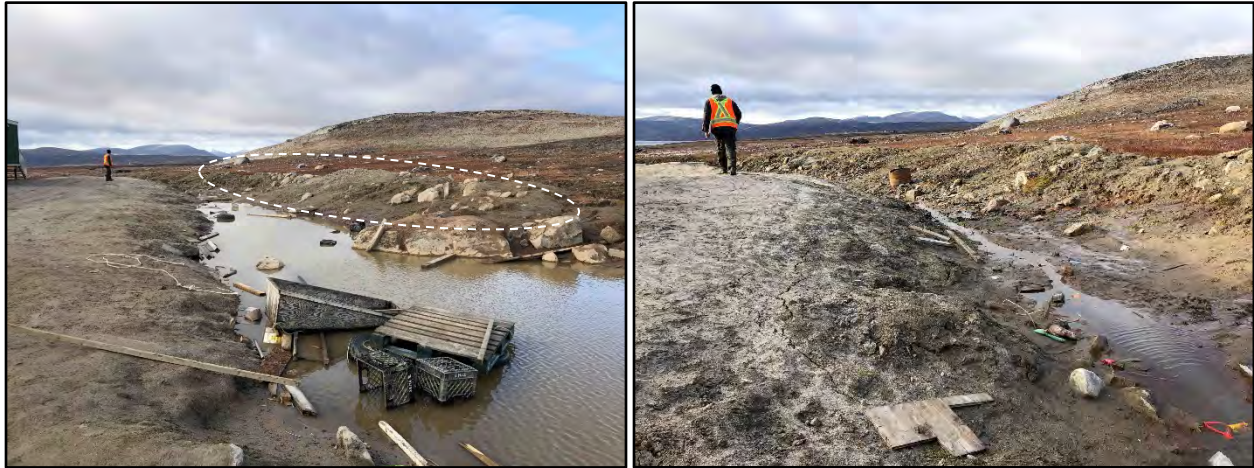
- Berm form by the placement of excavated material along a drainage ditch (see ditch D-01).
- The berm is located along the same drainage channel then berm B-02 (further downstream) and facilitates drainages away from recently constructed residential units.
- **Maintenance required.**

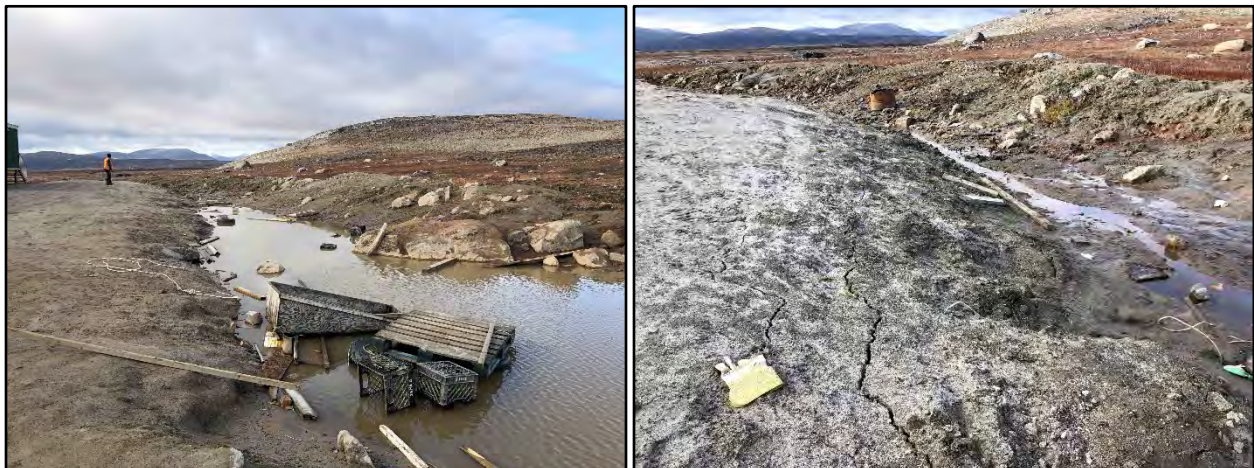
- Ditch located north of the northern district of the community (flow toward Block 2).
- Poor drainage leads to ponding upstream and downstream.
- Tension cracks observed along the southern section of the ditch.
- **Ditch needs better grading to avoid ponding which could lead to further permafrost degradation and ground subsidence.**

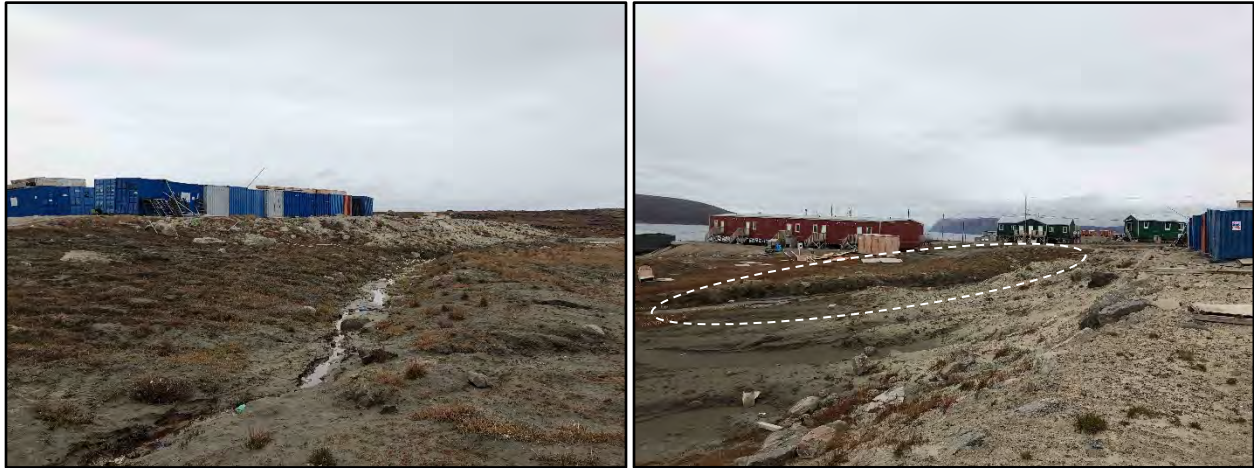
- Ditch located downslope from the housing corporation yard.
- Ditch feeds into a major drainage flow path downstream.
- Erosion and slope wash observed to have initiated along the edge of the yard.
- **Maintenance required. Adding fill would help confine the flow. Erosion control (e.g., rip rap) should be placed along the short steep slope marking the edge of the pad.**

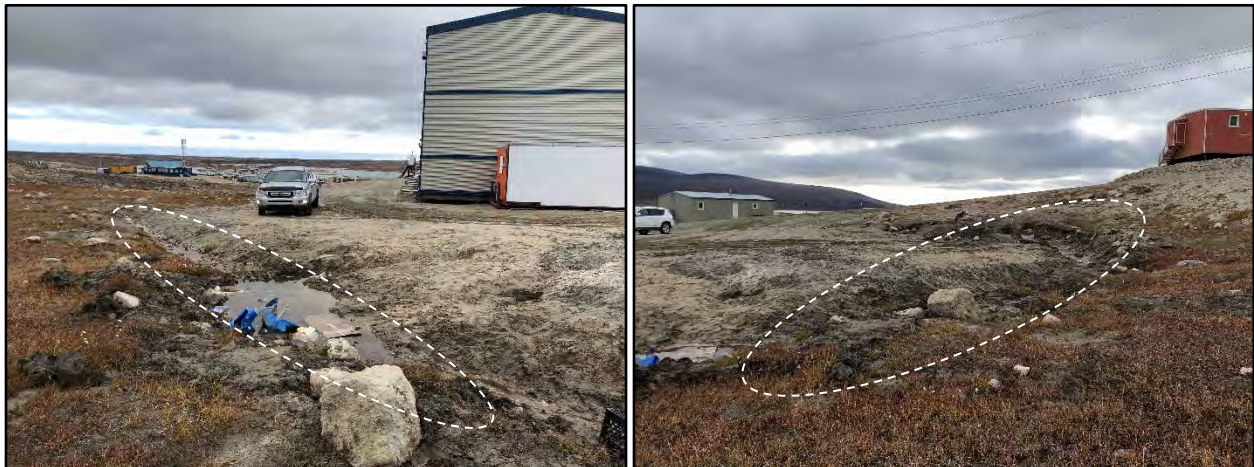
- Poorly defined ditch located across lots 246 and 247 (adjacent to road R20).
- Ditch feeds into a major stream that flows towards the sealift area.
- Poorly contoured portion of the ditch leads to water ponding. Minor erosion observed to initiate along the embankment of road R20.
- **Maintenance required. Ditch needs better grading to avoid ponding and erosion.**

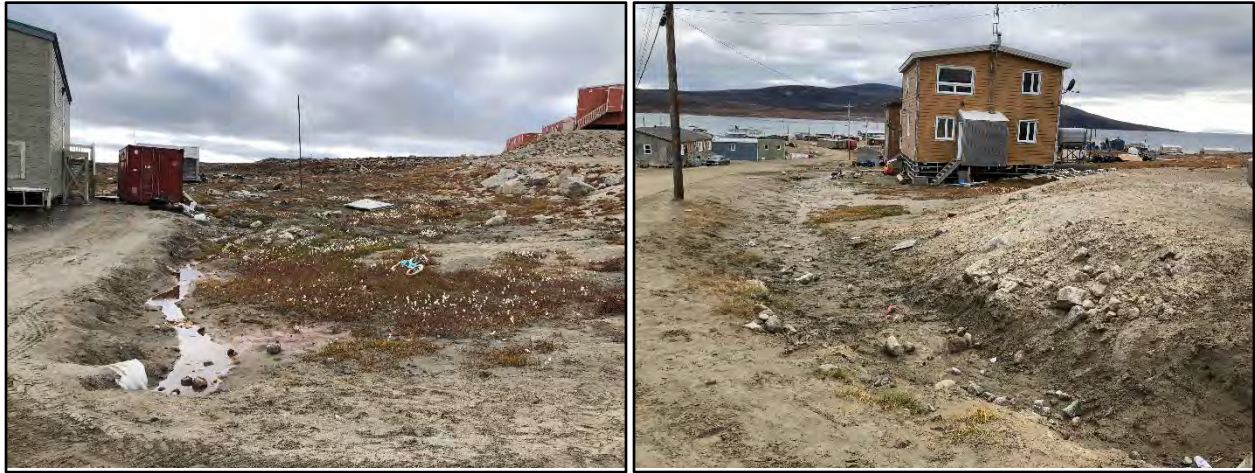
- Series of poorly defined ditch segments located alongside road R5.
- The ditch line is discontinuous, which lead to water ponding along several houses and seepage across the road.
- Some erosion and gullying observed.
- **Considerations should be given to add backfill material along the front portion of some of the residential lots in order to recontour low-lying areas and improved overall drainage.**
- **The ditch running along the west side of road R5 should be improved so to further confine water flow following snow melt and heavy rain events.**

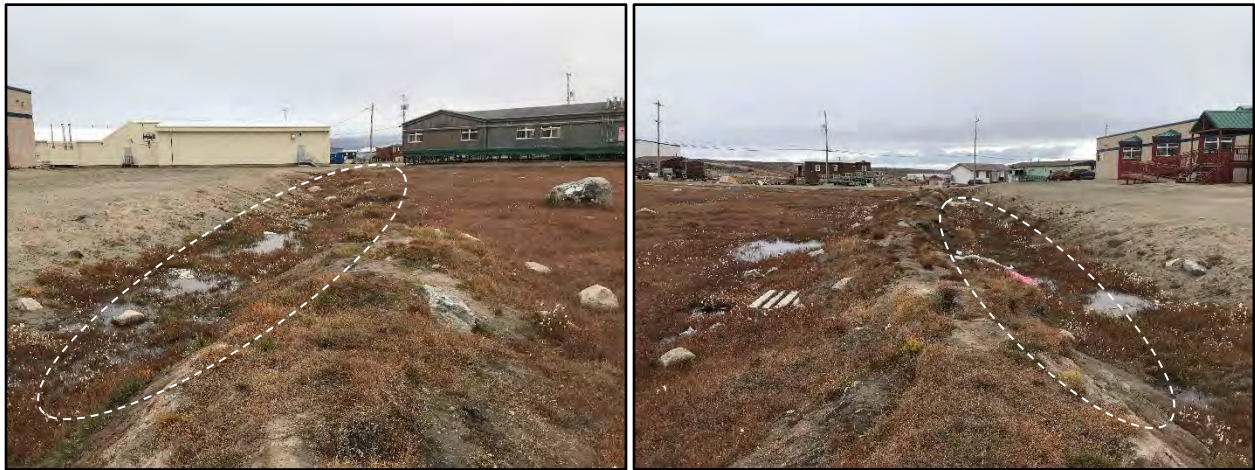
- Ditch located alongside from Quluuq school (northwest side of the building).
- Drainage from the southwest toward the northeast.
- Excavated material placed north for the ditch is acting as a berm. Water was observed to accumulated upslope from that material.
- **The improvised berm needs to be recontoured to allow for seepage water to cross into the ditch. Adjusting the grade of the ditch line would promote more efficient drainage.**

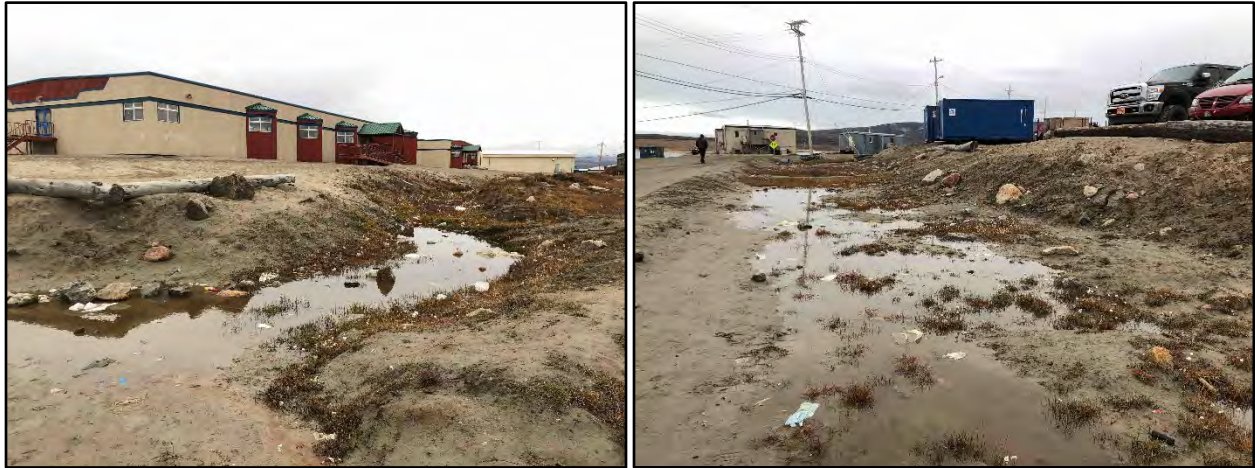
- Ditch located north from Quluaq school.
- Drainage from the southwest and northwest toward the southeast.
- Inadequate slope leading to accumulation of standing water within the ditch.
- **The overall grade of the ditch should be adjusted.**
- **Culvert C-27 located below the area of ponding water should be lowered.**

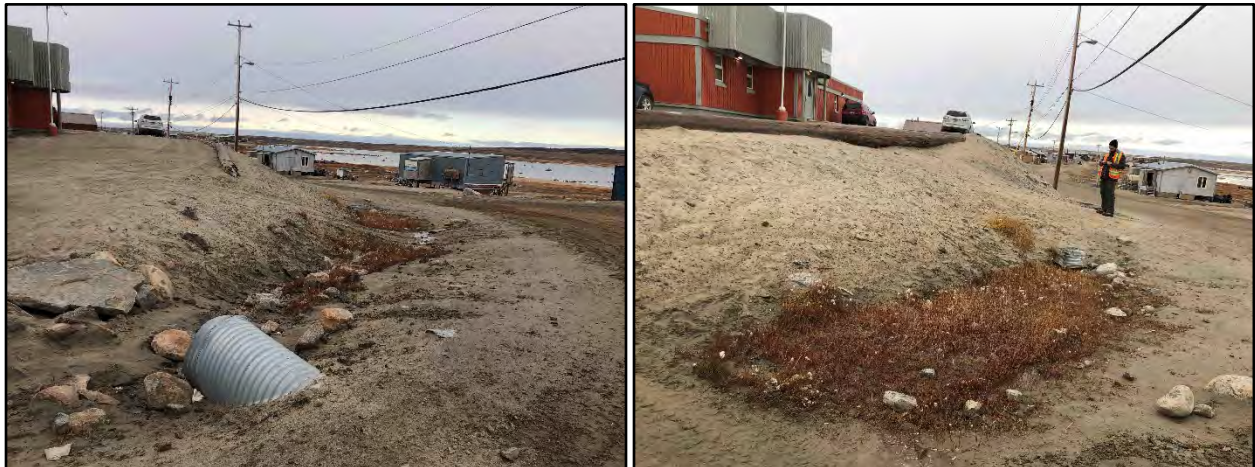
- Poorly defined ditch located alongside the Health Care Center.
- Drainage from culverts C-27 and C-28 toward culvert C-29.
- **Deepening of the ditch line would allow for a more confined flow. General maintenance required.**
