Geotechnical Investigation and Drainage Planning in Gjoa Haven, Nunavut

Gjoa Haven, NU

Final Report

September 2023

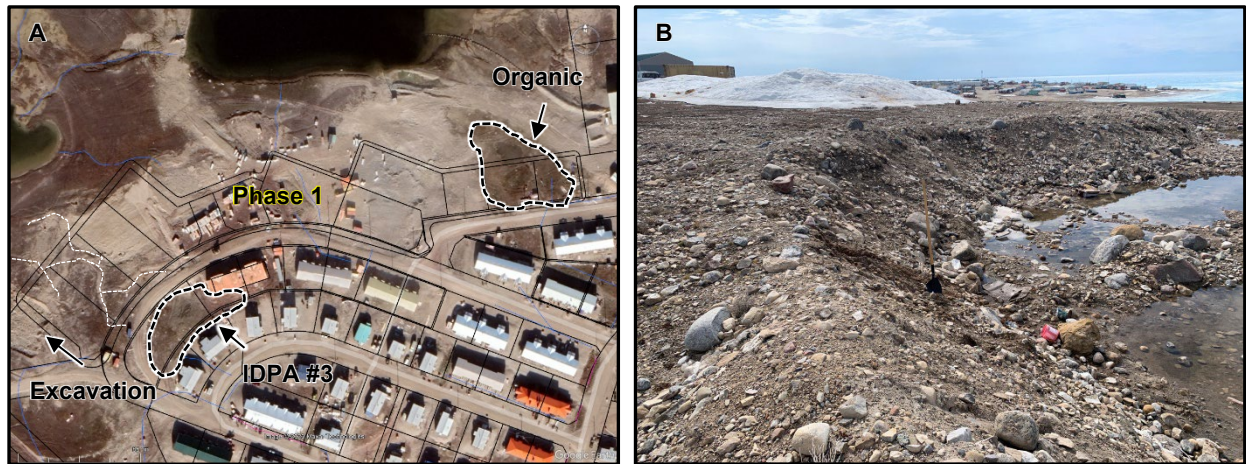
Along the eastern portion of the subdivision (below from the ridge) are soils covered with a thin organic layer (<10 cm). Drainage conditions were observed to be poor, with occasional ponding water taking place (see IDPA#3 in Section 4.3.1.2). A review of aerial imagery suggests that sparse ice wedges are present in the area.

Figure 4-1 Site Conditions Within Phase 1. A) Subdivision Overview (blue lines represent drainage flow path; white dash lines represent examples of ice wedge within Phase 1); B) Exposed Sand and Gravel from Excavation.

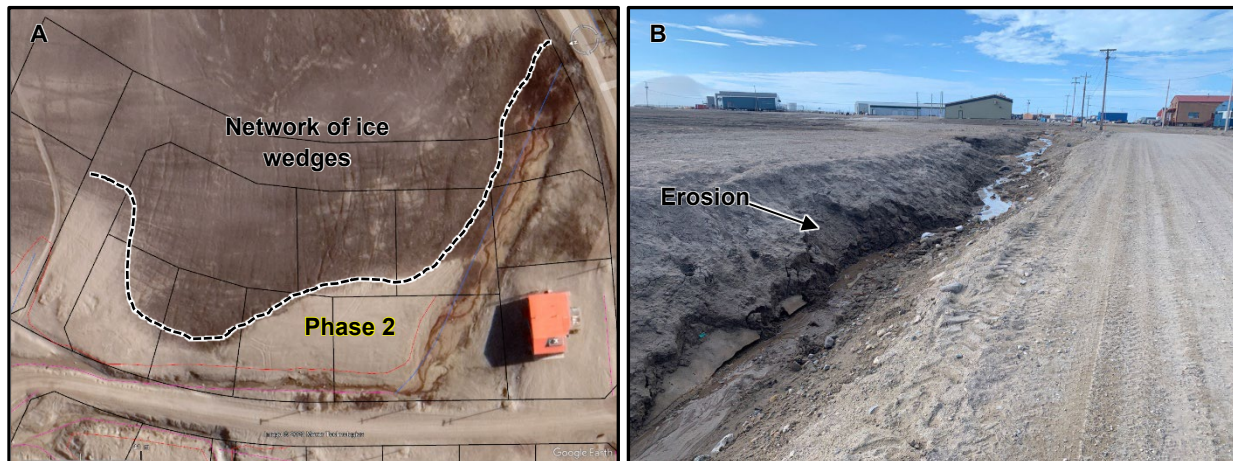
A network of ice wedges is present within this proposed subdivision. Similar polygonal networks are present in other planned future subdivisions (e.g., within Phases 4a, 5, 6, and 7).

Figure 4-2 Site Conditions Within Phase 2. A) Subdivision Overview (blue line represents drainage channel; purple line represents drainage ditch; red line represents surface erosion and gulying); B) Lateral Erosion Along the Stream.

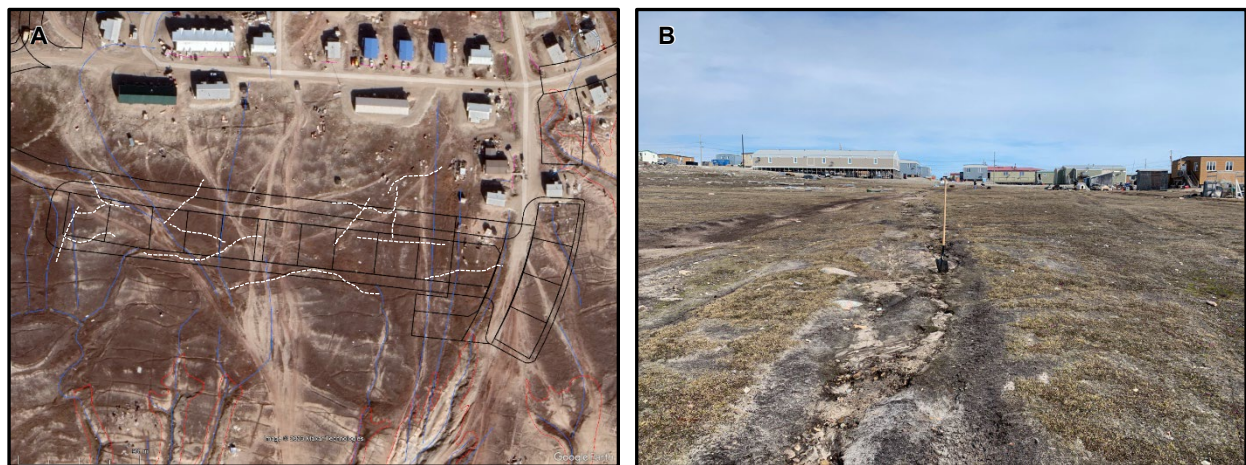
Phase 3 is located south of the northern subdivision and is facing the Peterson Bay. Slope gradients are generally under 10%. Cobbles and few boulders were observed at the ground surface. Overland flow paths initiating from the northern subdivision were observed crossing the Phase 3. Sparsely distributed ice wedges were observed within the subdivision. Surface erosion and gulying occur to the south.

Figure 4-3 Site Conditions Within Phase 2. A) Subdivision Overview (red lines represent surface erosion and gulying; blue lines represent drainage flow path; white dash lines represent examples of ice wedges); B) Overland Flow Path.

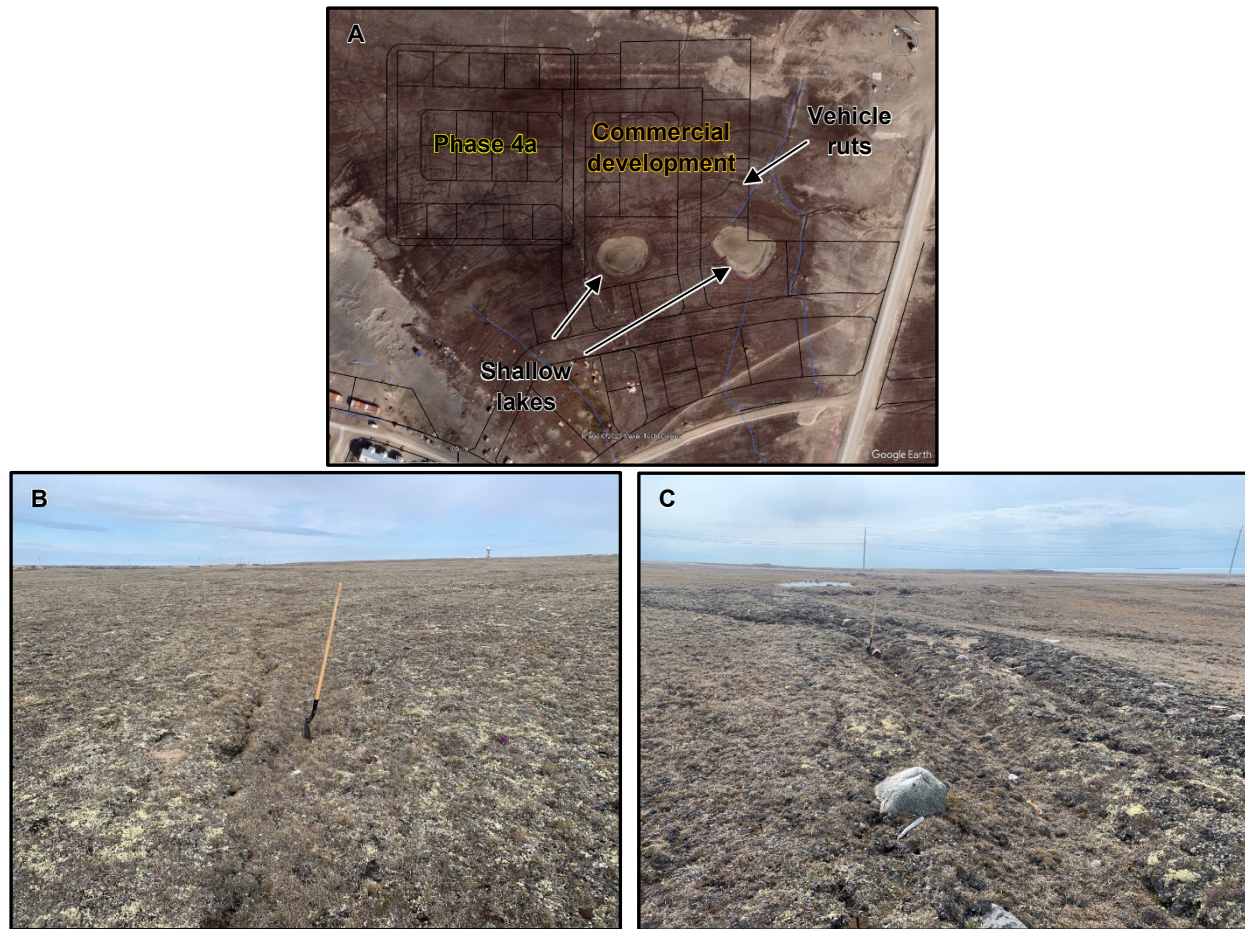
observed within the commercial development area. Vehicle ruts were observed; however, apparently not causing permafrost degradation.

Figure 4-4 Site Conditions Within Phase 4a and Adjacent Commercial Development Area. A) Overview of the Subdivisions (blue lines represent overland flow paths); C) Thermal-Contraction Crack Along an Ice Wedge; D) Ground Surface Disturbance from Vehicle Ruts.

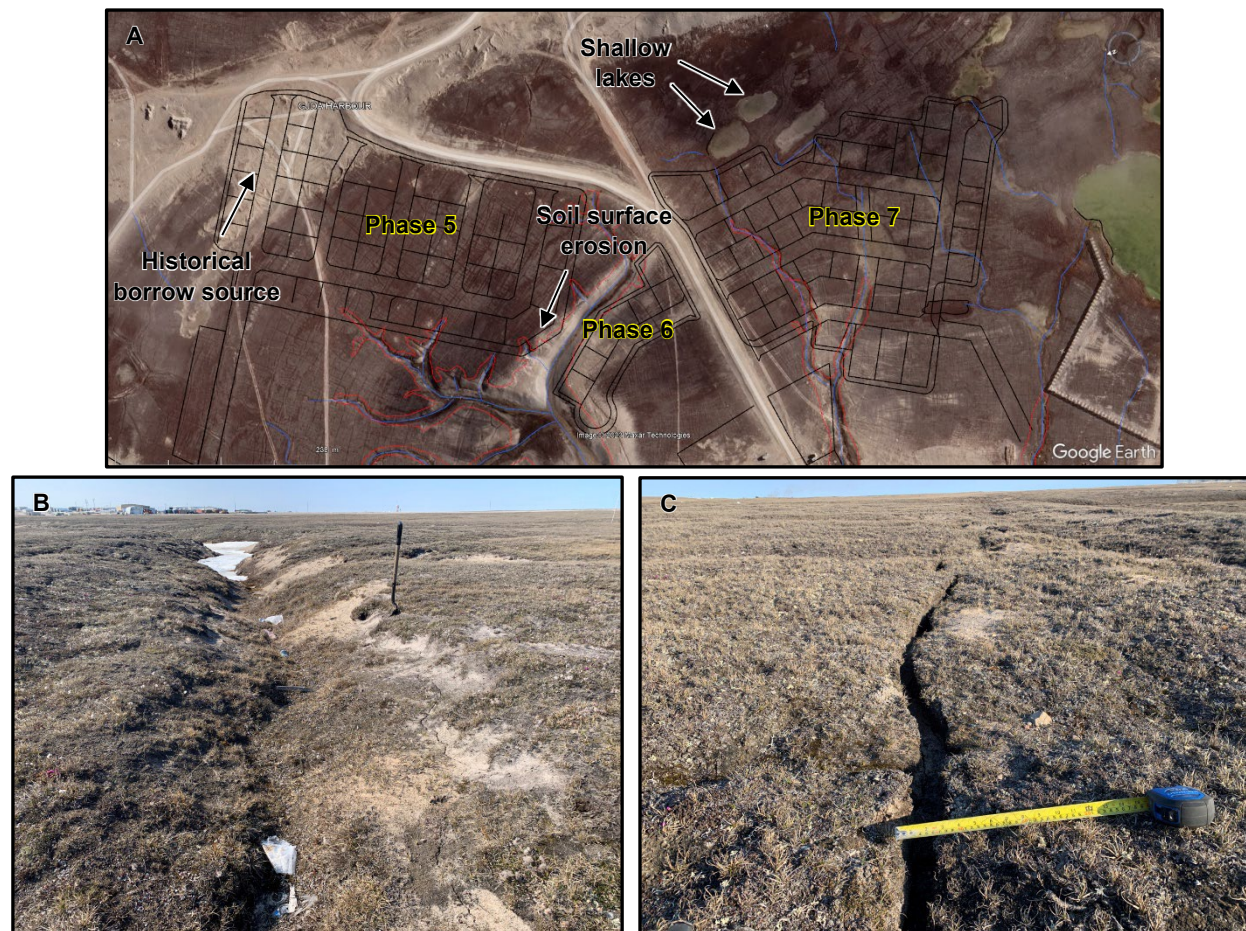
300 m long (and could be longer), and were interpreted as relatively fresh (i.e., likely occurred within the last years).

Figure 4-5 Site Conditions Within Phase 5, Phase 6 and Phase 7. A) Overview of the Subdivisions (red lines represent gully erosion; blue lines represent drainage channels and overland flow paths); B) Soil Surface Erosion and Gulying Along an Ice Wedge in Phase 5. C) 8 cm Wide Thermal-Contraction Crack in Phase 7.

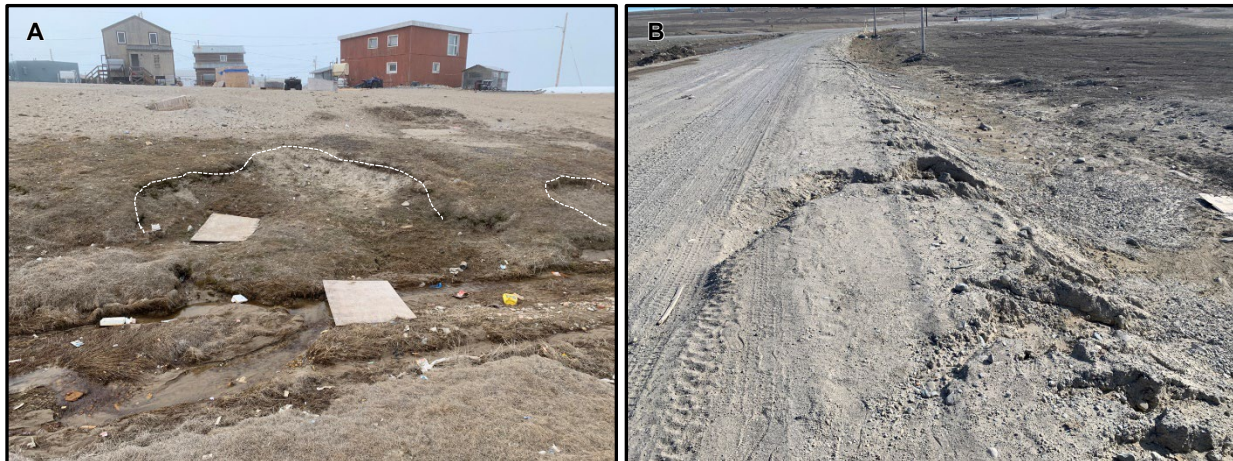
Figure 4-6 Examples of Soil Surface Erosion Observed Within the Existing Townsite. A) Erosion Scars Along the Gully that Crosses the Old Townsite (identified as white dash lines). B) Embankment Rill Erosion (IDPA #5).

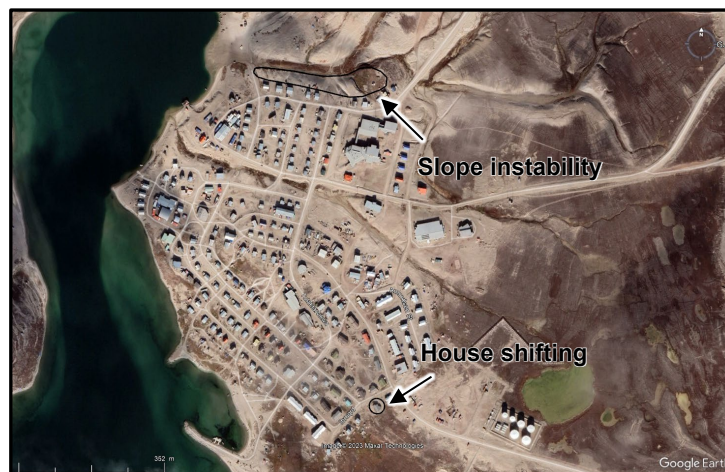
- Slope instabilities were reported along the Gullied Area in the section adjacent to the old townsite. The Gullied Area is discussed in the following Section 4.1.1.3.
- House shifting was reported south from the community. No visible sign of house shifting could be identified during field investigation. Ground settlement could be related to permafrost thaw degradation; however, other mechanisms such as improper construction and poor drainage could have caused the distress.

Figure 4-7 Other Problem Areas Identified by the Council.

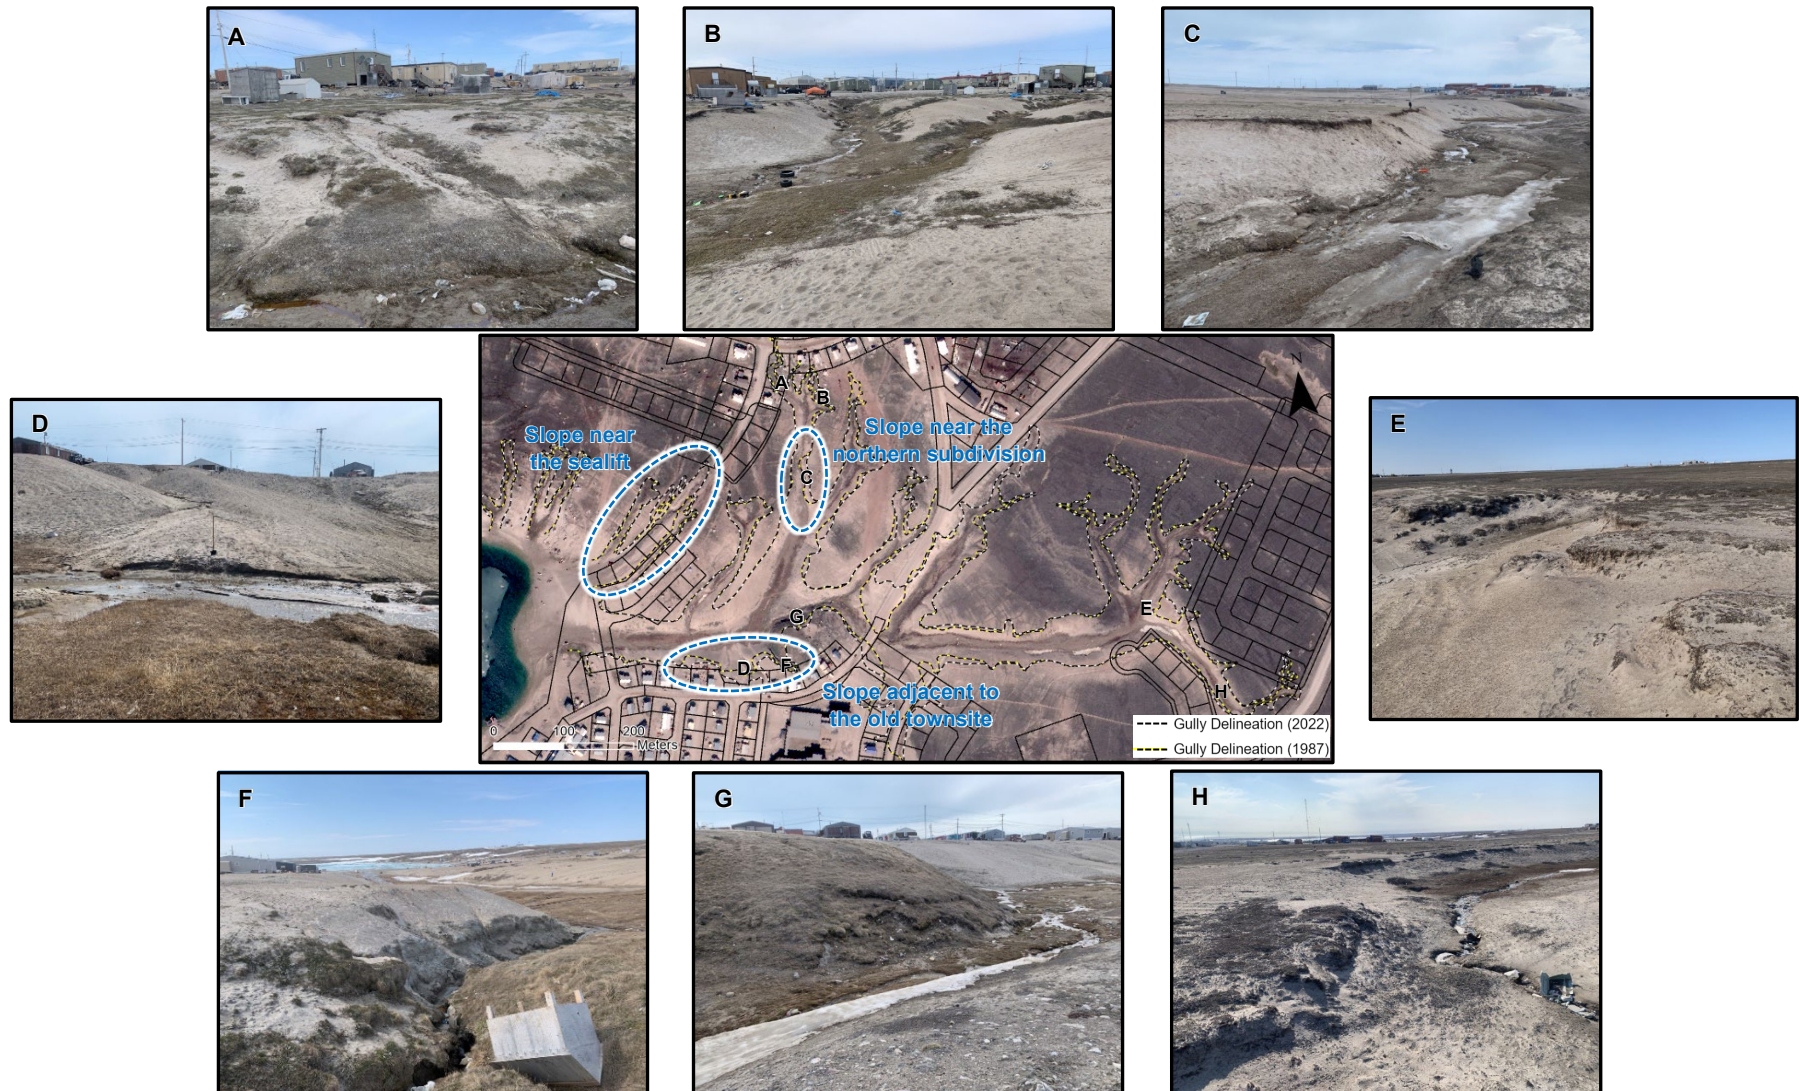
Figure 4-8 Soil Surface Erosion Observed Along the Gullied Area. Black Dash Lines Represent Areas Characterized with Higher Slope Regression Since 1987.

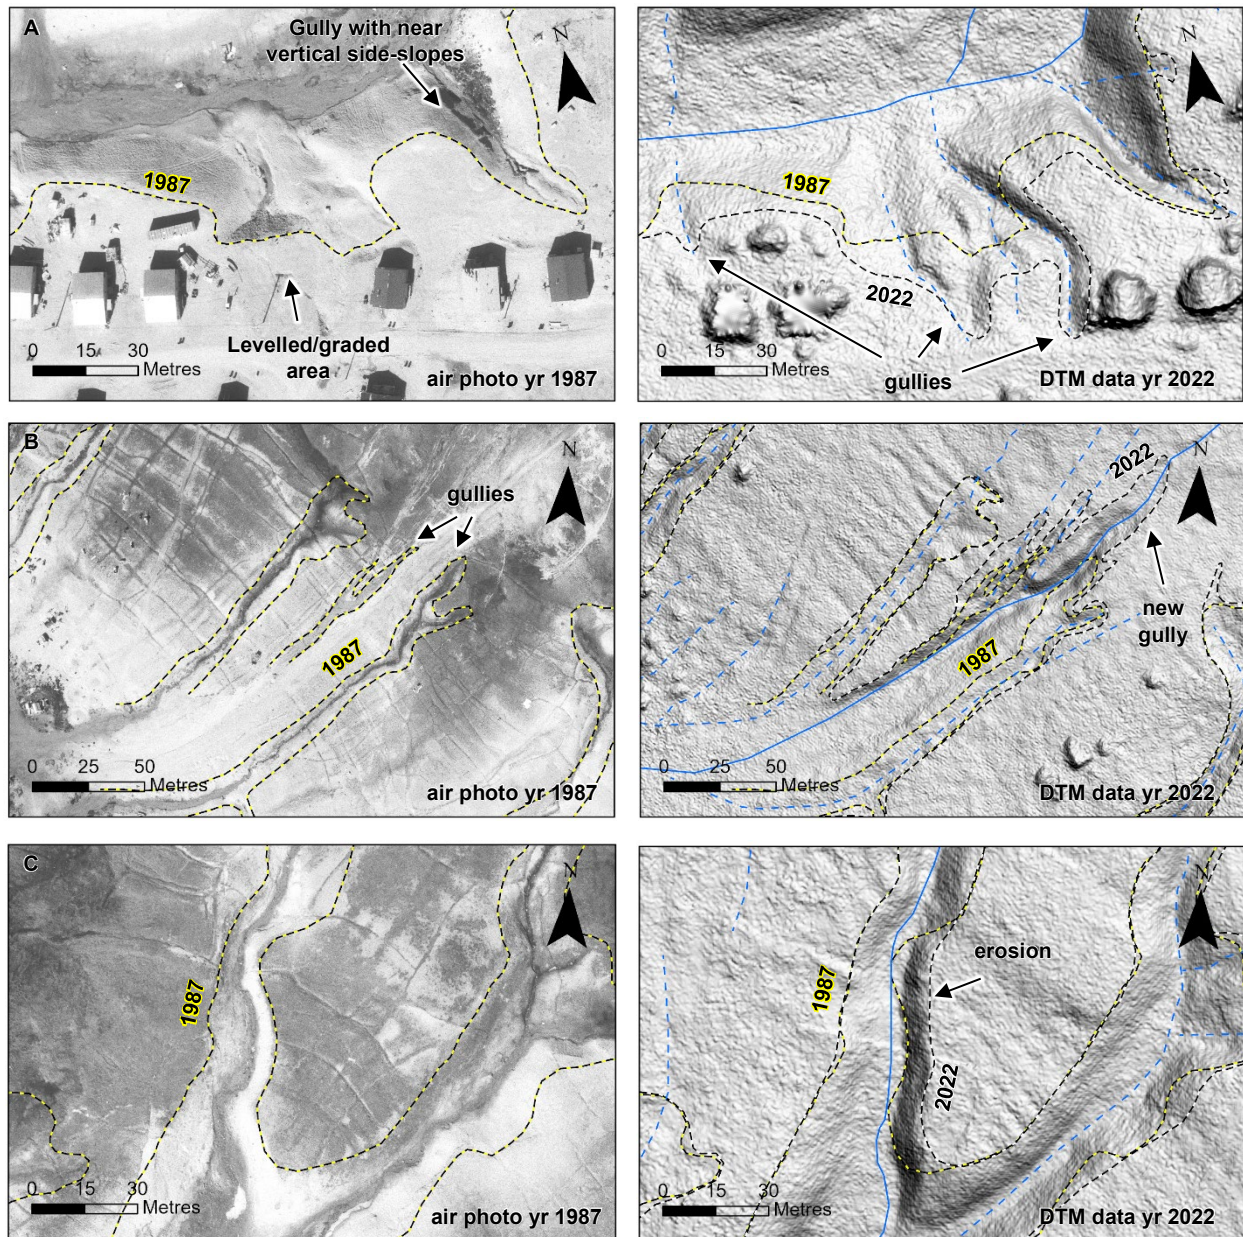
- The slope located near the sealift area (Figure 4-9b) initially consisted of two gullies that developed into one larger gully. The overall slope regression observed was up to 60 m (170 cm/yr) since 1987. The gully formed following the development of the northern subdivision, which allowed for additional water to transit within the gullies and soils to be eroded. This slope section also served as an access trail for vehicular transit between the old townsite and northern subdivision, which is believed to have accentuated the erosion process.
- The slope located south from the northern subdivision (Figure 4-9c) showed a regression up to 10 m (30 cm/yr) since 1987. The erosion occurred following the development of the northern subdivision, likely due to the increased amount of water transiting within the gully channel.

Figure 4-9 Delineation of the Gully System for the Years 1987 and 2022 (blue lines represent overland flow paths and drainage channels). A) Slope Adjacent to the Old Townsite; B) Slope Near the Sealift Area; C) Slope South From the Northern Subdivision.

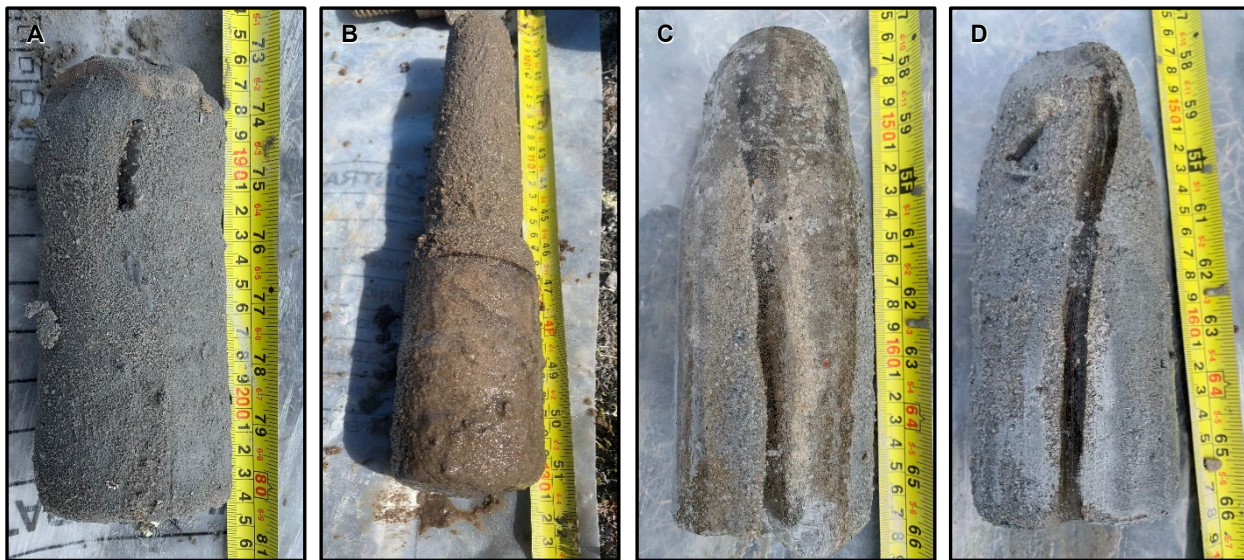
Figure 4-10 Examples of Cryostructures Observed. A) 1 cm-Thick Ice Vein (Vs) at BH22-01-DC-09 (1.9 – 2.0 m bgs); B) Ice with Soil Inclusions (I+S) at BH22-06-DC-05 (1.0 – 1.3 m bgs) Showing the Permafrost Table at 1.2 m bgs; C, D) Ice with Soil Inclusions (I+S) and 1 cm-Thick Ice Vein (Vs) at BH22-07-DC-08 (1.5 – 1.7 m bgs).
