**Geotechnical Evaluation and Drainage Planning
in Rankin Inlet, Nunavut**

Draft Report
REV-00

Prepared for:
The Municipality of Rankin Inlet

Prepared by:
Nunami Stantec Limited

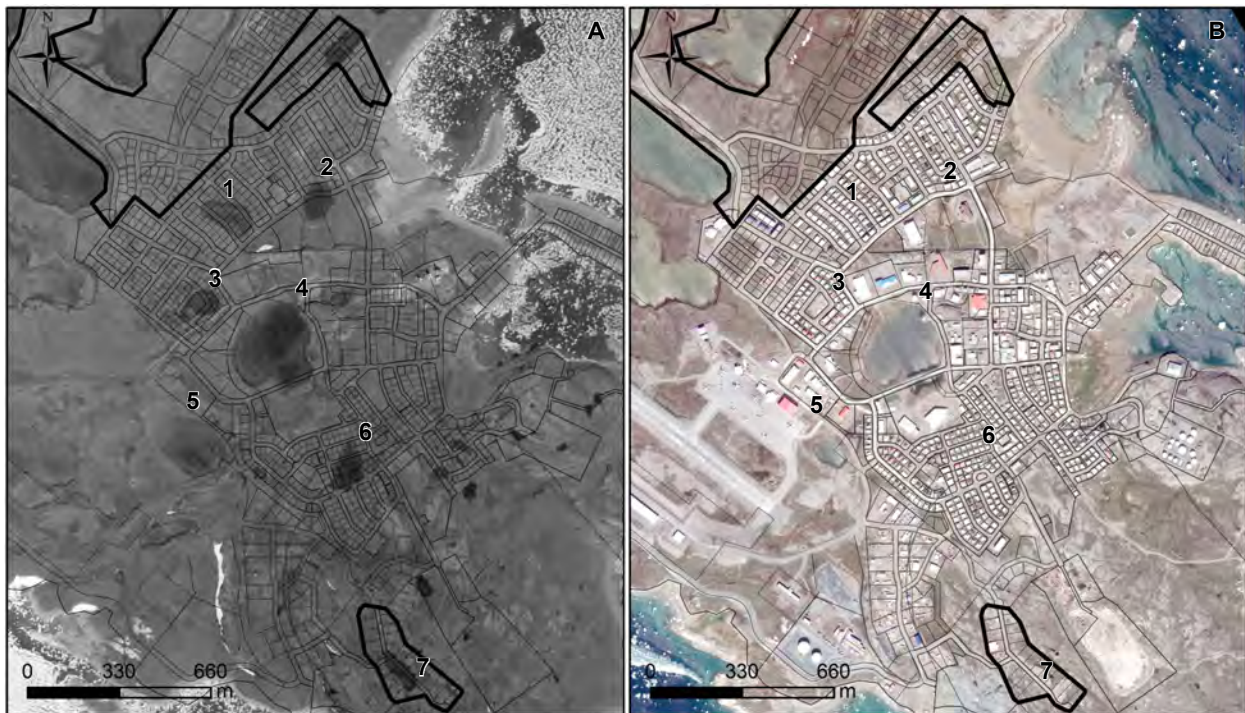
Figure 2-10 Historical Lakes and Adjacent Drainage Features. A) 1954 Historical Air Photo; B) 2019 Satellite Imagery

1. Ponding occurs in the back of houses. Ground movement causing the houses to shift shortly after construction was reported in the area (Oldenborger et al. 2016).
2. Poorly drained terrain still observed in the area.
3. Buildings in the area need levelling to adjust to ground movement (Oldenborger et al. 2016).
4. Ground movement causing damage to municipal pipe system was reported (Oldenborger et al. 2016). This section is located adjacent to the historical outlet of the lake (road appears subsided)
5. It is understood that fill in the area often needs repair.
6. Drainage problematics occur within this area.
7. Ponding occurs surrounding new pad in this area. Tension cracks observed along the road.

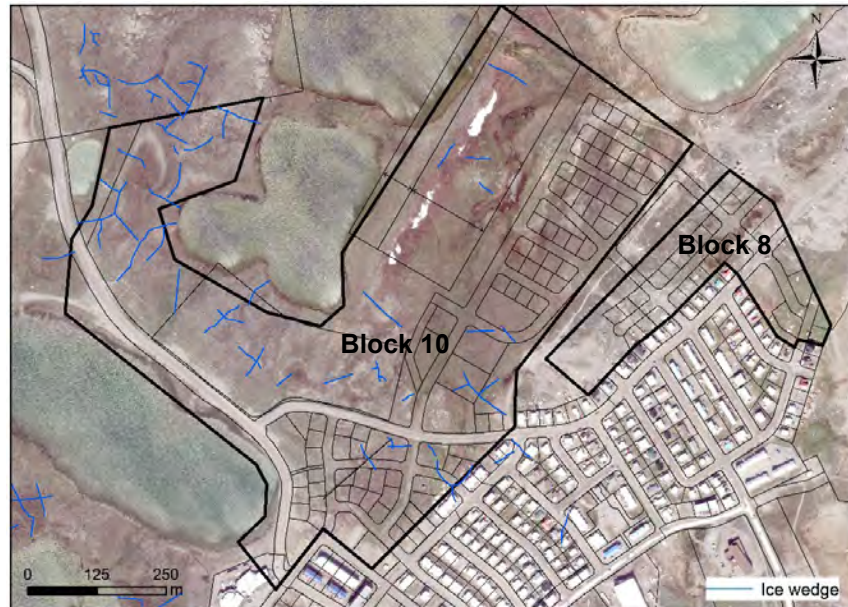
Figure 2-11 Location of Ice Wedges in Block 10 (blue lines represent ice wedges)

Ice wedges near Rankin Inlet were previously mapped by McMartin (2002). Based on the interpretation of satellite imagery and air photos, mapping of ice wedges surrounding the study area was refined as part of the present assessment. Leblanc and Oldenborger (2020) noted the presence of ice-rich permafrost in nearshore marine ice wedge polygons and in poorly drained alluvial and marine sediments. They also noted lenticular and layered cryostructures within the upper layer of till permafrost, though, the overall profile was characterized as not being ice rich.

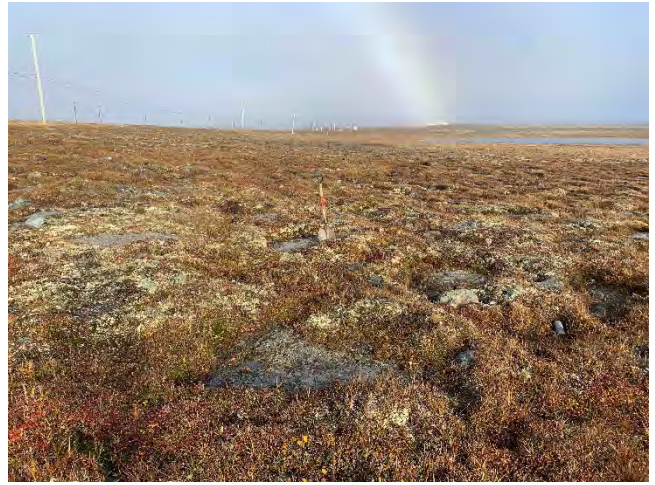
Photo 20: Frost boil that developed in marine washed till deposits within Block 10.

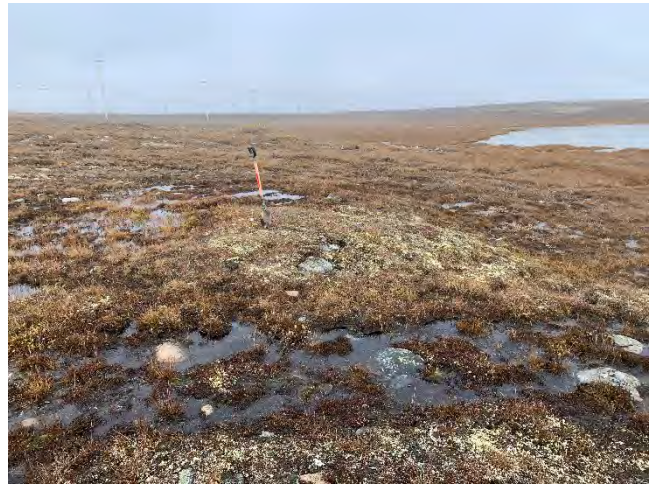
Photo 22: Solifluction lobe that developed in marine washed till deposit north of Block 10.

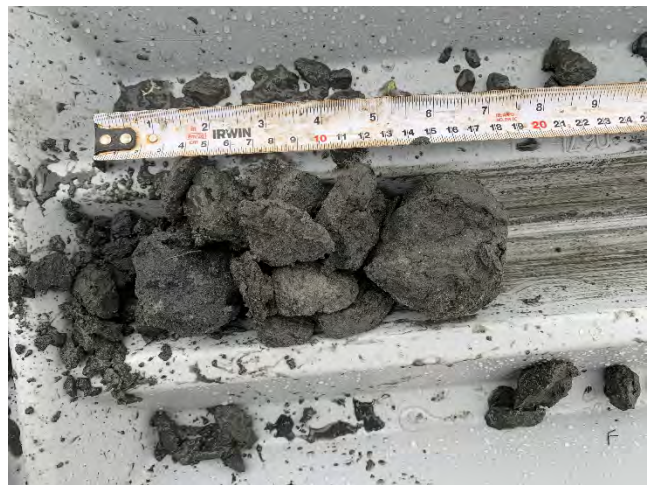
Photo 28: Photo of moderate ice content permafrost recovered at Borehole BH21-01. Includes well-bonded cryostructures with excess ice (Nbe).

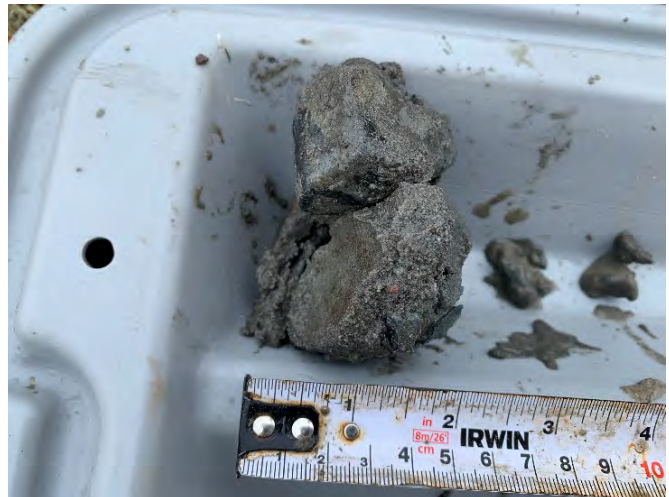
Photo 34: Photo of low ice content permafrost recovered at Borehole BH21-04. Includes well-bonded cryostructures with excess ice (Nbe).

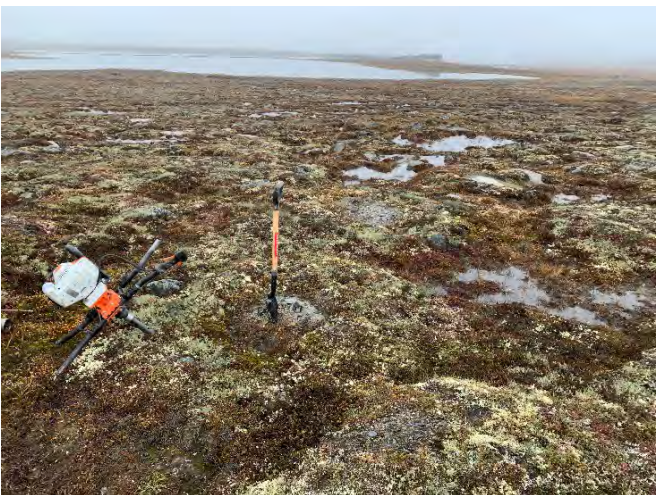
Photo 35: Location of borehole BH21-05 drilled within a frost boil.

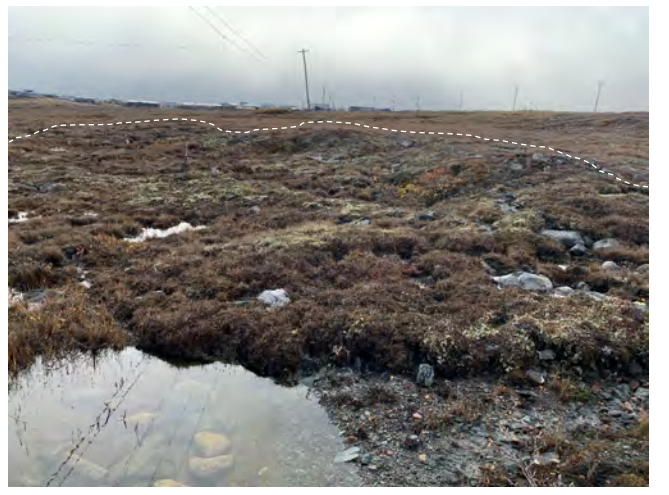
Photo 36: Potential signs of thaw degradation (tension cracks and ground subsidence) north of Block 10.

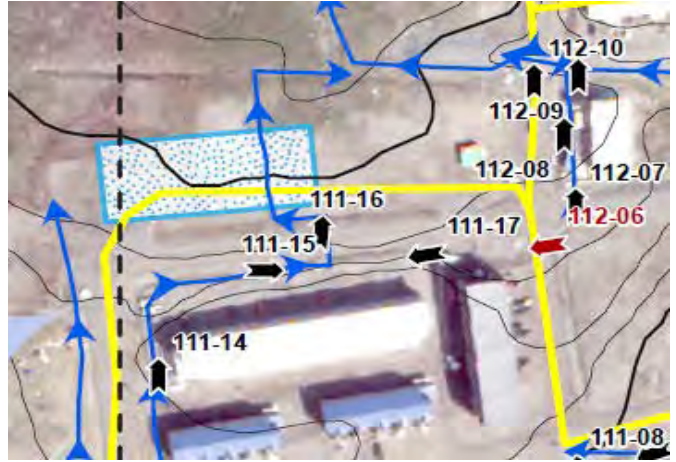
Culvert Condition Ratings (MTO 2013)				
Barrel Material (0-4)	Shape (0-4)	Capacity (0-2)	Erosion and Scour (0-2)	US/DS Channel (0-2)
1	4	2	2	1

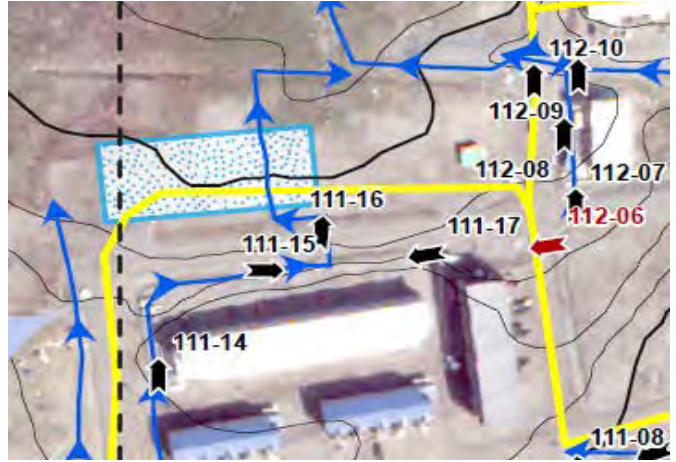
Culvert Condition Ratings (MTO 2013)				
Barrel Material (0-4)	Shape (0-4)	Capacity (0-2)	Erosion and Scour (0-2)	US/DS Channel (0-2)
1	4	2	2	1

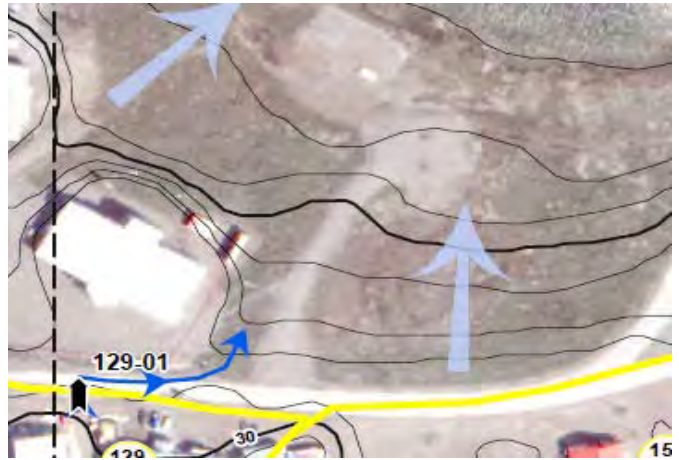
Culvert Condition Ratings (MTO 2013)				
Barrel Material (0-4)	Shape (0-4)	Capacity (0-2)	Erosion and Scour (0-2)	US/DS Channel (0-2)
0	4	2	2	2
