Drainage Report

Government of Nunavut

Final Report

Geotechnical Investigation and Drainage Planning Services in Sanikiluaq, NU

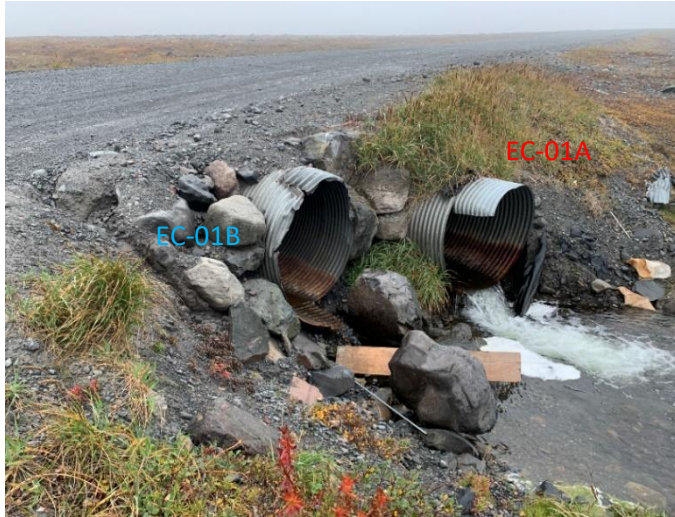
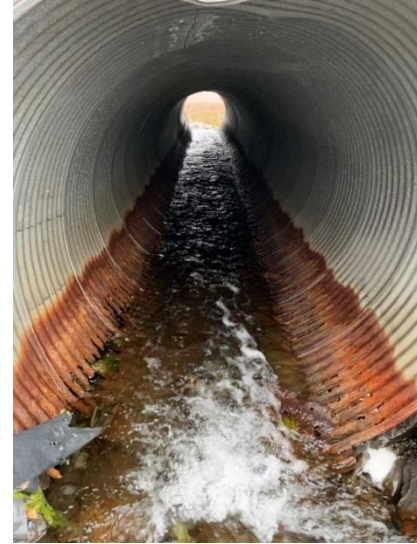
Culvert I.D.	EC-01A
Upstream / Downstream	Southeast / Northwest
Material / Size	CSP / 1500 mm
Interior Condition	Poor <ul style="list-style-type: none"> - Culvert bottom has severe rust penetration - Complete material failure
Exterior/End Condition	Poor <ul style="list-style-type: none"> - Northwest end is torn (CSP unravelling) - Northwest and southeast end do not extend far enough to protect embankment from erosion/collapse - North end is too high, resulting in creek bed erosion
Embankment Condition	Poor <ul style="list-style-type: none"> - Erosion present - Rock protection is too large and not adequate to protect bank (may also cause additional damage to culvert ends)
Ditch Conditions	Good <ul style="list-style-type: none"> - Minimal erosion present; only below outlet of culvert - Good vegetation (erosion control) along banks - Good stone bottom to protect from erosion upstream/downstream
Comments/Recommendations	Culvert is in working order and receives primary flow from creek, however, replacement is recommended due to poor interior condition. Extend new culvert sufficiently beyond toe of slope, and protect with 6" minus rip rap along embankment and creek bed.

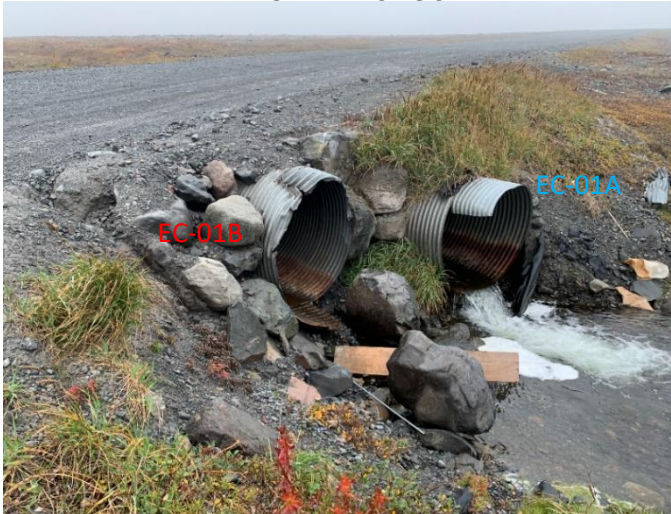
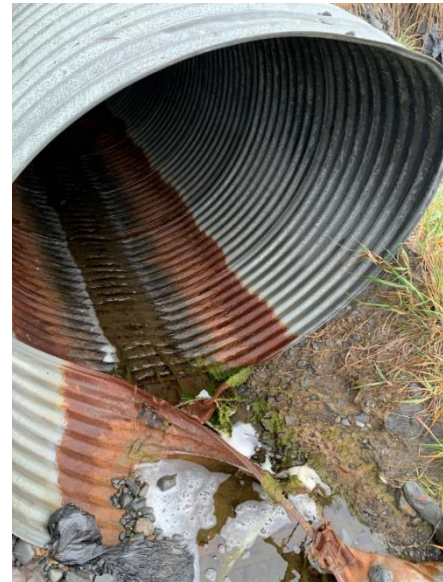
Culvert I.D.	EC-01B
Upstream / Downstream	Southeast / Northwest
Material / Size	CSP / 1500 mm
Interior Condition	Fair <ul style="list-style-type: none"> - Culvert bottom has moderate corrosion - No visible penetration
Exterior/End Condition	Poor <ul style="list-style-type: none"> - Both ends are torn/bent (CSP unravelling) - Northwest and southeast end do not extend far enough to protect embankment from erosion/collapse - Northeast end is too high, resulting in creek bed erosion
Embankment Condition	Poor <ul style="list-style-type: none"> - Erosion present - Rock protection is too large and not adequate to protect bank (may cause additional damage to culvert ends)
Ditch Conditions	Good <ul style="list-style-type: none"> - Minimal erosion present; only below outlet of culvert - Good vegetation (erosion control) along banks - Good stone bottom to protect from erosion upstream/downstream
Comments/Recommendations	Inverts are higher than EC-01A, and so culvert receives secondary flow (overflow). Interior condition is fair, however, due to EC-01A requiring replacement, EC-01B is also recommended to be replaced simultaneously for long term financial and operational benefits. Extend new culvert sufficiently beyond toe of slope, and protect with 6" minus rip rap along embankment and creek bed.

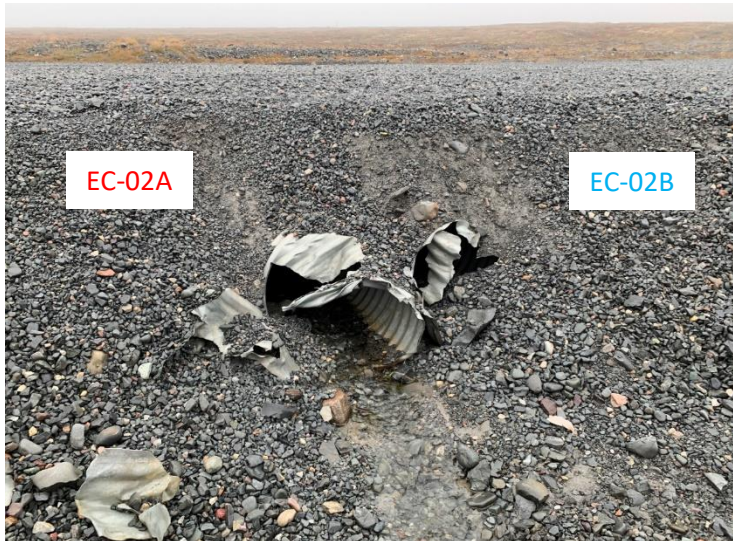
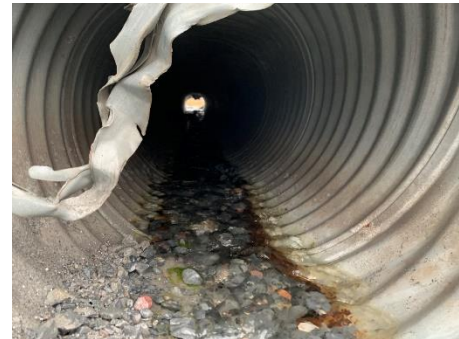
Culvert I.D.	EC-02A
Upstream / Downstream	Southeast / Northwest
Material / Size	CSP / 600 mm
Interior Condition	Fair <ul style="list-style-type: none"> - Culvert bottom has minor corrosion - No visible penetration - Good conveyance of water
Exterior/End Condition	Poor <ul style="list-style-type: none"> - Both ends are torn/damaged - Northwest and southeast end do not extend far enough to protect embankment from erosion/collapse
Embankment Condition	Poor <ul style="list-style-type: none"> - Erosion present due to minimal cover and inadequate end extension - Granular material is too small for proper erosion protection
Ditch Conditions	Poor <ul style="list-style-type: none"> - Silty material has built up near culvert inlet - No rip-rap material upstream to control sediment - Good stone bottom to protect from erosion downstream
Comments/Recommendations	Culvert appears to be inadequate size, and does not meet proper cover requirements. Culverts should be removed, and new culverts should have a minimum 900mm diameter. Invert elevations should be lowered to allow for 500-600mm of cover below road surface. Extend new culvert sufficiently beyond toe of slope, and protect with 6" minus rip rap along embankment and creek bed.

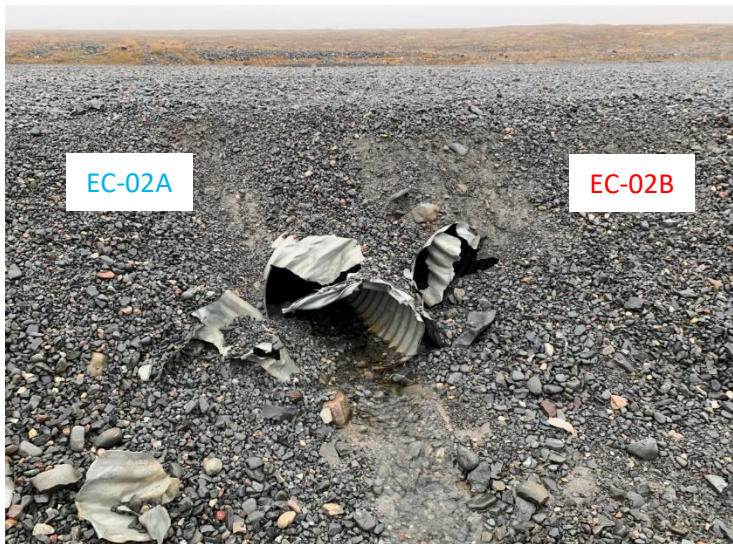
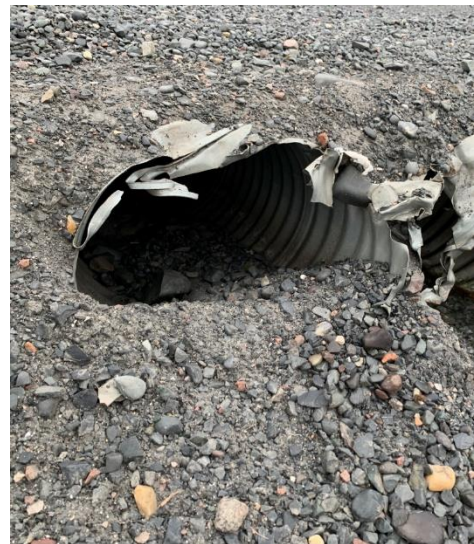
Culvert I.D.	EC-02B
Upstream / Downstream	Southeast / Northwest
Material / Size	CSP / 600 mm
Interior Condition	Poor <ul style="list-style-type: none"> - Culvert bottom has minor corrosion - No visible penetration - Lots of granular/sediment blocking flow
Exterior/End Condition	Poor <ul style="list-style-type: none"> - Both ends are torn/damaged - Northwest and southeast end do not extend far enough to protect embankment from erosion/collapse - Lots of granular/sediment blocking flow
Embankment Condition	Poor <ul style="list-style-type: none"> - Erosion present due to minimal cover and inadequate end extension - Granular material is too small for proper erosion protection
Ditch Conditions	Poor <ul style="list-style-type: none"> - Silty material has built up near culvert inlet - No rip-rap material upstream to control sediment - Good stone bottom to protect from erosion downstream
Comments/Recommendations	Culvert appears to be inadequate size, and does not meet proper cover requirements. Culverts should be removed, and new culverts should have a minimum 900mm diameter. Invert elevations should be lowered to allow for 500-600mm of cover below road surface. Extend new culvert sufficiently beyond toe of slope, and protect with 6" minus rip rap along embankment and creek bed.

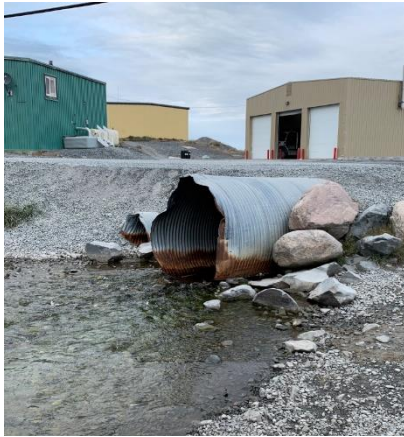
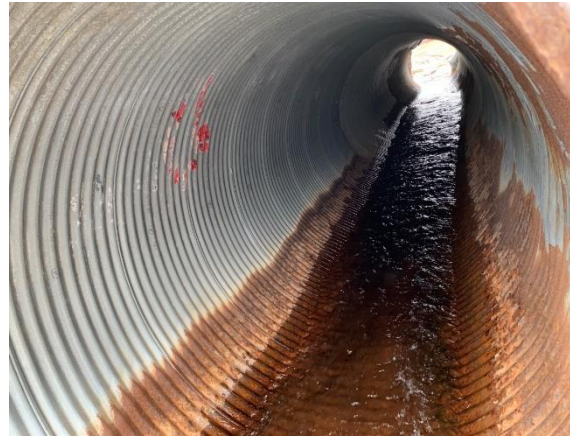
Culvert I.D.	EC-03A
Upstream / Downstream	Southwest / Northeast
Material / Size	CSP / 1800 mm
Interior Condition	Fair <ul style="list-style-type: none"> - Culvert bottom has minor corrosion - No visible penetration, and no debris/sediment
Exterior/End Condition	Fair <ul style="list-style-type: none"> - Both ends have deformation, but not significant damage/tearing - Southwest inlet extends well beyond toe of slope. Northeast outlet could be extended. - Large boulders surround ends; could cause further damage/deformation
Embankment Condition	Fair <ul style="list-style-type: none"> - Large boulders surround culvert ends, and do not adequately protect against erosion - Embankment is fairly steep
Ditch Conditions	Fair <ul style="list-style-type: none"> - Upstream could be channelized to reduce spread of flow (reduce chance of ice buildup in the winter) - Good stone bottom to protect from erosion upstream and downstream - Outlet could be built up with rip-rap to protect against further erosion

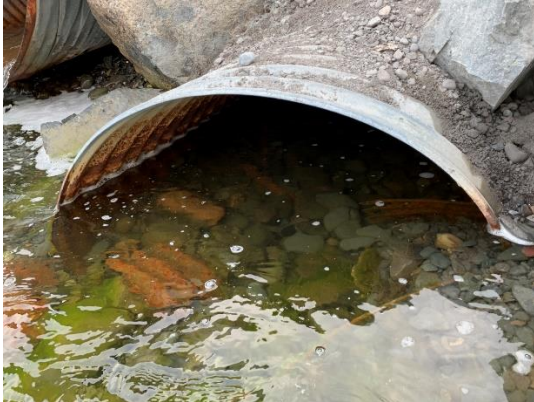
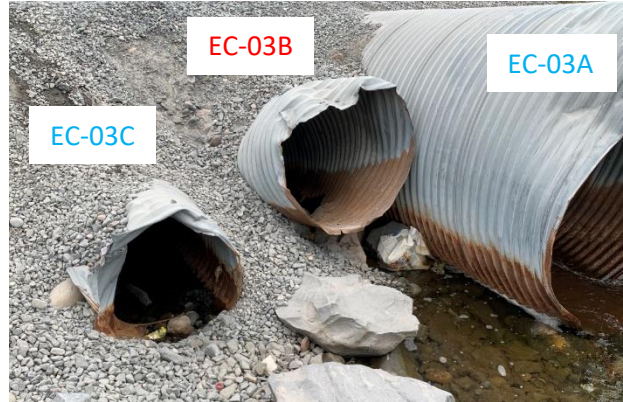
Culvert I.D.	EC-03B
Upstream / Downstream	Southwest / Northeast
Material / Size	CSP / 750 mm
Interior Condition	Poor <ul style="list-style-type: none"> - Appears to be collapsed / full of debris - Corrosion penetration / material failure
Exterior/End Condition	Poor <ul style="list-style-type: none"> - Appears to be out of place; southwest inlet has been pulled up out of position
Embankment Condition	NA (See EC-03A)
Ditch Conditions	NA (See EC-03A)
Comments/Recommendations	Culvert has completely failed and appears to be collapsed/full of debris. Due its size compared to EC-03A, this culvert does not appear to be required for regular flow rates. Replacement is recommended if culvert EC-03A is ever replaced in the future.

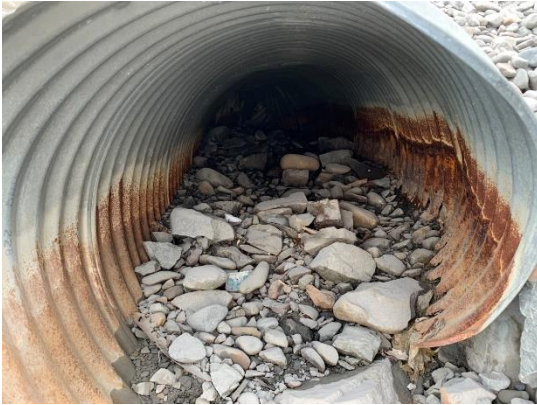
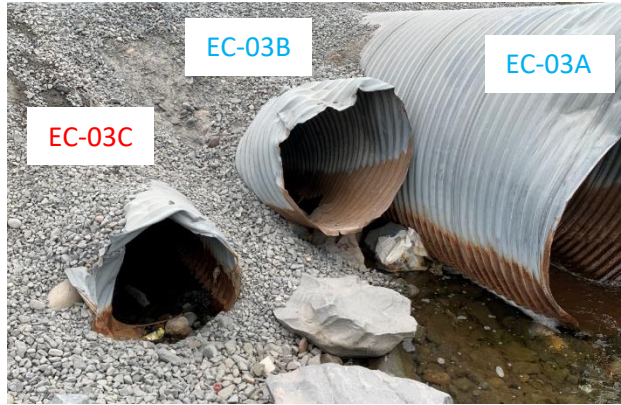
Culvert I.D.	EC-03C
Upstream / Downstream	Southwest / Northeast
Material / Size	CSP / 750 mm
Interior Condition	Poor <ul style="list-style-type: none"> - Appears to be collapsed / full of debris - Corrosion penetration / material failure
Exterior/End Condition	Poor
Embankment Condition	NA (See EC-03A)
Ditch Conditions	NA (See EC-03A)
Comments/Recommendations	Culvert has completely failed and appears to be collapsed/full of debris. Due its size compared to EC-03A, this culvert does not appear to be required for regular flow rates. Replacement is recommended if culvert EC-03A is ever replaced in the future.

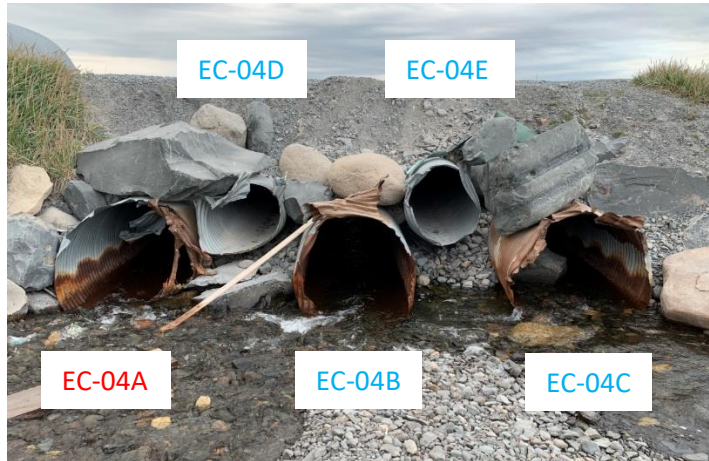
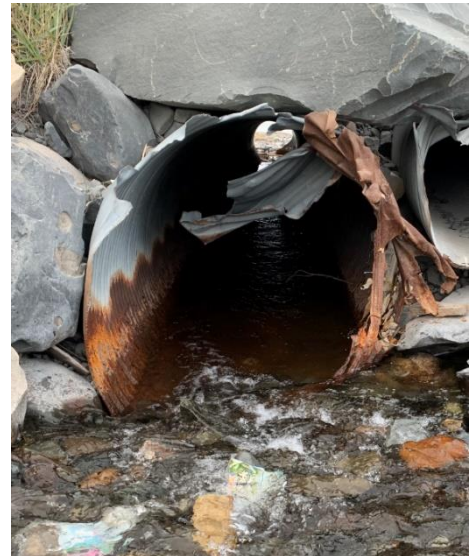
Culvert I.D.	EC-04A
Upstream / Downstream	Southeast / Northwest
Material / Size	CSP / 1200 mm
Interior Condition	Fair <ul style="list-style-type: none"> - Moderate to severe corrosion (possible penetration) - Minor debris/sediment
Exterior/End Condition	Poor <ul style="list-style-type: none"> - Both ends are damaged/torn (CSP unravelling)
Embankment Condition	Poor <ul style="list-style-type: none"> - Erosion present on northwest side - Embankment appears to be too steep (minor collapse) - Large boulders surround culvert ends; could cause further damage and do not protect against erosion well
Ditch Conditions	Good <ul style="list-style-type: none"> - Good stone bottom to protect from erosion upstream and downstream - Some debris present
Comments/Recommendations	Culvert is in working order and does not impede water flow. Condition is deteriorating and may require replacement soon. Recommend replacement simultaneously with adjacent culverts.

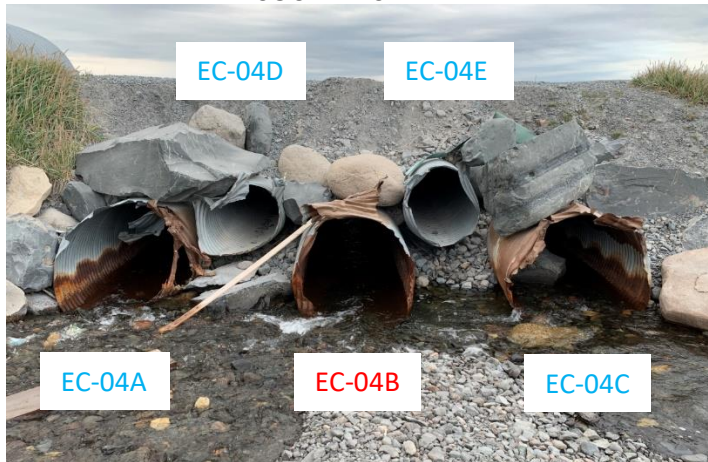
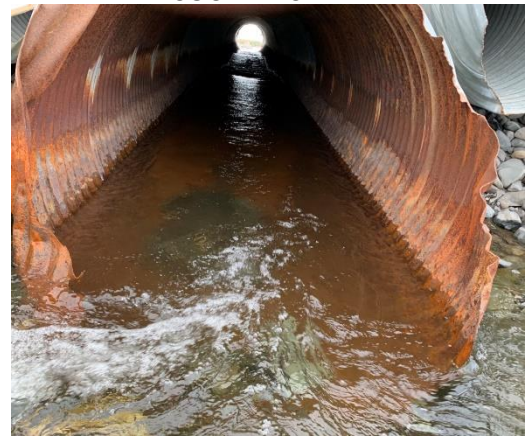
Culvert I.D.	EC-04B
Upstream / Downstream	Southeast / Northwest
Material / Size	CSP / 1200 mm
Interior Condition	Fair <ul style="list-style-type: none"> - Moderate to severe corrosion (possible penetration) - Minor debris/sediment
Exterior/End Condition	Fair <ul style="list-style-type: none"> - Both ends are damaged/torn - End extension appears adequate
Embankment Condition	Poor <ul style="list-style-type: none"> - Erosion present on northwest side - Embankment appears to be too steep (minor collapse) - Large boulders surround culvert ends; could cause further damage and do not protect against erosion well
Ditch Conditions	Good <ul style="list-style-type: none"> - Good stone bottom to protect from erosion upstream and downstream - Some debris present
Comments/Recommendations	Culvert is in working order and does not impede water flow. Condition is deteriorating and may require replacement soon. Recommend replacement simultaneously with adjacent culverts.

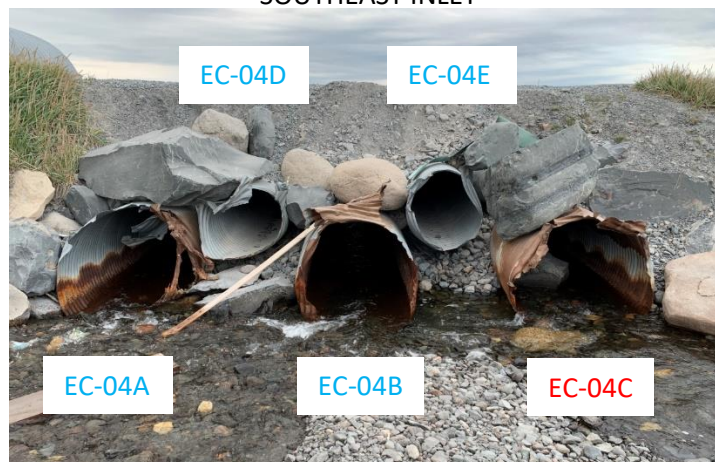
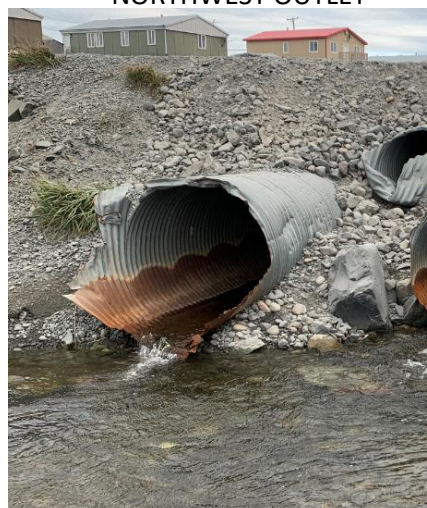
Culvert I.D.	EC-04C
Upstream / Downstream	Southeast / Northwest
Material / Size	CSP / 1200 mm
Interior Condition	Fair <ul style="list-style-type: none"> - Moderate to severe corrosion (possible penetration) - Minor debris/sediment
Exterior/End Condition	Poor <ul style="list-style-type: none"> - Both ends are damaged/torn (CSP unravelling) - End extension appears adequate
Embankment Condition	Poor <ul style="list-style-type: none"> - Erosion present on northwest side - Embankment appears to be too steep (minor collapse) - Large boulders surround culvert ends; could cause further damage and do not protect against erosion well
Ditch Conditions	Good <ul style="list-style-type: none"> - Good stone bottom to protect from erosion upstream and downstream - Some debris present
Comments/Recommendations	Culvert is in working order and does not impede water flow. Condition is deteriorating and may require replacement soon. Recommend replacement simultaneously with adjacent culverts.

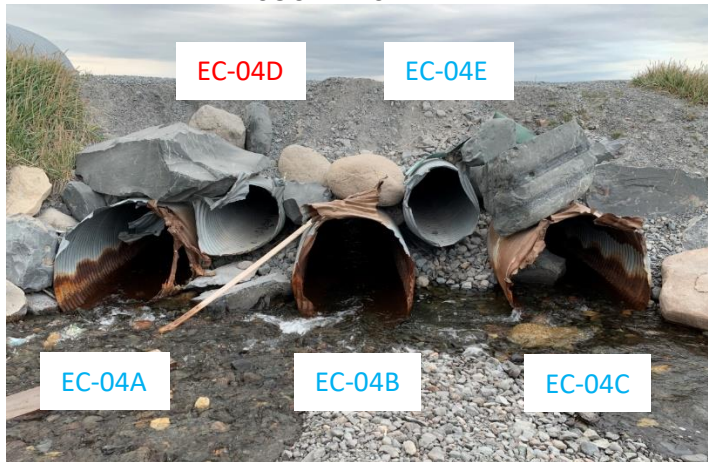
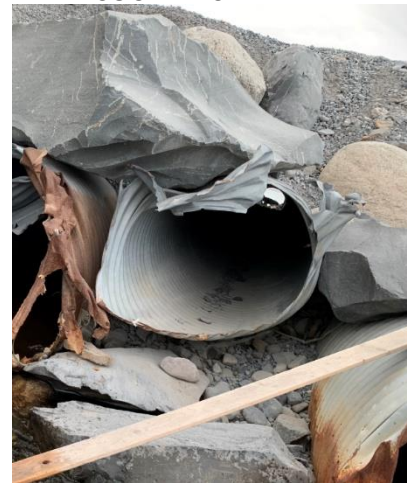
Culvert I.D.	EC-04D
Upstream / Downstream	Southeast / Northwest
Material / Size	CSP / 800 mm
Interior Condition	Good <ul style="list-style-type: none"> - No corrosion or sediment/debris present
Exterior/End Condition	Poor <ul style="list-style-type: none"> - Both ends are damaged/torn (CSP unravelling) - End extension appears adequate - Portion of North outlet end has been bent upwards (may impede flow)
Embankment Condition	Poor <ul style="list-style-type: none"> - Erosion present on northwest side - Embankment appears to be too steep (minor collapse) - Large boulders surround culvert ends; could cause further damage and do not protect against erosion well
Ditch Conditions	Good <ul style="list-style-type: none"> - Good stone bottom to protect from erosion upstream and downstream - Some debris present
Comments/Recommendations	Culvert is in working order and appears to be used for secondary overflow. Material is in good condition and does not require replacement at this time, however, replacement is recommended simultaneously with adjacent culverts for ease of construction and consistency. Culvert ends could be repaired in the short term to help in the event of an overflow/back up.

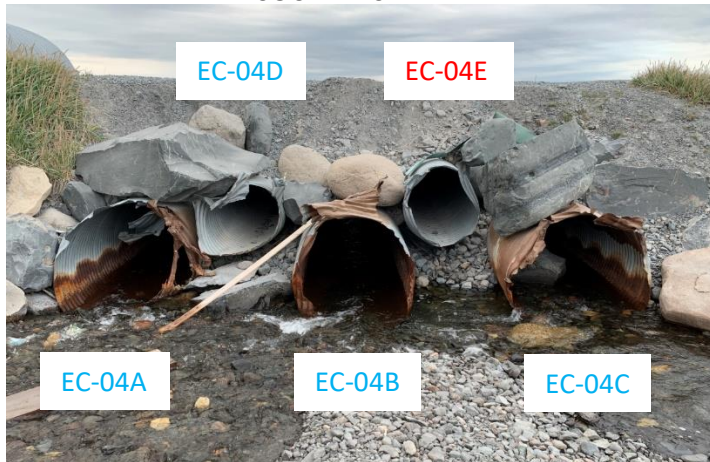
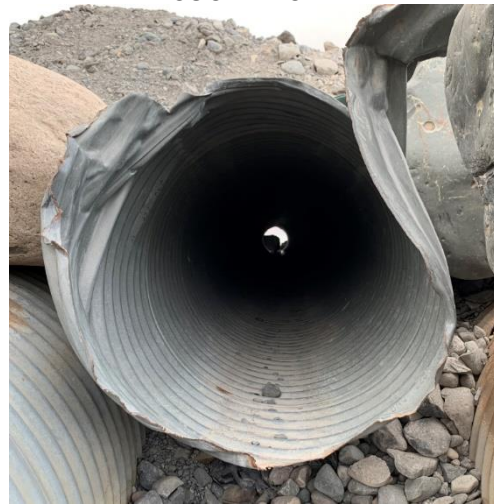
Culvert I.D.	EC-04E
Upstream / Downstream	Southeast / Northwest
Material / Size	CSP / 800 mm
Interior Condition	Good <ul style="list-style-type: none"> - No corrosion or sediment/debris present
Exterior/End Condition	Poor <ul style="list-style-type: none"> - Both ends are damaged/torn (CSP unravelling) - End extension appears adequate - Portion of North outlet end has been bent upwards (may impede flow)
Embankment Condition	Poor <ul style="list-style-type: none"> - Erosion present on northwest side - Embankment appears to be too steep (minor collapse) - Large boulders surround culvert ends; could cause further damage and do not protect against erosion well
Ditch Conditions	Good <ul style="list-style-type: none"> - Good stone bottom to protect from erosion upstream and downstream - Some debris present
Comments/Recommendations	Culvert is in working order and appears to be used for secondary overflow. Material is in good condition and does not require replacement at this time, however, replacement is recommended simultaneously with adjacent culverts for ease of construction and consistency. Culvert ends could be repaired in the short term to help in the event of an overflow/back up.

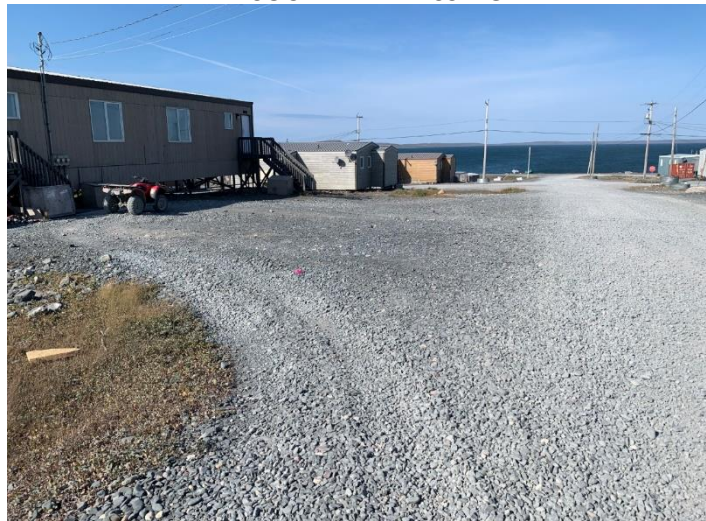
SOUTH END MISSING

Culvert I.D.	EC-05
Upstream / Downstream	South / North
Material / Size	CSP / 600 mm
Interior Condition	<p>NA</p> <ul style="list-style-type: none"> - Culvert is buried and/or possibly collapsed - South culvert end location is unknown
Exterior/End Condition	<p>Poor</p> <ul style="list-style-type: none"> - End extensions are not adequate - North outlet partially buried - South inlet completely buried - Likely damaged from vehicular traffic
Embankment Condition	NA
Ditch Conditions	<p>Poor</p> <ul style="list-style-type: none"> - Ditch is blocked by driveways - Some debris present
Comments/Recommendations	Roadside ditch should be regraded, and existing culverts should be replaced. Culvert should have adequate cover, and ends should be protected from vehicular traffic.

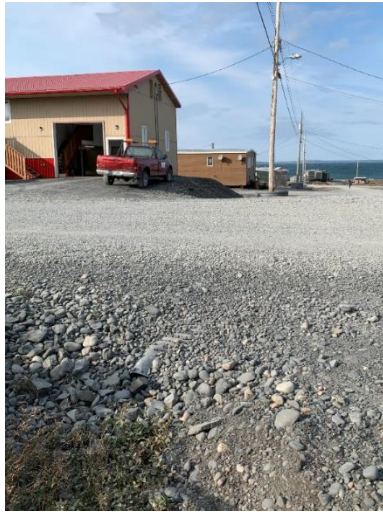
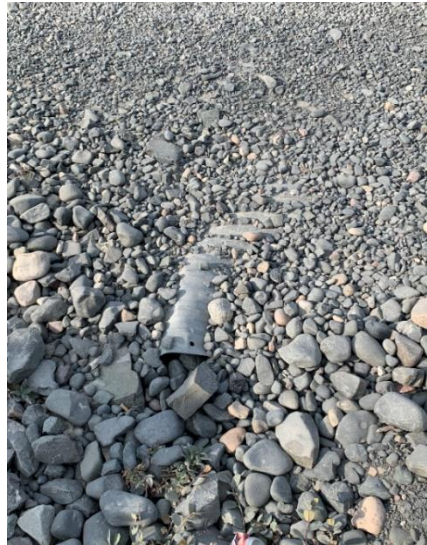
Culvert I.D.	EC-06
Upstream / Downstream	South / North
Material / Size	CSP / Unknown
Interior Condition	<p>NA</p> <ul style="list-style-type: none"> - Culvert is 95-100% buried and/or possibly collapsed - South culvert end is visible and north end is unknown
Exterior/End Condition	<p>Poor</p> <ul style="list-style-type: none"> - Cover does not appear to be adequate - End extensions are not adequate - North outlet completely buried - South inlet almost completely buried - Likely damaged from vehicular traffic
Embankment Condition	NA
Ditch Conditions	<p>Poor</p> <ul style="list-style-type: none"> - Ditch likely ponds due to lack of drainage - Some debris present - Not adequate for proper water conveyance
Comments/Recommendations	Roadside ditch should be regraded, and existing culverts should be replaced. Culvert should have adequate cover, and ends should be protected from vehicular traffic.

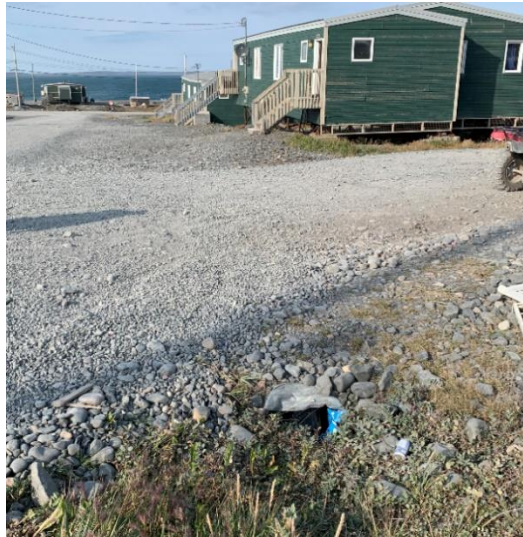
SOUTH INLET

Culvert I.D.	EC-07
Upstream / Downstream	South / North
Material / Size	CSP / 600 mm
Interior Condition	<p>NA</p> <ul style="list-style-type: none"> - Culvert is 95-100% buried and/or possibly collapsed - South culvert end is visible and north end is unknown
Exterior/End Condition	<p>Poor</p> <ul style="list-style-type: none"> - Cover does not appear adequate - End extensions are not adequate - North outlet completely buried - South inlet almost completely buried - Likely damaged from vehicular traffic
Embankment Condition	NA
Ditch Conditions	<p>Poor</p> <ul style="list-style-type: none"> - Ditch likely ponds due to lack of drainage - Some debris present - Not adequate depth for water conveyance
Comments/Recommendations	Roadside ditch should be regraded, and existing culverts should be replaced. Culvert should have adequate cover, and ends should be protected from vehicular traffic.

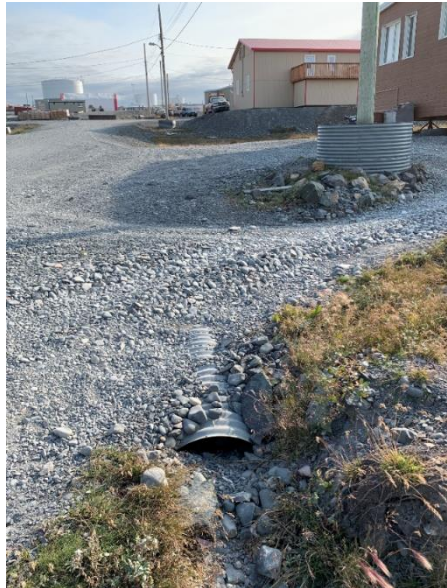
SOUTH INLET

Culvert I.D.	EC-08
Upstream / Downstream	South / North
Material / Size	CSP / 600 mm
Interior Condition	<p>NA</p> <ul style="list-style-type: none"> - Culvert is approximately 75% buried on the north outlet - South culvert end is visible but crushed from vehicular traffic
Exterior/End Condition	<p>Poor</p> <ul style="list-style-type: none"> - Cover does not appear adequate - End extensions are not adequate - South inlet crushed from vehicular traffic - North outlet partially buried
Embankment Condition	NA
Ditch Conditions	<p>Poor</p> <ul style="list-style-type: none"> - Ditch likely ponds due to lack of drainage - Some debris present - Not adequate depth for water conveyance
Comments/Recommendations	Roadside ditch should be regraded, and existing culverts should be replaced. Culvert should have adequate cover, and ends should be protected from vehicular traffic.

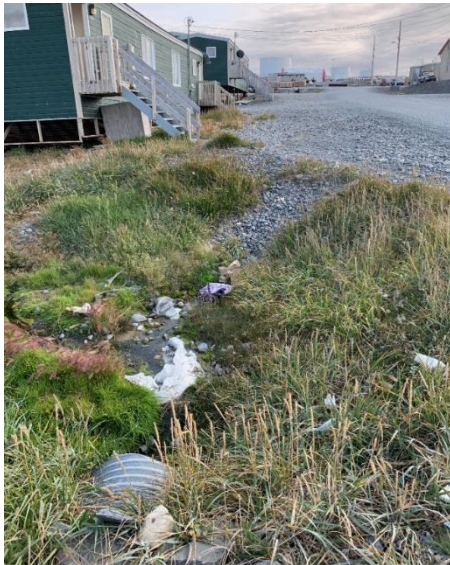
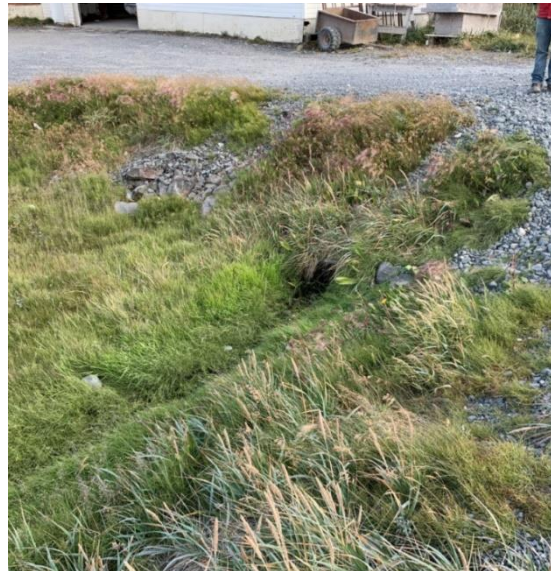
Culvert I.D.	EC-09
Upstream / Downstream	South / North
Material / Size	CSP / 600 mm
Interior Condition	Fair <ul style="list-style-type: none"> - Culvert appears to be in working order - Some sediment and debris present
Exterior/End Condition	Fair <ul style="list-style-type: none"> - Cover does not appear adequate on the north end - End extensions are adequate but could be improved - Thick vegetation could cause blockages at culvert ends
Embankment Condition	Fair <ul style="list-style-type: none"> - Vegetation is present and will protect against erosion
Ditch Conditions	Fair <ul style="list-style-type: none"> - Vegetation is present and will protect against erosion - Appears to be adequate depth for water conveyance
Comments/Recommendations	Culvert is in fair condition and working order, and does not require replacement at this time. Replacement is recommended simultaneously with other driveway culvert replacements. Ditch should be protected with rip-rap or vegetation.

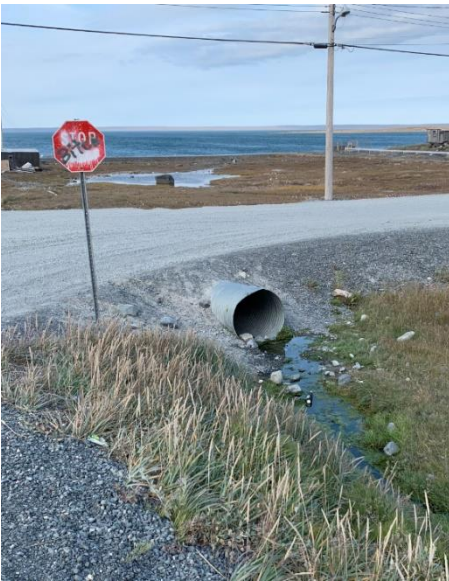
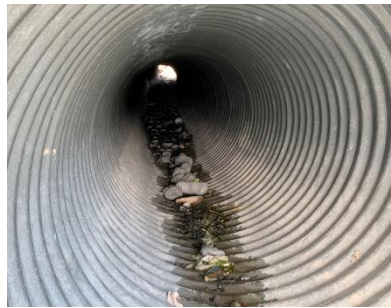
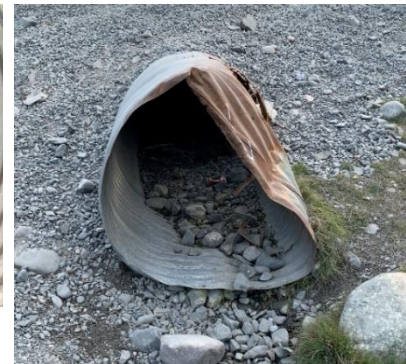
Culvert I.D.	EC-10
Upstream / Downstream	South / North
Material / Size	CSP / 900 mm
Interior Condition	<p>Good</p> <ul style="list-style-type: none"> - Some debris/sediment present - Material appears to be in good condition
Exterior/End Condition	<p>Fair</p> <ul style="list-style-type: none"> - Cover appears to be adequate but could be increased - South inlet is in good condition - North outlet is in poor condition; severe corrosion/penetration, and deformation
Embankment Condition	<p>Good</p> <ul style="list-style-type: none"> - Sloping is adequate to protect embankment - Rip-rap does not appear to be required
Ditch Conditions	<p>Poor</p> <ul style="list-style-type: none"> - Downstream ditch is not well defined - Could be regraded to improve water conveyance
Comments/Recommendations	<p>Culvert is in overall good condition and does not require replacement at this time, however, the north outlet should be repaired by removing the portion of corroded CSP and replaced with a new extension.</p>

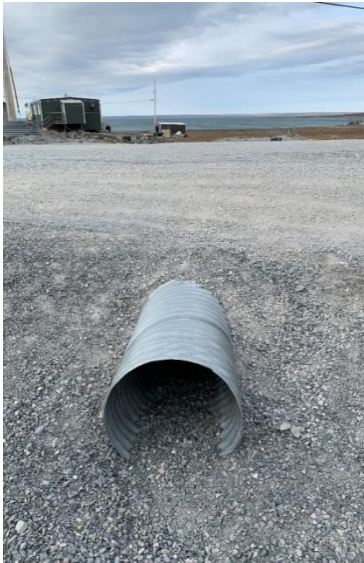
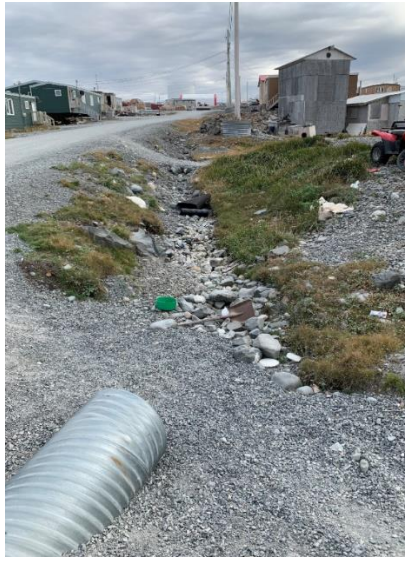
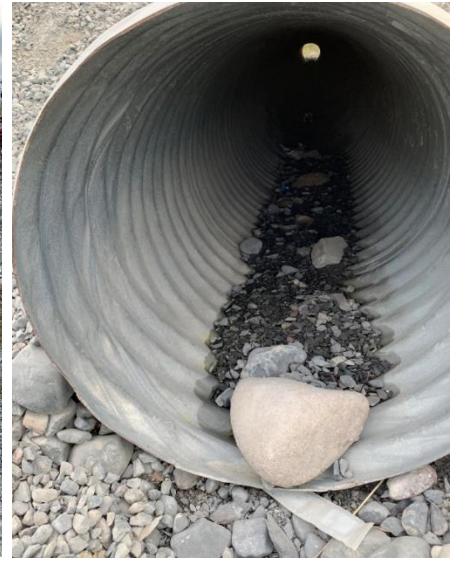
Culvert I.D.	EC-11
Upstream / Downstream	South / North
Material / Size	CSP / 600 mm
Interior Condition	<p>Good</p> <ul style="list-style-type: none"> - Material shows little to no signs of corrosion or damage - Some sediment. Should not impede flow.
Exterior/End Condition	<p>Good</p> <ul style="list-style-type: none"> - Cover to road surface could be increased - Ends are in good condition with no signs of damage
Embankment Condition	<p>Good</p> <ul style="list-style-type: none"> - Sloping is adequate to protect embankment - Rip-rap does not appear to be required
Ditch Conditions	<p>Poor</p> <ul style="list-style-type: none"> - Downstream ditch is not well defined - Upstream ditch is not graded properly, and is filled with debris and blocked by a resident pathway
Comments/Recommendations	<p>Culvert is in overall good condition and does not require replacement at this time. Ditches upstream and downstream should be repaired/regraded to ensure proper conveyance of water.</p>

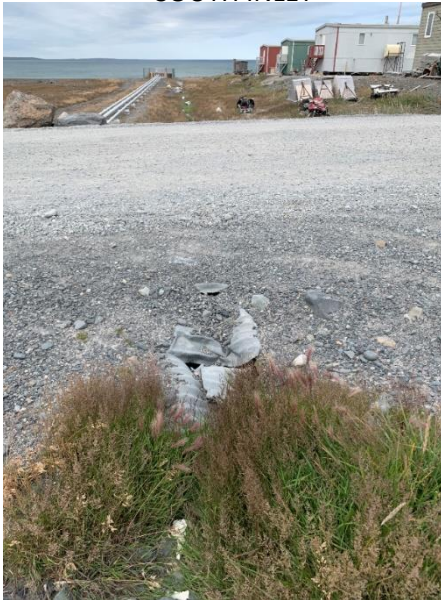
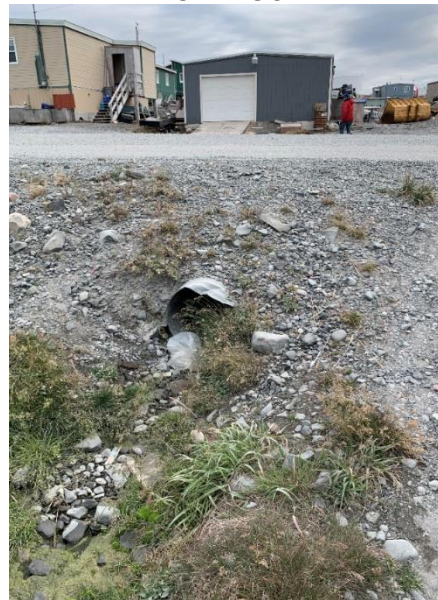
Culvert I.D.	EC-12
Upstream / Downstream	South / North
Material / Size	CSP / 600 mm
Interior Condition	Fair <ul style="list-style-type: none"> - Minimal corrosion with some damage and sediment present
Exterior/End Condition	Poor <ul style="list-style-type: none"> - Cover appears to be adequate - North outlet is in good condition with only minor deformation - South inlet is crushed/damaged and possibly blocked with debris
Embankment Condition	Good <ul style="list-style-type: none"> - Sloping is adequate to protect embankment - Rip-rap does not appear to be required
Ditch Conditions	Poor <ul style="list-style-type: none"> - Downstream ditch is well defined - Upstream ditch is not graded properly, and is filled with debris and vegetation
Comments/Recommendations	Culvert inlet end is in poor condition. Replacement is likely not required, however, culvert ends should be repaired and extended. Ditching should be regraded, and debris should be removed. Culvert ends should be protected with rip-rap and markers should be installed to deter drivers from crushing the ends.

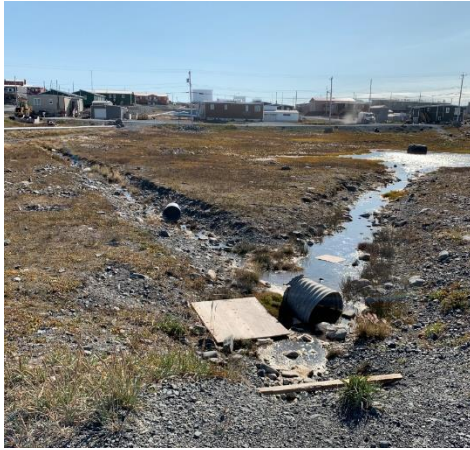
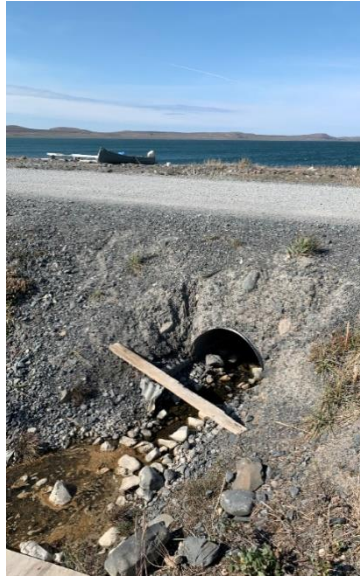
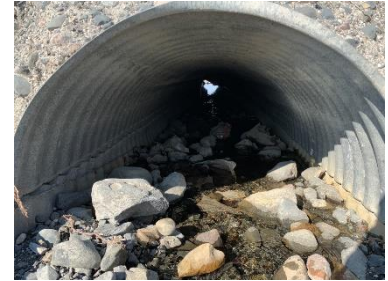
Culvert I.D.	EC-13
Upstream / Downstream	South / North
Material / Size	CSP / 800 mm
Interior Condition	<p>Poor</p> <ul style="list-style-type: none"> - Little to no corrosion, however, culvert is full of rocks, sediment and debris (approximately 40% full)
Exterior/End Condition	<p>Fair</p> <ul style="list-style-type: none"> - Cover appears to be adequate - End extensions are not adequate and may affect slope stability on the embankment
Embankment Condition	<p>Fair</p> <ul style="list-style-type: none"> - Sloping is fairly steep and may lead to minor collapse of the embankment - Rip-rap could help with slope protection
Ditch Conditions	<p>Fair</p> <ul style="list-style-type: none"> - Upstream and downstream ditches are well defined - Inlet ditches require cleaning due to build up of debris and sediment
Comments/Recommendations	<p>Culvert is in working order with adequate cover, and material appears to be in good condition. Highly recommend cleaning out the full length of the culvert, extending the ends, protecting the embankments with rip rap and cleaning the upstream and downstream ditches. Due to the effort required to clean the culvert, replacement is recommended. Replace with 900mm size culvert minimum to be consistent with upstream culvert sizes.</p>
