**Geotechnical Evaluation and Drainage Planning
in Arctic Bay, Nunavut**

Arctic Bay, NU

Final Report
REV-02

Prepared by:
Nunami Stantec Limited

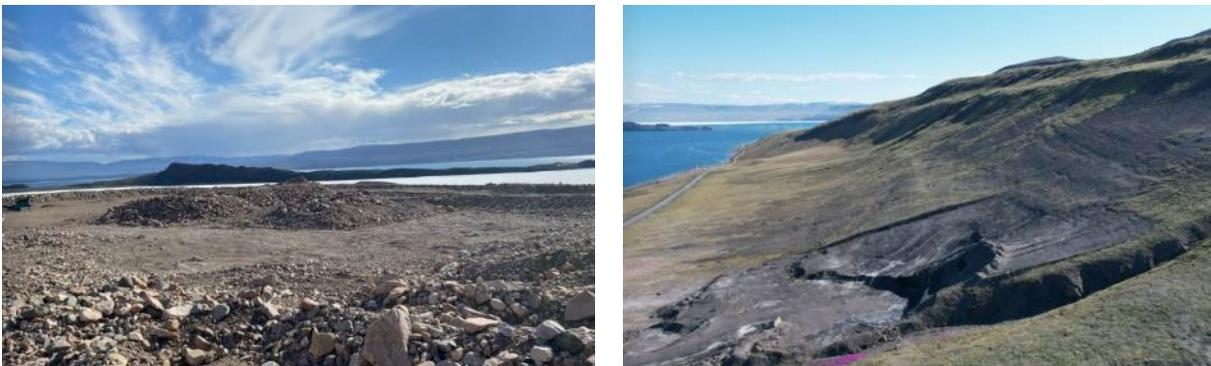
Figure 3-3 Granular aggregate (left) and quarry material (right) in Arctic Bay

- Mud shale is understood to be available from a quarry located in the western portion of the community (vicinity of Block 2). This material was reported to be relatively soft, can be dug with an excavator when unfrozen and does not require crushing. The material is used for surfacing some of the community roads, including the new access roads located within Block 2 and Block 3.

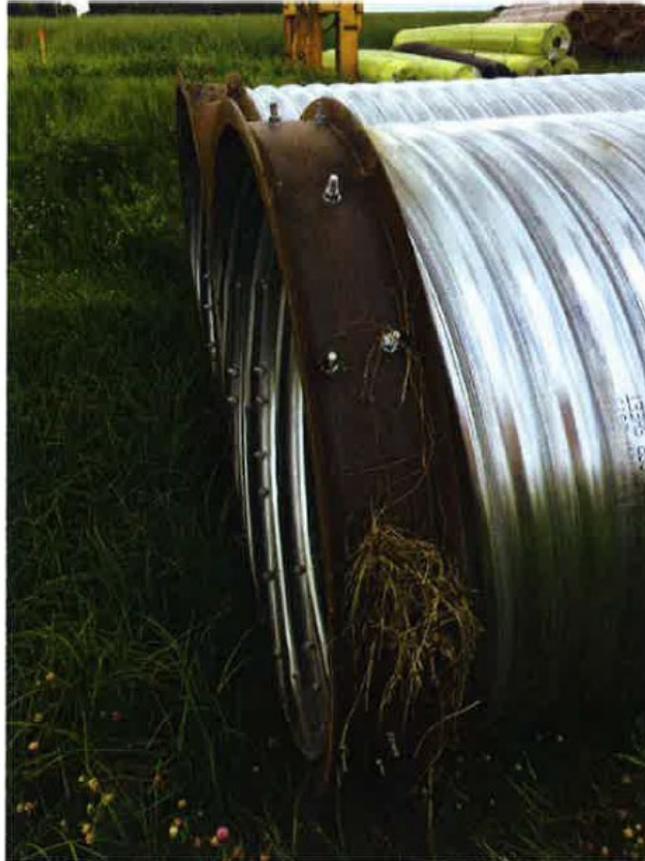
Figure 5-1 Culvert End Treatment – Culvert End Stiffener (Figure 17 from CSA 2020)

| Drainage Deficiency ¹ | Recommended Action(s) |
|---|---|
| Culverts were observed to have damaged ends, in most cases assumed to be related to snow plowing and/or road grading activities | <ul style="list-style-type: none"> • Repair the damaged/crushed culvert ends to re-establish hydraulic conveyance capacity of the culvert. • Culverts requiring remediation are identified in the detailed culvert database in Appendix E. • The severity of the damage will determine the required work at each culvert: <ul style="list-style-type: none"> ○ Culverts with minor deformation at the ends may be bent back to the intended shape with appropriate tools. ○ Where it is not possible, culverts may be repaired by cutting off the damaged portion and either leaving it square (if remaining culvert projects from embankment) or adding a short section of new culvert with an appropriate coupling. Culverts with more substantial end damage may require a portion of the road to be dug up to reach a section of non-crushed culvert prior to coupling with the culvert extension. ○ For severely damaged culverts where upon further inspection crushing extends through substantial portions of the barrel, complete culvert replacement may be required. ○ For CSP culverts, the repaired culvert ends should be reinforced with a steel end stiffener (e.g., Figure 5-1 as extracted from CSA 2020) or comparable stiff steel collar. This end treatment will make the culvert ends more resistant to damage in the future. As the hardened end treatments will not deform in the same way as CSP culverts, they pose a potential safety hazard to vehicles or humans who are accustomed to driving over the culvert ends (before or after deformation). The installation of the hardened end treatments should be communicated to the local community in advance of implementation. • Where warranted and/or practicable, efforts should be made to install SWSP culverts (CSA 2020). SWSP culverts are also more resistant to end deformation and do not require end treatments. Multi-level culvert arrangements, as illustrated in Figure 9 of CSA (2020), can be considered if culvert icing is an issue. Culvert diameter should be equal to or larger than the upstream culverts. |

Note: This culvert end stiffener detail was developed by the Ministry of Transportation in Saskatchewan (2018). Originally intended for large diameter culverts (1.8 to 2.4 m diameter), a similar detail would also be useful for the smaller diameter culverts commonly seen in the communities. A wider stiffener band could be considered for culvert sections more prone to damage from maintenance equipment or crushing from traffic.

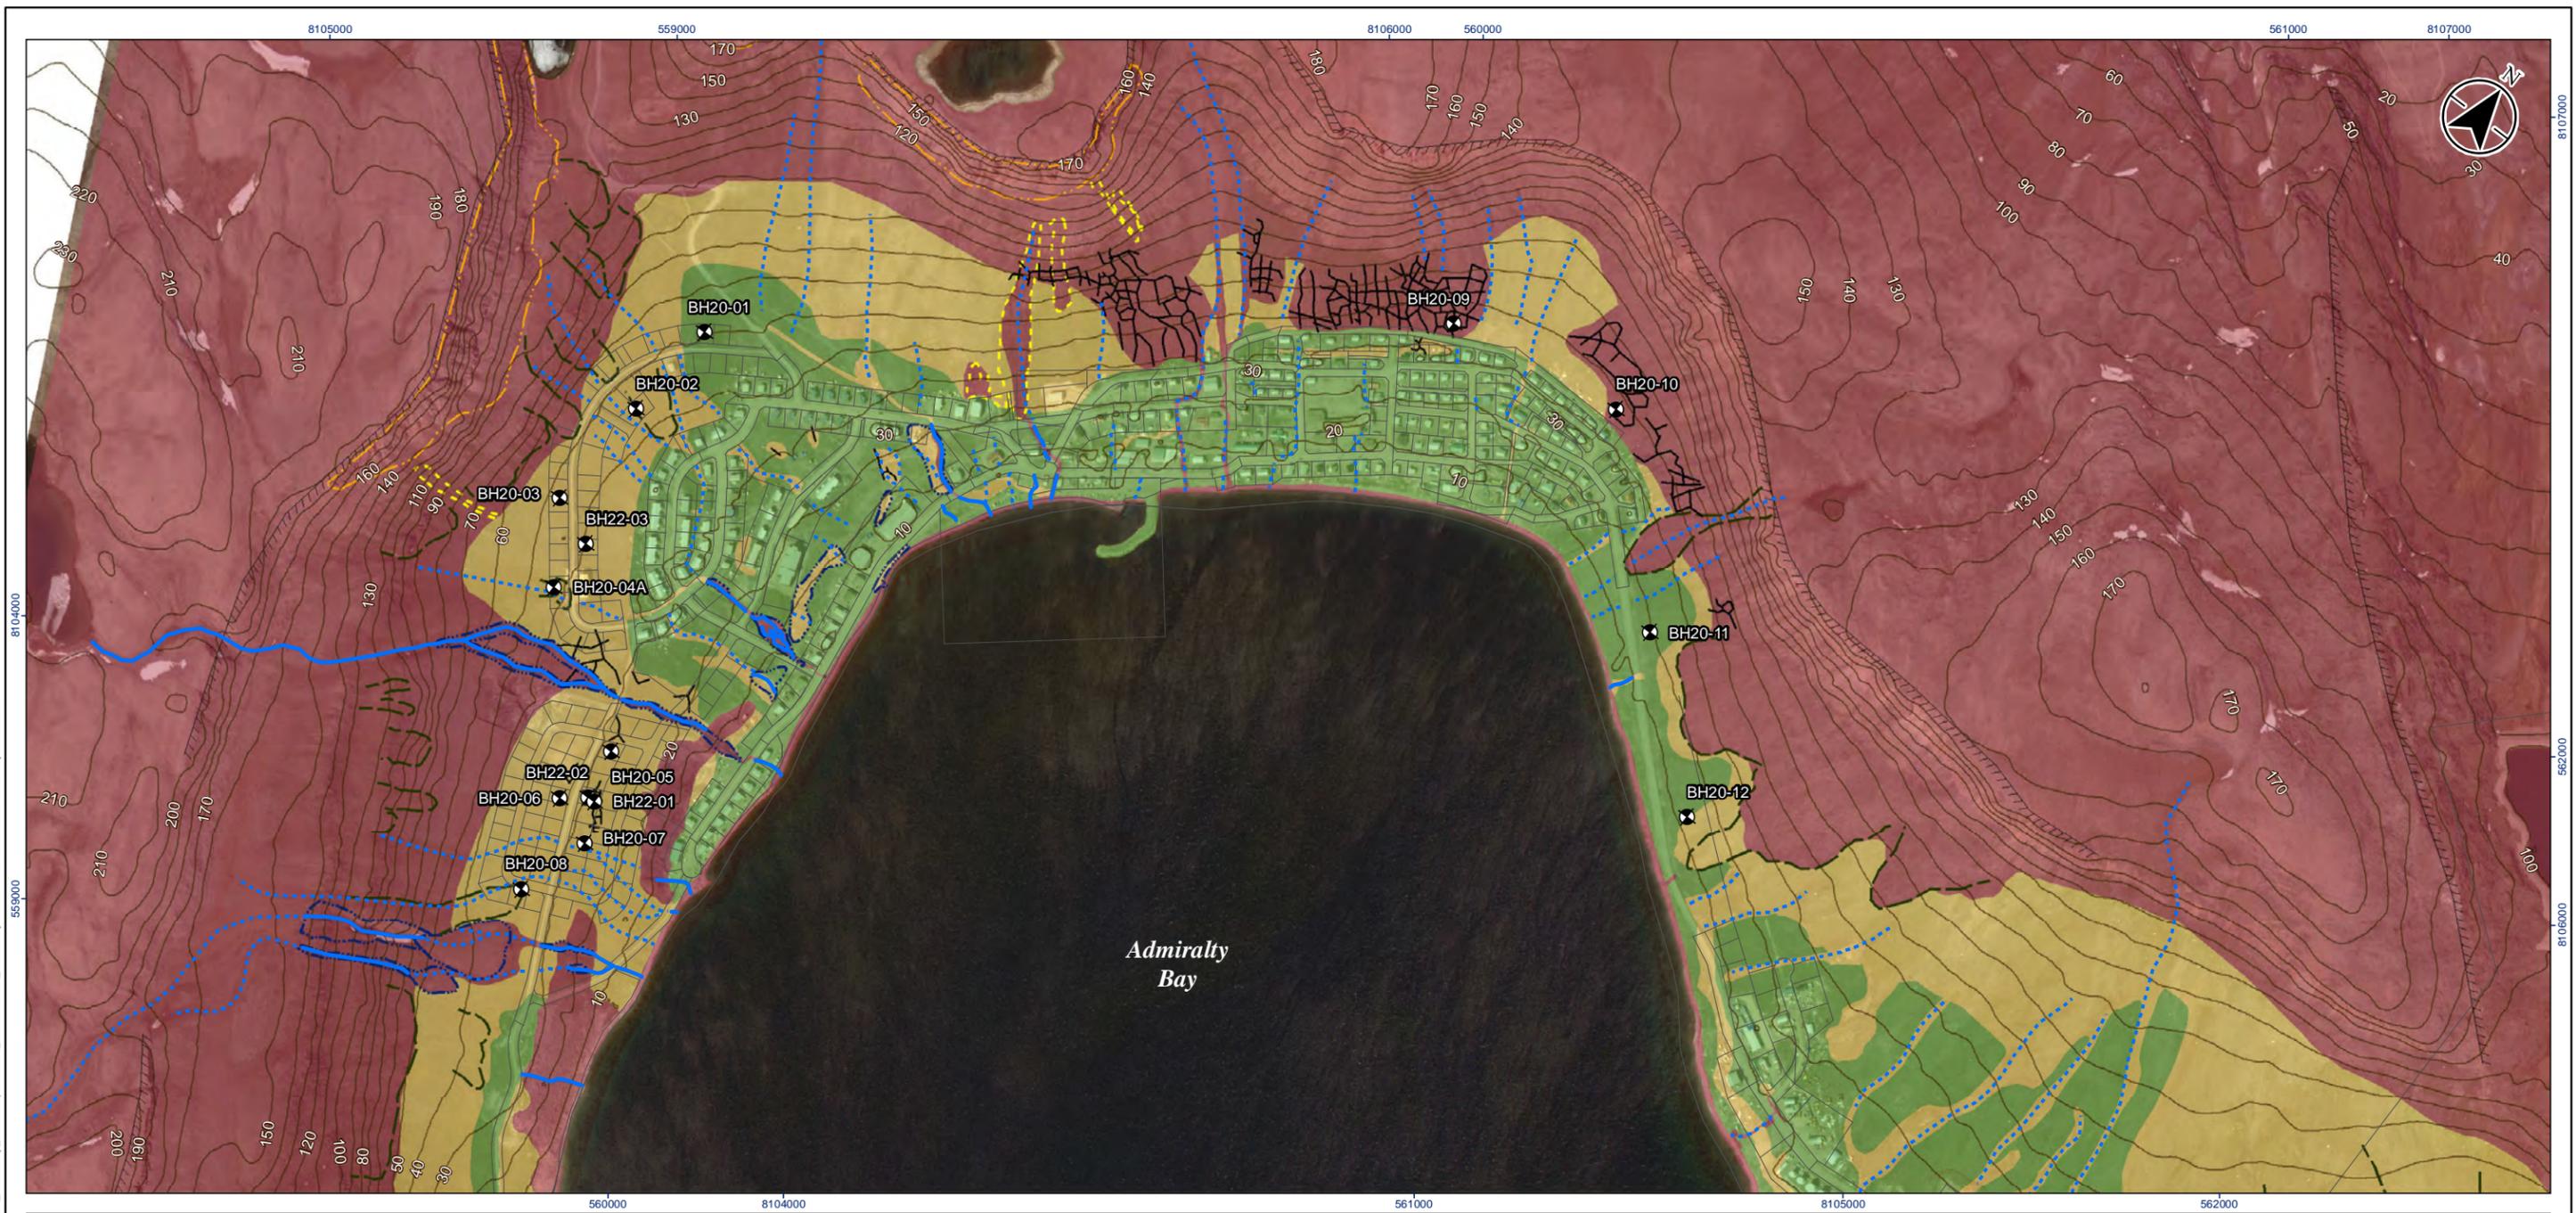
Figure No.: **B-5**
Title: Landscape Hazards and Land Development Suitability

Networks of ice wedges were identified along the slope marking the perimeter of the developed portion of the community and areas surrounding existing buildings. Wedges are predominant on the hillslope above Block 4 and undeveloped sectors of Blocks 2, 3 and 5. Based on existing literature, hillslope ice wedges can reach several meters in width and depth (Mackay 1995).

The locations of suspected ice wedges are displayed on the landscape hazard and land development suitability map presented on Figure B-5 (Appendix B).

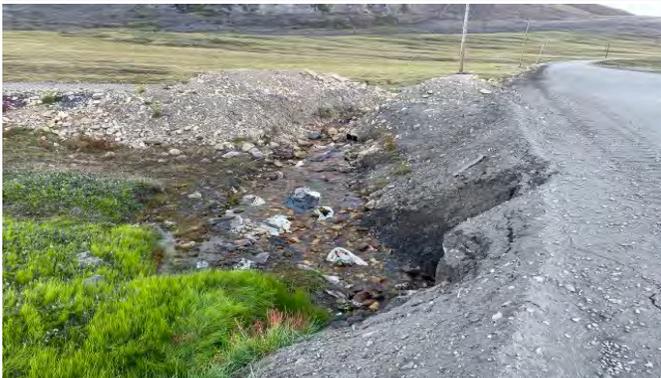
Upstream View

| Priority: | Medium |

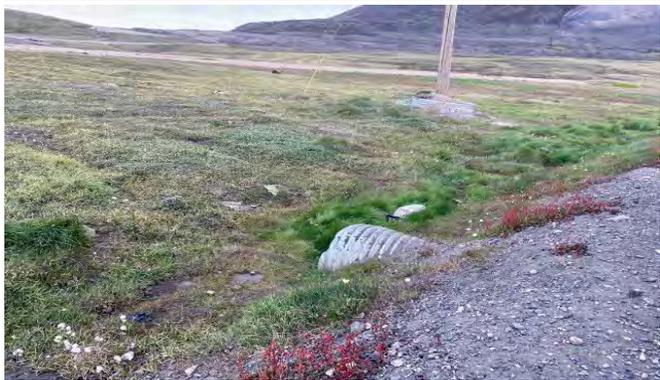
Upstream View

| Priority: | None |

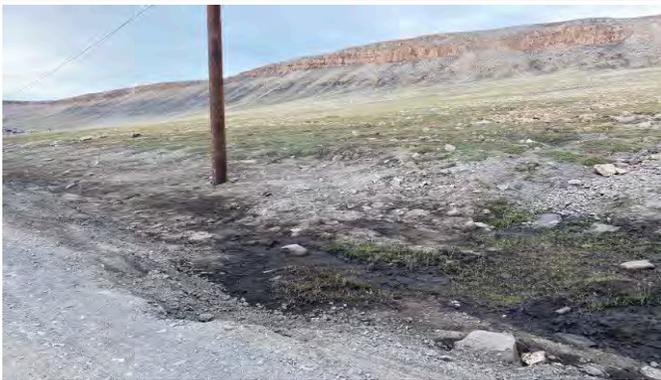
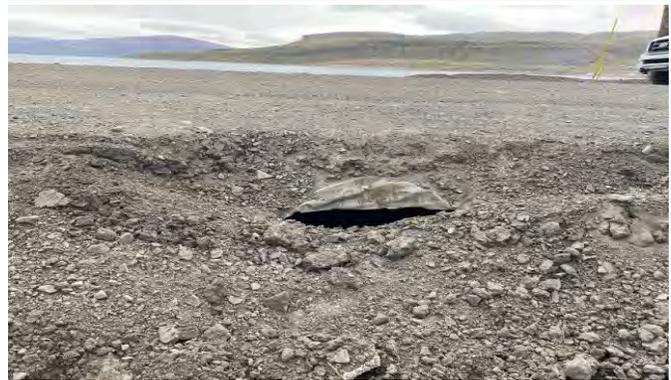
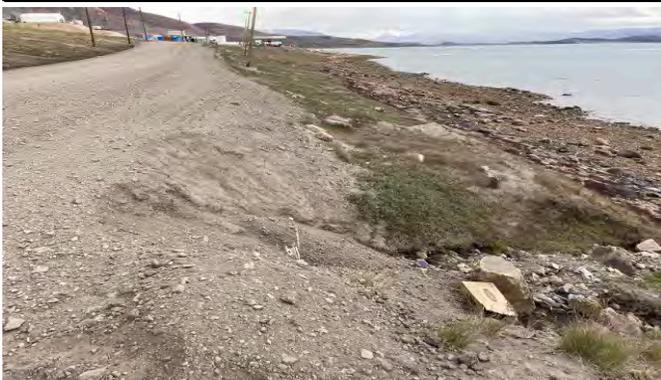
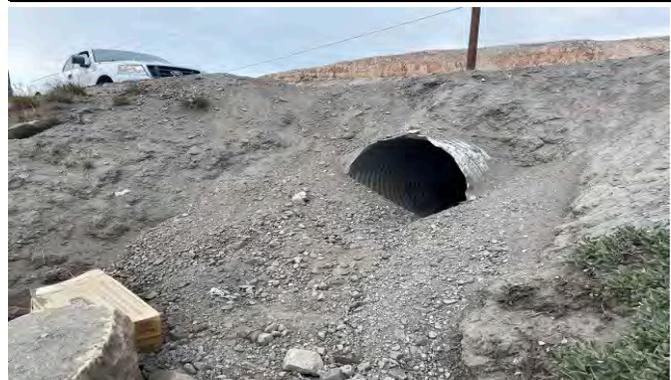
| Culvert Information | | | | |
|--|---|---|---|---|
| Other Comments | Absence of ditch at the inlet cause infill of material in the culvert. Erosion of the embankment causing obstruction at the outlet. | | | |

| Recommended Action(s): | Clean infill; extend inlet/outlet; erosion control at outlet |

| Priority: | High |

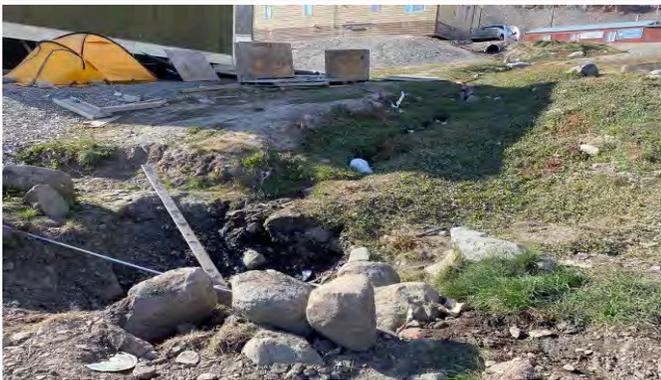
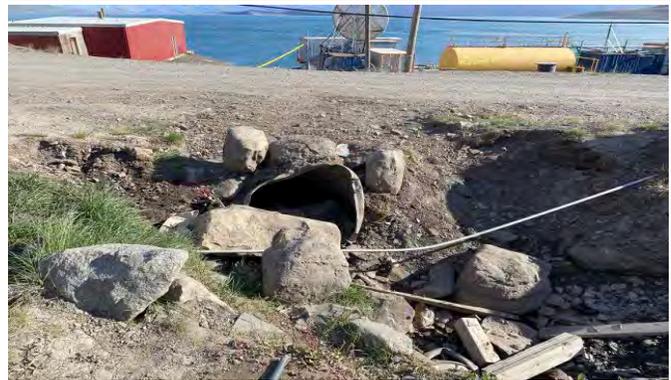
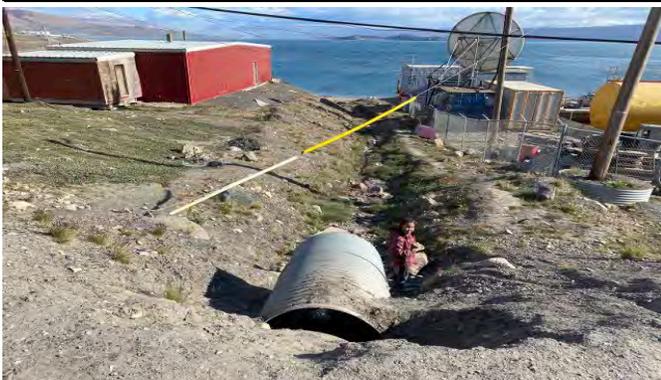
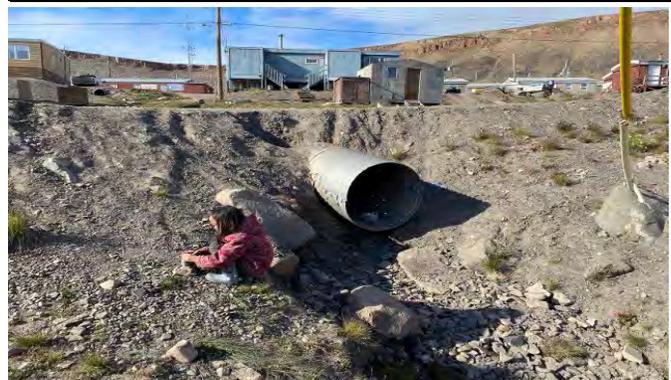
| Culvert Information | | |
|--|---|---|
| Other Comments | Inlet is damaged and partially blocked. Outlet extension is detached, likely caused by erosion of the embankment. | |

| Recommended Action(s): | Repair crushed inlet; erosion protection at outlet |

| Priority: | Low |

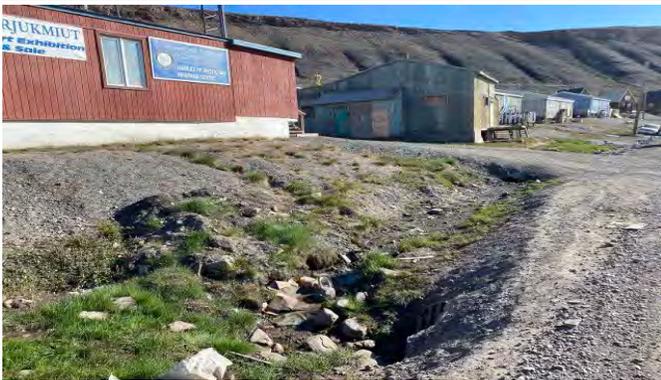
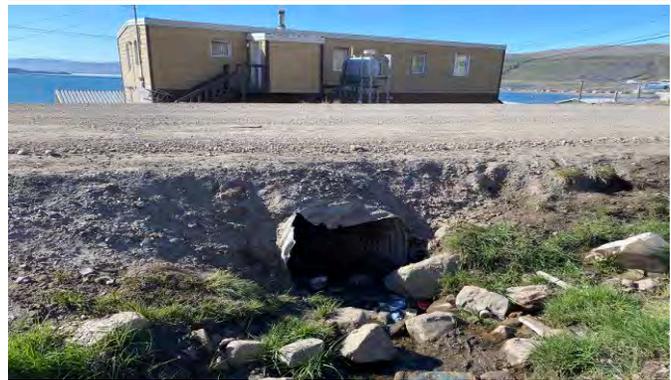
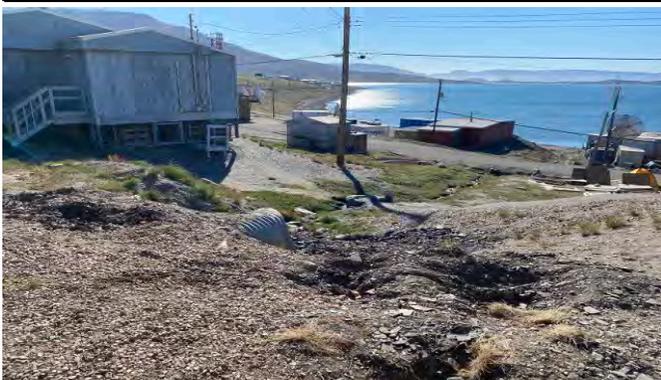
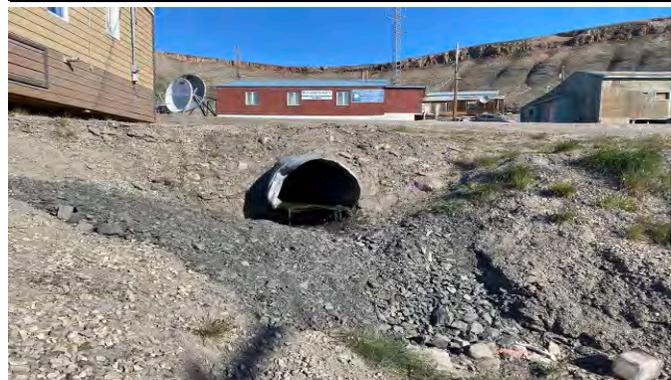
| Culvert Information | | |
|--|--|---|
| Other Comments | Long culvert across road and pad below. Erosion noted at outlet. | |

| Recommended Action(s): | Clean inlet area; apply erosion control at outlet |

| Priority: | Medium |

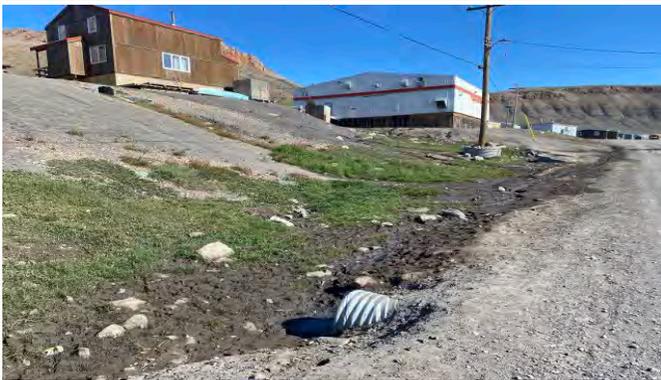
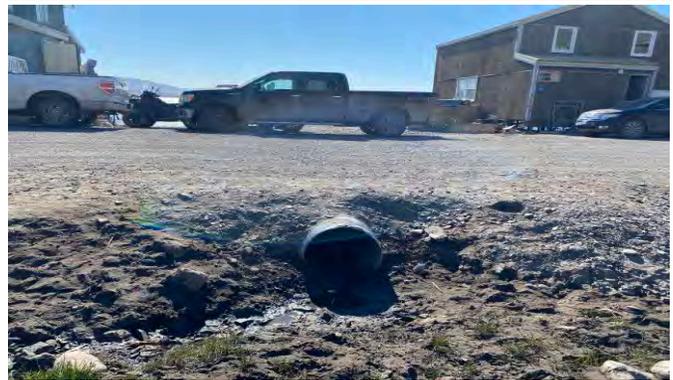
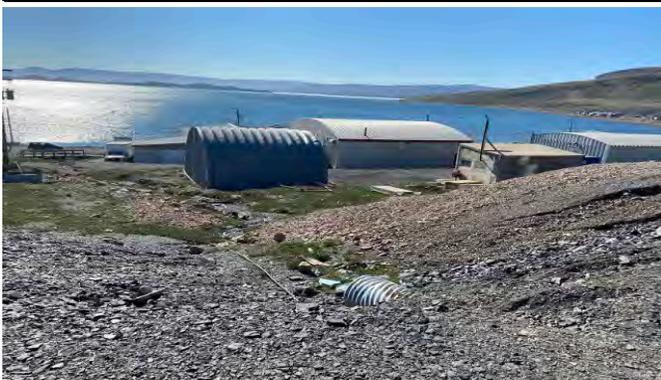
| Culvert Information | | | | |
|--|--|---|---|---|
| Other Comments | Culvert in good overall condition; ditch leading to inlet needs improvement. | | | |

| Recommended Action(s): | Excavate ditch between culverts |

| Priority: | High |

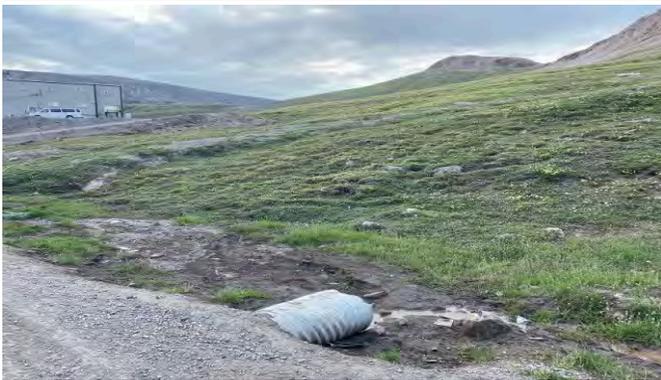
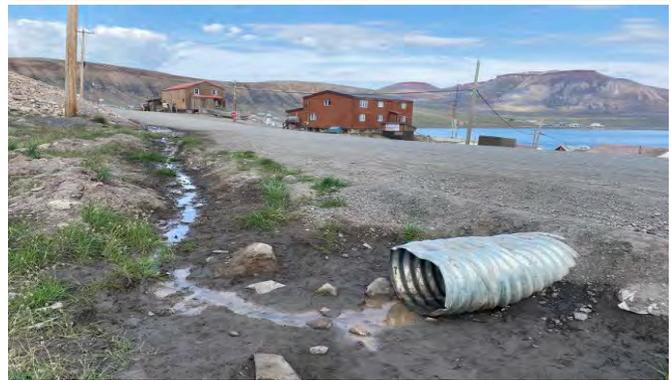
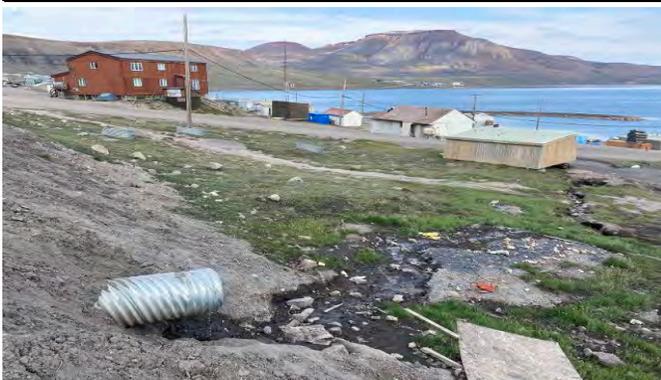
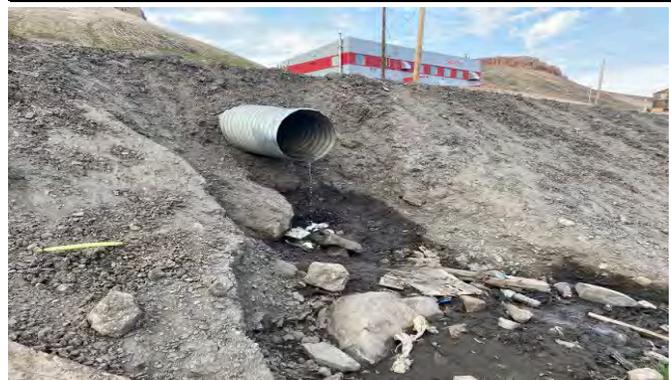
| Culvert Information | | | | |
|--|--|---|---|---|
| Other Comments | Perched outlet, caused by erosion of the embankment. | | | |

| Recommended Action(s): | Apply erosion control at outlet |

| Priority: | Medium |

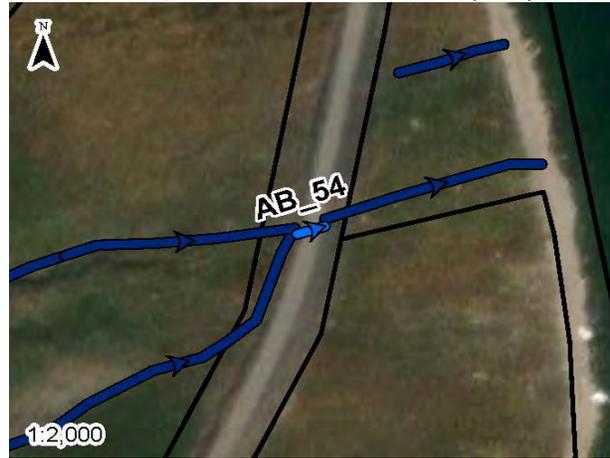
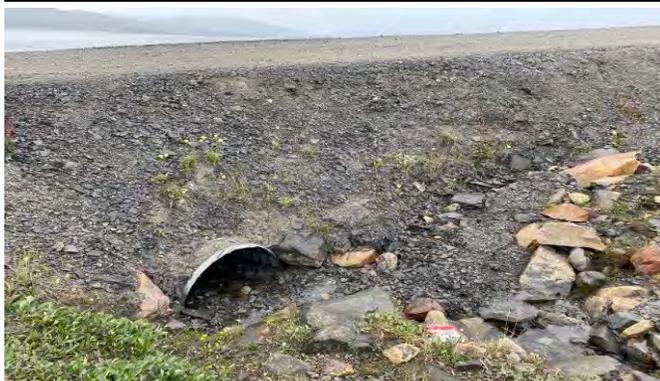
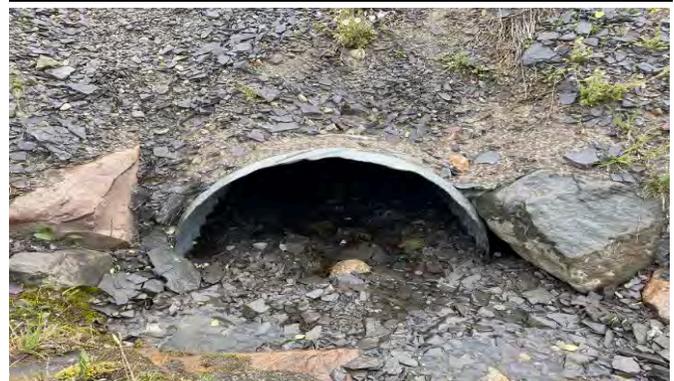
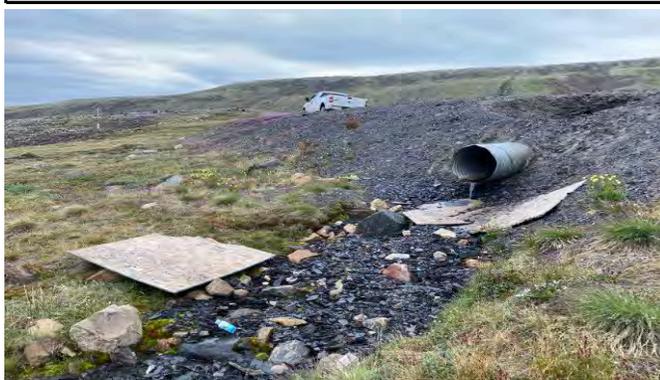
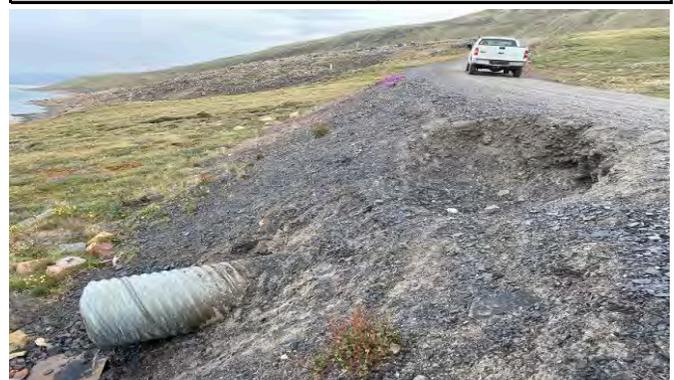
| Culvert Information | | | | |
|--|--|---|---|---|
| Other Comments | Culvert collapsed and blocked near center of road. Blockage has caused piping and erosion of the embankment. | | | |

| Recommended Action(s): | Excavate and replace culvert |

| Priority: | High |

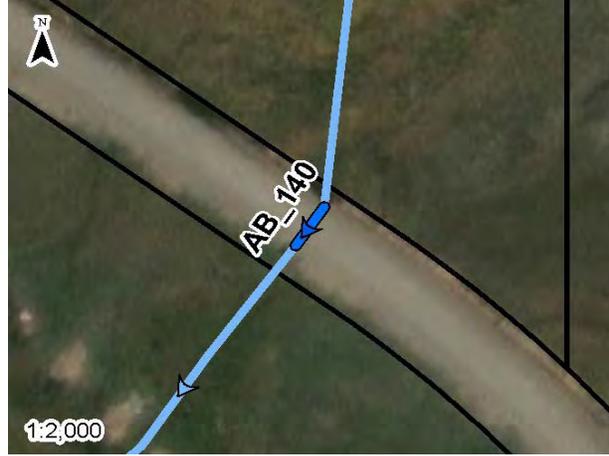
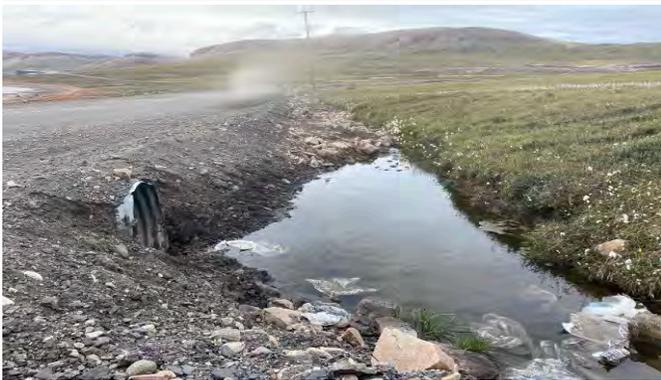
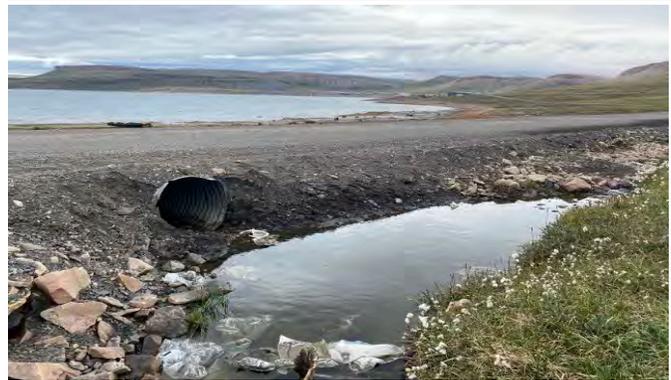
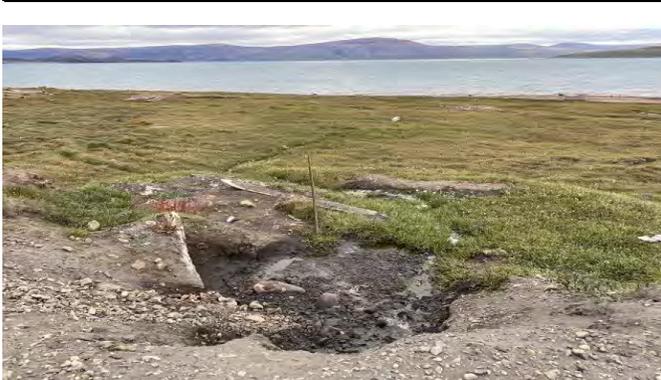
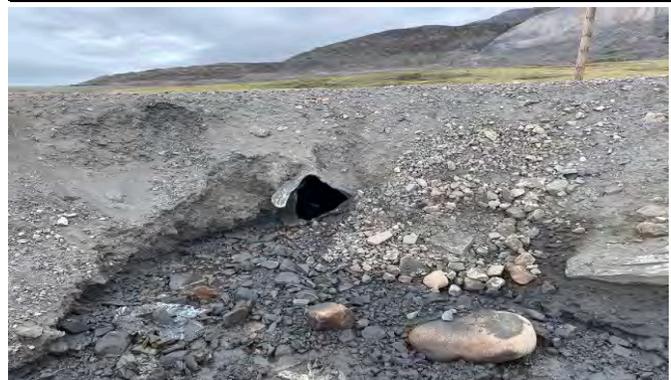
| Culvert Information | | | | |
|--|--|---|---|---|
| Other Comments | Inlet is high compared to depth of the ditch. Observed ponding. Crushed outlet and embankment stability issue. | | | |

| Recommended Action(s): | Lower culvert and extend inlet/outlet; erosion control at outlet |

| Priority: | Medium |

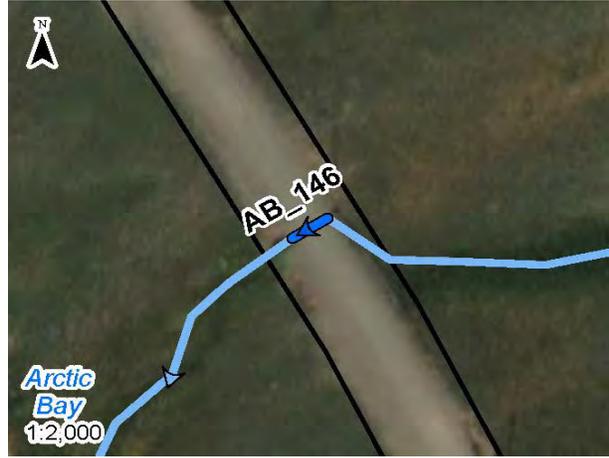
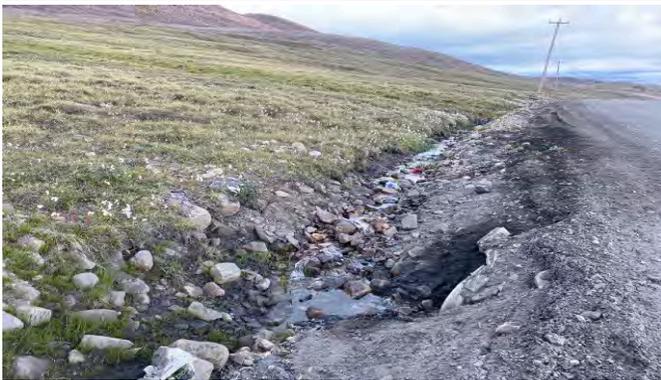
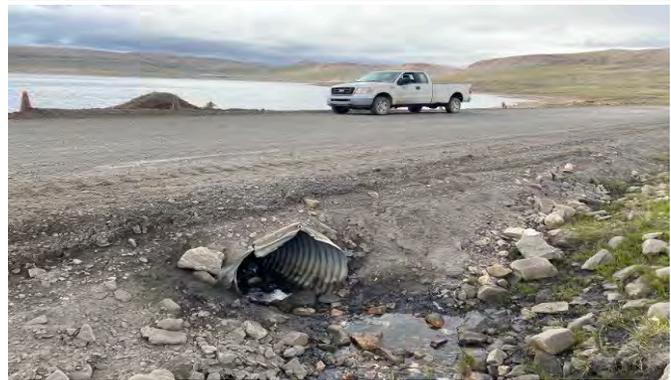
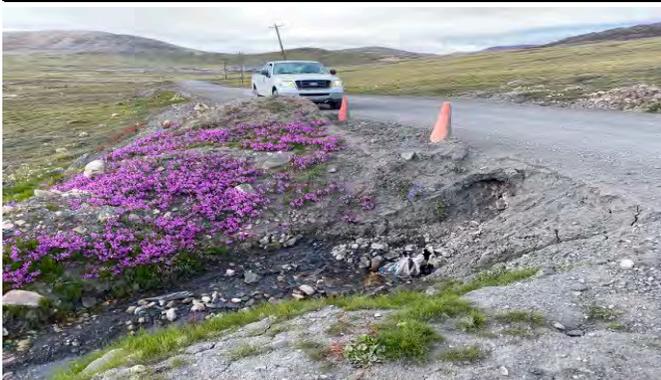
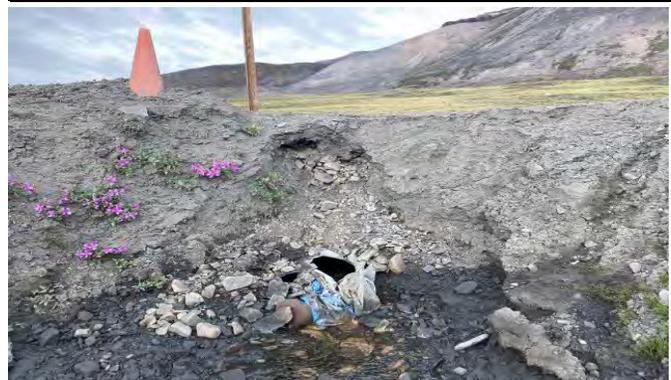
| Culvert Information | | | | |
|--|--|---|---|---|
| | Embankment stability issue. Roadside hazard. | | | |

| Recommended Action(s): | Clean inlet of infill; extend outlet; erosion control at outlet |

| Priority: | High |

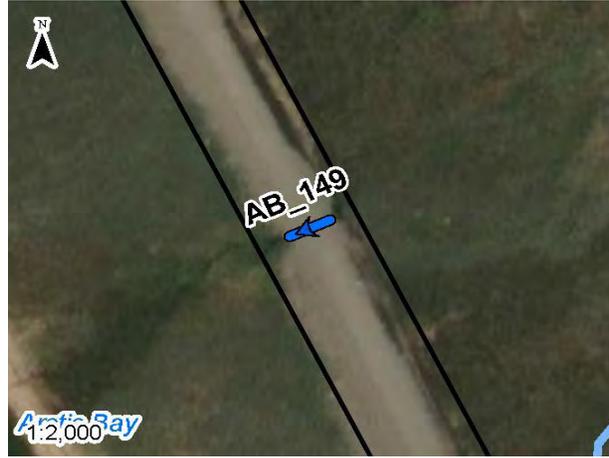
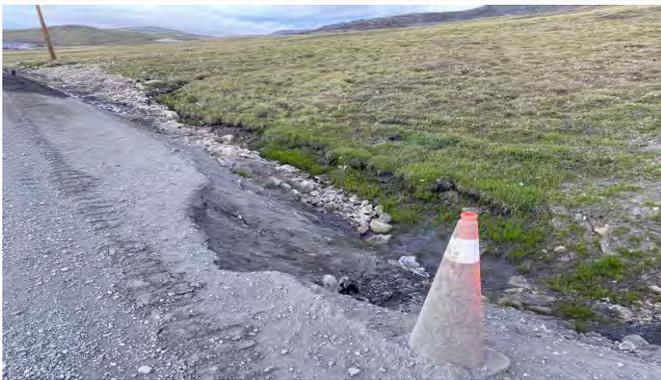
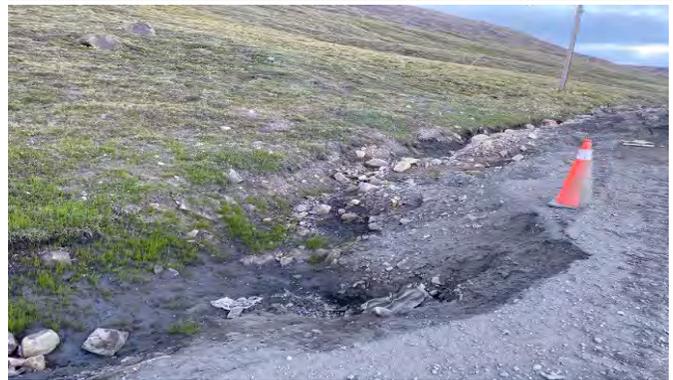
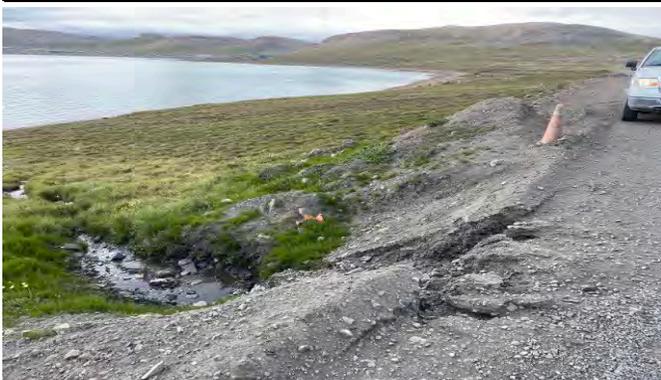
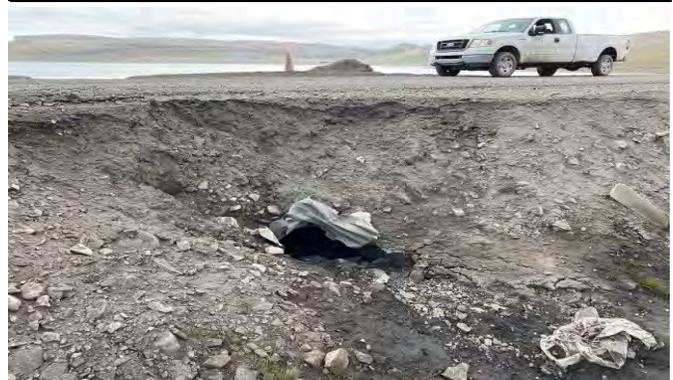
| Culvert Information | | | | |
|--|---|---|---|---|
| Other Comments | Crushed inlet. Infill limited to inlet/outlet areas, from embankment material caving. Embankment erosion at outlet. Roadway hazard. | | | |

| Recommended Action(s): | Clean infill; extend inlet/outlet; erosion control at outlet |

| Priority: | High |

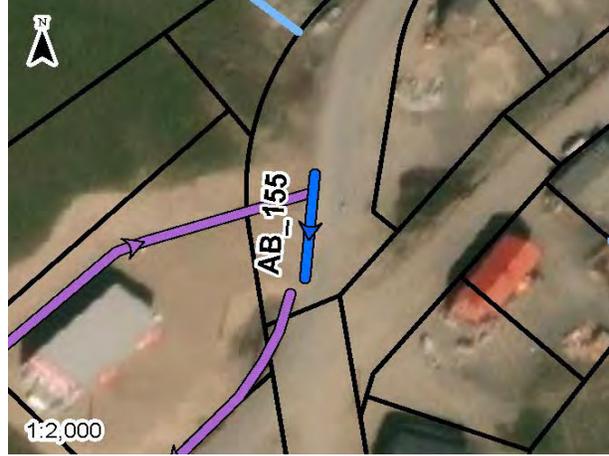
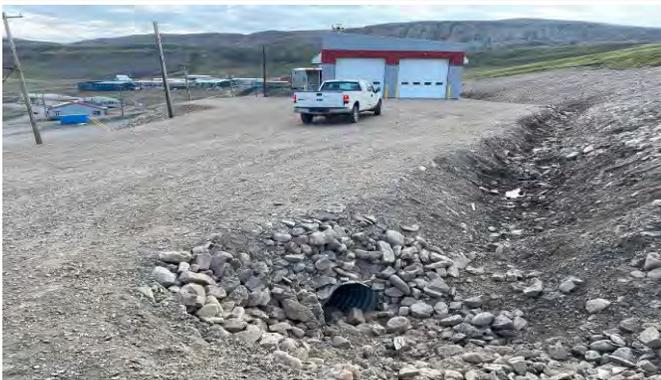
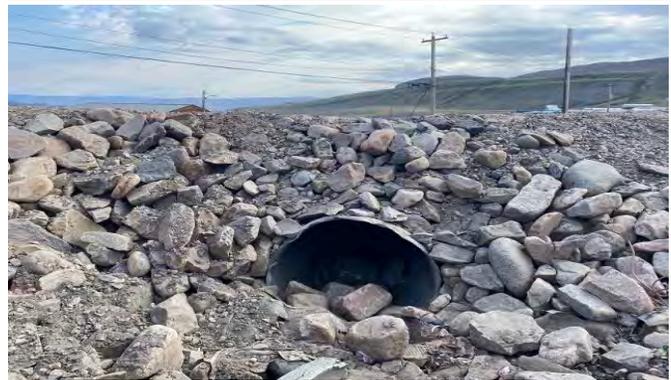
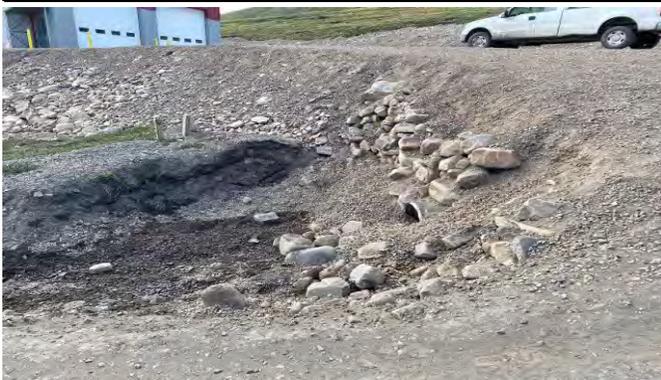
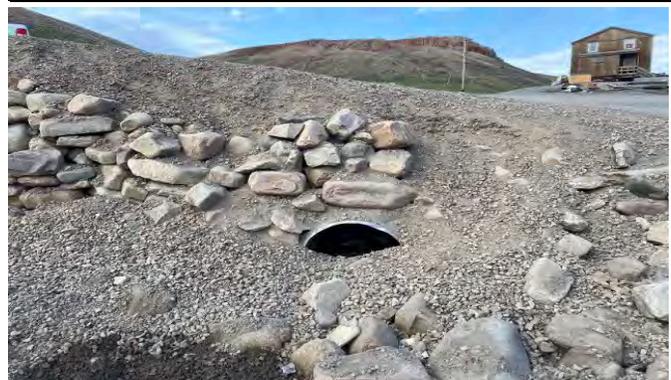
| Culvert Information | | | | |
|--|--|---|---|---|
| Other Comments | Good overall condition except for some riprap material obstructing the inlet/outlet areas. | | | |

| Recommended Action(s): | Clean inlet/outlet area |

| Priority: | Medium |

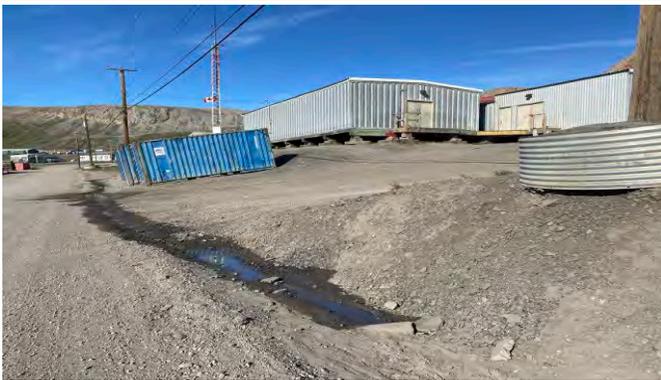
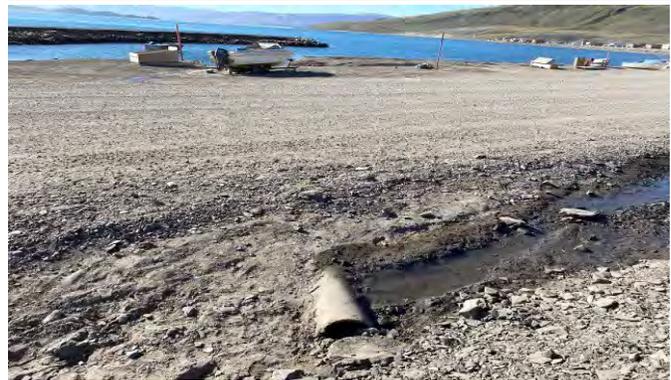
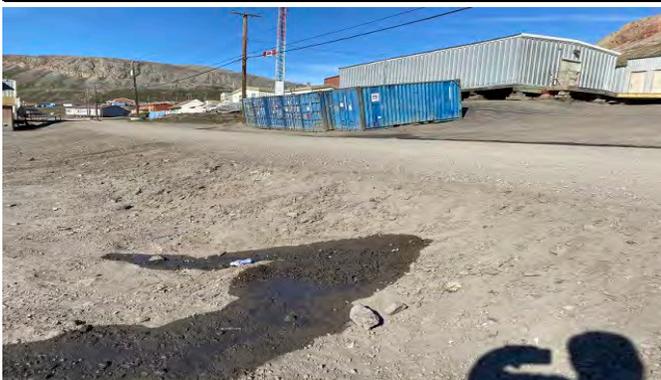
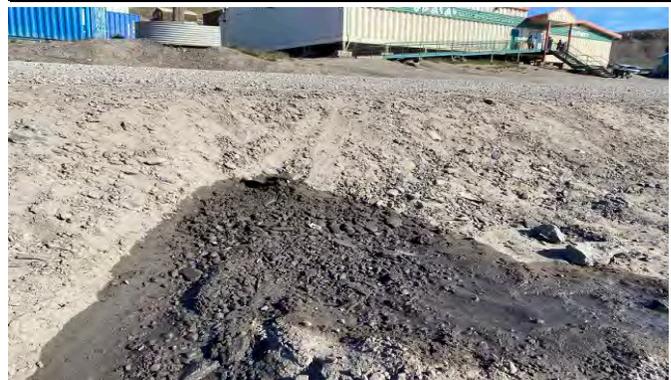
| Culvert Information | | | | |
|--|---|---|---|---|
| Other Comments | Improvised culvert using metal pipe (foundation pile), poorly placed inlet, with outlet inflilled by embankment material. | | | |

| Recommended Action(s): | Excavate and replace by 500 mm culvert |

| Priority: | Medium |

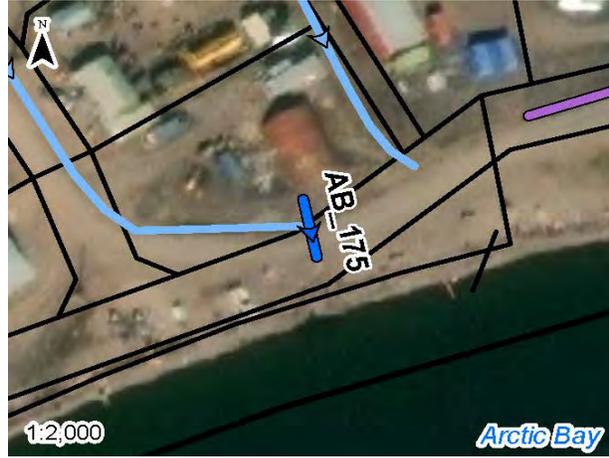
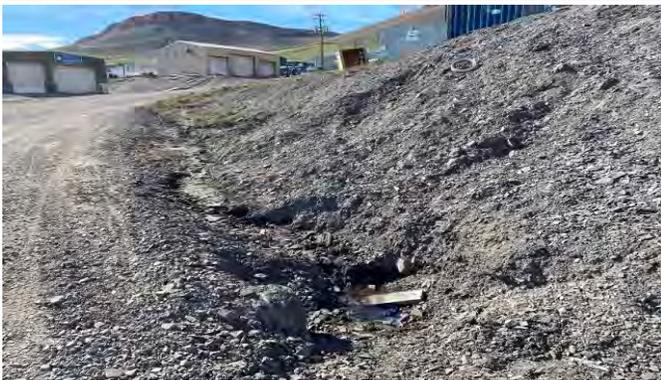
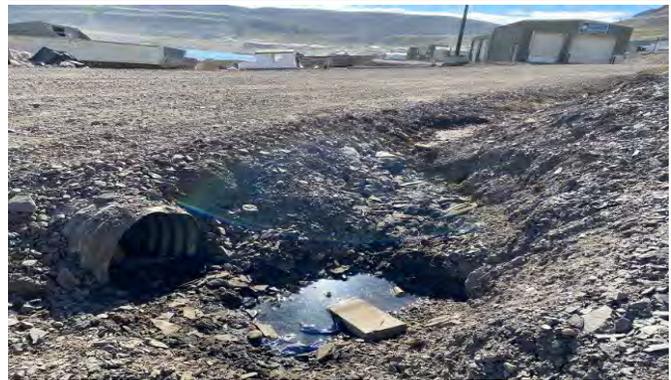
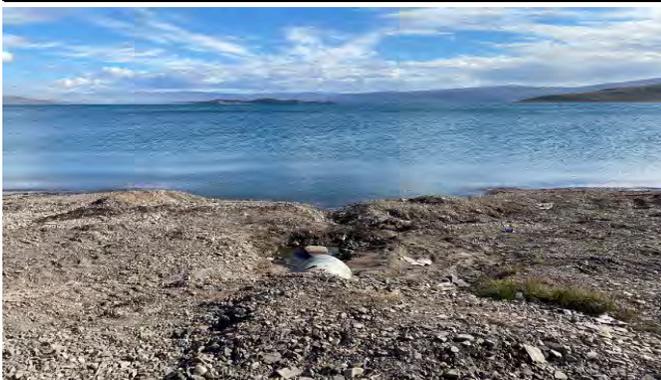
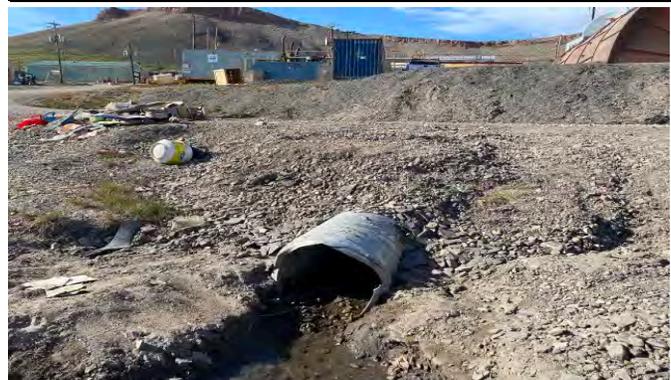
| Culvert Information | | | | |
|--|--|---|---|---|
| Other Comments | Signs of recent excavation in the ditch. Loose debris expected to cause future infill of the inlet area. | | | |

| Recommended Action(s): | Clean inlet/outlet if infill, excavate ditch |

| Priority: | Medium |

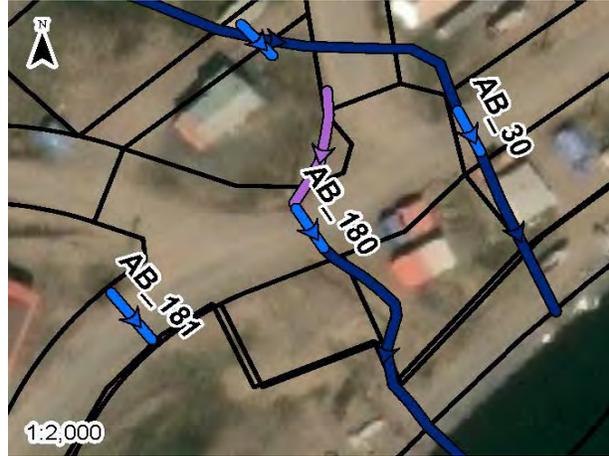
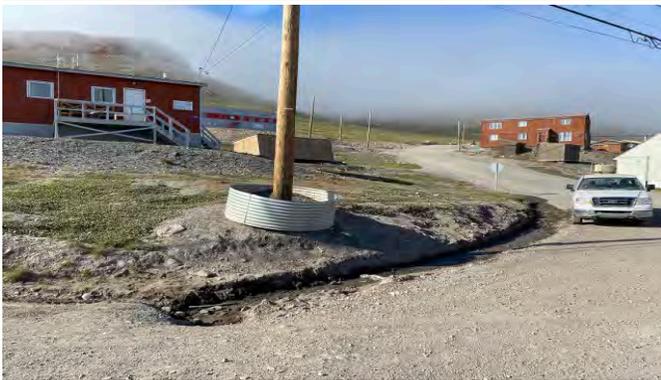
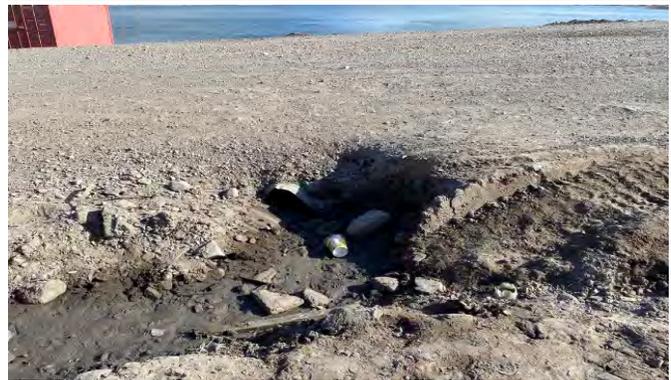
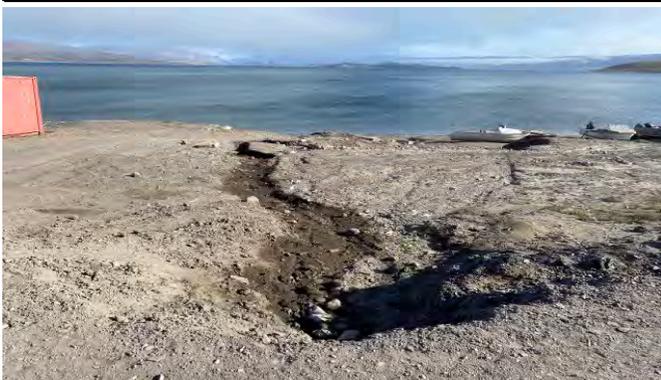
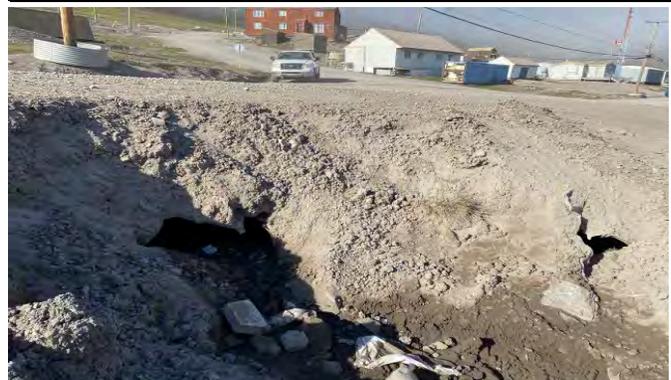
| Culvert Information | | | | |
|--|--|---|---|---|
| Other Comments | Long culvert across road and pad below. Erosion noted at outlet. | | | |

| Recommended Action(s): | Repair/extend inlet and outlet; apply erosion control |

| Priority: | High |

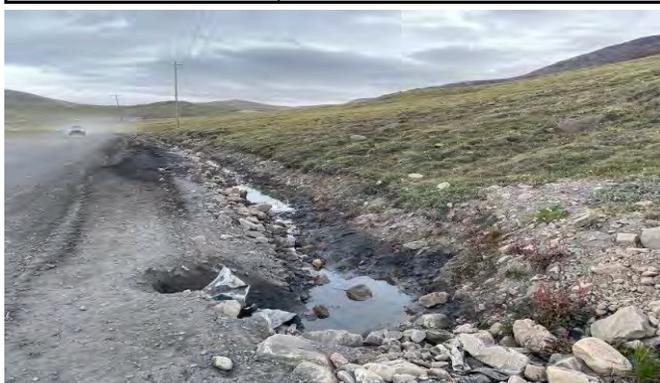
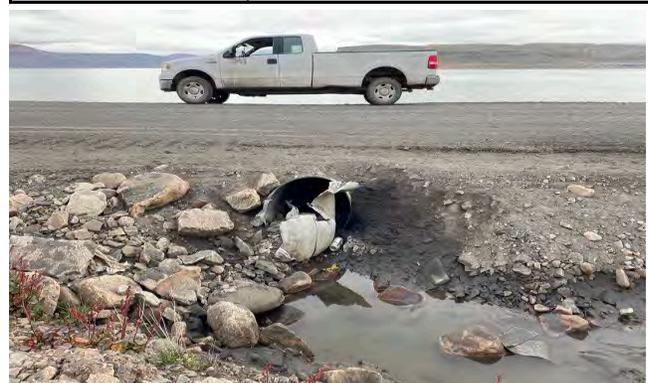
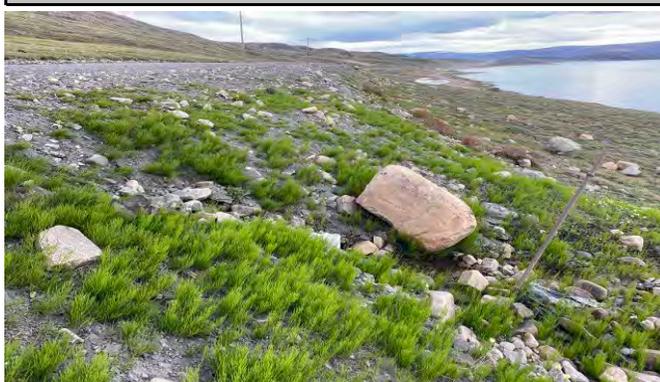
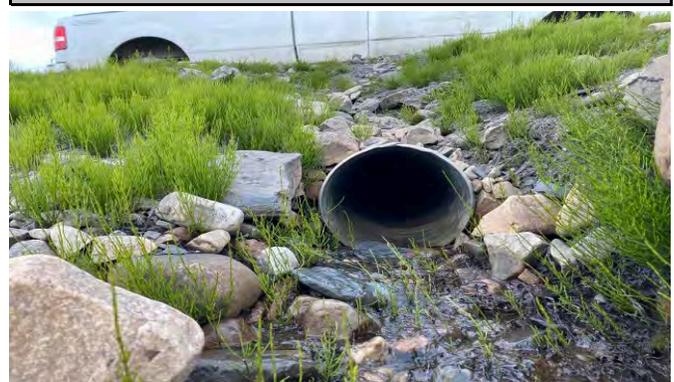
| Culvert Information | | | | |
|--|--|---|---|---|
| Other Comments | Culvert is 500 mm at inlet, 300 mm at outlet. Cracking alongside the embankment, above from outlet. | | | |

| Recommended Action(s): | Repair crushed inlet; embankment repair |

| Priority: | Low |
