**Geotechnical Evaluation and Drainage Planning
in Arctic Bay, Nunavut**

Arctic Bay, NU

Final Report
REV-02

Prepared by:
Nunami Stantec Limited

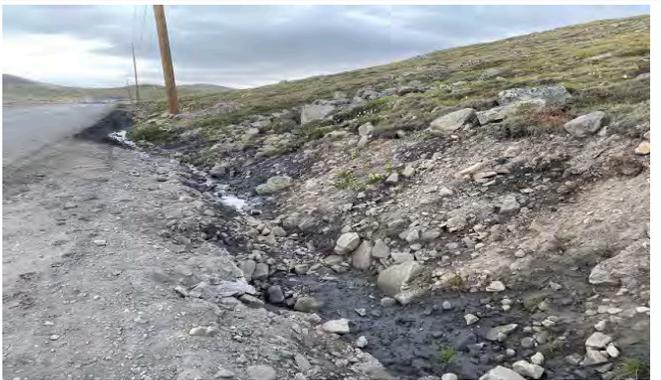
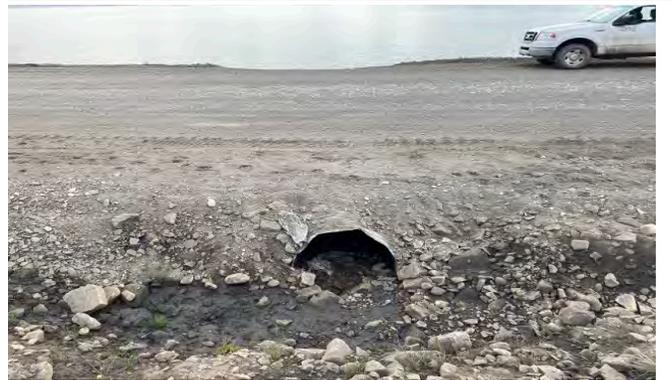
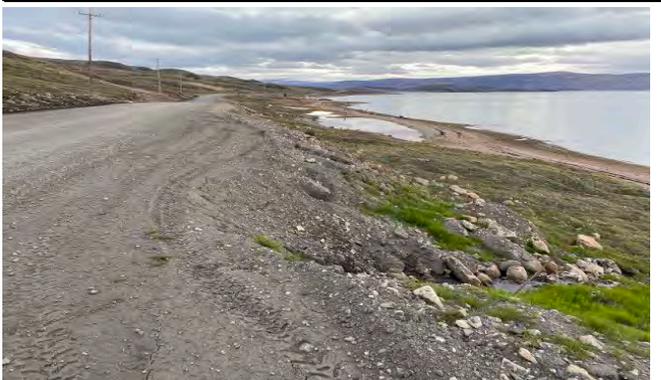
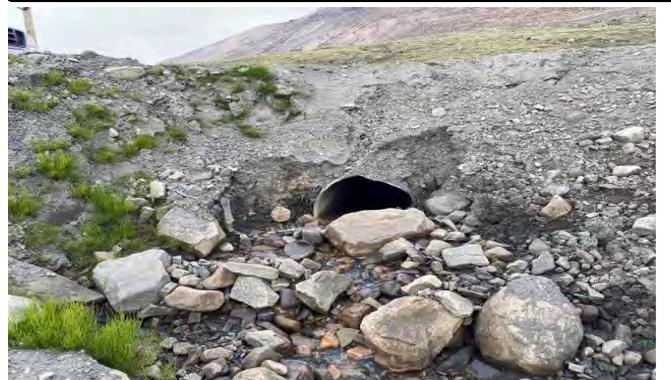
| Culvert Information | | | | |
|--|--|---|---|---|
| Other Comments | Sediments in the ditch. Erosion of the embankment at outlet. Roadway hazard. | | | |

| Recommended Action(s): | Clean inlet of infill; extend outlet; apply erosion control at outlet |

| Priority: | Medium |
