# **Geotechnical Evaluation and Drainage Planning in Baker Lake, Nunavut**

*Final Report Rev-00*

**The Municipality of Baker Lake, Nunavut**

**Nunami Stantec Limited**

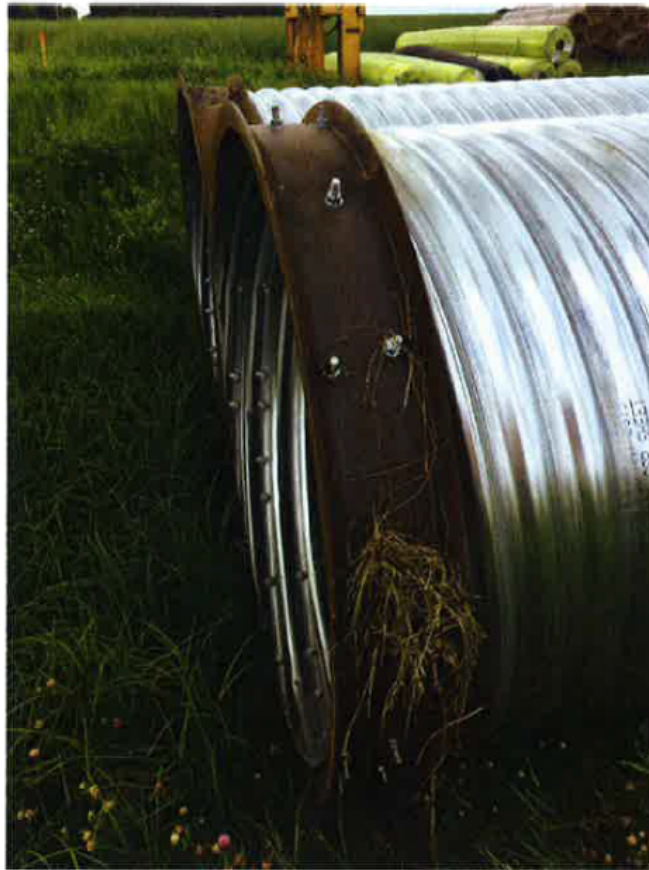
**Figure 4-1: Culvert End Treatment - Culvert End Stiffener (Figure 17 from CSA 2020)**

**Note:** This culvert end stiffener detail was developed by the Ministry of Transportation in Saskatchewan (2018). Originally intended for large diameter culverts (1.8 to 2.4 m diameter), a similar detail would also be useful for the smaller diameter culverts commonly seen in the communities. A wider stiffener band could be considered for culvert sections more prone to damage from maintenance equipment or crushing from traffic.

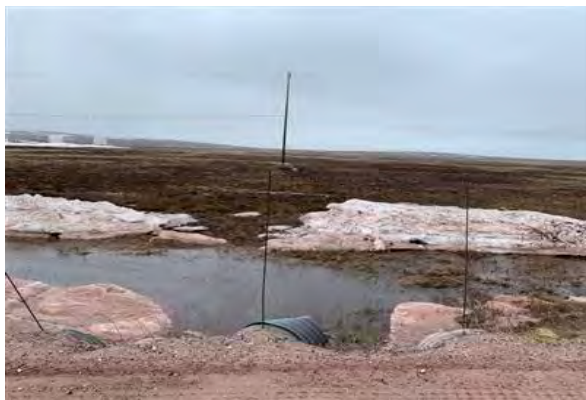
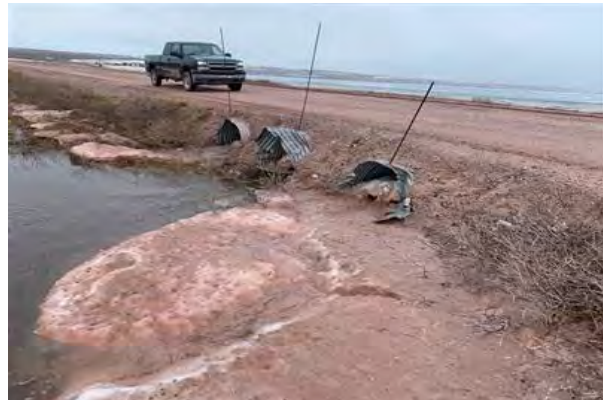
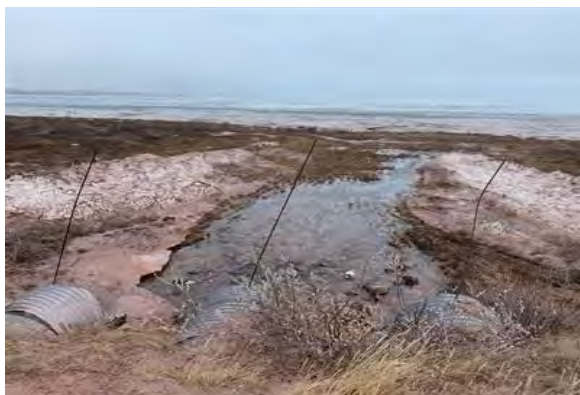
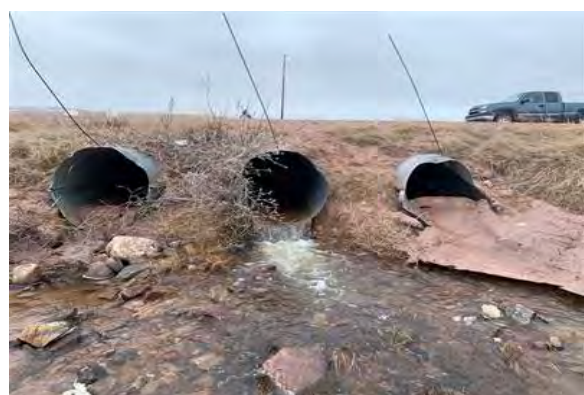
Culvert Information		
Culvert ID		102-01
Type		Cross
Shape		Round
Material		Csp
Diameter or Dimensions (mm)		1600
Marker Post Present		Y
End Crushing	Upstream	Y
	Downstream	N
Infill Depth (mm)	Upstream	0
	Downstream	0
Other		None
Comments

Recommended Action(s):	repair culvert end	Priority:	Medium
------------------------	--------------------	-----------	--------

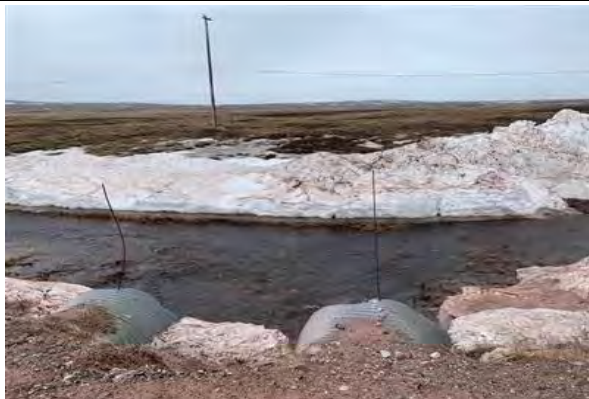
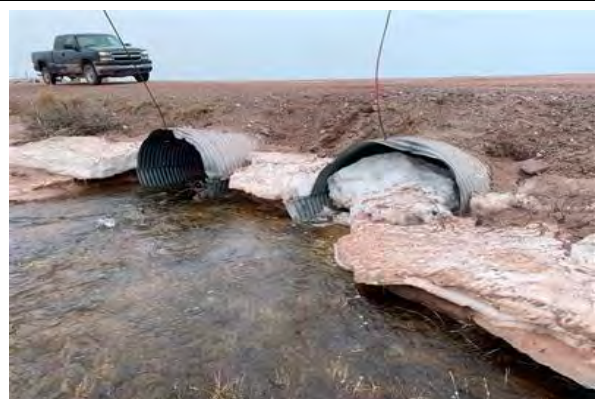
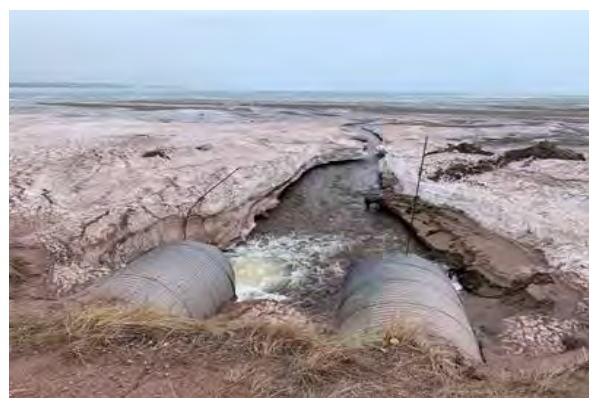
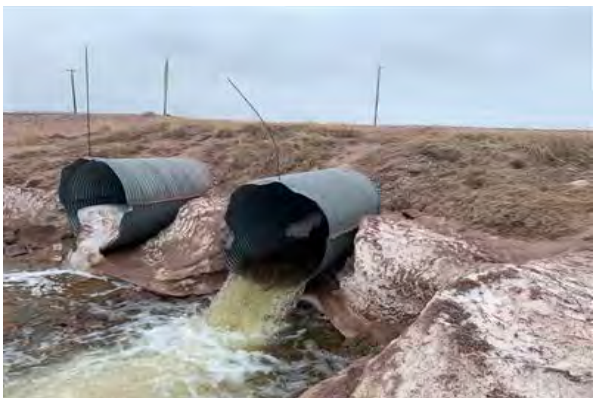
Culvert Condition Ratings (MTO 2013)				
Barrel Material (0-4)	Shape (0-4)	Capacity (0-2)	Erosion and Scour (0-2)	US/DS Channel (0-2)
0	2	0	1	1

Culvert Information		
Culvert ID		103-01
Type		Cross
Shape		Round
Material		Csp
Diameter or Dimensions (mm)		500
Marker Post Present		N
End Crushing	Upstream	N
	Downstream	Y
Infill Depth (mm)	Upstream	0
	Downstream	0
Other Comments	None

Recommended Action(s):	repair culvert end	Priority:	Medium
------------------------	--------------------	-----------	--------

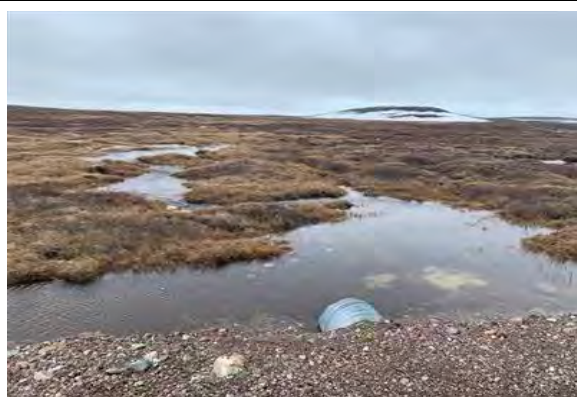
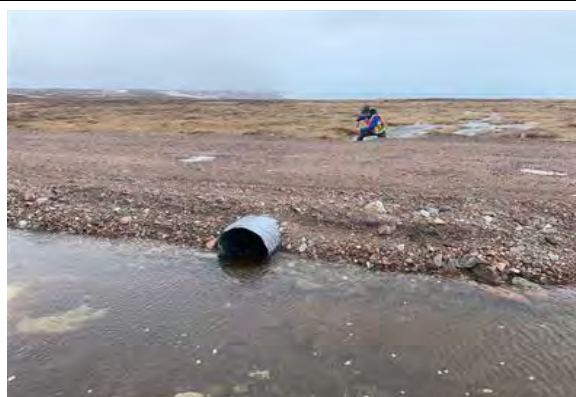
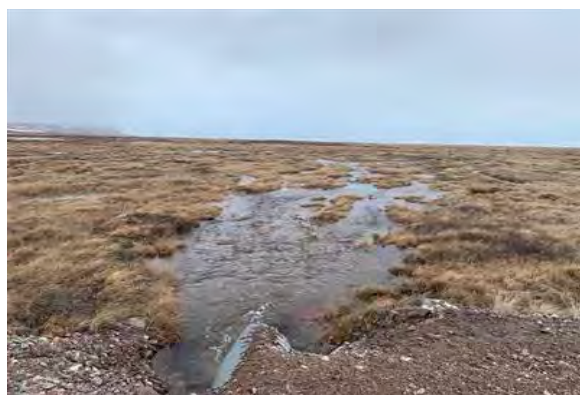
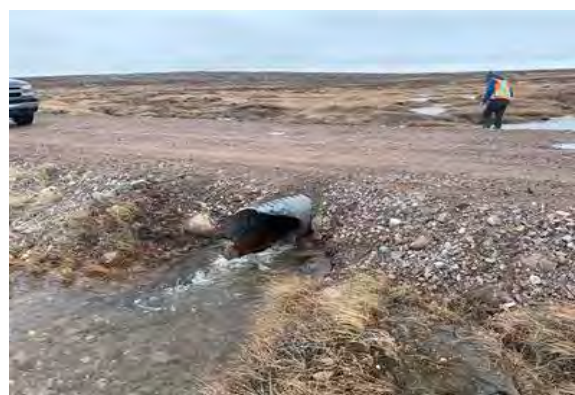
Culvert Information		
Culvert ID		103-02
Type		Cross
Shape		Round
Material		Csp
Diameter or Dimensions (mm)		500
Marker Post Present		N
End Crushing	Upstream	Y
	Downstream	Y
Infill Depth (mm)	Upstream	0
	Downstream	0
Other Comments	None

Recommended Action(s):	No action	Priority:	Low
------------------------	-----------	-----------	-----

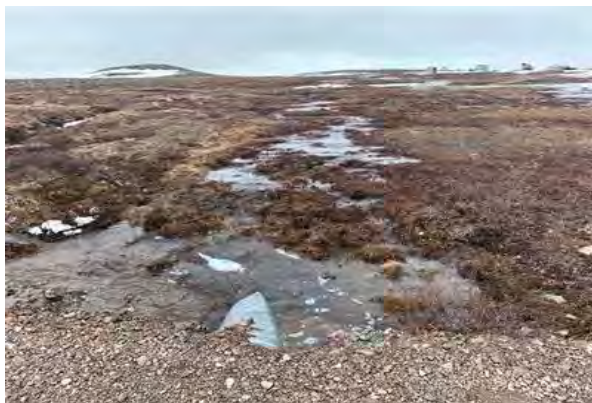
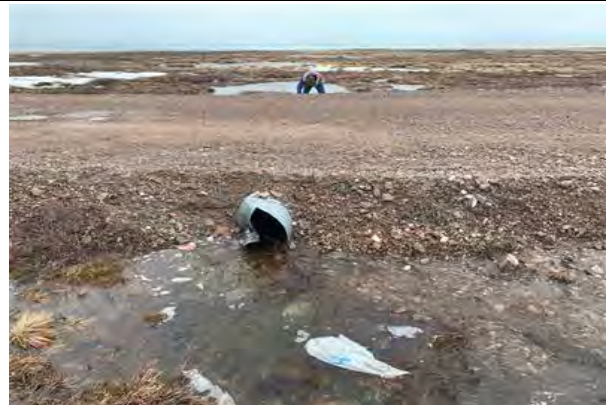
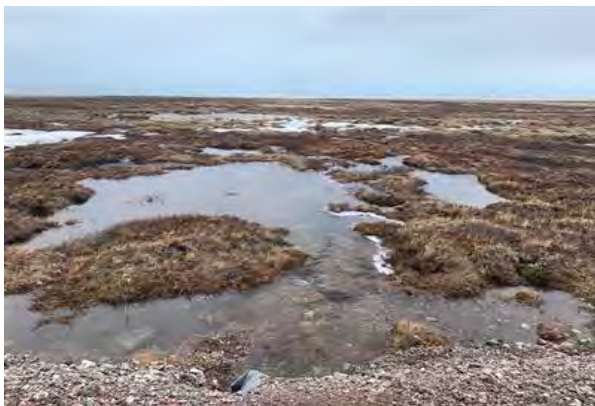
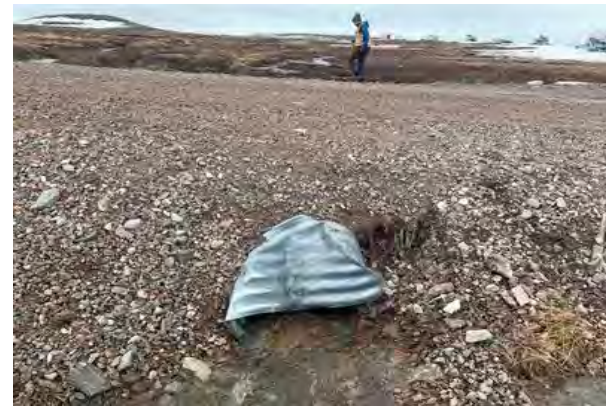
Culvert Information		
Culvert ID		103-03
Type		Cross
Shape		Round
Material		Csp
Diameter or Dimensions (mm)		800
Marker Post Present		N
End Crushing	Upstream	N
	Downstream	N
Infill Depth (mm)	Upstream	0
	Downstream	0
Other		None
Comments

Recommended Action(s):	Replace	Priority:	High
------------------------	---------	-----------	------

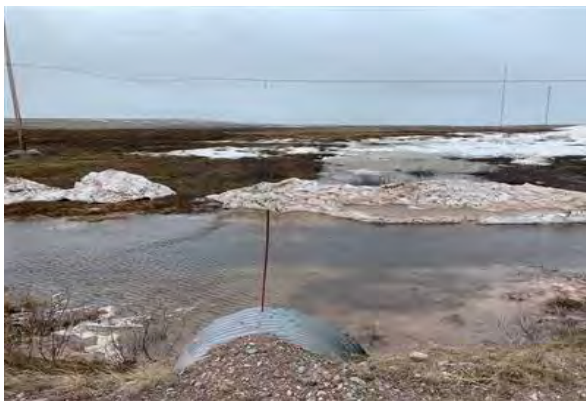
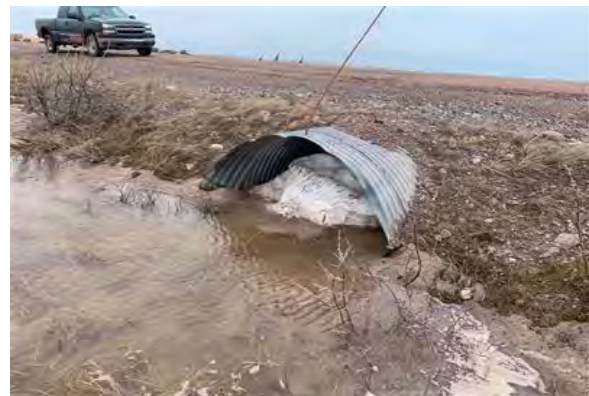
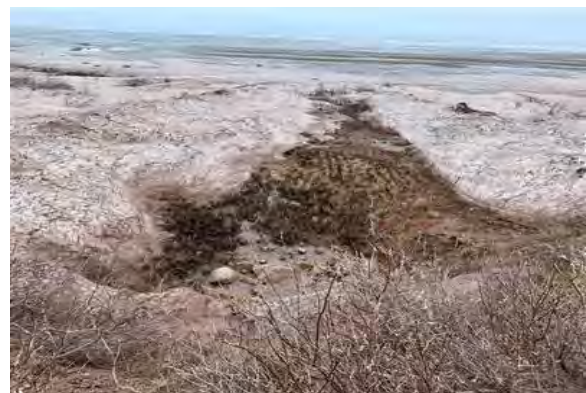
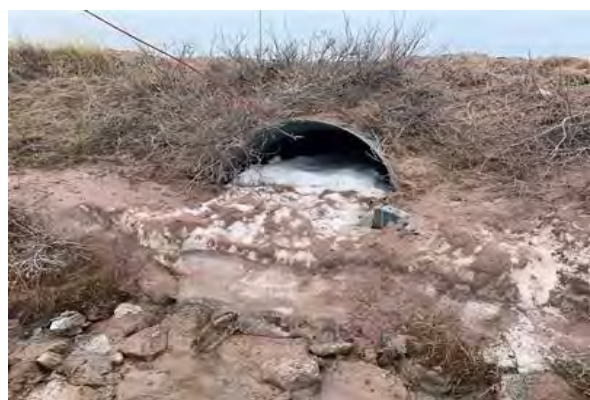
Culvert Information		
Culvert ID		103-04
Type		Cross
Shape		Round
Material		Csp
Diameter or Dimensions (mm)		1600
Marker Post Present		Y
End Crushing	Upstream	N
	Downstream	N
Infill Depth (mm)	Upstream	200
	Downstream	0
Other		None
Comments

Culvert Condition Ratings (MTO 2013)				
Barrel Material (0-4)	Shape (0-4)	Capacity (0-2)	Erosion and Scour (0-2)	US/DS Channel (0-2)
0	0	1	1	0

Recommended Action(s):	Flush	Priority:	High
------------------------	-------	-----------	------

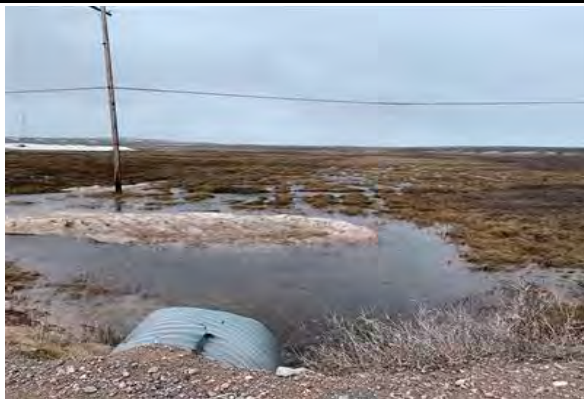
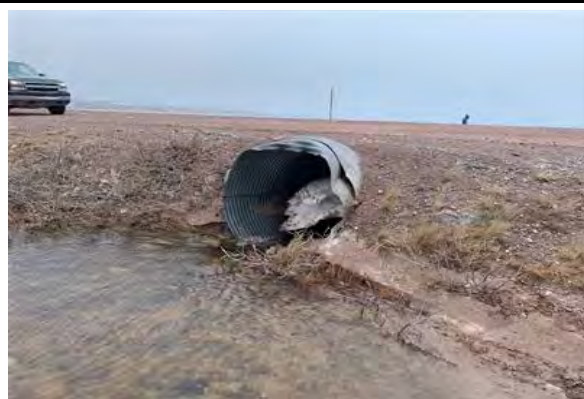
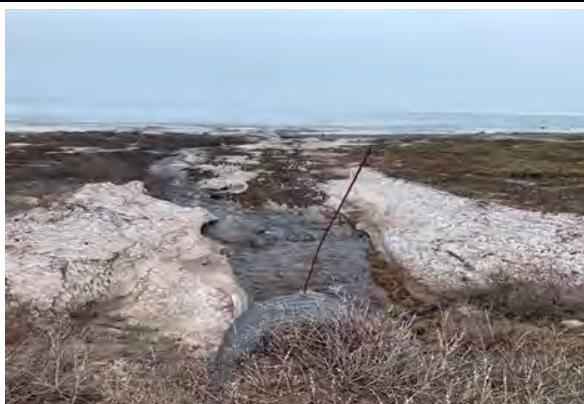
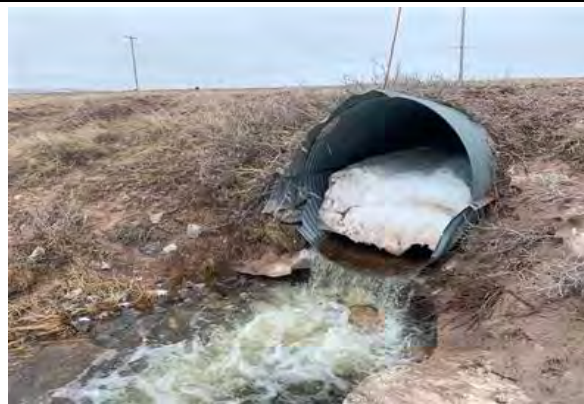
Culvert Information		
Culvert ID		104-01
Type		Cross
Shape		Round
Material		Csp
Diameter or Dimensions (mm)		1600
Marker Post Present		Y
End Crushing	Upstream	Y
	Downstream	Y
Infill Depth (mm)	Upstream	0
	Downstream	0
Other		None
Comments

Culvert Condition Ratings (MTO 2013)				
Barrel Material (0-4)	Shape (0-4)	Capacity (0-2)	Erosion and Scour (0-2)	US/DS Channel (0-2)
0	1	0	1	0

Recommended Action(s):	No action	Priority:	Low
------------------------	-----------	-----------	-----

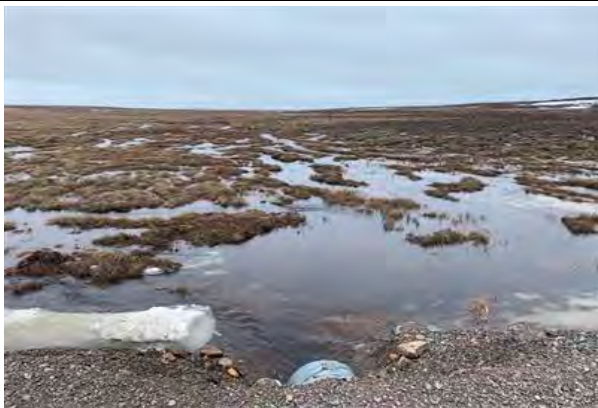
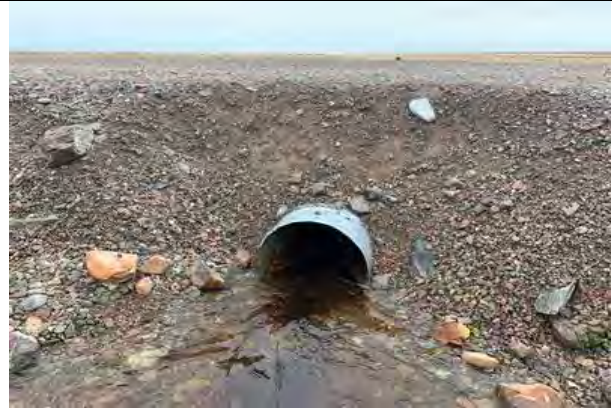
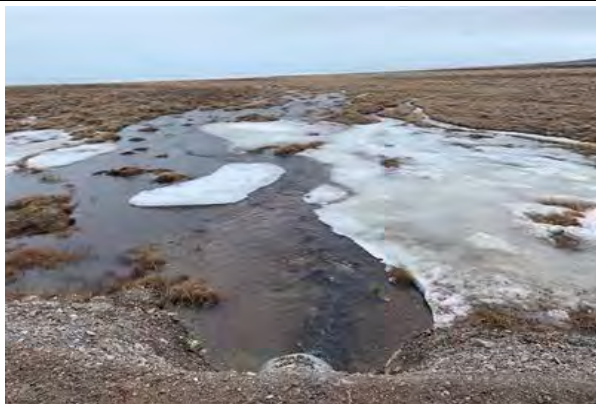
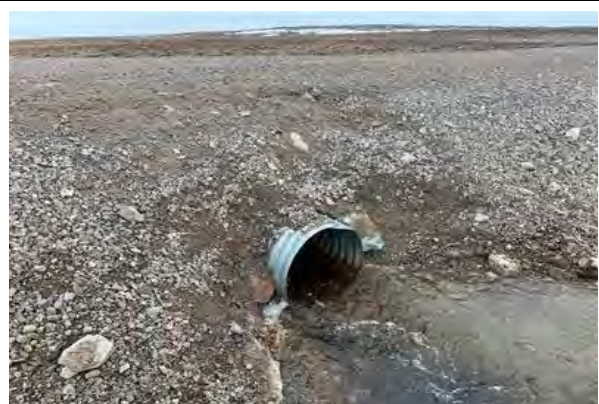
Culvert Information		
Culvert ID		105-01
Type		Cross
Shape		Round
Material		Csp
Diameter or Dimensions (mm)		600
Marker Post Present		N
End Crushing	Upstream	N
	Downstream	N
Infill Depth (mm)	Upstream	0
	Downstream	0
Other Comments	None

Culvert Condition Ratings (MTO 2013)				
Barrel Material (0-4)	Shape (0-4)	Capacity (0-2)	Erosion and Scour (0-2)	US/DS Channel (0-2)
0	0	0	1	0

Recommended Action(s):	No action	Priority:	Low
------------------------	-----------	-----------	-----

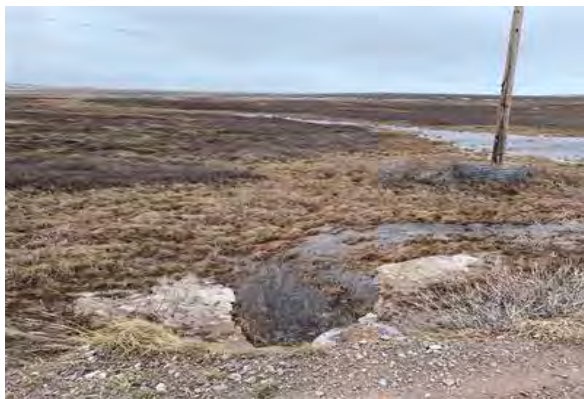
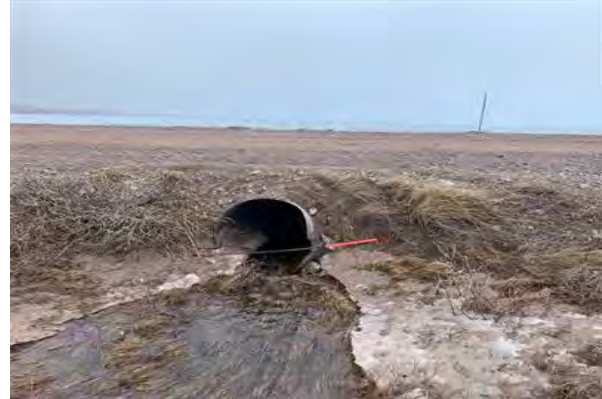
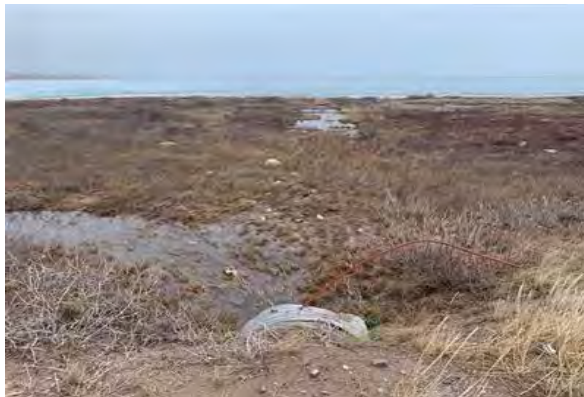
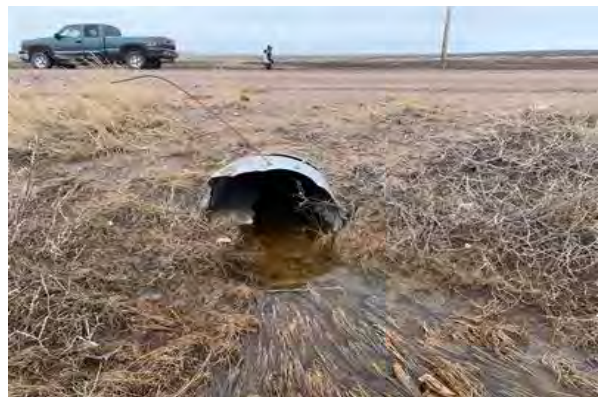
Culvert Information		
Culvert ID		105-02
Type		Cross
Shape		Round
Material		Csp
Diameter or Dimensions (mm)		1000
Marker Post Present		Y
End Crushing	Upstream	Y
	Downstream	Y
Infill Depth (mm)	Upstream	150
	Downstream	200
Other		None
Comments

Culvert Condition Ratings (MTO 2013)				
Barrel Material (0-4)	Shape (0-4)	Capacity (0-2)	Erosion and Scour (0-2)	US/DS Channel (0-2)
0	1	1	1	0

Recommended Action(s):	Flush	Priority:	High
------------------------	-------	-----------	------

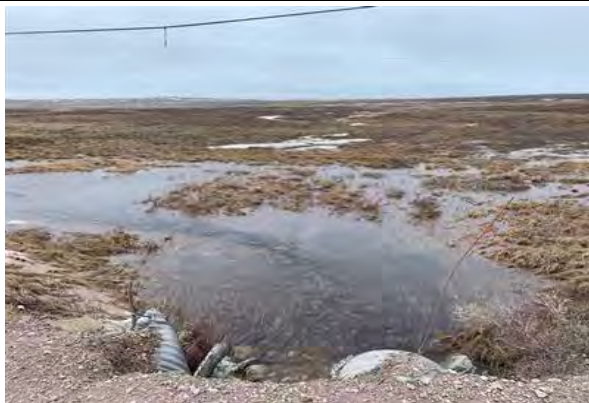
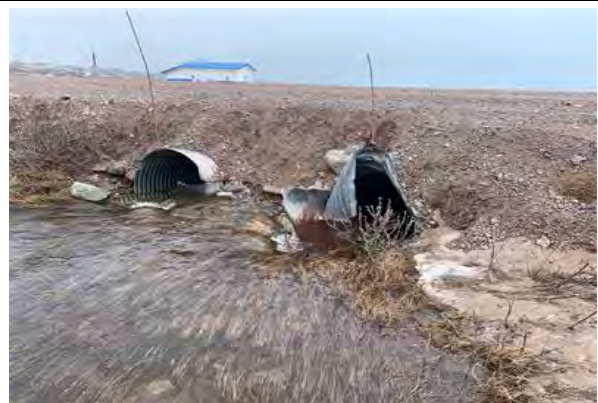
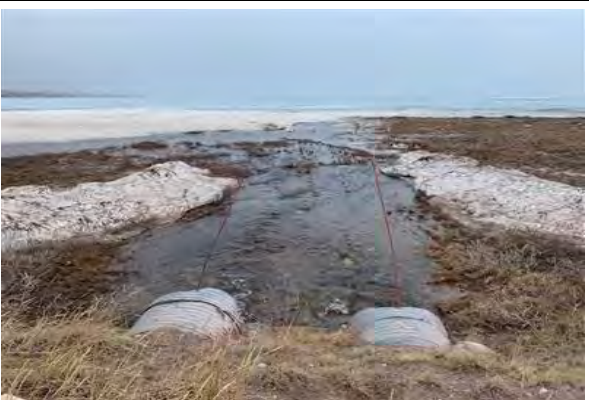
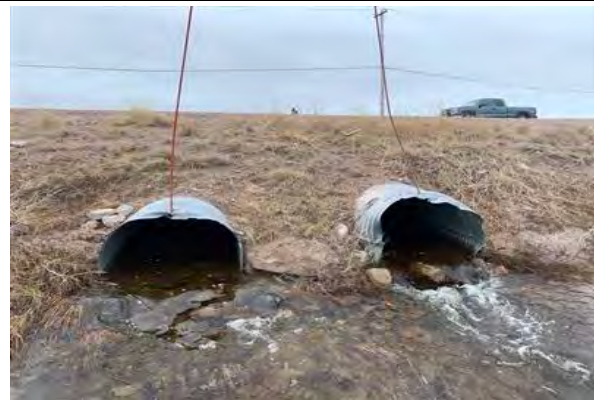
Culvert Information		
Culvert ID		105-03
Type		Cross
Shape		Round
Material		Csp
Diameter or Dimensions (mm)		1000
Marker Post Present		Y
End Crushing	Upstream	Y
	Downstream	N
Infill Depth (mm)	Upstream	0
	Downstream	200
Other		None
Comments

Culvert Condition Ratings (MTO 2013)				
Barrel Material (0-4)	Shape (0-4)	Capacity (0-2)	Erosion and Scour (0-2)	US/DS Channel (0-2)
0	3	1	1	0

Recommended Action(s):	Replace	Priority:	High
------------------------	---------	-----------	------

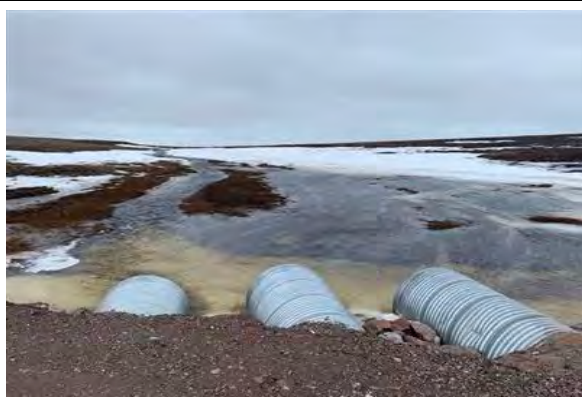
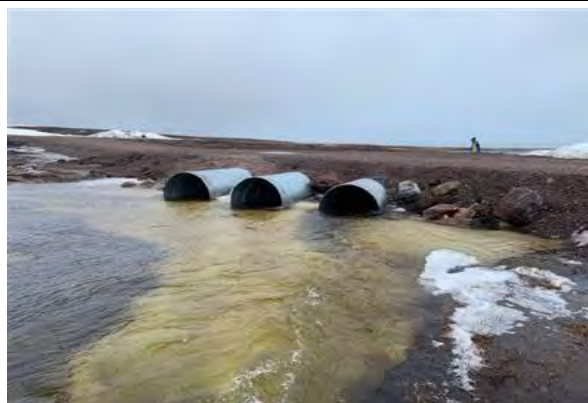
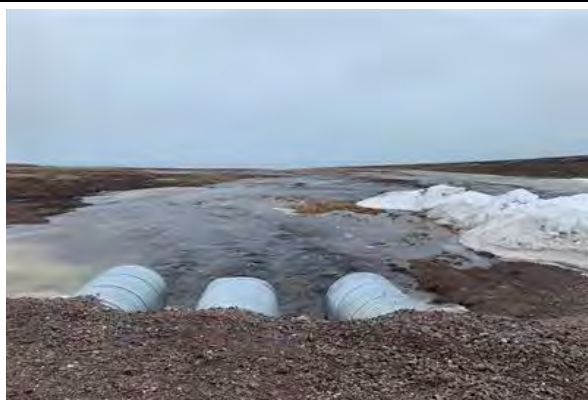
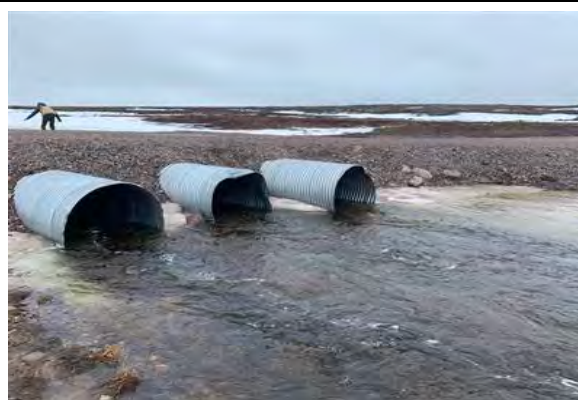
Culvert Information		
Culvert ID		106-01
Type		Cross
Shape		Round
Material		Csp
Diameter or Dimensions (mm)		1100
Marker Post Present		N
End Crushing	Upstream	N
	Downstream	N
Infill Depth (mm)	Upstream	0
	Downstream	0
Other Comments	None

Culvert Condition Ratings (MTO 2013)				
Barrel Material (0-4)	Shape (0-4)	Capacity (0-2)	Erosion and Scour (0-2)	US/DS Channel (0-2)
0	0	0	0	0

Recommended Action(s):	No action	Priority:	None
------------------------	-----------	-----------	------

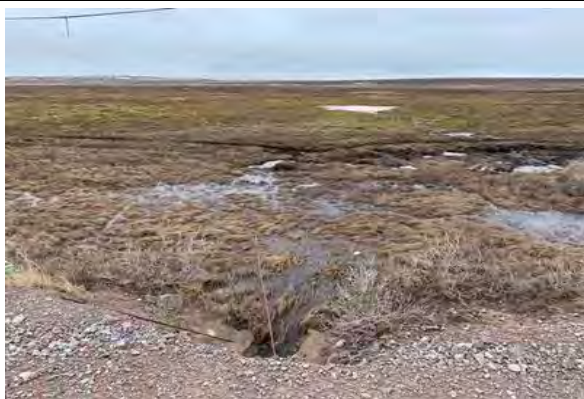
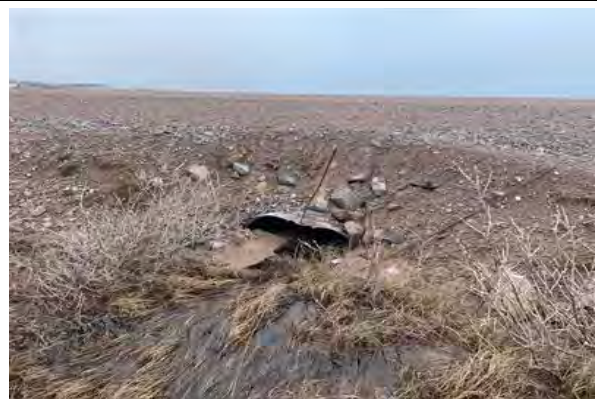
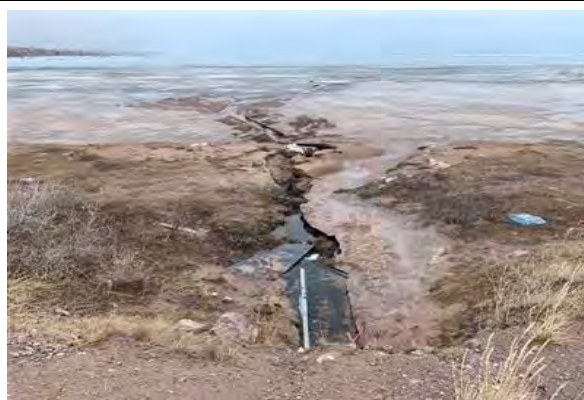
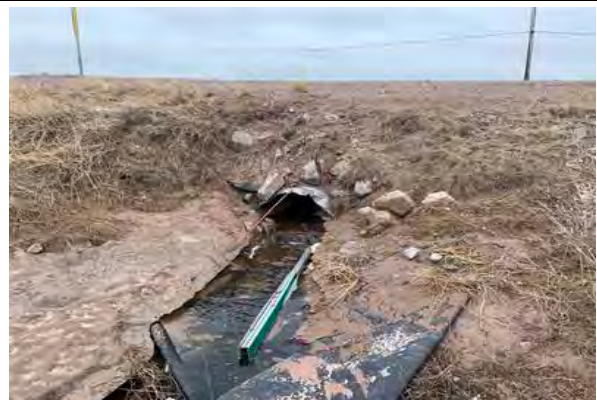
Culvert Information		
Culvert ID		106-02
Type		Cross
Shape		Round
Material		Csp
Diameter or Dimensions (mm)		1000
Marker Post Present		Y
End Crushing	Upstream	Y
	Downstream	Y
Infill Depth (mm)	Upstream	500
	Downstream	500
Other Comments	Upstream end crushed, infilled

Culvert Condition Ratings (MTO 2013)				
Barrel Material (0-4)	Shape (0-4)	Capacity (0-2)	Erosion and Scour (0-2)	US/DS Channel (0-2)
0	3	2	2	1

Recommended Action(s):	Replace	Priority:	High
------------------------	---------	-----------	------

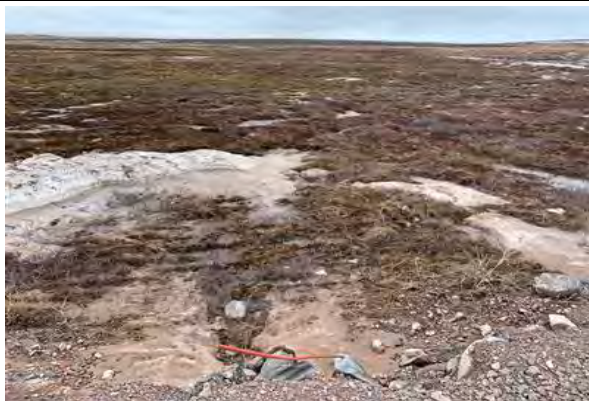
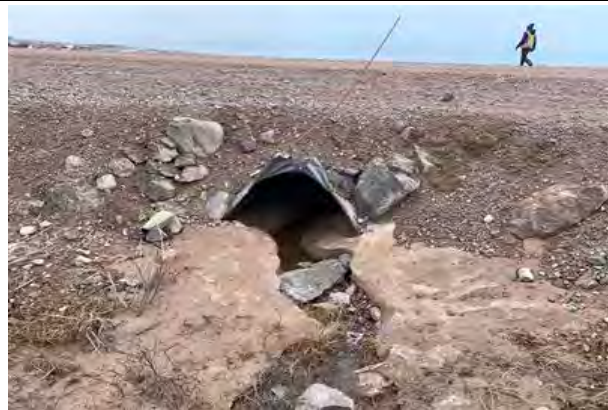
Culvert Information		
Culvert ID		106-03
Type		Cross
Shape		Round
Material		Csp
Diameter or Dimensions (mm)		1000
Marker Post Present		Y
End Crushing	Upstream	Y
	Downstream	Y
Infill Depth (mm)	Upstream	150
	Downstream	150
Other		None
Comments

Culvert Condition Ratings (MTO 2013)				
Barrel Material (0-4)	Shape (0-4)	Capacity (0-2)	Erosion and Scour (0-2)	US/DS Channel (0-2)
0	2	1	1	0

Recommended Action(s):	Flush	Priority:	High
------------------------	-------	-----------	------

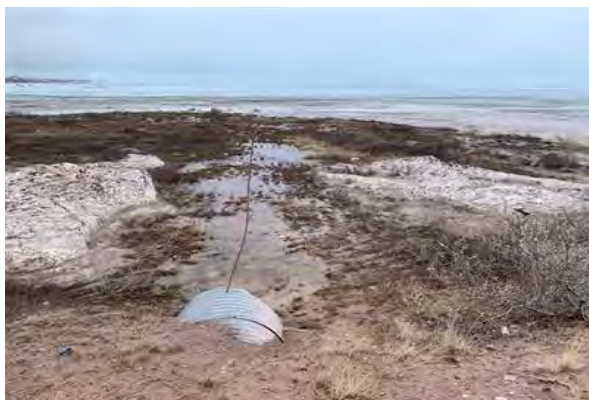
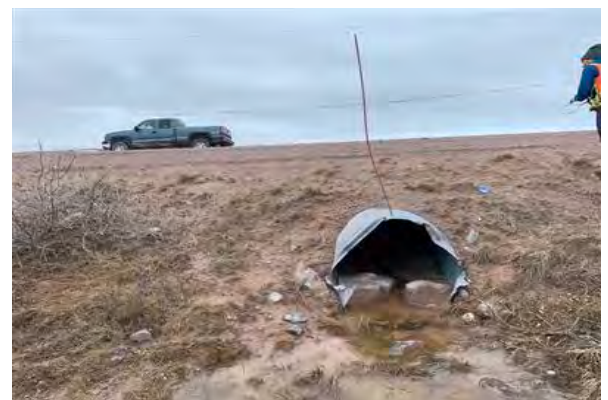
Culvert Information		
Culvert ID		106-04
Type		Cross
Shape		Round
Material		Csp
Diameter or Dimensions (mm)		1500
Marker Post Present		Y
End Crushing	Upstream	Y
	Downstream	Y
Infill Depth (mm)	Upstream	0
	Downstream	0
Other		None
Comments

Recommended Action(s):	Repair culvert end	Priority:	Low
------------------------	--------------------	-----------	-----

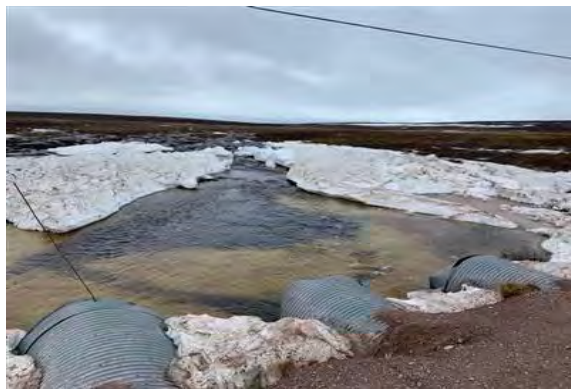
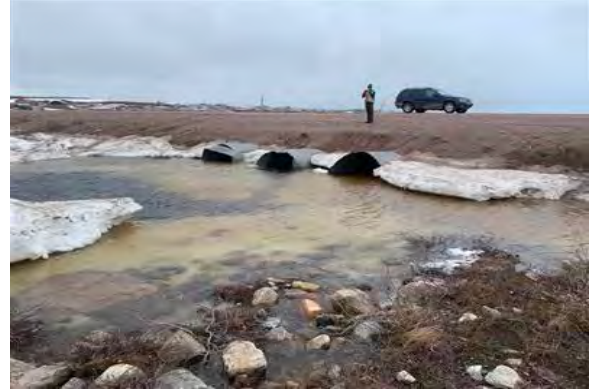
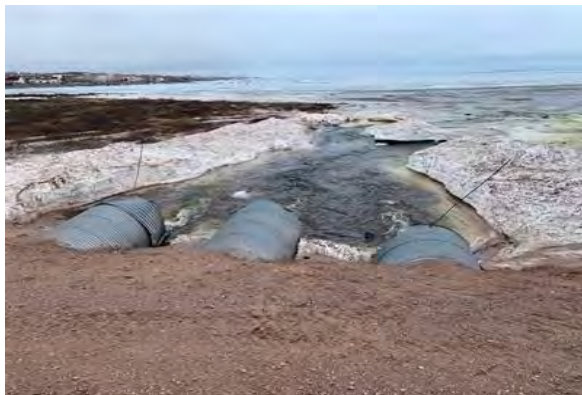
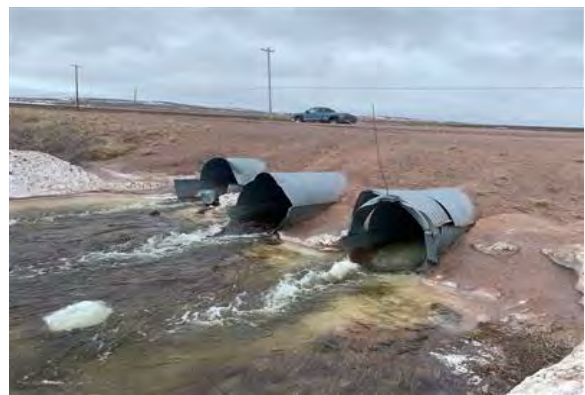
Culvert Information		
Culvert ID		107-01
Type		Cross
Shape		Round
Material		Csp
Diameter or Dimensions (mm)		600
Marker Post Present		N
End Crushing	Upstream	N
	Downstream	N
Infill Depth (mm)	Upstream	0
	Downstream	0
Other Comments	None

Culvert Condition Ratings (MTO 2013)				
Barrel Material (0-4)	Shape (0-4)	Capacity (0-2)	Erosion and Scour (0-2)	US/DS Channel (0-2)
0	0	0	0	0

Recommended Action(s):	No action	Priority:	None
------------------------	-----------	-----------	------

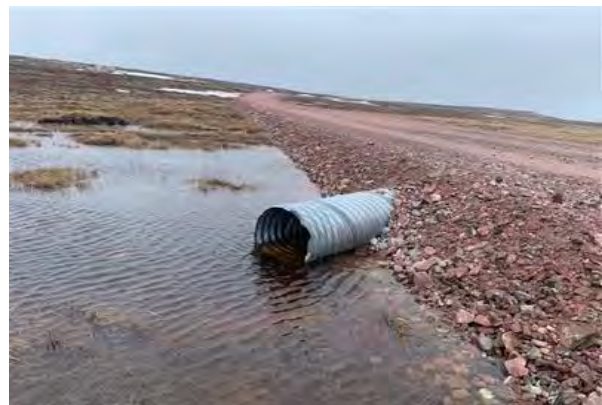
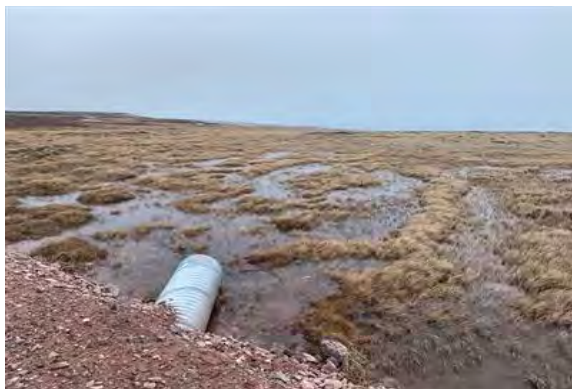
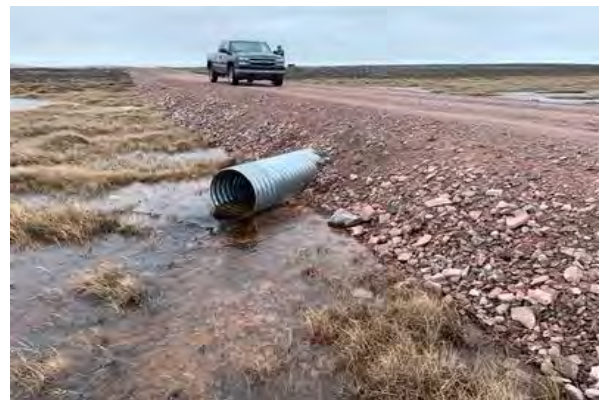
Culvert Information		
Culvert ID		107-02
Type		Cross
Shape		Round
Material		Csp
Diameter or Dimensions (mm)		1500
Marker Post Present		Y
End Crushing	Upstream	N
	Downstream	Y
Infill Depth (mm)	Upstream	0
	Downstream	0
Other		Downstream end crushed
Comments

Culvert Condition Ratings (MTO 2013)				
Barrel Material (0-4)	Shape (0-4)	Capacity (0-2)	Erosion and Scour (0-2)	US/DS Channel (0-2)
0	2	0	1	1

Recommended Action(s):	repair culvert end	Priority:	Medium
------------------------	--------------------	-----------	--------

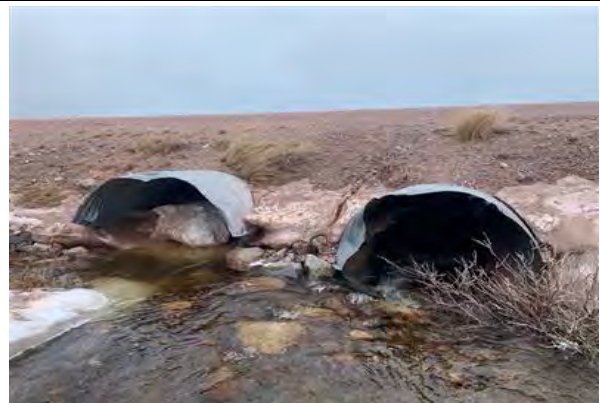
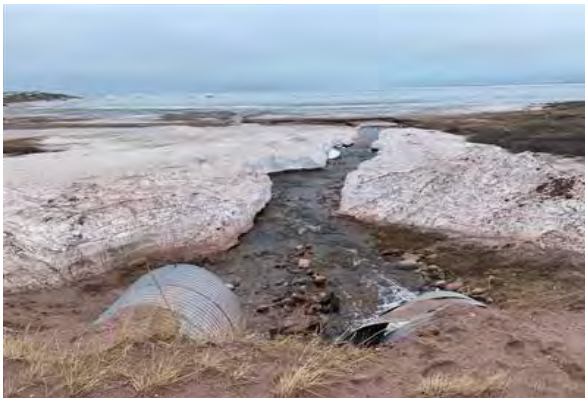
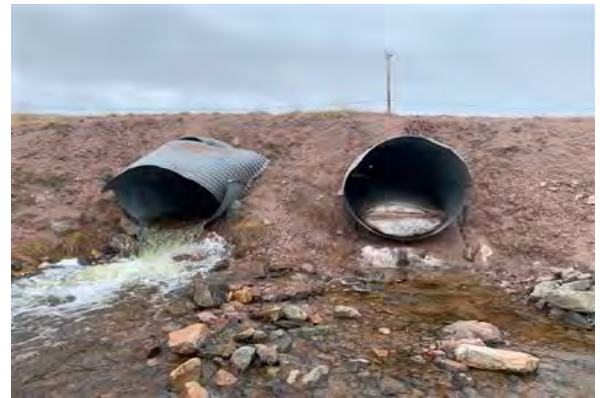
Culvert Information		
Culvert ID		108-01
Type		Cross
Shape		Round
Material		Csp
Diameter or Dimensions (mm)		600
Marker Post Present		N
End Crushing	Upstream	Y
	Downstream	Y
Infill Depth (mm)	Upstream	0
	Downstream	600
Other		None
Comments

Culvert Condition Ratings (MTO 2013)				
Barrel Material (0-4)	Shape (0-4)	Capacity (0-2)	Erosion and Scour (0-2)	US/DS Channel (0-2)
0	4	2	2	0

Recommended Action(s):	Replace	Priority:	High
------------------------	---------	-----------	------

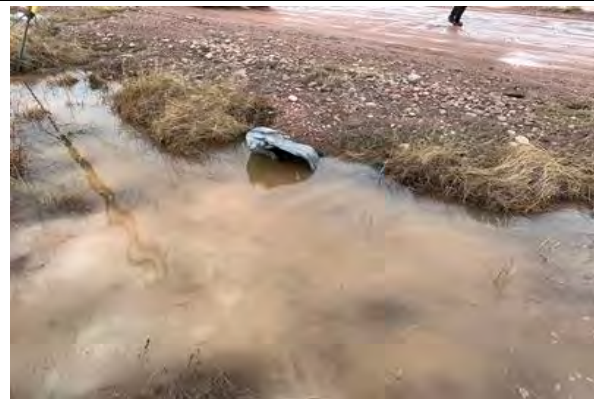
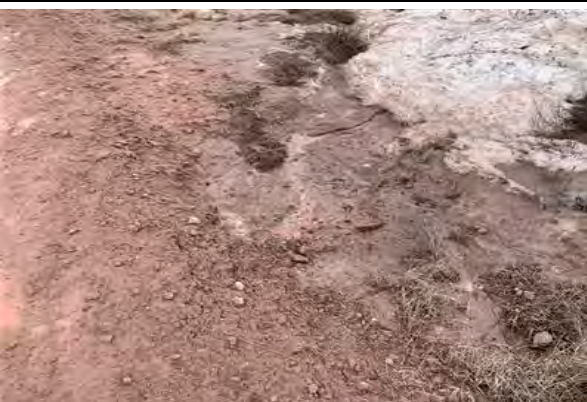
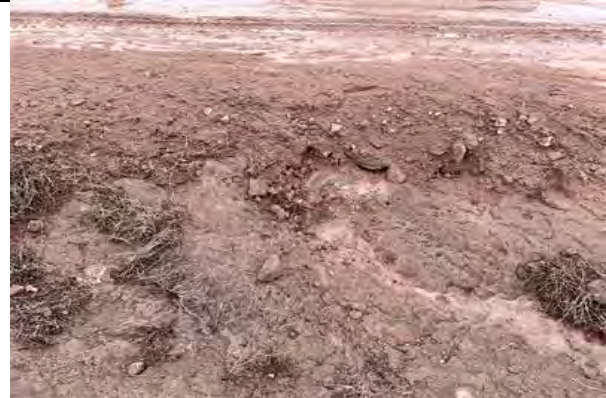
Culvert Information		
Culvert ID		108-02
Type		Cross
Shape		Round
Material		Csp
Diameter or Dimensions (mm)		600
Marker Post Present		N
End Crushing	Upstream	Y
	Downstream	Y
Infill Depth (mm)	Upstream	0
	Downstream	0
Other		None
Comments

Culvert Condition Ratings (MTO 2013)				
Barrel Material (0-4)	Shape (0-4)	Capacity (0-2)	Erosion and Scour (0-2)	US/DS Channel (0-2)
0	2	0	1	0

Recommended Action(s):	Repair culvert end	Priority:	Medium
------------------------	--------------------	-----------	--------

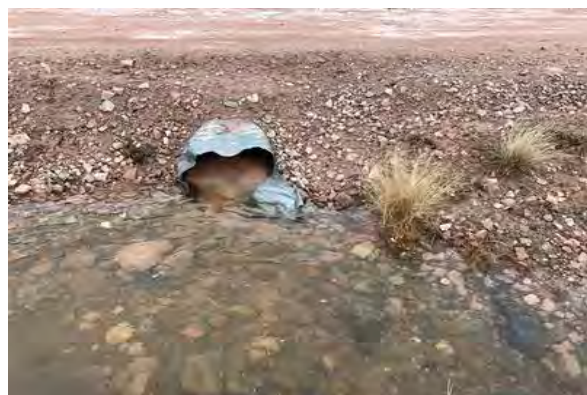
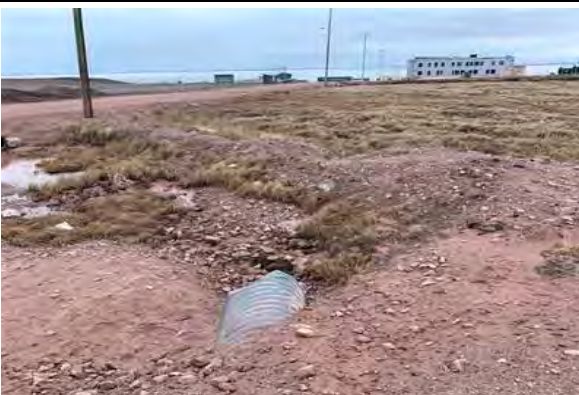
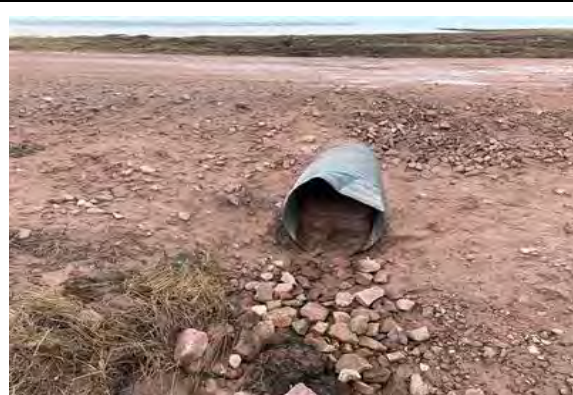
Culvert Information		
Culvert ID		108-03
Type		Cross
Shape		Round
Material		Csp
Diameter or Dimensions (mm)		600
Marker Post Present		0
End	Upstream	N
	Downstream	Y
Infill Depth (mm)	Upstream	0
	Downstream	0
Other		None
Comments

Culvert Condition Ratings (MTO 2013)				
Barrel Material (0-4)	Shape (0-4)	Capacity (0-2)	Erosion and Scour (0-2)	US/DS Channel (0-2)
0	1	0	1	1

Recommended Action(s):	No action	Priority:	Low
------------------------	-----------	-----------	-----

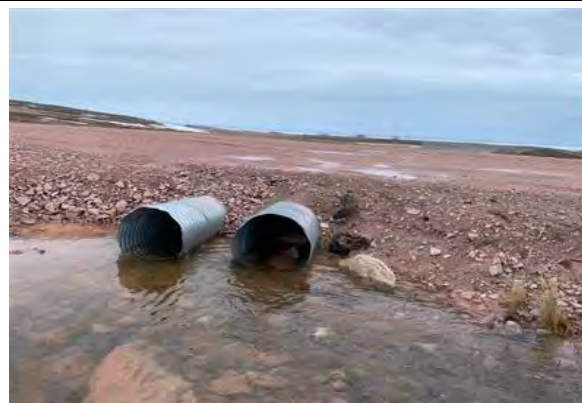
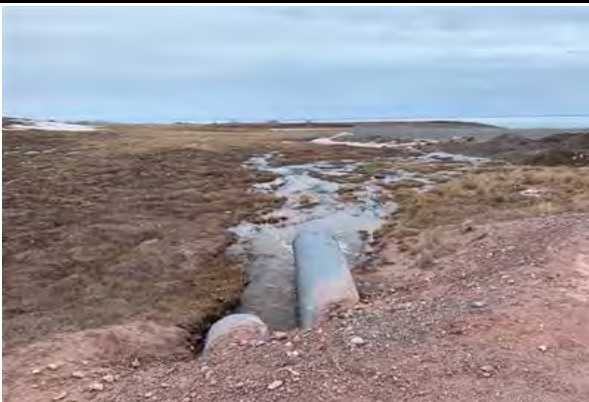
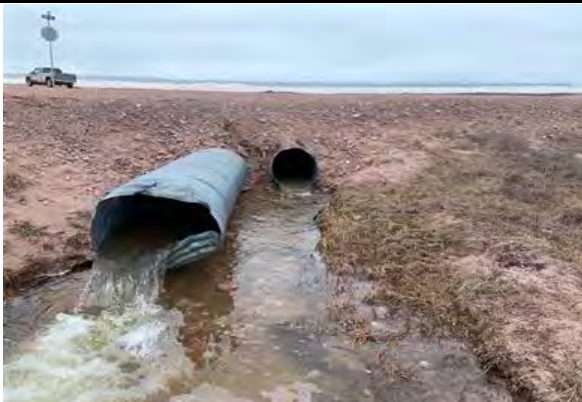
Culvert Information		
Culvert ID		108-04
Type		Cross
Shape		Round
Material		Csp
Diameter or Dimensions (mm)		600
Marker Post Present		N
End Crushing	Upstream	N
	Downstream	0
Infill Depth (mm)	Upstream	0
	Downstream	600
Other		None
Comments

Culvert Condition Ratings (MTO 2013)				
Barrel Material (0-4)	Shape (0-4)	Capacity (0-2)	Erosion and Scour (0-2)	US/DS Channel (0-2)
0	0	2	0	0

Recommended Action(s):	Flush	Priority:	High
------------------------	-------	-----------	------

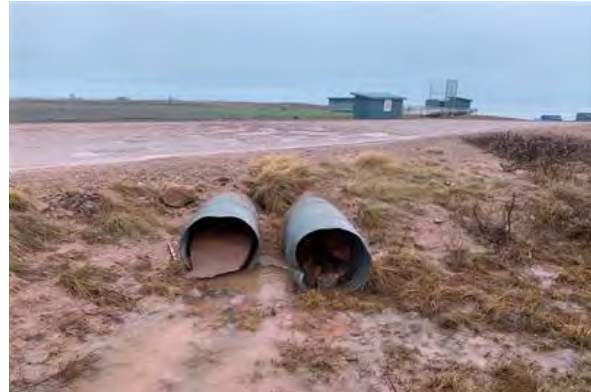
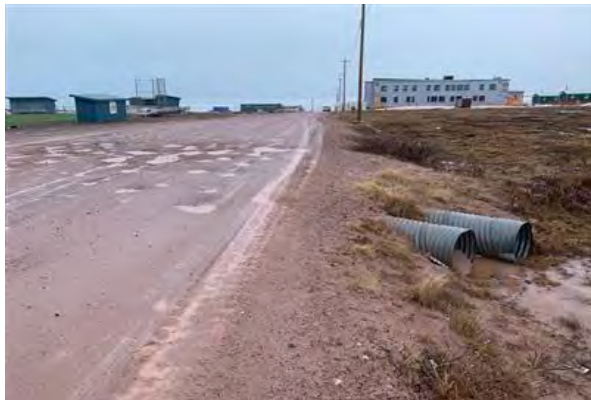
DS end of culvert not found

Culvert Condition Ratings (MTO 2013)				
Barrel Material (0-4)	Shape (0-4)	Capacity (0-2)	Erosion and Scour (0-2)	US/DS Channel (0-2)
0	4	2	1	1

Recommended Action(s):	Replace	Priority:	High
------------------------	---------	-----------	------

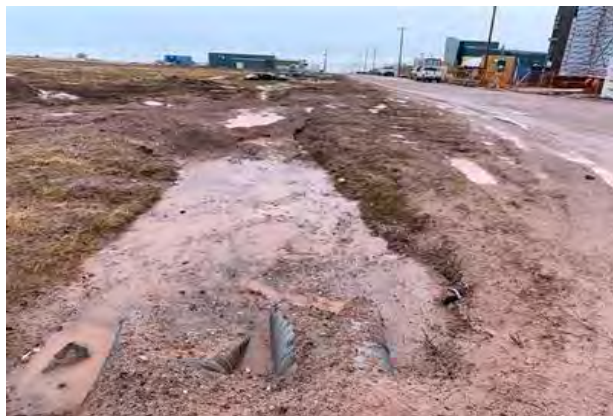
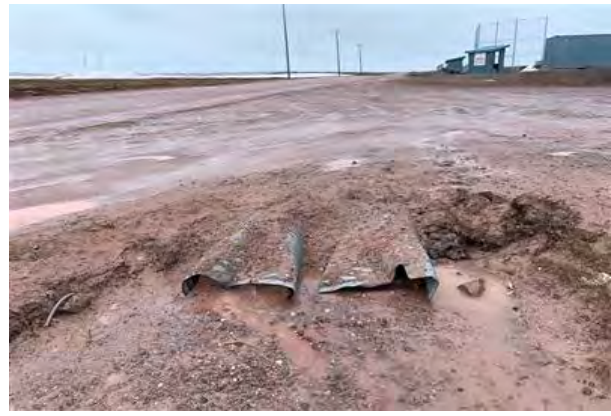
Culvert Information		
Culvert ID		108-06
Type		Entrance
Shape		Round
Material		Csp
Diameter or Dimensions (mm)		500
Marker Post Present		N
End Crushing	Upstream	Y
	Downstream	Y
Infill Depth (mm)	Upstream	100
	Downstream	300
Other		None
Comments

Culvert Condition Ratings (MTO 2013)				
Barrel Material (0-4)	Shape (0-4)	Capacity (0-2)	Erosion and Scour (0-2)	US/DS Channel (0-2)
0	4	2	2	1

Recommended Action(s):	Replace	Priority:	High
------------------------	---------	-----------	------

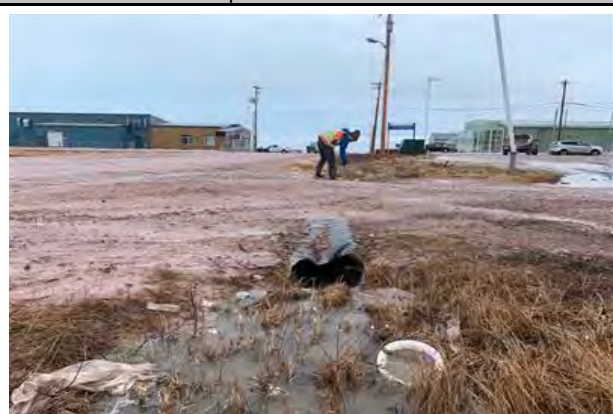
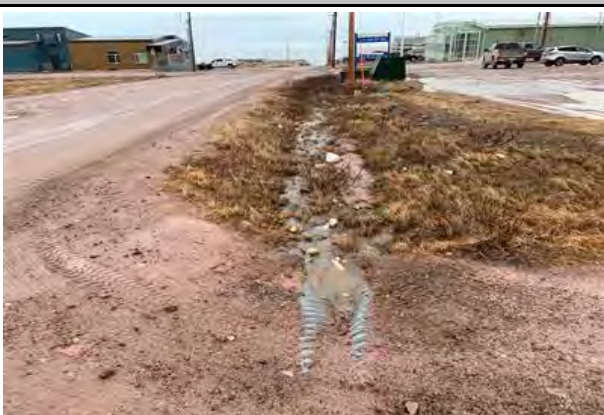
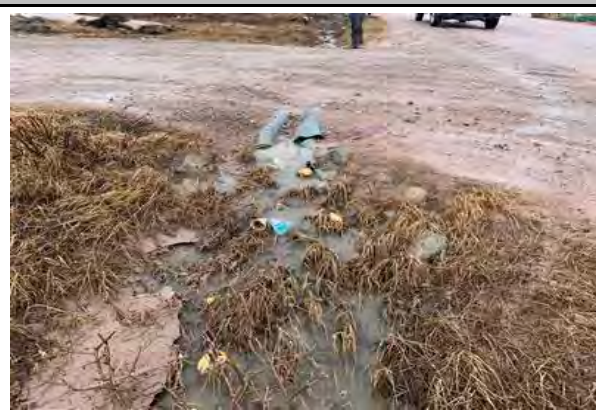
Culvert Information		
Culvert ID		108-07
Type		Cross
Shape		Round
Material		Csp
Diameter or Dimensions (mm)		500
Marker Post Present		N
End Crushing	Upstream	Y
	Downstream	Y
Infill Depth (mm)	Upstream	0
	Downstream	300
Other		None
Comments

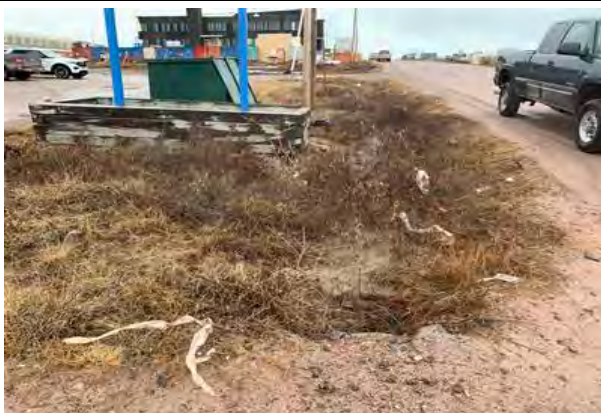
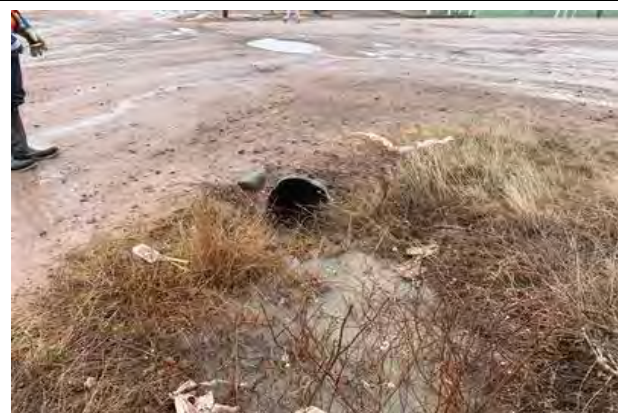
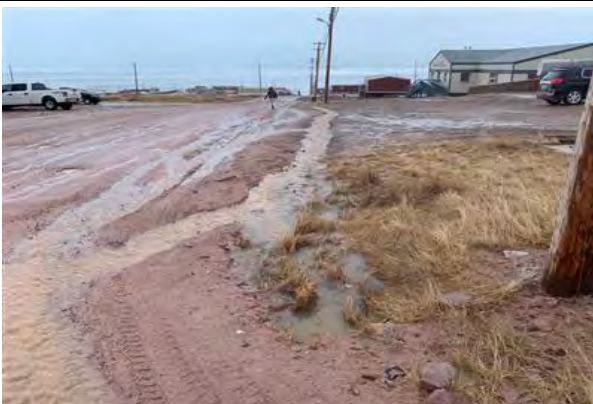
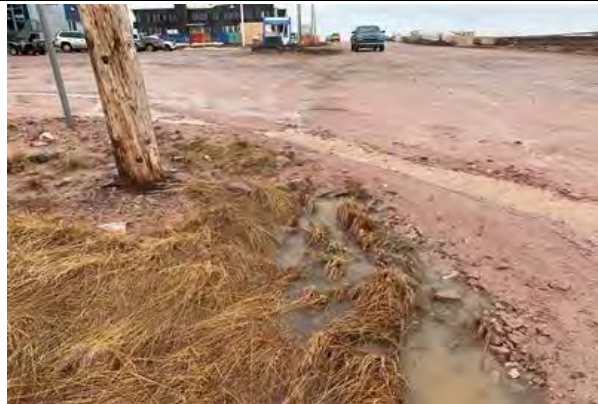
Culvert Information		
Culvert ID		108-08
Type		Cross
Shape		Round
Material		Csp
Diameter or Dimensions (mm)		600
Marker Post Present		N
End	Upstream	Y
	Downstream	Y
Infill Depth (mm)	Upstream	0
	Downstream	0
Other		None
Comments

Culvert Condition Ratings (MTO 2013)				
Barrel Material (0-4)	Shape (0-4)	Capacity (0-2)	Erosion and Scour (0-2)	US/DS Channel (0-2)
0	4	0	1	0

Recommended Action(s):	Replace	Priority:	High
------------------------	---------	-----------	------
