# **Geotechnical Evaluation and Drainage Planning in Baker Lake, Nunavut**

*Final Report Rev-00*

**The Municipality of Baker Lake, Nunavut**

**Nunami Stantec Limited**

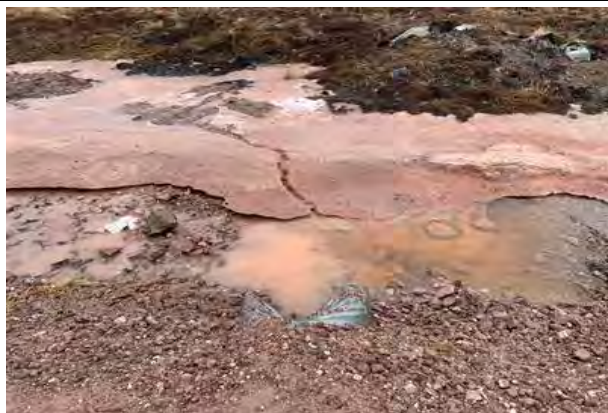
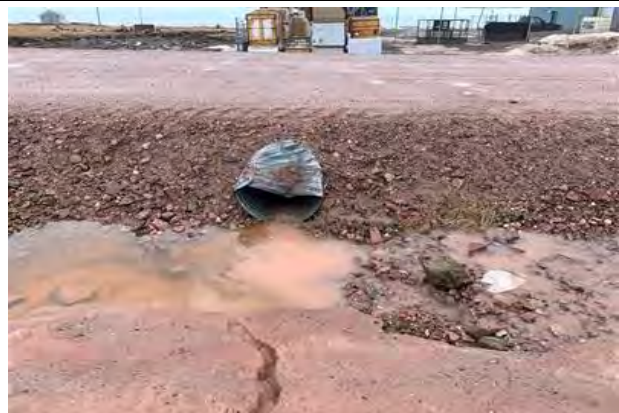
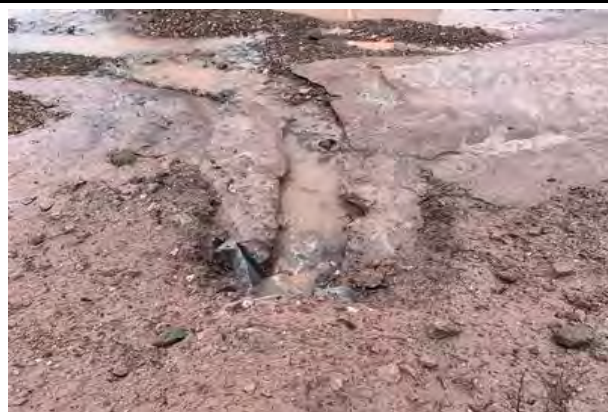
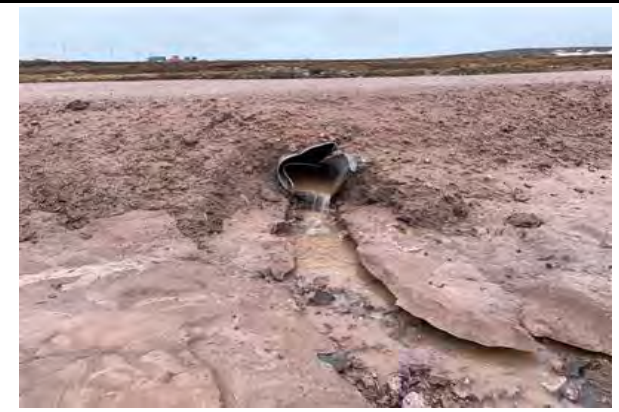
Culvert Information		
Culvert ID		108-09
Type		Cross
Shape		Round
Material		Csp
Diameter or Dimensions (mm)		900
Marker Post Present		N
End	Upstream	Y
	Downstream	N
Crushing	Upstream	0
	Downstream	0
Infill Depth (mm)		0
Other		None
Comments

Culvert Condition Ratings (MTO 2013)				
Barrel Material (0-4)	Shape (0-4)	Capacity (0-2)	Erosion and Scour (0-2)	US/DS Channel (0-2)
0	0	0	0	1

Recommended Action(s):	No action	Priority:	Low
------------------------	-----------	-----------	-----

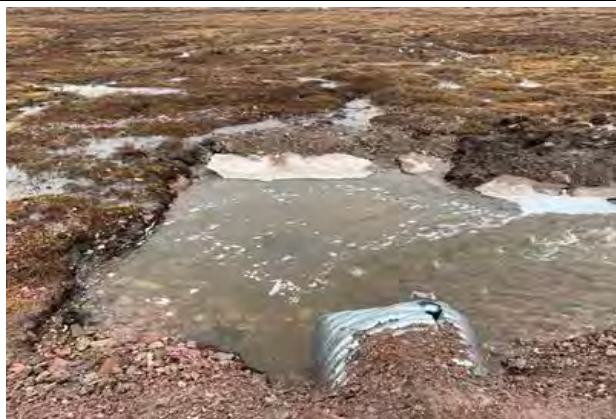
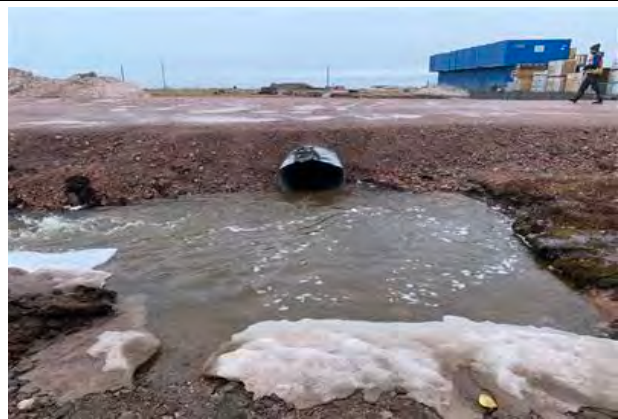
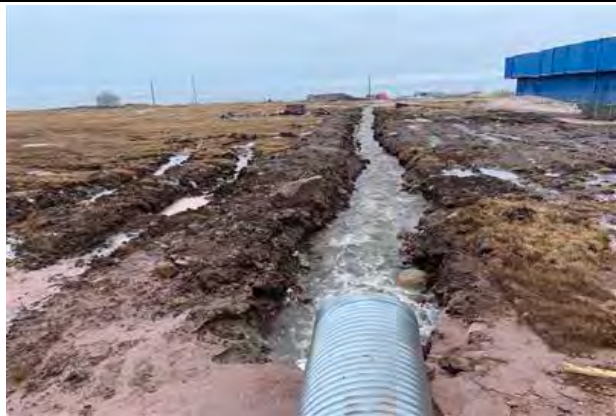
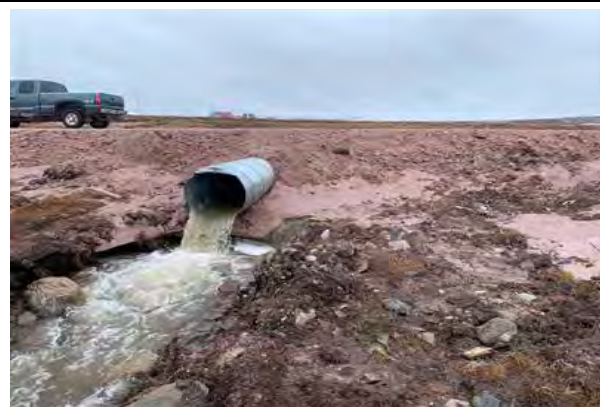
Culvert Information		
Culvert ID		108-10
Type		Cross
Shape		Round
Material		Csp
Diameter or Dimensions (mm)		500
Marker Post Present		N
End Crushing	Upstream	Y
	Downstream	Y
Infill Depth (mm)	Upstream	0
	Downstream	0
Other Comments	None

Culvert Condition Ratings (MTO 2013)				
Barrel Material (0-4)	Shape (0-4)	Capacity (0-2)	Erosion and Scour (0-2)	US/DS Channel (0-2)
0	2	0	1	0

Recommended Action(s):	Repair both ends of culvert	Priority:	Medium
------------------------	-----------------------------	-----------	--------

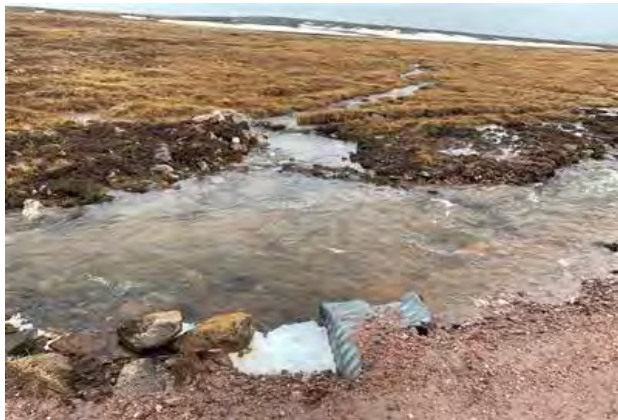
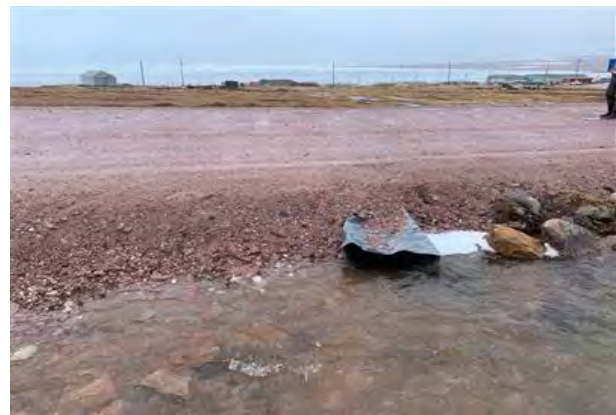
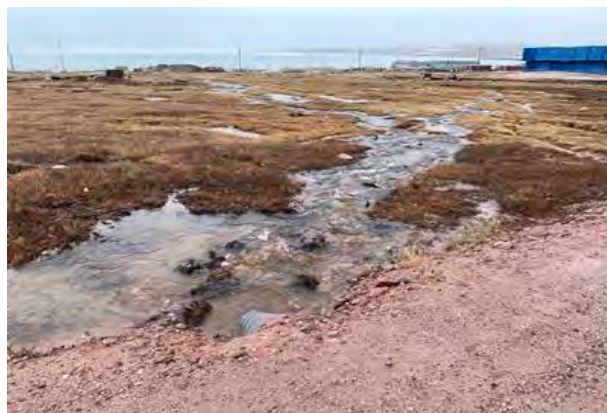
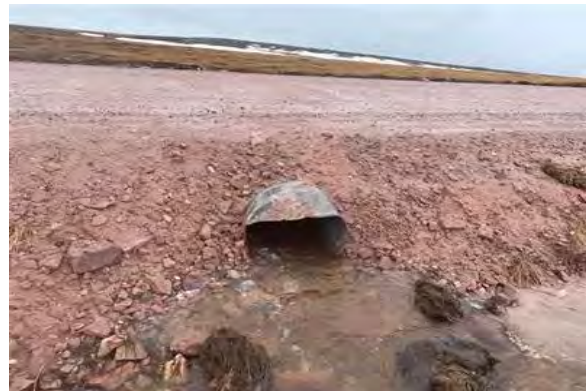
Culvert Information		
Culvert ID		108-11
Type		Cross
Shape		Round
Material		Csp
Diameter or Dimensions (mm)		600
Marker Post Present		N
End Crushing	Upstream	Y
	Downstream	Y
Infill Depth (mm)	Upstream	300
	Downstream	300
Other		Ends crushed and infilled
Comments

Culvert Condition Ratings (MTO 2013)				
Barrel Material (0-4)	Shape (0-4)	Capacity (0-2)	Erosion and Scour (0-2)	US/DS Channel (0-2)
0	2	2	1	1

Recommended Action(s):	Replace	Priority:	High
------------------------	---------	-----------	------

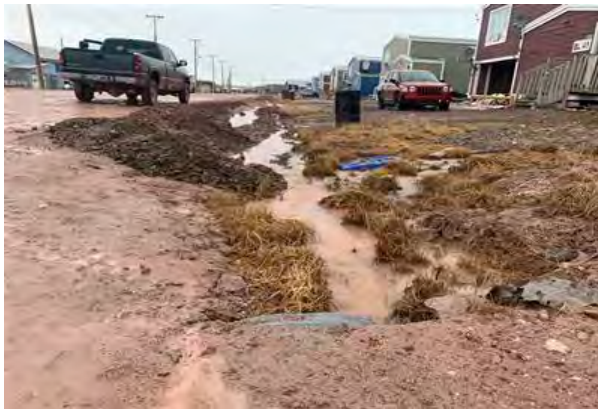
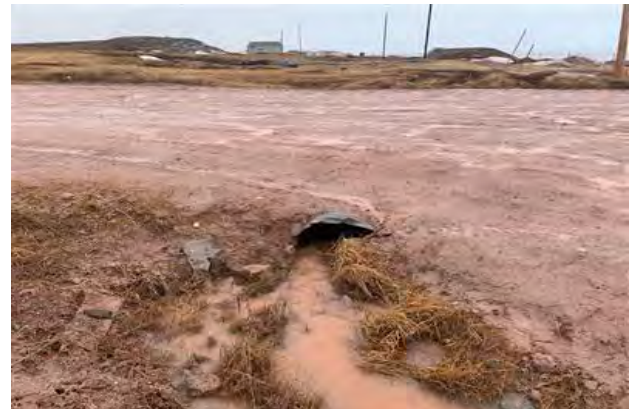
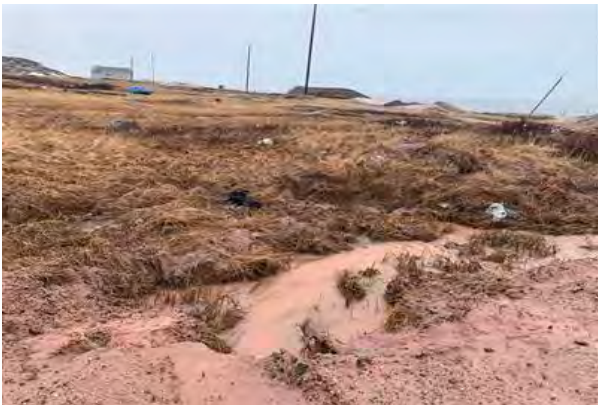
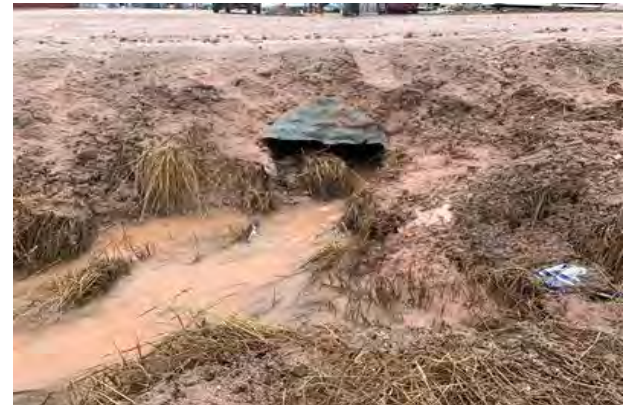
Culvert Information		
Culvert ID		108-12
Type		Cross
Shape		Round
Material		Csp
Diameter or Dimensions (mm)		600
Marker Post Present		N
End Crushing	Upstream	Y
	Downstream	0
Infill Depth (mm)	Upstream	200
	Downstream	600
Other		None
Comments

Culvert Condition Ratings (MTO 2013)				
Barrel Material (0-4)	Shape (0-4)	Capacity (0-2)	Erosion and Scour (0-2)	US/DS Channel (0-2)
0	1	2	1	0

Recommended Action(s):	Flush	Priority:	High
------------------------	-------	-----------	------

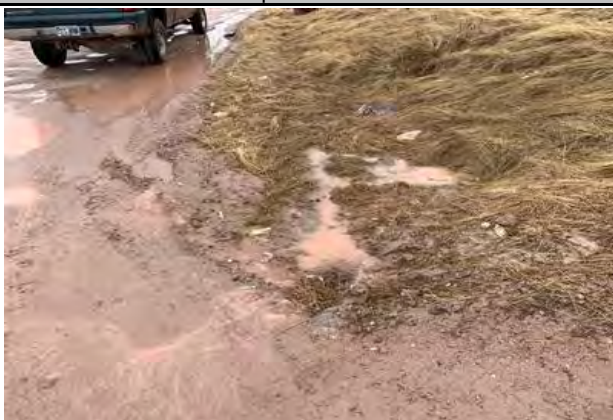
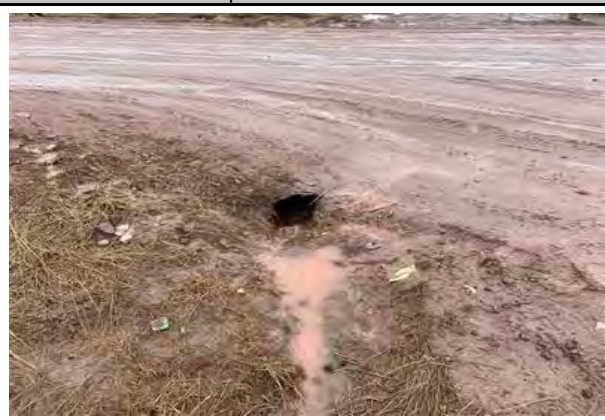
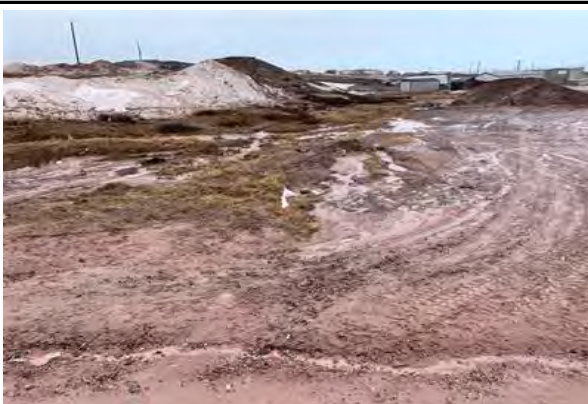
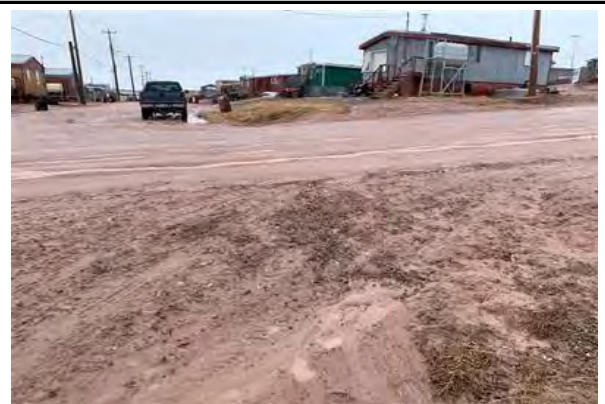
Culvert Information		
Culvert ID		108-13
Type		Entrance
Shape		Round
Material		Csp
Diameter or Dimensions (mm)		500
Marker Post Present		N
End Crushing	Upstream	Y
	Downstream	Y
Infill Depth (mm)	Upstream	150
	Downstream	150
Other		None
Comments

Culvert Condition Ratings (MTO 2013)				
Barrel Material (0-4)	Shape (0-4)	Capacity (0-2)	Erosion and Scour (0-2)	US/DS Channel (0-2)
0	4	2	1	0

Recommended Action(s):	Replace	Priority:	High
------------------------	---------	-----------	------

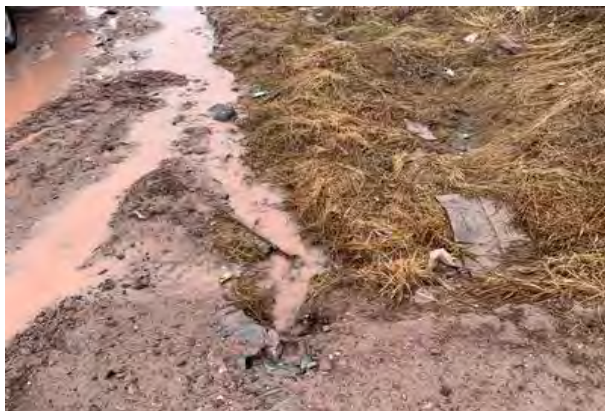
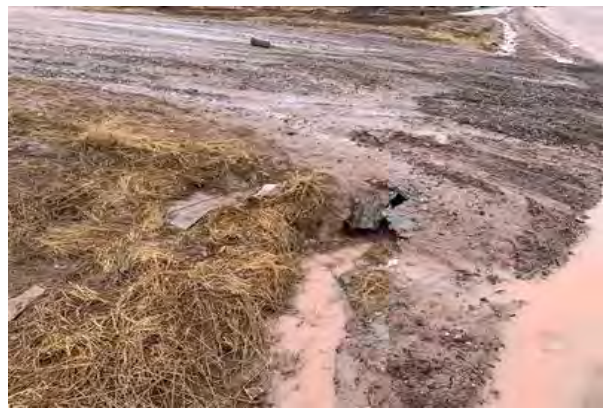
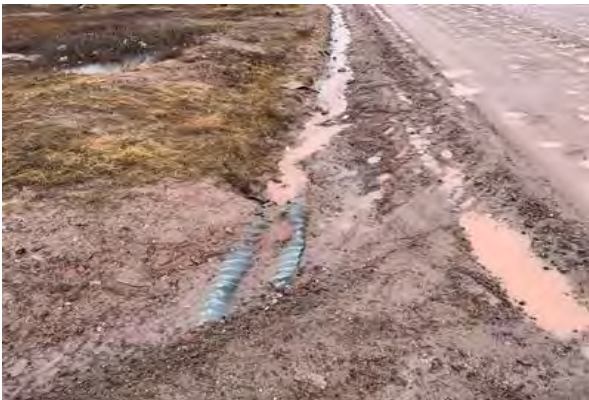
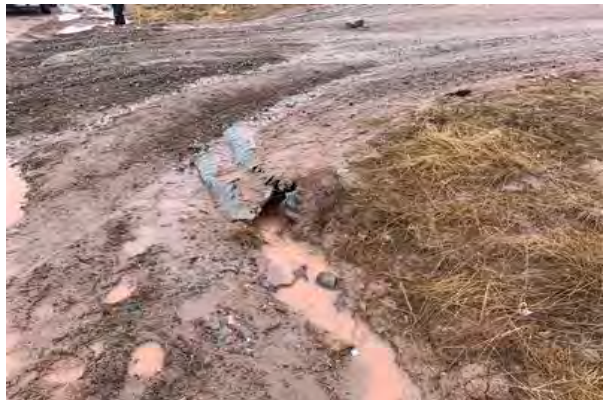
Culvert Information		
Culvert ID		108-14
Type		Cross
Shape		Round
Material		Csp
Diameter or Dimensions (mm)		1100
Marker Post Present		N
End	Upstream	Y
	Downstream	Y
Infill Depth (mm)	Upstream	0
	Downstream	0
Other Comments		Upstream end crushed and banks on both ends unstable

Culvert Condition Ratings (MTO 2013)				
Barrel Material (0-4)	Shape (0-4)	Capacity (0-2)	Erosion and Scour (0-2)	US/DS Channel (0-2)
0	1	0	2	1

Recommended Action(s):	Stabilize bank	Priority:	High
------------------------	----------------	-----------	------

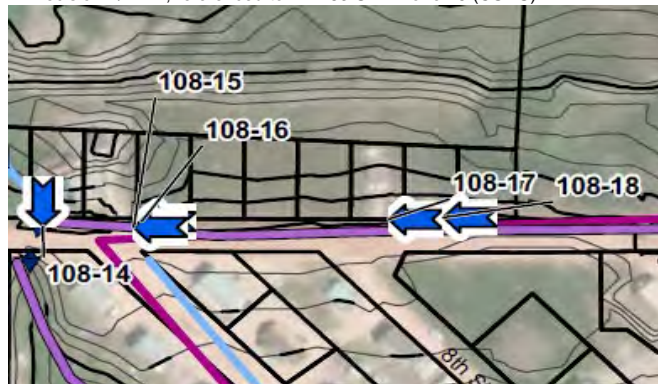
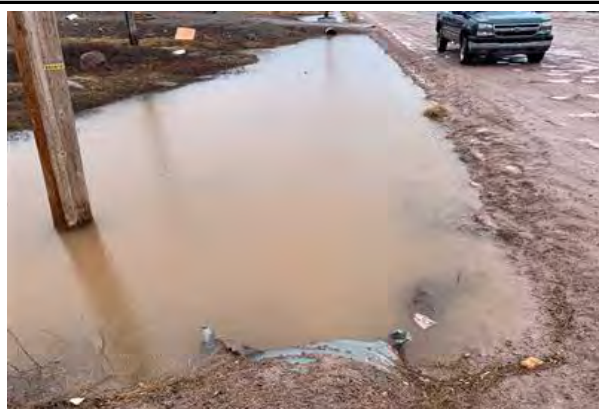
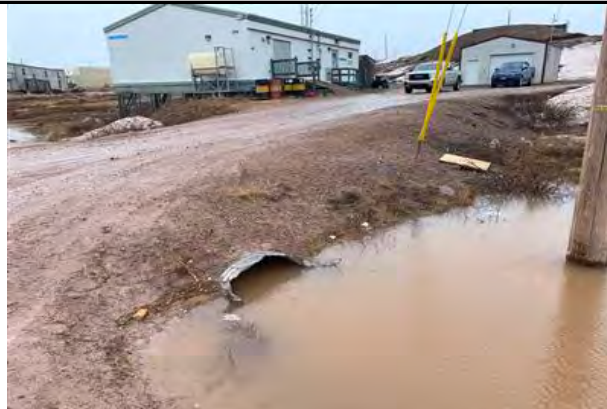
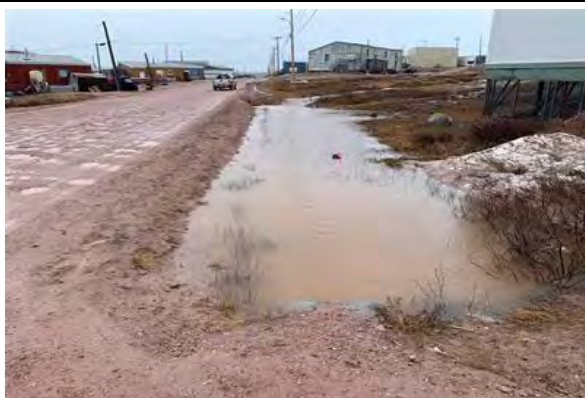
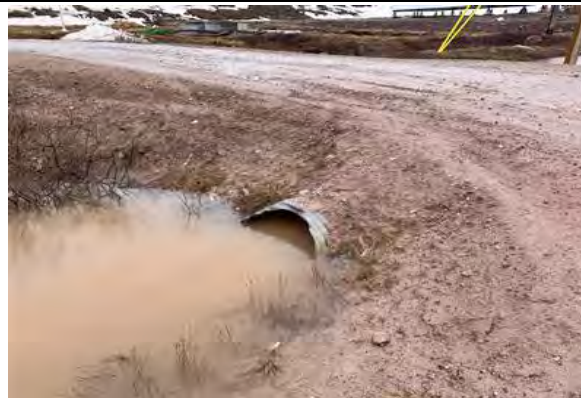
Culvert Information		
Culvert ID		108-15
Type		Entrance
Shape		Round
Material		Csp
Diameter or Dimensions (mm)		800
Marker Post Present		N
End Crushing	Upstream	Y
	Downstream	Y
Infill Depth (mm)	Upstream	100
	Downstream	200
Other		None
Comments

Culvert Condition Ratings (MTO 2013)				
Barrel Material (0-4)	Shape (0-4)	Capacity (0-2)	Erosion and Scour (0-2)	US/DS Channel (0-2)
0	1	1	0	0

Recommended Action(s):	Flush	Priority:	Medium
------------------------	-------	-----------	--------

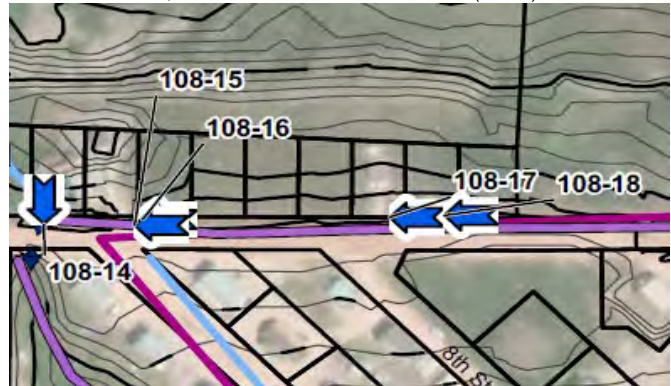
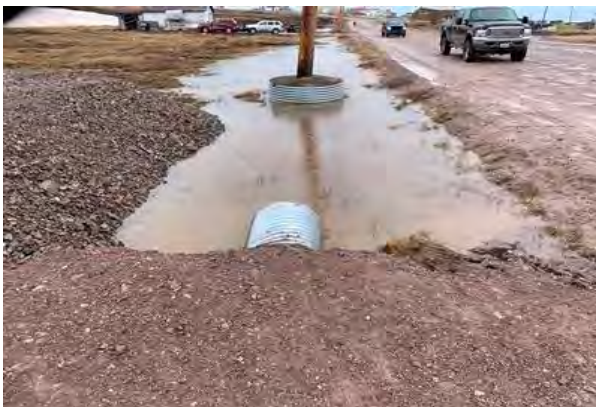
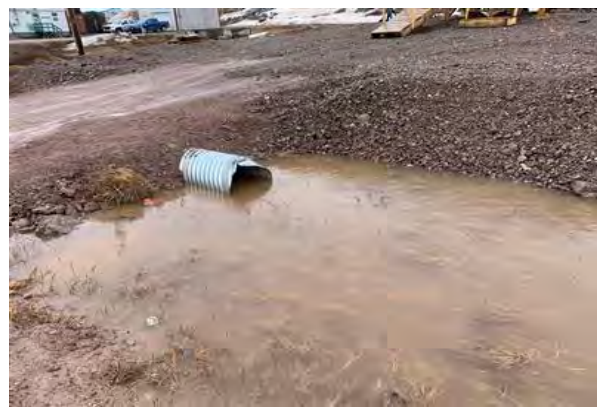
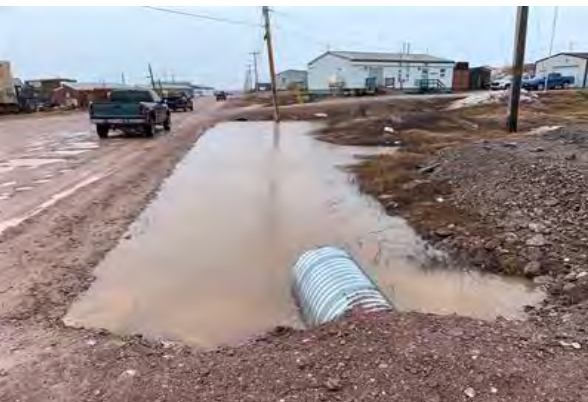
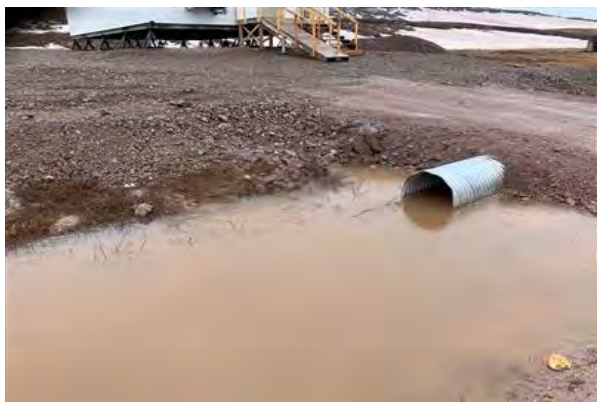
Culvert Information		
Culvert ID		108-16
Type		Entrance
Shape		Round
Material		Csp
Diameter or Dimensions (mm)		600
Marker Post Present		N
End Crushing	Upstream	Y
	Downstream	N
Infill Depth (mm)	Upstream	0
	Downstream	0
Other		None
Comments

Culvert Condition Ratings (MTO 2013)				
Barrel Material (0-4)	Shape (0-4)	Capacity (0-2)	Erosion and Scour (0-2)	US/DS Channel (0-2)
0	0	0	0	0

Recommended Action(s):	No action	Priority:	None
------------------------	-----------	-----------	------

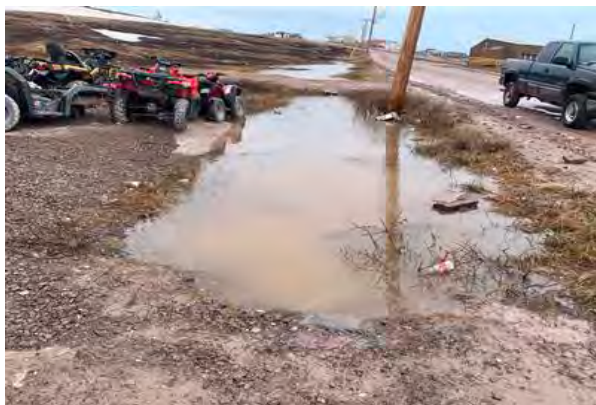
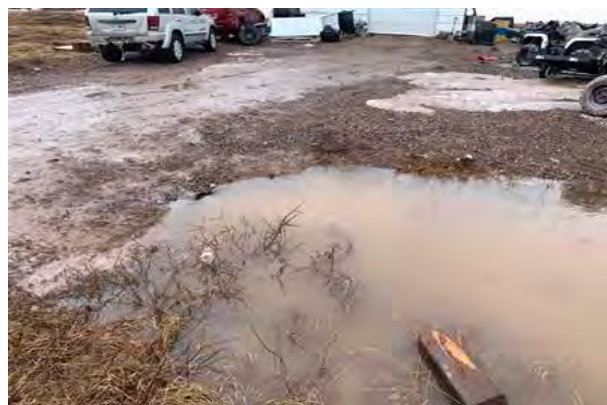
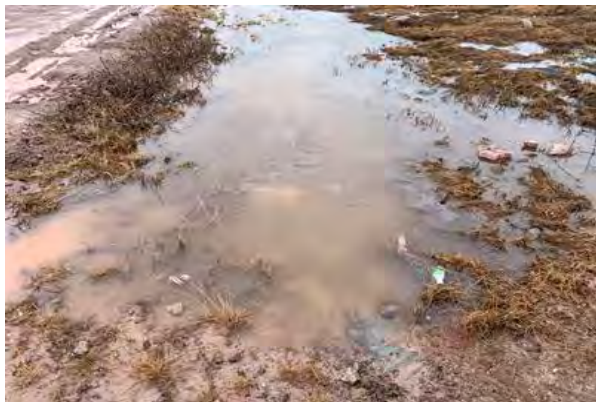
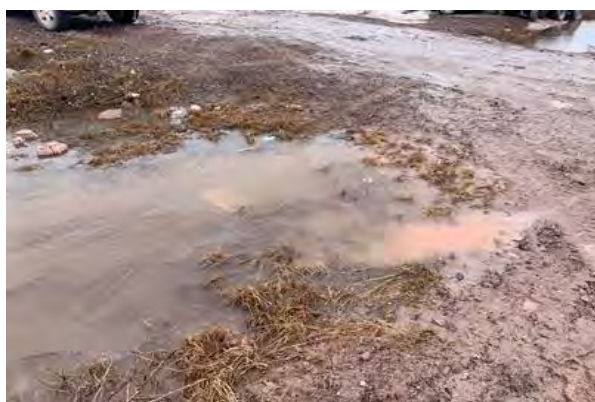
Culvert Information		
Culvert ID		108-17
Type		Entrance
Shape		Round
Material		Csp
Diameter or Dimensions (mm)		500
Marker Post Present		N
End Crushing	Upstream	Y
	Downstream	Y
Infill Depth (mm)	Upstream	200
	Downstream	200
Other		None
Comments

Culvert Condition Ratings (MTO 2013)				
Barrel Material (0-4)	Shape (0-4)	Capacity (0-2)	Erosion and Scour (0-2)	US/DS Channel (0-2)
0	4	2	0	0

Recommended Action(s):	Replace	Priority:	High
------------------------	---------	-----------	------

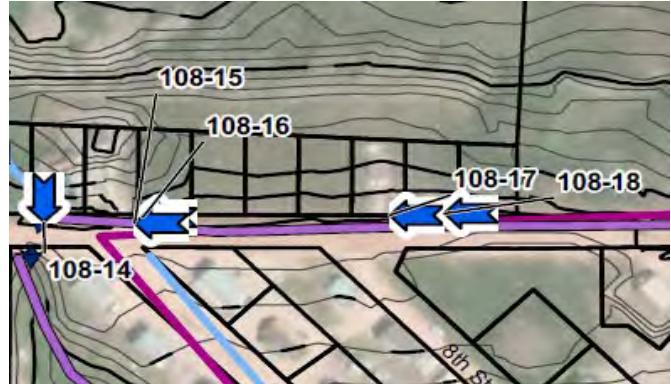
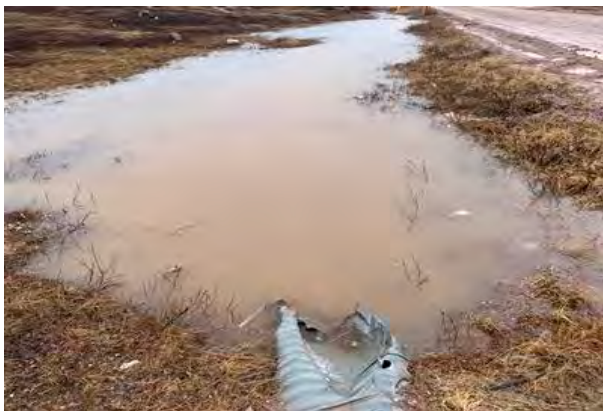
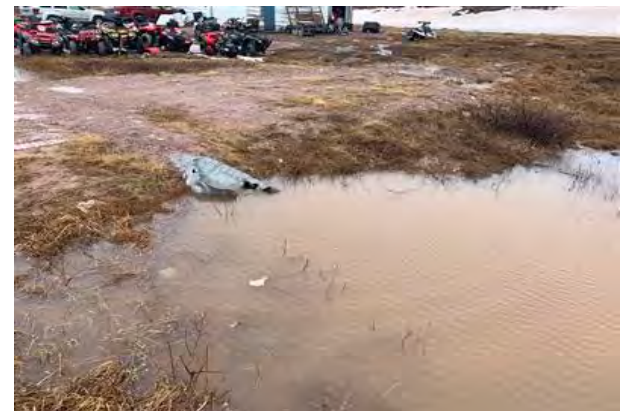
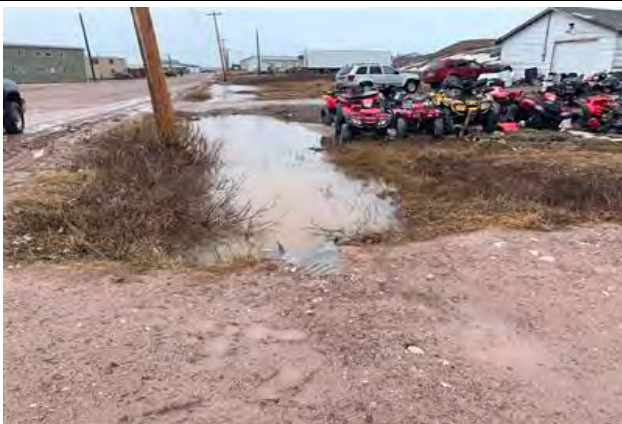
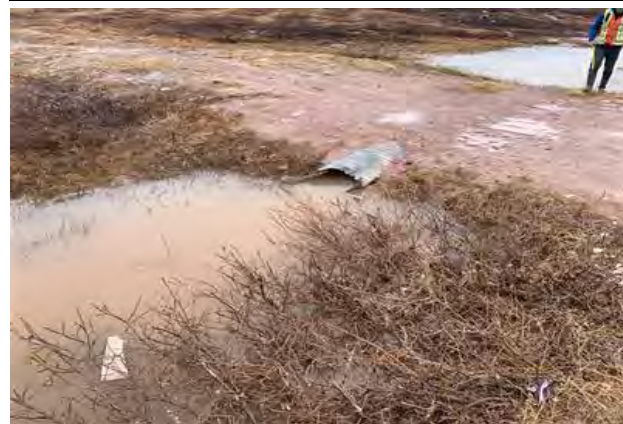
Culvert Information		
Culvert ID		108-18
Type		Entrance
Shape		Round
Material		Csp
Diameter or Dimensions (mm)		500
Marker Post Present		N
End Crushing	Upstream	Y
	Downstream	Y
Infill Depth (mm)	Upstream	0
	Downstream	0
Other		None
Comments

Culvert Condition Ratings (MTO 2013)				
Barrel Material (0-4)	Shape (0-4)	Capacity (0-2)	Erosion and Scour (0-2)	US/DS Channel (0-2)
0	4	0	0	0

Recommended Action(s):	Replace	Priority:	High
------------------------	---------	-----------	------

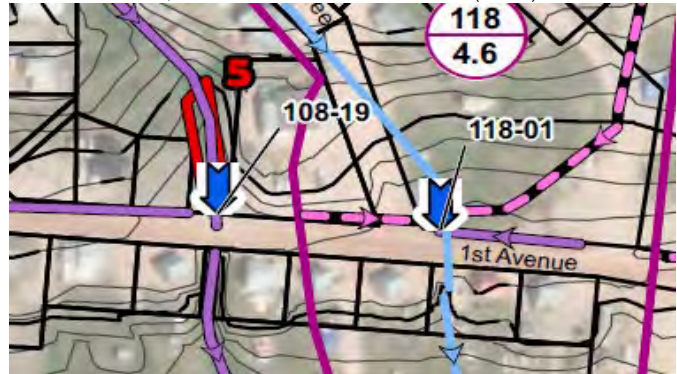
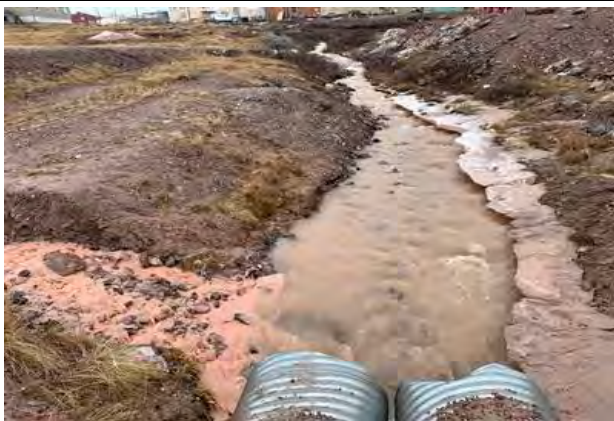
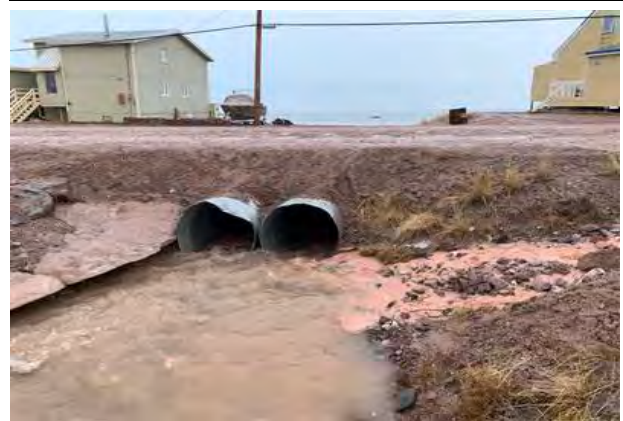
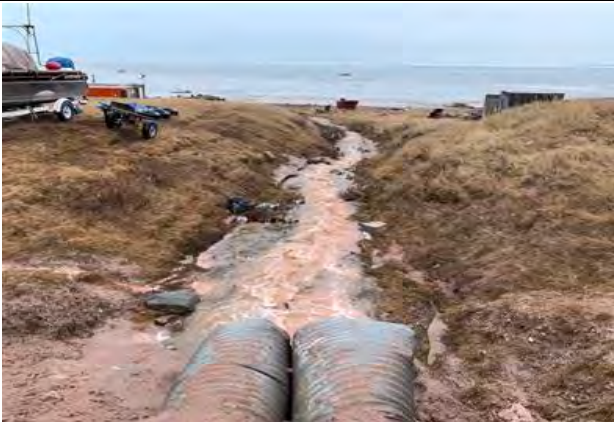
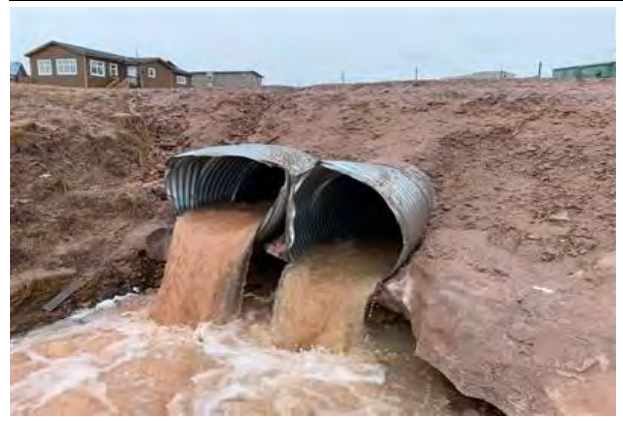
Culvert Information		
Culvert ID		108-19
Type		Cross
Shape		Round
Material		Csp
Diameter or Dimensions (mm)		800
Marker Post Present		N
End	Upstream	N
	Downstream	Y
Infill Depth (mm)	Upstream	0
	Downstream	0
Other		0
Comments

Culvert Condition Ratings (MTO 2013)				
Barrel Material (0-4)	Shape (0-4)	Capacity (0-2)	Erosion and Scour (0-2)	US/DS Channel (0-2)
0	1	0	1	1

Recommended Action(s):	No action	Priority:	Low
------------------------	-----------	-----------	-----

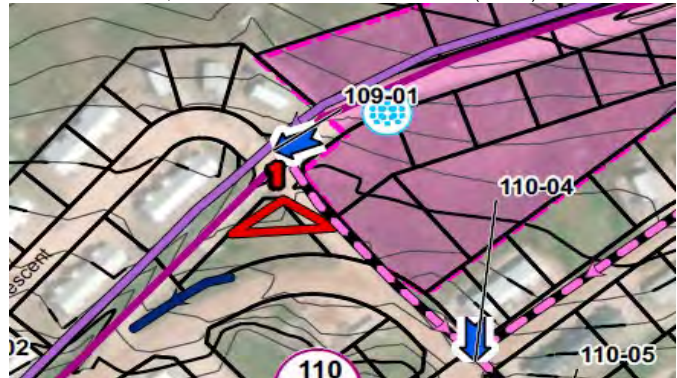
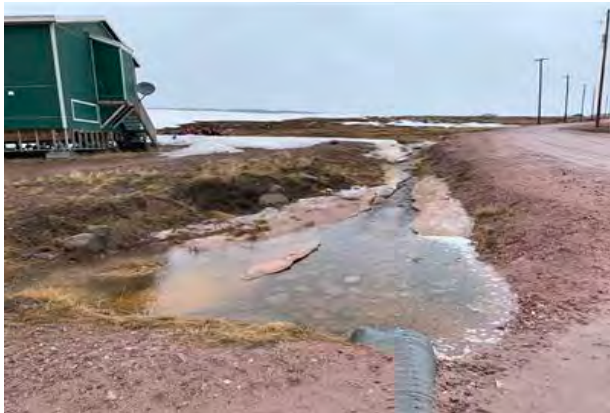
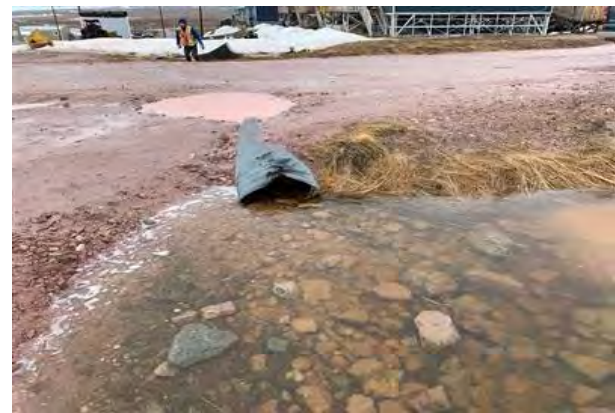
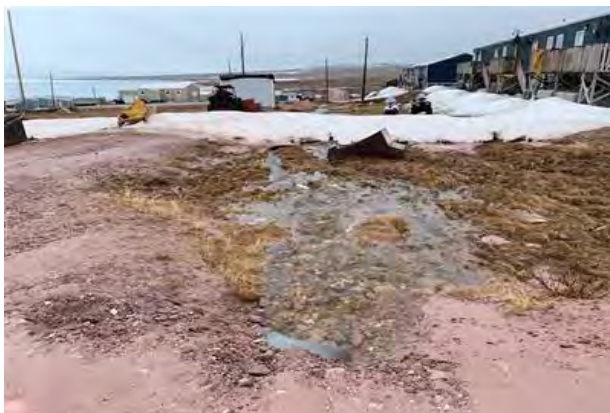
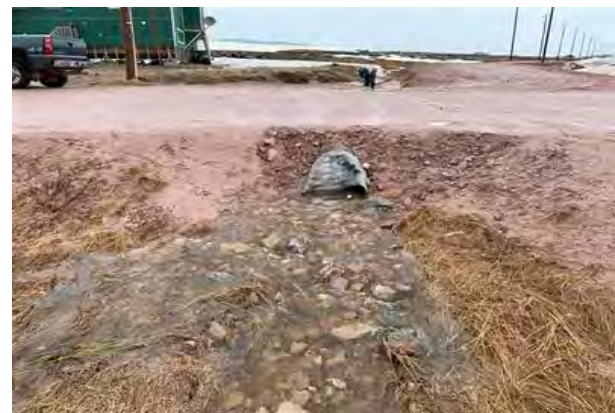
Culvert Information		
Culvert ID		109-01
Type		Cross
Shape		Round
Material		Csp
Diameter or Dimensions (mm)		600
Marker Post Present		N
End Crushing	Upstream	Y
	Downstream	Y
Infill Depth (mm)	Upstream	200
	Downstream	150
Other		None
Comments

Culvert Condition Ratings (MTO 2013)				
Barrel Material (0-4)	Shape (0-4)	Capacity (0-2)	Erosion and Scour (0-2)	US/DS Channel (0-2)
0	4	2	1	0

Recommended Action(s):	Replace	Priority:	High
------------------------	---------	-----------	------

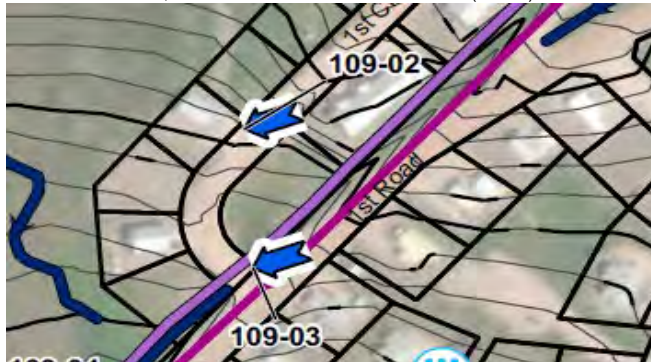
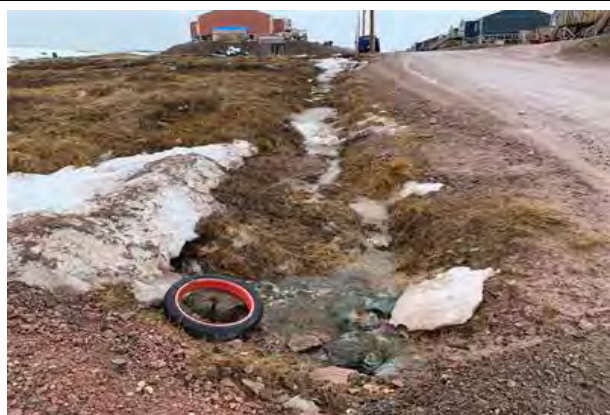
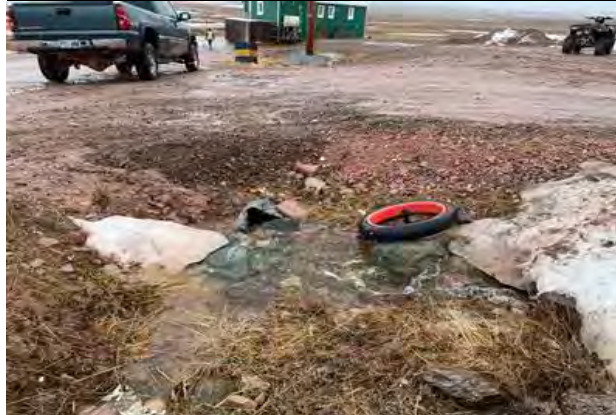
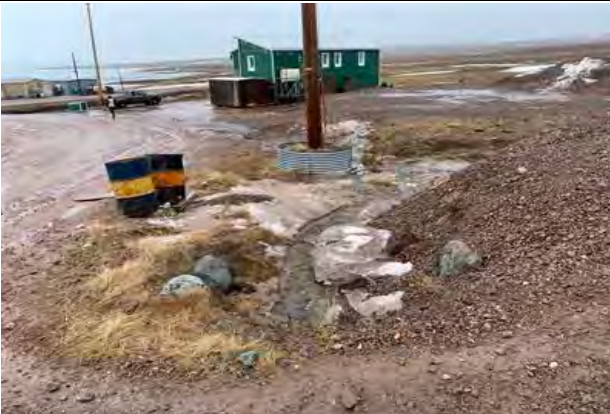
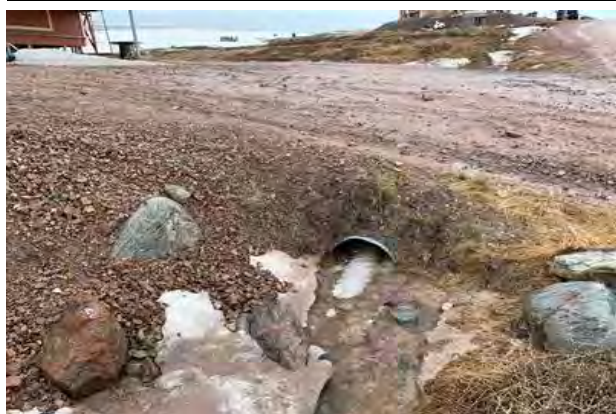
Culvert Information		
Culvert ID		109-02
Type		Entrance
Shape		Round
Material		Csp
Diameter or Dimensions (mm)		500
Marker Post Present		N
End	Upstream	Y
	Downstream	N
Infill Depth (mm)	Upstream	0
	Downstream	300
Other		None
Comments

Culvert Condition Ratings (MTO 2013)				
Barrel Material (0-4)	Shape (0-4)	Capacity (0-2)	Erosion and Scour (0-2)	US/DS Channel (0-2)
0	1	2	1	0

Recommended Action(s):	Flush	Priority:	High
------------------------	-------	-----------	------

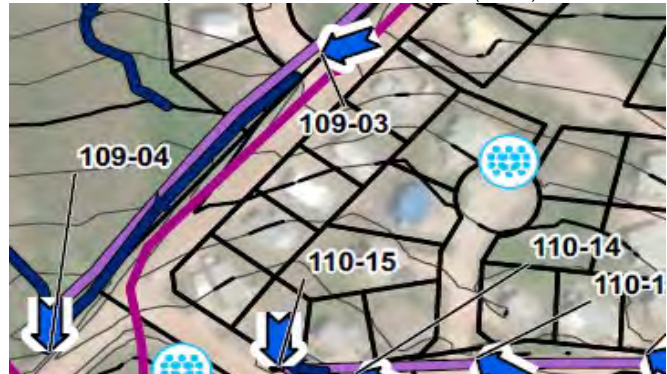
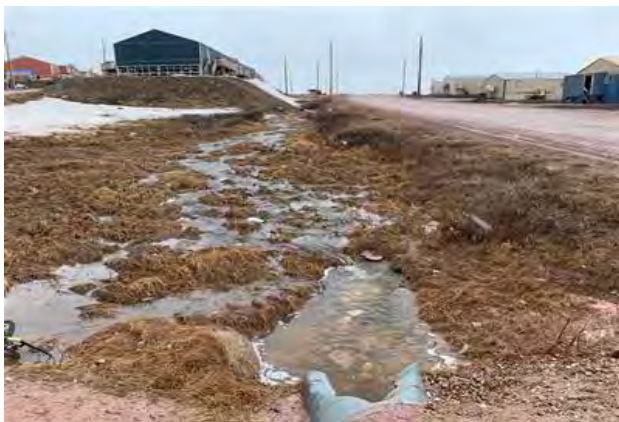
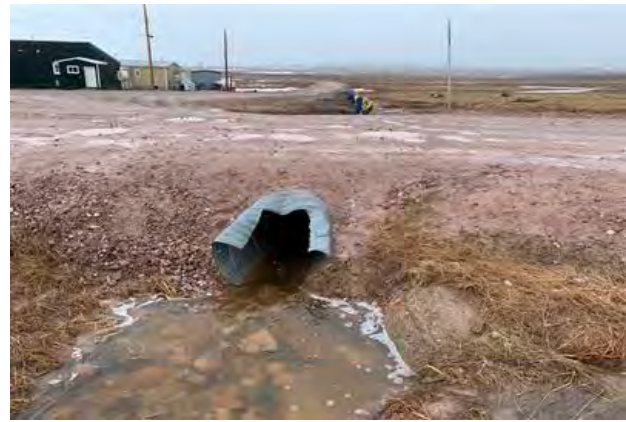
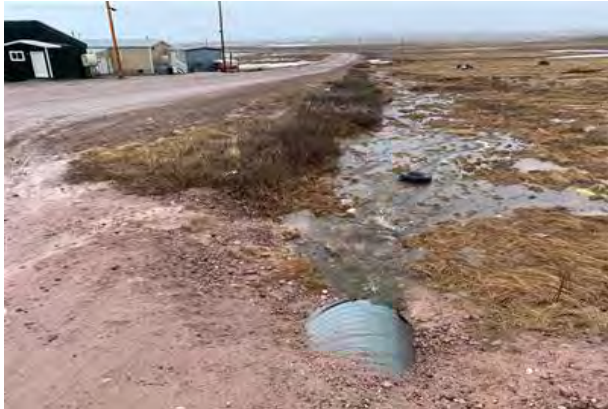
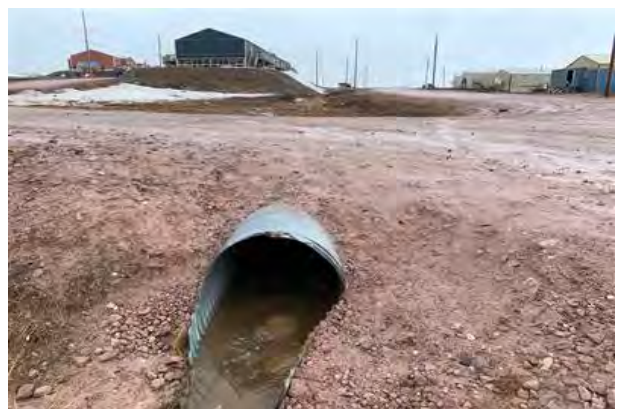
Culvert Information		
Culvert ID		109-03
Type		Cross
Shape		Round
Material		Csp
Diameter or Dimensions (mm)		700
Marker Post Present		N
End Crushing	Upstream	Y
	Downstream	N
Infill Depth (mm)	Upstream	0
	Downstream	150
Other		None
Comments

Culvert Condition Ratings (MTO 2013)				
Barrel Material (0-4)	Shape (0-4)	Capacity (0-2)	Erosion and Scour (0-2)	US/DS Channel (0-2)
0	1	1	1	0

Recommended Action(s):	Flush	Priority:	Medium
------------------------	-------	-----------	--------

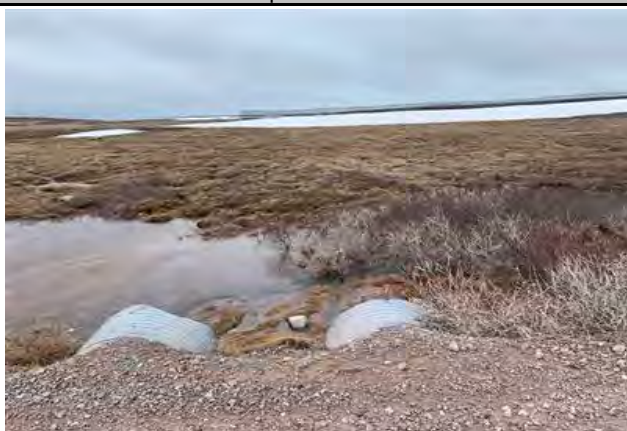
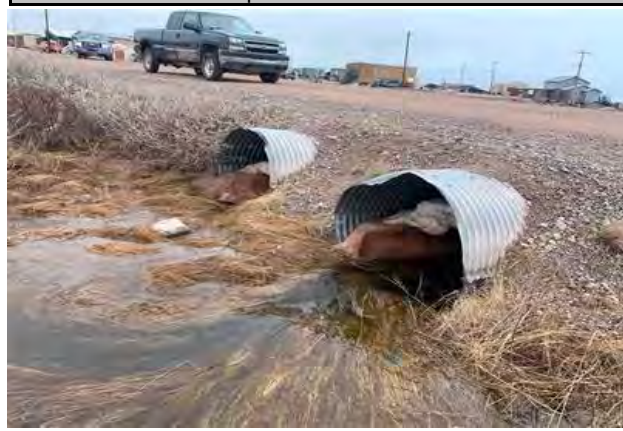
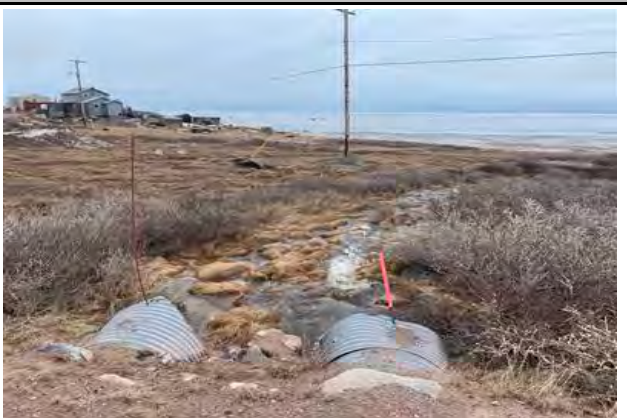
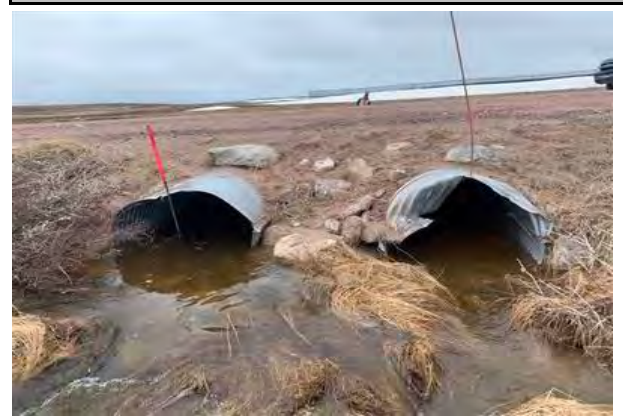
Culvert Condition Ratings (MTO 2013)				
Barrel Material (0-4)	Shape (0-4)	Capacity (0-2)	Erosion and Scour (0-2)	US/DS Channel (0-2)
0	1	1	1	0

Recommended Action(s):	Flush	Priority:	Medium
------------------------	-------	-----------	--------

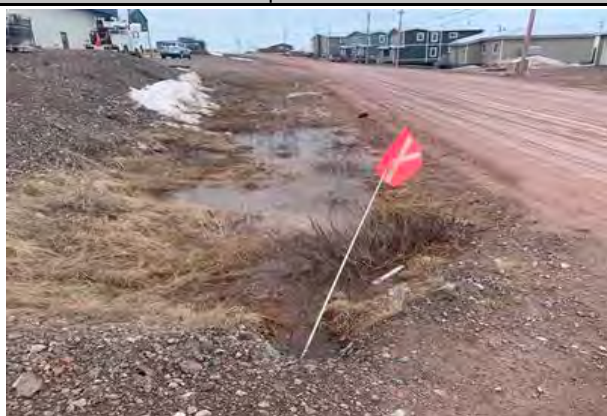
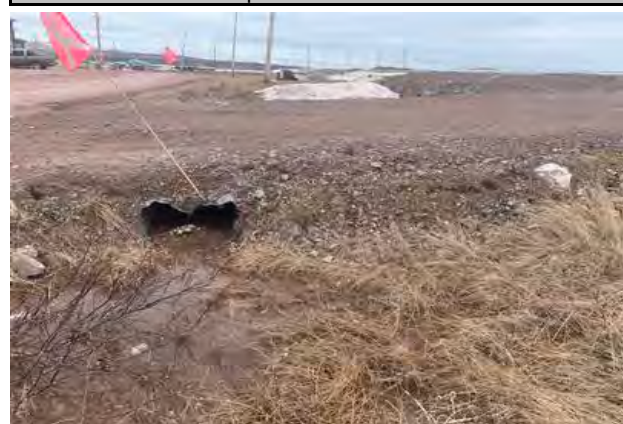
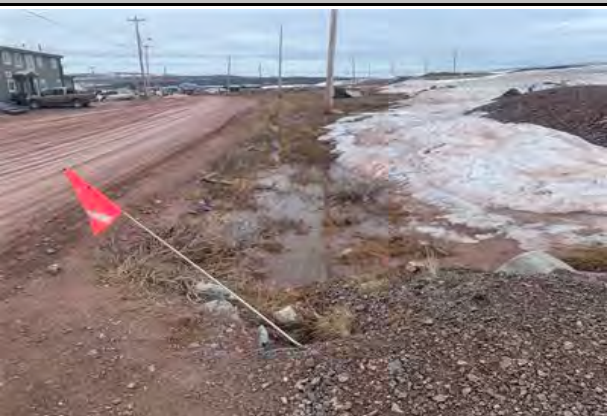
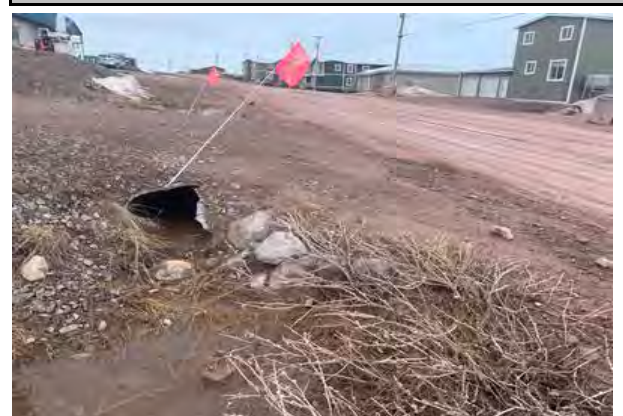
Culvert Information		
Culvert ID		110-01
Type		Entrance
Shape		Round
Material		Csp
Diameter or Dimensions (mm)		600
Marker Post Present		Y
End Crushing	Upstream	Y
	Downstream	Y
Infill Depth (mm)	Upstream	200
	Downstream	200
Other		None
Comments

Culvert Condition Ratings (MTO 2013)				
Barrel Material (0-4)	Shape (0-4)	Capacity (0-2)	Erosion and Scour (0-2)	US/DS Channel (0-2)
0	2	2	1	0

Recommended Action(s):	Replace	Priority:	High
------------------------	---------	-----------	------

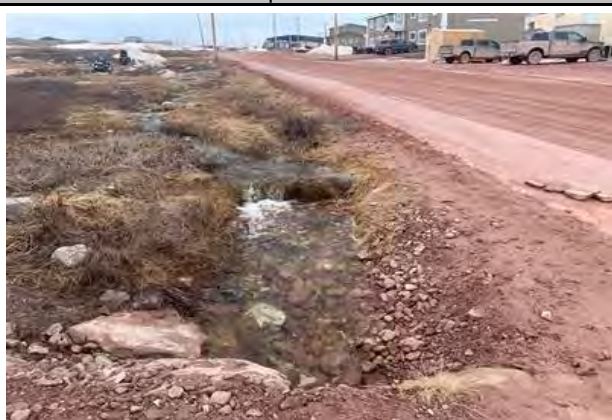
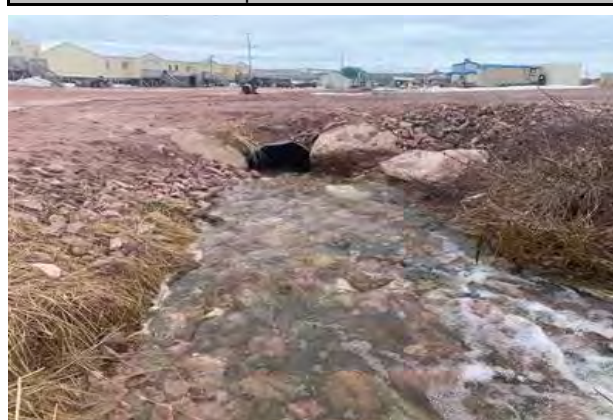
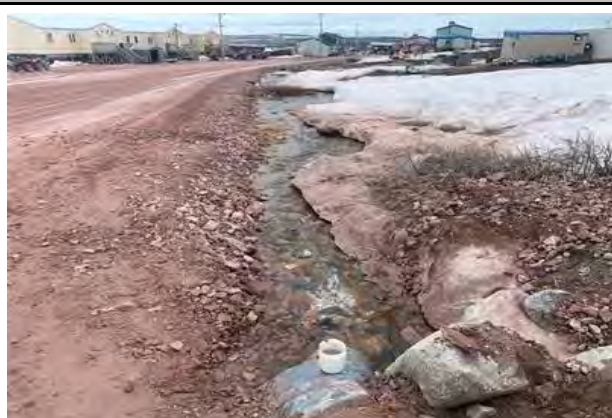
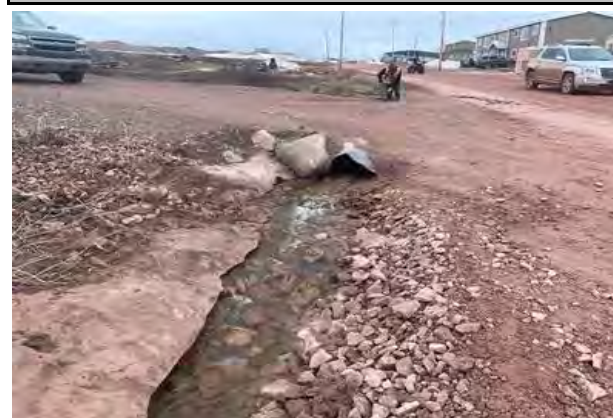
Culvert Information		
Culvert ID		110-02
Type		Entrance
Shape		Round
Material		Csp
Diameter or Dimensions (mm)		600
Marker Post Present		N
End Crushing	Upstream	Y
	Downstream	Y
Infill Depth (mm)	Upstream	200
	Downstream	200
Other		None
Comments

Culvert Condition Ratings (MTO 2013)				
Barrel Material (0-4)	Shape (0-4)	Capacity (0-2)	Erosion and Scour (0-2)	US/DS Channel (0-2)
0	2	2	1	0

Recommended Action(s):	Replace	Priority:	High
------------------------	---------	-----------	------

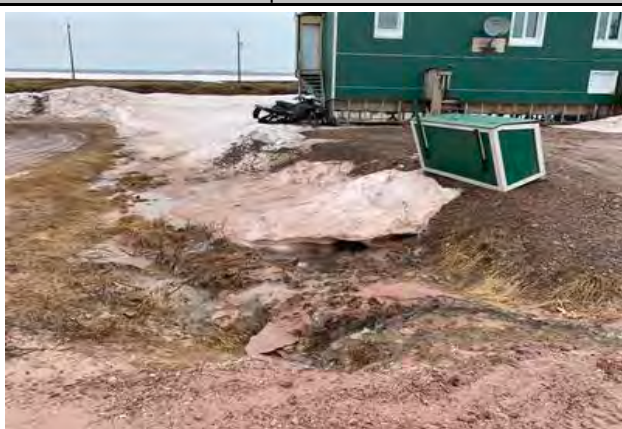
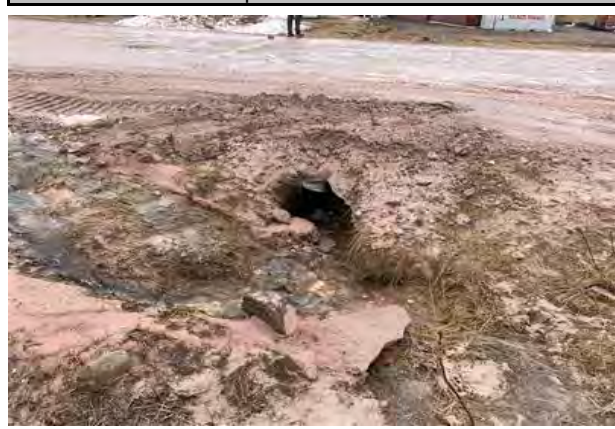
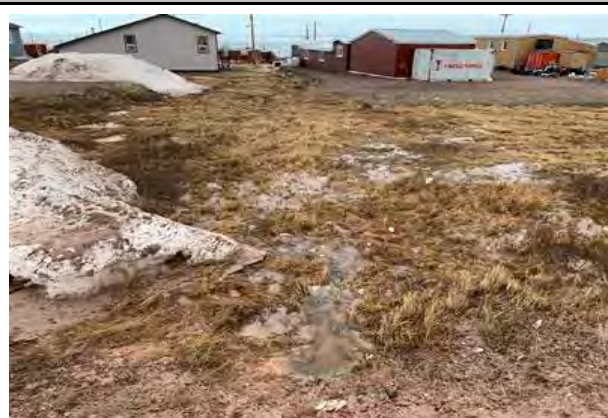
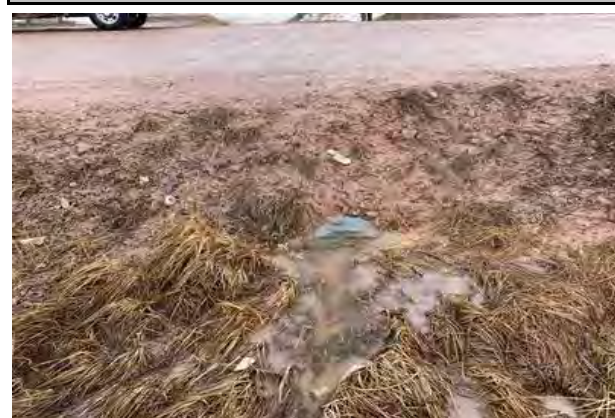
Culvert Information		
Culvert ID		110-03
Type		Cross
Shape		Round
Material		Csp
Diameter or Dimensions (mm)		600
Marker Post Present		N
End Crushing	Upstream	Y
	Downstream	Y
Infill Depth (mm)	Upstream	200
	Downstream	400
Other		None
Comments

Culvert Condition Ratings (MTO 2013)				
Barrel Material (0-4)	Shape (0-4)	Capacity (0-2)	Erosion and Scour (0-2)	US/DS Channel (0-2)
0	2	2	1	0

Recommended Action(s):	Replace	Priority:	High
------------------------	---------	-----------	------
