# **Geotechnical Evaluation and Drainage Planning in Baker Lake, Nunavut**

*Final Report Rev-00*

**The Municipality of Baker Lake, Nunavut**

**Nunami Stantec Limited**

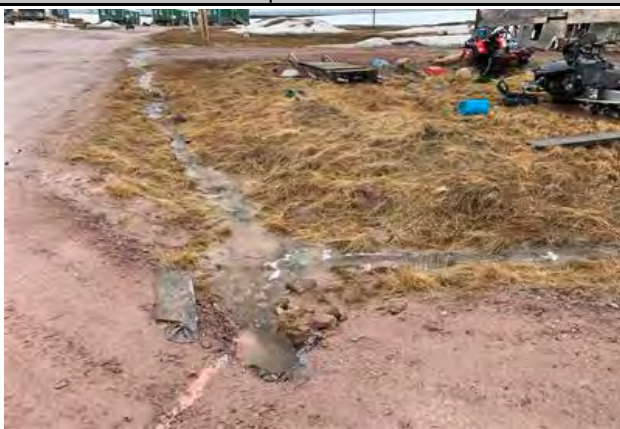
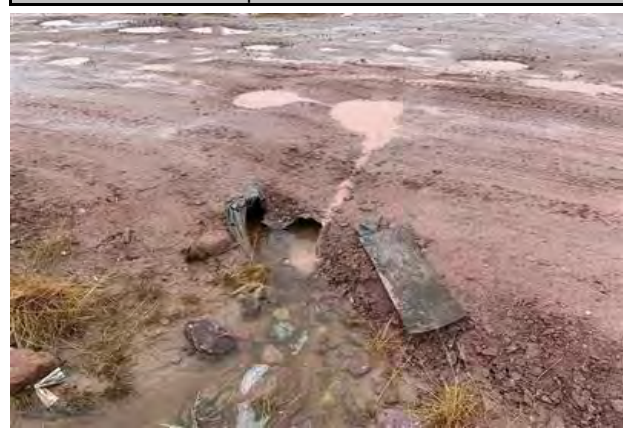
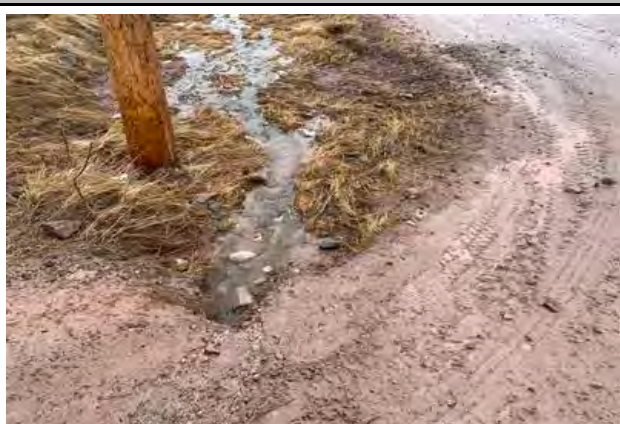
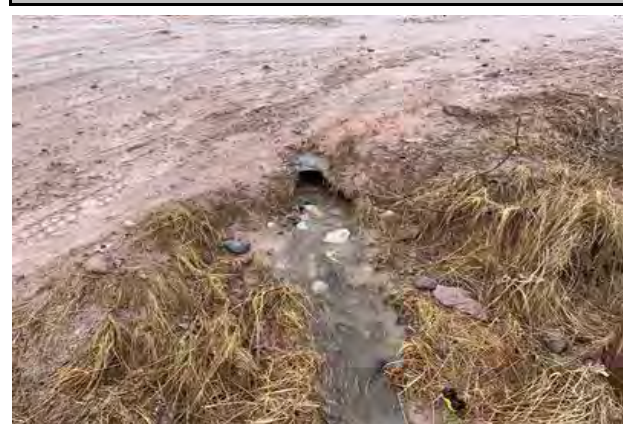
Culvert Information		
Culvert ID		110-04
Type		Cross
Shape		Round
Material		Csp
Diameter or Dimensions (mm)		500
Marker Post Present		N
End Crushing	Upstream	Y
	Downstream	Y
Infill Depth (mm)	Upstream	250
	Downstream	250
Other		None
Comments

Culvert Condition Ratings (MTO 2013)				
Barrel Material (0-4)	Shape (0-4)	Capacity (0-2)	Erosion and Scour (0-2)	US/DS Channel (0-2)
0	3	2	1	0

Recommended Action(s):	Replace	Priority:	High
------------------------	---------	-----------	------

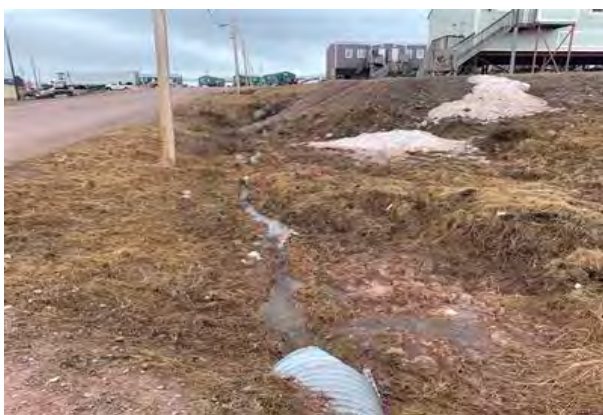
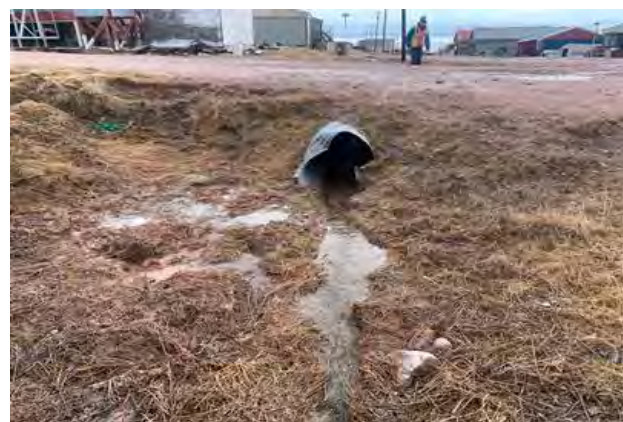
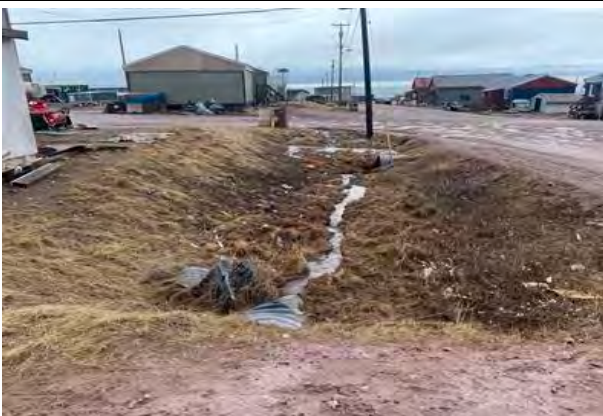
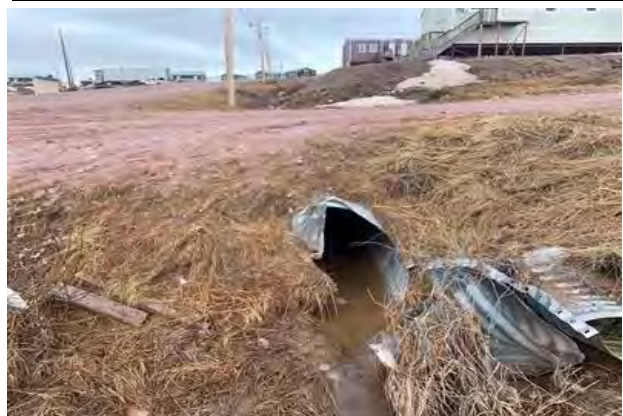
Culvert Information		
Culvert ID		110-05
Type		Entrance
Shape		Round
Material		Csp
Diameter or Dimensions (mm)		800
Marker Post Present		N
End	Upstream	Y
	Downstream	Y
Infill Depth (mm)	Upstream	0
	Downstream	0
Other		None
Comments

Culvert Condition Ratings (MTO 2013)				
Barrel Material (0-4)	Shape (0-4)	Capacity (0-2)	Erosion and Scour (0-2)	US/DS Channel (0-2)
0	2	0	0	0

Recommended Action(s):	Repair both ends of culvert	Priority:	Medium
------------------------	-----------------------------	-----------	--------

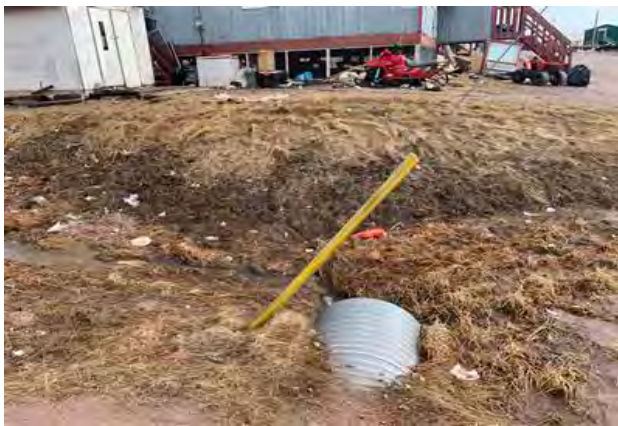
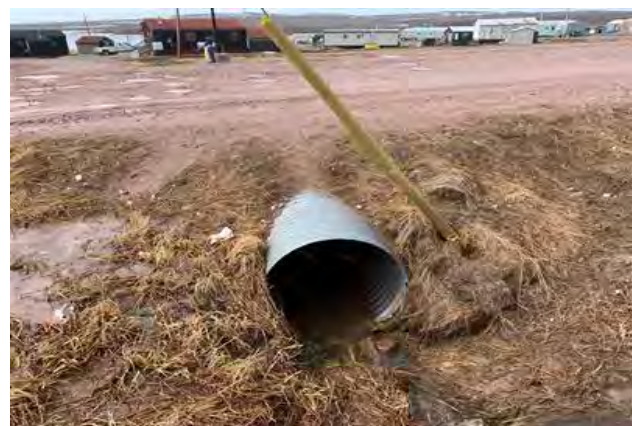
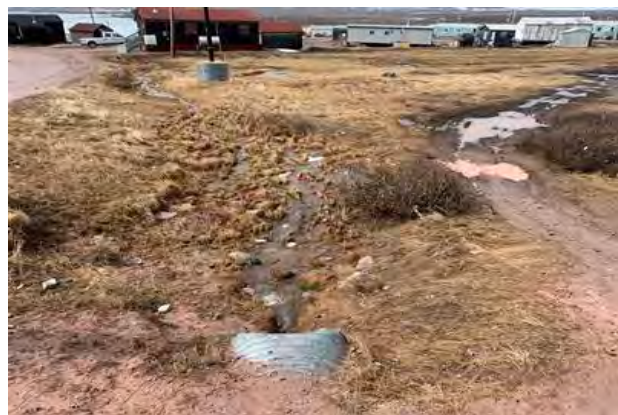
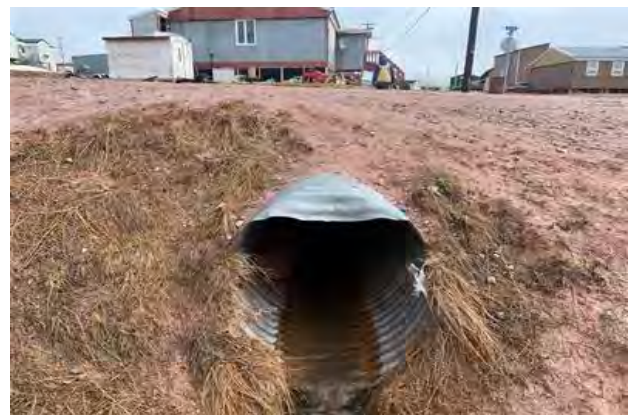
Culvert Information		
Culvert ID		110-06
Type		Cross
Shape		Round
Material		Csp
Diameter or Dimensions (mm)		1000
Marker Post Present		N
End	Upstream	N
	Downstream	Y
Infill Depth (mm)	Upstream	0
	Downstream	0
Other		None
Comments

Culvert Condition Ratings (MTO 2013)				
Barrel Material (0-4)	Shape (0-4)	Capacity (0-2)	Erosion and Scour (0-2)	US/DS Channel (0-2)
0	0	0	1	0

Recommended Action(s):	No action	Priority:	Low
------------------------	-----------	-----------	-----

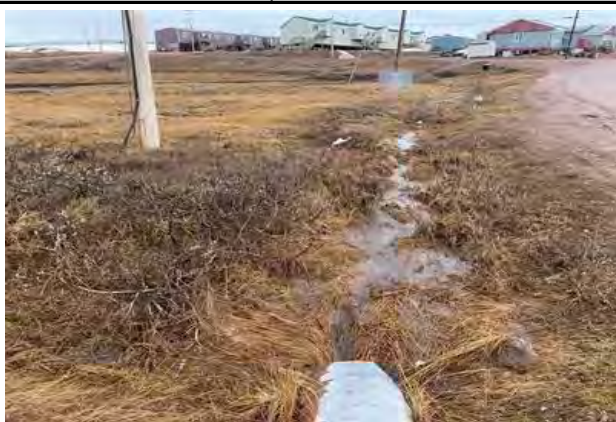
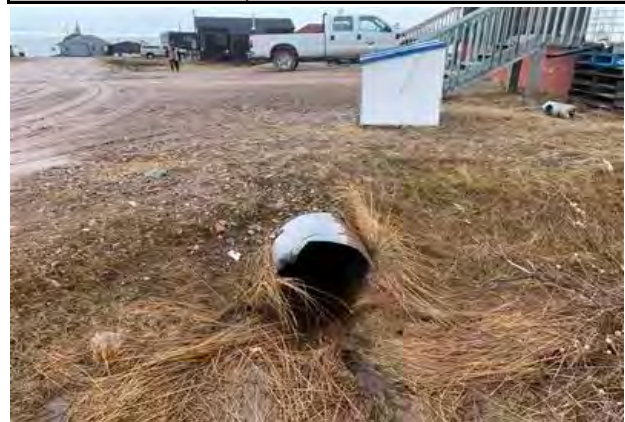
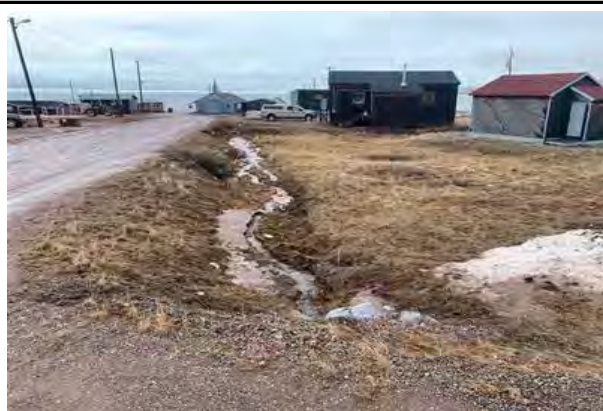
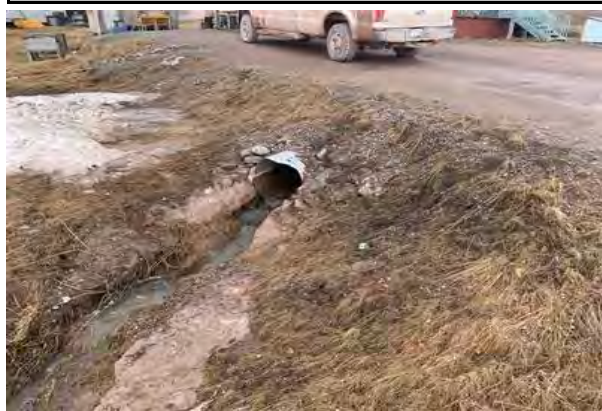
Culvert Information		
Culvert ID		110-07
Type		Entrance
Shape		Round
Material		Csp
Diameter or Dimensions (mm)		600
Marker Post Present		N
End Crushing	Upstream	Y
	Downstream	N
Infill Depth (mm)	Upstream	0
	Downstream	0
Other		None
Comments

Culvert Condition Ratings (MTO 2013)				
Barrel Material (0-4)	Shape (0-4)	Capacity (0-2)	Erosion and Scour (0-2)	US/DS Channel (0-2)
1	0	0	1	1

Recommended Action(s):	No action	Priority:	Low
------------------------	-----------	-----------	-----

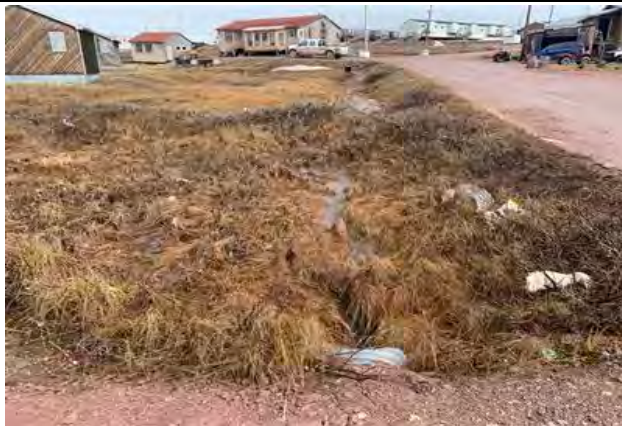
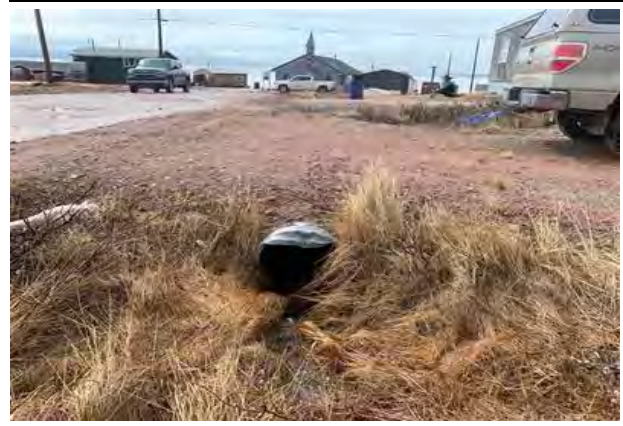
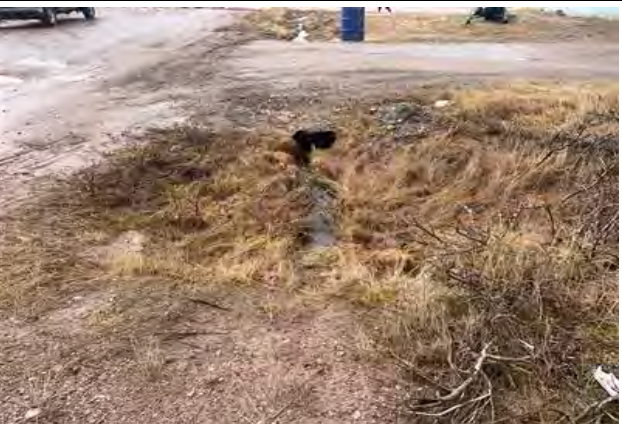
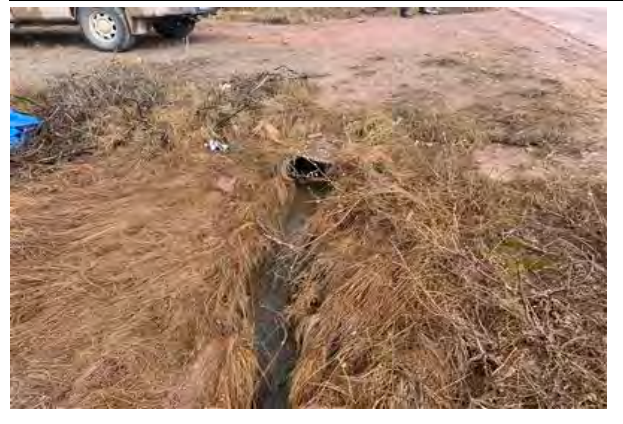
Culvert Information		
Culvert ID		110-09
Type		Cross
Shape		Round
Material		Csp
Diameter or Dimensions (mm)		1000
Marker Post Present		Y
End Crushing	Upstream	Y
	Downstream	Y
Infill Depth (mm)	Upstream	500
	Downstream	500
Other		None
Comments

Recommended Action(s):	Replace	Priority:	High
------------------------	---------	-----------	------

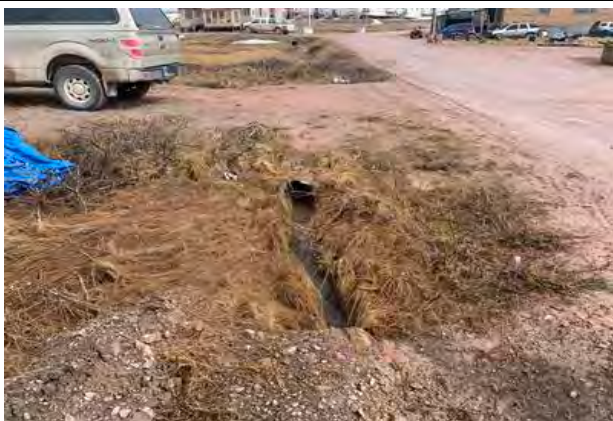
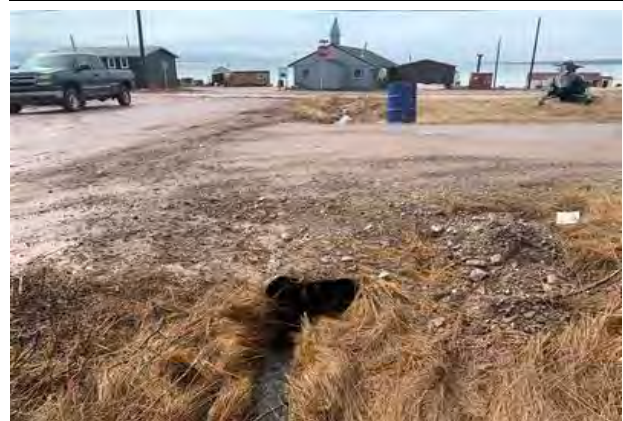
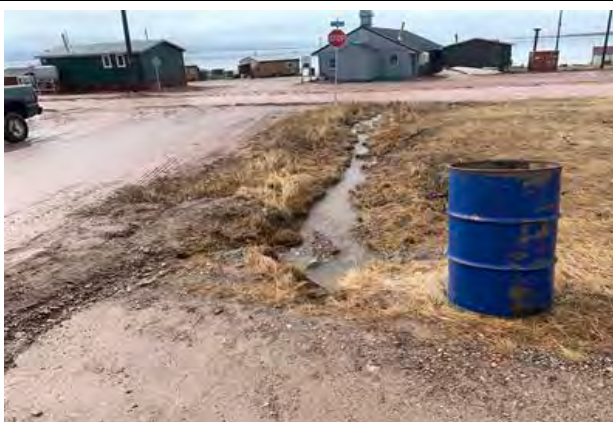
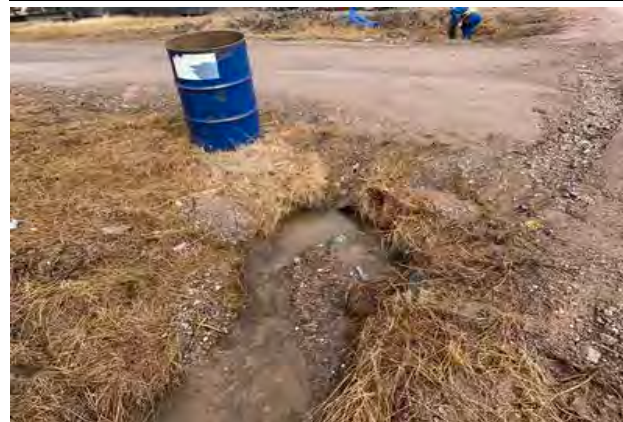
Culvert Information		
Culvert ID		110-10
Type		Cross
Shape		Round
Material		Csp
Diameter or Dimensions (mm)		400
Marker Post Present		0
End Crushing	Upstream	Y
	Downstream	N
Infill Depth (mm)	Upstream	150
	Downstream	0
Other		None
Comments

Culvert Condition Ratings (MTO 2013)				
Barrel Material (0-4)	Shape (0-4)	Capacity (0-2)	Erosion and Scour (0-2)	US/DS Channel (0-2)
1	0	2	1	1

Recommended Action(s):	Flush	Priority:	High
------------------------	-------	-----------	------

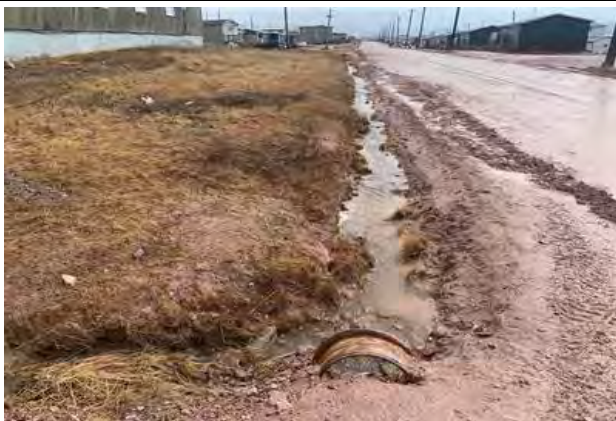
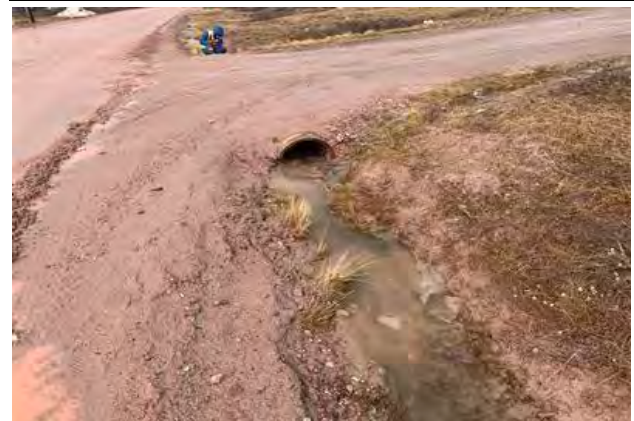
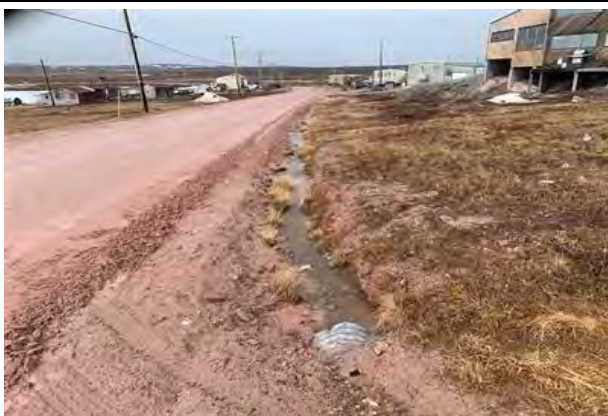
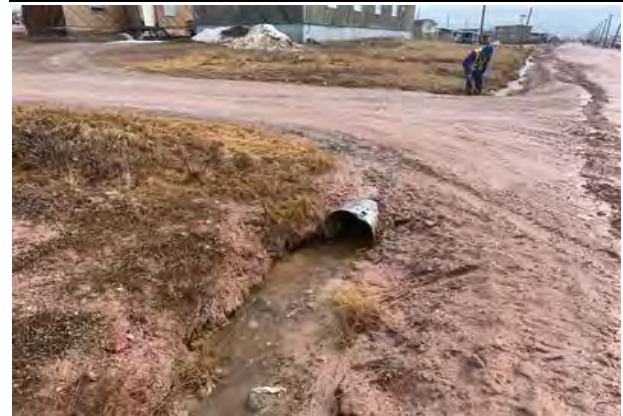
Culvert Information		
Culvert ID		110-11
Type		Cross
Shape		Round
Material		Csp
Diameter or Dimensions (mm)		600
Marker Post Present		N
End	Upstream	Y
	Downstream	Y
Infill Depth (mm)	Upstream	300
	Downstream	300
Other		Both ends crushed and infilled
Comments

Culvert Condition Ratings (MTO 2013)				
Barrel Material (0-4)	Shape (0-4)	Capacity (0-2)	Erosion and Scour (0-2)	US/DS Channel (0-2)
0	2	2	1	1

Recommended Action(s):	Replace	Priority:	High
------------------------	---------	-----------	------

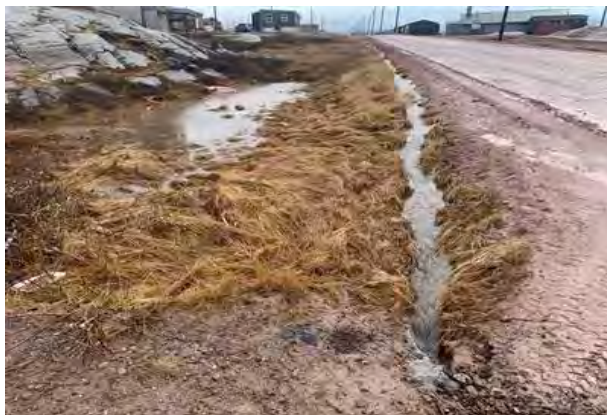
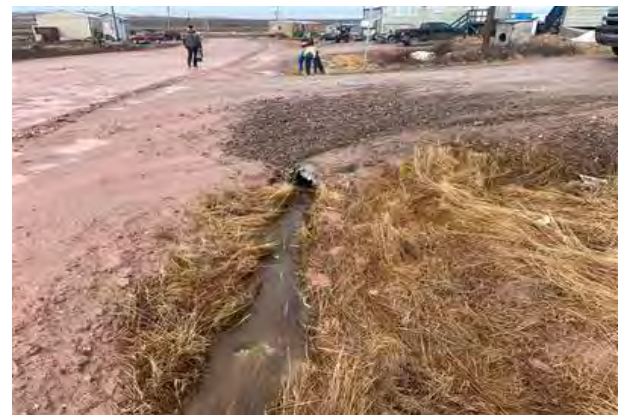
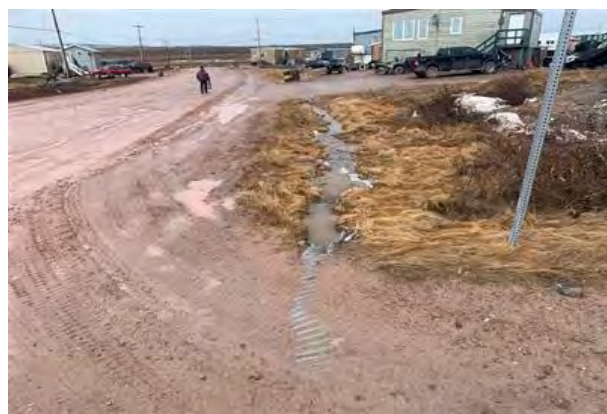
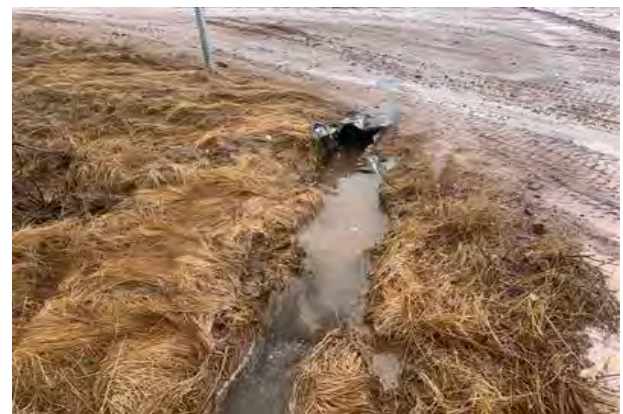
Culvert Information		
Culvert ID		110-12
Type		Entrance
Shape		Round
Material		Csp
Diameter or Dimensions (mm)		600
Marker Post Present		N
End Crushing	Upstream	Y
	Downstream	Y
Infill Depth (mm)	Upstream	100
	Downstream	100
Other		None
Comments

Culvert Condition Ratings (MTO 2013)				
Barrel Material (0-4)	Shape (0-4)	Capacity (0-2)	Erosion and Scour (0-2)	US/DS Channel (0-2)
0	4	1	0	0

Recommended Action(s):	Replace	Priority:	High
------------------------	---------	-----------	------

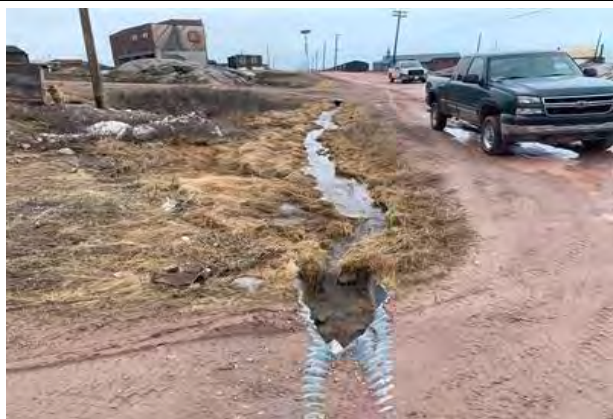
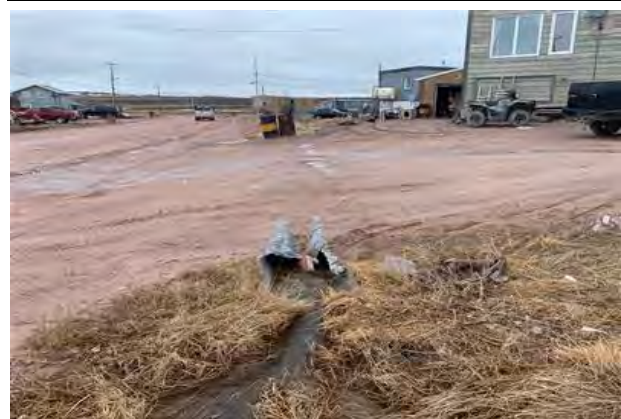
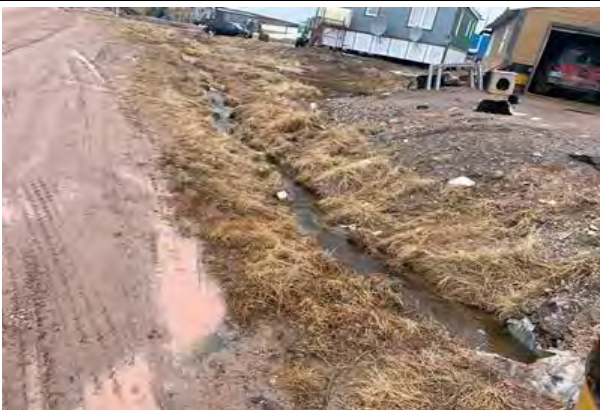
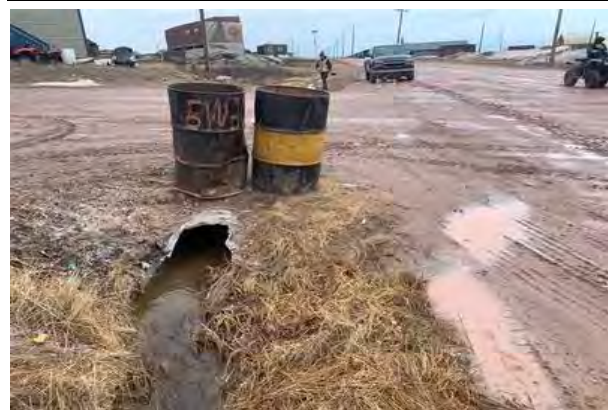
Culvert Information		
Culvert ID		110-13
Type		Cross
Shape		Round
Material		Csp
Diameter or Dimensions (mm)		600
Marker Post Present		N
End Crushing	Upstream	Y
	Downstream	Y
Infill Depth (mm)	Upstream	150
	Downstream	150
Other		None
Comments

Culvert Condition Ratings (MTO 2013)				
Barrel Material (0-4)	Shape (0-4)	Capacity (0-2)	Erosion and Scour (0-2)	US/DS Channel (0-2)
0	4	1	1	0

Recommended Action(s):	Replace	Priority:	High
------------------------	---------	-----------	------

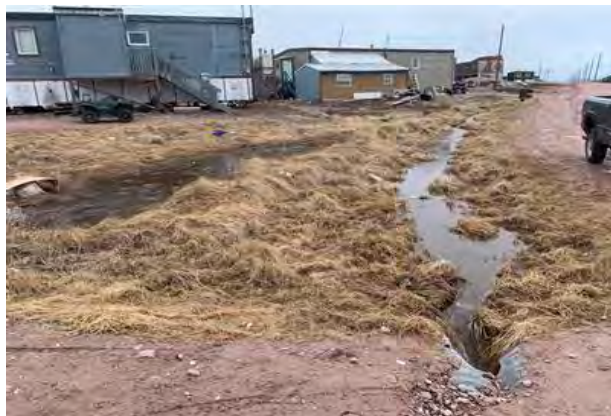
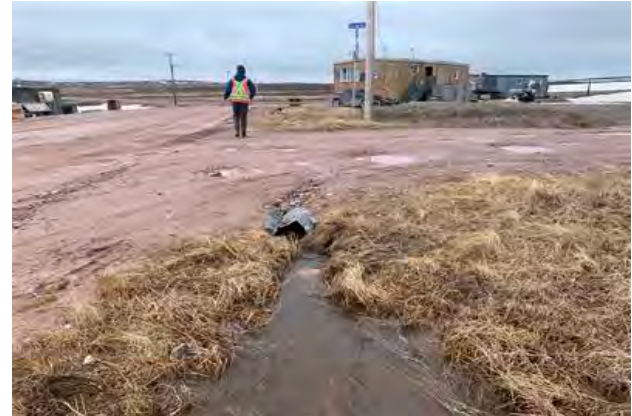
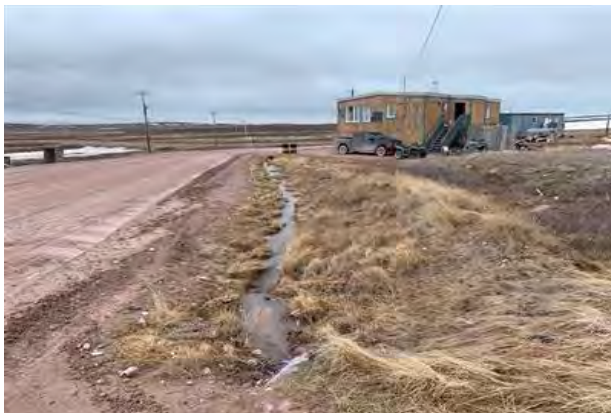
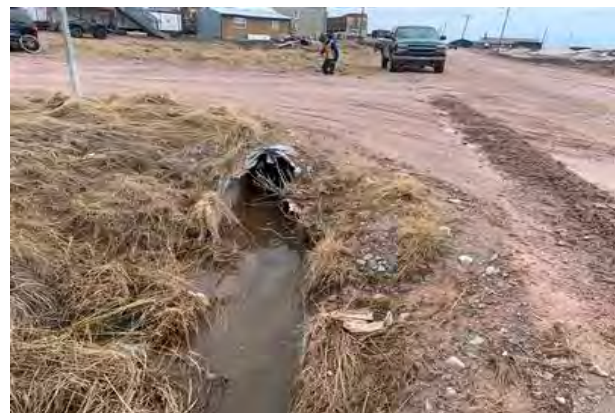
Culvert Information		
Culvert ID		110-14
Type		Entrance
Shape		Round
Material		Csp
Diameter or Dimensions (mm)		800
Marker Post Present		N
End Crushing	Upstream	N
	Downstream	Y
Infill Depth (mm)	Upstream	100
	Downstream	200
Other		None
Comments

Culvert Condition Ratings (MTO 2013)				
Barrel Material (0-4)	Shape (0-4)	Capacity (0-2)	Erosion and Scour (0-2)	US/DS Channel (0-2)
0	2	1	1	0

Recommended Action(s):	Replace	Priority:	High
------------------------	---------	-----------	------

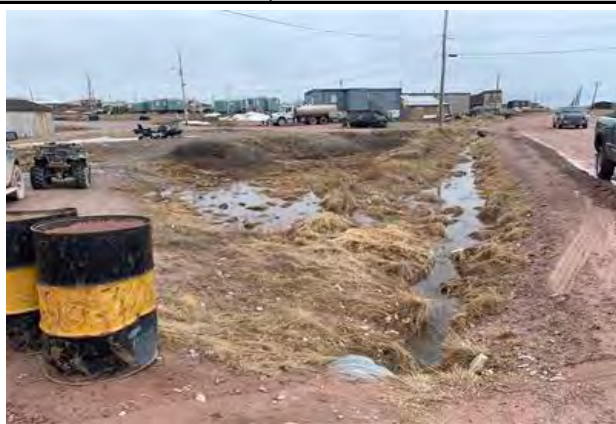
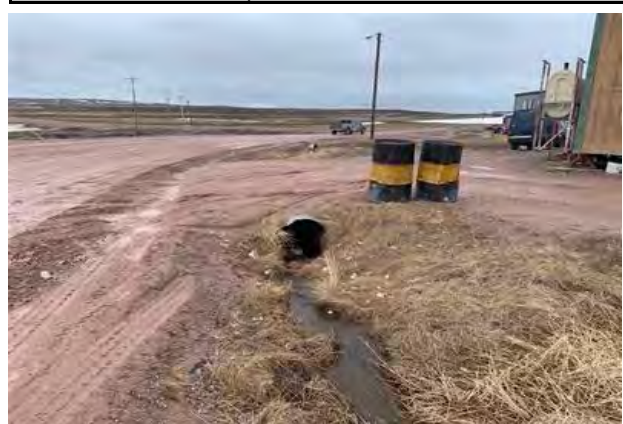
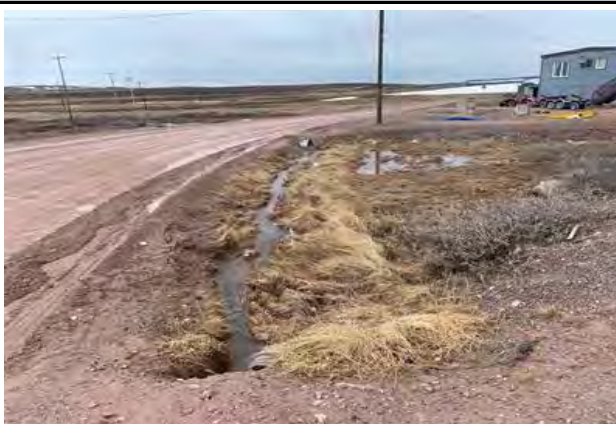
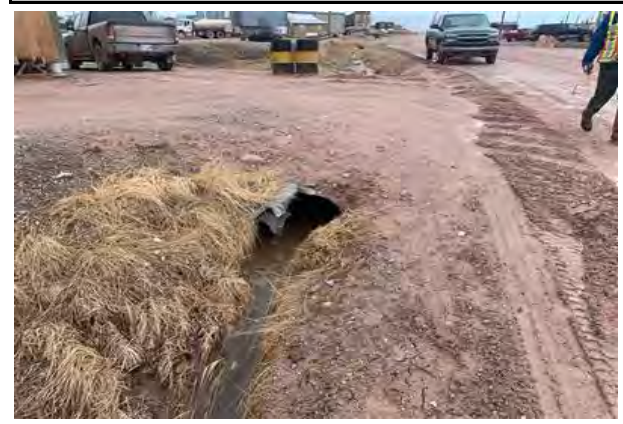
Culvert Information		
Culvert ID		110-15
Type		Cross
Shape		Round
Material		Csp
Diameter or Dimensions (mm)		600
Marker Post Present		N
End Crushing	Upstream	N
	Downstream	N
Infill Depth (mm)	Upstream	0
	Downstream	0
Other		None
Comments

Culvert Condition Ratings (MTO 2013)				
Barrel Material (0-4)	Shape (0-4)	Capacity (0-2)	Erosion and Scour (0-2)	US/DS Channel (0-2)
0	0	0	1	0

Recommended Action(s):	No action	Priority:	Low
------------------------	-----------	-----------	-----

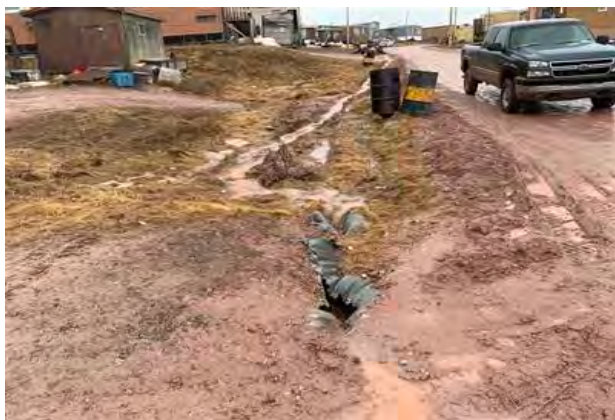
Upstream View

Culvert Information		
Culvert ID		112-01
Type		Entrance
Shape		Round
Material		Csp
Diameter or Dimensions (mm)		600
Marker Post Present		0
End Crushing	Upstream	Y
	Downstream	Y
Infill Depth (mm)	Upstream	150
	Downstream	300
Other		Both ends crushed and infilled
Comments

Culvert Condition Ratings (MTO 2013)				
Barrel Material (0-4)	Shape (0-4)	Capacity (0-2)	Erosion and Scour (0-2)	US/DS Channel (0-2)
0	4	2	1	1

Recommended Action(s):	Replace	Priority:	High
------------------------	---------	-----------	------

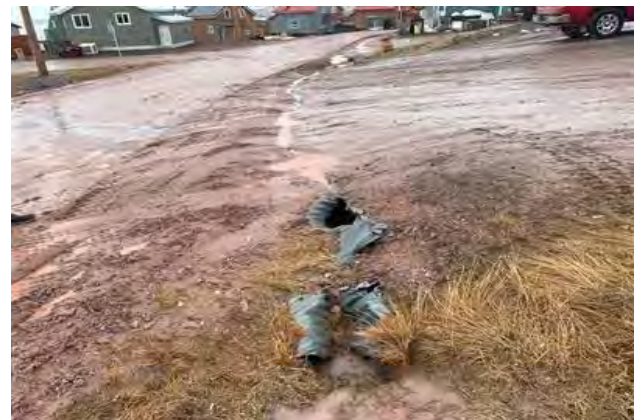
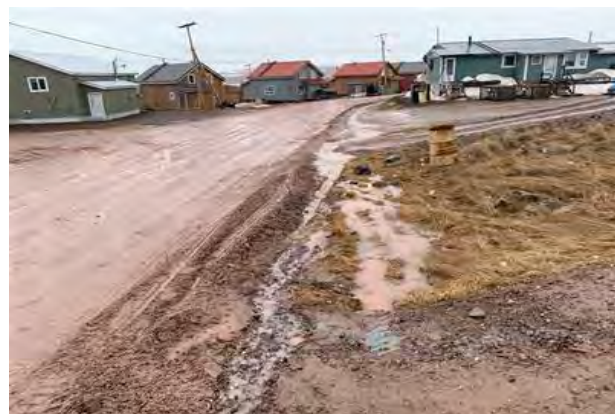
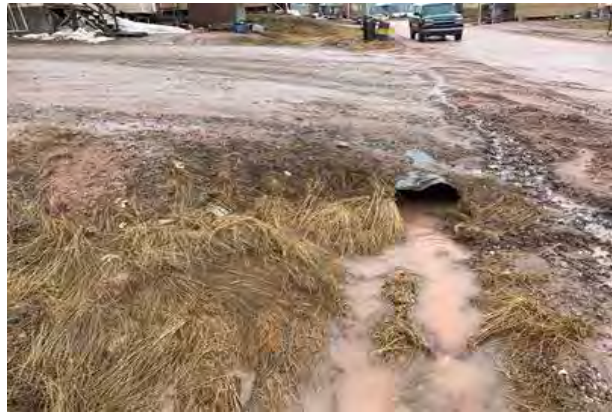
Culvert Information		
Culvert ID		112-02
Type		Entrance
Shape		Round
Material		Csp
Diameter or Dimensions (mm)		600
Marker Post Present		N
End Crushing	Upstream	Y
	Downstream	Y
Infill Depth (mm)	Upstream	200
	Downstream	200
Other		None
Comments

Recommended Action(s):	Replace	Priority:	High
------------------------	---------	-----------	------

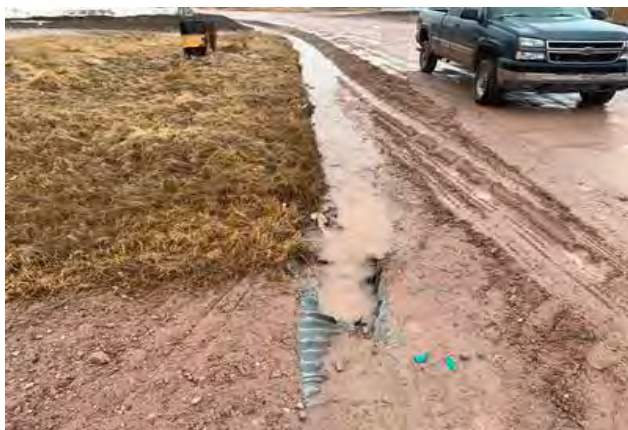
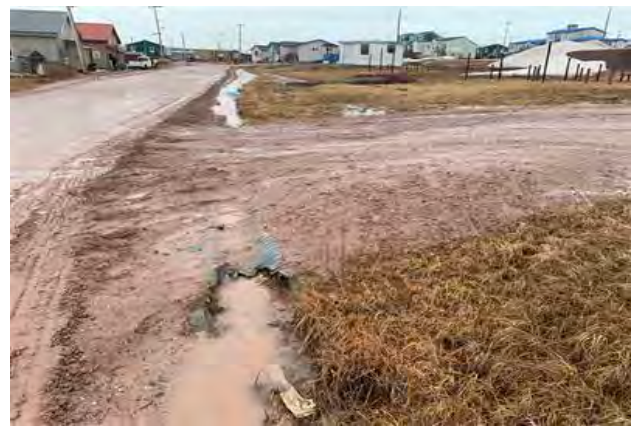
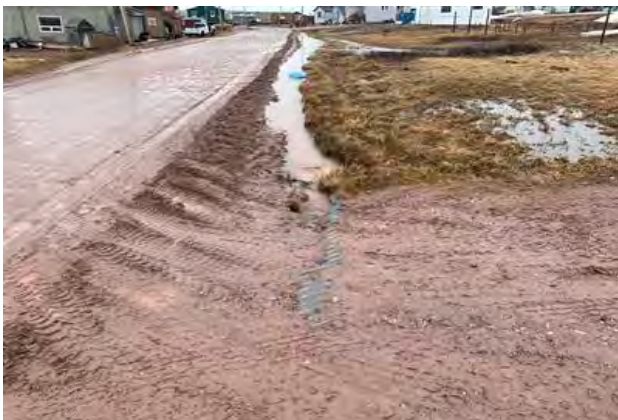
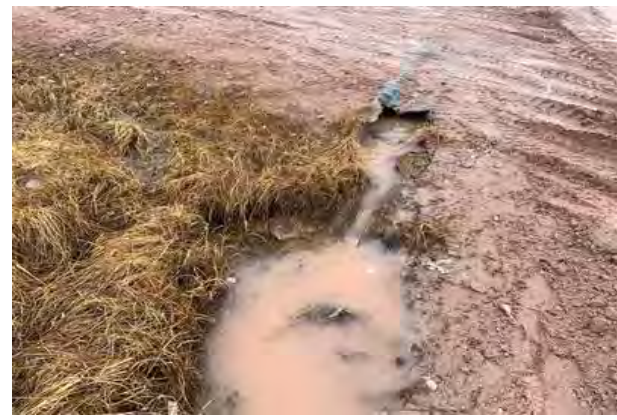
Culvert Information		
Culvert ID		112-03
Type		Entrance
Shape		Round
Material		Csp
Diameter or Dimensions (mm)		500
Marker Post Present		N
End Crushing	Upstream	Y
	Downstream	Y
Infill Depth (mm)	Upstream	500
	Downstream	200
Other		Both ends crushed and infilled
Comments

Culvert Condition Ratings (MTO 2013)				
Barrel Material (0-4)	Shape (0-4)	Capacity (0-2)	Erosion and Scour (0-2)	US/DS Channel (0-2)
0	3	2	1	2

Recommended Action(s):	Replace	Priority:	High
------------------------	---------	-----------	------

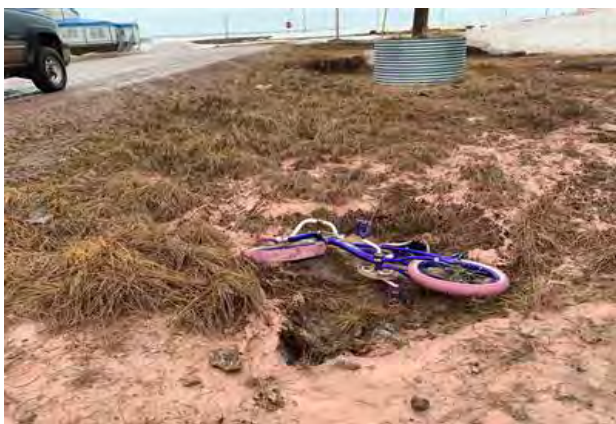
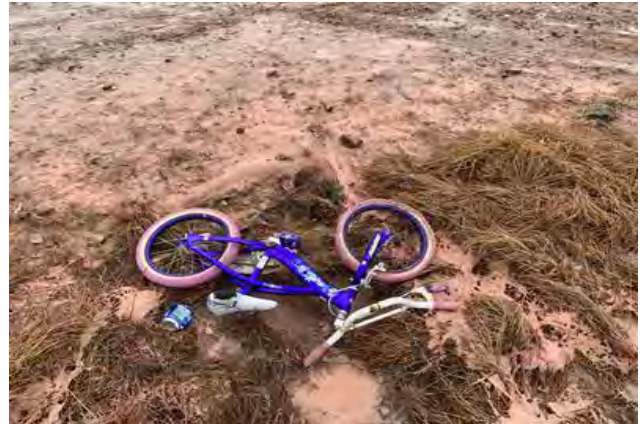
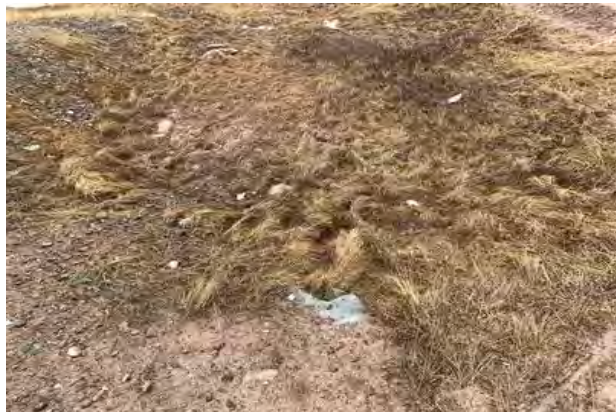
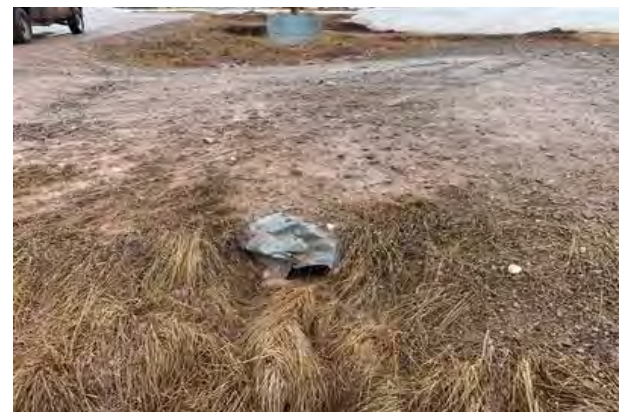
Culvert Information		
Culvert ID		112-04
Type		Entrance
Shape		Round
Material		Csp
Diameter or Dimensions (mm)		600
Marker Post Present		N
End Crushing	Upstream	Y
	Downstream	Y
Infill Depth (mm)	Upstream	200
	Downstream	150
Other		None
Comments

Culvert Condition Ratings (MTO 2013)				
Barrel Material (0-4)	Shape (0-4)	Capacity (0-2)	Erosion and Scour (0-2)	US/DS Channel (0-2)
0	1	2	1	0

Recommended Action(s):	Flush	Priority:	High
------------------------	-------	-----------	------

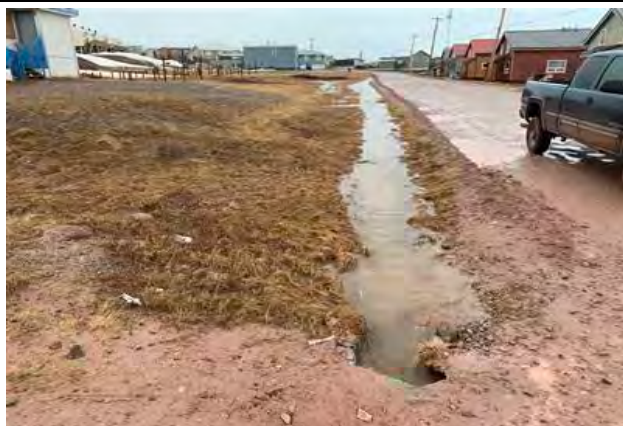
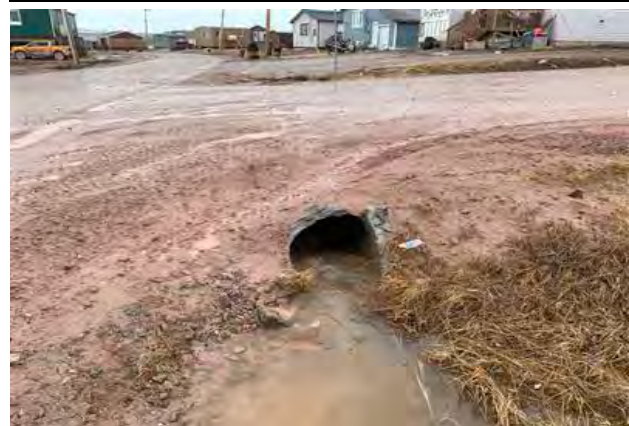
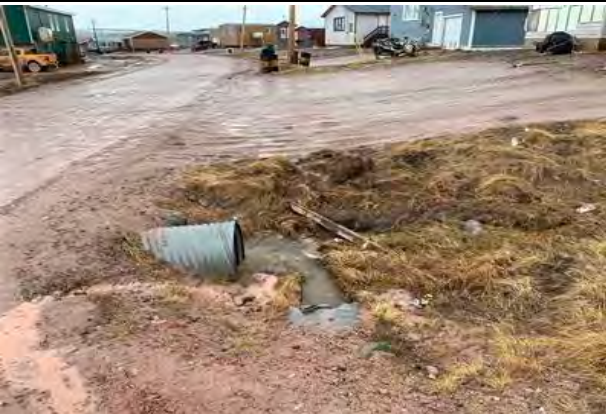
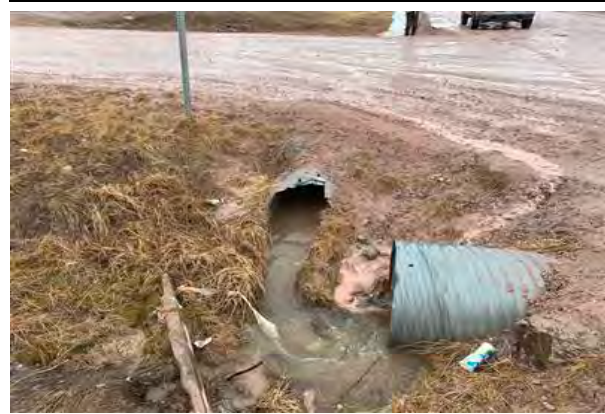
Culvert Information		
Culvert ID		112-05
Type		Cross
Shape		Round
Material		Csp
Diameter or Dimensions (mm)		700
Marker Post Present		N
End	Upstream	N
	Downstream	Y
Infill Depth (mm)	Upstream	0
	Downstream	100
Other		None
Comments

Culvert Condition Ratings (MTO 2013)				
Barrel Material (0-4)	Shape (0-4)	Capacity (0-2)	Erosion and Scour (0-2)	US/DS Channel (0-2)
0	0	1	1	0

Recommended Action(s):	Flush	Priority:	Medium
------------------------	-------	-----------	--------

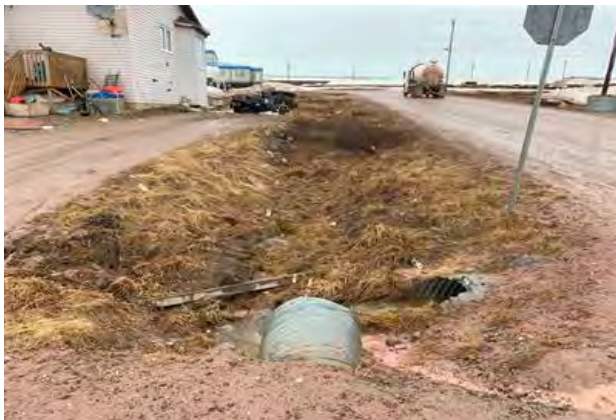
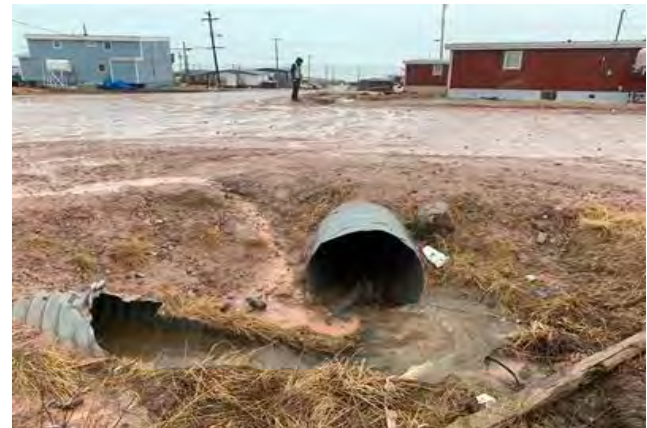
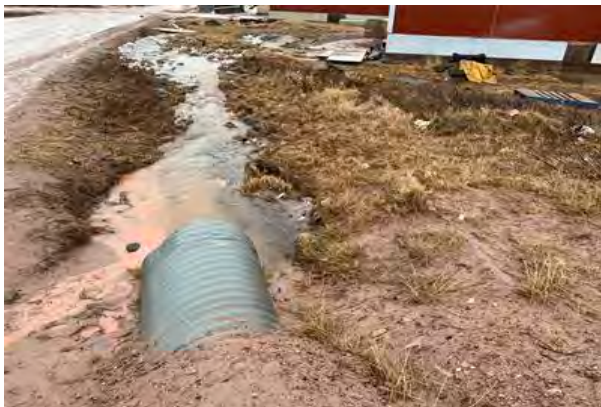
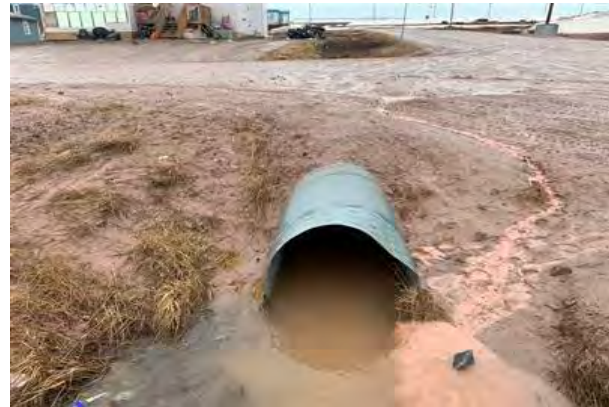
Culvert Information		
Culvert ID		112-06
Type		Cross
Shape		Round
Material		Csp
Diameter or Dimensions (mm)		600
Marker Post Present		N
End Crushing	Upstream	Y
	Downstream	Y
Infill Depth (mm)	Upstream	500
	Downstream	550
Other Comments		Both ends crushed and infilled

Culvert Condition Ratings (MTO 2013)				
Barrel Material (0-4)	Shape (0-4)	Capacity (0-2)	Erosion and Scour (0-2)	US/DS Channel (0-2)
0	2	2	1	2

Recommended Action(s):	Replace	Priority:	High
------------------------	---------	-----------	------

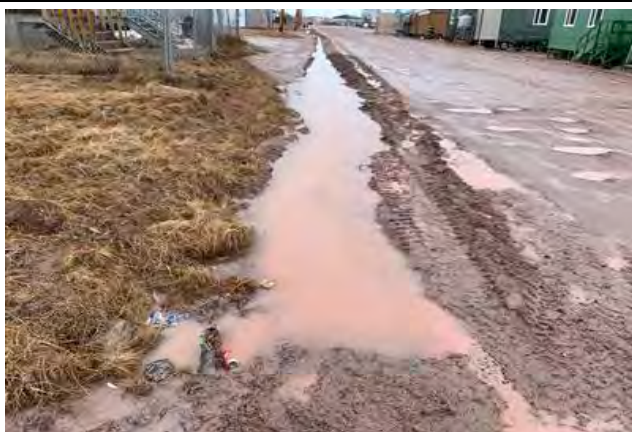
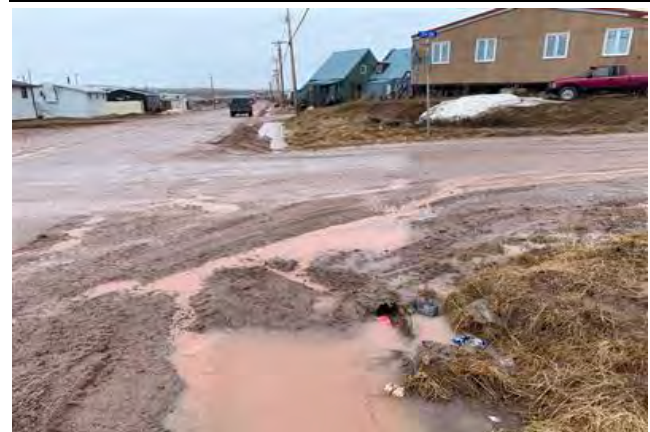
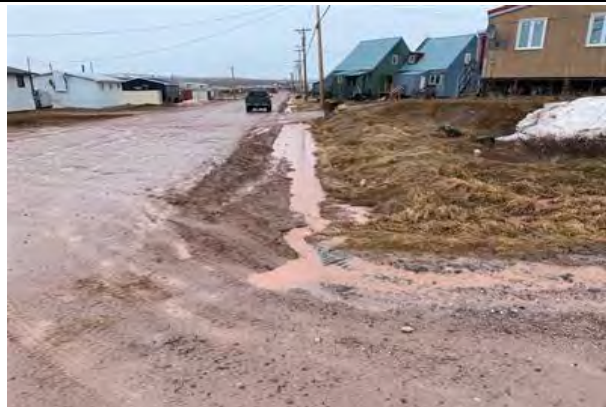
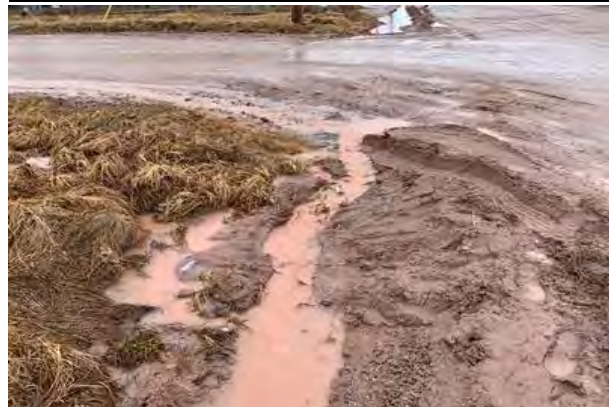
Culvert Information		
Culvert ID		112-07
Type		Entrance
Shape		Round
Material		Csp
Diameter or Dimensions (mm)		500
Marker Post Present		N
End Crushing	Upstream	Y
	Downstream	Y
Infill Depth (mm)	Upstream	250
	Downstream	250
Other		Both ends crushed and infilled
Comments

Culvert Condition Ratings (MTO 2013)				
Barrel Material (0-4)	Shape (0-4)	Capacity (0-2)	Erosion and Scour (0-2)	US/DS Channel (0-2)
0	3	2	1	1

Recommended Action(s):	Replace	Priority:	High
------------------------	---------	-----------	------

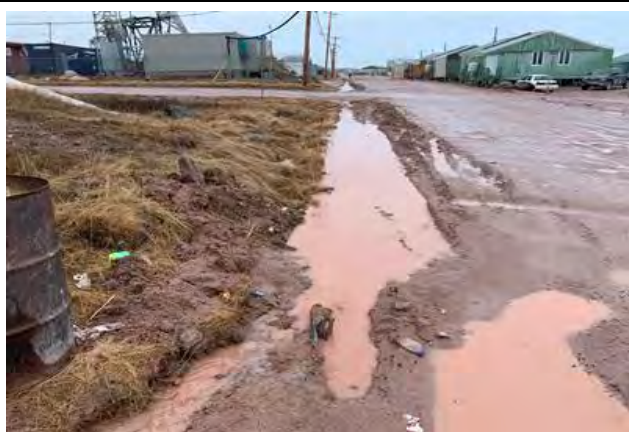
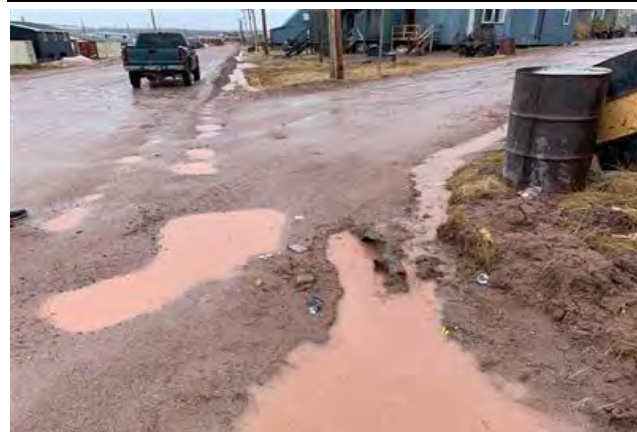
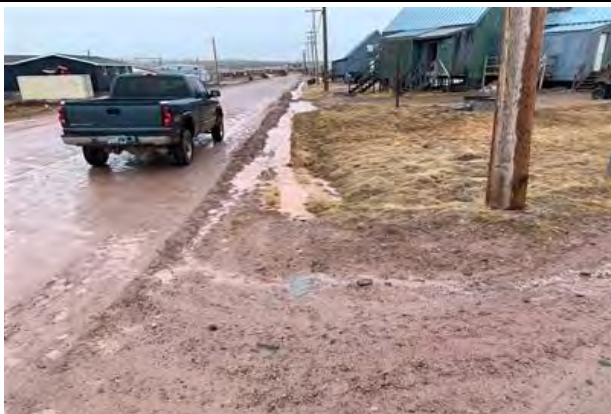
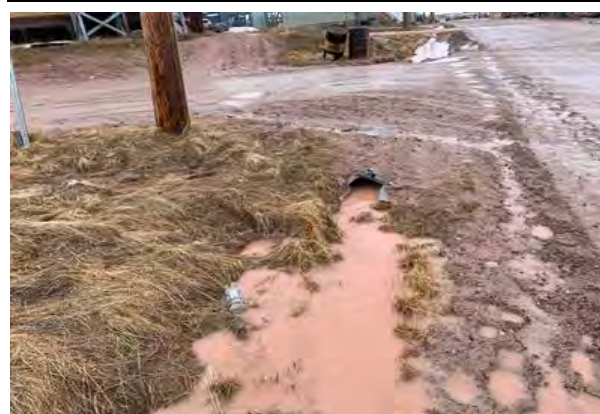
Culvert Information		
Culvert ID		112-08
Type		Entrance
Shape		Round
Material		Csp
Diameter or Dimensions (mm)		500
Marker Post Present		N
End	Upstream	Y
	Downstream	Y
Infill Depth (mm)	Upstream	250
	Downstream	250
Other		Both ends crushed and infilled
Comments

Culvert Condition Ratings (MTO 2013)				
Barrel Material (0-4)	Shape (0-4)	Capacity (0-2)	Erosion and Scour (0-2)	US/DS Channel (0-2)
0	2	2	0	2

Recommended Action(s):	Replace	Priority:	High
------------------------	---------	-----------	------

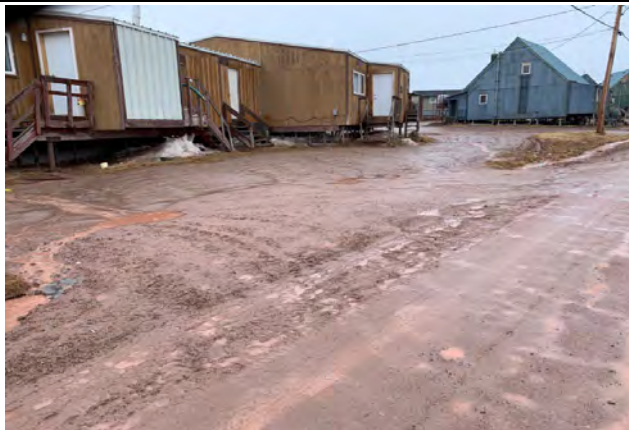
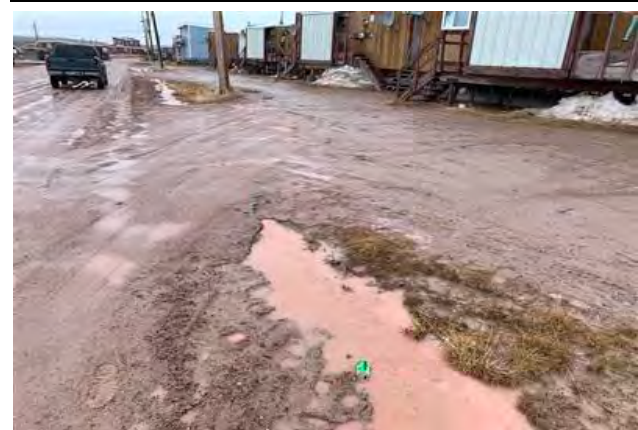
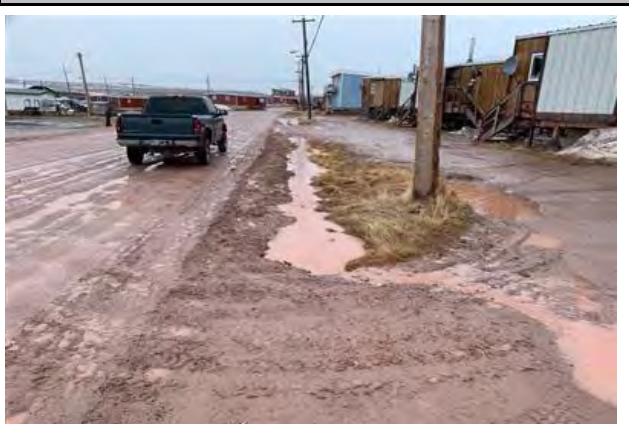
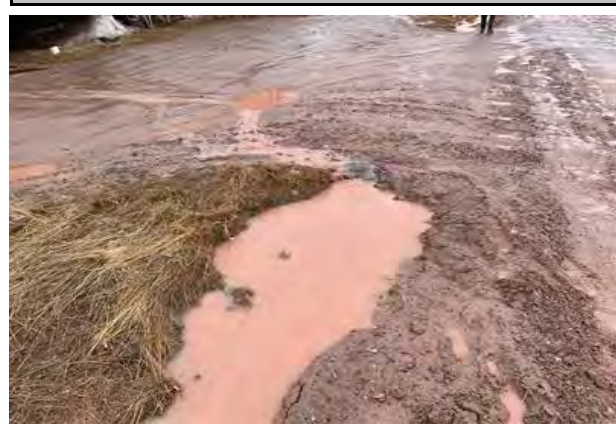
Culvert Information		
Culvert ID		112-09
Type		Entrance
Shape		Round
Material		Csp
Diameter or Dimensions (mm)		500
Marker Post Present		N
End	Upstream	Y
	Downstream	Y
Infill Depth (mm)	Upstream	300
	Downstream	300
Other		Both ends crushed and infilled
Comments

Culvert Condition Ratings (MTO 2013)				
Barrel Material (0-4)	Shape (0-4)	Capacity (0-2)	Erosion and Scour (0-2)	US/DS Channel (0-2)
0	2	2	0	2

Recommended Action(s):	Replace	Priority:	High
------------------------	---------	-----------	------
