# **Geotechnical Evaluation and Drainage Planning in Baker Lake, Nunavut**

*Final Report Rev-00*

**The Municipality of Baker Lake, Nunavut**

**Nunami Stantec Limited**

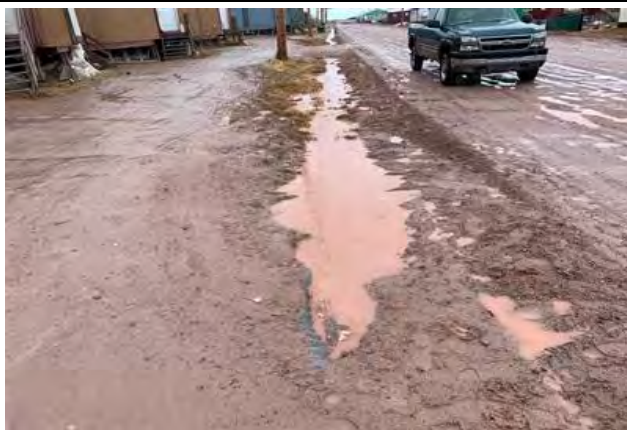
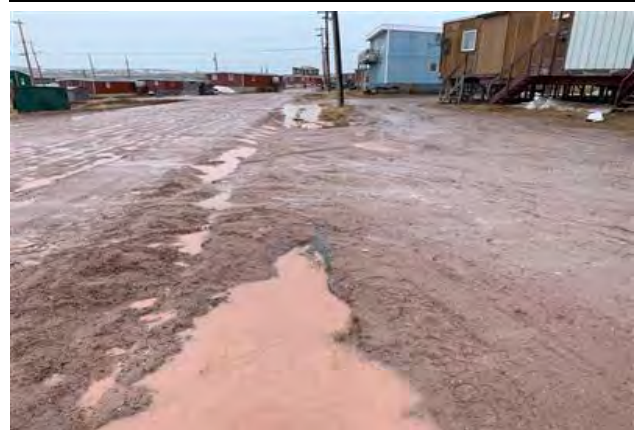
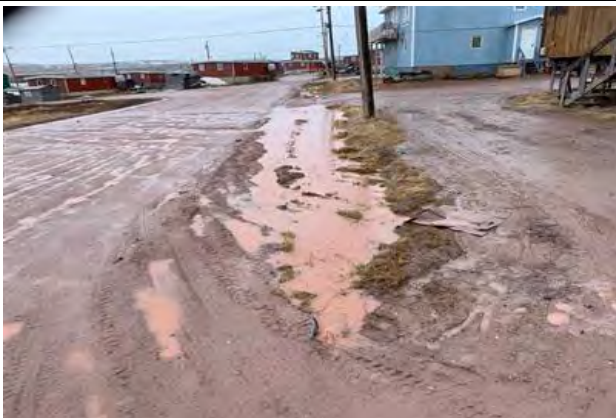
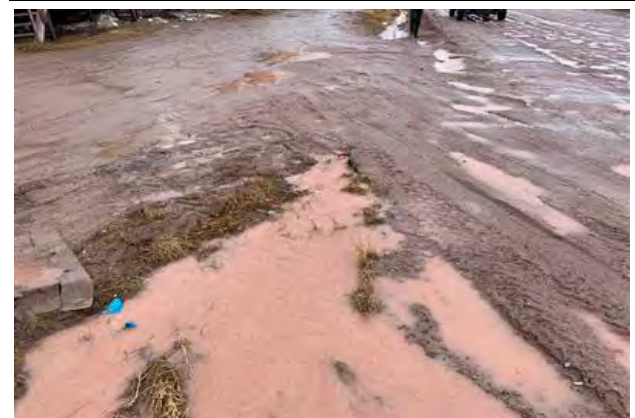
Culvert Information		
Culvert ID		112-10
Type		Entrance
Shape		Round
Material		Csp
Diameter or Dimensions (mm)		500
Marker Post Present		N
End Crushing	Upstream	Y
	Downstream	Y
Infill Depth (mm)	Upstream	400
	Downstream	250
Other		Both ends crushed and infilled
Comments

Culvert Condition Ratings (MTO 2013)				
Barrel Material (0-4)	Shape (0-4)	Capacity (0-2)	Erosion and Scour (0-2)	US/DS Channel (0-2)
0	3	2	0	2

Recommended Action(s):	Replace	Priority:	High
------------------------	---------	-----------	------

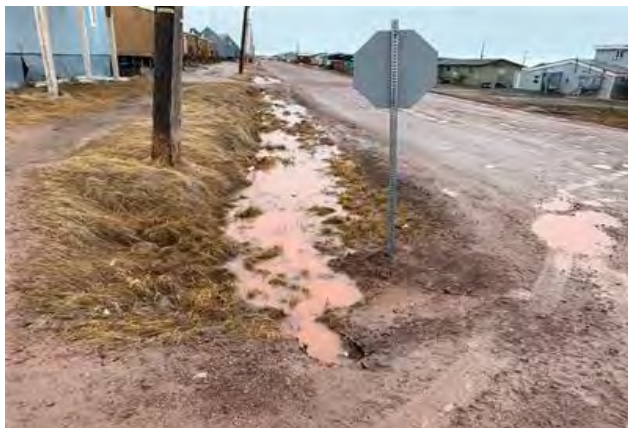
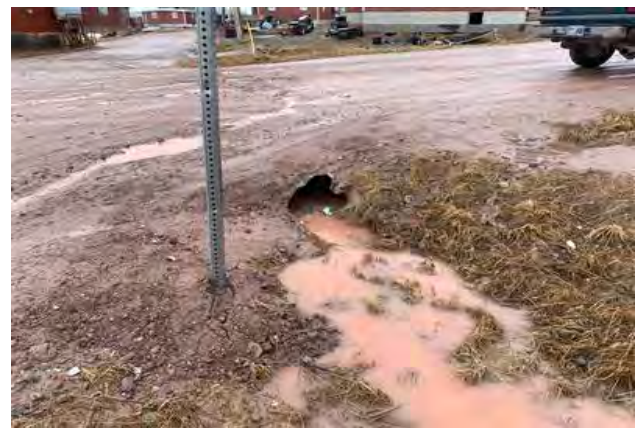
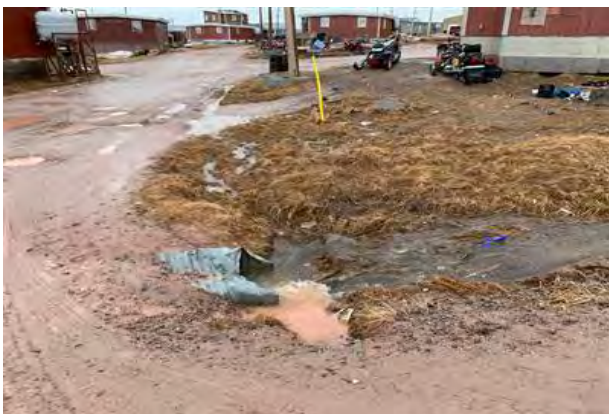
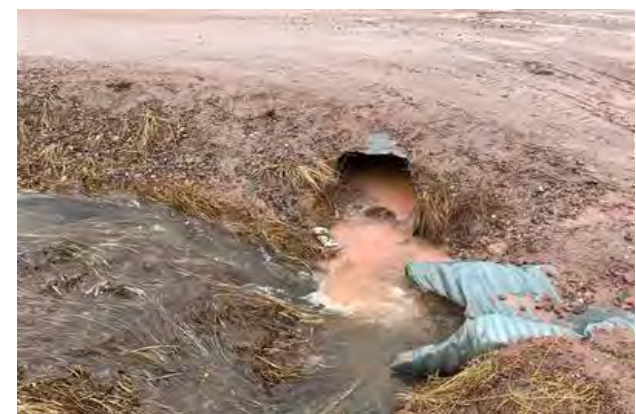
Culvert Information		
Culvert ID		112-11
Type		Cross
Shape		Round
Material		Csp
Diameter or Dimensions (mm)		600
Marker Post Present		N
End Crushing	Upstream	Y
	Downstream	Y
Infill Depth (mm)	Upstream	200
	Downstream	200
Other		None
Comments

Culvert Condition Ratings (MTO 2013)				
Barrel Material (0-4)	Shape (0-4)	Capacity (0-2)	Erosion and Scour (0-2)	US/DS Channel (0-2)
0	1	2	1	1

Recommended Action(s):	Flush	Priority:	High
------------------------	-------	-----------	------

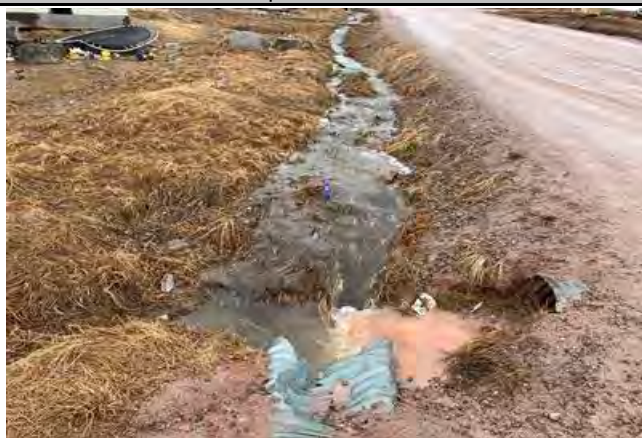
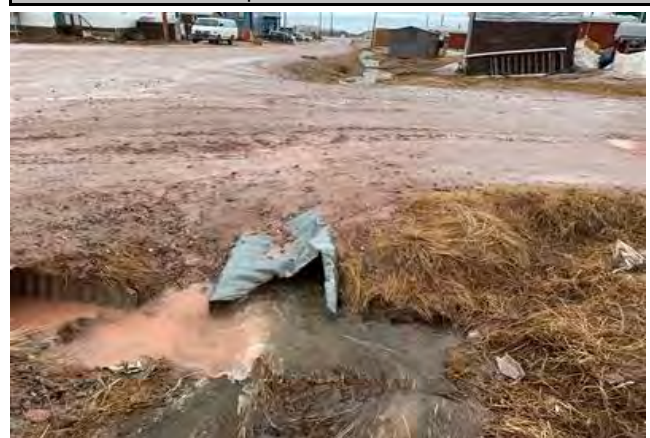
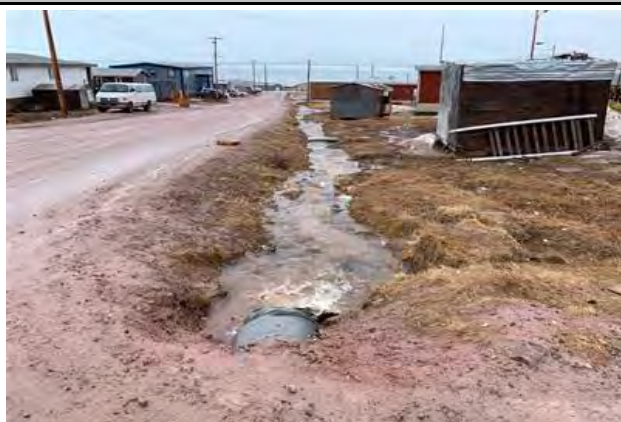
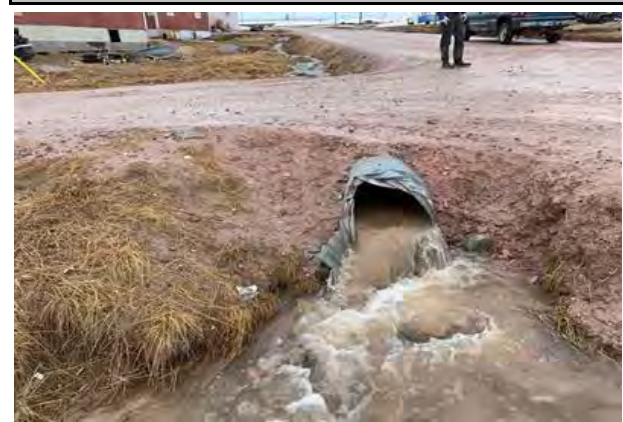
Culvert Information		
Culvert ID		112-12
Type		Cross
Shape		Round
Material		Csp
Diameter or Dimensions (mm)		600
Marker Post Present		N
End	Upstream	Y
	Downstream	Y
Infill Depth (mm)	Upstream	150
	Downstream	0
Other		None
Comments

Culvert Condition Ratings (MTO 2013)				
Barrel Material (0-4)	Shape (0-4)	Capacity (0-2)	Erosion and Scour (0-2)	US/DS Channel (0-2)
0	3	1	1	0

Recommended Action(s):	Replace	Priority:	High
------------------------	---------	-----------	------

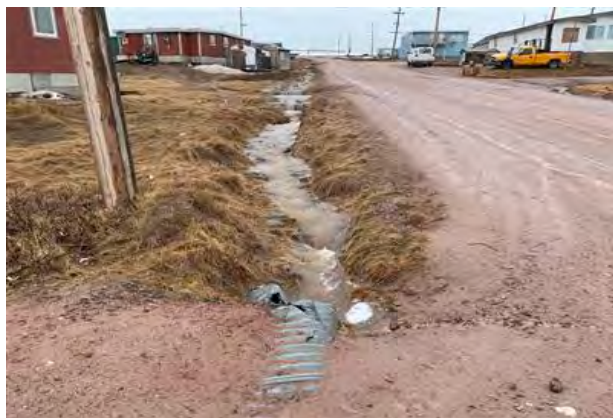
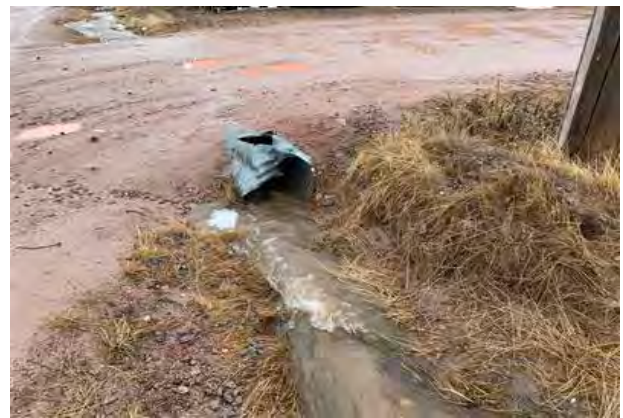
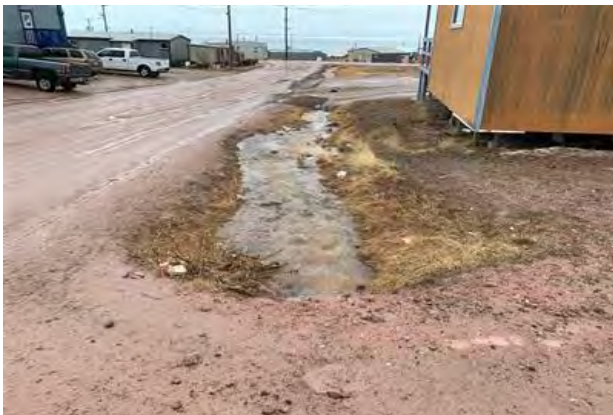
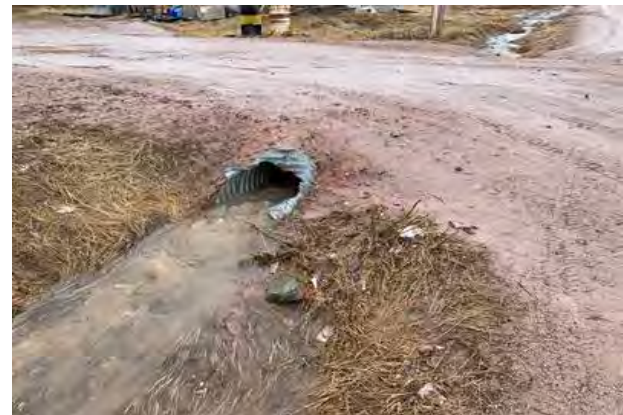
Culvert Information		
Culvert ID		112-13
Type		Entrance
Shape		Round
Material		Csp
Diameter or Dimensions (mm)		600
Marker Post Present		N
End Crushing	Upstream	Y
	Downstream	Y
Infill Depth (mm)	Upstream	0
	Downstream	100
Other		None
Comments

Culvert Condition Ratings (MTO 2013)				
Barrel Material (0-4)	Shape (0-4)	Capacity (0-2)	Erosion and Scour (0-2)	US/DS Channel (0-2)
1	3	1	1	0

Recommended Action(s):	Replace	Priority:	High
------------------------	---------	-----------	------

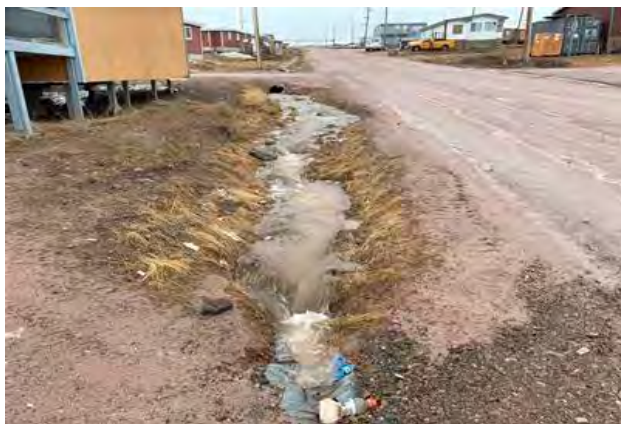
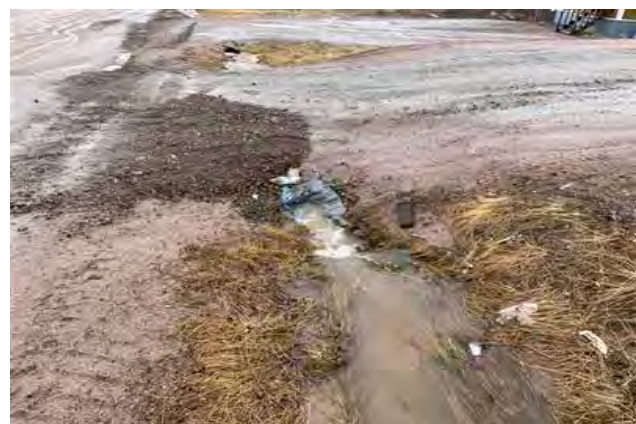
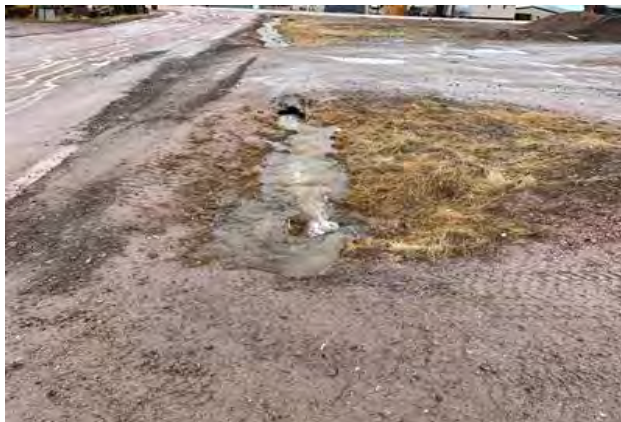
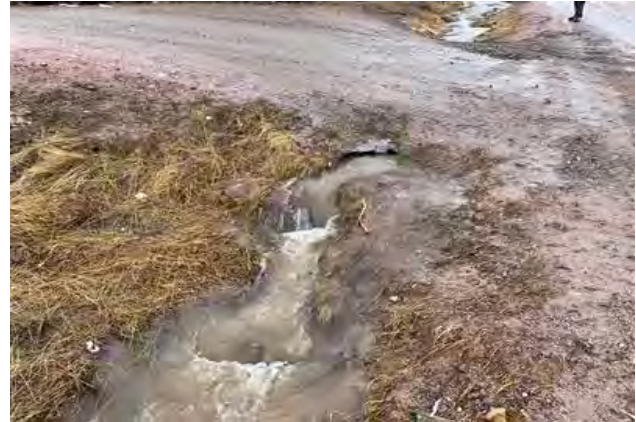
Culvert Information		
Culvert ID		112-14
Type		Entrance
Shape		Round
Material		Csp
Diameter or Dimensions (mm)		600
Marker Post Present		N
End Crushing	Upstream	Y
	Downstream	Y
Infill Depth (mm)	Upstream	200
	Downstream	200
Other		Both ends crushed and infilled
Comments

Culvert Condition Ratings (MTO 2013)				
Barrel Material (0-4)	Shape (0-4)	Capacity (0-2)	Erosion and Scour (0-2)	US/DS Channel (0-2)
1	3	2	0	1

Recommended Action(s):	Replace	Priority:	High
------------------------	---------	-----------	------

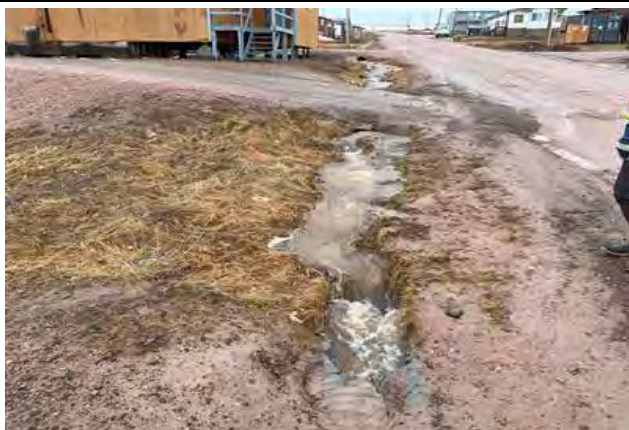
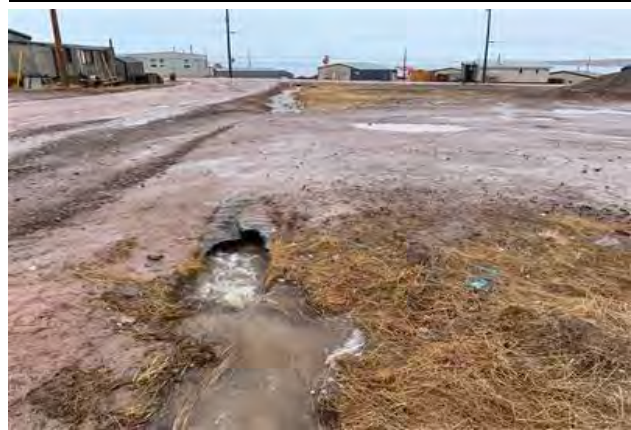
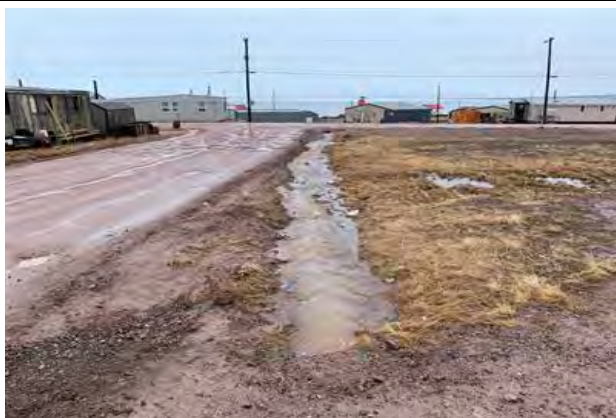
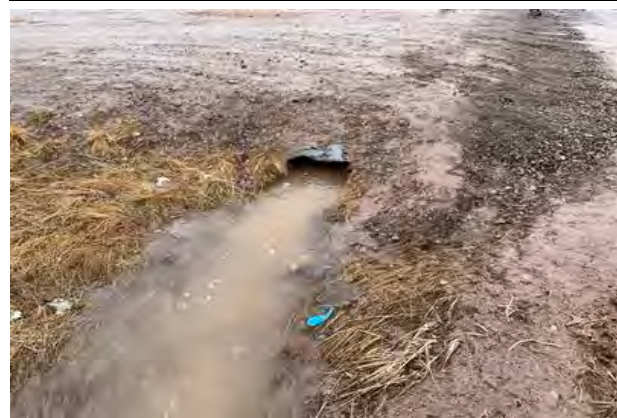
Culvert Information		
Culvert ID		112-15
Type		Entrance
Shape		Round
Material		Csp
Diameter or Dimensions (mm)		600
Marker Post Present		N
End Crushing	Upstream	Y
	Downstream	Y
Infill Depth (mm)	Upstream	150
	Downstream	150
Other		None
Comments

Culvert Condition Ratings (MTO 2013)				
Barrel Material (0-4)	Shape (0-4)	Capacity (0-2)	Erosion and Scour (0-2)	US/DS Channel (0-2)
0	2	1	1	0

Recommended Action(s):	Replace	Priority:	High
------------------------	---------	-----------	------

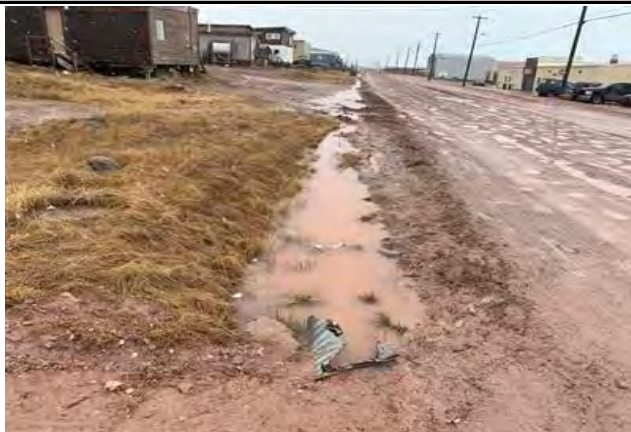
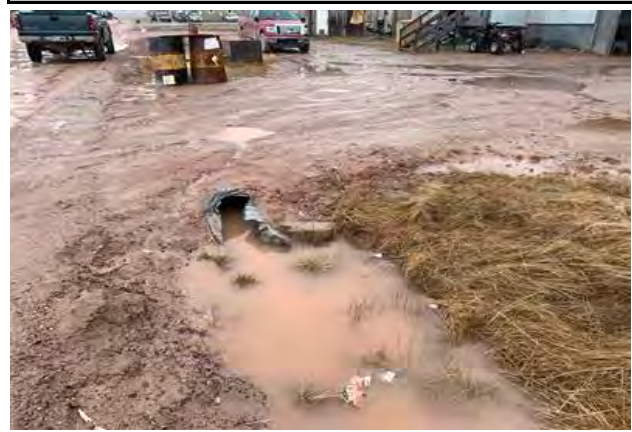
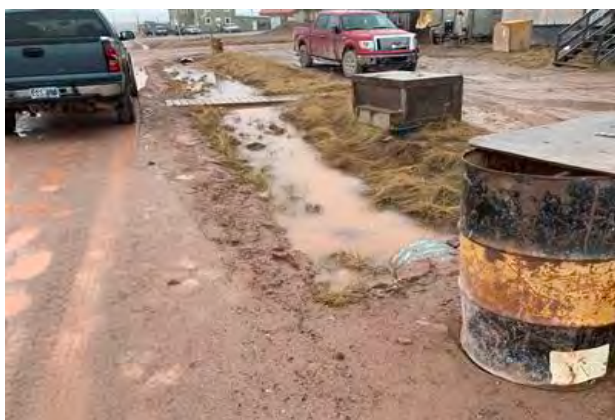
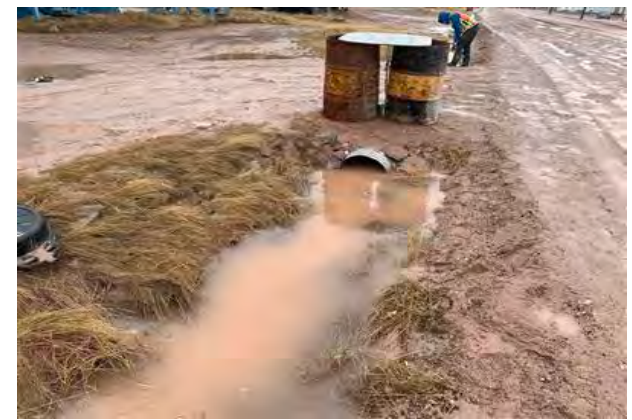
Culvert Information		
Culvert ID		112-16
Type		Entrance
Shape		Round
Material		Csp
Diameter or Dimensions (mm)		500
Marker Post Present		N
End Crushing	Upstream	Y
	Downstream	N
Infill Depth (mm)	Upstream	150
	Downstream	150
Other		None
Comments

Culvert Condition Ratings (MTO 2013)				
Barrel Material (0-4)	Shape (0-4)	Capacity (0-2)	Erosion and Scour (0-2)	US/DS Channel (0-2)
0	2	2	1	0

Recommended Action(s):	Replace	Priority:	High
------------------------	---------	-----------	------

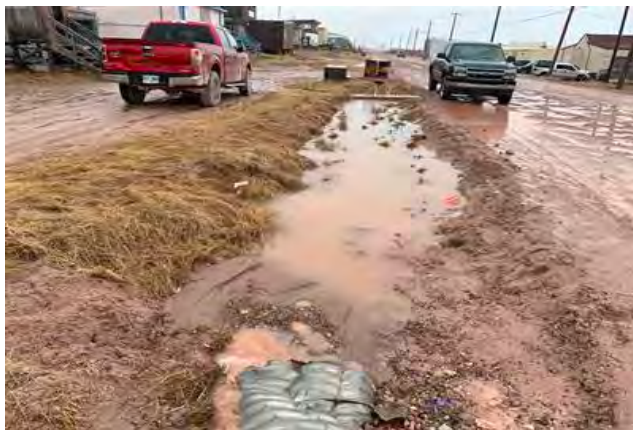
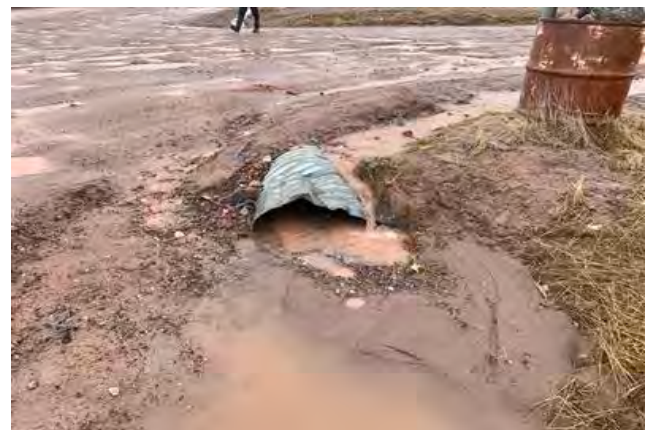
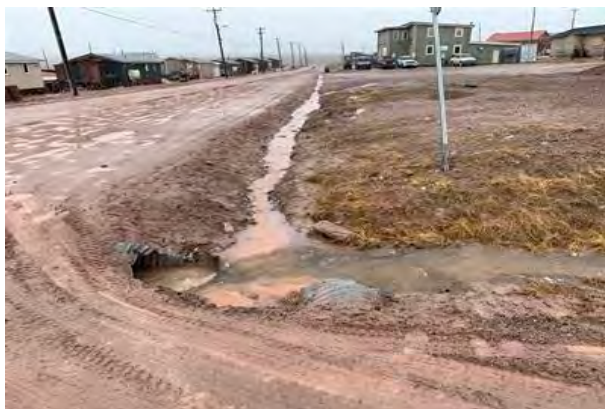
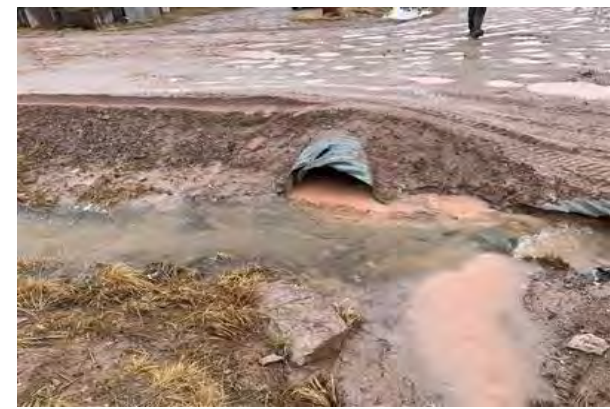
Culvert Information		
Culvert ID		112-17
Type		Cross
Shape		Round
Material		Csp
Diameter or Dimensions (mm)		600
Marker Post Present		N
End Crushing	Upstream	Y
	Downstream	Y
Infill Depth (mm)	Upstream	300
	Downstream	300
Other		None
Comments

Culvert Condition Ratings (MTO 2013)				
Barrel Material (0-4)	Shape (0-4)	Capacity (0-2)	Erosion and Scour (0-2)	US/DS Channel (0-2)
0	2	2	1	0

Recommended Action(s):	Replace	Priority:	High
------------------------	---------	-----------	------

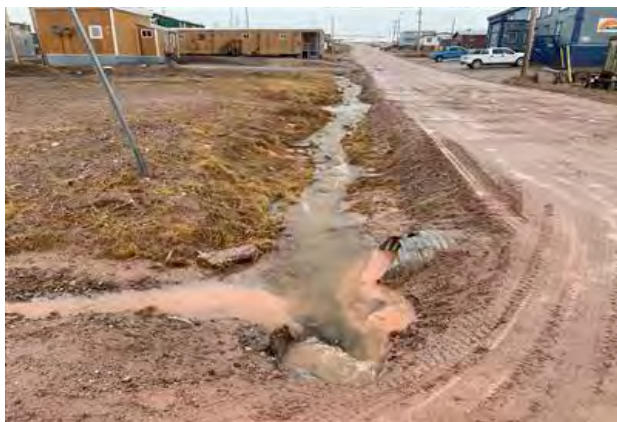
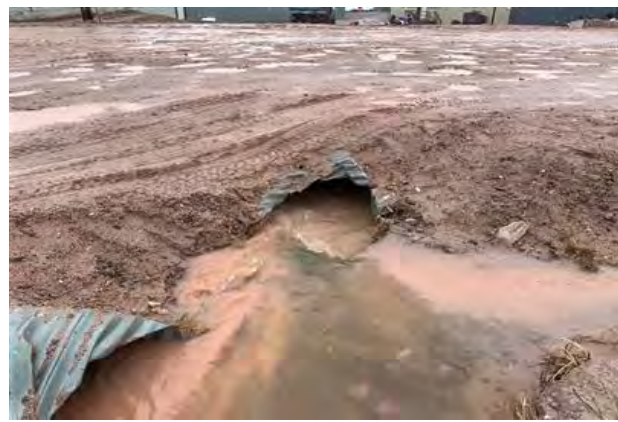
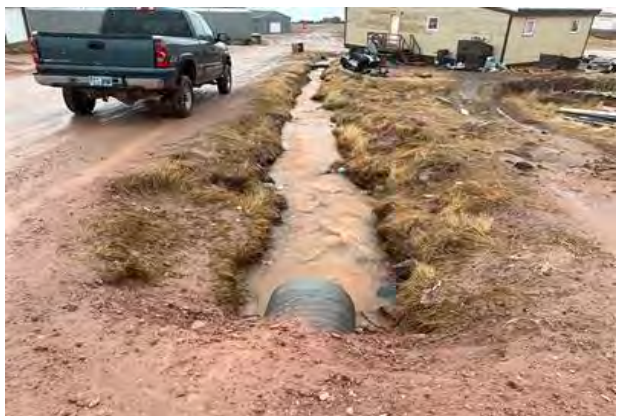
Culvert Information		
Culvert ID		112-18
Type		Cross
Shape		Round
Material		Csp
Diameter or Dimensions (mm)		600
Marker Post Present		N
End Crushing	Upstream	Y
	Downstream	N
Infill Depth (mm)	Upstream	100
	Downstream	0
Other		None
Comments

Culvert Condition Ratings (MTO 2013)				
Barrel Material (0-4)	Shape (0-4)	Capacity (0-2)	Erosion and Scour (0-2)	US/DS Channel (0-2)
0	2	1	1	0

Recommended Action(s):	Replace	Priority:	High
------------------------	---------	-----------	------

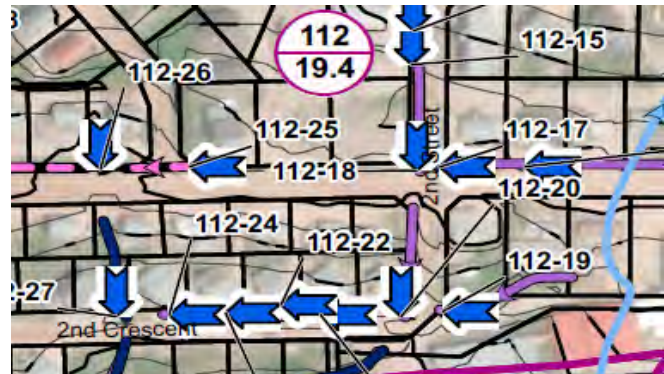
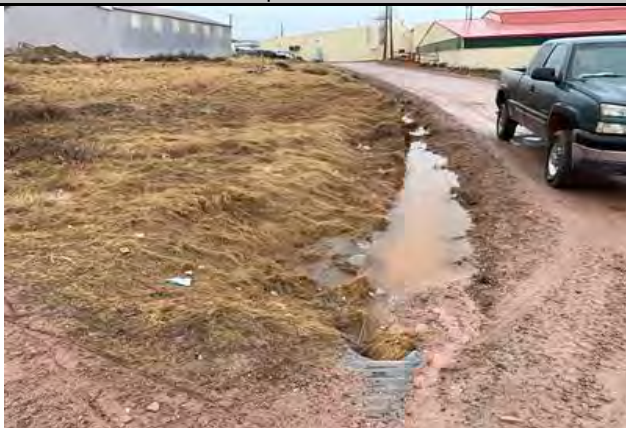
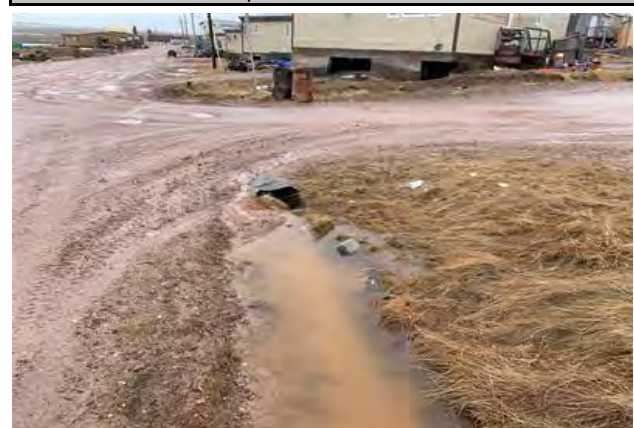
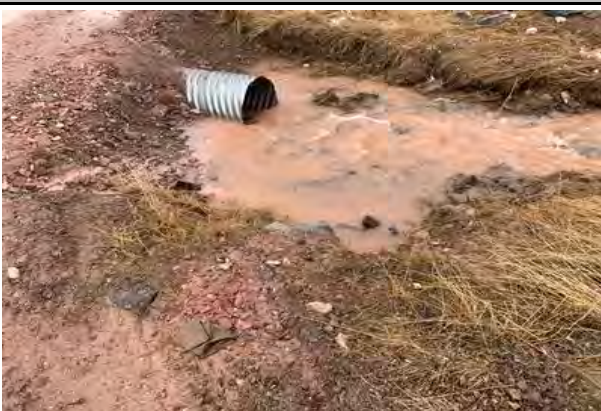
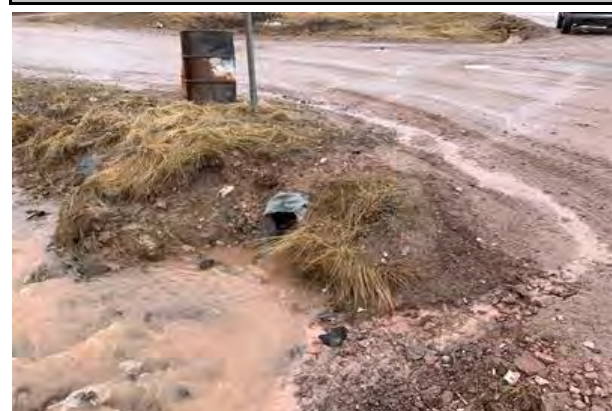
Culvert Information		
Culvert ID		112-19
Type		Cross
Shape		Round
Material		Csp
Diameter or Dimensions (mm)		600
Marker Post Present		N
End Crushing	Upstream	Y
	Downstream	Y
Infill Depth (mm)	Upstream	0
	Downstream	100
Other Comments		None

Culvert Condition Ratings (MTO 2013)				
Barrel Material (0-4)	Shape (0-4)	Capacity (0-2)	Erosion and Scour (0-2)	US/DS Channel (0-2)
0	2	1	1	0

Recommended Action(s):	Replace	Priority:	High
------------------------	---------	-----------	------

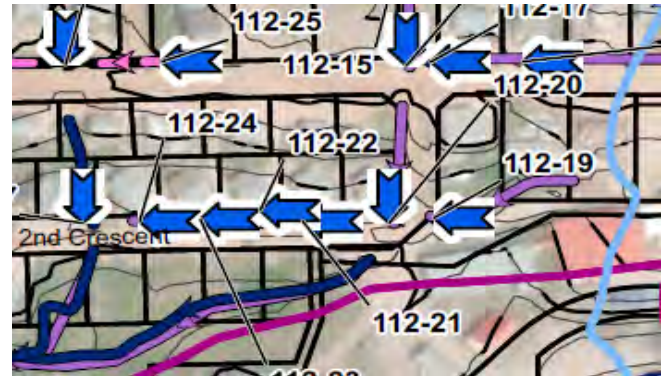
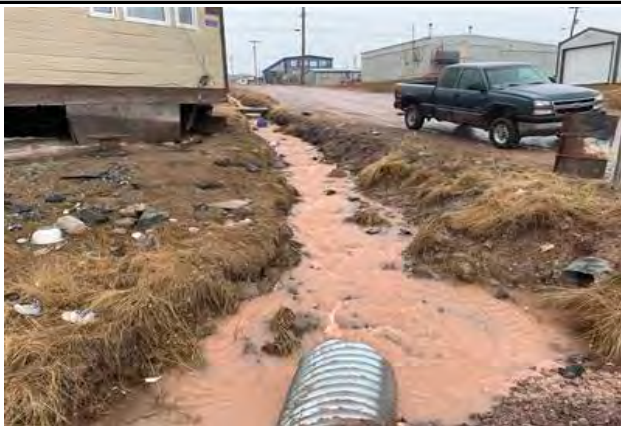
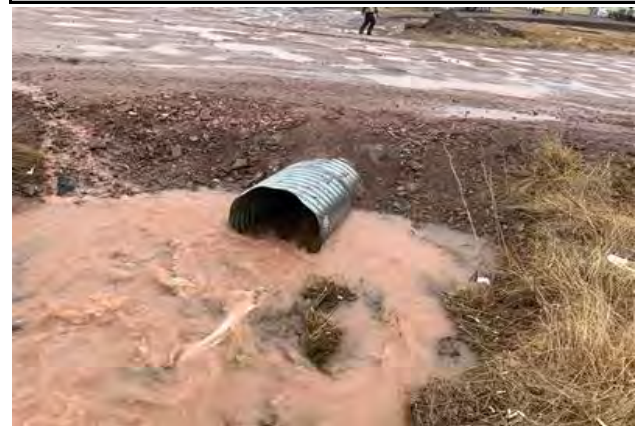
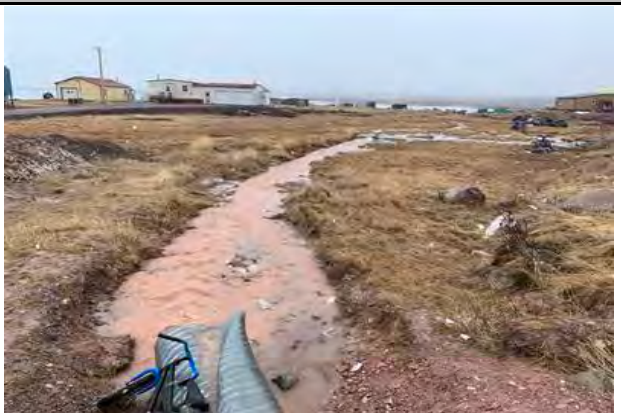
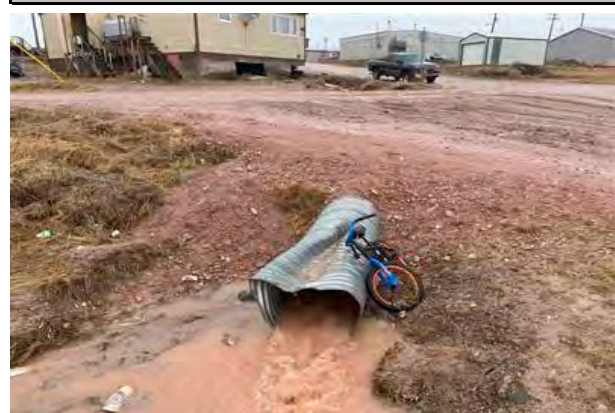
Culvert Information		
Culvert ID		112-20
Type		Cross
Shape		Round
Material		Csp
Diameter or Dimensions (mm)		600
Marker Post Present		N
End	Upstream	N
	Downstream	Y
Infill Depth (mm)	Upstream	0
	Downstream	0
Other		None
Comments

Culvert Condition Ratings (MTO 2013)				
Barrel Material (0-4)	Shape (0-4)	Capacity (0-2)	Erosion and Scour (0-2)	US/DS Channel (0-2)
0	2	0	1	0

Recommended Action(s):	Repair culvert end	Priority:	Medium
------------------------	--------------------	-----------	--------

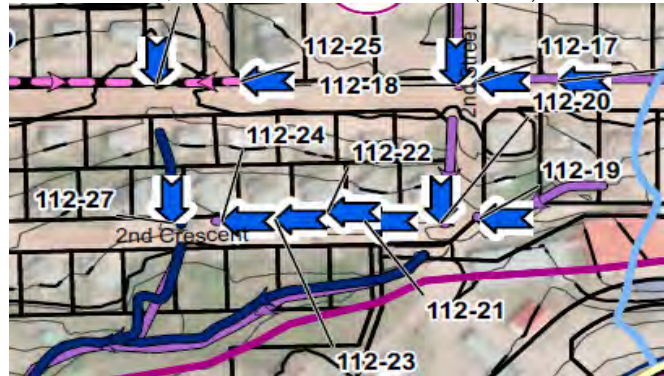
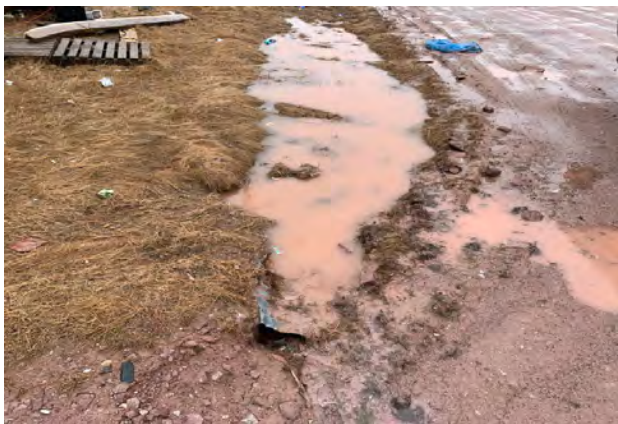
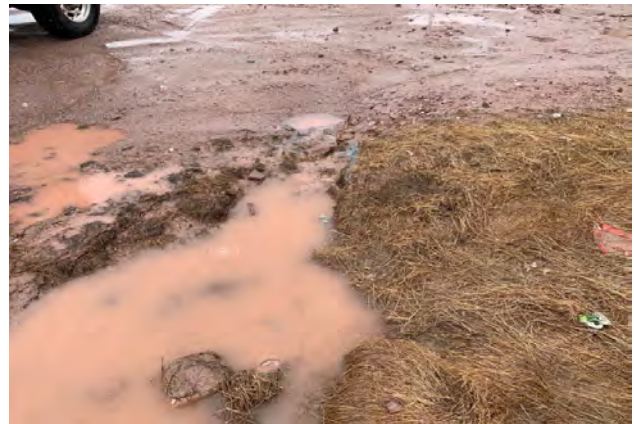
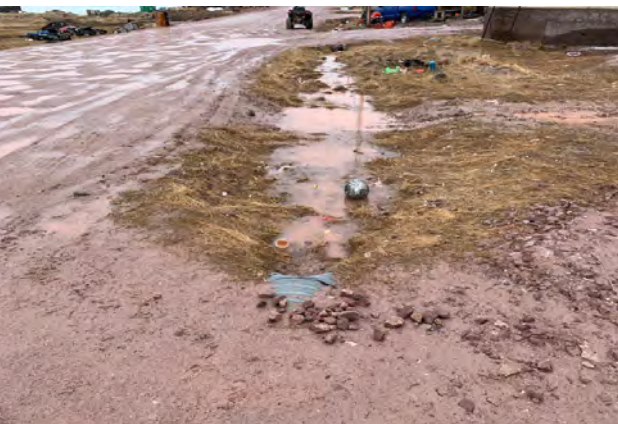
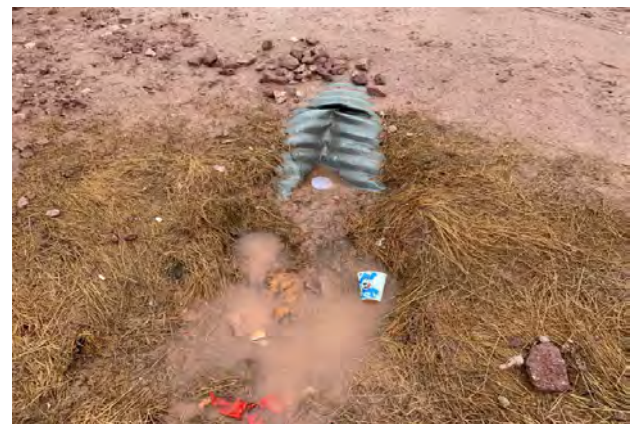
Culvert Information		
Culvert ID		112-21
Type		Entrance
Shape		Round
Material		Csp
Diameter or Dimensions (mm)		600
Marker Post Present		N
End Crushing	Upstream	Y
	Downstream	Y
Infill Depth (mm)	Upstream	600
	Downstream	200
Other		Both ends crushed and infilled
Comments

Culvert Condition Ratings (MTO 2013)				
Barrel Material (0-4)	Shape (0-4)	Capacity (0-2)	Erosion and Scour (0-2)	US/DS Channel (0-2)
0	4	2	1	1

Recommended Action(s):	Replace	Priority:	High
------------------------	---------	-----------	------

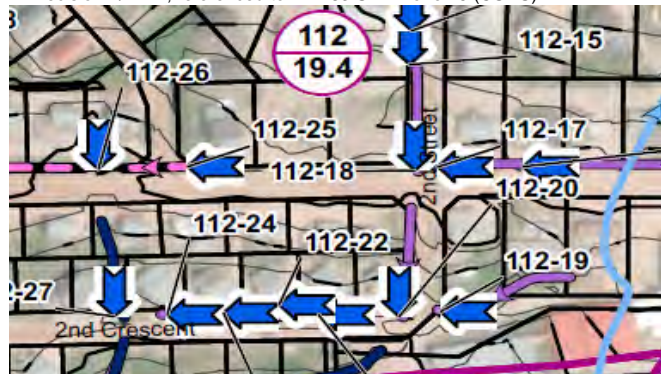
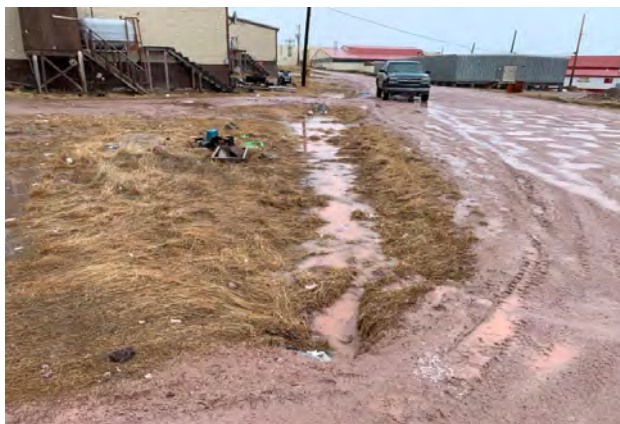
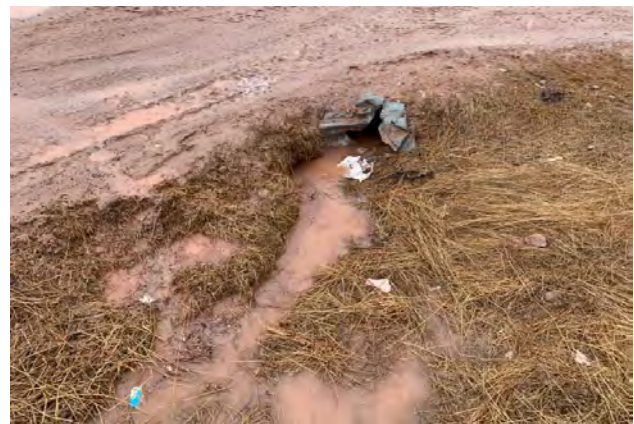
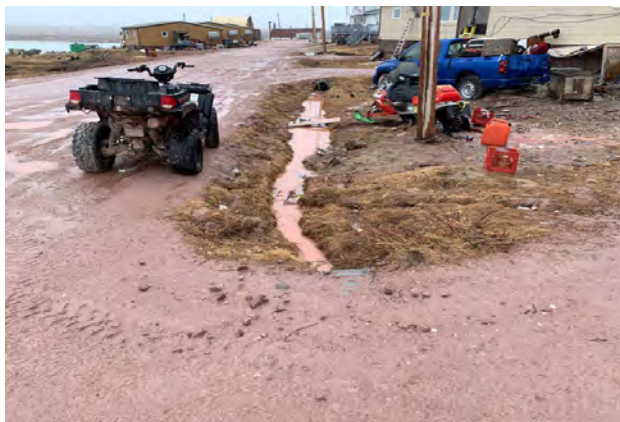
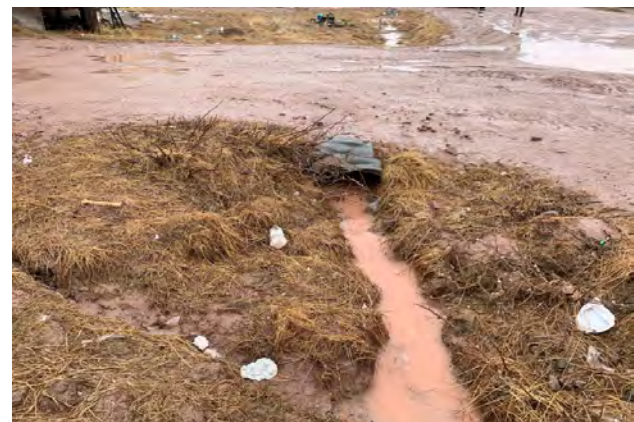
Culvert Information		
Culvert ID		112-22
Type		Entrance
Shape		Round
Material		Csp
Diameter or Dimensions (mm)		600
Marker Post Present		N
End Crushing	Upstream	Y
	Downstream	Y
Infill Depth (mm)	Upstream	200
	Downstream	200
Other		None
Comments

Culvert Condition Ratings (MTO 2013)				
Barrel Material (0-4)	Shape (0-4)	Capacity (0-2)	Erosion and Scour (0-2)	US/DS Channel (0-2)
0	2	2	1	0

Recommended Action(s):	Replace	Priority:	High
------------------------	---------	-----------	------

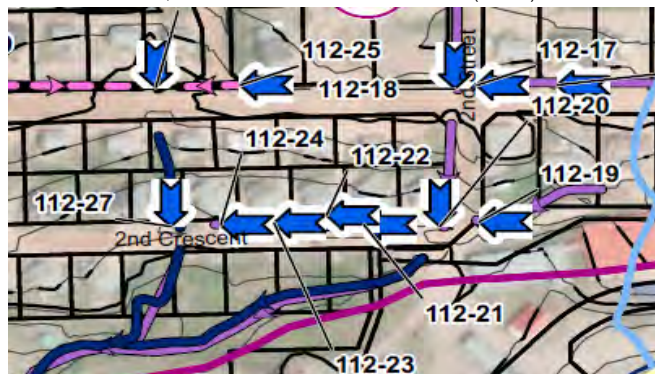
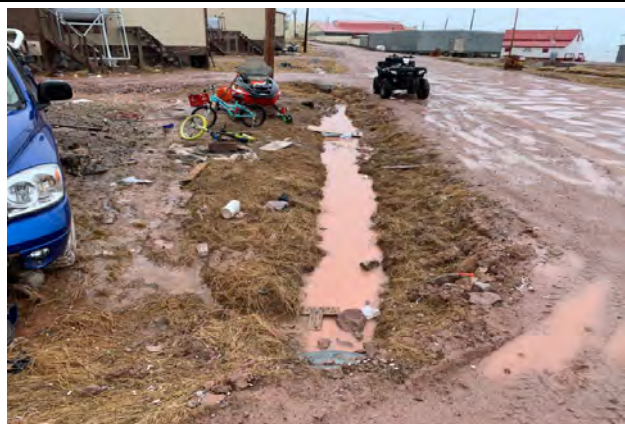
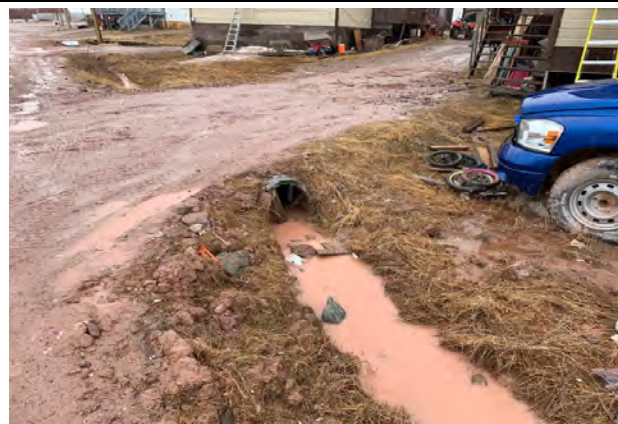
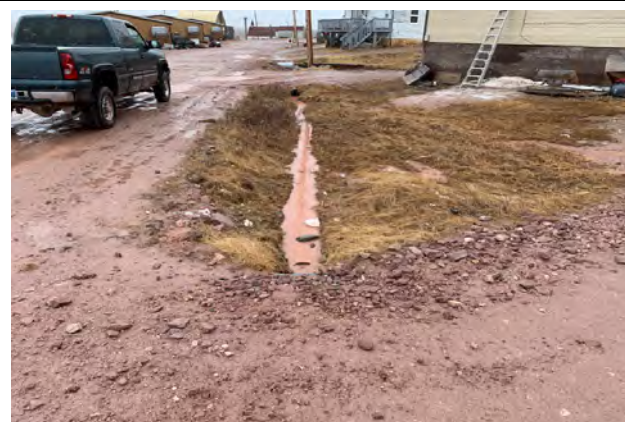
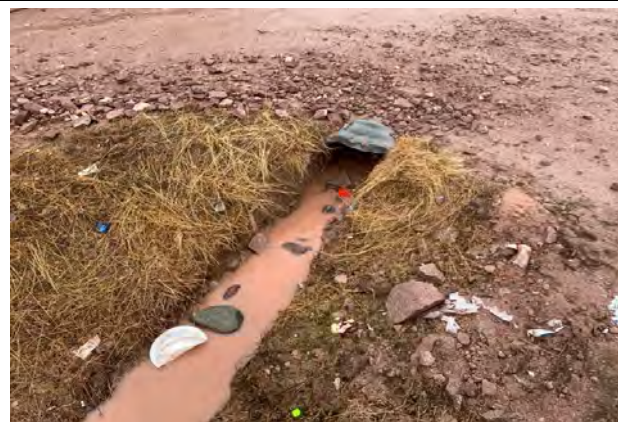
Culvert Information		
Culvert ID		112-23
Type		Entrance
Shape		Round
Material		Csp
Diameter or Dimensions (mm)		600
Marker Post Present		N
End Crushing	Upstream	Y
	Downstream	Y
Infill Depth (mm)	Upstream	200
	Downstream	200
Other		None
Comments

Culvert Condition Ratings (MTO 2013)				
Barrel Material (0-4)	Shape (0-4)	Capacity (0-2)	Erosion and Scour (0-2)	US/DS Channel (0-2)
0	1	2	0	0

Recommended Action(s):	Flush	Priority:	High
------------------------	-------	-----------	------

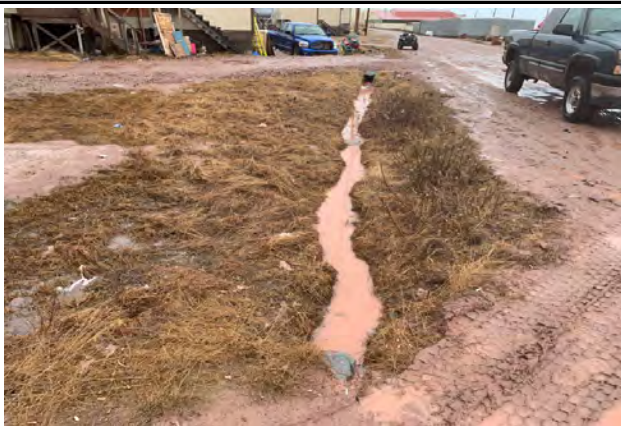
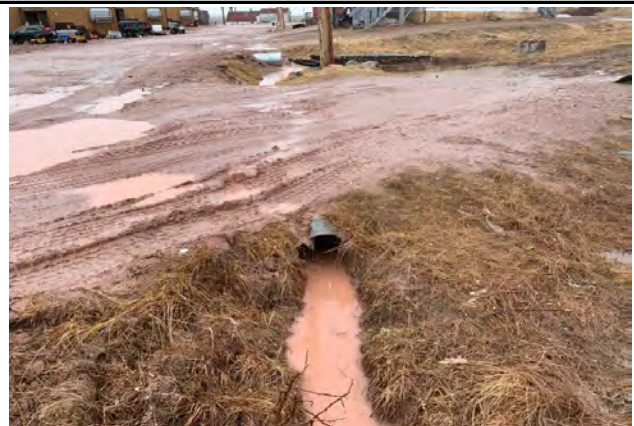
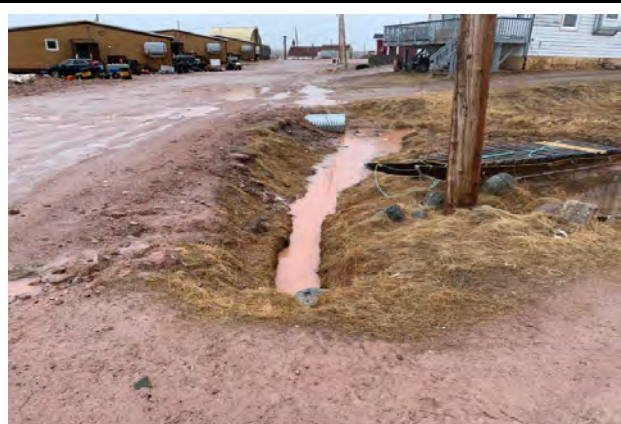
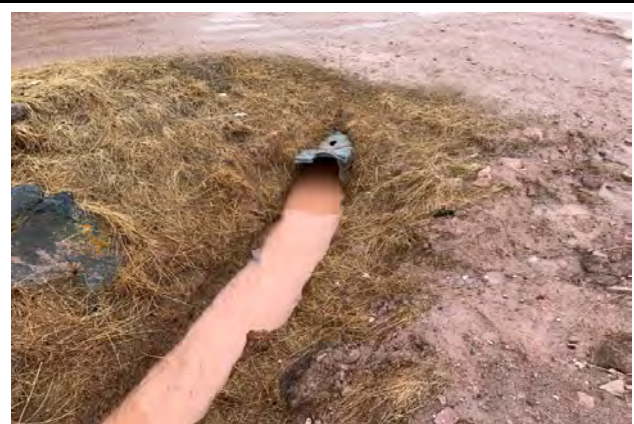
Culvert Information		
Culvert ID		112-24
Type		Entrance
Shape		Round
Material		Csp
Diameter or Dimensions (mm)		500
Marker Post Present		0
End Crushing	Upstream	Y
	Downstream	Y
Infill Depth (mm)	Upstream	200
	Downstream	200
Other		None
Comments

Culvert Condition Ratings (MTO 2013)				
Barrel Material (0-4)	Shape (0-4)	Capacity (0-2)	Erosion and Scour (0-2)	US/DS Channel (0-2)
0	1	2	0	0

Recommended Action(s):	Flush	Priority:	High
------------------------	-------	-----------	------

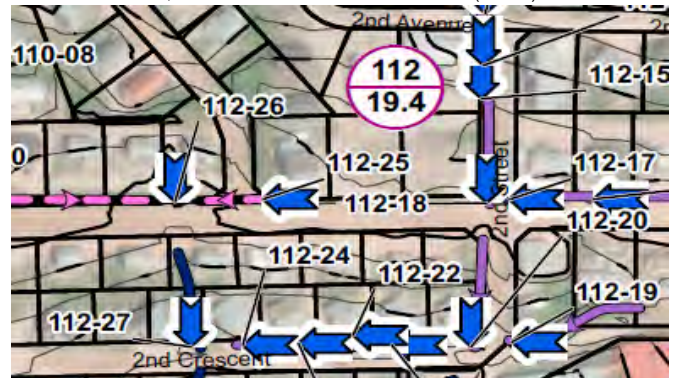
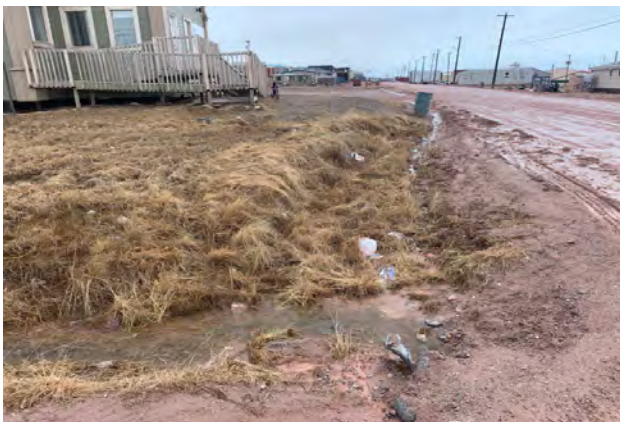
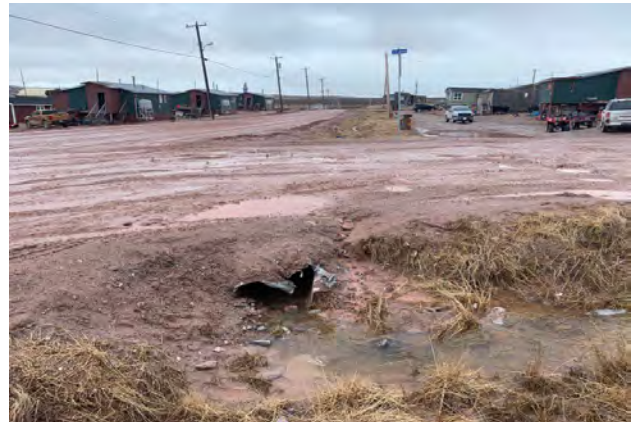
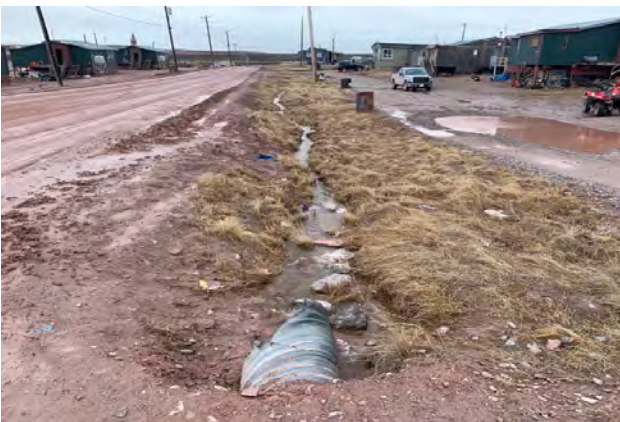
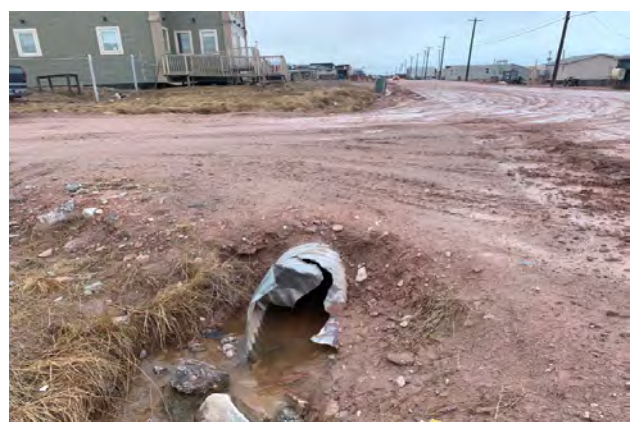
Culvert Information		
Culvert ID		112-25
Type		Cross
Shape		Round
Material		Csp
Diameter or Dimensions (mm)		500
Marker Post Present		N
End Crushing	Upstream	Y
	Downstream	Y
Infill Depth (mm)	Upstream	100
	Downstream	100
Other		None
Comments

Culvert Condition Ratings (MTO 2013)				
Barrel Material (0-4)	Shape (0-4)	Capacity (0-2)	Erosion and Scour (0-2)	US/DS Channel (0-2)
0	3	1	1	0

Recommended Action(s):	Replace	Priority:	High
------------------------	---------	-----------	------

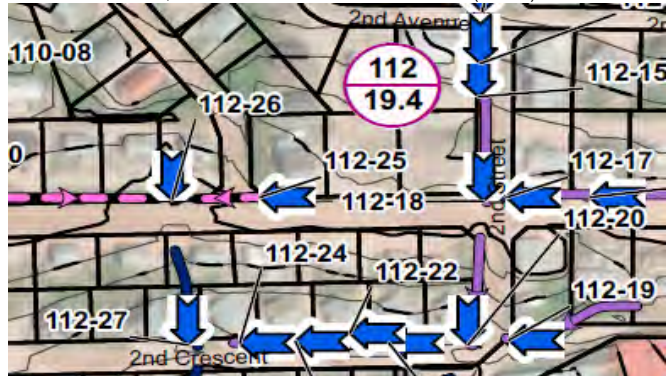
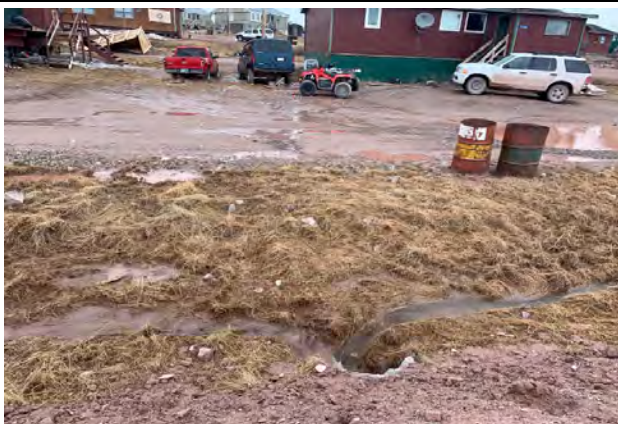
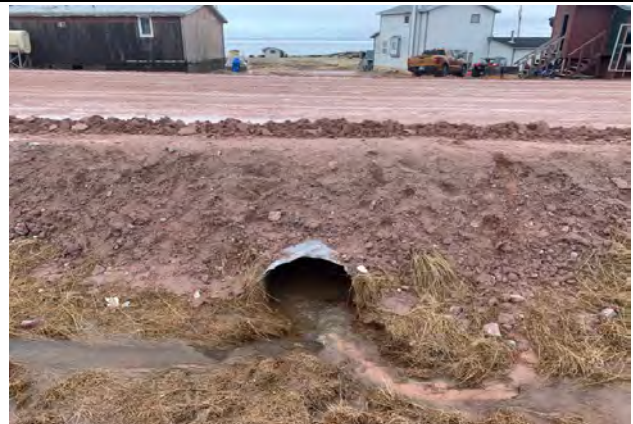
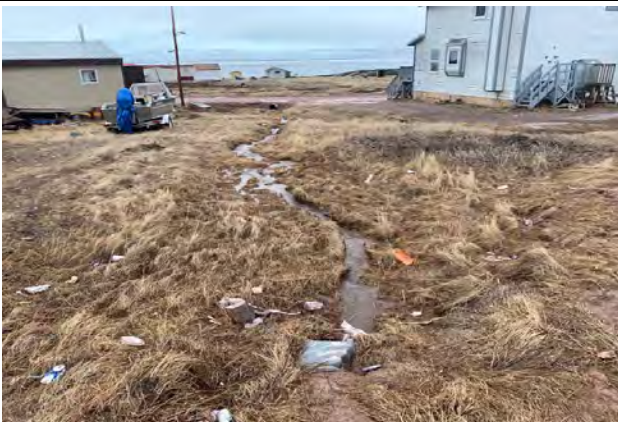
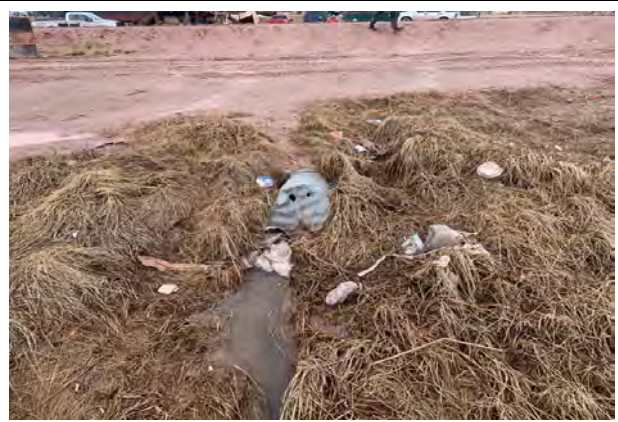
Culvert Information		
Culvert ID		112-26
Type		Cross
Shape		Round
Material		Csp
Diameter or Dimensions (mm)		600
Marker Post Present		N
End Crushing	Upstream	N
	Downstream	Y
Infill Depth (mm)	Upstream	150
	Downstream	100
Other		None
Comments

Culvert Condition Ratings (MTO 2013)				
Barrel Material (0-4)	Shape (0-4)	Capacity (0-2)	Erosion and Scour (0-2)	US/DS Channel (0-2)
1	2	1	0	0

Recommended Action(s):	Replace	Priority:	High
------------------------	---------	-----------	------

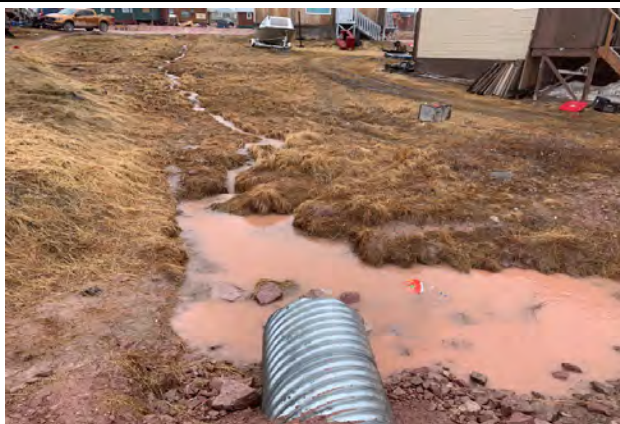
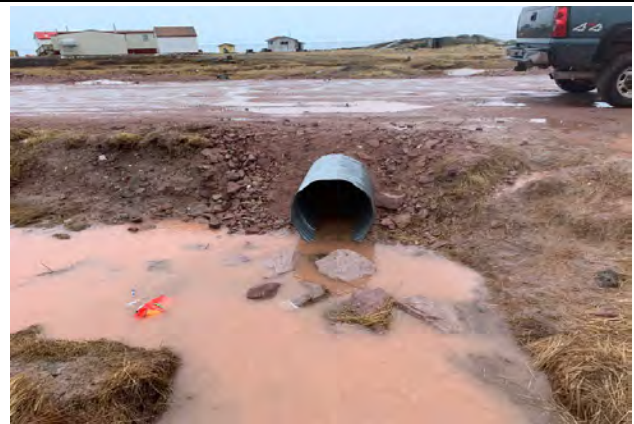
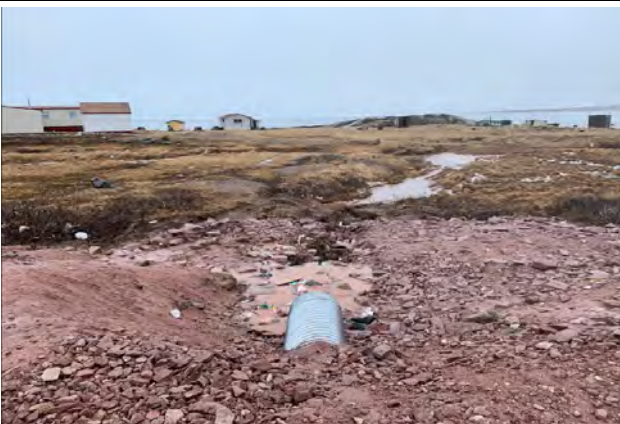
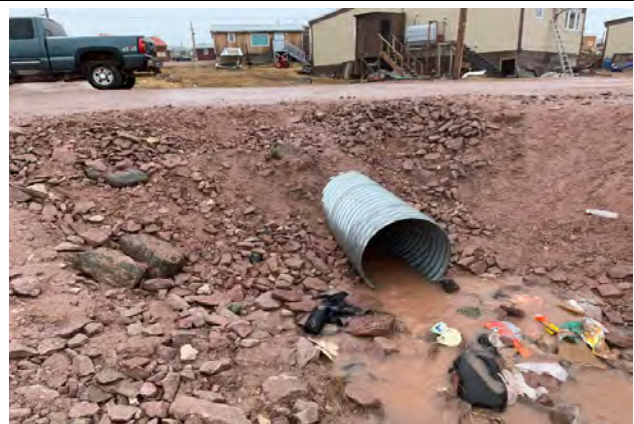
Culvert Condition Ratings (MTO 2013)				
Barrel Material (0-4)	Shape (0-4)	Capacity (0-2)	Erosion and Scour (0-2)	US/DS Channel (0-2)
0	0	0	1	1

Recommended Action(s):	No action	Priority:	Low
------------------------	-----------	-----------	-----
