# **Geotechnical Evaluation and Drainage Planning in Baker Lake, Nunavut**

*Final Report Rev-00*

**The Municipality of Baker Lake, Nunavut**

**Nunami Stantec Limited**

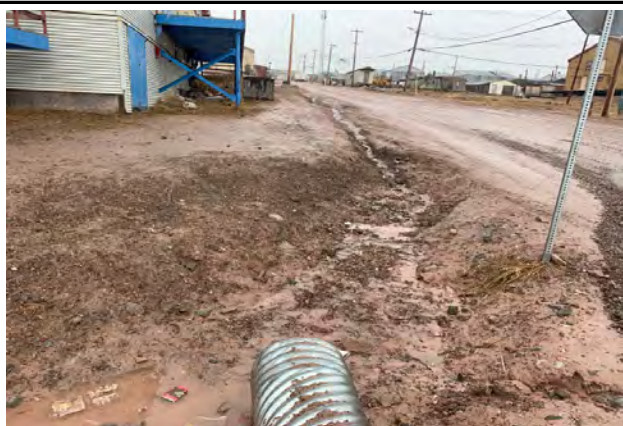
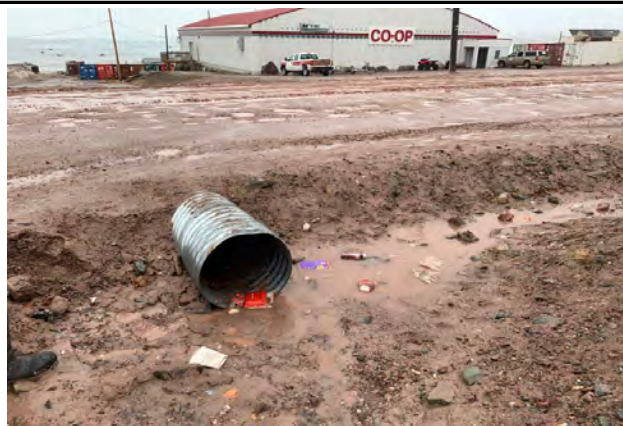
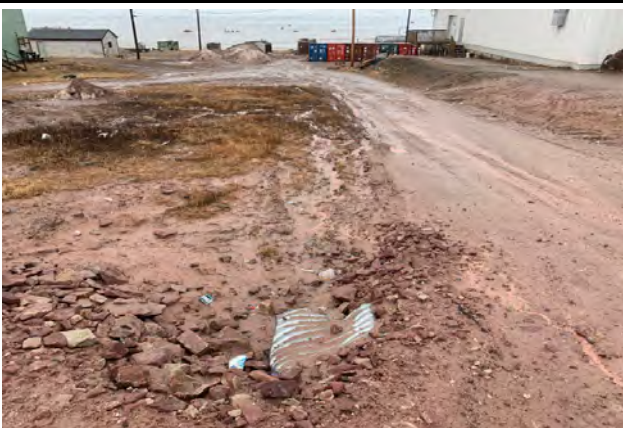
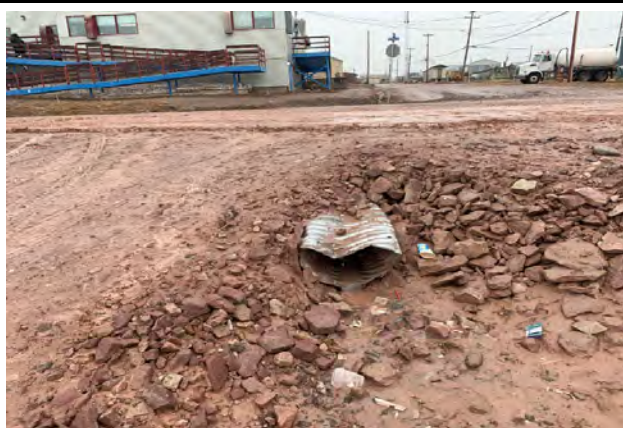
Culvert Information		
Culvert ID		114-01
Type		Cross
Shape		Round
Material		Csp
Diameter or Dimensions (mm)		500
Marker Post Present		N
End	Upstream	N
	Downstream	Y
Infill Depth (mm)	Upstream	0
	Downstream	0
Other		None
Comments

Culvert Condition Ratings (MTO 2013)				
Barrel Material (0-4)	Shape (0-4)	Capacity (0-2)	Erosion and Scour (0-2)	US/DS Channel (0-2)
0	2	0	1	0

Recommended Action(s):	Repair culvert end	Priority:	Medium
------------------------	--------------------	-----------	--------

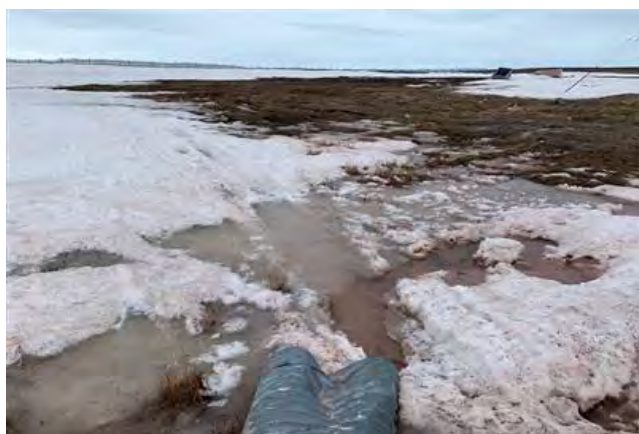
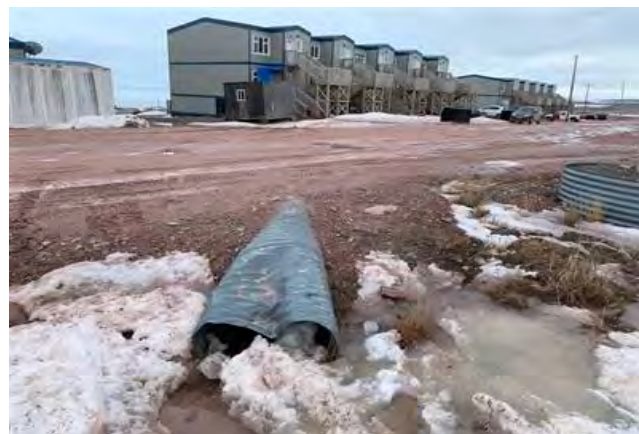
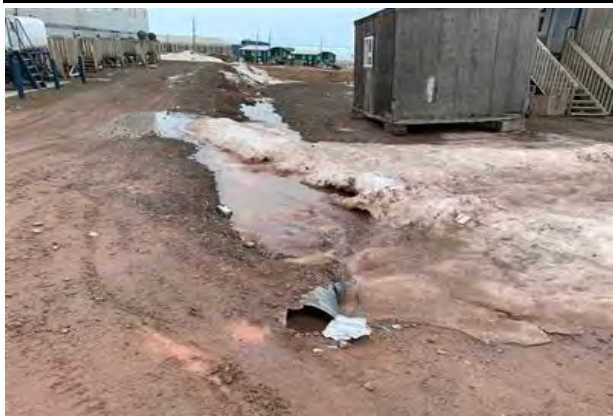
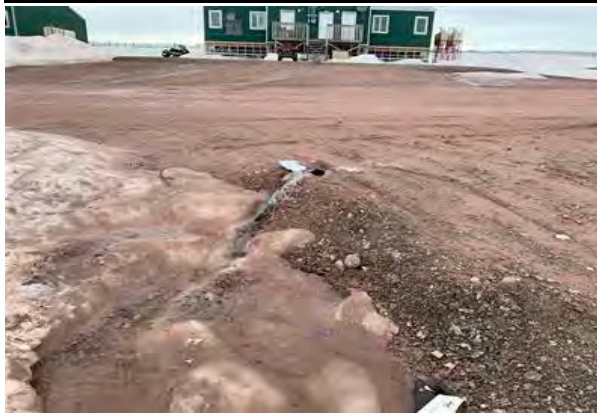
Culvert Information		
Culvert ID		115-01
Type		Cross
Shape		Round
Material		Csp
Diameter or Dimensions (mm)		600
Marker Post Present		N
End	Upstream	Y
	Downstream	Y
Infill Depth (mm)	Upstream	0
	Downstream	0
Other		Both ends crushed
Comments

Culvert Condition Ratings (MTO 2013)				
Barrel Material (0-4)	Shape (0-4)	Capacity (0-2)	Erosion and Scour (0-2)	US/DS Channel (0-2)
0	4	0	1	1

Recommended Action(s):	Replace	Priority:	High
------------------------	---------	-----------	------

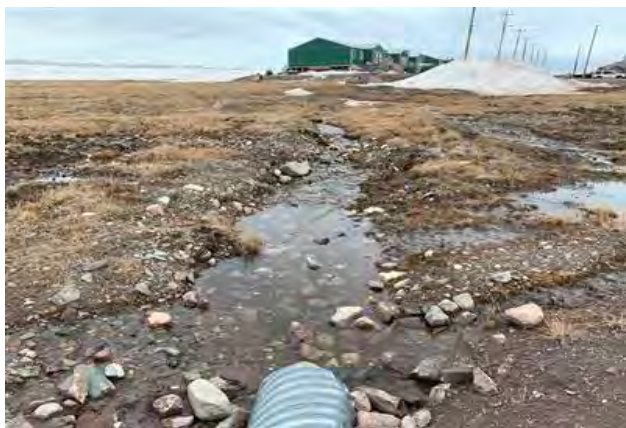
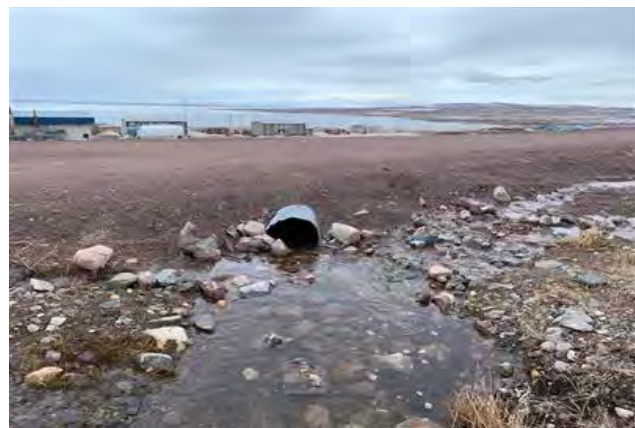
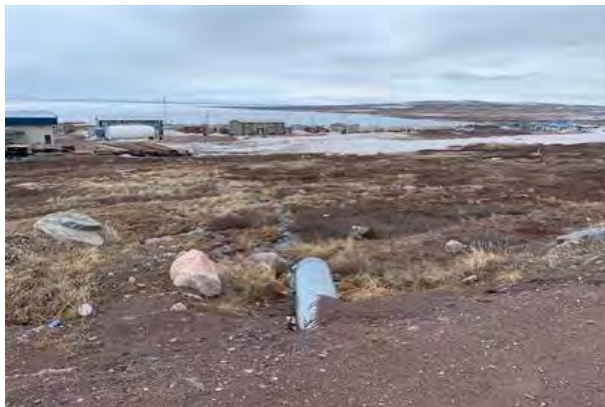
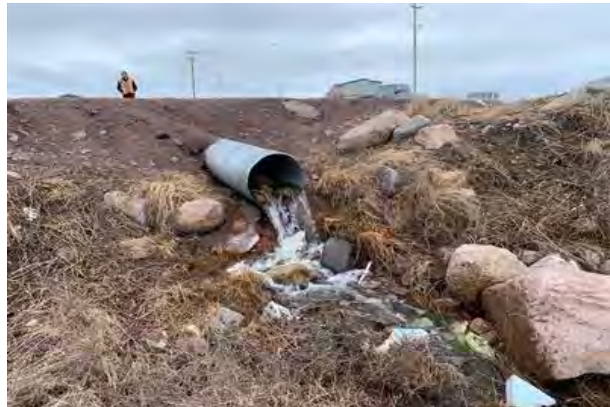
Culvert Information		
Culvert ID		115-02
Type		Cross
Shape		Round
Material		Csp
Diameter or Dimensions (mm)		500
Marker Post Present		N
End	Upstream	N
	Downstream	N
Infill Depth (mm)	Upstream	0
	Downstream	0
Other		None
Comments

Culvert Condition Ratings (MTO 2013)				
Barrel Material (0-4)	Shape (0-4)	Capacity (0-2)	Erosion and Scour (0-2)	US/DS Channel (0-2)
0	0	0	2	0

Recommended Action(s):	Stabilize bank	Priority:	High
------------------------	----------------	-----------	------

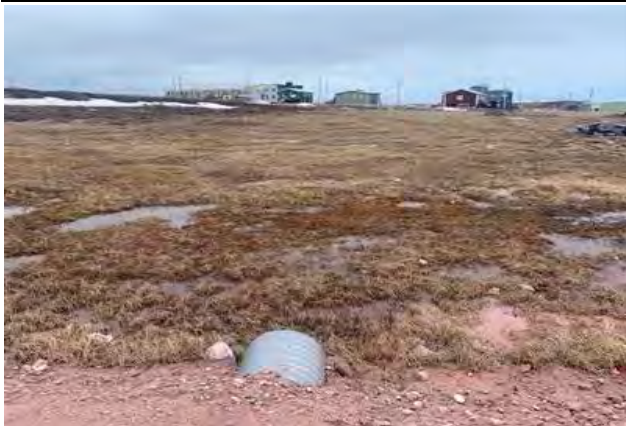
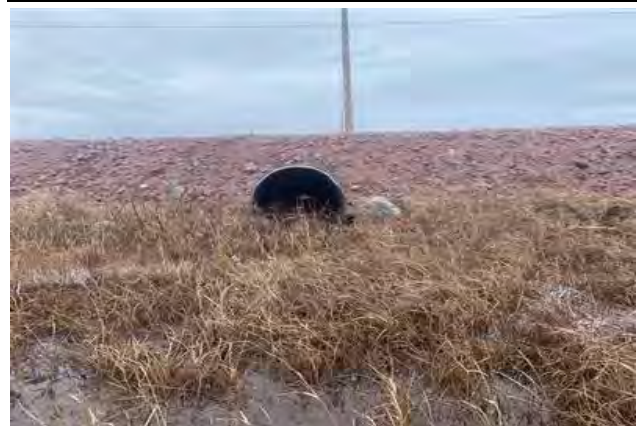
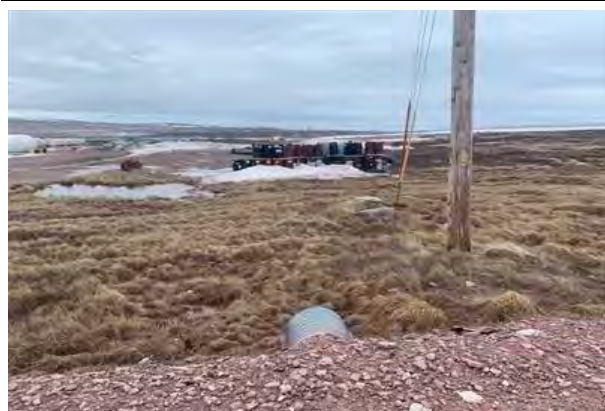
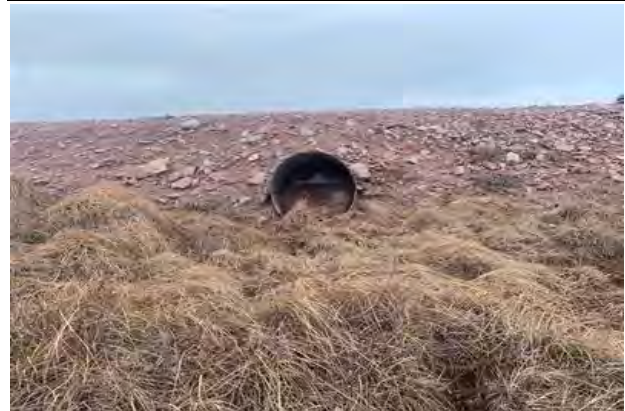
Culvert Information		
Culvert ID		115-03
Type		Cross
Shape		Round
Material		Csp
Diameter or Dimensions (mm)		600
Marker Post Present		N
End	Upstream	N
	Downstream	N
Infill Depth (mm)	Upstream	150
	Downstream	0
Other		None
Comments

Culvert Condition Ratings (MTO 2013)				
Barrel Material (0-4)	Shape (0-4)	Capacity (0-2)	Erosion and Scour (0-2)	US/DS Channel (0-2)
0	0	1	0	0

Recommended Action(s):	Flush	Priority:	Medium
------------------------	-------	-----------	--------

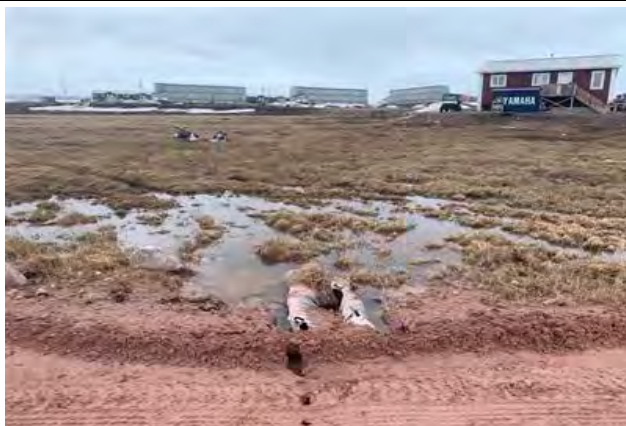
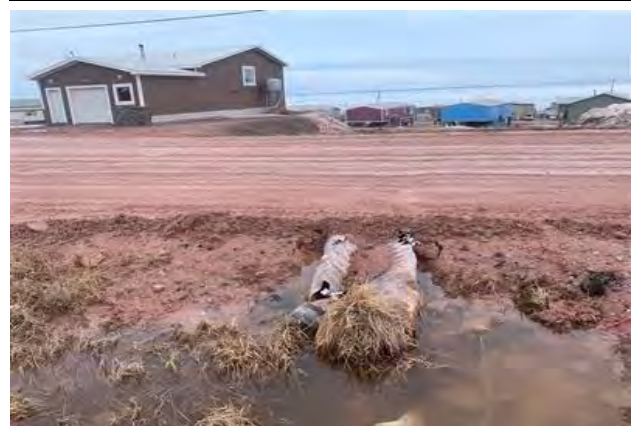
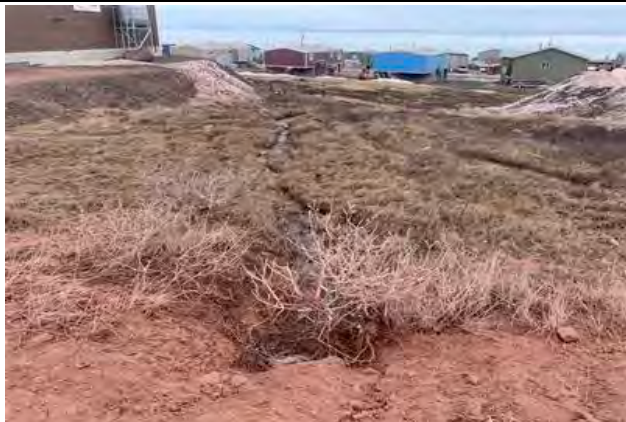
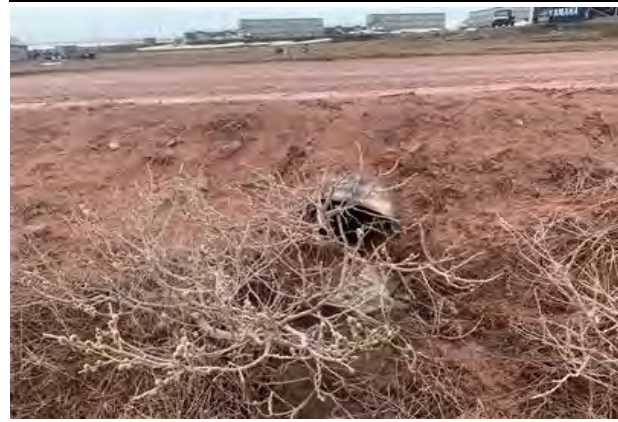
Culvert Information		
Culvert ID		115-04
Type		Cross
Shape		Round
Material		Csp
Diameter or Dimensions (mm)		500
Marker Post Present		N
End	Upstream	Y
	Downstream	Y
Infill Depth (mm)	Upstream	100
	Downstream	0
Other		None
Comments

Culvert Condition Ratings (MTO 2013)				
Barrel Material (0-4)	Shape (0-4)	Capacity (0-2)	Erosion and Scour (0-2)	US/DS Channel (0-2)
0	3	1	1	0

Recommended Action(s):	Replace	Priority:	High
------------------------	---------	-----------	------

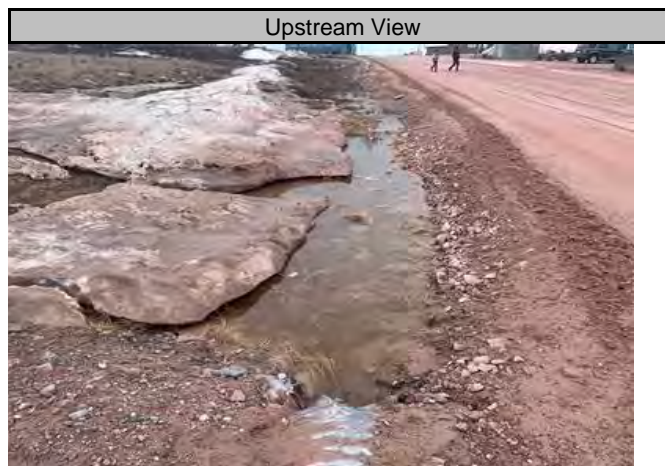
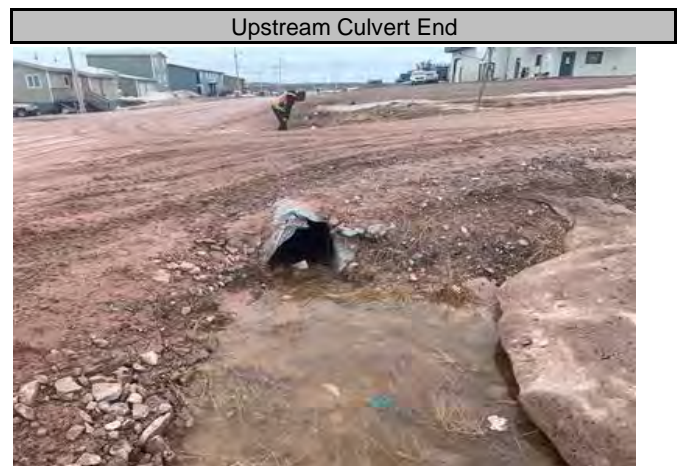
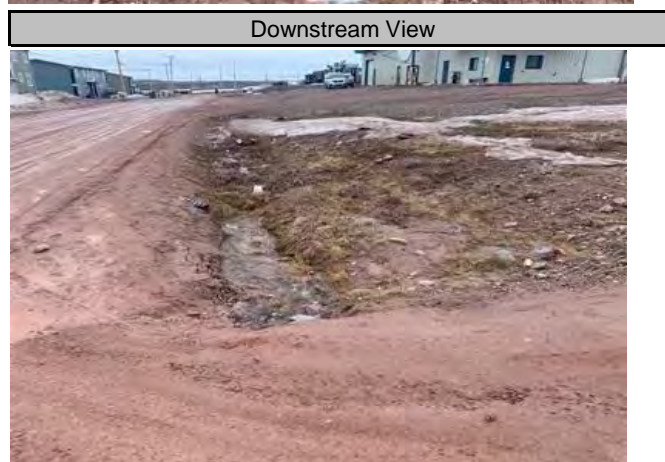
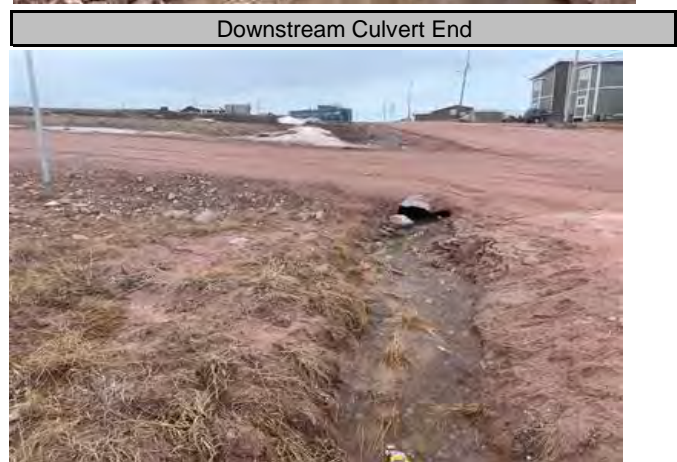
Culvert Information		
Culvert ID		115-05
Type		Entrance
Shape		Round
Material		Csp
Diameter or Dimensions (mm)		600
Marker Post Present		N
End Crushing	Upstream	Y
	Downstream	Y
Infill Depth (mm)	Upstream	200
	Downstream	200
Other		None
Comments

Culvert Condition Ratings (MTO 2013)				
Barrel Material (0-4)	Shape (0-4)	Capacity (0-2)	Erosion and Scour (0-2)	US/DS Channel (0-2)
0	2	2	1	0

Recommended Action(s):	Replace	Priority:	High
------------------------	---------	-----------	------

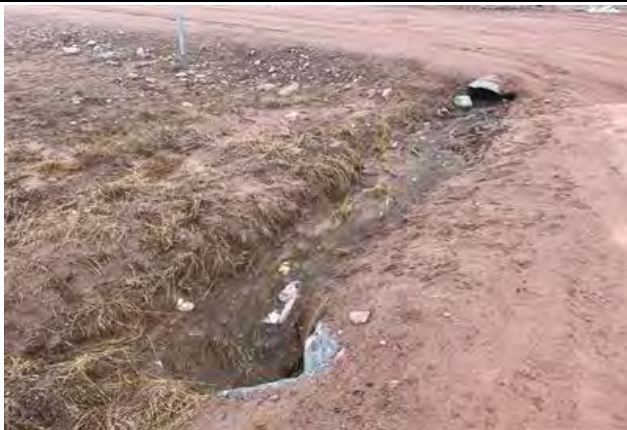
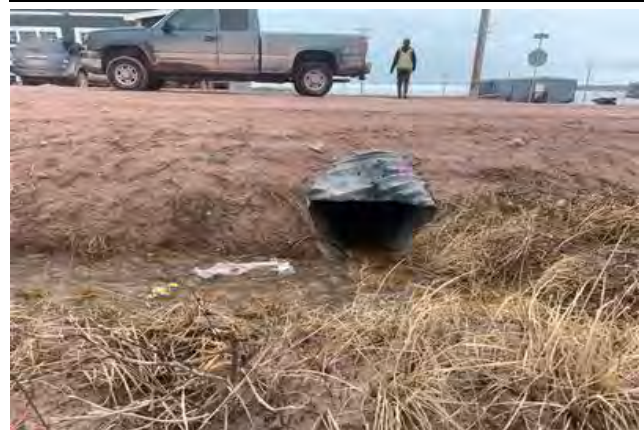
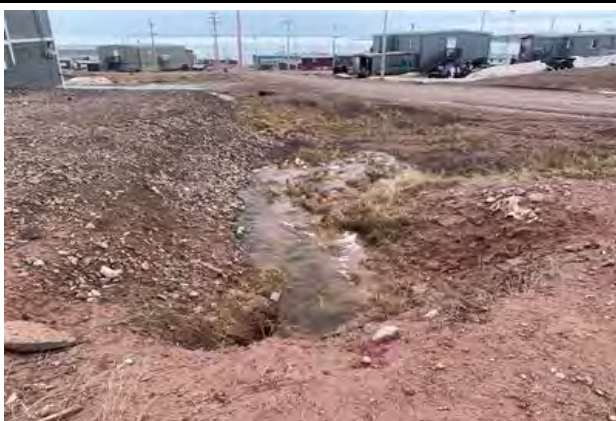
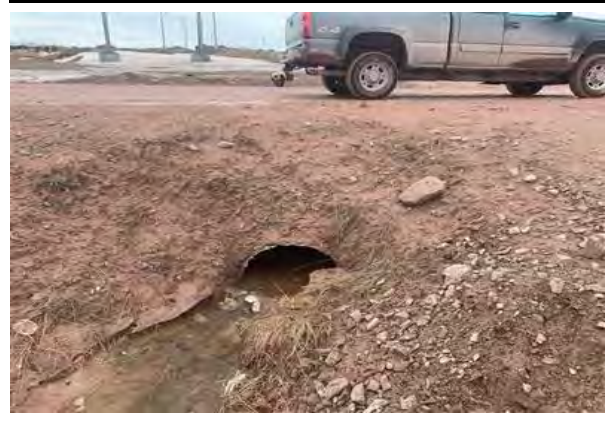
Culvert Information		
Culvert ID		115-06
Type		Cross
Shape		Round
Material		Csp
Diameter or Dimensions (mm)		600
Marker Post Present		N
End	Upstream	Y
	Downstream	Y
Infill Depth (mm)	Upstream	0
	Downstream	300
Other		None
Comments

Culvert Condition Ratings (MTO 2013)				
Barrel Material (0-4)	Shape (0-4)	Capacity (0-2)	Erosion and Scour (0-2)	US/DS Channel (0-2)
0	2	2	1	0

Recommended Action(s):	Replace	Priority:	High
------------------------	---------	-----------	------

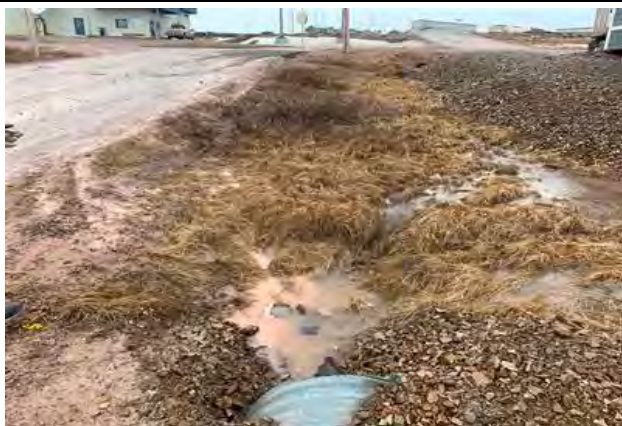
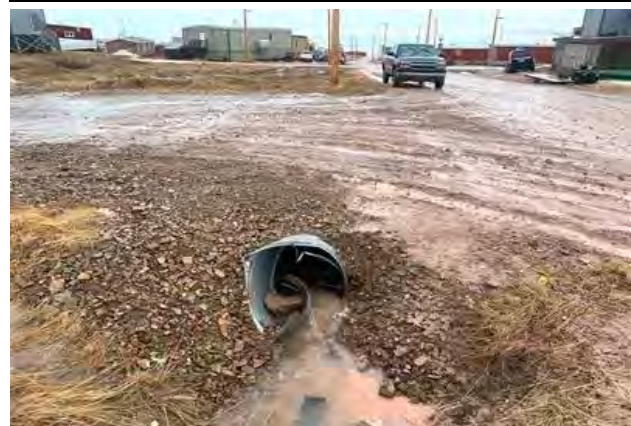
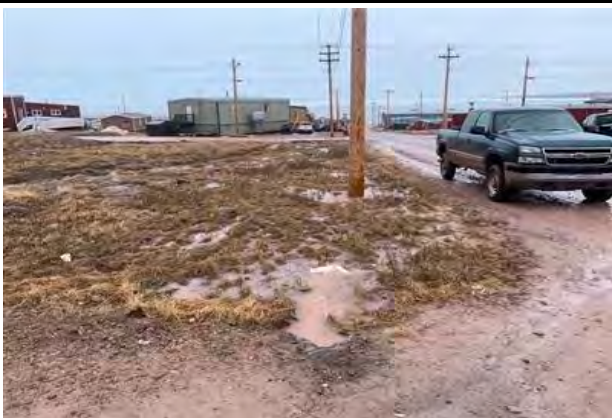
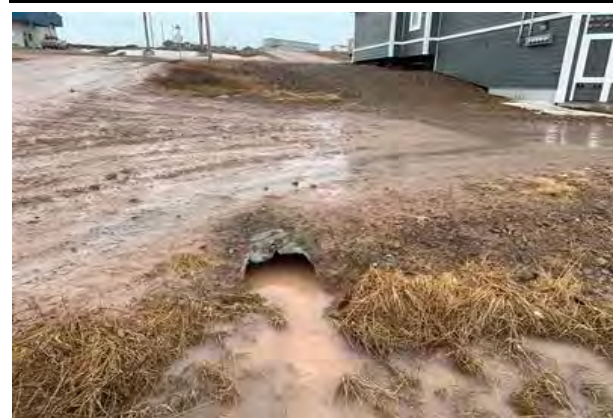
Culvert Condition Ratings (MTO 2013)				
Barrel Material (0-4)	Shape (0-4)	Capacity (0-2)	Erosion and Scour (0-2)	US/DS Channel (0-2)
0	2	2	0	0

Recommended Action(s):	Replace	Priority:	High
------------------------	---------	-----------	------

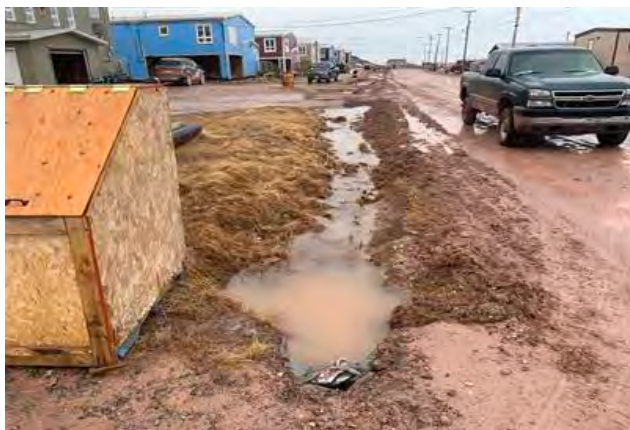
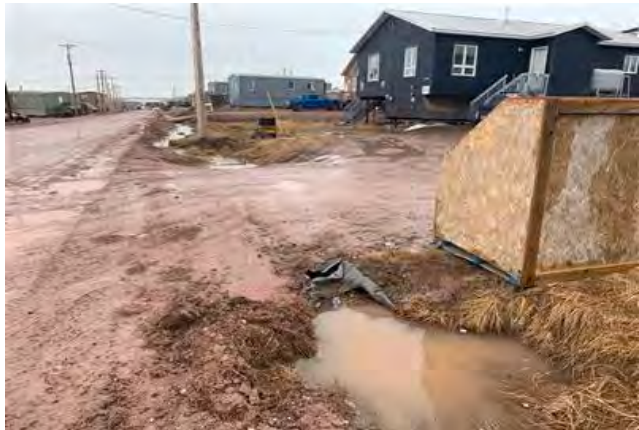
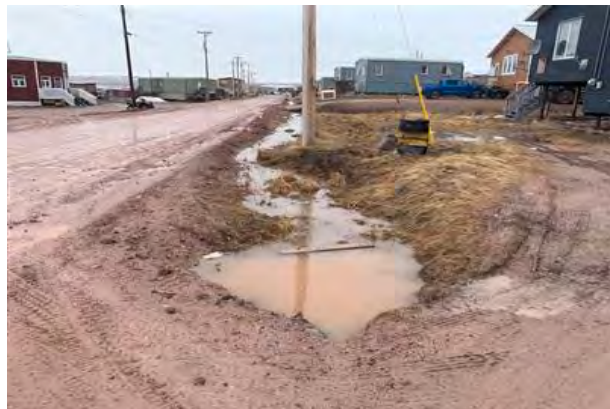
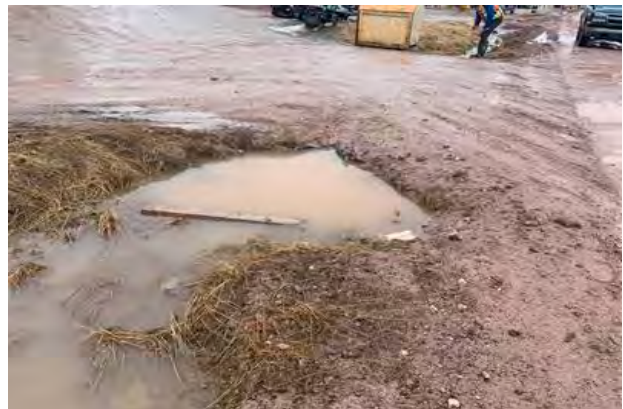
Culvert Information		
Culvert ID		115-08
Type		Entrance
Shape		Round
Material		Csp
Diameter or Dimensions (mm)		600
Marker Post Present		N
End	Upstream	Y
	Downstream	Y
Infill Depth (mm)	Upstream	200
	Downstream	200
Other		Both ends crushed and infilled
Comments

Culvert Condition Ratings (MTO 2013)				
Barrel Material (0-4)	Shape (0-4)	Capacity (0-2)	Erosion and Scour (0-2)	US/DS Channel (0-2)
0	2	2	1	1

Recommended Action(s):	Replace	Priority:	High
------------------------	---------	-----------	------

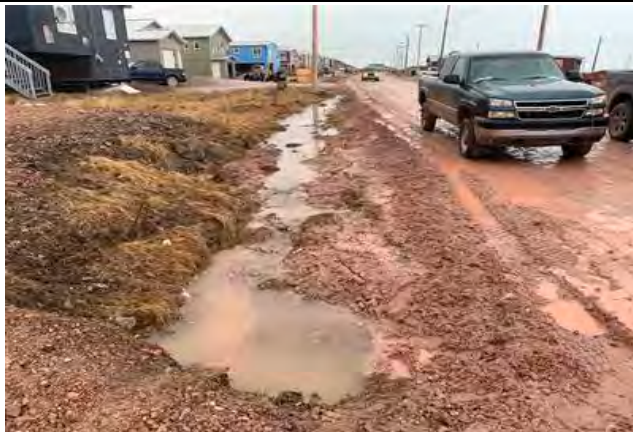
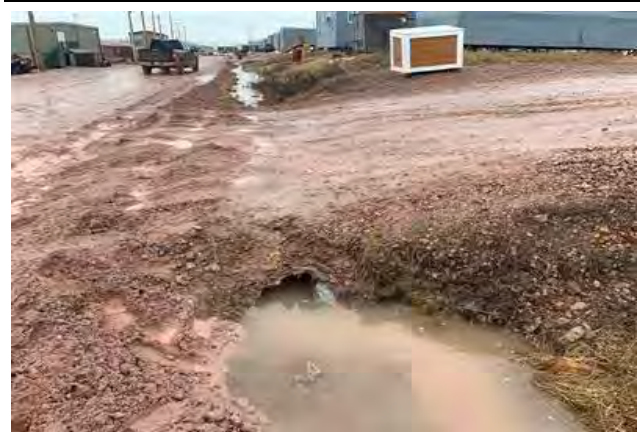
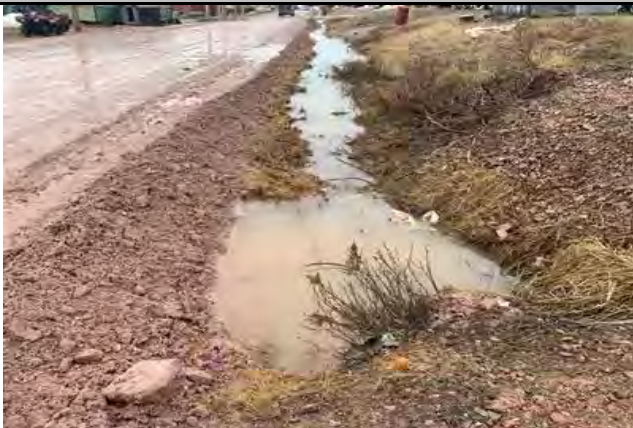
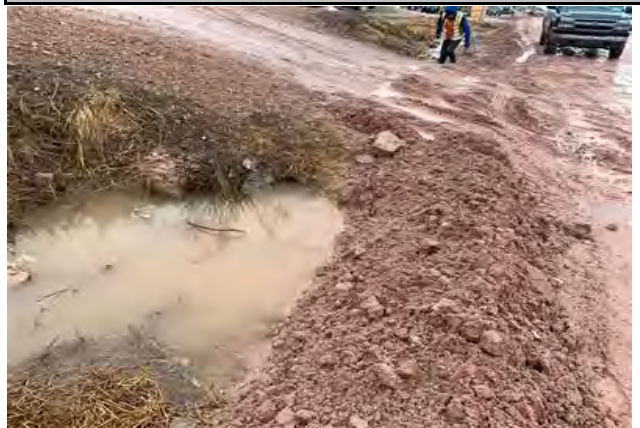
Culvert Information		
Culvert ID		115-09
Type		Entrance
Shape		Round
Material		Csp
Diameter or Dimensions (mm)		500
Marker Post Present		N
End	Upstream	Y
	Downstream	Y
Infill Depth (mm)	Upstream	150
	Downstream	150
Other		Both ends crushed and infilled
Comments

Culvert Condition Ratings (MTO 2013)				
Barrel Material (0-4)	Shape (0-4)	Capacity (0-2)	Erosion and Scour (0-2)	US/DS Channel (0-2)
0	2	2	1	1

Recommended Action(s):	Replace	Priority:	High
------------------------	---------	-----------	------

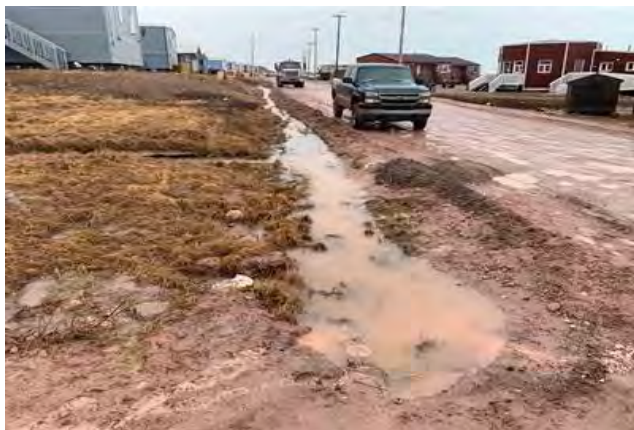
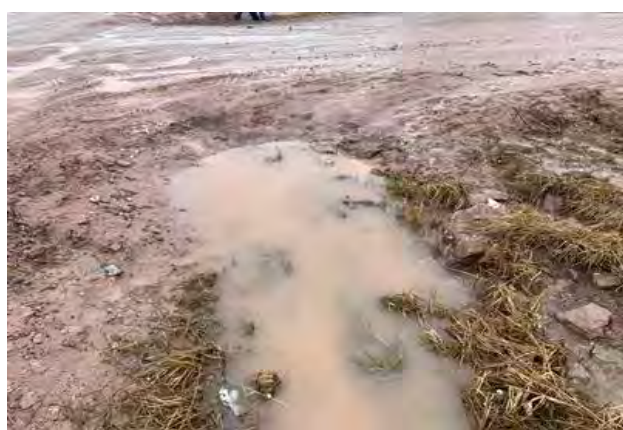
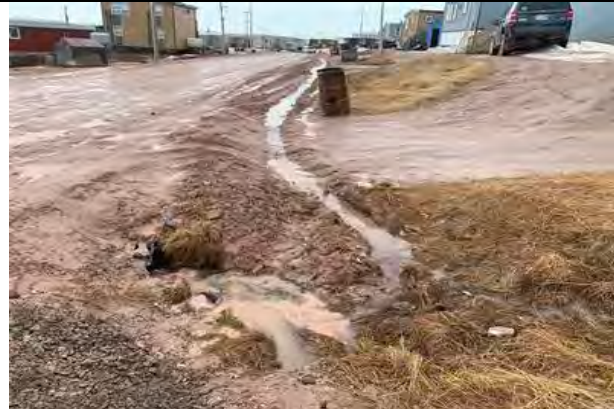
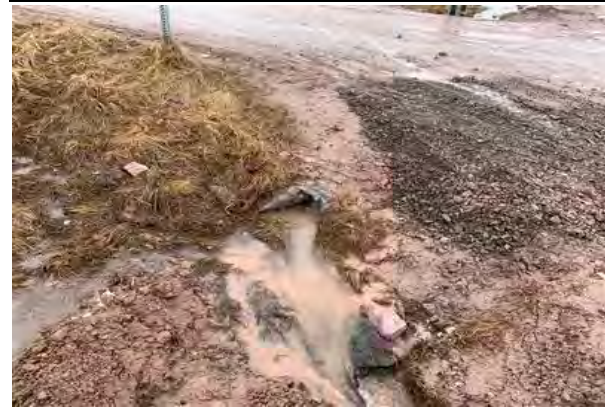
Culvert Information		
Culvert ID		115-10
Type		Entrance
Shape		Round
Material		Csp
Diameter or Dimensions (mm)		500
Marker Post Present		N
End	Upstream	Y
	Downstream	Y
Infill Depth (mm)	Upstream	200
	Downstream	0
Other		Both ends crushed and infilled
Comments

Culvert Condition Ratings (MTO 2013)				
Barrel Material (0-4)	Shape (0-4)	Capacity (0-2)	Erosion and Scour (0-2)	US/DS Channel (0-2)
0	2	2	1	1

Recommended Action(s):	Replace	Priority:	High
------------------------	---------	-----------	------

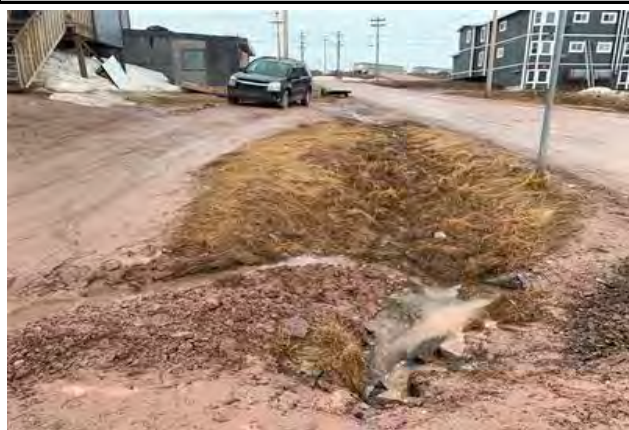
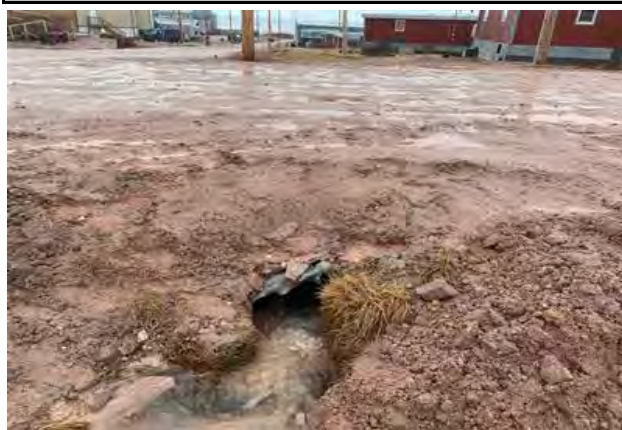
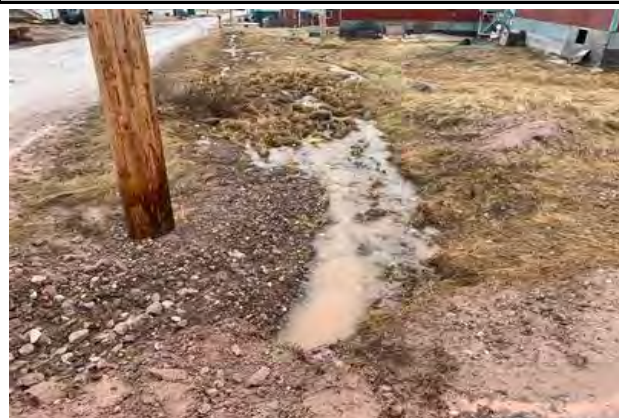
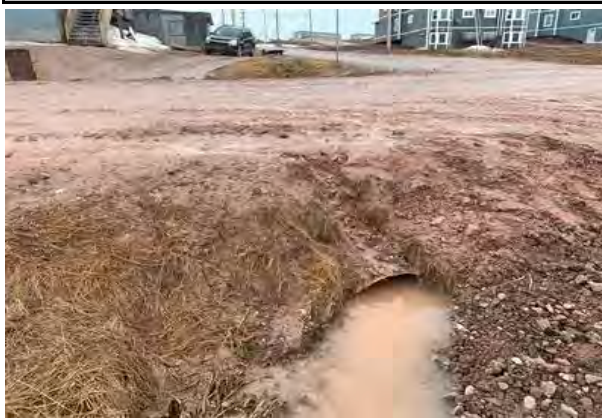
Culvert Information		
Culvert ID		115-11
Type		Cross
Shape		Round
Material		Csp
Diameter or Dimensions (mm)		600
Marker Post Present		N
End Crushing	Upstream	Y
	Downstream	Y
Infill Depth (mm)	Upstream	100
	Downstream	400
Other		Both ends crushed and infilled
Comments

Culvert Condition Ratings (MTO 2013)				
Barrel Material (0-4)	Shape (0-4)	Capacity (0-2)	Erosion and Scour (0-2)	US/DS Channel (0-2)
0	0	2	1	1

Recommended Action(s):	Flush	Priority:	High
------------------------	-------	-----------	------

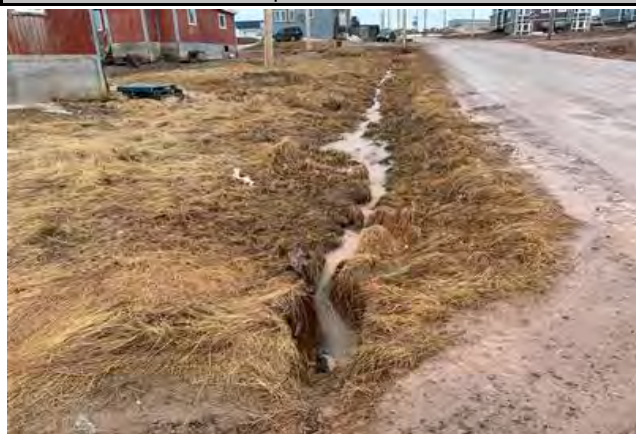
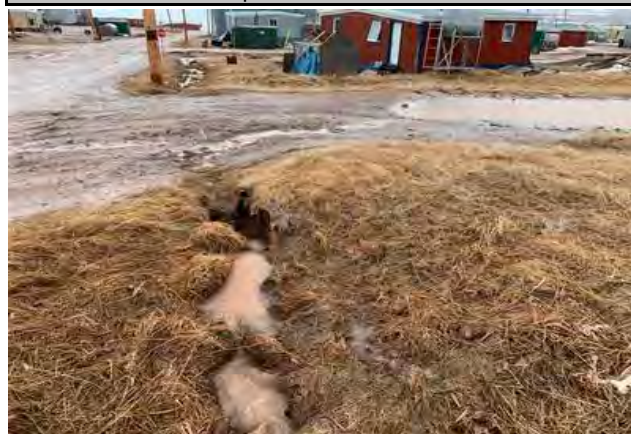
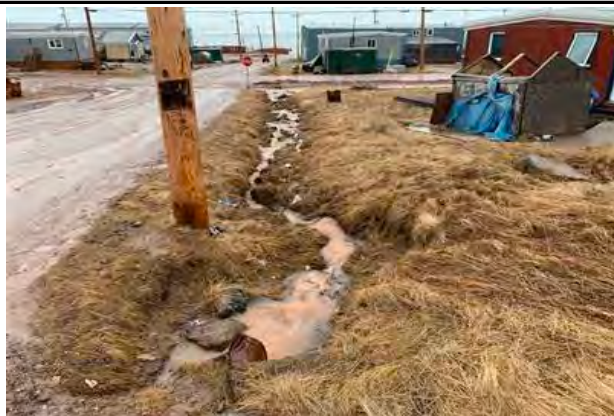
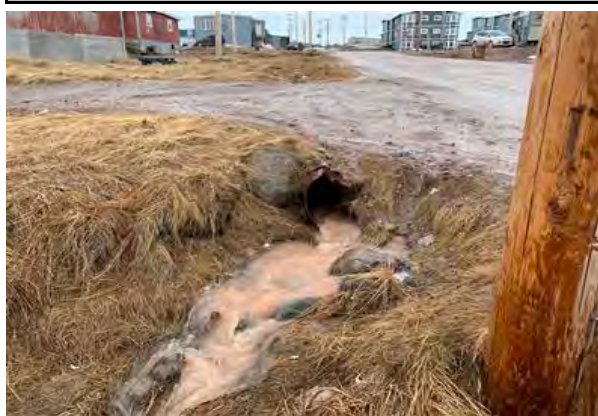
Culvert Information		
Culvert ID		115-12
Type		Entrance
Shape		Round
Material		Steel
Diameter or Dimensions (mm)		500
Marker Post Present		N
End	Upstream	Y
	Downstream	Y
Infill Depth (mm)	Upstream	0
	Downstream	0
Other		None
Comments

Culvert Condition Ratings (MTO 2013)				
Barrel Material (0-4)	Shape (0-4)	Capacity (0-2)	Erosion and Scour (0-2)	US/DS Channel (0-2)
2	2	0	1	0

Recommended Action(s):	Repair both ends of culvert	Priority:	Medium
------------------------	-----------------------------	-----------	--------

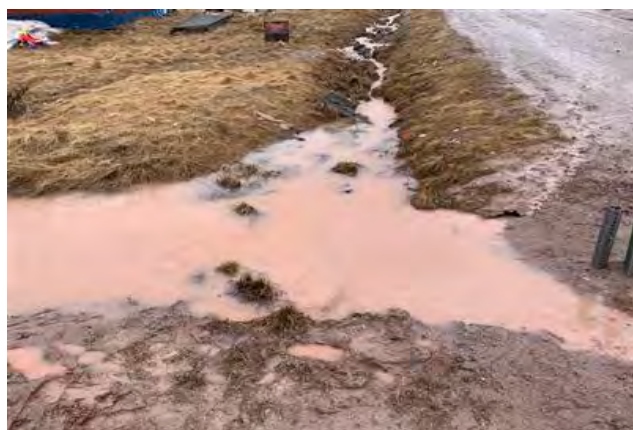
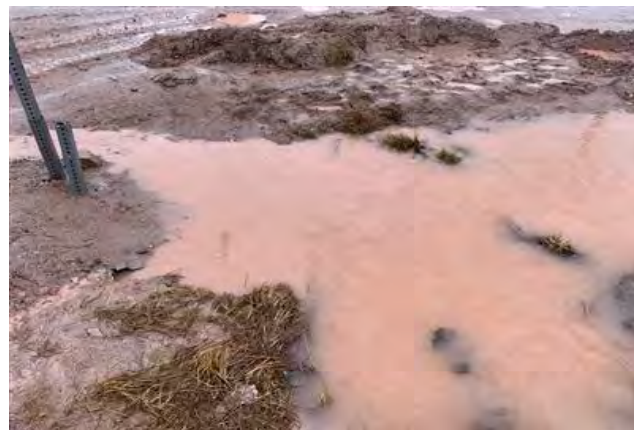
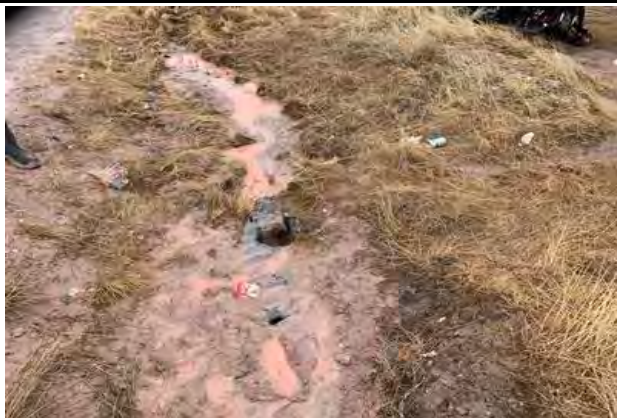
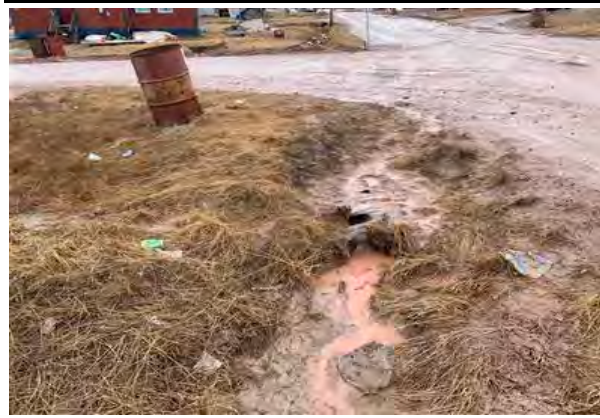
Culvert Information		
Culvert ID		115-13
Type		Cross
Shape		Round
Material		Csp
Diameter or Dimensions (mm)		500
Marker Post Present		N
End Crushing	Upstream	0
	Downstream	Y
Infill Depth (mm)	Upstream	500
	Downstream	0
Other Comments	Both ends crushed and infilled

Culvert Condition Ratings (MTO 2013)				
Barrel Material (0-4)	Shape (0-4)	Capacity (0-2)	Erosion and Scour (0-2)	US/DS Channel (0-2)
0	2	2	0	2

Recommended Action(s):	Replace	Priority:	High
------------------------	---------	-----------	------

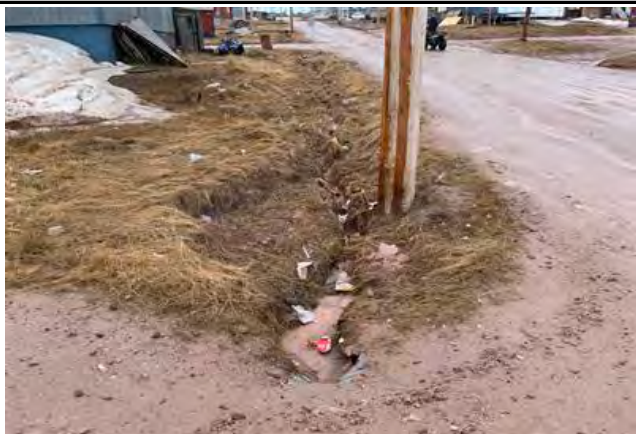
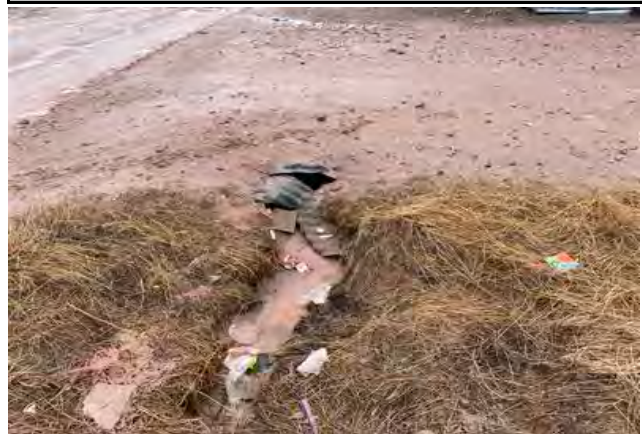
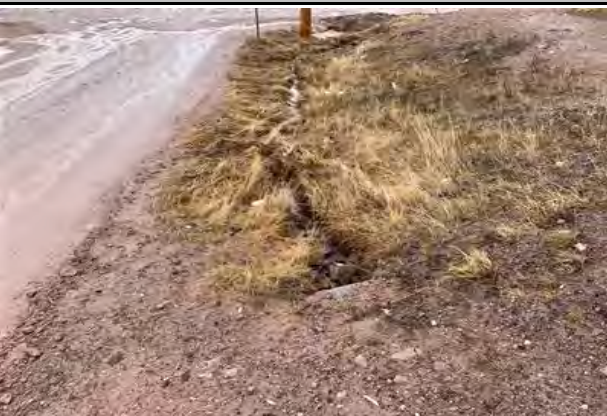
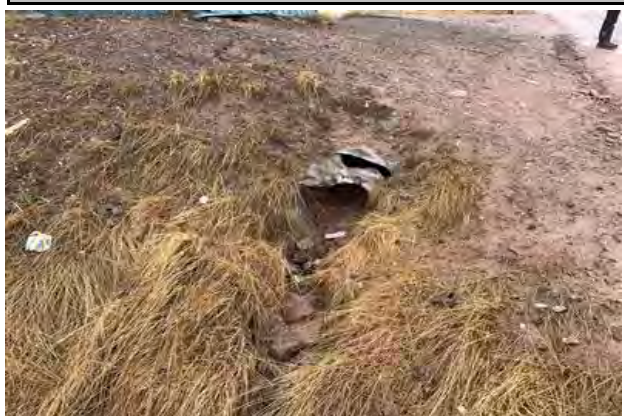
Culvert Information		
Culvert ID		115-14
Type		Entrance
Shape		Round
Material		Csp
Diameter or Dimensions (mm)		600
Marker Post Present		N
End Crushing	Upstream	Y
	Downstream	Y
Infill Depth (mm)	Upstream	100
	Downstream	100
Other		None
Comments

Culvert Condition Ratings (MTO 2013)				
Barrel Material (0-4)	Shape (0-4)	Capacity (0-2)	Erosion and Scour (0-2)	US/DS Channel (0-2)
0	3	1	1	0

Recommended Action(s):	Replace	Priority:	High
------------------------	---------	-----------	------

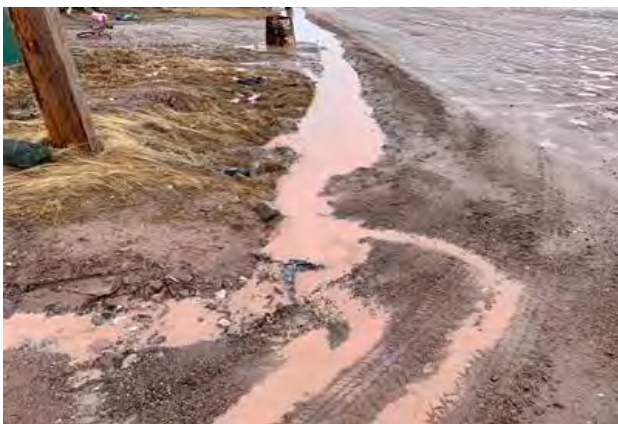
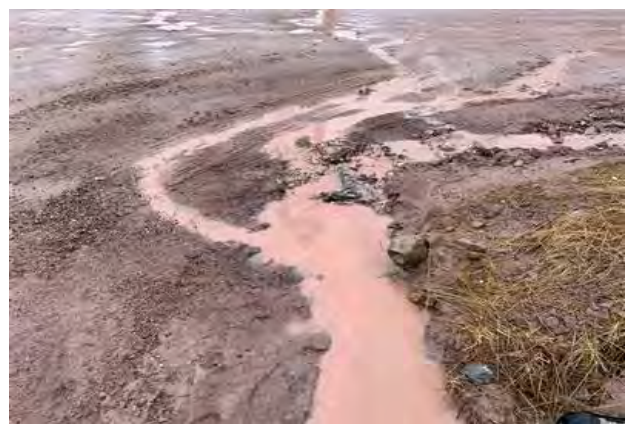
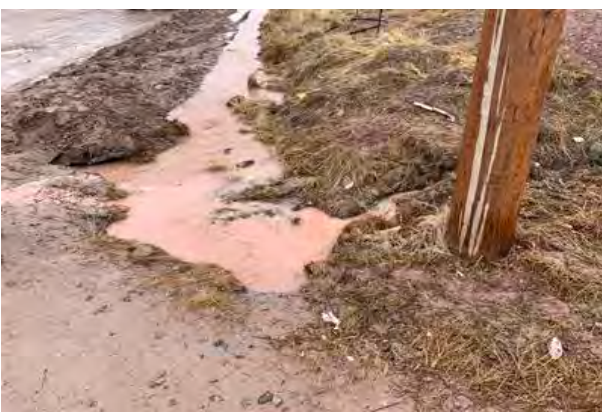
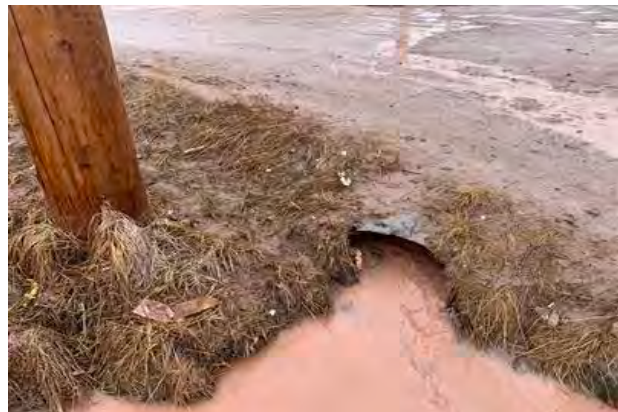
Culvert Information		
Culvert ID		115-15
Type		Cross
Shape		Round
Material		Csp
Diameter or Dimensions (mm)		500
Marker Post Present		N
End Crushing	Upstream	Y
	Downstream	Y
Infill Depth (mm)	Upstream	400
	Downstream	200
Other		Both ends crushed and infilled
Comments

Culvert Condition Ratings (MTO 2013)				
Barrel Material (0-4)	Shape (0-4)	Capacity (0-2)	Erosion and Scour (0-2)	US/DS Channel (0-2)
0	2	2	0	1

Recommended Action(s):	Replace	Priority:	High
------------------------	---------	-----------	------

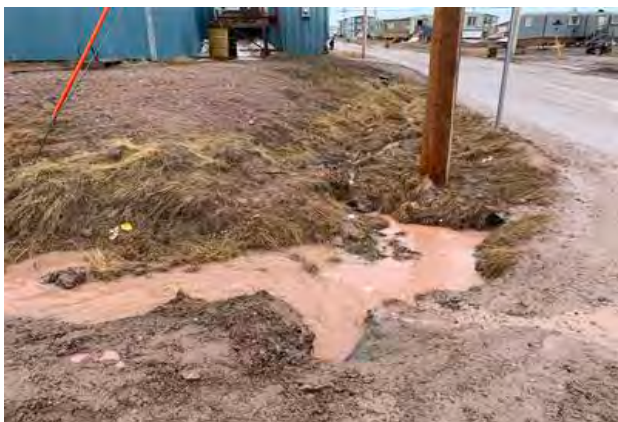
Upstream View

Culvert Information		
Culvert ID		115-17
Type		Entrance
Shape		Round
Material		Csp
Diameter or Dimensions (mm)		600
Marker Post Present		N
End	Upstream	Y
	Downstream	Y
Infill Depth (mm)	Upstream	0
	Downstream	0
Other		Both ends crushed
Comments

Culvert Condition Ratings (MTO 2013)				
Barrel Material (0-4)	Shape (0-4)	Capacity (0-2)	Erosion and Scour (0-2)	US/DS Channel (0-2)
0	2	0	1	1

Recommended Action(s):	Repair both ends of culvert	Priority:	Medium
------------------------	-----------------------------	-----------	--------

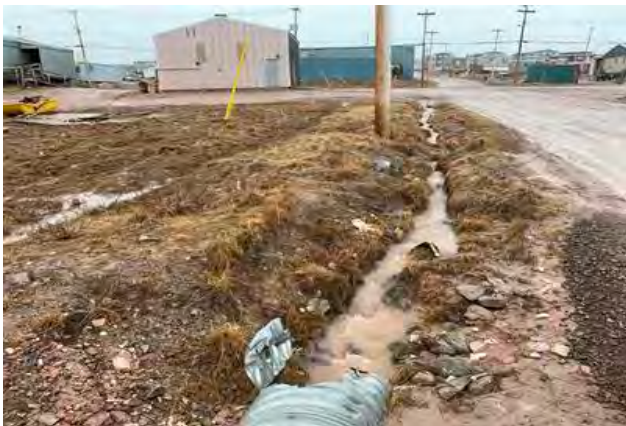
Upstream View

Culvert Information		
Culvert ID		115-18
Type		Entrance
Shape		Round
Material		Csp
Diameter or Dimensions (mm)		600
Marker Post Present		N
End	Upstream	Y
	Downstream	Y
Infill Depth (mm)	Upstream	0
	Downstream	0
Other		None
Comments

Culvert Condition Ratings (MTO 2013)				
Barrel Material (0-4)	Shape (0-4)	Capacity (0-2)	Erosion and Scour (0-2)	US/DS Channel (0-2)
0	2	0	1	0

Recommended Action(s):	Repair both ends of culvert	Priority:	Medium
------------------------	-----------------------------	-----------	--------

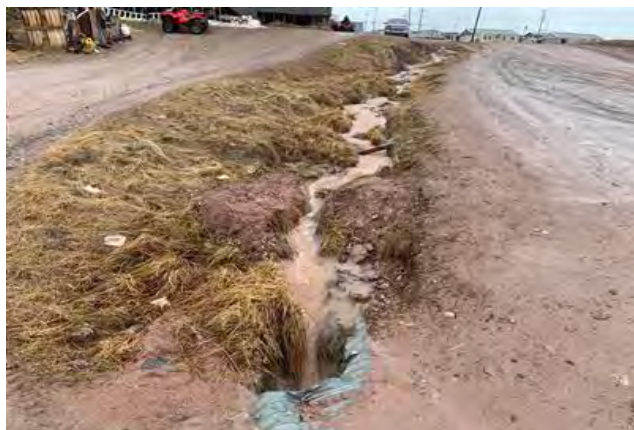
Upstream View

Culvert Information		
Culvert ID		115-19
Type		Entrance
Shape		Round
Material		Csp
Diameter or Dimensions (mm)		600
Marker Post Present		N
End Crushing	Upstream	Y
	Downstream	Y
Infill Depth (mm)	Upstream	300
	Downstream	300
Other		None
Comments

Culvert Condition Ratings (MTO 2013)				
Barrel Material (0-4)	Shape (0-4)	Capacity (0-2)	Erosion and Scour (0-2)	US/DS Channel (0-2)
0	0	2	0	2

Recommended Action(s):	Align ditch with culvert	Priority:	High
------------------------	--------------------------	-----------	------

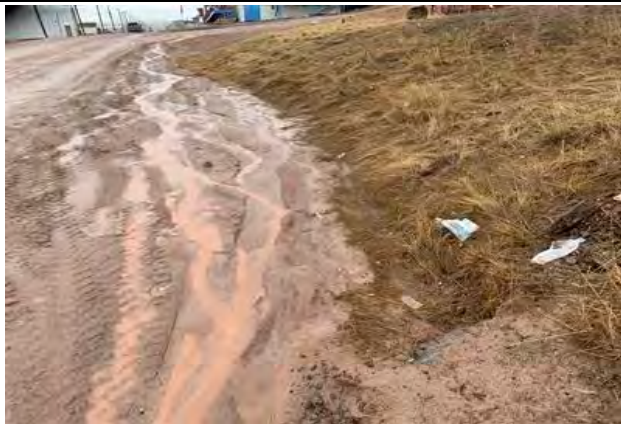
Upstream View

Culvert Information		
Culvert ID		115-20
Type		Cross
Shape		Round
Material		Csp
Diameter or Dimensions (mm)		600
Marker Post Present		N
End	Upstream	N
	Downstream	Y
Infill Depth (mm)	Upstream	0
	Downstream	0
Other		None
Comments

Culvert Condition Ratings (MTO 2013)				
Barrel Material (0-4)	Shape (0-4)	Capacity (0-2)	Erosion and Scour (0-2)	US/DS Channel (0-2)
0	2	0	1	0

Recommended Action(s):	Repair culvert end	Priority:	Medium
------------------------	--------------------	-----------	--------

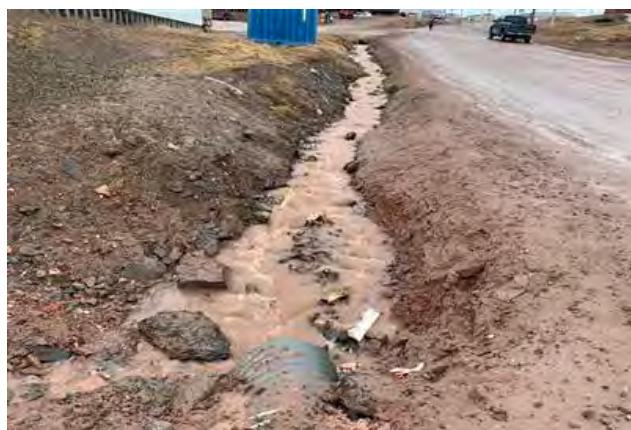
Upstream View

Culvert Information		
Culvert ID		115-21
Type		Entrance
Shape		Round
Material		Csp
Diameter or Dimensions (mm)		600
Marker Post Present		N
End	Upstream	Y
	Downstream	Y
Infill Depth (mm)	Upstream	0
	Downstream	0
Other		None
Comments

Culvert Condition Ratings (MTO 2013)				
Barrel Material (0-4)	Shape (0-4)	Capacity (0-2)	Erosion and Scour (0-2)	US/DS Channel (0-2)
0	3	0	1	0

Recommended Action(s):	Replace	Priority:	High
------------------------	---------	-----------	------

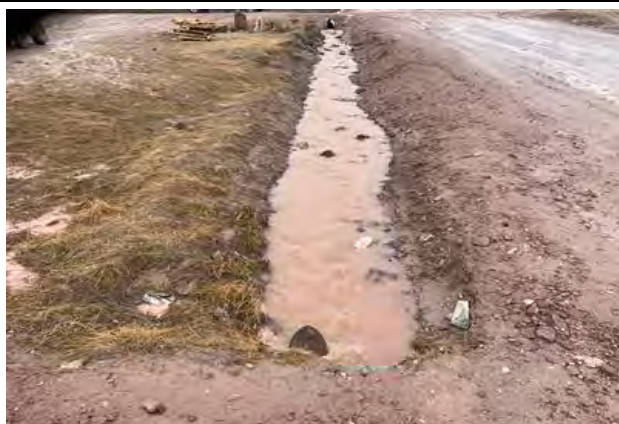
Upstream View

Culvert Information		
Culvert ID		115-22
Type		Entrance
Shape		Round
Material		Csp
Diameter or Dimensions (mm)		600
Marker Post Present		N
End	Upstream	Y
	Downstream	Y
Infill Depth (mm)	Upstream	0
	Downstream	0
Other		None
Comments

Culvert Condition Ratings (MTO 2013)				
Barrel Material (0-4)	Shape (0-4)	Capacity (0-2)	Erosion and Scour (0-2)	US/DS Channel (0-2)
0	2	0	0	0

Recommended Action(s):	Repair both ends of culvert	Priority:	Medium
------------------------	-----------------------------	-----------	--------

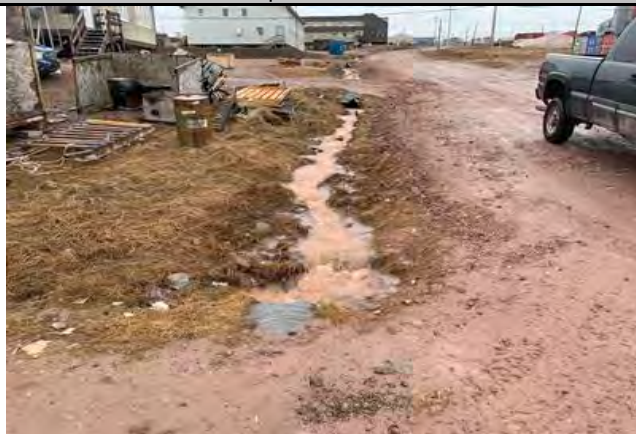
Upstream View

Culvert Information		
Culvert ID		115-23
Type		Entrance
Shape		Round
Material		Csp
Diameter or Dimensions (mm)		600
Marker Post Present		N
End	Upstream	Y
	Downstream	Y
Infill Depth (mm)	Upstream	0
	Downstream	0
Other		Downstream end crushed
Comments

Culvert Condition Ratings (MTO 2013)				
Barrel Material (0-4)	Shape (0-4)	Capacity (0-2)	Erosion and Scour (0-2)	US/DS Channel (0-2)
0	2	0	0	1

Recommended Action(s):	Repair culvert end	Priority:	Medium
------------------------	--------------------	-----------	--------

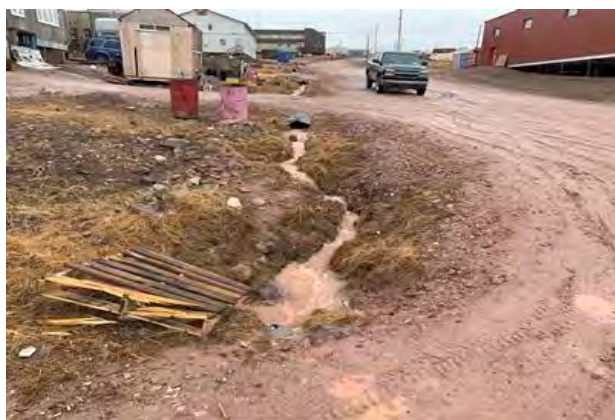
Upstream View

Culvert Information		
Culvert ID		116-01
Type		Entrance
Shape		Round
Material		Csp
Diameter or Dimensions (mm)		600
Marker Post Present		N
End Crushing	Upstream	Y
	Downstream	Y
Infill Depth (mm)	Upstream	250
	Downstream	100
Other		None
Comments

Culvert Condition Ratings (MTO 2013)				
Barrel Material (0-4)	Shape (0-4)	Capacity (0-2)	Erosion and Scour (0-2)	US/DS Channel (0-2)
0	0	2	2	1

Recommended Action(s):	Flush	Priority:	High
------------------------	-------	-----------	------

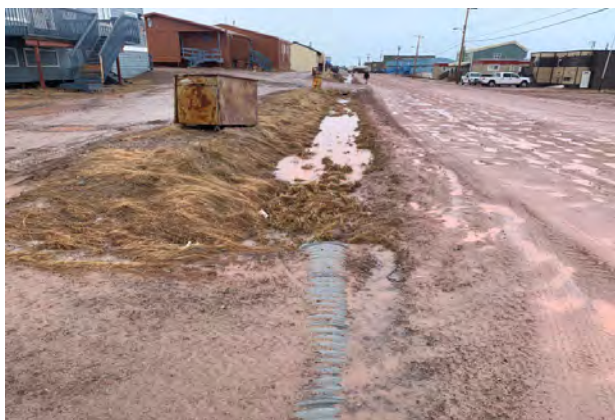
Upstream View

Culvert Condition Ratings (MTO 2013)				
Barrel Material (0-4)	Shape (0-4)	Capacity (0-2)	Erosion and Scour (0-2)	US/DS Channel (0-2)
0	0	0	1	0

Recommended Action(s):	No action	Priority:	Low
------------------------	-----------	-----------	-----
