# **Geotechnical Evaluation and Drainage Planning in Baker Lake, Nunavut**

*Final Report Rev-00*

**The Municipality of Baker Lake, Nunavut**

**Nunami Stantec Limited**

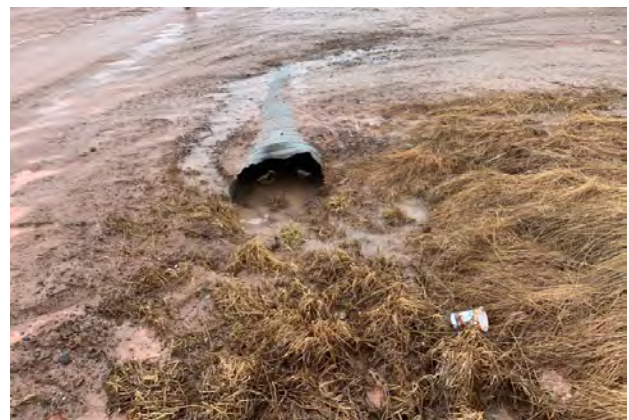
Upstream Culvert End

Culvert Condition Ratings (MTO 2013)				
Barrel Material (0-4)	Shape (0-4)	Capacity (0-2)	Erosion and Scour (0-2)	US/DS Channel (0-2)
0	0	0	1	0

Recommended Action(s):	No action	Priority:	Low
------------------------	-----------	-----------	-----

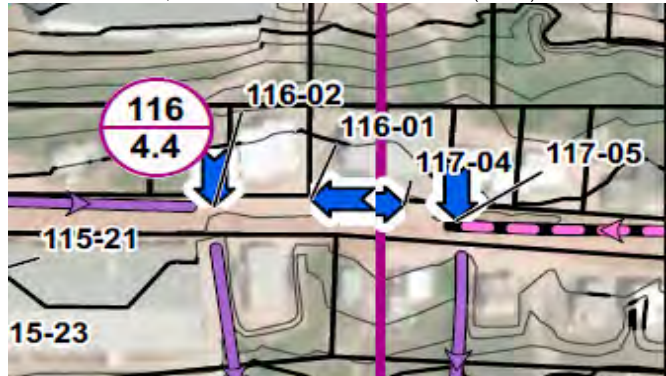
Culvert Information		
Culvert ID		116-02
Type		Cross
Shape		Round
Material		Csp
Diameter or Dimensions (mm)		900
Marker Post Present		N
End	Upstream	N
	Downstream	N
Infill Depth (mm)	Upstream	0
	Downstream	0
Other		None
Comments

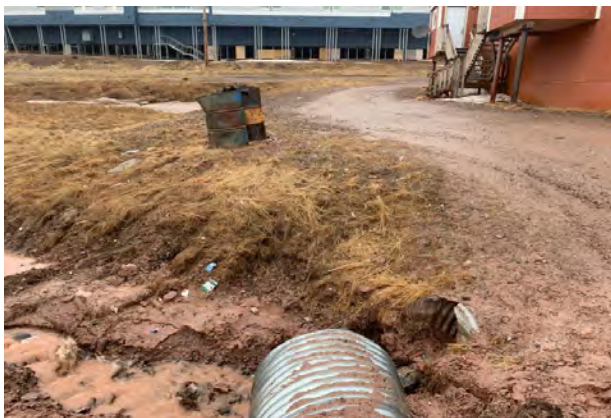
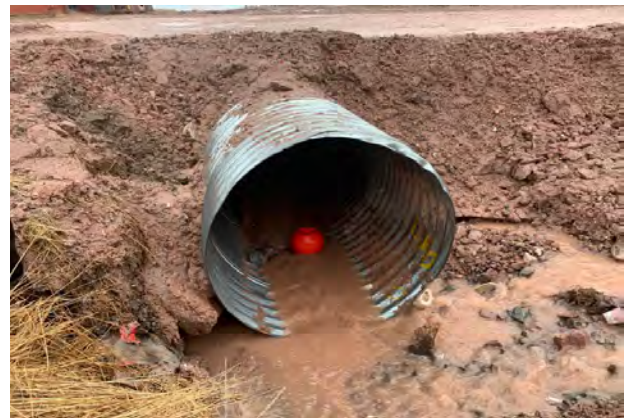
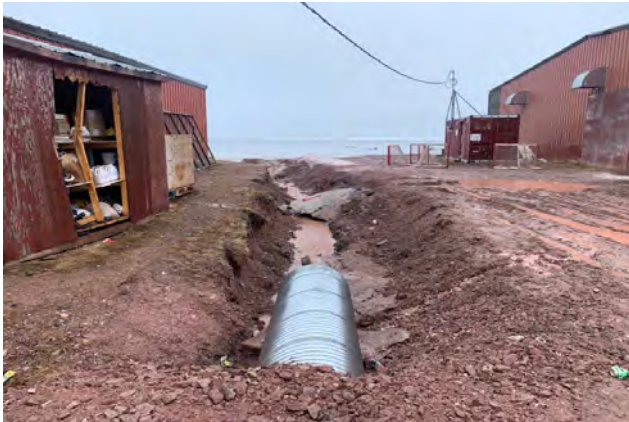
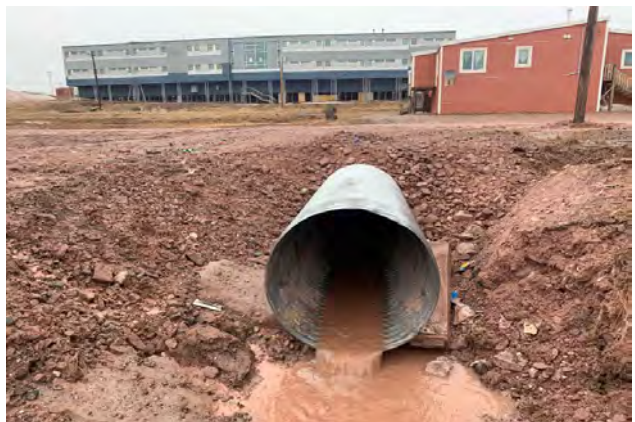
Culvert Information		
Culvert ID		117-01
Type		Entrance
Shape		Round
Material		Csp
Diameter or Dimensions (mm)		500
Marker Post Present		N
End Crushing	Upstream	Y
	Downstream	Y
Infill Depth (mm)	Upstream	200
	Downstream	200
Other		Both ends crushed and infilled
Comments

Culvert Condition Ratings (MTO 2013)				
Barrel Material (0-4)	Shape (0-4)	Capacity (0-2)	Erosion and Scour (0-2)	US/DS Channel (0-2)
0	2	2	1	2

Recommended Action(s):	Replace	Priority:	High
------------------------	---------	-----------	------

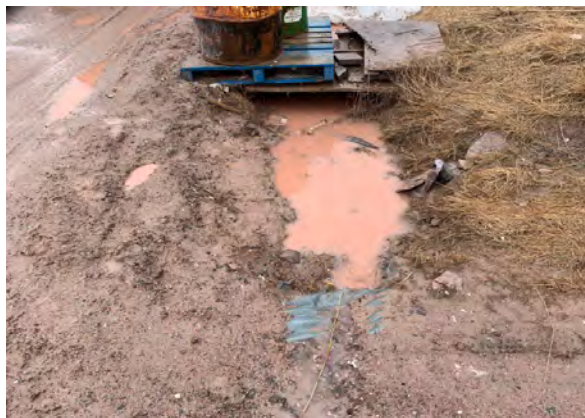
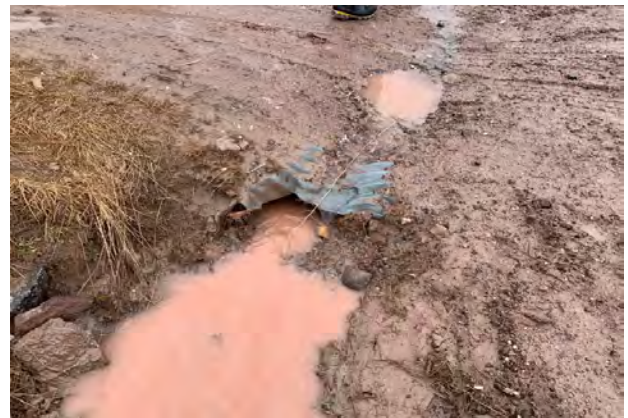
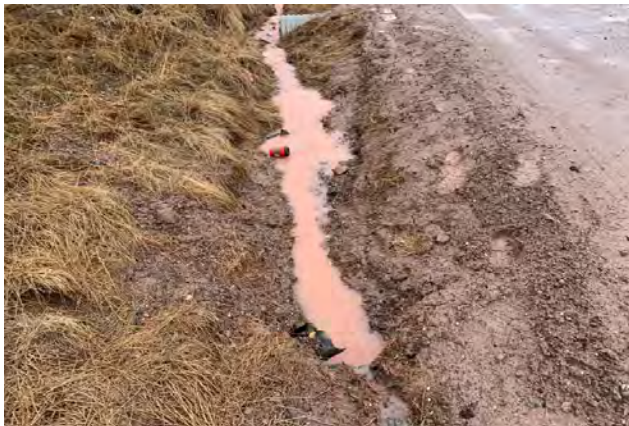
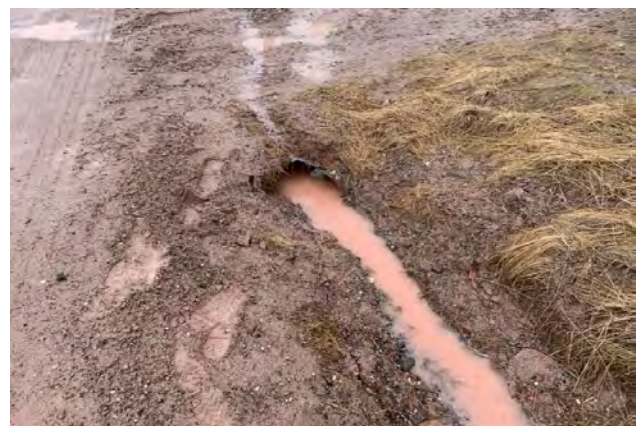
Culvert Information		
Culvert ID		117-02
Type		Cross
Shape		Round
Material		Csp
Diameter or Dimensions (mm)		600
Marker Post Present		N
End Crushing	Upstream	N
	Downstream	Y
Infill Depth (mm)	Upstream	150
	Downstream	150
Other		None
Comments

Culvert Condition Ratings (MTO 2013)				
Barrel Material (0-4)	Shape (0-4)	Capacity (0-2)	Erosion and Scour (0-2)	US/DS Channel (0-2)
0	1	1	0	2

Recommended Action(s):	Flush	Priority:	Medium
------------------------	-------	-----------	--------

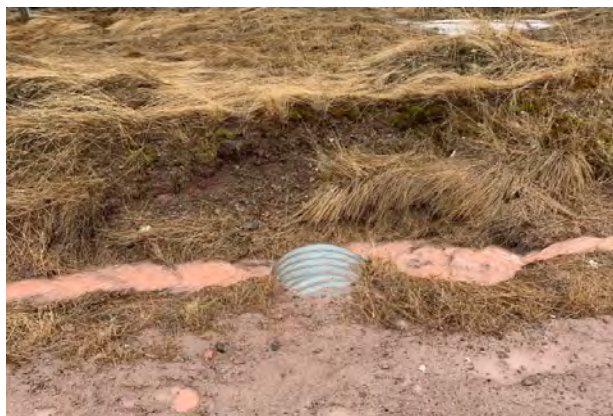
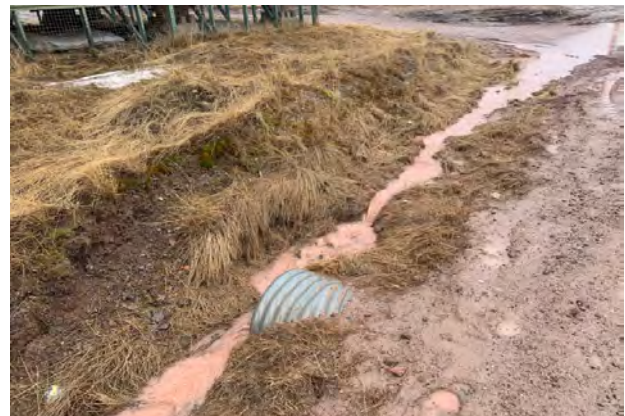
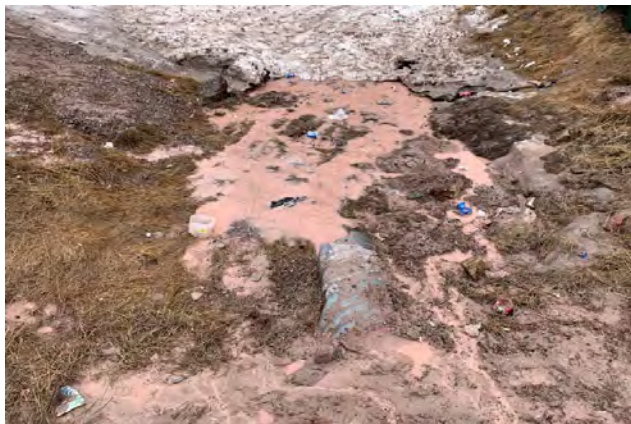
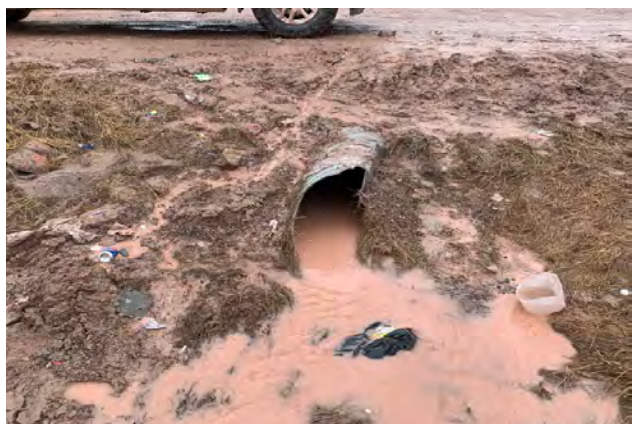
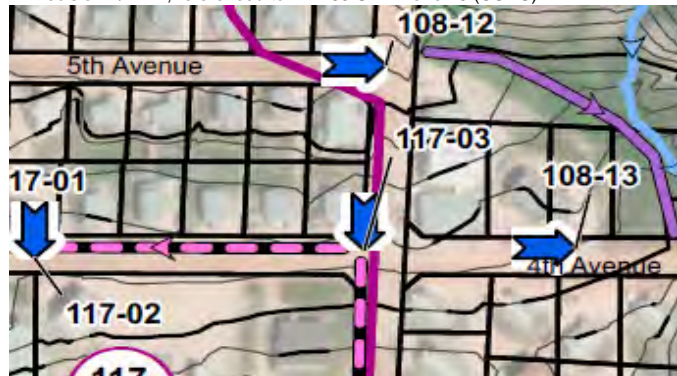
Culvert Information		
Culvert ID		117-03
Type		Cross
Shape		Round
Material		Steel
Diameter or Dimensions (mm)		160
Marker Post Present		N
End Crushing	Upstream	N
	Downstream	N
Infill Depth (mm)	Upstream	0
	Downstream	0
Other Comments		Channel infilled, minimal conveyance of runoff

Culvert Condition Ratings (MTO 2013)				
Barrel Material (0-4)	Shape (0-4)	Capacity (0-2)	Erosion and Scour (0-2)	US/DS Channel (0-2)
1	0	0	0	2

Recommended Action(s):	Stabilize channel	Priority:	High
------------------------	-------------------	-----------	------

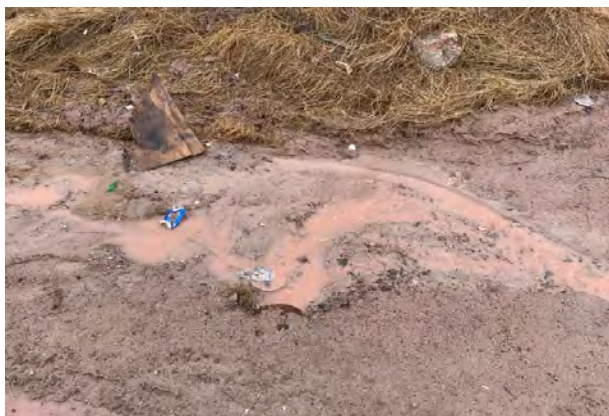
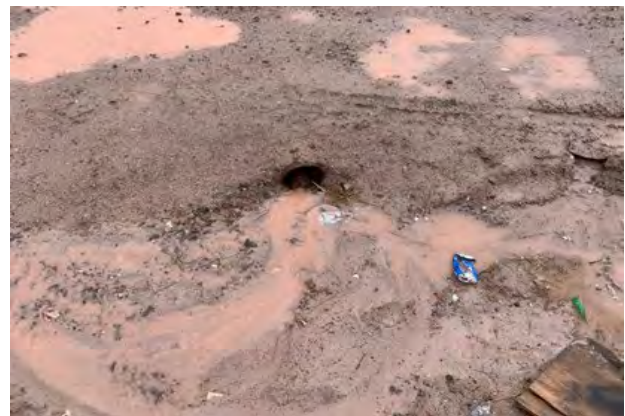
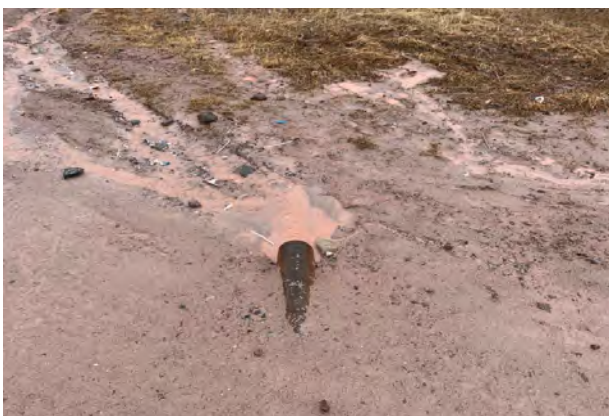
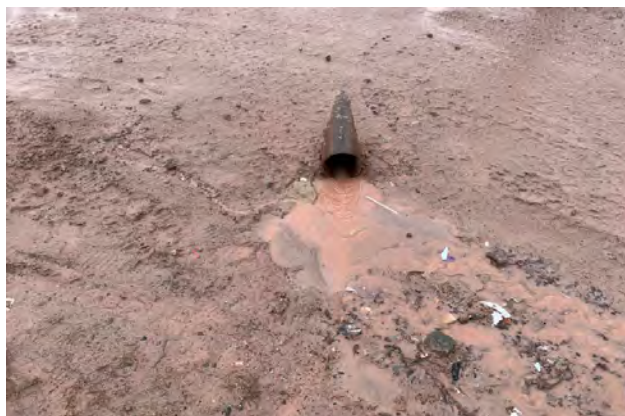
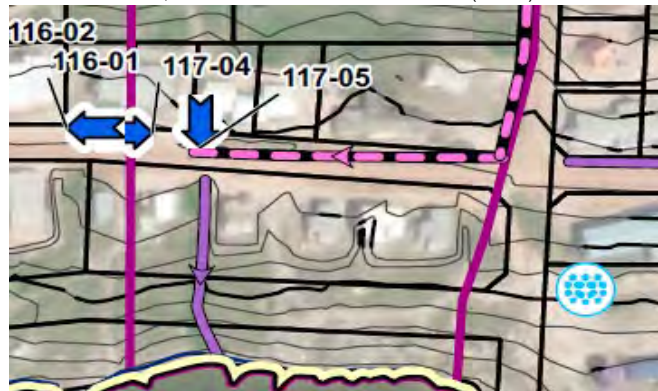
Culvert Information		
Culvert ID		117-04
Type		Entrance
Shape		Round
Material		Csp
Diameter or Dimensions (mm)		600
Marker Post Present		N
End Crushing	Upstream	Y
	Downstream	Y
Infill Depth (mm)	Upstream	300
	Downstream	300
Other		Both ends crushed and infilled
Comments

Culvert Condition Ratings (MTO 2013)				
Barrel Material (0-4)	Shape (0-4)	Capacity (0-2)	Erosion and Scour (0-2)	US/DS Channel (0-2)
0	2	2	1	1

Recommended Action(s):	Replace	Priority:	High
------------------------	---------	-----------	------

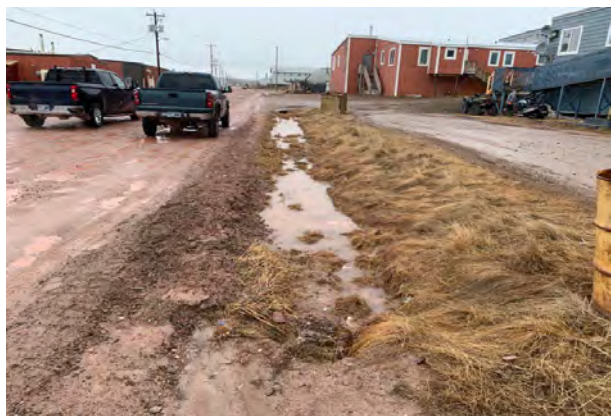
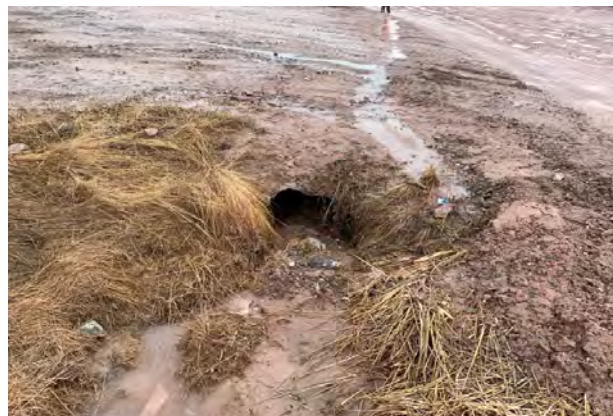
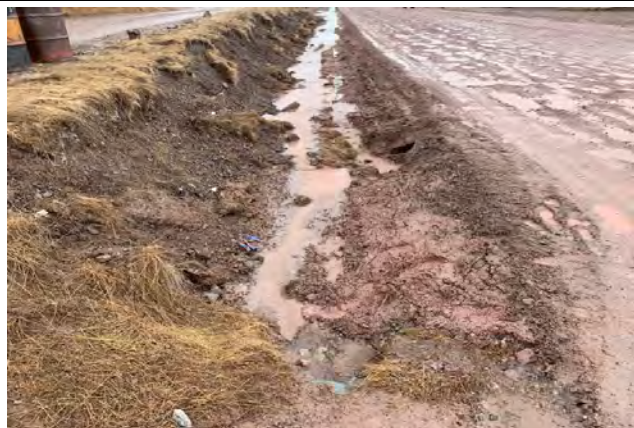
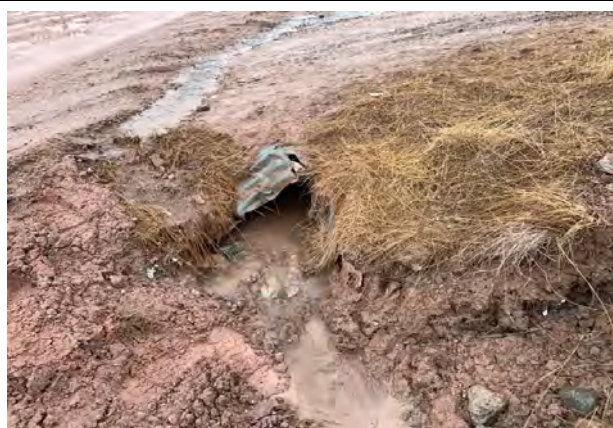
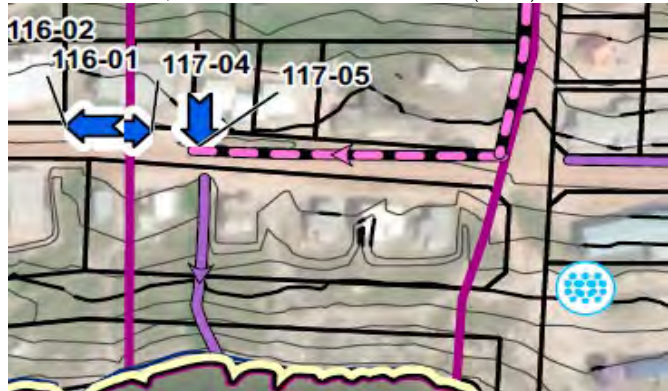
Culvert Information		
Culvert ID		117-05
Type		Cross
Shape		Round
Material		Csp
Diameter or Dimensions (mm)		600
Marker Post Present		N
End	Upstream	Y
	Downstream	Y
Infill Depth (mm)	Upstream	300
	Downstream	300
Other		Both ends crushed and infilled
Comments

Culvert Condition Ratings (MTO 2013)				
Barrel Material (0-4)	Shape (0-4)	Capacity (0-2)	Erosion and Scour (0-2)	US/DS Channel (0-2)
0	2	2	1	1

Recommended Action(s):	Replace	Priority:	High
------------------------	---------	-----------	------

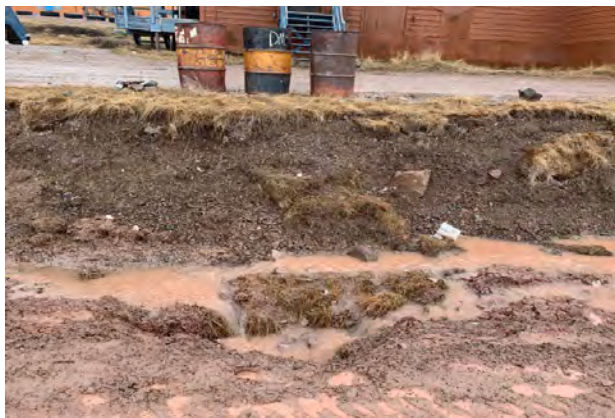
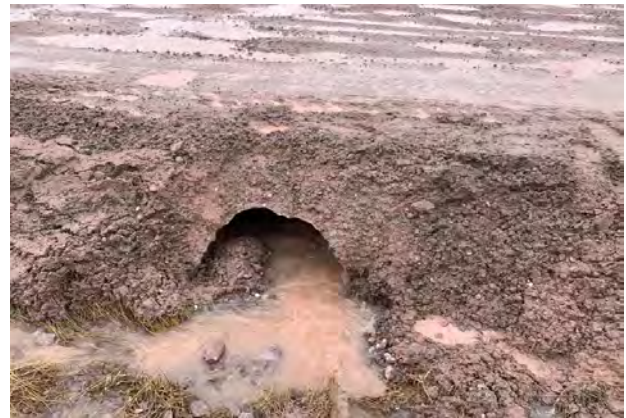
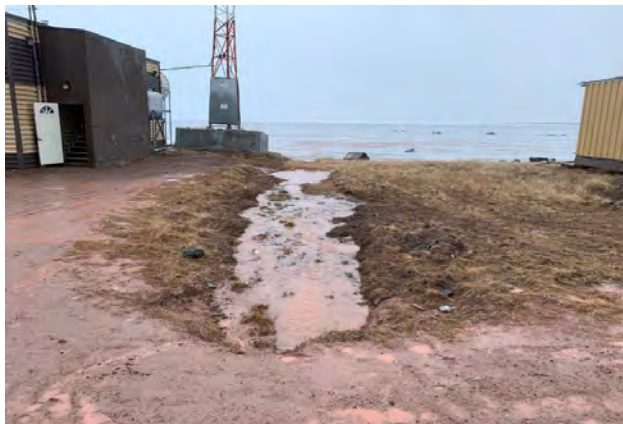
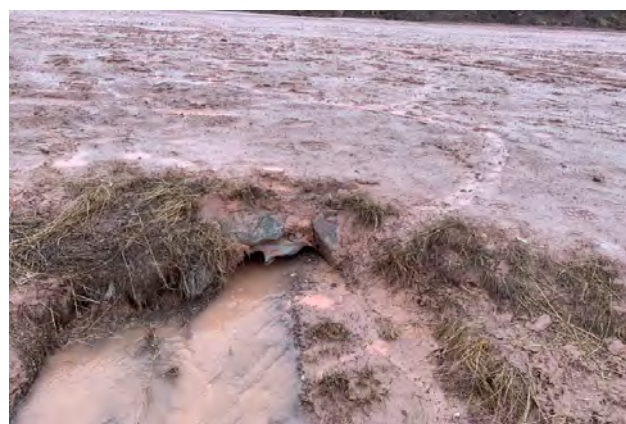
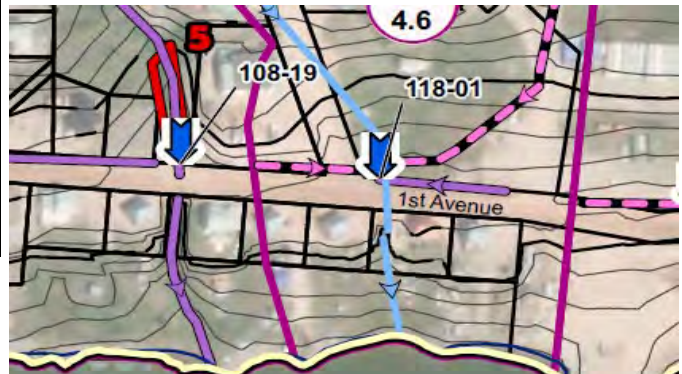
Culvert Information		
Culvert ID		118-01
Type		Cross
Shape		Round
Material		Csp
Diameter or Dimensions (mm)		500
Marker Post Present		N
End	Upstream	Y
	Downstream	N
Infill Depth (mm)	Upstream	0
	Downstream	0
Other		None
Comments

Culvert Condition Ratings (MTO 2013)				
Barrel Material (0-4)	Shape (0-4)	Capacity (0-2)	Erosion and Scour (0-2)	US/DS Channel (0-2)
0	0	0	1	1

Recommended Action(s):	No action	Priority:	Low
------------------------	-----------	-----------	-----

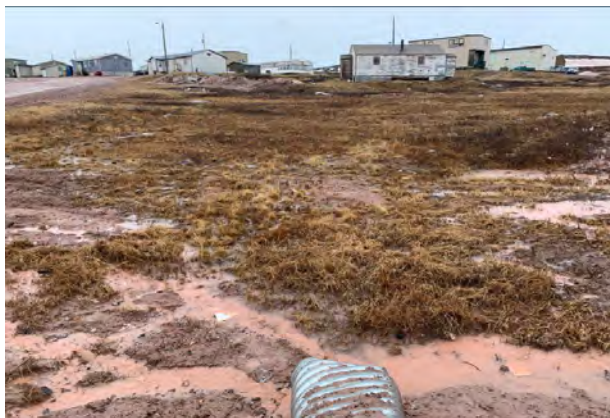
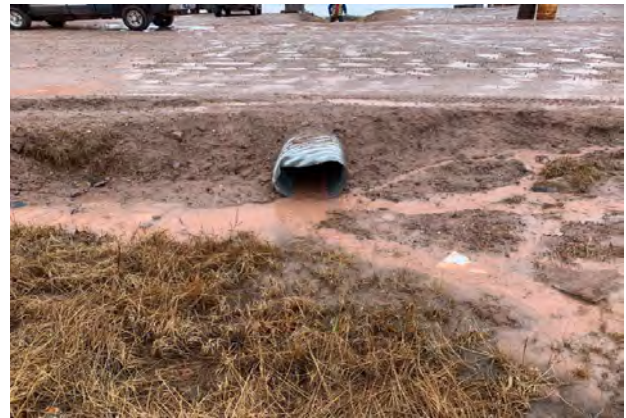
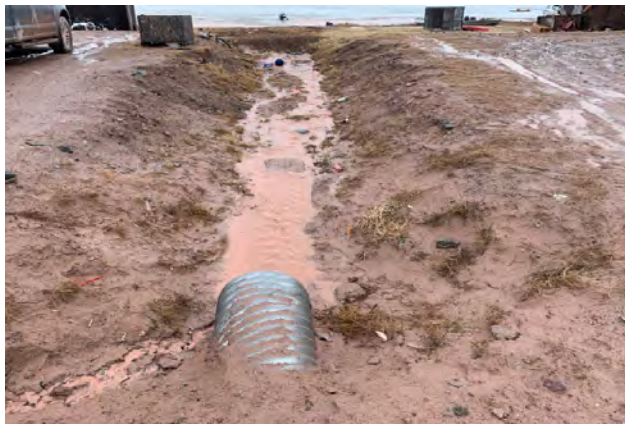
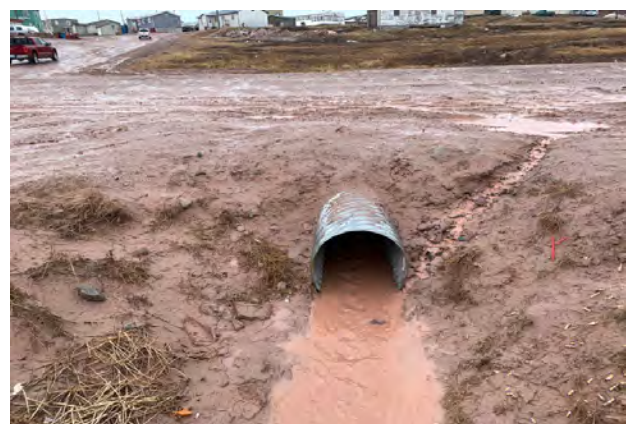
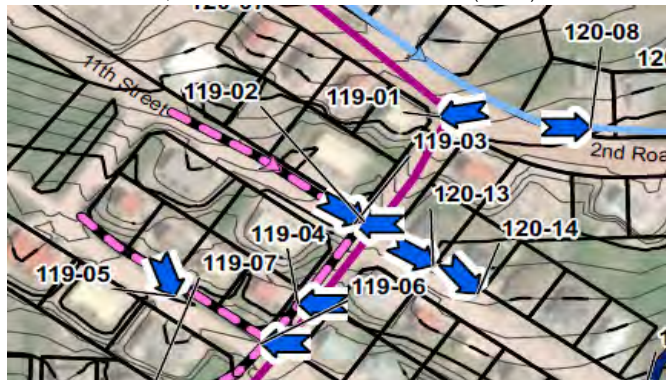
Culvert Information		
Culvert ID		119-01
Type		Entrance
Shape		Round
Material		Csp
Diameter or Dimensions (mm)		600
Marker Post Present		N
End Crushing	Upstream	Y
	Downstream	Y
Infill Depth (mm)	Upstream	0
	Downstream	400
Other		Both ends crushed and infilled
Comments

Culvert Condition Ratings (MTO 2013)				
Barrel Material (0-4)	Shape (0-4)	Capacity (0-2)	Erosion and Scour (0-2)	US/DS Channel (0-2)
0	2	2	0	2

Recommended Action(s):	Replace	Priority:	High
------------------------	---------	-----------	------

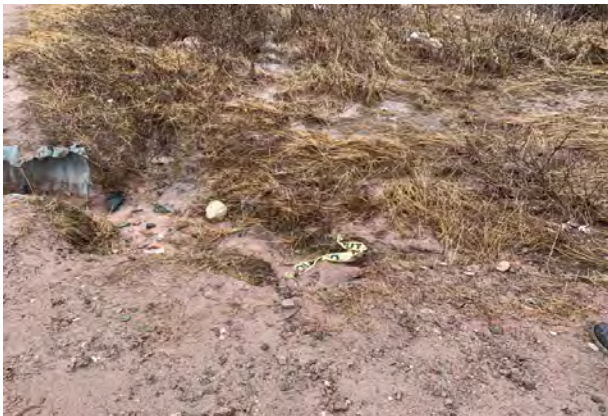
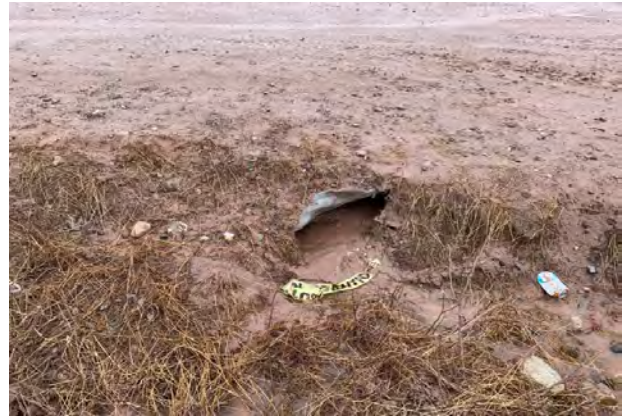
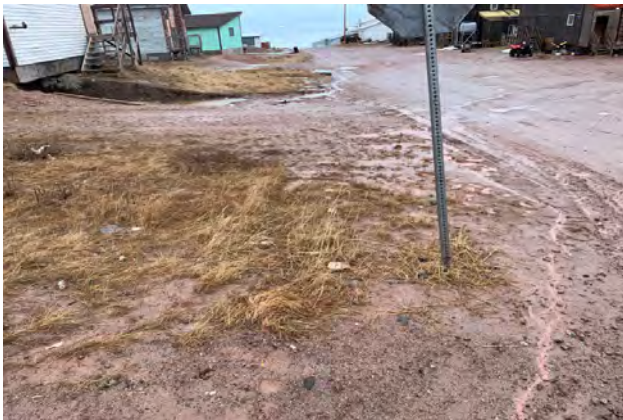
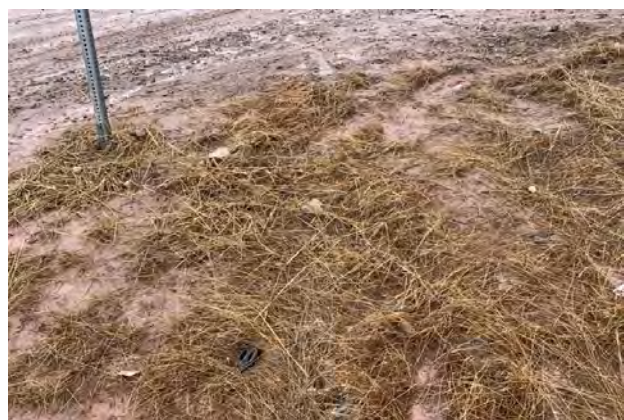
Culvert Information		
Culvert ID		119-02
Type		Cross
Shape		Round
Material		Csp
Diameter or Dimensions (mm)		600
Marker Post Present		N
End Crushing	Upstream	Y
	Downstream	0
Infill Depth (mm)	Upstream	300
	Downstream	600
Other		Both ends crushed and infilled
Comments

Culvert Condition Ratings (MTO 2013)				
Barrel Material (0-4)	Shape (0-4)	Capacity (0-2)	Erosion and Scour (0-2)	US/DS Channel (0-2)
0	2	2	0	2

Recommended Action(s):	Replace	Priority:	High
------------------------	---------	-----------	------

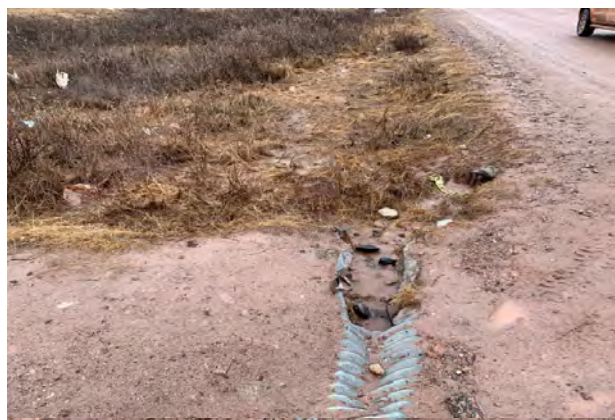
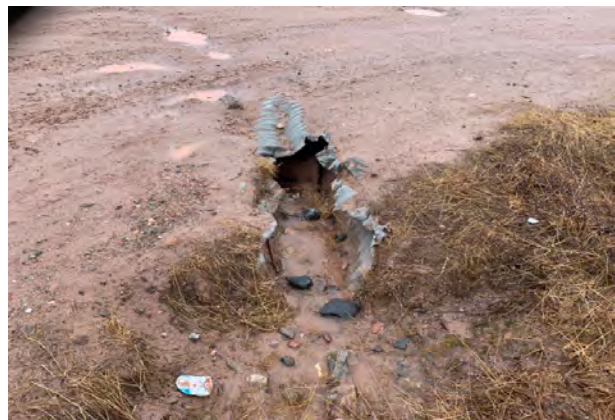
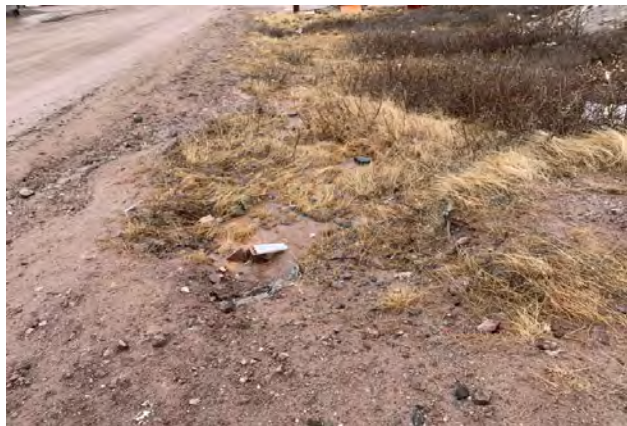
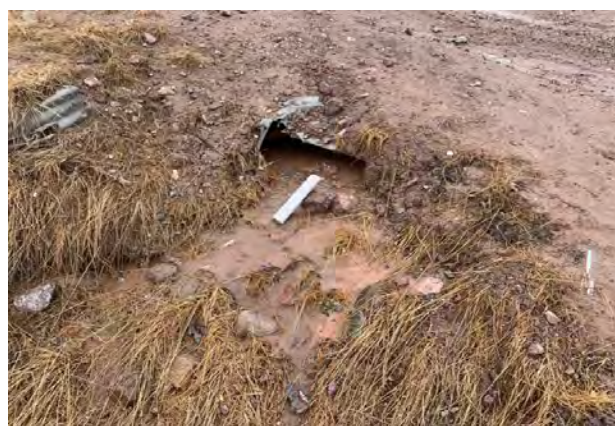
Culvert Information		
Culvert ID		119-03
Type		Cross
Shape		Round
Material		Csp
Diameter or Dimensions (mm)		600
Marker Post Present		0
End Crushing	Upstream	Y
	Downstream	Y
Infill Depth (mm)	Upstream	200
	Downstream	300
Other		None
Comments

Culvert Condition Ratings (MTO 2013)				
Barrel Material (0-4)	Shape (0-4)	Capacity (0-2)	Erosion and Scour (0-2)	US/DS Channel (0-2)
0	3	2	1	0

Recommended Action(s):	Replace	Priority:	High
------------------------	---------	-----------	------

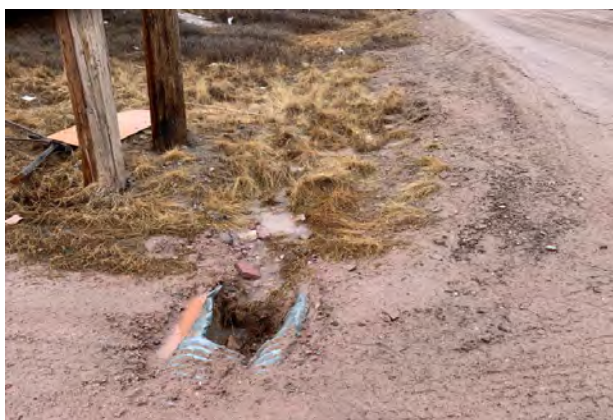
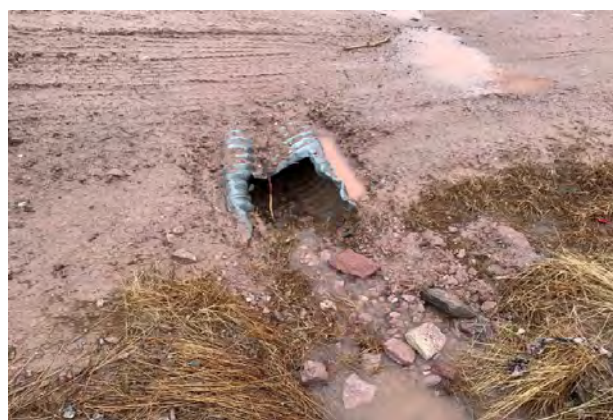
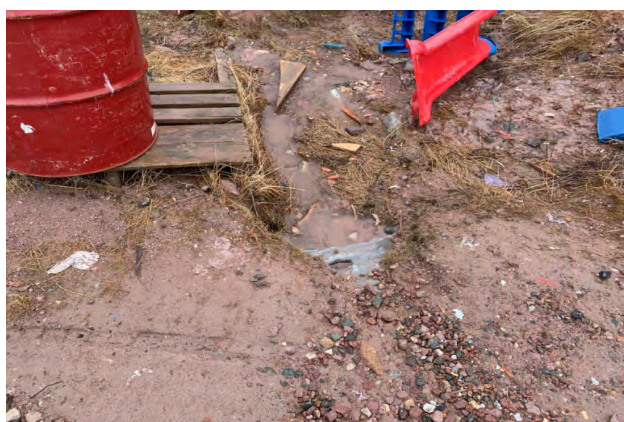
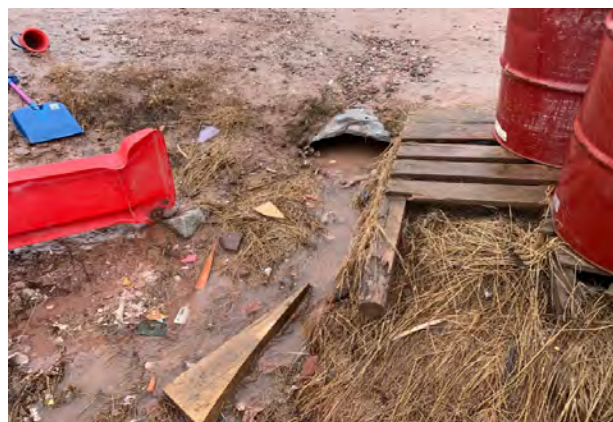
Culvert Information		
Culvert ID		119-04
Type		Entrance
Shape		Round
Material		Csp
Diameter or Dimensions (mm)		600
Marker Post Present		N
End Crushing	Upstream	Y
	Downstream	Y
Infill Depth (mm)	Upstream	100
	Downstream	300
Other		Both ends crushed and infilled
Comments

Culvert Condition Ratings (MTO 2013)				
Barrel Material (0-4)	Shape (0-4)	Capacity (0-2)	Erosion and Scour (0-2)	US/DS Channel (0-2)
0	2	2	2	1

Recommended Action(s):	Replace	Priority:	High
------------------------	---------	-----------	------

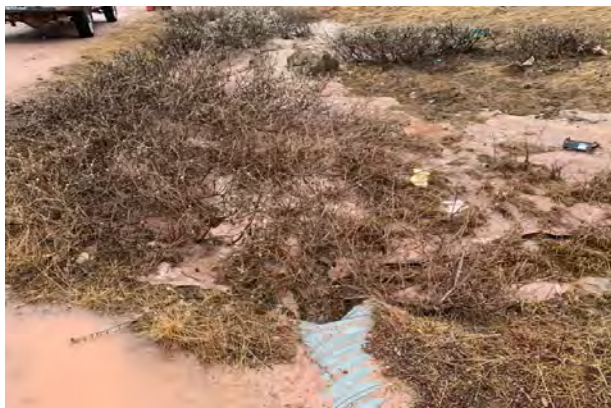
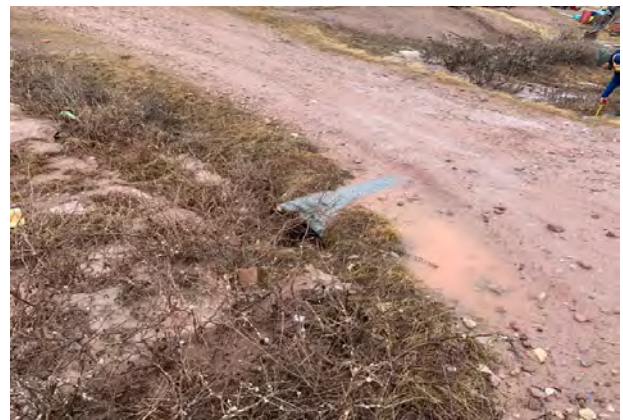
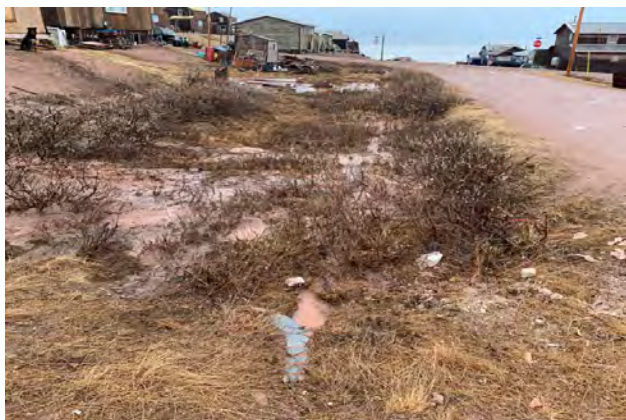
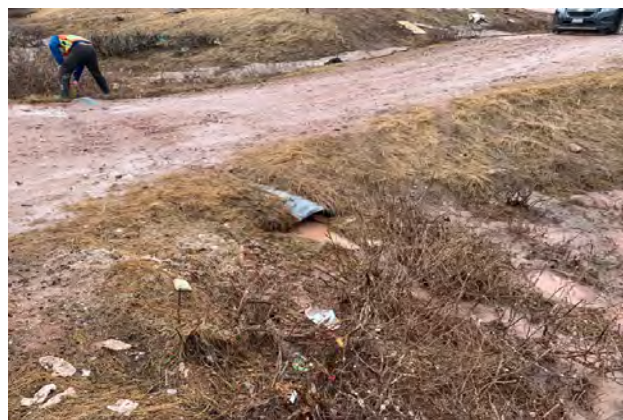
Culvert Information		
Culvert ID		119-05
Type		Entrance
Shape		Round
Material		Csp
Diameter or Dimensions (mm)		600
Marker Post Present		N
End Crushing	Upstream	Y
	Downstream	Y
Infill Depth (mm)	Upstream	200
	Downstream	300
Other		Both ends crushed and infilled
Comments

Culvert Condition Ratings (MTO 2013)				
Barrel Material (0-4)	Shape (0-4)	Capacity (0-2)	Erosion and Scour (0-2)	US/DS Channel (0-2)
0	0	2	0	1

Recommended Action(s):	Flush	Priority:	High
------------------------	-------	-----------	------

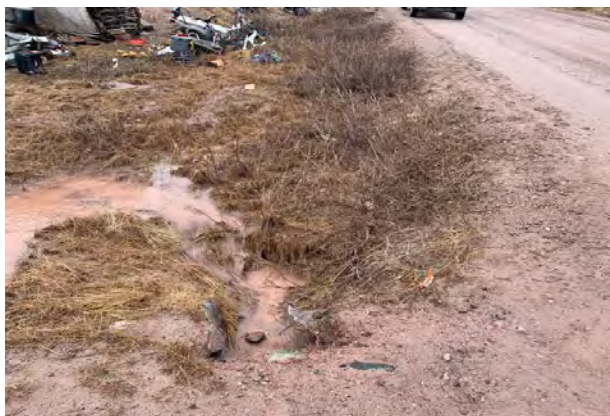
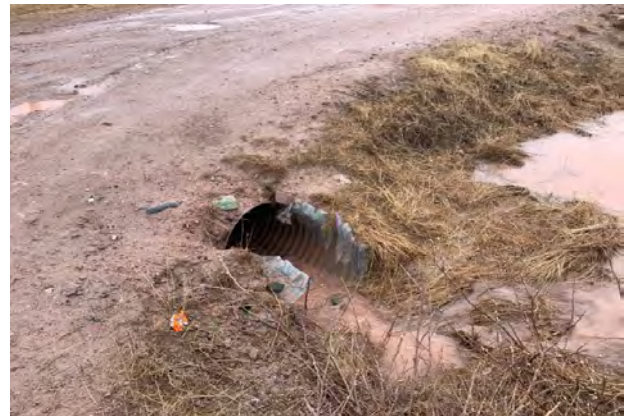
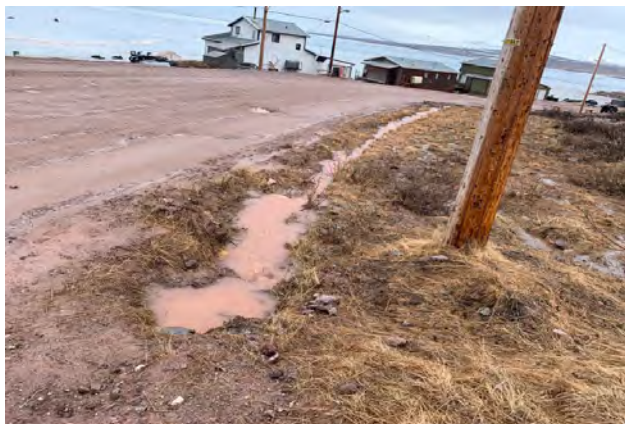
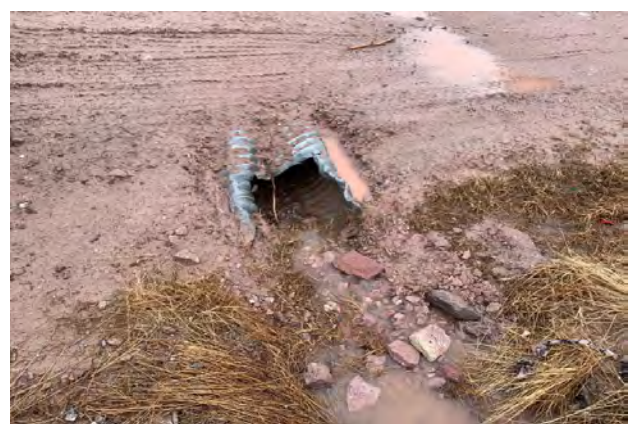
Culvert Information		
Culvert ID		119-06
Type		Cross
Shape		Round
Material		Csp
Diameter or Dimensions (mm)		700
Marker Post Present		N
End Crushing	Upstream	Y
	Downstream	Y
Infill Depth (mm)	Upstream	100
	Downstream	500
Other		Both ends crushed and infilled
Comments

Culvert Condition Ratings (MTO 2013)				
Barrel Material (0-4)	Shape (0-4)	Capacity (0-2)	Erosion and Scour (0-2)	US/DS Channel (0-2)
0	2	2	1	1

Recommended Action(s):	Replace	Priority:	High
------------------------	---------	-----------	------

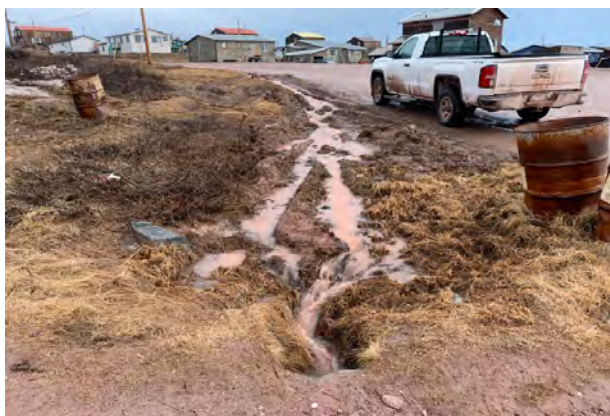
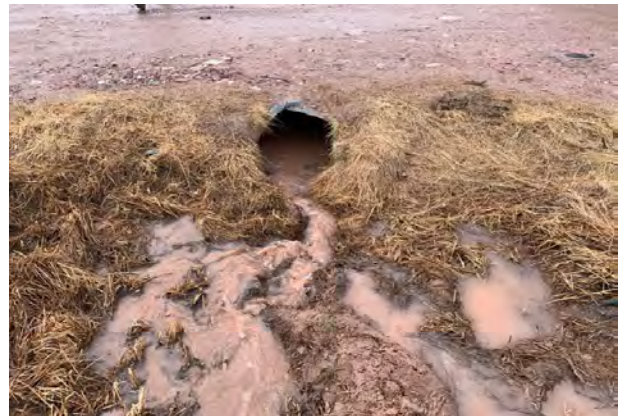
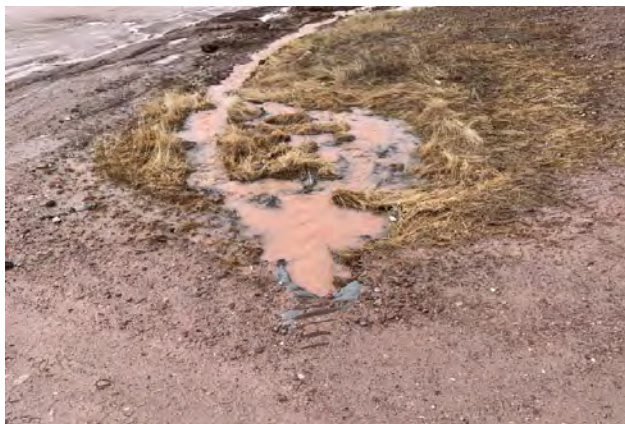
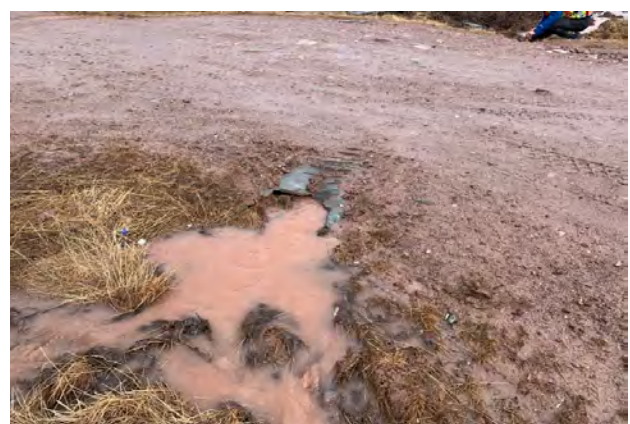
Culvert Information		
Culvert ID		119-07
Type		Entrance
Shape		Round
Material		Csp
Diameter or Dimensions (mm)		600
Marker Post Present		N
End Crushing	Upstream	Y
	Downstream	Y
Infill Depth (mm)	Upstream	100
	Downstream	500
Other		Both ends crushed and infilled
Comments

Culvert Condition Ratings (MTO 2013)				
Barrel Material (0-4)	Shape (0-4)	Capacity (0-2)	Erosion and Scour (0-2)	US/DS Channel (0-2)
0	2	2	1	1

Recommended Action(s):	Replace	Priority:	High
------------------------	---------	-----------	------

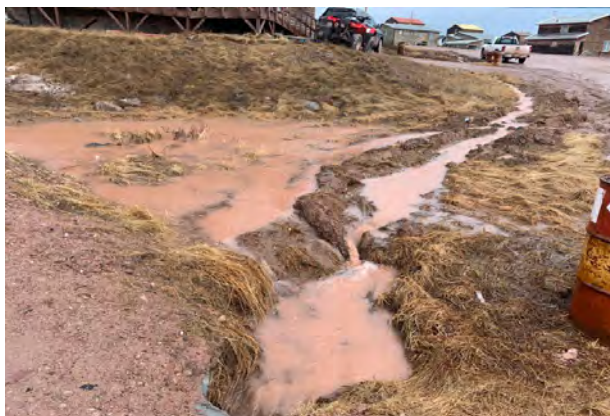
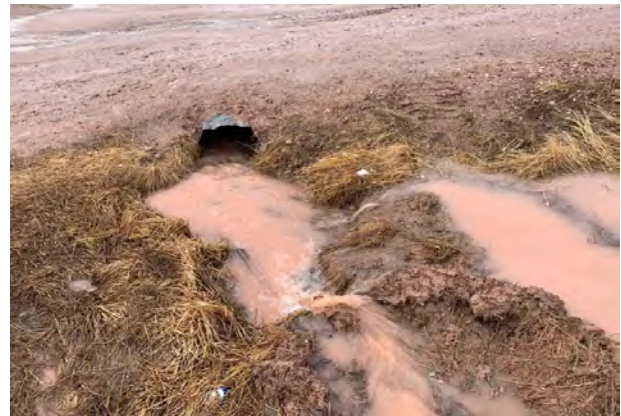
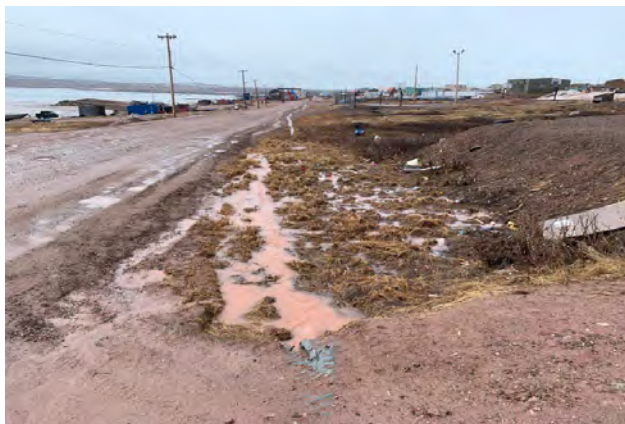
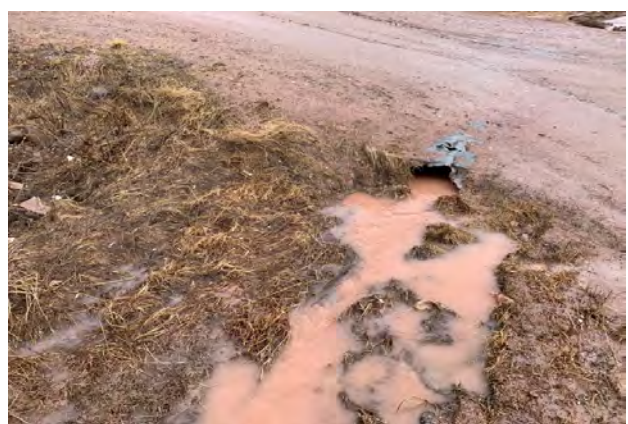
Culvert Information		
Culvert ID		119-08
Type		Entrance
Shape		Round
Material		Csp
Diameter or Dimensions (mm)		500
Marker Post Present		N
End	Upstream	Y
	Downstream	Y
Infill Depth (mm)	Upstream	100
	Downstream	200
Other		Both ends crushed and infilled
Comments

Culvert Condition Ratings (MTO 2013)				
Barrel Material (0-4)	Shape (0-4)	Capacity (0-2)	Erosion and Scour (0-2)	US/DS Channel (0-2)
0	2	2	0	1

Recommended Action(s):	Replace	Priority:	High
------------------------	---------	-----------	------

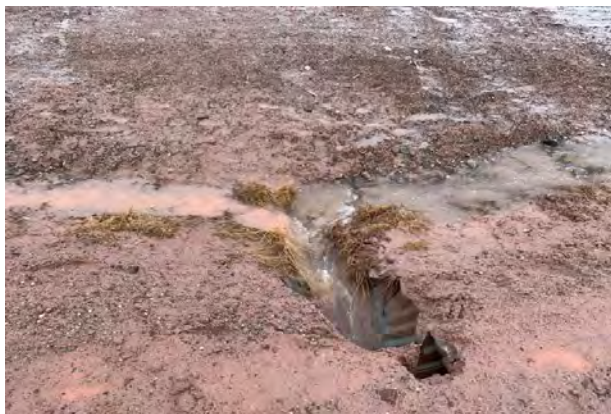
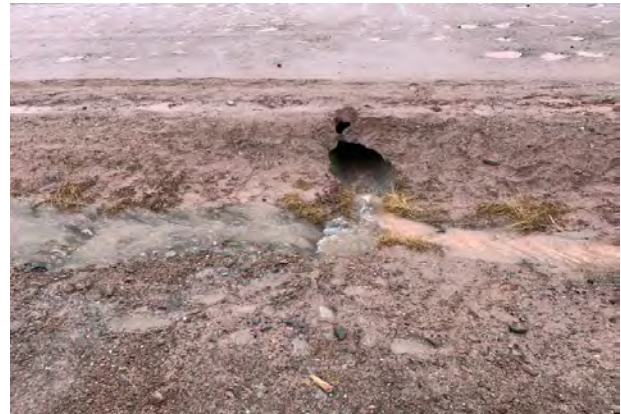
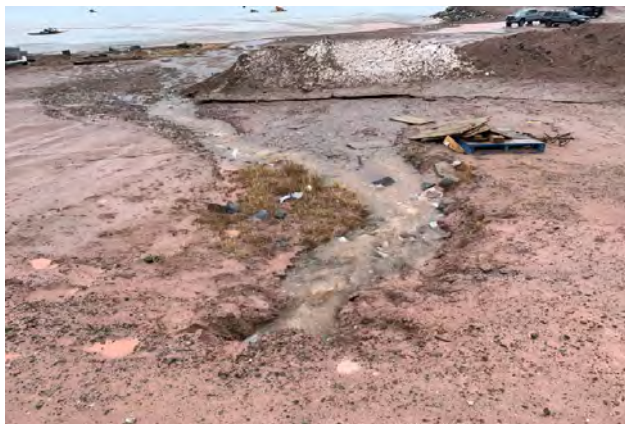
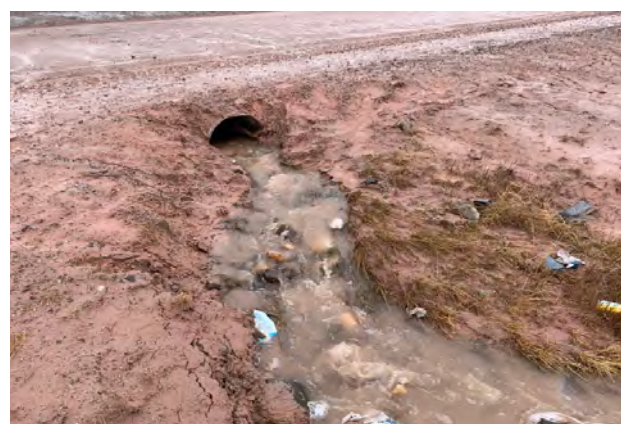
Culvert Information		
Culvert ID		119-09
Type		Cross
Shape		Round
Material		Csp
Diameter or Dimensions (mm)		600
Marker Post Present		N
End Crushing	Upstream	Y
	Downstream	N
Infill Depth (mm)	Upstream	0
	Downstream	200
Other Comments		Both ends crushed and infilled

Culvert Condition Ratings (MTO 2013)				
Barrel Material (0-4)	Shape (0-4)	Capacity (0-2)	Erosion and Scour (0-2)	US/DS Channel (0-2)
0	2	2	1	1

Recommended Action(s):	Replace	Priority:	High
------------------------	---------	-----------	------

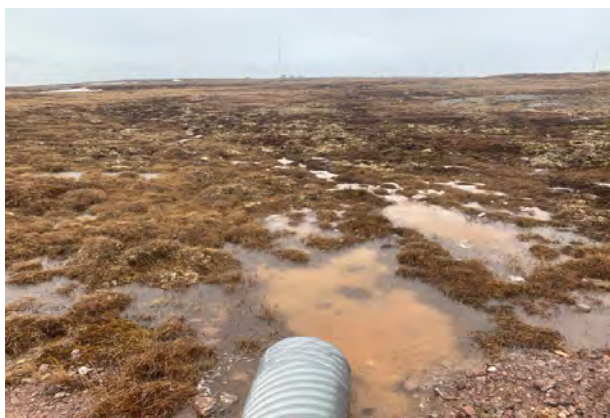
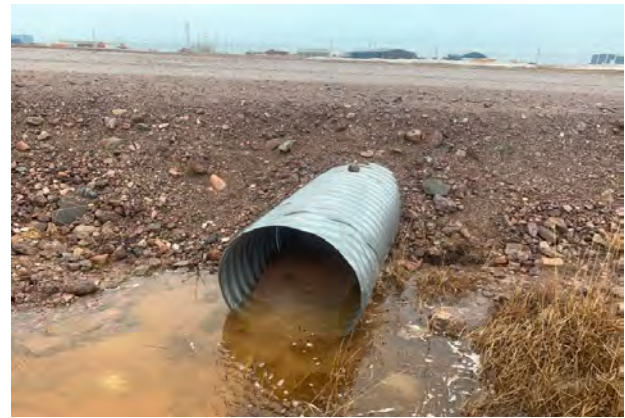
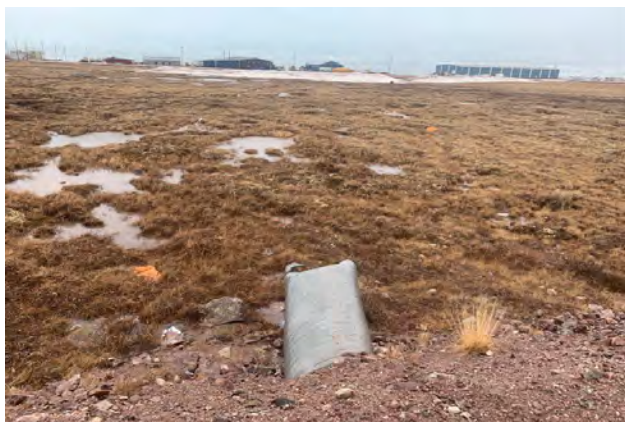
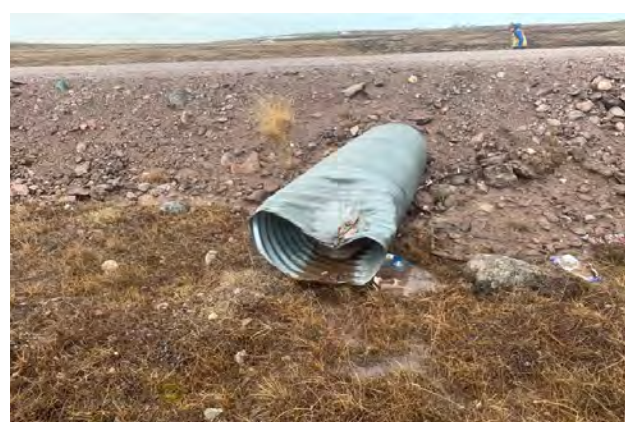
Culvert Condition Ratings (MTO 2013)				
Barrel Material (0-4)	Shape (0-4)	Capacity (0-2)	Erosion and Scour (0-2)	US/DS Channel (0-2)
1	2	0	0	0

Recommended Action(s):	Repair culvert end	Priority:	Medium
------------------------	--------------------	-----------	--------

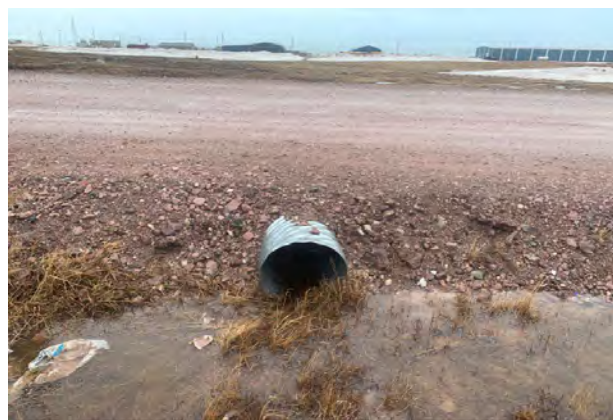
Upstream Culvert End
----------------------

Culvert Information		
Culvert ID		120-02
Type		Cross
Shape		Round
Material		Csp
Diameter or Dimensions (mm)		500
Marker Post Present		N
End Crushing	Upstream	N
	Downstream	N
Infill Depth (mm)	Upstream	0
	Downstream	0
Other Comments	None

Culvert Condition Ratings (MTO 2013)				
Barrel Material (0-4)	Shape (0-4)	Capacity (0-2)	Erosion and Scour (0-2)	US/DS Channel (0-2)
0	0	0	1	0

Recommended Action(s):	No action	Priority:	Low
------------------------	-----------	-----------	-----

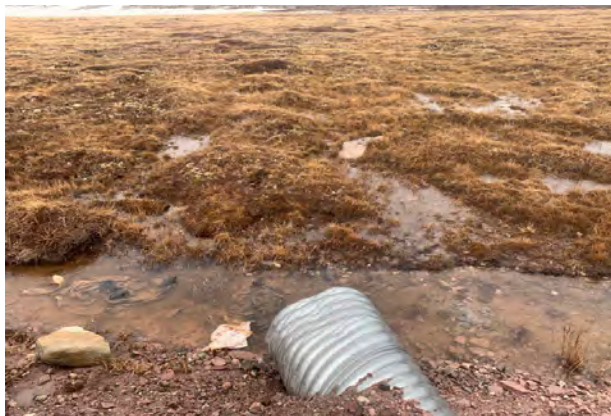
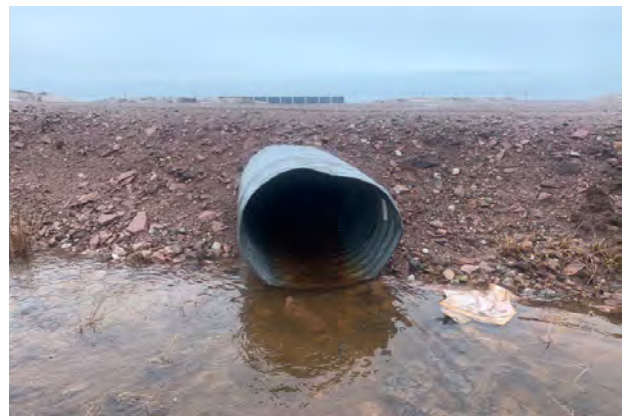
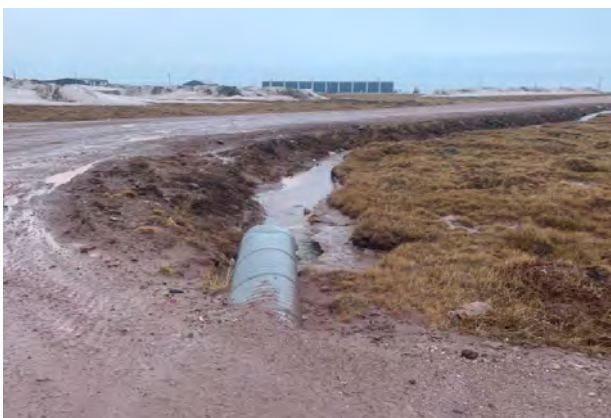
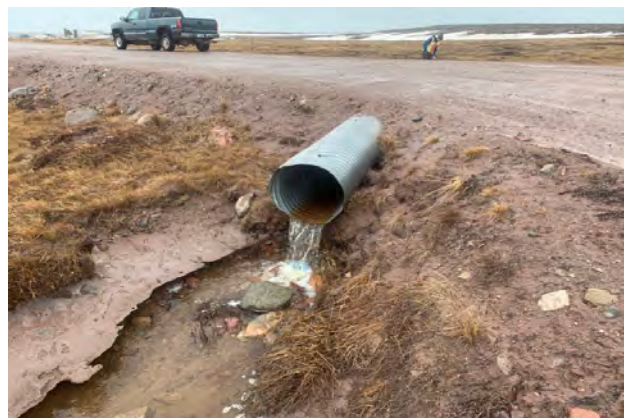
Culvert Condition Ratings (MTO 2013)				
Barrel Material (0-4)	Shape (0-4)	Capacity (0-2)	Erosion and Scour (0-2)	US/DS Channel (0-2)
1	0	0	0	0

Recommended Action(s):	No action	Priority:	Low
------------------------	-----------	-----------	-----
