# **Geotechnical Evaluation and Drainage Planning in Baker Lake, Nunavut**

*Final Report Rev-00*

**The Municipality of Baker Lake, Nunavut**

**Nunami Stantec Limited**

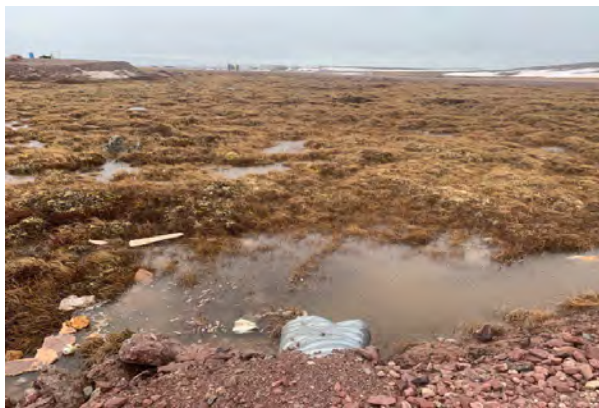
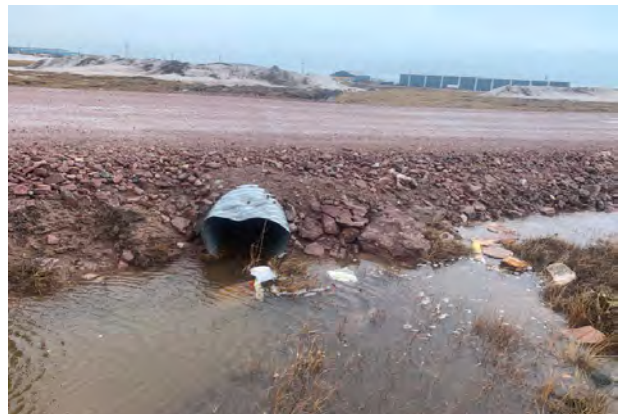
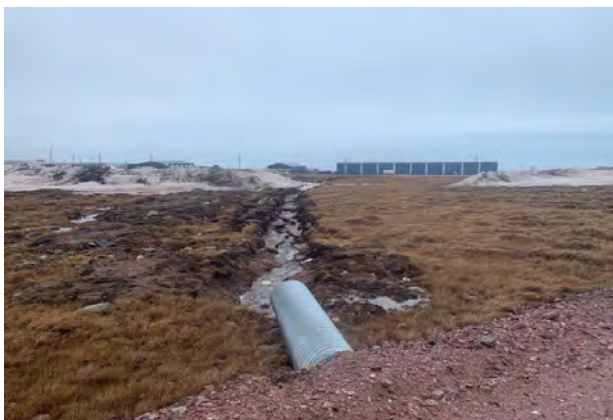
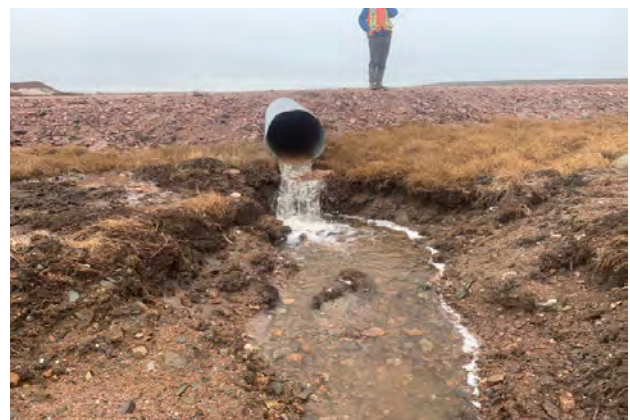
Culvert Information		
Culvert ID		120-04
Type		Cross
Shape		Round
Material		Csp
Diameter or Dimensions (mm)		500
Marker Post Present		N
End	Upstream	Y
	Downstream	N
Crushing	Upstream	0
	Downstream	0
Infill Depth (mm)		0
Other		None
Comments

Culvert Condition Ratings (MTO 2013)				
Barrel Material (0-4)	Shape (0-4)	Capacity (0-2)	Erosion and Scour (0-2)	US/DS Channel (0-2)
0	0	0	1	1

Recommended Action(s):	No action	Priority:	Low
------------------------	-----------	-----------	-----

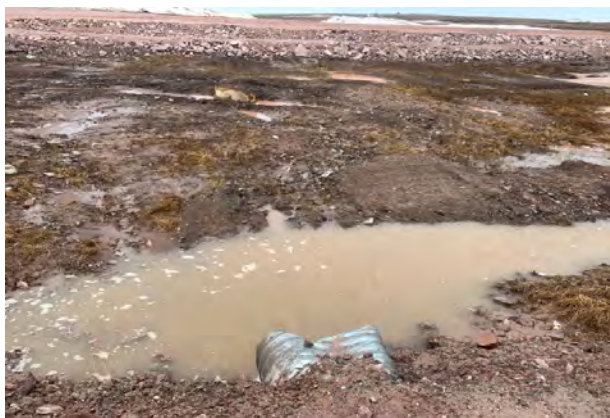
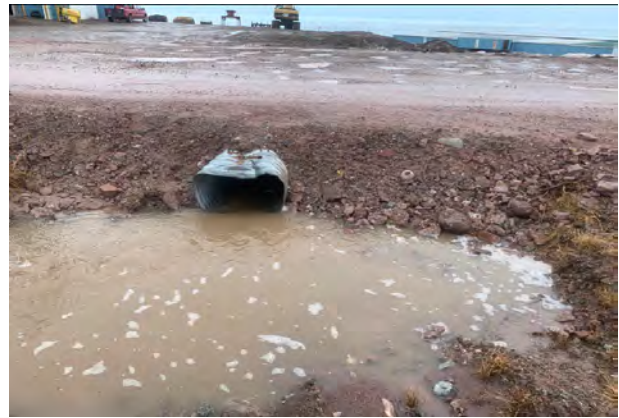
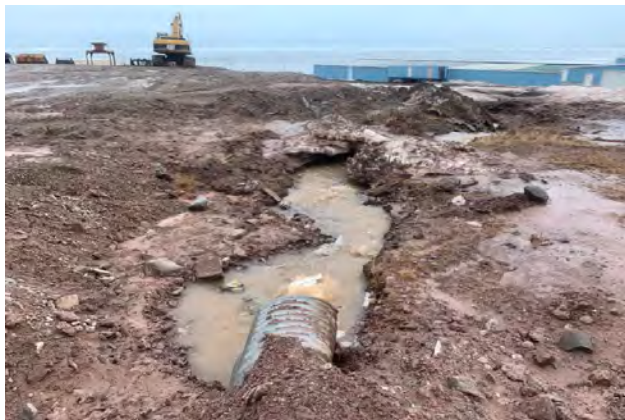
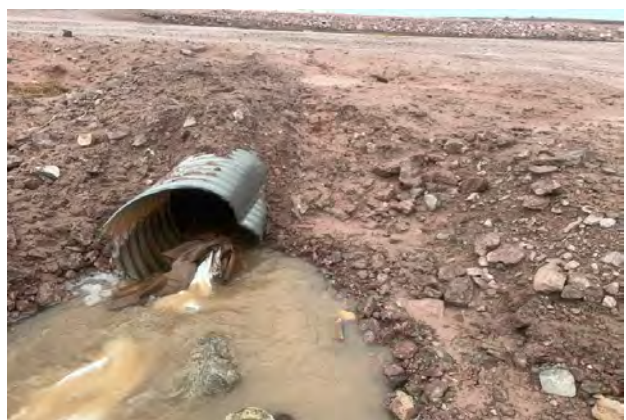
Culvert Information		
Culvert ID		120-05
Type		Cross
Shape		Round
Material		Csp
Diameter or Dimensions (mm)		600
Marker Post Present		N
End Crushing	Upstream	Y
	Downstream	Y
Infill Depth (mm)	Upstream	0
	Downstream	0
Other		Upstream end crushed
Comments

Culvert Condition Ratings (MTO 2013)				
Barrel Material (0-4)	Shape (0-4)	Capacity (0-2)	Erosion and Scour (0-2)	US/DS Channel (0-2)
0	2	0	1	1

Recommended Action(s):	Repair culvert end	Priority:	Medium
------------------------	--------------------	-----------	--------

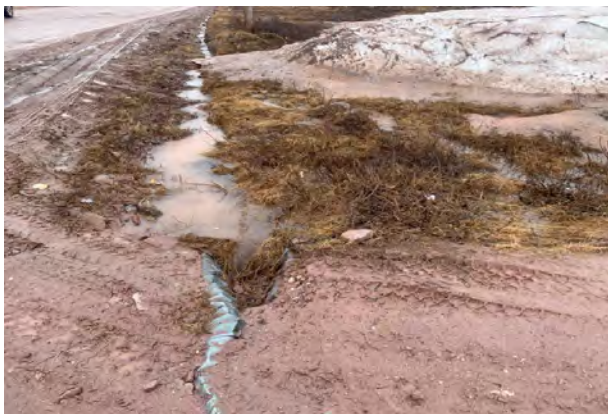
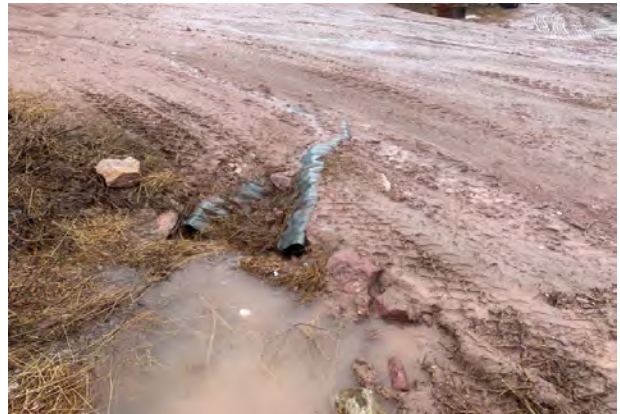
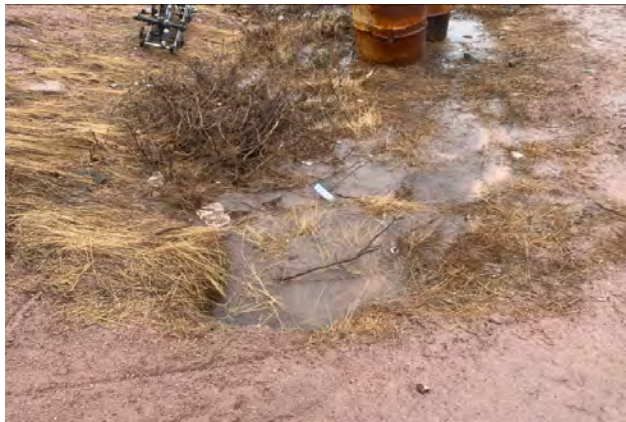
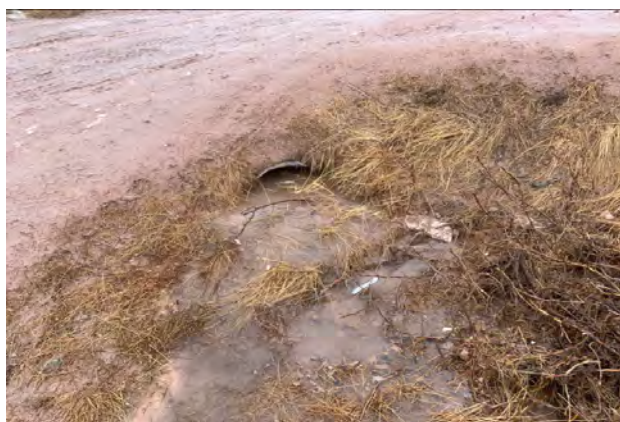
Culvert Information		
Culvert ID		120-06
Type		Entrance
Shape		Round
Material		Csp
Diameter or Dimensions (mm)		600
Marker Post Present		N
End Crushing	Upstream	Y
	Downstream	Y
Infill Depth (mm)	Upstream	200
	Downstream	300
Other		Both ends crushed and infilled
Comments

Culvert Condition Ratings (MTO 2013)				
Barrel Material (0-4)	Shape (0-4)	Capacity (0-2)	Erosion and Scour (0-2)	US/DS Channel (0-2)
0	2	2	1	1

Recommended Action(s):	Replace	Priority:	High
------------------------	---------	-----------	------

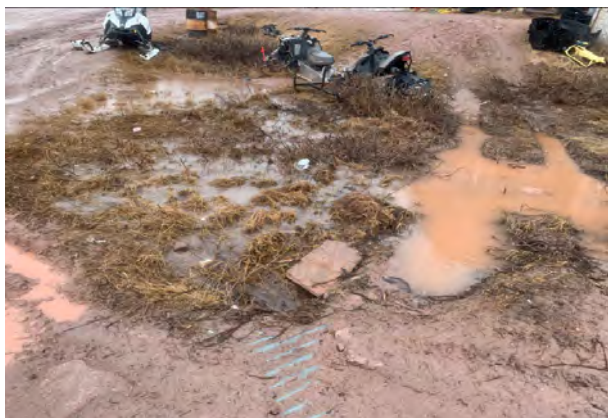
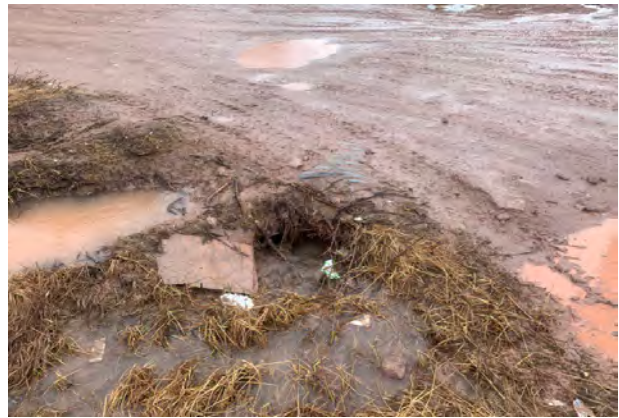
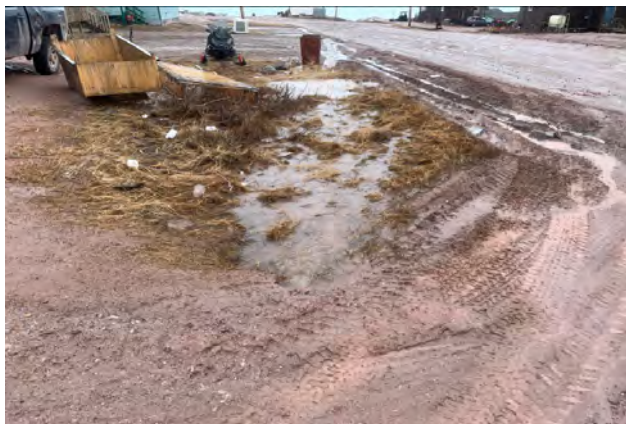
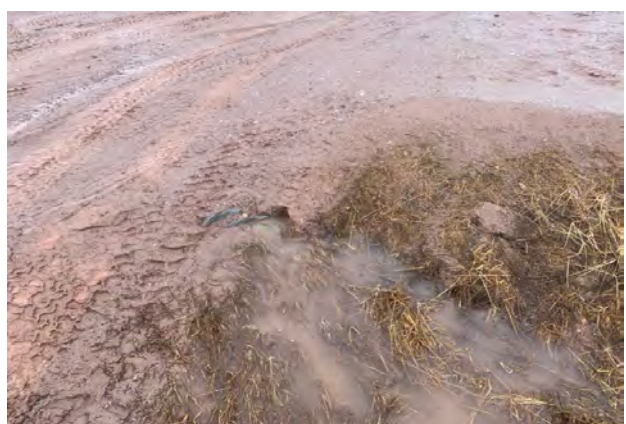
Culvert Information		
Culvert ID		120-07
Type		Entrance
Shape		Round
Material		Csp
Diameter or Dimensions (mm)		600
Marker Post Present		N
End Crushing	Upstream	Y
	Downstream	Y
Infill Depth (mm)	Upstream	200
	Downstream	400
Other		Both ends crushed and infilled
Comments

Culvert Condition Ratings (MTO 2013)				
Barrel Material (0-4)	Shape (0-4)	Capacity (0-2)	Erosion and Scour (0-2)	US/DS Channel (0-2)
0	0	2	0	2

Recommended Action(s):	Stabilize channel	Priority:	High
------------------------	-------------------	-----------	------

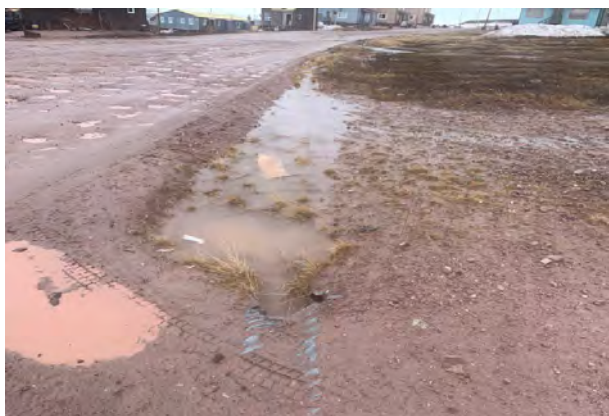
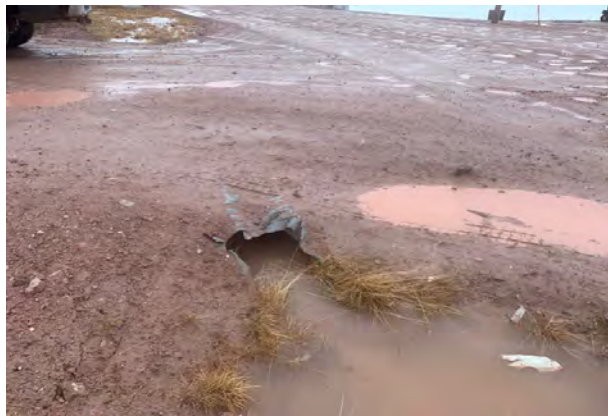
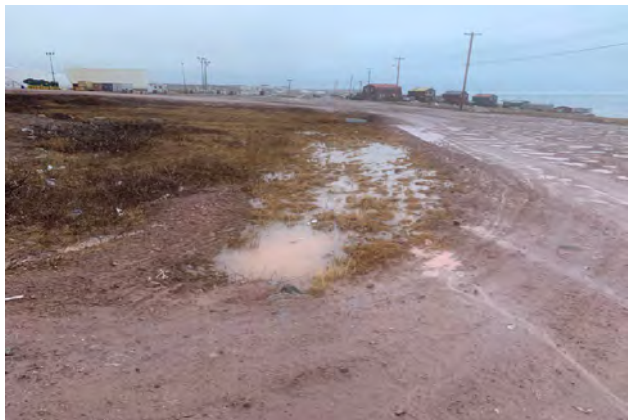
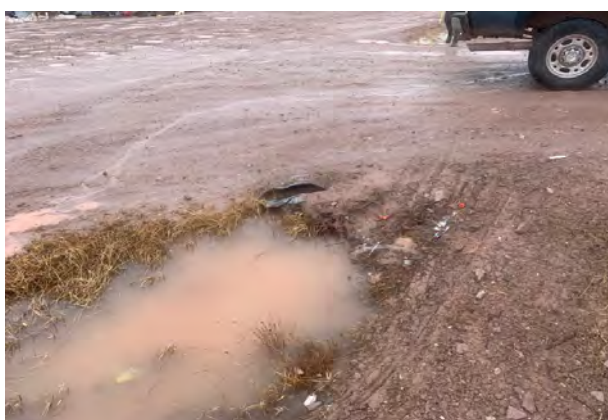
Culvert Information		
Culvert ID		120-08
Type		Entrance
Shape		Round
Material		Csp
Diameter or Dimensions (mm)		500
Marker Post Present		N
End	Upstream	Y
	Downstream	Y
Infill Depth (mm)	Upstream	200
	Downstream	300
Other		None
Comments

Culvert Condition Ratings (MTO 2013)				
Barrel Material (0-4)	Shape (0-4)	Capacity (0-2)	Erosion and Scour (0-2)	US/DS Channel (0-2)
0	0	2	1	1

Recommended Action(s):	Flush	Priority:	High
------------------------	-------	-----------	------

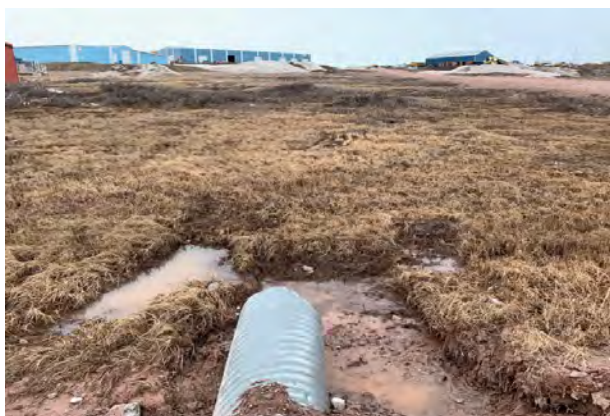
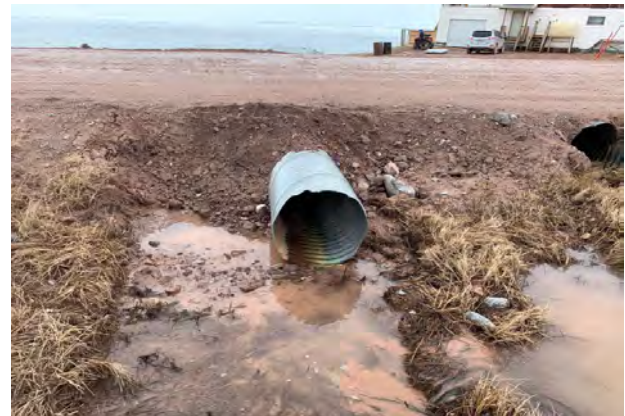
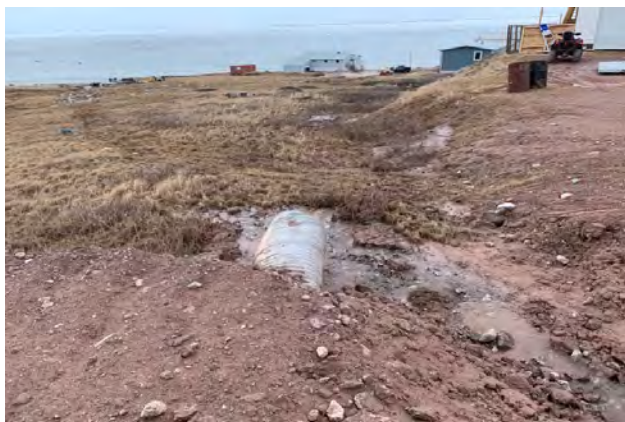
Culvert Information		
Culvert ID		120-09
Type		Cross
Shape		Round
Material		Csp
Diameter or Dimensions (mm)		600
Marker Post Present		N
End	Upstream	N
	Downstream	Y
Infill Depth (mm)	Upstream	0
	Downstream	400
Other		None
Comments

Culvert Condition Ratings (MTO 2013)				
Barrel Material (0-4)	Shape (0-4)	Capacity (0-2)	Erosion and Scour (0-2)	US/DS Channel (0-2)
1	0	2	1	0

Recommended Action(s):	Flush	Priority:	High
------------------------	-------	-----------	------

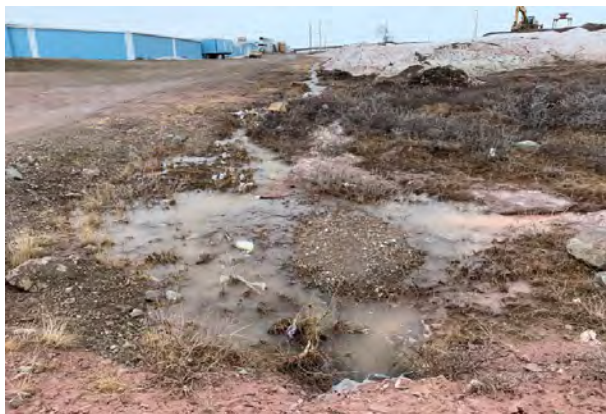
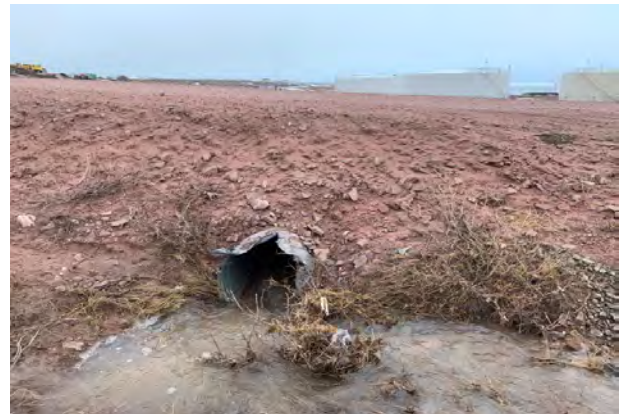
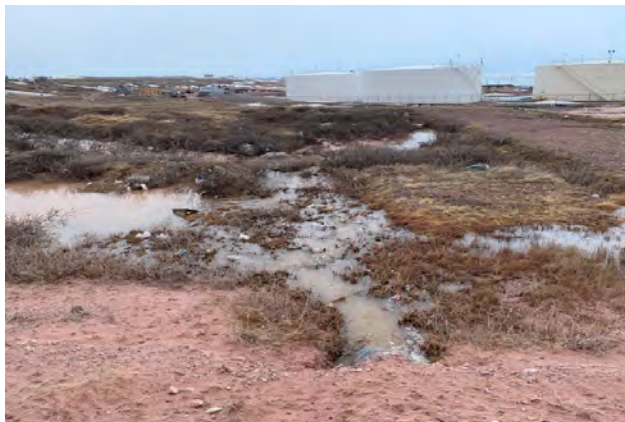
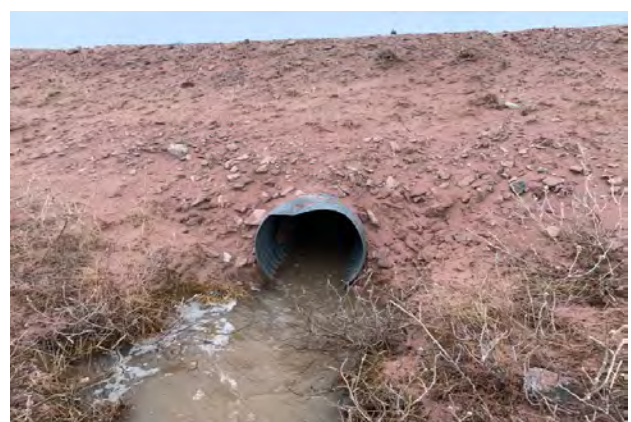
Culvert Information		
Culvert ID		120-10
Type		Cross
Shape		Round
Material		Csp
Diameter or Dimensions (mm)		600
Marker Post Present		0
End Crushing	Upstream	Y
	Downstream	N
Infill Depth (mm)	Upstream	0
	Downstream	0
Other		None
Comments

Culvert Condition Ratings (MTO 2013)				
Barrel Material (0-4)	Shape (0-4)	Capacity (0-2)	Erosion and Scour (0-2)	US/DS Channel (0-2)
0	0	0	1	1

Recommended Action(s):	No action	Priority:	Low
------------------------	-----------	-----------	-----

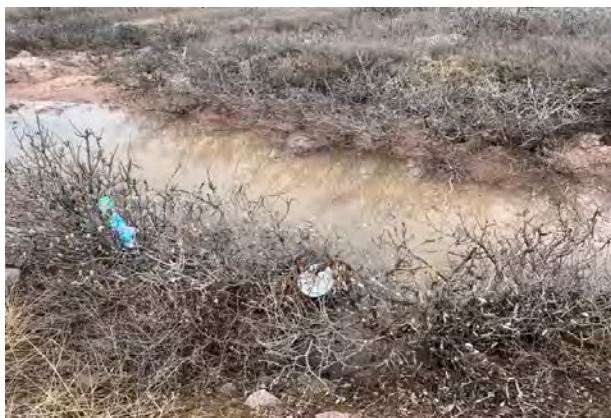
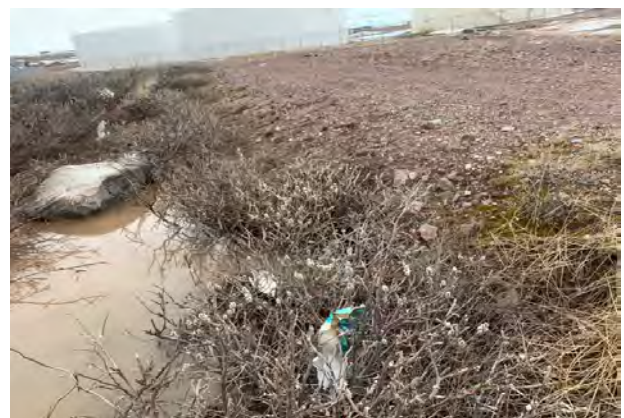
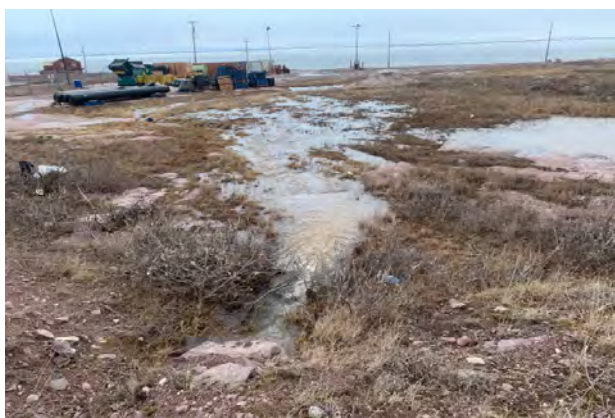
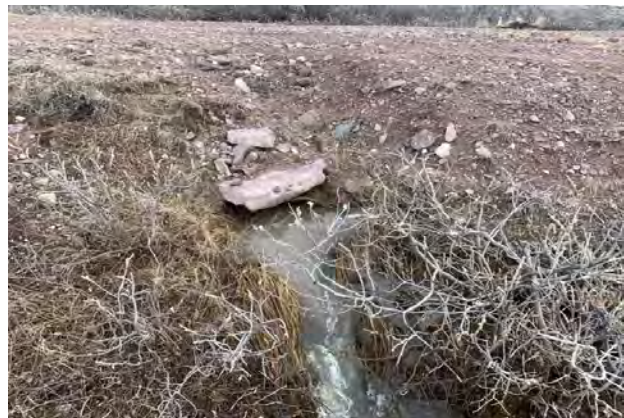
Culvert Information		
Culvert ID		120-11
Type		Cross
Shape		Round
Material		Steel
Diameter or Dimensions (mm)		500
Marker Post Present		0
End	Upstream	0
	Downstream	0
Infill Depth (mm)	Upstream	0
	Downstream	0
Other		None
Comments

Culvert Condition Ratings (MTO 2013)				
Barrel Material (0-4)	Shape (0-4)	Capacity (0-2)	Erosion and Scour (0-2)	US/DS Channel (0-2)
0	0	0	0	1

Recommended Action(s):	No action	Priority:	Low
------------------------	-----------	-----------	-----

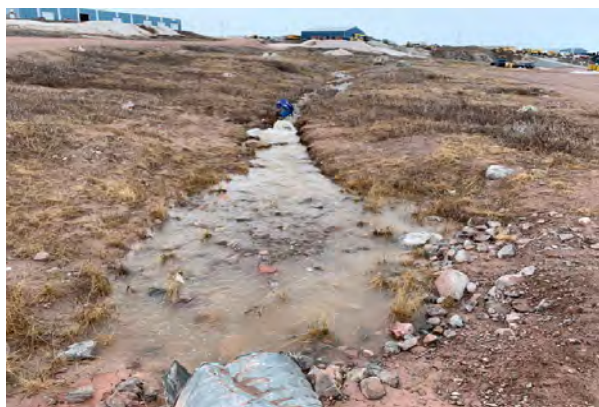
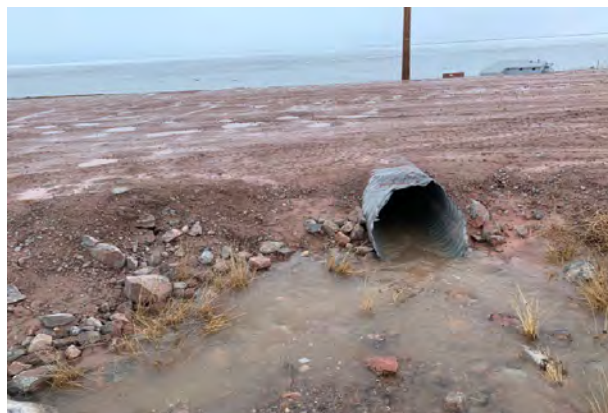
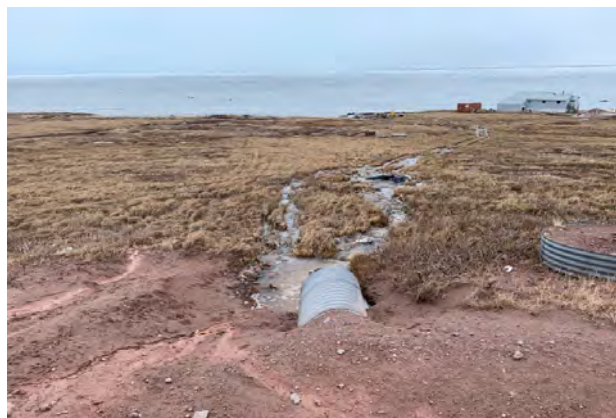
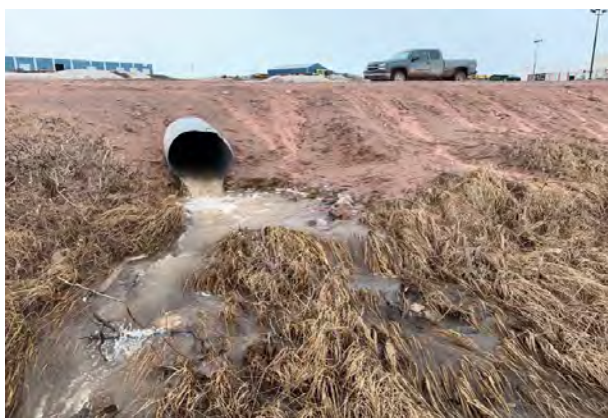
Culvert Information		
Culvert ID		120-12
Type		Cross
Shape		Round
Material		Csp
Diameter or Dimensions (mm)		600
Marker Post Present		N
End Crushing	Upstream	Y
	Downstream	N
Infill Depth (mm)	Upstream	0
	Downstream	0
Other		None
Comments

Culvert Condition Ratings (MTO 2013)				
Barrel Material (0-4)	Shape (0-4)	Capacity (0-2)	Erosion and Scour (0-2)	US/DS Channel (0-2)
0	0	0	1	1

Recommended Action(s):	No action	Priority:	Low
------------------------	-----------	-----------	-----

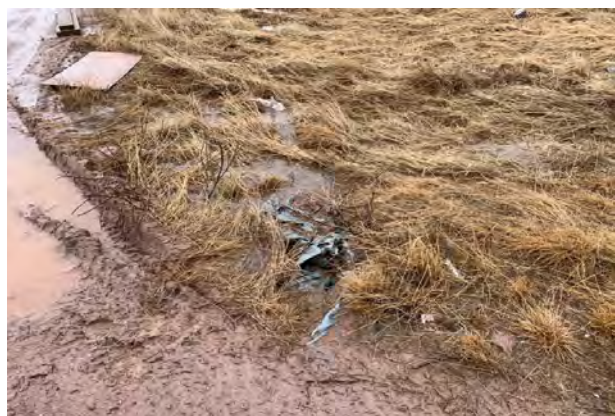
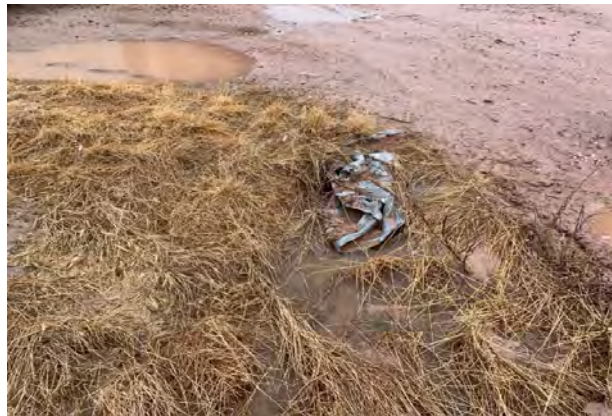
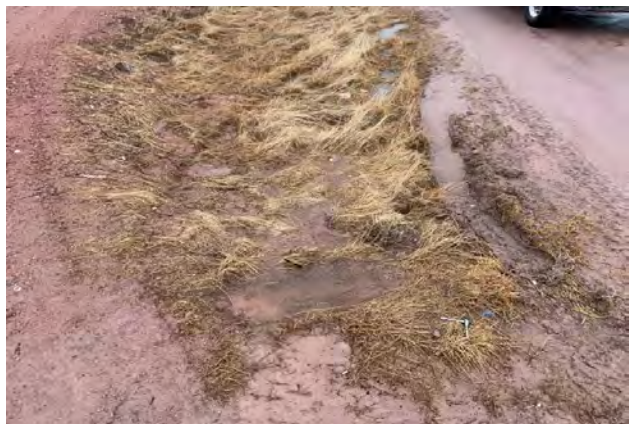
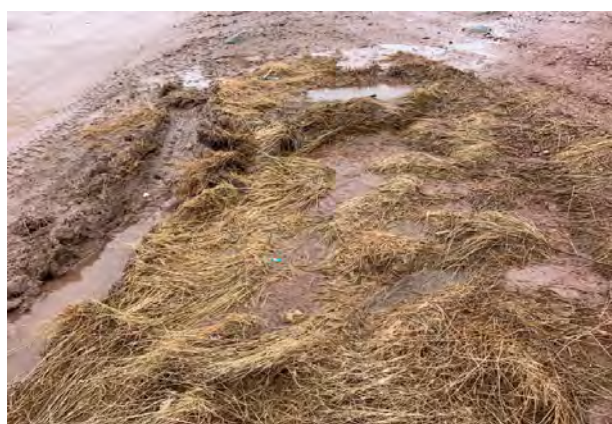
Culvert Information		
Culvert ID		120-13
Type		Entrance
Shape		Round
Material		Csp
Diameter or Dimensions (mm)		500
Marker Post Present		0
End	Upstream	Y
	Downstream	0
Crushing	Upstream	400
	Downstream	500
Infill Depth (mm)		500
Other		Both ends crushed and infilled
Comments

Culvert Condition Ratings (MTO 2013)				
Barrel Material (0-4)	Shape (0-4)	Capacity (0-2)	Erosion and Scour (0-2)	US/DS Channel (0-2)
0	3	2	0	1

Recommended Action(s):	Replace	Priority:	High
------------------------	---------	-----------	------

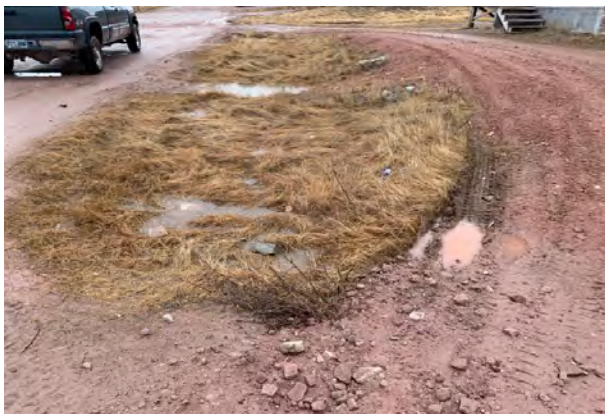
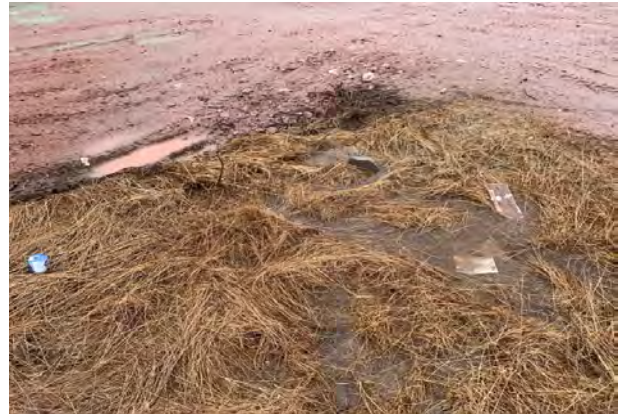
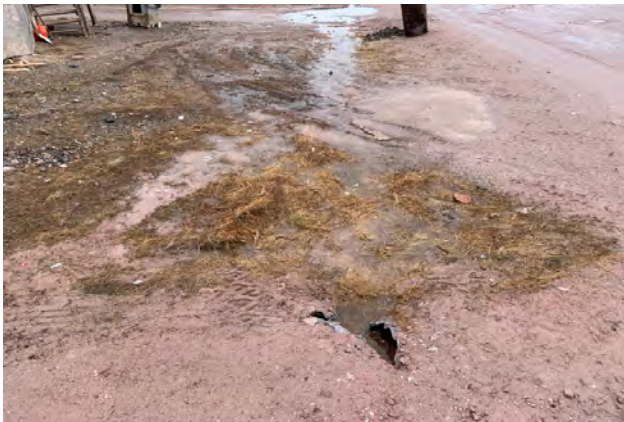
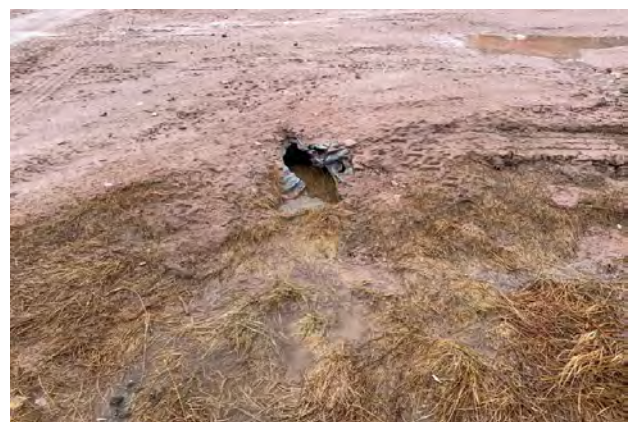
Culvert Information		
Culvert ID		120-14
Type		Entrance
Shape		Round
Material		Csp
Diameter or Dimensions (mm)		500
Marker Post Present		N
End Crushing	Upstream	0
	Downstream	Y
Infill Depth (mm)	Upstream	500
	Downstream	300
Other		Both ends crushed and infilled
Comments

Culvert Condition Ratings (MTO 2013)				
Barrel Material (0-4)	Shape (0-4)	Capacity (0-2)	Erosion and Scour (0-2)	US/DS Channel (0-2)
0	2	2	1	1

Recommended Action(s):	Replace	Priority:	High
------------------------	---------	-----------	------

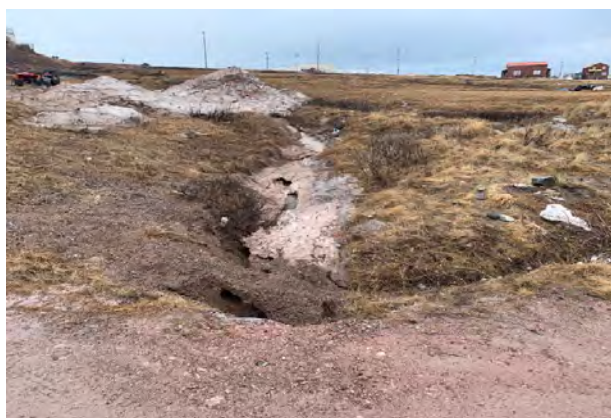
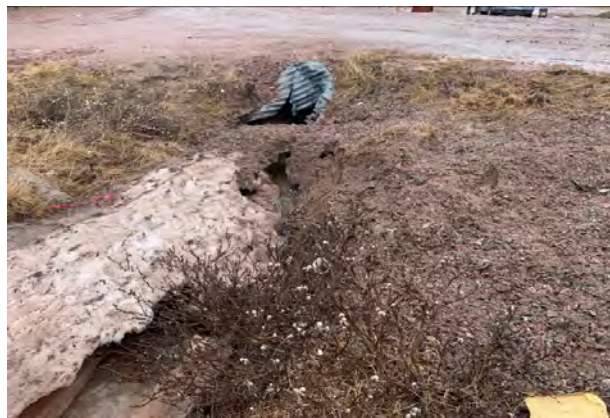
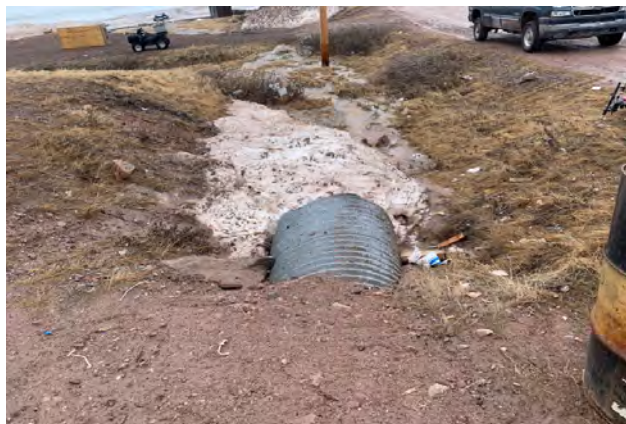
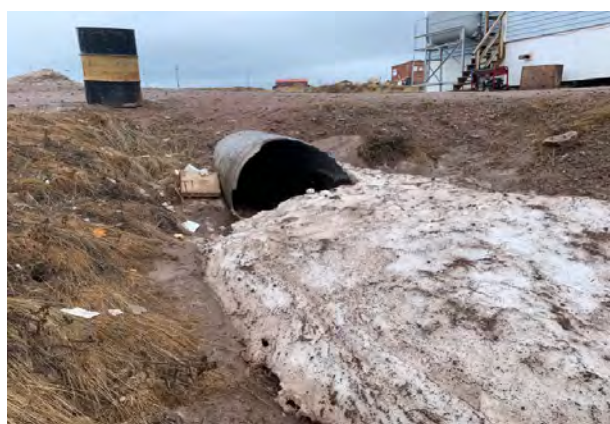
Culvert Information		
Culvert ID		120-15
Type		Entrance
Shape		Round
Material		Csp
Diameter or Dimensions (mm)		1000
Marker Post Present		N
End	Upstream	Y
	Downstream	Y
Infill Depth (mm)	Upstream	0
	Downstream	0
Other		None
Comments

Culvert Condition Ratings (MTO 2013)				
Barrel Material (0-4)	Shape (0-4)	Capacity (0-2)	Erosion and Scour (0-2)	US/DS Channel (0-2)
0	2	0	1	0

Recommended Action(s):	Repair culvert end	Priority:	Medium
------------------------	--------------------	-----------	--------

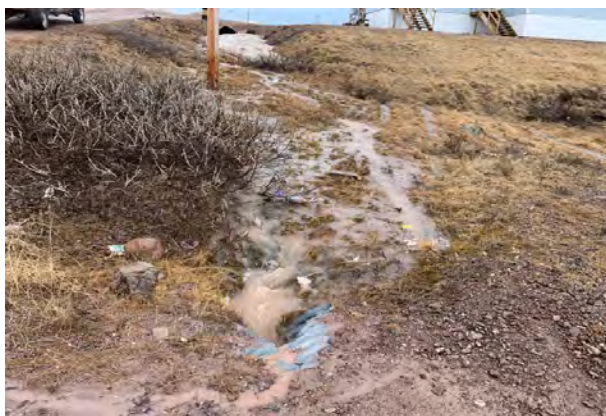
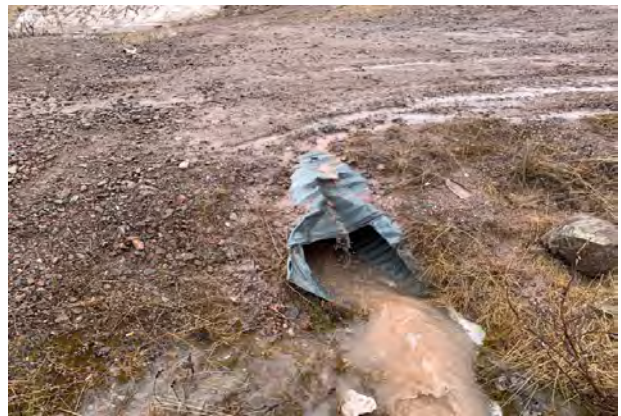
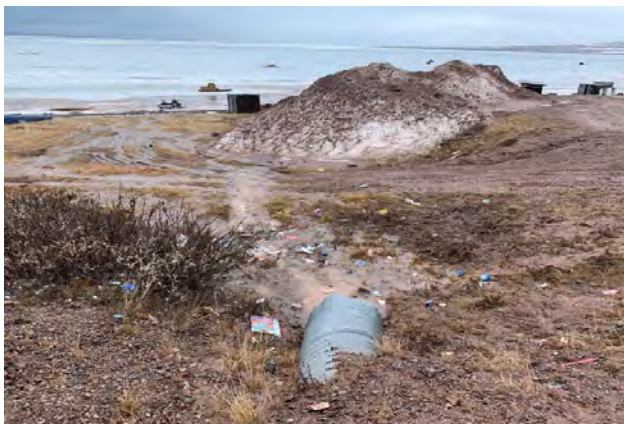
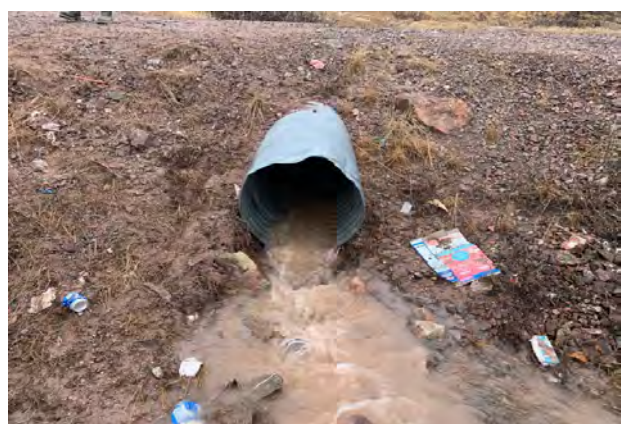
Culvert Information		
Culvert ID		120-16
Type		Entrance
Shape		Round
Material		Csp
Diameter or Dimensions (mm)		600
Marker Post Present		N
End	Upstream	Y
	Downstream	N
Crushing	Upstream	0
	Downstream	0
Infill Depth (mm)		0
Other		None
Comments

Culvert Condition Ratings (MTO 2013)				
Barrel Material (0-4)	Shape (0-4)	Capacity (0-2)	Erosion and Scour (0-2)	US/DS Channel (0-2)
0	2	0	1	0

Recommended Action(s):	Repair culvert end	Priority:	Medium
------------------------	--------------------	-----------	--------

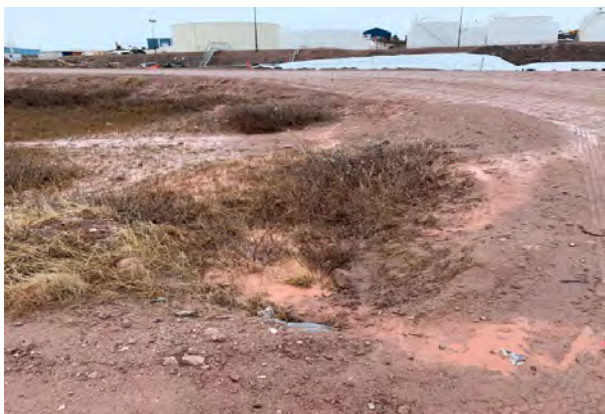
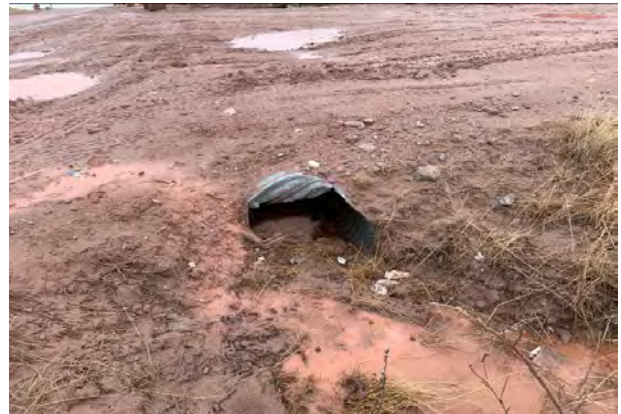
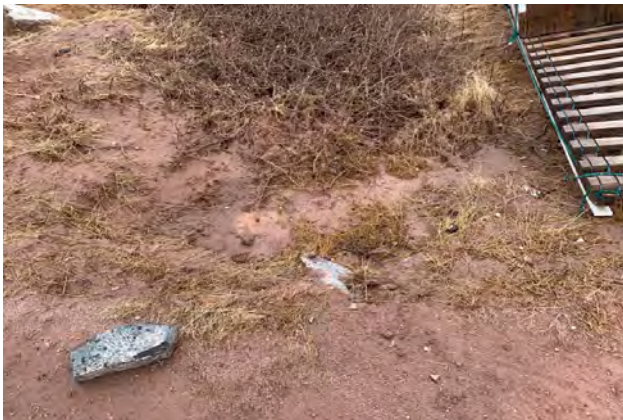
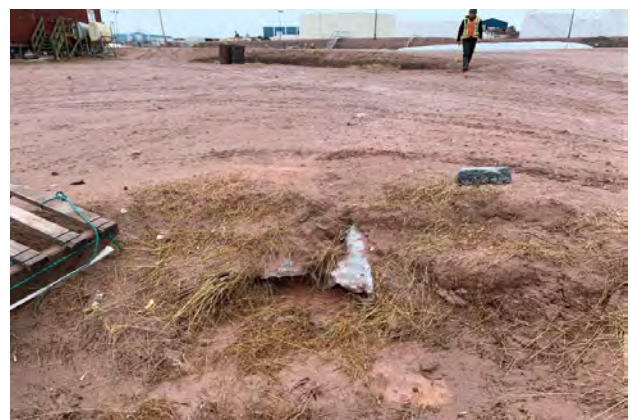
Culvert Information		
Culvert ID		121-01
Type		Entrance
Shape		Round
Material		Csp
Diameter or Dimensions (mm)		600
Marker Post Present		N
End	Upstream	Y
	Downstream	Y
Infill Depth (mm)	Upstream	300
	Downstream	300
Other		Both ends crushed and infilled
Comments

Culvert Condition Ratings (MTO 2013)				
Barrel Material (0-4)	Shape (0-4)	Capacity (0-2)	Erosion and Scour (0-2)	US/DS Channel (0-2)
0	2	2	1	1

Recommended Action(s):	Replace	Priority:	High
------------------------	---------	-----------	------

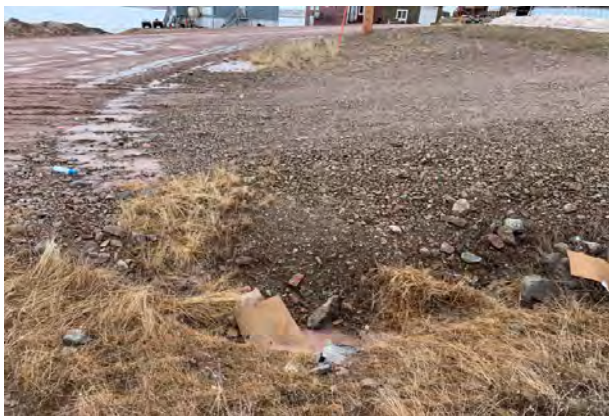
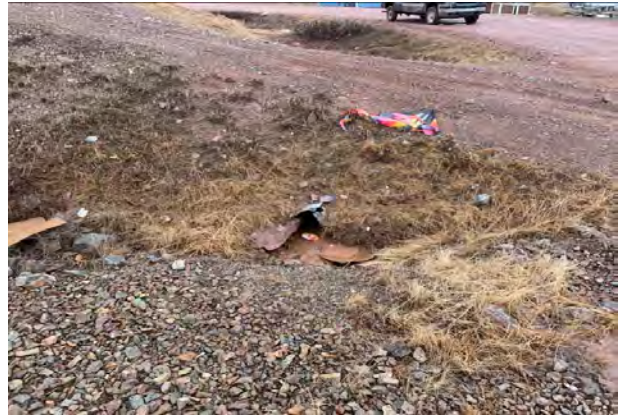
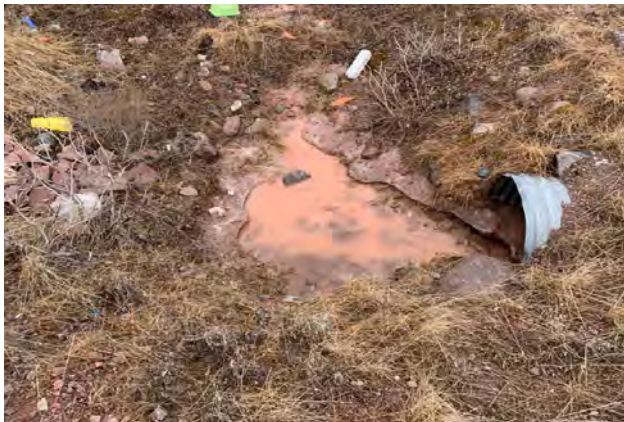
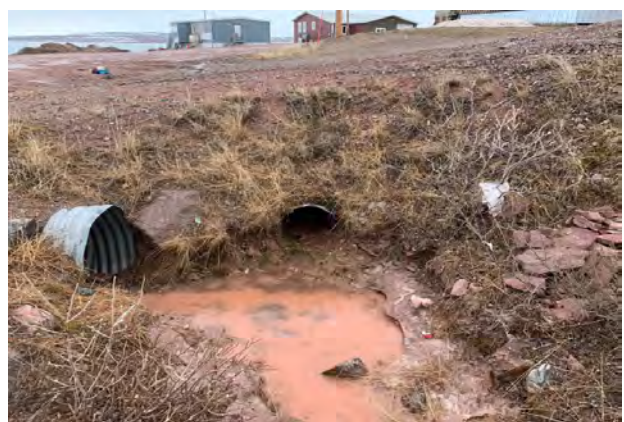
Culvert Condition Ratings (MTO 2013)				
Barrel Material (0-4)	Shape (0-4)	Capacity (0-2)	Erosion and Scour (0-2)	US/DS Channel (0-2)
0	0	0	1	2

Recommended Action(s):	Flush	Priority:	High
------------------------	-------	-----------	------

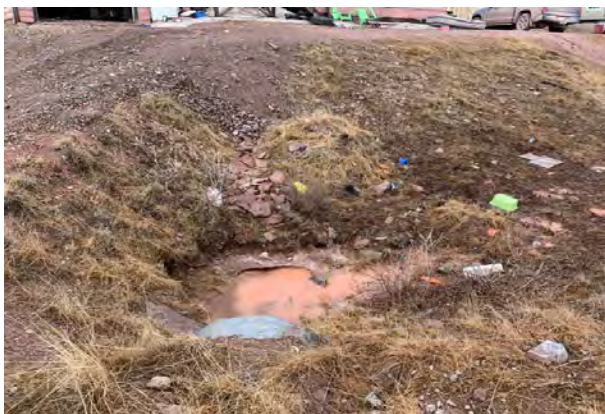
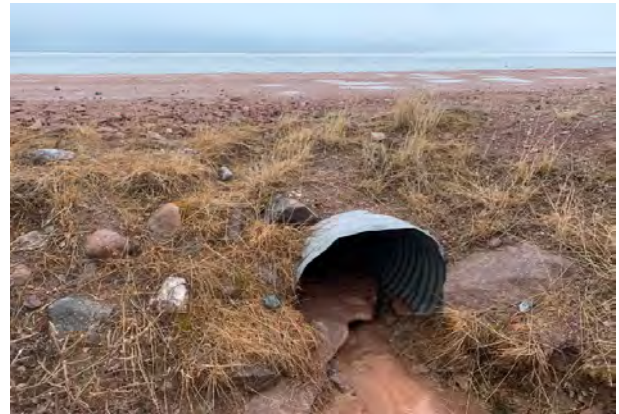
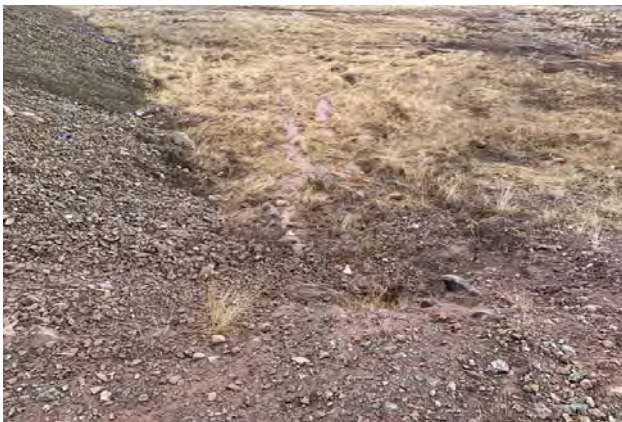
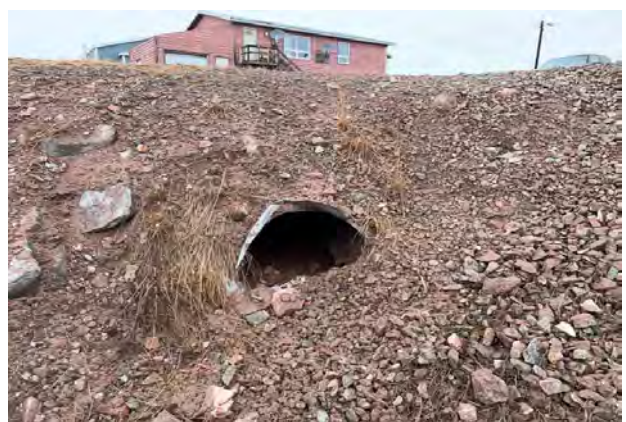
Culvert Information		
Culvert ID		121-03
Type		Cross
Shape		Round
Material		Csp
Diameter or Dimensions (mm)		750
Marker Post Present		0
End	Upstream	0
	Downstream	0
Infill Depth (mm)	Upstream	100
	Downstream	300
Other		None
Comments

Culvert Condition Ratings (MTO 2013)				
Barrel Material (0-4)	Shape (0-4)	Capacity (0-2)	Erosion and Scour (0-2)	US/DS Channel (0-2)
0	0	2	1	1

Recommended Action(s):	Flush	Priority:	High
------------------------	-------	-----------	------

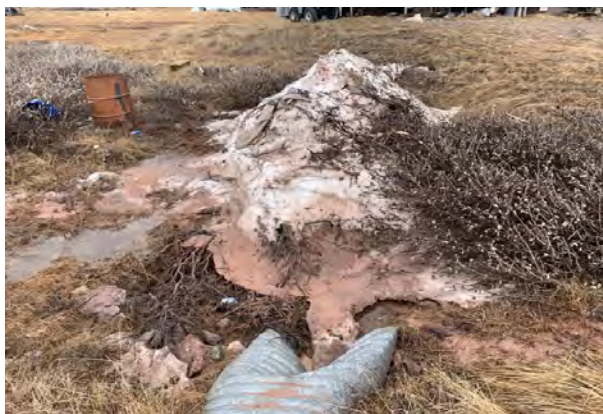
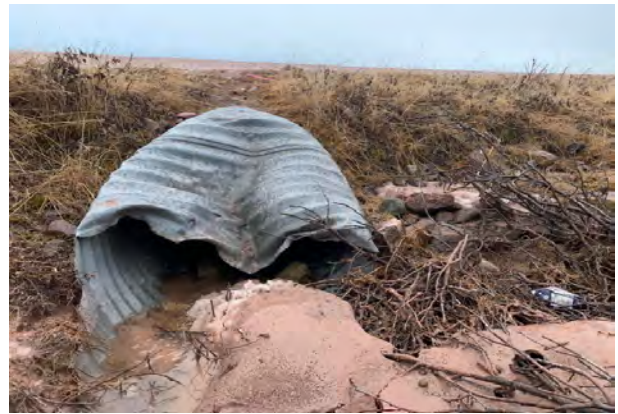
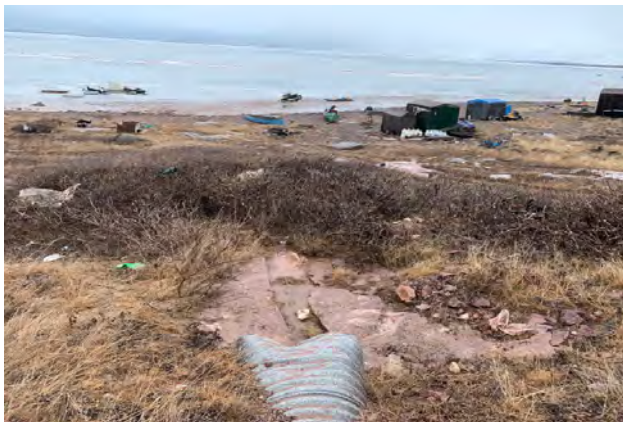
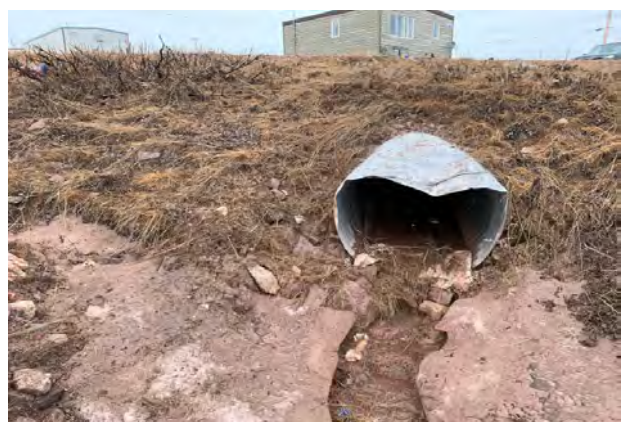
Culvert Information		
Culvert ID		122-01
Type		Cross
Shape		Round
Material		Csp
Diameter or Dimensions (mm)		700
Marker Post Present		N
End	Upstream	Y
	Downstream	Y
Infill Depth (mm)	Upstream	0
	Downstream	0
Other		None
Comments

Culvert Condition Ratings (MTO 2013)				
Barrel Material (0-4)	Shape (0-4)	Capacity (0-2)	Erosion and Scour (0-2)	US/DS Channel (0-2)
0	2	0	1	0

Recommended Action(s):	Repair both ends of culvert	Priority:	Medium
------------------------	-----------------------------	-----------	--------

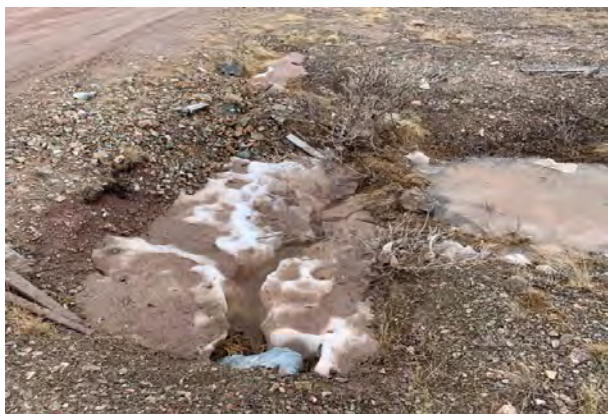
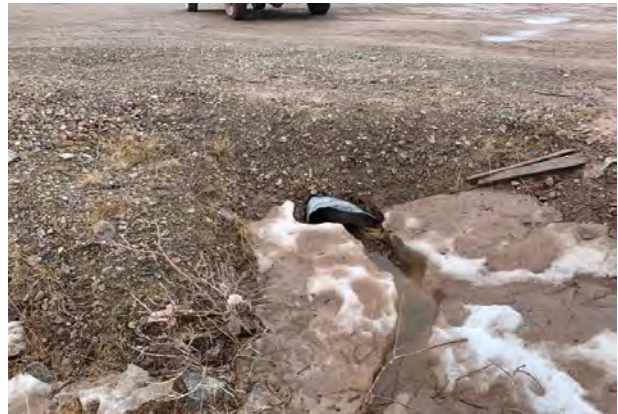
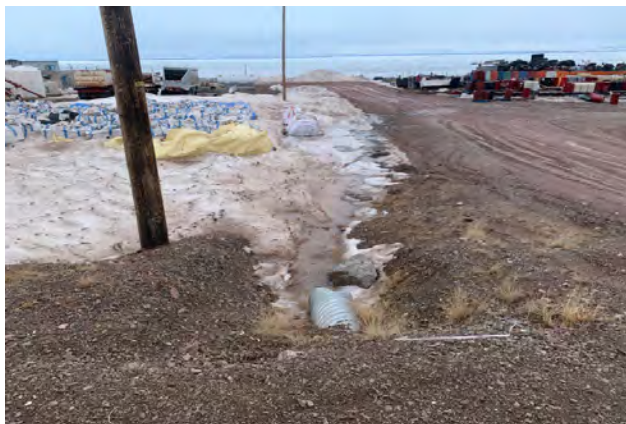
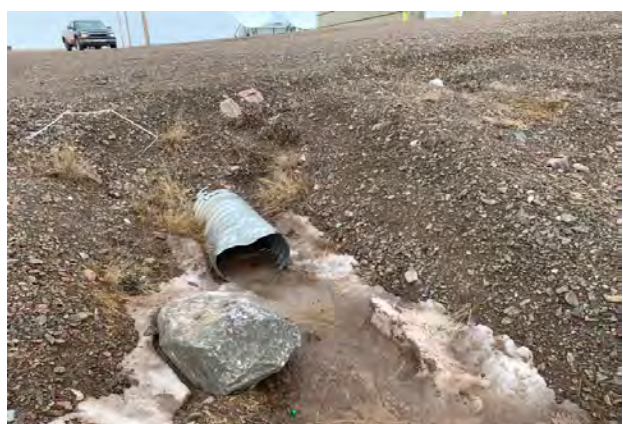
Culvert Information		
Culvert ID		123-01
Type		Entrance
Shape		Round
Material		Csp
Diameter or Dimensions (mm)		400
Marker Post Present		N
End Crushing	Upstream	Y
	Downstream	Y
Infill Depth (mm)	Upstream	200
	Downstream	0
Other		None
Comments

Culvert Condition Ratings (MTO 2013)				
Barrel Material (0-4)	Shape (0-4)	Capacity (0-2)	Erosion and Scour (0-2)	US/DS Channel (0-2)
0	0	2	0	1

Recommended Action(s):	Flush	Priority:	High
------------------------	-------	-----------	------

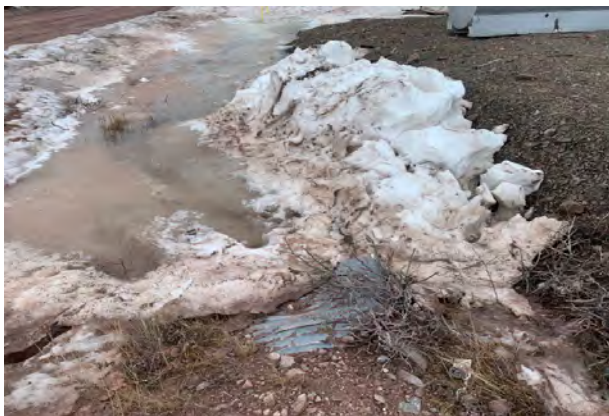
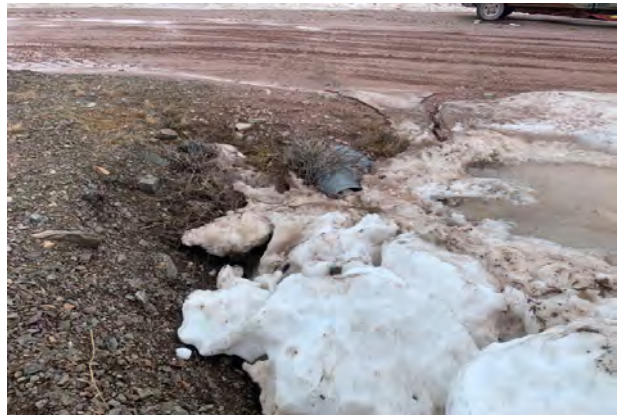
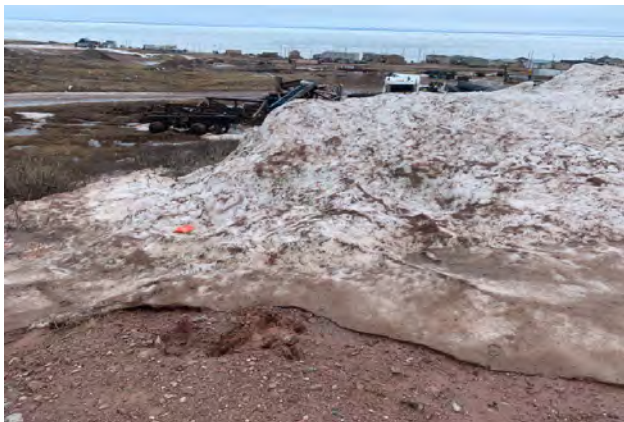
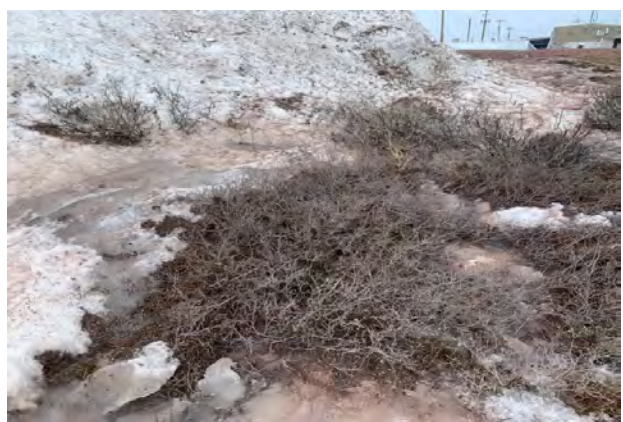
Culvert Information		
Culvert ID		123-02
Type		Cross
Shape		Round
Material		Csp
Diameter or Dimensions (mm)		700
Marker Post Present		N
End	Upstream	Y
	Downstream	0
Crushing	Upstream	0
	Downstream	0
Infill Depth (mm)	Upstream	0
	Downstream	0
Other		None
Comments

Culvert Condition Ratings (MTO 2013)				
Barrel Material (0-4)	Shape (0-4)	Capacity (0-2)	Erosion and Scour (0-2)	US/DS Channel (0-2)
0	0	0	1	0

Recommended Action(s):	No action	Priority:	Low
------------------------	-----------	-----------	-----

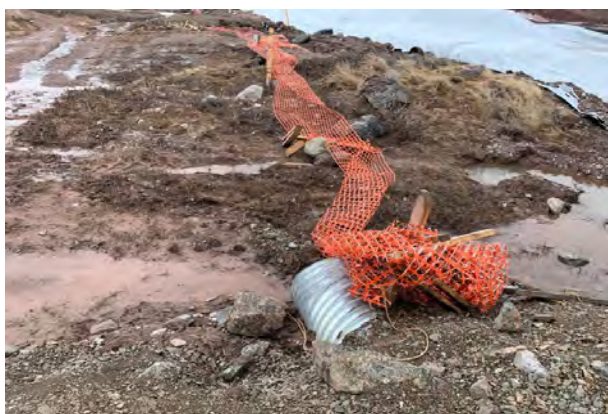
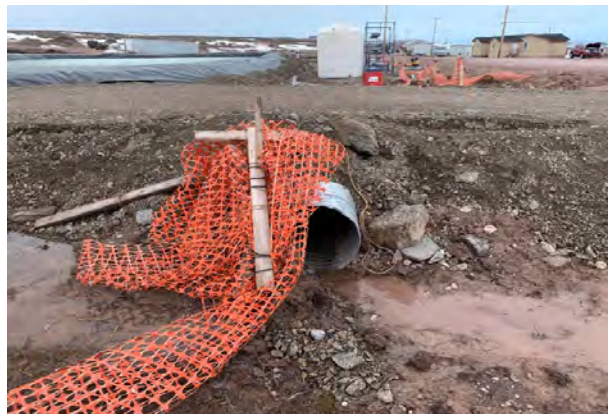
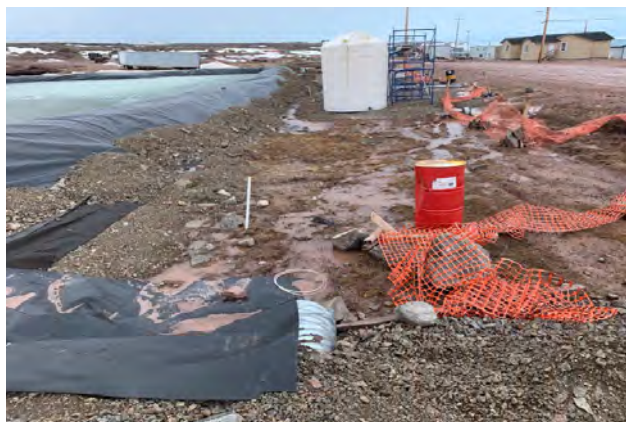
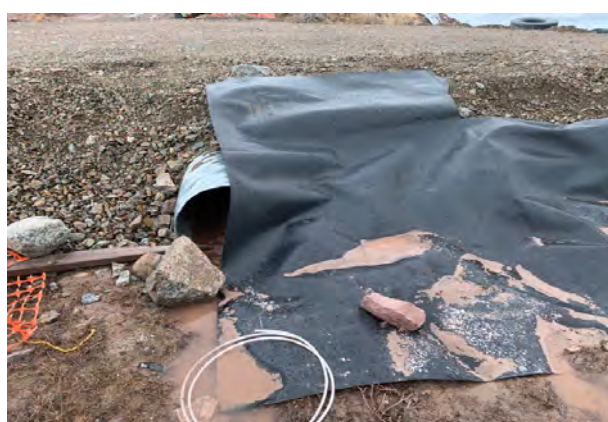
Culvert Information		
Culvert ID		123-03
Type		Entrance
Shape		Round
Material		Csp
Diameter or Dimensions (mm)		500
Marker Post Present		N
End	Upstream	N
	Downstream	N
Infill Depth (mm)	Upstream	0
	Downstream	0
Other		None
Comments

Culvert Condition Ratings (MTO 2013)				
Barrel Material (0-4)	Shape (0-4)	Capacity (0-2)	Erosion and Scour (0-2)	US/DS Channel (0-2)
0	0	0	1	1

Recommended Action(s):	No action	Priority:	Low
------------------------	-----------	-----------	-----
