# **Geotechnical Evaluation and Drainage Planning in Baker Lake, Nunavut**

*Final Report Rev-00*

**The Municipality of Baker Lake, Nunavut**

**Nunami Stantec Limited**

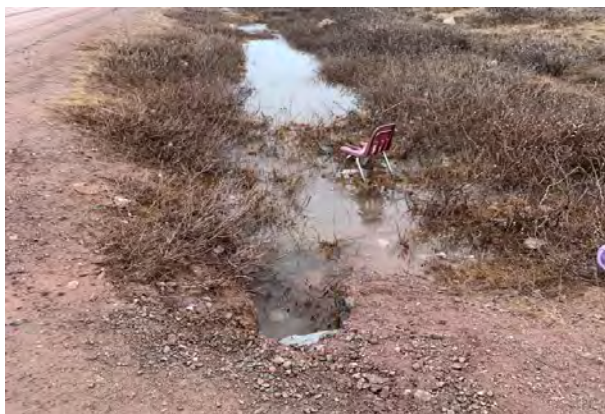
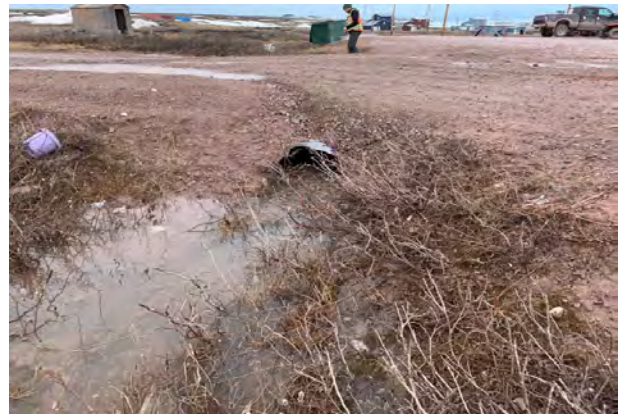
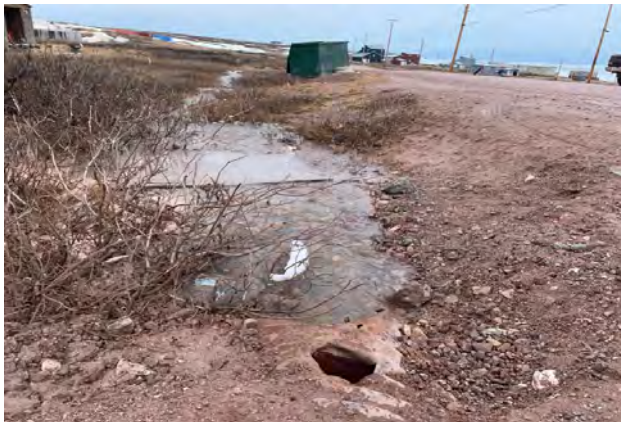
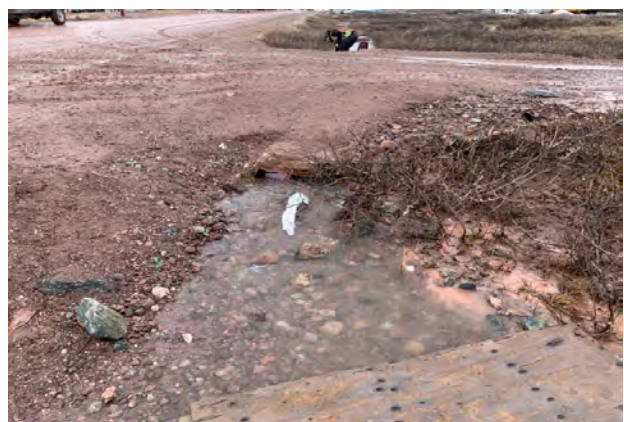
Culvert Information		
Culvert ID		123-04
Type		Entrance
Shape		Round
Material		Csp
Diameter or Dimensions (mm)		600
Marker Post Present		N
End	Upstream	Y
	Downstream	Y
Infill Depth (mm)	Upstream	0
	Downstream	0
Other		None
Comments

Culvert Condition Ratings (MTO 2013)				
Barrel Material (0-4)	Shape (0-4)	Capacity (0-2)	Erosion and Scour (0-2)	US/DS Channel (0-2)
2	2	0	1	0

Recommended Action(s):	Repair both ends of culvert	Priority:	Medium
------------------------	-----------------------------	-----------	--------

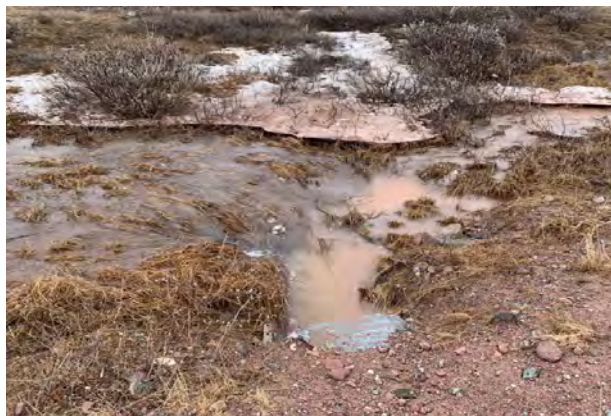
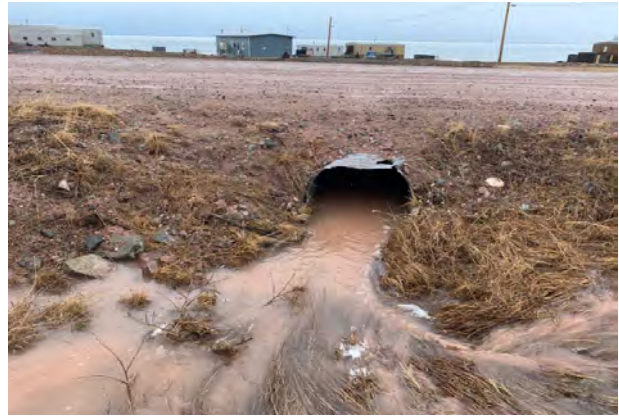
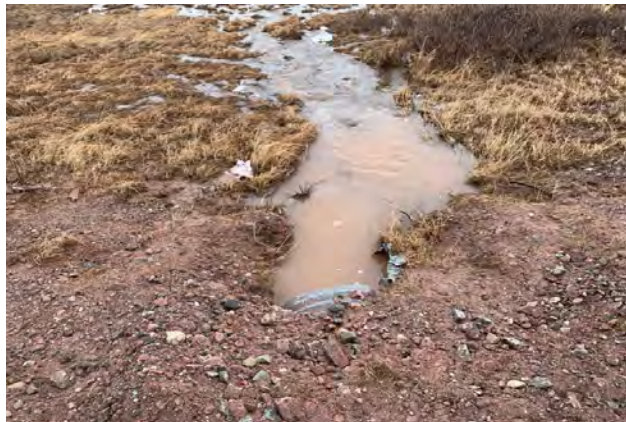
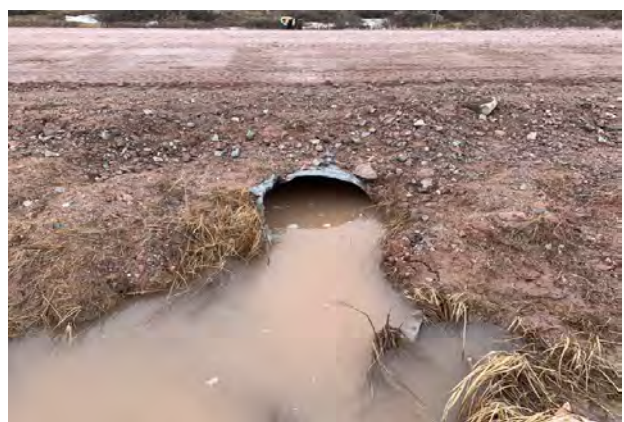
Culvert Information		
Culvert ID		123-05
Type		Cross
Shape		Round
Material		Csp
Diameter or Dimensions (mm)		750
Marker Post Present		0
End Crushing	Upstream	Y
	Downstream	Y
Infill Depth (mm)	Upstream	100
	Downstream	200
Other		None
Comments

Culvert Condition Ratings (MTO 2013)				
Barrel Material (0-4)	Shape (0-4)	Capacity (0-2)	Erosion and Scour (0-2)	US/DS Channel (0-2)
0	0	1	1	0

Recommended Action(s):	Flush	Priority:	Medium
------------------------	-------	-----------	--------

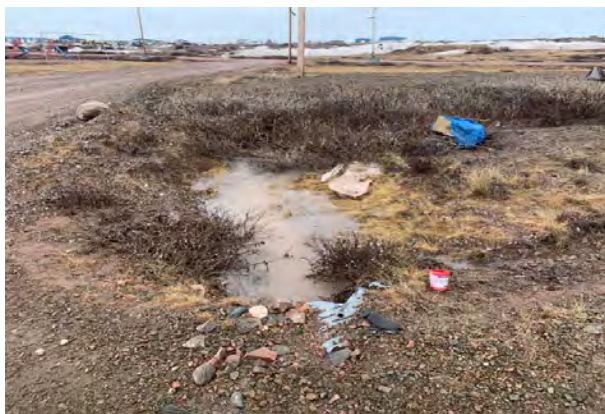
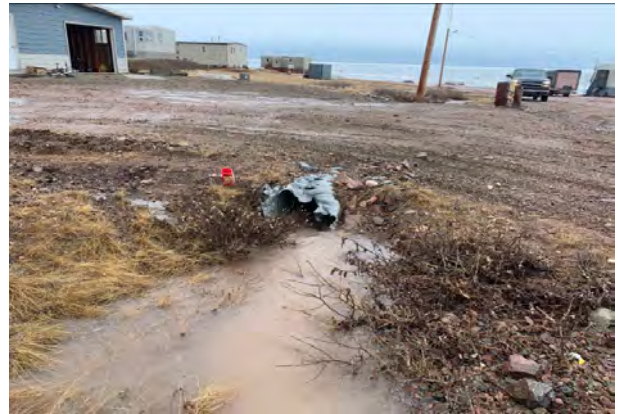
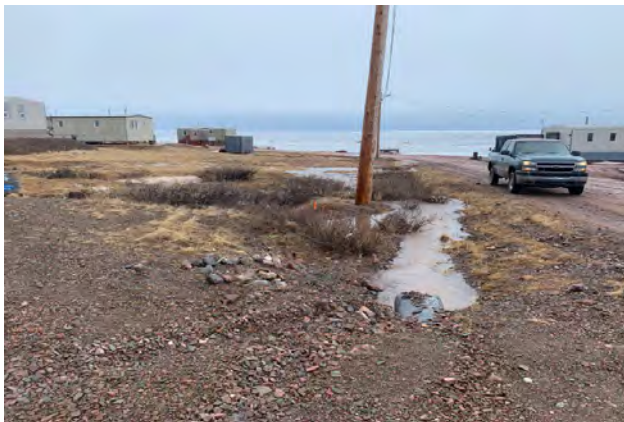
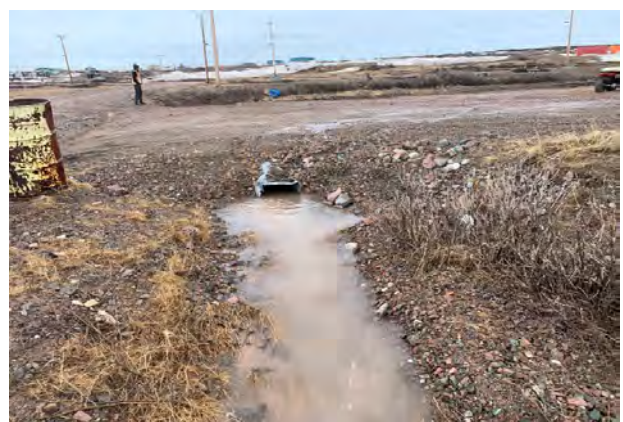
Culvert Condition Ratings (MTO 2013)				
Barrel Material (0-4)	Shape (0-4)	Capacity (0-2)	Erosion and Scour (0-2)	US/DS Channel (0-2)
0	2	0	1	0

Recommended Action(s):	Repair both ends of culvert	Priority:	Medium
------------------------	-----------------------------	-----------	--------

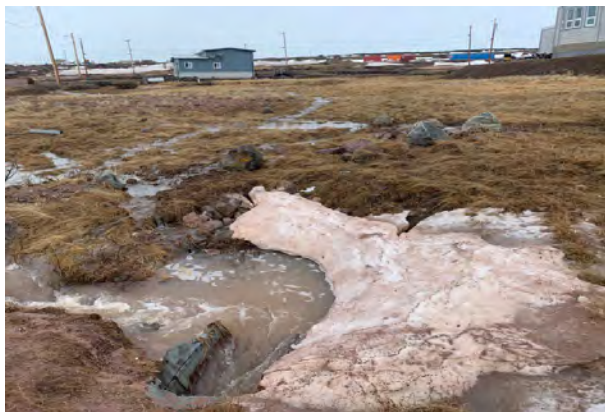
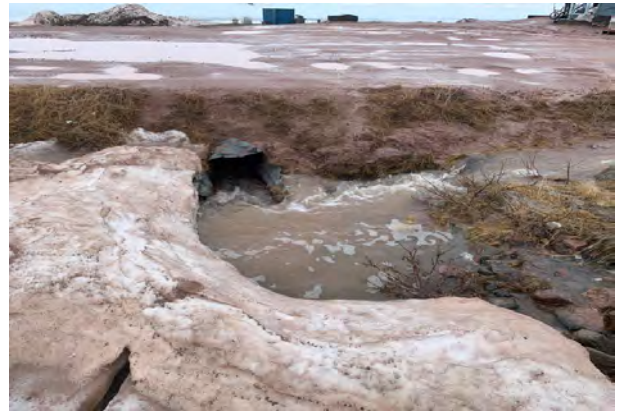
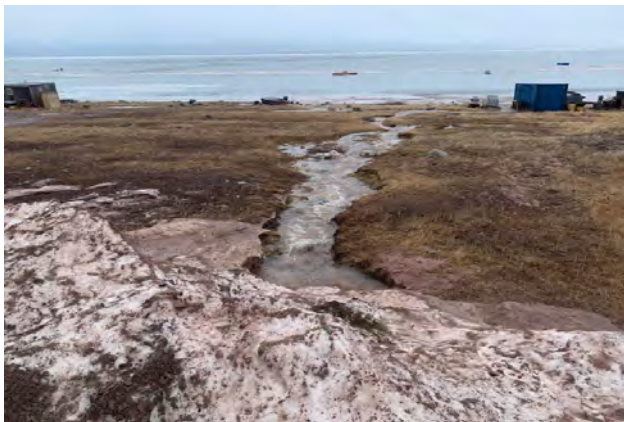
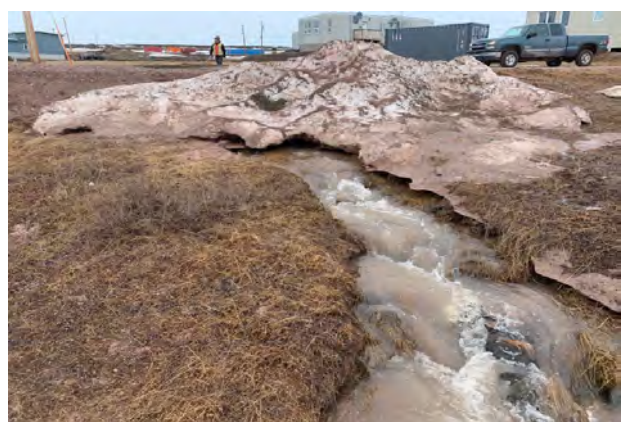
Culvert Information		
Culvert ID		123-07
Type		Cross
Shape		Circular
Material		Csp
Diameter or Dimensions (mm)		600
Marker Post Present		N
End	Upstream	Y
	Downstream	0
Infill Depth (mm)	Upstream	0
	Downstream	0
Other		None
Comments

Culvert Condition Ratings (MTO 2013)				
Barrel Material (0-4)	Shape (0-4)	Capacity (0-2)	Erosion and Scour (0-2)	US/DS Channel (0-2)
0	0	0	1	1

Recommended Action(s):	No action	Priority:	Low
------------------------	-----------	-----------	-----

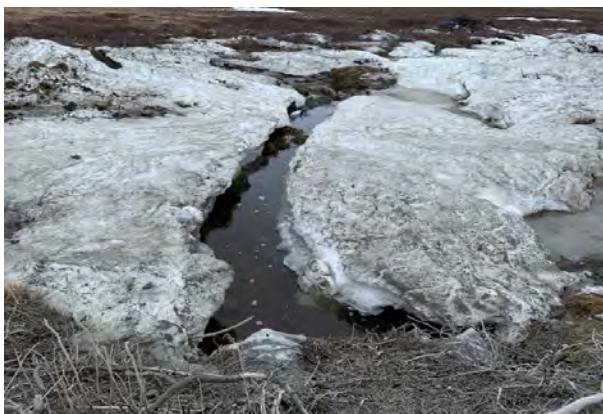
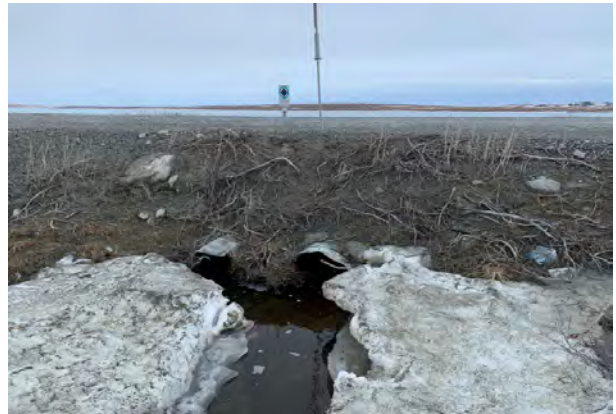
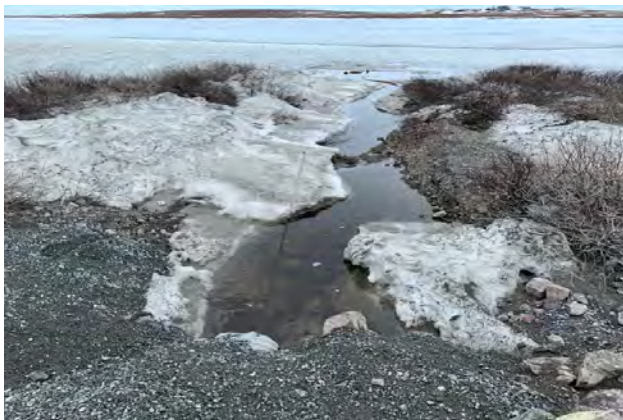
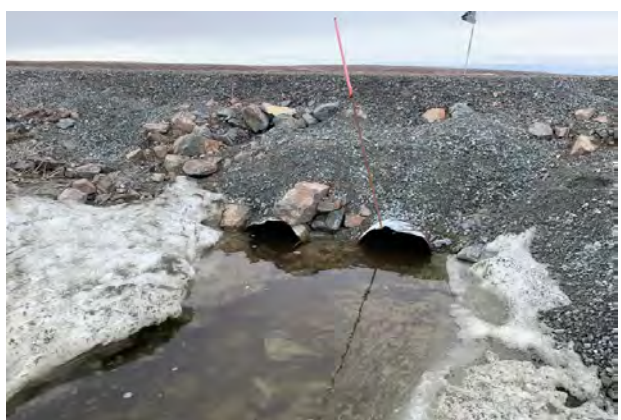
Culvert Information		
Culvert ID		124-01
Type		Cross
Shape		Round
Material		Csp
Diameter or Dimensions (mm)		600
Marker Post Present		Y
End	Upstream	Y
	Downstream	Y
Infill Depth (mm)	Upstream	0
	Downstream	100
Other		None
Comments

Culvert Condition Ratings (MTO 2013)				
Barrel Material (0-4)	Shape (0-4)	Capacity (0-2)	Erosion and Scour (0-2)	US/DS Channel (0-2)
0	0	1	1	0

Recommended Action(s):	Flush	Priority:	Medium
------------------------	-------	-----------	--------

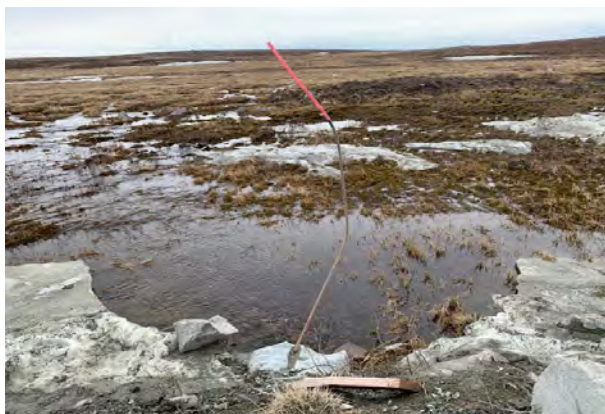
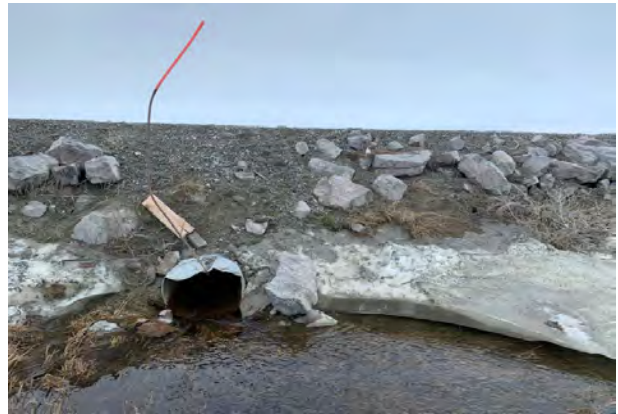
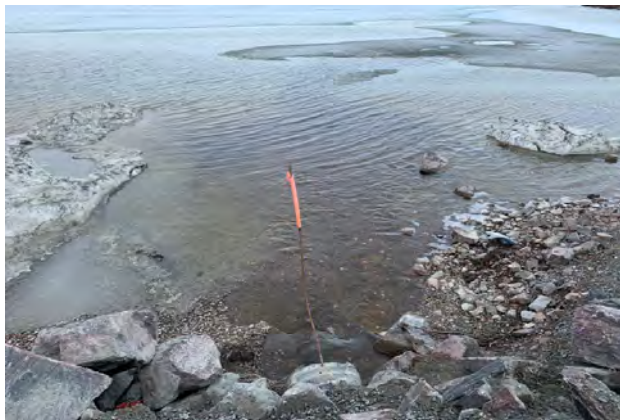
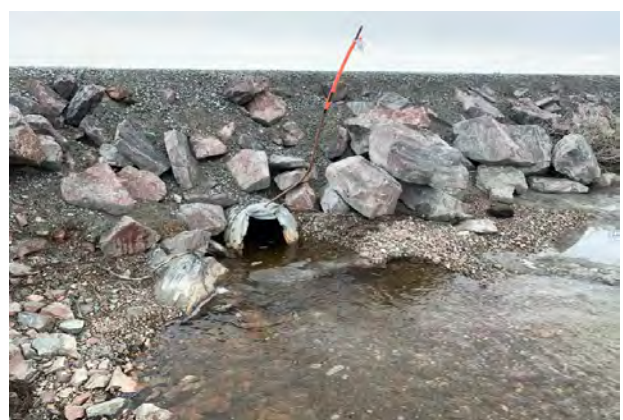
Culvert Information		
Culvert ID		124-02
Type		Cross
Shape		Round
Material		Csp
Diameter or Dimensions (mm)		600
Marker Post Present		Y
End Crushing	Upstream	Y
	Downstream	Y
Infill Depth (mm)	Upstream	0
	Downstream	100
Other		None
Comments

Culvert Condition Ratings (MTO 2013)				
Barrel Material (0-4)	Shape (0-4)	Capacity (0-2)	Erosion and Scour (0-2)	US/DS Channel (0-2)
0	0	1	1	0

Recommended Action(s):	Flush	Priority:	Medium
------------------------	-------	-----------	--------

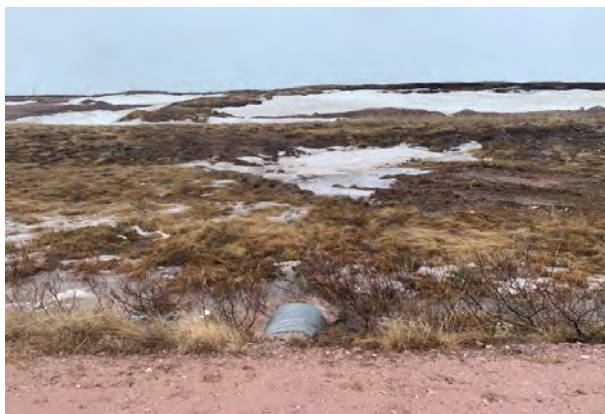
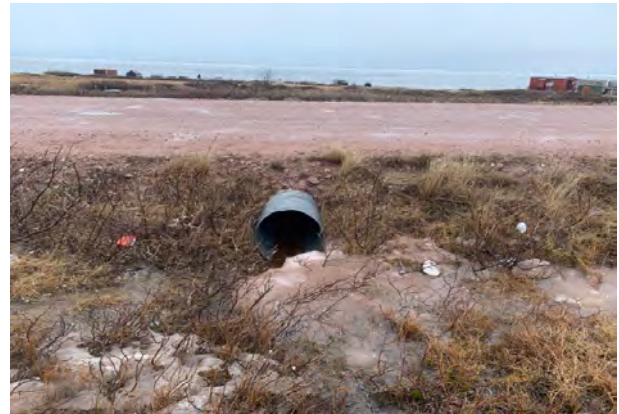
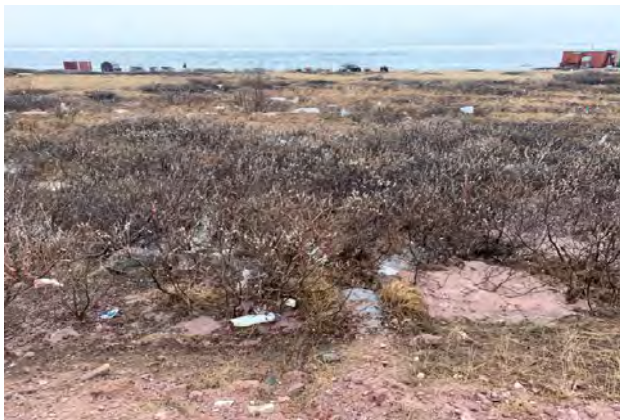
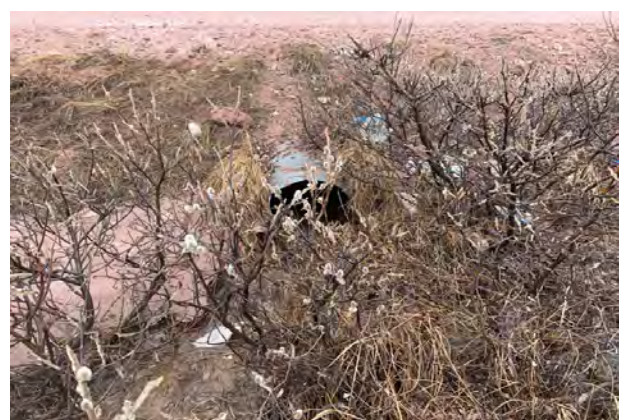
Culvert Information		
Culvert ID		125-01
Type		Cross
Shape		Round
Material		Csp
Diameter or Dimensions (mm)		500
Marker Post Present		N
End Crushing	Upstream	N
	Downstream	N
Infill Depth (mm)	Upstream	0
	Downstream	150
Other Comments	None

Culvert Condition Ratings (MTO 2013)				
Barrel Material (0-4)	Shape (0-4)	Capacity (0-2)	Erosion and Scour (0-2)	US/DS Channel (0-2)
1	0	2	1	1

Recommended Action(s):	Flush	Priority:	High
------------------------	-------	-----------	------

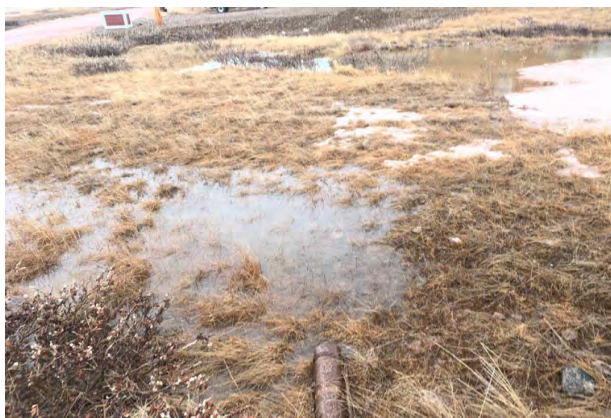
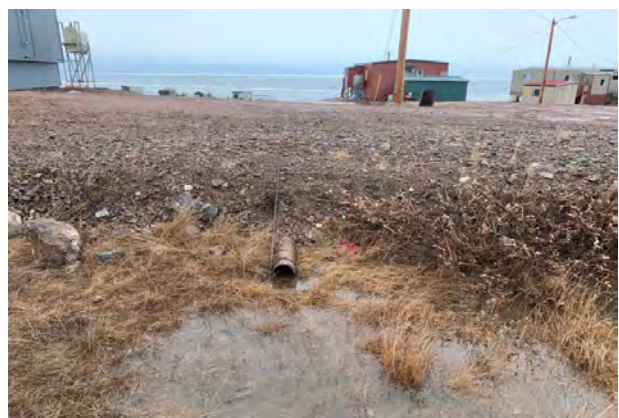
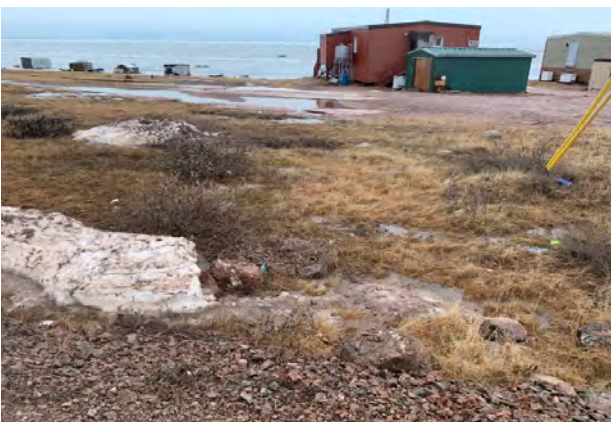
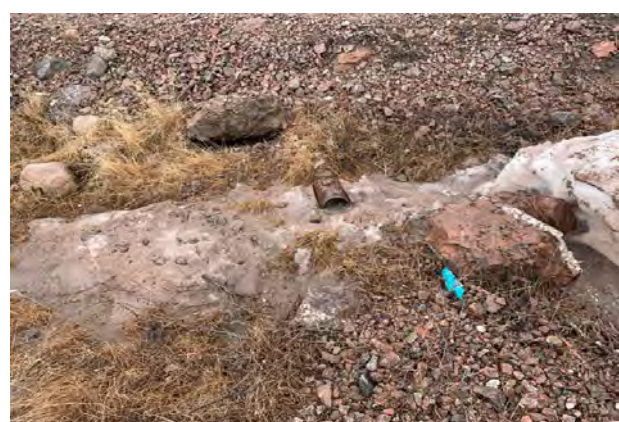
Culvert Information		
Culvert ID		125-02
Type		Entrance
Shape		Circular
Material		Steel
Diameter or Dimensions (mm)		140
Marker Post Present		N
End	Upstream	N
	Downstream	N
Infill Depth (mm)	Upstream	0
	Downstream	0
Other		None
Comments

Culvert Condition Ratings (MTO 2013)				
Barrel Material (0-4)	Shape (0-4)	Capacity (0-2)	Erosion and Scour (0-2)	US/DS Channel (0-2)
1	0	0	1	0

Recommended Action(s):	No action	Priority:	Low
------------------------	-----------	-----------	-----

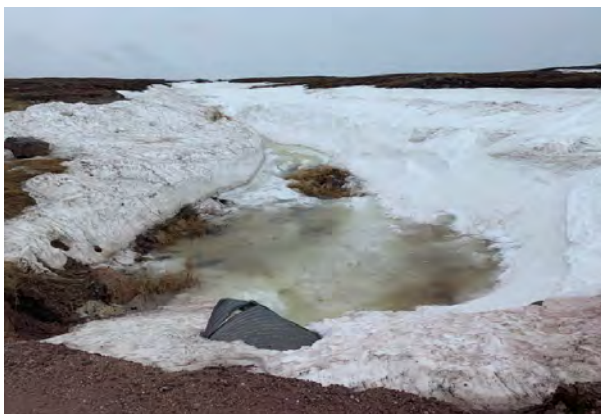
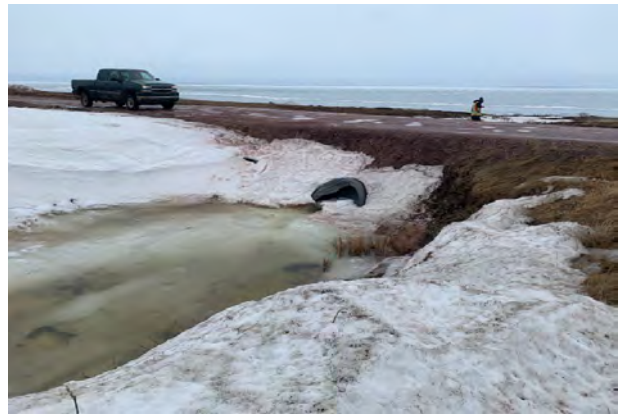
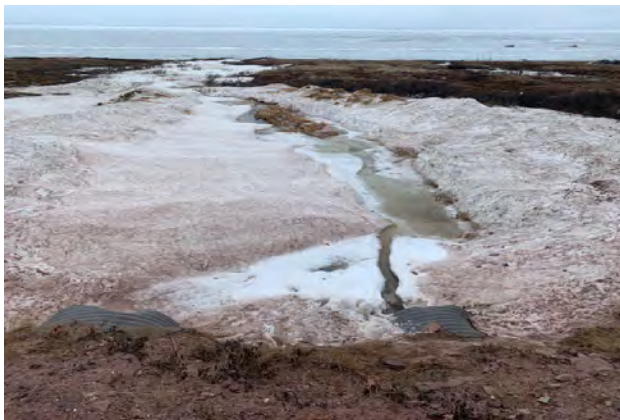
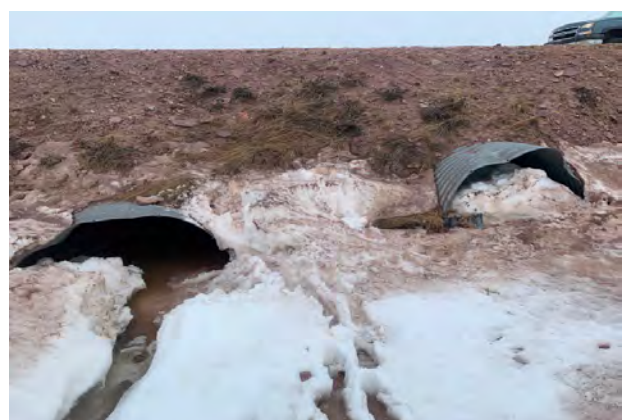
Culvert Information		
Culvert ID		126-01
Type		Cross
Shape		Round
Material		Csp
Diameter or Dimensions (mm)		1500
Marker Post Present		N
End Crushing	Upstream	Y
	Downstream	Y
Infill Depth (mm)	Upstream	0
	Downstream	0
Other		None
Comments

Culvert Condition Ratings (MTO 2013)				
Barrel Material (0-4)	Shape (0-4)	Capacity (0-2)	Erosion and Scour (0-2)	US/DS Channel (0-2)
0	0	0	1	0

Recommended Action(s):	No action	Priority:	Low
------------------------	-----------	-----------	-----

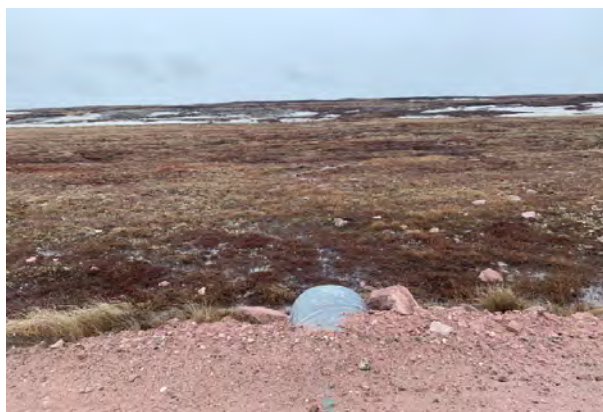
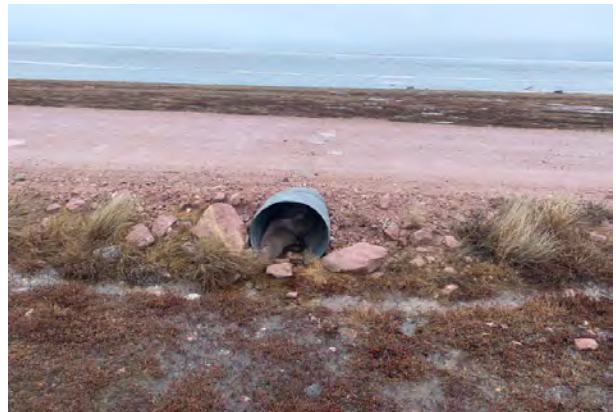
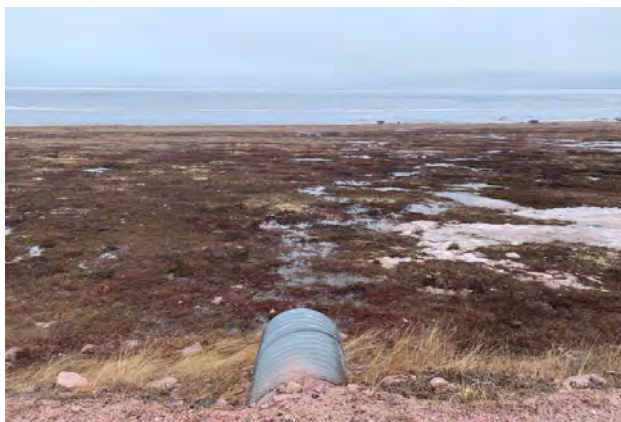
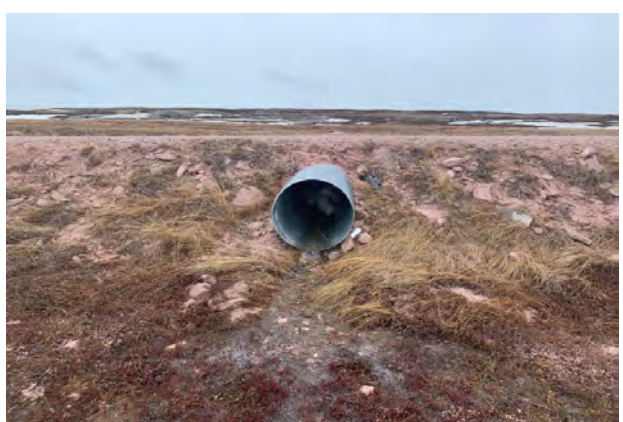
Culvert Information		
Culvert ID		127-01
Type		Cross
Shape		Round
Material		Csp
Diameter or Dimensions (mm)		600
Marker Post Present		N
End	Upstream	N
	Downstream	N
Infill Depth (mm)	Upstream	0
	Downstream	0
Other		None
Comments

Culvert Condition Ratings (MTO 2013)				
Barrel Material (0-4)	Shape (0-4)	Capacity (0-2)	Erosion and Scour (0-2)	US/DS Channel (0-2)
0	0	0	0	0

Recommended Action(s):	No action	Priority:	None
------------------------	-----------	-----------	------

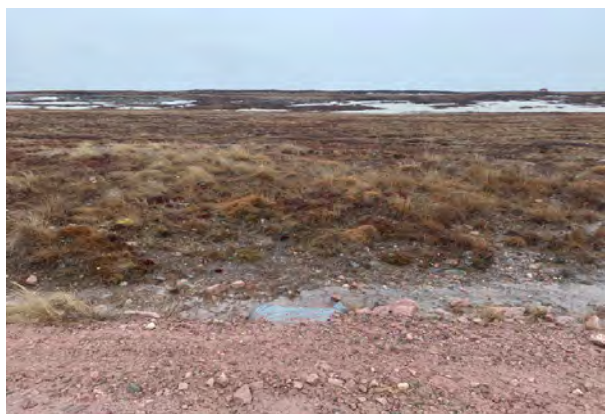
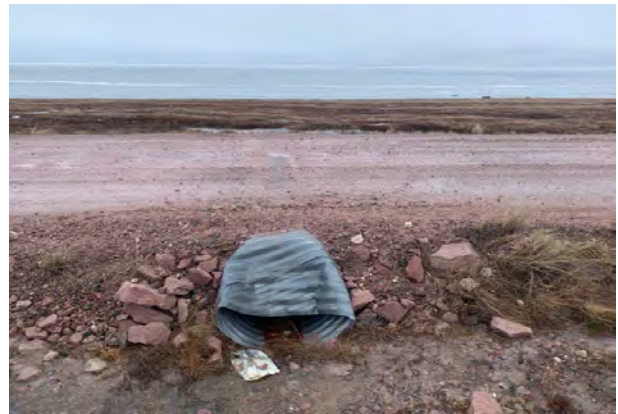
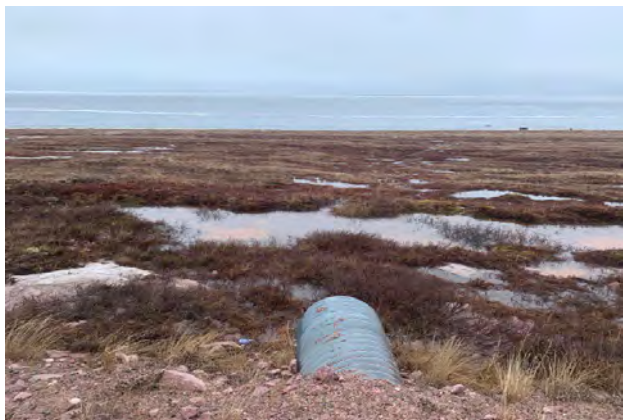
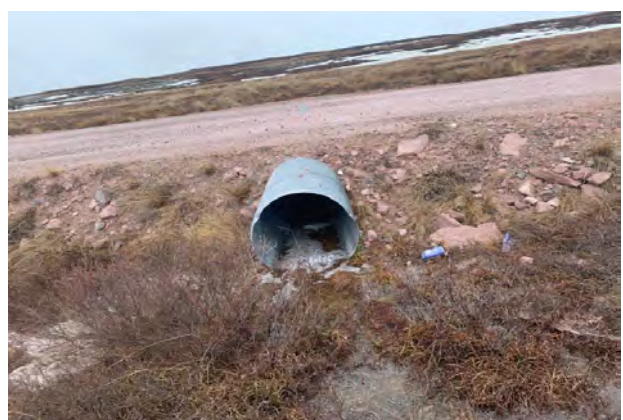
Culvert Condition Ratings (MTO 2013)				
Barrel Material (0-4)	Shape (0-4)	Capacity (0-2)	Erosion and Scour (0-2)	US/DS Channel (0-2)
0	2	0	0	0

Recommended Action(s):	Repair culvert end	Priority:	Medium
------------------------	--------------------	-----------	--------

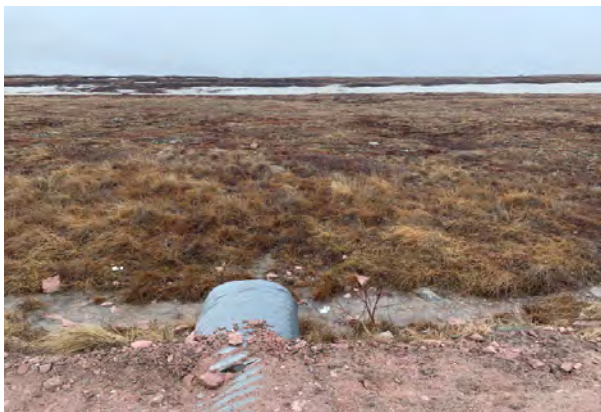
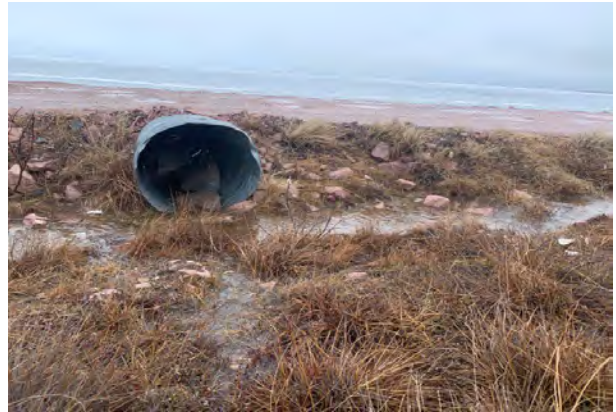
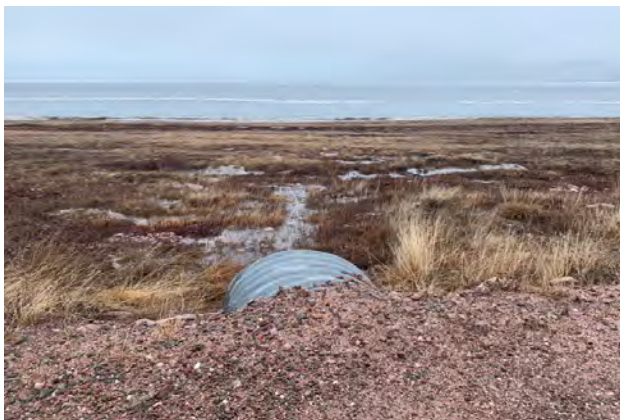
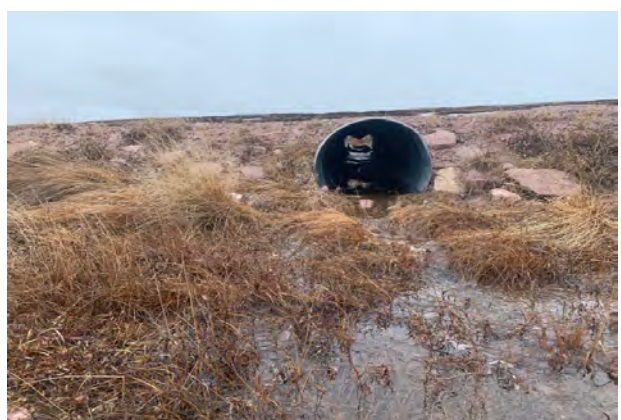
Culvert Information		
Culvert ID		127-03
Type		Cross
Shape		Round
Material		Csp
Diameter or Dimensions (mm)		600
Marker Post Present		N
End Crushing	Upstream	N
	Downstream	N
Infill Depth (mm)	Upstream	0
	Downstream	100
Other		None
Comments

Culvert Condition Ratings (MTO 2013)				
Barrel Material (0-4)	Shape (0-4)	Capacity (0-2)	Erosion and Scour (0-2)	US/DS Channel (0-2)
0	0	1	0	0

Recommended Action(s):	Flush	Priority:	Medium
------------------------	-------	-----------	--------

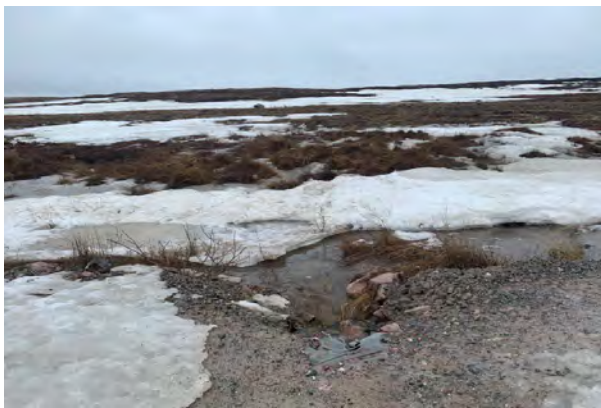
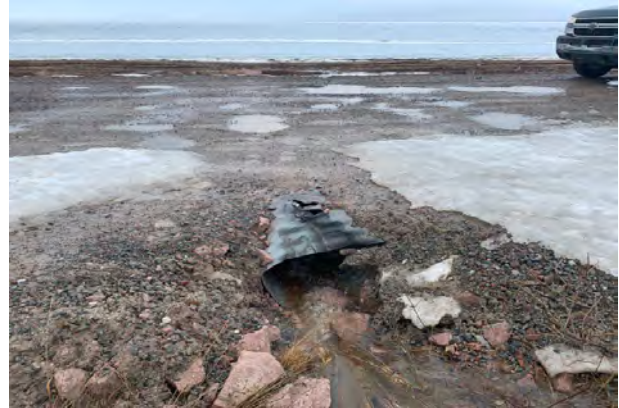
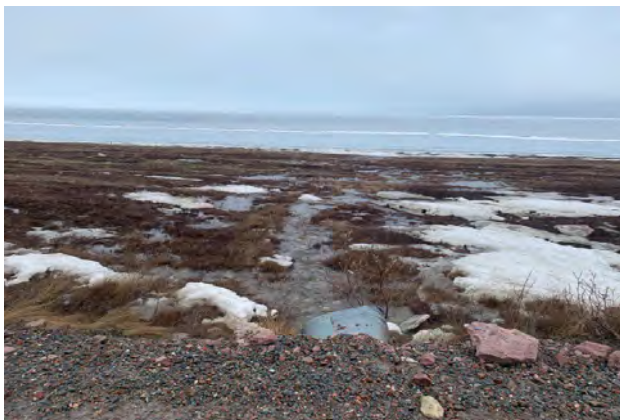
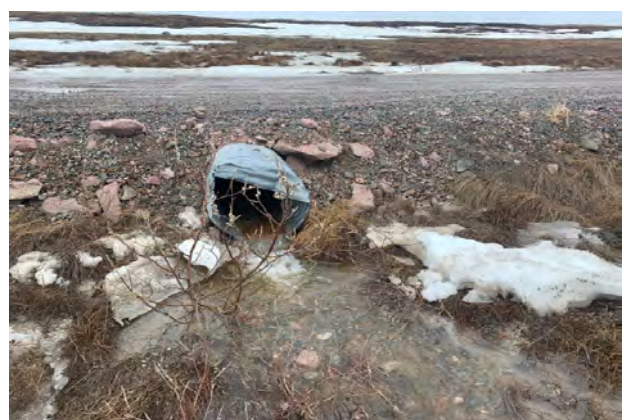
Culvert Information		
Culvert ID		127-04
Type		Cross
Shape		Round
Material		Csp
Diameter or Dimensions (mm)		600
Marker Post Present		N
End Crushing	Upstream	Y
	Downstream	Y
Infill Depth (mm)	Upstream	0
	Downstream	0
Other		None
Comments

Culvert Condition Ratings (MTO 2013)				
Barrel Material (0-4)	Shape (0-4)	Capacity (0-2)	Erosion and Scour (0-2)	US/DS Channel (0-2)
0	2	0	1	0

Recommended Action(s):	Repair both ends of culvert	Priority:	Medium
------------------------	-----------------------------	-----------	--------

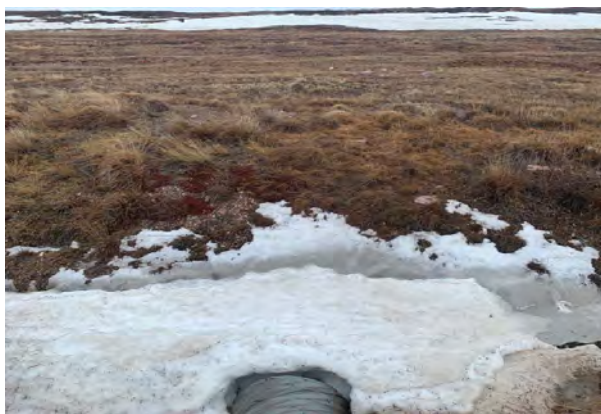
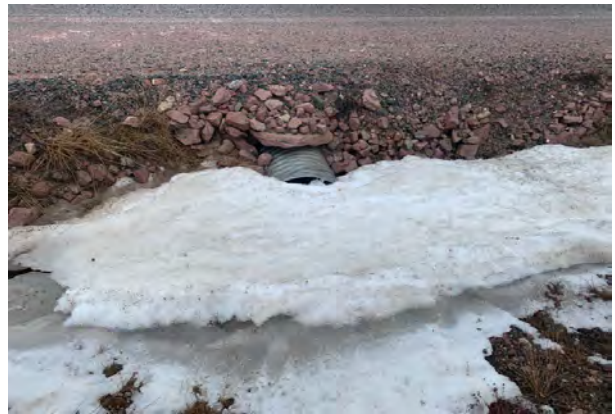
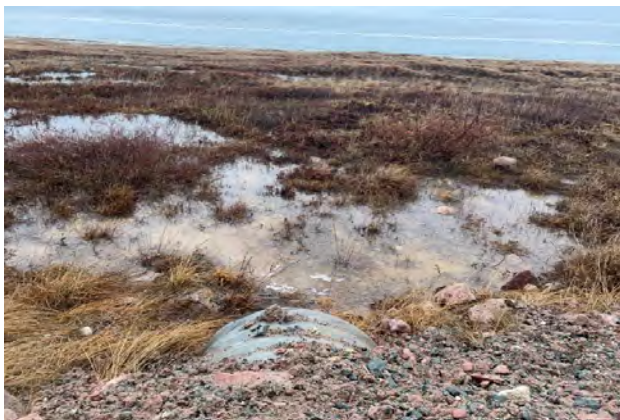
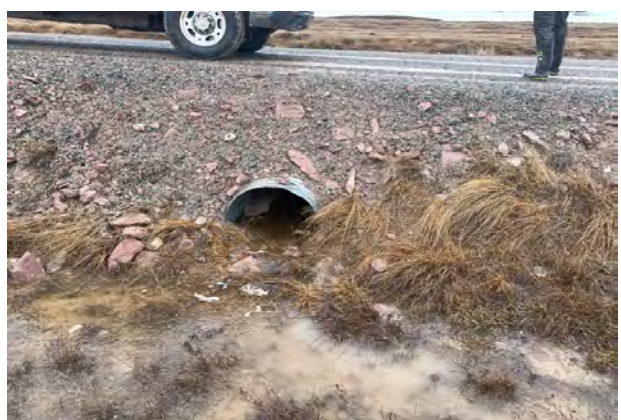
Culvert Information		
Culvert ID		127-05
Type		Cross
Shape		Round
Material		Csp
Diameter or Dimensions (mm)		600
Marker Post Present		N
End Crushing	Upstream	N
	Downstream	N
Infill Depth (mm)	Upstream	0
	Downstream	0
Other		None
Comments

Culvert Condition Ratings (MTO 2013)				
Barrel Material (0-4)	Shape (0-4)	Capacity (0-2)	Erosion and Scour (0-2)	US/DS Channel (0-2)
0	0	0	1	0

Recommended Action(s):	No action	Priority:	Low
------------------------	-----------	-----------	-----

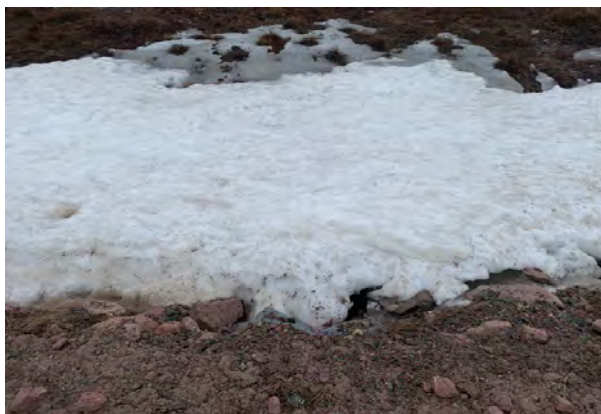
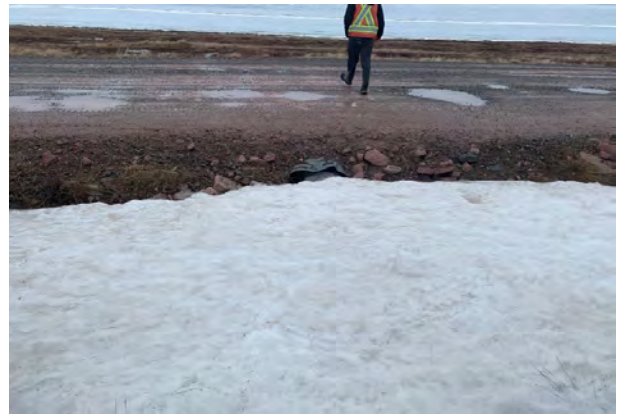
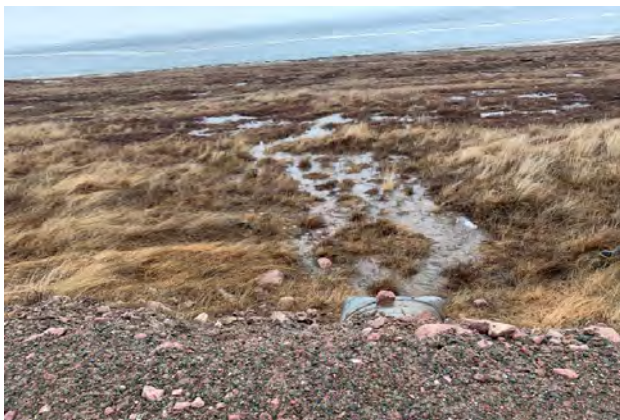
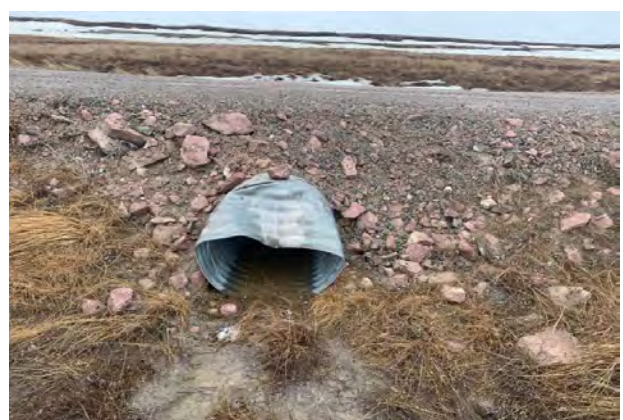
Culvert Information		
Culvert ID		127-06
Type		Cross
Shape		Round
Material		Csp
Diameter or Dimensions (mm)		600
Marker Post Present		N
End Crushing	Upstream	Y
	Downstream	Y
Infill Depth (mm)	Upstream	0
	Downstream	0
Other		None
Comments

Culvert Condition Ratings (MTO 2013)				
Barrel Material (0-4)	Shape (0-4)	Capacity (0-2)	Erosion and Scour (0-2)	US/DS Channel (0-2)
0	2	0	0	0

Recommended Action(s):	Repair culvert end	Priority:	Medium
------------------------	--------------------	-----------	--------

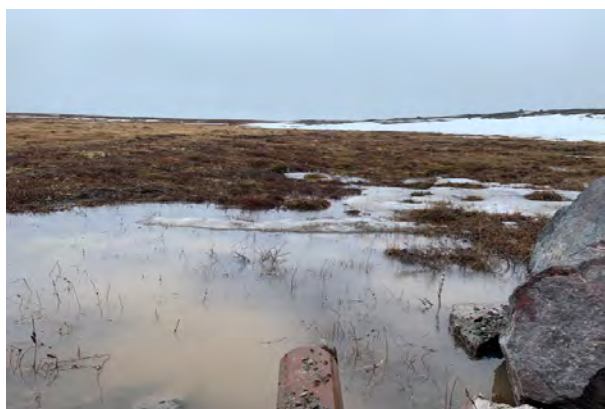
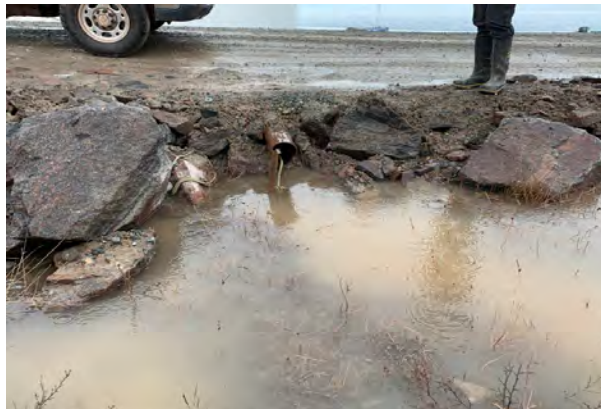
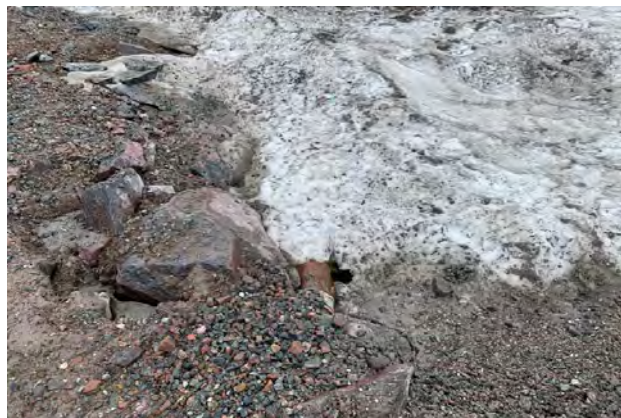
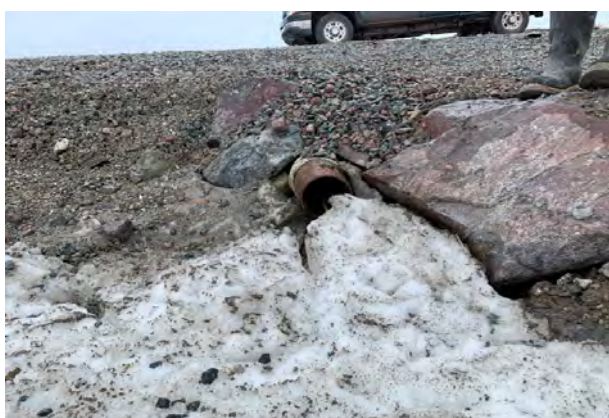
Culvert Information		
Culvert ID		128-01
Type		Cross
Shape		Circular
Material		Steel
Diameter or Dimensions (mm)		140
Marker Post Present		N
End Crushing	Upstream	N
	Downstream	N
Infill Depth (mm)	Upstream	0
	Downstream	0
Other Comments	None

Culvert Condition Ratings (MTO 2013)				
Barrel Material (0-4)	Shape (0-4)	Capacity (0-2)	Erosion and Scour (0-2)	US/DS Channel (0-2)
1	0	0	2	0

Recommended Action(s):	Stabilize banks	Priority:	High
------------------------	-----------------	-----------	------

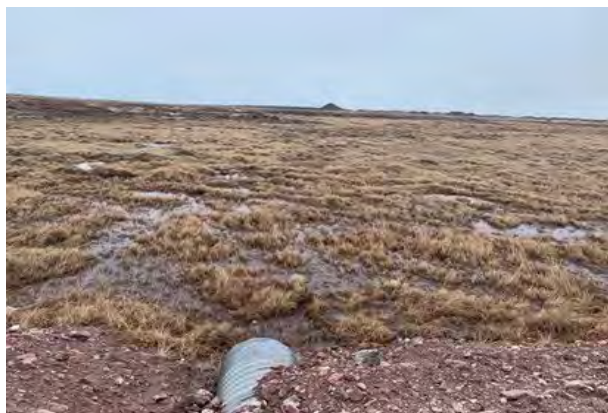
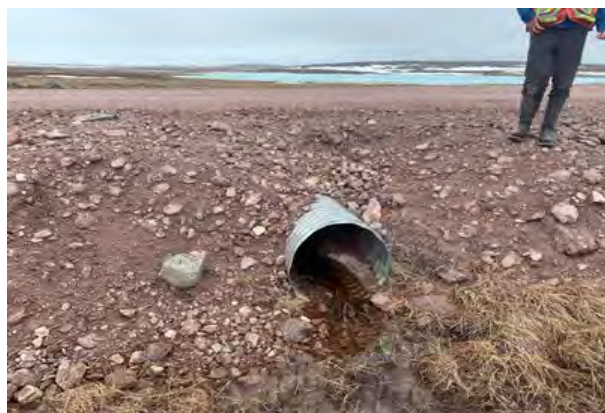
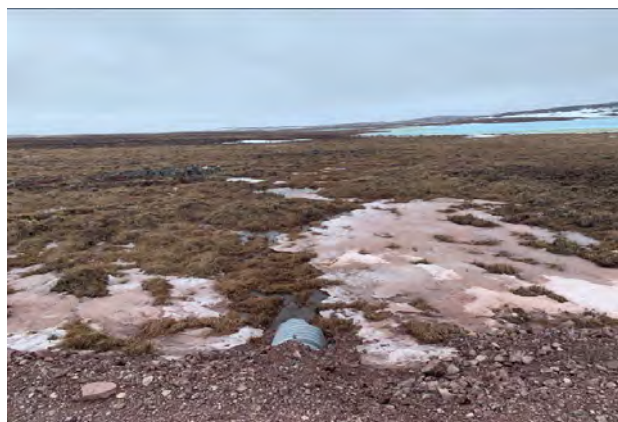
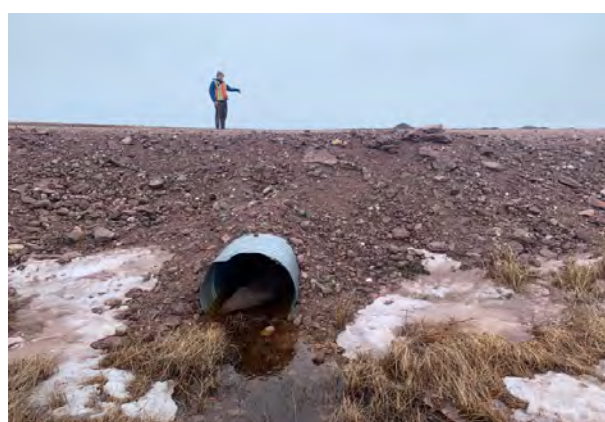
Culvert Information		
Culvert ID		129-01
Type		Cross
Shape		Round
Material		Csp
Diameter or Dimensions (mm)		600
Marker Post Present		N
End Crushing	Upstream	N
	Downstream	N
Infill Depth (mm)	Upstream	100
	Downstream	100
Other Comments	None

Culvert Condition Ratings (MTO 2013)				
Barrel Material (0-4)	Shape (0-4)	Capacity (0-2)	Erosion and Scour (0-2)	US/DS Channel (0-2)
0	0	1	0	0

Recommended Action(s):	Flush	Priority:	Medium
------------------------	-------	-----------	--------

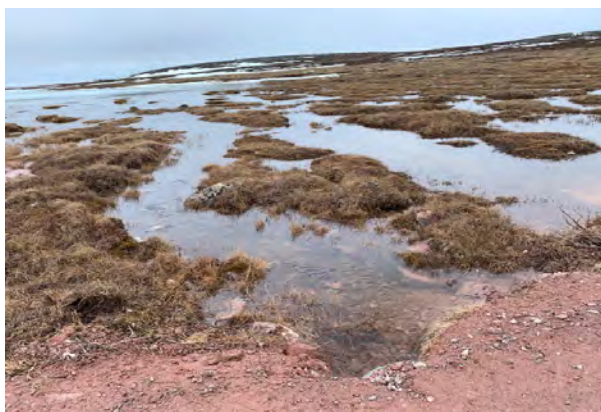
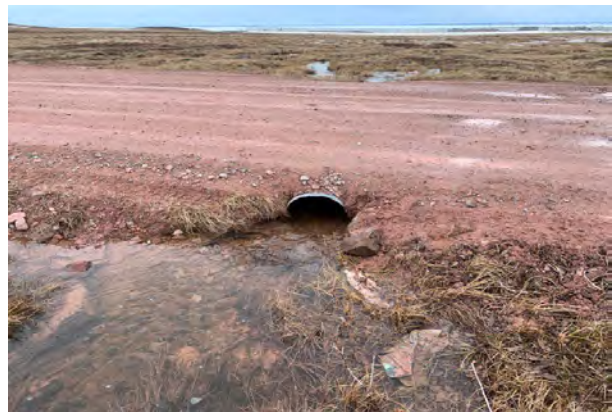
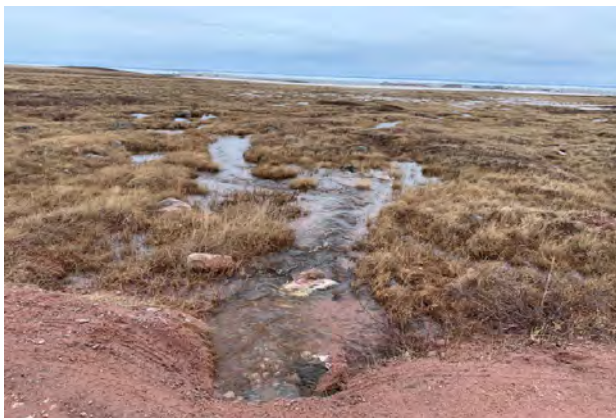
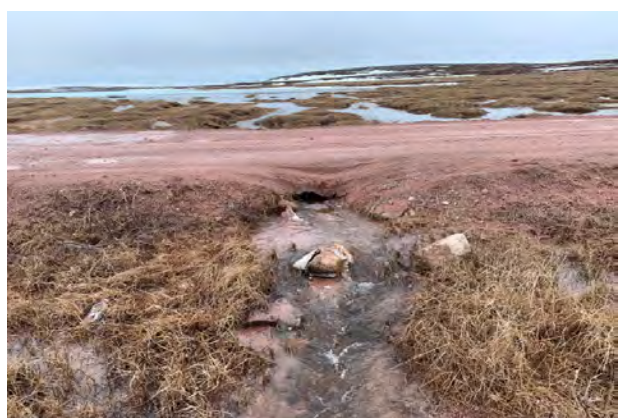
Culvert Information		
Culvert ID		129-02
Type		Cross
Shape		Round
Material		Csp
Diameter or Dimensions (mm)		400
Marker Post Present		N
End Crushing	Upstream	N
	Downstream	N
Infill Depth (mm)	Upstream	100
	Downstream	200
Other		None
Comments

Culvert Condition Ratings (MTO 2013)				
Barrel Material (0-4)	Shape (0-4)	Capacity (0-2)	Erosion and Scour (0-2)	US/DS Channel (0-2)
0	0	2	2	0

Recommended Action(s):	Flush	Priority:	High
------------------------	-------	-----------	------
