**Geotechnical Investigations  
and Drainage Planning in  
Clyde River, Nunavut**

Clyde River, NU

Final Report  
REV-02

Nunami Stantec Limited

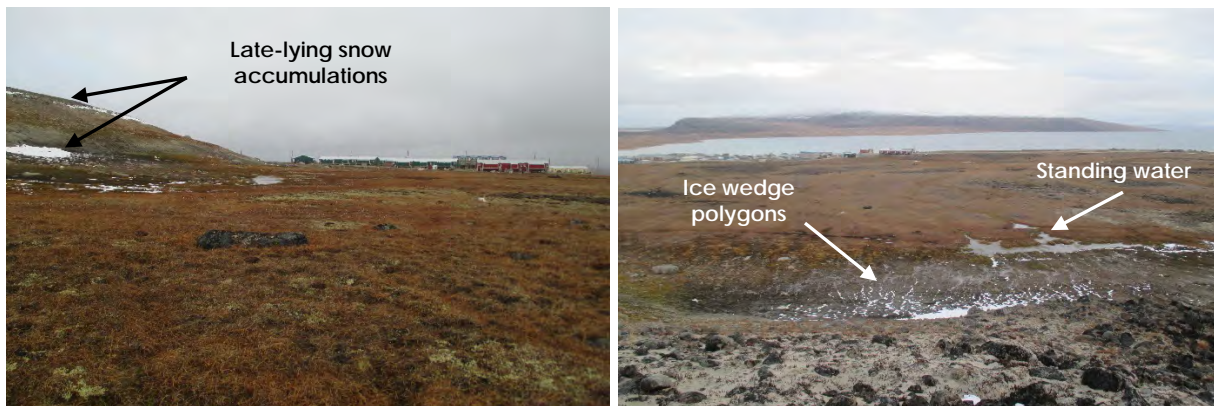
Figure 3-3 Snow patches residues and downslope hydrology

An example of a nivation hollow was observed immediately north of Block 2, along the base of the moderately steep slope (~ 30%) located below the existing borrow source (Figure 3-3). At this location, late-lying snow patches are often observed late in the thawing season, therefore impacting local drainage conditions. Ice wedges were identified at this location. A schematic representation of the topography in the area is shown in Figure 3-4.

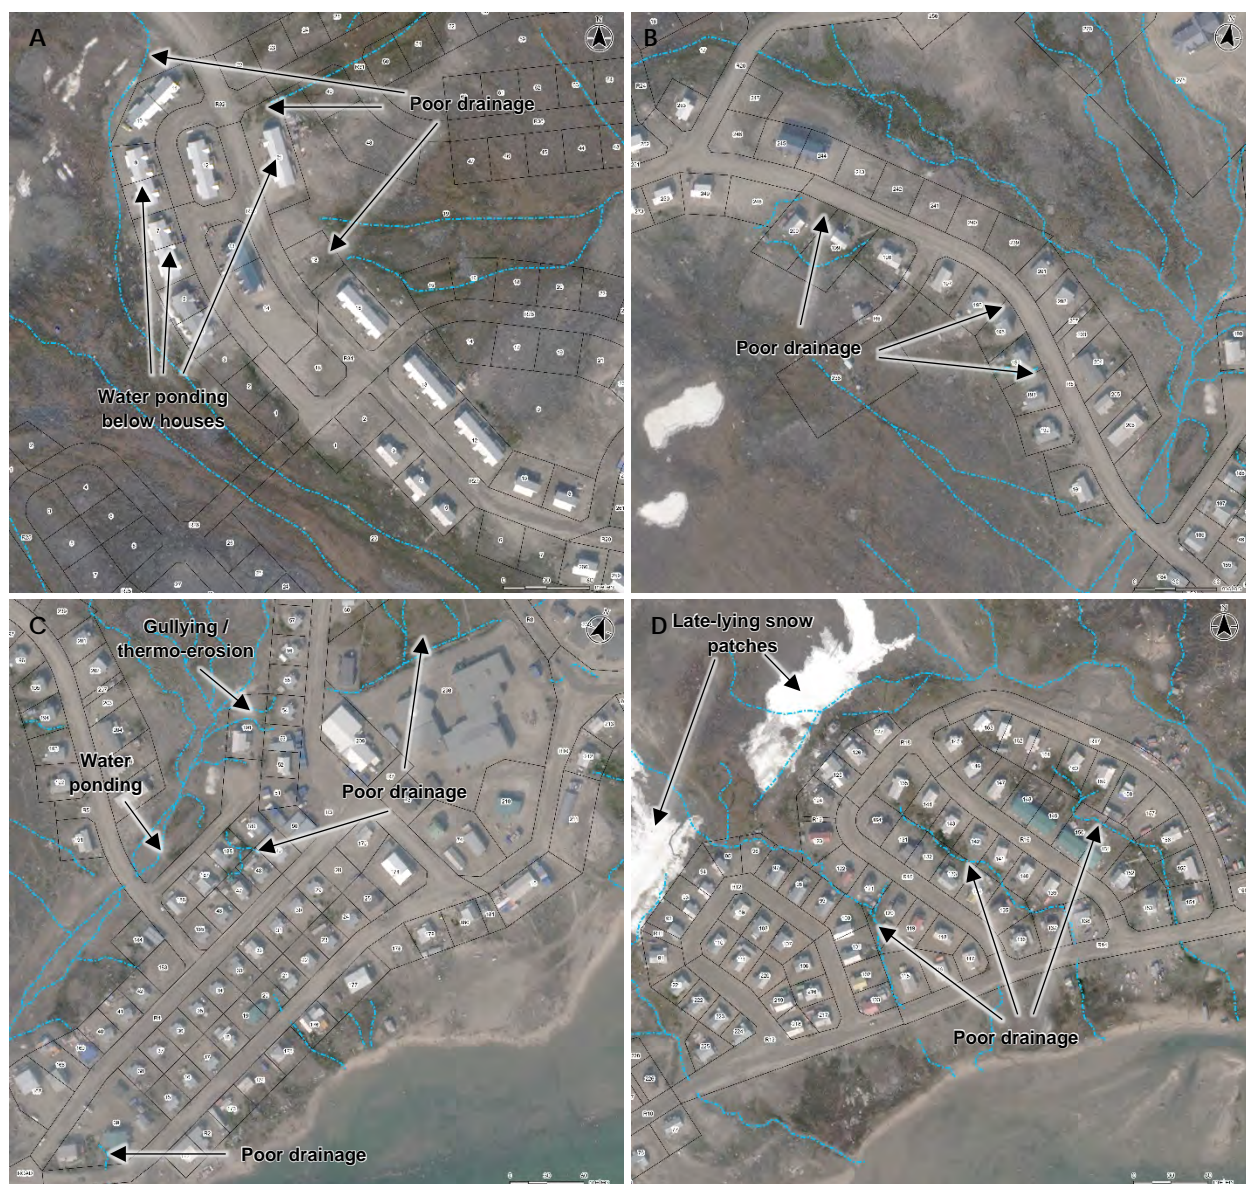
Figure 3-5 Flow paths and drainage features within the community. A) Northern district; B) Area surrounding road R5; C) Sealift and Quluaq school districts; D) Eastern district.

Adverse drainage conditions specific to the different community districts are highlighted in Figure 3-5, and are summarized below.

It is also noted that surface runoff over roads and driveways was also observed throughout the community.

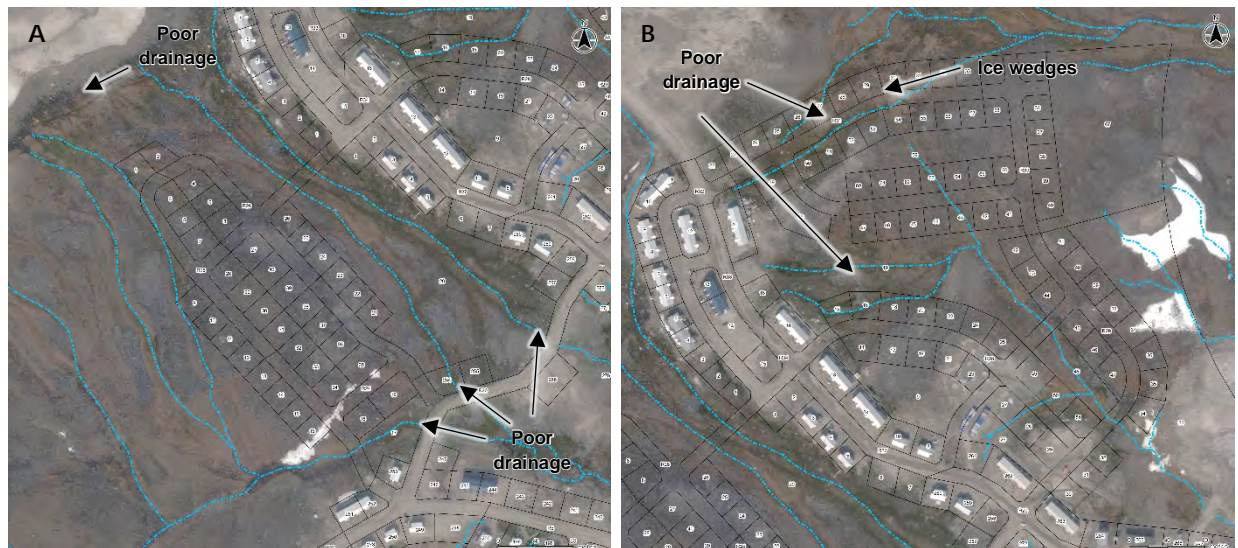
Figure 3-6 Flow paths surrounding Block 2 (A) and Blocks 3 and 4 (B)

Example locations of adverse drainage conditions specific to Blocks 2, 3 and 4 are highlighted in Figure 3-6.

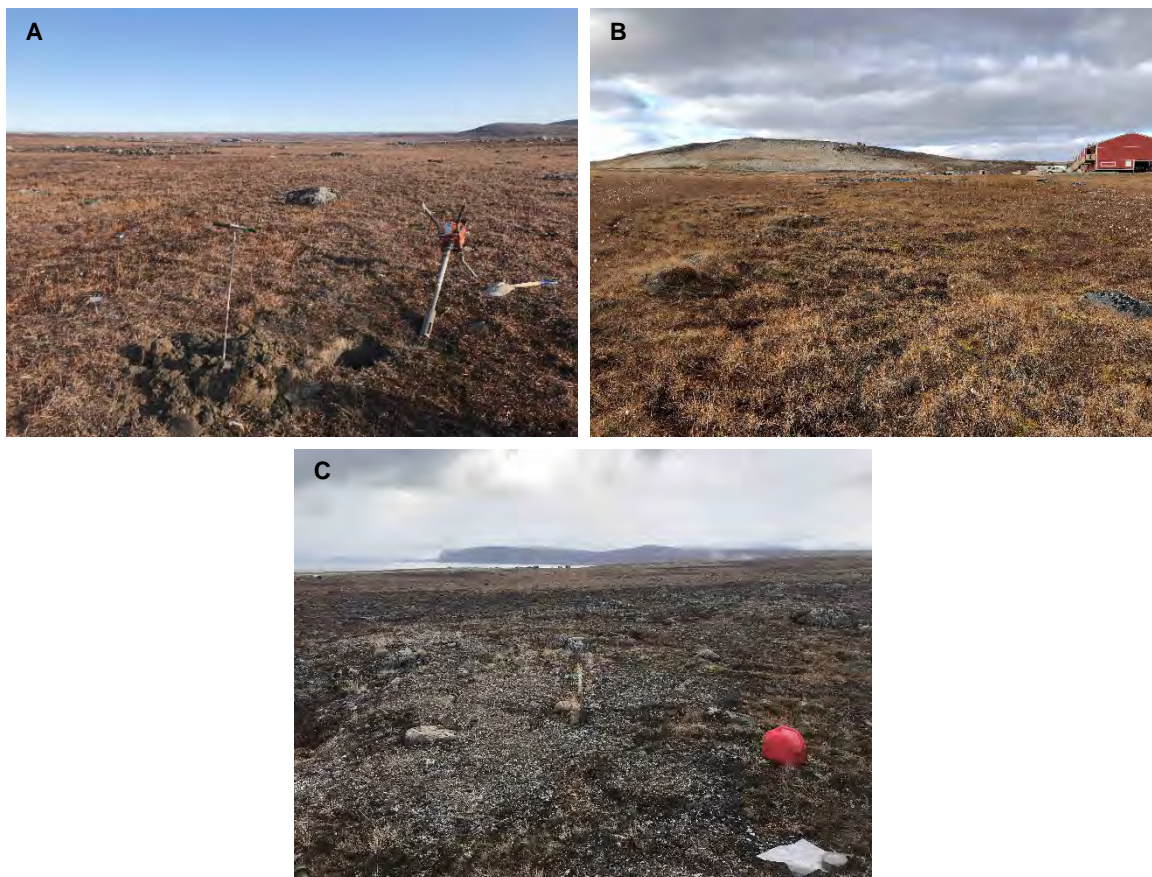
**Figure 4-2 Surficial organic observed within the study area. A) Mosses and sod overlying topsoil; B) Peat accumulation; C) Sparse vegetation coverage.**

Organic accumulations characterized by a cover of mosses and sod overlying a thin topsoil were found in moderately well to poorly drained soils and were widespread across Blocks 2, 3 and 4. Peat accumulations were restricted to poorly drained soils and mostly occurred within drainage flow paths. Areas with a sparse vegetation coverage were confined to moderately well drained topographic highs and patterned ground features often occurred in these areas. Refer to Figure 4-2 for an example of the different organic types observed.

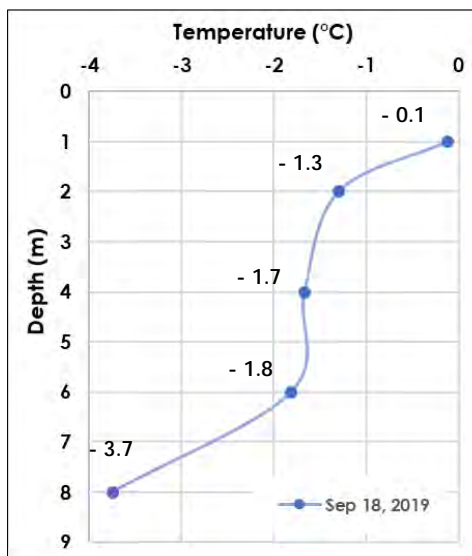
Figure 4-4 Ground temperature profile recorded at borehole BH19-14

Ground temperatures recorded at borehole BH19-14 varied from -0.1°C at 1 m depth to -3.7°C at 8 m depth. Ground temperature profile is presented in Figure 4-4. Note that this temperature profile was obtained within a few hours following borehole drilling and therefore represents local temperature profile with potential impact due to ground disturbance during drilling.

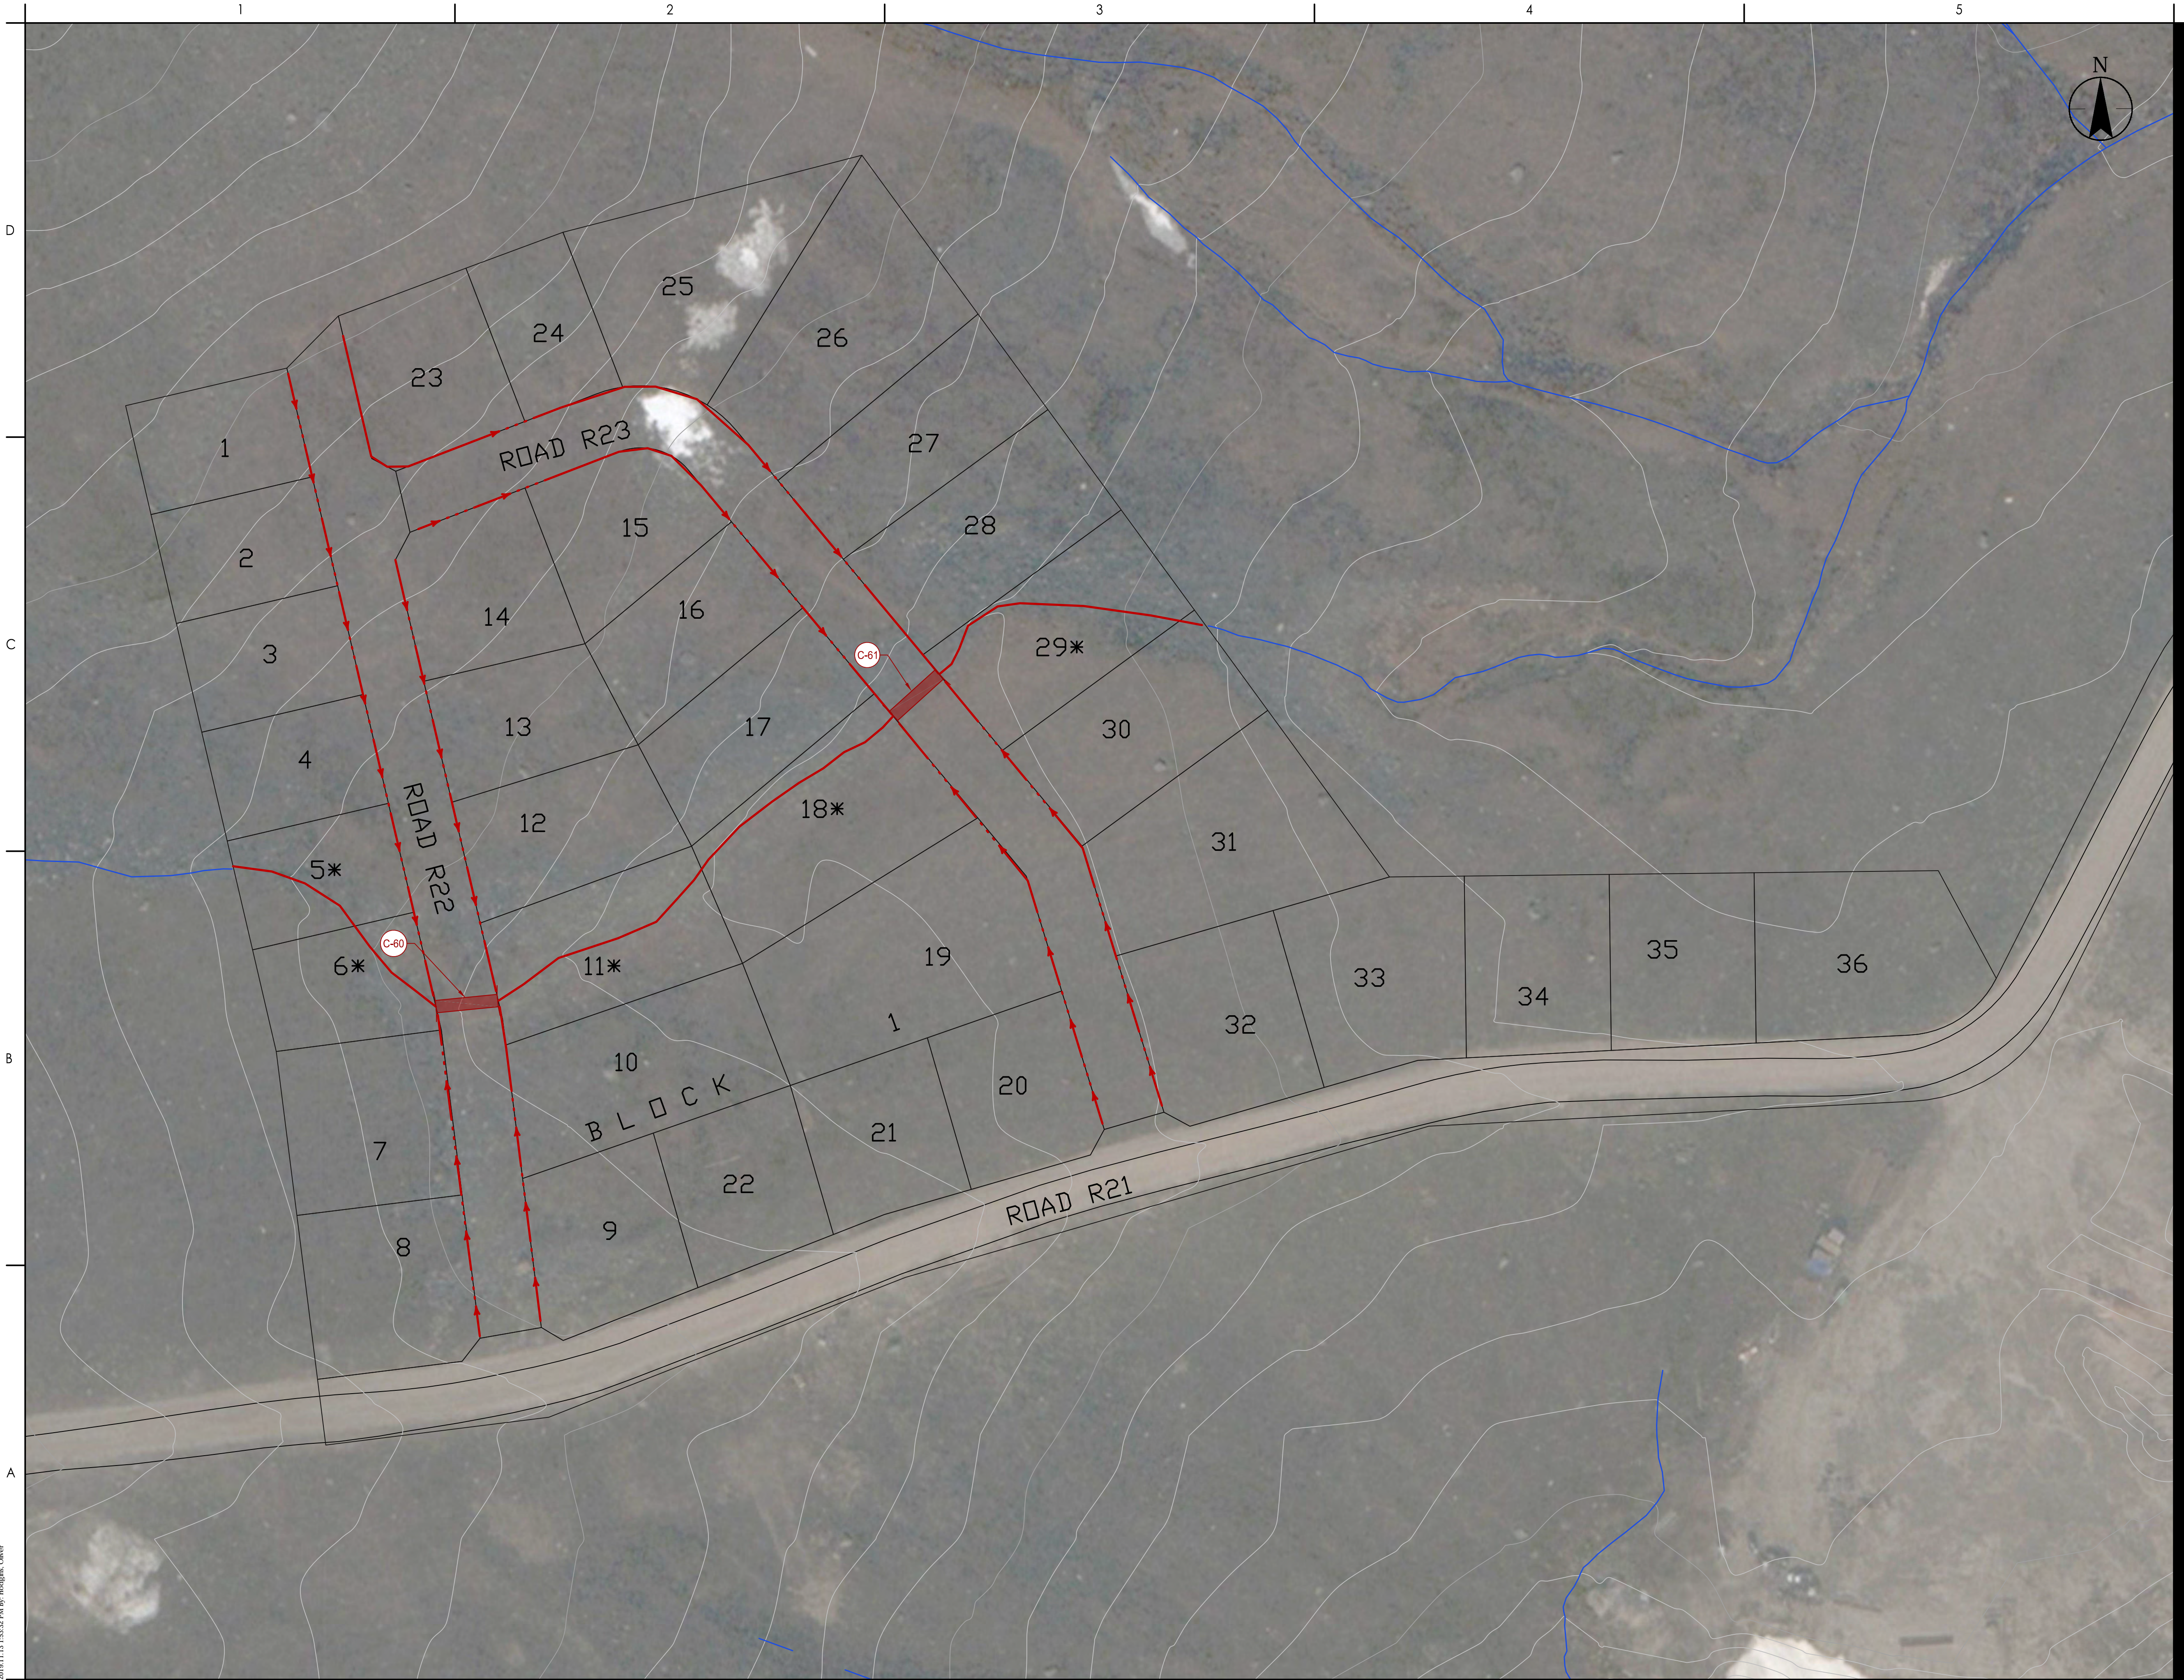
Only one drainage flow path was identified within Block 1. This flow path drains the northwesternmost portion of the study area (initiating near the current waste disposal site), then flows east and south toward the community. Waterlogged fine-grained soils were observed alongside this flow path. Drawing C-101 (Appendix C) shows that the flow path crosses Lots 5, 6, 11, 18 and 29, as well as proposed road R22 and R23.
