Geotechnical Investigation and Drainage Planning in Gjoa Haven, Nunavut

Gjoa Haven, NU

Final Report

September 2023

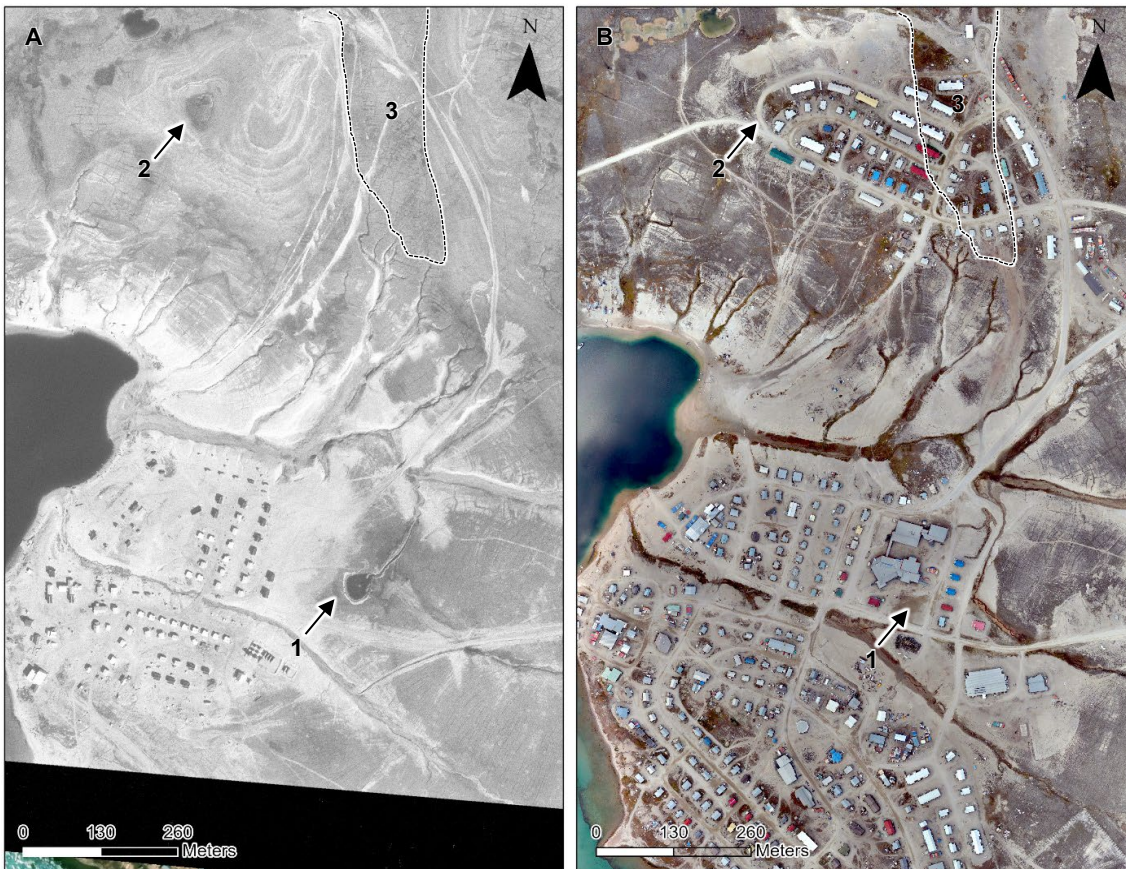
Figure 3-4 Development Occurring Over Historical Lakes and poorly drained areas.
A) 1975 Historical Air Photo; B) 2022 Orthophoto.

A review of historical air photos indicated that development in the old townsite (at the school) and in the northern subdivision, was conducted on historical lakes and within poorly drained areas. Drainage-related problems now occur at these locations (Figure 3-4) and are discussed further in Section 4.3.1.2.

1. Ponding occurs in the school's playground located over an historical lake (refer to IDPA #7).
2. Ponding occurs in and adjacent to new development area located over an historical lake (Refer to IDPA #3).
3. Ponding occurs in a subdivision built over poorly drained area (Refer to IDPA #2).

IDPA #3: Low-Lying Area That Consistently Ponds: IDPA #3 is located at the upstream end of catchment 107. Since ditching within the community is poor it is possible that runoff from adjacent catchments 101 and 102 may cut across the road to pond in the existing low-lying area. IDPA #3 is located over an historical lake as shown as point 2 in Figure 3-4.

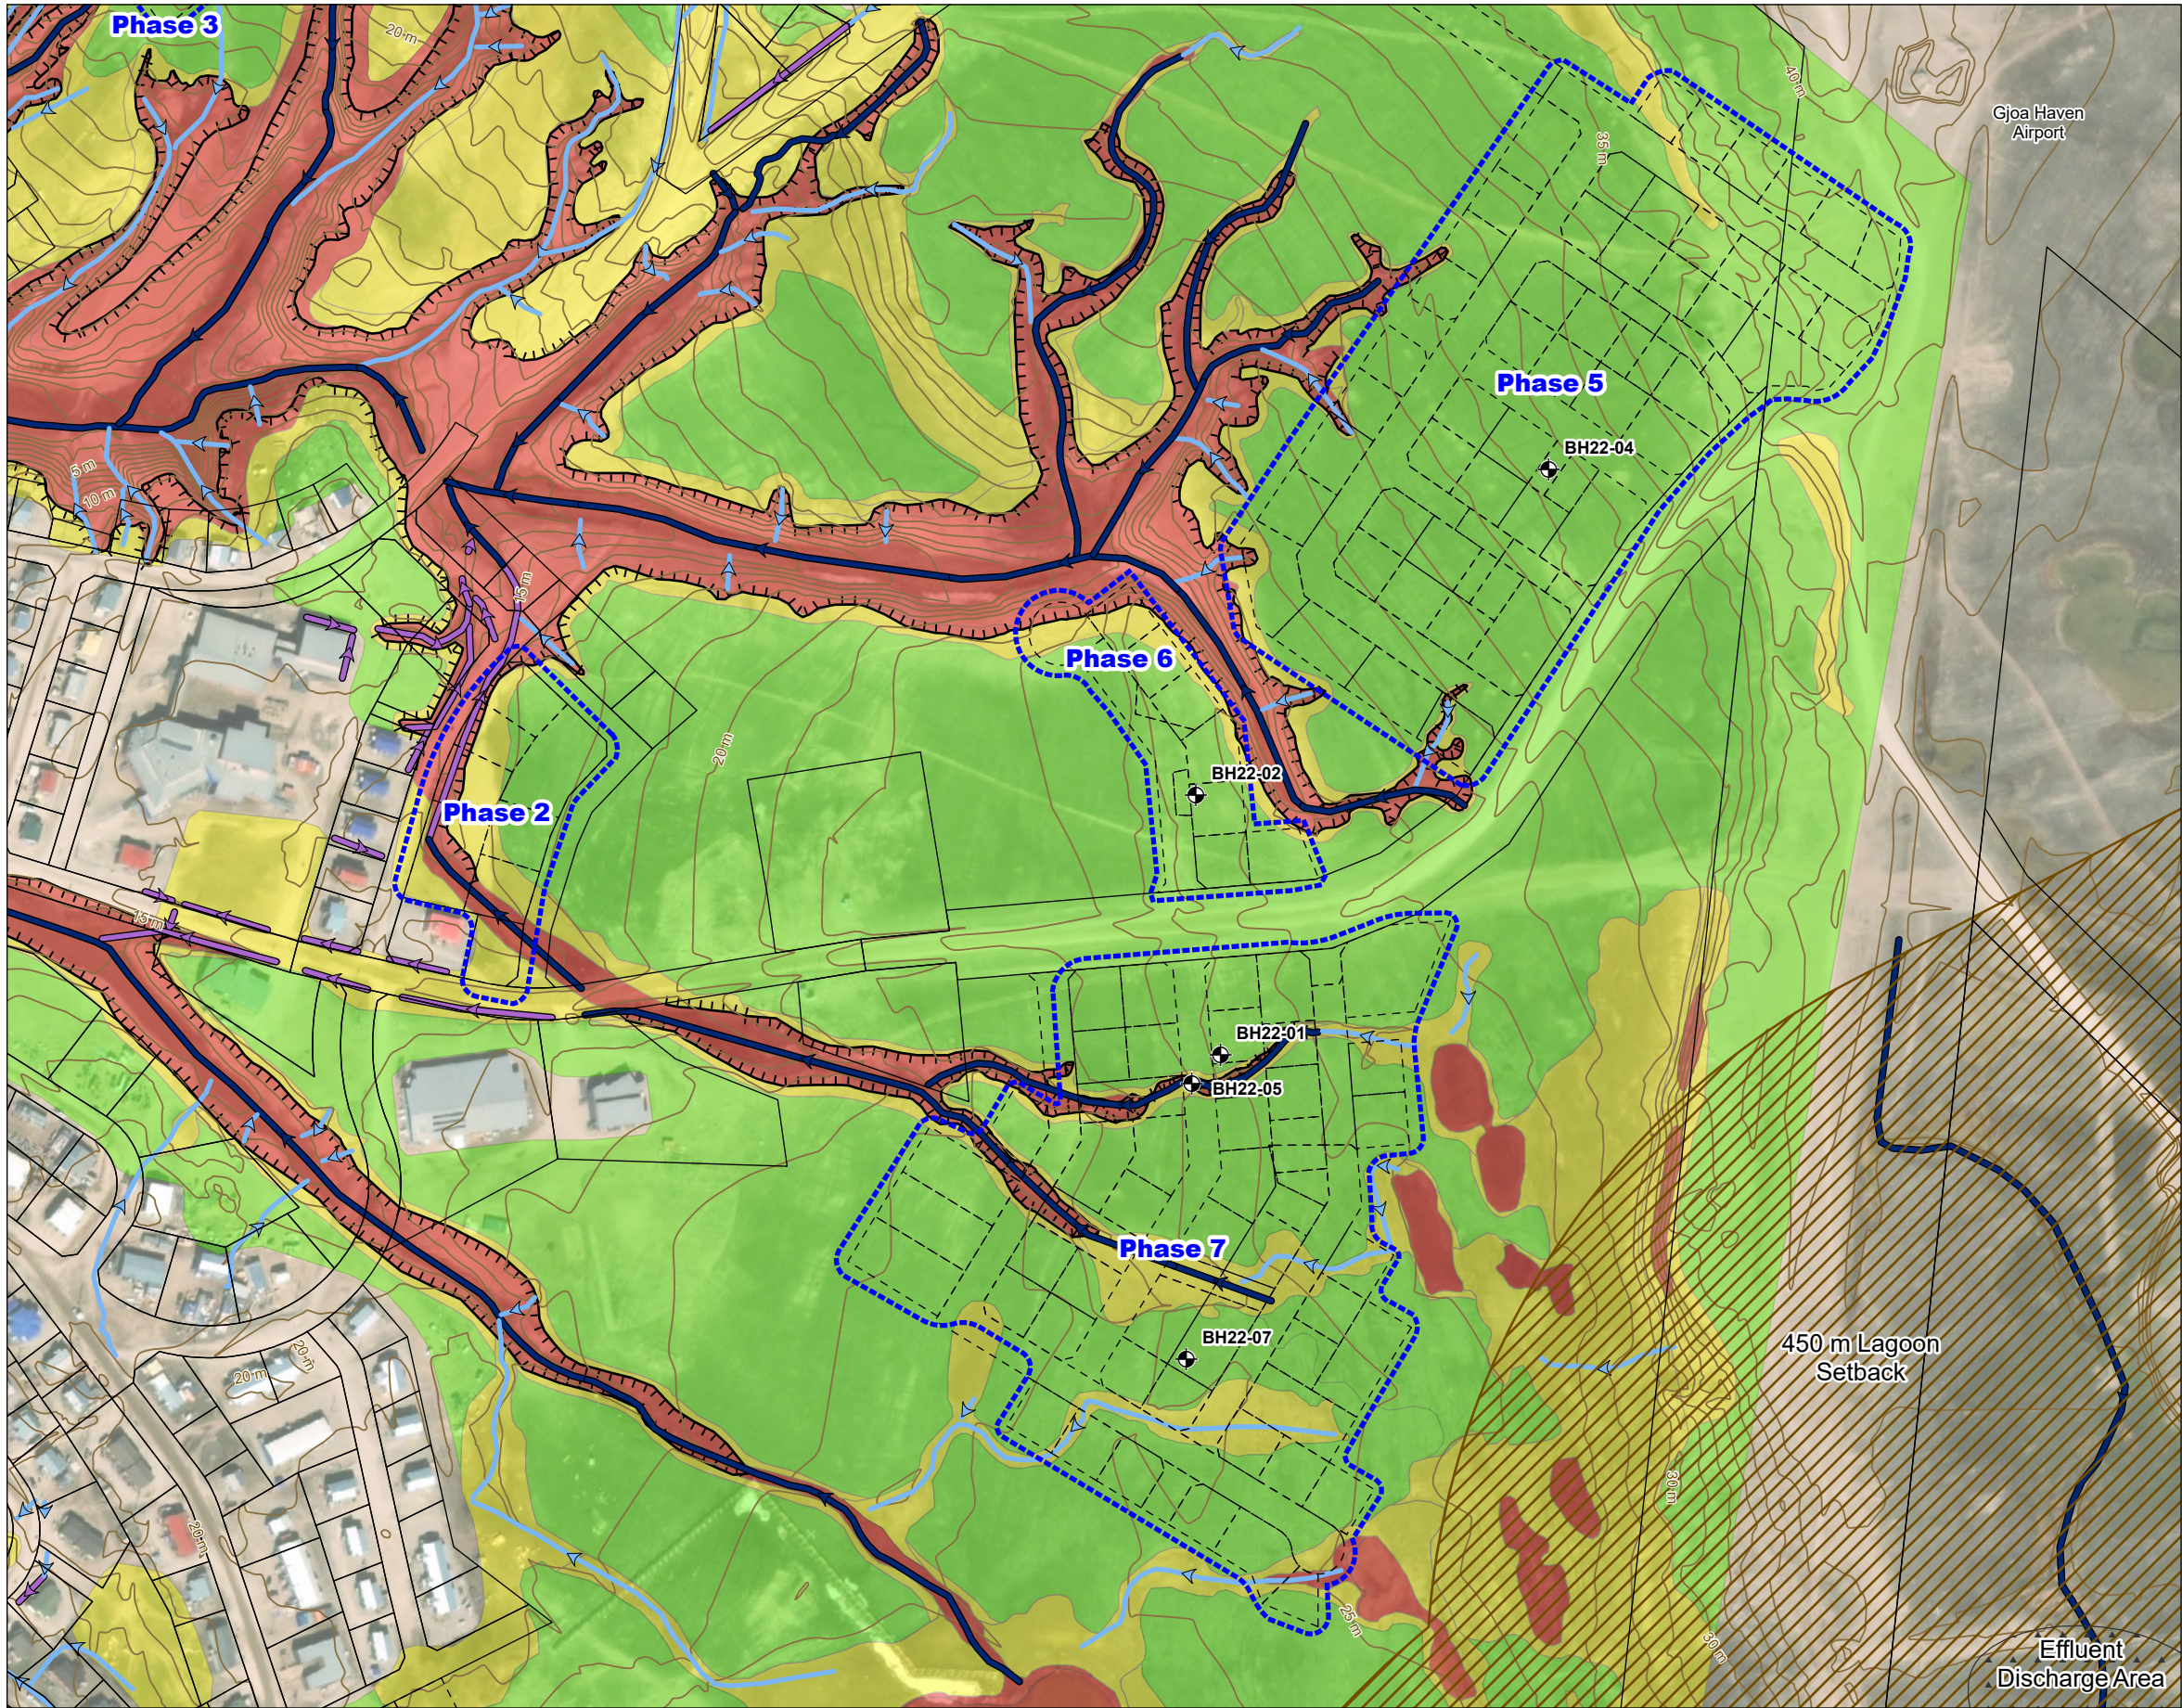
Figure No.
Appendix C-2b

Title
Qualitative Construction Suitability
(Phase 1, Phase 3 and Phase 4a)

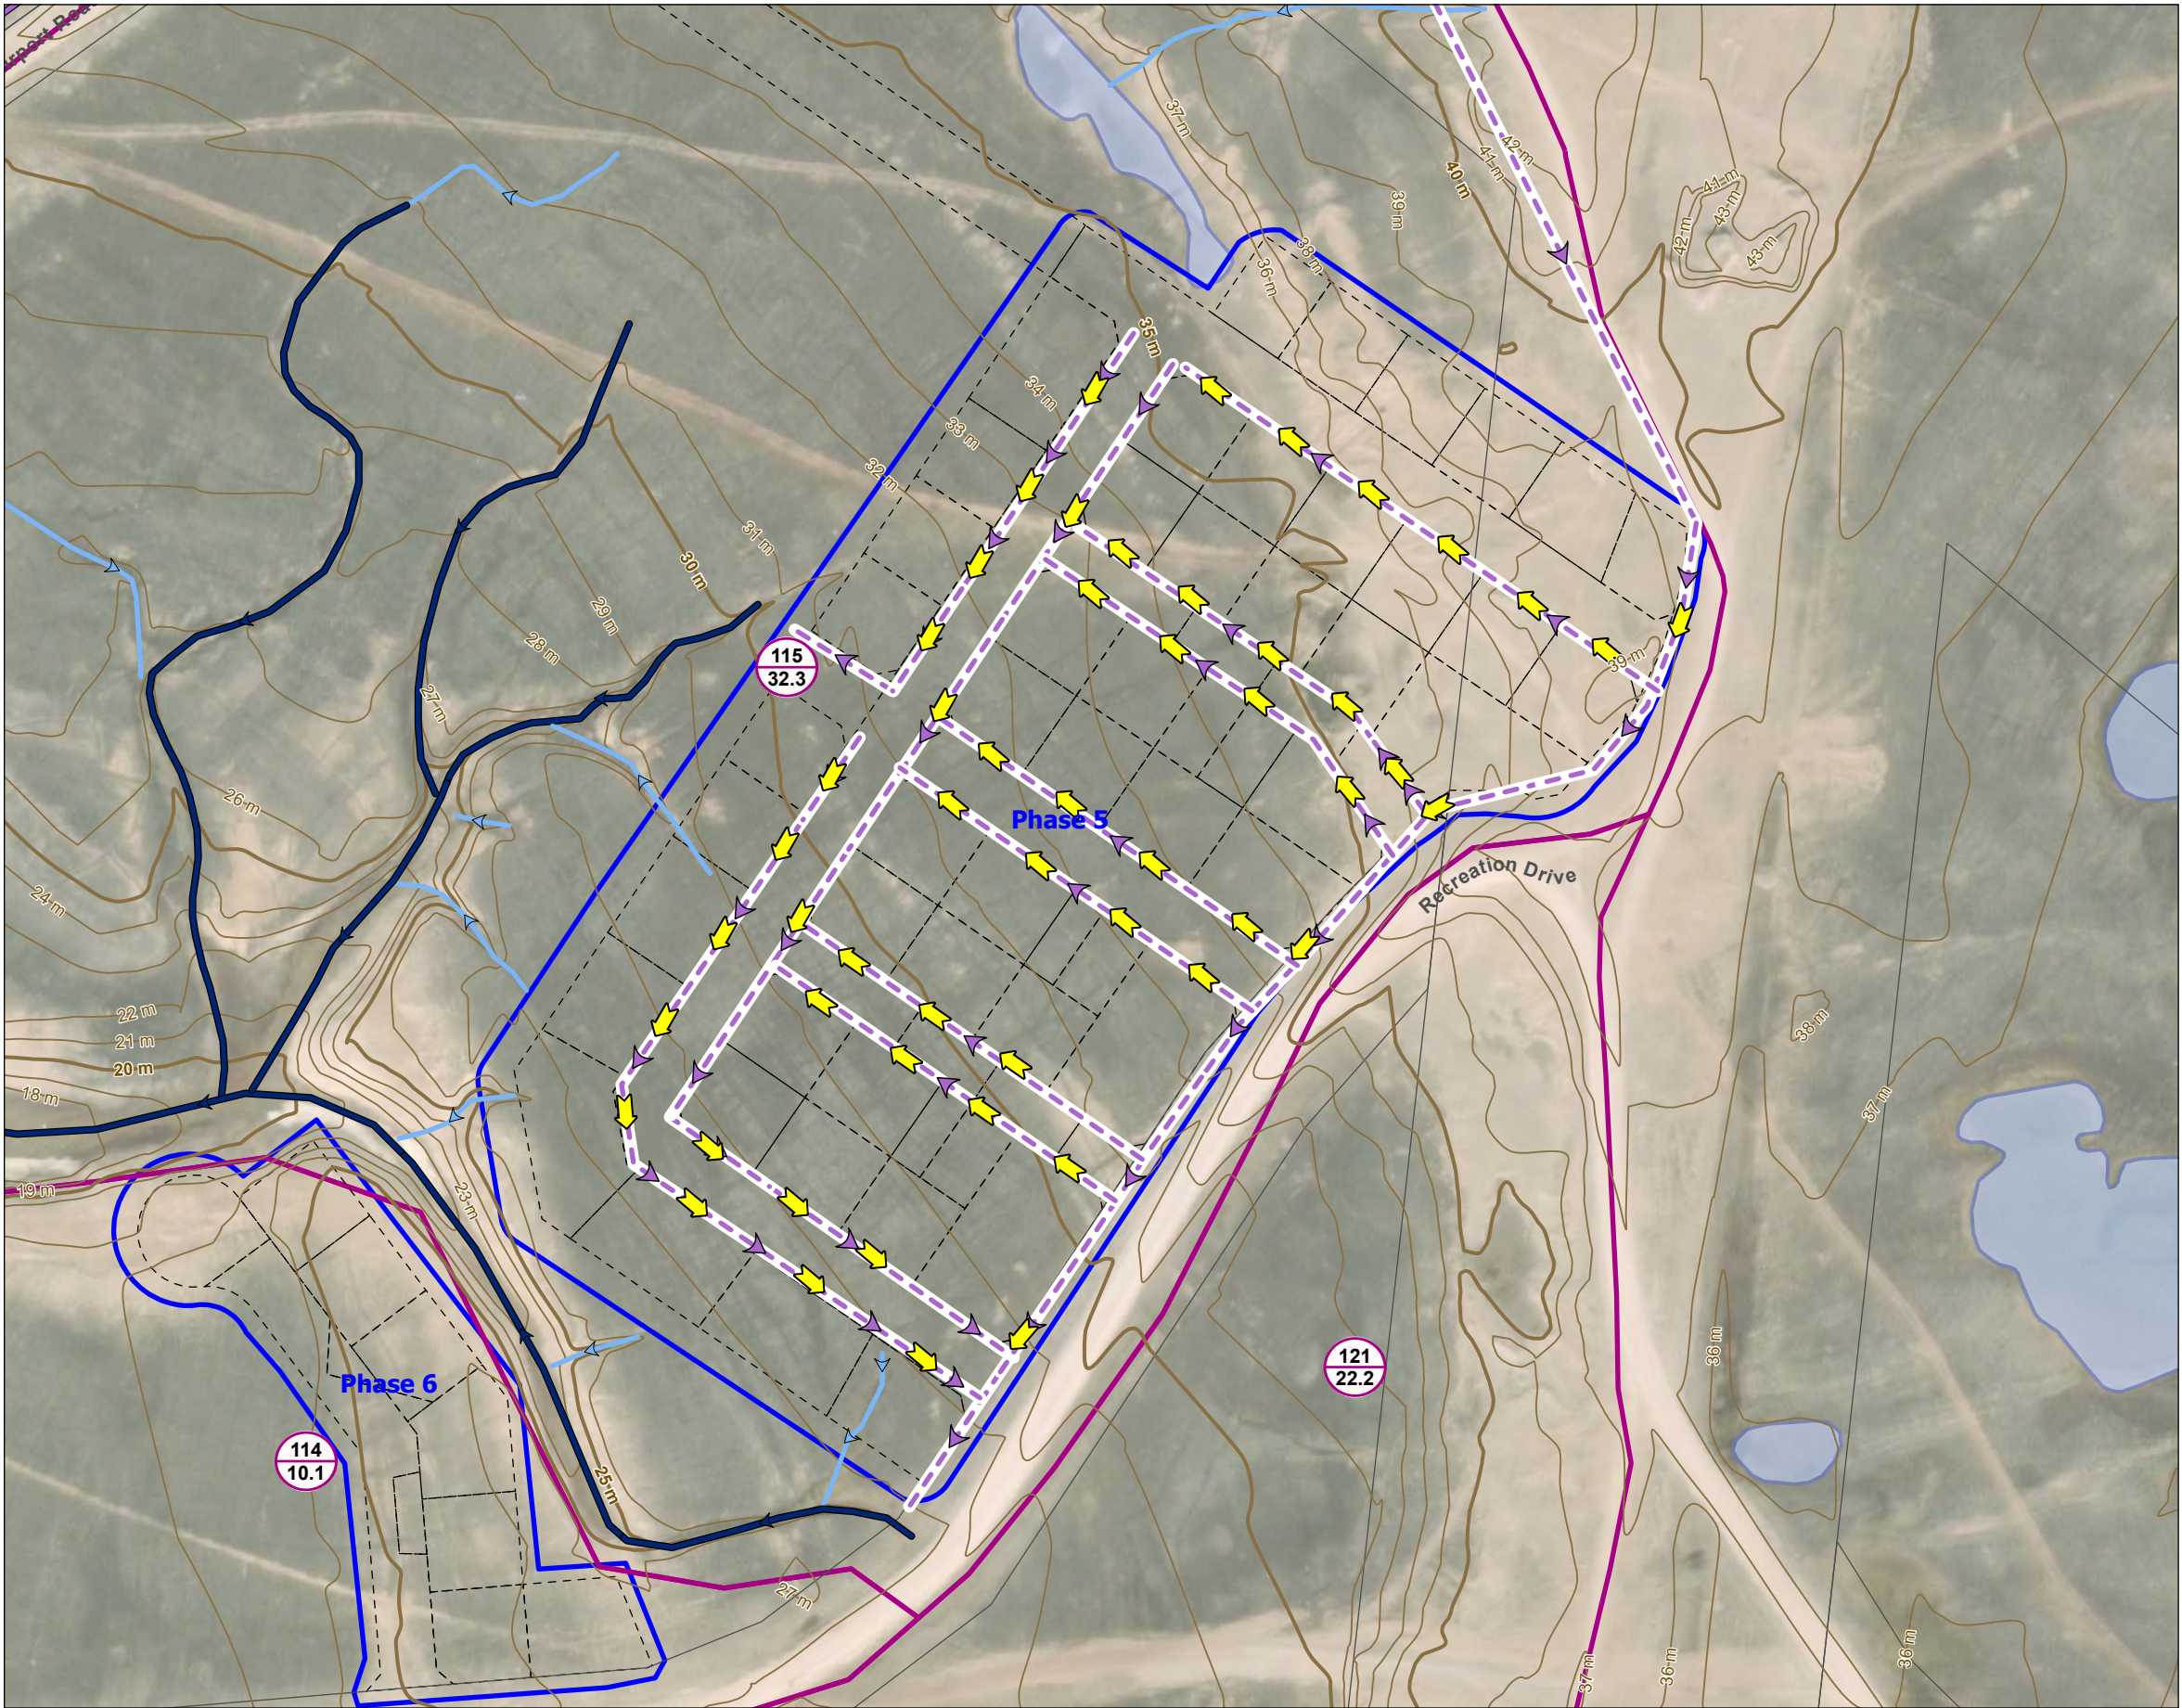
Title
Proposed Development Area
Phase 4a

Figure 4 in Appendix D-3 illustrates the proposed conditions drainage plan for Phase 4a. The existing drainage boundaries will be generally preserved with the exceptions to some changes to the catchment 104 and 106 due to the proposed ditches.

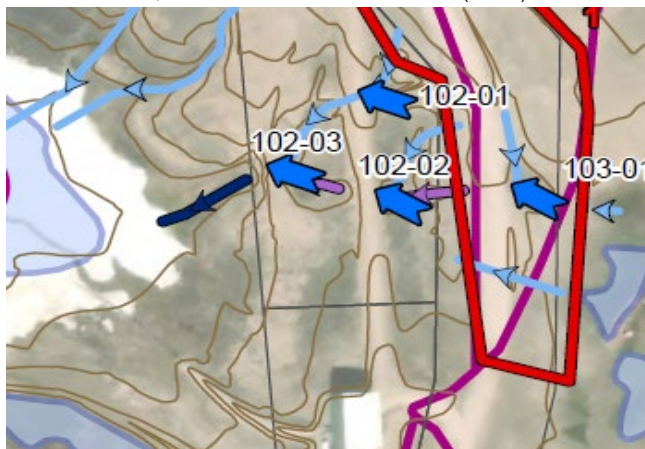
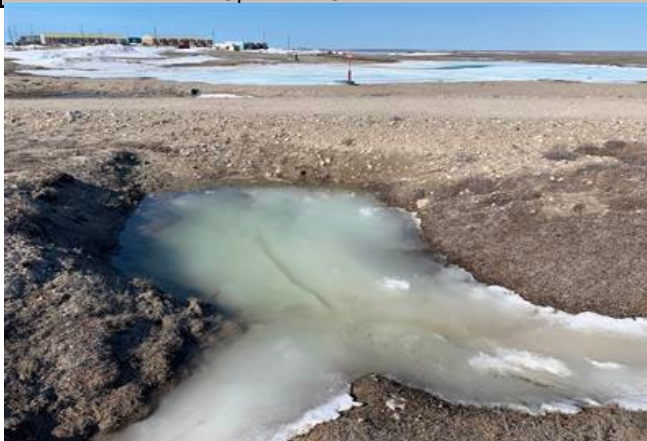
Culvert Information		
Culvert ID		Culvert ID
Type		Cross
Shape		0
Material		0
Diameter or Dimensions (mm)		0
Marker Post Present		No
End Crushing	Upstream	0
	Downstream	0
Infill Depth (mm)	Upstream	0
	Downstream	0
Other Comments	Covered by ice could not analyze culvert condition.

Culvert Condition Ratings (MTO 2013)				
Barrel Material (0-4)	Shape (0-4)	Capacity (0-2)	Erosion and Scour (0-2)	US/DS Channel (0-2)
NM	NM	0	NM	NM

Recommended Action(s):	Inspect when unfrozen	Priority:	None
------------------------	-----------------------	-----------	------

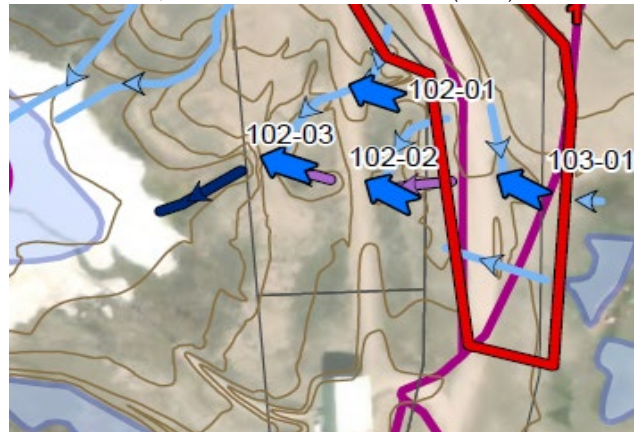
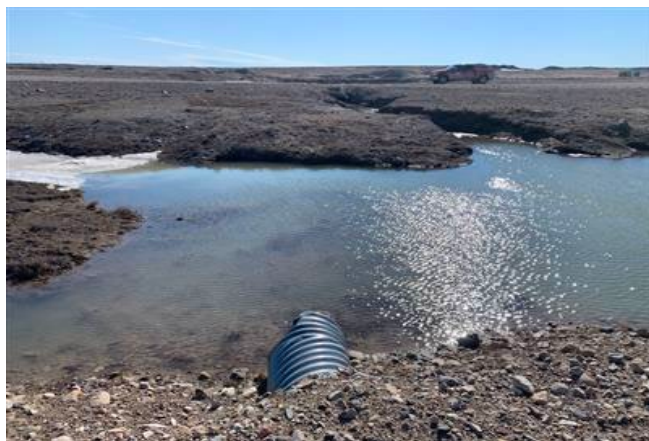
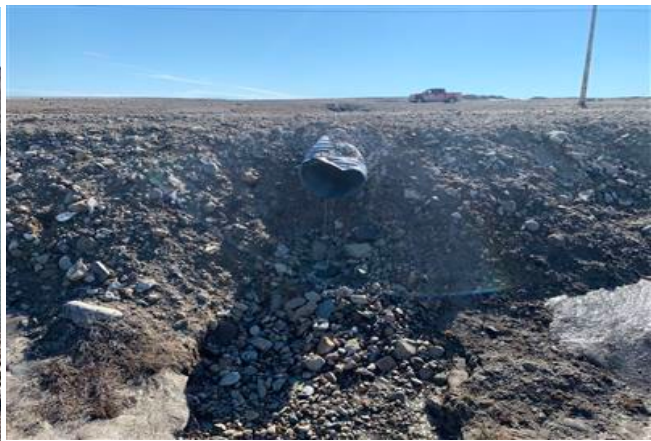
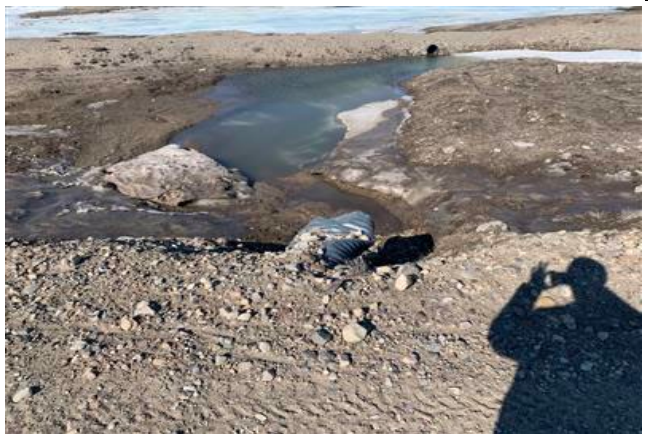
Culvert Condition Ratings (MTO 2013)				
Barrel Material (0-4)	Shape (0-4)	Capacity (0-2)	Erosion and Scour (0-2)	US/DS Channel (0-2)
0	2	0	1	0

Recommended Action(s):	Reinstall culvert at a lower elevation	Priority:	Medium
------------------------	--	-----------	--------

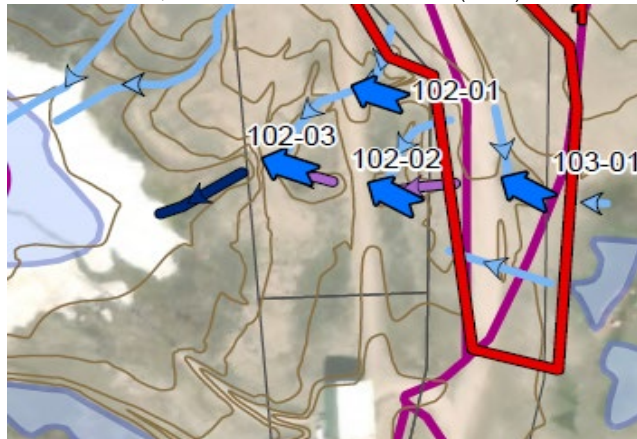
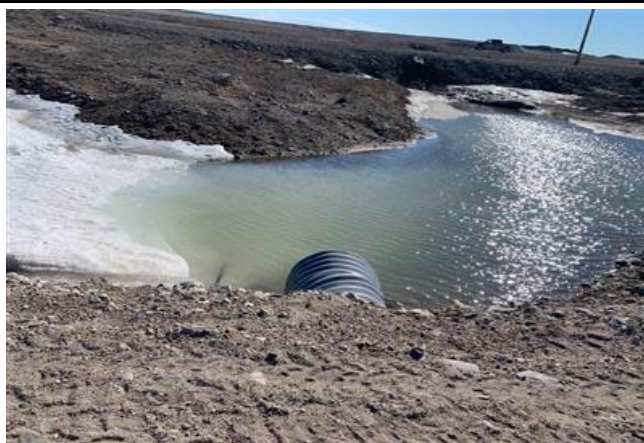
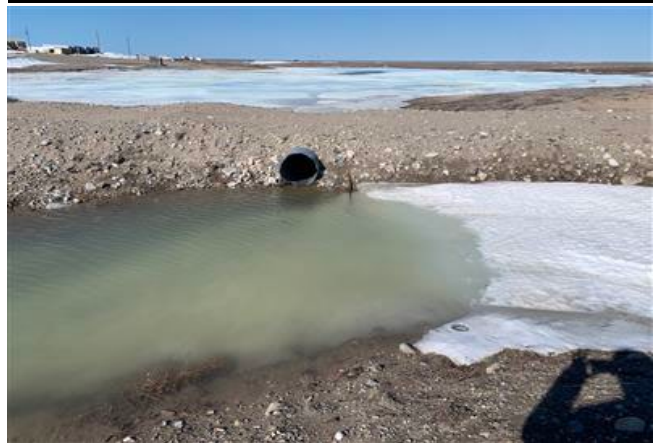
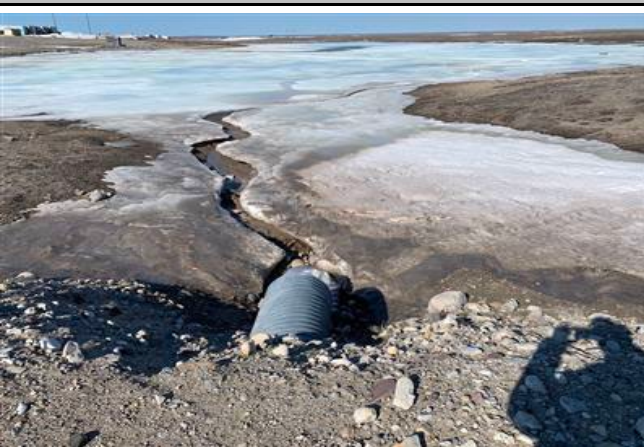
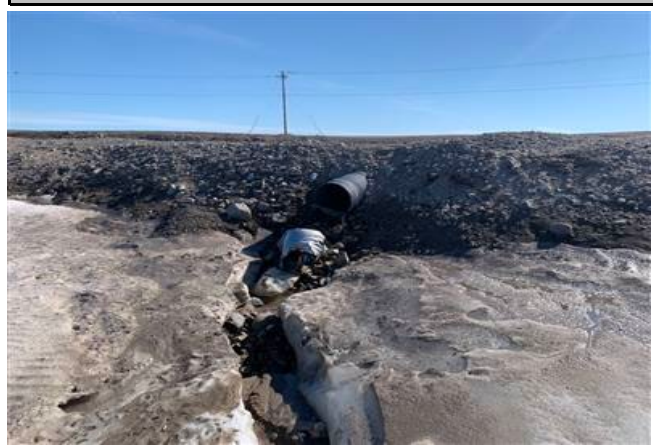
Culvert Condition Ratings (MTO 2013)				
Barrel Material (0-4)	Shape (0-4)	Capacity (0-2)	Erosion and Scour (0-2)	US/DS Channel (0-2)
0	0	0	1	1

Recommended Action(s):	Reinstall culvert at a lower elevation	Priority:	Low
------------------------	--	-----------	-----

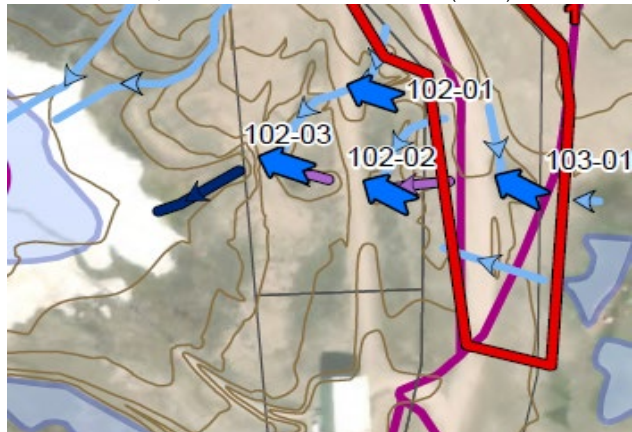
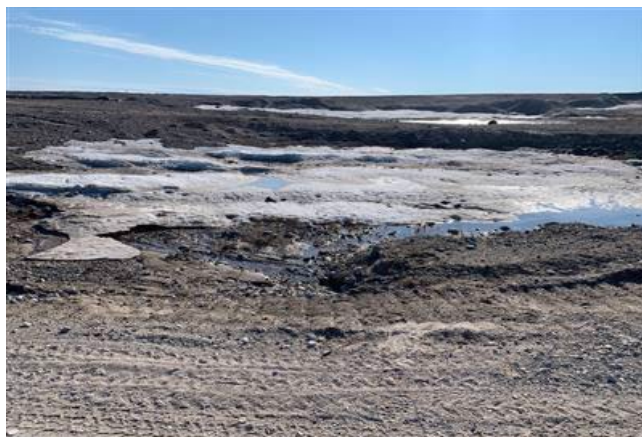
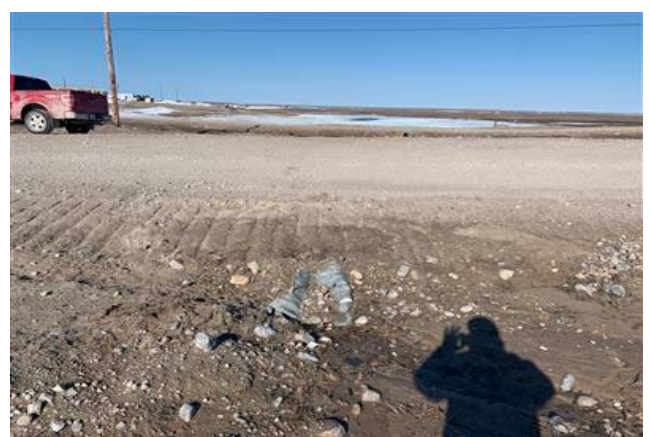
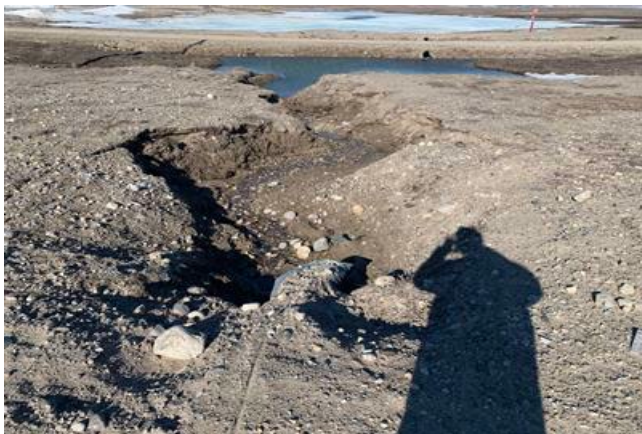
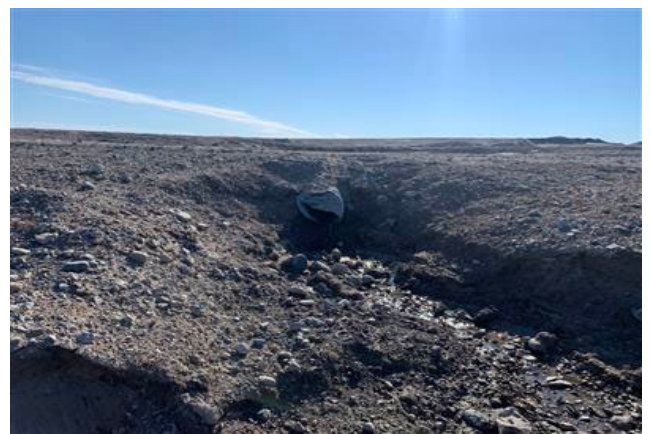
Culvert Information		
Culvert ID		103-01
Type		Cross
Shape		Round
Material		CSP
Diameter or Dimensions (mm)		500
Marker Post Present		No
End	Upstream	Yes
	Downstream	Yes
Infill Depth (mm)	Upstream	5
	Downstream	0
Other Comments	Water ponding upstream, material upstream preventing good drainage. Downstream end perched. Erosion downstream. Isolated culvert. Cant properly drain all upstream ponding in old gravel pit

Culvert Condition Ratings (MTO 2013)				
Barrel Material (0-4)	Shape (0-4)	Capacity (0-2)	Erosion and Scour (0-2)	US/DS Channel (0-2)
0	4	1	1	1

Recommended Action(s):	Replace culvert	Priority:	High
------------------------	-----------------	-----------	------

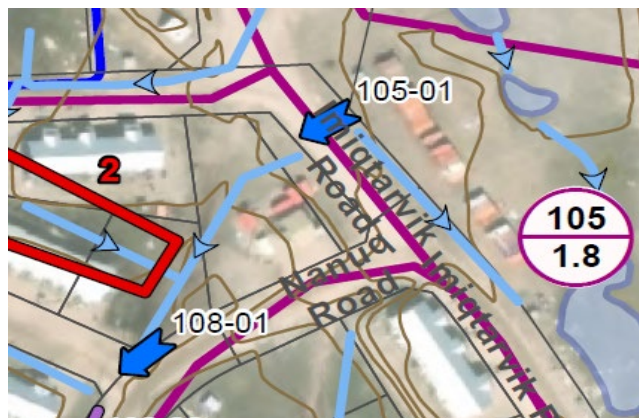
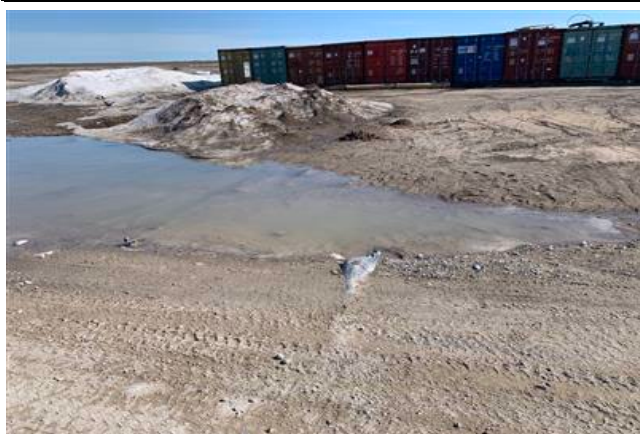
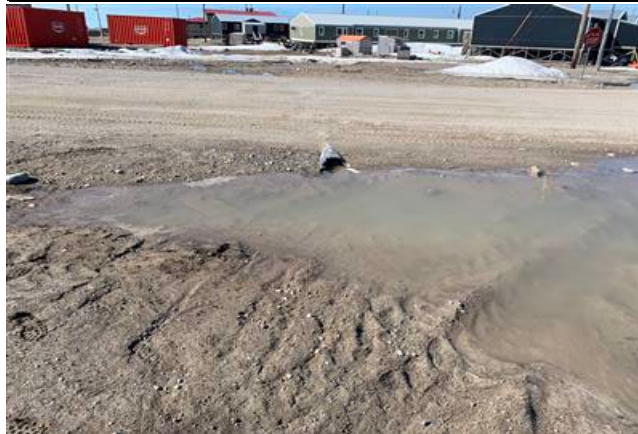
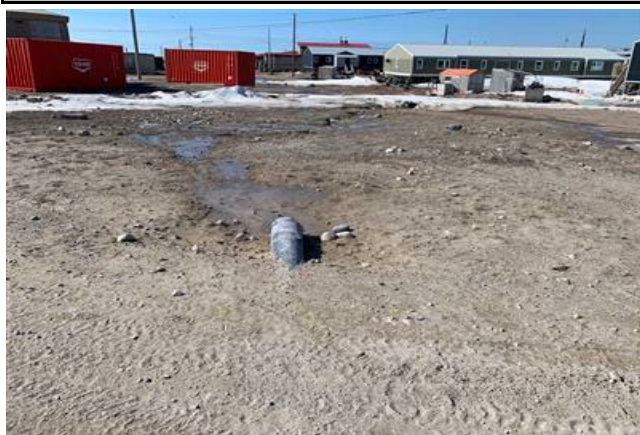
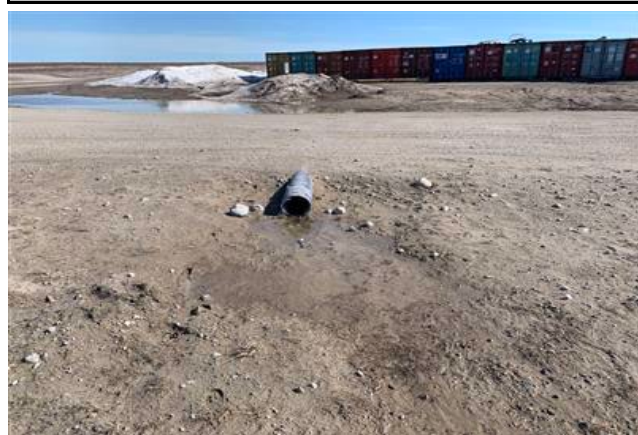
Culvert Information		
Culvert ID		105-01
Type		Cross
Shape		Round
Material		PVC
Diameter or Dimensions (mm)		250
Marker Post Present		No
End Crushing	Upstream	No
	Downstream	No
Infill Depth (mm)	Upstream	50
	Downstream	0
Other Comments	Shallow overburden. Inadequate size, invert elevation too high. Ponding upstream

Culvert Condition Ratings (MTO 2013)				
Barrel Material (0-4)	Shape (0-4)	Capacity (0-2)	Erosion and Scour (0-2)	US/DS Channel (0-2)
0	1	1	0	0

Recommended Action(s):	Reinstall culvert at a lower elevation	Priority:	Low
------------------------	--	-----------	-----

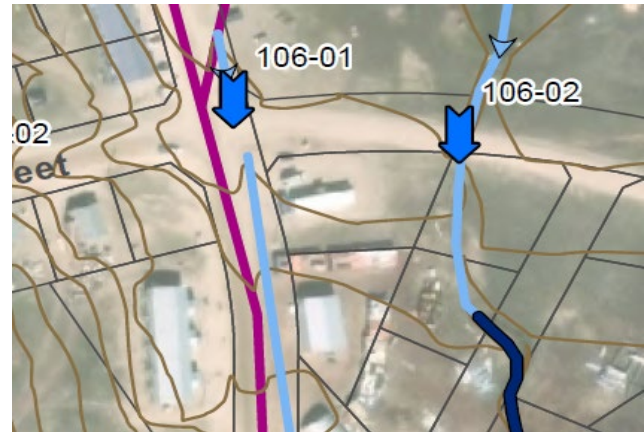
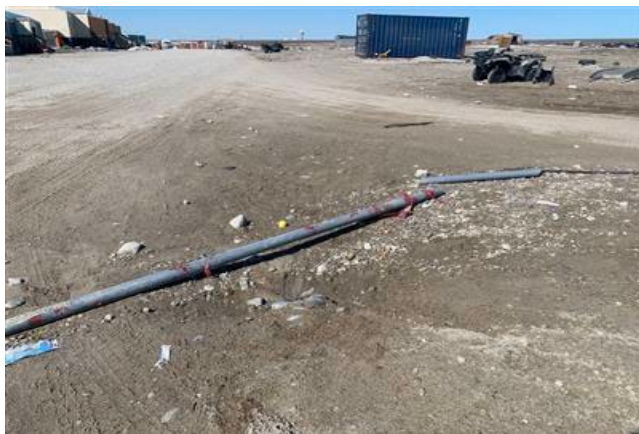
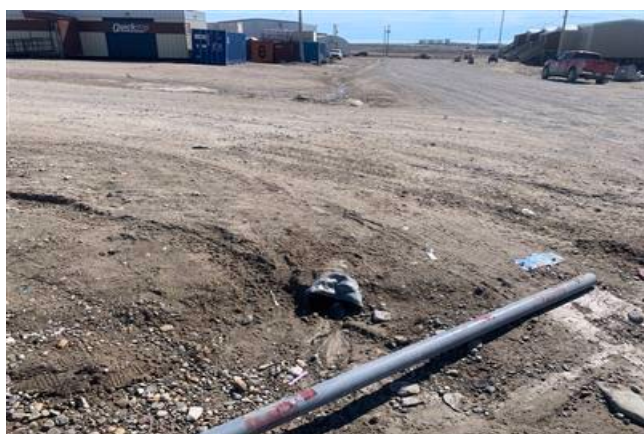
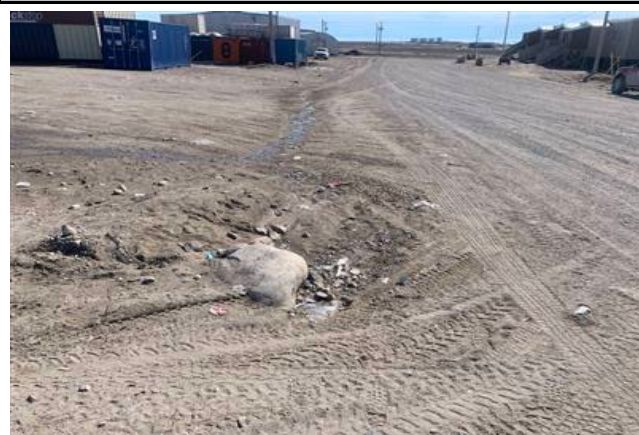
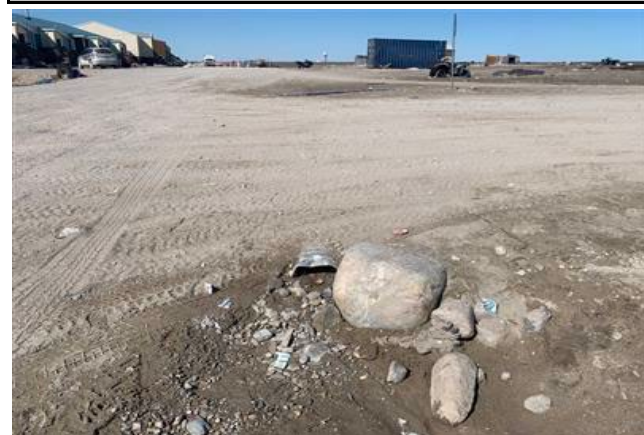
Culvert Condition Ratings (MTO 2013)				
Barrel Material (0-4)	Shape (0-4)	Capacity (0-2)	Erosion and Scour (0-2)	US/DS Channel (0-2)
0	2	2	0	0

Recommended Action(s):	Unblock culvert	Priority:	High
------------------------	-----------------	-----------	------

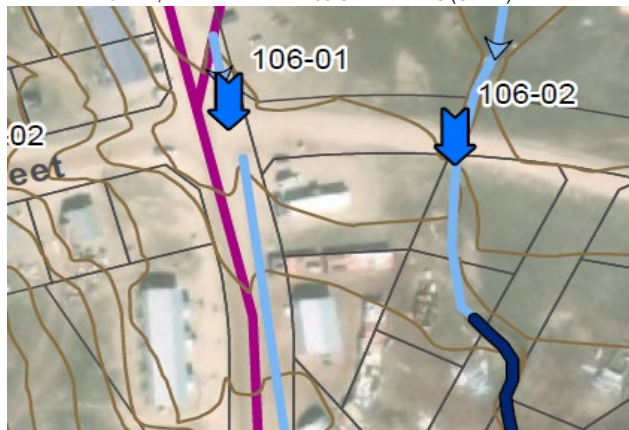
Culvert Information		
Culvert ID		106-01
Type		Cross
Shape		Round
Material		CSP
Diameter or Dimensions (mm)		300
Marker Post Present		No
End	Upstream	Yes
	Downstream	No
Infill Depth (mm)	Upstream	50
	Downstream	100
Other Comments	Upstream end is under water. Blocked, potentially frozen inside.

Culvert Condition Ratings (MTO 2013)				
Barrel Material (0-4)	Shape (0-4)	Capacity (0-2)	Erosion and Scour (0-2)	US/DS Channel (0-2)
0	1	2	0	0

Recommended Action(s):	Flush culvert	Priority:	High
------------------------	---------------	-----------	------

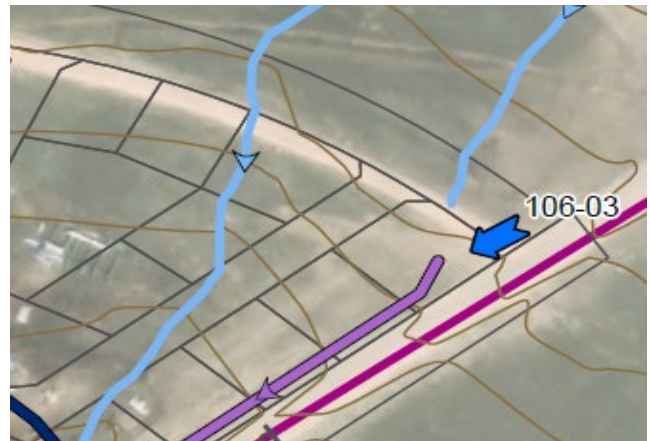
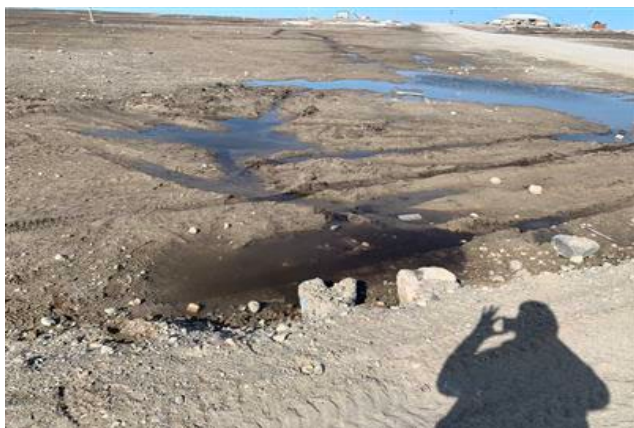
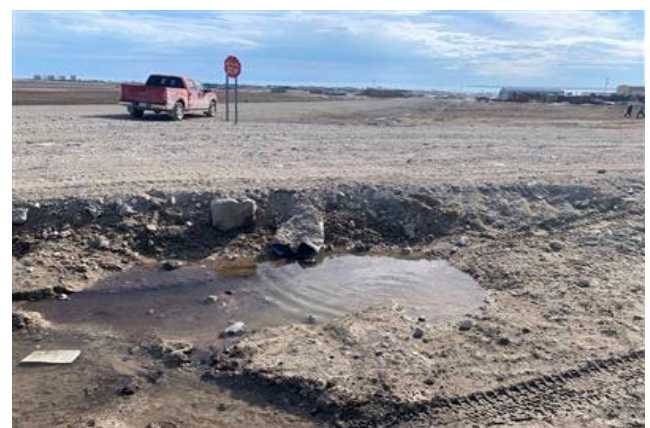
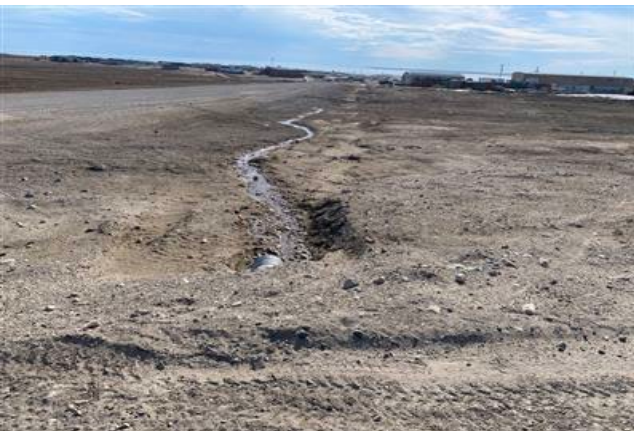
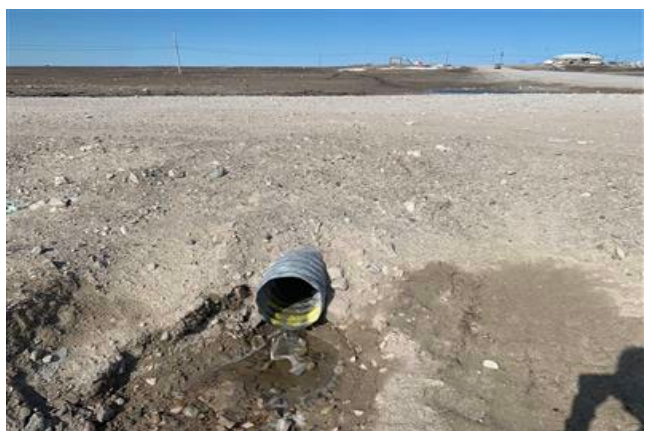
Culvert Information		
Culvert ID		106-03
Type		Cross
Shape		Round
Material		CSP
Diameter or Dimensions (mm)		300
Marker Post Present		No
End	Upstream	Yes
	Downstream	No
Infill Depth (mm)	Upstream	0
	Downstream	0
Other Comments	Minor perched upstream and downstream. Ponding upstream

Culvert Condition Ratings (MTO 2013)				
Barrel Material (0-4)	Shape (0-4)	Capacity (0-2)	Erosion and Scour (0-2)	US/DS Channel (0-2)
0	4	0	1	1

Recommended Action(s):	Replace culvert at a lower elevation	Priority:	High
------------------------	--------------------------------------	-----------	------

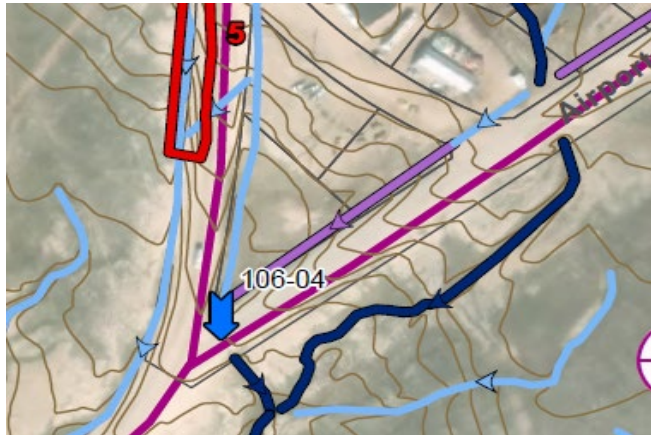
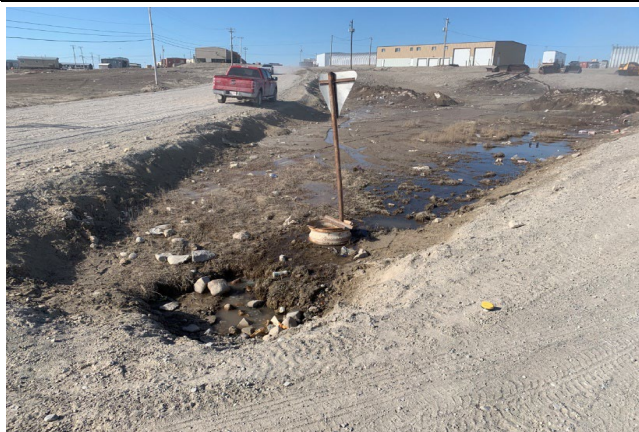
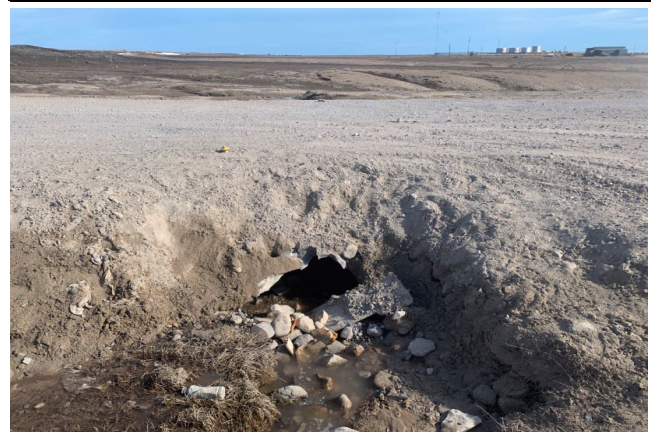
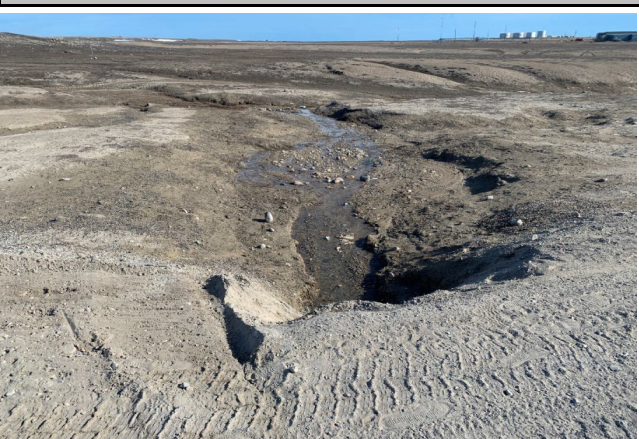
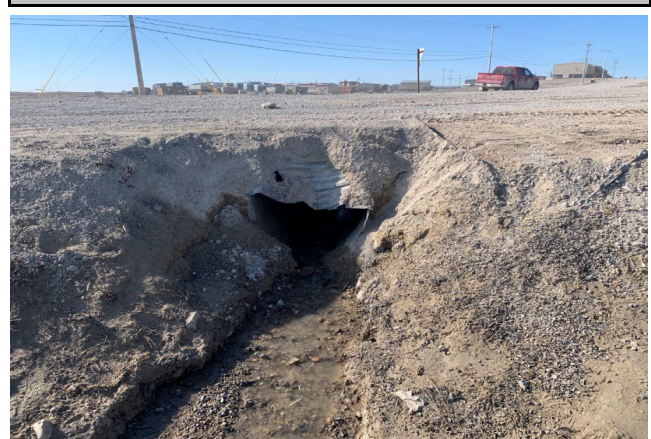
Culvert Information		
Culvert ID		106-04
Type		Cross
Shape		Round
Material		CSP
Diameter or Dimensions (mm)		900
Marker Post Present		No
End	Upstream	Yes
	Downstream	Yes
Infill Depth (mm)	Upstream	50
	Downstream	0
Other Comments	Few debris(rock, wood) at culvert inlet

Culvert Condition Ratings (MTO 2013)				
Barrel Material (0-4)	Shape (0-4)	Capacity (0-2)	Erosion and Scour (0-2)	US/DS Channel (0-2)
0	2	1	1	0

Recommended Action(s):	None	Priority:	Medium
------------------------	------	-----------	--------

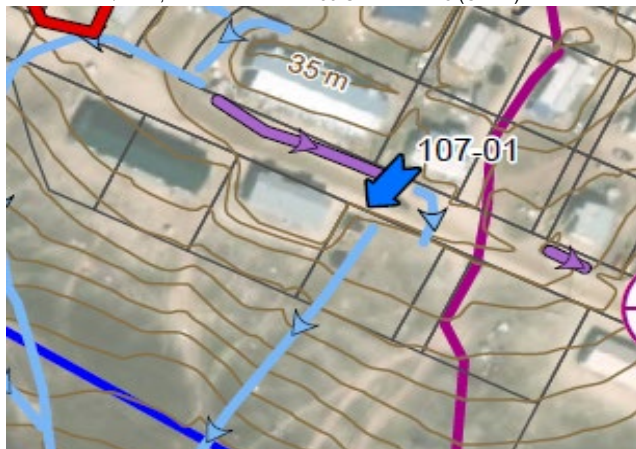
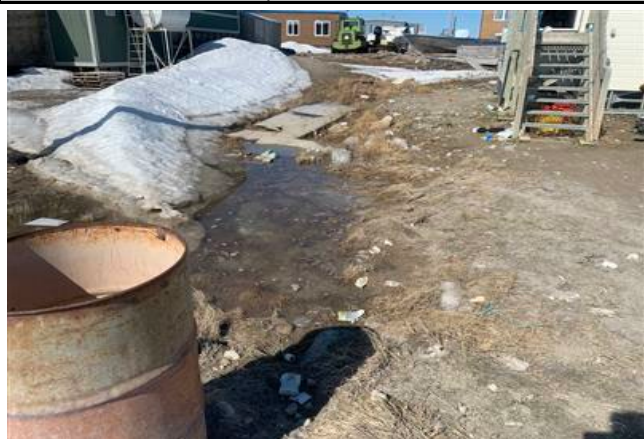
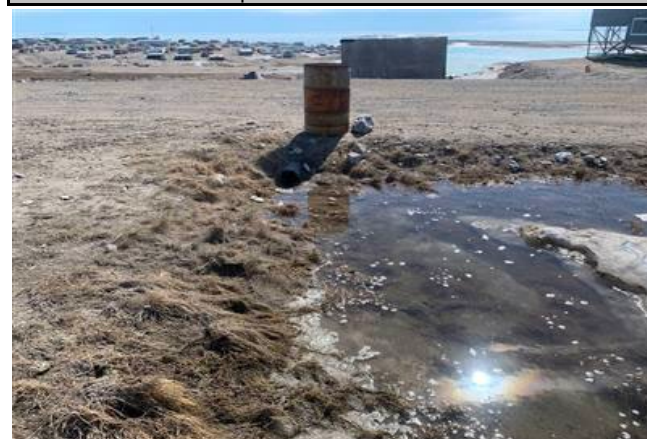
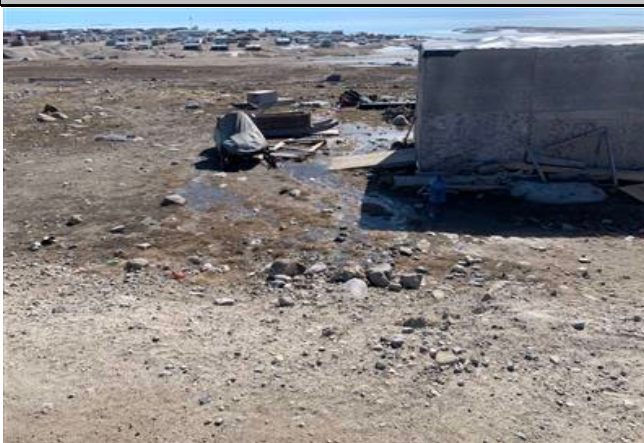
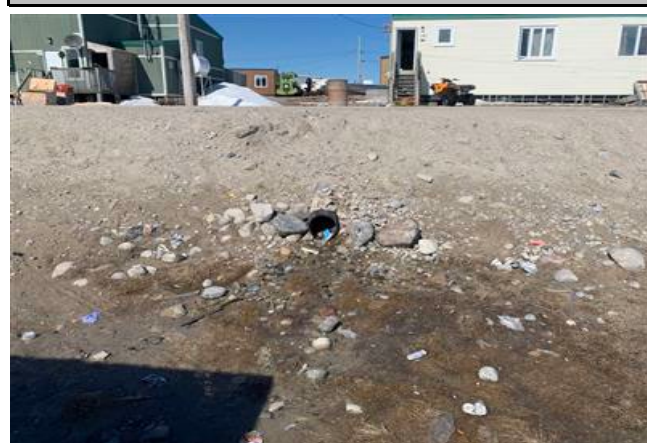
Culvert Information		
Culvert ID		107-01
Type		Cross
Shape		Round
Material		PVC
Diameter or Dimensions (mm)		250
Marker Post Present		No
End Crushing	Upstream	No
	Downstream	No
Infill Depth (mm)	Upstream	50
	Downstream	0
Other Comments		Ponding upstream, no flow through to downstream end. Upstream end likely block.

Culvert Condition Ratings (MTO 2013)				
Barrel Material (0-4)	Shape (0-4)	Capacity (0-2)	Erosion and Scour (0-2)	US/DS Channel (0-2)
0	0	2	0	0

Recommended Action(s):	Unblock culvert	Priority:	High
------------------------	-----------------	-----------	------
