Geotechnical Investigation and Drainage Planning in Gjoa Haven, Nunavut

Gjoa Haven, NU

Final Report

September 2023

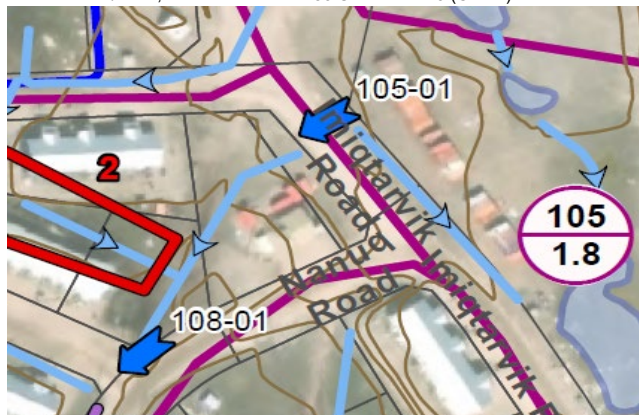
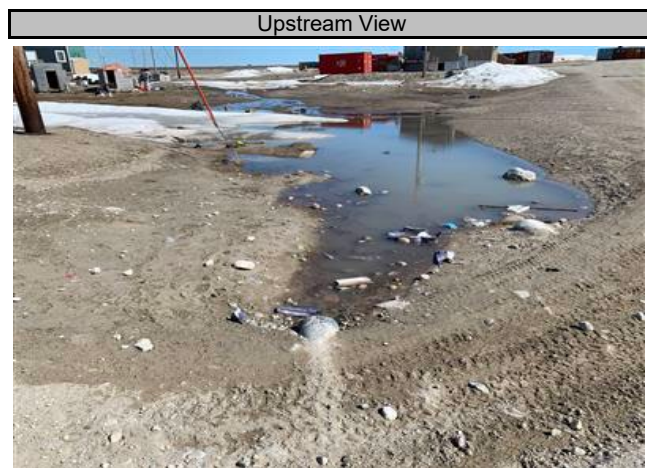
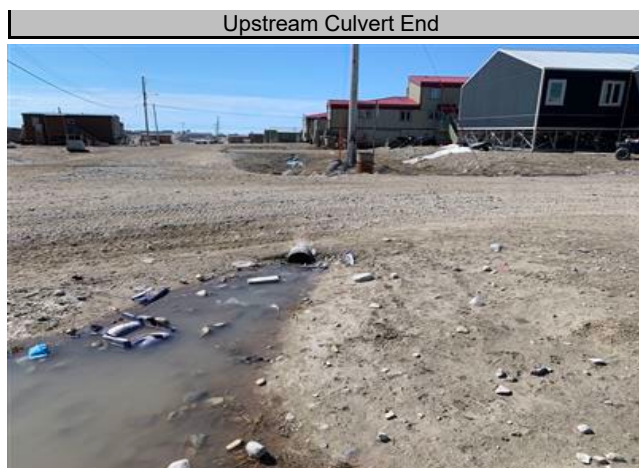
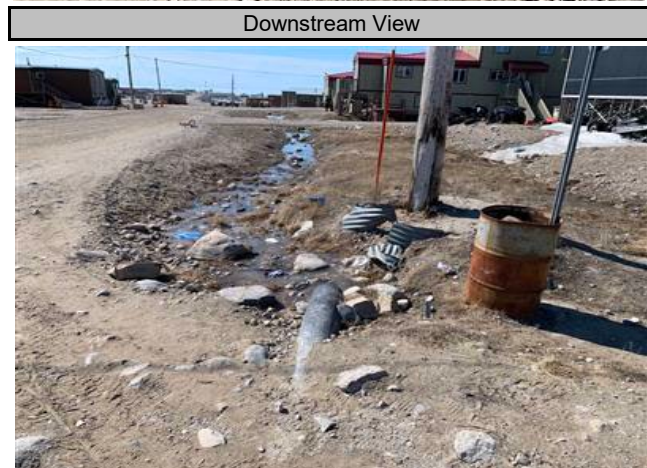
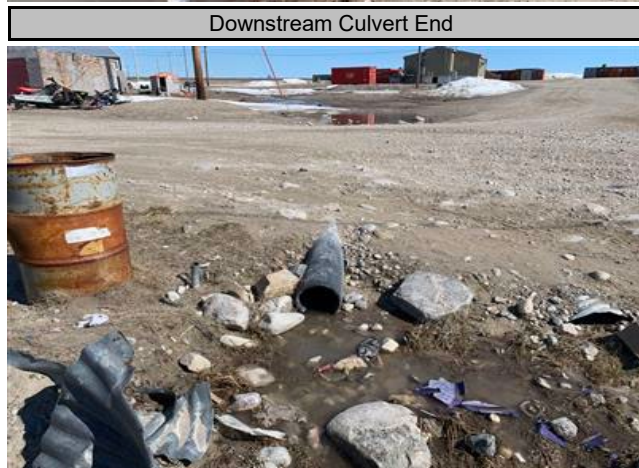
Culvert Information		
Culvert ID		108-01
Type		Entrance
Shape		Round
Material		PVC
Diameter or Dimensions (mm)		250
Marker Post Present		No
End	Upstream	No
	Downstream	No
Infill Depth (mm)	Upstream	50
	Downstream	0
Other Comments	Ponding upstream, shallow overburden.

Culvert Condition Ratings (MTO 2013)				
Barrel Material (0-4)	Shape (0-4)	Capacity (0-2)	Erosion and Scour (0-2)	US/DS Channel (0-2)
0	0	1	0	2

Recommended Action(s):	Regrade upstream ditch	Priority:	High
------------------------	------------------------	-----------	------

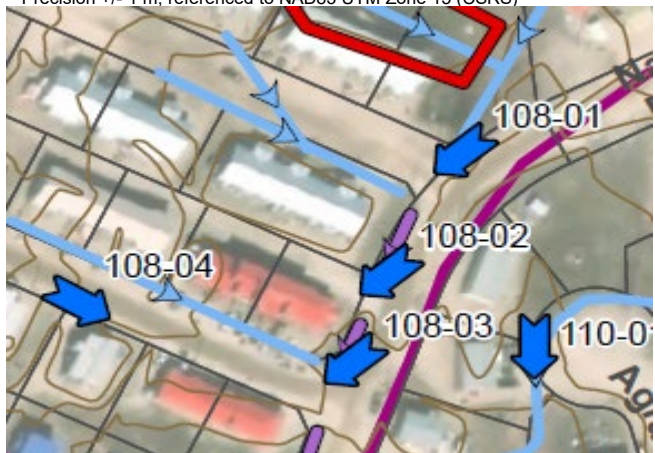
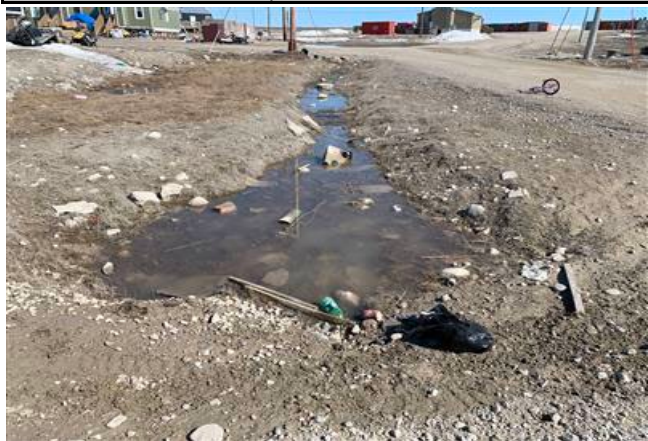
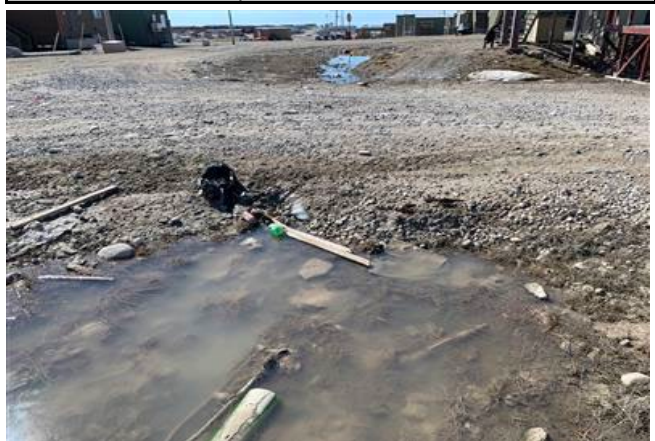
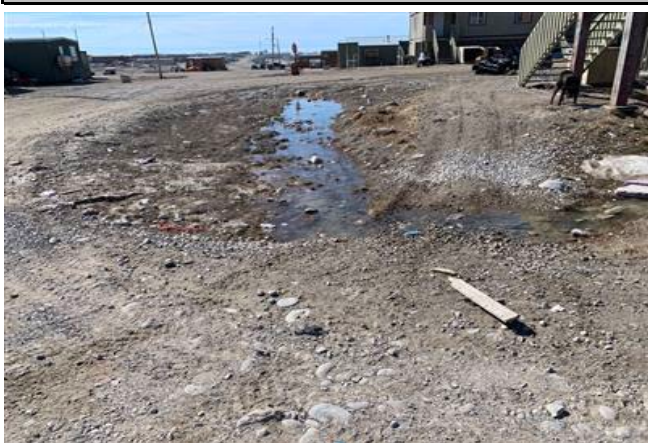
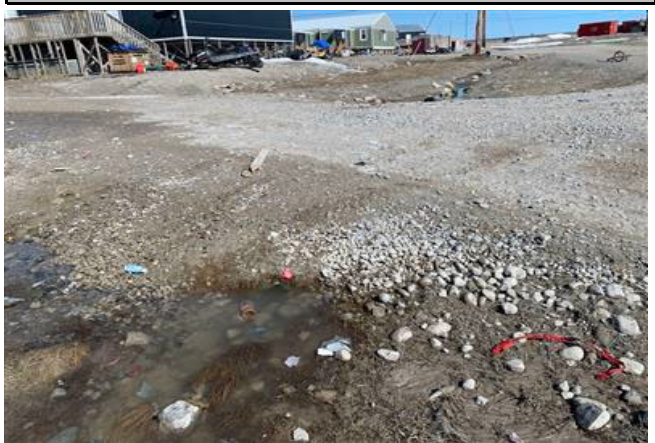
Culvert Information		
Culvert ID		108-02
Type		Entrance
Shape		Round
Material		CSP
Diameter or Dimensions (mm)		400
Marker Post Present		No
End	Upstream	Yes
	Downstream	Yes
Infill Depth (mm)	Upstream	200
	Downstream	350
Other Comments		Ponding, garbage and infill upstream. Downstream end partially buried

Culvert Condition Ratings (MTO 2013)				
Barrel Material (0-4)	Shape (0-4)	Capacity (0-2)	Erosion and Scour (0-2)	US/DS Channel (0-2)
0	0	2	0	1

Recommended Action(s):	Unblock culvert	Priority:	High
------------------------	-----------------	-----------	------

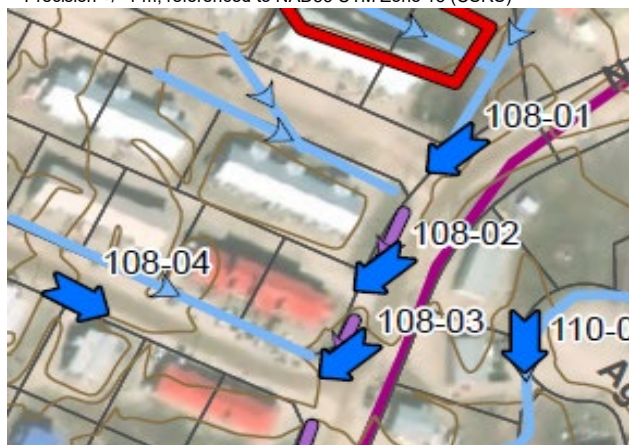
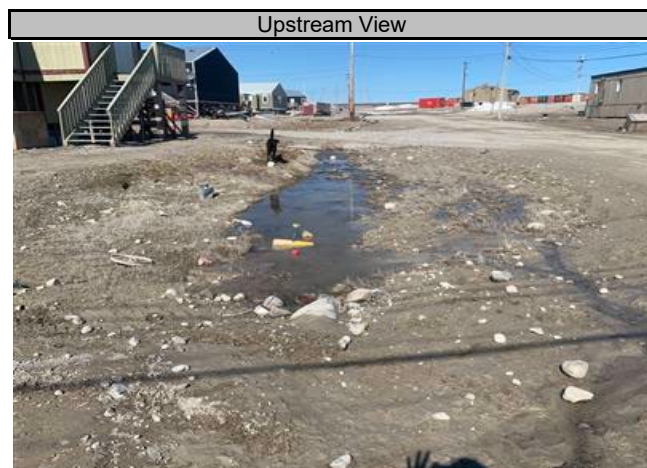
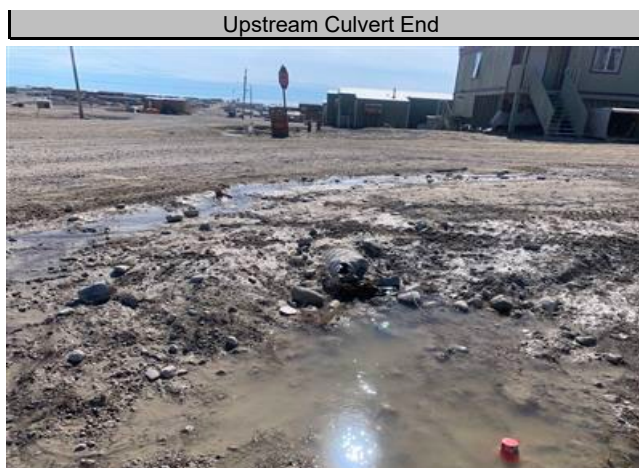
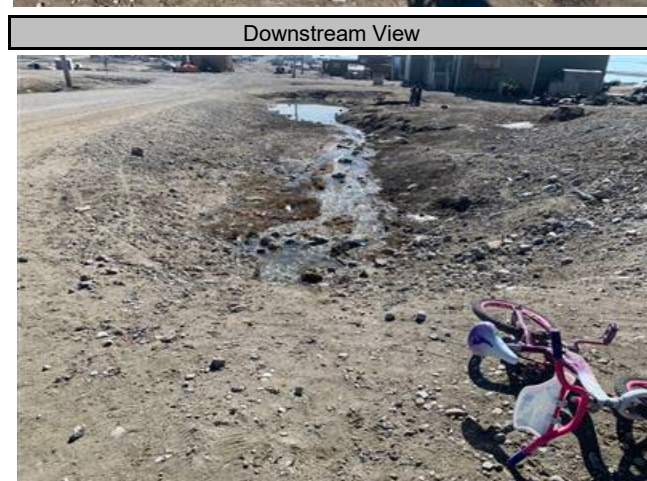
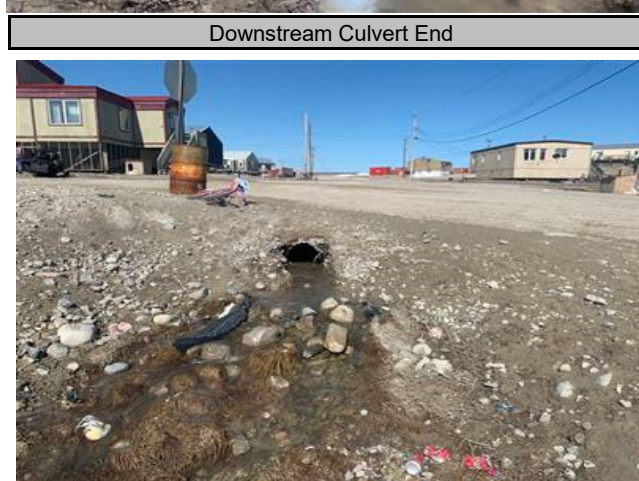
Culvert Information		
Culvert ID		108-03
Type		Cross
Shape		Round
Material		CSP
Diameter or Dimensions (mm)		500
Marker Post Present		No
End	Upstream	Yes
	Downstream	Yes
Infill Depth (mm)	Upstream	0
	Downstream	0
Other Comments	Ponding upstream. Should clean upstream ditch to better drain

Culvert Condition Ratings (MTO 2013)				
Barrel Material (0-4)	Shape (0-4)	Capacity (0-2)	Erosion and Scour (0-2)	US/DS Channel (0-2)
0	1	0	0	2

Recommended Action(s):	Regrade upstream ditch	Priority:	High
------------------------	------------------------	-----------	------

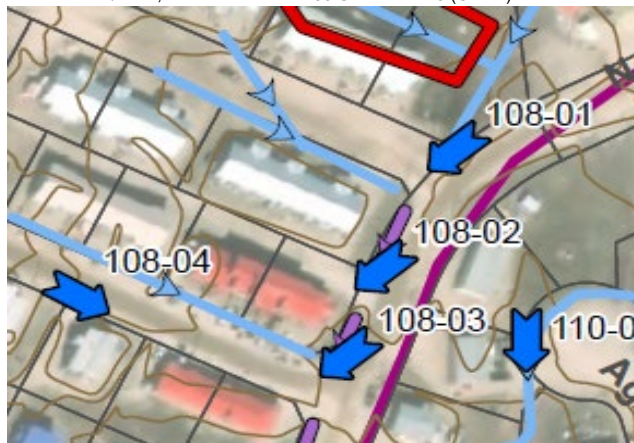
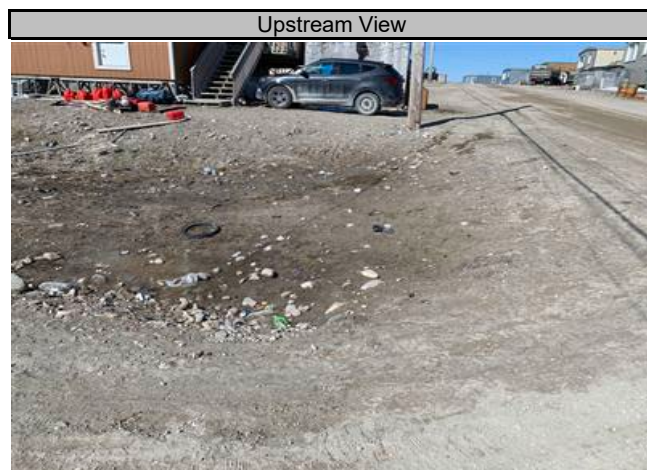
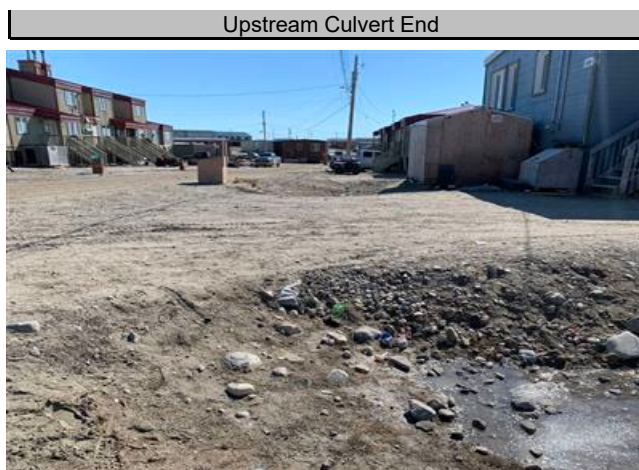
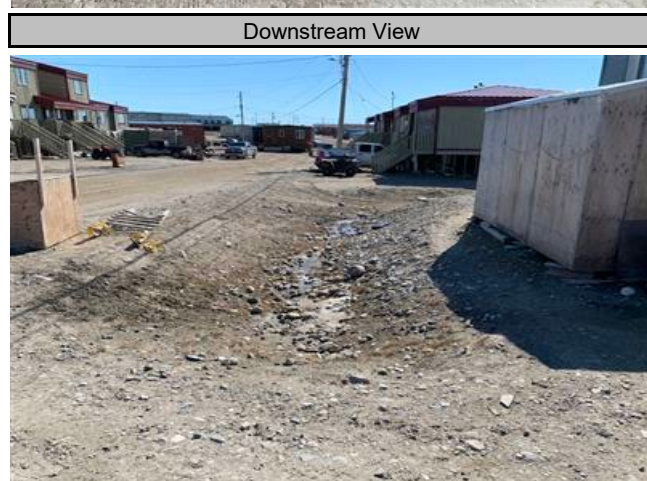
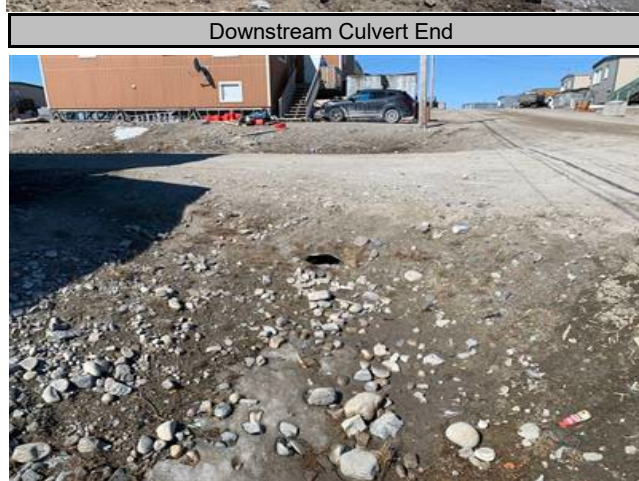
Culvert Information		
Culvert ID		108-04
Type		Entrance
Shape		Round
Material		CSP
Diameter or Dimensions (mm)		400
Marker Post Present		No
End	Upstream	Yes
	Downstream	No
Infill Depth (mm)	Upstream	50
	Downstream	150
Other Comments		None

Culvert Condition Ratings (MTO 2013)				
Barrel Material (0-4)	Shape (0-4)	Capacity (0-2)	Erosion and Scour (0-2)	US/DS Channel (0-2)
0	1	2	0	0

Recommended Action(s):	Unblock culvert	Priority:	High
------------------------	-----------------	-----------	------

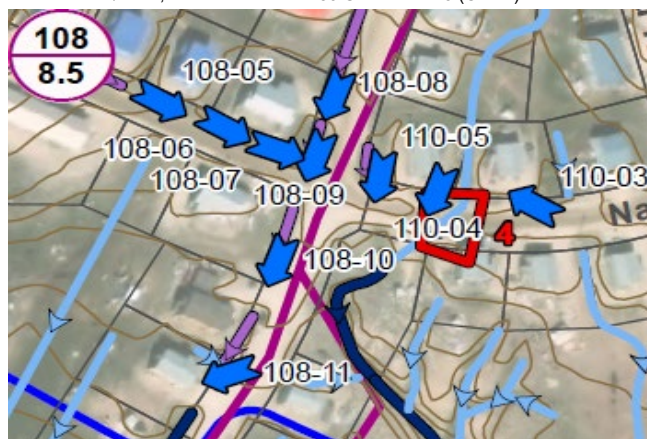
Culvert Information		
Culvert ID		108-05
Type		Entrance
Shape		Round
Material		PVC
Diameter or Dimensions (mm)		250
Marker Post Present		No
End	Upstream	Yes
	Downstream	No
Infill Depth (mm)	Upstream	0
	Downstream	50
Other Comments		Shallow overburden. Upstream invert is too high. Poor drainage efficiency

Culvert Condition Ratings (MTO 2013)				
Barrel Material (0-4)	Shape (0-4)	Capacity (0-2)	Erosion and Scour (0-2)	US/DS Channel (0-2)
0	1	1	0	2

Recommended Action(s):	Reinstall culvert at a lower elevation	Priority:	High
------------------------	--	-----------	------

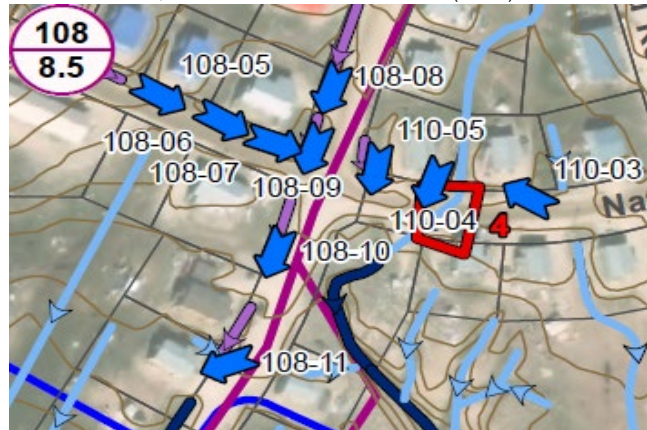
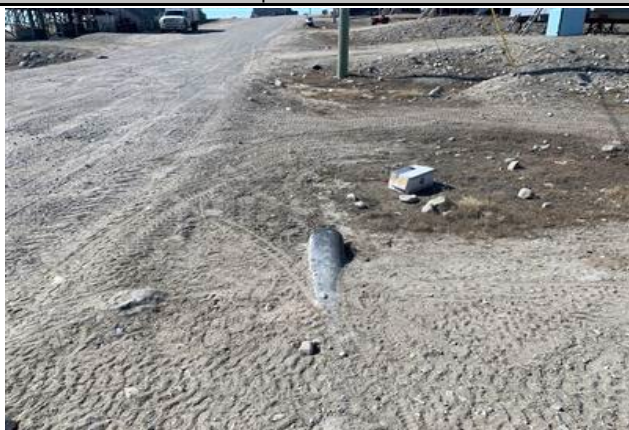
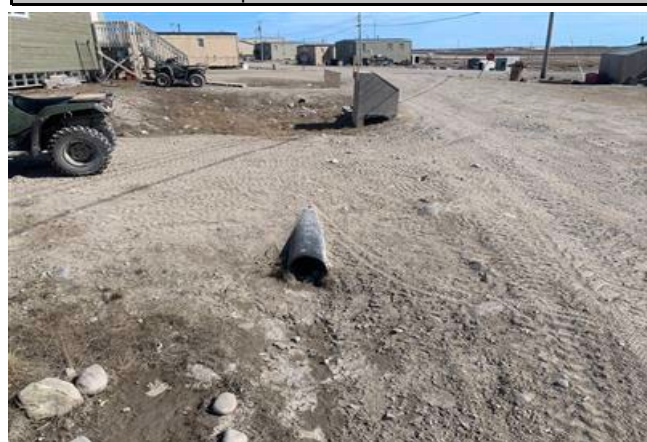
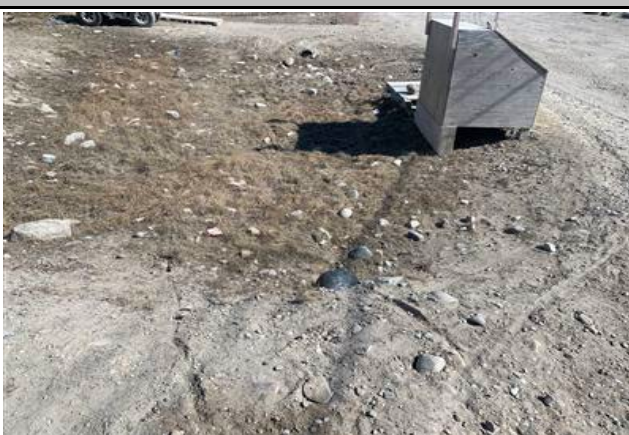
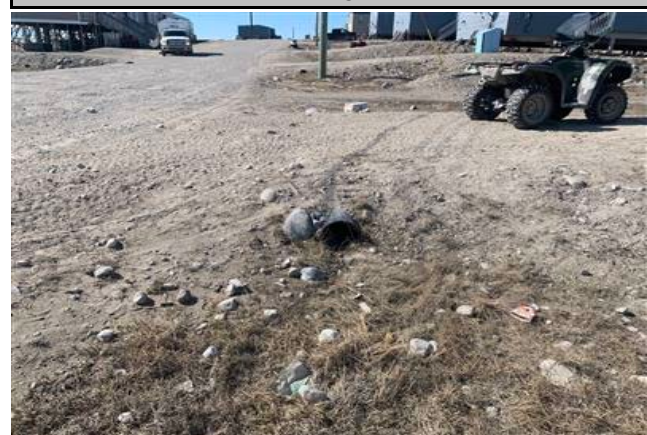
Culvert Information		
Culvert ID		108-06
Type		Entrance
Shape		Round
Material		PVC
Diameter or Dimensions (mm)		250
Marker Post Present		No
End Crushing	Upstream	No
	Downstream	No
Infill Depth (mm)	Upstream	0
	Downstream	0
Other Comments	Culvert invert too high.

Culvert Condition Ratings (MTO 2013)				
Barrel Material (0-4)	Shape (0-4)	Capacity (0-2)	Erosion and Scour (0-2)	US/DS Channel (0-2)
0	0	2	0	2

Recommended Action(s):	Reinstall culvert at a lower elevation	Priority:	High
------------------------	--	-----------	------

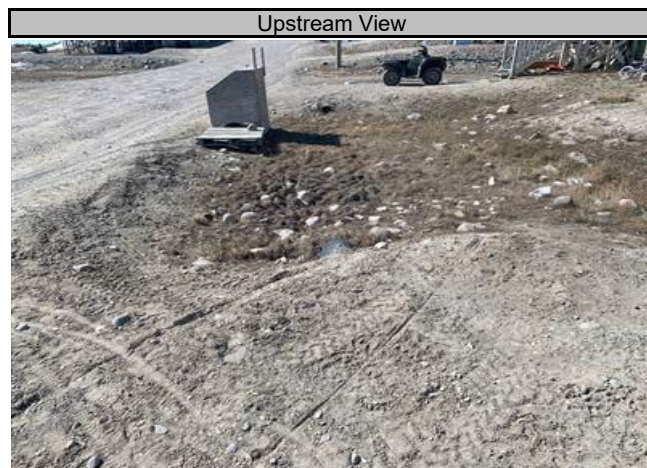
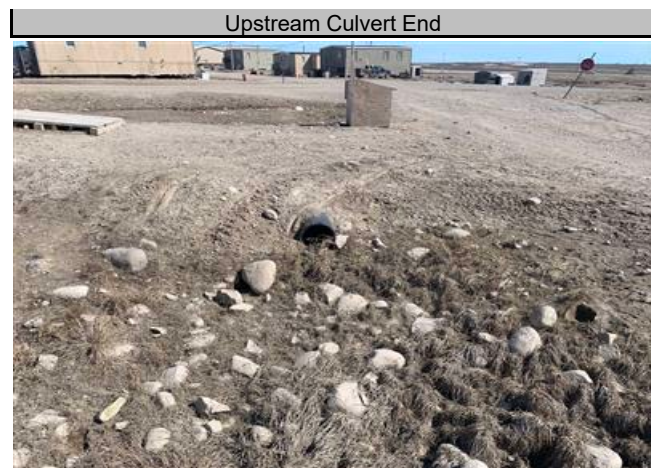
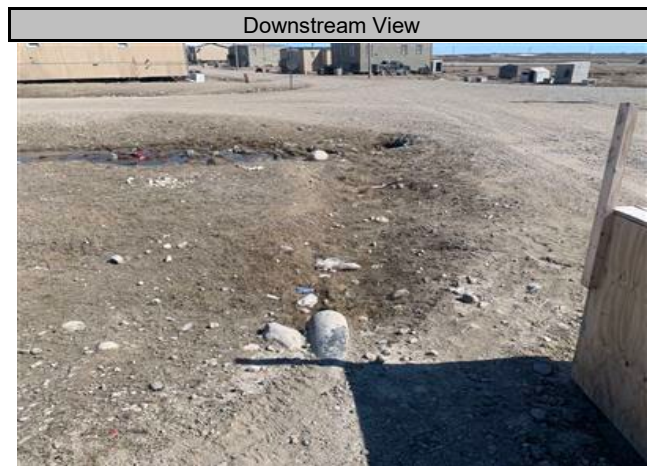
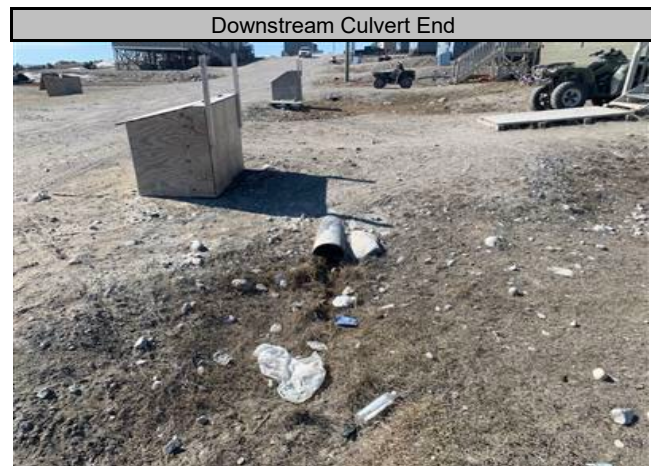
Culvert Information		
Culvert ID		108-07
Type		Entrance
Shape		Round
Material		PVC
Diameter or Dimensions (mm)		250
Marker Post Present		No
End	Upstream	No
	Downstream	No
Infill Depth (mm)	Upstream	0
	Downstream	0
Other Comments		Upstream invert high. Appears to pond upstream.

Culvert Condition Ratings (MTO 2013)				
Barrel Material (0-4)	Shape (0-4)	Capacity (0-2)	Erosion and Scour (0-2)	US/DS Channel (0-2)
0	0	0	0	2

Recommended Action(s):	Reinstall culvert at a lower elevation	Priority:	High
------------------------	--	-----------	------

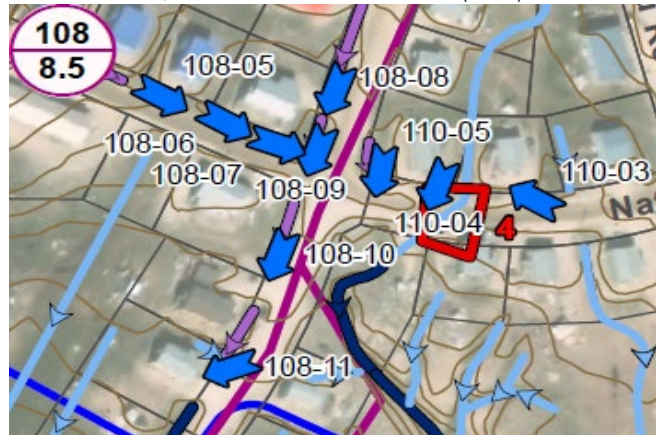
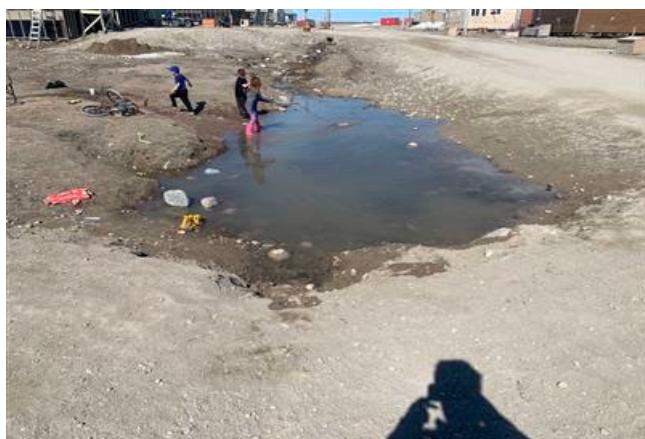
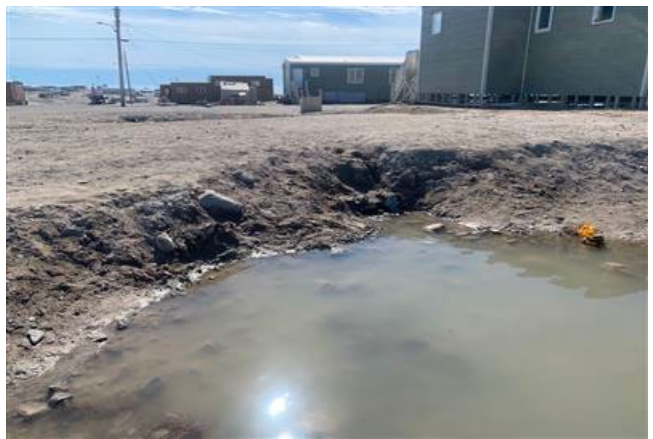
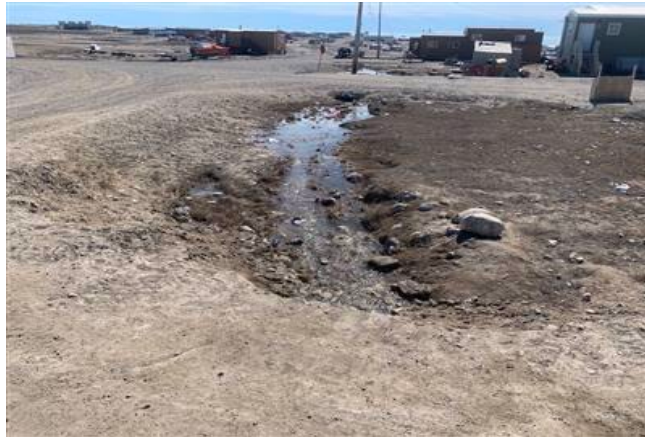
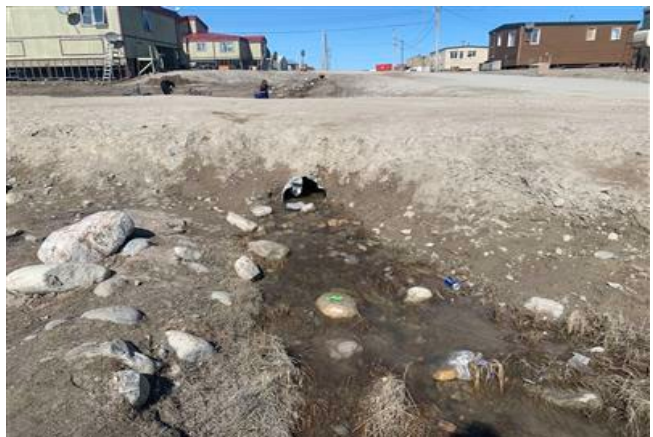
Culvert Information		
Culvert ID		108-08
Type		Entrance
Shape		Round
Material		CSP
Diameter or Dimensions (mm)		500
Marker Post Present		No
End Crushing	Upstream	Yes
	Downstream	Yes
Infill Depth (mm)	Upstream	200
	Downstream	100
Other Comments		Major ponding upstream. Better defined ditch would help

Culvert Condition Ratings (MTO 2013)				
Barrel Material (0-4)	Shape (0-4)	Capacity (0-2)	Erosion and Scour (0-2)	US/DS Channel (0-2)
0	1	2	1	2

Recommended Action(s):	Regrade ditch, flush culvert	Priority:	High
------------------------	------------------------------	-----------	------

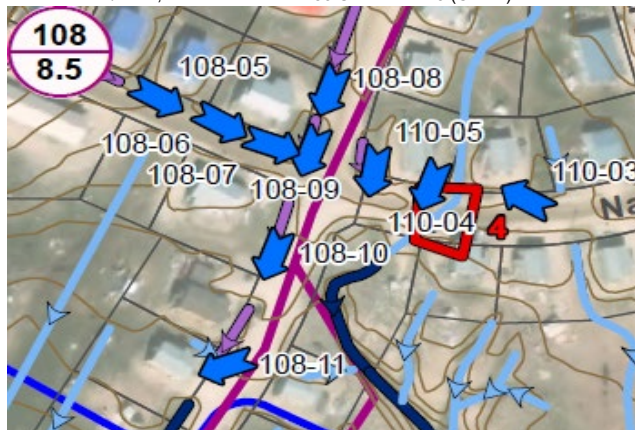
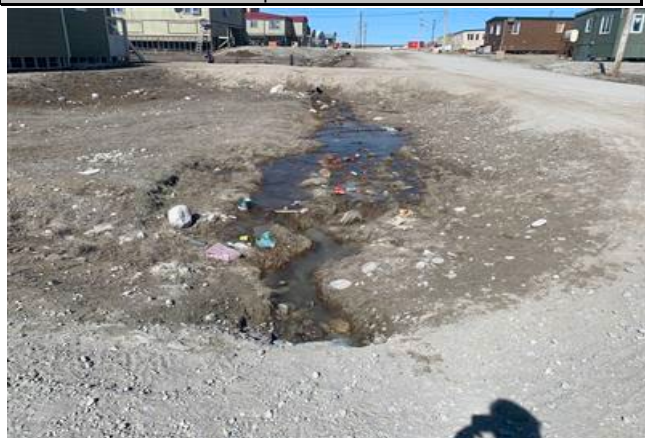
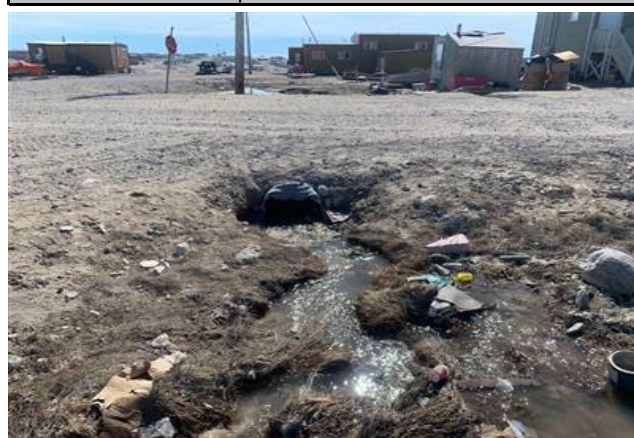
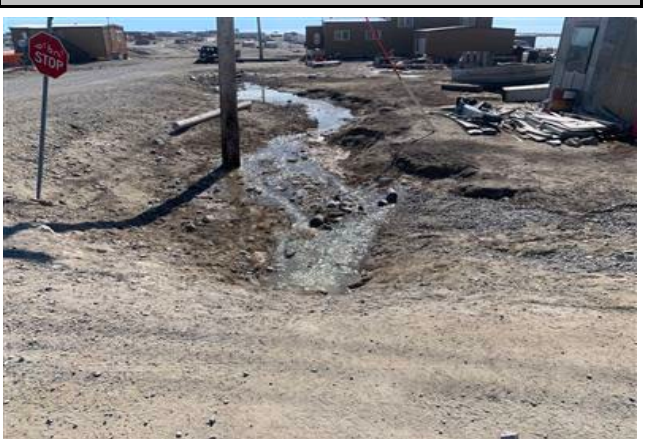
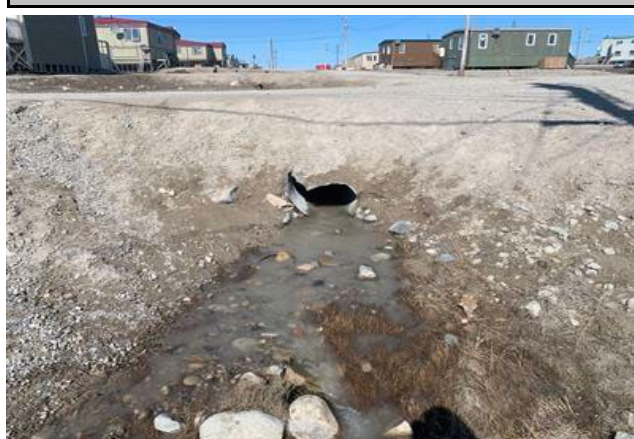
Culvert Information		
Culvert ID		108-09
Type		Cross
Shape		Round
Material		CSP
Diameter or Dimensions (mm)		500
Marker Post Present		No
End	Upstream	Yes
	Downstream	Yes
Infill Depth (mm)	Upstream	50
	Downstream	0
Other Comments		None

Culvert Condition Ratings (MTO 2013)				
Barrel Material (0-4)	Shape (0-4)	Capacity (0-2)	Erosion and Scour (0-2)	US/DS Channel (0-2)
0	2	1	1	0

Recommended Action(s):	Flush culvert	Priority:	Medium
------------------------	---------------	-----------	--------

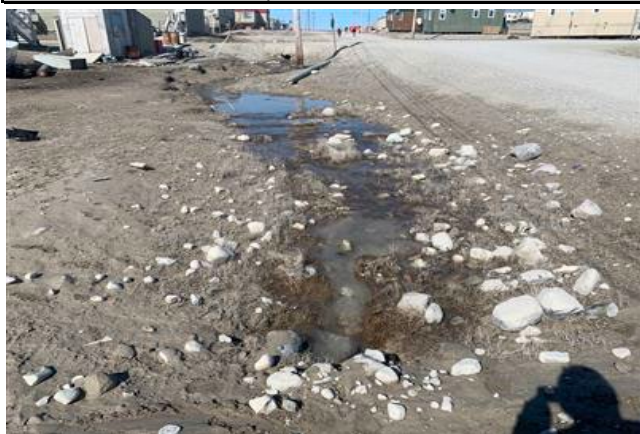
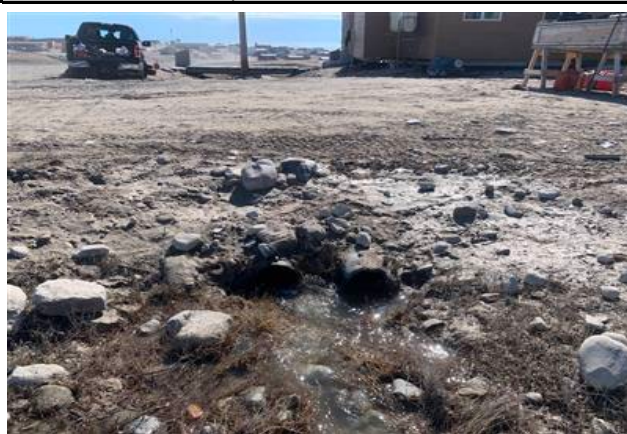
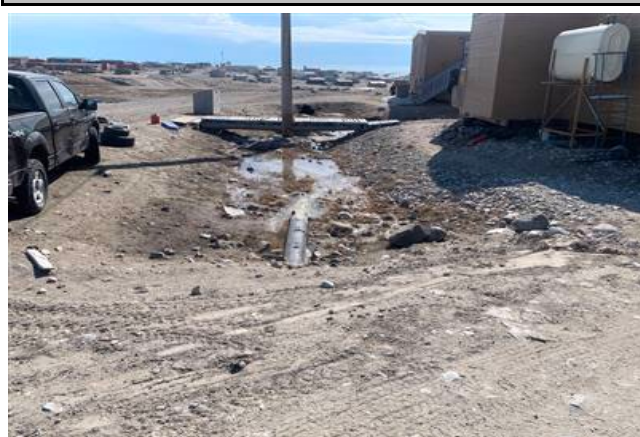
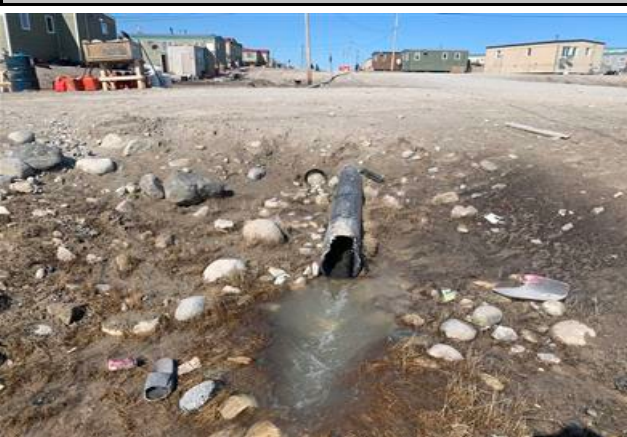
Culvert Information		
Culvert ID		108-10
Type		Entrance
Shape		Round
Material		PVC
Diameter or Dimensions (mm)		250
Marker Post Present		No
End Crushing	Upstream	No
	Downstream	Yes
Infill Depth (mm)	Upstream	0
	Downstream	0
Other Comments		Some ponding upstream. Ditch undefined. Two culverts. One is flowing the other is blocked.

Culvert Condition Ratings (MTO 2013)				
Barrel Material (0-4)	Shape (0-4)	Capacity (0-2)	Erosion and Scour (0-2)	US/DS Channel (0-2)
0	0	1	1	2

Recommended Action(s):	Regrade ditch, flush culvert	Priority:	High
------------------------	------------------------------	-----------	------

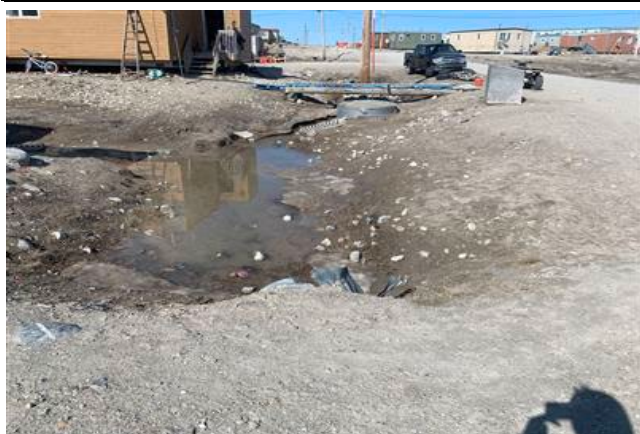
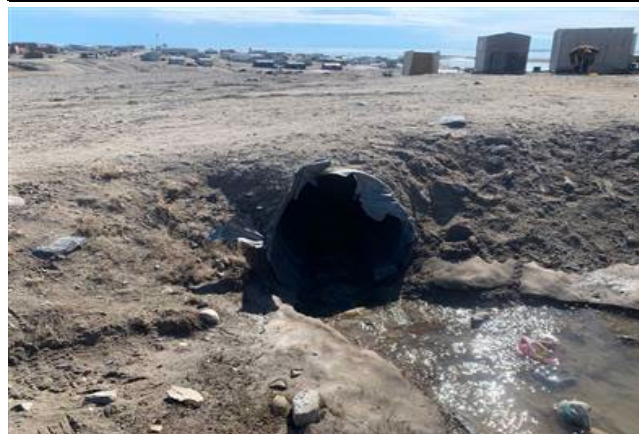
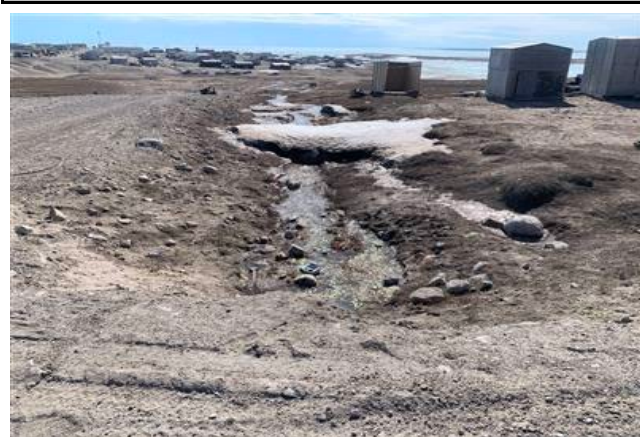
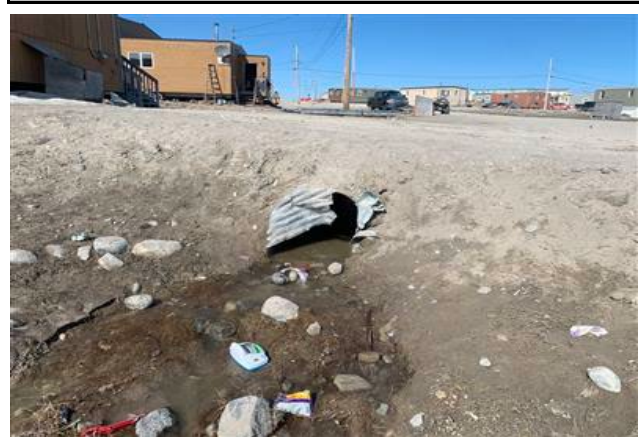
Culvert Information		
Culvert ID		108-11
Type		Entrance
Shape		Round
Material		CSP
Diameter or Dimensions (mm)		900
Marker Post Present		No
End	Upstream	Yes
	Downstream	Yes
Infill Depth (mm)	Upstream	0
	Downstream	50
Other Comments		None

Culvert Condition Ratings (MTO 2013)				
Barrel Material (0-4)	Shape (0-4)	Capacity (0-2)	Erosion and Scour (0-2)	US/DS Channel (0-2)
0	2	1	1	0

Recommended Action(s):	Remove bent CSP at the downstream end	Priority:	Medium
------------------------	---------------------------------------	-----------	--------

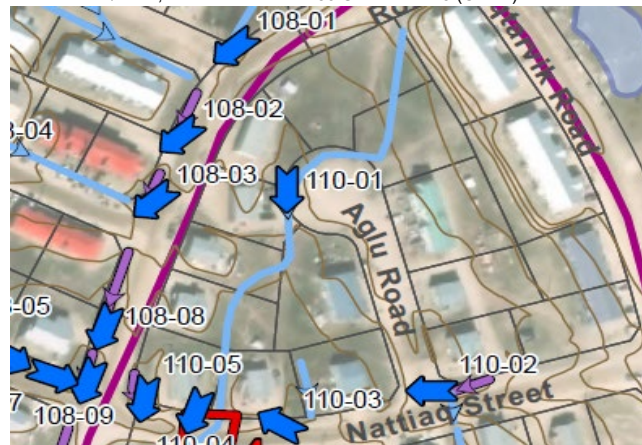
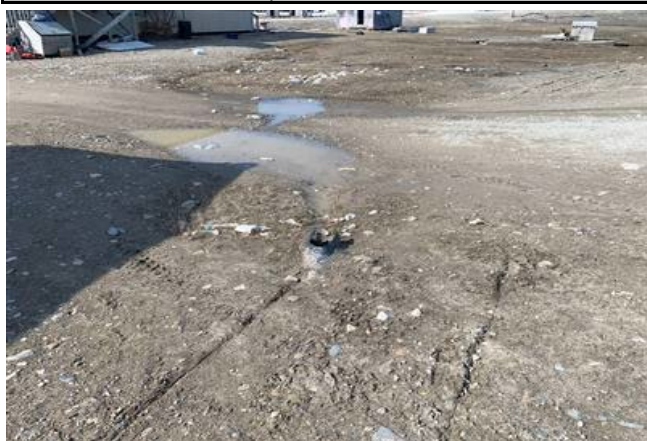
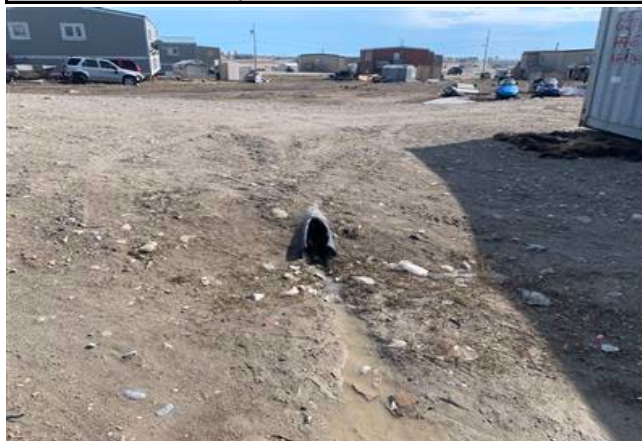
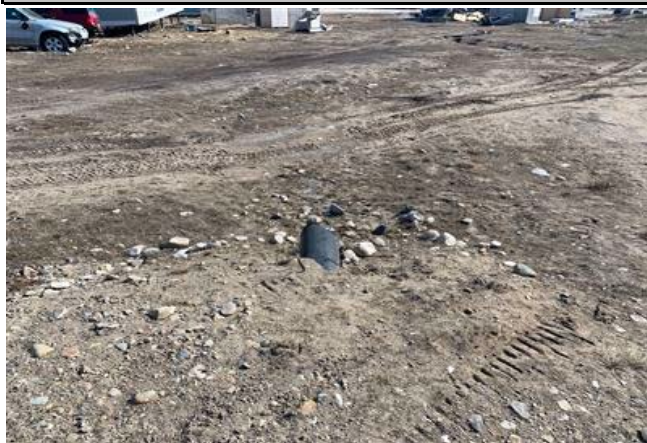
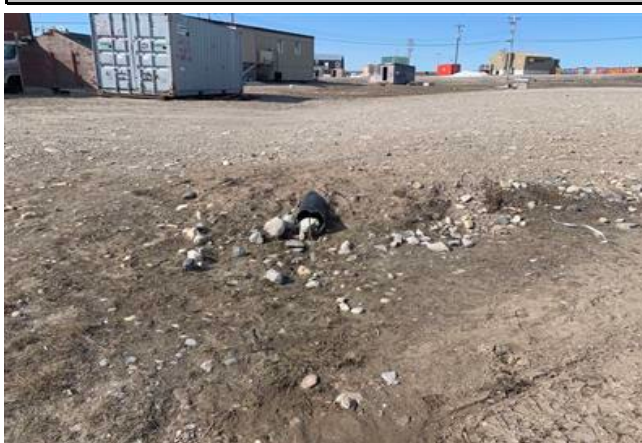
Culvert Information		
Culvert ID		110-01
Type		Entrance
Shape		Round
Material		PVC
Diameter or Dimensions (mm)		250
Marker Post Present		No
End	Upstream	No
	Downstream	No
Infill Depth (mm)	Upstream	0
	Downstream	0
Other Comments		Shallow overburden, perched at the downstream end (minor)

Culvert Condition Ratings (MTO 2013)				
Barrel Material (0-4)	Shape (0-4)	Capacity (0-2)	Erosion and Scour (0-2)	US/DS Channel (0-2)
0	1	0	0	2

Recommended Action(s):	Reinstall culvert at a lower elevation	Priority:	High
------------------------	--	-----------	------

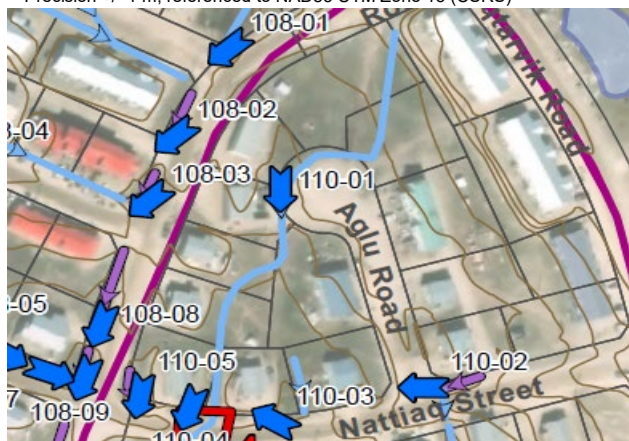
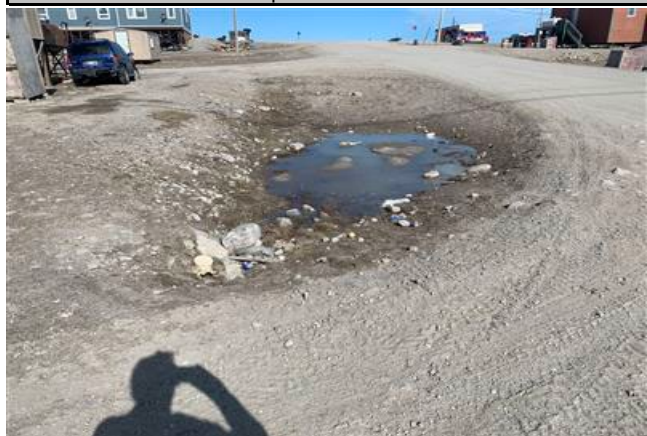
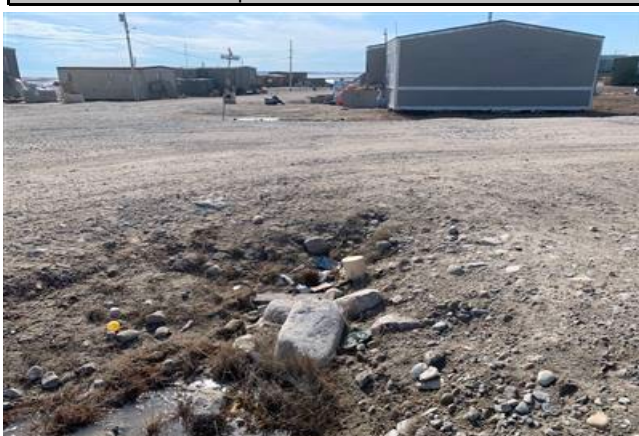
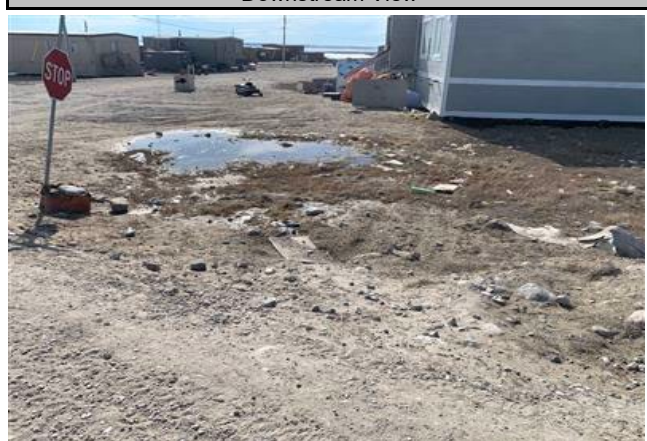
Culvert Information		
Culvert ID		110-02
Type		Cross
Shape		Round
Material		CSP
Diameter or Dimensions (mm)		500
Marker Post Present		No
End	Upstream	?
	Downstream	Yes
Infill Depth (mm)	Upstream	500
	Downstream	200
Other Comments		Upstream buried. Does not work. Need repair

Culvert Condition Ratings (MTO 2013)				
Barrel Material (0-4)	Shape (0-4)	Capacity (0-2)	Erosion and Scour (0-2)	US/DS Channel (0-2)
0	2	2	1	1

Recommended Action(s):	Repair or replace culvert	Priority:	High
------------------------	---------------------------	-----------	------

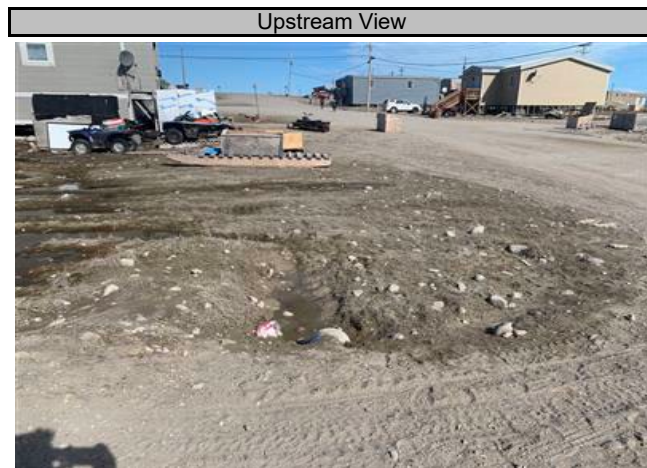
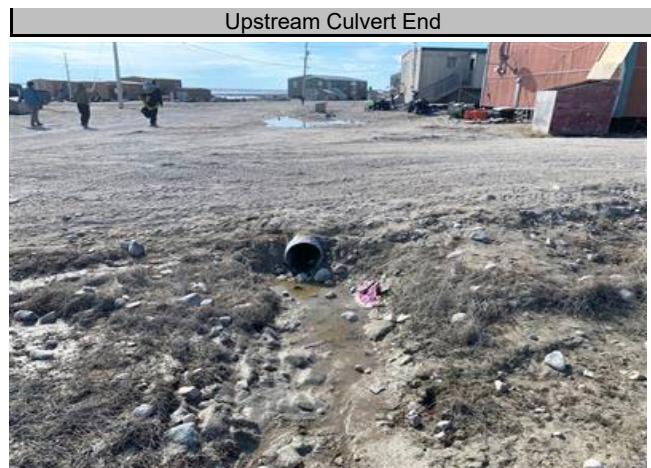
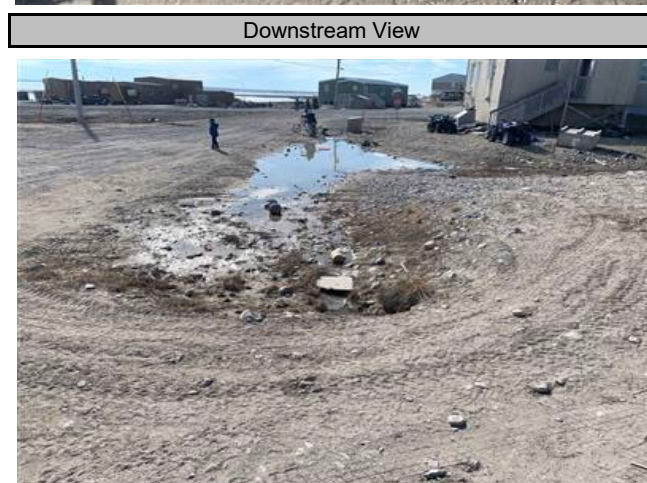
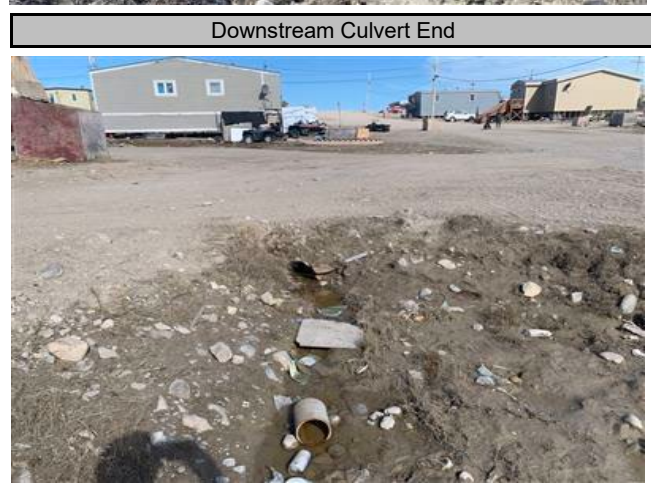
Culvert Information		
Culvert ID		110-03
Type		Entrance
Shape		Round
Material		CSP
Diameter or Dimensions (mm)		280
Marker Post Present		No
End	Upstream	No
	Downstream	No
Infill Depth (mm)	Upstream	0
	Downstream	100
Other Comments		Downstream end infilled

Culvert Condition Ratings (MTO 2013)				
Barrel Material (0-4)	Shape (0-4)	Capacity (0-2)	Erosion and Scour (0-2)	US/DS Channel (0-2)
0	2	2	1	1

Recommended Action(s):	Clean downstream end to maximize drainage	Priority:	High
------------------------	---	-----------	------

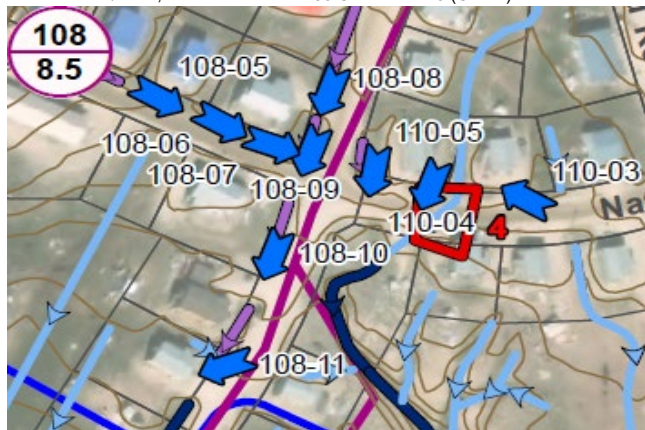
Culvert Information		
Culvert ID		110-04
Type		Cross
Shape		Round
Material		PVC
Diameter or Dimensions (mm)		250
Marker Post Present		No
End Crushing	Upstream	No
	Downstream	No
Infill Depth (mm)	Upstream	50
	Downstream	0
Other Comments	Not well placed. Ponding upstream. Improper ditch.

Culvert Condition Ratings (MTO 2013)				
Barrel Material (0-4)	Shape (0-4)	Capacity (0-2)	Erosion and Scour (0-2)	US/DS Channel (0-2)
0	0	1	0	2

Recommended Action(s):	Consider relocating culvert	Priority:	High
------------------------	-----------------------------	-----------	------

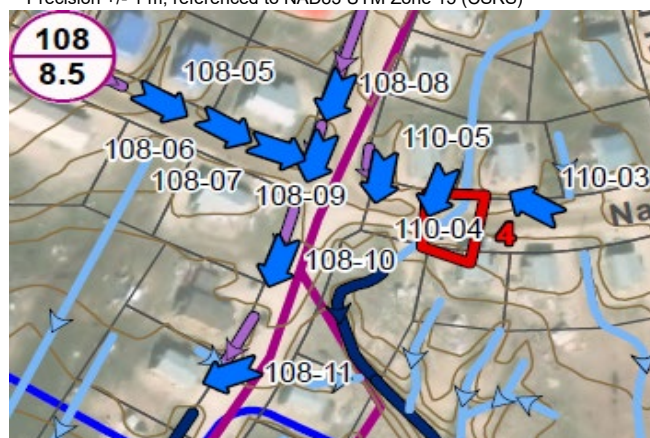
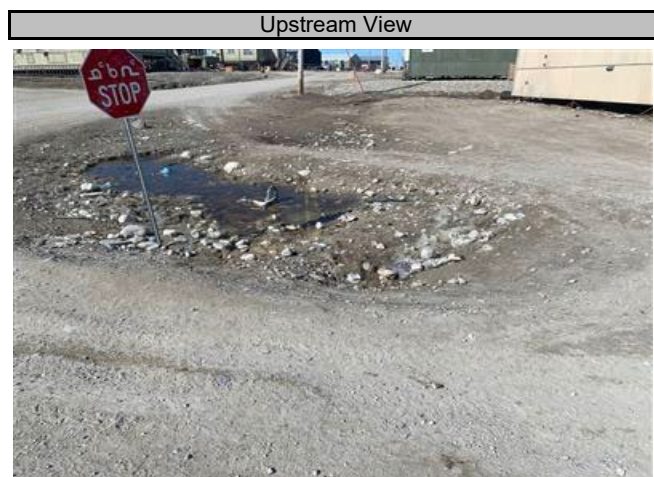
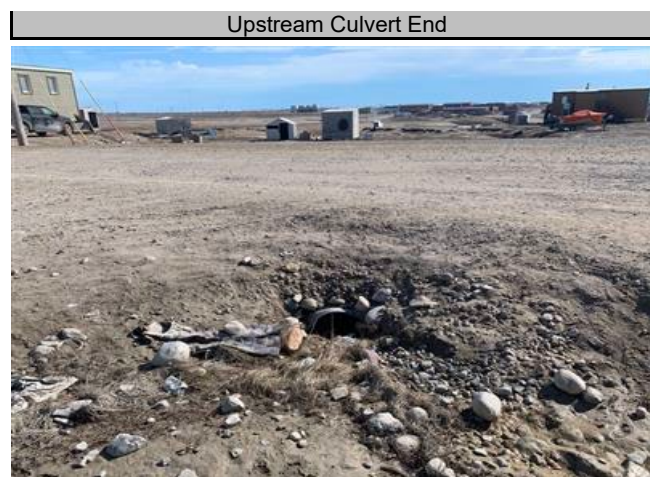
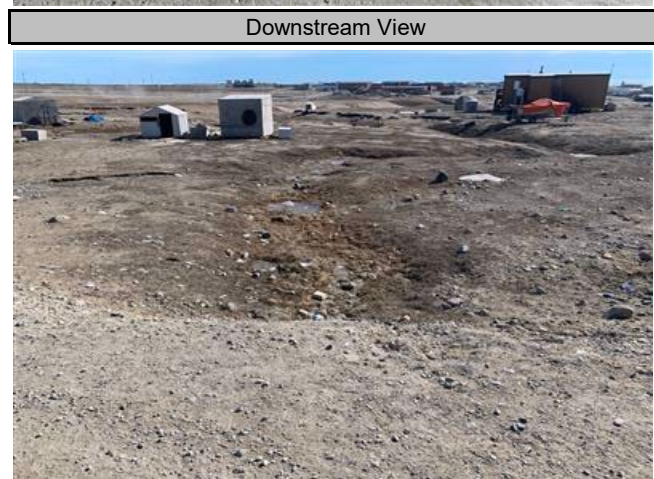
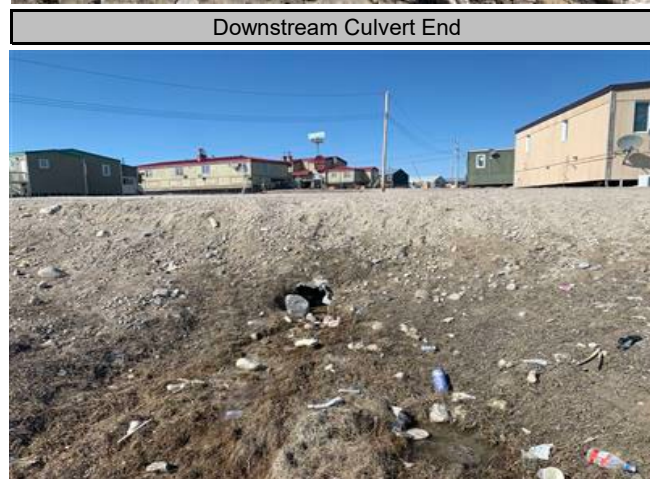
Culvert Information		
Culvert ID		110-05
Type		Cross
Shape		Round
Material		CSP
Diameter or Dimensions (mm)		500
Marker Post Present		No
End	Upstream	Yes
	Downstream	Yes
Infill Depth (mm)	Upstream	200
	Downstream	50
Other Comments		Upstream half filled with rocks

Culvert Condition Ratings (MTO 2013)				
Barrel Material (0-4)	Shape (0-4)	Capacity (0-2)	Erosion and Scour (0-2)	US/DS Channel (0-2)
0	1	2	1	2

Recommended Action(s):	Regrade upstream ditchn remove rocks	Priority:	High
------------------------	--------------------------------------	-----------	------
