Geotechnical Investigation and Drainage Planning in Gjoa Haven, Nunavut

Gjoa Haven, NU

Final Report

September 2023

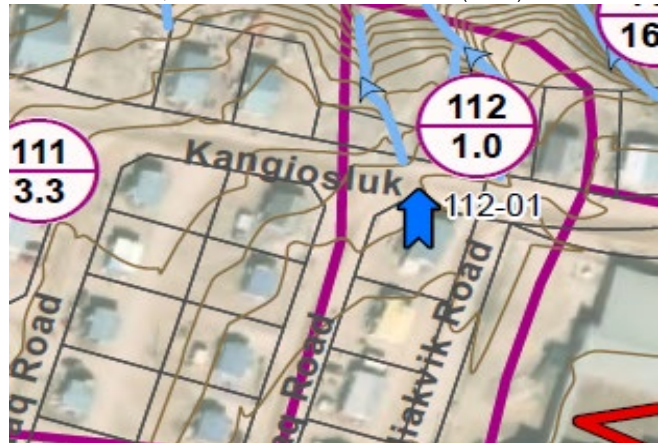
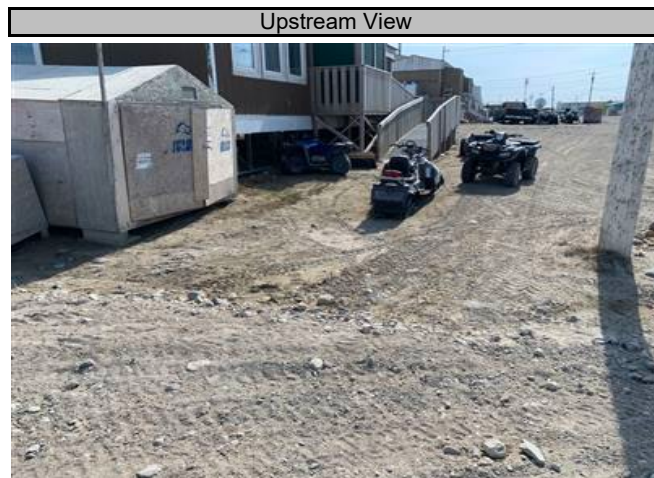
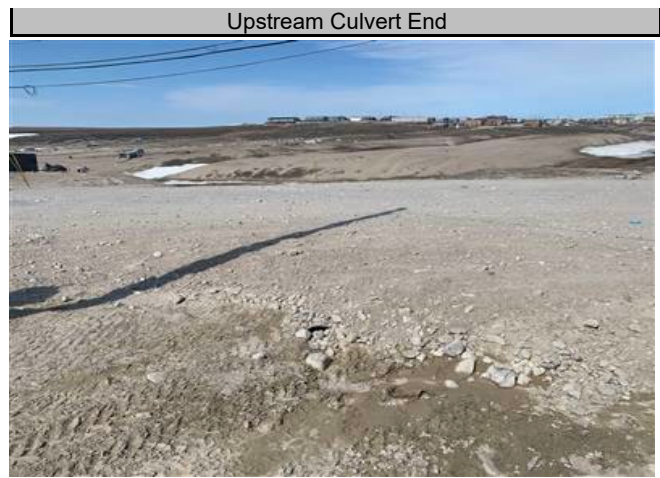
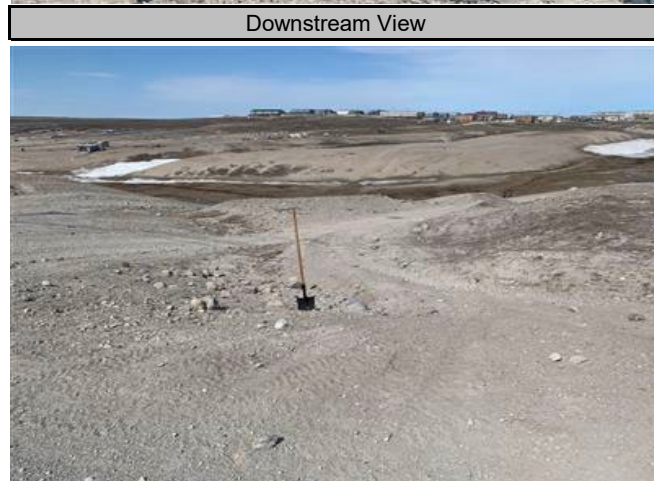
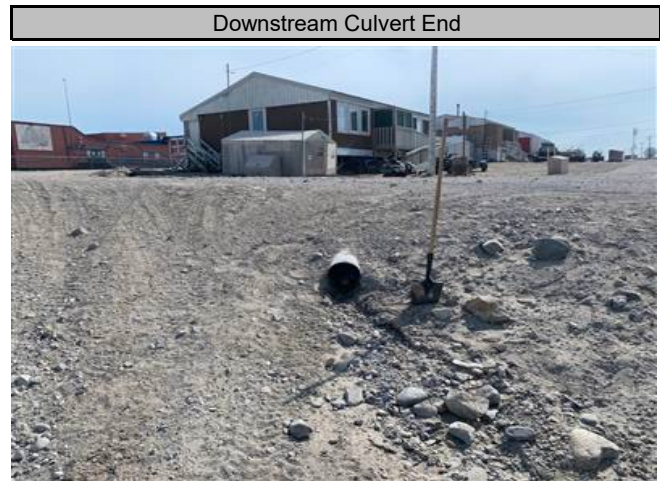
Culvert Information		
Culvert ID		112-01
Type		Cross
Shape		Round
Material		PVC
Diameter or Dimensions (mm)		250
Marker Post Present		No
End	Upstream	No
	Downstream	No
Infill Depth (mm)	Upstream	200
	Downstream	0
Other Comments		Upstream almost buried

Culvert Condition Ratings (MTO 2013)				
Barrel Material (0-4)	Shape (0-4)	Capacity (0-2)	Erosion and Scour (0-2)	US/DS Channel (0-2)
0	0	2	0	2

Recommended Action(s):	Clear conveyance channel to upstream end	Priority:	High
------------------------	--	-----------	------

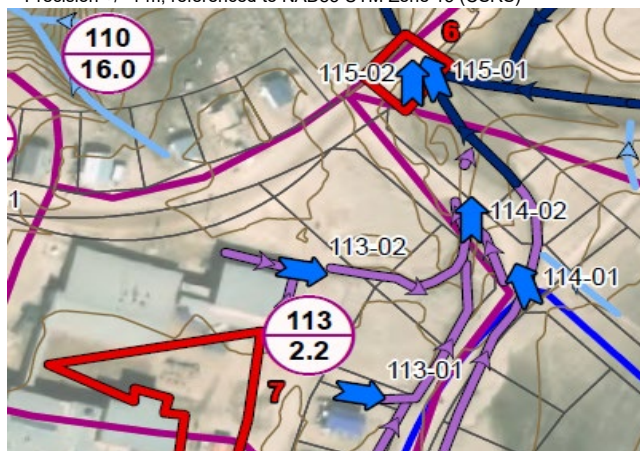
Culvert Information		
Culvert ID		113-01
Type		Entrance
Shape		Round
Material		CSP
Diameter or Dimensions (mm)		500
Marker Post Present		No
End	Upstream	0
	Downstream	No
Infill Depth (mm)	Upstream	0
	Downstream	500
Other Comments		All frozen and filled. Can't find the inlet. Maybe near school

Culvert Condition Ratings (MTO 2013)				
Barrel Material (0-4)	Shape (0-4)	Capacity (0-2)	Erosion and Scour (0-2)	US/DS Channel (0-2)
0	0	2	1	2

Recommended Action(s):	Flush inlet, reinstall culvert	Priority:	High
------------------------	--------------------------------	-----------	------

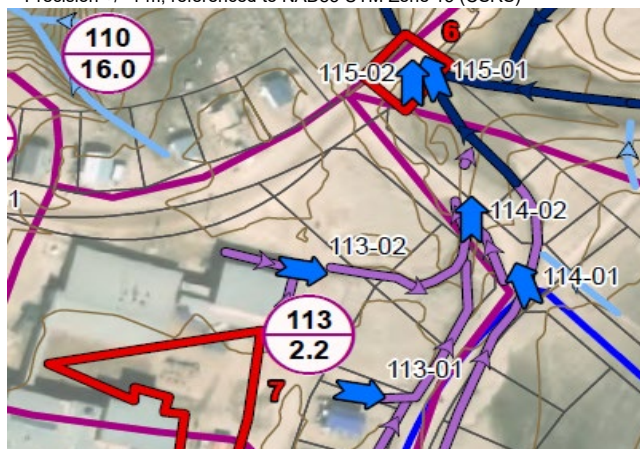
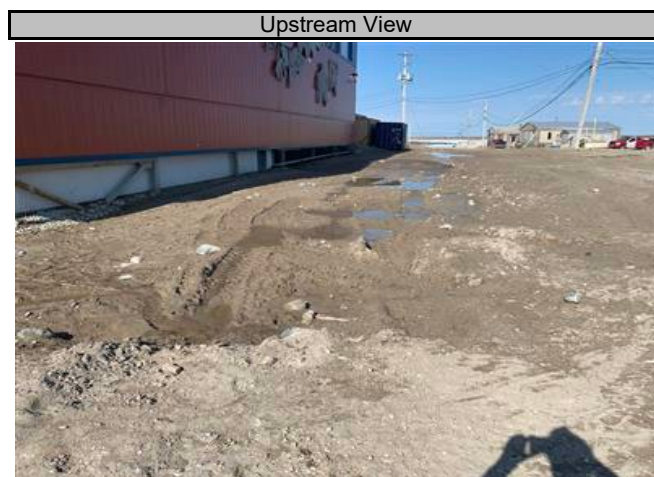
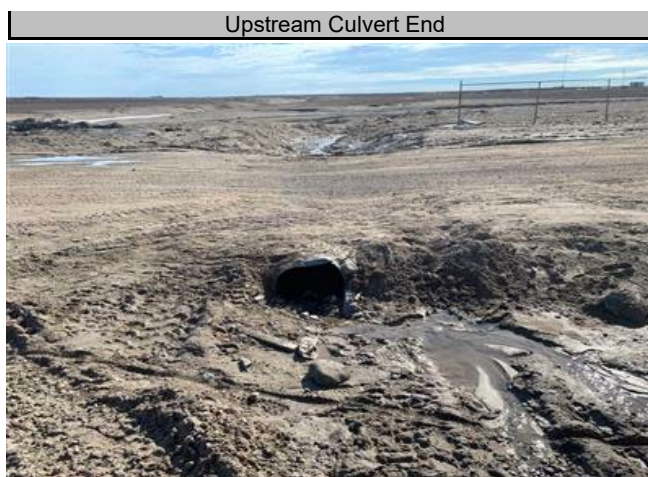
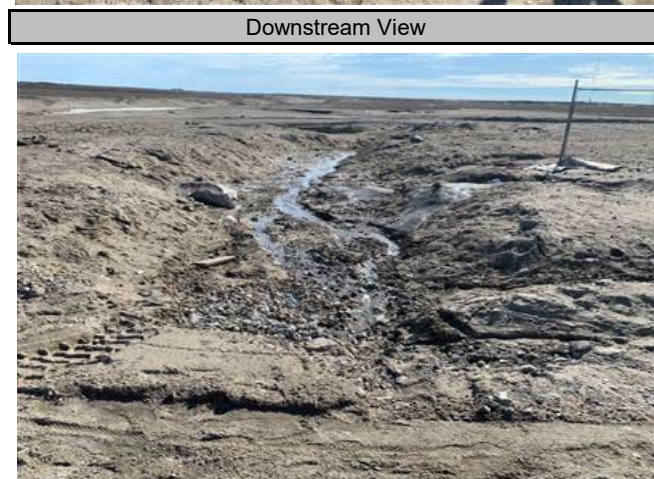
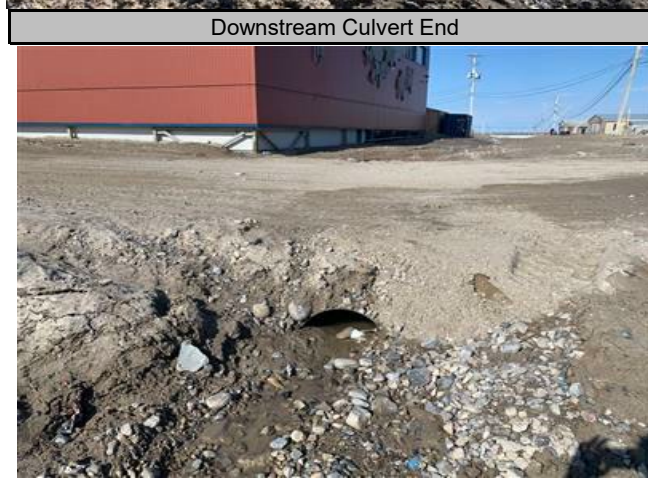
Culvert Information		
Culvert ID		113-02
Type		Entrance
Shape		Round
Material		CSP
Diameter or Dimensions (mm)		600
Marker Post Present		No
End	Upstream	No
	Downstream	No
Infill Depth (mm)	Upstream	200
	Downstream	350
Other Comments		Downstream end infilled

Culvert Condition Ratings (MTO 2013)				
Barrel Material (0-4)	Shape (0-4)	Capacity (0-2)	Erosion and Scour (0-2)	US/DS Channel (0-2)
0	1	2	1	0

Recommended Action(s):	Flush culvert	Priority:	High
------------------------	---------------	-----------	------

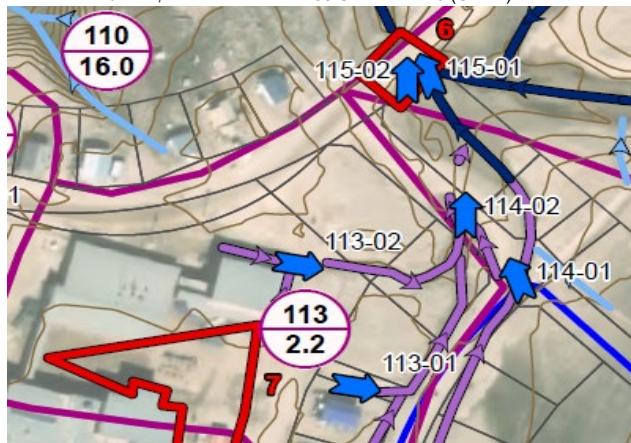
Culvert Information		
Culvert ID		114-01
Type		Cross
Shape		Round
Material		PVC
Diameter or Dimensions (mm)		1120
Marker Post Present		No
End	Upstream	No
	Downstream	No
Infill Depth (mm)	Upstream	75
	Downstream	550
Other Comments	4 x 280 mm pvc put together. 1 1/2 partially filled downstream. Tension cracks present on

Culvert Condition Ratings (MTO 2013)				
Barrel Material (0-4)	Shape (0-4)	Capacity (0-2)	Erosion and Scour (0-2)	US/DS Channel (0-2)
0	0	2	2	0

Recommended Action(s):	place with one larger capacity culvert at a lower elevation	Priority:	High
------------------------	---	-----------	------

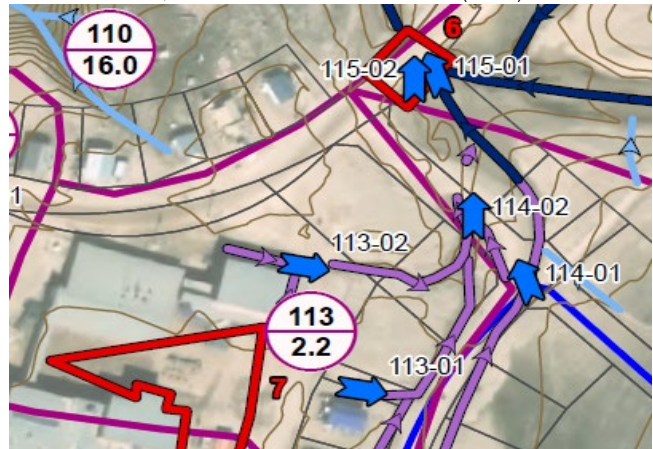
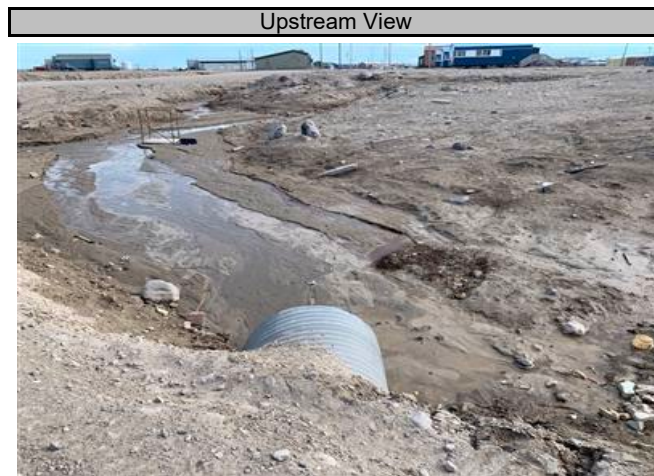
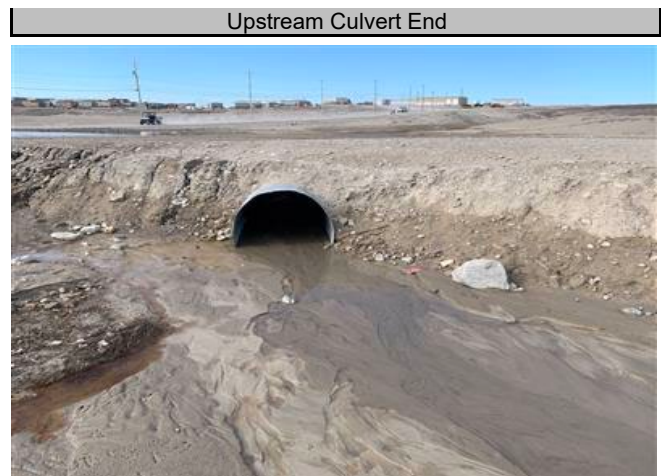
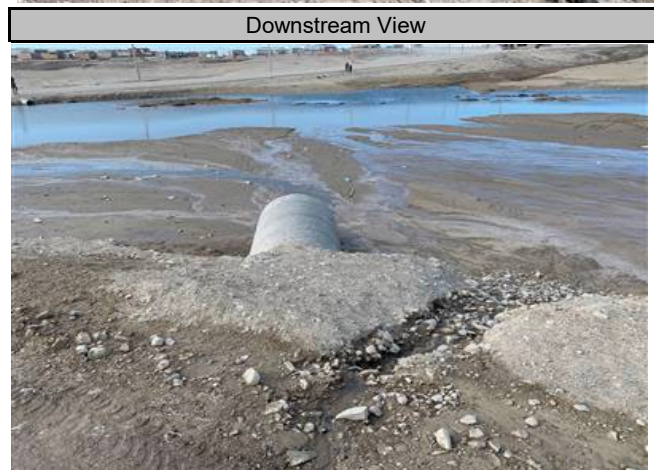
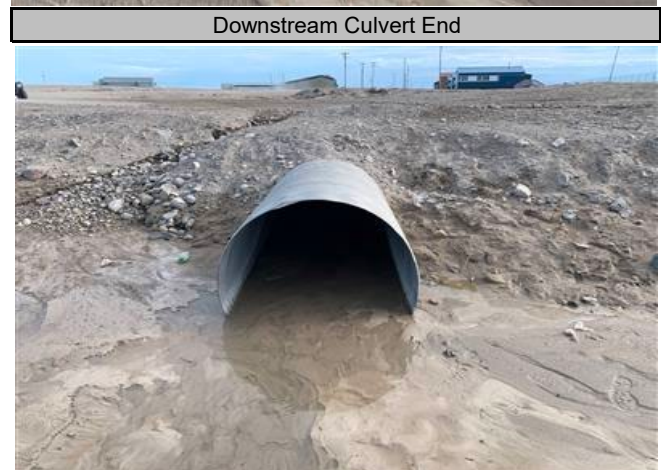
Culvert Information		
Culvert ID		114-02
Type		Cross
Shape		Round
Material		CSP
Diameter or Dimensions (mm)		1100
Marker Post Present		No
End	Upstream	No
	Downstream	No
Infill Depth (mm)	Upstream	350
	Downstream	300
Other Comments		0

Culvert Condition Ratings (MTO 2013)				
Barrel Material (0-4)	Shape (0-4)	Capacity (0-2)	Erosion and Scour (0-2)	US/DS Channel (0-2)
0	0	2	0	0

Recommended Action(s):	Flush culvert	Priority:	High
------------------------	---------------	-----------	------

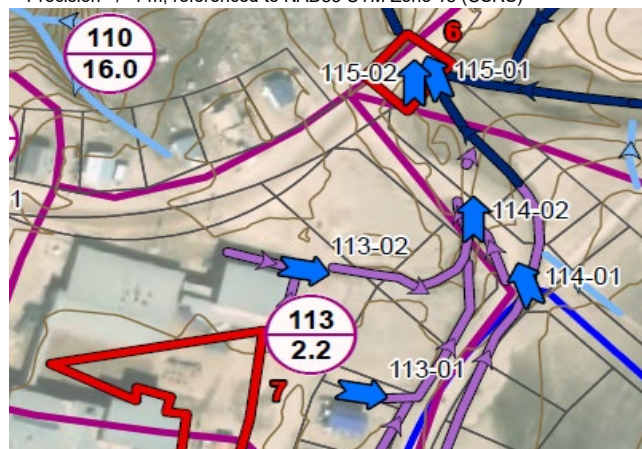
Culvert Information		
Culvert ID		115-01
Type		Cross
Shape		Round
Material		CSP
Diameter or Dimensions (mm)		900
Marker Post Present		No
End	Upstream	Yes
	Downstream	Yes
Infill Depth (mm)	Upstream	0
	Downstream	0
Other Comments	Upstream mostly under water. Major ponding. Blocked by ice. No drainage

Culvert Condition Ratings (MTO 2013)				
Barrel Material (0-4)	Shape (0-4)	Capacity (0-2)	Erosion and Scour (0-2)	US/DS Channel (0-2)
0	3	2	1	0

Recommended Action(s):	Flush culvert	Priority:	High
------------------------	---------------	-----------	------

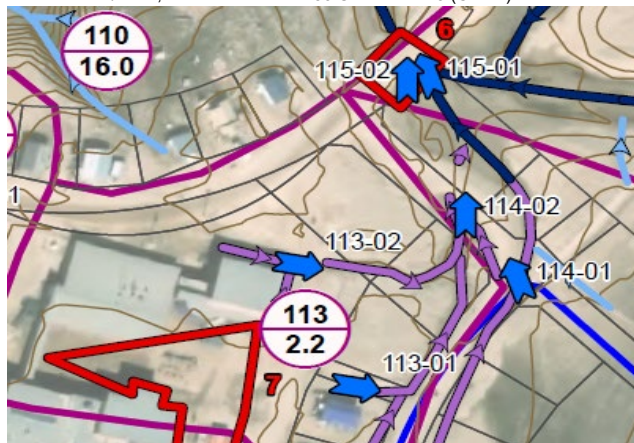
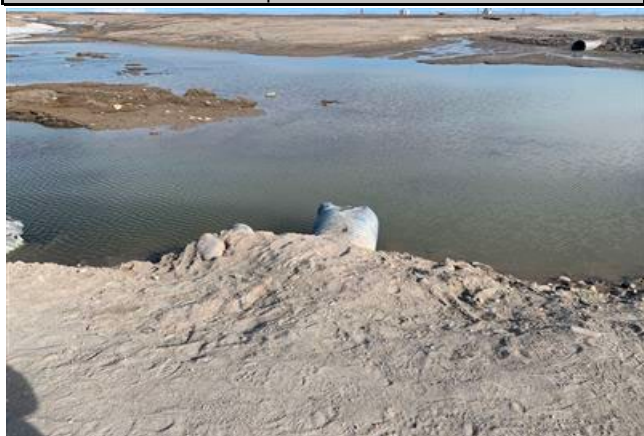
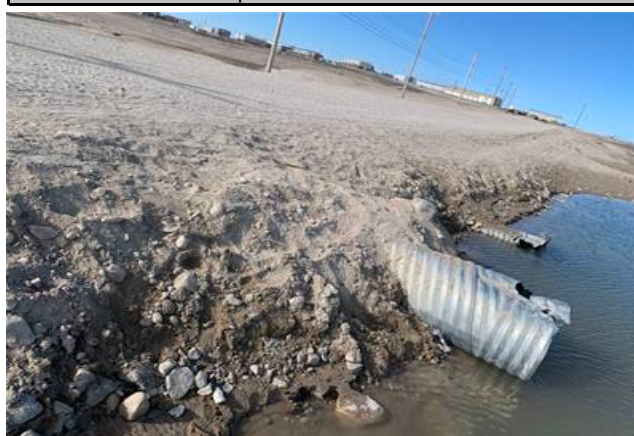
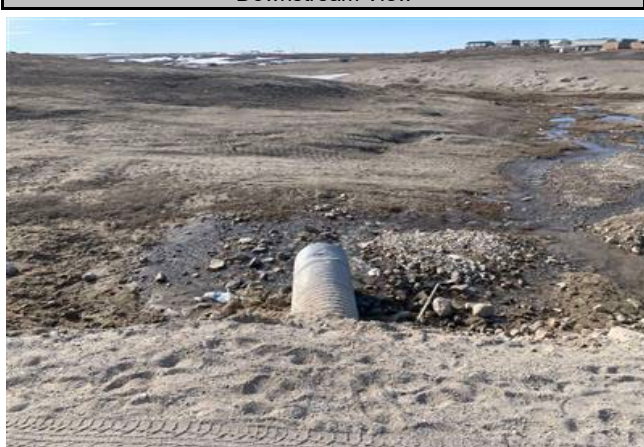
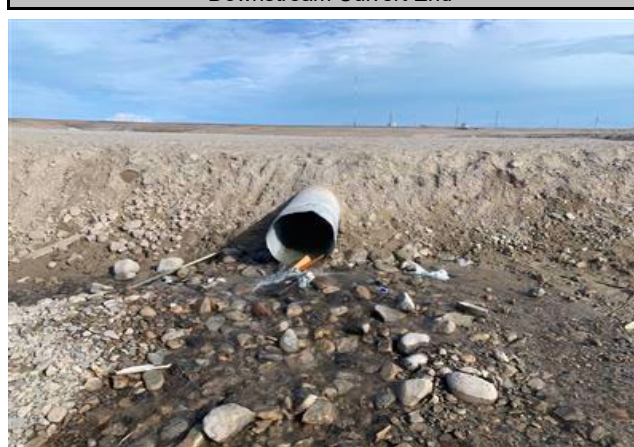
Culvert Information		
Culvert ID		115-02
Type		Cross
Shape		Round
Material		CSP
Diameter or Dimensions (mm)		600
Marker Post Present		No
End	Upstream	No
	Downstream	No
Infill Depth (mm)	Upstream	0
	Downstream	0
Other Comments		Perched upstream and downstream. Major ponding upstream

Culvert Condition Ratings (MTO 2013)				
Barrel Material (0-4)	Shape (0-4)	Capacity (0-2)	Erosion and Scour (0-2)	US/DS Channel (0-2)
0	0	0	0	2

Recommended Action(s):	Lower invert elevation to maximize drainage	Priority:	High
------------------------	---	-----------	------

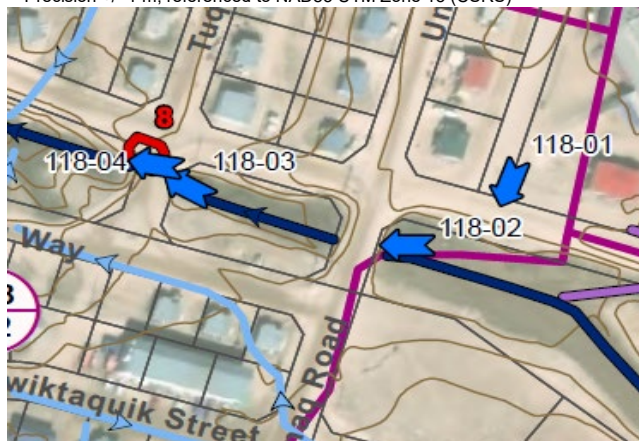
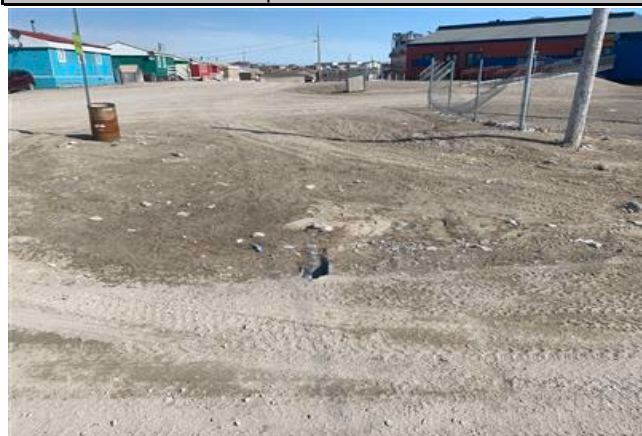
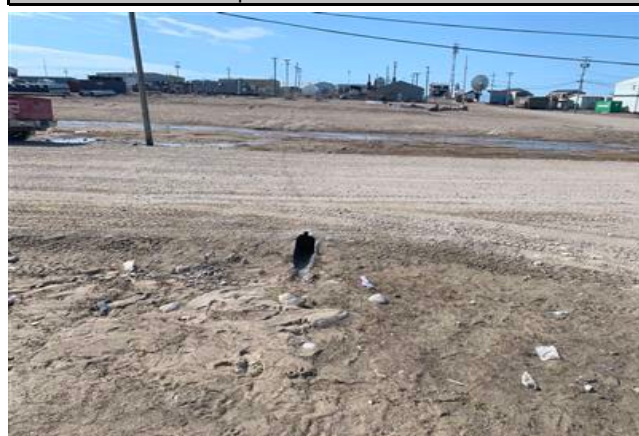
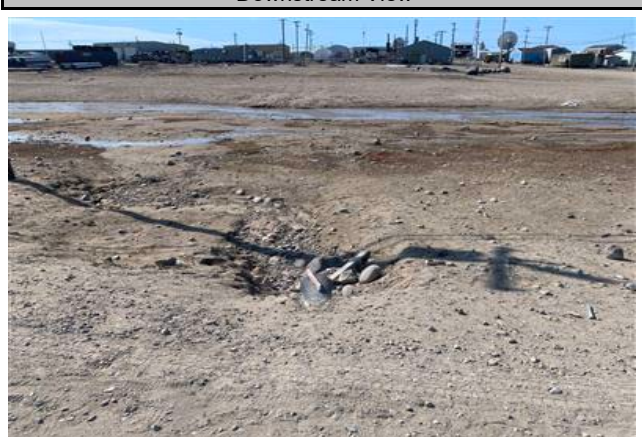
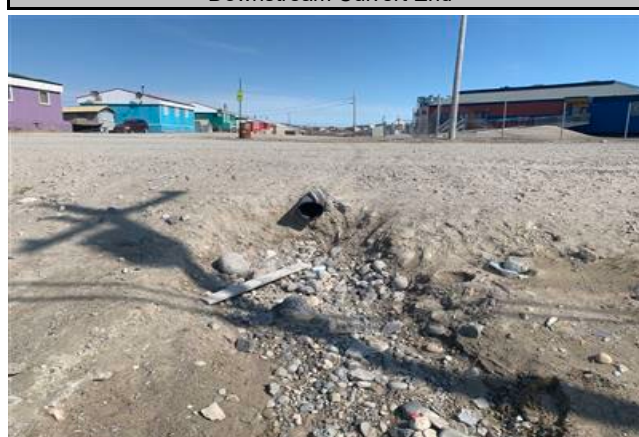
Culvert Information		
Culvert ID		118-01
Type		Cross
Shape		Round
Material		PVC
Diameter or Dimensions (mm)		250
Marker Post Present		No
End	Upstream	Yes
	Downstream	No
Infill Depth (mm)	Upstream	0
	Downstream	0
Other Comments	No proper ditch drain to culvert. Downstream perched

Culvert Condition Ratings (MTO 2013)				
Barrel Material (0-4)	Shape (0-4)	Capacity (0-2)	Erosion and Scour (0-2)	US/DS Channel (0-2)
0	1	0	0	1

Recommended Action(s):	Create conveyance channel towards culvert	Priority:	Low
------------------------	---	-----------	-----

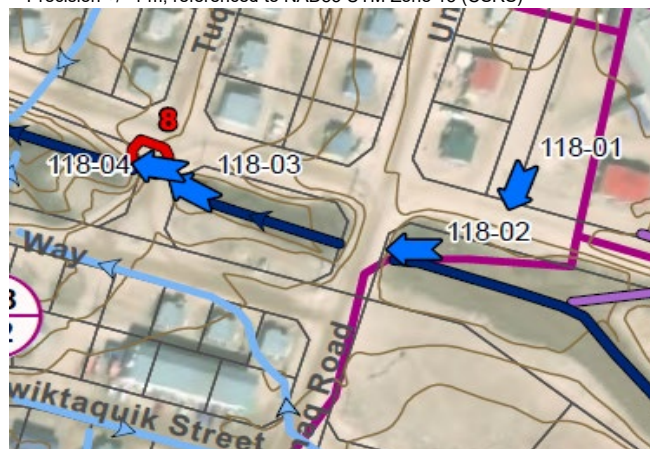
Culvert Information		
Culvert ID		118-02
Type		Cross
Shape		Round
Material		CSP
Diameter or Dimensions (mm)		0
Marker Post Present		No
End	Upstream	0
	Downstream	0
Infill Depth (mm)	Upstream	0
	Downstream	0
Other Comments	Two CSP Culverts not analyzed

Culvert Condition Ratings (MTO 2013)				
Barrel Material (0-4)	Shape (0-4)	Capacity (0-2)	Erosion and Scour (0-2)	US/DS Channel (0-2)
NM	NM	0	NM	NM

Recommended Action(s):	Analyze culvert	Priority:	None
------------------------	-----------------	-----------	------

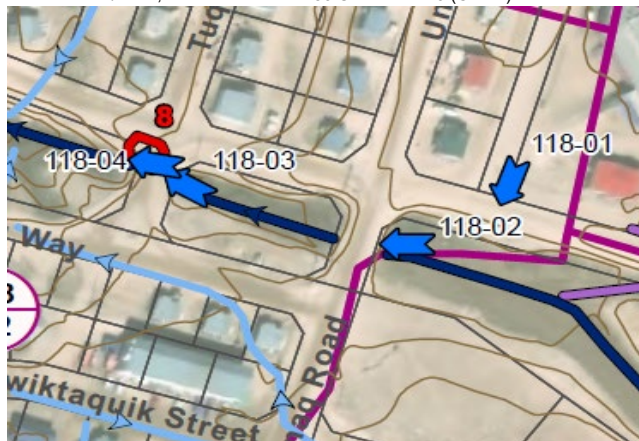
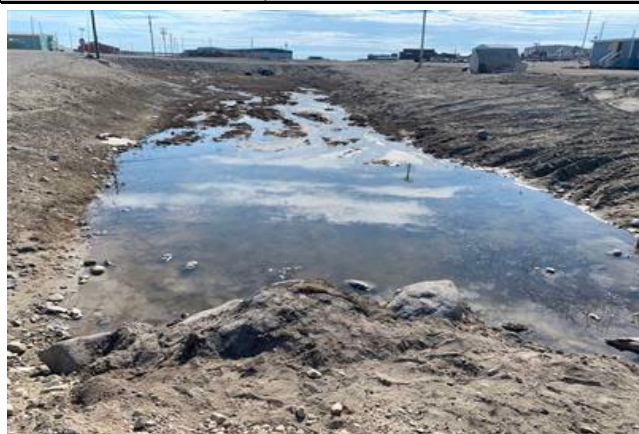
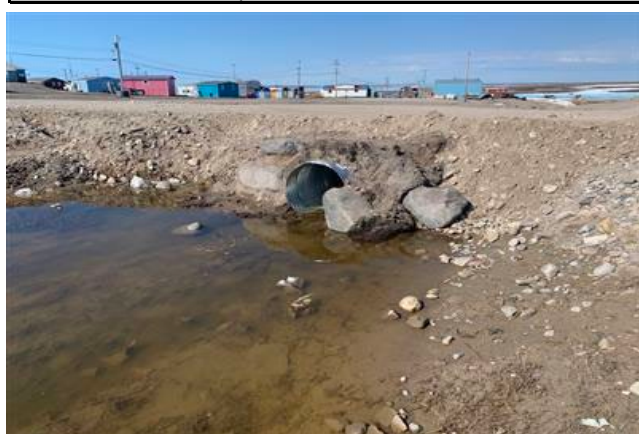
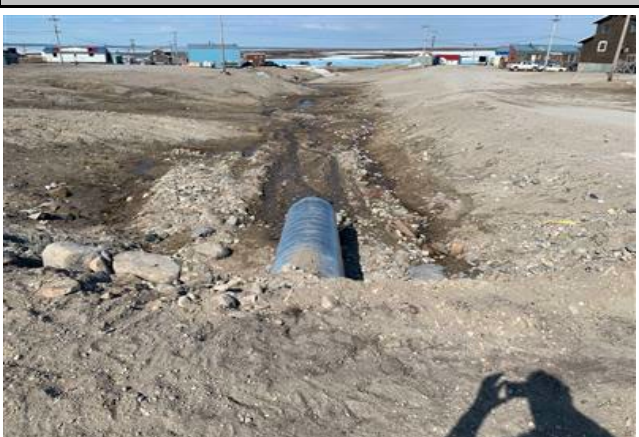
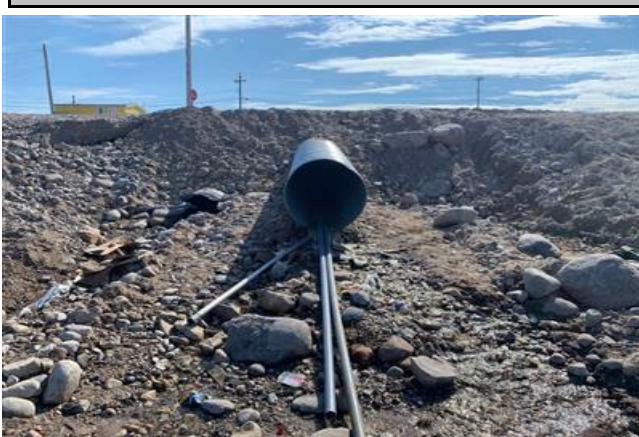
Culvert Condition Ratings (MTO 2013)				
Barrel Material (0-4)	Shape (0-4)	Capacity (0-2)	Erosion and Scour (0-2)	US/DS Channel (0-2)
0	0	1	0	2

Recommended Action(s):	Reinstall culvert at a lower elevation	Priority:	High
------------------------	--	-----------	------

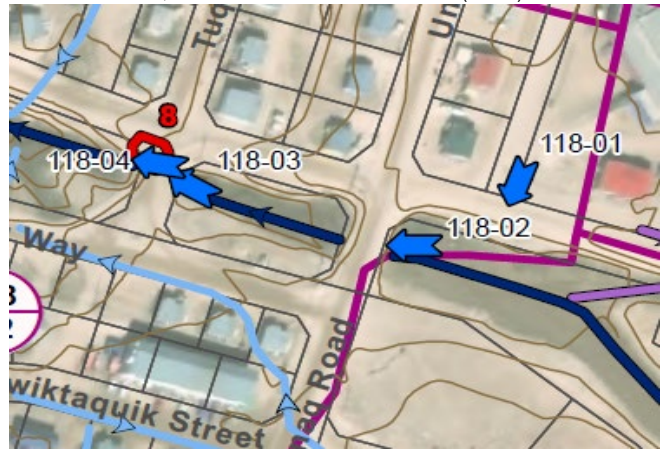
Culvert Information		
Culvert ID		118-04
Type		Cross
Shape		0
Material		0
Diameter or Dimensions (mm)		800
Marker Post Present		No
End Crushing	Upstream	0
	Downstream	Yes
Infill Depth (mm)	Upstream	150
	Downstream	500
Other Comments	Culvert inlet buried. But still minor flow. Culvert located close to slope instability. If culvert was effective it may trigger additional bank instability

Culvert Condition Ratings (MTO 2013)				
Barrel Material (0-4)	Shape (0-4)	Capacity (0-2)	Erosion and Scour (0-2)	US/DS Channel (0-2)
NM	NM	2	NM	NM

Recommended Action(s):	Flush Culvert	Priority:	None
------------------------	---------------	-----------	------

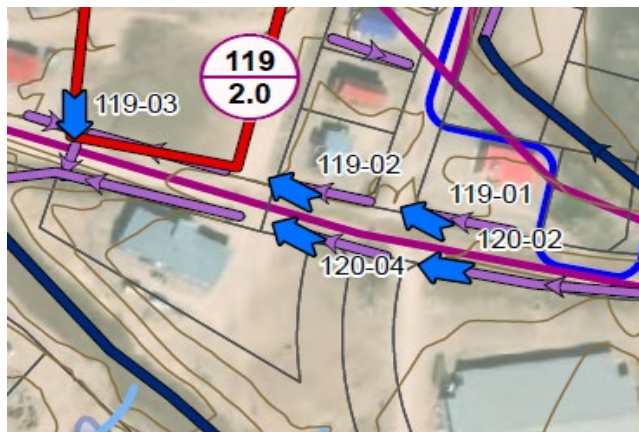
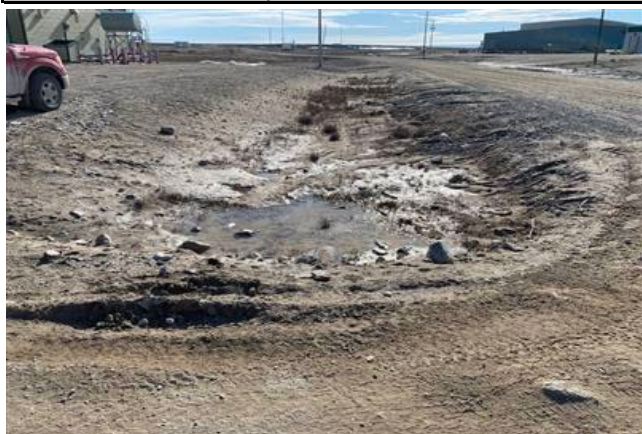
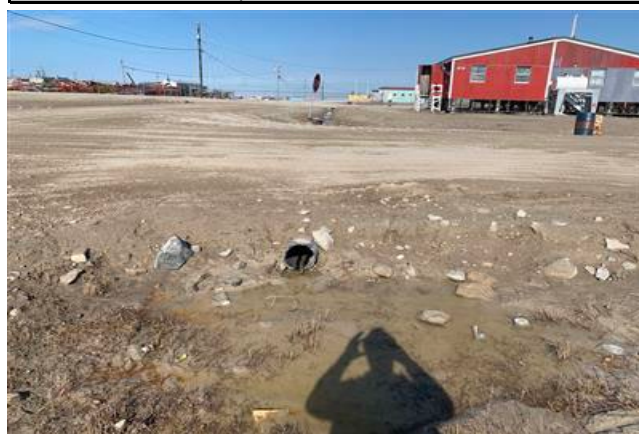
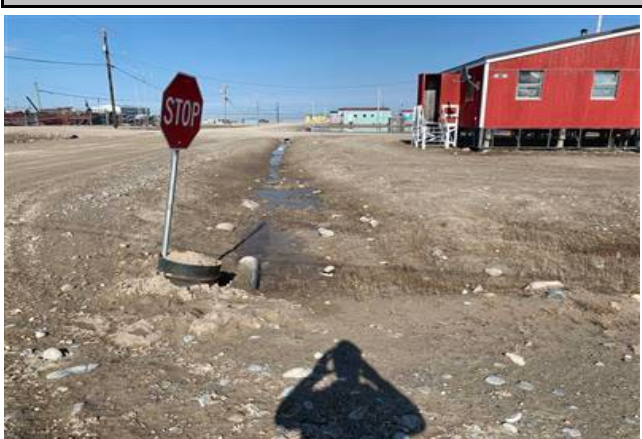
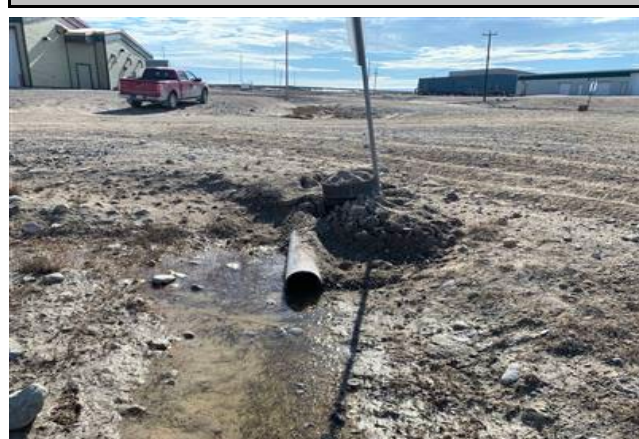
Culvert Condition Ratings (MTO 2013)				
Barrel Material (0-4)	Shape (0-4)	Capacity (0-2)	Erosion and Scour (0-2)	US/DS Channel (0-2)
0	0	0	0	1

Recommended Action(s):	Regrade upstream and downstream ditch	Priority:	Low
------------------------	---------------------------------------	-----------	-----

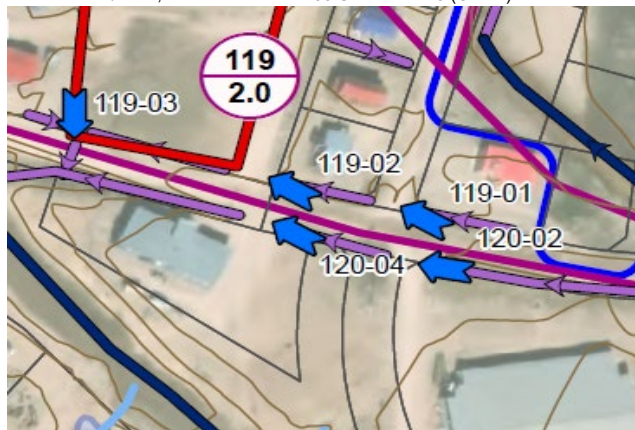
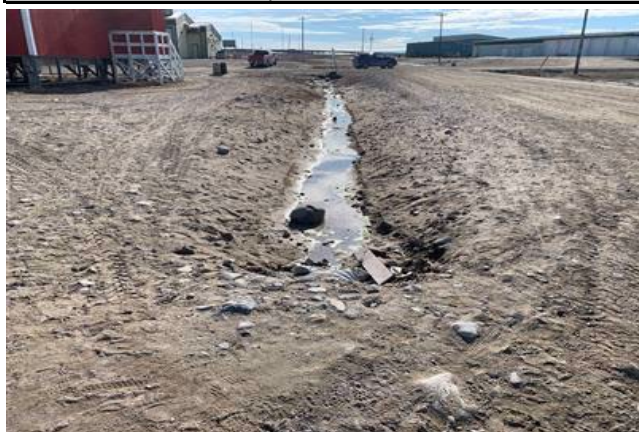
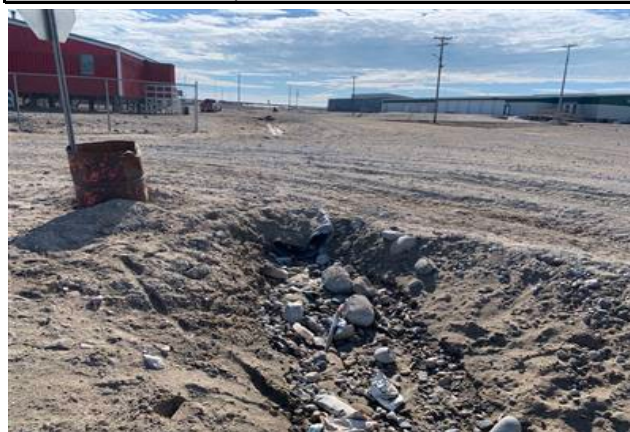
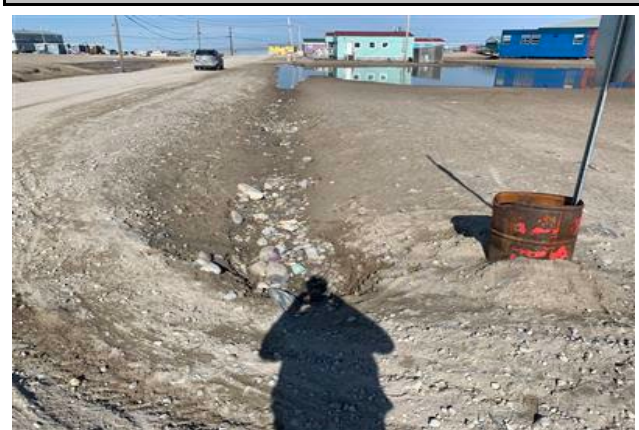
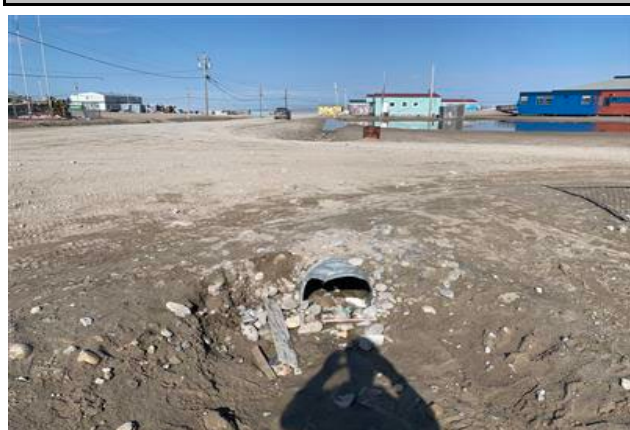
Culvert Information		
Culvert ID		119-02
Type		Cross
Shape		Round
Material		CSP
Diameter or Dimensions (mm)		500
Marker Post Present		No
End	Upstream	No
	Downstream	Yes
Infill Depth (mm)	Upstream	50
	Downstream	0
Other Comments	Upstream end of culvert crushed

Culvert Condition Ratings (MTO 2013)				
Barrel Material (0-4)	Shape (0-4)	Capacity (0-2)	Erosion and Scour (0-2)	US/DS Channel (0-2)
0	3	1	0	1

Recommended Action(s):	Replace culvert	Priority:	High
------------------------	-----------------	-----------	------

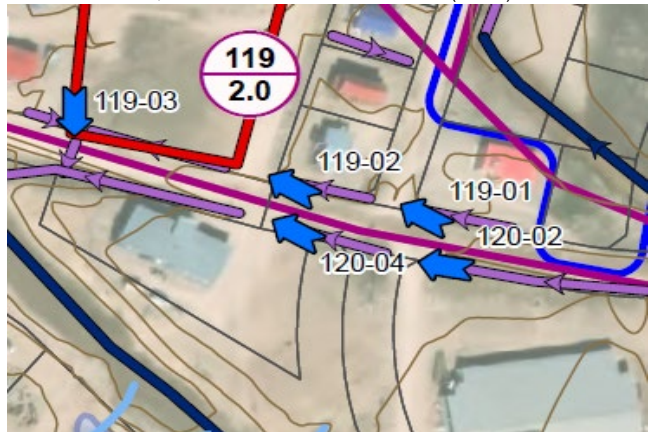
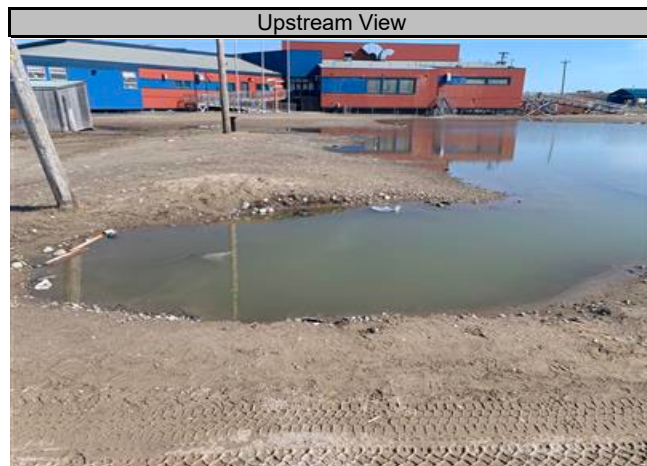
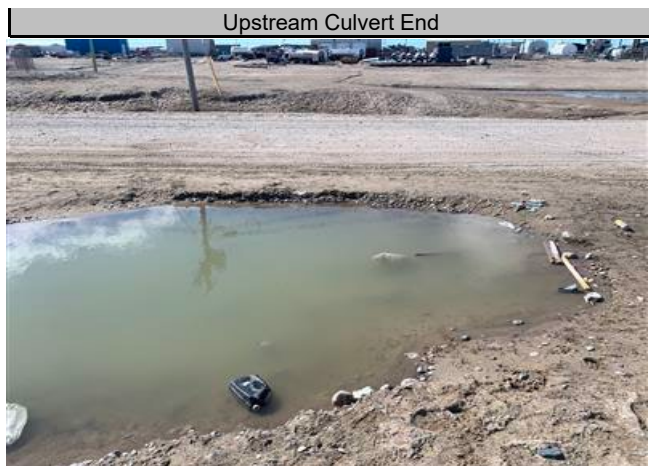
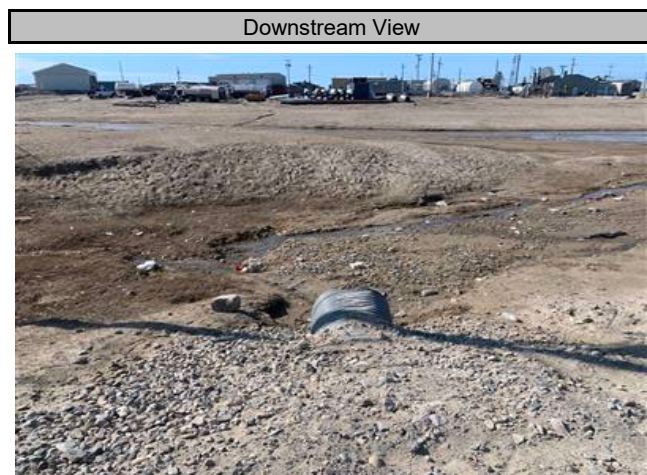
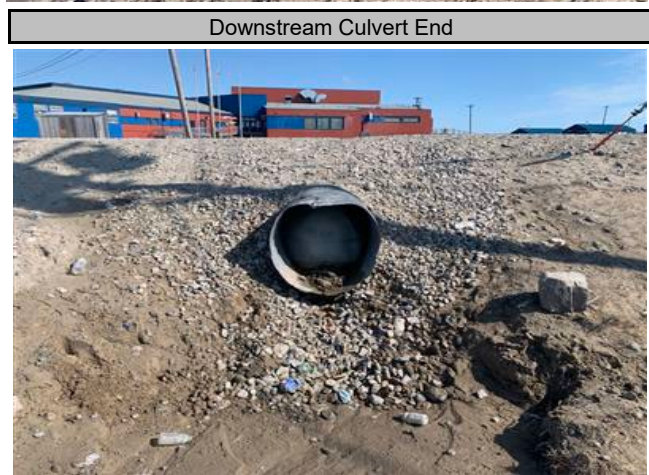
Culvert Information		
Culvert ID		119-03
Type		Cross
Shape		Round
Material		CSP
Diameter or Dimensions (mm)		800
Marker Post Present		No
End	Upstream	0
	Downstream	No
Infill Depth (mm)	Upstream	800
	Downstream	50
Other Comments		Can't find upstream end. Either buried or under water. Downstream culvert end blocked by ice

Culvert Condition Ratings (MTO 2013)				
Barrel Material (0-4)	Shape (0-4)	Capacity (0-2)	Erosion and Scour (0-2)	US/DS Channel (0-2)
0	0	2	0	0

Recommended Action(s):	Rplace culvert	Priority:	High
------------------------	----------------	-----------	------

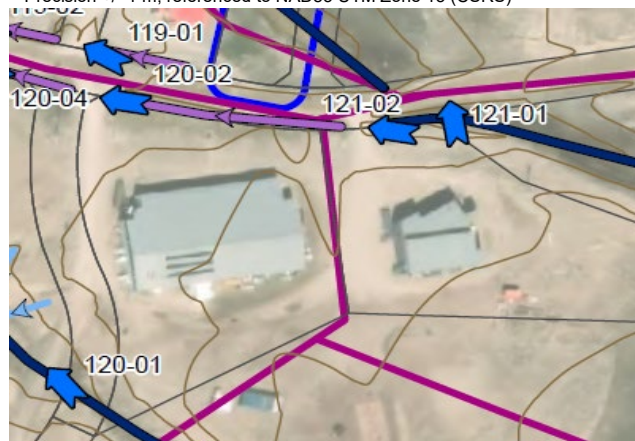
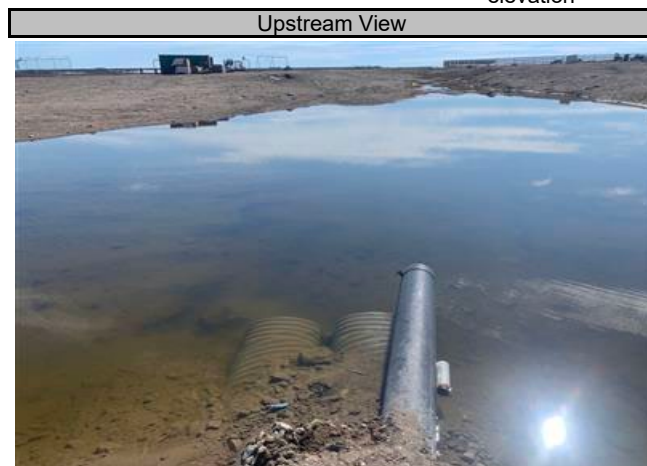
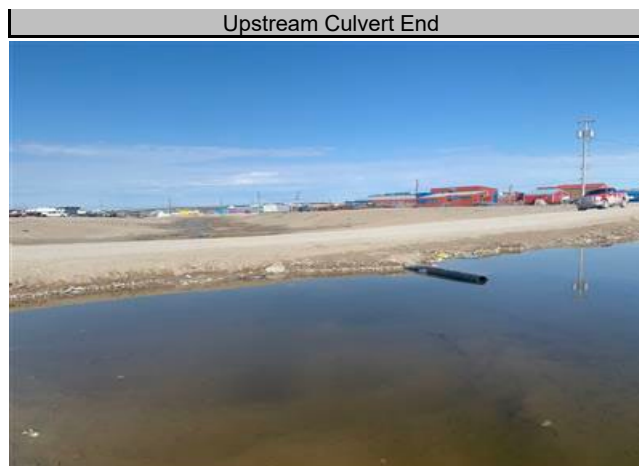
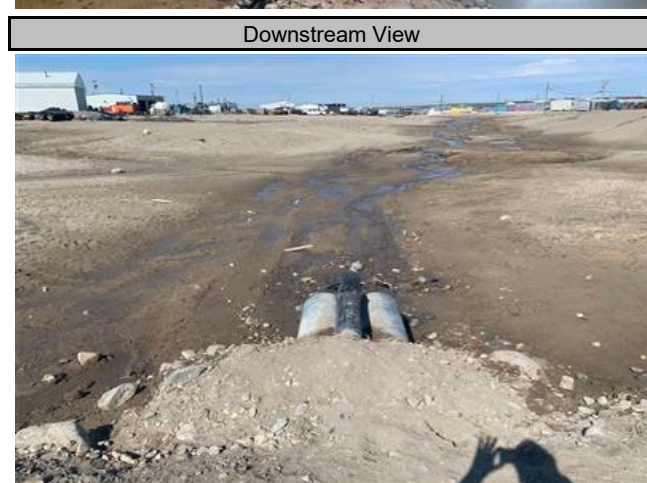
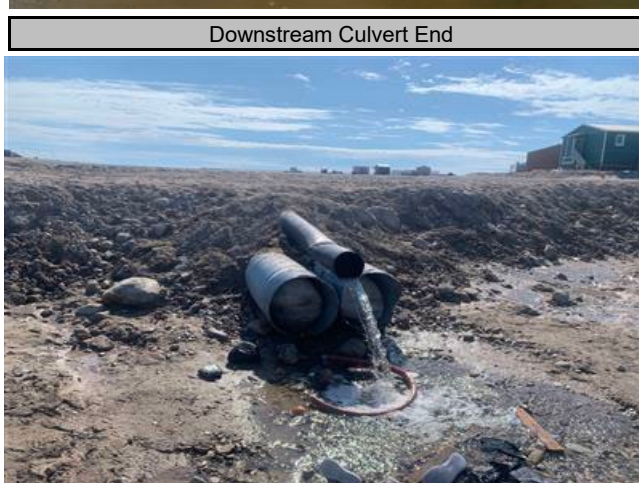
Culvert Information		
Culvert ID		120-01
Type		Cross
Shape		Round
Material		PVC/CSP
Diameter or Dimensions (mm)		250/600
Marker Post Present		No
End	Upstream	No
	Downstream	No
Infill Depth (mm)	Upstream	0
	Downstream	0
Other Comments	Major ponding upstream. 2 metal under water and blocked by ice. Pvc downstream end is perched.

Culvert Condition Ratings (MTO 2013)				
Barrel Material (0-4)	Shape (0-4)	Capacity (0-2)	Erosion and Scour (0-2)	US/DS Channel (0-2)
0	0	2	0	0

Recommended Action(s):	Flush CSP Culverts, install PVC culvert at lower elevation	Priority:	High
------------------------	--	-----------	------

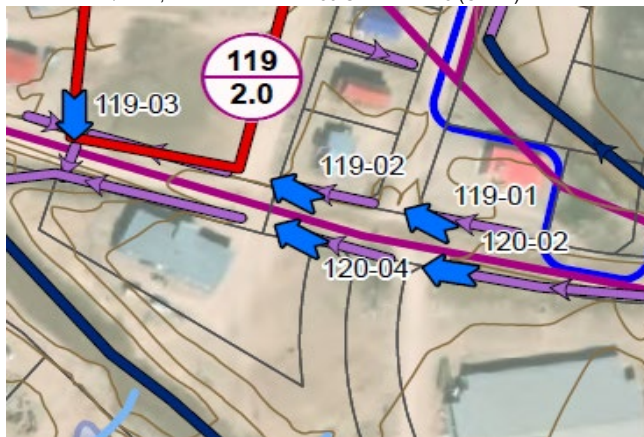
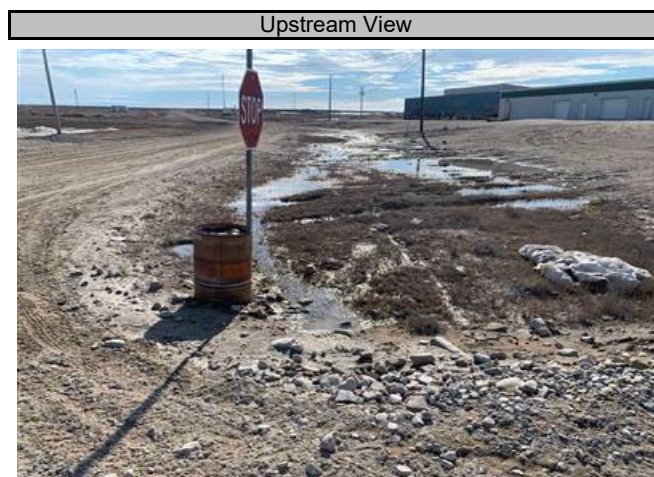
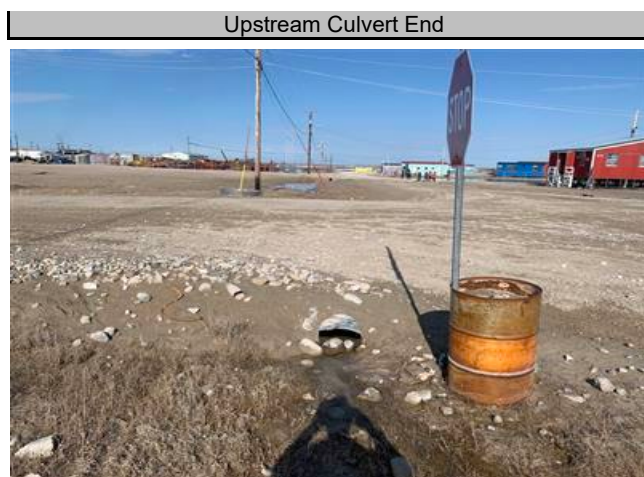
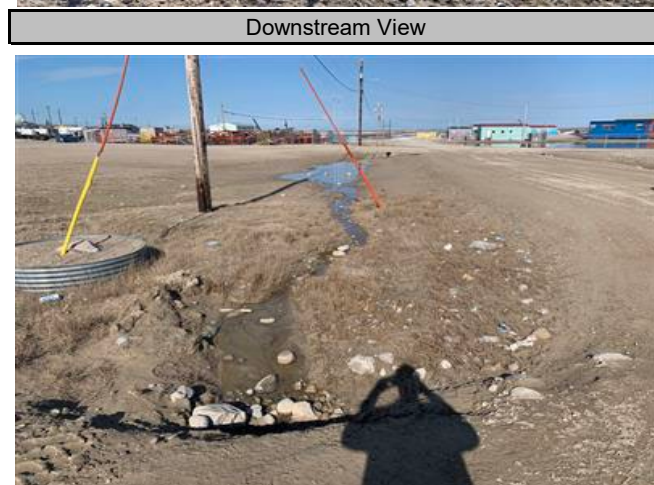
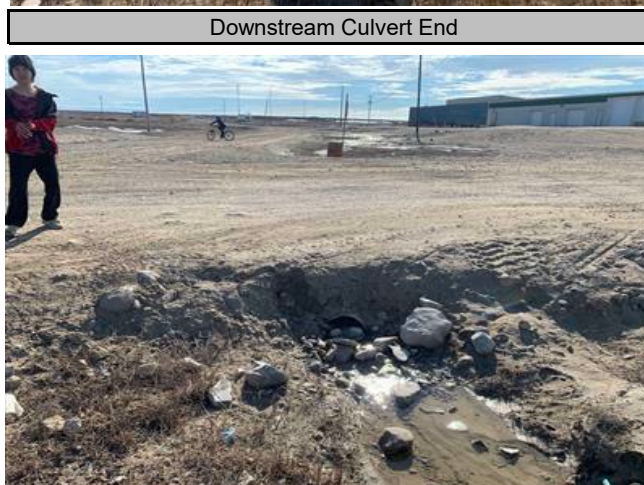
Culvert Condition Ratings (MTO 2013)				
Barrel Material (0-4)	Shape (0-4)	Capacity (0-2)	Erosion and Scour (0-2)	US/DS Channel (0-2)
0	1	1	1	0

Recommended Action(s):	None	Priority:	None
------------------------	------	-----------	------

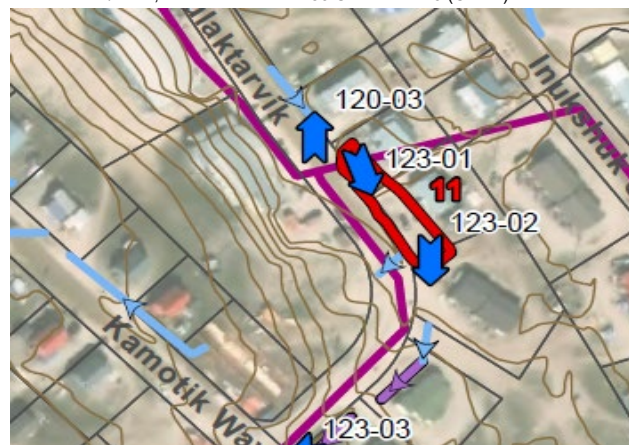
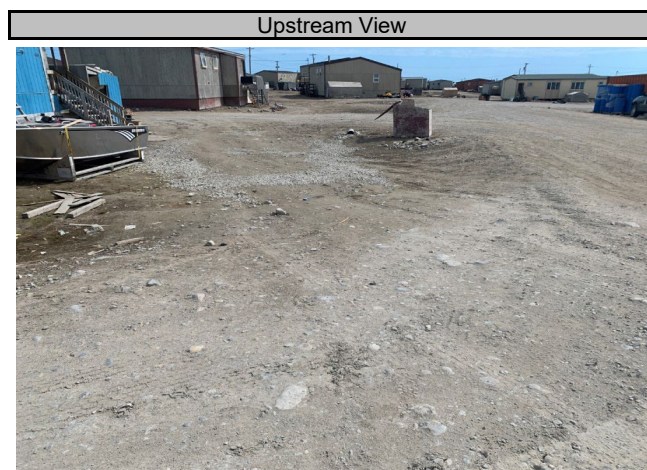
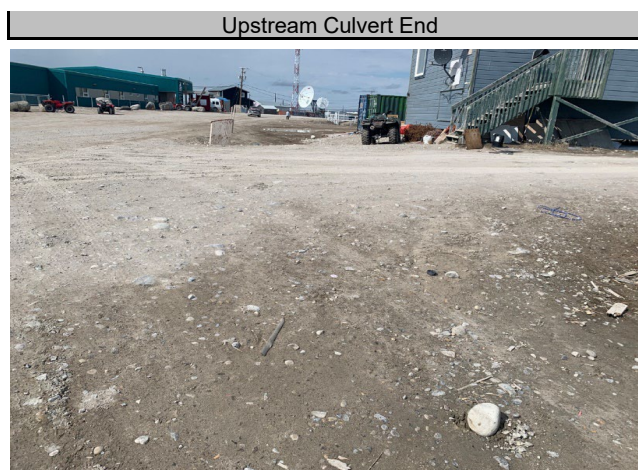
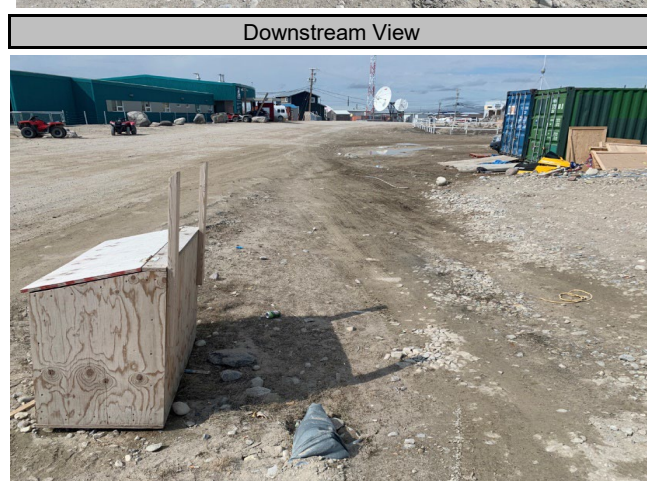
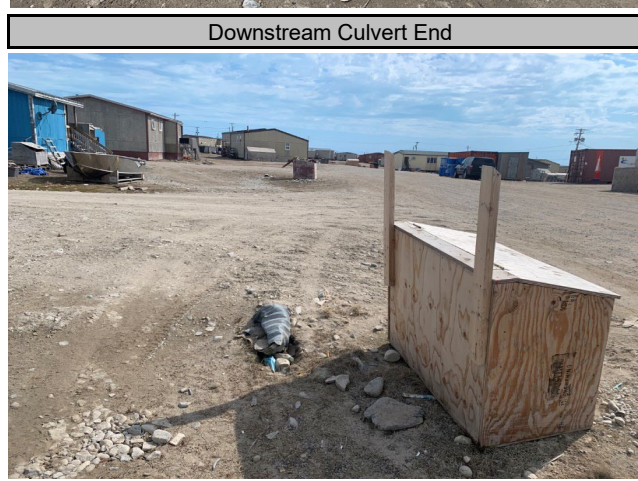
Culvert Information		
Culvert ID		120-03
Type		Entrance
Shape		Round
Material		CSP
Diameter or Dimensions (mm)		300
Marker Post Present		No
End	Upstream	0
	Downstream	Yes
Infill Depth (mm)	Upstream	300
	Downstream	150
Other Comments	Only outlet visible. Inlet is buried. Not too clear where low point is. Resident says ponding occurs

Culvert Condition Ratings (MTO 2013)				
Barrel Material (0-4)	Shape (0-4)	Capacity (0-2)	Erosion and Scour (0-2)	US/DS Channel (0-2)
0	4	2	0	2

Recommended Action(s):	Replace culvert at a lower elevation	Priority:	High
------------------------	--------------------------------------	-----------	------

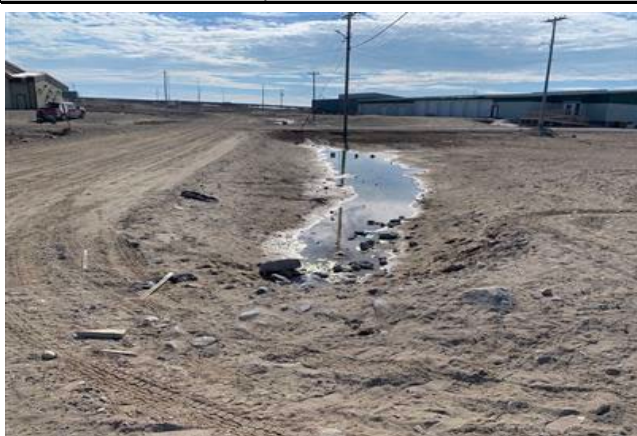
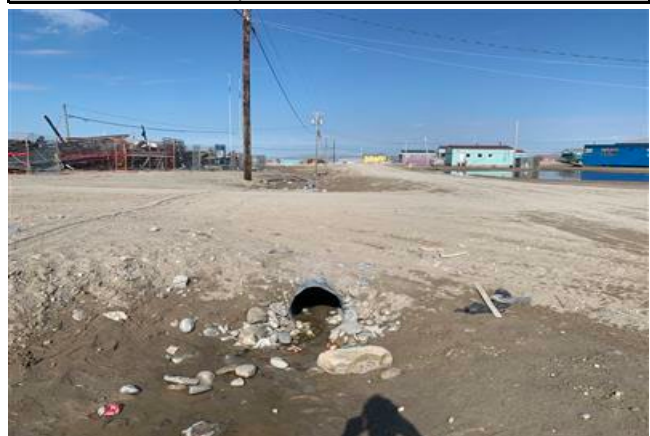
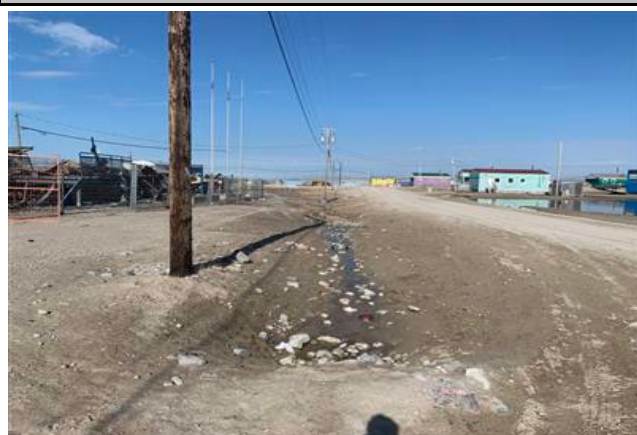
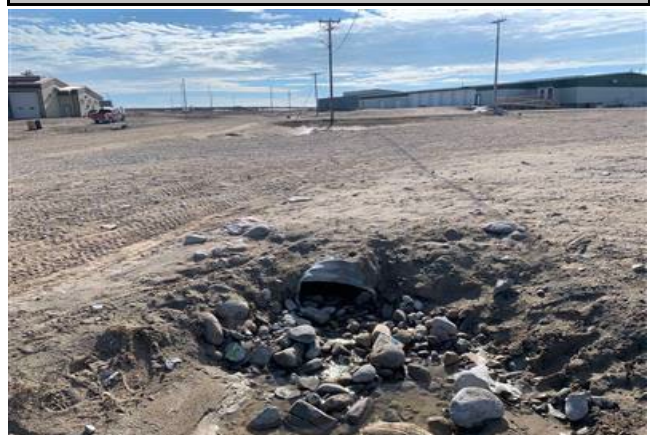
Culvert Information		
Culvert ID		120-04
Type		Cross
Shape		Round
Material		CSP
Diameter or Dimensions (mm)		500
Marker Post Present		No
End	Upstream	No
	Downstream	Yes
Infill Depth (mm)	Upstream	50
	Downstream	50
Other		None
Comments

Culvert Condition Ratings (MTO 2013)				
Barrel Material (0-4)	Shape (0-4)	Capacity (0-2)	Erosion and Scour (0-2)	US/DS Channel (0-2)
0	2	1	0	1

Recommended Action(s):	Regrade channel	Priority:	Low
------------------------	-----------------	-----------	-----
