Geotechnical Investigation and Drainage Planning in Gjoa Haven, Nunavut

Gjoa Haven, NU

Final Report

September 2023

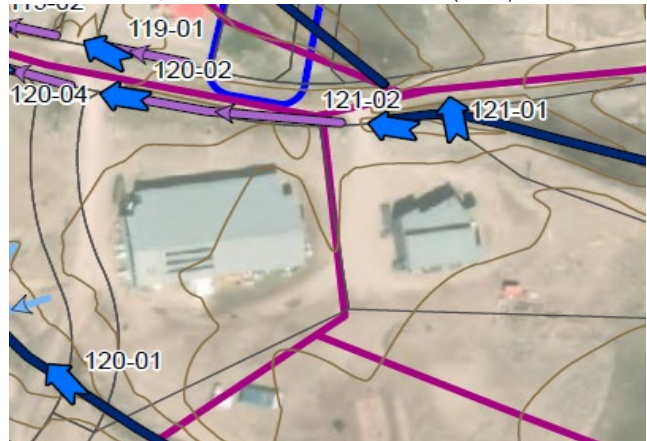
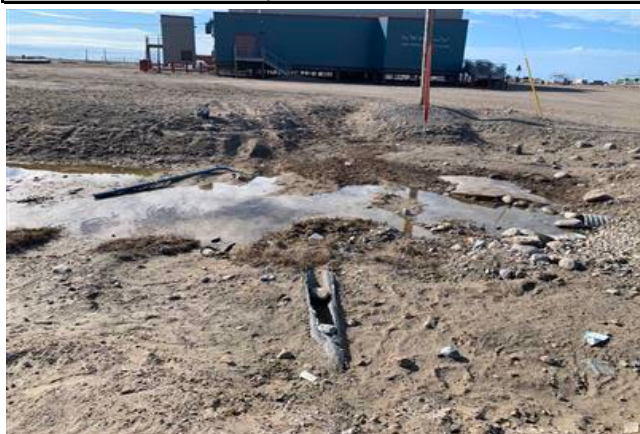
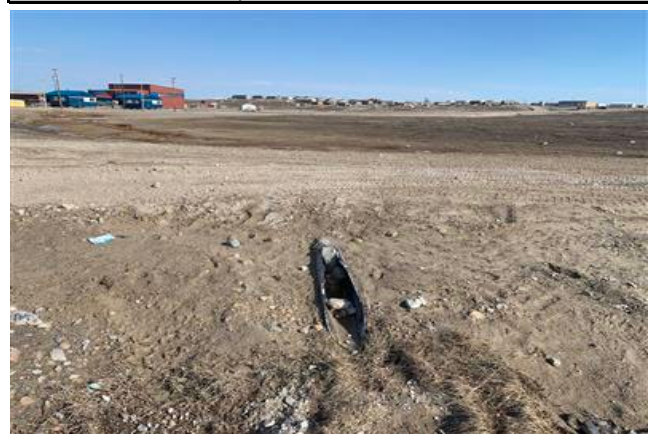
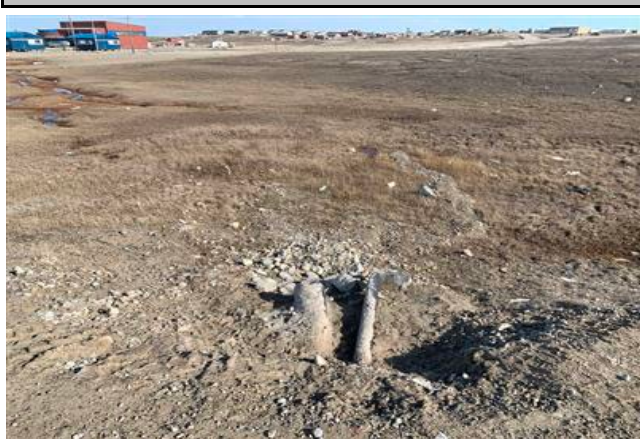
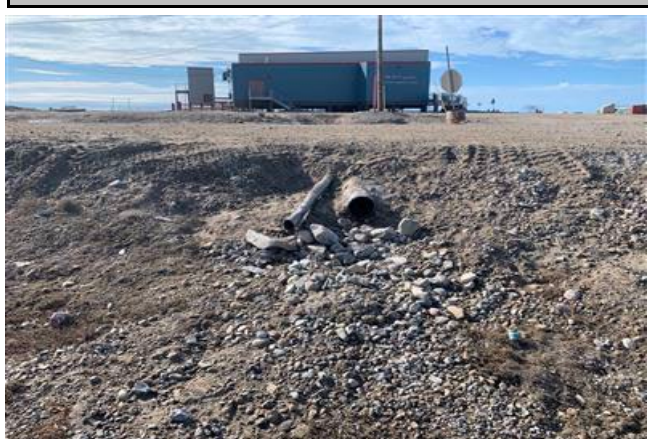
Culvert Information		
Culvert ID		121-01
Type		Cross
Shape		Round
Material		PVC
Diameter or Dimensions (mm)		250
Marker Post Present		No
End	Upstream	Yes
	Downstream	No
Infill Depth (mm)	Upstream	0
	Downstream	0
Other Comments		Upstream invert high. Not good drainage. Ponding upstream

Culvert Condition Ratings (MTO 2013)				
Barrel Material (0-4)	Shape (0-4)	Capacity (0-2)	Erosion and Scour (0-2)	US/DS Channel (0-2)
0	1	0	0	2

Recommended Action(s):	Regrade upstream channel	Priority:	High
------------------------	--------------------------	-----------	------

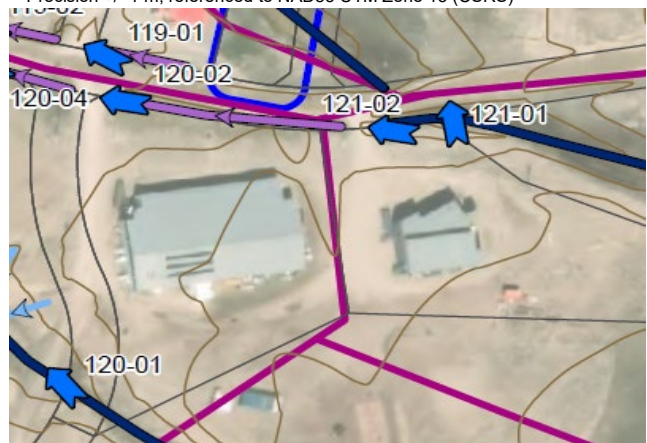
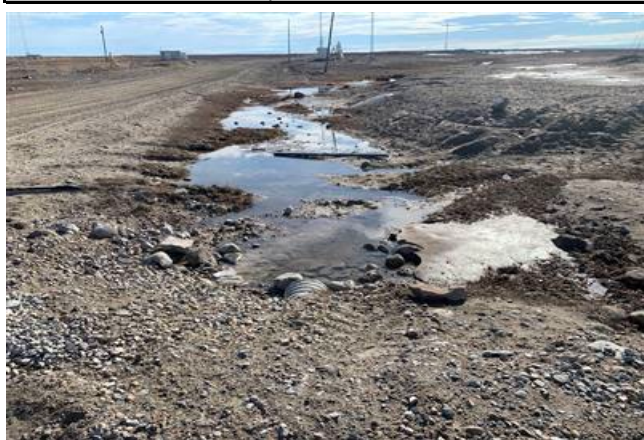
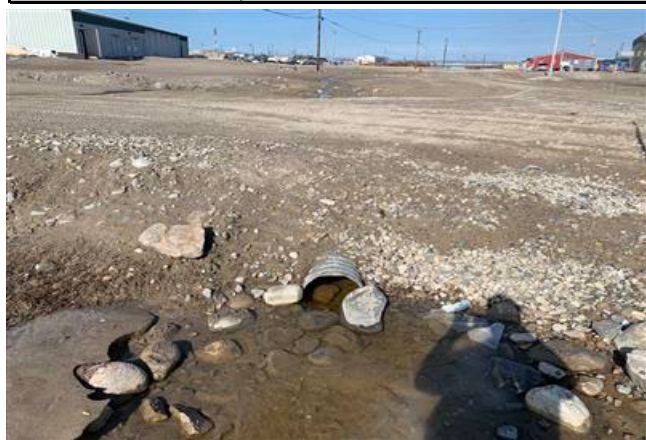
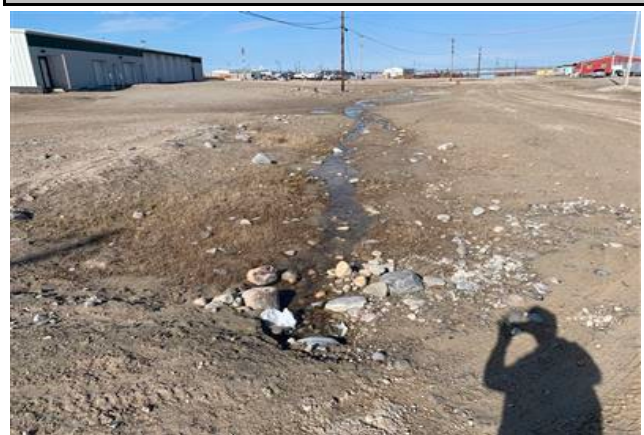
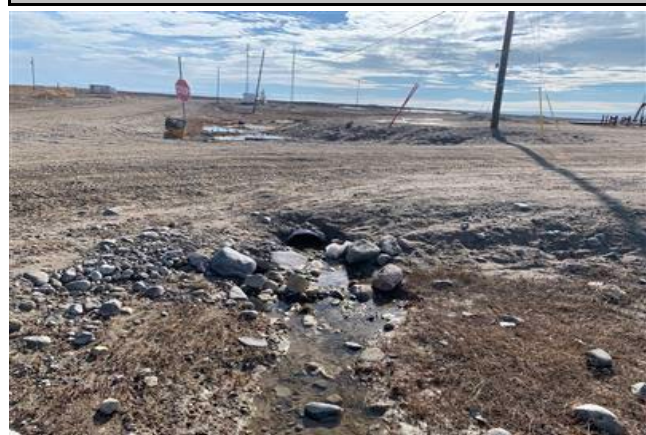
Culvert Information		
Culvert ID		121-02
Type		Entrance
Shape		Round
Material		CSP
Diameter or Dimensions (mm)		400
Marker Post Present		No
End	Upstream	No
	Downstream	No
Infill Depth (mm)	Upstream	0
	Downstream	200
Other Comments		None

Culvert Condition Ratings (MTO 2013)				
Barrel Material (0-4)	Shape (0-4)	Capacity (0-2)	Erosion and Scour (0-2)	US/DS Channel (0-2)
0	0	2	1	0

Recommended Action(s):	Flush culvert	Priority:	High
------------------------	---------------	-----------	------

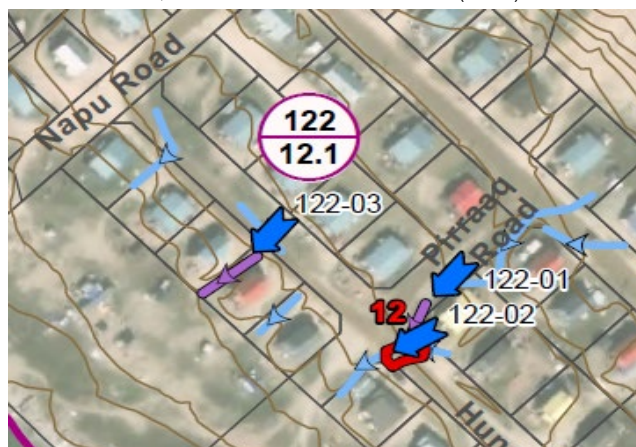
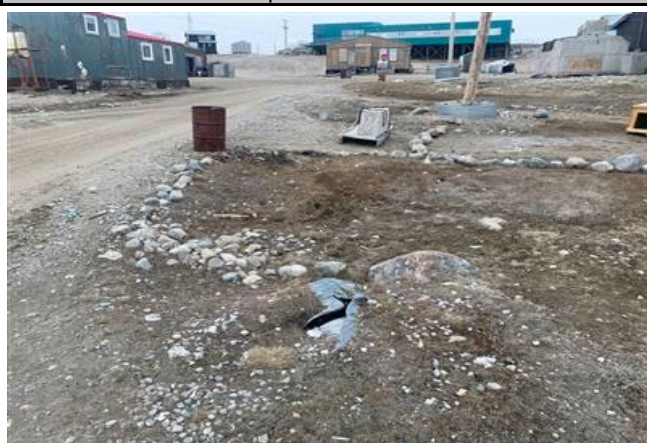
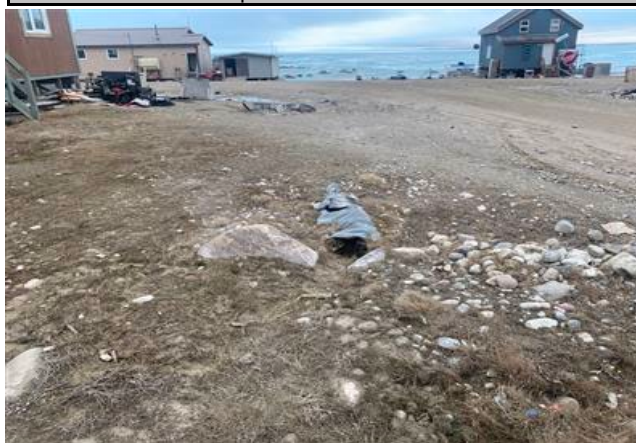
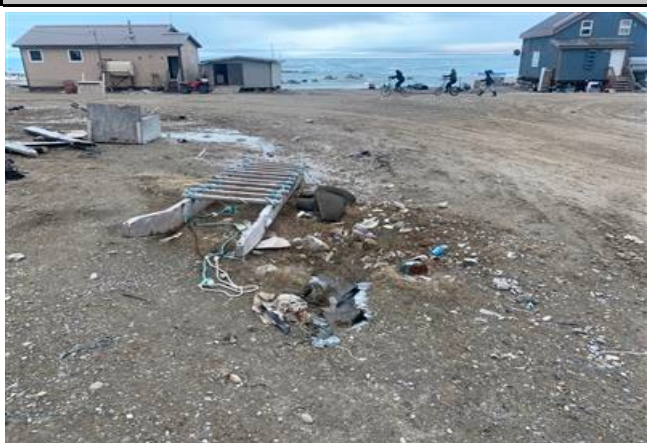
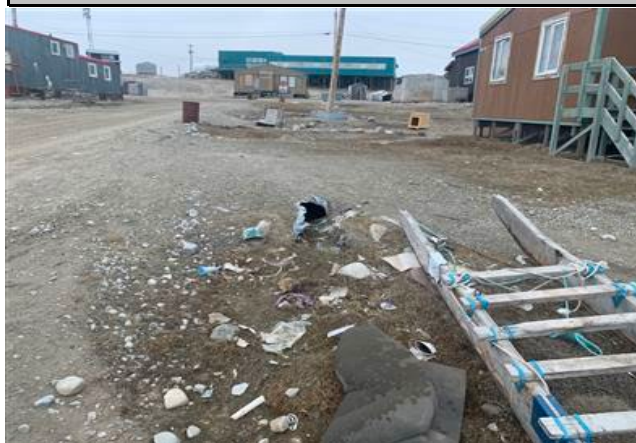
Culvert Information		
Culvert ID		122-01
Type		Entrance
Shape		Round
Material		CSP
Diameter or Dimensions (mm)		600
Marker Post Present		No
End Crushing	Upstream	Yes
	Downstream	Yes
Infill Depth (mm)	Upstream	300
	Downstream	100
Other Comments		Upstream end crushed

Culvert Condition Ratings (MTO 2013)				
Barrel Material (0-4)	Shape (0-4)	Capacity (0-2)	Erosion and Scour (0-2)	US/DS Channel (0-2)
0	4	2	0	2

Recommended Action(s):	Upstream culvert end crushed, improve upstream conveyance	Priority:	High
------------------------	---	-----------	------

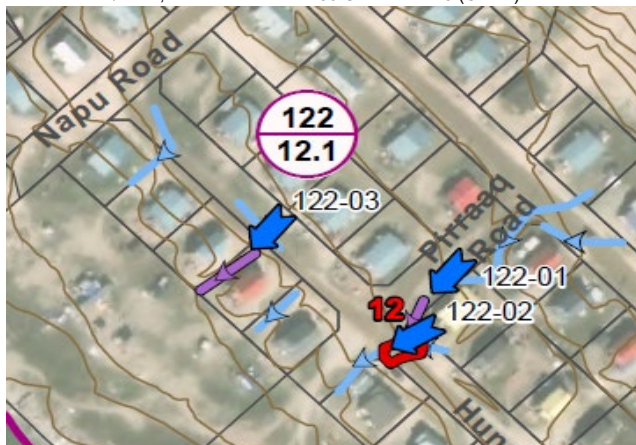
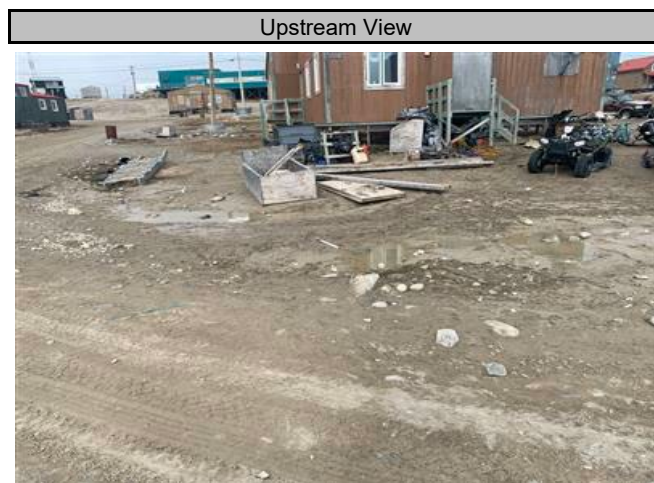
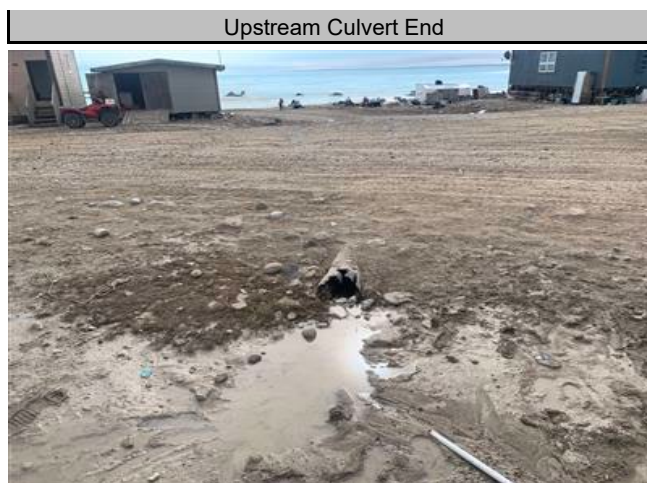
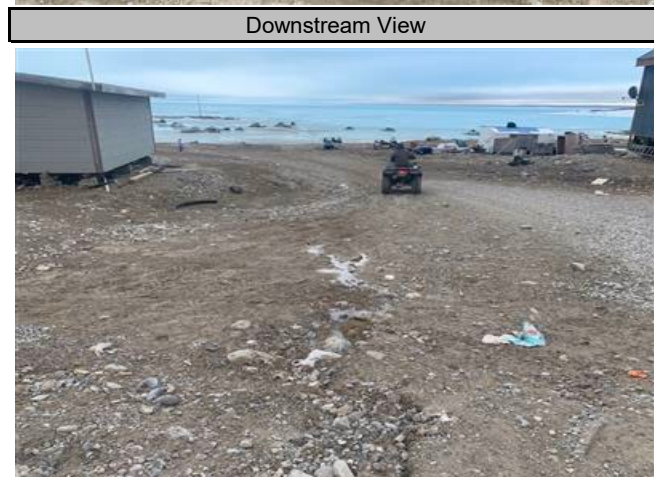
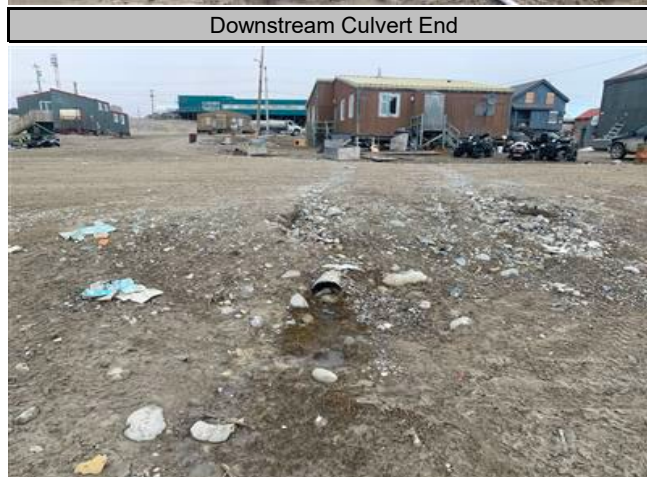
Culvert Information		
Culvert ID		122-02
Type		Cross
Shape		Round
Material		PVC
Diameter or Dimensions (mm)		250
Marker Post Present		No
End	Upstream	Yes
	Downstream	No
Infill Depth (mm)	Upstream	0
	Downstream	100
Other Comments		Inlet obstructed by rock and material. Minor ponding upstream. Undefined ditch upstream

Culvert Condition Ratings (MTO 2013)				
Barrel Material (0-4)	Shape (0-4)	Capacity (0-2)	Erosion and Scour (0-2)	US/DS Channel (0-2)
0	0	2	0	2

Recommended Action(s):	Flush culvert, improve upstream conveyance	Priority:	High
------------------------	--	-----------	------

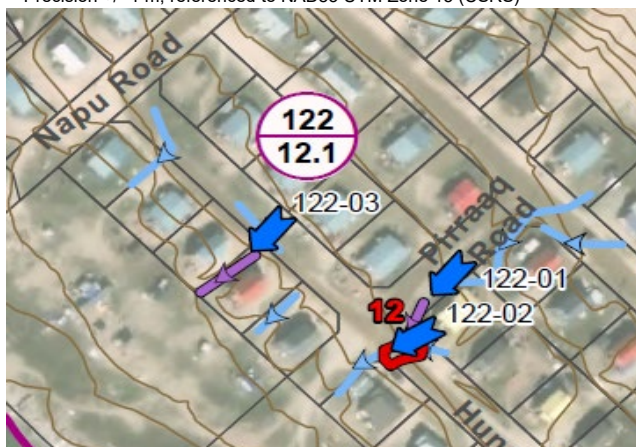
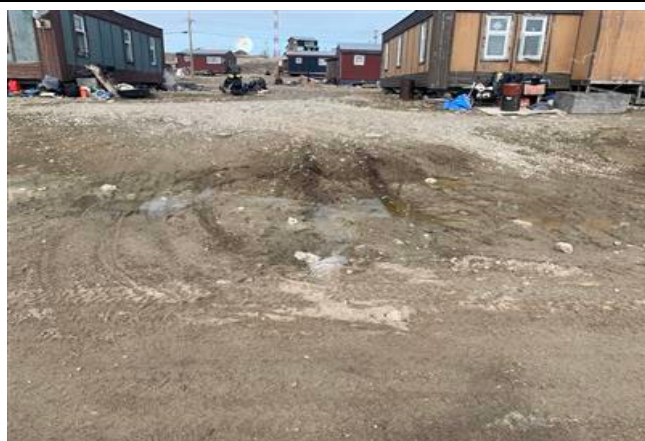
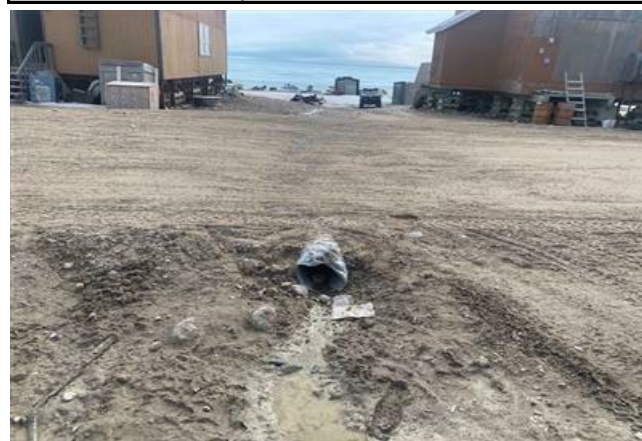
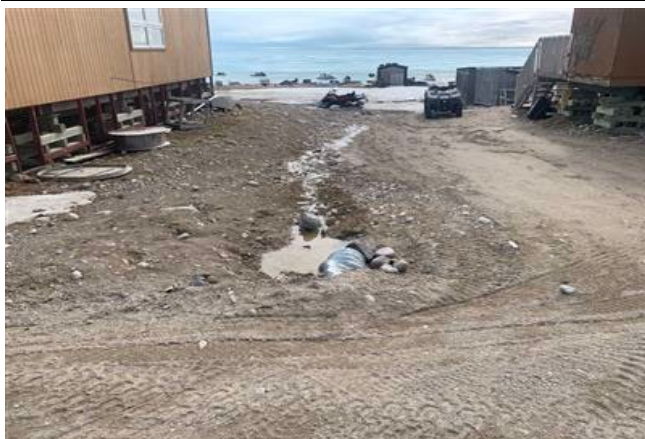
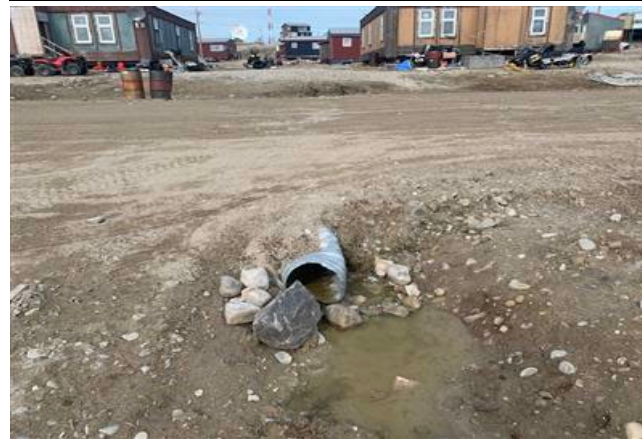
Culvert Information		
Culvert ID		122-03
Type		Cross
Shape		Round
Material		CSP
Diameter or Dimensions (mm)		300
Marker Post Present		No
End	Upstream	No
	Downstream	No
Infill Depth (mm)	Upstream	0
	Downstream	0
Other Comments		Undefined ditch upstream. Minor ponding

Culvert Condition Ratings (MTO 2013)				
Barrel Material (0-4)	Shape (0-4)	Capacity (0-2)	Erosion and Scour (0-2)	US/DS Channel (0-2)
0	2	2	0	1

Recommended Action(s):	Flush culvert, improve upstream conveyance	Priority:	High
------------------------	--	-----------	------

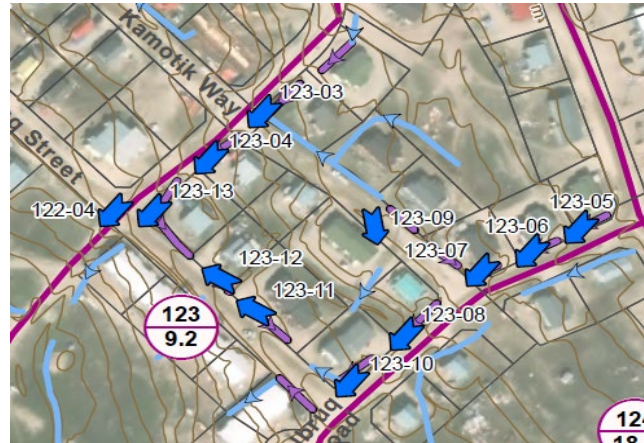
Culvert Information		
Culvert ID		122-04
Type		Cross
Shape		Round
Material		CSP
Diameter or Dimensions (mm)		500
Marker Post Present		No
End	Upstream	0
	Downstream	Yes
Infill Depth (mm)	Upstream	500
	Downstream	200
Other Comments	Upstream end buried

Culvert Condition Ratings (MTO 2013)				
Barrel Material (0-4)	Shape (0-4)	Capacity (0-2)	Erosion and Scour (0-2)	US/DS Channel (0-2)
0	3	2	0	1

Recommended Action(s):	Replace culvert	Priority:	High
------------------------	-----------------	-----------	------

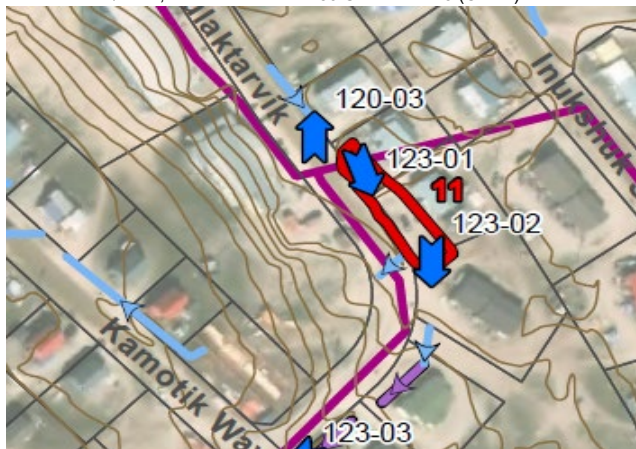
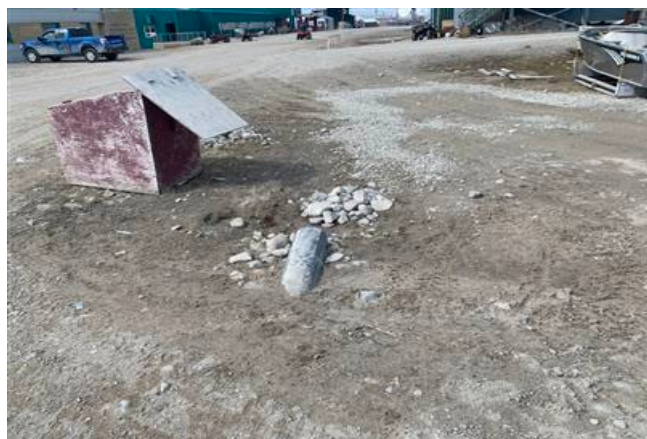
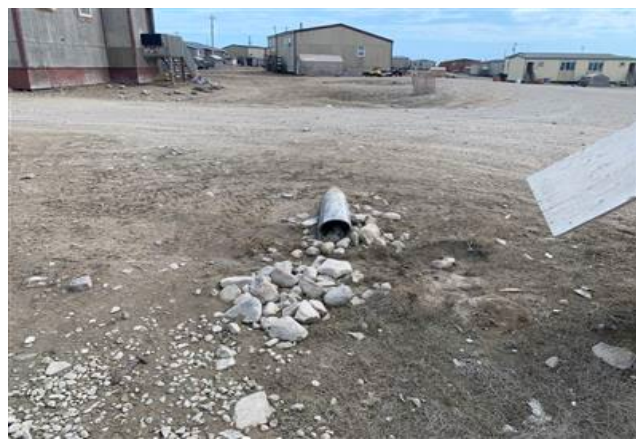
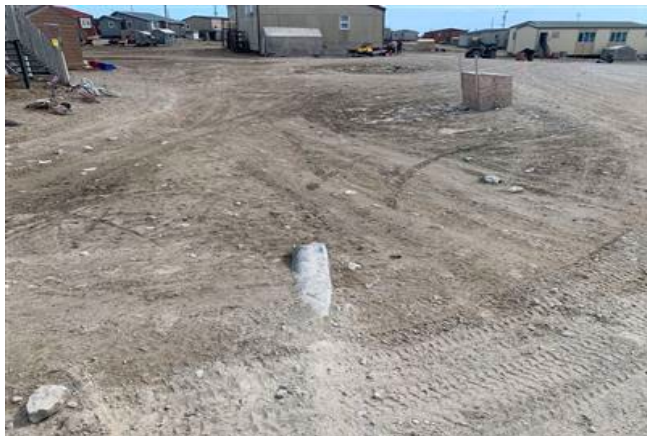
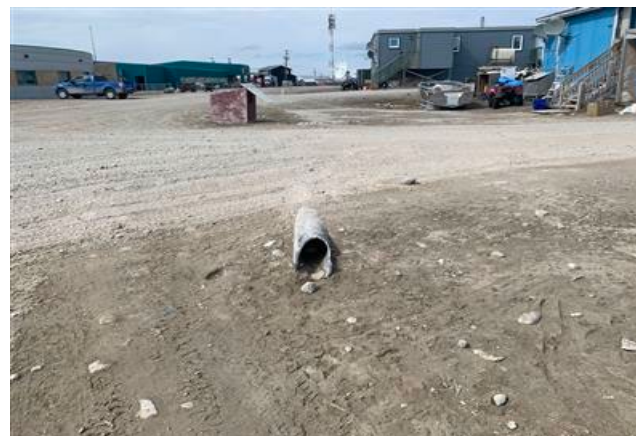
Culvert Information		
Culvert ID		123-01
Type		Entrance
Shape		Round
Material		PVC
Diameter or Dimensions (mm)		250
Marker Post Present		No
End	Upstream	No
	Downstream	No
Infill Depth (mm)	Upstream	0
	Downstream	0
Other Comments		Low and high points unknown

Culvert Condition Ratings (MTO 2013)				
Barrel Material (0-4)	Shape (0-4)	Capacity (0-2)	Erosion and Scour (0-2)	US/DS Channel (0-2)
0	0	0	0	0

Recommended Action(s):	Survey to determine culvert orientation	Priority:	Low
------------------------	---	-----------	-----

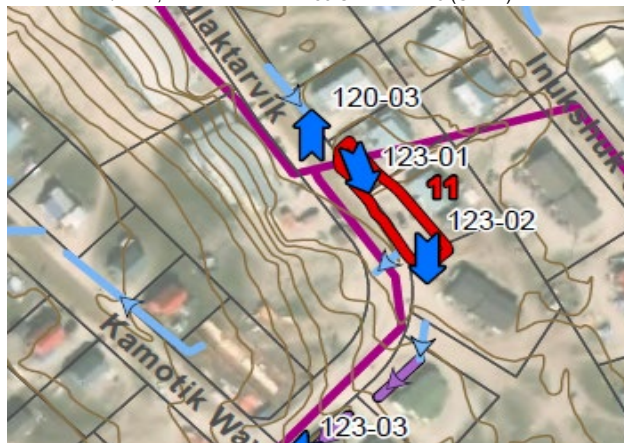
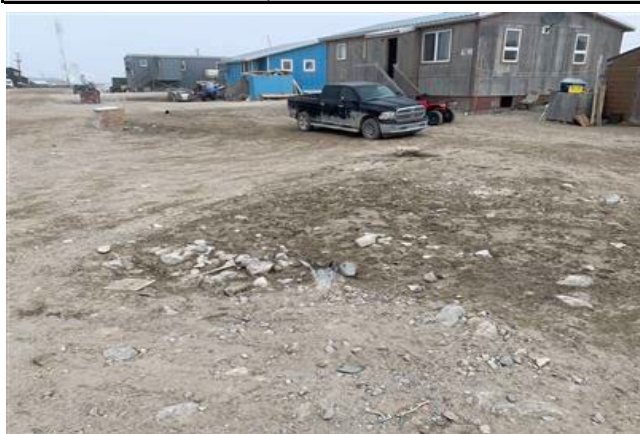
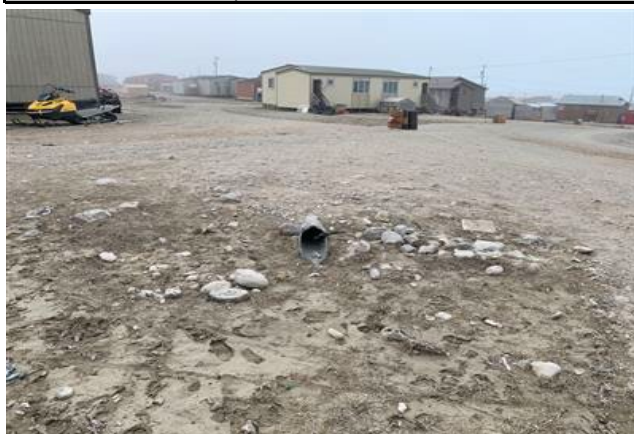
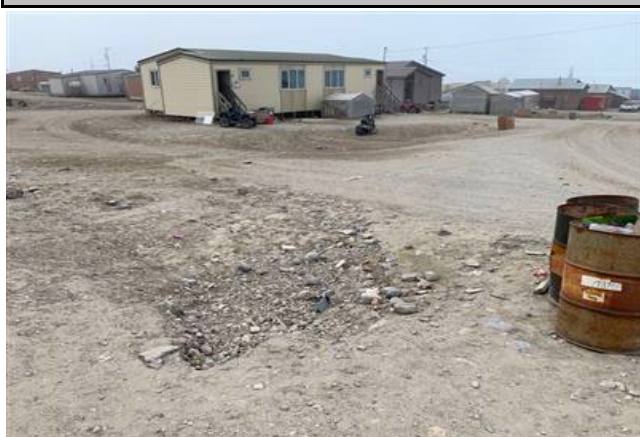
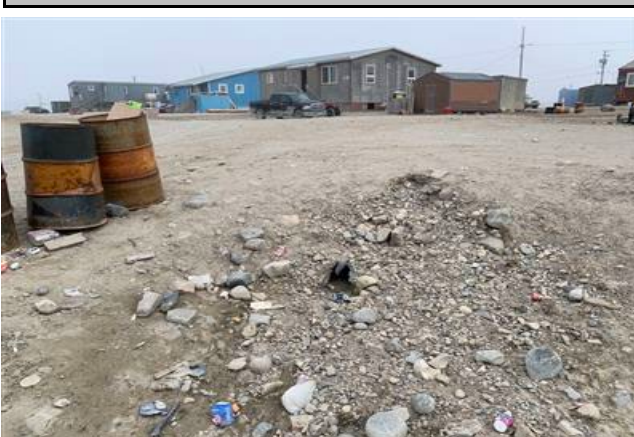
Culvert Information		
Culvert ID		123-02
Type		Cross
Shape		Round
Material		PVC
Diameter or Dimensions (mm)		250
Marker Post Present		No
End	Upstream	Yes
	Downstream	Yes
Infill Depth (mm)	Upstream	0
	Downstream	50
Other Comments		None

Culvert Condition Ratings (MTO 2013)				
Barrel Material (0-4)	Shape (0-4)	Capacity (0-2)	Erosion and Scour (0-2)	US/DS Channel (0-2)
0	2	1	0	1

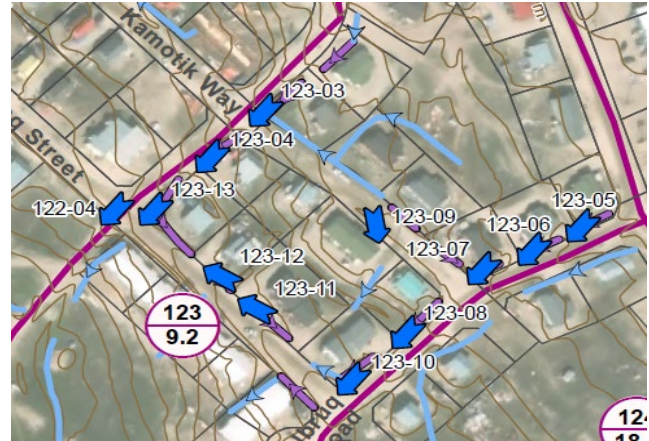
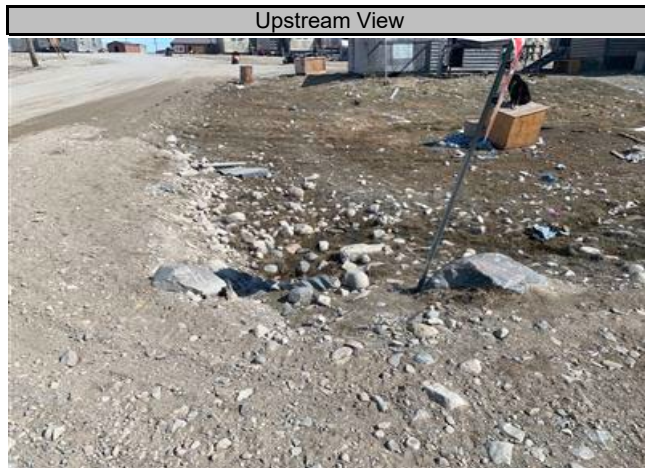
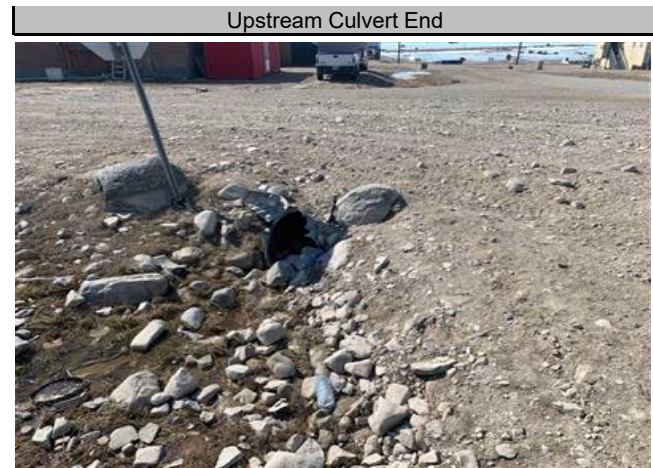
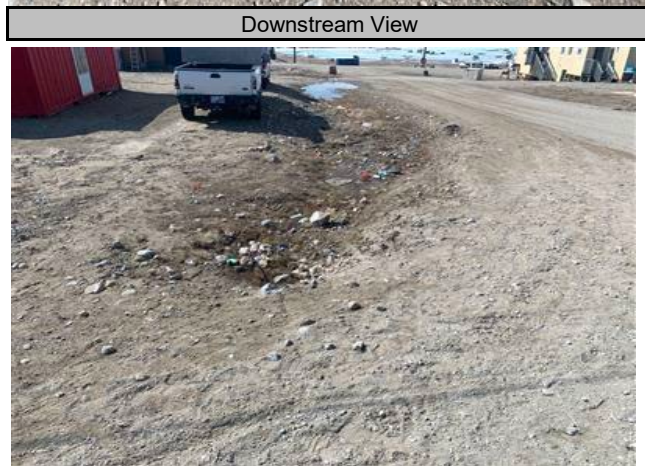
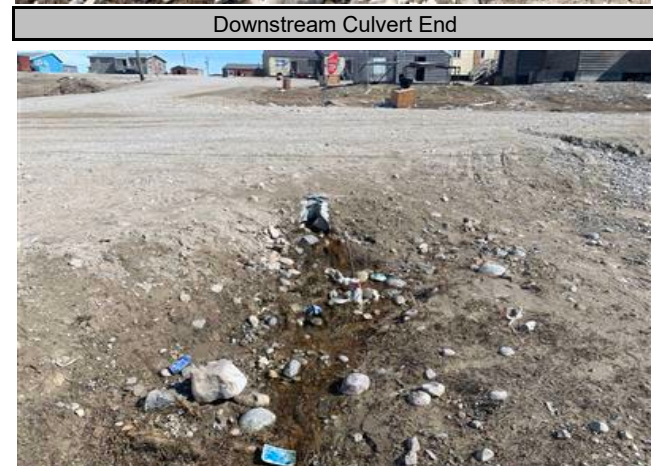
Culvert Information		
Culvert ID		123-03
Type		Cross
Shape		Round
Material		CSP
Diameter or Dimensions (mm)		400
Marker Post Present		No
End	Upstream	Yes
	Downstream	Yes
Infill Depth (mm)	Upstream	50
	Downstream	50
Other Comments	Upstream and downstream end crushed

Culvert Condition Ratings (MTO 2013)				
Barrel Material (0-4)	Shape (0-4)	Capacity (0-2)	Erosion and Scour (0-2)	US/DS Channel (0-2)
0	4	1	0	1

Recommended Action(s):	Replace culvert	Priority:	High
------------------------	-----------------	-----------	------

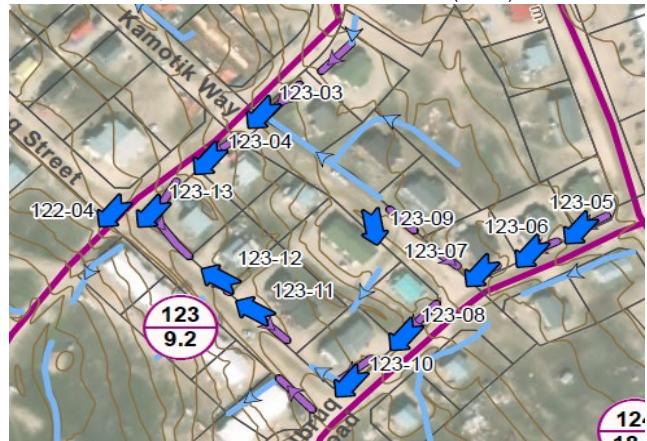
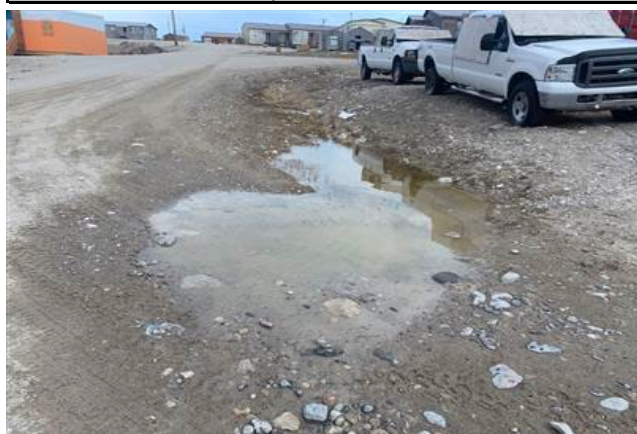
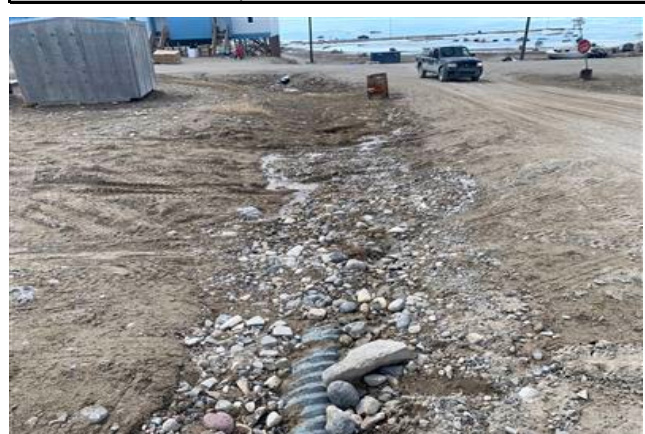
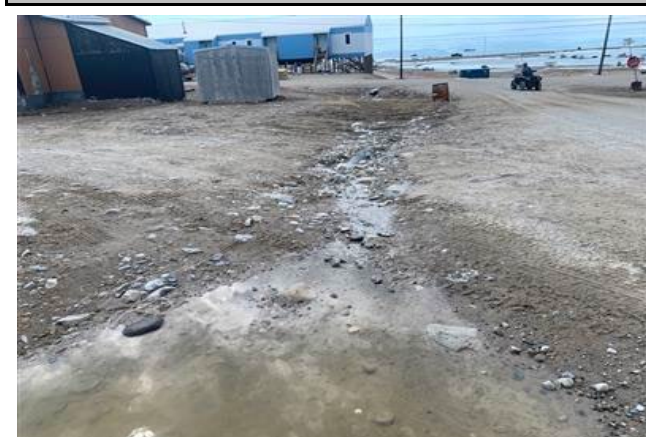
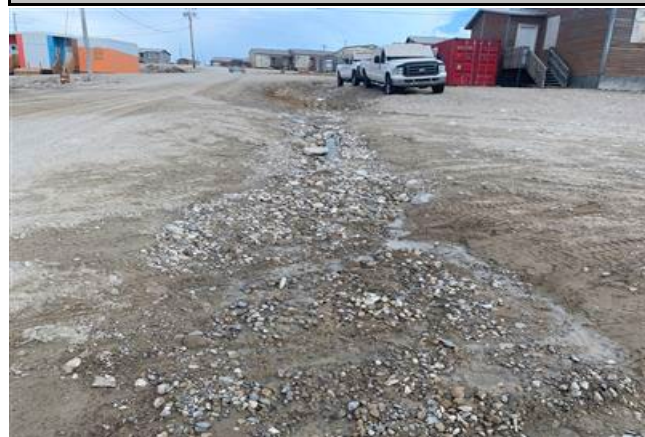
Culvert Information		
Culvert ID		123-04
Type		Entrance
Shape		Round
Material		CSP
Diameter or Dimensions (mm)		400
Marker Post Present		No
End	Upstream	Na
	Downstream	Na
Infill Depth (mm)	Upstream	400
	Downstream	400
Other Comments	Both ends buried. Shallow overburden. Flow occurs over the culvert. Ponding upstream

Culvert Condition Ratings (MTO 2013)				
Barrel Material (0-4)	Shape (0-4)	Capacity (0-2)	Erosion and Scour (0-2)	US/DS Channel (0-2)
0	0	2	0	0

Recommended Action(s):	Replace culvert at a lower elevation	Priority:	High
------------------------	--------------------------------------	-----------	------

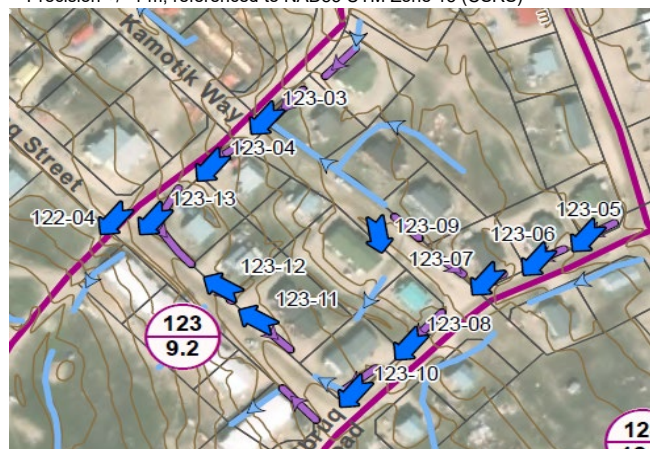
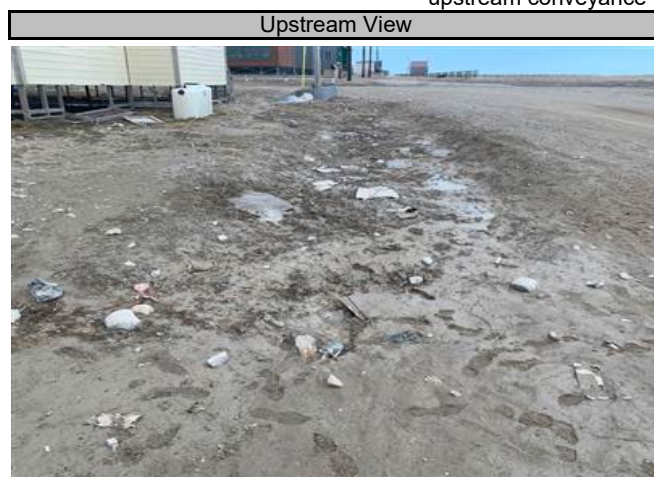
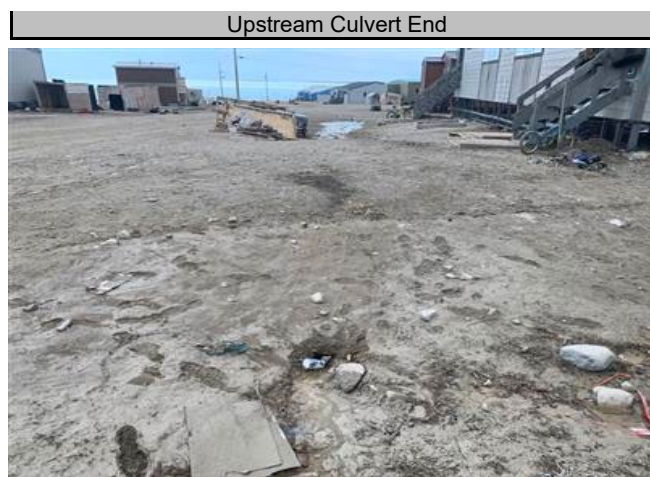
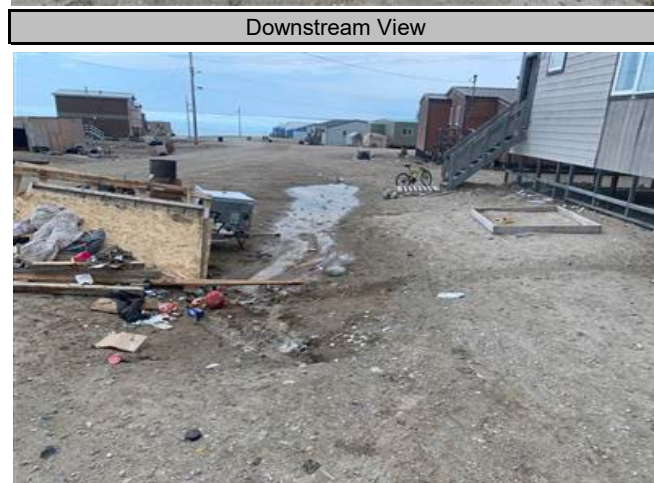
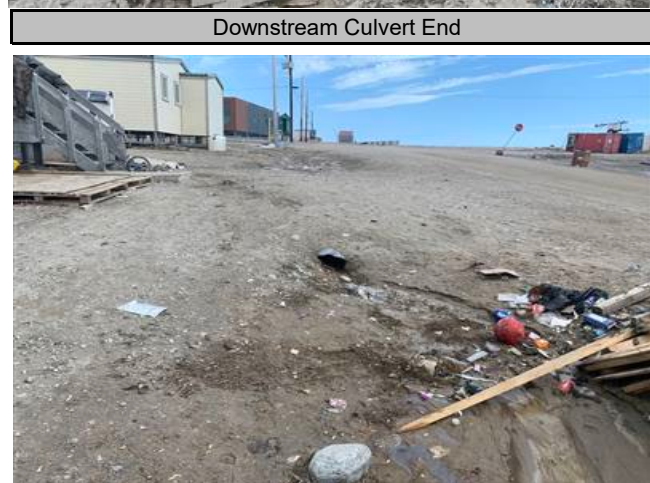
Culvert Information		
Culvert ID		123-05
Type		Entrance
Shape		Round
Material		CSP
Diameter or Dimensions (mm)		400
Marker Post Present		No
End	Upstream	Yes
	Downstream	No
Infill Depth (mm)	Upstream	300
	Downstream	150
Other Comments		Upstream end almost buried

Culvert Condition Ratings (MTO 2013)				
Barrel Material (0-4)	Shape (0-4)	Capacity (0-2)	Erosion and Scour (0-2)	US/DS Channel (0-2)
0	1	2	0	2

Recommended Action(s):	Replace culvert at a lower elevation, improve upstream conveyance	Priority:	High
------------------------	---	-----------	------

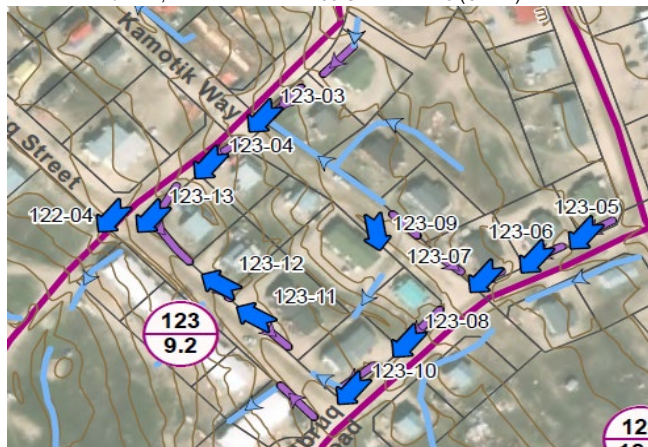
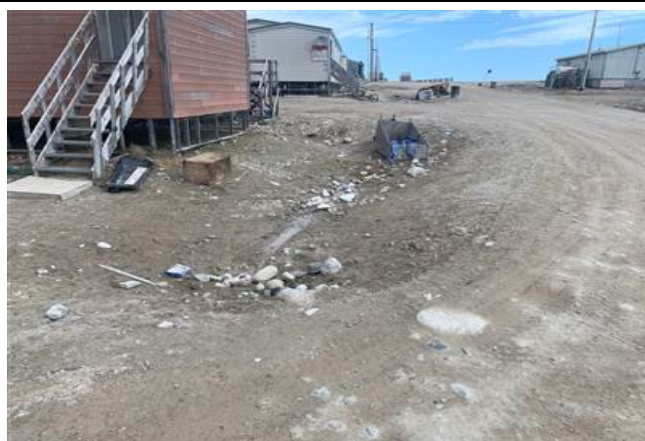
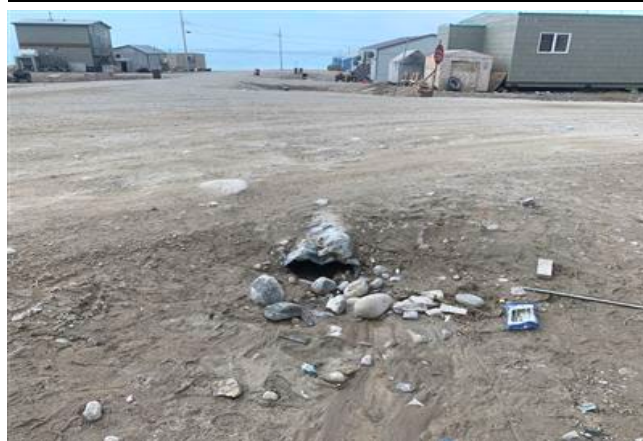
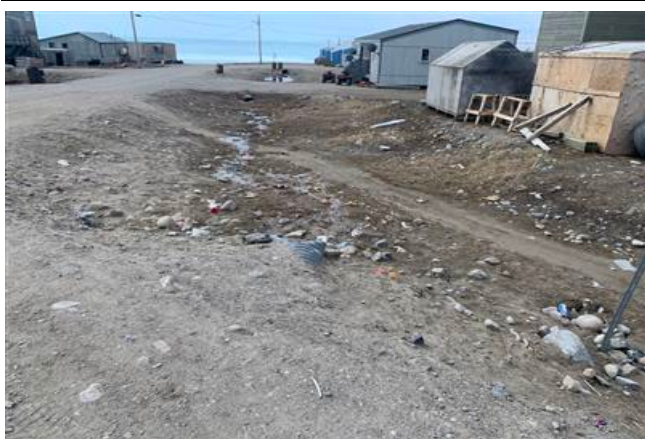
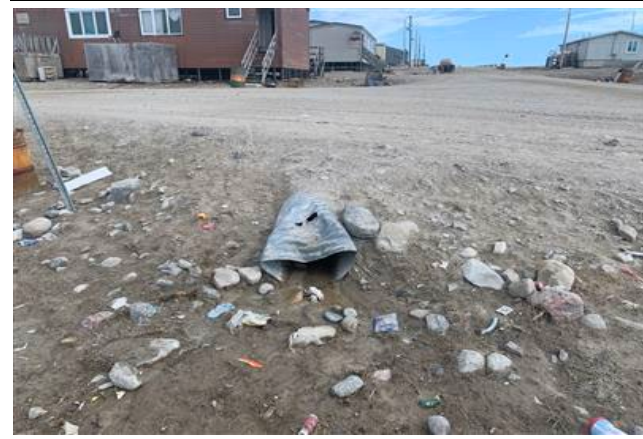
Culvert Information		
Culvert ID		123-07
Type		Cross
Shape		Round
Material		CSP
Diameter or Dimensions (mm)		500
Marker Post Present		No
End Crushing	Upstream	Yes
	Downstream	Yes
Infill Depth (mm)	Upstream	50
	Downstream	0
Other Comments		None

Culvert Condition Ratings (MTO 2013)				
Barrel Material (0-4)	Shape (0-4)	Capacity (0-2)	Erosion and Scour (0-2)	US/DS Channel (0-2)
0	3	1	0	0

Recommended Action(s):	Replace culvert, ends crushed	Priority:	High
------------------------	-------------------------------	-----------	------

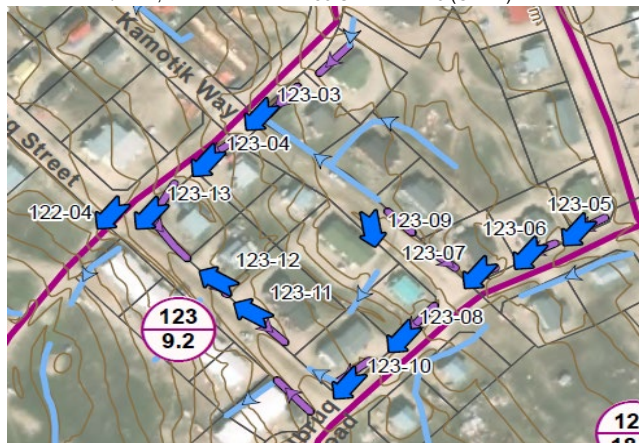
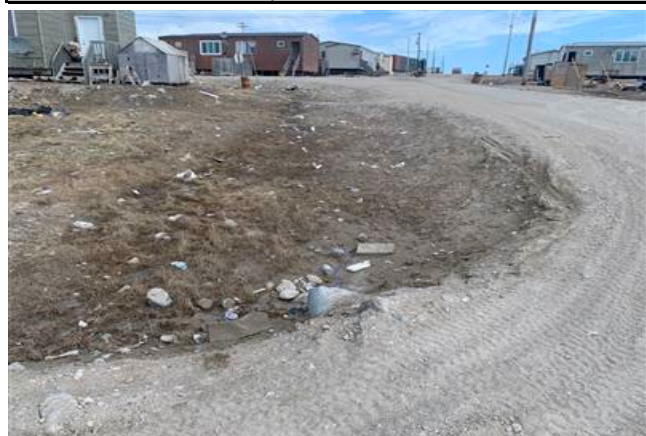
Culvert Information		
Culvert ID		123-08
Type		Entrance
Shape		Round
Material		CSP
Diameter or Dimensions (mm)		500
Marker Post Present		No
End	Upstream	No
	Downstream	No
Infill Depth (mm)	Upstream	50
	Downstream	350
Other Comments		None

Culvert Condition Ratings (MTO 2013)				
Barrel Material (0-4)	Shape (0-4)	Capacity (0-2)	Erosion and Scour (0-2)	US/DS Channel (0-2)
0	2	2	0	0

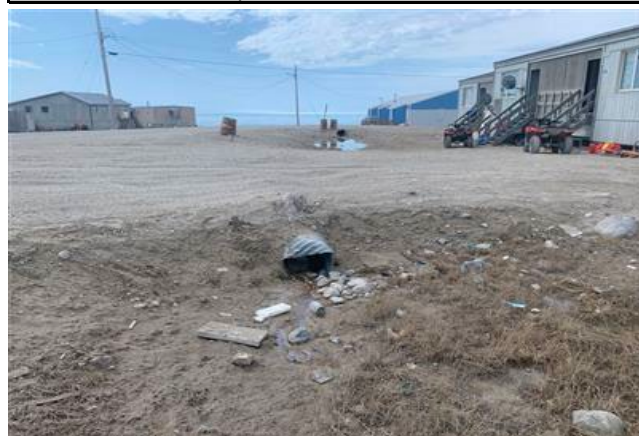
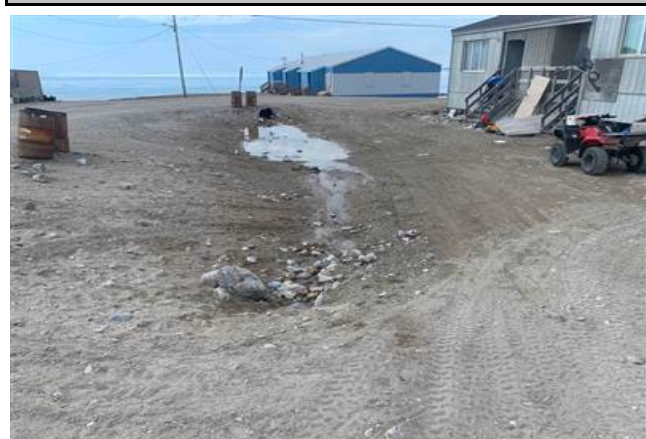
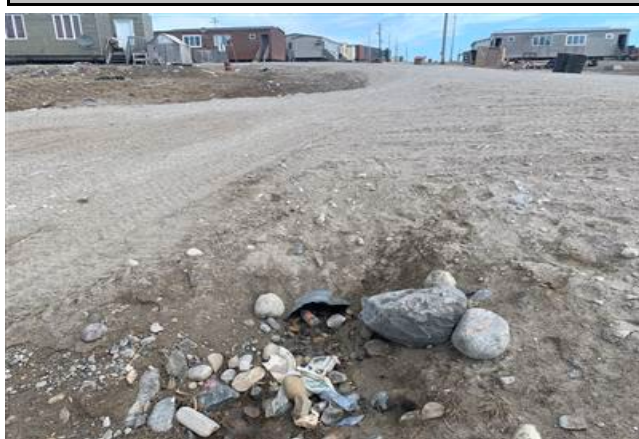
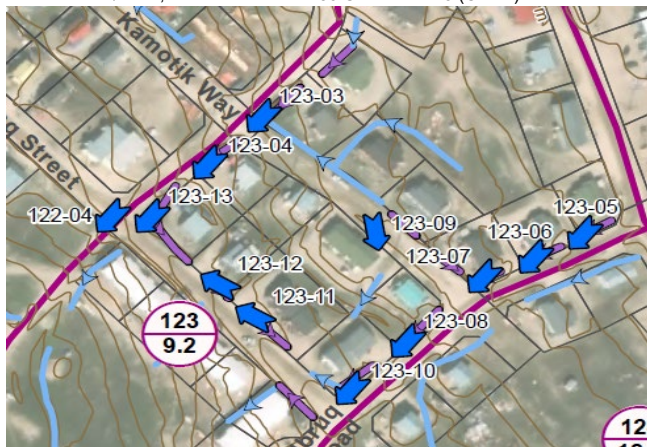
Culvert Information		
Culvert ID		123-09
Type		Entrance
Shape		Round
Material		PVC
Diameter or Dimensions (mm)		250
Marker Post Present		No
End Crushing	Upstream	No
	Downstream	No
Infill Depth (mm)	Upstream	150
	Downstream	0
Other Comments		Shallow overburden. No proper ditch to convey flow.

Culvert Condition Ratings (MTO 2013)				
Barrel Material (0-4)	Shape (0-4)	Capacity (0-2)	Erosion and Scour (0-2)	US/DS Channel (0-2)
0	0	2	0	2

Recommended Action(s):	Reinstall culvert at a lower elevation	Priority:	High
------------------------	--	-----------	------

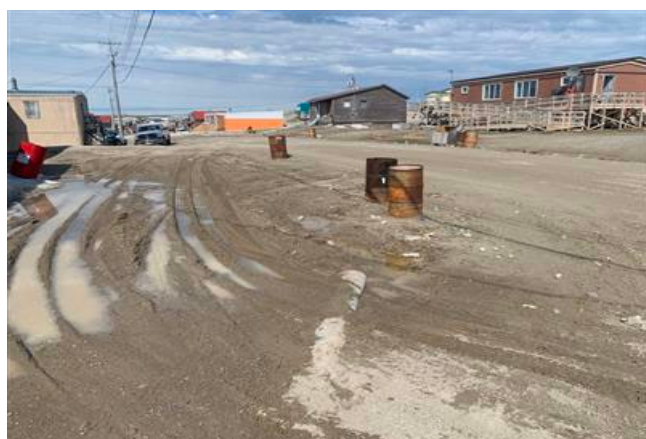
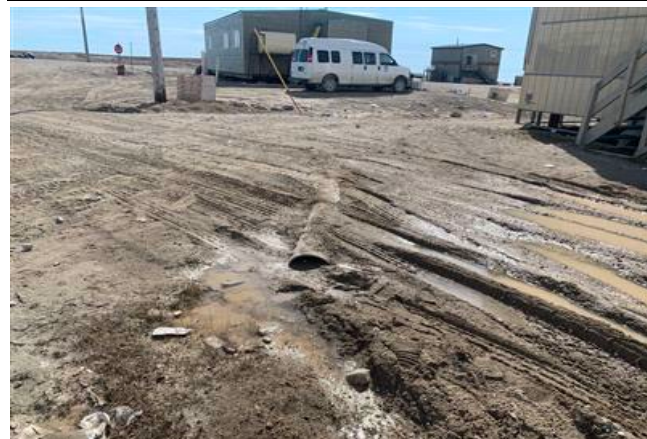
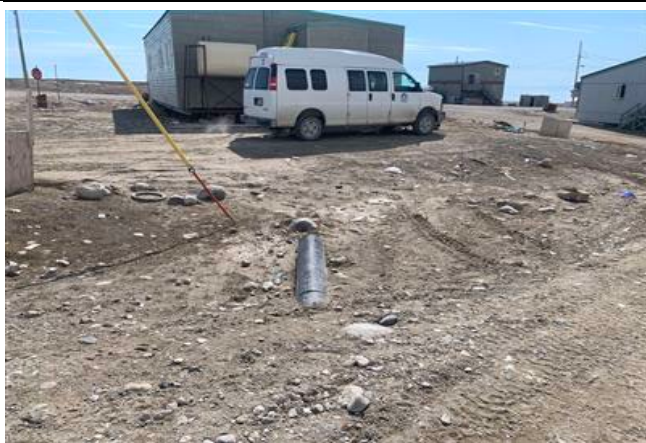
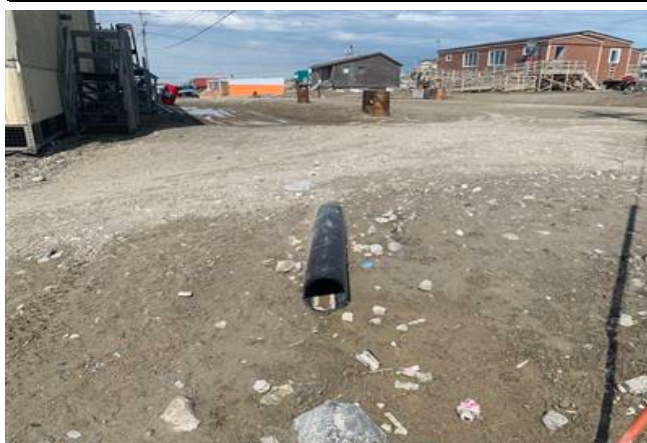
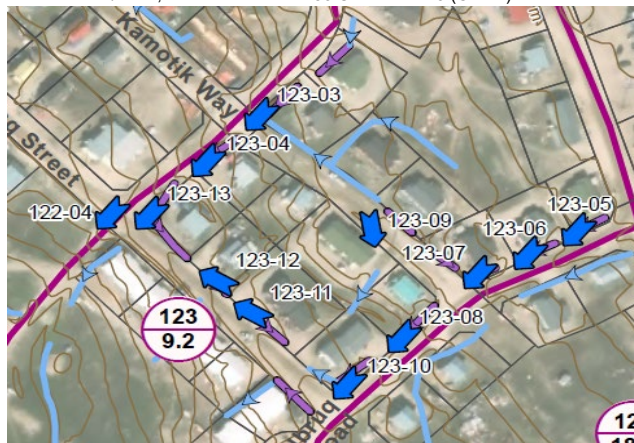
Culvert Information		
Culvert ID		123-10
Type		Cross
Shape		Round
Material		CSP
Diameter or Dimensions (mm)		800
Marker Post Present		No
End	Upstream	Yes
	Downstream	No
Infill Depth (mm)	Upstream	50
	Downstream	400
Other Comments		Partially blocked by ice downstream. Ponding upstream. Ditch not defined

Culvert Condition Ratings (MTO 2013)				
Barrel Material (0-4)	Shape (0-4)	Capacity (0-2)	Erosion and Scour (0-2)	US/DS Channel (0-2)
0	1	2	0	0

Recommended Action(s):	Flush culvert	Priority:	High
------------------------	---------------	-----------	------

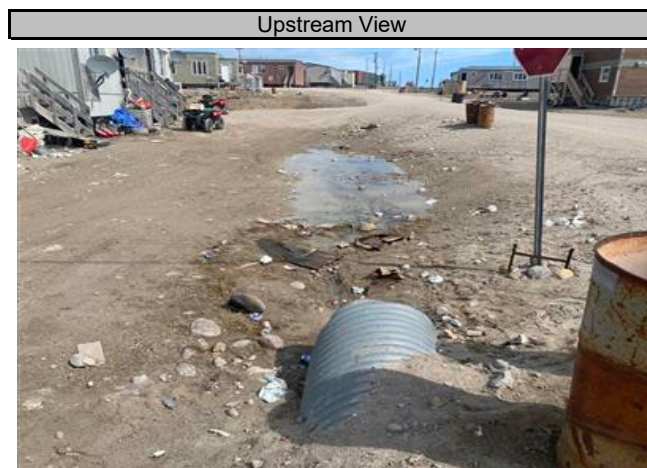
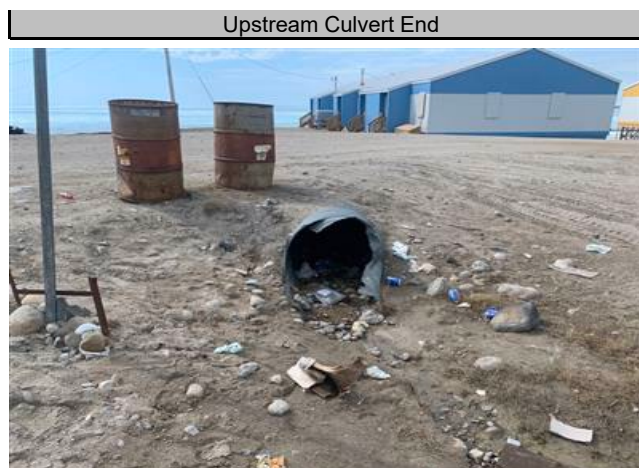
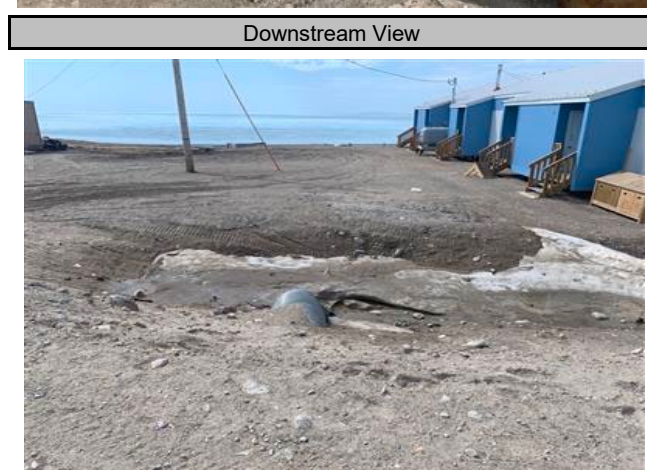
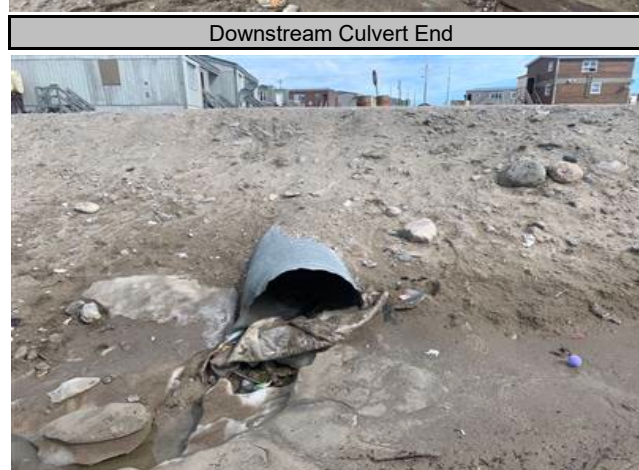
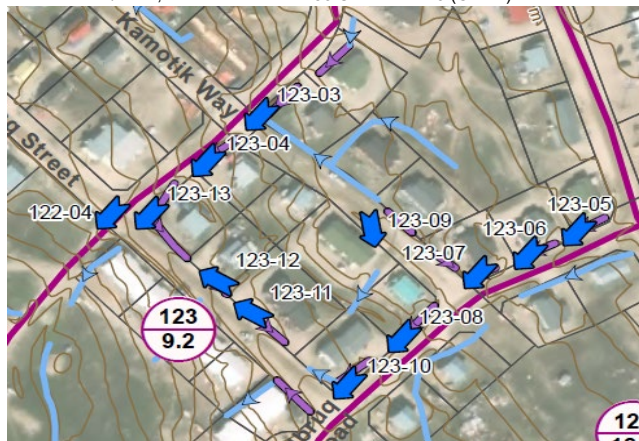
Culvert Information		
Culvert ID		123-11
Type		Entrance
Shape		Round
Material		CSP
Diameter or Dimensions (mm)		400
Marker Post Present		No
End	Upstream	Yes
	Downstream	No
Infill Depth (mm)	Upstream	0
	Downstream	0
Other Comments	Upstream almost buried and very crushed. Cant see inside

Culvert Condition Ratings (MTO 2013)				
Barrel Material (0-4)	Shape (0-4)	Capacity (0-2)	Erosion and Scour (0-2)	US/DS Channel (0-2)
0	4	0	0	0

Recommended Action(s):	Repalce culvert	Priority:	High
------------------------	-----------------	-----------	------
