Geotechnical Investigation and Drainage Planning in Gjoa Haven, Nunavut

Gjoa Haven, NU

Final Report

September 2023

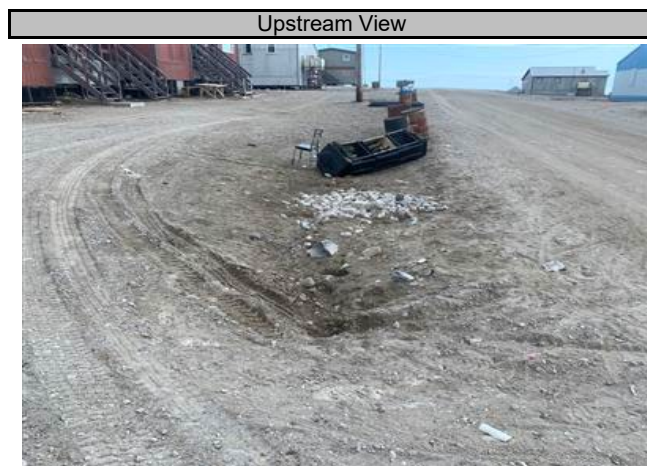
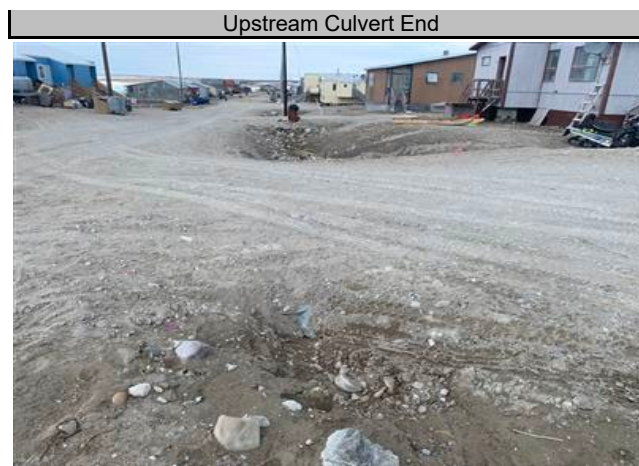
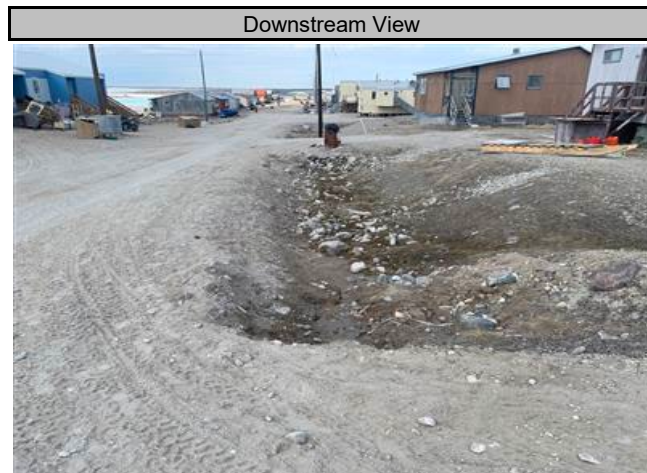
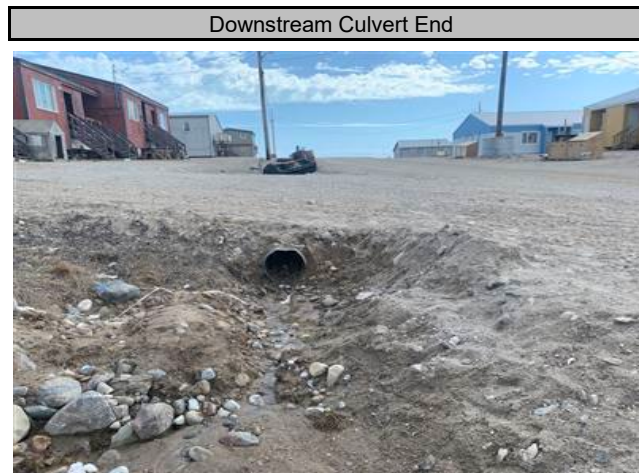
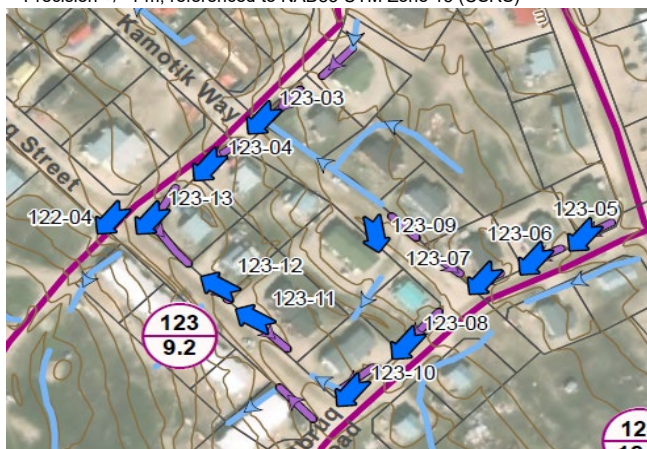
Culvert Information		
Culvert ID		123-12
Type		Entrance
Shape		Round
Material		CSP
Diameter or Dimensions (mm)		400
Marker Post Present		No
End	Upstream	No
	Downstream	No
Infill Depth (mm)	Upstream	100
	Downstream	250
Other Comments		Debris in front of upstream end

Culvert Condition Ratings (MTO 2013)				
Barrel Material (0-4)	Shape (0-4)	Capacity (0-2)	Erosion and Scour (0-2)	US/DS Channel (0-2)
0	2	2	0	0

Recommended Action(s):	Clear rock	Priority:	High
------------------------	------------	-----------	------

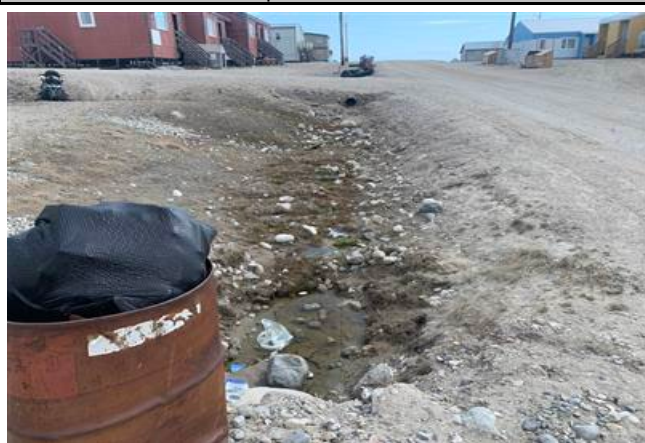
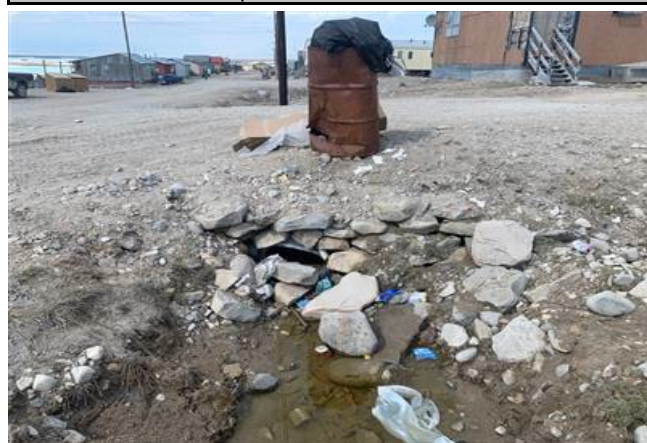
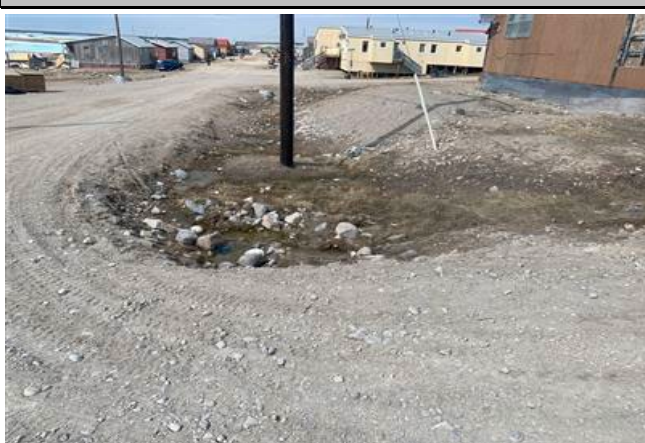
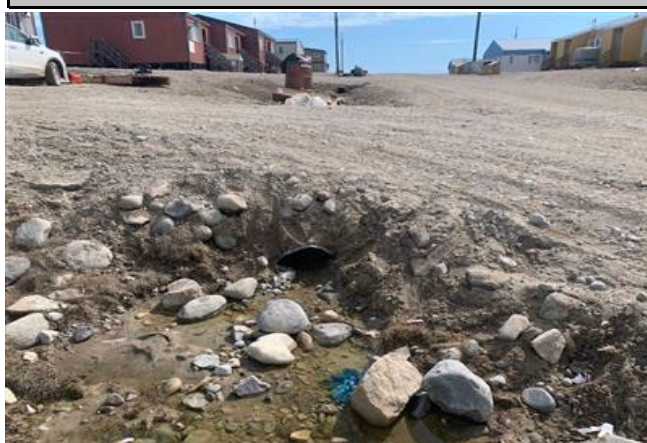
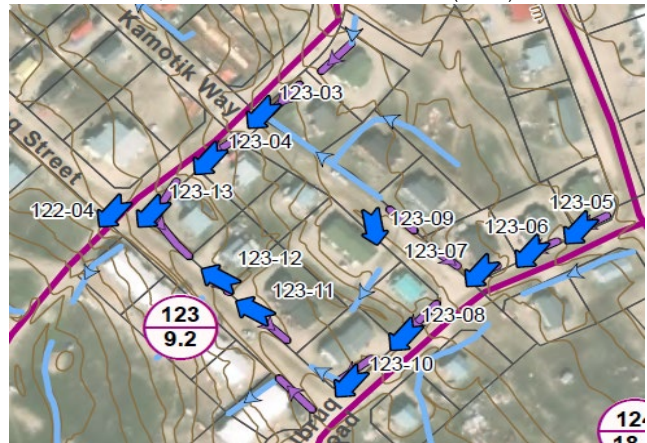
Culvert Information		
Culvert ID		123-13
Type		Cross
Shape		Round
Material		CSP
Diameter or Dimensions (mm)		600
Marker Post Present		No
End	Upstream	Yes
	Downstream	No
Infill Depth (mm)	Upstream	0
	Downstream	0
Other Comments		Upstream invert high. Dont drain efficiently

Culvert Condition Ratings (MTO 2013)				
Barrel Material (0-4)	Shape (0-4)	Capacity (0-2)	Erosion and Scour (0-2)	US/DS Channel (0-2)
0	2	2	1	0

Recommended Action(s):	Reinstall culvert at a lower elevation	Priority:	High
------------------------	--	-----------	------

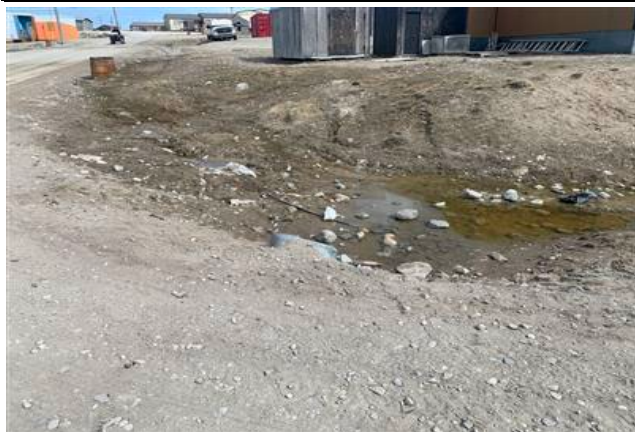
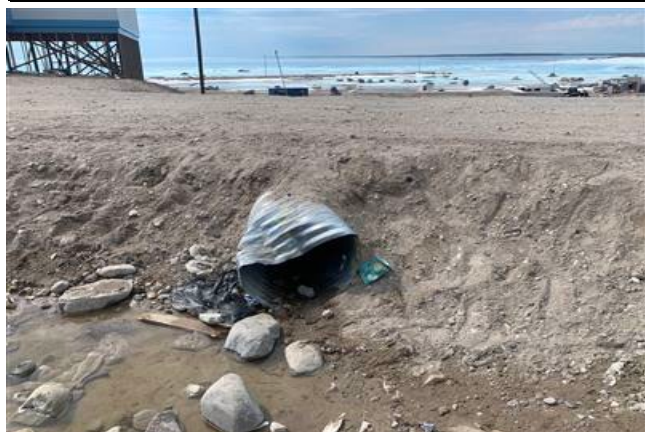
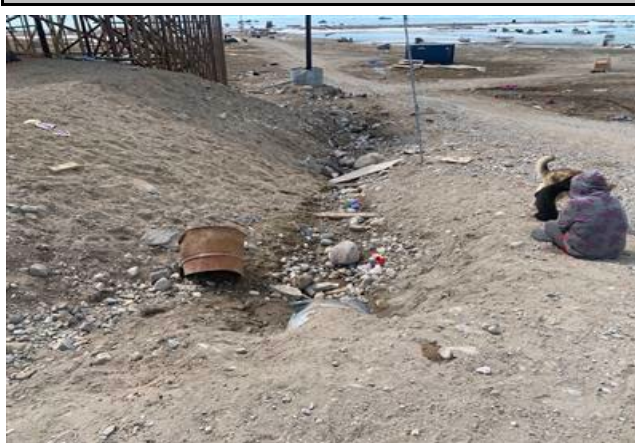
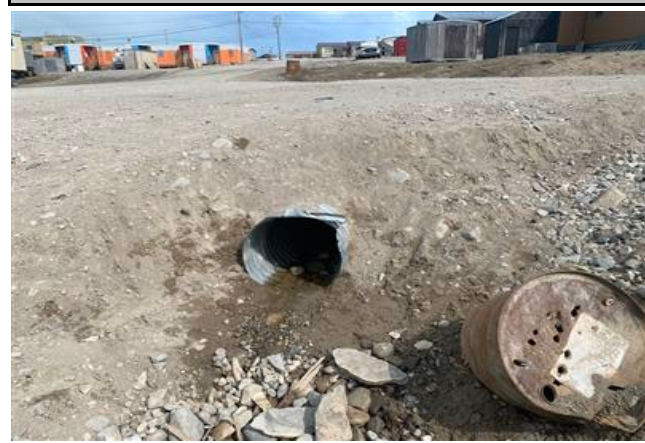
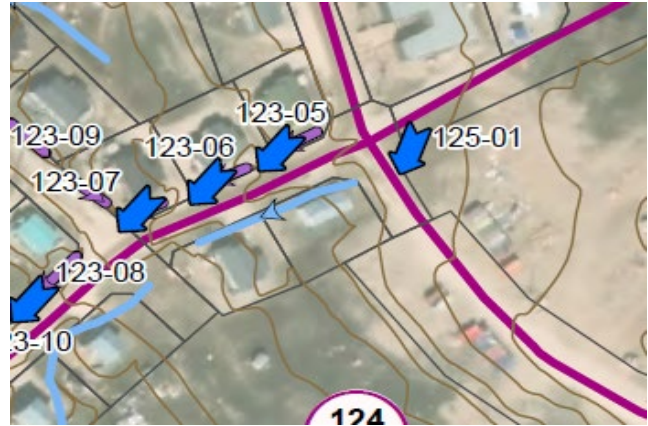
Culvert Information		
Culvert ID		125-01
Type		Cross
Shape		Round
Material		PVC
Diameter or Dimensions (mm)		250
Marker Post Present		No
End	Upstream	No
	Downstream	No
Infill Depth (mm)	Upstream	200
	Downstream	0
Other Comments	Culvert inlet almost buried. Ponding upstream. No clear ditch to the culvert

Culvert Condition Ratings (MTO 2013)				
Barrel Material (0-4)	Shape (0-4)	Capacity (0-2)	Erosion and Scour (0-2)	US/DS Channel (0-2)
0	0	2	0	1

Recommended Action(s):	Flush culvert	Priority:	High
------------------------	---------------	-----------	------
