**Geotechnical Evaluation and Drainage Planning
in Rankin Inlet, Nunavut**

Draft Report
REV-00

Prepared for:
The Municipality of Rankin Inlet

Prepared by:
Nunami Stantec Limited

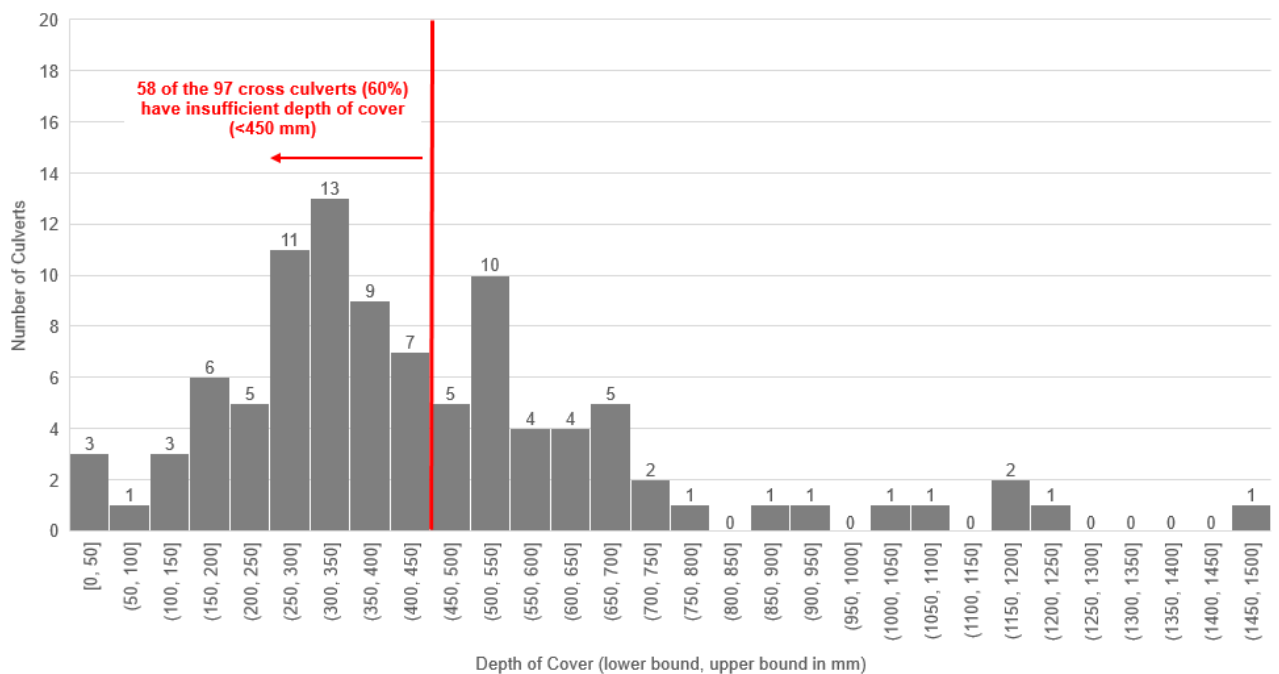
Figure 4-1 Depth of Cover for Cross Culverts in Rankin Inlet

Culvert Depth of Cover. Figure 4-1 and Figure 4-2 illustrate the frequency of depth of cover in 50 mm increments for cross culverts and entrance culverts, respectively. Figure 4-1 and Figure 4-2 also indicate the minimum depth of cover requirements for cross culverts and entrance culverts, respectively.

- *Drainage deficiency: 58 of the 97 cross culverts (60%) and 18 of the 51 entrance culverts (35%) have insufficient depth of cover according to the minimum depth of cover requirements from CSA (2020).*

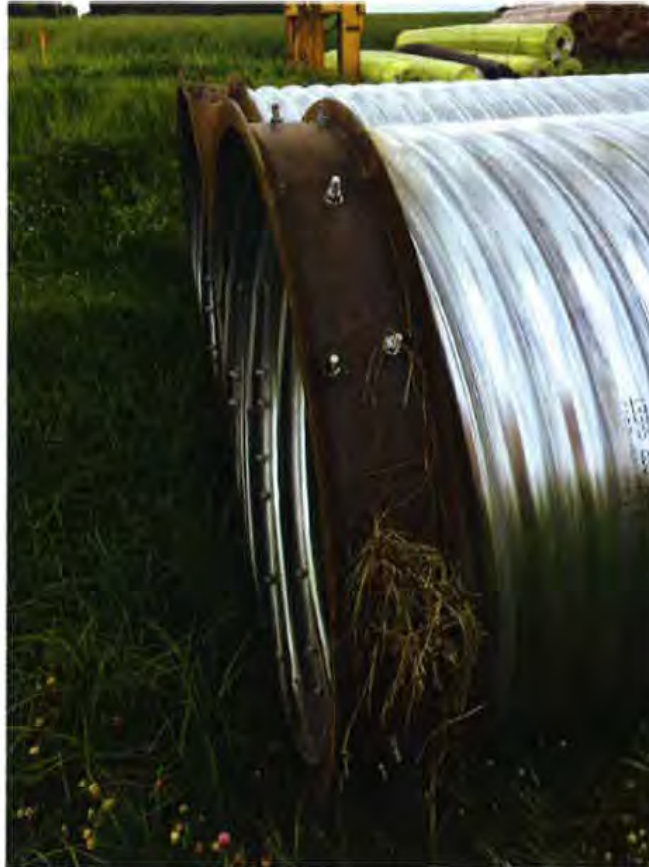
Figure 4-3 Culvert End Treatment – Culvert End Stiffener (Figure 17 from CSA 2020)

50 culverts have damaged ends with a high priority for remediation; an additional 17 culverts have damaged ends with a medium priority for remediation	<p>Repair the damaged/crushed culvert ends to re-establish hydraulic conveyance capacity of the culvert.</p> <p>The 67 culverts requiring remediation are identified in the detailed culvert database in Appendix F.</p> <p>The severity of the damage will determine the required work at each culvert:</p> <ol style="list-style-type: none"> i. Culverts with minor deformation at the ends may be bent back to the intended shape with appropriate tools ii. Where i) is not possible, culverts may be repaired by cutting off the damaged portion and either leaving it square (if remaining culvert projects from embankment) or adding a short section of new culvert with an appropriate coupling. Culverts with more substantial end damage may require a portion of the road to be dug up to reach a section of non-crushed culvert prior to coupling with the culvert extension. iii. For severely damaged culverts where upon further inspection crushing extends through substantial portions of the barrel, complete culvert replacement may be required. If the culvert is to be replaced, efforts should be made to install SWSP culverts (CSA 2020). <p>For CSP culverts, the repaired culvert ends should be reinforced with a steel end stiffener (e.g., Figure 4-3 as extracted from CSA 2020) or comparable stiff steel collar. This end treatment will make the culvert ends more resistant to damage in the future. As the hardened end treatments will not deform in the same way as CSP culverts, they pose a potential safety hazard to vehicles or humans who are accustomed to driving over the culvert ends (before or after deformation). The installation of the hardened end treatments should be communicated to the local community in advance of implementation.</p> <p>Where warranted and/or practicable, efforts should be made to install SWSP culverts (CSA 2020). SWSP culverts are also more resistant to end deformation and do not require end treatments. Multi-level culvert arrangements, as illustrated in Figure 9 of CSA (2020), can be considered if culvert icing is an issue. Culvert diameter should be equal to or larger than the upstream culverts; the hydrologic model produced in this report may provide design flows for culvert sizing analyses if desired.</p>

Note: This culvert end stiffener detail was developed by the Ministry of Transportation in Saskatchewan (2018). Originally intended for large diameter culverts (1.8 to 2.4 m diameter), a similar detail would also be useful for the smaller diameter culverts commonly seen in the communities. A wider stiffener band could be considered for culvert sections more prone to damage from maintenance equipment or crushing from traffic.

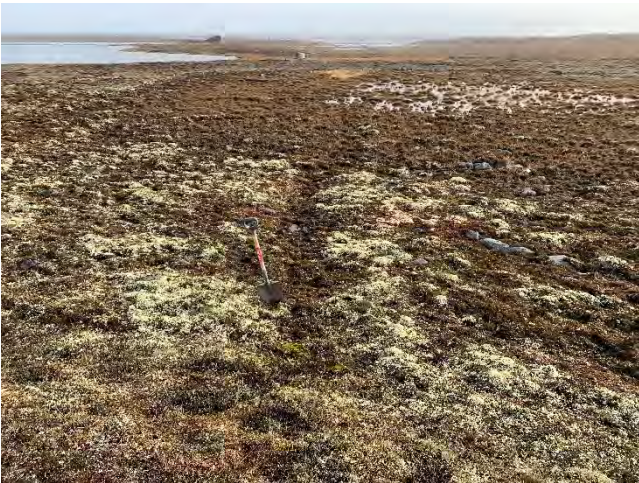
Photo 15: Ice wedge within Block 10.

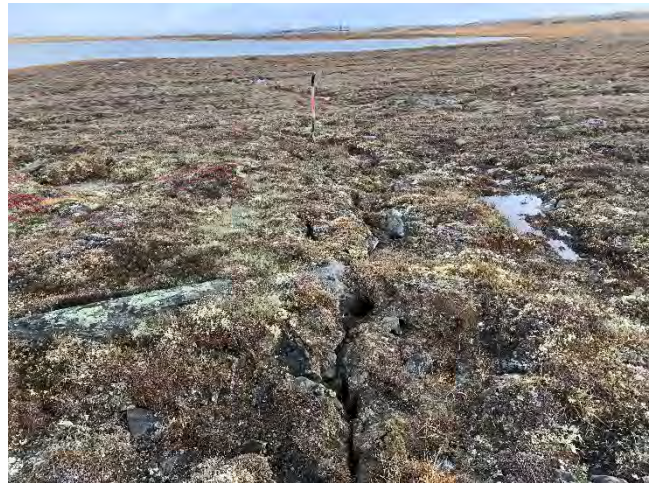
Photo 16: Ice wedge within Block 10.

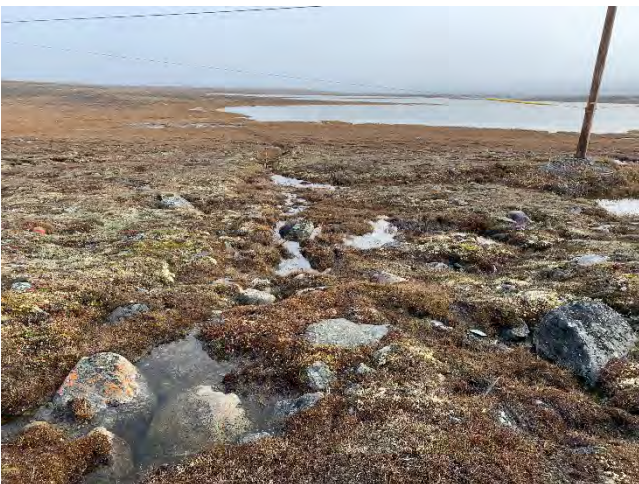
Photo 17: Ice wedge north of Block 10. Water flows within.

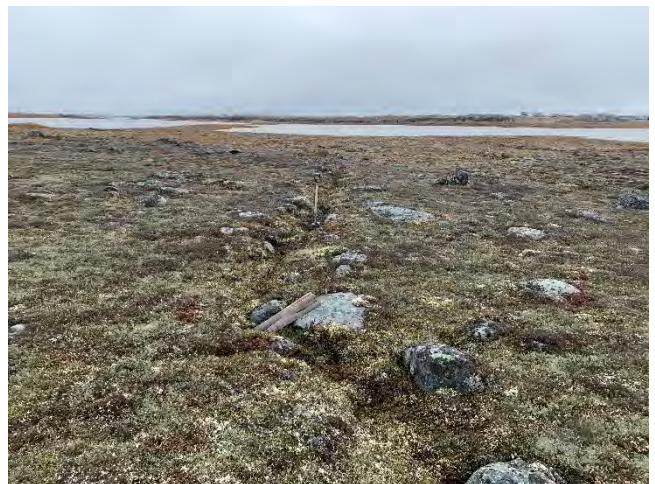
Photo 18: Ice wedge north of Block 10.

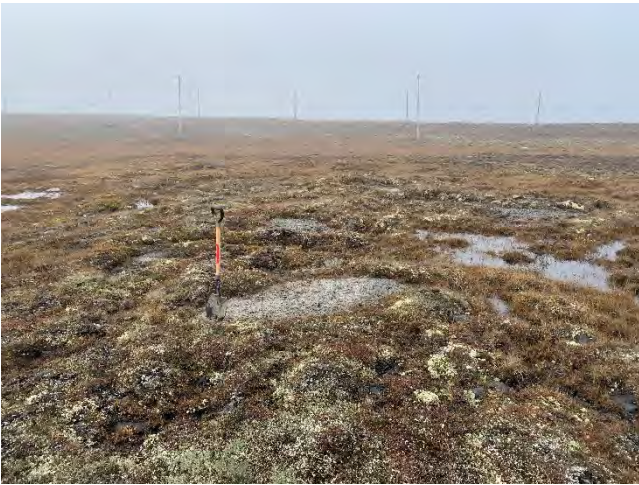
Photo 21: Frost boils that developed in marine washed till deposits north of Block 10.

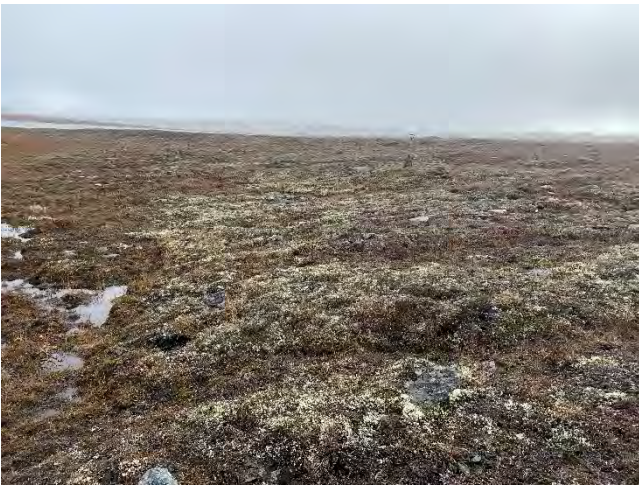
Photo 23: Solifluction sheet that developed in marine washed till deposit north of Block 10.

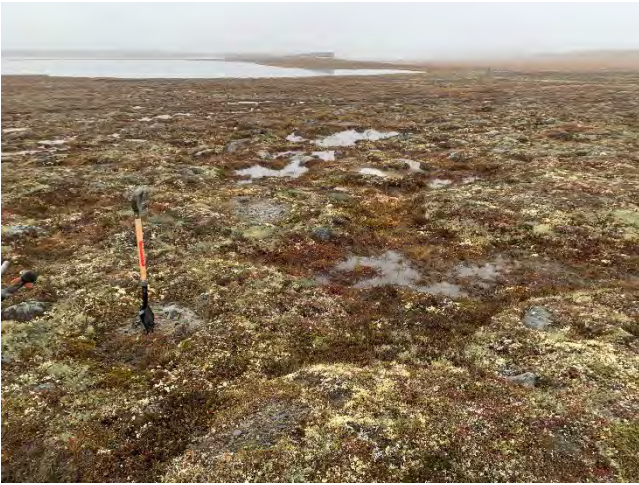
Photo 25: Moderately well to imperfectly drained surficial organics consisting of mosses overlying a thin topsoil. Patterned ground features occur.

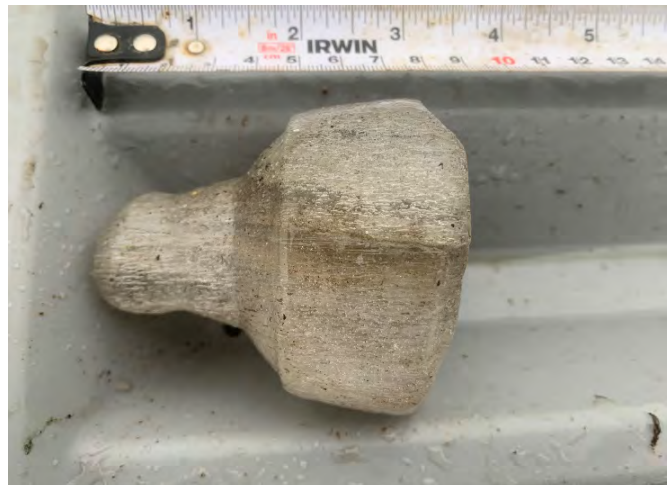
Photo 30: Massive ice recovered at borehole BH21-02. Includes vertical ice foliation typical of an ice wedge.

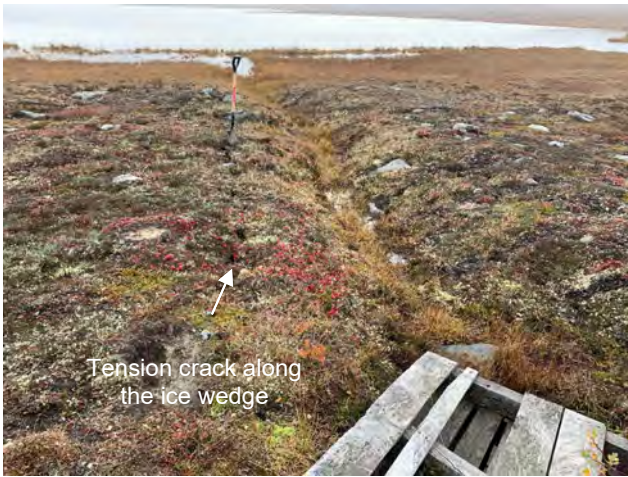
Refer to photos 36 to 39 in Appendix E for the permafrost degradation features observed.

Photo 37: Ice wedge north of Block 10. Tension cracks along the wedge suggest thaw degradation occur.

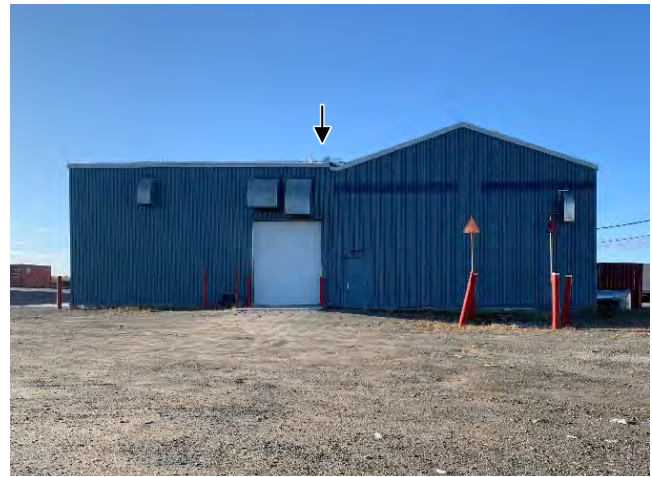
Photo 38: Shifting of a recent building within an industrial district east of the municipality.

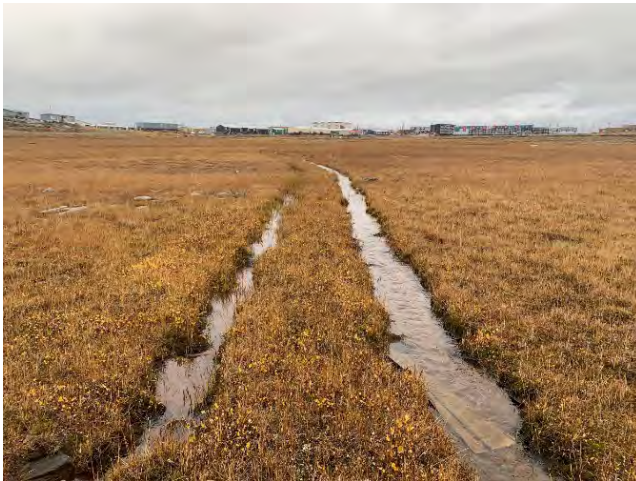
Photo 39: Ruts crossing a drainage flow path in Block 10 (no thaw degradation observed).

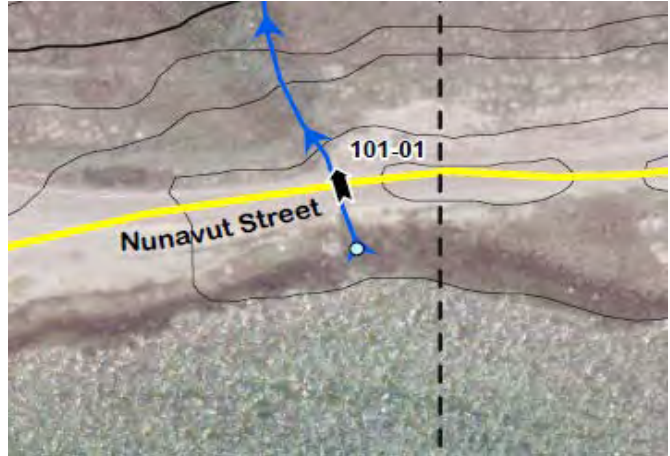
Culvert Location	
Street	Nunavut St
Northing (m) ¹	6965689
Easting (m) ¹	545509

Culvert Condition Ratings (MTO 2013)				
Barrel Material (0-4)	Shape (0-4)	Capacity (0-2)	Erosion and Scour (0-2)	US/DS Channel (0-2)
0	4	0	0	0

Recommended Action(s):	Replace culvert	Priority:	High
------------------------	-----------------	-----------	------

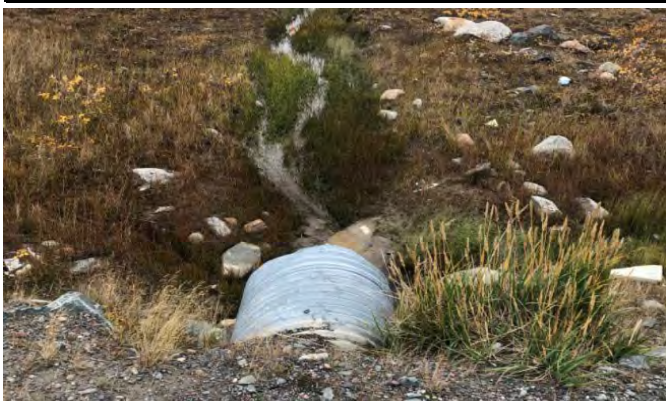
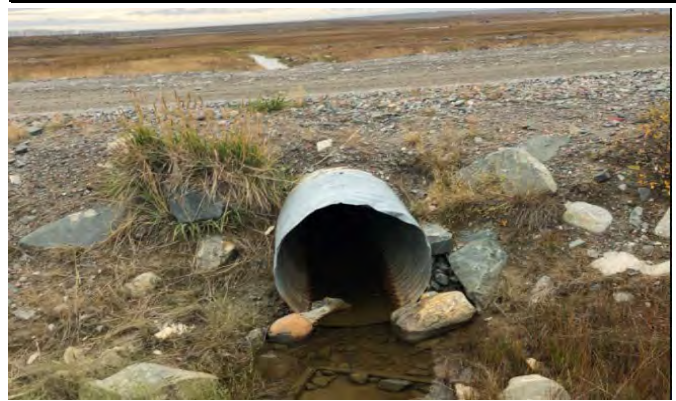
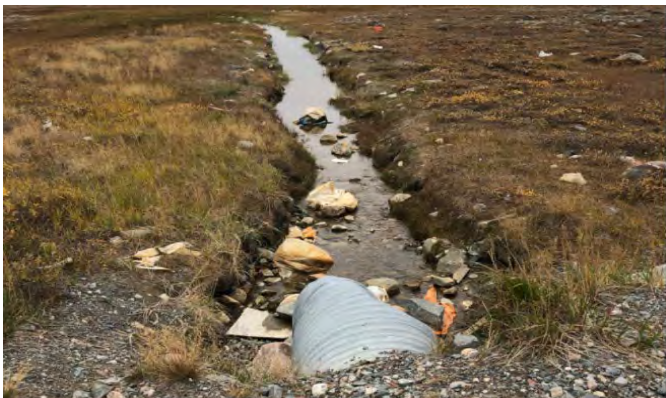
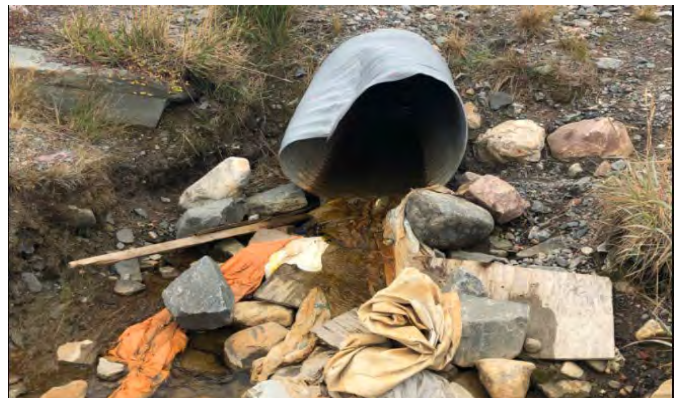
Culvert Information				
Culvert ID	104-01			
Type	Cross			
Shape	Circular			
Material	CSP			
Diameter or Dimensions (mm)	800			
Marker Post Present	N			
Barrel Length (m)	14.1			
Approx. Barrel Slope (%)	1.8%			
Approx. Depth of Cover (m)	340			
End	Upstream			
Crushing	Downstream			
Infill Depth (mm)	Upstream			
	Downstream			
Other	Debris in DS end			
Comments				
Culvert Elevations (masl) ²				
Upstream		Downstream		Road Crown
Invert	Obvert	Invert	Obvert	
9.67	10.46	9.42	10.18	10.66

Culvert Condition Ratings (MTO 2013)				
Barrel Material (0-4)	Shape (0-4)	Capacity (0-2)	Erosion and Scour (0-2)	US/DS Channel (0-2)
1	0	0	2	0

Recommended Action(s):	Investigate embankment scour/erosion	Priority:	High
------------------------	--------------------------------------	-----------	------

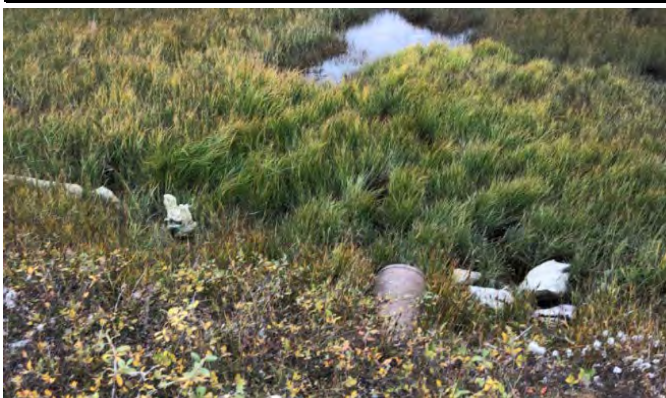
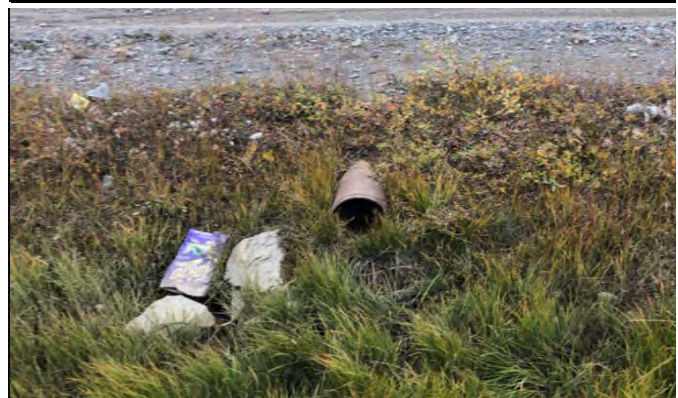
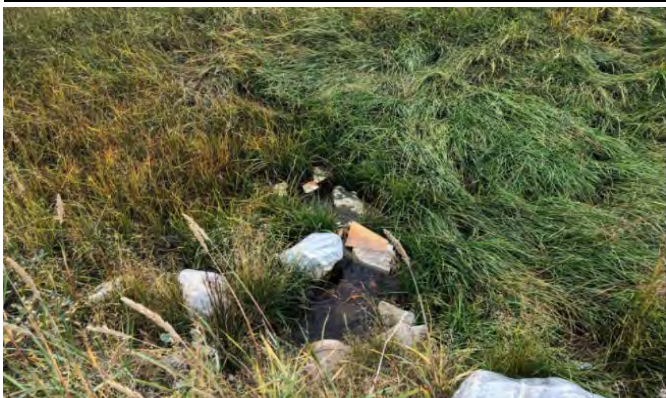
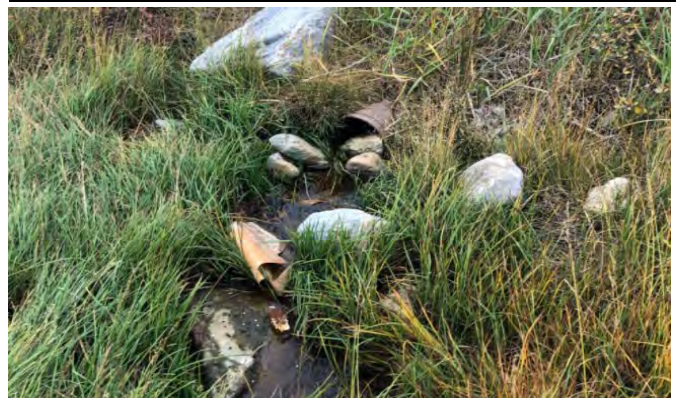
Culvert Information	
Culvert ID	105-01
Type	Cross
Shape	Circular
Material	SWSP
Diameter or Dimensions (mm)	200
Marker Post Present	N
Barrel Length (m)	15.2
Approx. Barrel Slope (%)	2.7%
Approx. Depth of Cover (m)	400
End	Upstream
Crushing	Downstream
Infill Depth (mm)	Upstream
	Downstream
Other Comments	DS end plugged by rocks

Culvert Condition Ratings (MTO 2013)				
Barrel Material (0-4)	Shape (0-4)	Capacity (0-2)	Erosion and Scour (0-2)	US/DS Channel (0-2)
1	0	0	0	0

Recommended Action(s):	No Action	Priority:	Low
------------------------	-----------	-----------	-----

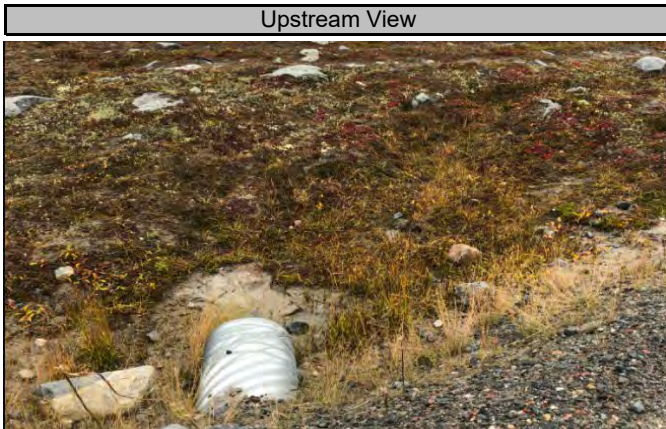
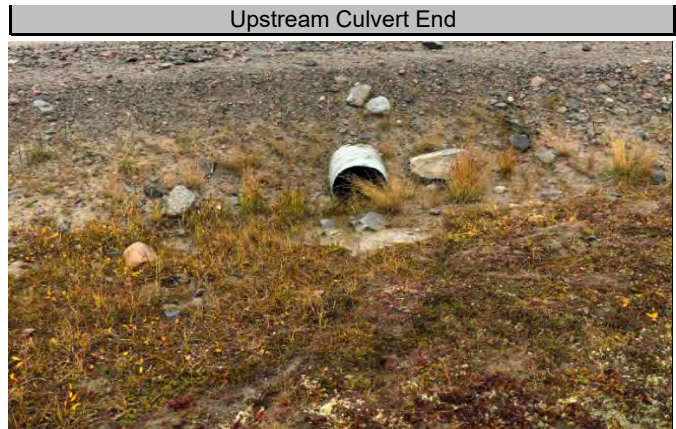
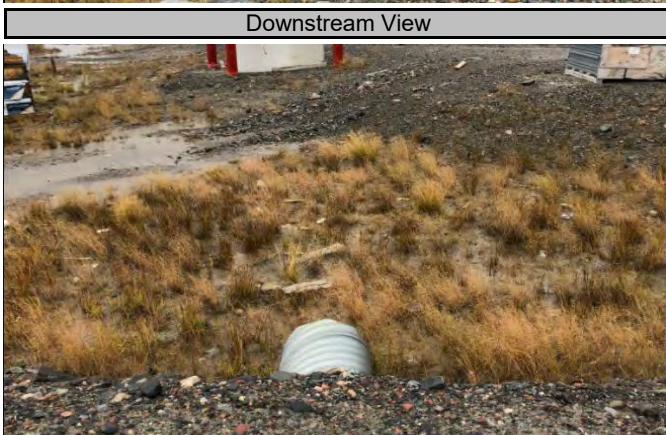
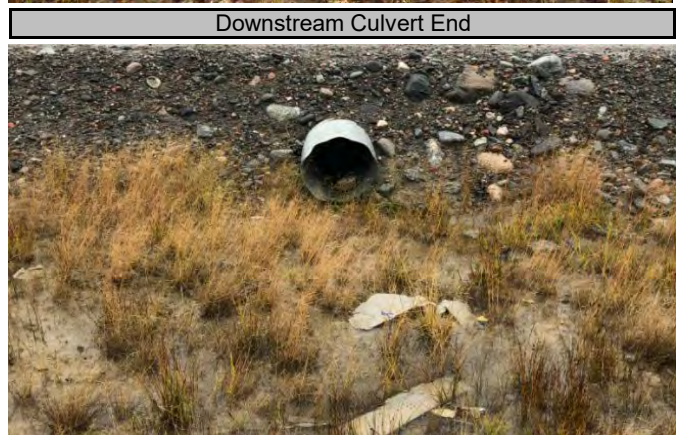
Culvert Information				
Culvert ID	111-01			
Type	Cross			
Shape	Circular			
Material	CSP			
Diameter or Dimensions (mm)	450			
Marker Post Present	N			
Barrel Length (m)	13.8			
Approx. Barrel Slope (%)	0.9%			
Approx. Depth of Cover (m)	535			
End	Upstream			
Crushing	Downstream			
Infill Depth (mm)	Upstream			
	Downstream			
Other Comments	Flow direction unknown			
Culvert Elevations (masl) ²				
Upstream		Downstream		Road Crown
Invert	Obvert	Invert	Obvert	
22.81	23.16	22.68	23.15	23.69

Culvert Condition Ratings (MTO 2013)				
Barrel Material (0-4)	Shape (0-4)	Capacity (0-2)	Erosion and Scour (0-2)	US/DS Channel (0-2)
0	0	1	2	0

Recommended Action(s):	Clear blockage. Investigate embankment scour/erosion	Priority:	High
------------------------	------------------------------------------------------	-----------	------

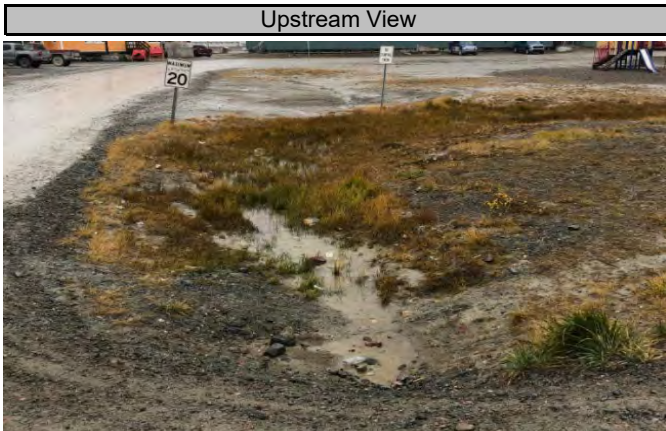
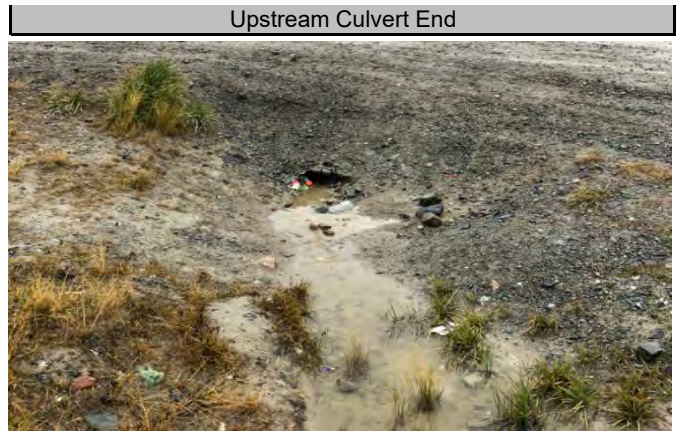
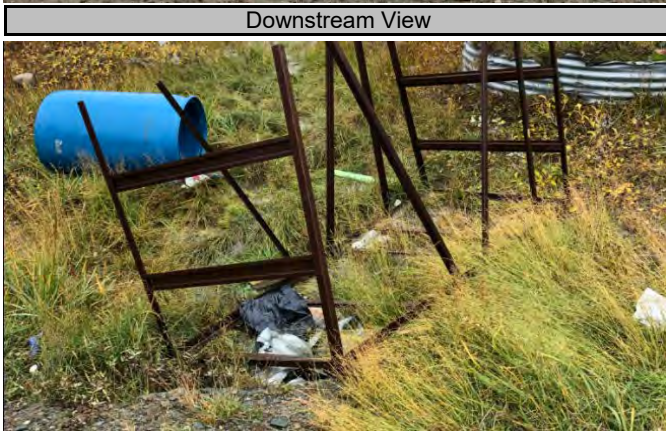
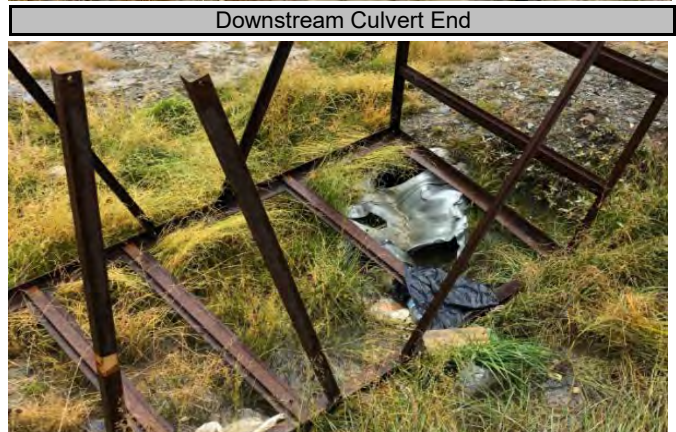
Culvert Information				
Culvert ID	111-02			
Type	Cross			
Shape	Circular			
Material	CSP			
Diameter or Dimensions (mm)	450			
Marker Post Present	N			
Barrel Length (m)	31.2			
Approx. Barrel Slope (%)	0.6%			
Approx. Depth of Cover (m)	730			
End	Upstream			
Crushing	Downstream			
Infill Depth (mm)	Upstream			
	Downstream			
Other Comments	Debris & standing water in ditch			
Culvert Elevations (masl) ²				
Upstream		Downstream		Road Crown
Invert	Obvert	Invert	Obvert	
25.62	25.79	25.44	25.83	26.54

Culvert Condition Ratings (MTO 2013)				
Barrel Material (0-4)	Shape (0-4)	Capacity (0-2)	Erosion and Scour (0-2)	US/DS Channel (0-2)
1	4	2	0	0

Recommended Action(s):	Replace culvert	Priority:	High
------------------------	-----------------	-----------	------

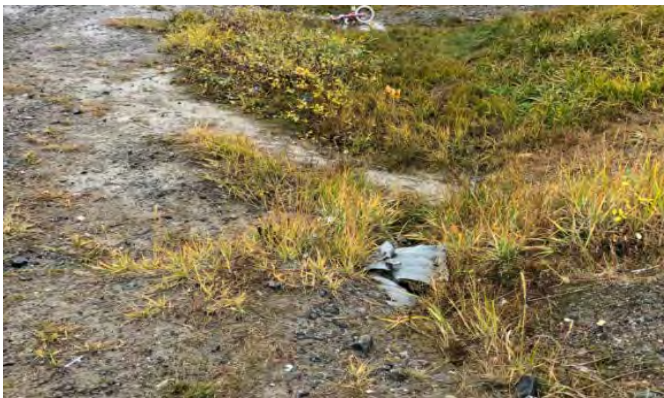
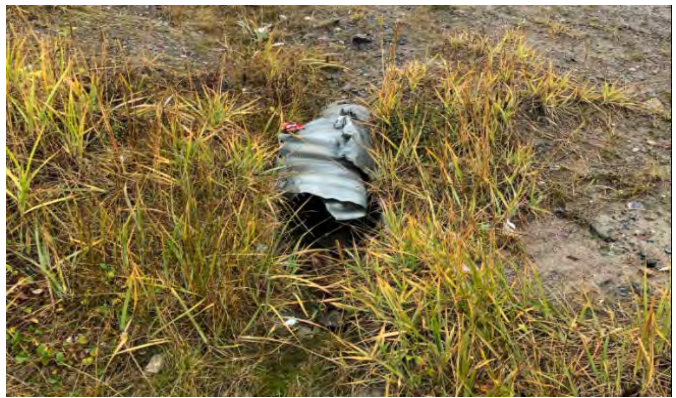
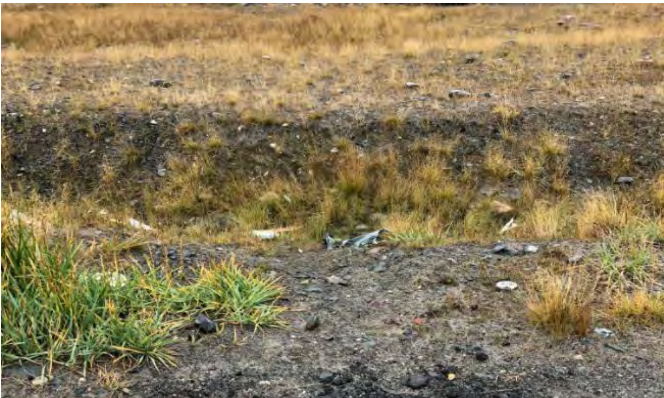
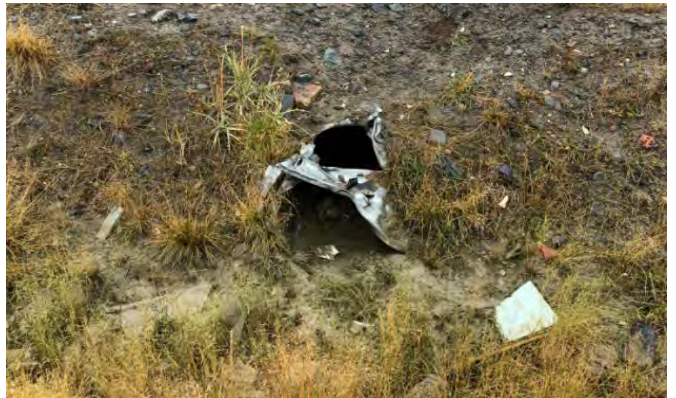
Culvert Information				
Culvert ID	111-03			
Type	Cross			
Shape	Circular			
Material	CSP			
Diameter or Dimensions (mm)	450			
Marker Post Present	N			
Barrel Length (m)	16.3			
Approx. Barrel Slope (%)	3.1%			
Approx. Depth of Cover (m)	730			
End	Upstream			
Crushing	Downstream			
Infill Depth (mm)	Upstream			
	Downstream			
Other Comments	0			
Culvert Elevations (masl) ²				
Upstream		Downstream		Road Crown
Invert	Obvert	Invert	Obvert	
24.95	25.3	24.45	25	25.88

Culvert Condition Ratings (MTO 2013)				
Barrel Material (0-4)	Shape (0-4)	Capacity (0-2)	Erosion and Scour (0-2)	US/DS Channel (0-2)
1	0	0	0	0

Recommended Action(s):	No Action	Priority:	Low
------------------------	-----------	-----------	-----

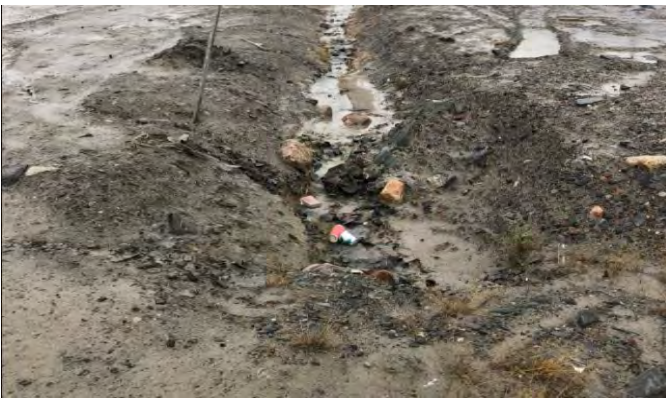
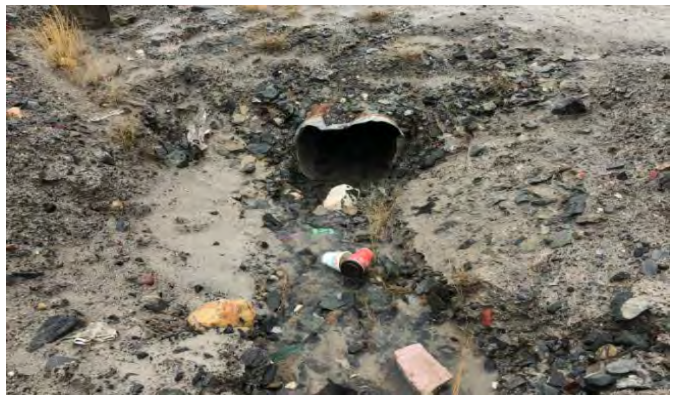
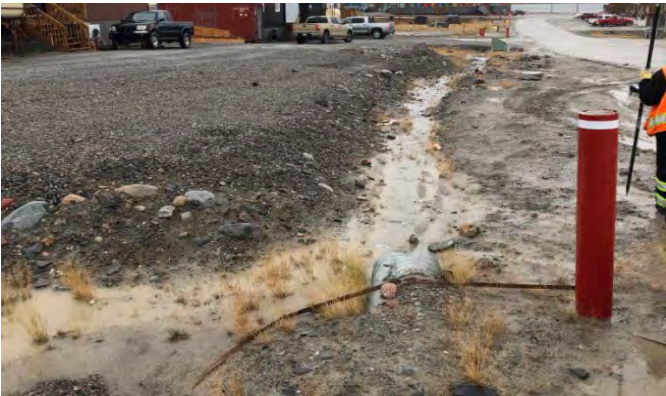
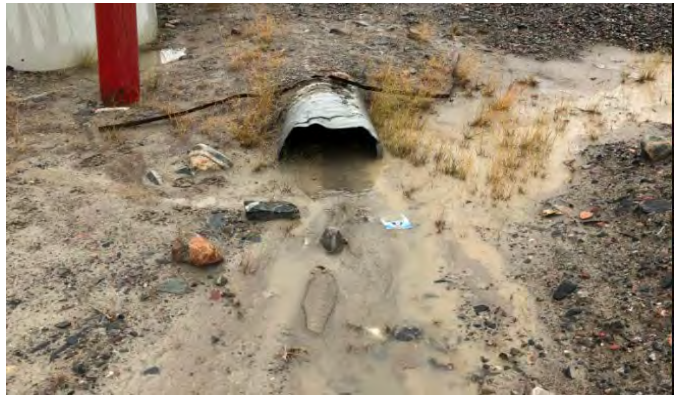
Culvert Information				
Culvert ID	111-04			
Type	Cross			
Shape	Circular			
Material	CSP			
Diameter or Dimensions (mm)	500			
Marker Post Present	N			
Barrel Length (m)	16.2			
Approx. Barrel Slope (%)	2.1%			
Approx. Depth of Cover (m)	525			
End	Upstream			
Crushing	Downstream			
Infill Depth (mm)	Upstream			
	Downstream			
Other Comments	Sedimentation in DS end			
Culvert Elevations (masl) ²				
Upstream		Downstream		Road Crown
Invert	Obvert	Invert	Obvert	
22.93	23.31	22.59	22.84	23.6

Culvert Condition Ratings (MTO 2013)				
Barrel Material (0-4)	Shape (0-4)	Capacity (0-2)	Erosion and Scour (0-2)	US/DS Channel (0-2)
1	0	2	1	1

Recommended Action(s):	Clear blockage	Priority:	High
------------------------	----------------	-----------	------

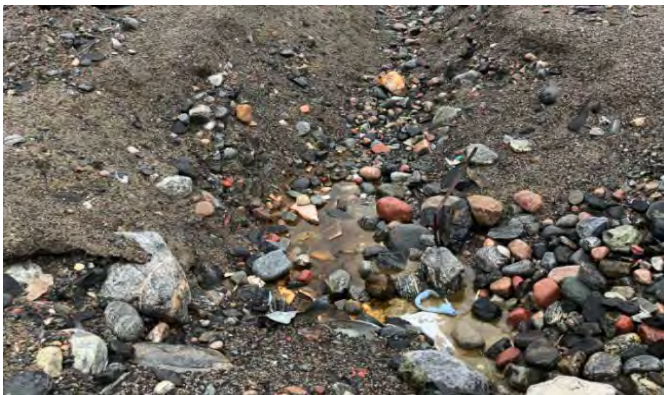
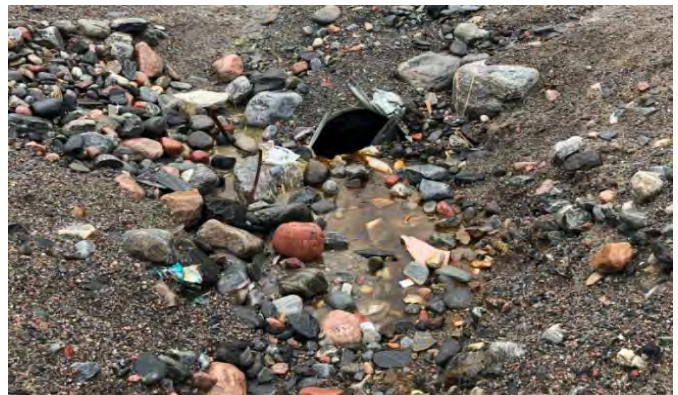
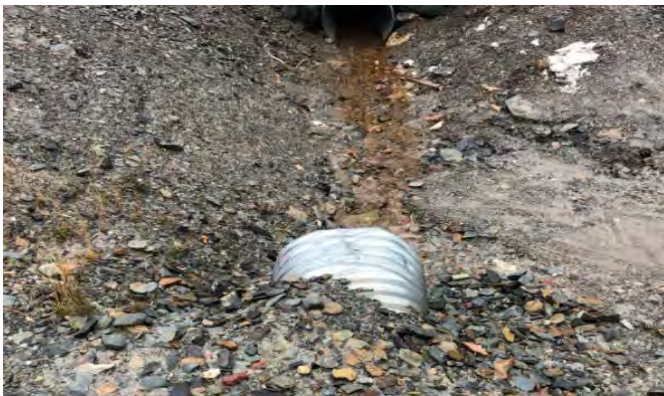
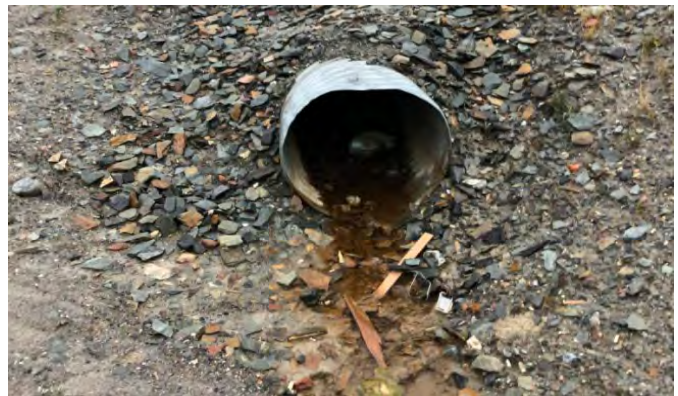
Culvert Information	
Culvert ID	111-05
Type	Entrance
Shape	Circular
Material	CSP
Diameter or Dimensions (mm)	600
Marker Post Present	N
Barrel Length (m)	13.3
Approx. Barrel Slope (%)	3.2%
Approx. Depth of Cover (m)	565
End	Upstream
Crushing	Downstream
Infill Depth (mm)	Upstream
	Downstream
Other Comments	300mm rocks blocking inlet

Culvert Condition Ratings (MTO 2013)				
Barrel Material (0-4)	Shape (0-4)	Capacity (0-2)	Erosion and Scour (0-2)	US/DS Channel (0-2)
1	0	0	1	0

Recommended Action(s):	No Action	Priority:	Low
------------------------	-----------	-----------	-----

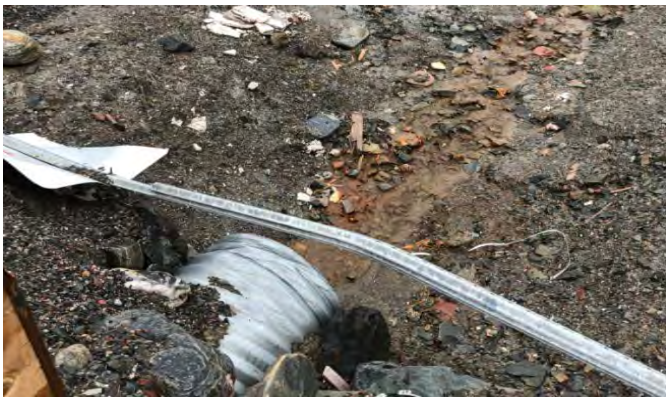
Upstream View

Culvert Information		
Culvert ID	111-06	
Type	Entrance	
Shape	Circular	
Material	CSP	
Diameter or Dimensions (mm)	600	
Marker Post Present	N	
Barrel Length (m)	48.1	
Approx. Barrel Slope (%)	1.1%	
Approx. Depth of Cover (m)	635	
End	Upstream	N
Crushing	Downstream	N
Infill Depth (mm)	Upstream	50
	Downstream	0
Other	0	
Comments

Culvert Condition Ratings (MTO 2013)				
Barrel Material (0-4)	Shape (0-4)	Capacity (0-2)	Erosion and Scour (0-2)	US/DS Channel (0-2)
1	0	1	1	0

Recommended Action(s):	Clear blockage	Priority:	High
------------------------	----------------	-----------	------

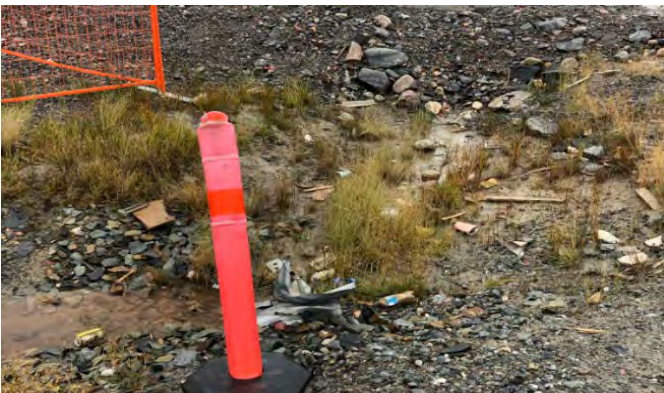
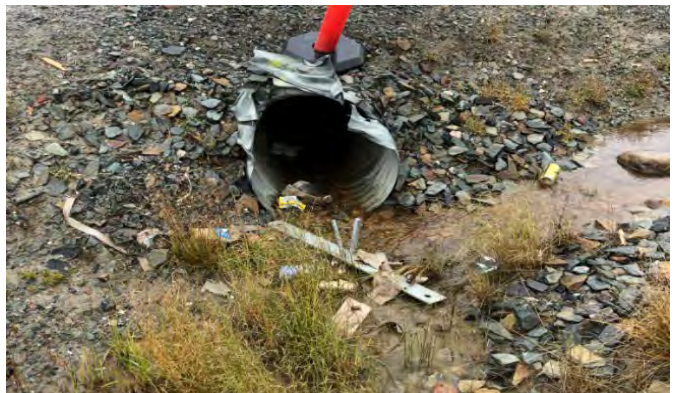
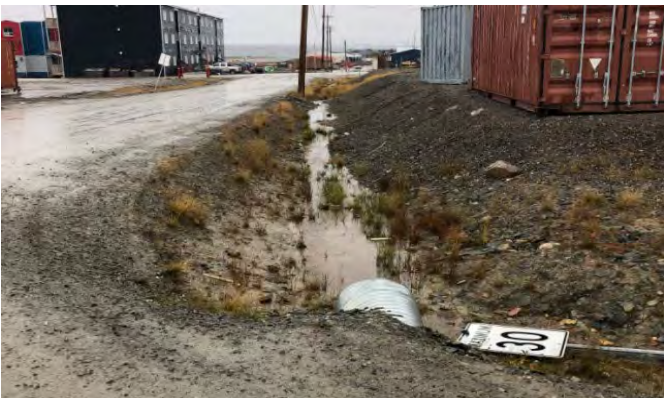
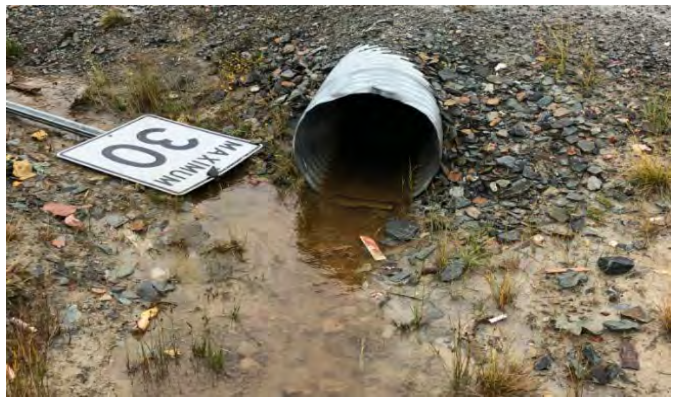
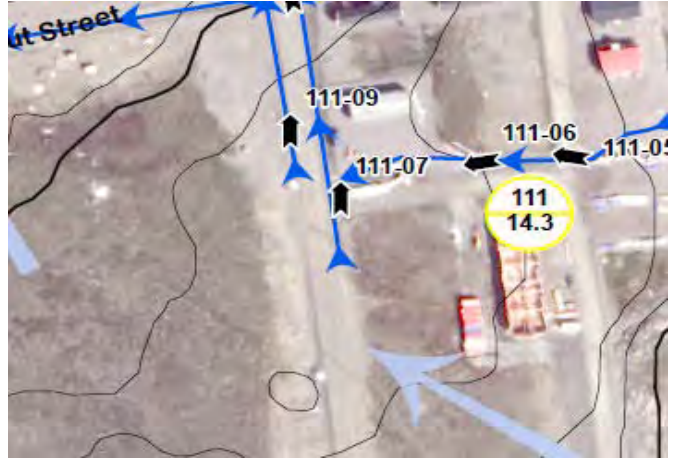
Culvert Information				
Culvert ID	111-08			
Type	Cross			
Shape	Circular			
Material	CSP			
Diameter or Dimensions (mm)	600			
Marker Post Present	N			
Barrel Length (m)	15.9			
Approx. Barrel Slope (%)	2.0%			
Approx. Depth of Cover (m)	210			
End	Upstream			
Crushing	Downstream			
Infill Depth (mm)	Upstream			
	Downstream			
Other Comments	DS end damaged. Barrel clear.			
Culvert Elevations (masl) ²				
Upstream		Downstream		Road Crown
Invert	Obvert	Invert	Obvert	
19.66	20.27	19.34	19.91

Culvert Condition Ratings (MTO 2013)				
Barrel Material (0-4)	Shape (0-4)	Capacity (0-2)	Erosion and Scour (0-2)	US/DS Channel (0-2)
1	0	2	0	0

Recommended Action(s):	Clear blockage	Priority:	High
------------------------	----------------	-----------	------

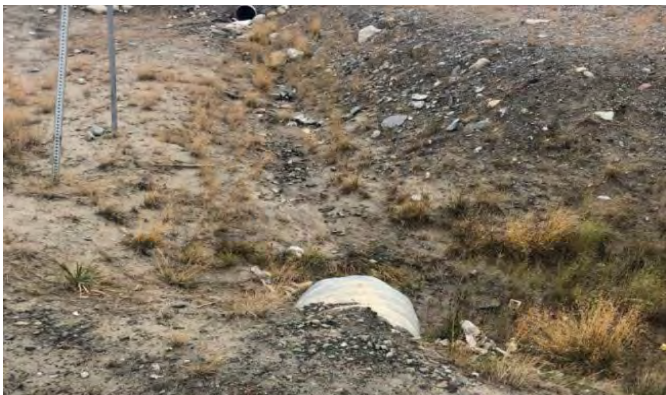
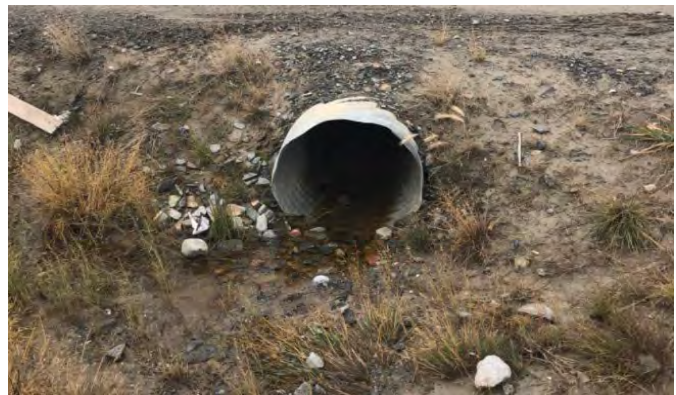
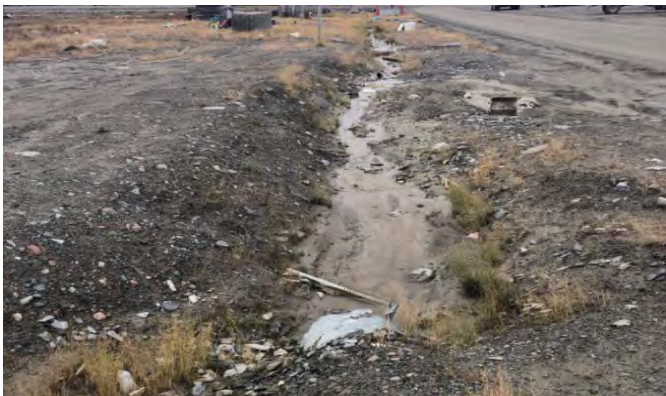
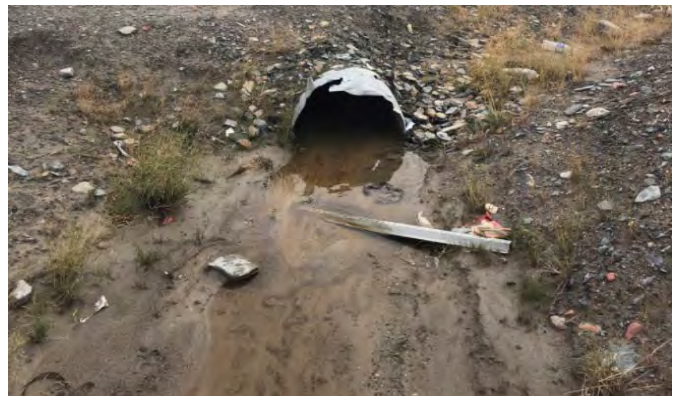
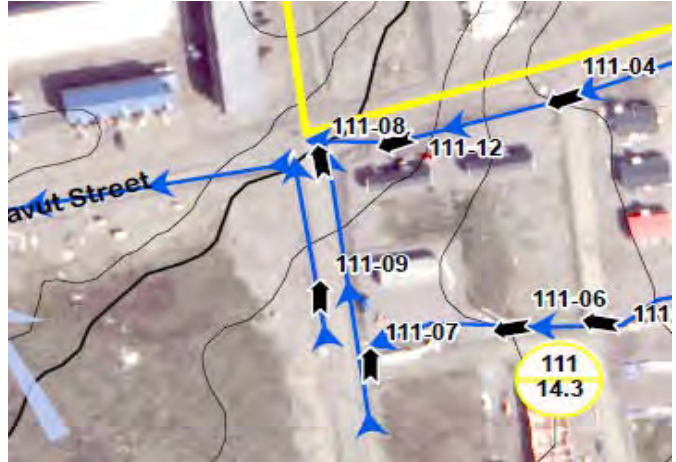
Culvert Information	
Culvert ID	111-09
Type	Entrance
Shape	Circular
Material	PVC
Diameter or Dimensions (mm)	150
Marker Post Present	N
Barrel Length (m)	10.4
Approx. Barrel Slope (%)	175.8%
Approx. Depth of Cover (m)	165
End	Upstream
Crushing	Downstream
Infill Depth (mm)	Upstream
	Downstream
Other Comments	Perched US end

Culvert Condition Ratings (MTO 2013)				
Barrel Material (0-4)	Shape (0-4)	Capacity (0-2)	Erosion and Scour (0-2)	US/DS Channel (0-2)
0	0	0	0	1

Recommended Action(s):	No Action	Priority:	Low
------------------------	-----------	-----------	-----

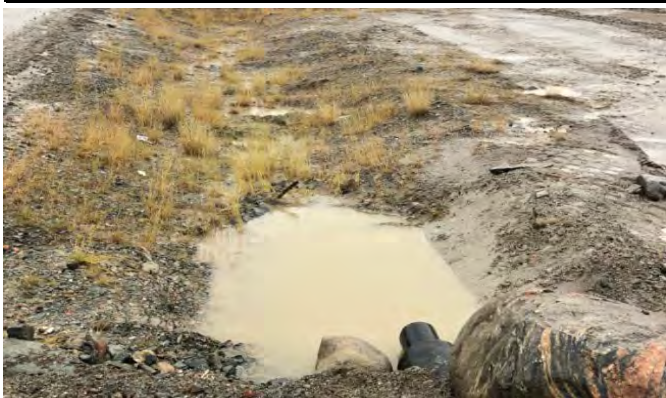
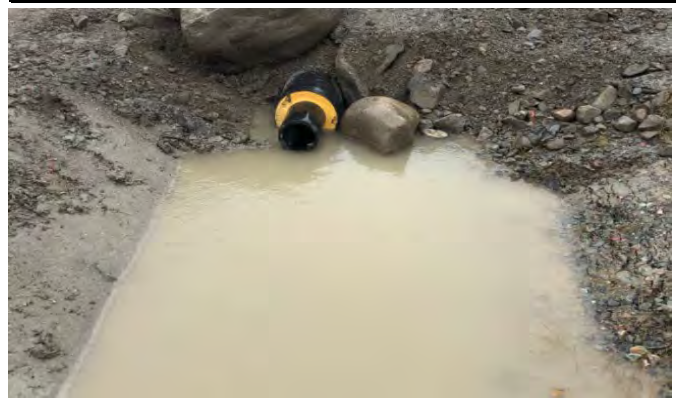
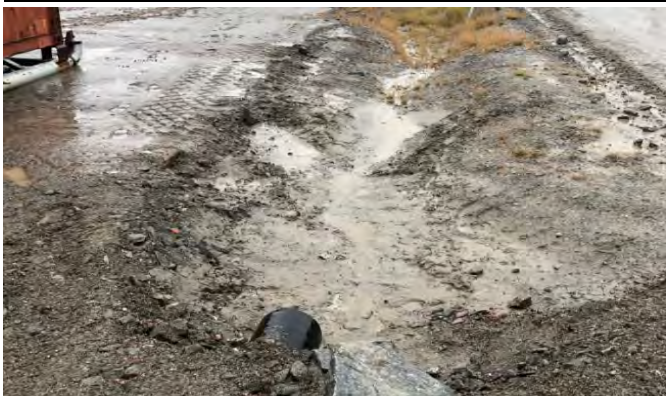
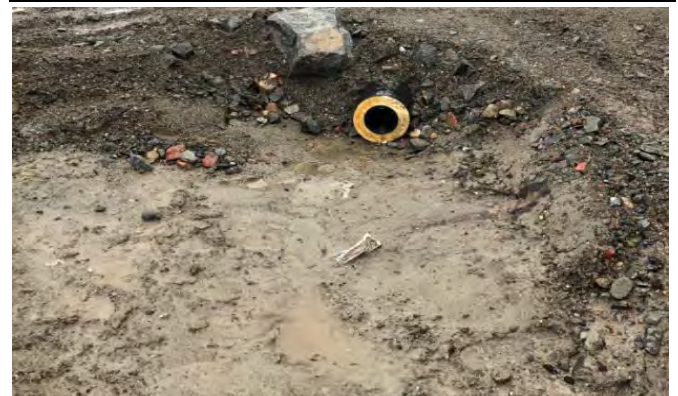
Culvert Information	
Culvert ID	111-10
Type	Entrance
Shape	Circular
Material	CSP
Diameter or Dimensions (mm)	450
Marker Post Present	N
Barrel Length (m)	9.6
Approx. Barrel Slope (%)	2.3%
Approx. Depth of Cover (m)	210
End	Upstream
Crushing	Downstream
Infill Depth (mm)	Upstream
	Downstream
Other Comments	US end crushed. Barrel clear

Culvert Condition Ratings (MTO 2013)				
Barrel Material (0-4)	Shape (0-4)	Capacity (0-2)	Erosion and Scour (0-2)	US/DS Channel (0-2)
1	3	1	0	0

Recommended Action(s):	Clear blockage, repair culvert end	Priority:	High
------------------------	------------------------------------	-----------	------

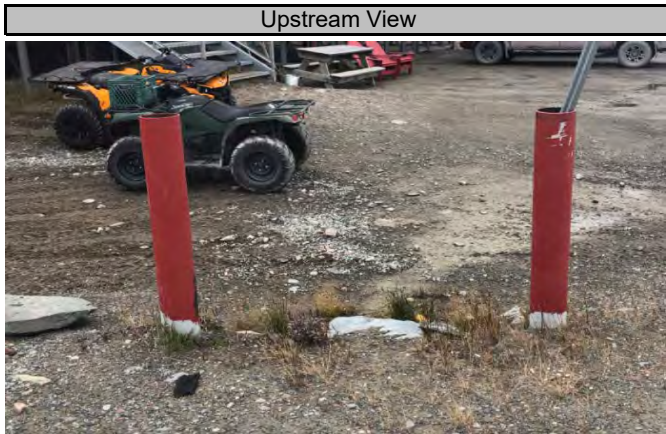
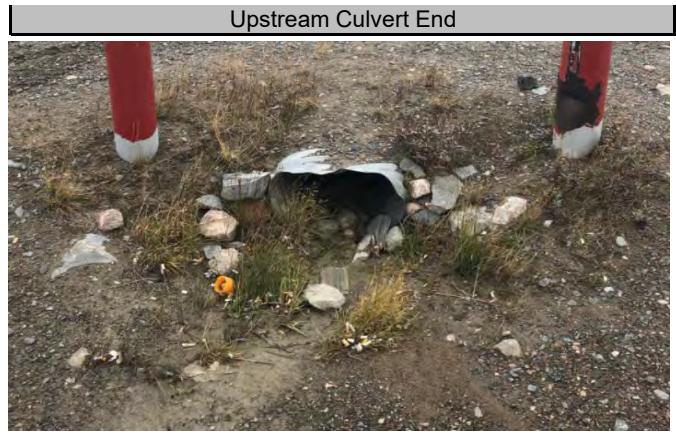
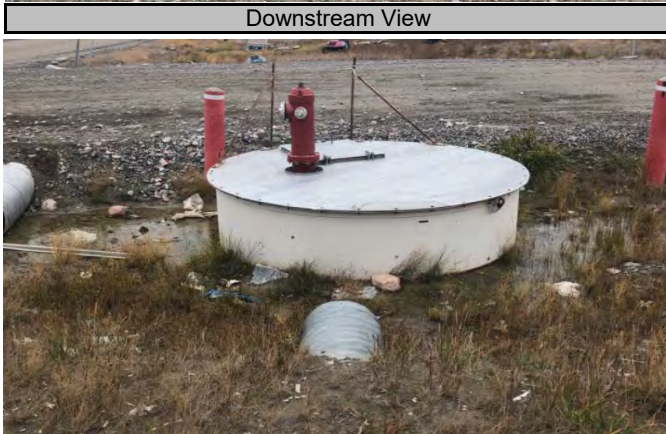
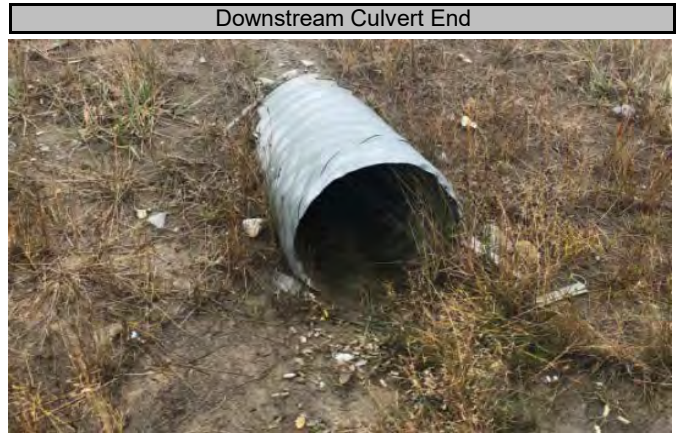
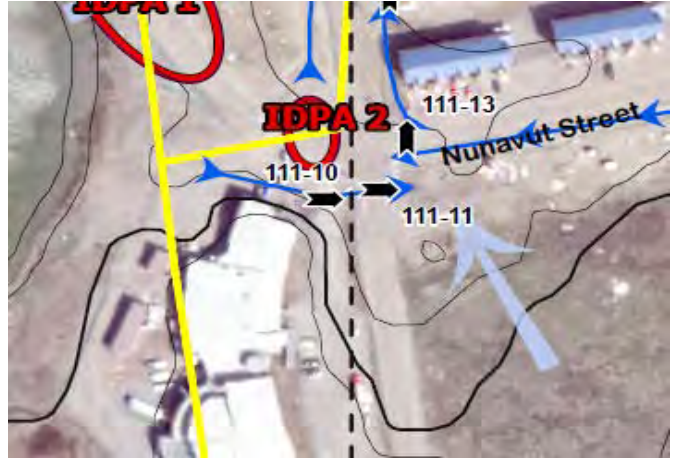
Culvert Information				
Culvert ID	111-11			
Type	Cross			
Shape	Circular			
Material	CSP			
Diameter or Dimensions (mm)	600			
Marker Post Present	N			
Barrel Length (m)	18.0			
Approx. Barrel Slope (%)	0.4%			
Approx. Depth of Cover (m)	280			
End	Upstream			
Crushing	Downstream			
Infill Depth (mm)	Upstream			
	Downstream			
Other Comments	Barrel clear. Minor material buildup on ends from road. Likely to continue accumulating. DS end			
Culvert Elevations (masl) ²				
Upstream		Downstream		Road Crown
Invert	Obvert	Invert	Obvert	
18.52	19.02	18.45	19.04

Culvert Condition Ratings (MTO 2013)				
Barrel Material (0-4)	Shape (0-4)	Capacity (0-2)	Erosion and Scour (0-2)	US/DS Channel (0-2)
0	0	0	0	0

Recommended Action(s):	No Action	Priority:	Low
------------------------	-----------	-----------	-----
