**Geotechnical Evaluation and Drainage Planning
in Rankin Inlet, Nunavut**

Draft Report
REV-00

Prepared for:
The Municipality of Rankin Inlet

Prepared by:
Nunami Stantec Limited

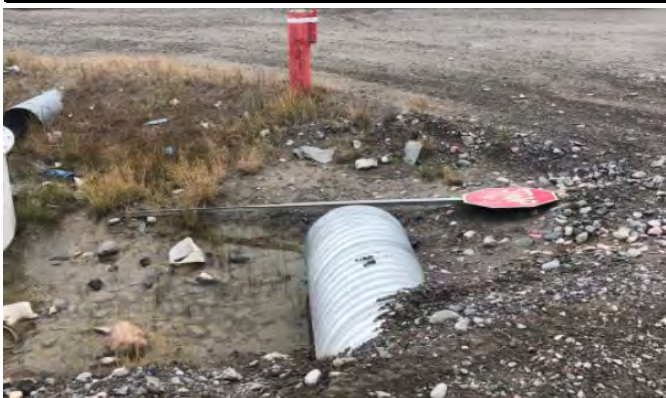
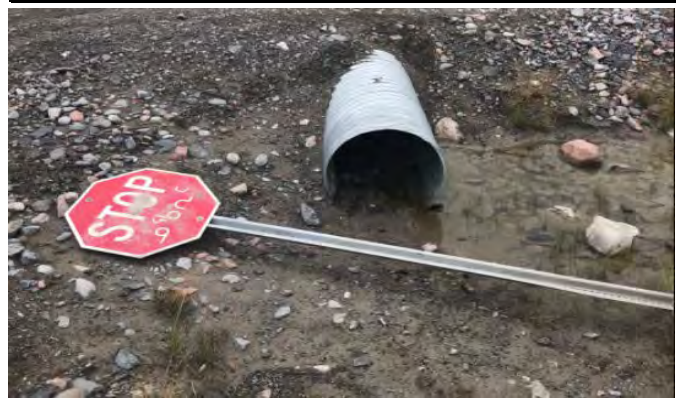
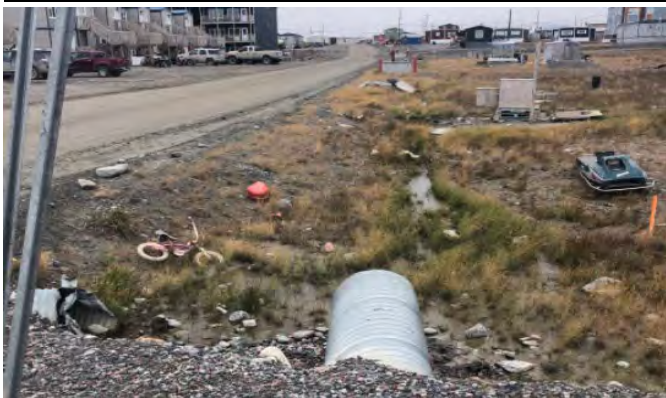
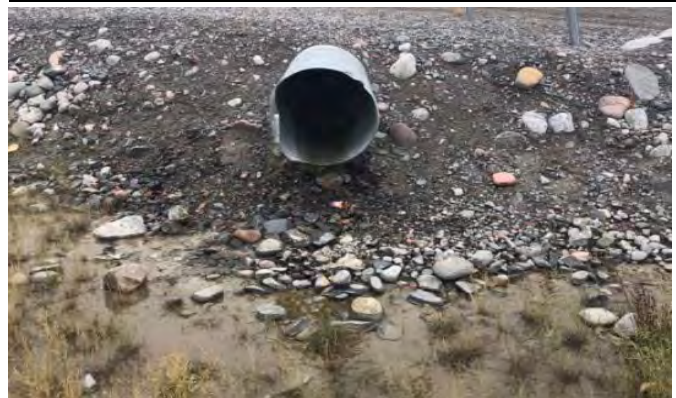
Culvert Information				
Culvert ID	111-12			
Type	Entrance			
Shape	Circular			
Material	CSP			
Diameter or Dimensions (mm)	350			
Marker Post Present	N			
Barrel Length (m)	8.7			
Approx. Barrel Slope (%)	4.1%			
Approx. Depth of Cover (m)	430			
End	Upstream			
Crushing	Downstream			
Infill Depth (mm)	Upstream			
	Downstream			
Other Comments	Rill erosion on US embankment			
Culvert Elevations (masl) ²				
Upstream		Downstream		Road Crown
Invert	Obvert	Invert	Obvert	
20.59	20.91	20.23	20.63

Culvert Condition Ratings (MTO 2013)				
Barrel Material (0-4)	Shape (0-4)	Capacity (0-2)	Erosion and Scour (0-2)	US/DS Channel (0-2)
0	0	0	0	2

Recommended Action(s):	Remediate channel erosion	Priority:	High
------------------------	---------------------------	-----------	------

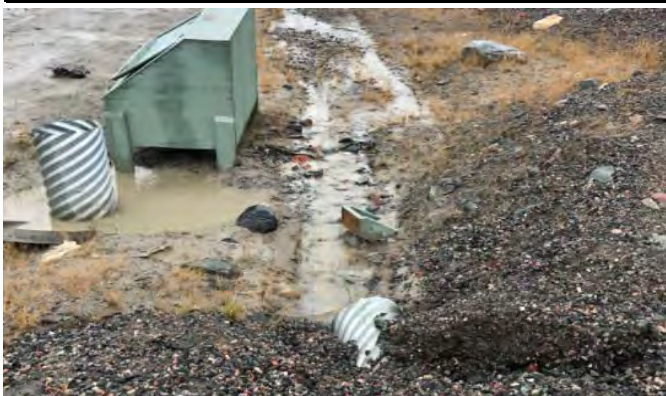
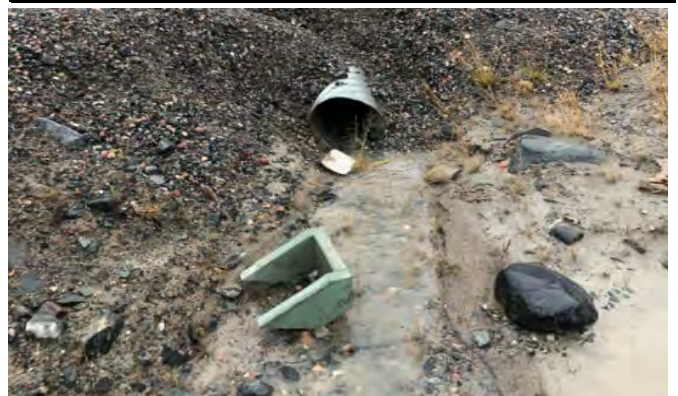
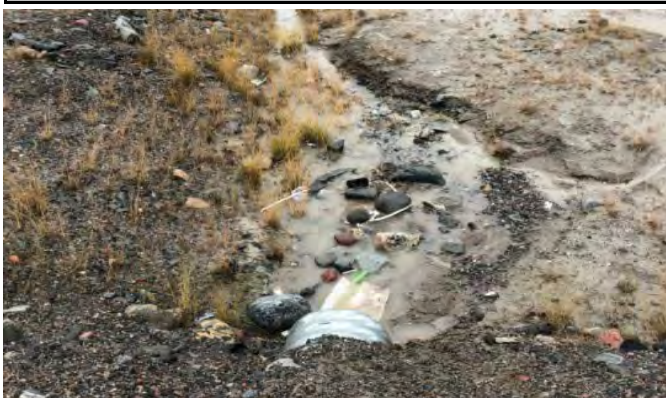
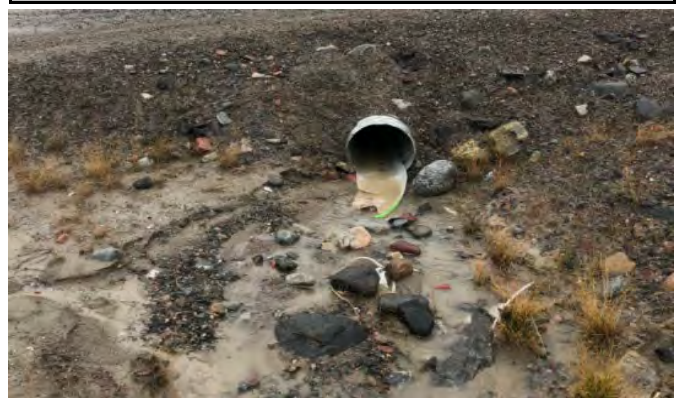
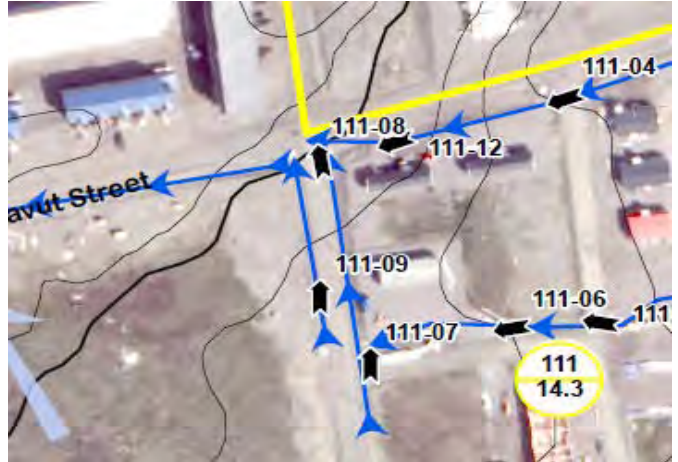
Culvert Information				
Culvert ID	111-13			
Type	Cross			
Shape	Circular			
Material	CSP			
Diameter or Dimensions (mm)	600			
Marker Post Present	N			
Barrel Length (m)	13.9			
Approx. Barrel Slope (%)	2.0%			
Approx. Depth of Cover (m)	600			
End	Upstream			
Crushing	Downstream			
Infill Depth (mm)	Upstream			
	Downstream			
Other Comments	Both ends damaged. Rill erosion at DS end from road drainage.			
Culvert Elevations (masl) ²				
Upstream		Downstream		Road Crown
Invert	Obvert	Invert	Obvert	
17.94	18.52	17.66	18.24

Culvert Condition Ratings (MTO 2013)				
Barrel Material (0-4)	Shape (0-4)	Capacity (0-2)	Erosion and Scour (0-2)	US/DS Channel (0-2)
1	2	2	1	2

Recommended Action(s):	Clear blockage. Remediate channel erosion	Priority:	High
------------------------	-------------------------------------------	-----------	------

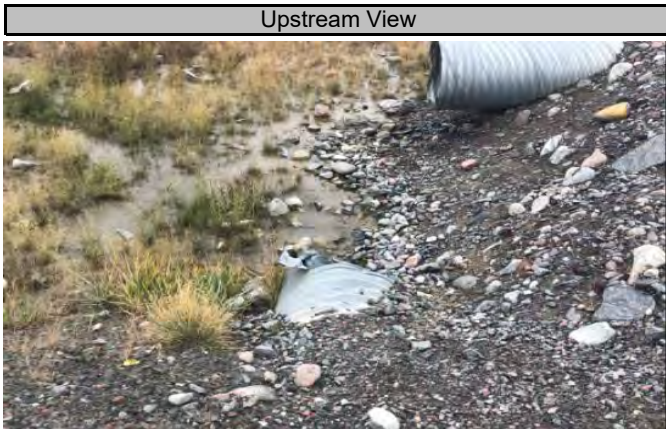
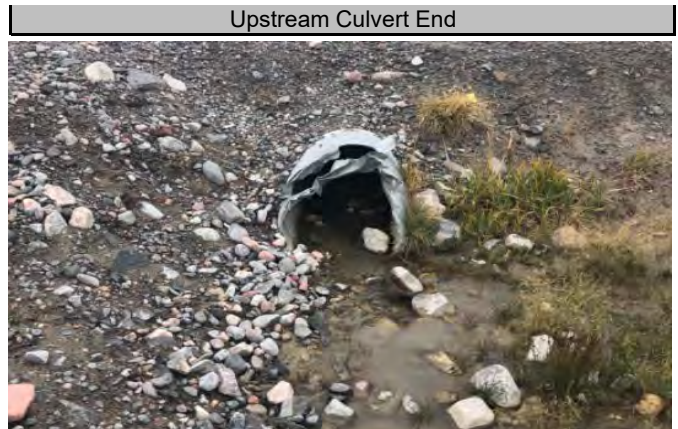
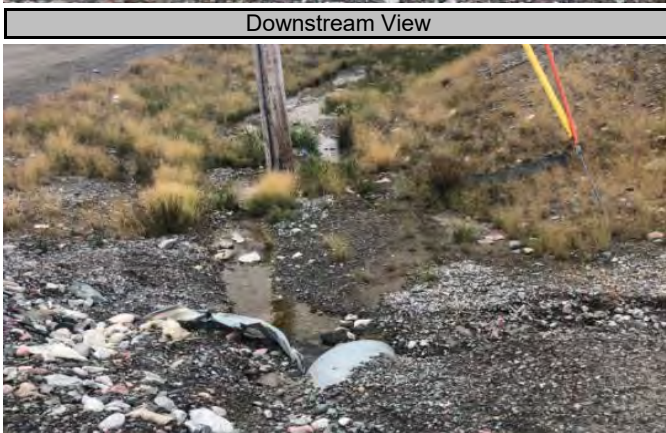
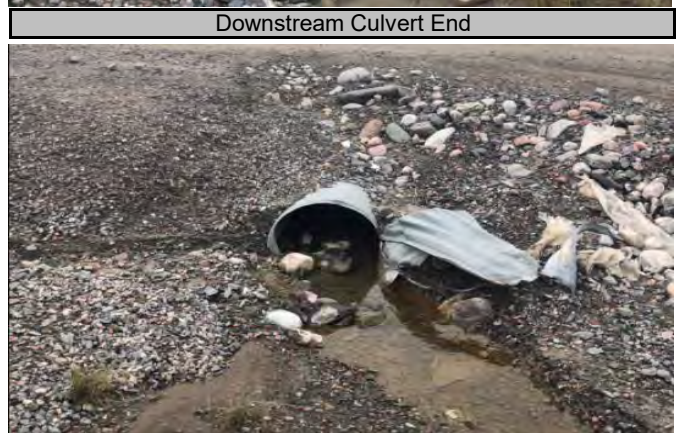
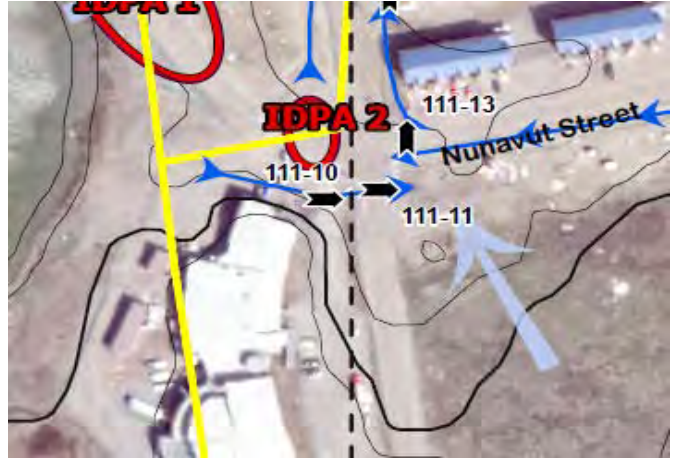
Culvert Information				
Culvert ID	111-14			
Type	Entrance			
Shape	Circular			
Material	CSP			
Diameter or Dimensions (mm)	600			
Marker Post Present	N			
Barrel Length (m)	9.5			
Approx. Barrel Slope (%)	0.9%			
Approx. Depth of Cover (m)	250			
End	Upstream			
Crushing	Downstream			
Infill Depth (mm)	Upstream			
	Downstream			
Other Comments	Both ends damaged and infilled.			
Culvert Elevations (masl) ²				
Upstream		Downstream		Road Crown
Invert	Obvert	Invert	Obvert	
16.76	17.17	16.67	17.13

Culvert Condition Ratings (MTO 2013)				
Barrel Material (0-4)	Shape (0-4)	Capacity (0-2)	Erosion and Scour (0-2)	US/DS Channel (0-2)
-	-	-	-	-

Recommended Action(s):	No Action	Priority:	-
------------------------	-----------	-----------	---

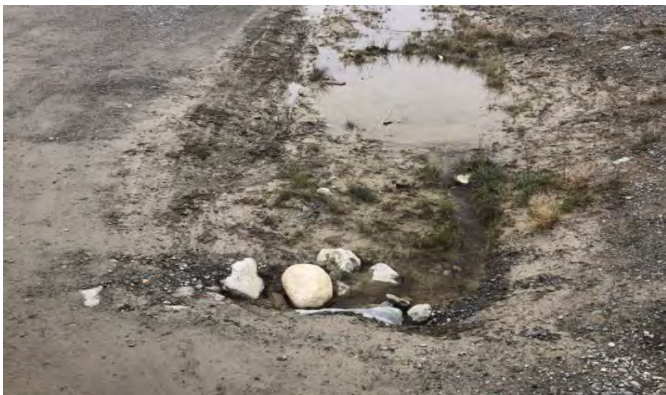
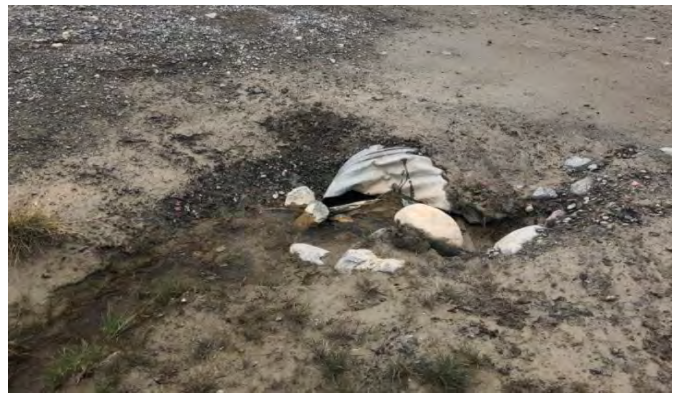
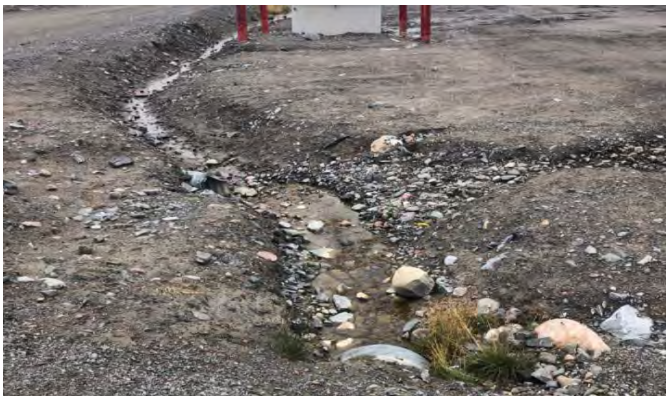
Culvert Condition Ratings (MTO 2013)				
Barrel Material (0-4)	Shape (0-4)	Capacity (0-2)	Erosion and Scour (0-2)	US/DS Channel (0-2)
1	4	2	2	1

Recommended Action(s):	Clear blockage. Investigate embankment scour/erosion	Priority:	High
------------------------	------------------------------------------------------	-----------	------

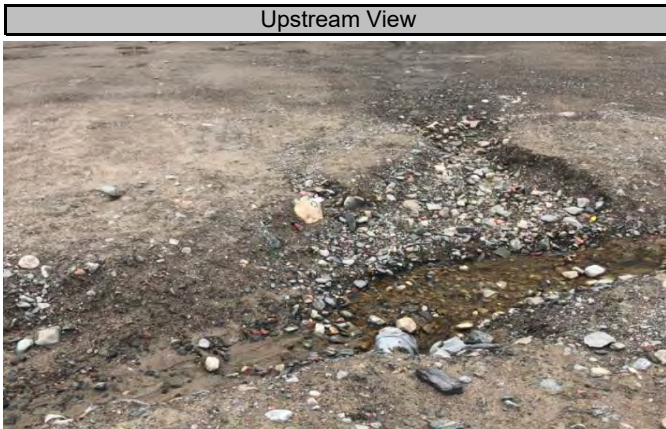
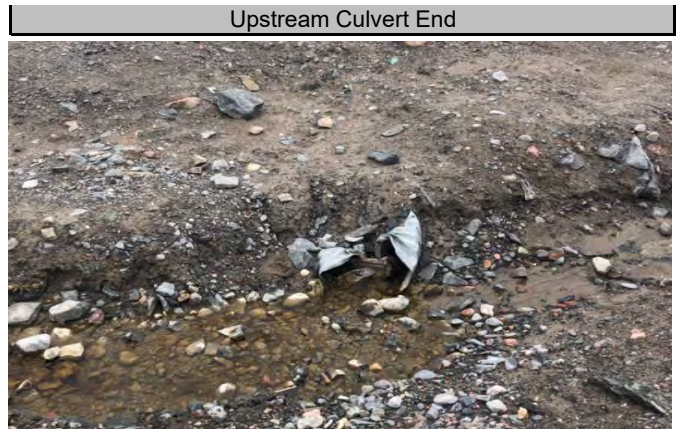
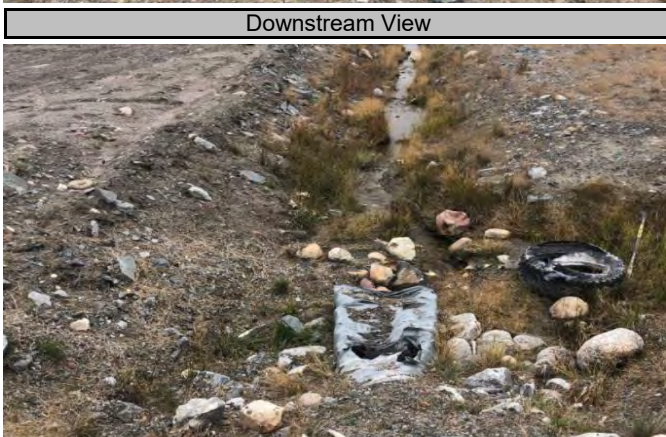
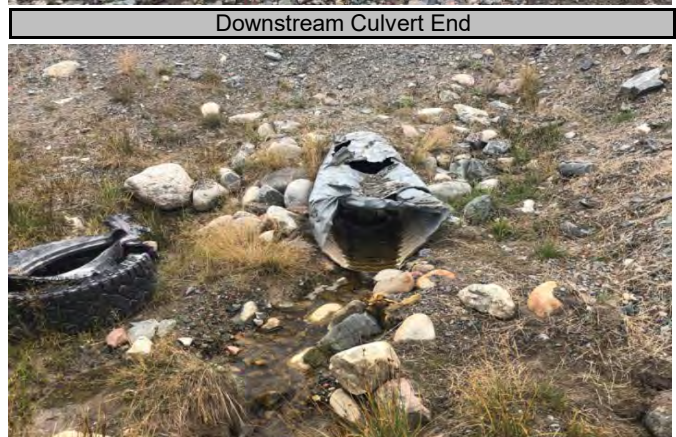
Culvert Information				
Culvert ID	111-16			
Type	Cross			
Shape	Circular			
Material	CSP			
Diameter or Dimensions (mm)	600			
Marker Post Present	N			
Barrel Length (m)	16.1			
Approx. Barrel Slope (%)	2.3%			
Approx. Depth of Cover (m)	1055			
End	Upstream			
Crushing	Downstream			
Infill Depth (mm)	Upstream			
	Downstream			
Other Comments	Both end crushed. Debris blocking flow. Barrel clearance unknown.			
Culvert Elevations (masl) ²				
Upstream		Downstream		Road Crown
Invert	Obvert	Invert	Obvert	
15.62	15.97	15.25	15.62

Culvert Condition Ratings (MTO 2013)				
Barrel Material (0-4)	Shape (0-4)	Capacity (0-2)	Erosion and Scour (0-2)	US/DS Channel (0-2)
1	4	2	2	1

Recommended Action(s):	Clear blockage. Investigate embankment scour/erosion	Priority:	High
------------------------	------------------------------------------------------	-----------	------

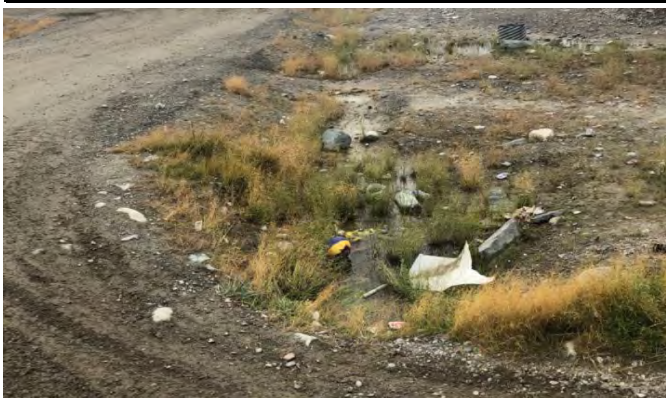
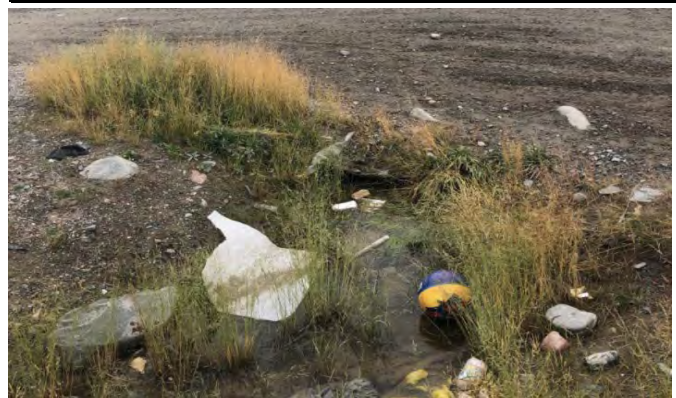
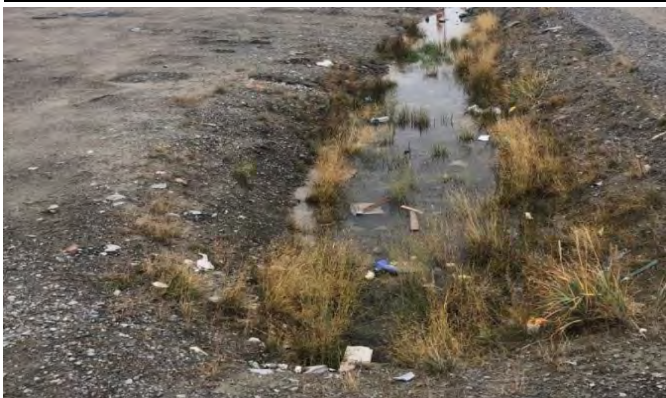
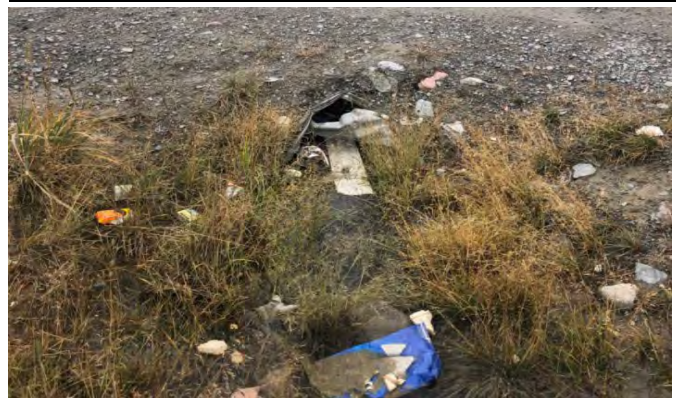
Culvert Information				
Culvert ID	111-17			
Type	Entrance			
Shape	Circular			
Material	CSP			
Diameter or Dimensions (mm)	600			
Marker Post Present	N			
Barrel Length (m)	8.8			
Approx. Barrel Slope (%)	0.1%			
Approx. Depth of Cover (m)	390			
End	Upstream			
Crushing	Downstream			
Infill Depth (mm)	Upstream			
	Downstream			
Other Comments	Both end crushed. Debris in barrel			
Culvert Elevations (masl) ²				
Upstream		Downstream		Road Crown
Invert	Obvert	Invert	Obvert	
15.85	16.25	15.84	16.27

Culvert Condition Ratings (MTO 2013)				
Barrel Material (0-4)	Shape (0-4)	Capacity (0-2)	Erosion and Scour (0-2)	US/DS Channel (0-2)
1	3	2	1	1

Recommended Action(s):	Clear blockage, repair culvert end	Priority:	High
------------------------	------------------------------------	-----------	------

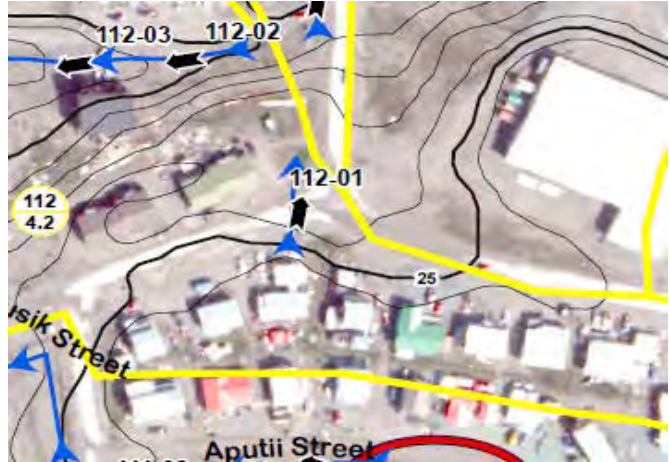
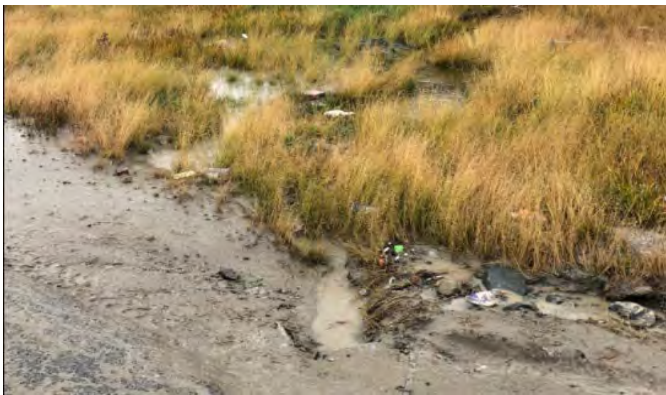
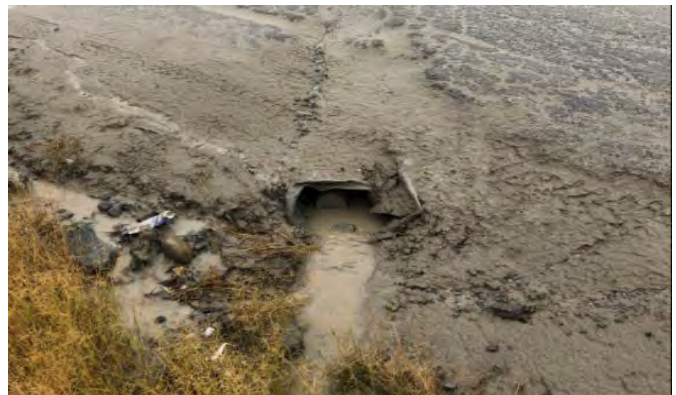
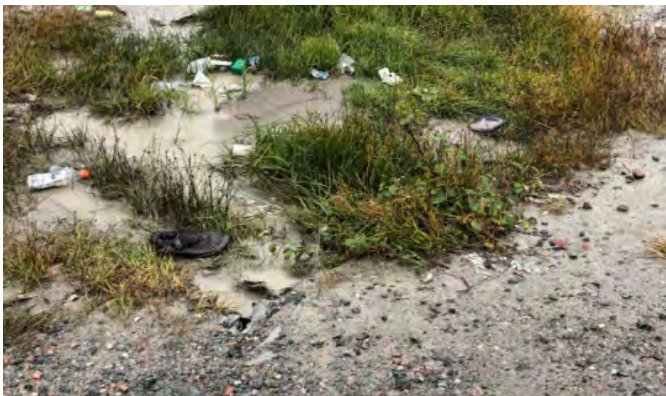
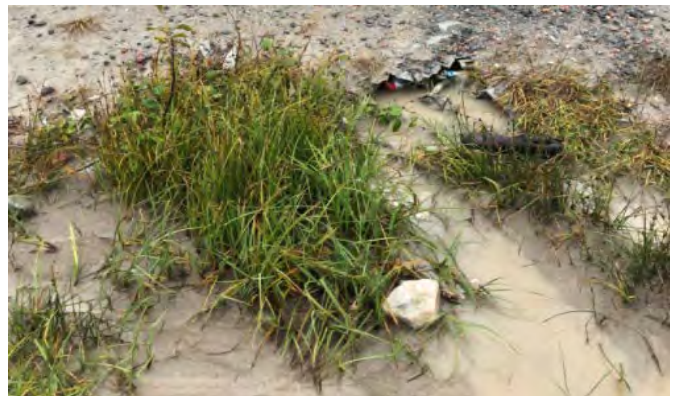
Culvert Information	
Culvert ID	112-01
Type	Cross
Shape	Circular
Material	CSP
Diameter or Dimensions (mm)	500
Marker Post Present	N
Barrel Length (m)	12.9
Approx. Barrel Slope (%)	1.3%
Approx. Depth of Cover (m)	655
End	Upstream
Crushing	Downstream
Infill Depth (mm)	Upstream
	Downstream
Other Comments	0

Culvert Condition Ratings (MTO 2013)				
Barrel Material (0-4)	Shape (0-4)	Capacity (0-2)	Erosion and Scour (0-2)	US/DS Channel (0-2)
1	2	2	0	0

Recommended Action(s):	Clear blockage, repair culvert end	Priority:	High
------------------------	------------------------------------	-----------	------

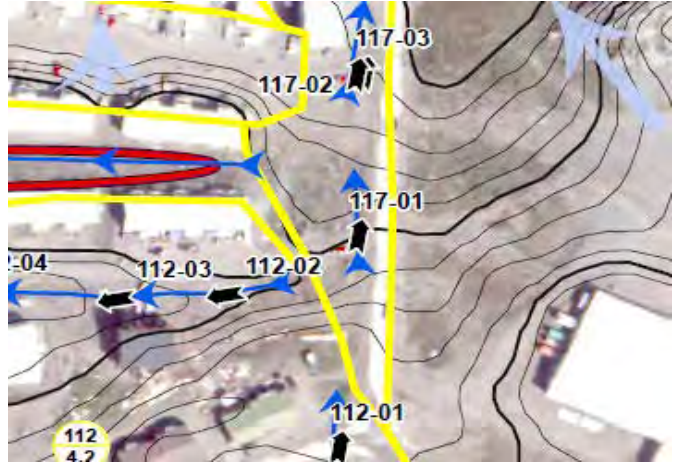
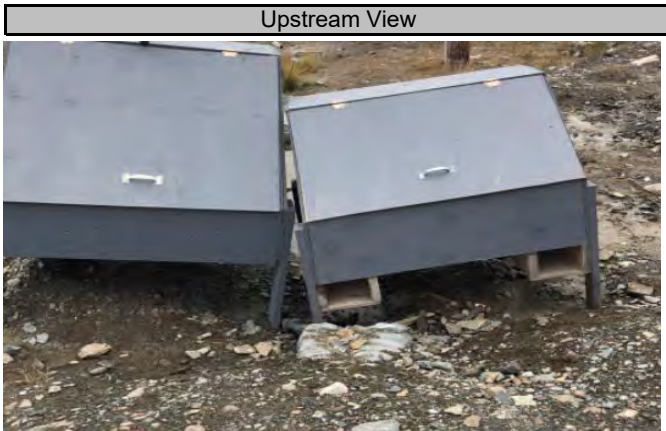
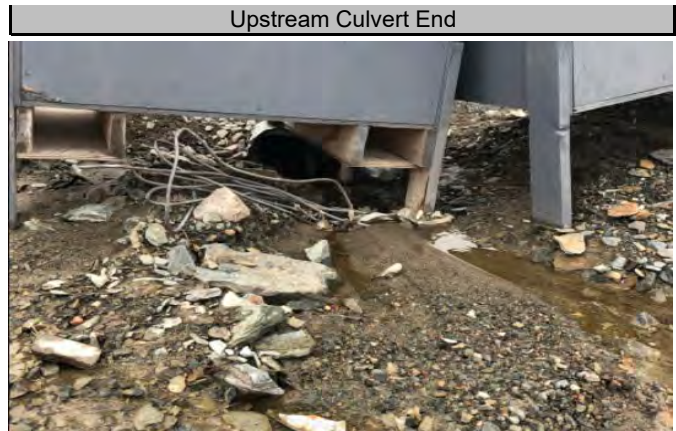
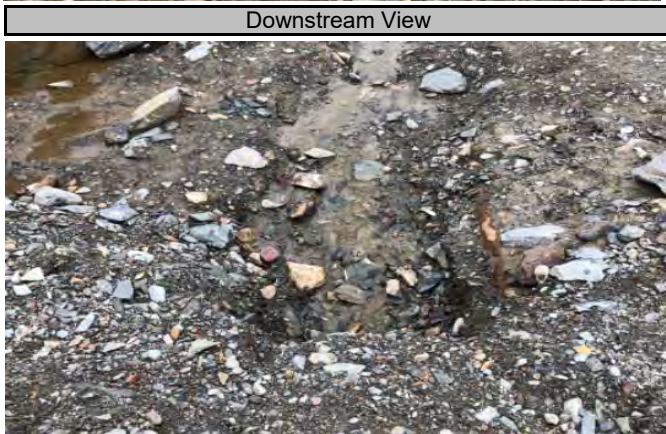
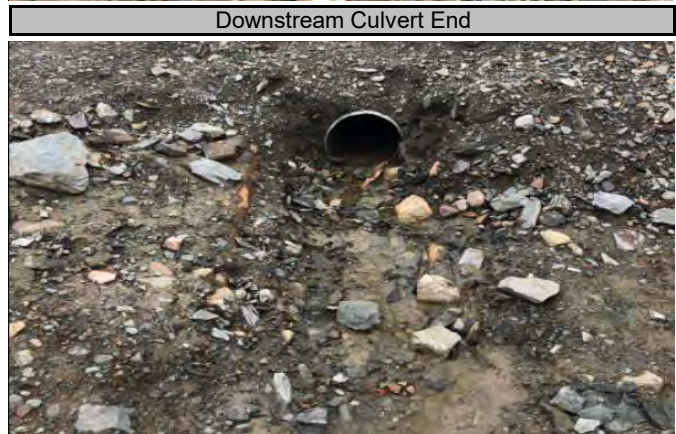
Culvert Information				
Culvert ID	112-02			
Type	Entrance			
Shape	Circular			
Material	CSP			
Diameter or Dimensions (mm)	450			
Marker Post Present	N			
Barrel Length (m)	18.1			
Approx. Barrel Slope (%)	2.0%			
Approx. Depth of Cover (m)	355			
End	Upstream			
Crushing	Downstream			
Infill Depth (mm)	Upstream			
	Downstream			
Other	US end crushed			
Comments				
Culvert Elevations (masl) ²				
Upstream		Downstream		Road Crown
Invert	Obvert	Invert	Obvert	
19.56	19.84	19.19	19.57

Culvert Condition Ratings (MTO 2013)				
Barrel Material (0-4)	Shape (0-4)	Capacity (0-2)	Erosion and Scour (0-2)	US/DS Channel (0-2)
1	0	0	1	1

Recommended Action(s):	No Action	Priority:	Low
------------------------	-----------	-----------	-----

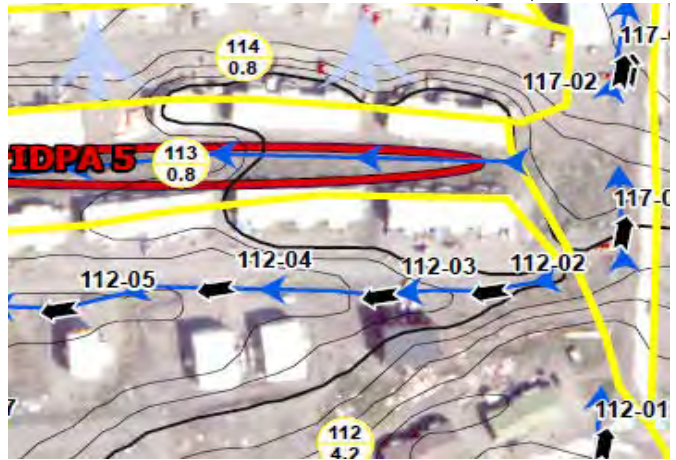
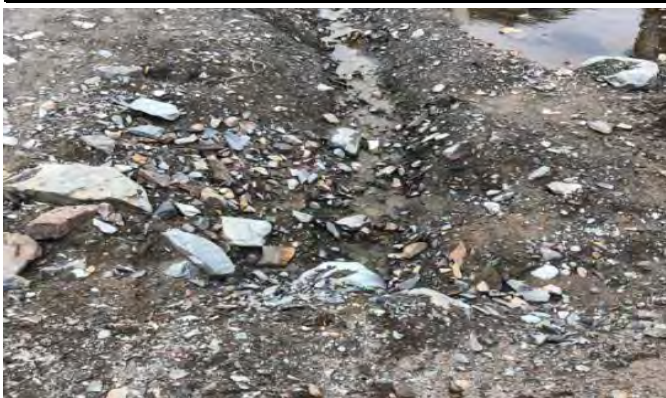
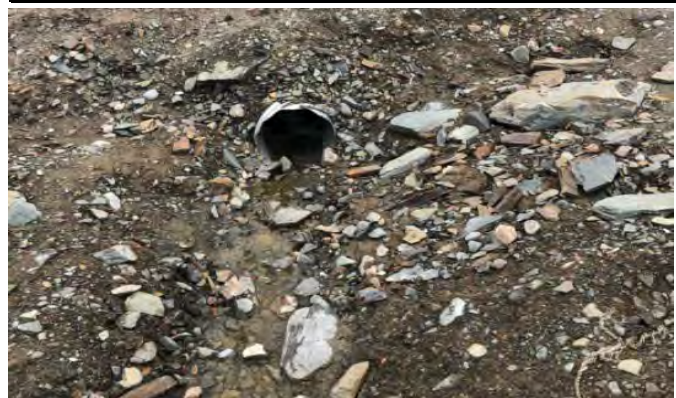
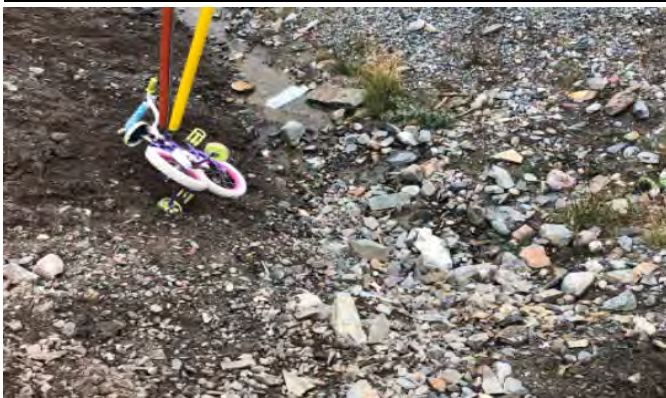
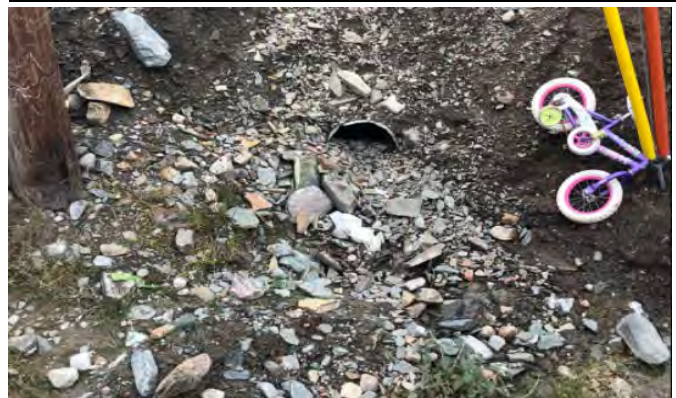
Culvert Information				
Culvert ID	112-03			
Type	Entrance			
Shape	Circular			
Material	CSP			
Diameter or Dimensions (mm)	450			
Marker Post Present	N			
Barrel Length (m)	15.8			
Approx. Barrel Slope (%)	2.5%			
Approx. Depth of Cover (m)	790			
End	Upstream			
Crushing	Downstream			
Infill Depth (mm)	Upstream			
	Downstream			
Other Comments	Infilled DS end			
Culvert Elevations (masl) ²				
Upstream		Downstream		Road Crown
Invert	Obvert	Invert	Obvert	
18.9	19.3	18.5	18.84	19.86

Culvert Condition Ratings (MTO 2013)				
Barrel Material (0-4)	Shape (0-4)	Capacity (0-2)	Erosion and Scour (0-2)	US/DS Channel (0-2)
0	0	2	1	1

Recommended Action(s):	Clear blockage	Priority:	High
------------------------	----------------	-----------	------

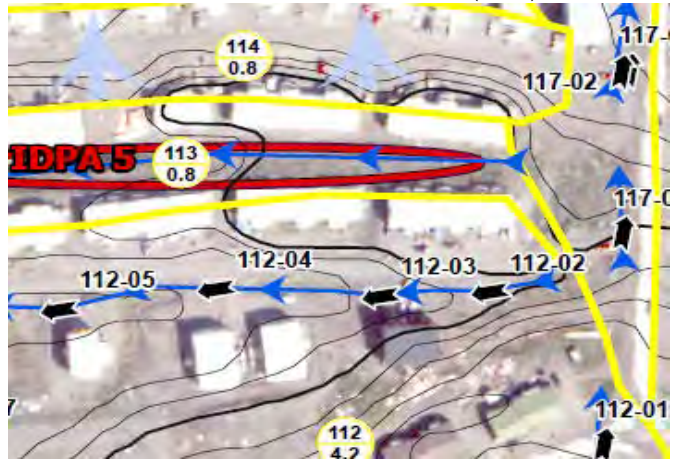
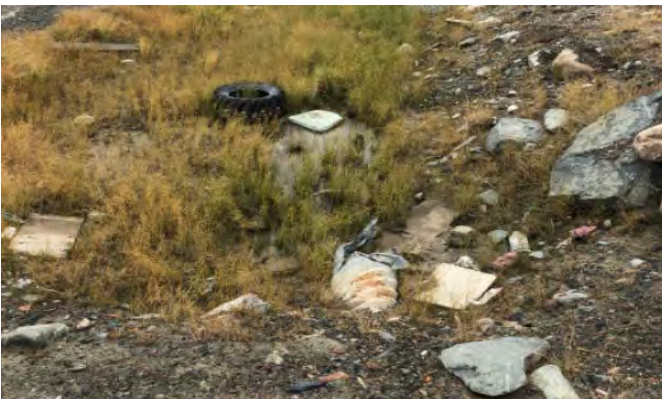
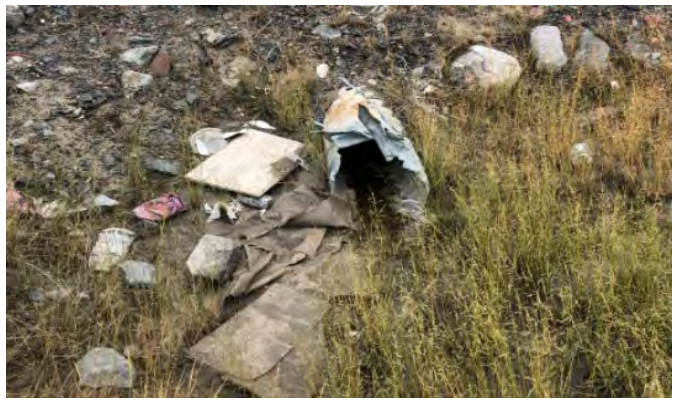
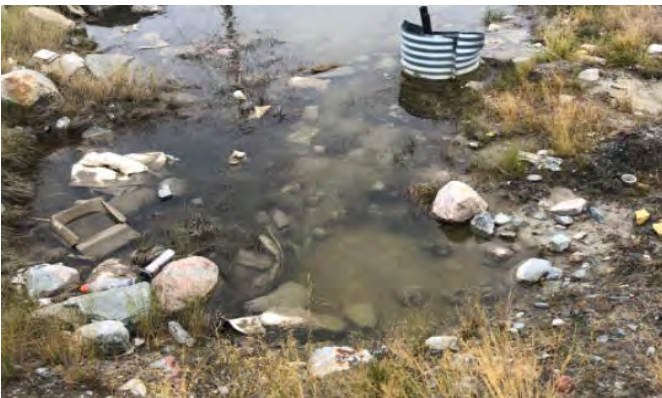
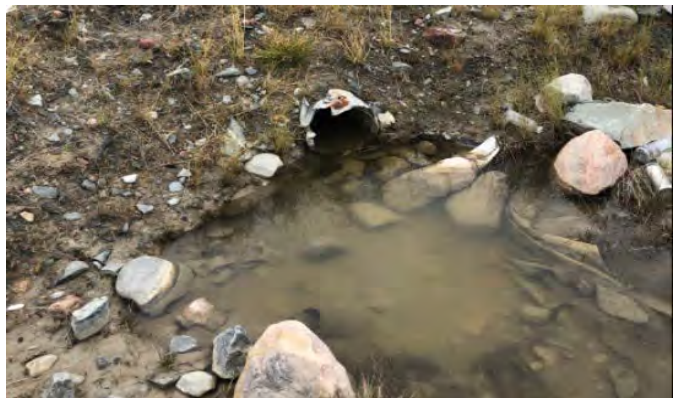
Culvert Information				
Culvert ID	112-04			
Type	Entrance			
Shape	Circular			
Material	CSP			
Diameter or Dimensions (mm)	300			
Marker Post Present	N			
Barrel Length (m)	24.1			
Approx. Barrel Slope (%)	1.8%			
Approx. Depth of Cover (m)	460			
End	Upstream			
Crushing	Downstream			
Infill Depth (mm)	Upstream			
	Downstream			
Other Comments	Ends slightly crushed. DS end close to being buried by driveway embankment.			
Culvert Elevations (masl) ²				
Upstream		Downstream		Road Crown
Invert	Obvert	Invert	Obvert	
17.35	17.65	16.92	17.25

Culvert Condition Ratings (MTO 2013)				
Barrel Material (0-4)	Shape (0-4)	Capacity (0-2)	Erosion and Scour (0-2)	US/DS Channel (0-2)
0	1	0	0	1

Recommended Action(s):	No Action	Priority:	Low
------------------------	-----------	-----------	-----

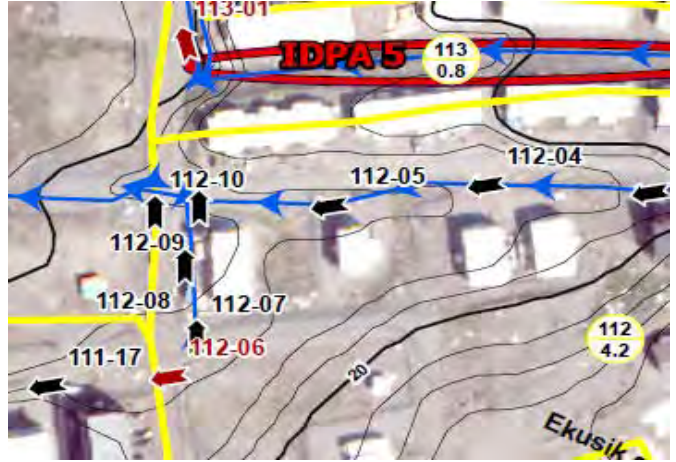
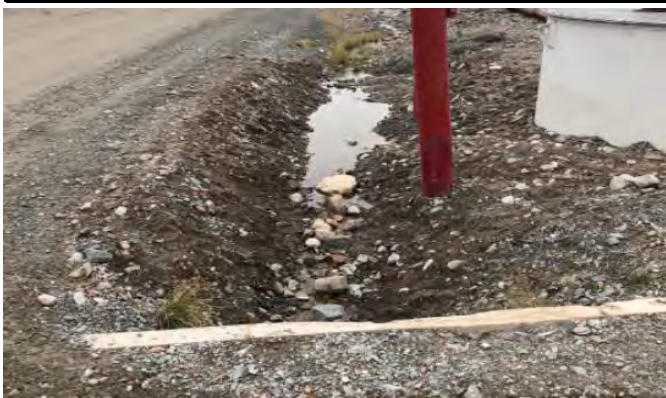
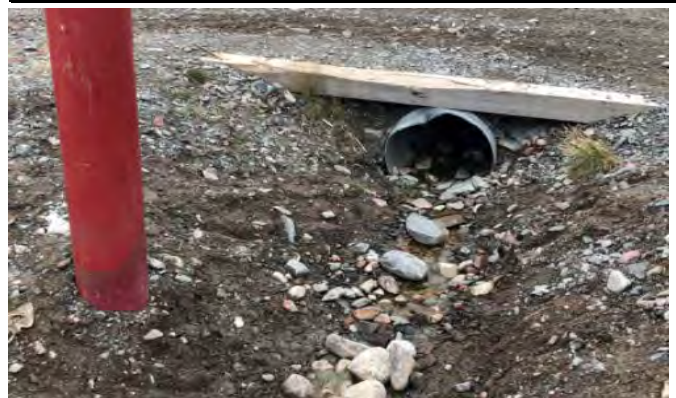
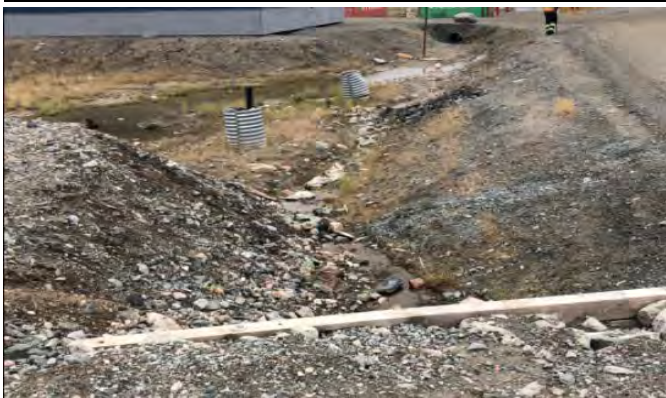
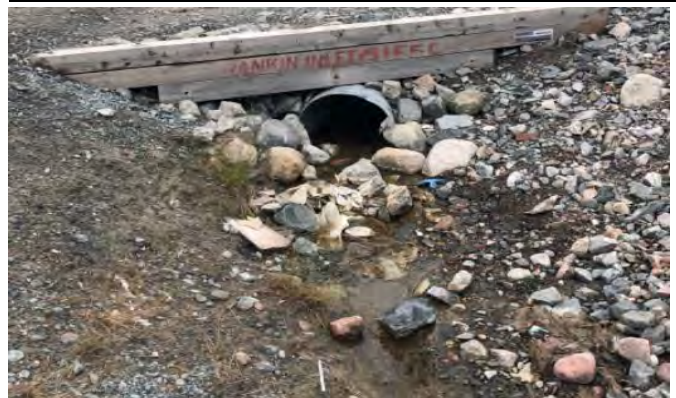
Culvert Information				
Culvert ID	112-05			
Type	Entrance			
Shape	Circular			
Material	CSP			
Diameter or Dimensions (mm)	600			
Marker Post Present	N			
Barrel Length (m)	12.2			
Approx. Barrel Slope (%)	2.9%			
Approx. Depth of Cover (m)	325			
End	Upstream			
Crushing	Downstream			
Infill Depth (mm)	Upstream			
	Downstream			
Other Comments	Infilled in both ends			
Culvert Elevations (masl) ²				
Upstream		Downstream		Road Crown
Invert	Obvert	Invert	Obvert	
16.62	17.14	16.27	16.75

Culvert Condition Ratings (MTO 2013)				
Barrel Material (0-4)	Shape (0-4)	Capacity (0-2)	Erosion and Scour (0-2)	US/DS Channel (0-2)
1	0	1	0	0

Recommended Action(s):	Clear blockage	Priority:	High
------------------------	----------------	-----------	------

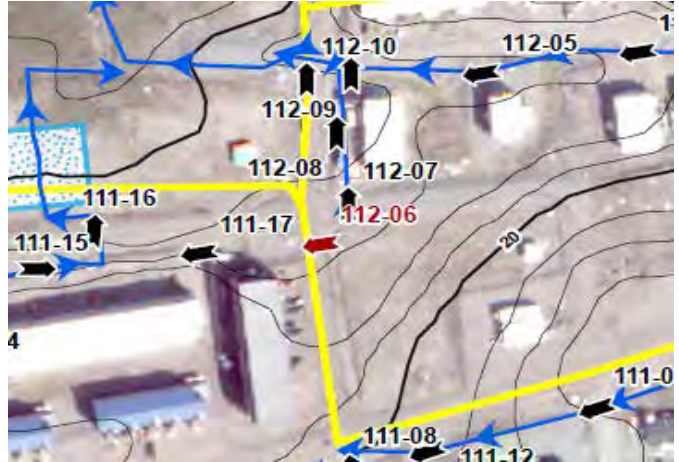
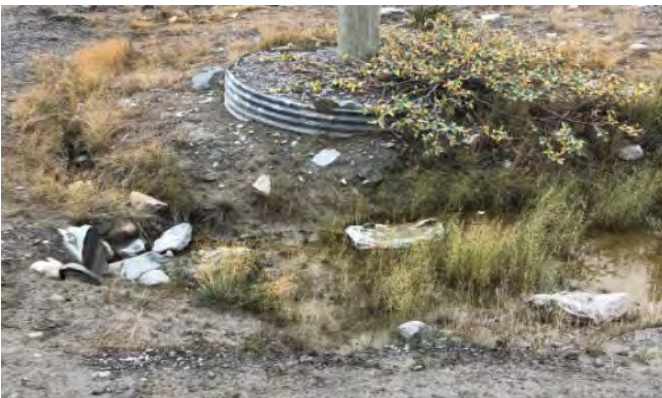
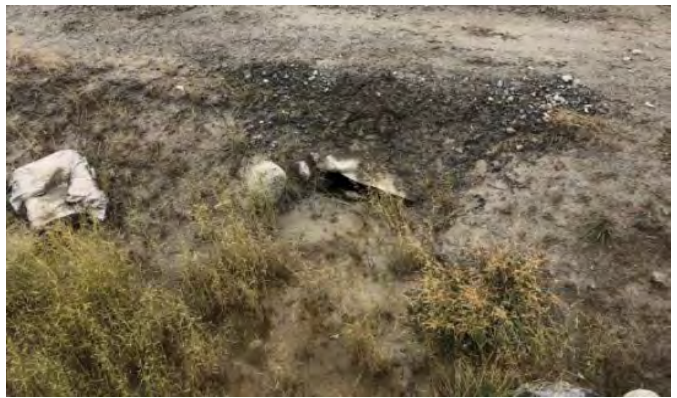
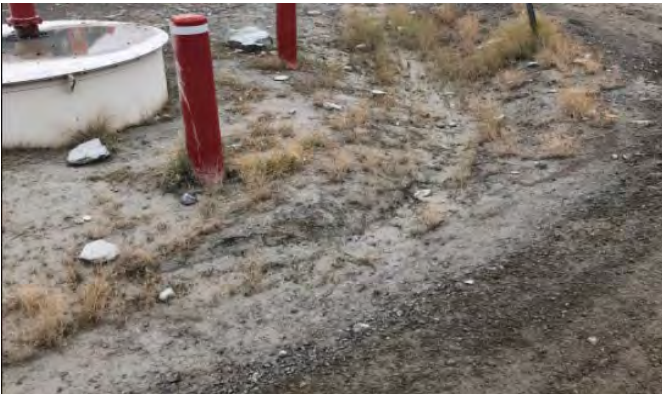
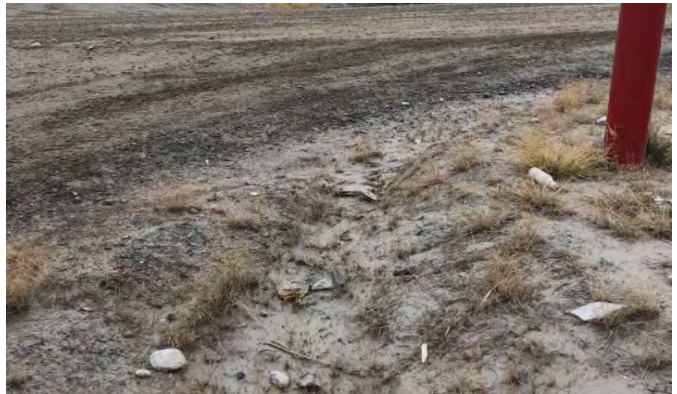
Culvert Information			
Culvert ID	112-06		
Type	Cross		
Shape	Circular		
Material	CSP		
Diameter or Dimensions (mm)	-		
Marker Post Present	N		
Barrel Length (m)	-		
Approx. Barrel Slope (%)	N/A		
Approx. Depth of Cover (m)	-		
End	Upstream	Y	
Crushing	Downstream	N	
Infill Depth (mm)	Upstream	0	
	Downstream	0	
Other Comments	US crushed and barely visible. DS end not visible. Not conveying any flow. No CAD points		
Culvert Elevations (masl) ²			
	Upstream	Downstream	Road Crown
	Invert	Invert	Obvert
	-	-	-

Culvert Condition Ratings (MTO 2013)				
Barrel Material (0-4)	Shape (0-4)	Capacity (0-2)	Erosion and Scour (0-2)	US/DS Channel (0-2)
1	0	0	0	0

Recommended Action(s):	No Action	Priority:	Low
------------------------	-----------	-----------	-----

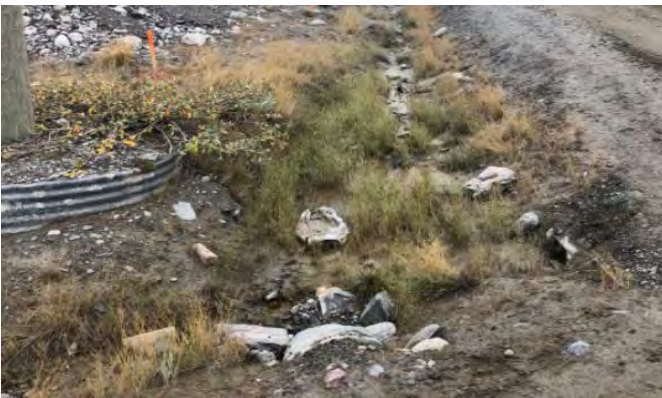
Upstream View

Culvert Information				
Culvert ID	112-07			
Type	Cross			
Shape	Circular			
Material	CSP			
Diameter or Dimensions (mm)	450			
Marker Post Present	N			
Barrel Length (m)	14.0			
Approx. Barrel Slope (%)	2.1%			
Approx. Depth of Cover (m)	380			
End	Upstream			
Crushing	Downstream			
Infill Depth (mm)	Upstream			
	Downstream			
Other Comments	DS end infilled. Barrel clearance unknown			
Culvert Elevations (masl) ²				
Upstream		Downstream		Road Crown
Invert	Obvert	Invert	Obvert	
16.22	16.68	15.93	16.28

Culvert Condition Ratings (MTO 2013)				
Barrel Material (0-4)	Shape (0-4)	Capacity (0-2)	Erosion and Scour (0-2)	US/DS Channel (0-2)
1	0	2	1	0

Recommended Action(s):	Clear blockage	Priority:	High
------------------------	----------------	-----------	------

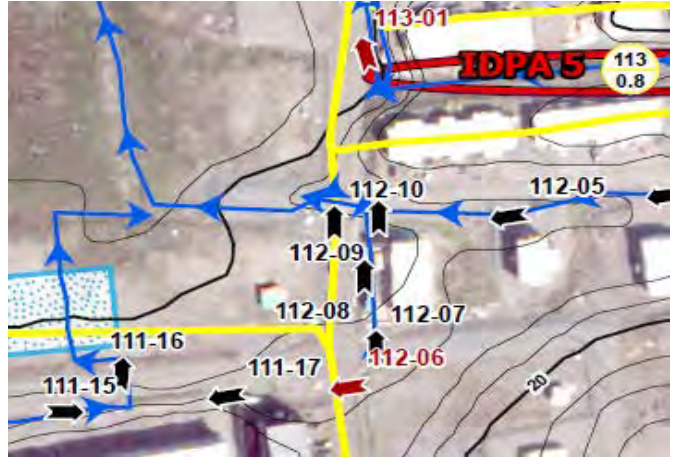
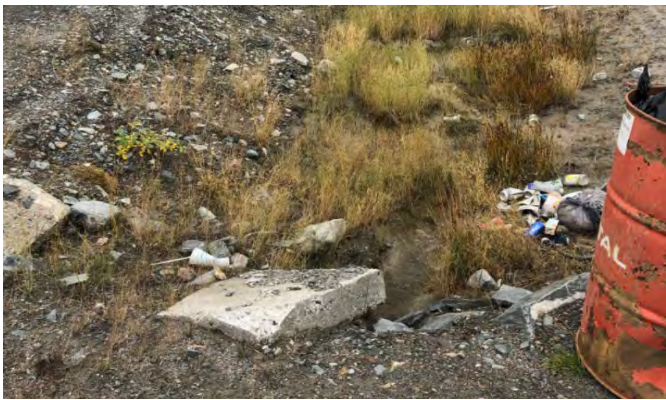
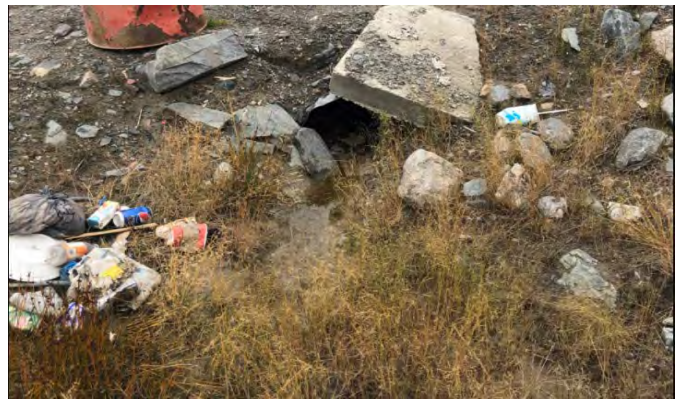
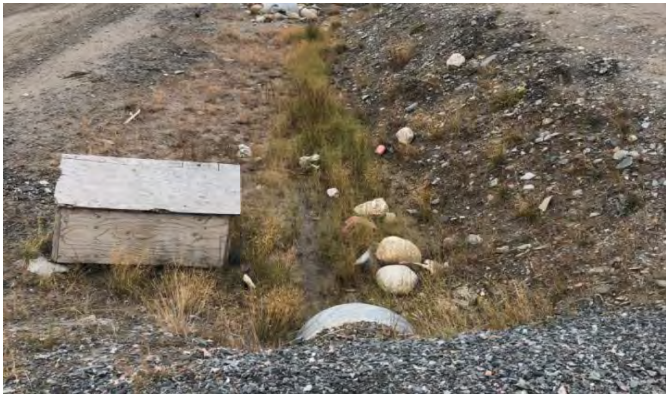
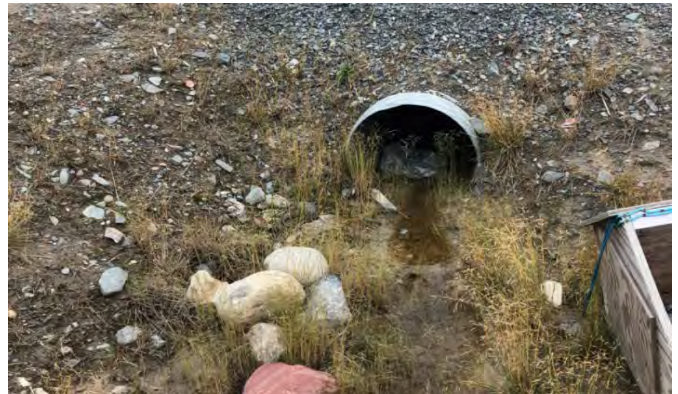
Culvert Information	
Culvert ID	112-08
Type	Entrance
Shape	Circular
Material	CSP
Diameter or Dimensions (mm)	450/600
Marker Post Present	N
Barrel Length (m)	10.1
Approx. Barrel Slope (%)	0.7%
Approx. Depth of Cover (m)	465
End	Upstream
Crushing	Downstream
Infill Depth (mm)	Upstream
	Downstream
Other Comments	0

Culvert Condition Ratings (MTO 2013)				
Barrel Material (0-4)	Shape (0-4)	Capacity (0-2)	Erosion and Scour (0-2)	US/DS Channel (0-2)
0	0	1	0	0

Recommended Action(s):	Clear blockage	Priority:	High
------------------------	----------------	-----------	------

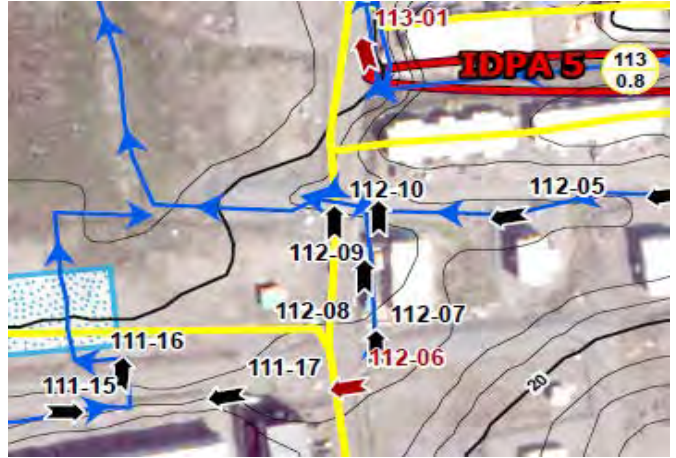
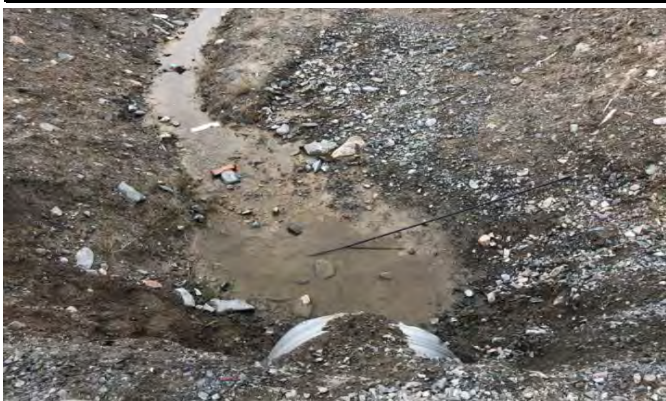
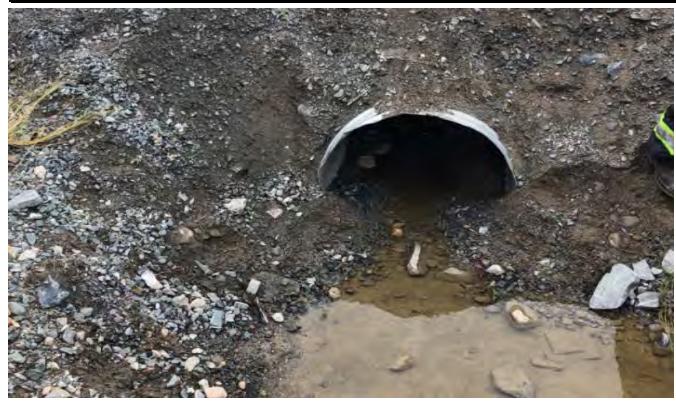
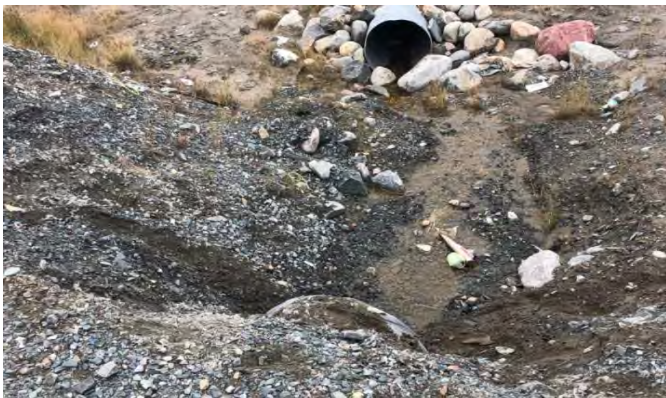
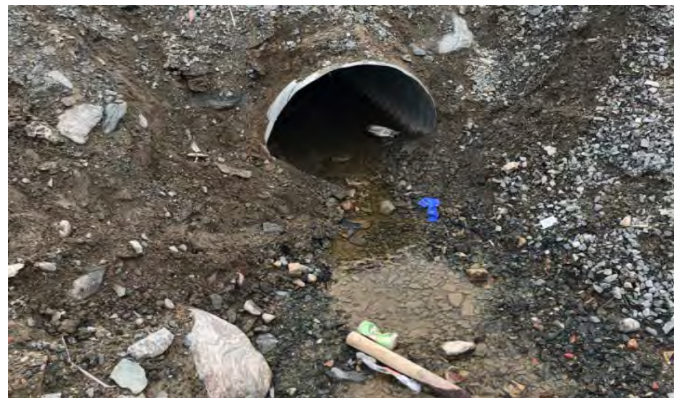
Culvert Information				
Culvert ID	112-09			
Type	Entrance			
Shape	Circular			
Material	CSP			
Diameter or Dimensions (mm)	800			
Marker Post Present	N			
Barrel Length (m)	4.1			
Approx. Barrel Slope (%)	1.0%			
Approx. Depth of Cover (m)	420			
End	Upstream			
Crushing	Downstream			
Infill Depth (mm)	Upstream			
	Downstream			
Other Comments	Infilled in both ends			
Culvert Elevations (masl) ²				
Upstream		Downstream		Road Crown
Invert	Obvert	Invert	Obvert	
15.68	16.29	15.64	16.27

Culvert Condition Ratings (MTO 2013)				
Barrel Material (0-4)	Shape (0-4)	Capacity (0-2)	Erosion and Scour (0-2)	US/DS Channel (0-2)
0	0	1	1	1

Recommended Action(s):	Clear blockage	Priority:	High
------------------------	----------------	-----------	------
