**Geotechnical Evaluation and Drainage Planning
in Rankin Inlet, Nunavut**

Draft Report
REV-00

Prepared for:
The Municipality of Rankin Inlet

Prepared by:
Nunami Stantec Limited

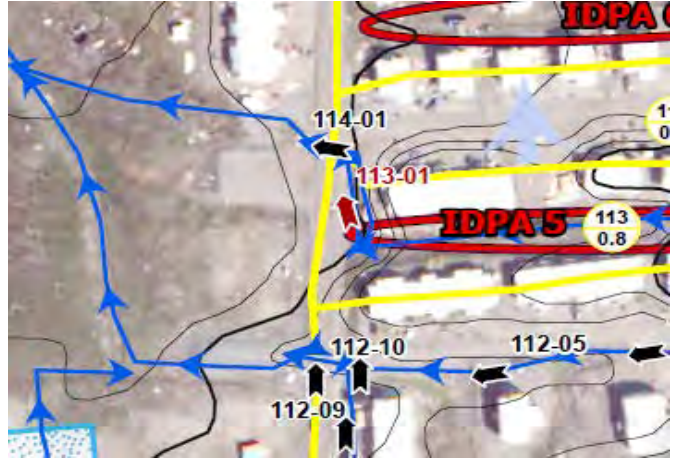
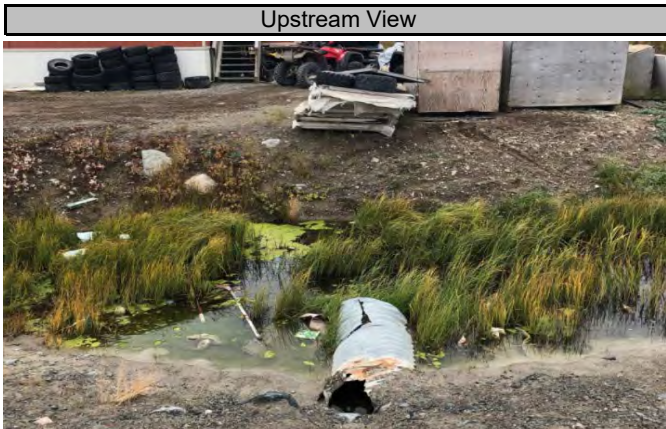
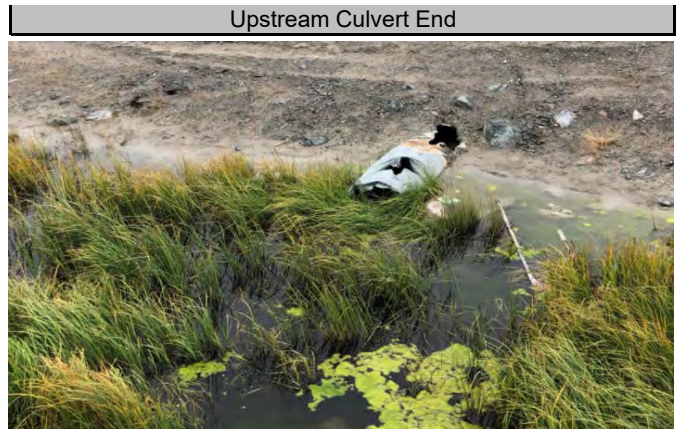
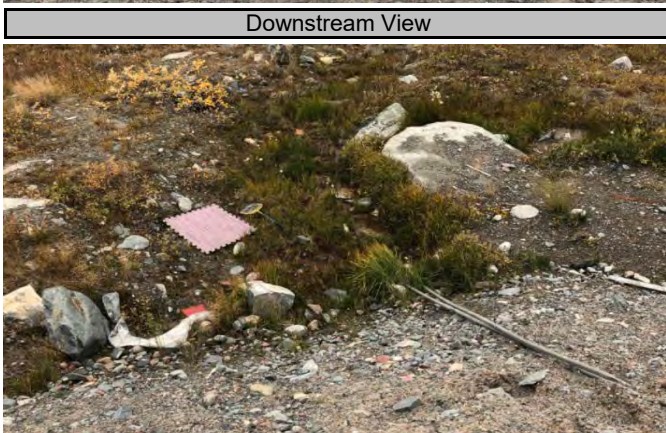
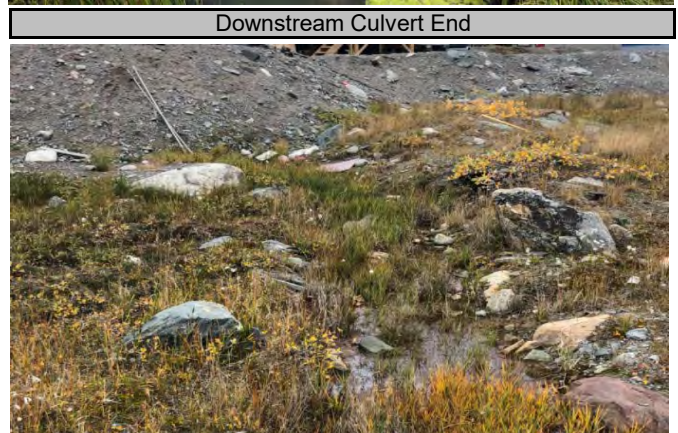
Culvert Information				
Culvert ID	113-01			
Type	Cross			
Shape	Circular			
Material	CSP			
Diameter or Dimensions (mm)	600			
Marker Post Present	N			
Barrel Length (m)	-			
Approx. Barrel Slope (%)	N/A			
Approx. Depth of Cover (m)	670			
End	Upstream			
Crushing	Downstream			
Infill Depth (mm)	Upstream			
	Downstream			
Other Comments	US end damaged. No flow observed. No sign of DS, likely covered by development. Culvert			
Culvert Elevations (masl) ²				
Upstream		Downstream		Road Crown
Invert	Obvert	Invert	Obvert	
14.19	14.76	-	-

Culvert Condition Ratings (MTO 2013)				
Barrel Material (0-4)	Shape (0-4)	Capacity (0-2)	Erosion and Scour (0-2)	US/DS Channel (0-2)
1	4	2	1	0

Recommended Action(s):	Replace culvert	Priority:	High
------------------------	-----------------	-----------	------

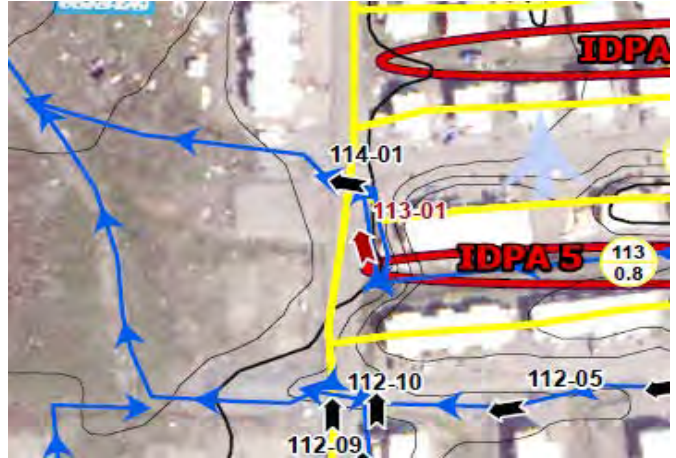
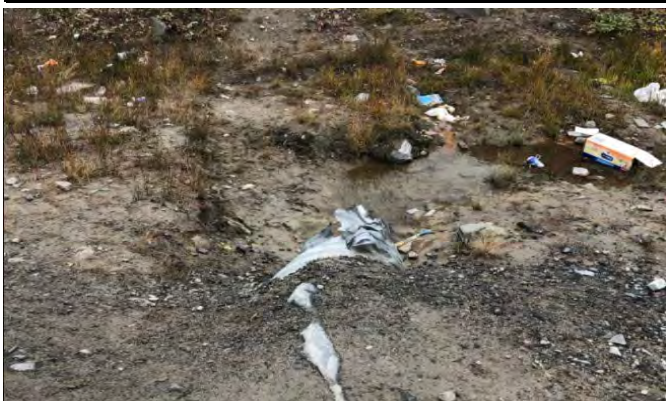
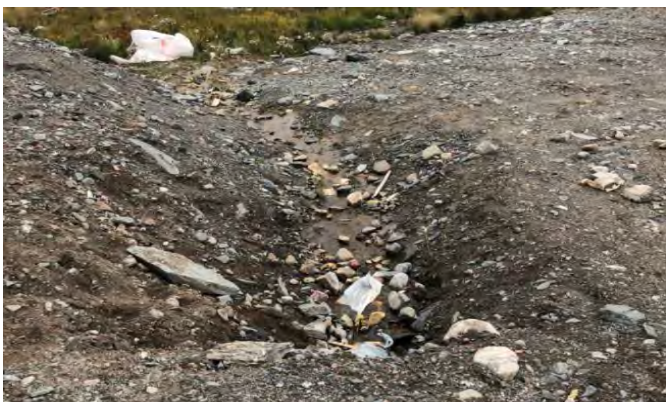
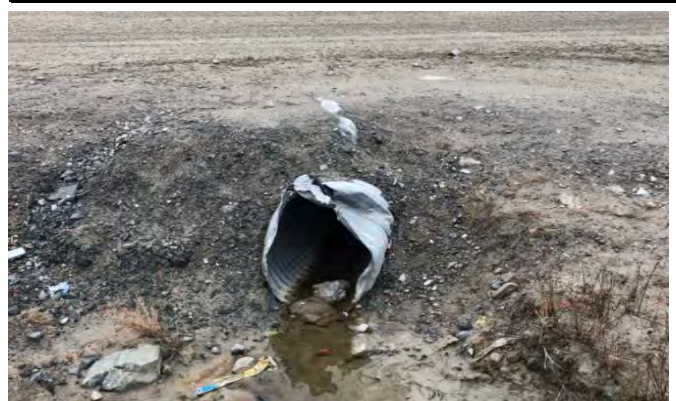
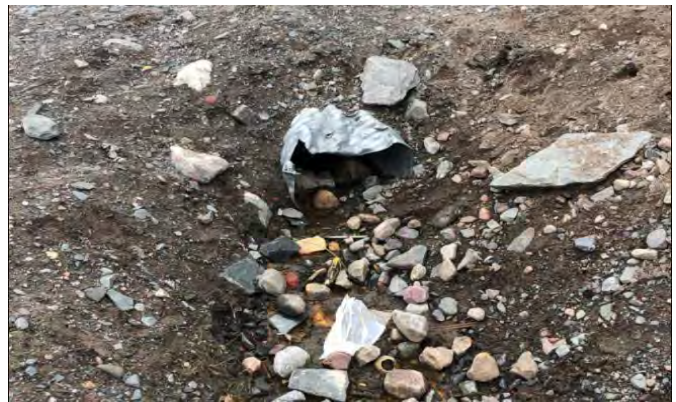
Culvert Information				
Culvert ID	114-01			
Type	Cross			
Shape	Circular			
Material	CSP			
Diameter or Dimensions (mm)	600			
Marker Post Present	N			
Barrel Length (m)	23.8			
Approx. Barrel Slope (%)	0.6%			
Approx. Depth of Cover (m)	590			
End	Upstream	Y		
Crushing	Downstream	N		
Infill Depth (mm)	Upstream	0		
	Downstream	0		
Other Comments	US end damaged but clear. DS end has some damage. Culvert seems to be bowed based on			
Culvert Elevations (masl) ²				
Upstream		Downstream	Road Crown	
Invert	Obvert	Invert		Obvert
14.41	15	14.26		14.84

Culvert Condition Ratings (MTO 2013)				
Barrel Material (0-4)	Shape (0-4)	Capacity (0-2)	Erosion and Scour (0-2)	US/DS Channel (0-2)
1	0	0	1	1

Recommended Action(s):	No Action	Priority:	Low
------------------------	-----------	-----------	-----

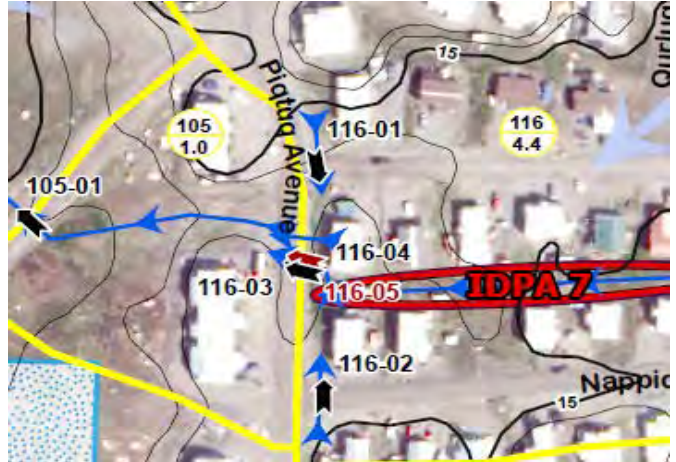
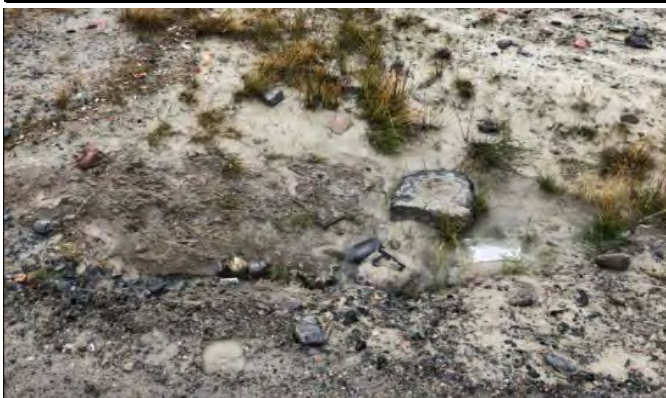
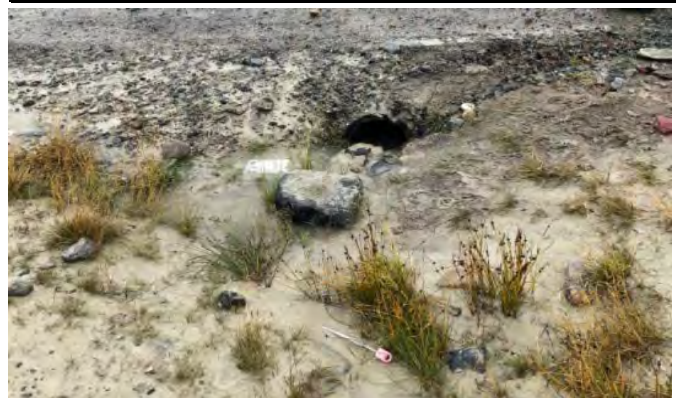
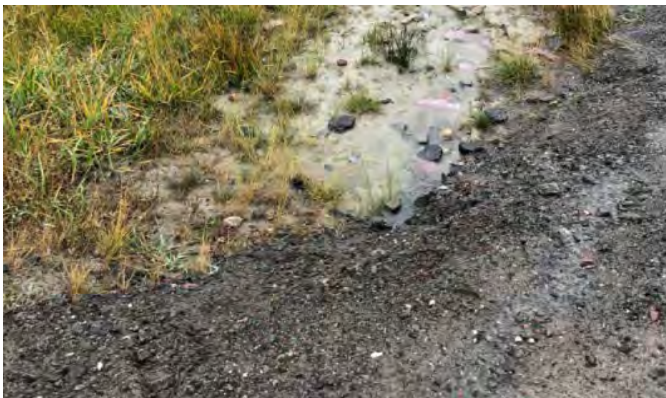
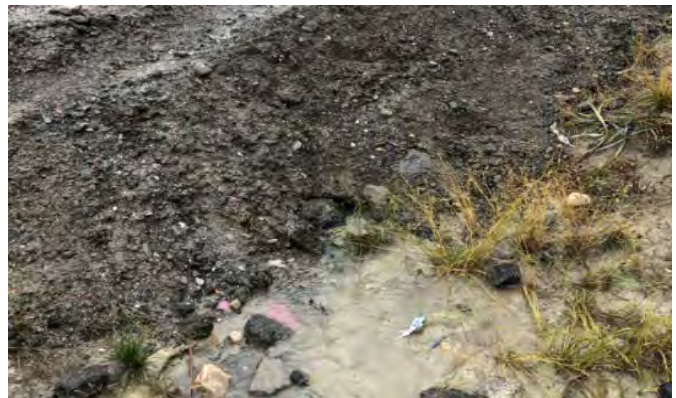
Culvert Information	
Culvert ID	116-01
Type	Cross
Shape	Circular
Material	PVC
Diameter or Dimensions (mm)	250
Marker Post Present	N
Barrel Length (m)	10.7
Approx. Barrel Slope (%)	3.7%
Approx. Depth of Cover (m)	670
End	Upstream
Crushing	Downstream
Infill Depth (mm)	Upstream
	Downstream
Other Comments	Conveying flow. PVC culvert almost buried

Culvert Condition Ratings (MTO 2013)				
Barrel Material (0-4)	Shape (0-4)	Capacity (0-2)	Erosion and Scour (0-2)	US/DS Channel (0-2)
0	0	2	0	1

Recommended Action(s):	Clear blockage	Priority:	High
------------------------	----------------	-----------	------

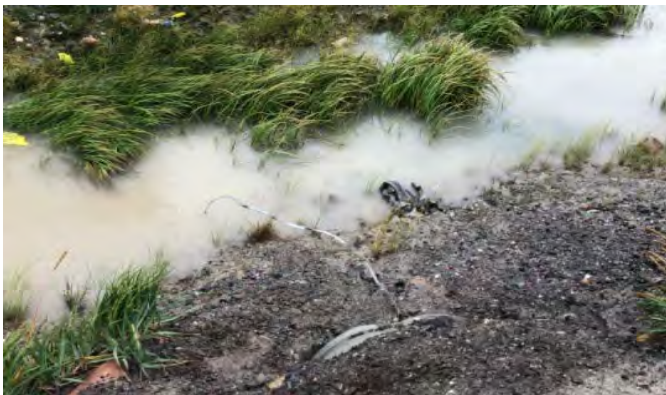
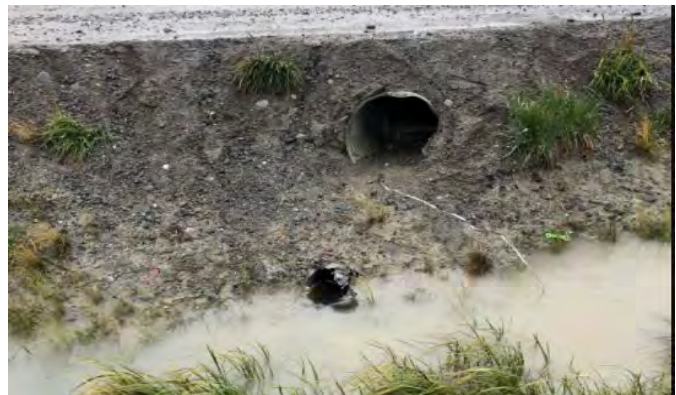
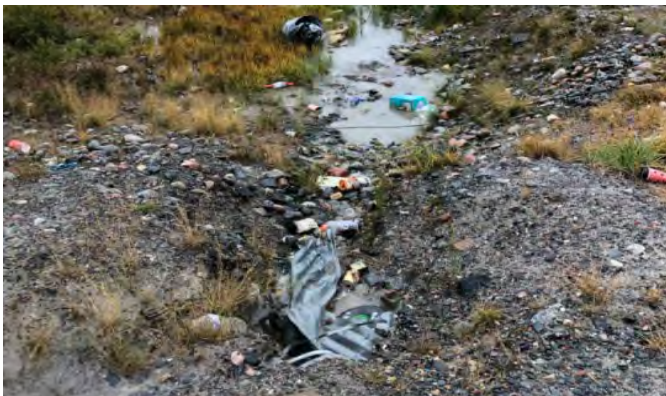
Culvert Information				
Culvert ID	116-03			
Type	Cross			
Shape	Circular			
Material	CSP			
Diameter or Dimensions (mm)	300			
Marker Post Present	N			
Barrel Length (m)	23.1			
Approx. Barrel Slope (%)	2.7%			
Approx. Depth of Cover (m)	1450			
End	Upstream			
Crushing	Downstream			
Infill Depth (mm)	Upstream			
	Downstream			
Other Comments	Conveying flow			
Culvert Elevations (masl) ²				
Upstream		Downstream		Road Crown
Invert	Obvert	Invert	Obvert	
12.33	12.53	11.71	12.03	13.73

Culvert Condition Ratings (MTO 2013)				
Barrel Material (0-4)	Shape (0-4)	Capacity (0-2)	Erosion and Scour (0-2)	US/DS Channel (0-2)
1	2	0	0	1

Recommended Action(s):	Repair culvert end	Priority:	Medium
------------------------	--------------------	-----------	--------

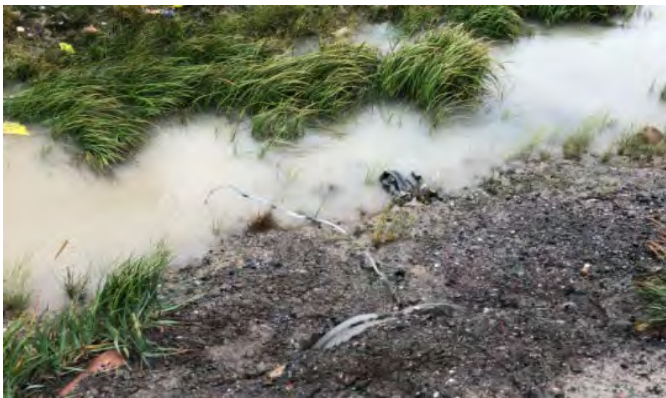
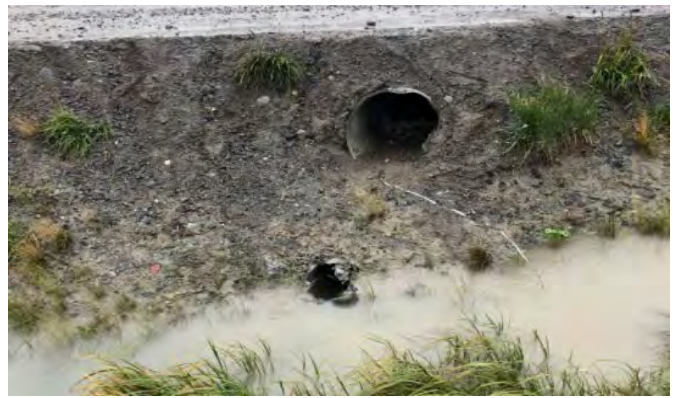
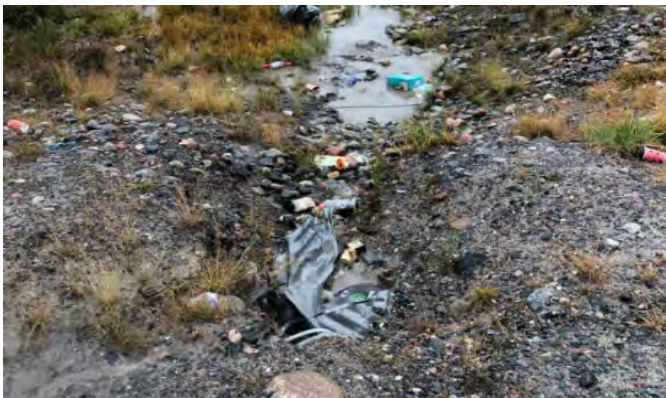
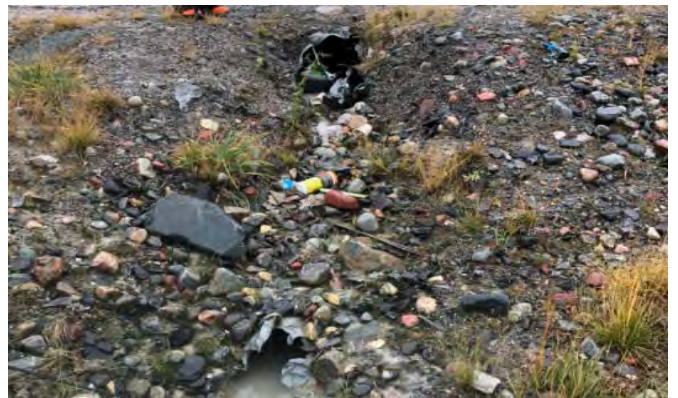
Culvert Information	
Culvert ID	116-04
Type	Cross
Shape	Circular
Material	CSP
Diameter or Dimensions (mm)	600
Marker Post Present	N
Barrel Length (m)	17.9
Approx. Barrel Slope (%)	1.0%
Approx. Depth of Cover (m)	540
End	Upstream
Crushing	Downstream
Infill Depth (mm)	Upstream
	Downstream
Other Comments	0

Culvert Condition Ratings (MTO 2013)				
Barrel Material (0-4)	Shape (0-4)	Capacity (0-2)	Erosion and Scour (0-2)	US/DS Channel (0-2)
1	2	0	1	1

Recommended Action(s):	Repair culvert end	Priority:	Medium
------------------------	--------------------	-----------	--------

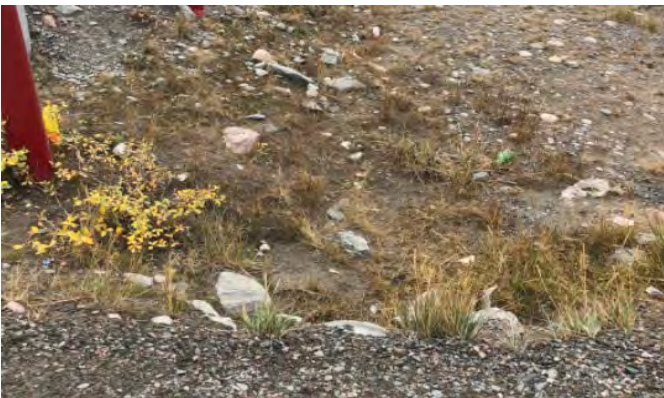
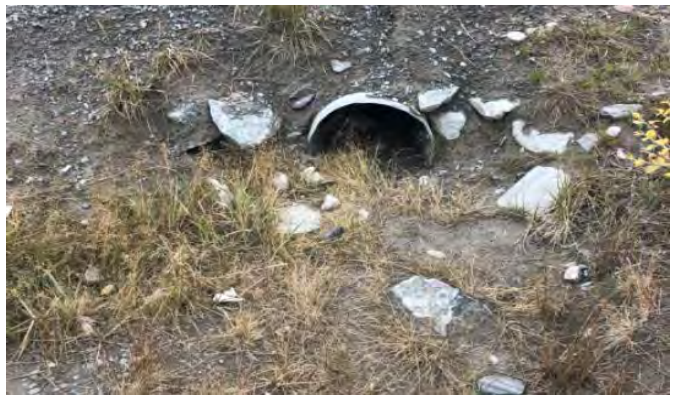
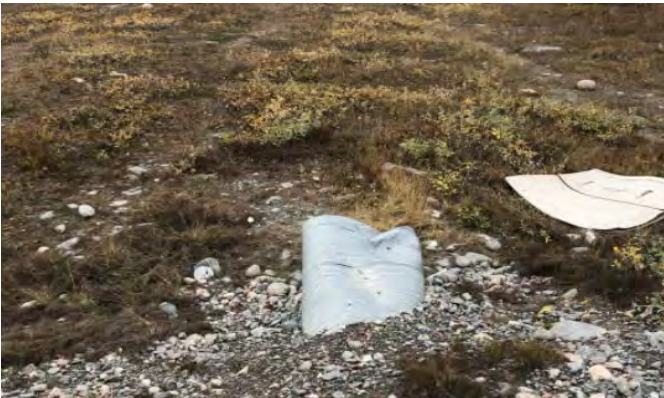
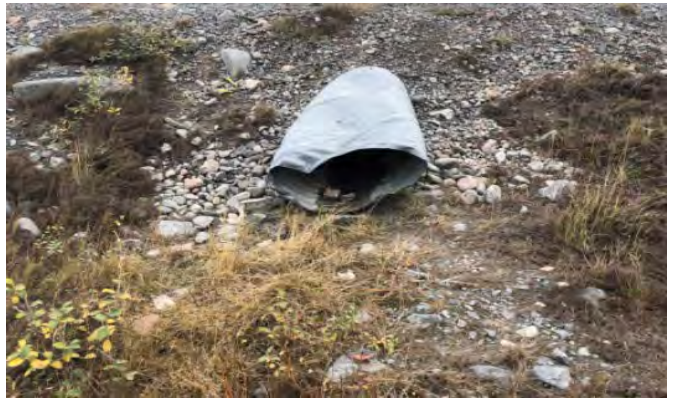
Culvert Condition Ratings (MTO 2013)				
Barrel Material (0-4)	Shape (0-4)	Capacity (0-2)	Erosion and Scour (0-2)	US/DS Channel (0-2)
0	4	1	1	0

Recommended Action(s):	Replace culvert	Priority:	High
------------------------	-----------------	-----------	------

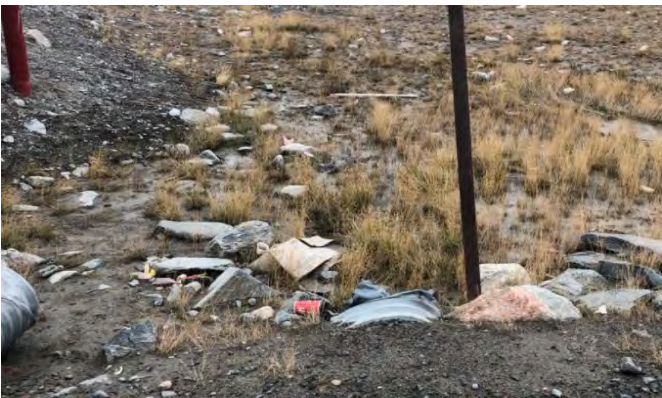
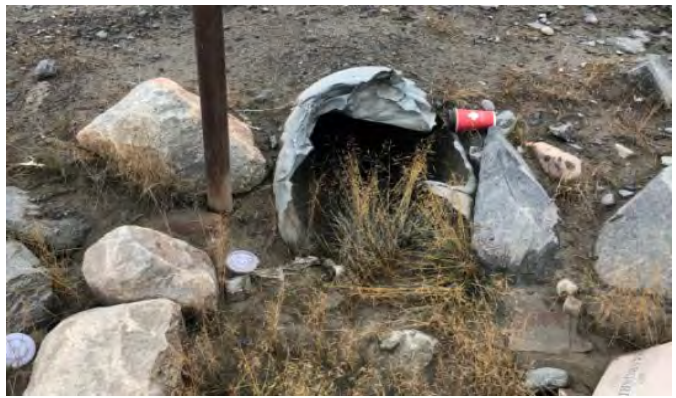
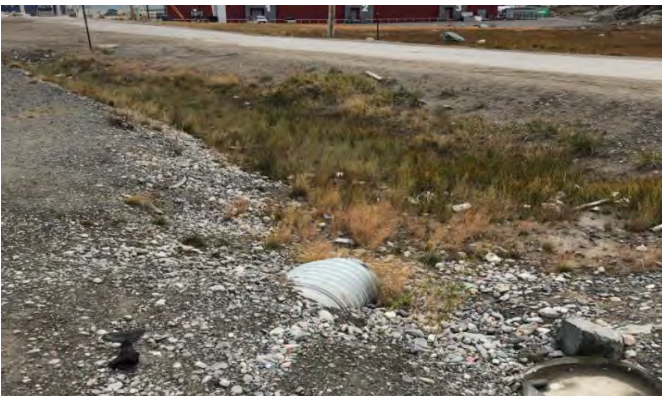
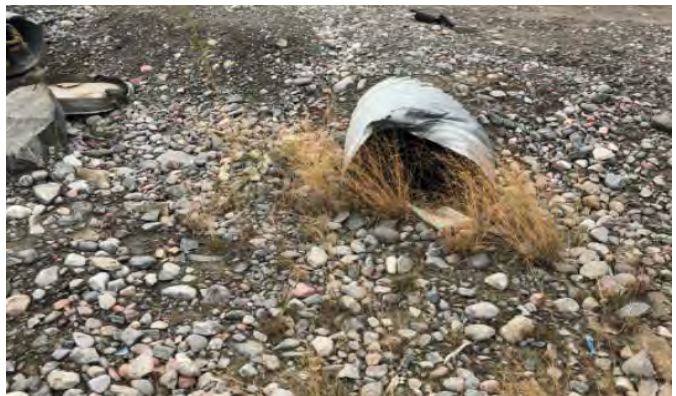
Culvert Information				
Culvert ID	117-02			
Type	Cross			
Shape	Circular			
Material	CSP			
Diameter or Dimensions (mm)	600			
Marker Post Present	N			
Barrel Length (m)	15.3			
Approx. Barrel Slope (%)	1.4%			
Approx. Depth of Cover (m)	345			
End	Upstream	Y		
	Downstream	Y		
Crushing	Upstream	Y		
	Downstream	Y		
Infill Depth (mm)	Upstream	0		
	Downstream	150		
Other Comments	Both ends damaged. Culvert barrel bent or angled based on outlet angle			
Culvert Elevations (masl) ²				
Upstream		Downstream	Road Crown	
Invert	Obvert	Invert		Obvert
15.17	15.76	14.95		15.39

Culvert Condition Ratings (MTO 2013)				
Barrel Material (0-4)	Shape (0-4)	Capacity (0-2)	Erosion and Scour (0-2)	US/DS Channel (0-2)
0	2	1	0	0

Recommended Action(s):	Clear blockage, repair culvert end	Priority:	High
------------------------	------------------------------------	-----------	------

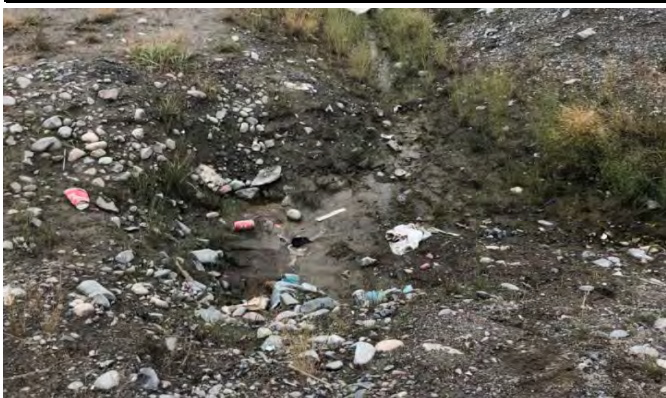
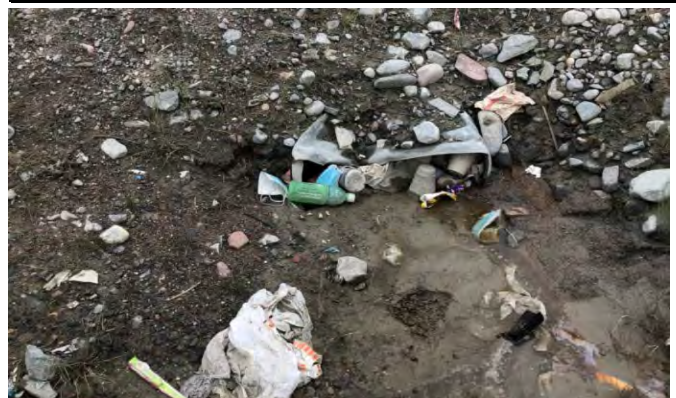
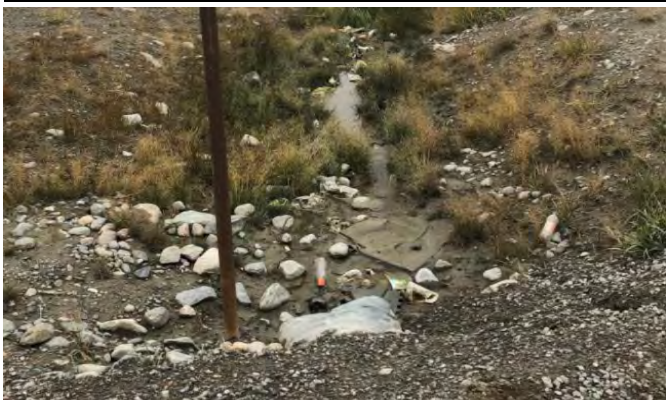
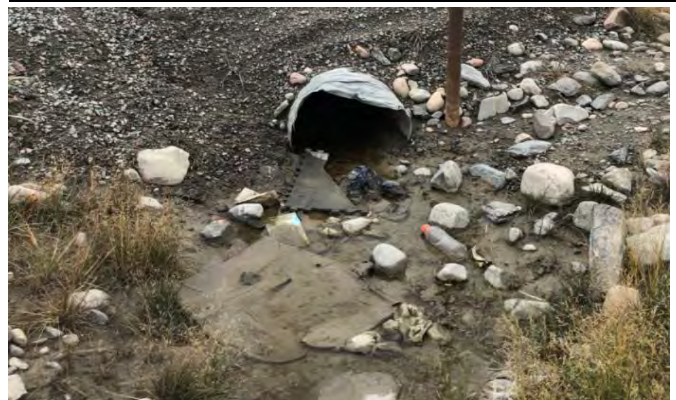
Culvert Information				
Culvert ID	117-04			
Type	Cross			
Shape	Circular			
Material	CSP			
Diameter or Dimensions (mm)	600			
Marker Post Present	N			
Barrel Length (m)	48.3			
Approx. Barrel Slope (%)	0.7%			
Approx. Depth of Cover (m)	910			
End	Upstream			
Crushing	Downstream			
Infill Depth (mm)	Upstream			
	Downstream			
Other Comments	Near 61			
Culvert Elevations (masl) ²				
Upstream		Downstream		Road Crown
Invert	Obvert	Invert	Obvert	
13.92	14.2	13.56	14.06

Culvert Condition Ratings (MTO 2013)				
Barrel Material (0-4)	Shape (0-4)	Capacity (0-2)	Erosion and Scour (0-2)	US/DS Channel (0-2)
1	4	2	0	0

Recommended Action(s):	Replace culvert	Priority:	High
------------------------	-----------------	-----------	------

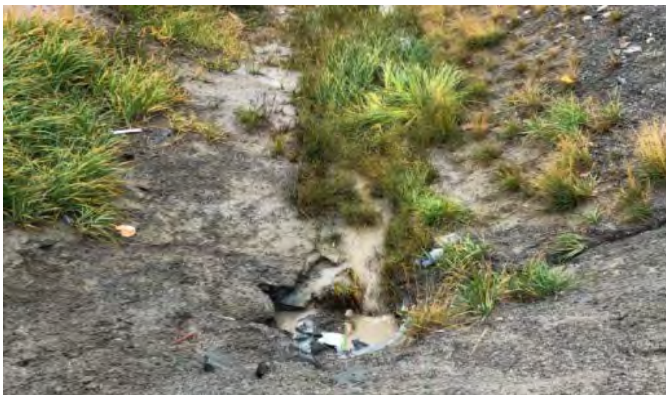
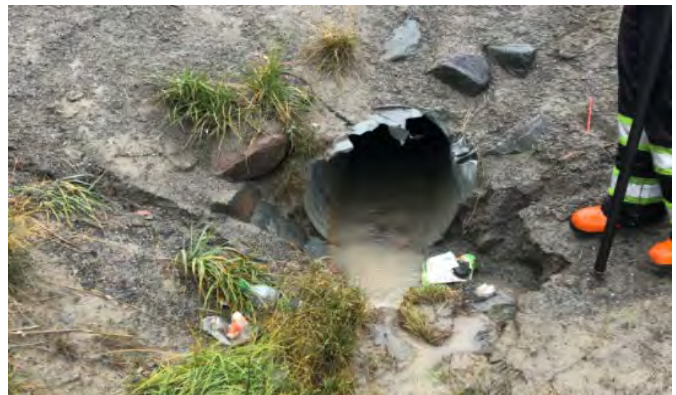
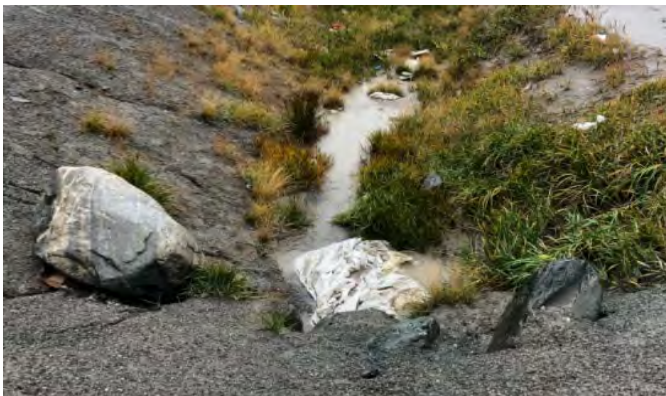
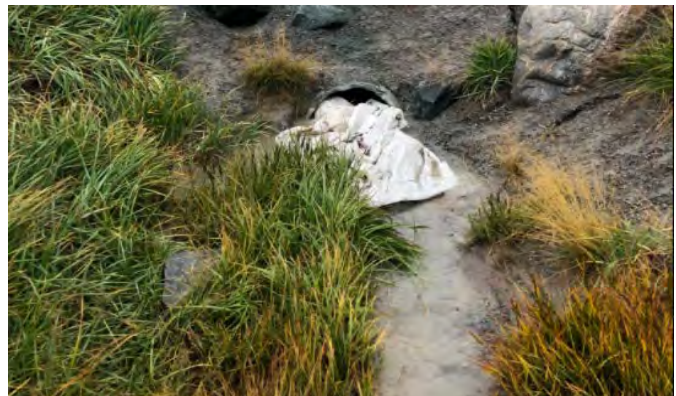
Culvert Information				
Culvert ID	117-05			
Type	Entrance			
Shape	Circular			
Material	CSP			
Diameter or Dimensions (mm)	600			
Marker Post Present	N			
Barrel Length (m)	12.9			
Approx. Barrel Slope (%)	1.6%			
Approx. Depth of Cover (m)	1030			
End	Upstream	Y		
Crushing	Downstream	Y		
Infill Depth (mm)	Upstream	0		
	Downstream	20		
Other Comments	Horizontally compressed. DS end blocked			
Culvert Elevations (masl) ²				
Upstream		Downstream	Road Crown	
Invert	Obvert	Invert		Obvert
12.9	13.48	12.69	13.1	14.32

Culvert Condition Ratings (MTO 2013)				
Barrel Material (0-4)	Shape (0-4)	Capacity (0-2)	Erosion and Scour (0-2)	US/DS Channel (0-2)
1	1	1	0	0

Recommended Action(s):	Clear blockage	Priority:	High
------------------------	----------------	-----------	------

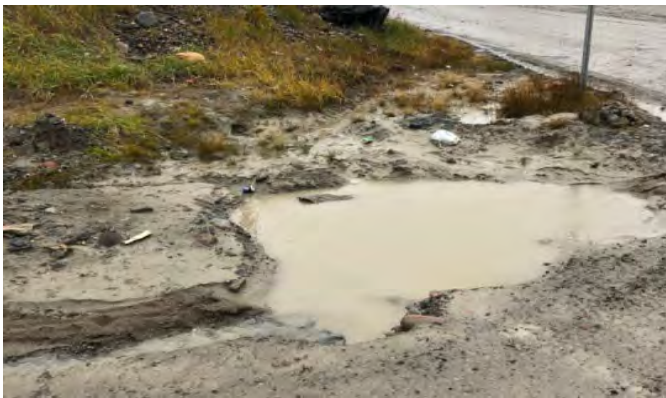
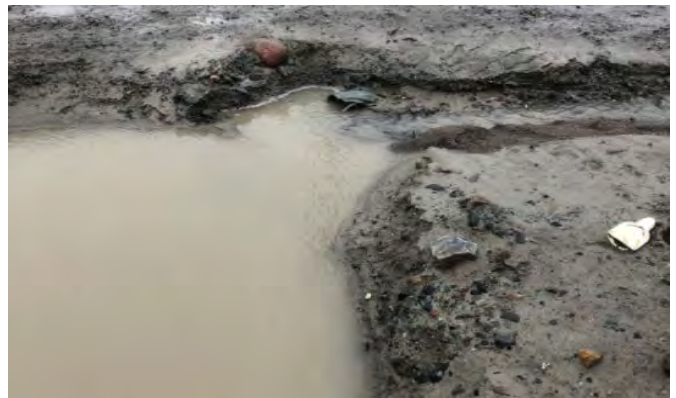
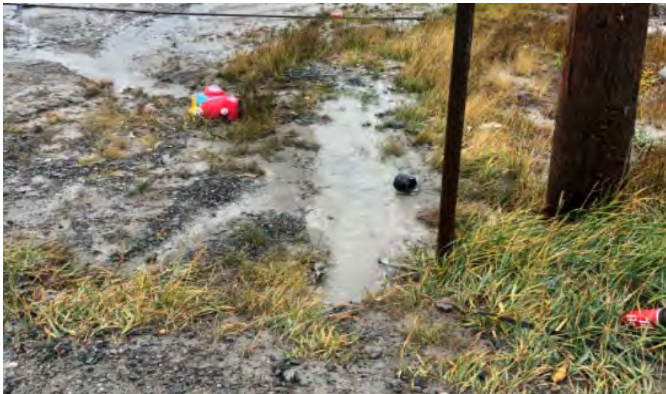
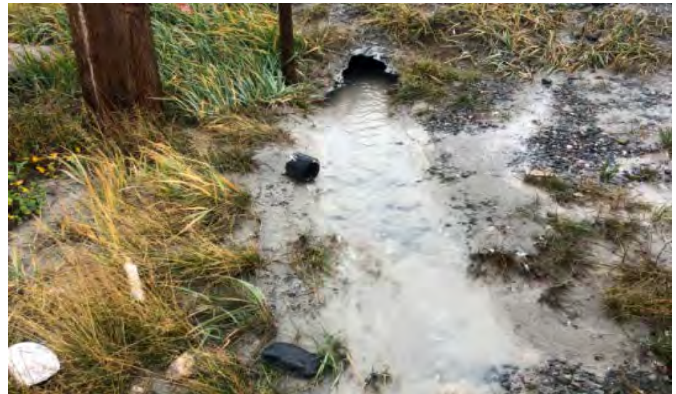
Culvert Information				
Culvert ID	117-07			
Type	Cross			
Shape	Circular			
Material	CSP			
Diameter or Dimensions (mm)	450			
Marker Post Present	N			
Barrel Length (m)	11.2			
Approx. Barrel Slope (%)	3.0%			
Approx. Depth of Cover (m)	350			
End	Upstream			
Crushing	Downstream			
Infill Depth (mm)	Upstream			
	Downstream			
Other Comments	Sedimentation in US end			
Culvert Elevations (masl) ²				
Upstream		Downstream		Road Crown
Invert	Obvert	Invert	Obvert	
7.09	7.27	6.75	6.99

Culvert Condition Ratings (MTO 2013)				
Barrel Material (0-4)	Shape (0-4)	Capacity (0-2)	Erosion and Scour (0-2)	US/DS Channel (0-2)
0	2	2	0	2

Recommended Action(s):	Clear blockage, emediate channel erosion	Priority:	High
------------------------	------------------------------------------	-----------	------

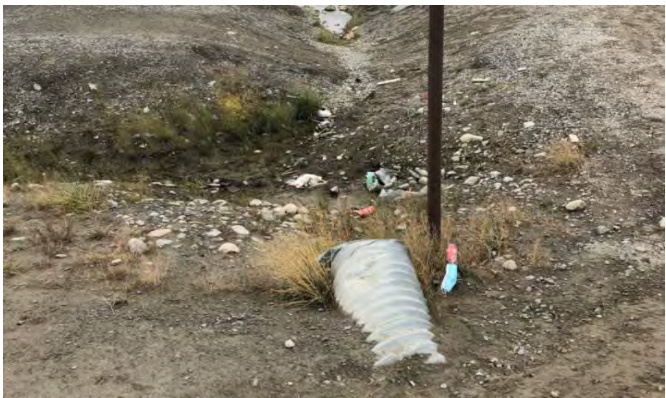
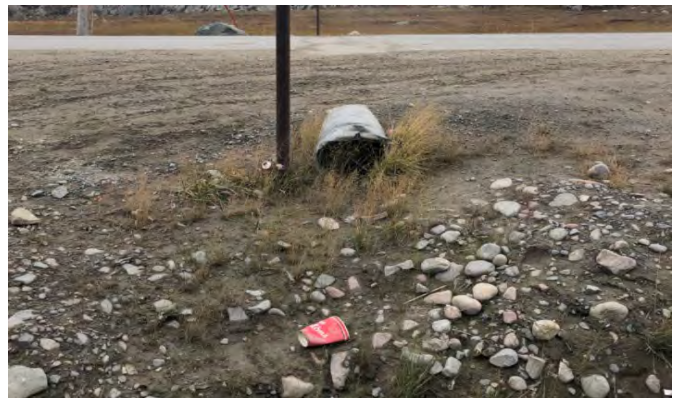
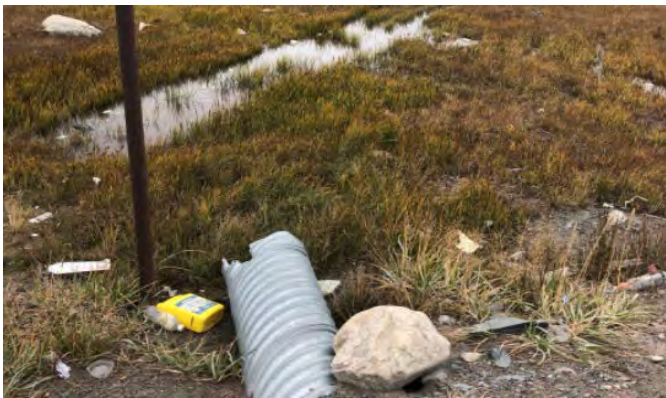
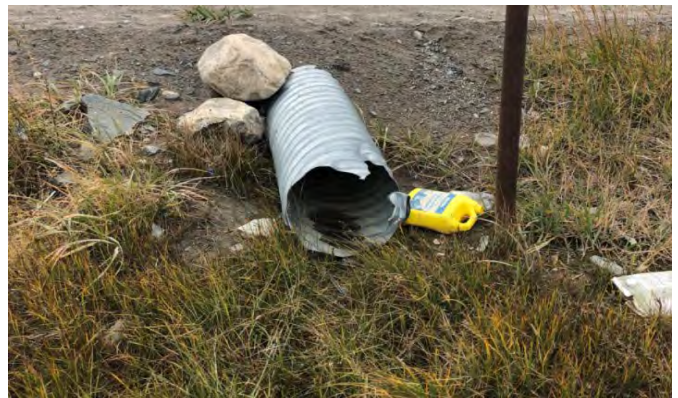
Culvert Information	
Culvert ID	118-01
Type	Cross
Shape	Circular
Material	CSP
Diameter or Dimensions (mm)	450
Marker Post Present	N
Barrel Length (m)	18.9
Approx. Barrel Slope (%)	1.5%
Approx. Depth of Cover (m)	290
End	Upstream
Crushing	Downstream
Infill Depth (mm)	Upstream
	Downstream
Other Comments	Cracking/slumping on road evident

Culvert Condition Ratings (MTO 2013)				
Barrel Material (0-4)	Shape (0-4)	Capacity (0-2)	Erosion and Scour (0-2)	US/DS Channel (0-2)
0	0	0	0	0

Recommended Action(s):	No Action	Priority:	Low
------------------------	-----------	-----------	-----

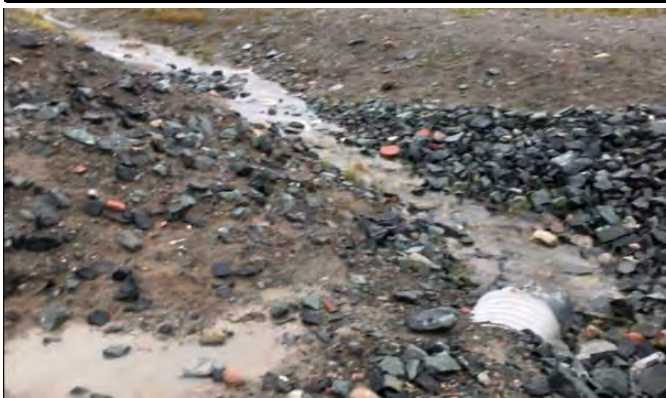
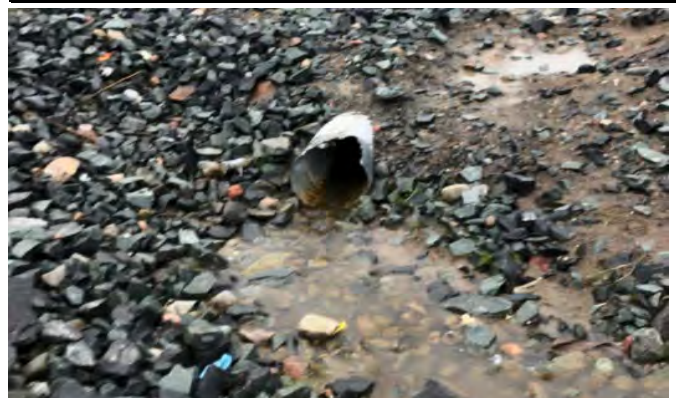
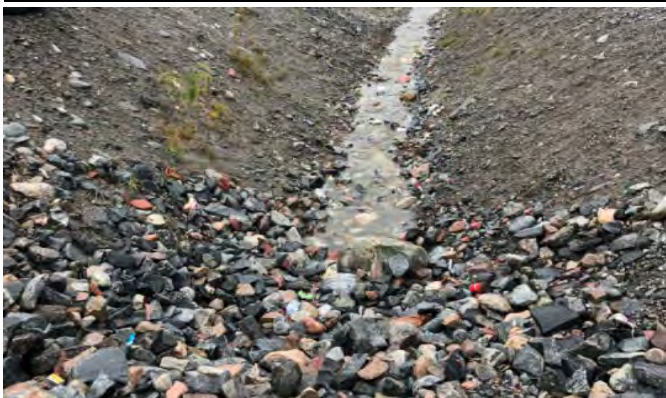
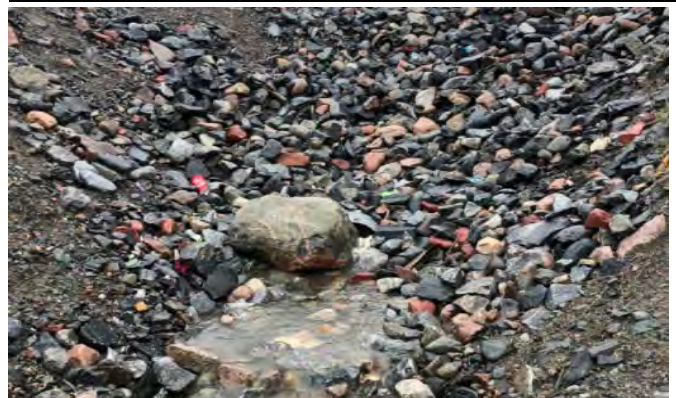
Culvert Information	
Culvert ID	118-02
Type	Entrance
Shape	Circular
Material	CSP
Diameter or Dimensions (mm)	500
Marker Post Present	N
Barrel Length (m)	30.0
Approx. Barrel Slope (%)	0.5%
Approx. Depth of Cover (m)	1605
End	Upstream
Crushing	Downstream
Infill Depth (mm)	Upstream
	Downstream
Other Comments	DS end blocked by rocks

Culvert Condition Ratings (MTO 2013)				
Barrel Material (0-4)	Shape (0-4)	Capacity (0-2)	Erosion and Scour (0-2)	US/DS Channel (0-2)
1	0	1	0	0

Recommended Action(s):	Clear blockage	Priority:	High
------------------------	----------------	-----------	------

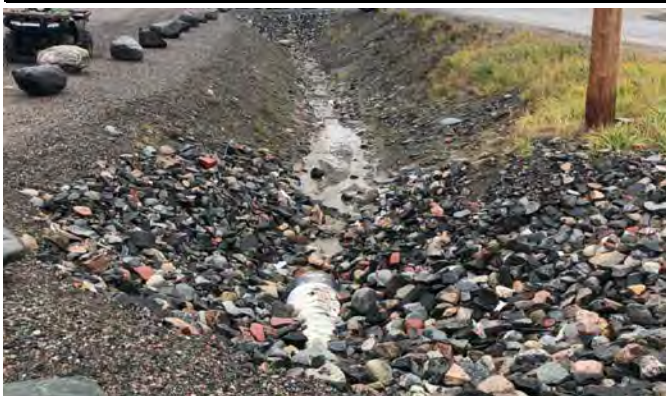
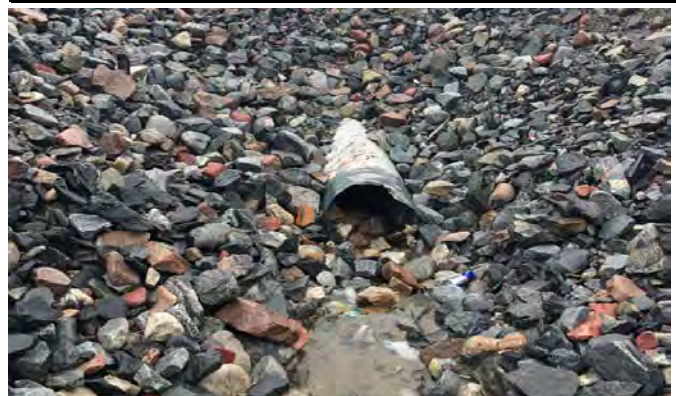
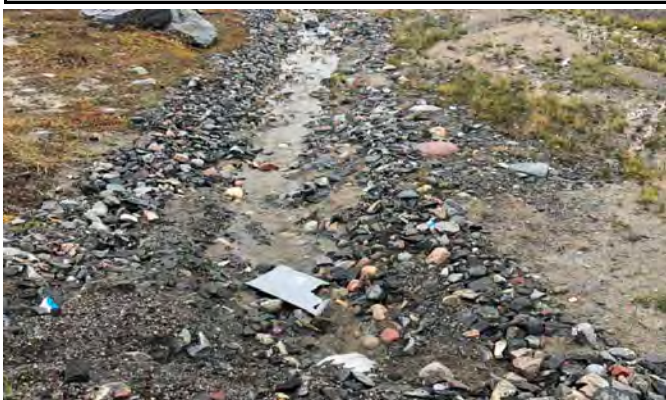
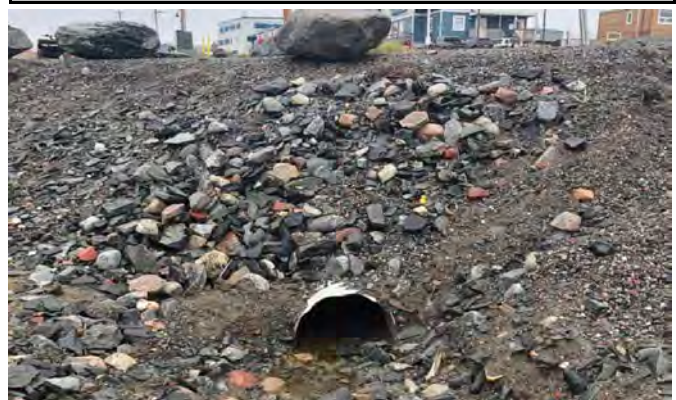
Culvert Information				
Culvert ID	118-04			
Type	Entrance			
Shape	Circular			
Material	CSP			
Diameter or Dimensions (mm)	500			
Marker Post Present	N			
Barrel Length (m)	21.1			
Approx. Barrel Slope (%)	2.4%			
Approx. Depth of Cover (m)	1425			
End	Upstream			
Crushing	Downstream			
Infill Depth (mm)	Upstream			
	Downstream			
Other Comments	Embankments material covering ends			
Culvert Elevations (masl) ²				
Upstream		Downstream		Road Crown
Invert	Obvert	Invert	Obvert	
8.53	8.97	8.03	8.4	10.11

Culvert Condition Ratings (MTO 2013)				
Barrel Material (0-4)	Shape (0-4)	Capacity (0-2)	Erosion and Scour (0-2)	US/DS Channel (0-2)
0	0	2	0	0

Recommended Action(s):	Clear blockage	Priority:	High
------------------------	----------------	-----------	------

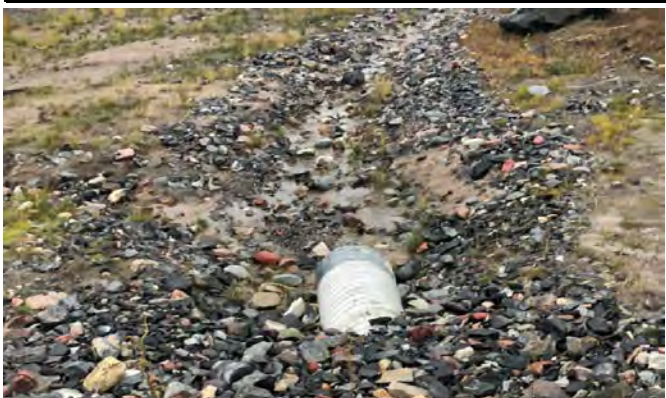
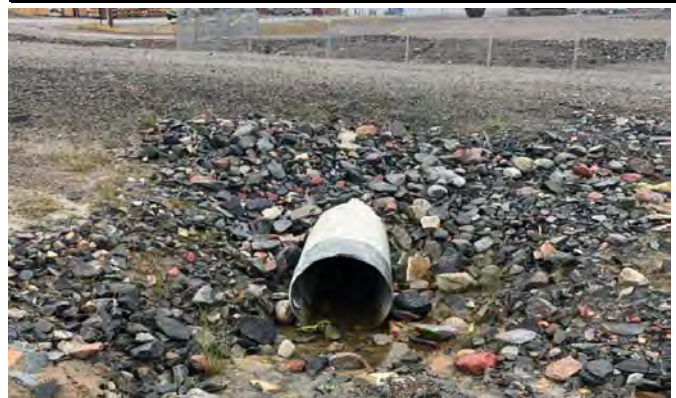
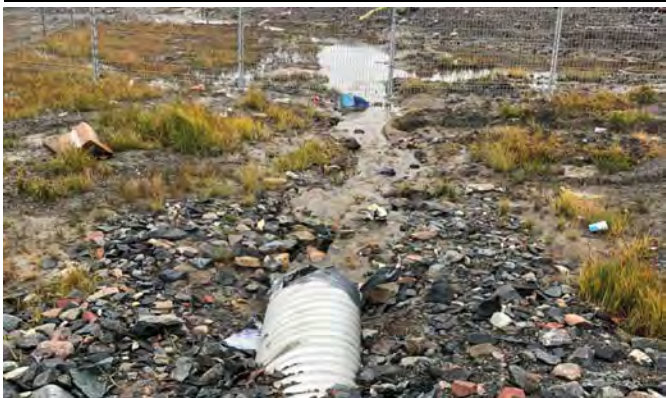
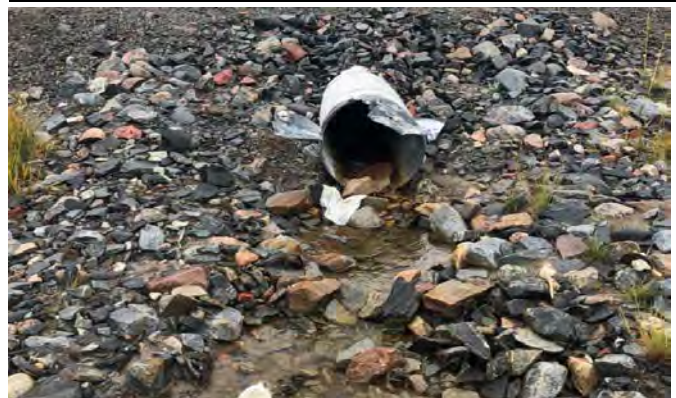
Culvert Information				
Culvert ID	118-05			
Type	Entrance			
Shape	Circular			
Material	CSP			
Diameter or Dimensions (mm)	500			
Marker Post Present	N			
Barrel Length (m)	12.0			
Approx. Barrel Slope (%)	1.2%			
Approx. Depth of Cover (m)	610			
End	Upstream			
Crushing	Downstream			
Infill Depth (mm)	Upstream			
	Downstream			
Other Comments	CSP. projecting both ends			
Culvert Elevations (masl) ²				
Upstream		Downstream		Road Crown
Invert	Obvert	Invert	Obvert	
6.94	7.42	6.8	7.3

Culvert Condition Ratings (MTO 2013)				
Barrel Material (0-4)	Shape (0-4)	Capacity (0-2)	Erosion and Scour (0-2)	US/DS Channel (0-2)
1	0	0	0	0

Recommended Action(s):	No Action	Priority:	Low
------------------------	-----------	-----------	-----

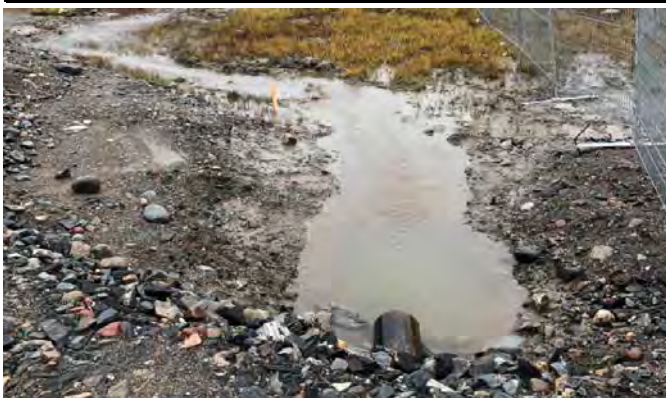
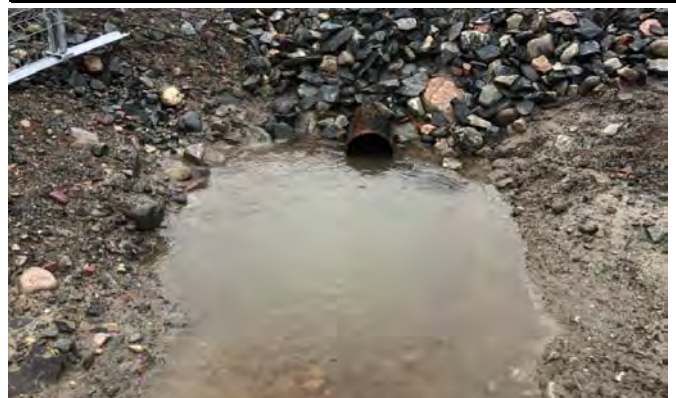
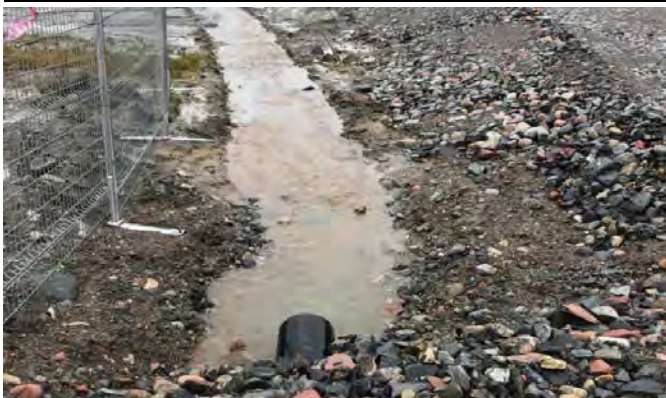
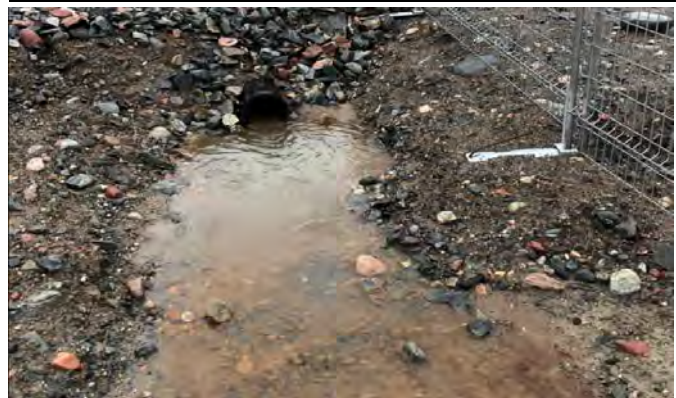
Culvert Information				
Culvert ID	118-06			
Type	Entrance			
Shape	Circular			
Material	PVC			
Diameter or Dimensions (mm)	200			
Marker Post Present	N			
Barrel Length (m)	9.3			
Approx. Barrel Slope (%)	0.3%			
Approx. Depth of Cover (m)	510			
End	Upstream			
Crushing	Downstream			
Infill Depth (mm)	Upstream			
	Downstream			
Other Comments	Scour US & DS, steel Culvert much smaller US than DS. PVC 230 mm DS			
Culvert Elevations (masl) ²				
Upstream		Downstream		Road Crown
Invert	Obvert	Invert	Obvert	
6.35	6.56	6.32	6.58

Culvert Condition Ratings (MTO 2013)				
Barrel Material (0-4)	Shape (0-4)	Capacity (0-2)	Erosion and Scour (0-2)	US/DS Channel (0-2)
0	0	0	0	1

Recommended Action(s):	No Action	Priority:	Low
------------------------	-----------	-----------	-----

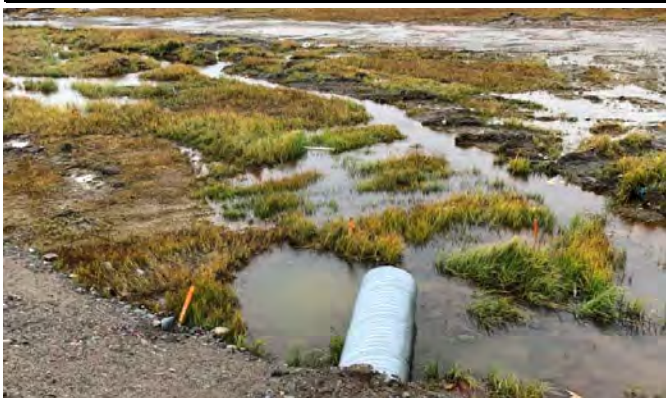
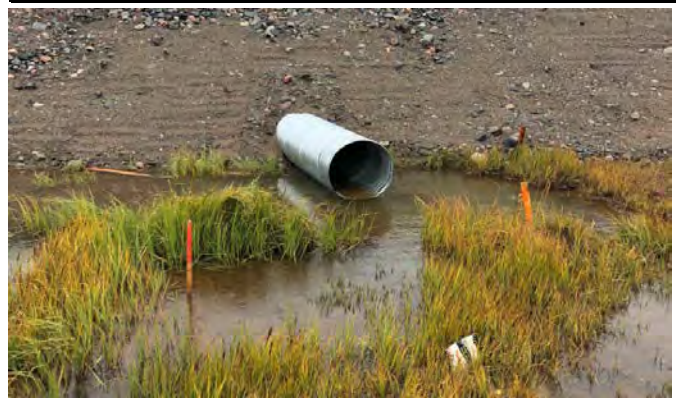
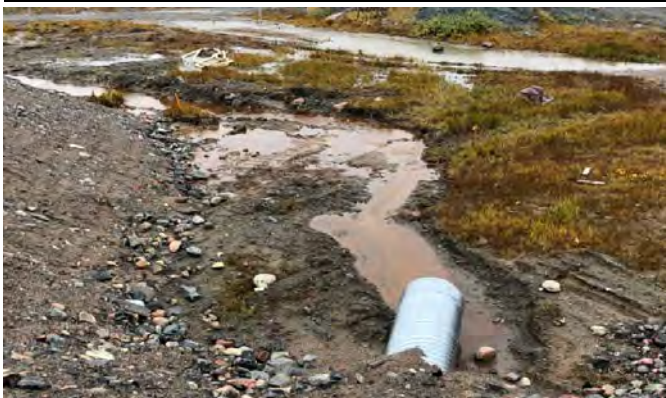
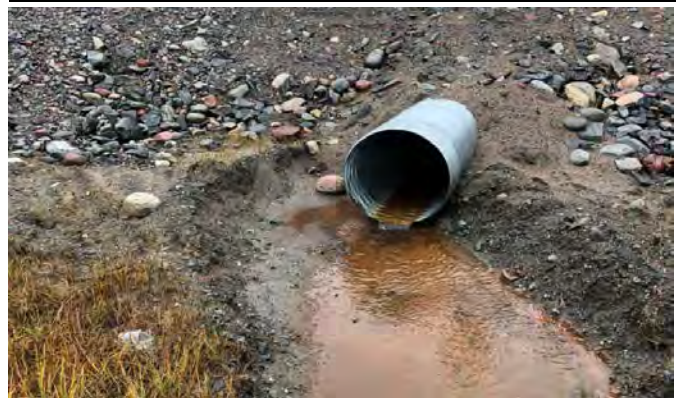
Culvert Information				
Culvert ID	118-07			
Type	Entrance			
Shape	Circular			
Material	CSP			
Diameter or Dimensions (mm)	600			
Marker Post Present	N			
Barrel Length (m)	18.1			
Approx. Barrel Slope (%)	0.1%			
Approx. Depth of Cover (m)	2210			
End	Upstream			
Crushing	Downstream			
Infill Depth (mm)	Upstream			
	Downstream			
Other Comments	Slight DS perch, some scouring at DS end. US end elevated but wet			
Culvert Elevations (masl) ²				
Upstream		Downstream		Road Crown
Invert	Obvert	Invert	Obvert	
5.88	6.49	5.86	6.47

Culvert Condition Ratings (MTO 2013)				
Barrel Material (0-4)	Shape (0-4)	Capacity (0-2)	Erosion and Scour (0-2)	US/DS Channel (0-2)
1	0	0	2	1

Recommended Action(s):	Investigate embankment scour/erosion	Priority:	High
------------------------	--------------------------------------	-----------	------

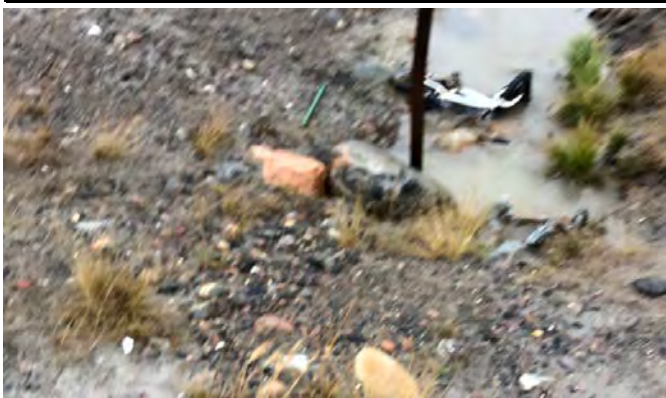
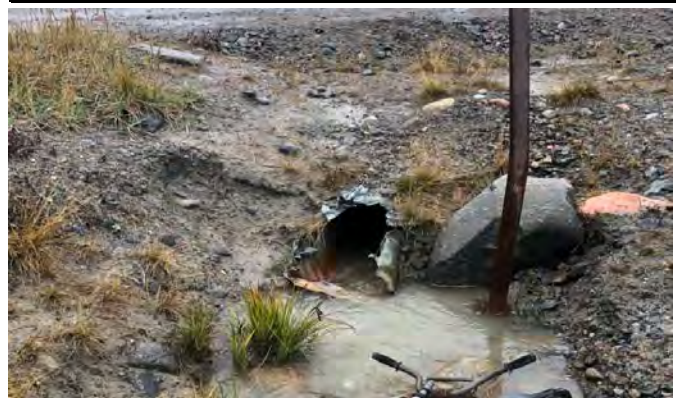
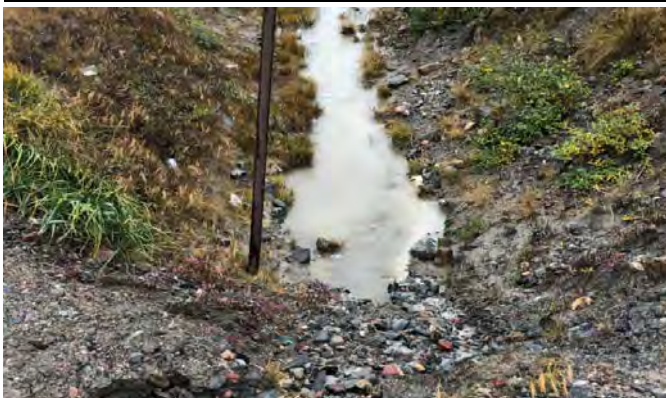
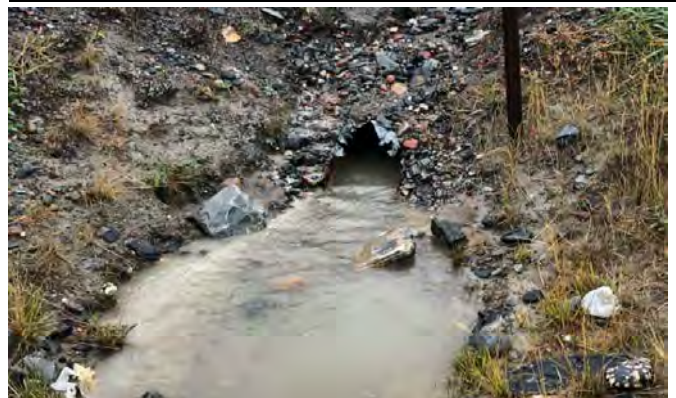
Culvert Information	
Culvert ID	118-08
Type	Entrance
Shape	Circular
Material	CSP
Diameter or Dimensions (mm)	450
Marker Post Present	N
Barrel Length (m)	23.2
Approx. Barrel Slope (%)	2.5%
Approx. Depth of Cover (m)	1430
End	Upstream
Crushing	Downstream
Infill Depth (mm)	Upstream
	Downstream
Other Comments	Debris in US. Rill erosion on embankment

Culvert Condition Ratings (MTO 2013)				
Barrel Material (0-4)	Shape (0-4)	Capacity (0-2)	Erosion and Scour (0-2)	US/DS Channel (0-2)
2	3	1	2	0

Recommended Action(s):	Rusting, clear blockage, Investigate embankment scour	Priority:	High
------------------------	-------------------------------------------------------	-----------	------
