**Geotechnical Evaluation and Drainage Planning
in Rankin Inlet, Nunavut**

Draft Report
REV-00

Prepared for:
The Municipality of Rankin Inlet

Prepared by:
Nunami Stantec Limited

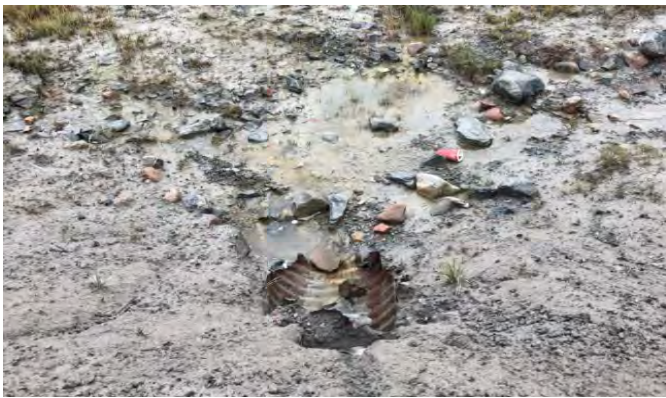
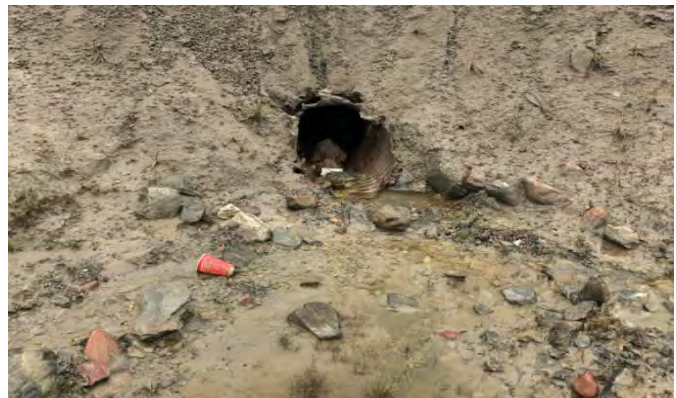
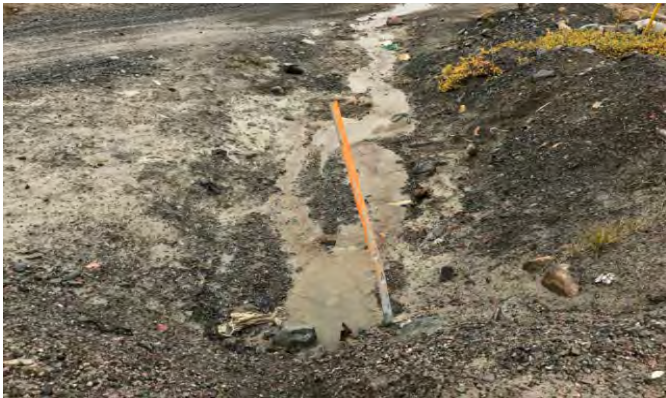
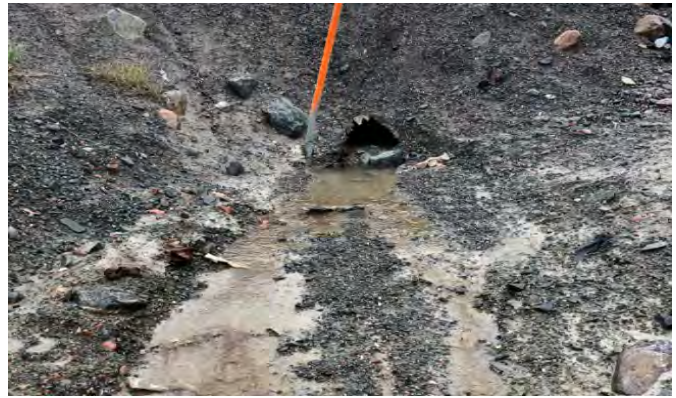
Culvert Information				
Culvert ID	118-09			
Type	Cross			
Shape	Circular			
Material	CSP			
Diameter or Dimensions (mm)	600			
Marker Post Present	N			
Barrel Length (m)	15.2			
Approx. Barrel Slope (%)	3.0%			
Approx. Depth of Cover (m)	1240			
End	Upstream			
Crushing	Downstream			
Infill Depth (mm)	Upstream			
	Downstream			
Other Comments	0			
Culvert Elevations (masl) ²				
Upstream		Downstream		Road Crown
Invert	Obvert	Invert	Obvert	
2.64	3.06	2.18	2.6	4.07

Culvert Condition Ratings (MTO 2013)				
Barrel Material (0-4)	Shape (0-4)	Capacity (0-2)	Erosion and Scour (0-2)	US/DS Channel (0-2)
2	2	2	1	1

Recommended Action(s):	Monitor Rusting, clean blockage and sediment	Priority:	High
------------------------	----------------------------------------------	-----------	------

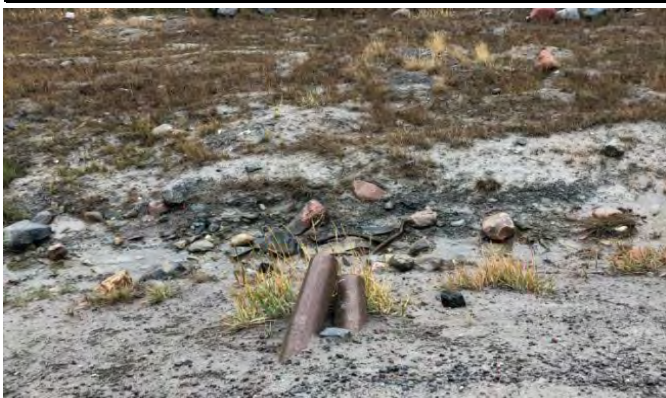
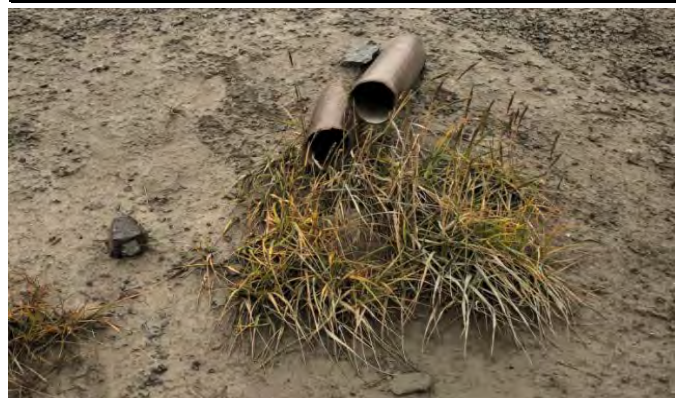
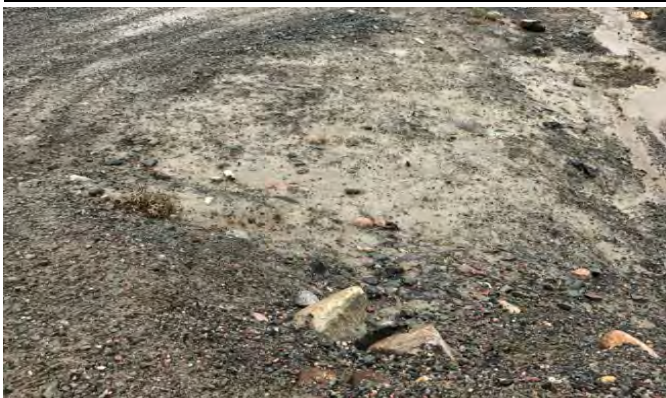
Culvert Information				
Culvert ID	118-10			
Type	Cross			
Shape	Circular			
Material	SWSP			
Diameter or Dimensions (mm)	120			
Marker Post Present	N			
Barrel Length (m)	13.4			
Approx. Barrel Slope (%)	1.6%			
Approx. Depth of Cover (m)	285			
End	Upstream			
Crushing	Downstream			
Infill Depth (mm)	Upstream			
	Downstream			
Other Comments	South of 46, north of 48			
Culvert Elevations (masl) ²				
Upstream		Downstream		Road Crown
Invert	Obvert	Invert	Obvert	
3.82	3.95	3.6	3.74	4.13

Culvert Condition Ratings (MTO 2013)				
Barrel Material (0-4)	Shape (0-4)	Capacity (0-2)	Erosion and Scour (0-2)	US/DS Channel (0-2)
1	0	0	1	0

Recommended Action(s):	No Action	Priority:	Low
------------------------	-----------	-----------	-----

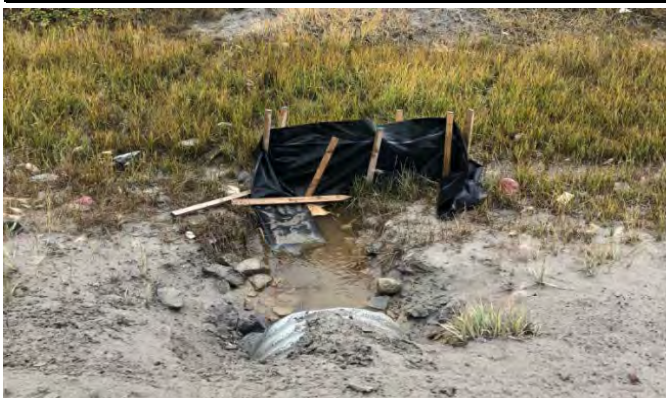
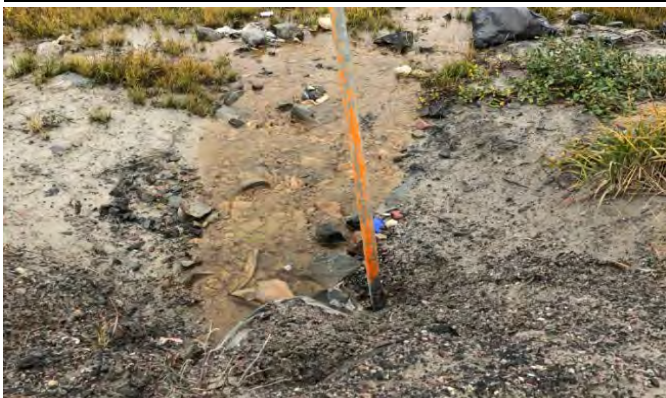
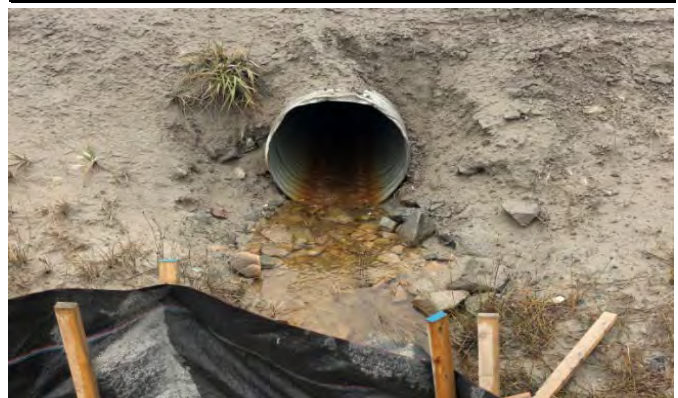
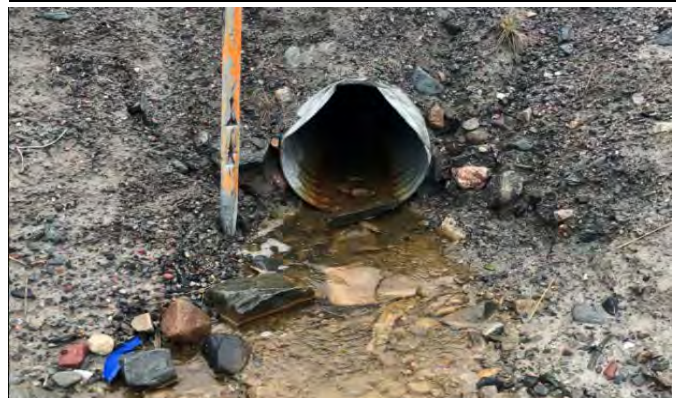
Culvert Information				
Culvert ID	119-01			
Type	Entrance			
Shape	Circular			
Material	CSP			
Diameter or Dimensions (mm)	600			
Marker Post Present	N			
Barrel Length (m)	5.7			
Approx. Barrel Slope (%)	1.4%			
Approx. Depth of Cover (m)	215			
End	Upstream	Y		
	Downstream	N		
Infill Depth (mm)	Upstream	.		
	Downstream	0		
Other Comments	0			
Culvert Elevations (masl) ²				
Upstream		Downstream		Road Crown
Invert	Obvert	Invert	Obvert	
6.64	7.19	6.56	6.94

Culvert Condition Ratings (MTO 2013)				
Barrel Material (0-4)	Shape (0-4)	Capacity (0-2)	Erosion and Scour (0-2)	US/DS Channel (0-2)
1	0	0	0	0

Recommended Action(s):	No Action	Priority:	Low
------------------------	-----------	-----------	-----

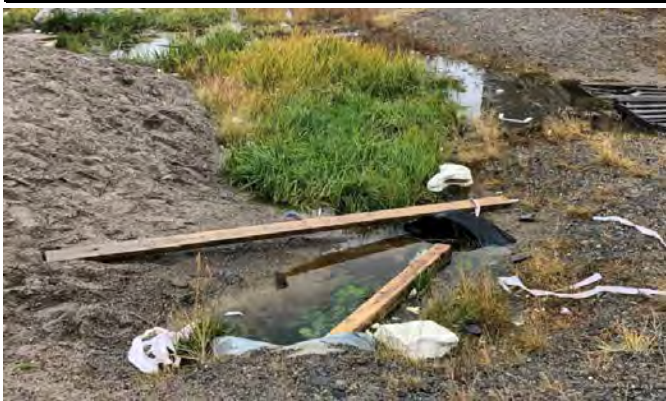
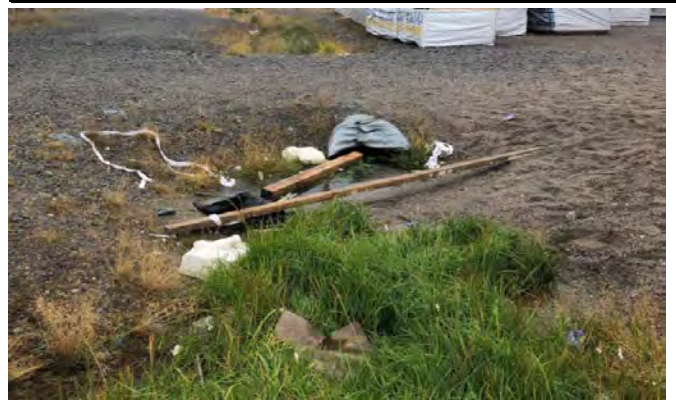
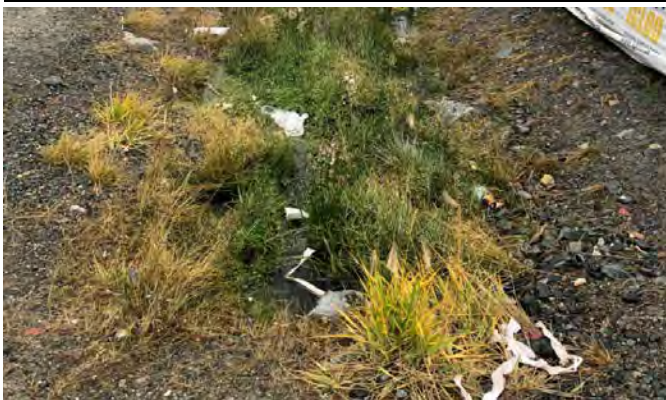
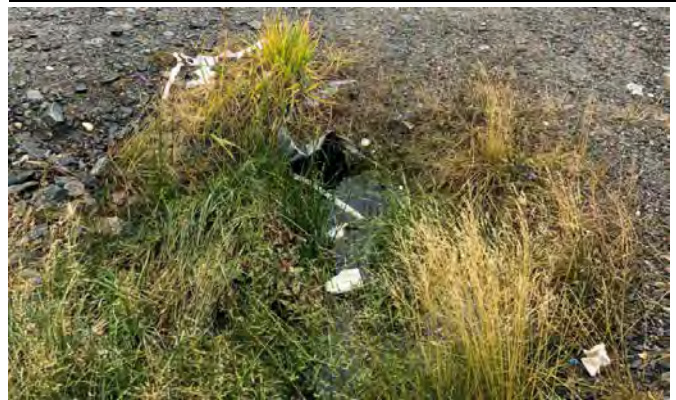
Culvert Information	
Culvert ID	119-02
Type	Cross
Shape	Circular
Material	SWSP
Diameter or Dimensions (mm)	150
Marker Post Present	N
Barrel Length (m)	-
Approx. Barrel Slope (%)	N/A
Approx. Depth of Cover (m)	410
End	Upstream
Crushing	Downstream
Infill Depth (mm)	Upstream
	Downstream
Other Comments	No US end

Culvert Condition Ratings (MTO 2013)				
Barrel Material (0-4)	Shape (0-4)	Capacity (0-2)	Erosion and Scour (0-2)	US/DS Channel (0-2)
1	0	0	0	0

Recommended Action(s):	No Action	Priority:	Low
------------------------	-----------	-----------	-----

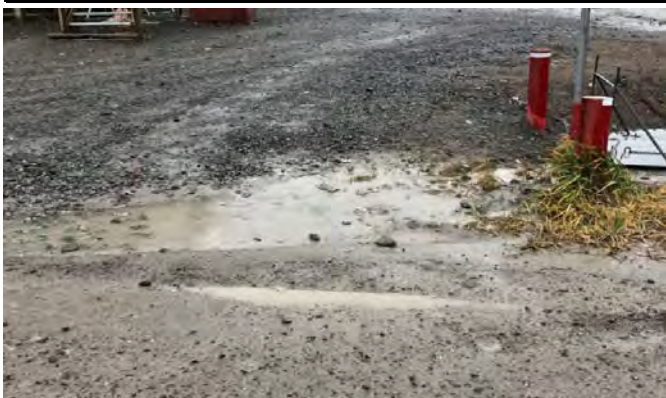
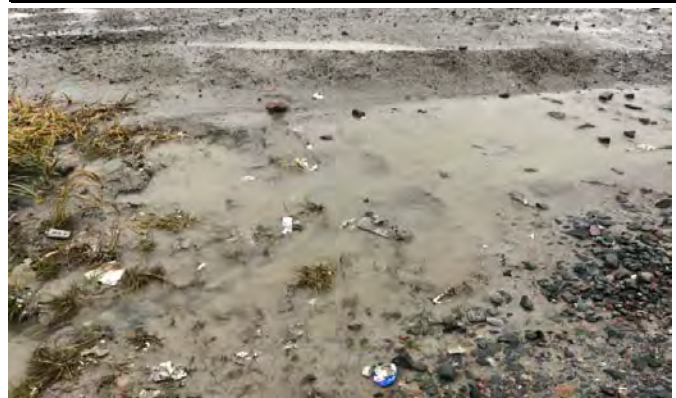
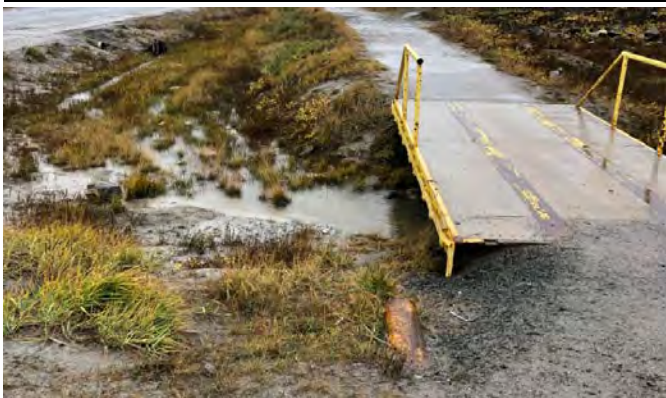
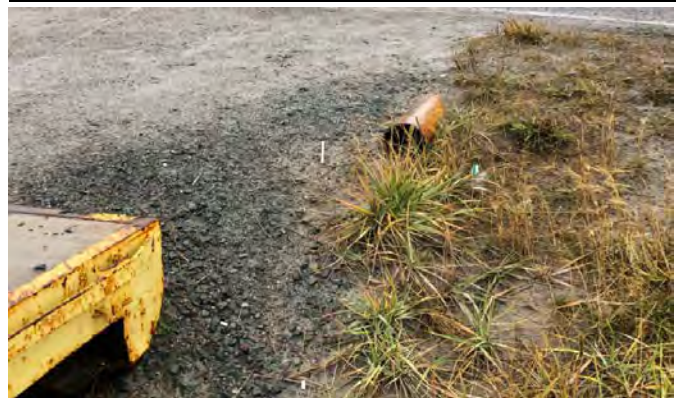
Culvert Information	
Culvert ID	119-03
Type	Cross
Shape	Circular
Material	CSP
Diameter or Dimensions (mm)	400
Marker Post Present	N
Barrel Length (m)	12.0
Approx. Barrel Slope (%)	3.2%
Approx. Depth of Cover (m)	680
End	Upstream
Crushing	Downstream
Infill Depth (mm)	Upstream
	Downstream
Other Comments	Flow under culvert. Culvert perched

Culvert Condition Ratings (MTO 2013)				
Barrel Material (0-4)	Shape (0-4)	Capacity (0-2)	Erosion and Scour (0-2)	US/DS Channel (0-2)
0	0	0	1	2

Recommended Action(s):	Remediate channel erosion	Priority:	High
------------------------	---------------------------	-----------	------

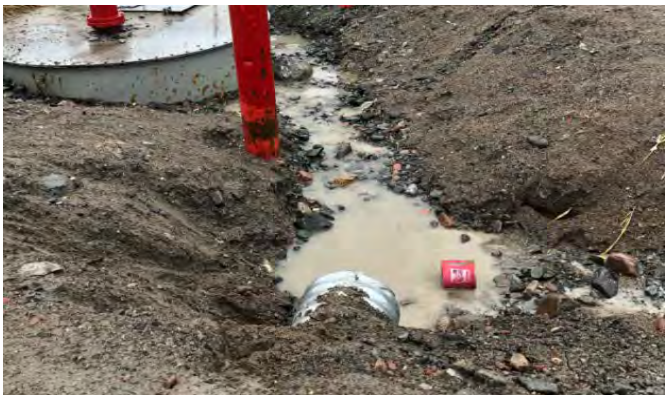
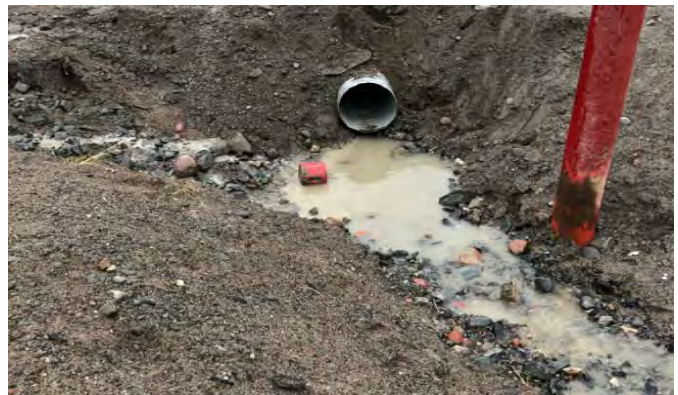
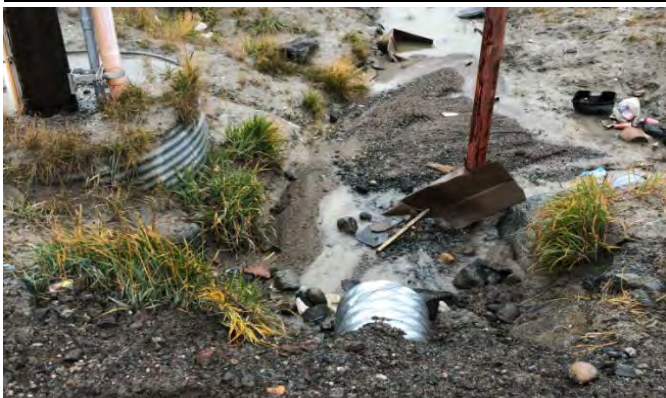
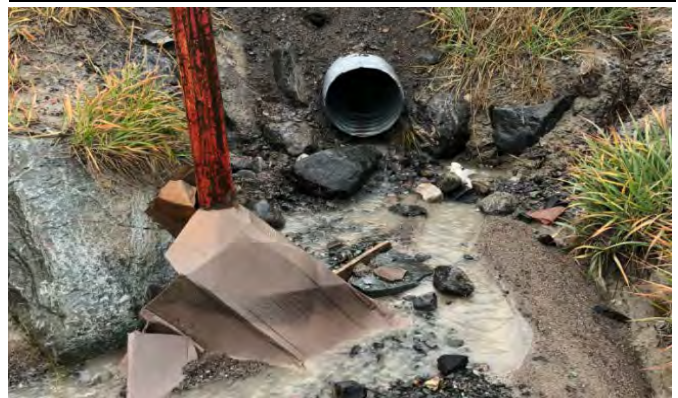
Culvert Information				
Culvert ID	120-01			
Type	Cross			
Shape	Circular			
Material	CSP			
Diameter or Dimensions (mm)	600			
Marker Post Present	N			
Barrel Length (m)	13.8			
Approx. Barrel Slope (%)	-0.1%			
Approx. Depth of Cover (m)	400			
End	Upstream			
Crushing	Downstream			
Infill Depth (mm)	Upstream			
	Downstream			
Other Comments	Buried. Sedimentation			
Culvert Elevations (masl) ²				
Upstream		Downstream		Road Crown
Invert	Obvert	Invert	Obvert	
6.79	7.01	6.8	7.05

Culvert Condition Ratings (MTO 2013)				
Barrel Material (0-4)	Shape (0-4)	Capacity (0-2)	Erosion and Scour (0-2)	US/DS Channel (0-2)
2	0	2	0	0

Recommended Action(s):	Monitor Rusting, clear blockage	Priority:	High
------------------------	---------------------------------	-----------	------

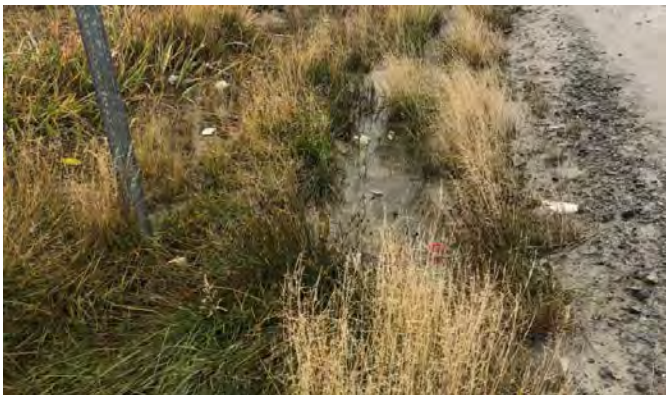
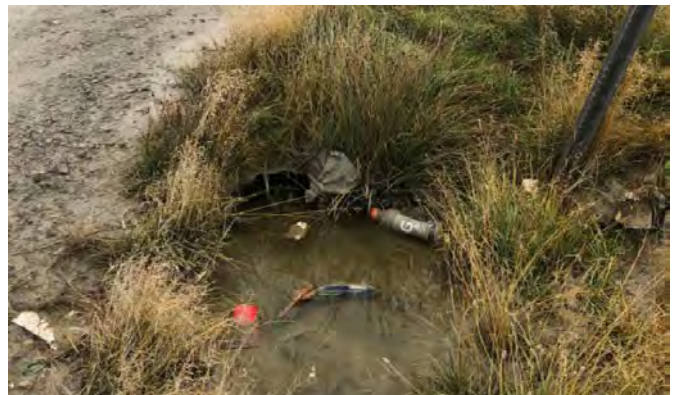
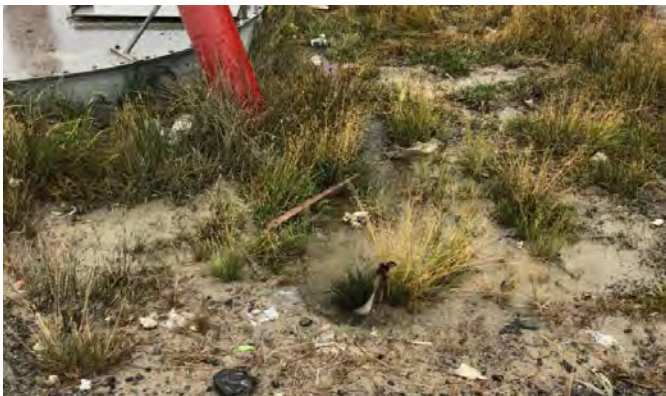
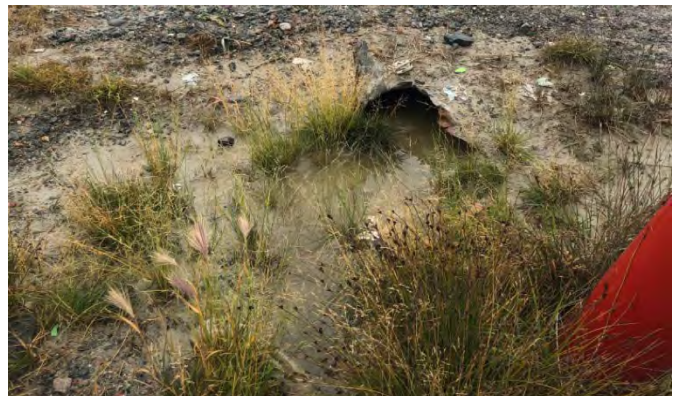
Culvert Information				
Culvert ID	120-02			
Type	Cross			
Shape	Circular			
Material	CSP			
Diameter or Dimensions (mm)	600			
Marker Post Present	N			
Barrel Length (m)	11.3			
Approx. Barrel Slope (%)	0.6%			
Approx. Depth of Cover (m)	540			
End	Upstream			
Crushing	Downstream			
Infill Depth (mm)	Upstream			
	Downstream			
Other Comments	Sunken/buried. Sedimentation			
Culvert Elevations (masl) ²				
Upstream		Downstream		Road Crown
Invert	Obvert	Invert	Obvert	
6.38	6.84	6.31	6.66	7.29

Culvert Condition Ratings (MTO 2013)				
Barrel Material (0-4)	Shape (0-4)	Capacity (0-2)	Erosion and Scour (0-2)	US/DS Channel (0-2)
1	3	1	0	0

Recommended Action(s):	Clear blockage, repair culvert end	Priority:	High
------------------------	------------------------------------	-----------	------

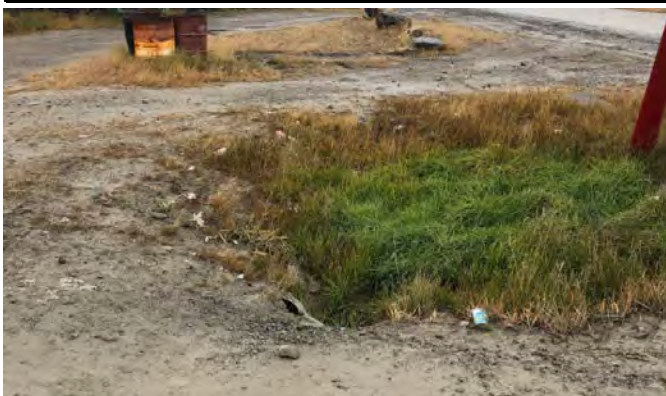
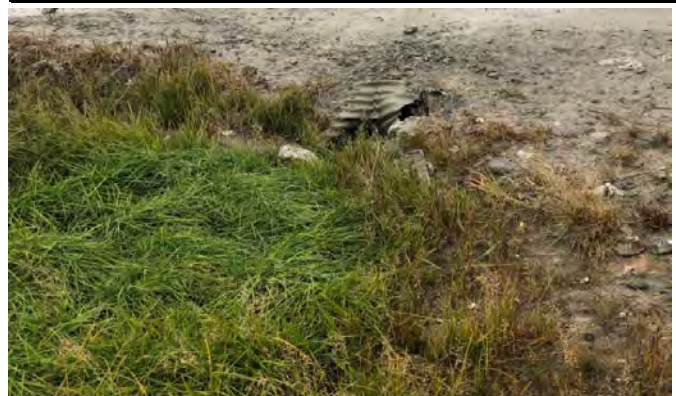
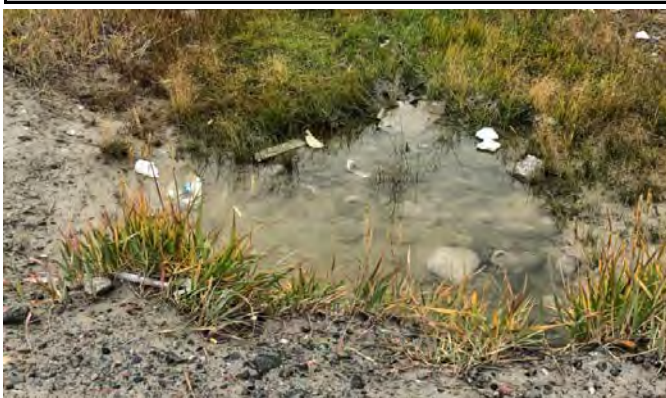
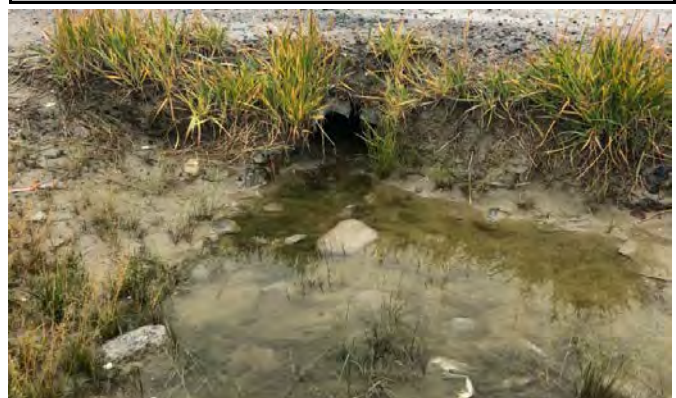
Culvert Information				
Culvert ID	121-01			
Type	Cross			
Shape	Circular			
Material	CSP			
Diameter or Dimensions (mm)	400			
Marker Post Present	N			
Barrel Length (m)	16.9			
Approx. Barrel Slope (%)	-2.7%			
Approx. Depth of Cover (m)	470			
End	Upstream			
Crushing	Downstream			
Infill Depth (mm)	Upstream			
	Downstream			
Other Comments	DS filled with debris			
Culvert Elevations (masl) ²				
Upstream		Downstream		Road Crown
Invert	Obvert	Invert	Obvert	
5.24	6.12	5.7	6.06	6.56

Culvert Condition Ratings (MTO 2013)				
Barrel Material (0-4)	Shape (0-4)	Capacity (0-2)	Erosion and Scour (0-2)	US/DS Channel (0-2)
1	3	1	0	0

Recommended Action(s):	Clear blockage, repair culvert end	Priority:	High
------------------------	------------------------------------	-----------	------

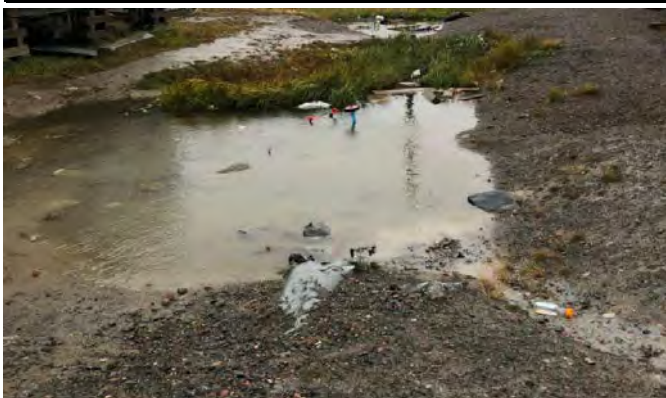
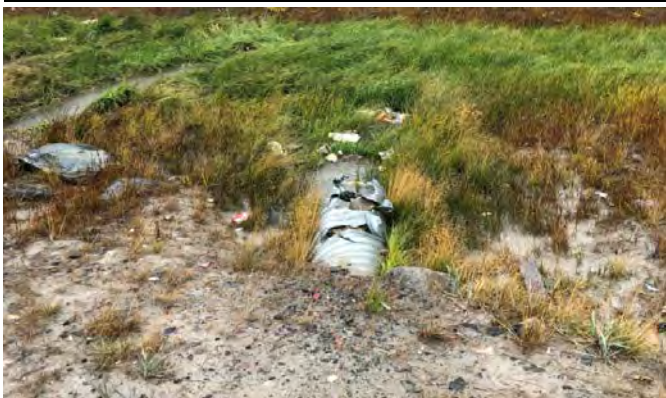
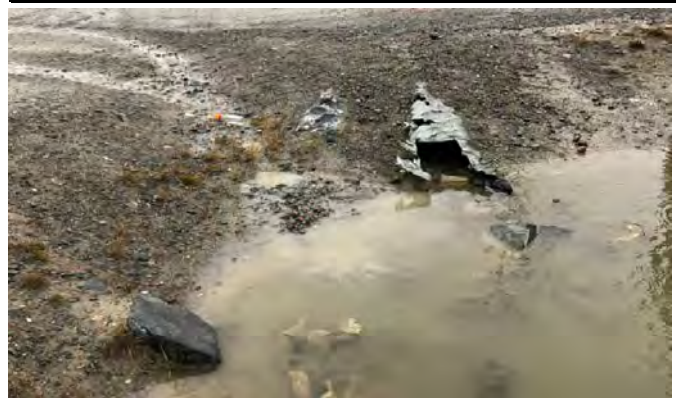
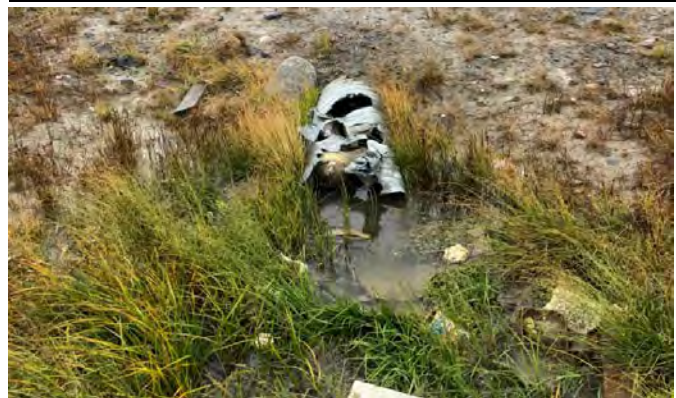
Culvert Information	
Culvert ID	122-01
Type	Entrance
Shape	Circular
Material	CSP
Diameter or Dimensions (mm)	500
Marker Post Present	N
Barrel Length (m)	12.3
Approx. Barrel Slope (%)	-0.5%
Approx. Depth of Cover (m)	710
End	Upstream
Crushing	Downstream
Infill Depth (mm)	Upstream
	Downstream
Other Comments	Drainage from under house

Culvert Condition Ratings (MTO 2013)				
Barrel Material (0-4)	Shape (0-4)	Capacity (0-2)	Erosion and Scour (0-2)	US/DS Channel (0-2)
1	3	2	1	1

Recommended Action(s):	Clear blockage, repair culvert end	Priority:	High
------------------------	------------------------------------	-----------	------

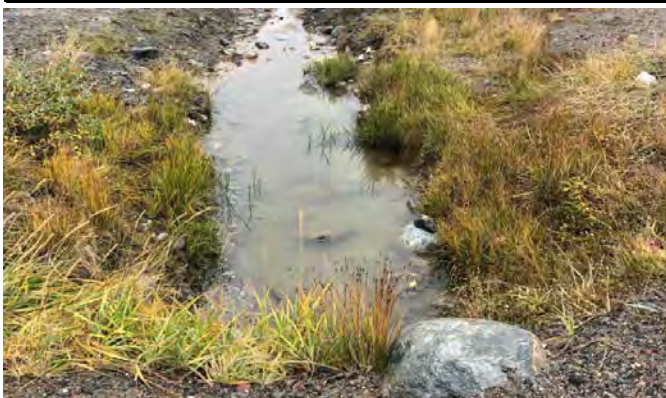
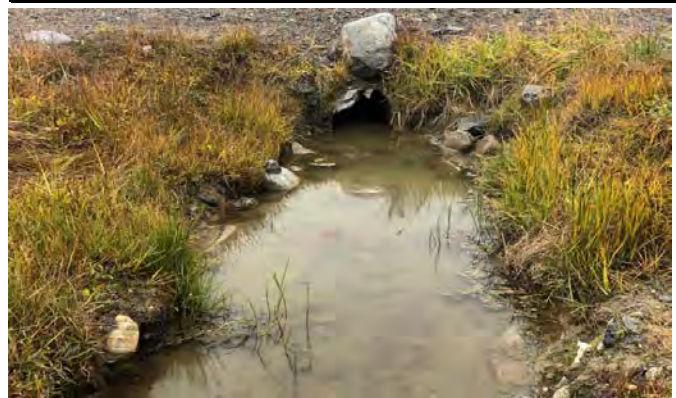
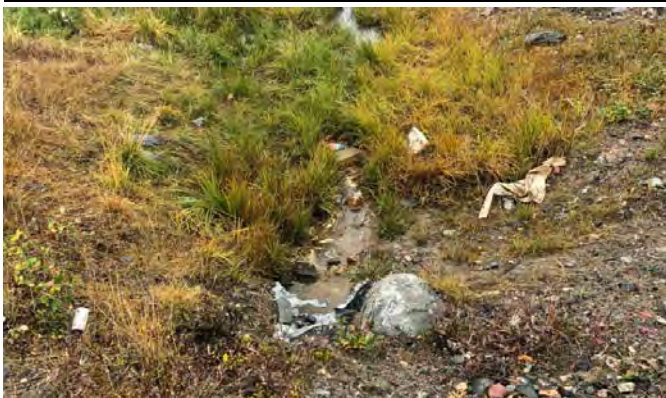
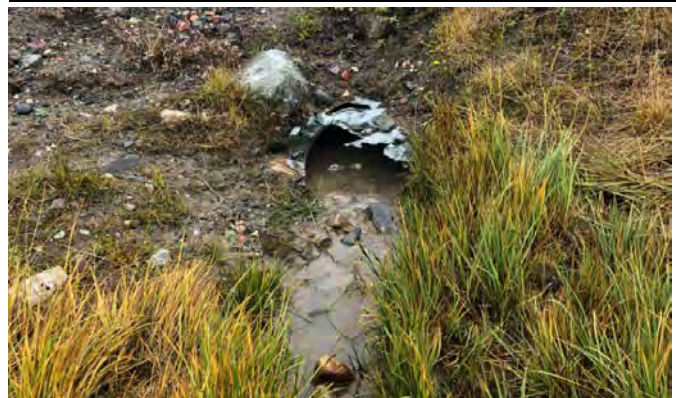
Culvert Information		
Culvert ID	122-02	
Type	Entrance	
Shape	Circular	
Material	CSP	
Diameter or Dimensions (mm)	500	
Marker Post Present	N	
Barrel Length (m)	11.3	
Approx. Barrel Slope (%)	1.6%	
Approx. Depth of Cover (m)	680	
End	Upstream	Y
Crushing	Downstream	Y
Infill Depth (mm)	Upstream	50
	Downstream	50
Other Comments	0

Culvert Condition Ratings (MTO 2013)				
Barrel Material (0-4)	Shape (0-4)	Capacity (0-2)	Erosion and Scour (0-2)	US/DS Channel (0-2)
1	3	1	0	1

Recommended Action(s):	Clear blockage, repair culvert end	Priority:	High
------------------------	------------------------------------	-----------	------

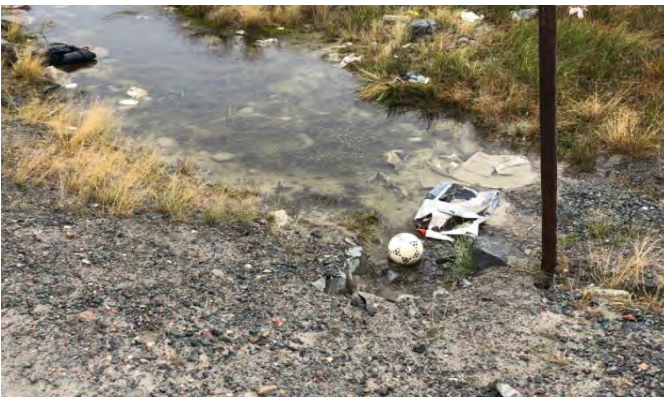
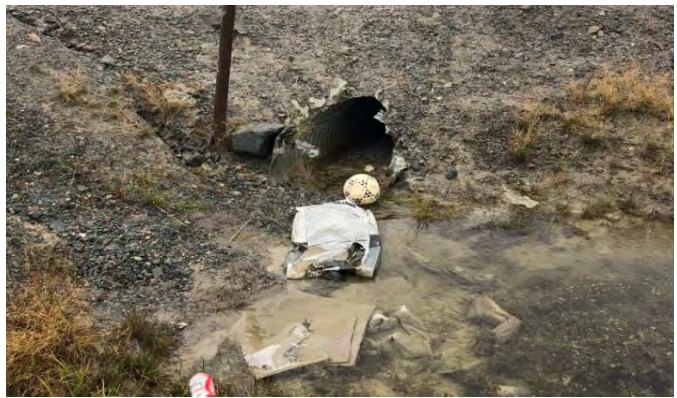
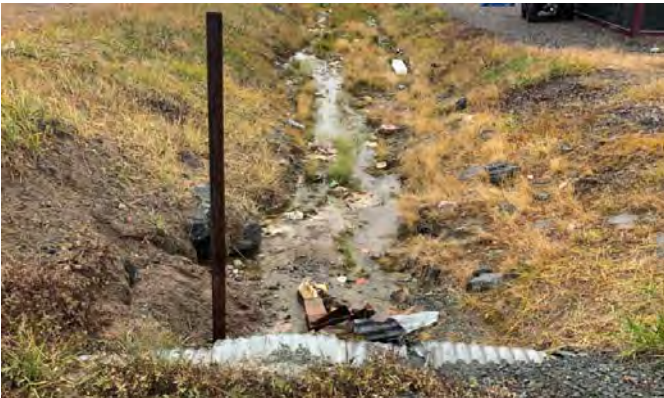
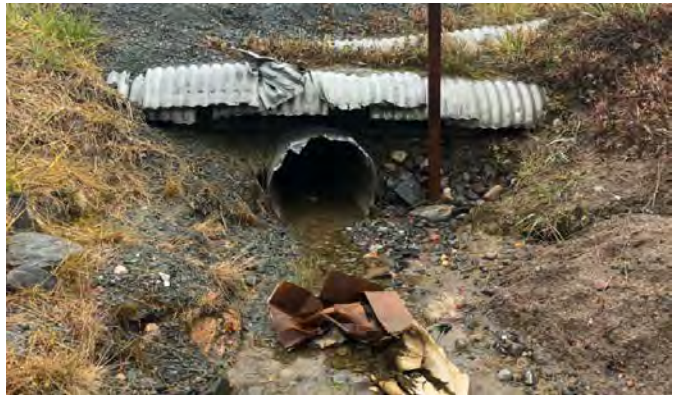
Culvert Information				
Culvert ID	122-03			
Type	Cross			
Shape	Circular			
Material	CSP			
Diameter or Dimensions (mm)	600			
Marker Post Present	N			
Barrel Length (m)	17.4			
Approx. Barrel Slope (%)	2.9%			
Approx. Depth of Cover (m)	1045			
End	Upstream	Y		
Crushing	Downstream	Y		
Infill Depth (mm)	Upstream	50		
	Downstream	150		
Other Comments	DS end has culvert used for embankment stability. Standing water & sediment at US end. Problem			
Culvert Elevations (masl) ²				
Upstream		Downstream	Road Crown	
Invert	Obvert	Invert		Obvert
3.57	4.04	3.06		3.63
4.88

Culvert Condition Ratings (MTO 2013)				
Barrel Material (0-4)	Shape (0-4)	Capacity (0-2)	Erosion and Scour (0-2)	US/DS Channel (0-2)
1	1	1	0	1

Recommended Action(s):	Clear blockage	Priority:	High
------------------------	----------------	-----------	------

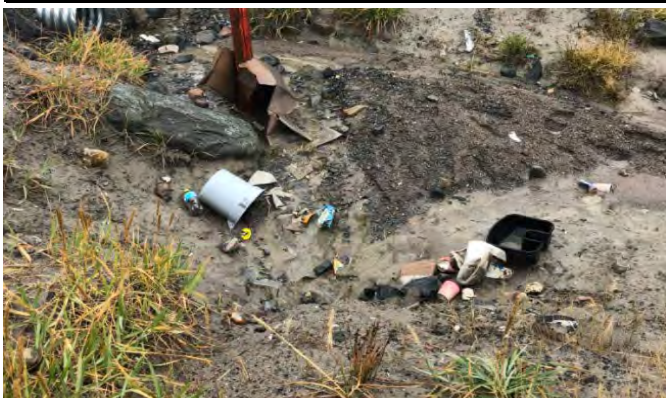
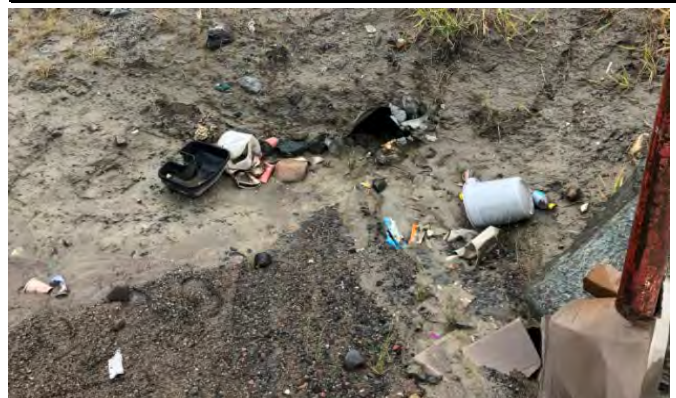
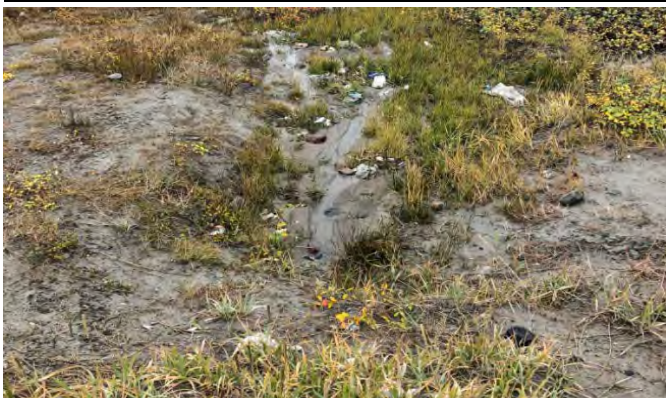
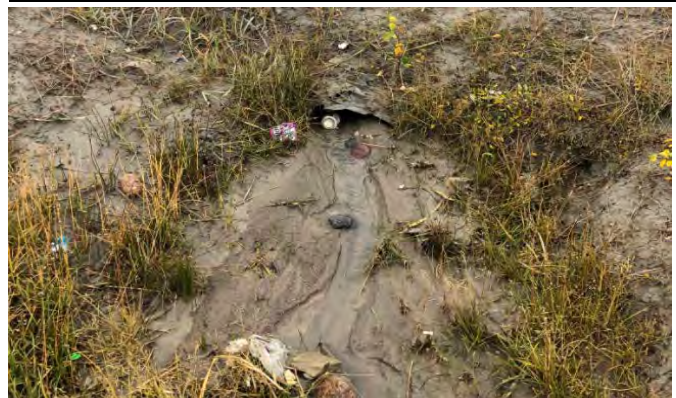
Culvert Information				
Culvert ID	124-01			
Type	Cross			
Shape	Circular			
Material	CSP			
Diameter or Dimensions (mm)	400			
Marker Post Present	N			
Barrel Length (m)	14.1			
Approx. Barrel Slope (%)	3.1%			
Approx. Depth of Cover (m)	-			
End	Upstream			
Crushing	Downstream			
Infill Depth (mm)	Upstream			
	Downstream			
Other Comments	Sedimentation in DS end			
Culvert Elevations (masl) ²				
Upstream		Downstream		Road Crown
Invert	Obvert	Invert	Obvert	
4.64	4.94	4.21	4.4

Culvert Condition Ratings (MTO 2013)				
Barrel Material (0-4)	Shape (0-4)	Capacity (0-2)	Erosion and Scour (0-2)	US/DS Channel (0-2)
1	2	2	0	1

Recommended Action(s):	Clear blockage, repair culvert end	Priority:	High
------------------------	------------------------------------	-----------	------

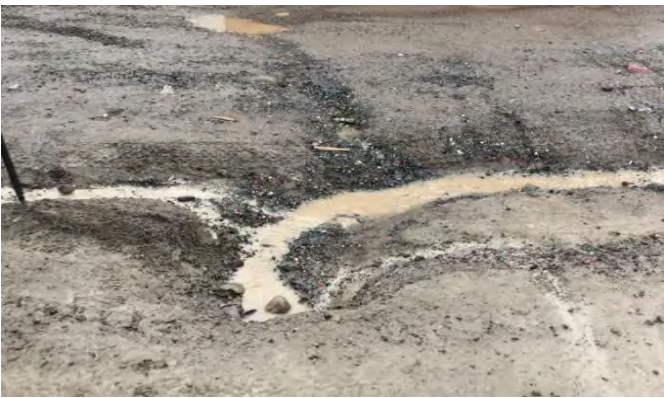
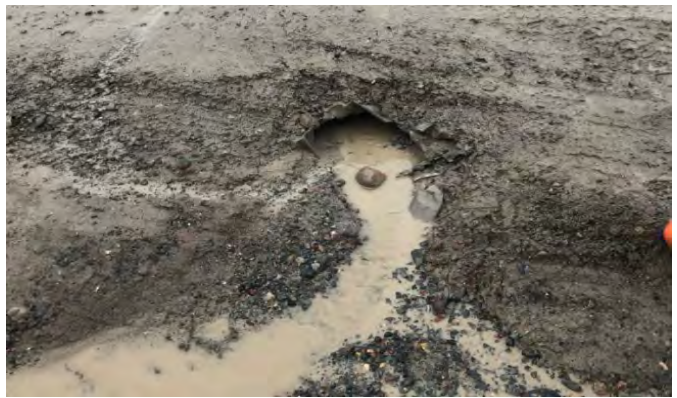
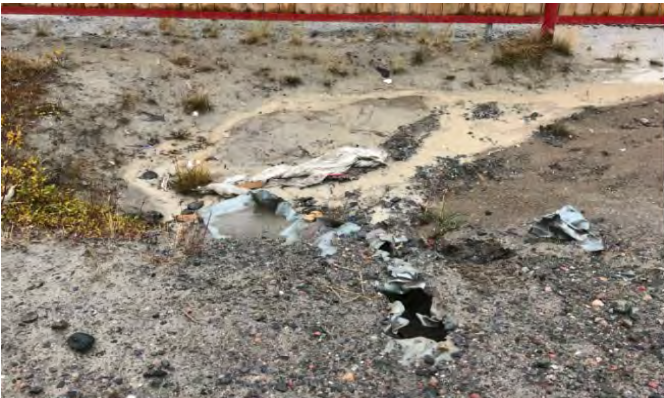
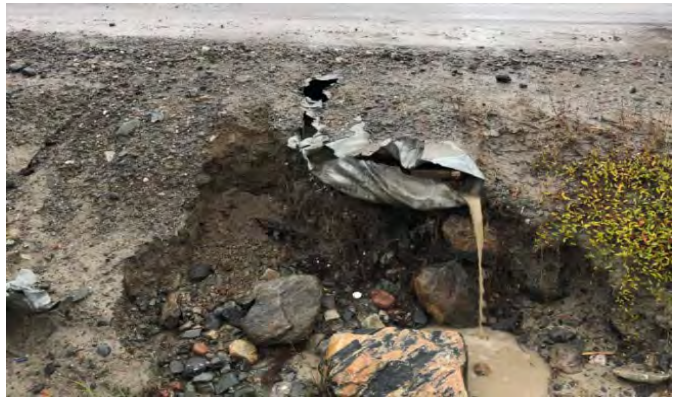
Culvert Information				
Culvert ID	129-01			
Type	Cross			
Shape	Circular			
Material	CSP			
Diameter or Dimensions (mm)	600			
Marker Post Present	N			
Barrel Length (m)	11.2			
Approx. Barrel Slope (%)	1.1%			
Approx. Depth of Cover (m)	335			
End	Upstream	Y		
	Downstream	Y		
Infill Depth (mm)	Upstream	300		
	Downstream	0		
Other Comments	Major scouring, perched DS end			
Culvert Elevations (masl) ²				
Upstream		Downstream	Road Crown	
Invert	Obvert	Invert		Obvert
28.92	29.13	28.8		29
			29.4

Culvert Condition Ratings (MTO 2013)				
Barrel Material (0-4)	Shape (0-4)	Capacity (0-2)	Erosion and Scour (0-2)	US/DS Channel (0-2)
0	4	2	2	2

Recommended Action(s):	Investigate embankment scour/erosion, Remediate	Priority:	High
------------------------	-------------------------------------------------	-----------	------

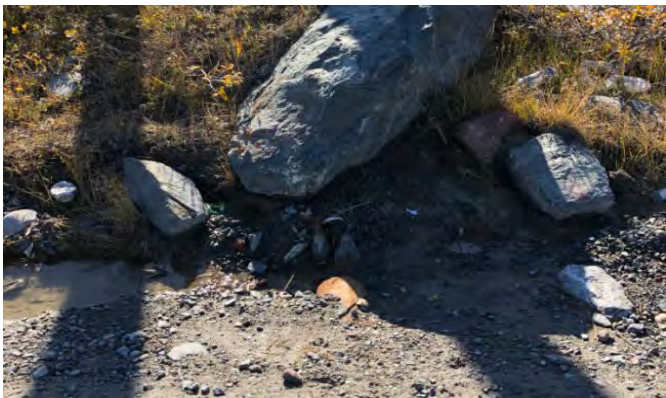
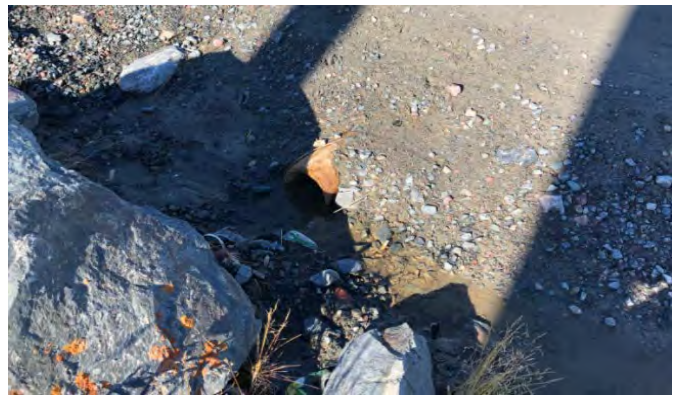
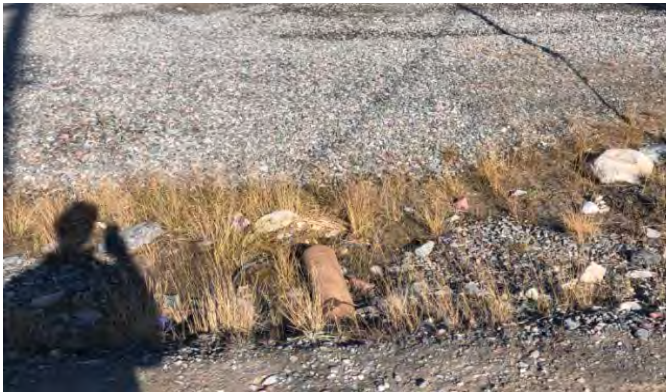
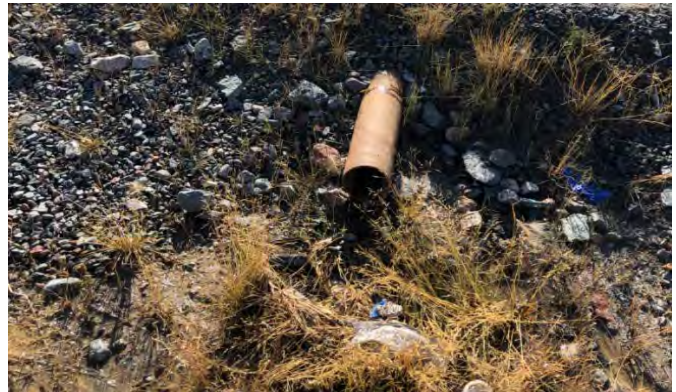
Culvert Information	
Culvert ID	130-01
Type	Cross
Shape	Circular
Material	SWSP
Diameter or Dimensions (mm)	150
Marker Post Present	N
Barrel Length (m)	7.3
Approx. Barrel Slope (%)	0.7%
Approx. Depth of Cover (m)	185
End	Upstream
Crushing	Downstream
Infill Depth (mm)	Upstream
	Downstream
Other Comments	DS perched 0.15 m

Culvert Condition Ratings (MTO 2013)				
Barrel Material (0-4)	Shape (0-4)	Capacity (0-2)	Erosion and Scour (0-2)	US/DS Channel (0-2)
2	0	0	1	0

Recommended Action(s):	Monitor Rusting	Priority:	Low
------------------------	-----------------	-----------	-----

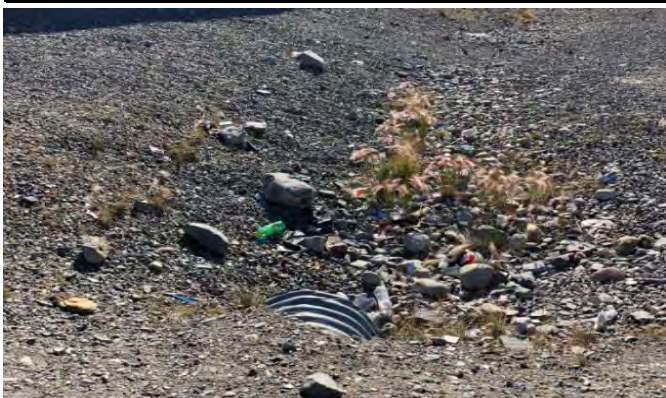
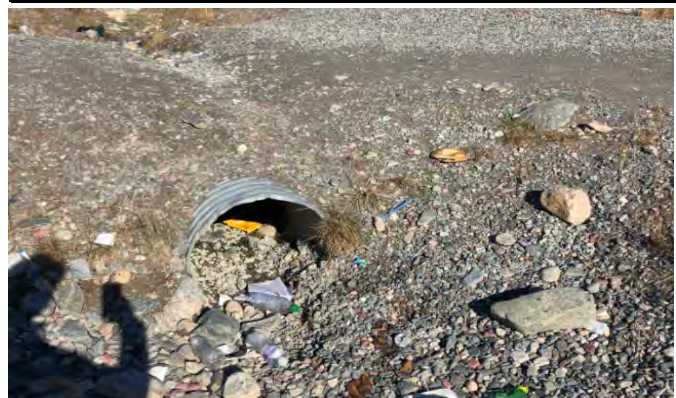
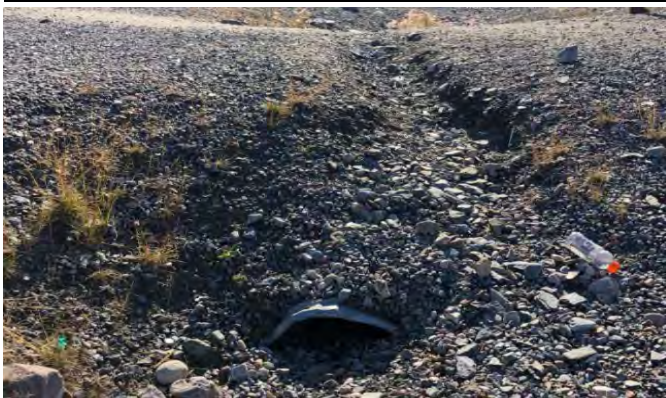
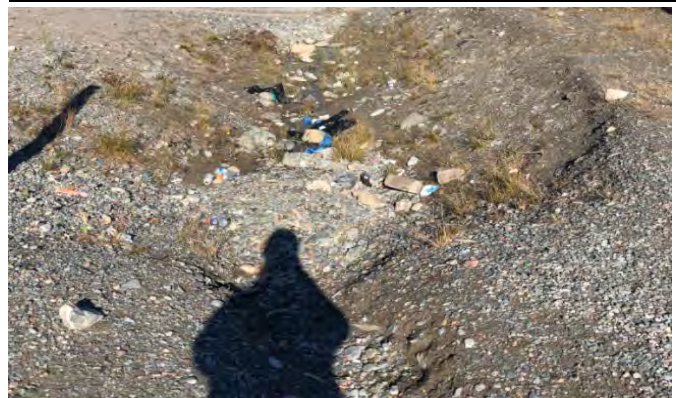
Culvert Information	
Culvert ID	130-02
Type	Cross
Shape	Circular
Material	CSP
Diameter or Dimensions (mm)	600
Marker Post Present	N
Barrel Length (m)	6.1
Approx. Barrel Slope (%)	3.0%
Approx. Depth of Cover (m)	395
End	Upstream
Crushing	Downstream
Infill Depth (mm)	Upstream
	Downstream
Other Comments	Rill erosion on road crest & DS embankment

Culvert Condition Ratings (MTO 2013)				
Barrel Material (0-4)	Shape (0-4)	Capacity (0-2)	Erosion and Scour (0-2)	US/DS Channel (0-2)
1	0	2	1	0

Recommended Action(s):	Clear blockage	Priority:	High
------------------------	----------------	-----------	------

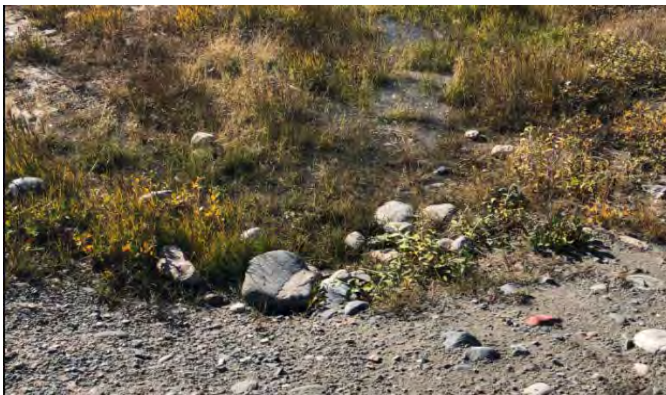
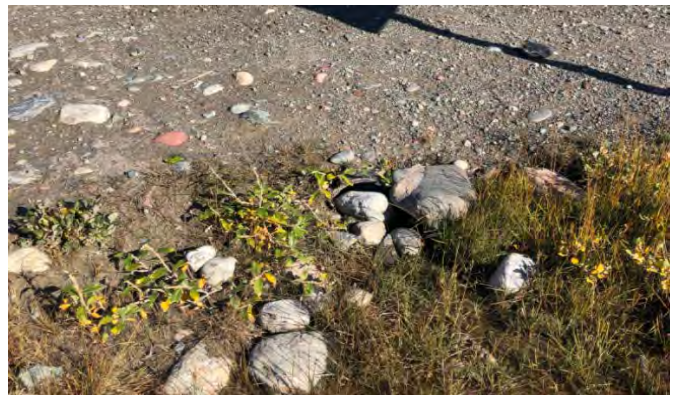
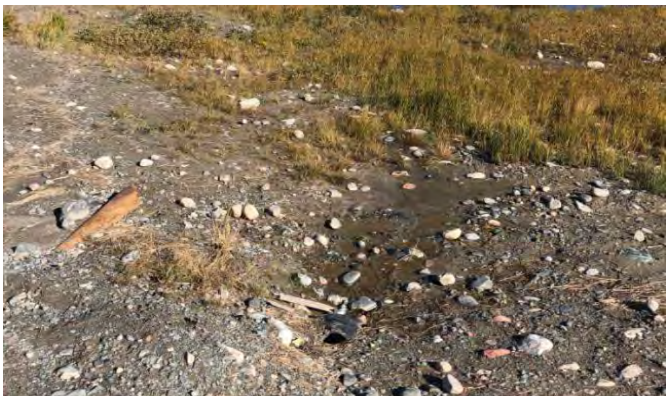
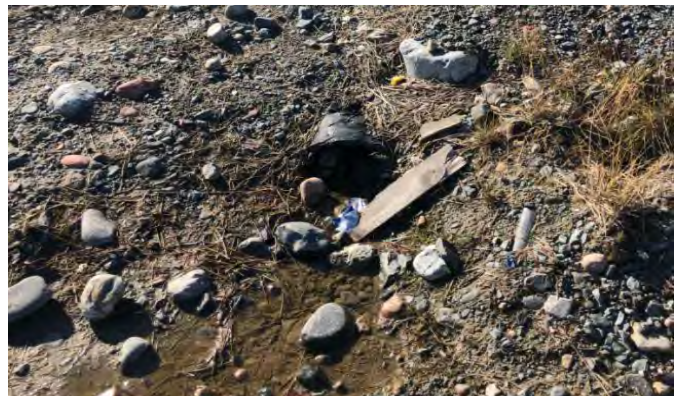
Culvert Information	
Culvert ID	130-03
Type	Cross
Shape	Circular
Material	PVC
Diameter or Dimensions (mm)	240
Marker Post Present	N
Barrel Length (m)	10.7
Approx. Barrel Slope (%)	0.9%
Approx. Depth of Cover (m)	535
End	Upstream
Crushing	Downstream
Infill Depth (mm)	Upstream
	Downstream
Other Comments	US blocked by rocks

Culvert Condition Ratings (MTO 2013)				
Barrel Material (0-4)	Shape (0-4)	Capacity (0-2)	Erosion and Scour (0-2)	US/DS Channel (0-2)
2	0	1	0	0

Recommended Action(s):	Monitor Rusting, clear blockage	Priority:	High
------------------------	---------------------------------	-----------	------

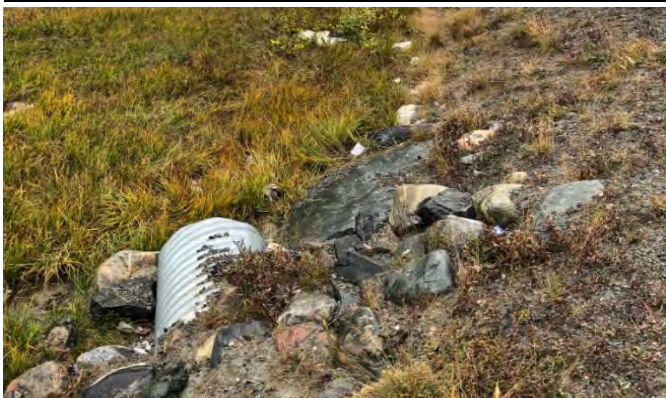
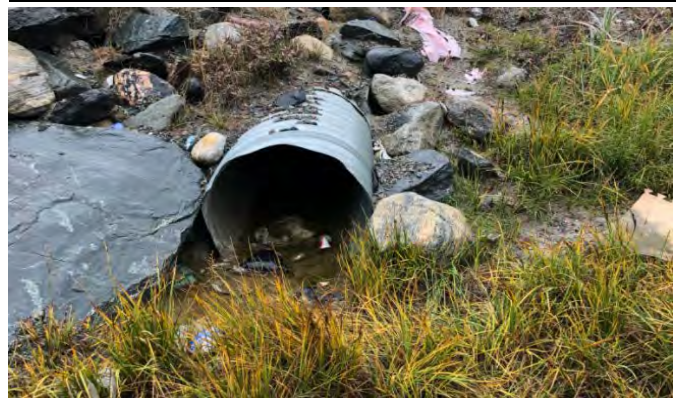
Culvert Information	
Culvert ID	131-01
Type	Entrance
Shape	Circular
Material	CSP
Diameter or Dimensions (mm)	600
Marker Post Present	N
Barrel Length (m)	-
Approx. Barrel Slope (%)	N/A
Approx. Depth of Cover (m)	1170
End	Upstream
Crushing	Downstream
Infill Depth (mm)	Upstream
	Downstream
Other Comments	US end not found

Culvert Condition Ratings (MTO 2013)				
Barrel Material (0-4)	Shape (0-4)	Capacity (0-2)	Erosion and Scour (0-2)	US/DS Channel (0-2)
1	0	2	0	0

Recommended Action(s):	Clear blockage	Priority:	High
------------------------	----------------	-----------	------

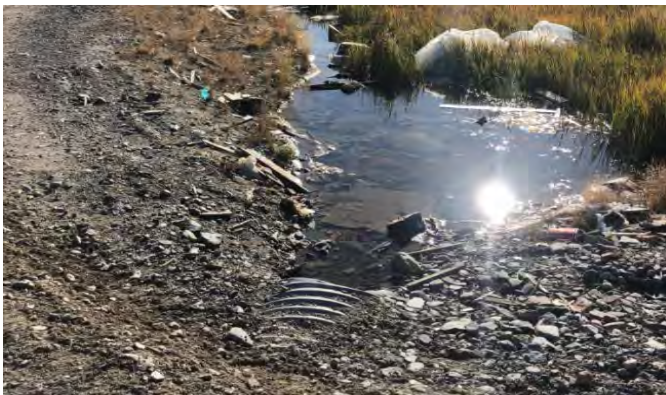
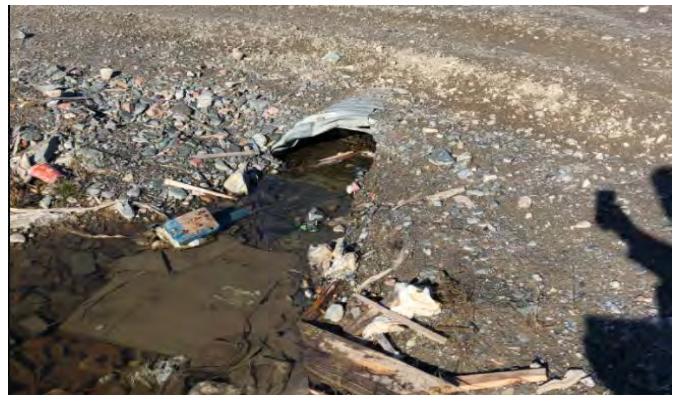
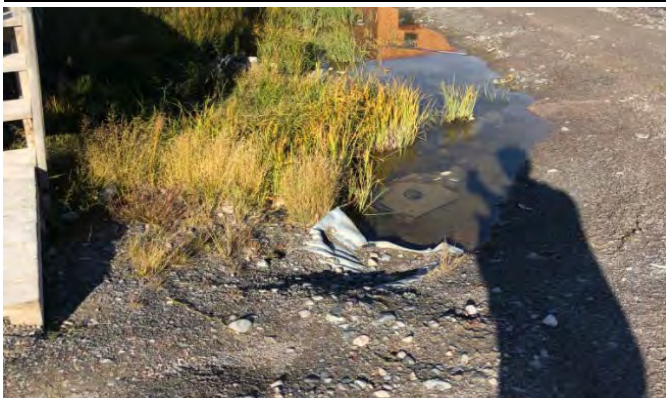
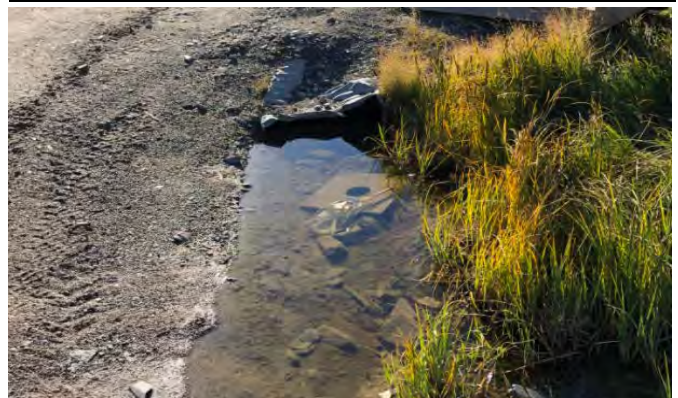
Culvert Information	
Culvert ID	132-01
Type	Entrance
Shape	Circular
Material	CSP
Diameter or Dimensions (mm)	600
Marker Post Present	N
Barrel Length (m)	16.4
Approx. Barrel Slope (%)	1.7%
Approx. Depth of Cover (m)	330
End	Upstream
Crushing	Downstream
Infill Depth (mm)	Upstream
	Downstream
Other Comments	Standing water DS

Culvert Condition Ratings (MTO 2013)				
Barrel Material (0-4)	Shape (0-4)	Capacity (0-2)	Erosion and Scour (0-2)	US/DS Channel (0-2)
1	4	2	0	0

Recommended Action(s):	Replace culvert	Priority:	High
------------------------	-----------------	-----------	------

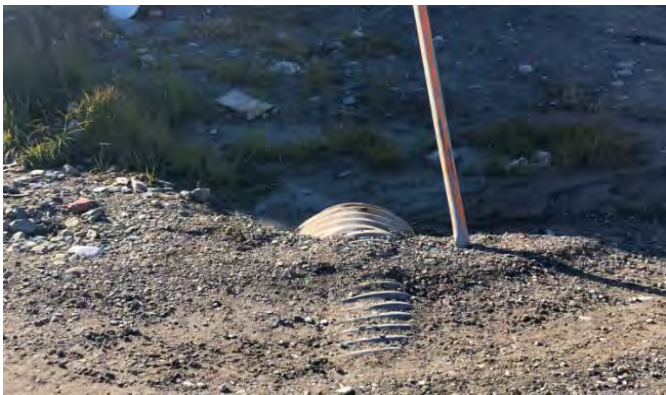
Culvert Information	
Culvert ID	132-02
Type	Entrance
Shape	Circular
Material	CSP
Diameter or Dimensions (mm)	600
Marker Post Present	Y
Barrel Length (m)	6.0
Approx. Barrel Slope (%)	-0.8%
Approx. Depth of Cover (m)	100
End	Upstream
Crushing	Downstream
Infill Depth (mm)	Upstream
	Downstream
Other Comments	Attempts made to protect ends (poles)

Culvert Condition Ratings (MTO 2013)				
Barrel Material (0-4)	Shape (0-4)	Capacity (0-2)	Erosion and Scour (0-2)	US/DS Channel (0-2)
0	0	2	1	0

Recommended Action(s):	Clear blockage	Priority:	High
------------------------	----------------	-----------	------
