**Geotechnical Evaluation and Drainage Planning
in Rankin Inlet, Nunavut**

Draft Report
REV-00

Prepared for:
The Municipality of Rankin Inlet

Prepared by:
Nunami Stantec Limited

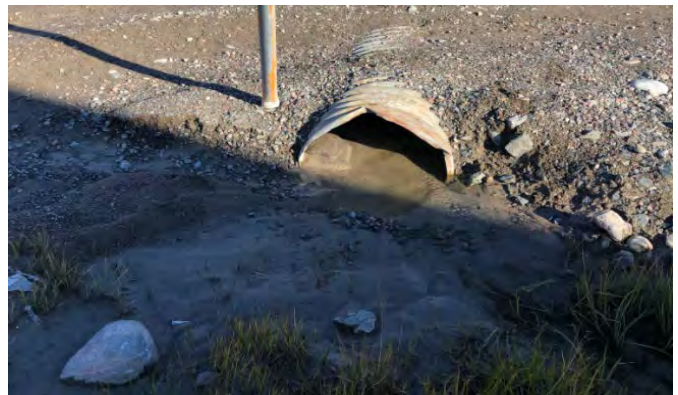
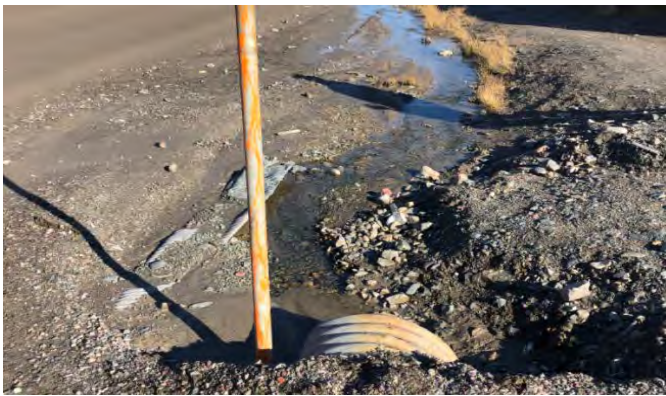
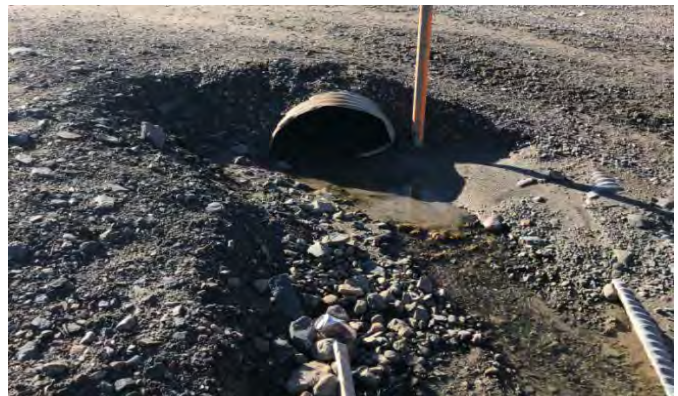
Culvert Information	
Culvert ID	132-03
Type	Cross
Shape	Circular
Material	CSP
Diameter or Dimensions (mm)	400
Marker Post Present	N
Barrel Length (m)	16.2
Approx. Barrel Slope (%)	1.4%
Approx. Depth of Cover (m)	160
End	Upstream
Crushing	Downstream
Infill Depth (mm)	Upstream
	Downstream
Other Comments	DS badly blocked with debris

Culvert Condition Ratings (MTO 2013)				
Barrel Material (0-4)	Shape (0-4)	Capacity (0-2)	Erosion and Scour (0-2)	US/DS Channel (0-2)
1	4	1	1	0

Recommended Action(s):	Replace culvert	Priority:	High
------------------------	-----------------	-----------	------

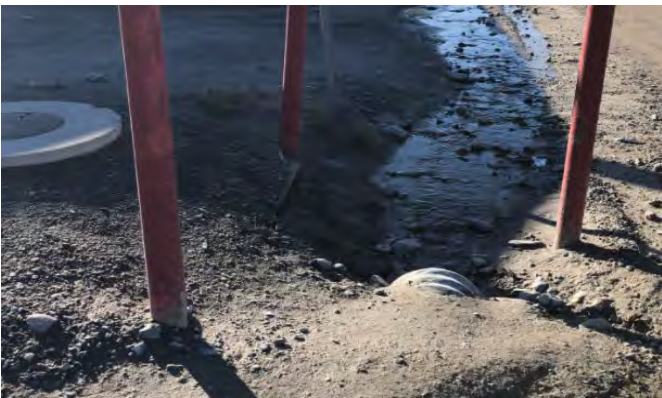
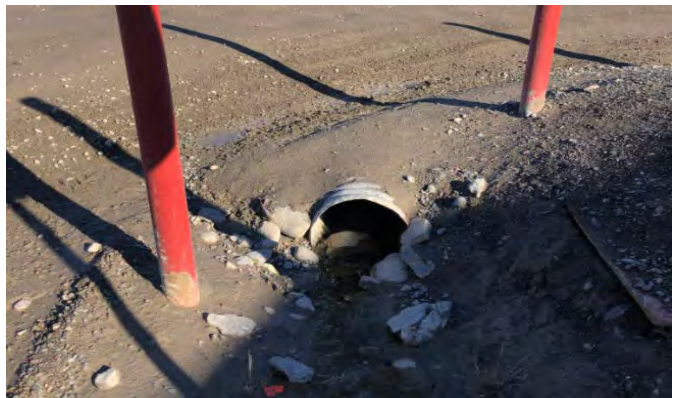
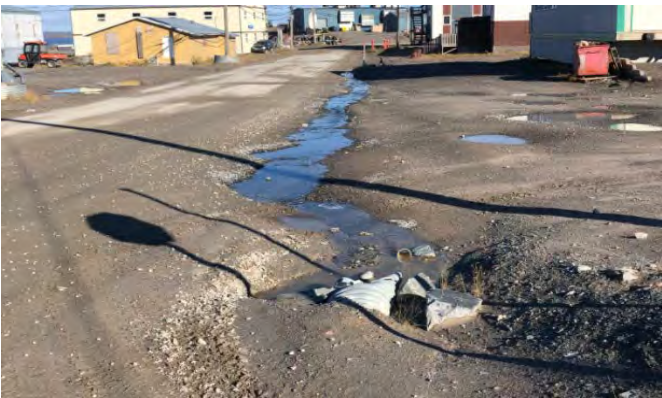
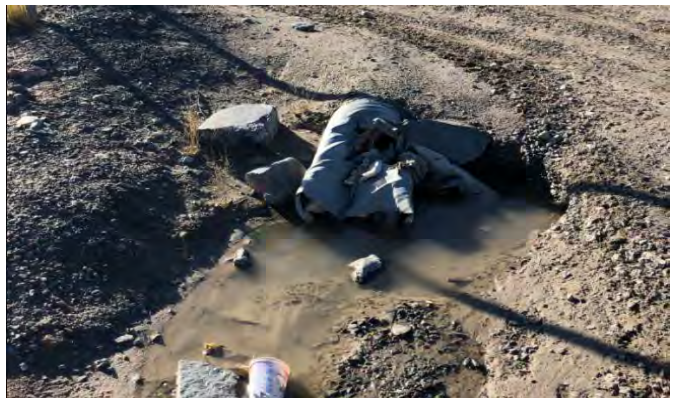
Culvert Information				
Culvert ID	133-01			
Type	Cross			
Shape	Circular			
Material	CSP			
Diameter or Dimensions (mm)	400			
Marker Post Present	N			
Barrel Length (m)	11.4			
Approx. Barrel Slope (%)	0.9%			
Approx. Depth of Cover (m)	315			
End	Upstream			
Crushing	Downstream			
Infill Depth (mm)	Upstream			
	Downstream			
Other Comments	Clogged by debris causing problems			
Culvert Elevations (masl) ²				
Upstream		Downstream		Road Crown
Invert	Obvert	Invert	Obvert	
11.38	11.62	11.28	11.59	11.92

Culvert Condition Ratings (MTO 2013)				
Barrel Material (0-4)	Shape (0-4)	Capacity (0-2)	Erosion and Scour (0-2)	US/DS Channel (0-2)
1	4	1	1	1

Recommended Action(s):	Replace culvert	Priority:	High
------------------------	-----------------	-----------	------

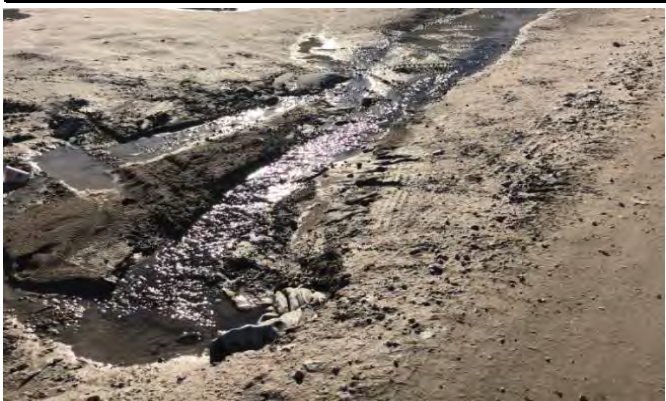
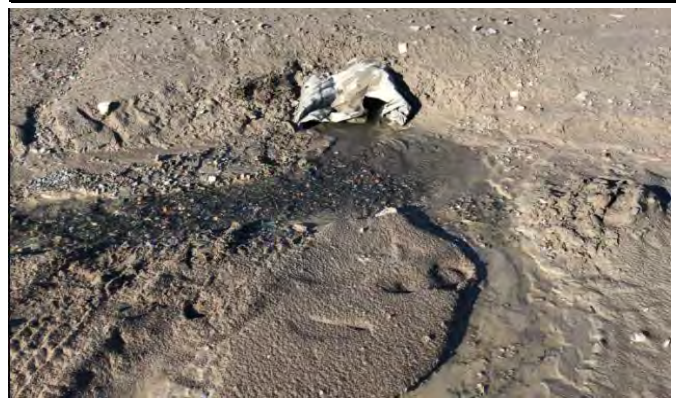
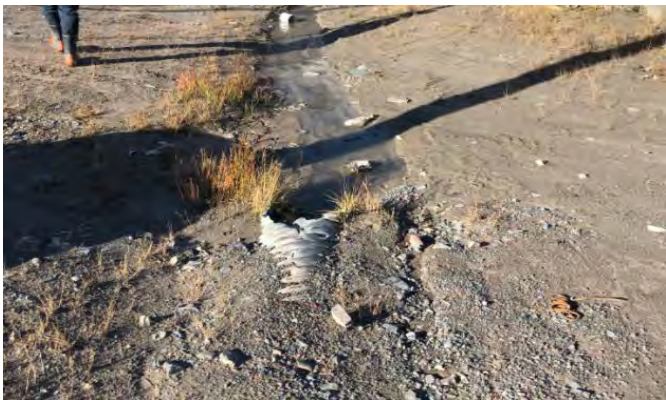
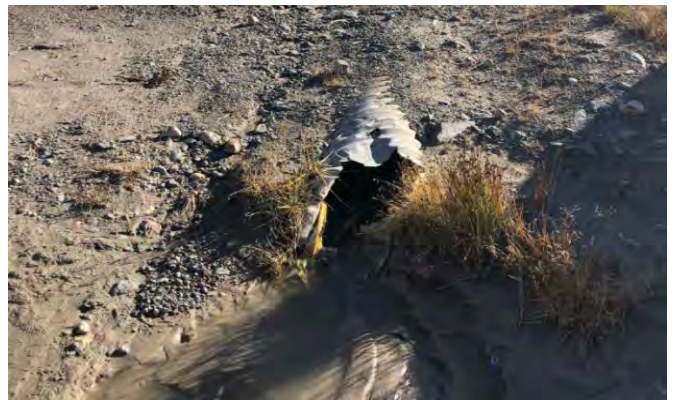
Culvert Information				
Culvert ID	133-02			
Type	Cross			
Shape	Circular			
Material	CSP			
Diameter or Dimensions (mm)	250			
Marker Post Present	N			
Barrel Length (m)	8.8			
Approx. Barrel Slope (%)	2.5%			
Approx. Depth of Cover (m)	300			
End	Upstream			
Crushing	Downstream			
Infill Depth (mm)	Upstream			
	Downstream			
Other Comments	US end almost buried			
Culvert Elevations (masl) ²				
Upstream		Downstream		Road Crown
Invert	Obvert	Invert	Obvert	
11.43	11.52	11.21	11.46

Culvert Condition Ratings (MTO 2013)				
Barrel Material (0-4)	Shape (0-4)	Capacity (0-2)	Erosion and Scour (0-2)	US/DS Channel (0-2)
1	4	2	1	1

Recommended Action(s):	Replace culvert	Priority:	High
------------------------	-----------------	-----------	------

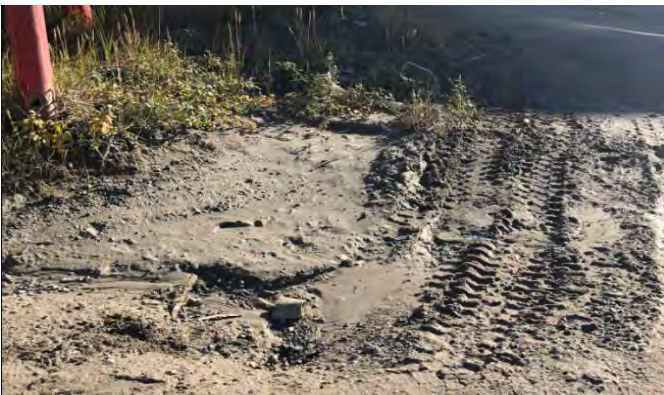
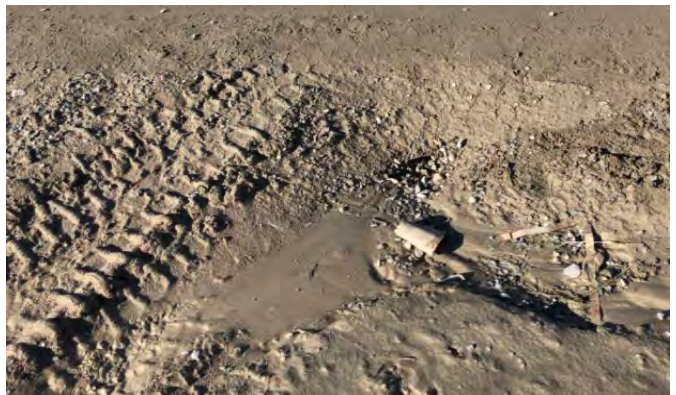
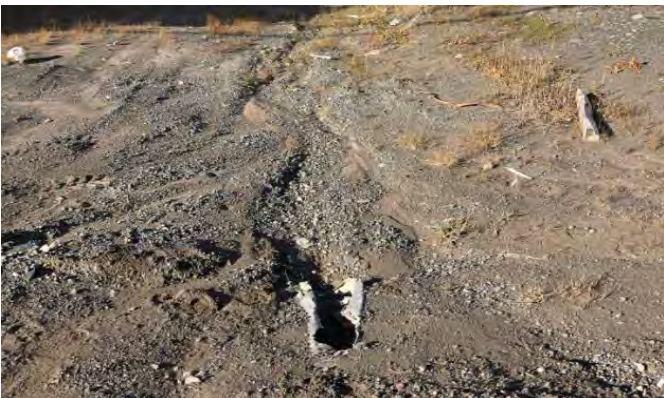
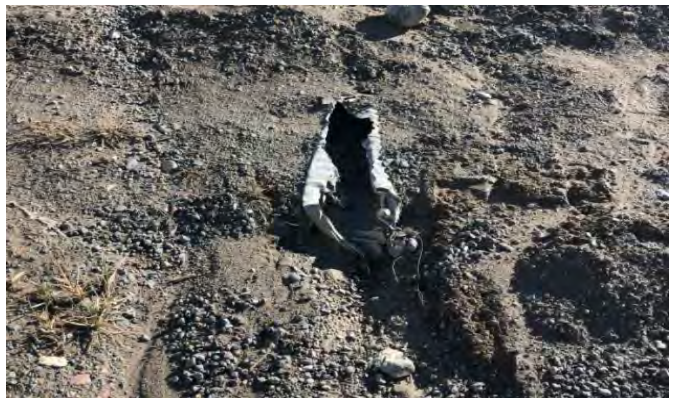
Culvert Information	
Culvert ID	133-03
Type	Entrance
Shape	Circular
Material	CSP
Diameter or Dimensions (mm)	250
Marker Post Present	N
Barrel Length (m)	6.0
Approx. Barrel Slope (%)	4.5%
Approx. Depth of Cover (m)	1165
End	Upstream
Crushing	Downstream
Infill Depth (mm)	Upstream
	Downstream
Other Comments	US end almost blocked by rocks & sediment

Culvert Condition Ratings (MTO 2013)				
Barrel Material (0-4)	Shape (0-4)	Capacity (0-2)	Erosion and Scour (0-2)	US/DS Channel (0-2)
1	0	0	2	2

Recommended Action(s):	gate embankment scour/erosion, Remediate channel	Priority:	High
------------------------	--------------------------------------------------	-----------	------

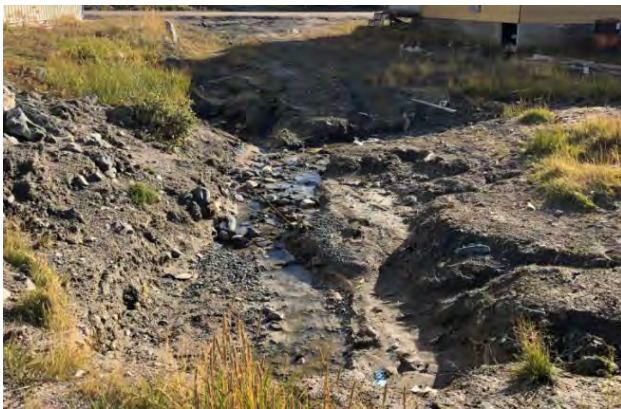
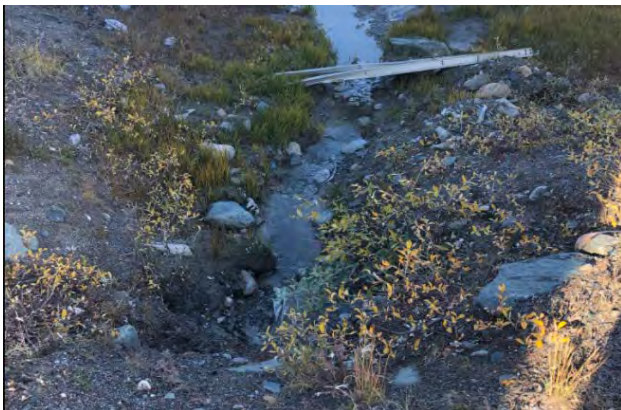
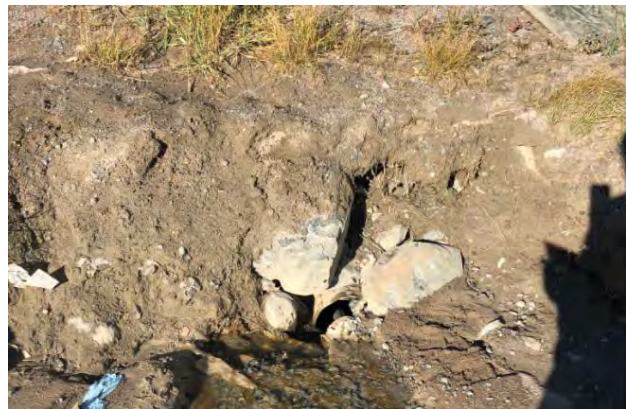
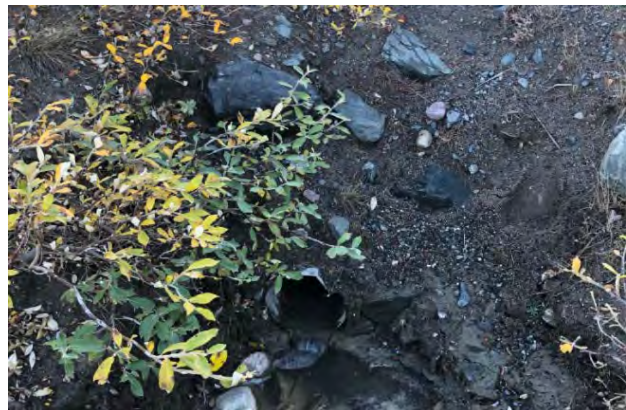
Culvert Information	
Culvert ID	134-01
Type	Cross
Shape	Circular
Material	CSP
Diameter or Dimensions (mm)	400
Marker Post Present	N
Barrel Length (m)	8.6
Approx. Barrel Slope (%)	1.5%
Approx. Depth of Cover (m)	380
End	Upstream
Crushing	Downstream
Infill Depth (mm)	Upstream
	Downstream
Other Comments	DS pblocked by rocks

Culvert Condition Ratings (MTO 2013)				
Barrel Material (0-4)	Shape (0-4)	Capacity (0-2)	Erosion and Scour (0-2)	US/DS Channel (0-2)
1	1	2	0	0

Recommended Action(s):	Clear blockage	Priority:	High
------------------------	----------------	-----------	------

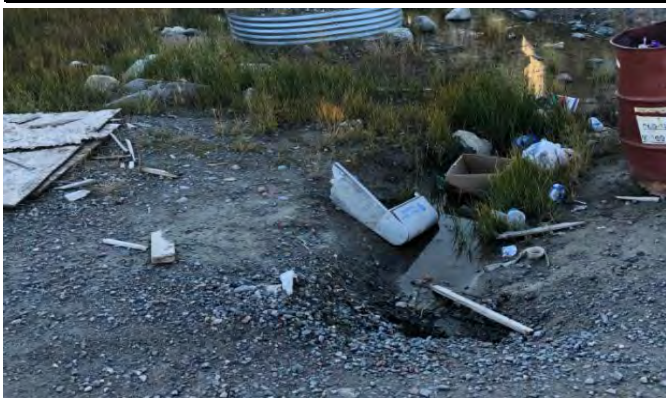
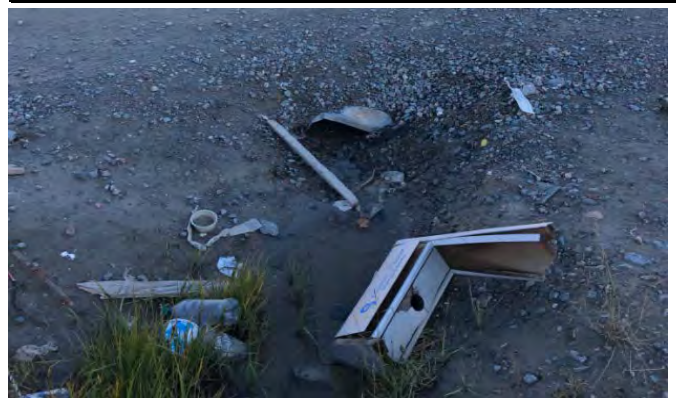
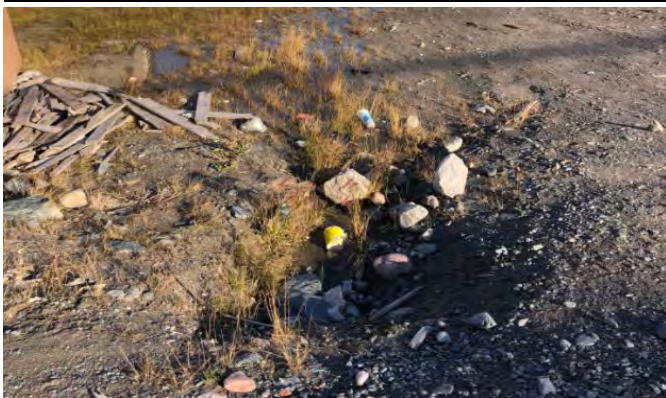
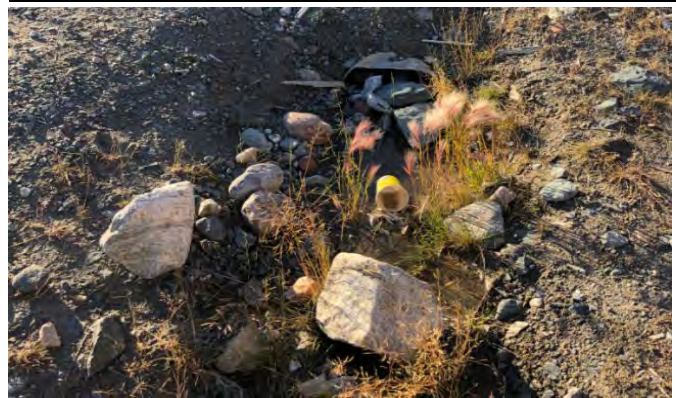
Culvert Information	
Culvert ID	134-02
Type	Cross
Shape	Circular
Material	CSP
Diameter or Dimensions (mm)	400
Marker Post Present	N
Barrel Length (m)	11.3
Approx. Barrel Slope (%)	2.0%
Approx. Depth of Cover (m)	135
End	Upstream
Crushing	Downstream
Infill Depth (mm)	Upstream
	Downstream
Other Comments	US very crushed. DS end perched

Culvert Condition Ratings (MTO 2013)				
Barrel Material (0-4)	Shape (0-4)	Capacity (0-2)	Erosion and Scour (0-2)	US/DS Channel (0-2)
0	4	2	1	0

Recommended Action(s):	Replace culvert	Priority:	High
------------------------	-----------------	-----------	------

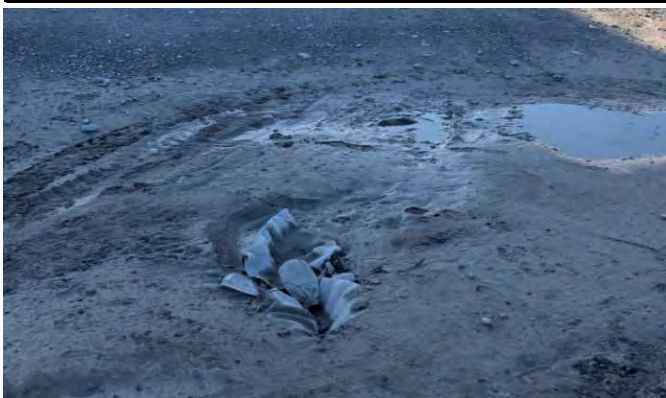
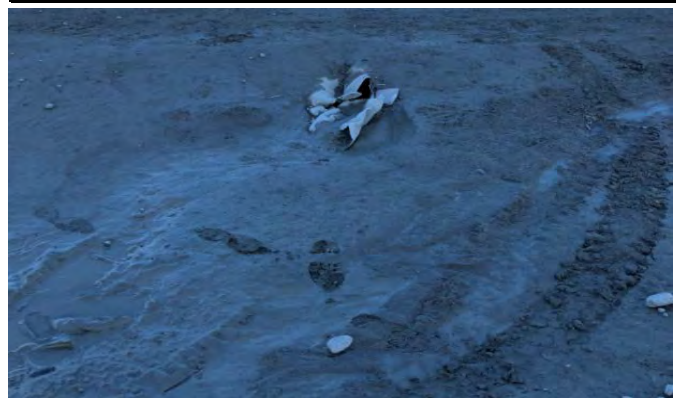
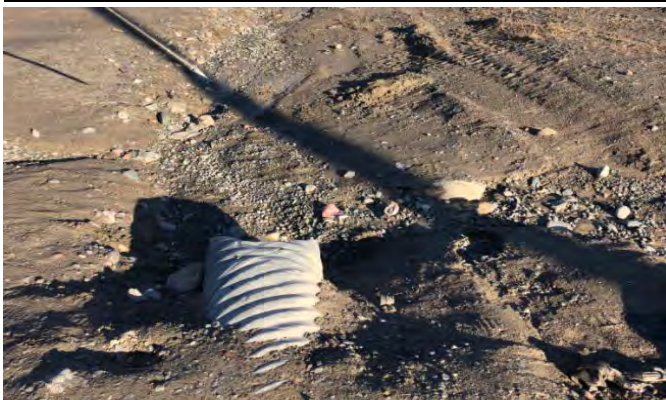
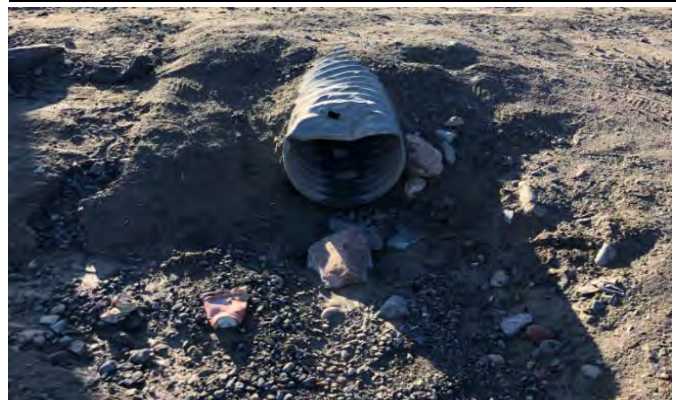
Culvert Information	
Culvert ID	134-03
Type	Cross
Shape	Circular
Material	CSP
Diameter or Dimensions (mm)	500
Marker Post Present	N
Barrel Length (m)	9.2
Approx. Barrel Slope (%)	-0.9%
Approx. Depth of Cover (m)	595
End	Upstream
Crushing	Downstream
Infill Depth (mm)	Upstream
	Downstream
Other Comments	DS end buried

Culvert Condition Ratings (MTO 2013)				
Barrel Material (0-4)	Shape (0-4)	Capacity (0-2)	Erosion and Scour (0-2)	US/DS Channel (0-2)
0	4	2	0	0

Recommended Action(s):	Replace culvert	Priority:	High
------------------------	-----------------	-----------	------

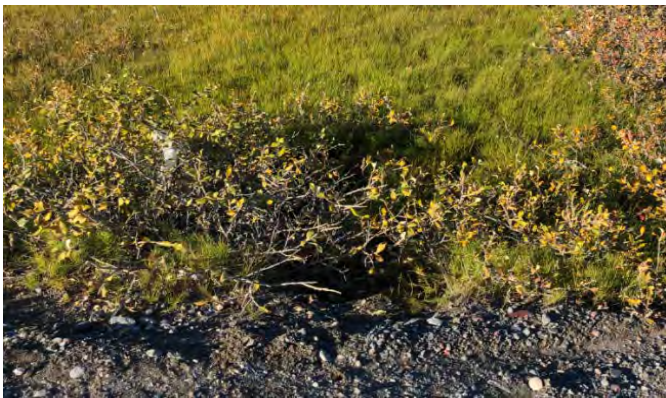
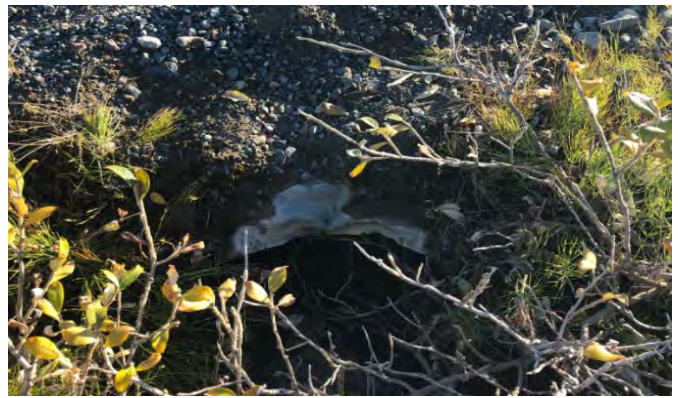
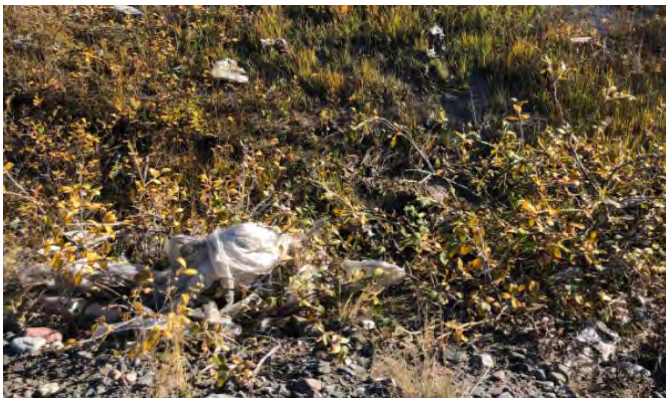
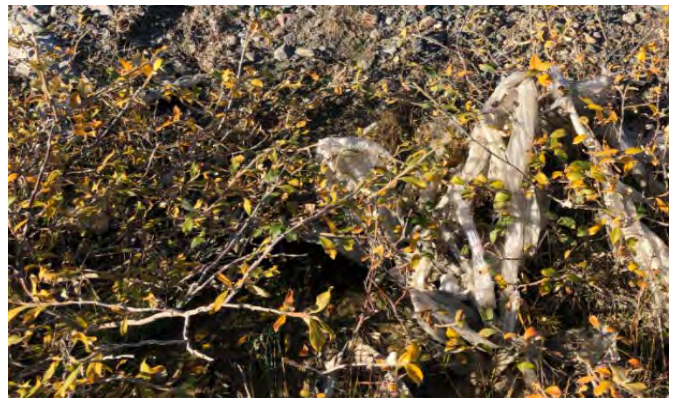
Culvert Information	
Culvert ID	134-04
Type	Entrance
Shape	Circular
Material	CSP
Diameter or Dimensions (mm)	400
Marker Post Present	N
Barrel Length (m)	10.0
Approx. Barrel Slope (%)	0.2%
Approx. Depth of Cover (m)	780
End	Upstream
Crushing	Downstream
Infill Depth (mm)	Upstream
	Downstream
Other Comments	DS end perched

Culvert Condition Ratings (MTO 2013)				
Barrel Material (0-4)	Shape (0-4)	Capacity (0-2)	Erosion and Scour (0-2)	US/DS Channel (0-2)
1	2	0	0	1

Recommended Action(s):	Repair culvert end	Priority:	Medium
------------------------	--------------------	-----------	--------

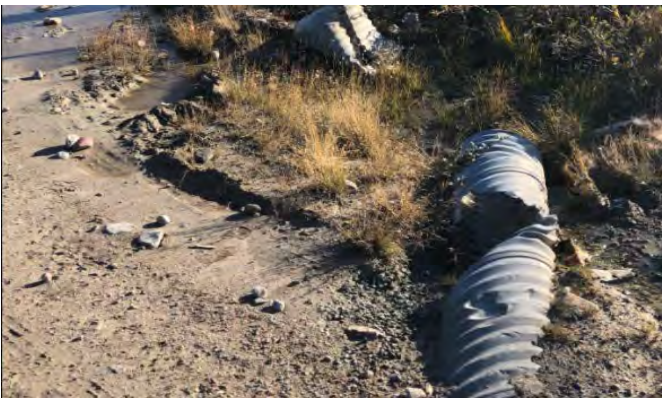
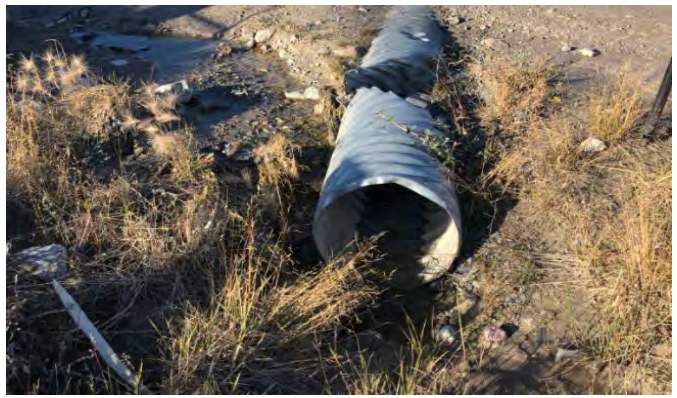
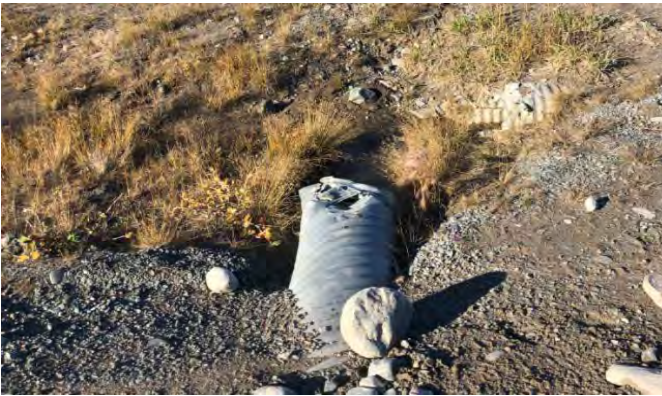
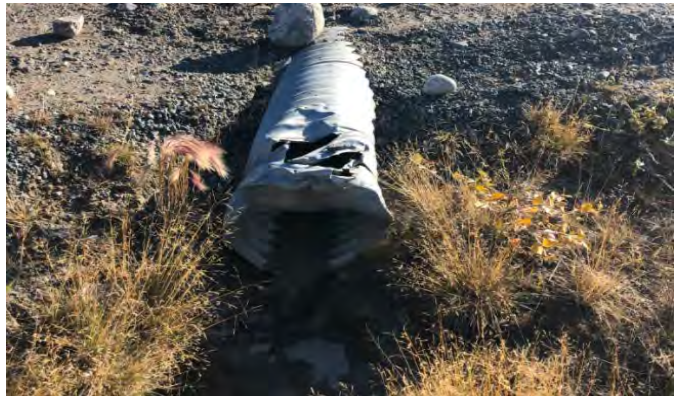
Culvert Information				
Culvert ID	134-05			
Type	Cross			
Shape	Circular			
Material	CSP			
Diameter or Dimensions (mm)	400			
Marker Post Present	N			
Barrel Length (m)	11.6			
Approx. Barrel Slope (%)	1.3%			
Approx. Depth of Cover (m)	235			
End	Upstream			
Crushing	Downstream			
Infill Depth (mm)	Upstream			
	Downstream			
Other	Outlet perched			
Comments				
Culvert Elevations (masl) ²				
Upstream		Downstream		Road Crown
Invert	Obvert	Invert	Obvert	
7.99	8.38	7.84	8.19

Culvert Condition Ratings (MTO 2013)				
Barrel Material (0-4)	Shape (0-4)	Capacity (0-2)	Erosion and Scour (0-2)	US/DS Channel (0-2)
0	4	0	0	0

Recommended Action(s):	Replace culvert	Priority:	High
------------------------	-----------------	-----------	------

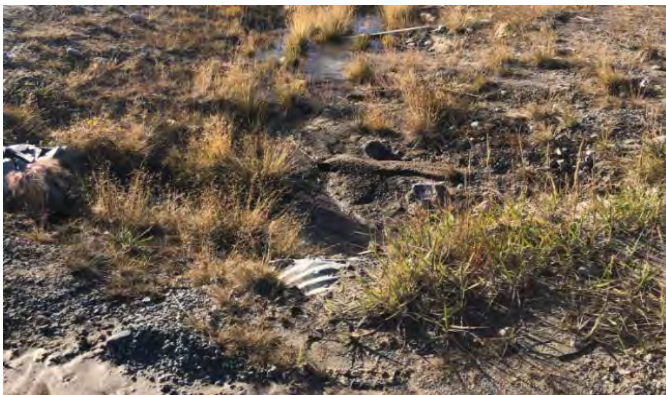
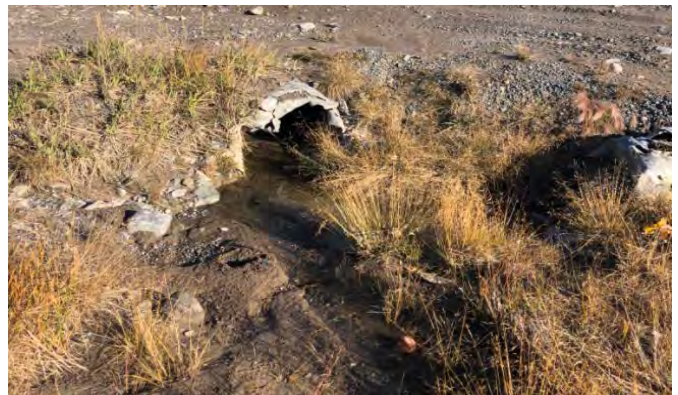
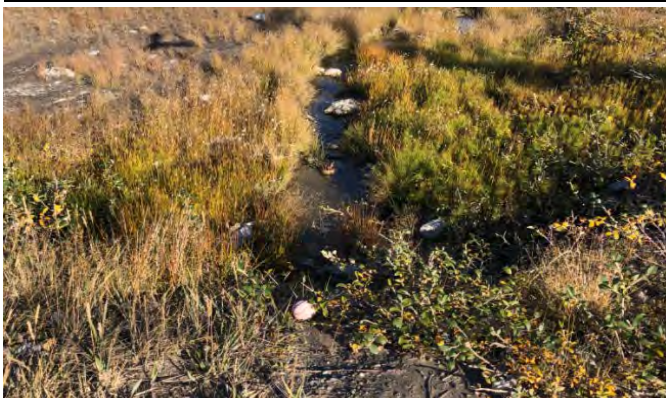
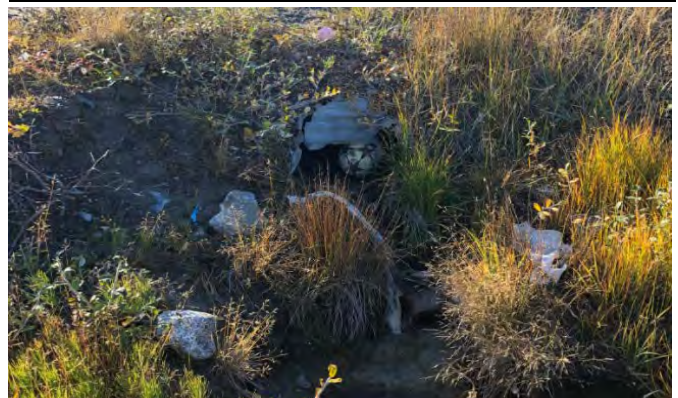
Culvert Information				
Culvert ID	134-06			
Type	Cross			
Shape	Circular			
Material	CSP			
Diameter or Dimensions (mm)	600			
Marker Post Present	N			
Barrel Length (m)	13.2			
Approx. Barrel Slope (%)	1.6%			
Approx. Depth of Cover (m)	530			
End	Upstream	Y		
Crushing	Downstream	Y		
Infill Depth (mm)	Upstream	50		
	Downstream	50		
Other Comments	0			
Culvert Elevations (masl) ²				
Upstream		Downstream	Road Crown	
Invert	Obvert	Invert		Obvert
7.7	8.2	7.49	8.02	8.64

Culvert Condition Ratings (MTO 2013)				
Barrel Material (0-4)	Shape (0-4)	Capacity (0-2)	Erosion and Scour (0-2)	US/DS Channel (0-2)
1	2	1	0	0

Recommended Action(s):	Clear blockage, repair culvert end	Priority:	High
------------------------	------------------------------------	-----------	------

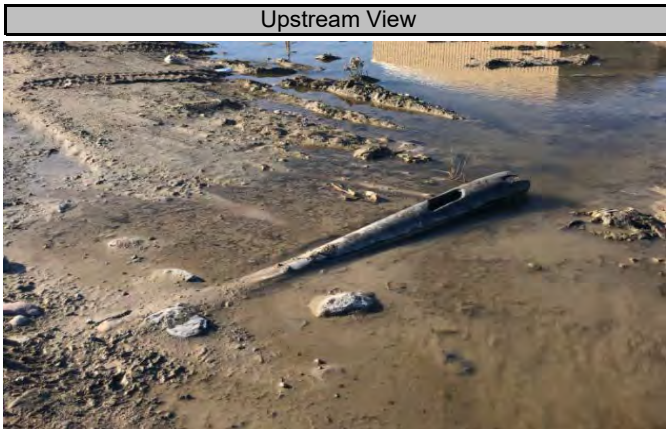
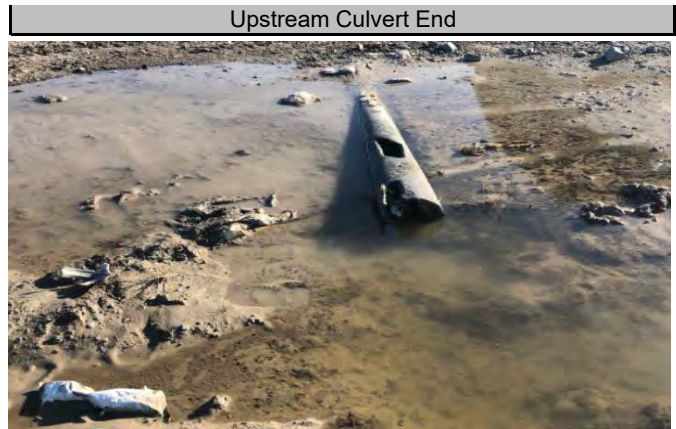
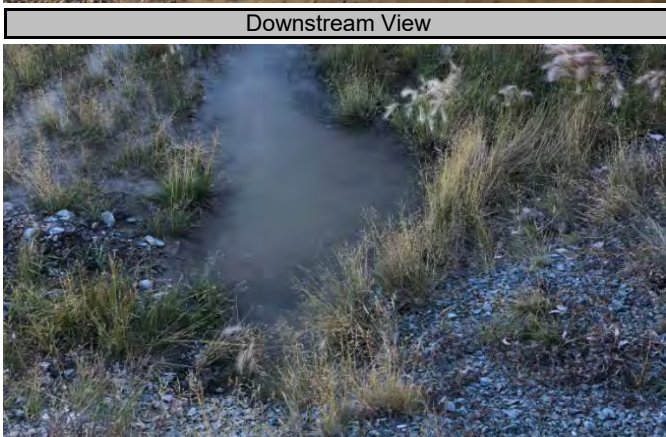
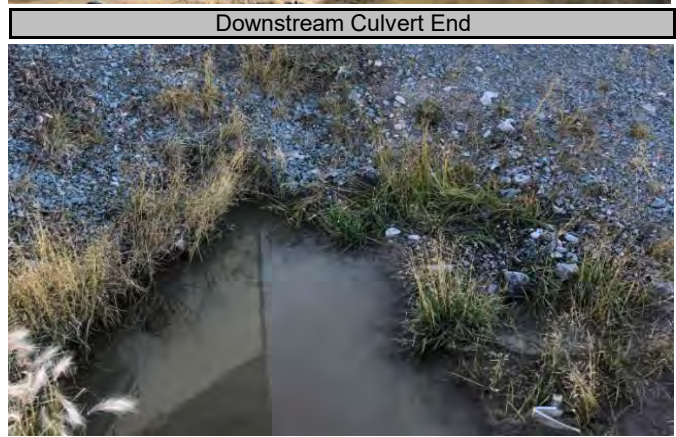
Culvert Information				
Culvert ID	134-07			
Type	Cross			
Shape	Circular			
Material	PVC			
Diameter or Dimensions (mm)	240			
Marker Post Present	N			
Barrel Length (m)	24.5			
Approx. Barrel Slope (%)	2.2%			
Approx. Depth of Cover (m)	-			
End	Upstream			
Crushing	Downstream			
Infill Depth (mm)	Upstream			
	Downstream			
Other Comments	Couldn't locate DS end but flow was observed. Took CE point at invert of visible outflow.			
Culvert Elevations (masl) ²				
Upstream		Downstream		Road Crown
Invert	Obvert	Invert	Obvert	
6.38	6.49	5.84	-

Culvert Condition Ratings (MTO 2013)				
Barrel Material (0-4)	Shape (0-4)	Capacity (0-2)	Erosion and Scour (0-2)	US/DS Channel (0-2)
1	4	2	2	1

Recommended Action(s):	Clear blockage. Investigate embankment scour/erosion	Priority:	High
------------------------	------------------------------------------------------	-----------	------

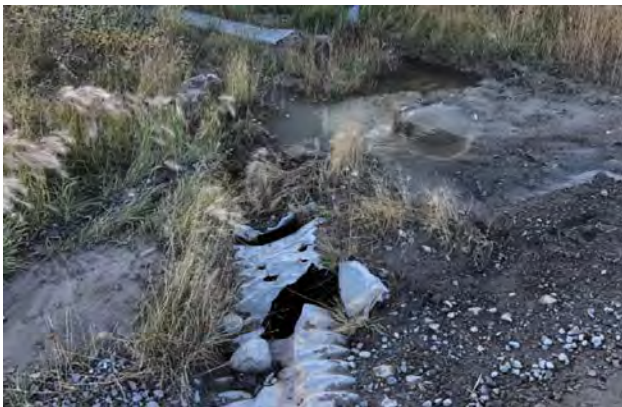
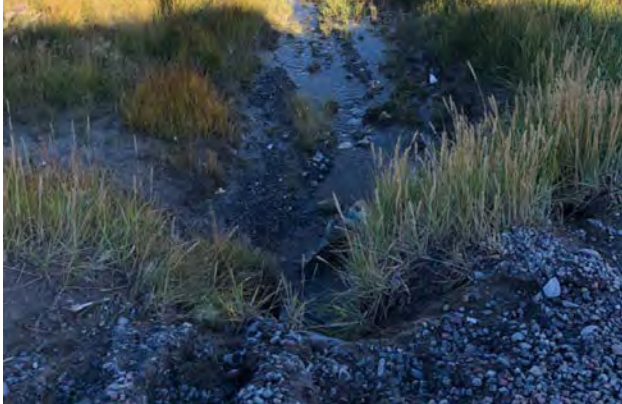
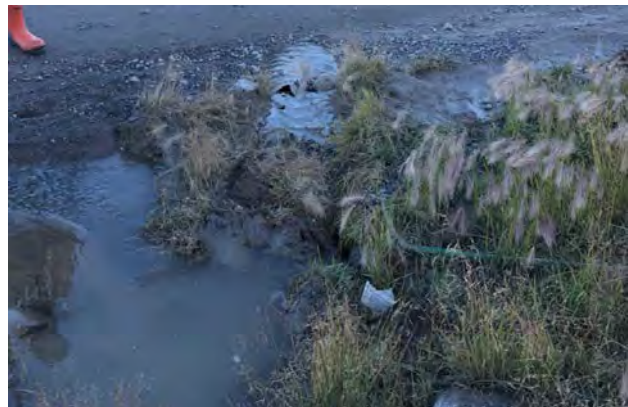
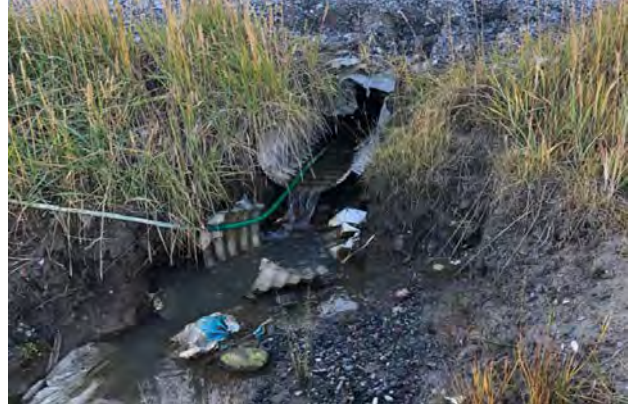
Culvert Information	
Culvert ID	134-08
Type	Cross
Shape	Circular
Material	CSP
Diameter or Dimensions (mm)	600
Marker Post Present	N
Barrel Length (m)	10.3
Approx. Barrel Slope (%)	4.5%
Approx. Depth of Cover (m)	320
End	Upstream
Crushing	Downstream
Infill Depth (mm)	Upstream
	Downstream
Other Comments	DS end perched. Sedimentation @ US end. Almost at culvert top

Culvert Condition Ratings (MTO 2013)				
Barrel Material (0-4)	Shape (0-4)	Capacity (0-2)	Erosion and Scour (0-2)	US/DS Channel (0-2)
0	4	2	2	0

Recommended Action(s):	Clear blockage. Investigate embankment scour/erosion	Priority:	High
------------------------	------------------------------------------------------	-----------	------

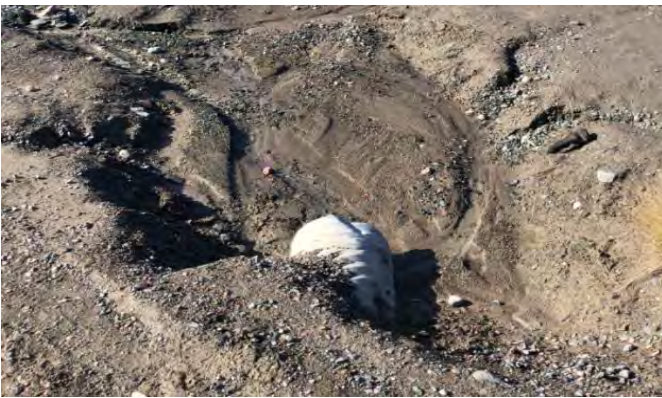
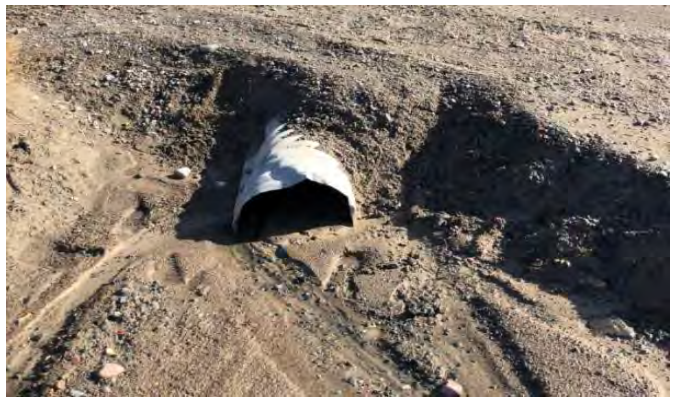
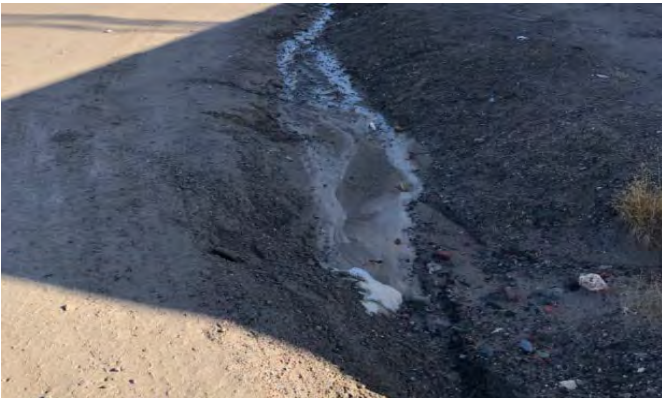
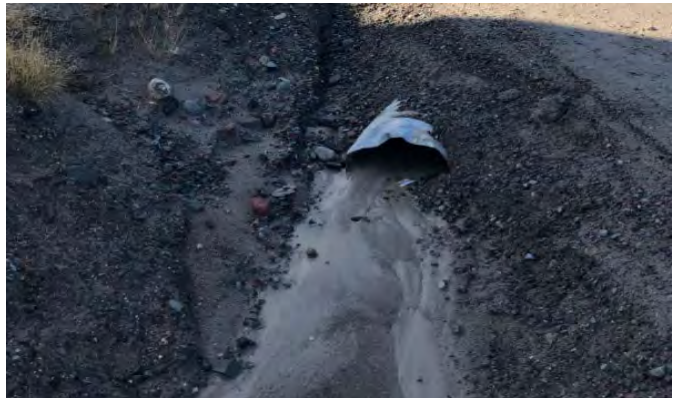
Culvert Information				
Culvert ID	135-01			
Type	Cross			
Shape	Circular			
Material	CSP			
Diameter or Dimensions (mm)	400			
Marker Post Present	N			
Barrel Length (m)	12.0			
Approx. Barrel Slope (%)	1.9%			
Approx. Depth of Cover (m)	265			
End	Upstream			
Crushing	Downstream			
Infill Depth (mm)	Upstream			
	Downstream			
Other Comments	Accepts drainage from 2 ditches. Infilled with sediment being washed down			
Culvert Elevations (masl) ²				
Upstream		Downstream		Road Crown
Invert	Obvert	Invert	Obvert	
17.13	17.39	16.9	17.12

Culvert Condition Ratings (MTO 2013)				
Barrel Material (0-4)	Shape (0-4)	Capacity (0-2)	Erosion and Scour (0-2)	US/DS Channel (0-2)
1	0	2	1	1

Recommended Action(s):	Clear blockage	Priority:	High
------------------------	----------------	-----------	------

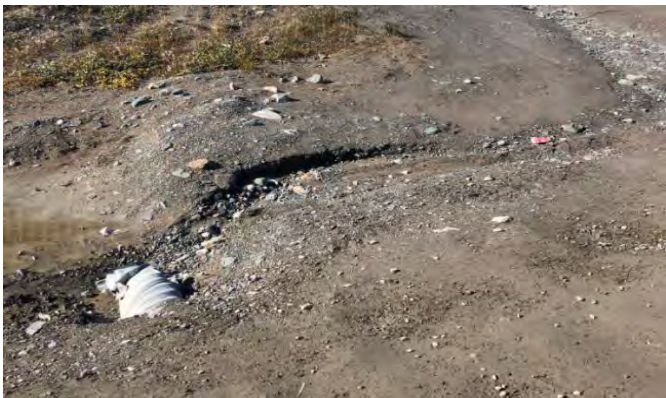
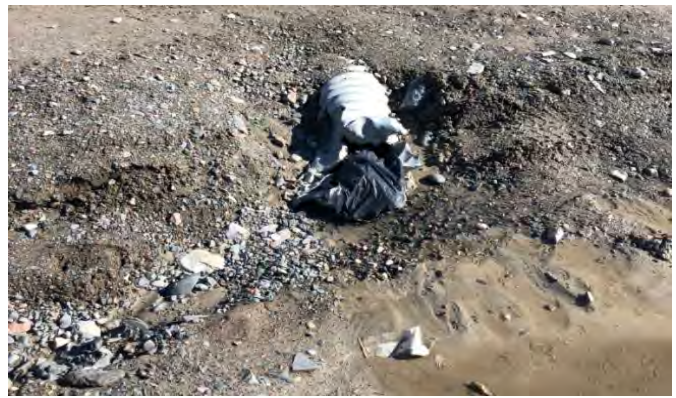
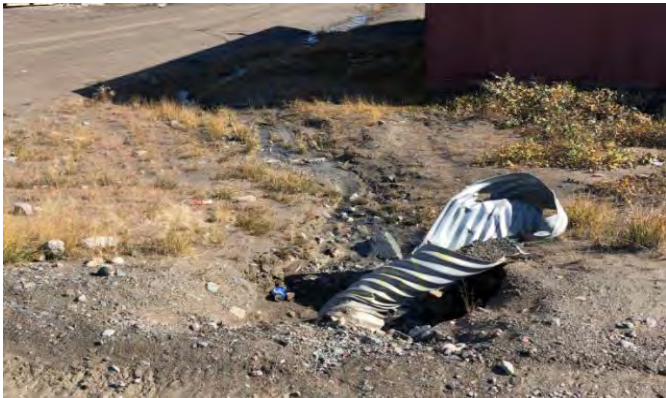
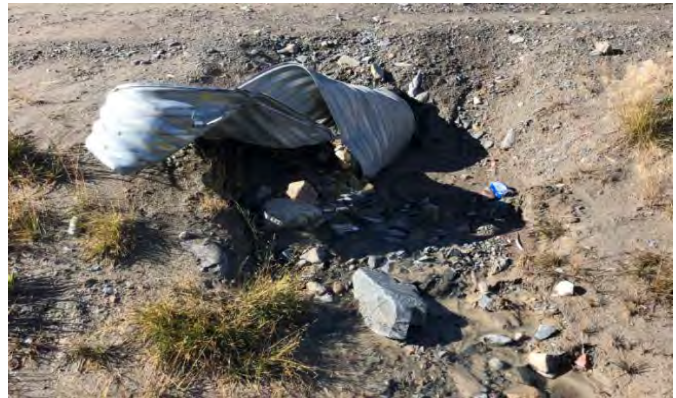
Culvert Information				
Culvert ID	135-02			
Type	Cross			
Shape	Circular			
Material	CSP			
Diameter or Dimensions (mm)	400			
Marker Post Present	N			
Barrel Length (m)	10.9			
Approx. Barrel Slope (%)	2.0%			
Approx. Depth of Cover (m)	325			
End	Upstream	Y		
Crushing	Downstream	Y		
Infill Depth (mm)	Upstream	0		
	Downstream	0		
Other Comments	Debris US end. DS end twisted & perched			
Culvert Elevations (masl) ²				
Upstream		Downstream	Road Crown	
Invert	Obvert	Invert		Obvert
14.95	15.3	14.73	15.01	15.48

Culvert Condition Ratings (MTO 2013)				
Barrel Material (0-4)	Shape (0-4)	Capacity (0-2)	Erosion and Scour (0-2)	US/DS Channel (0-2)
0	4	0	1	0

Recommended Action(s):	Replace culvert	Priority:	High
------------------------	-----------------	-----------	------

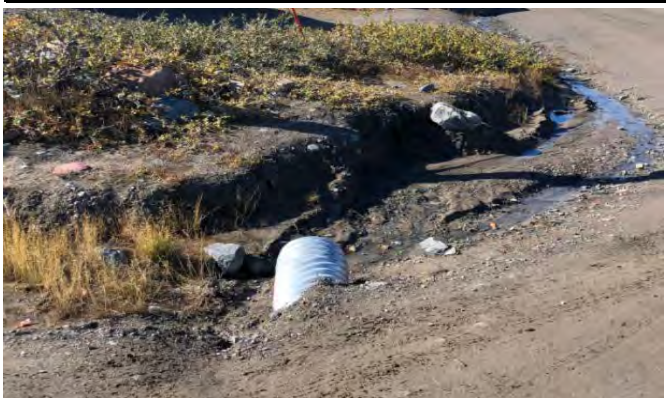
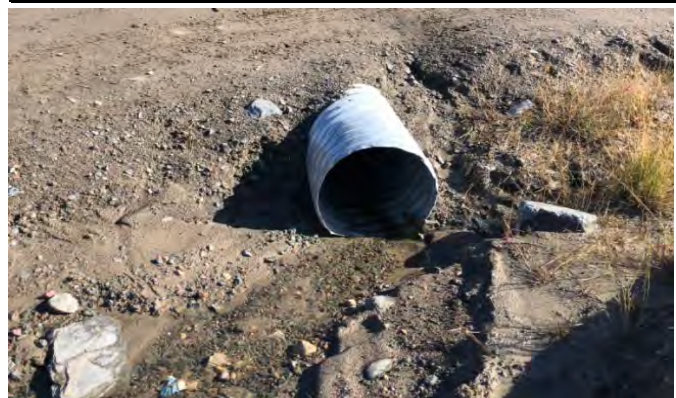
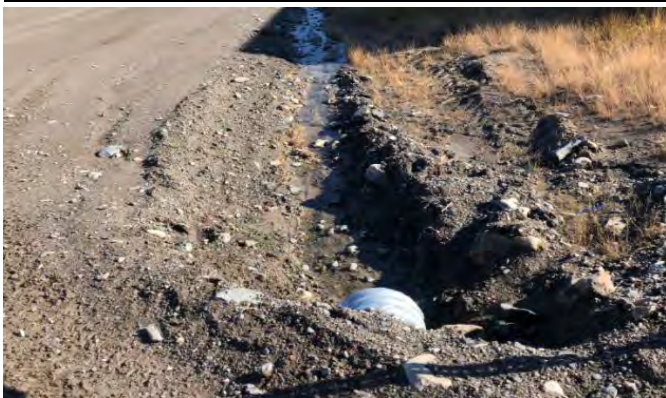
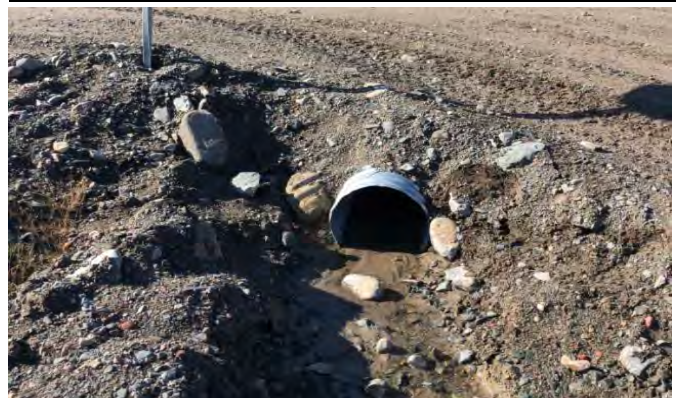
Culvert Information	
Culvert ID	135-03
Type	Cross
Shape	Circular
Material	CSP
Diameter or Dimensions (mm)	400
Marker Post Present	N
Barrel Length (m)	12.0
Approx. Barrel Slope (%)	2.8%
Approx. Depth of Cover (m)	330
End	Upstream
Crushing	Downstream
Infill Depth (mm)	Upstream
	Downstream
Other	Good condition
Comments

Culvert Condition Ratings (MTO 2013)				
Barrel Material (0-4)	Shape (0-4)	Capacity (0-2)	Erosion and Scour (0-2)	US/DS Channel (0-2)
1	0	0	0	1

Recommended Action(s):	No Action	Priority:	Low
------------------------	-----------	-----------	-----

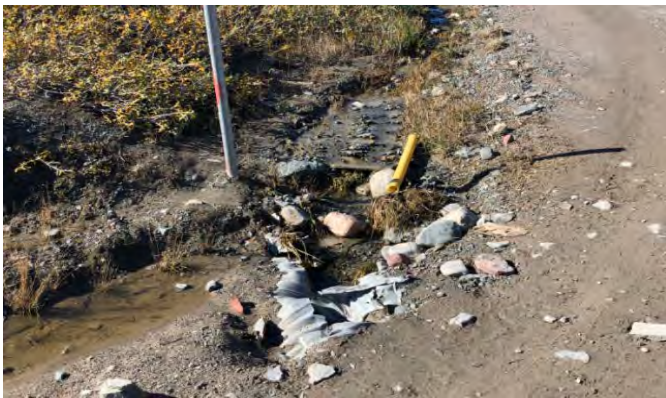
Culvert Information				
Culvert ID	135-04			
Type	Cross			
Shape	Circular			
Material	CSP			
Diameter or Dimensions (mm)	600			
Marker Post Present	N			
Barrel Length (m)	11.3			
Approx. Barrel Slope (%)	4.4%			
Approx. Depth of Cover (m)	235			
End	Upstream			
Crushing	Downstream			
Infill Depth (mm)	Upstream			
	Downstream			
Other Comments	Likely overroad spillage during high flow due to low capacity			
Culvert Elevations (masl) ²				
Upstream		Downstream		Road Crown
Invert	Obvert	Invert	Obvert	
8.98	9.39	8.48	8.9

Culvert Condition Ratings (MTO 2013)				
Barrel Material (0-4)	Shape (0-4)	Capacity (0-2)	Erosion and Scour (0-2)	US/DS Channel (0-2)
1	4	1	1	0

Recommended Action(s):	Replace culvert	Priority:	High
------------------------	-----------------	-----------	------

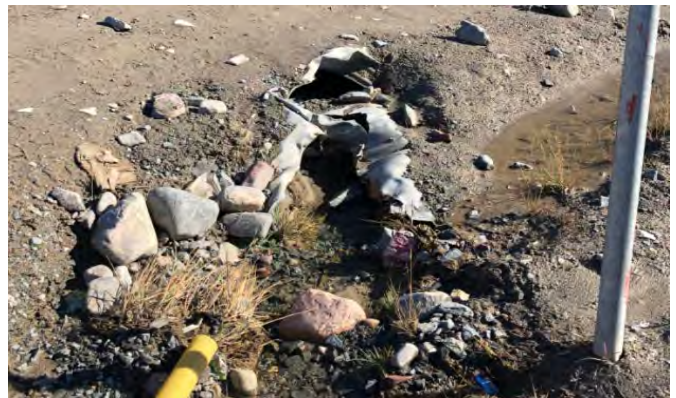
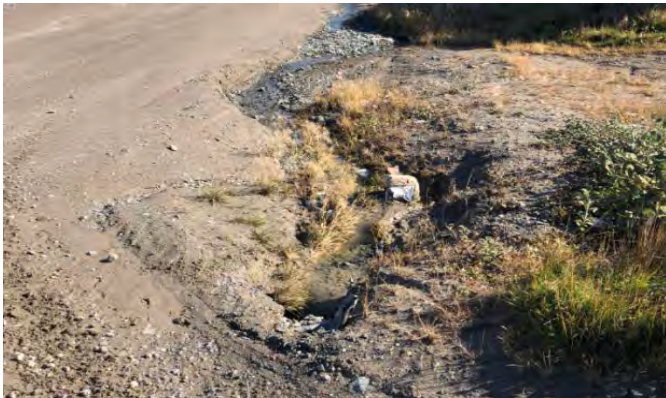
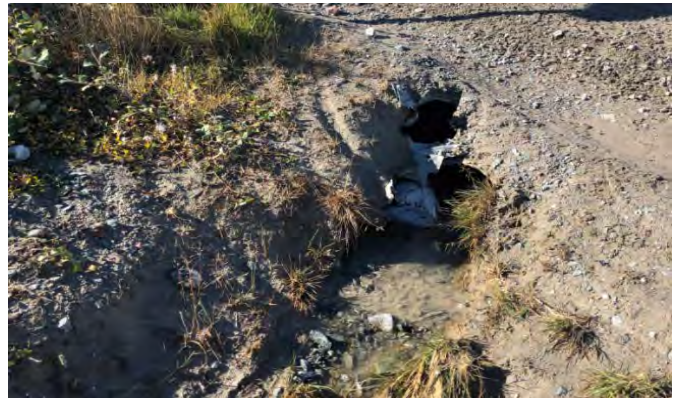
Culvert Information	
Culvert ID	135-05
Type	Cross
Shape	Circular
Material	CSP
Diameter or Dimensions (mm)	400
Marker Post Present	N
Barrel Length (m)	14.4
Approx. Barrel Slope (%)	3.8%
Approx. Depth of Cover (m)	415
End	Upstream
Crushing	Downstream
Infill Depth (mm)	Upstream
	Downstream
Other Comments	Poor ditch def'n US

Culvert Condition Ratings (MTO 2013)				
Barrel Material (0-4)	Shape (0-4)	Capacity (0-2)	Erosion and Scour (0-2)	US/DS Channel (0-2)
1	1	2	1	0

Recommended Action(s):	Clear blockage	Priority:	High
------------------------	----------------	-----------	------

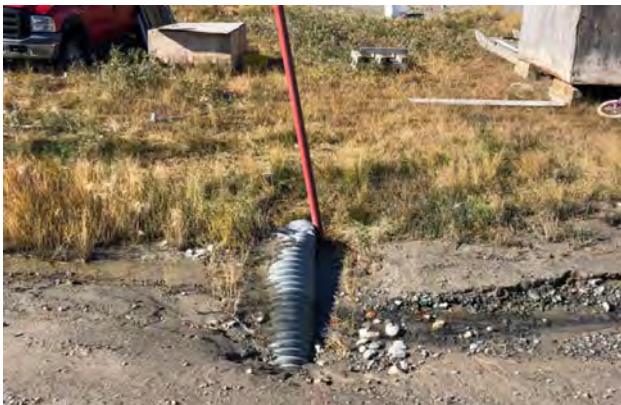
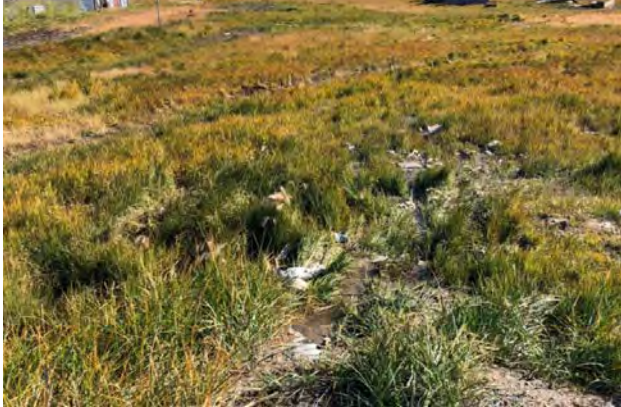
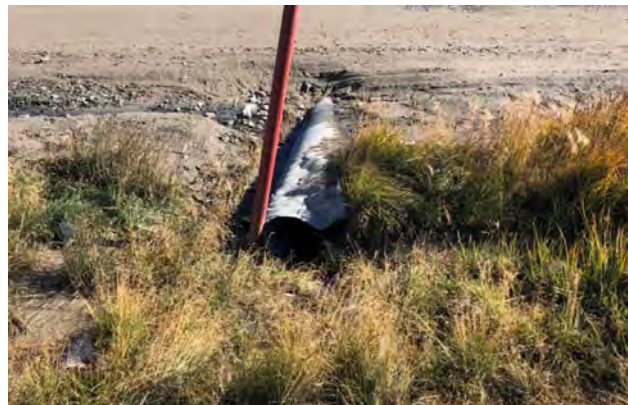
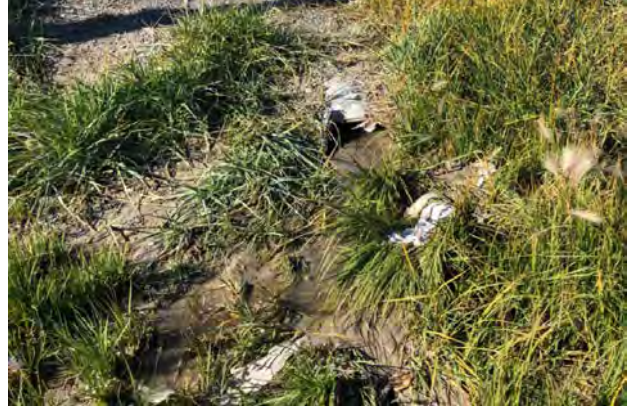
Culvert Information				
Culvert ID	136-01			
Type	Entrance			
Shape	Circular			
Material	CSP			
Diameter or Dimensions (mm)	500			
Marker Post Present	N			
Barrel Length (m)	-			
Approx. Barrel Slope (%)	N/A			
Approx. Depth of Cover (m)	460			
End	Upstream	N		
	Downstream	N		
Infill Depth (mm)	Upstream	0		
	Downstream	0		
Other Comments	Blocked. Only DS end located. Near 58			
Culvert Elevations (masl) ²				
Upstream		Downstream		Road Crown
Invert	Obvert	Invert	Obvert	
-	-	27.43	27.6	28.06

Culvert Condition Ratings (MTO 2013)				
Barrel Material (0-4)	Shape (0-4)	Capacity (0-2)	Erosion and Scour (0-2)	US/DS Channel (0-2)
0	0	0	0	0

Recommended Action(s):	No Action	Priority:	Low
------------------------	-----------	-----------	-----

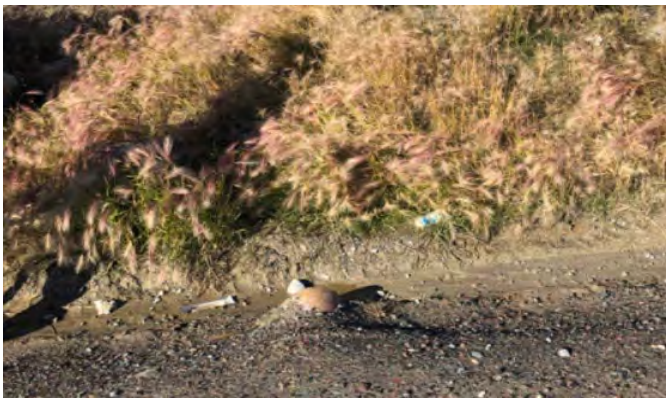
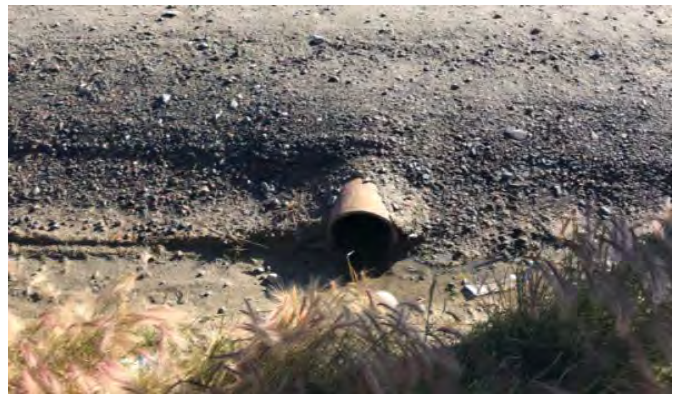
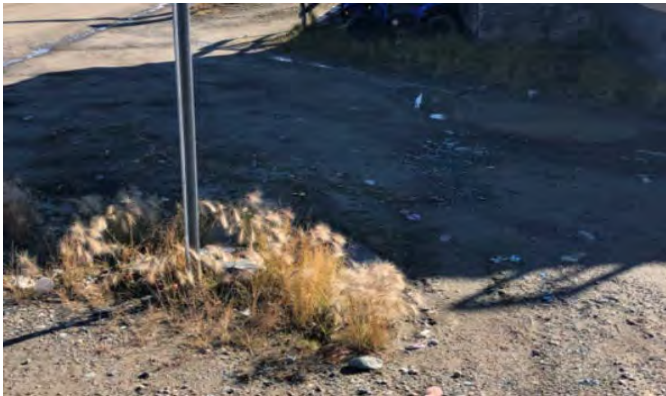
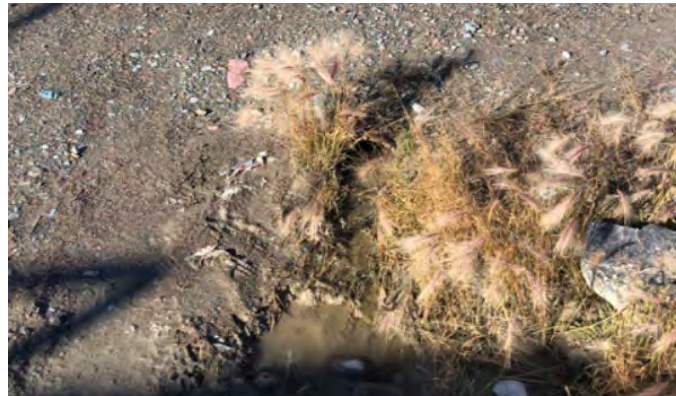
Culvert Information				
Culvert ID	136-02			
Type	Cross			
Shape	Circular			
Material	SP			
Diameter or Dimensions (mm)	200			
Marker Post Present	N			
Barrel Length (m)	9.2			
Approx. Barrel Slope (%)	0.9%			
Approx. Depth of Cover (m)	245			
End	Upstream			
Crushing	Downstream			
Infill Depth (mm)	Upstream			
	Downstream			
Other Comments	Flow conveyed South under road. Collects two ditches from NW. Eastern, near 58			
Culvert Elevations (masl) ²				
Upstream		Downstream		Road Crown
Invert	Obvert	Invert	Obvert	
25.55	25.76	25.47	25.63

Culvert Condition Ratings (MTO 2013)				
Barrel Material (0-4)	Shape (0-4)	Capacity (0-2)	Erosion and Scour (0-2)	US/DS Channel (0-2)
1	0	1	0	0

Recommended Action(s):	Clear blockage	Priority:	High
------------------------	----------------	-----------	------
