**Geotechnical Evaluation and Drainage Planning
in Rankin Inlet, Nunavut**

Draft Report
REV-00

Prepared for:
The Municipality of Rankin Inlet

Prepared by:
Nunami Stantec Limited

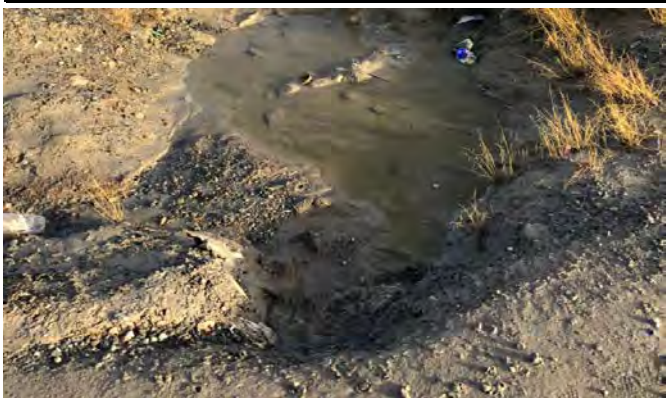
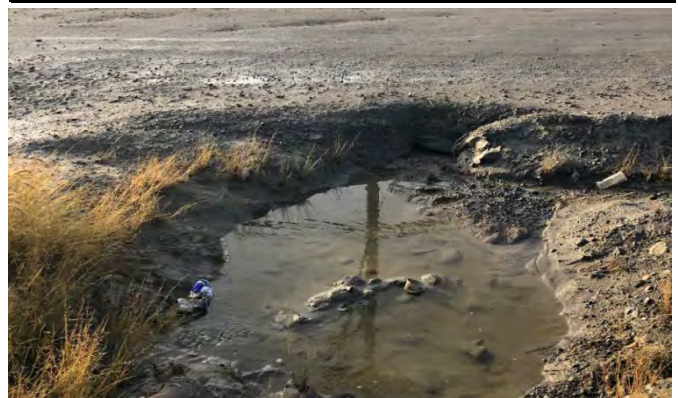
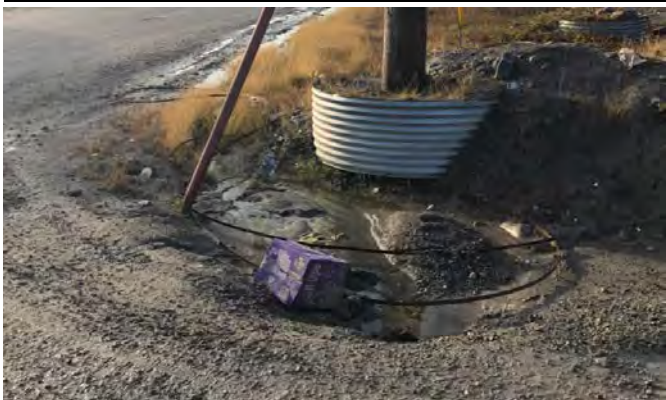
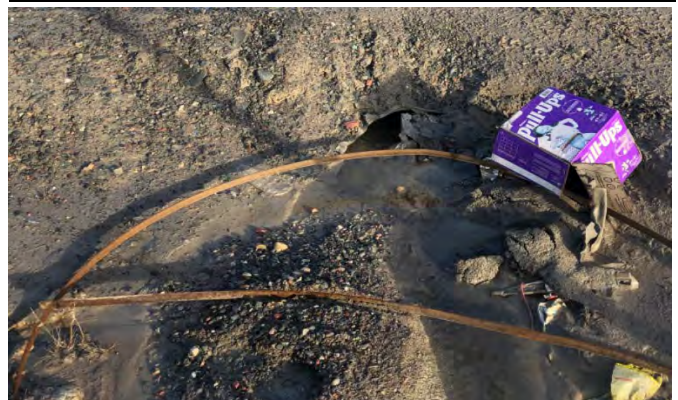
Culvert Information	
Culvert ID	136-03
Type	Cross
Shape	Circular
Material	CSP
Diameter or Dimensions (mm)	600
Marker Post Present	N
Barrel Length (m)	9.5
Approx. Barrel Slope (%)	0.1%
Approx. Depth of Cover (m)	300
End	Upstream
Crushing	Downstream
Infill Depth (mm)	Upstream
	Downstream
Other Comments	Debris & sediment blocking culvert

Culvert Condition Ratings (MTO 2013)				
Barrel Material (0-4)	Shape (0-4)	Capacity (0-2)	Erosion and Scour (0-2)	US/DS Channel (0-2)
1	4	2	1	1

Recommended Action(s):	Replace culvert	Priority:	High
------------------------	-----------------	-----------	------

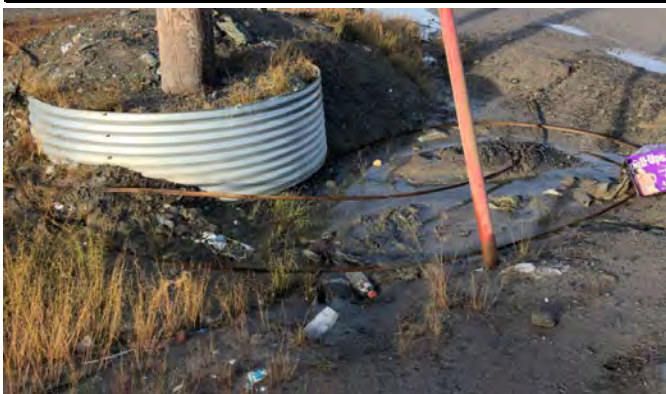
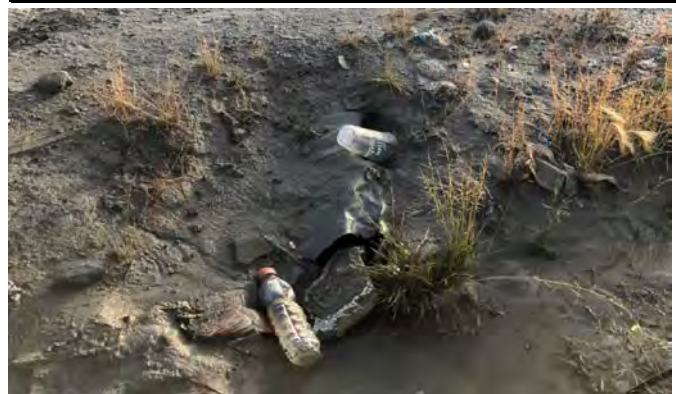
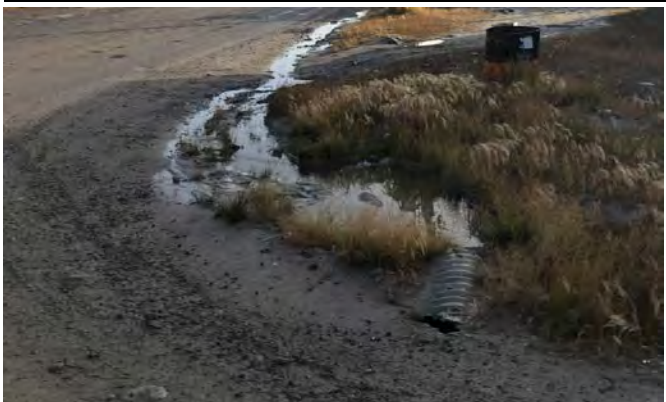
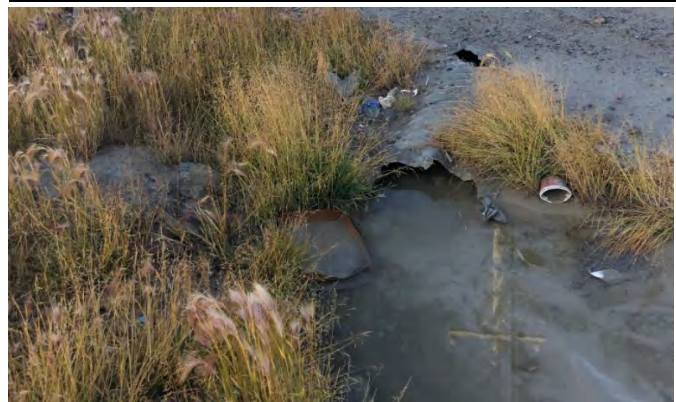
Culvert Information				
Culvert ID	136-04			
Type	Cross			
Shape	Circular			
Material	CSP			
Diameter or Dimensions (mm)	500			
Marker Post Present	N			
Barrel Length (m)	11.2			
Approx. Barrel Slope (%)	0.3%			
Approx. Depth of Cover (m)	250			
End	Upstream			
Crushing	Downstream			
Infill Depth (mm)	Upstream			
	Downstream			
Other Comments	Debris & sediment blocking culvert			
Culvert Elevations (masl) ²				
Upstream		Downstream		Road Crown
Invert	Obvert	Invert	Obvert	
22.86	23.12	22.83	23.14

Culvert Condition Ratings (MTO 2013)				
Barrel Material (0-4)	Shape (0-4)	Capacity (0-2)	Erosion and Scour (0-2)	US/DS Channel (0-2)
1	4	2	0	1

Recommended Action(s):	Replace culvert	Priority:	High
------------------------	-----------------	-----------	------

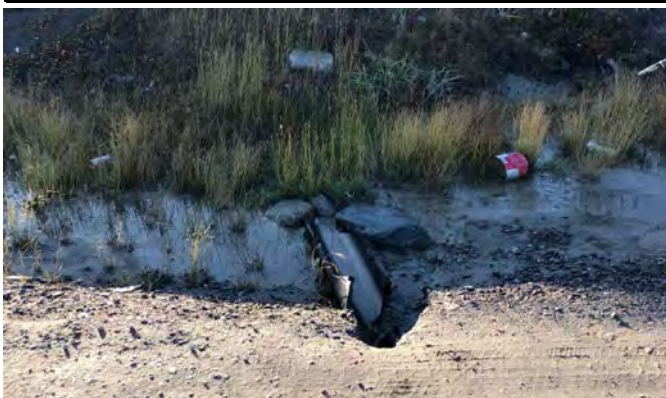
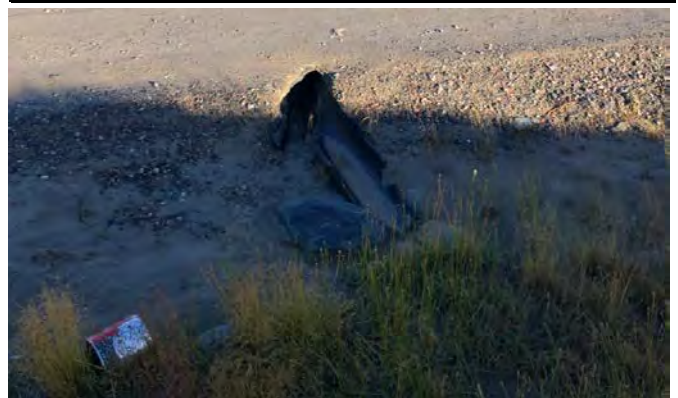
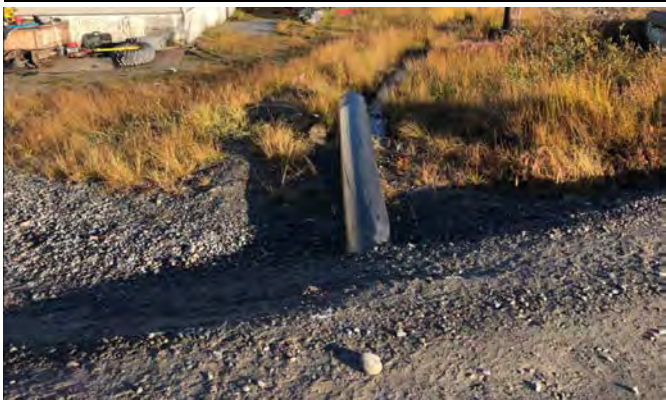
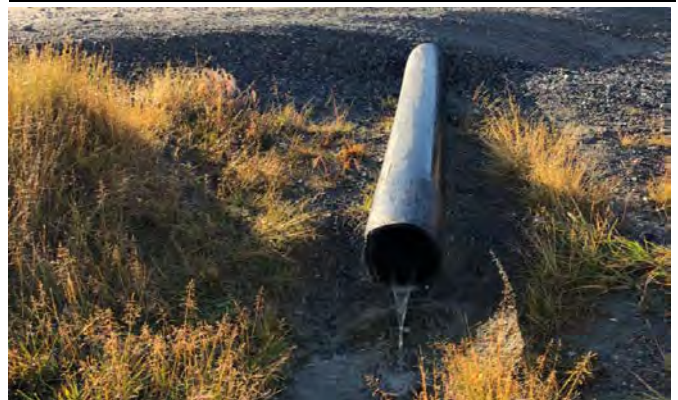
Culvert Information	
Culvert ID	137-01
Type	Cross
Shape	Circular
Material	PVC
Diameter or Dimensions (mm)	200
Marker Post Present	N
Barrel Length (m)	10.1
Approx. Barrel Slope (%)	2.2%
Approx. Depth of Cover (m)	105
End	Upstream
Crushing	Downstream
Infill Depth (mm)	Upstream
	Downstream
Other Comments	Likely bent path. Scouring DS end, perched 0.4 m

Culvert Condition Ratings (MTO 2013)				
Barrel Material (0-4)	Shape (0-4)	Capacity (0-2)	Erosion and Scour (0-2)	US/DS Channel (0-2)
1	4	0	0	1

Recommended Action(s):	Replace culvert	Priority:	High
------------------------	-----------------	-----------	------

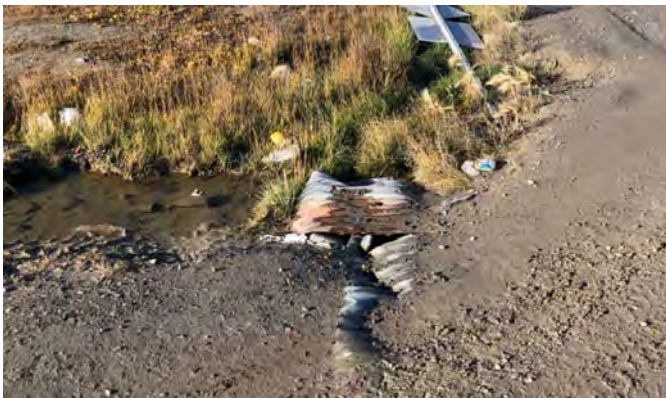
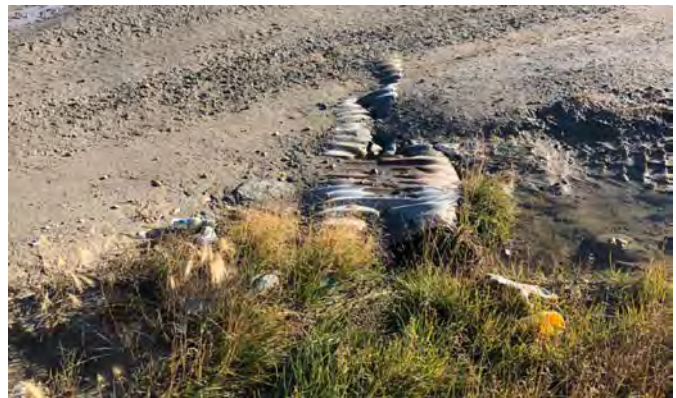
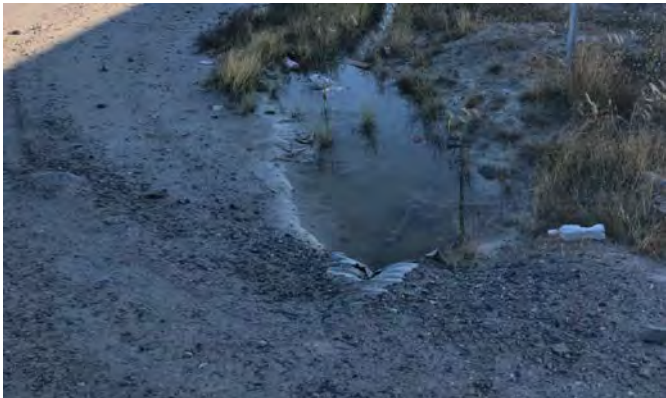
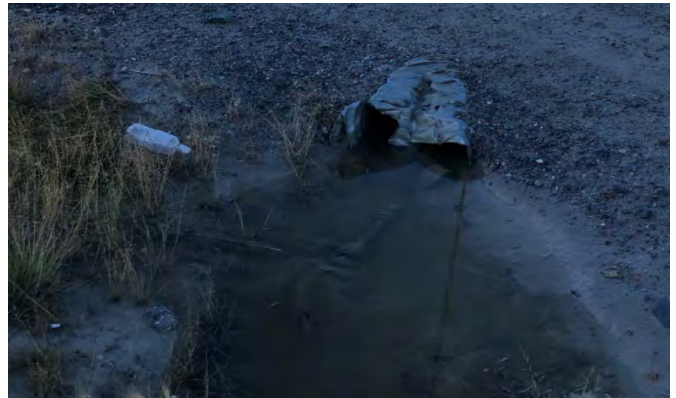
Culvert Information				
Culvert ID	137-02			
Type	Cross			
Shape	Circular			
Material	CSP			
Diameter or Dimensions (mm)	400			
Marker Post Present	N			
Barrel Length (m)	11.4			
Approx. Barrel Slope (%)	0.8%			
Approx. Depth of Cover (m)	260			
End	Upstream	Y		
Crushing	Downstream	Y		
Infill Depth (mm)	Upstream	50		
	Downstream	50		
Other Comments	Standing water @ DS, blockage US. Very crushed. Put in an extension US because it is crushed and			
Culvert Elevations (masl) ²				
Upstream		Downstream	Road Crown	
Invert	Obvert	Invert		Obvert
22.22	22.54	22.13	22.48	22.77

Culvert Condition Ratings (MTO 2013)				
Barrel Material (0-4)	Shape (0-4)	Capacity (0-2)	Erosion and Scour (0-2)	US/DS Channel (0-2)
1	3	1	0	0

Recommended Action(s):	Clear blockage, repair culvert end	Priority:	High
------------------------	------------------------------------	-----------	------

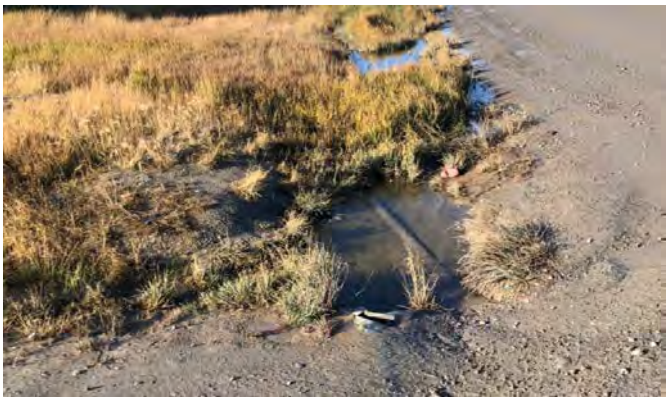
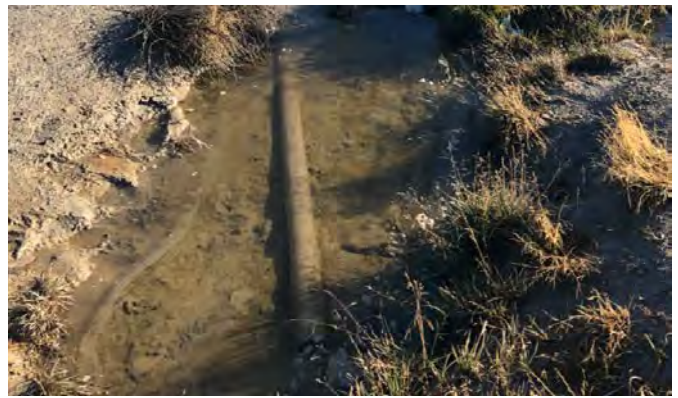
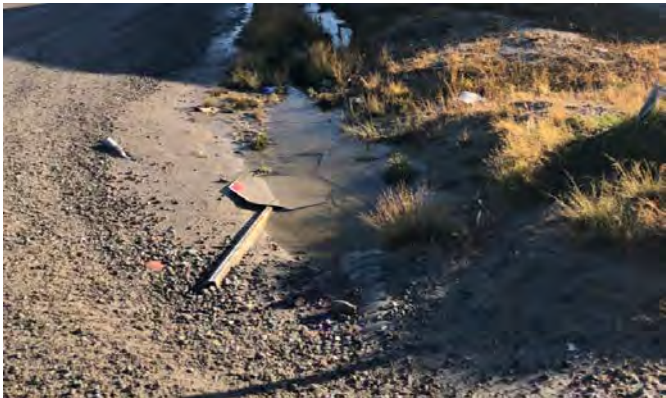
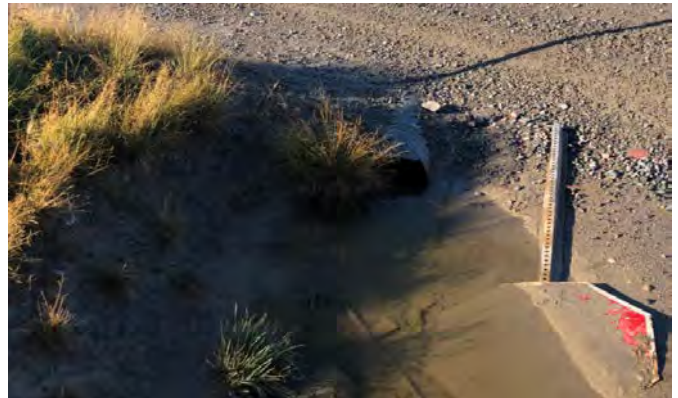
Culvert Information				
Culvert ID	137-03			
Type	Cross			
Shape	Circular			
Material	CSP			
Diameter or Dimensions (mm)	400			
Marker Post Present	N			
Barrel Length (m)	11.5			
Approx. Barrel Slope (%)	0.1%			
Approx. Depth of Cover (m)	270			
End	Upstream			
Crushing	Downstream			
Infill Depth (mm)	Upstream			
	Downstream			
Other Comments	Standing water @ US & DS ends, ditching improvements			
Culvert Elevations (masl) ²				
Upstream		Downstream		Road Crown
Invert	Obvert	Invert	Obvert	
21.49	21.84	21.48	21.88

Culvert Condition Ratings (MTO 2013)				
Barrel Material (0-4)	Shape (0-4)	Capacity (0-2)	Erosion and Scour (0-2)	US/DS Channel (0-2)
1	3	1	0	1

Recommended Action(s):	Clear blockage, repair culvert end	Priority:	High
------------------------	------------------------------------	-----------	------

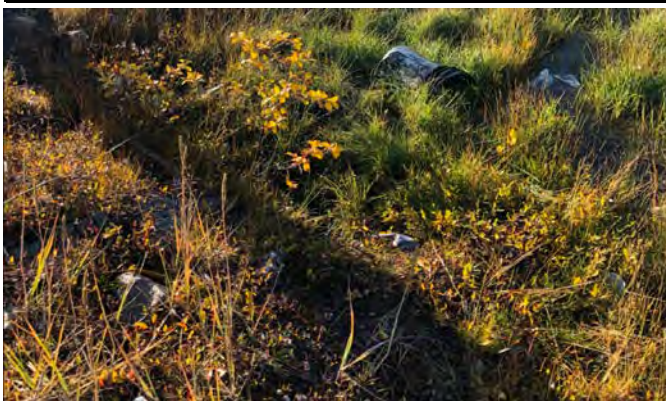
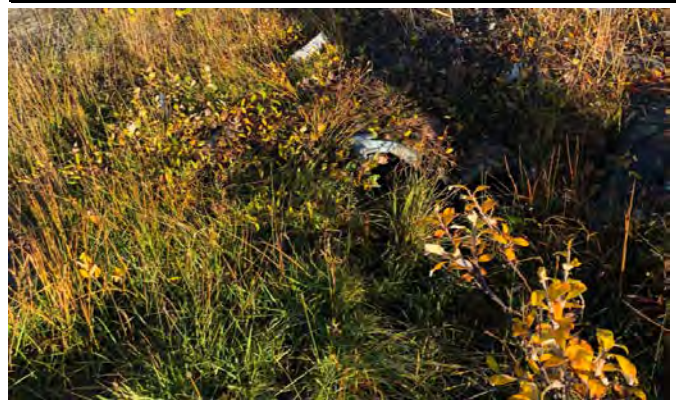
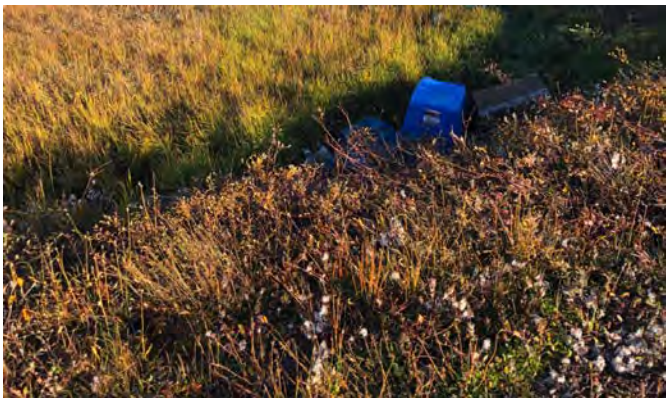
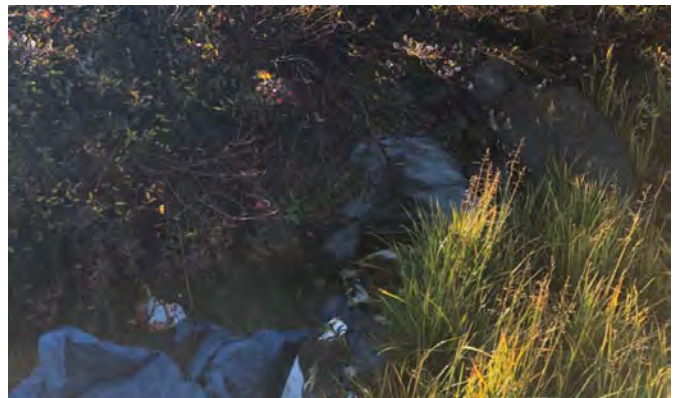
Culvert Condition Ratings (MTO 2013)				
Barrel Material (0-4)	Shape (0-4)	Capacity (0-2)	Erosion and Scour (0-2)	US/DS Channel (0-2)
1	3	1	0	0

Culvert Information				
Culvert ID	137-05			
Type	Entrance			
Shape	Circular			
Material	CSP			
Diameter or Dimensions (mm)	300			
Marker Post Present	N			
Barrel Length (m)	5.1			
Approx. Barrel Slope (%)	-0.4%			
Approx. Depth of Cover (m)	70			
End	Upstream	Y		
	Downstream	Y		
Infill Depth (mm)	Upstream	100		
	Downstream	0		
Other Comments	Entrance culvert			
Culvert Elevations (masl) ²				
Upstream		Downstream	Road Crown	
Invert	Obvert	Invert		Obvert
21.77	22	21.79	21.96	22.05

Recommended Action(s):	Clear blockage, repair culvert end	Priority:	High
------------------------	------------------------------------	-----------	------

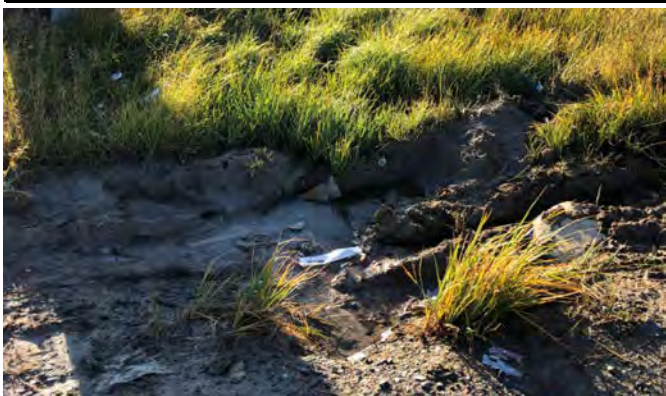
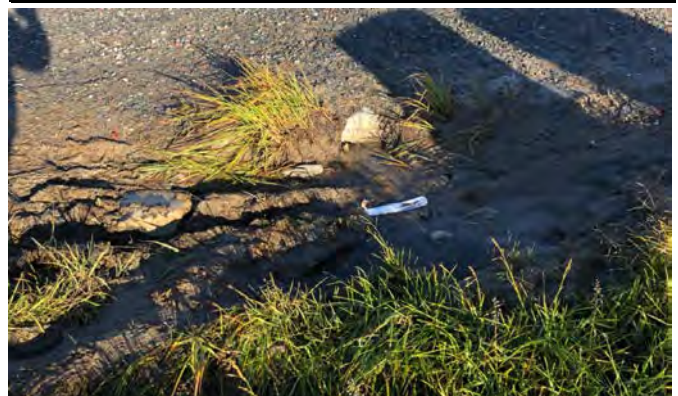
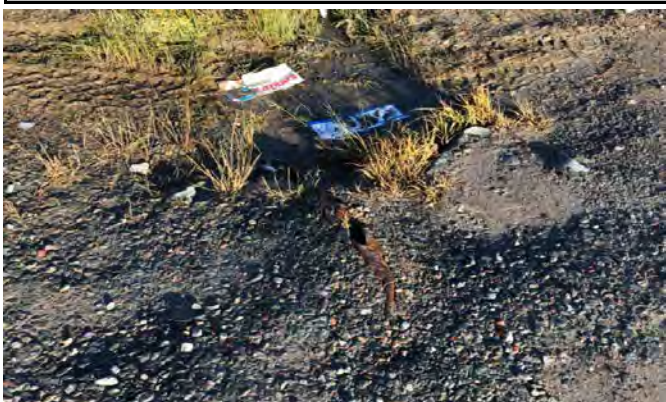
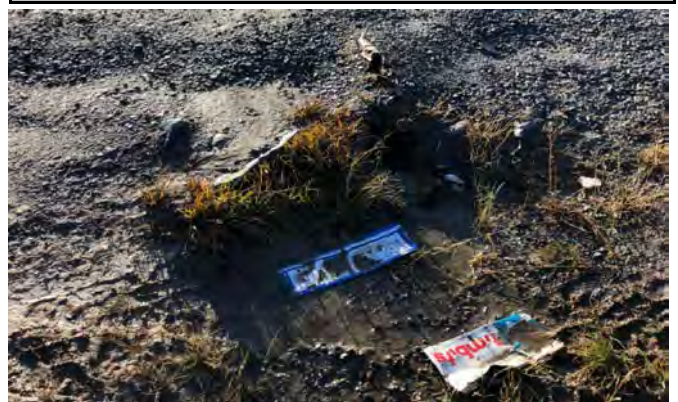
Culvert Condition Ratings (MTO 2013)				
Barrel Material (0-4)	Shape (0-4)	Capacity (0-2)	Erosion and Scour (0-2)	US/DS Channel (0-2)
1	4	2	0	0

Culvert Information				
Culvert ID	137-06			
Type	Entrance			
Shape	Circular			
Material	CSP			
Diameter or Dimensions (mm)	300			
Marker Post Present	N			
Barrel Length (m)	6.0			
Approx. Barrel Slope (%)	1.5%			
Approx. Depth of Cover (m)	175			
End	Upstream			
Crushing	Downstream			
Infill Depth (mm)	Upstream			
	Downstream			
Other Comments	US end partial blockage by vegetation			
Culvert Elevations (masl) ²				
Upstream		Downstream		Road Crown
Invert	Obvert	Invert	Obvert	
21.63	21.86	21.54	21.75	21.98

Recommended Action(s):	Replace culvert	Priority:	High
------------------------	-----------------	-----------	------

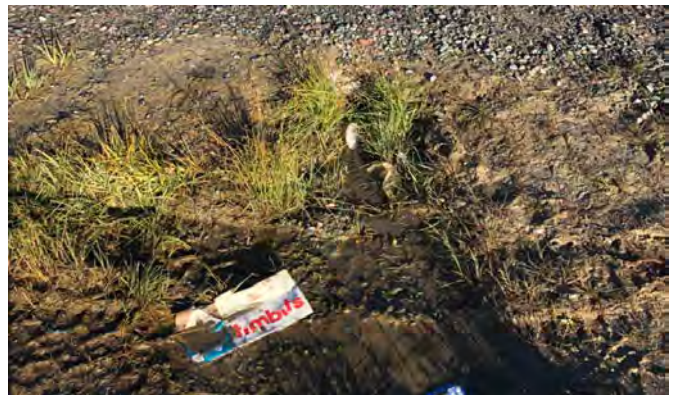
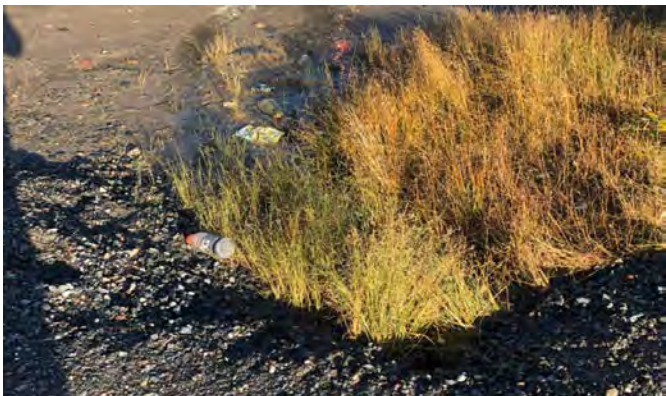
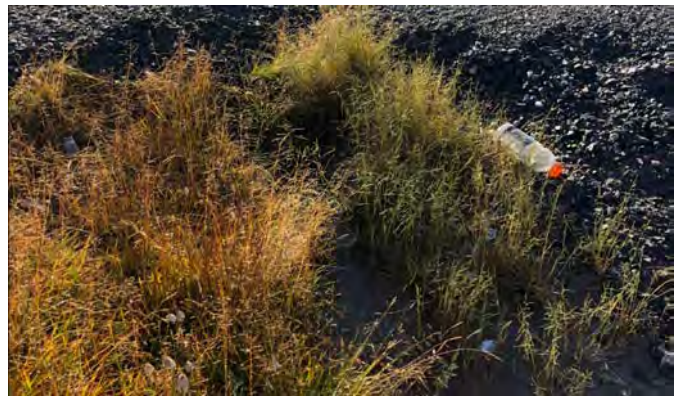
Culvert Condition Ratings (MTO 2013)				
Barrel Material (0-4)	Shape (0-4)	Capacity (0-2)	Erosion and Scour (0-2)	US/DS Channel (0-2)
1	1	2	0	0

Culvert Information				
Culvert ID	137-07			
Type	Cross			
Shape	Circular			
Material	CSP			
Diameter or Dimensions (mm)	400			
Marker Post Present	N			
Barrel Length (m)	11.2			
Approx. Barrel Slope (%)	4.3%			
Approx. Depth of Cover (m)	505			
End	Upstream	Y		
	Downstream	Y		
Crushing	Upstream	Y		
	Downstream	Y		
Infill Depth (mm)	Upstream	0		
	Downstream	150		
Other Comments	Vegetation at DS end impacting conveyance			
Culvert Elevations (masl) ²				
Upstream		Downstream	Road Crown	
Invert	Obvert	Invert		Obvert
20.84	21.17	20.36	20.7	21.44

Recommended Action(s):	Clear blockage	Priority:	High
------------------------	----------------	-----------	------

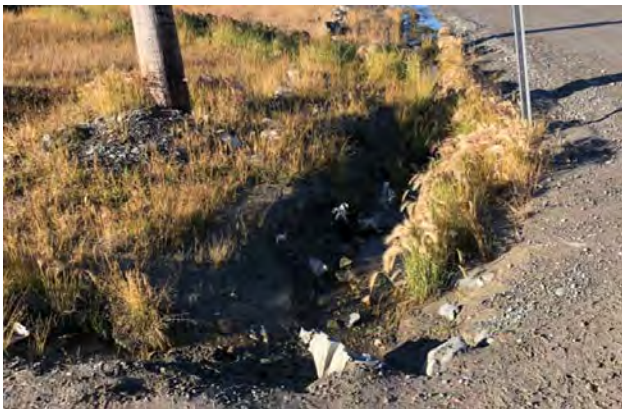
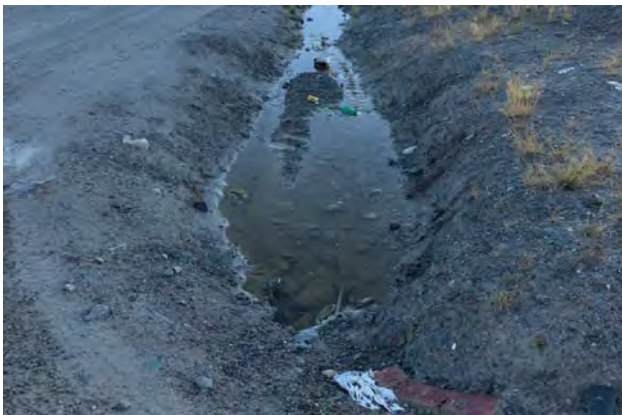
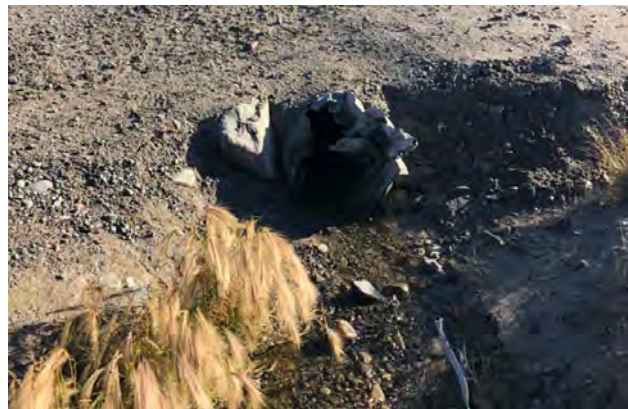
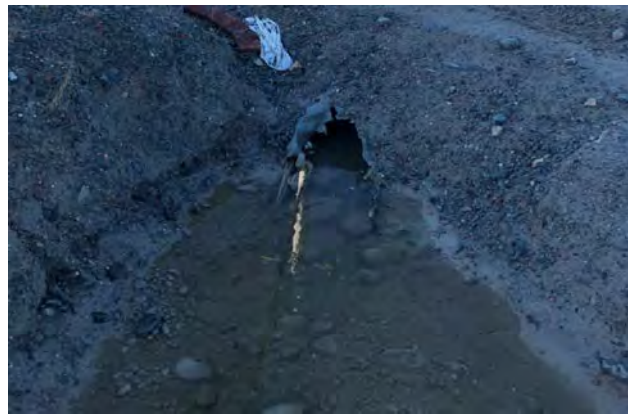
Culvert Condition Ratings (MTO 2013)				
Barrel Material (0-4)	Shape (0-4)	Capacity (0-2)	Erosion and Scour (0-2)	US/DS Channel (0-2)
1	2	2	1	0

Culvert Information				
Culvert ID	138-01			
Type	Entrance			
Shape	Circular			
Material	PVC			
Diameter or Dimensions (mm)	200			
Marker Post Present	N			
Barrel Length (m)	-			
Approx. Barrel Slope (%)	N/A			
Approx. Depth of Cover (m)	540			
End	Upstream			
Crushing	Downstream			
Infill Depth (mm)	Upstream			
	Downstream			
Other Comments	US end not found. Likely under parking lot. DS buried, not functional			
Culvert Elevations (masl) ²				
Upstream		Downstream		Road Crown
Invert	Obvert	Invert	Obvert	
-	-	22.72	22.79	23.33

Recommended Action(s):	Clear blockage, repair culvert end	Priority:	High
------------------------	------------------------------------	-----------	------

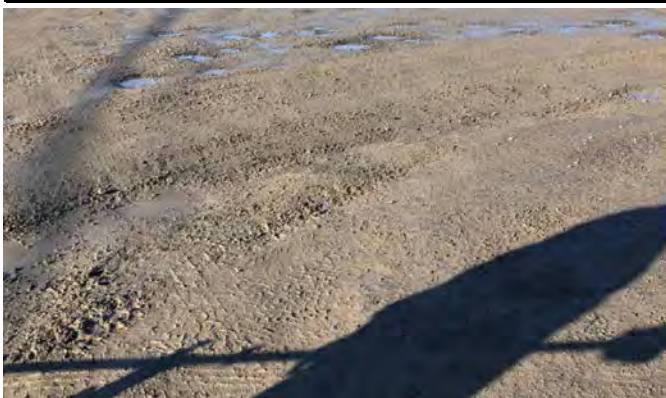
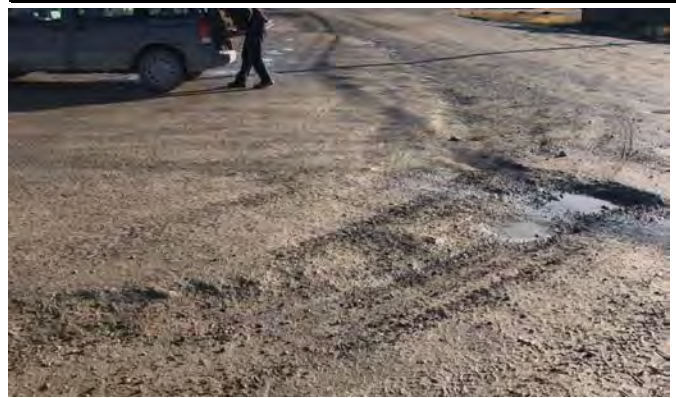
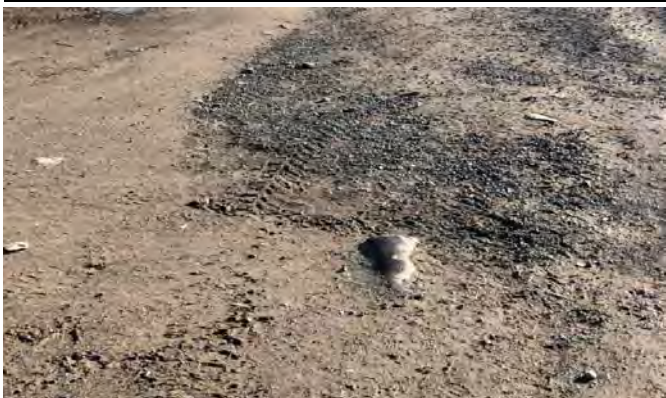
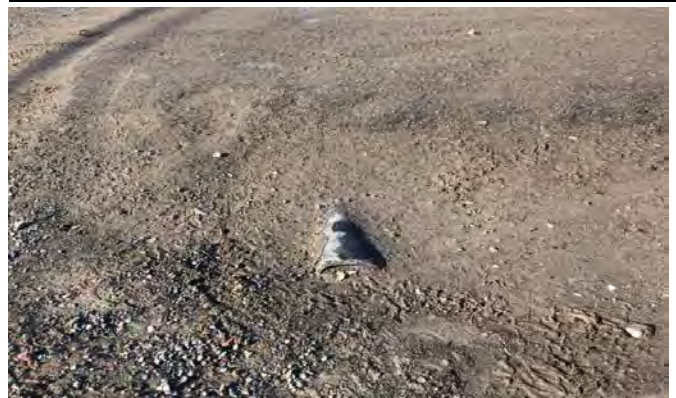
Culvert Condition Ratings (MTO 2013)				
Barrel Material (0-4)	Shape (0-4)	Capacity (0-2)	Erosion and Scour (0-2)	US/DS Channel (0-2)
0	0	2	0	0

Culvert Information				
Culvert ID	138-02			
Type	Entrance			
Shape	Circular			
Material	SWSP			
Diameter or Dimensions (mm)	150			
Marker Post Present	N			
Barrel Length (m)	12.9			
Approx. Barrel Slope (%)	2.6%			
Approx. Depth of Cover (m)	310			
End	Upstream	N		
Crushing	Downstream	N		
Infill Depth (mm)	Upstream	0		
	Downstream	50		
Other Comments	Likely undersized causing ponding and rutted area US			
Culvert Elevations (masl) ²				
Upstream		Downstream	Road Crown	
Invert	Obvert	Invert		Obvert
22.32	22.45	21.99	22.19	22.63

Recommended Action(s):	Clear blockage	Priority:	High
------------------------	----------------	-----------	------

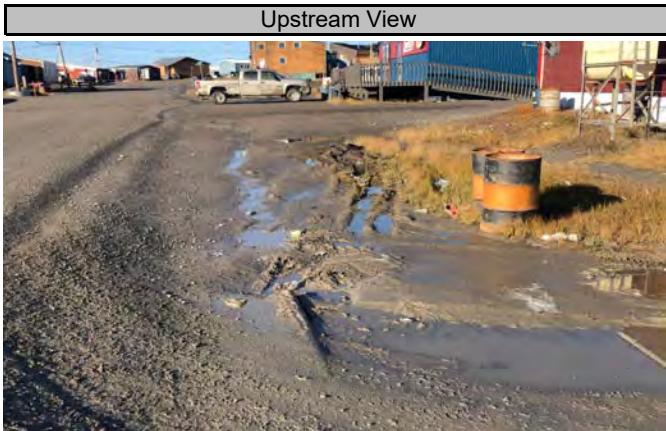
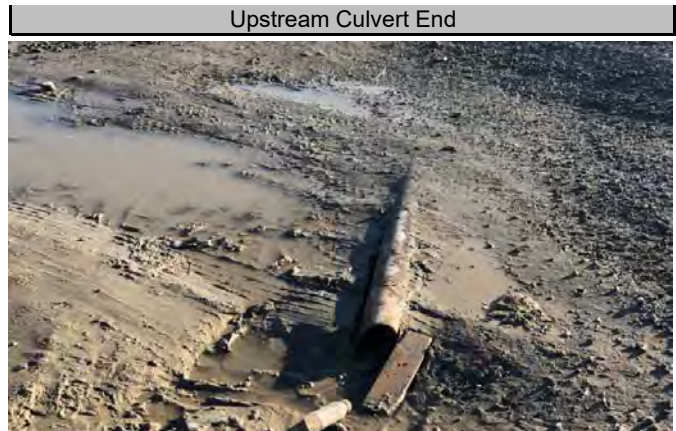
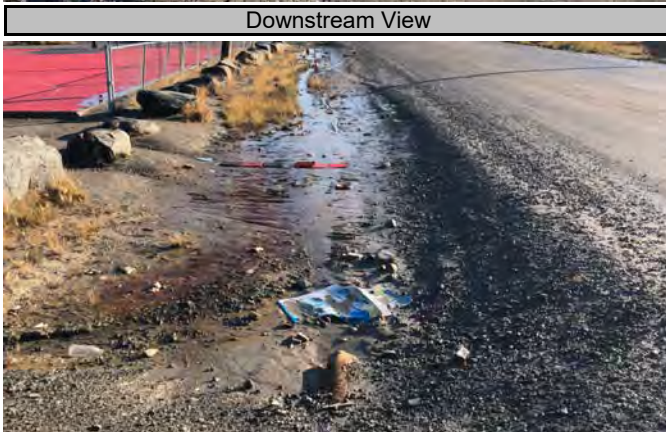
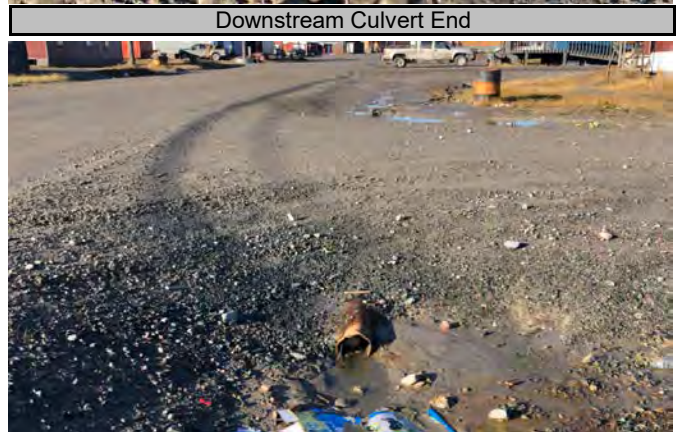
Culvert Condition Ratings (MTO 2013)				
Barrel Material (0-4)	Shape (0-4)	Capacity (0-2)	Erosion and Scour (0-2)	US/DS Channel (0-2)
2	0	2	0	0

Culvert Information				
Culvert ID	138-03			
Type	Entrance			
Shape	Circular			
Material	CSP			
Diameter or Dimensions (mm)	400			
Marker Post Present	N			
Barrel Length (m)	6.4			
Approx. Barrel Slope (%)	0.0%			
Approx. Depth of Cover (m)	120			
End	Upstream	Y		
	Downstream	Y		
Crushing	Upstream	Y		
	Downstream	Y		
Infill Depth (mm)	Upstream	0		
	Downstream	50		
Other Comments	Poor ditching to DS end from problem area. Some of playground drains to US side of culvert. Poor			
Culvert Elevations (masl) ²				
Upstream		Downstream	Road Crown	
Invert	Obvert	Invert		Obvert
21.69	21.97	21.69	21.91	22.06

Recommended Action(s):	Monitor Rusting, clean blockage and sediment	Priority:	High
------------------------	----------------------------------------------	-----------	------

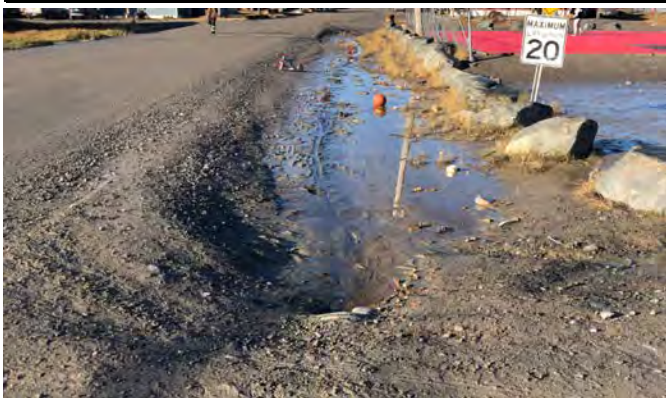
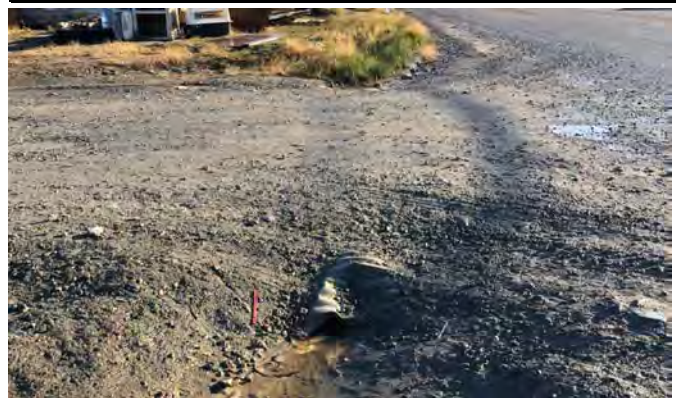
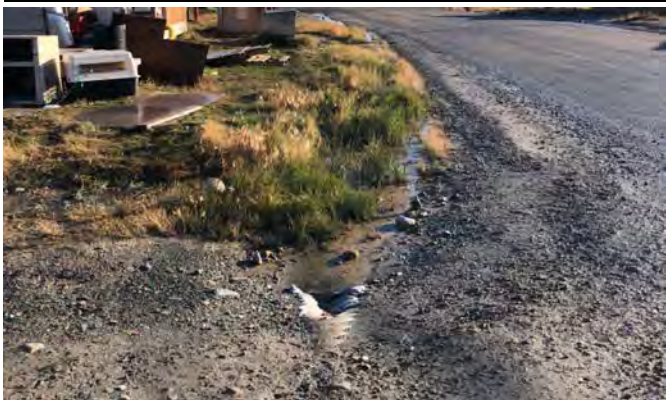
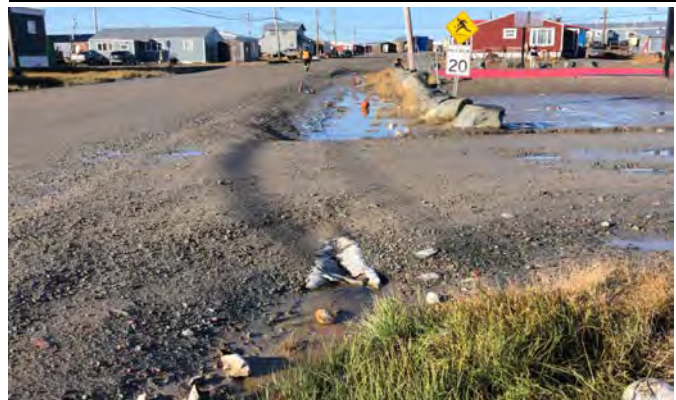
Culvert Condition Ratings (MTO 2013)				
Barrel Material (0-4)	Shape (0-4)	Capacity (0-2)	Erosion and Scour (0-2)	US/DS Channel (0-2)
1	4	1	0	0

Culvert Information				
Culvert ID	138-04			
Type	Cross			
Shape	Circular			
Material	CSP			
Diameter or Dimensions (mm)	400			
Marker Post Present	N			
Barrel Length (m)	11.7			
Approx. Barrel Slope (%)	2.7%			
Approx. Depth of Cover (m)	385			
End	Upstream	Y		
	Downstream	Y		
Crushing	Upstream	Y		
	Downstream	Y		
Infill Depth (mm)	Upstream	0		
	Downstream	100		
Other Comments	Vegetation & sedimentation at DS end impacting conveyance			
Culvert Elevations (masl) ²				
Upstream		Downstream	Road Crown	
Invert	Obvert	Invert		Obvert
20.98	21.29	20.66		20.94

Recommended Action(s):	Replace culvert	Priority:	High
------------------------	-----------------	-----------	------

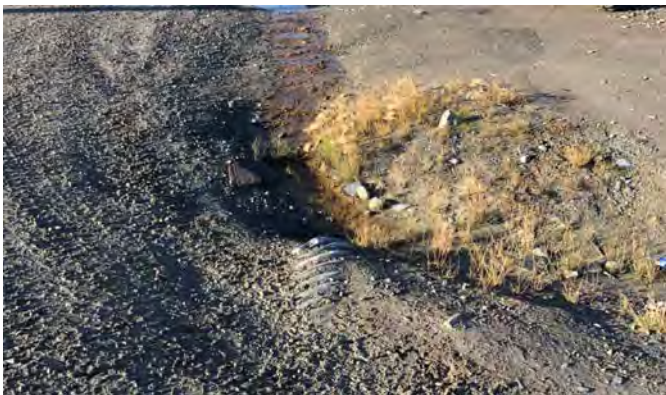
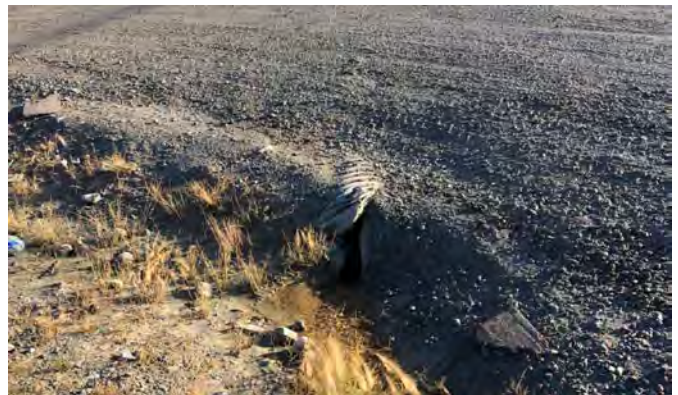
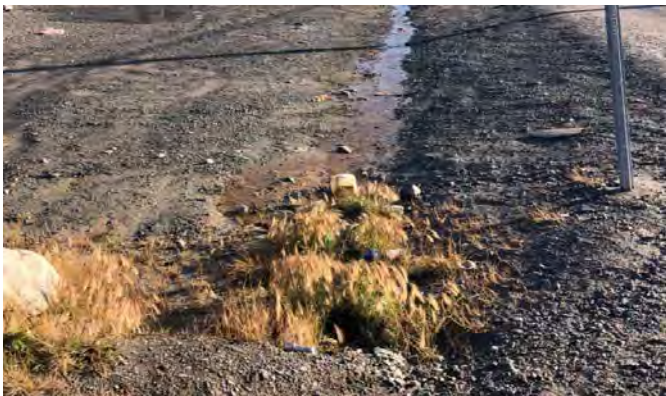
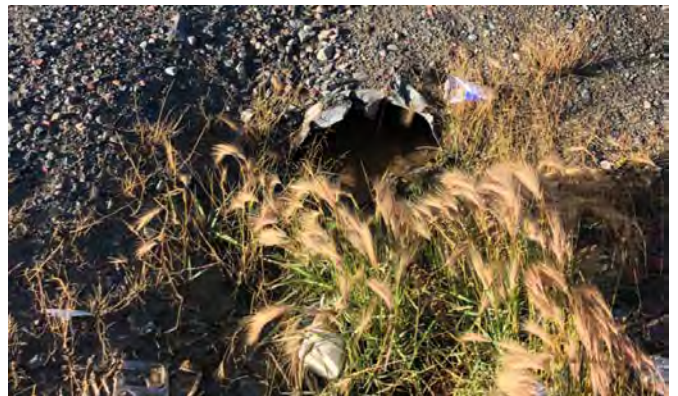
Culvert Condition Ratings (MTO 2013)				
Barrel Material (0-4)	Shape (0-4)	Capacity (0-2)	Erosion and Scour (0-2)	US/DS Channel (0-2)
1	4	1	0	1

Culvert Information				
Culvert ID	138-05			
Type	Cross			
Shape	Circular			
Material	PVC			
Diameter or Dimensions (mm)	200			
Marker Post Present	N			
Barrel Length (m)	12.2			
Approx. Barrel Slope (%)	2.5%			
Approx. Depth of Cover (m)	280			
End	Upstream			
Crushing	Downstream			
Infill Depth (mm)	Upstream			
	Downstream			
Other Comments	0			
Culvert Elevations (masl) ²				
Upstream		Downstream		Road Crown
Invert	Obvert	Invert	Obvert	
20.74	20.97	20.44	20.61

Recommended Action(s):	Replace culvert	Priority:	High
------------------------	-----------------	-----------	------

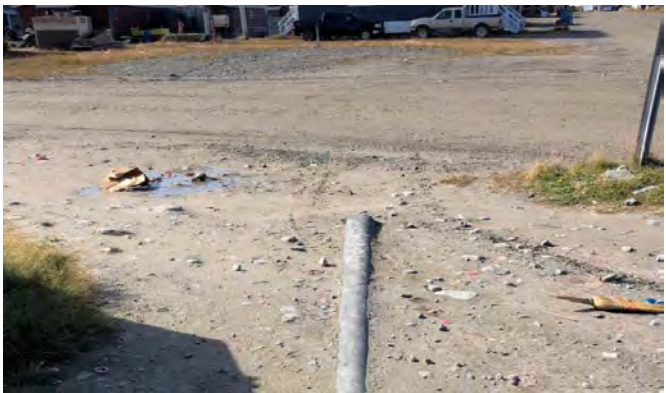
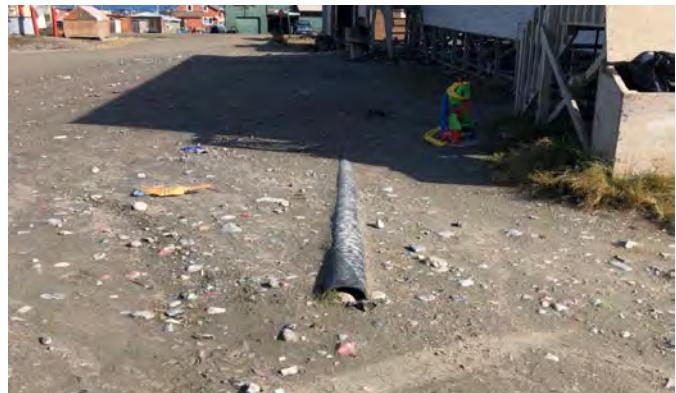
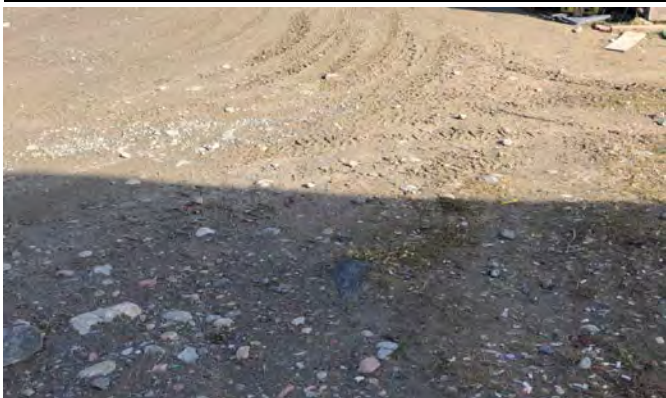
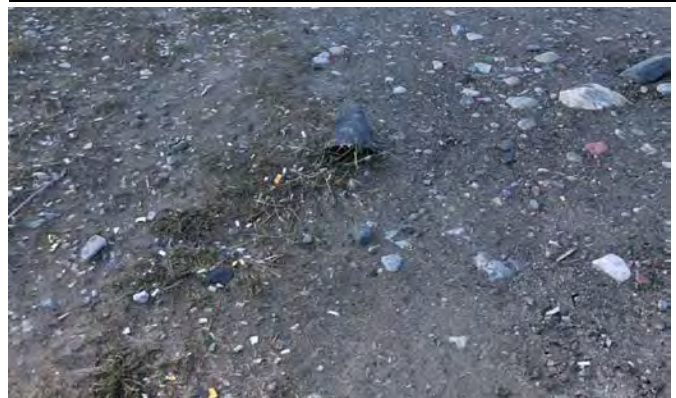
Culvert Condition Ratings (MTO 2013)				
Barrel Material (0-4)	Shape (0-4)	Capacity (0-2)	Erosion and Scour (0-2)	US/DS Channel (0-2)
0	0	2	0	0

Culvert Information				
Culvert ID	138-06			
Type	Cross			
Shape	Circular			
Material	CSP			
Diameter or Dimensions (mm)	600			
Marker Post Present	N			
Barrel Length (m)	11.6			
Approx. Barrel Slope (%)	2.6%			
Approx. Depth of Cover (m)	460			
End	Upstream			
Crushing	Downstream			
Infill Depth (mm)	Upstream			
	Downstream			
Other Comments	Reduced capacity due to infilling			
Culvert Elevations (masl) ²				
Upstream		Downstream		Road Crown
Invert	Obvert	Invert	Obvert	
16.49	16.89	16.19	16.51

Recommended Action(s):	Clear blockage	Priority:	High
------------------------	----------------	-----------	------

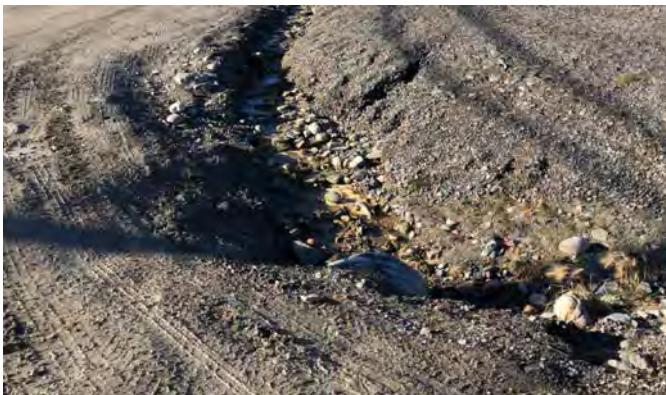
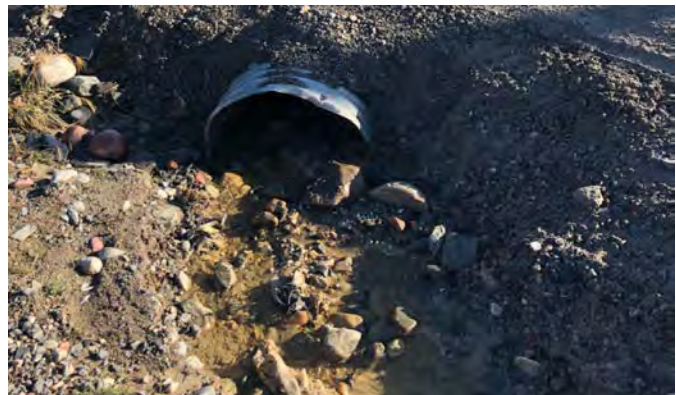
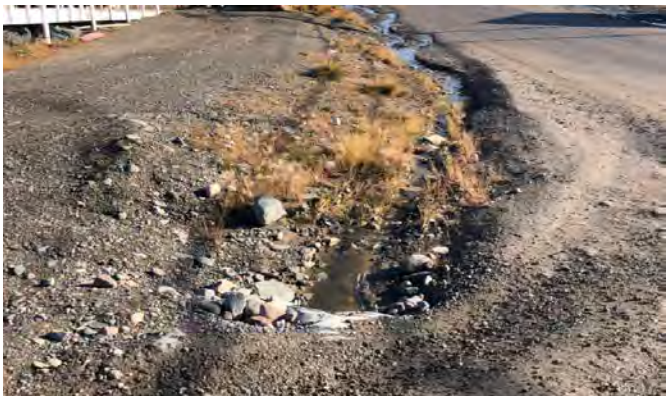
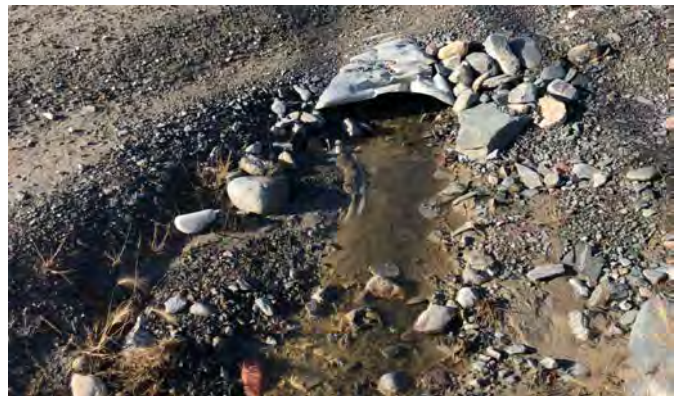
Culvert Condition Ratings (MTO 2013)				
Barrel Material (0-4)	Shape (0-4)	Capacity (0-2)	Erosion and Scour (0-2)	US/DS Channel (0-2)
1	2	2	0	1

Recommended Action(s):	Clear blockage, repair culvert end	Priority:	High
------------------------	------------------------------------	-----------	------

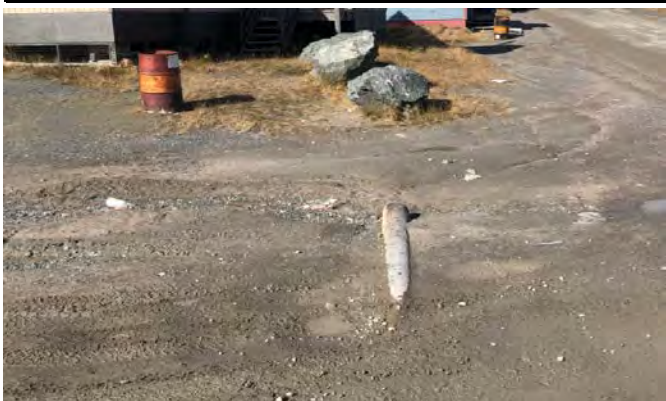
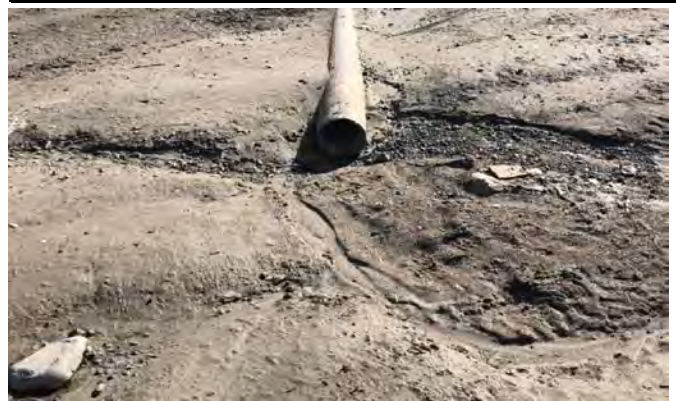
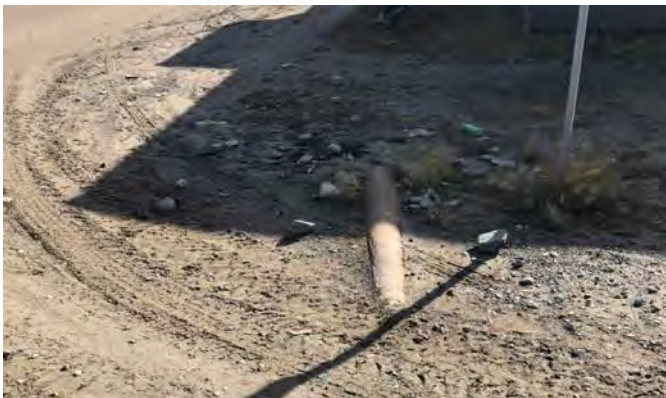
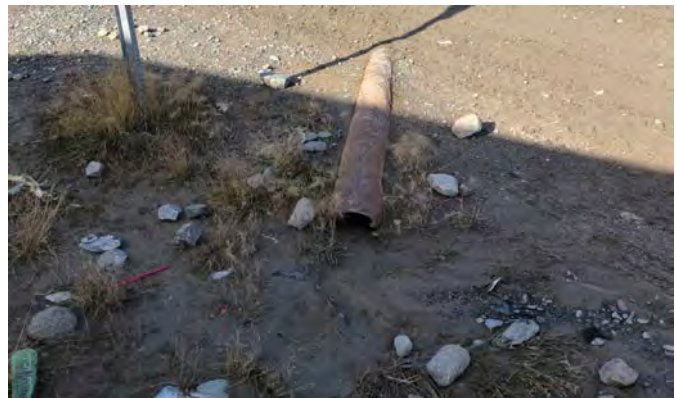
Culvert Condition Ratings (MTO 2013)				
Barrel Material (0-4)	Shape (0-4)	Capacity (0-2)	Erosion and Scour (0-2)	US/DS Channel (0-2)
2	0	2	1	0

Recommended Action(s):	Monitor Rusting, clear blockage	Priority:	High
------------------------	---------------------------------	-----------	------

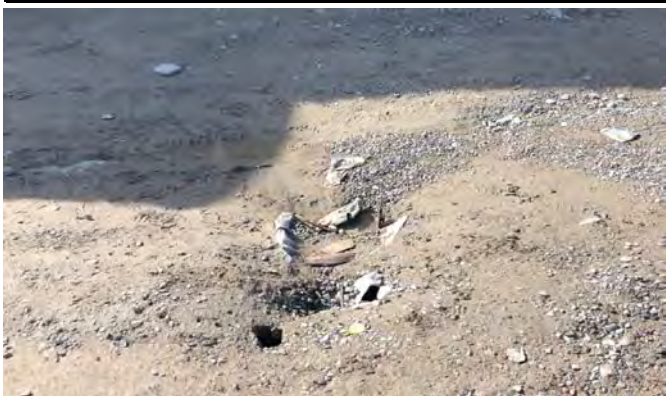
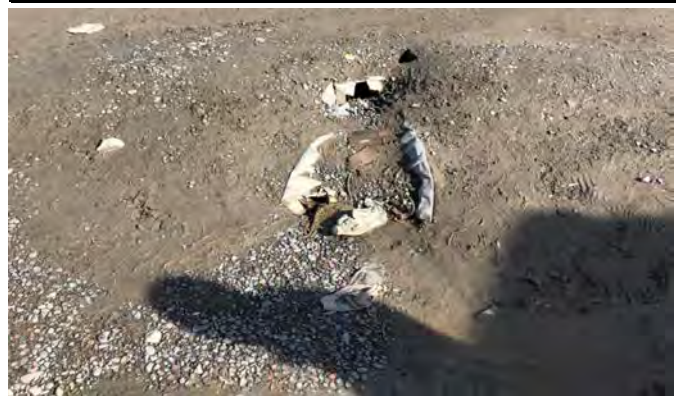
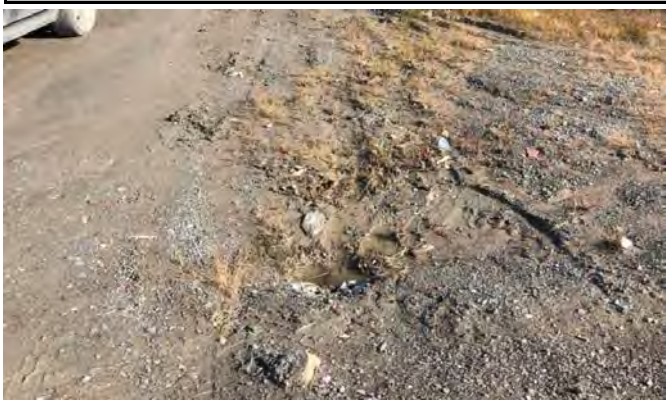
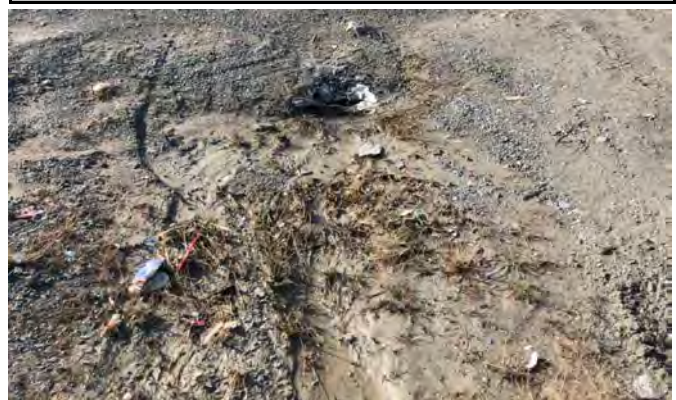
Culvert Information				
Culvert ID	138-08			
Type	Cross			
Shape	Circular			
Material	CSP			
Diameter or Dimensions (mm)	400			
Marker Post Present	N			
Barrel Length (m)	11.4			
Approx. Barrel Slope (%)	2.9%			
Approx. Depth of Cover (m)	315			
End	Upstream			
Crushing	Downstream			
Infill Depth (mm)	Upstream			
	Downstream			
Other Comments	Backyard drainage			
Culvert Elevations (masl) ²				
Upstream		Downstream		Road Crown
Invert	Obvert	Invert	Obvert	
20.23	20.49	19.9	20.08

Culvert Condition Ratings (MTO 2013)				
Barrel Material (0-4)	Shape (0-4)	Capacity (0-2)	Erosion and Scour (0-2)	US/DS Channel (0-2)
0	4	1	0	0

Recommended Action(s):	Replace culvert	Priority:	High
------------------------	-----------------	-----------	------

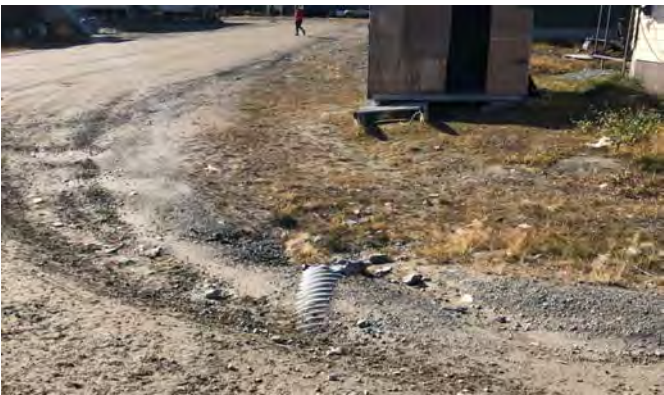
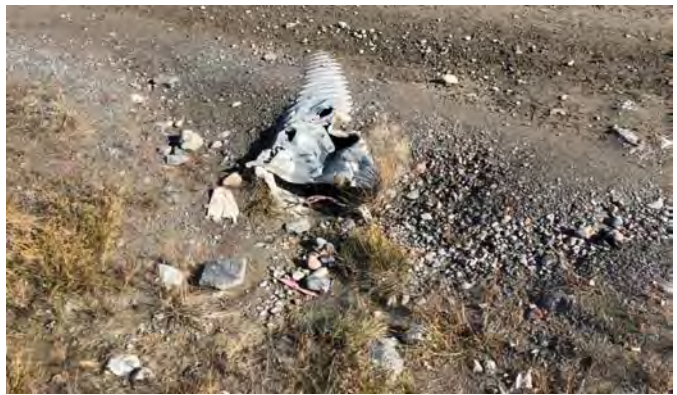
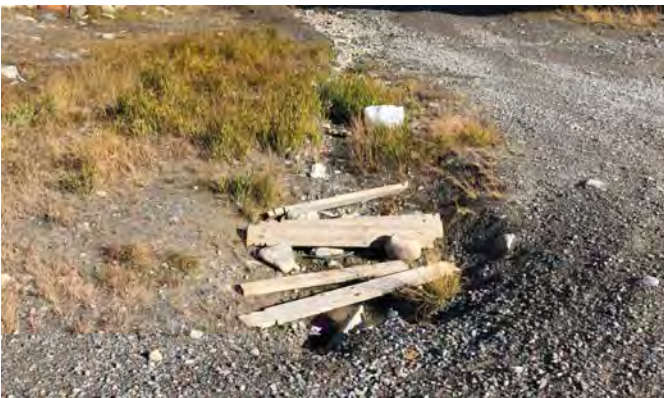
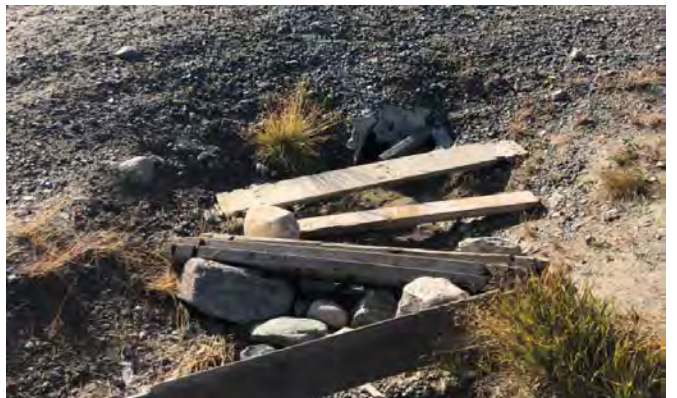
Culvert Information				
Culvert ID	138-09			
Type	Cross			
Shape	Circular			
Material	CSP			
Diameter or Dimensions (mm)	400			
Marker Post Present	N			
Barrel Length (m)	11.2			
Approx. Barrel Slope (%)	4.7%			
Approx. Depth of Cover (m)	440			
End	Upstream			
Crushing	Downstream			
Infill Depth (mm)	Upstream			
	Downstream			
Other Comments	Debris in DS end. Backyard drainage			
Culvert Elevations (masl) ²				
Upstream		Downstream		Road Crown
Invert	Obvert	Invert	Obvert	
18.41	18.78	17.88	18.28

Culvert Condition Ratings (MTO 2013)				
Barrel Material (0-4)	Shape (0-4)	Capacity (0-2)	Erosion and Scour (0-2)	US/DS Channel (0-2)
1	4	1	0	0

Recommended Action(s):	Replace culvert	Priority:	High
------------------------	-----------------	-----------	------
