**Geotechnical Evaluation and Drainage Planning
in Rankin Inlet, Nunavut**

Draft Report
REV-00

Prepared for:
The Municipality of Rankin Inlet

Prepared by:
Nunami Stantec Limited

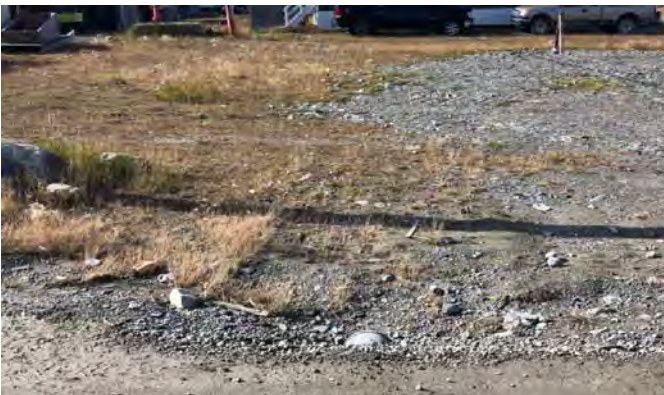
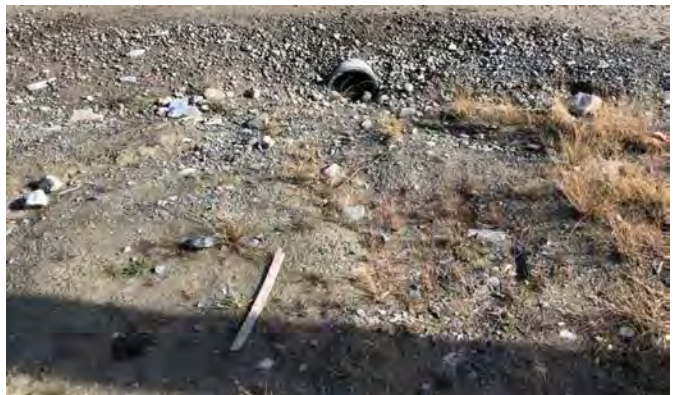
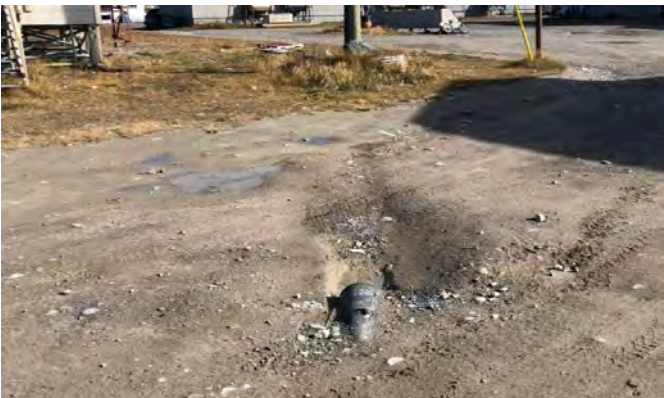
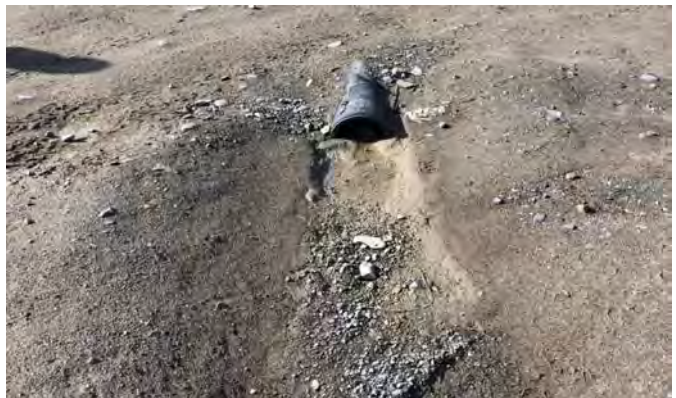
Culvert Condition Ratings (MTO 2013)				
Barrel Material (0-4)	Shape (0-4)	Capacity (0-2)	Erosion and Scour (0-2)	US/DS Channel (0-2)
0	0	2	0	1

Recommended Action(s):	Clear blockage	Priority:	High
------------------------	----------------	-----------	------

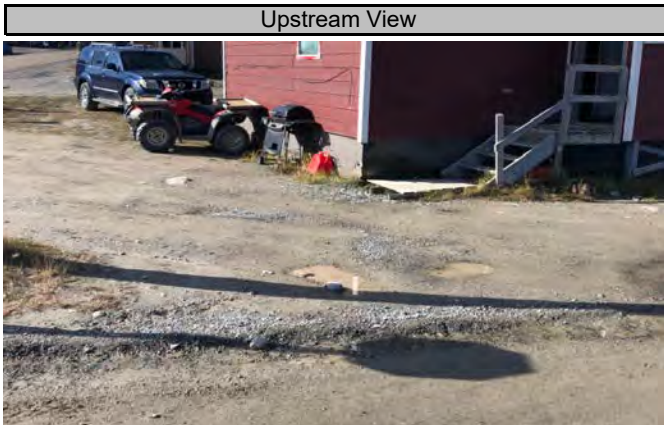
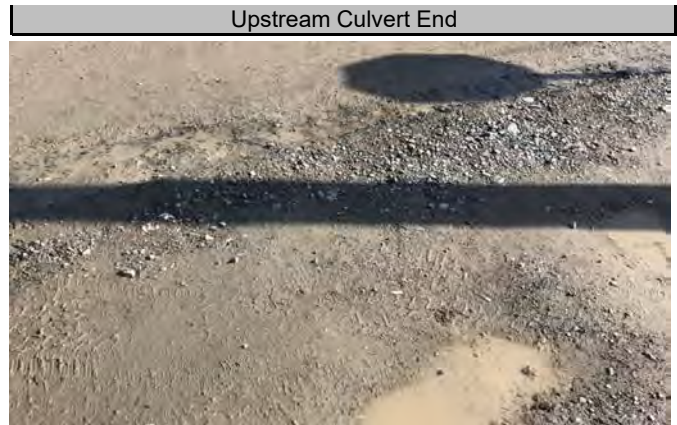
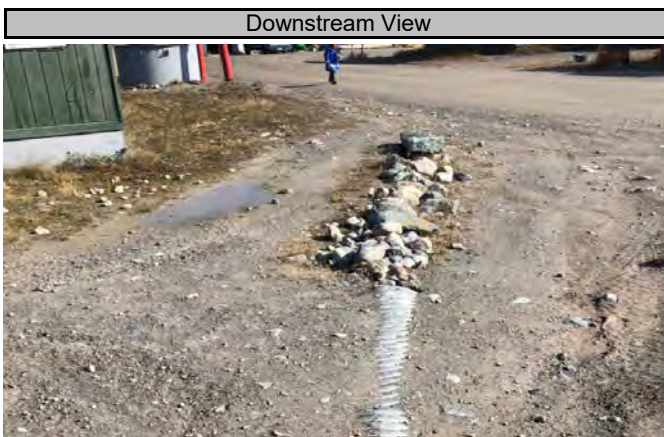
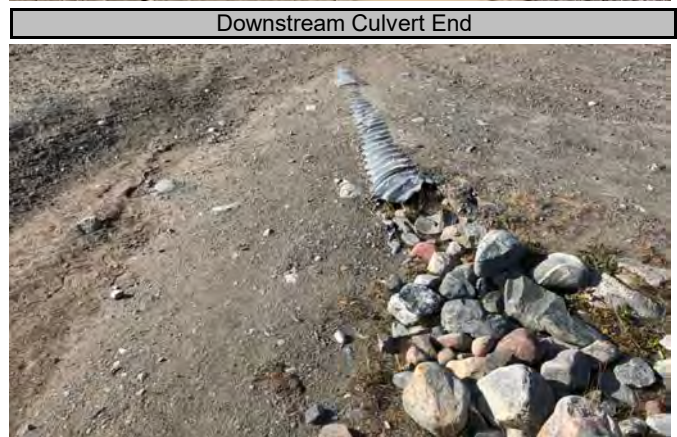
Culvert Information				
Culvert ID	138-11			
Type	Cross			
Shape	Circular			
Material	CSP			
Diameter or Dimensions (mm)	400			
Marker Post Present	N			
Barrel Length (m)	-			
Approx. Barrel Slope (%)	N/A			
Approx. Depth of Cover (m)	360			
End	Upstream	N/A		
Crushing	Downstream	Y		
Infill Depth (mm)	Upstream	N/A		
	Downstream	400		
Other Comments	Couldn't locate US end - Likely buried			
Culvert Elevations (masl) ²				
Upstream		Downstream	Road Crown	
Invert	Obvert	Invert		Obvert
-	-	20.12	20.31	20.67

Culvert Condition Ratings (MTO 2013)				
Barrel Material (0-4)	Shape (0-4)	Capacity (0-2)	Erosion and Scour (0-2)	US/DS Channel (0-2)
1	2	2	0	0

Recommended Action(s):	Clear blockage, repair culvert end	Priority:	High
------------------------	------------------------------------	-----------	------

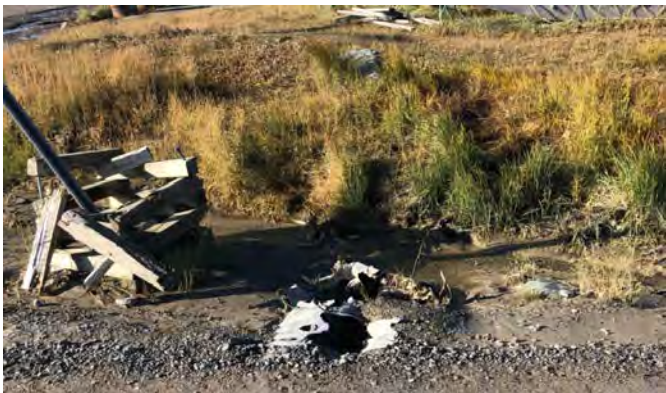
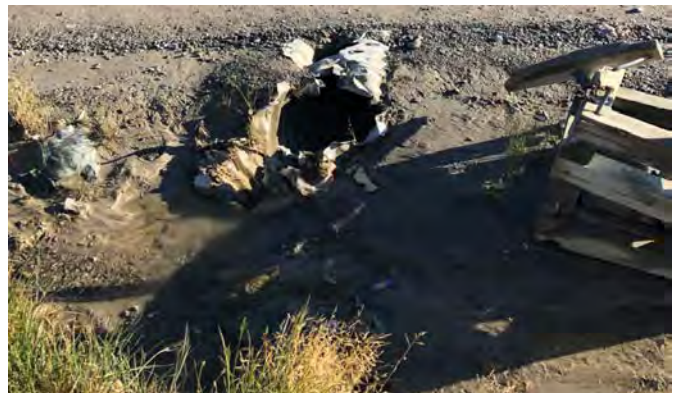
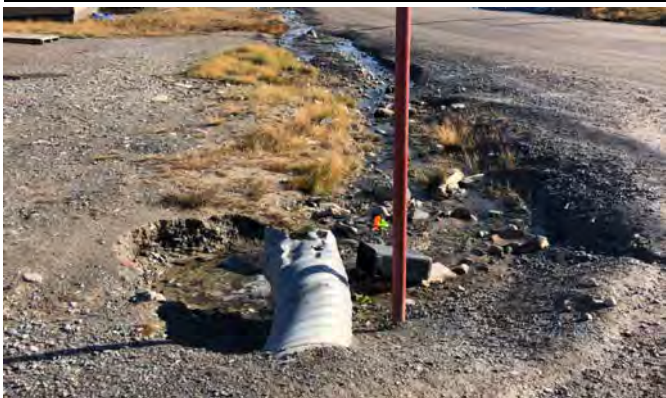
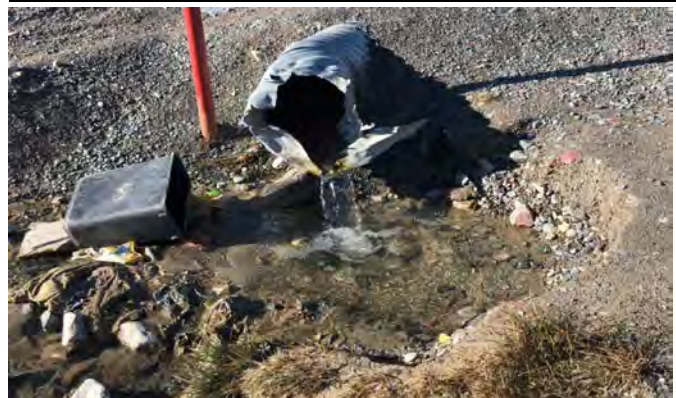
Culvert Information				
Culvert ID	138-12			
Type	Cross			
Shape	Circular			
Material	CSP			
Diameter or Dimensions (mm)	400			
Marker Post Present	N			
Barrel Length (m)	11.0			
Approx. Barrel Slope (%)	3.2%			
Approx. Depth of Cover (m)	145			
End	Upstream	Y		
Crushing	Downstream	Y		
Infill Depth (mm)	Upstream	0		
	Downstream	0		
Other Comments	Partially blocked by debris. DS perched 0.4 m, scoured.			
Culvert Elevations (masl) ²				
Upstream		Downstream	Road Crown	
Invert	Obvert	Invert		Obvert
13.99	14.4	13.64	13.99	14.34

Culvert Condition Ratings (MTO 2013)				
Barrel Material (0-4)	Shape (0-4)	Capacity (0-2)	Erosion and Scour (0-2)	US/DS Channel (0-2)
1	3	0	2	0

Recommended Action(s):	Investigate embankment scour/erosion, repair culvert end	Priority:	High
------------------------	----------------------------------------------------------	-----------	------

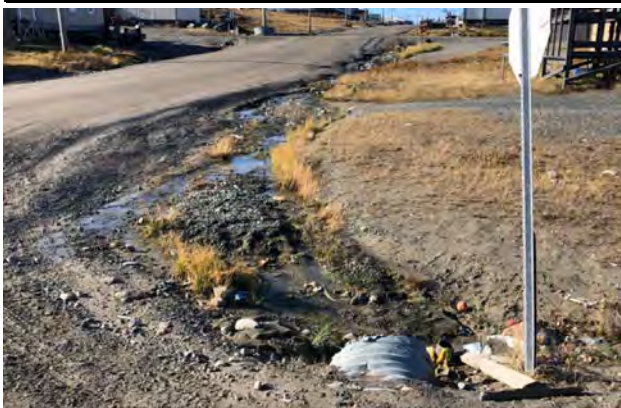
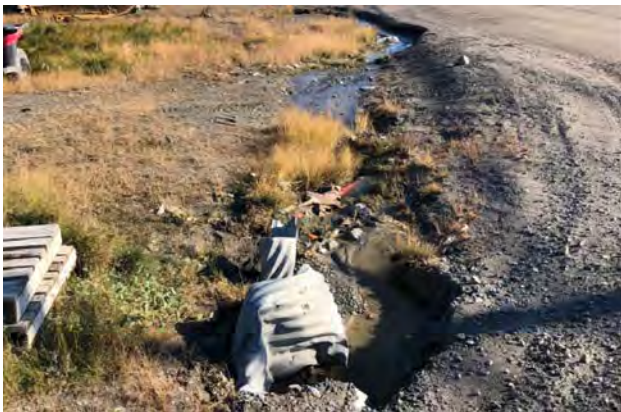
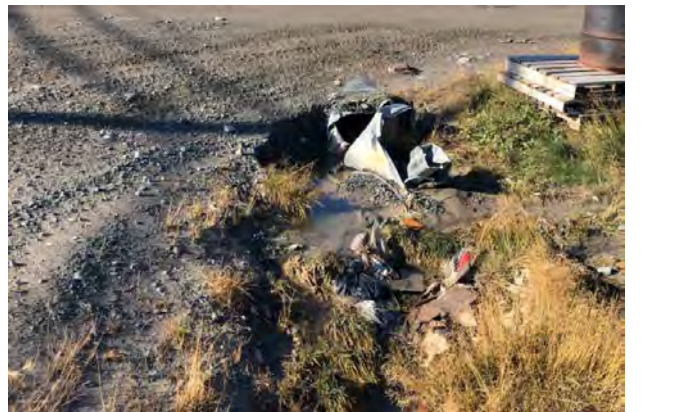
Culvert Information	
Culvert ID	138-13
Type	Cross
Shape	Circular
Material	CSP
Diameter or Dimensions (mm)	600
Marker Post Present	N
Barrel Length (m)	10.3
Approx. Barrel Slope (%)	4.2%
Approx. Depth of Cover (m)	870
End	Upstream
Crushing	Downstream
Infill Depth (mm)	Upstream
	Downstream
Other Comments	Scouring on DS end. Debris

Culvert Condition Ratings (MTO 2013)				
Barrel Material (0-4)	Shape (0-4)	Capacity (0-2)	Erosion and Scour (0-2)	US/DS Channel (0-2)
0	4	1	2	2

Recommended Action(s):	Investigate embankment scour/erosion, Remediate	Priority:	High
------------------------	-------------------------------------------------	-----------	------

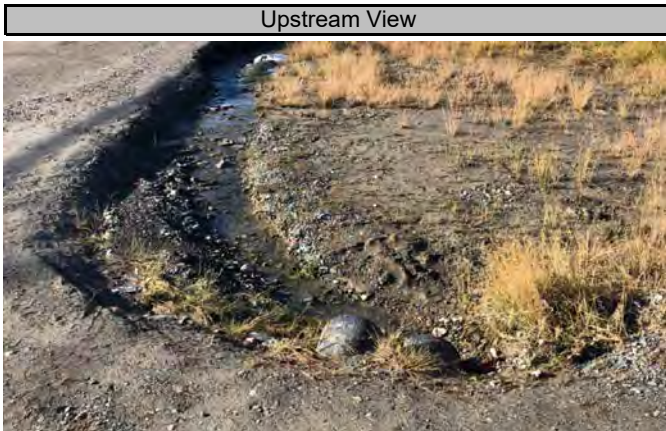
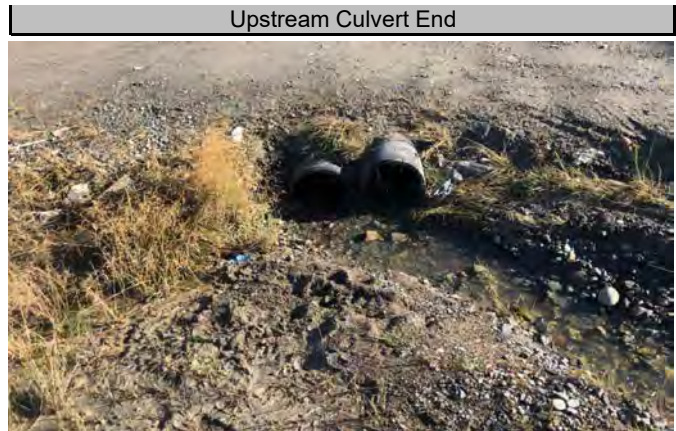
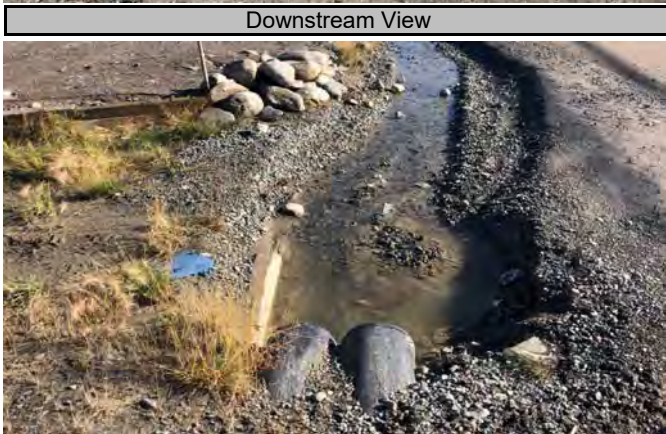
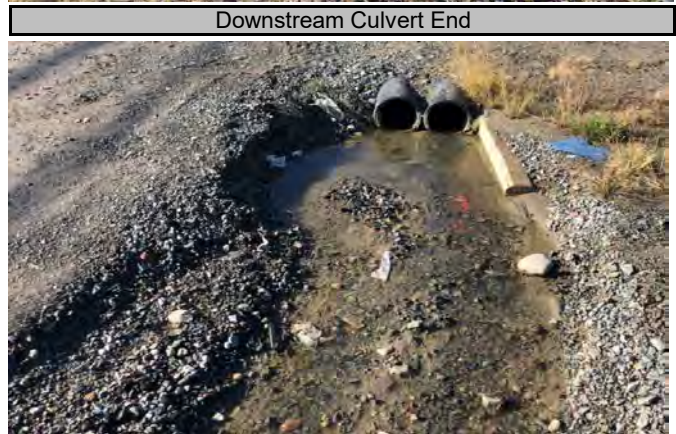
Culvert Condition Ratings (MTO 2013)				
Barrel Material (0-4)	Shape (0-4)	Capacity (0-2)	Erosion and Scour (0-2)	US/DS Channel (0-2)
0	0	0	2	2

Recommended Action(s):	gate embankment scour/erosion, Remediate channel	Priority:	High
------------------------	--------------------------------------------------	-----------	------

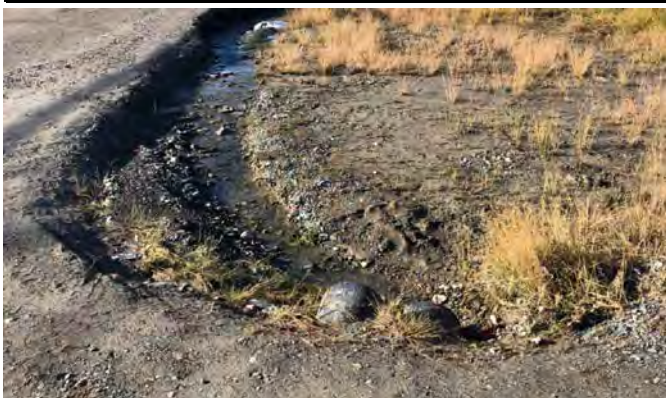
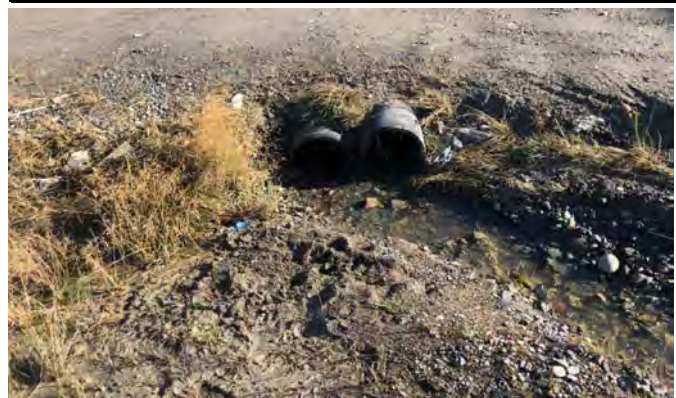
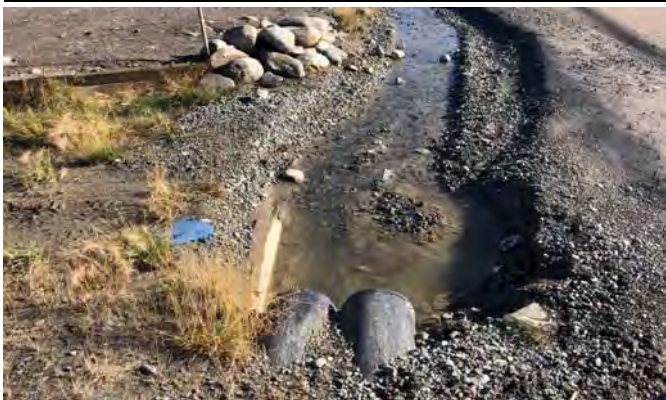
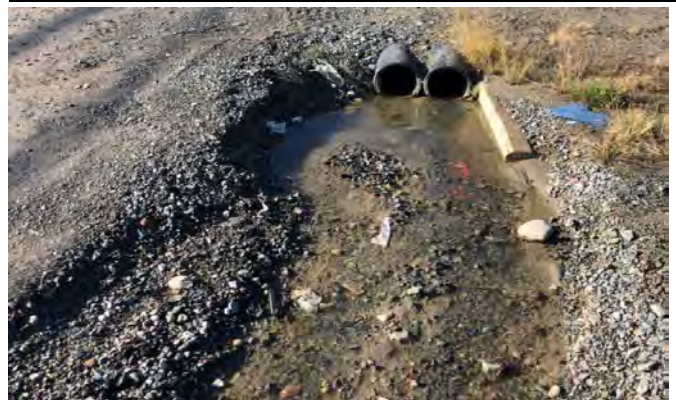
Culvert Information	
Culvert ID	139-02
Type	Entrance
Shape	Circular
Material	PVC
Diameter or Dimensions (mm)	250
Marker Post Present	N
Barrel Length (m)	12.2
Approx. Barrel Slope (%)	2.5%
Approx. Depth of Cover (m)	140
End	Upstream
Crushing	Downstream
Infill Depth (mm)	Upstream
	Downstream
Other Comments	Twinned 88/89. 1 set of photos

Culvert Condition Ratings (MTO 2013)				
Barrel Material (0-4)	Shape (0-4)	Capacity (0-2)	Erosion and Scour (0-2)	US/DS Channel (0-2)
0	0	0	2	2

Recommended Action(s):	gate embankment scour/erosion, Remediate channel	Priority:	High
------------------------	--------------------------------------------------	-----------	------

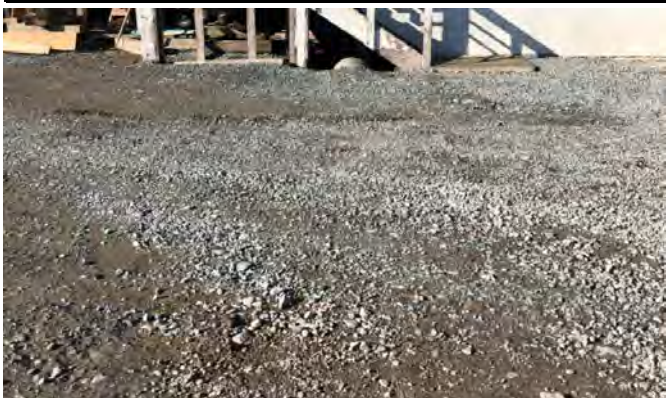
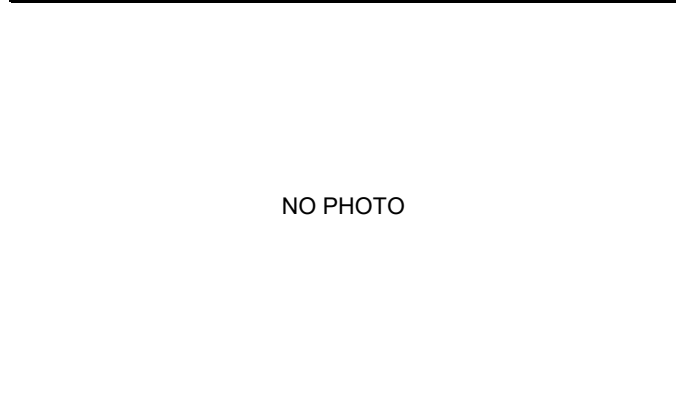
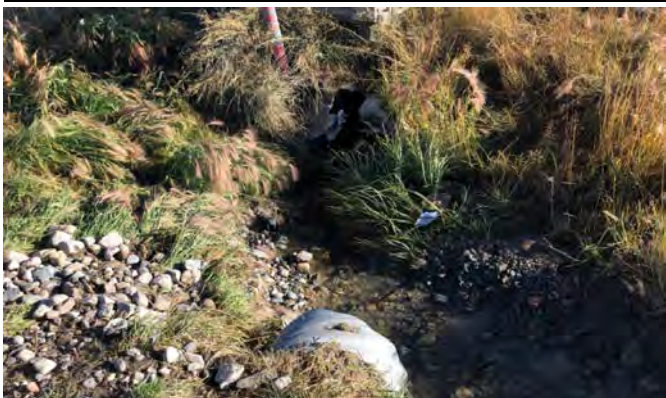
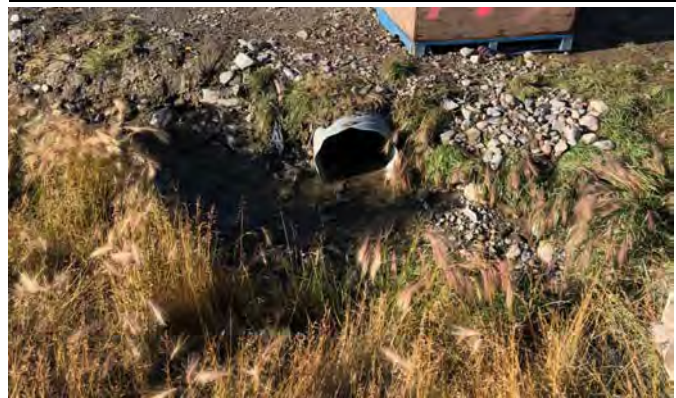
Culvert Information	
Culvert ID	139-03
Type	Entrance
Shape	Circular
Material	CSP
Diameter or Dimensions (mm)	400
Marker Post Present	N
Barrel Length (m)	9.6
Approx. Barrel Slope (%)	4.9%
Approx. Depth of Cover (m)	0
End	Upstream
Crushing	Downstream
Infill Depth (mm)	Upstream
	Downstream
Other Comments	Good condition

Culvert Condition Ratings (MTO 2013)				
Barrel Material (0-4)	Shape (0-4)	Capacity (0-2)	Erosion and Scour (0-2)	US/DS Channel (0-2)
1	0	0	1	0

Recommended Action(s):	No Action	Priority:	Low
------------------------	-----------	-----------	-----

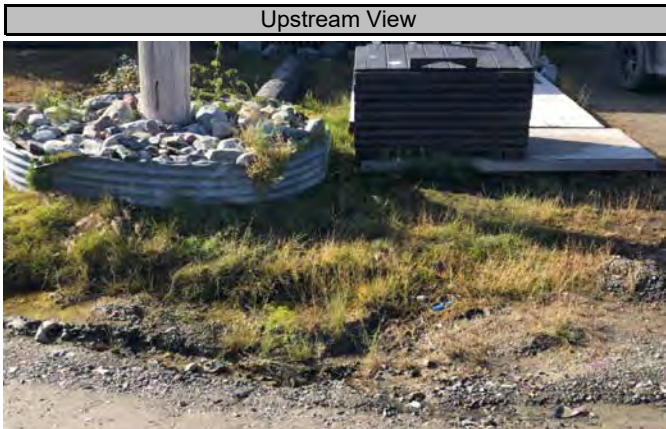
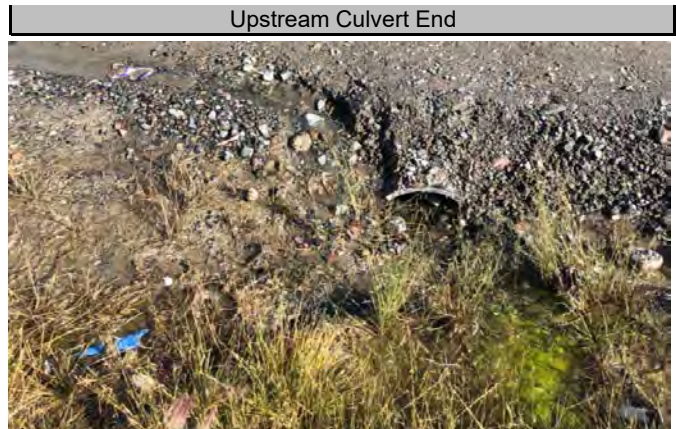
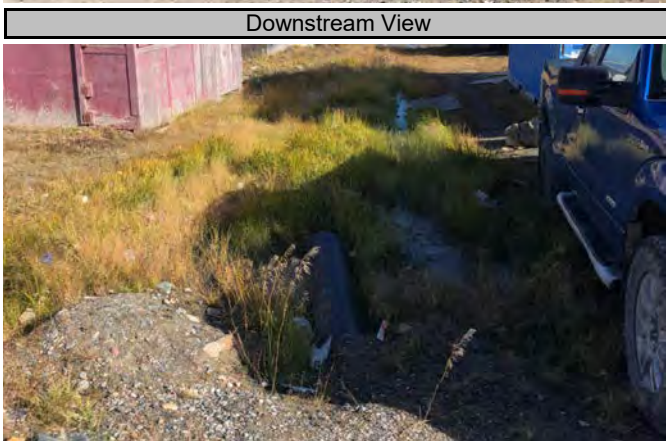
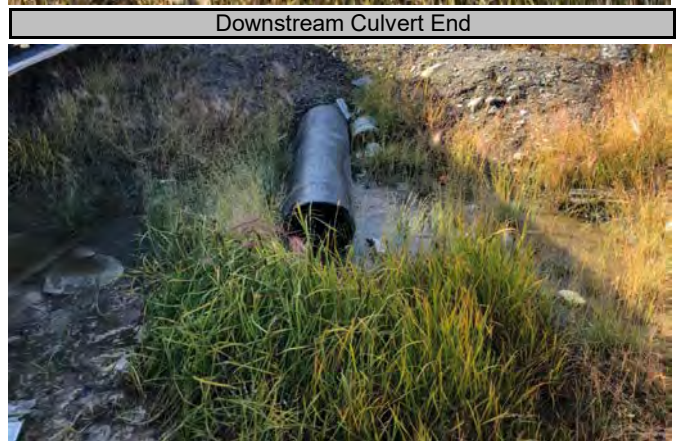
Culvert Information				
Culvert ID	139-04			
Type	Cross			
Shape	Circular			
Material	PVC			
Diameter or Dimensions (mm)	240			
Marker Post Present	N			
Barrel Length (m)	12.2			
Approx. Barrel Slope (%)	2.1%			
Approx. Depth of Cover (m)	260			
End	Upstream	N		
	Downstream	N		
Crushing	Upstream	50		
	Downstream	150		
Infill Depth (mm)	Upstream	50		
	Downstream	150		
Other Comments	0			
Culvert Elevations (masl) ²				
Upstream		Downstream	Road Crown	
Invert	Obvert	Invert		Obvert
9.07	9.22	8.82	9.08	9.41

Culvert Condition Ratings (MTO 2013)				
Barrel Material (0-4)	Shape (0-4)	Capacity (0-2)	Erosion and Scour (0-2)	US/DS Channel (0-2)
0	0	2	0	0

Recommended Action(s):	Clear blockage	Priority:	High
------------------------	----------------	-----------	------

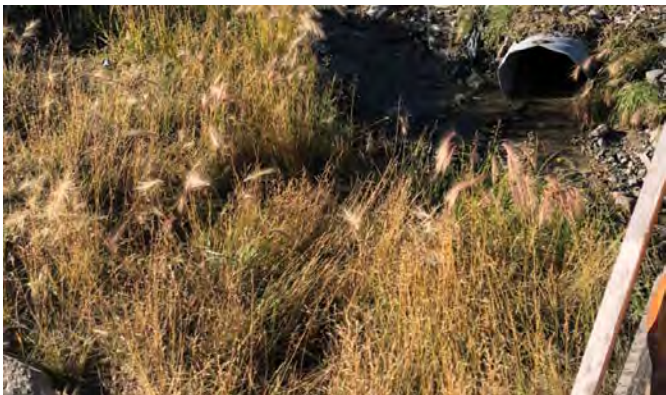
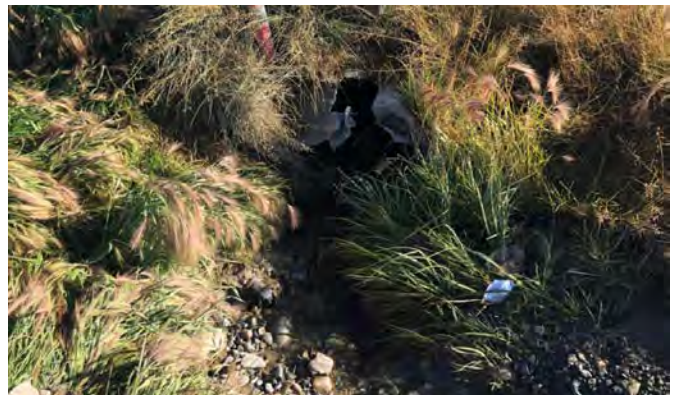
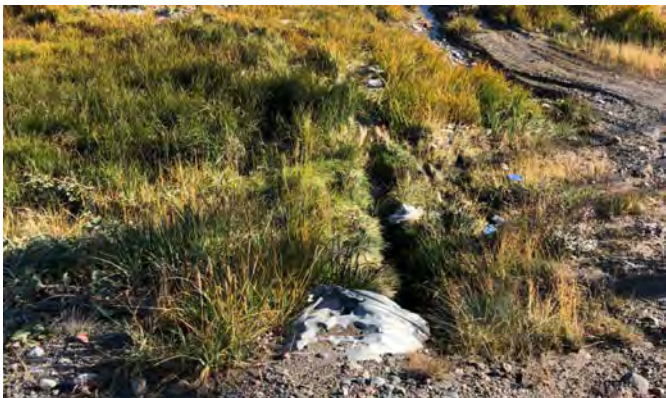
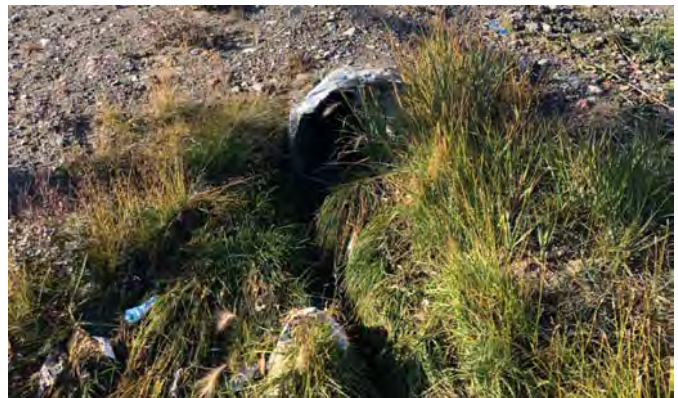
Culvert Information	
Culvert ID	139-05
Type	Cross
Shape	Circular
Material	CSP
Diameter or Dimensions (mm)	600
Marker Post Present	N
Barrel Length (m)	16.8
Approx. Barrel Slope (%)	2.6%
Approx. Depth of Cover (m)	605
End	Upstream
Crushing	Downstream
Infill Depth (mm)	Upstream
	Downstream
Other Comments	0

Culvert Condition Ratings (MTO 2013)				
Barrel Material (0-4)	Shape (0-4)	Capacity (0-2)	Erosion and Scour (0-2)	US/DS Channel (0-2)
1	1	1	1	1

Recommended Action(s):	Clear blockage	Priority:	High
------------------------	----------------	-----------	------

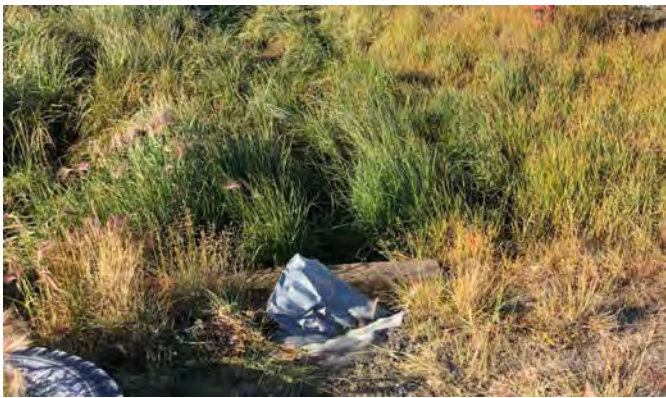
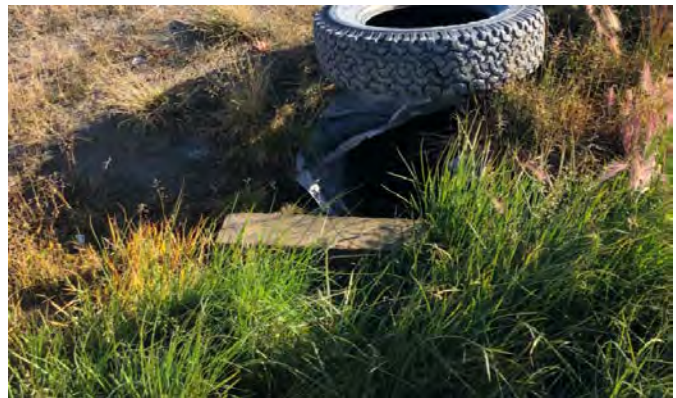
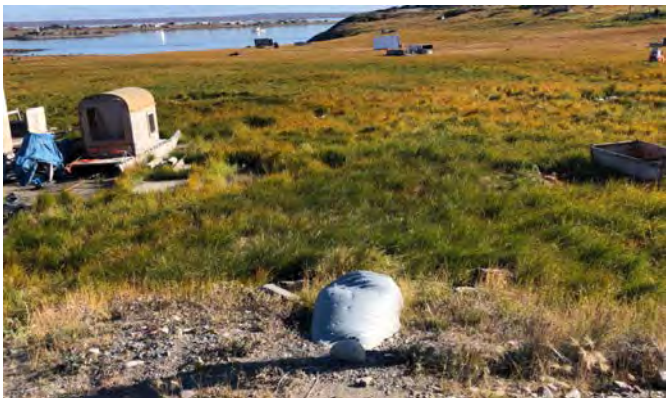
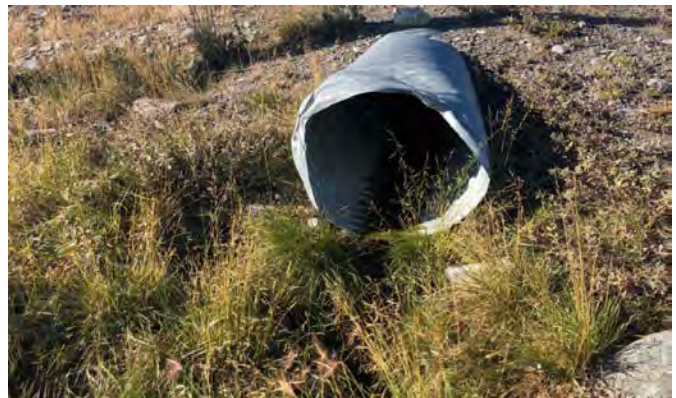
Culvert Information				
Culvert ID	139-06			
Type	Cross			
Shape	Circular			
Material	CSP			
Diameter or Dimensions (mm)	600			
Marker Post Present	N			
Barrel Length (m)	17.3			
Approx. Barrel Slope (%)	2.2%			
Approx. Depth of Cover (m)	490			
End	Upstream			
Crushing	Downstream			
Infill Depth (mm)	Upstream			
	Downstream			
Other Comments	Backyard drainage			
Culvert Elevations (masl) ²				
Upstream		Downstream		Road Crown
Invert	Obvert	Invert	Obvert	
7.68	8.23	7.3	7.85	8.53

Culvert Condition Ratings (MTO 2013)				
Barrel Material (0-4)	Shape (0-4)	Capacity (0-2)	Erosion and Scour (0-2)	US/DS Channel (0-2)
0	0	0	0	0

Recommended Action(s):	No Action	Priority:	Low
------------------------	-----------	-----------	-----

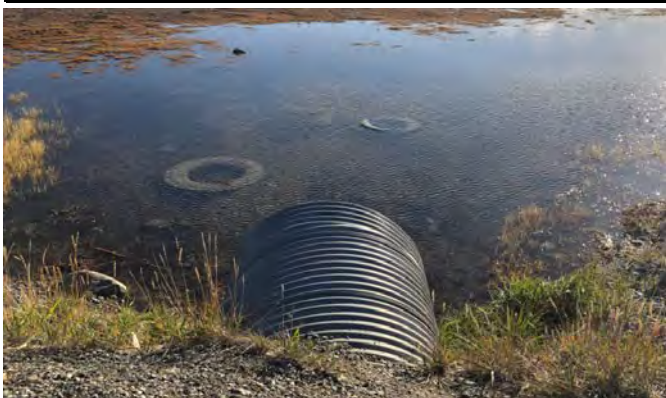
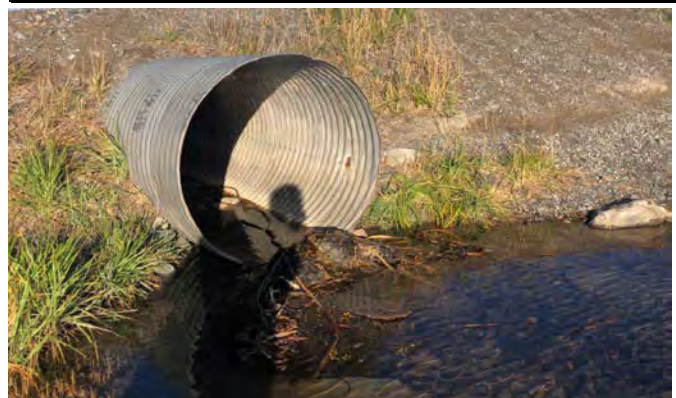
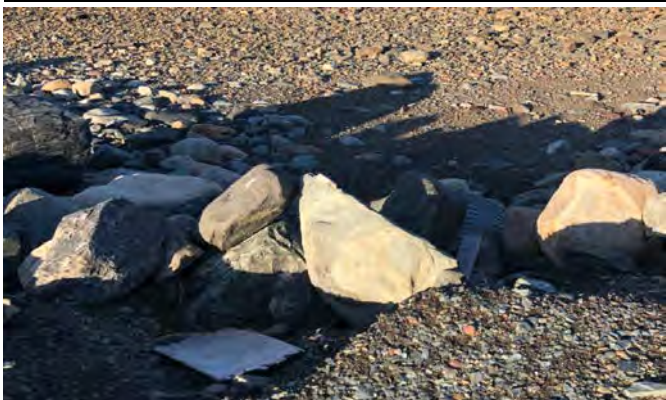
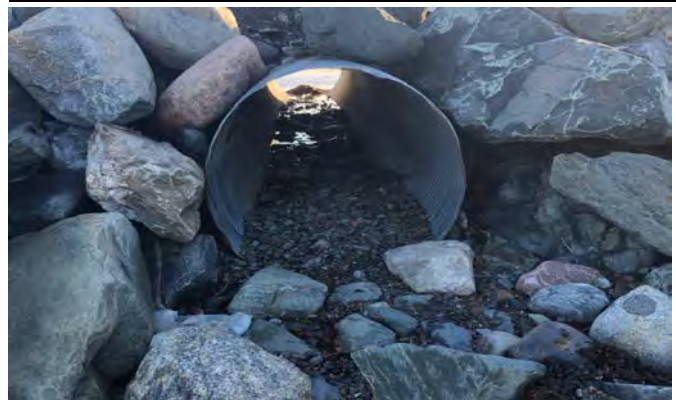
Culvert Information		
Culvert ID	142-01	
Type	Cross	
Shape	Circular	
Material	CSP	
Diameter or Dimensions (mm)	2800	
Marker Post Present	N	
Barrel Length (m)	9.1	
Approx. Barrel Slope (%)	0.9%	
Approx. Depth of Cover (m)	580	
End	Upstream	N
Crushing	Downstream	N
Infill Depth (mm)	Upstream	0
	Downstream	20
Other Comments	0

Culvert Condition Ratings (MTO 2013)				
Barrel Material (0-4)	Shape (0-4)	Capacity (0-2)	Erosion and Scour (0-2)	US/DS Channel (0-2)
1	0	1	0	0

Recommended Action(s):	Clear blockage	Priority:	High
------------------------	----------------	-----------	------

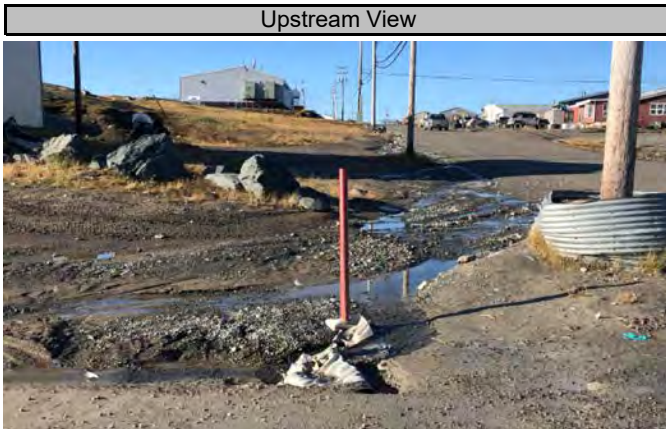
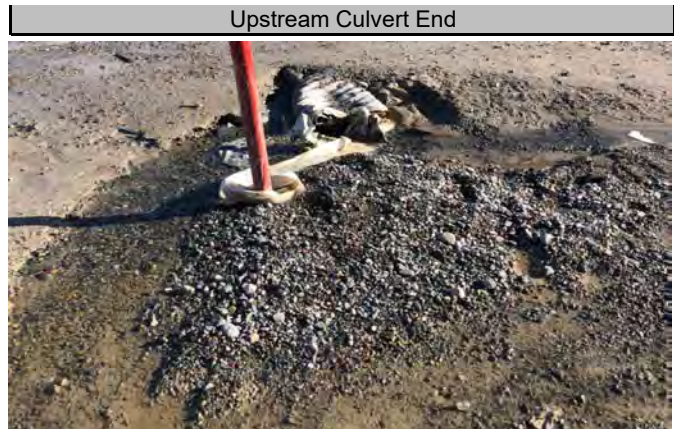
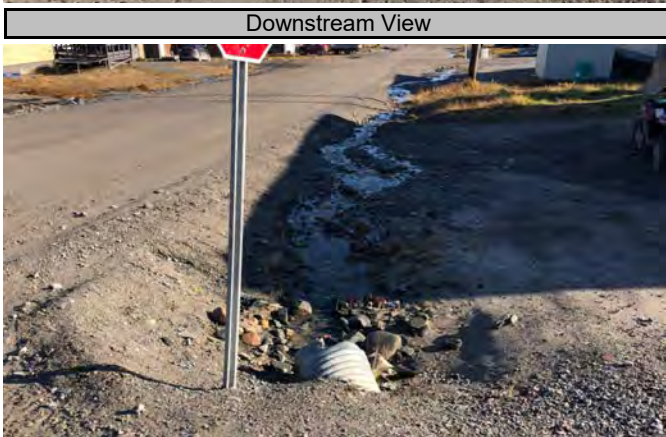
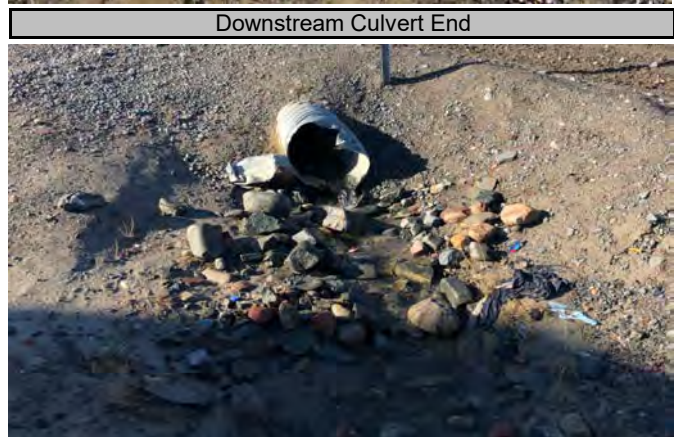
Culvert Information	
Culvert ID	145-01
Type	Cross
Shape	Circular
Material	CSP
Diameter or Dimensions (mm)	400
Marker Post Present	N
Barrel Length (m)	11.0
Approx. Barrel Slope (%)	5.1%
Approx. Depth of Cover (m)	370
End	Upstream
Crushing	Downstream
Infill Depth (mm)	Upstream
	Downstream
Other Comments	Partially blocked by debris. DS slightly perched

Culvert Condition Ratings (MTO 2013)				
Barrel Material (0-4)	Shape (0-4)	Capacity (0-2)	Erosion and Scour (0-2)	US/DS Channel (0-2)
0	4	0	2	1

Recommended Action(s):	Investigate embankment scour/erosion	Priority:	High
------------------------	--------------------------------------	-----------	------

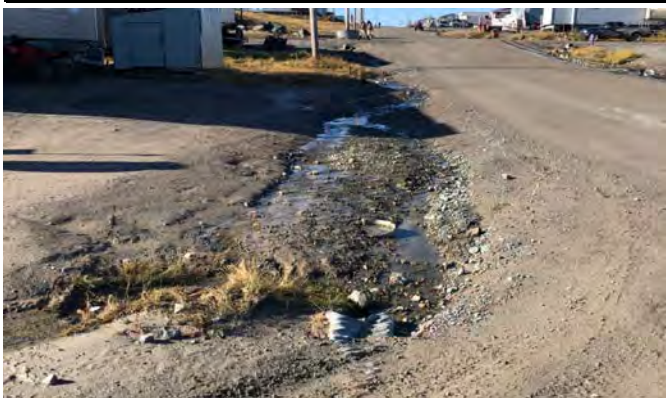
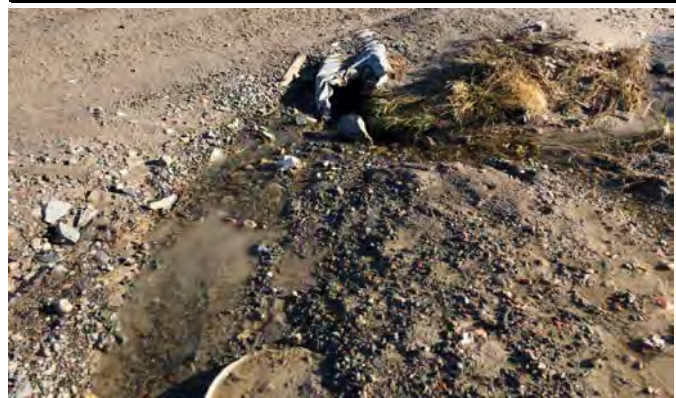
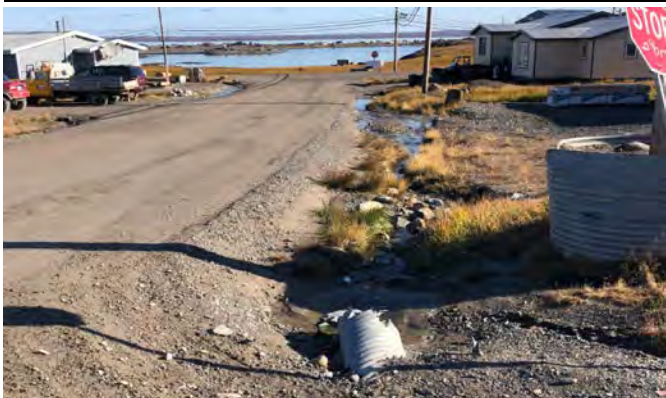
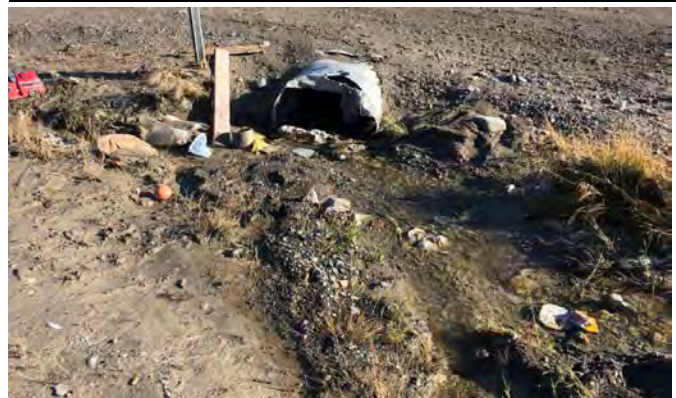
Culvert Information				
Culvert ID	145-02			
Type	Cross			
Shape	Circular			
Material	CSP			
Diameter or Dimensions (mm)	400			
Marker Post Present	N			
Barrel Length (m)	11.3			
Approx. Barrel Slope (%)	4.0%			
Approx. Depth of Cover (m)	380			
End	Upstream			
Crushing	Downstream			
Infill Depth (mm)	Upstream			
	Downstream			
Other Comments	Slight DS perch, scouring at DS end. Debris			
Culvert Elevations (masl) ²				
Upstream		Downstream		Road Crown
Invert	Obvert	Invert	Obvert	
11.09	11.34	10.64	11.06

Culvert Condition Ratings (MTO 2013)				
Barrel Material (0-4)	Shape (0-4)	Capacity (0-2)	Erosion and Scour (0-2)	US/DS Channel (0-2)
1	3	0	0	1

Recommended Action(s):	Repair culvert end	Priority:	High
------------------------	--------------------	-----------	------

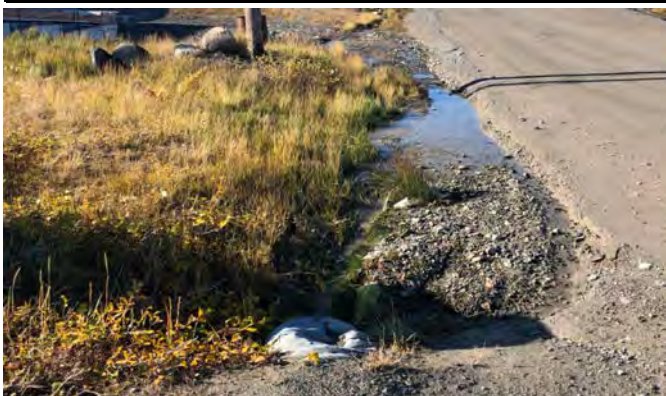
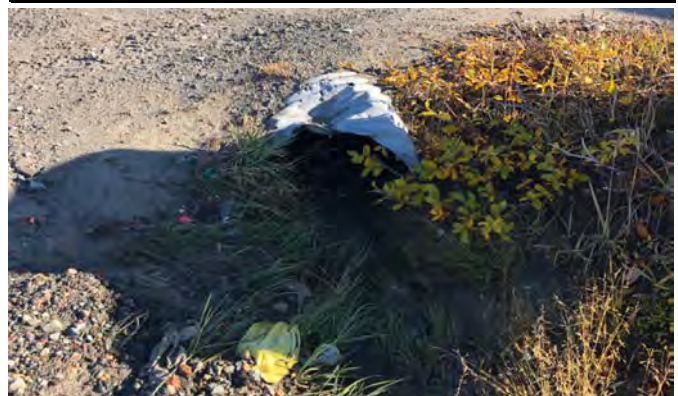
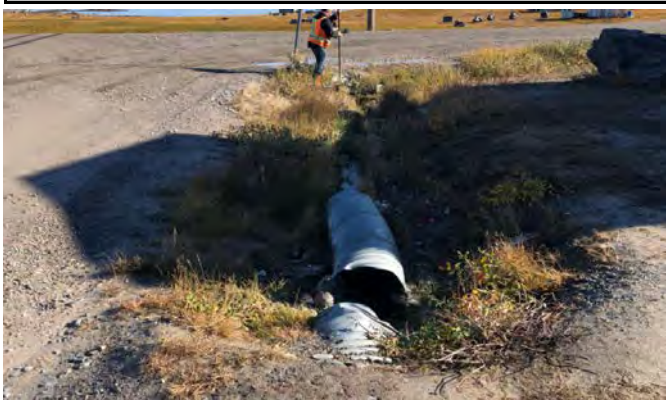
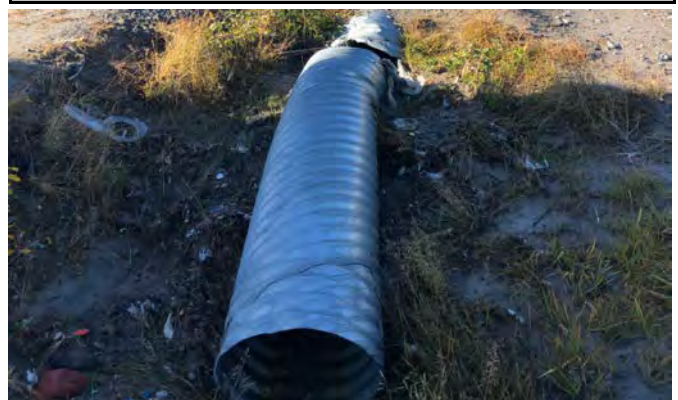
Culvert Condition Ratings (MTO 2013)				
Barrel Material (0-4)	Shape (0-4)	Capacity (0-2)	Erosion and Scour (0-2)	US/DS Channel (0-2)
1	3	1	0	0

Recommended Action(s):	Clear blockage, repair culvert end	Priority:	High
------------------------	------------------------------------	-----------	------

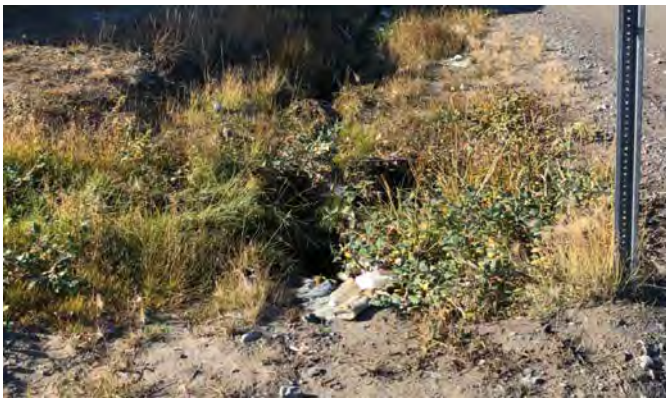
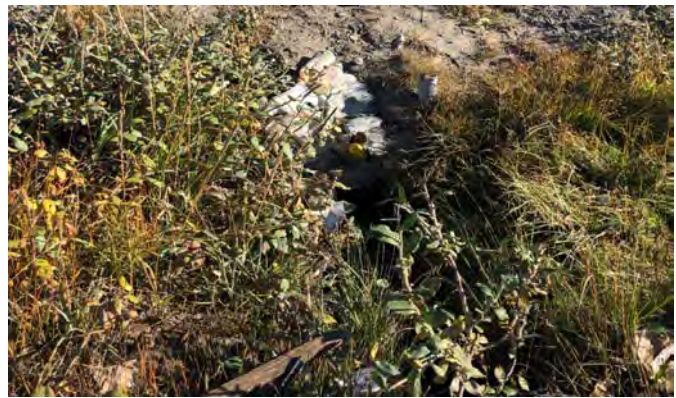
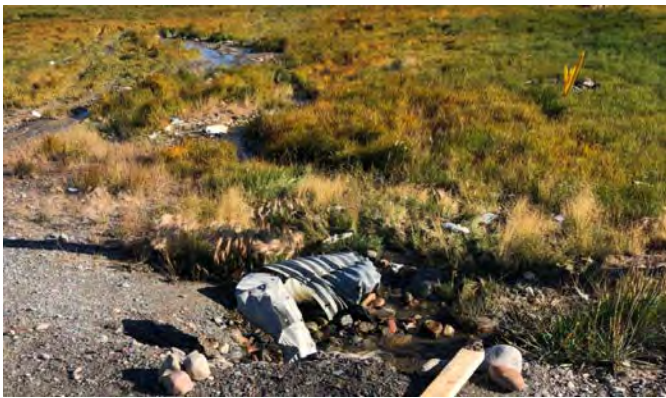
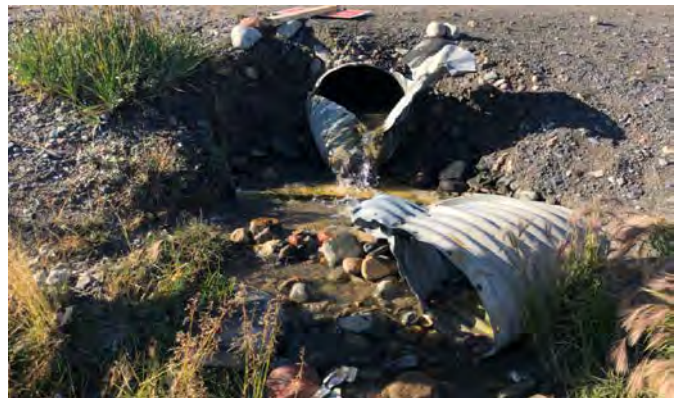
Culvert Information				
Culvert ID	145-04			
Type	Cross			
Shape	Circular			
Material	CSP			
Diameter or Dimensions (mm)	600			
Marker Post Present	N			
Barrel Length (m)	17.8			
Approx. Barrel Slope (%)	0.7%			
Approx. Depth of Cover (m)	560			
End	Upstream	Y		
Crushing	Downstream	Y		
Infill Depth (mm)	Upstream	50		
	Downstream	50		
Other Comments	Debris pileup US end. DS end perched, scouring			
Culvert Elevations (masl) ²				
Upstream		Downstream	Road Crown	
Invert	Obvert	Invert		Obvert
8.31	8.88	8.18		8.58
			9.29

Culvert Condition Ratings (MTO 2013)				
Barrel Material (0-4)	Shape (0-4)	Capacity (0-2)	Erosion and Scour (0-2)	US/DS Channel (0-2)
1	4	1	2	1

Recommended Action(s):	Clear blockage. Investigate embankment scour/erosion	Priority:	High
------------------------	------------------------------------------------------	-----------	------

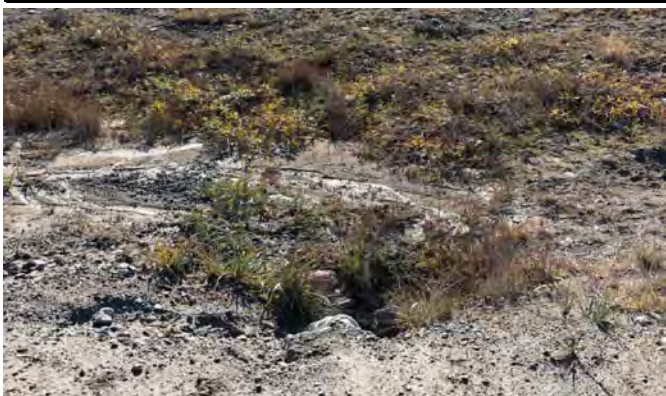
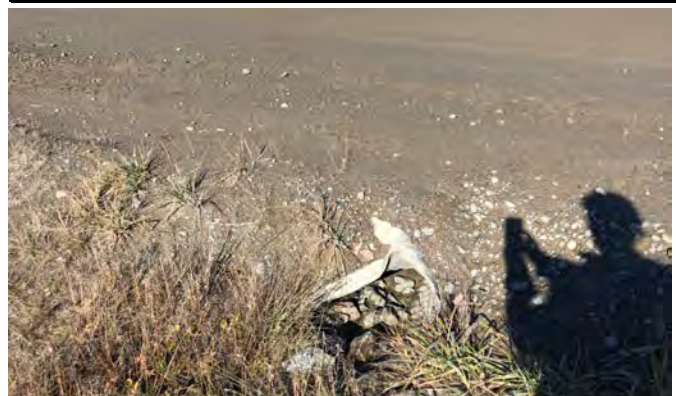
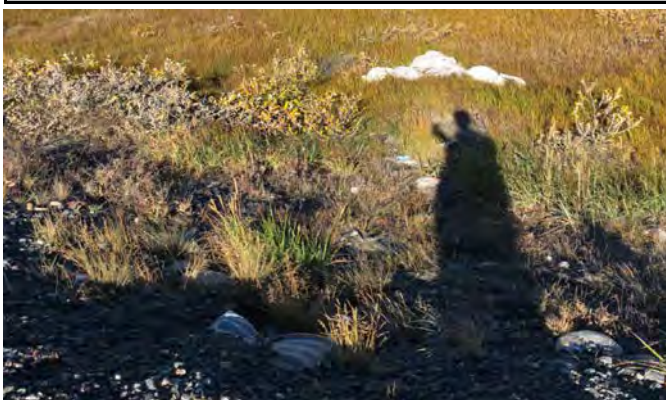
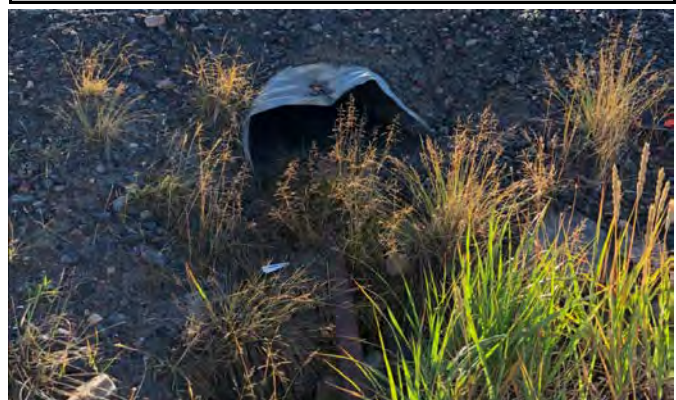
Culvert Information				
Culvert ID	146-01			
Type	Cross			
Shape	Circular			
Material	CSP			
Diameter or Dimensions (mm)	600			
Marker Post Present	N			
Barrel Length (m)	12.3			
Approx. Barrel Slope (%)	2.9%			
Approx. Depth of Cover (m)	455			
End	Upstream	Y		
Crushing	Downstream	Y		
Infill Depth (mm)	Upstream	50		
	Downstream	250		
Other Comments	Takes drainage which cuts across road entrance from upslope ditch			
Culvert Elevations (masl) ²				
Upstream		Downstream	Road Crown	
Invert	Obvert	Invert		Obvert
9.31	9.84	8.96	9.37	10.06

Culvert Condition Ratings (MTO 2013)				
Barrel Material (0-4)	Shape (0-4)	Capacity (0-2)	Erosion and Scour (0-2)	US/DS Channel (0-2)
0	3	2	0	0

Recommended Action(s):	Clear blockage, repair culvert end	Priority:	High
------------------------	------------------------------------	-----------	------

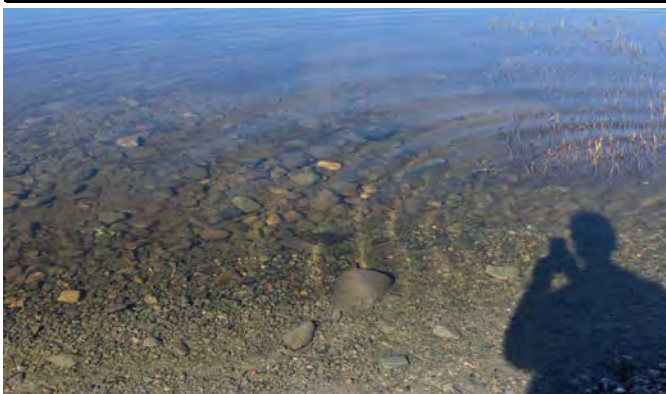
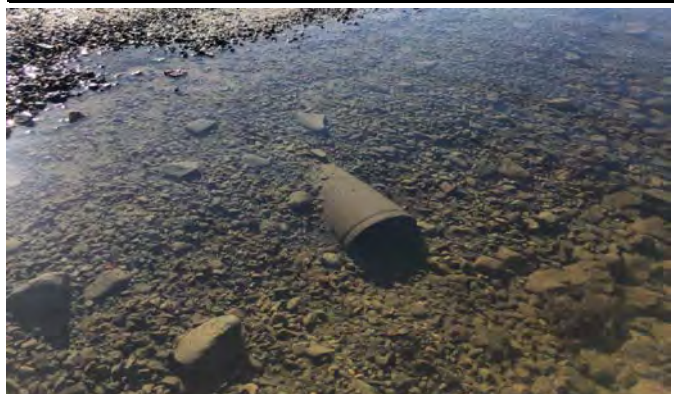
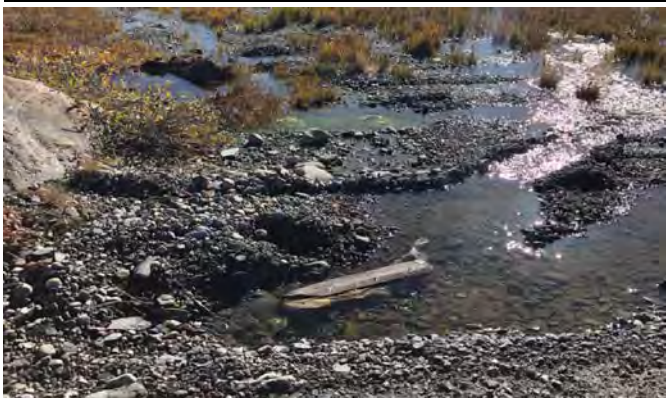
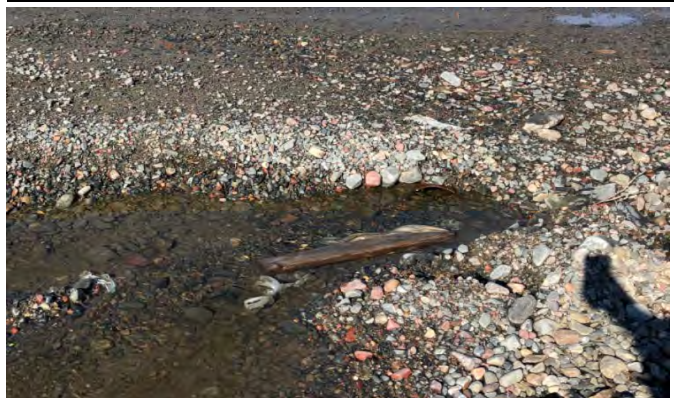
Culvert Information	
Culvert ID	148-01
Type	Cross
Shape	Circular
Material	SWSP
Diameter or Dimensions (mm)	200
Marker Post Present	N
Barrel Length (m)	7.0
Approx. Barrel Slope (%)	1.6%
Approx. Depth of Cover (m)	180
End	Upstream
Crushing	Downstream
Infill Depth (mm)	Upstream
	Downstream
Other Comments	Not working well. Road wet

Culvert Condition Ratings (MTO 2013)				
Barrel Material (0-4)	Shape (0-4)	Capacity (0-2)	Erosion and Scour (0-2)	US/DS Channel (0-2)
2	0	2	1	1

Recommended Action(s):	Monitor Rusting, clean blockage and sediment	Priority:	High
------------------------	----------------------------------------------	-----------	------

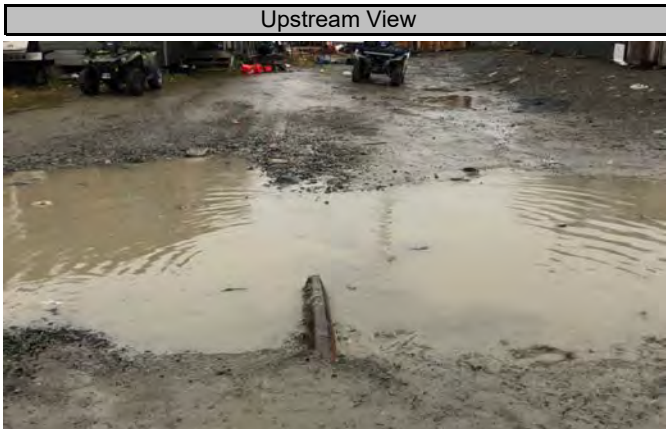
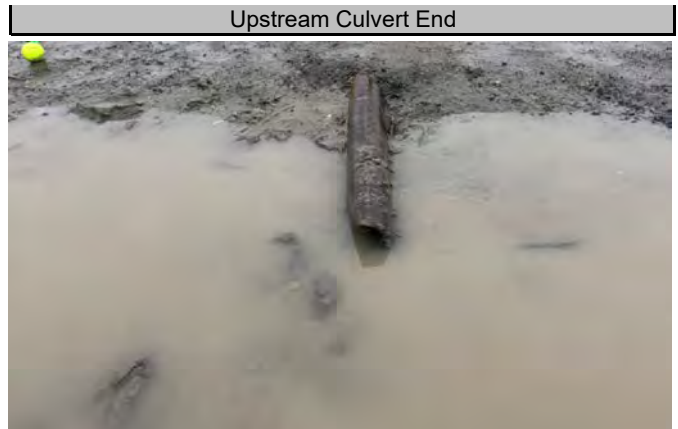
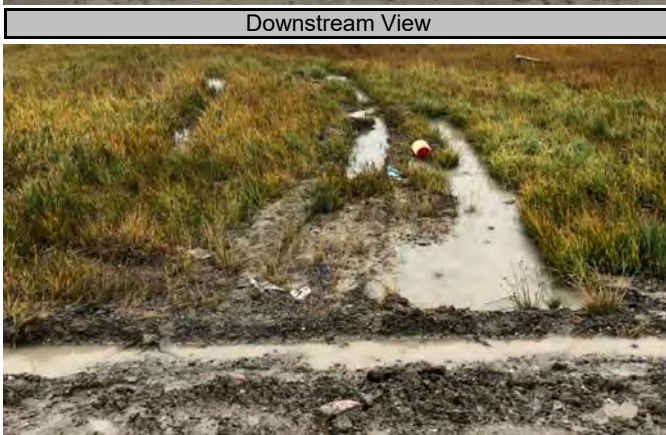
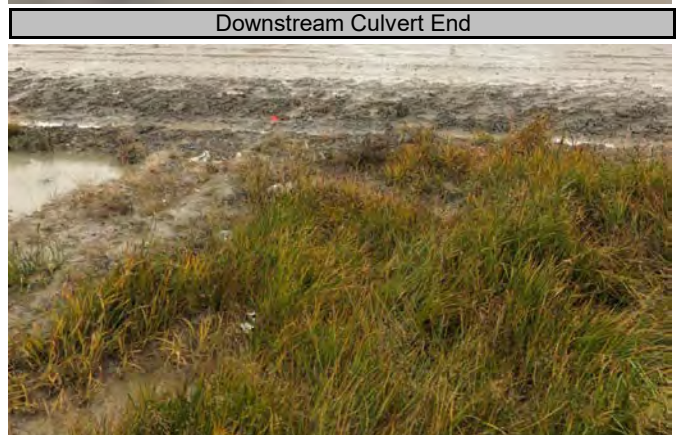
Culvert Information				
Culvert ID	153-01			
Type	Cross			
Shape	Circular			
Material	SWSP			
Diameter or Dimensions (mm)	120			
Marker Post Present	N			
Barrel Length (m)	-			
Approx. Barrel Slope (%)	N/A			
Approx. Depth of Cover (m)	50			
End	Upstream			
Crushing	Downstream			
Infill Depth (mm)	Upstream			
	Downstream			
Other	DS end buried			
Comments				
Culvert Elevations (masl) ²				
Upstream		Downstream		Road Crown
Invert	Obvert	Invert	Obvert	
23.07	23.16	-	-

Culvert Condition Ratings (MTO 2013)				
Barrel Material (0-4)	Shape (0-4)	Capacity (0-2)	Erosion and Scour (0-2)	US/DS Channel (0-2)
1	3	0	1	1

Recommended Action(s):	Repair culvert end	Priority:	High
------------------------	--------------------	-----------	------
