**Geotechnical Evaluation and Drainage Planning
in Rankin Inlet, Nunavut**

Draft Report
REV-00

Prepared for:
The Municipality of Rankin Inlet

Prepared by:
Nunami Stantec Limited

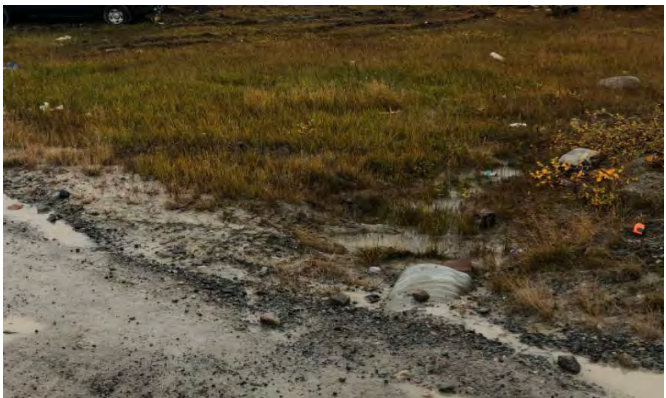
Upstream View

Culvert Information				
Culvert ID	153-02			
Type	Cross			
Shape	Circular			
Material	CSP			
Diameter or Dimensions (mm)	400			
Marker Post Present	N			
Barrel Length (m)	11.6			
Approx. Barrel Slope (%)	1.3%			
Approx. Depth of Cover (m)	340			
End	Upstream	Y		
Crushing	Downstream	Y		
Infill Depth (mm)	Upstream	50		
	Downstream	100		
Other Comments	0			
Culvert Elevations (masl) ²				
Upstream		Downstream	Road Crown	
Invert	Obvert	Invert		Obvert
22	22.26	21.85	22.1	22.52

Culvert Condition Ratings (MTO 2013)				
Barrel Material (0-4)	Shape (0-4)	Capacity (0-2)	Erosion and Scour (0-2)	US/DS Channel (0-2)
1	3	1	1	0

Recommended Action(s):	Clear blockage, repair culvert end	Priority:	High
------------------------	------------------------------------	-----------	------

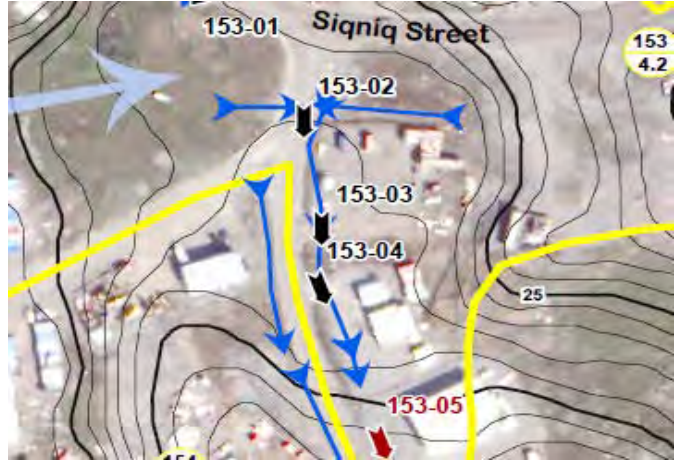
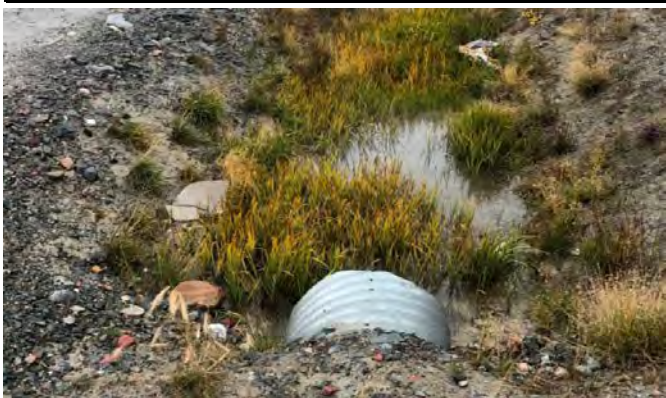
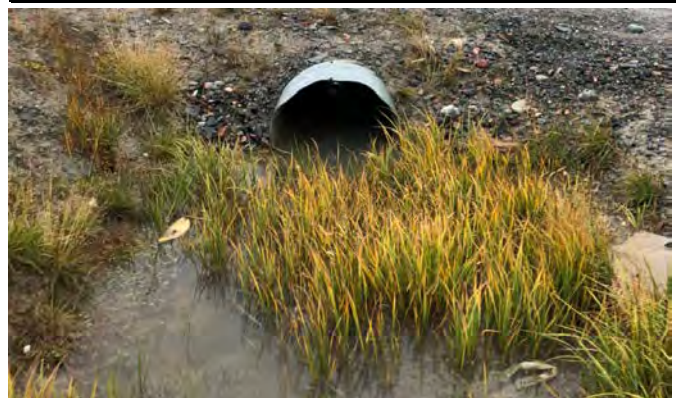
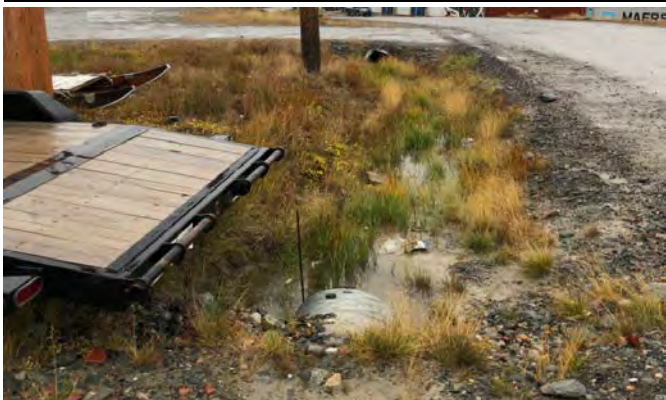
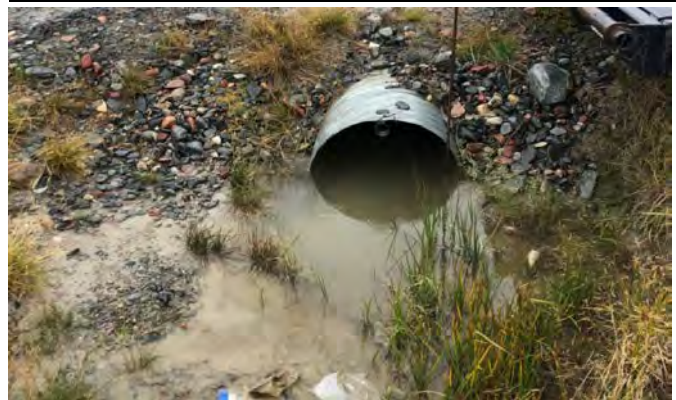
Culvert Condition Ratings (MTO 2013)				
Barrel Material (0-4)	Shape (0-4)	Capacity (0-2)	Erosion and Scour (0-2)	US/DS Channel (0-2)
1	0	1	0	0

Recommended Action(s):	Clean blockage and sediment	Priority:	High
------------------------	-----------------------------	-----------	------

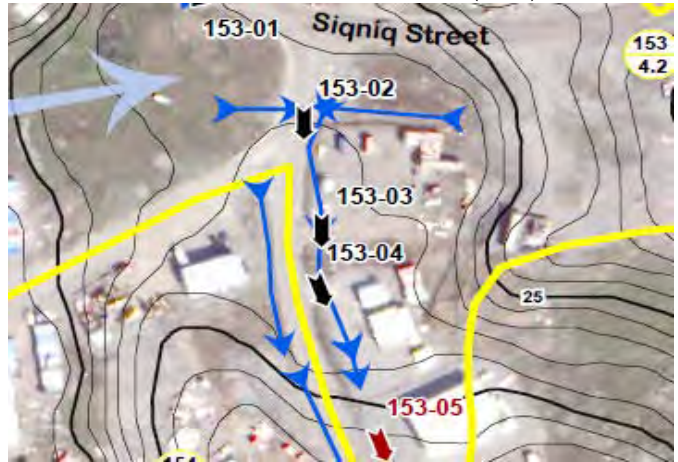
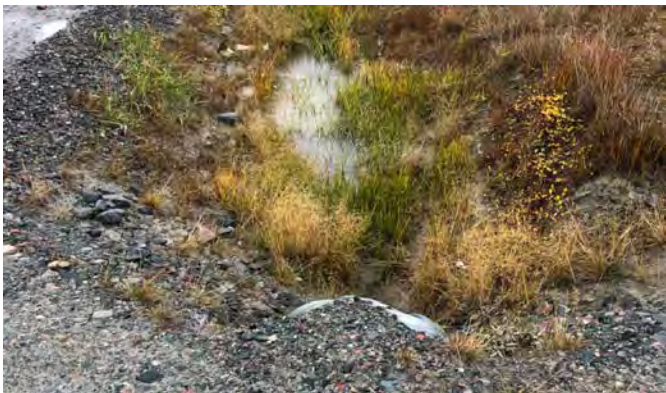
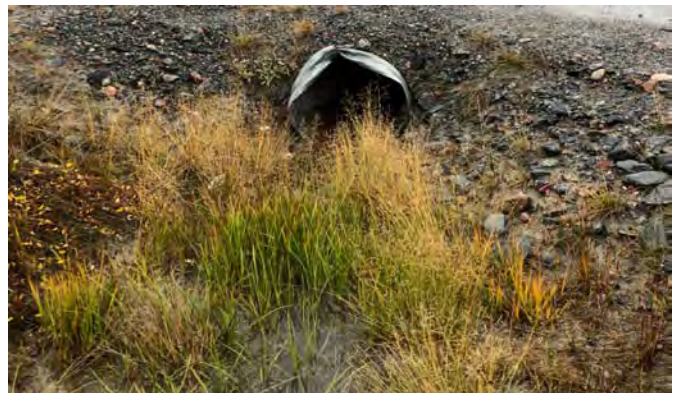
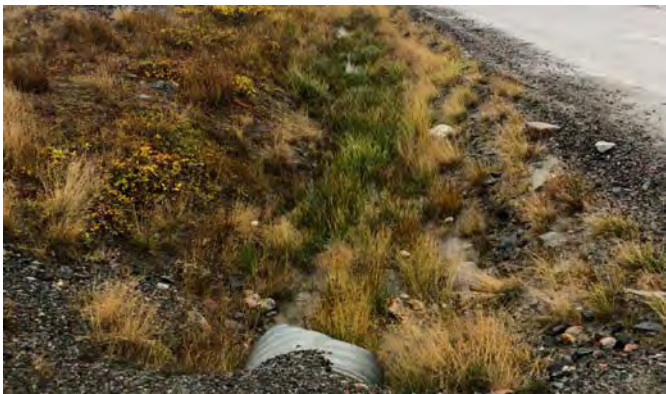
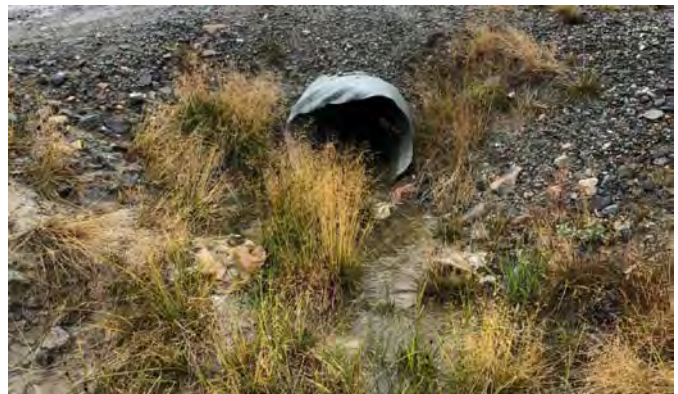
Culvert Condition Ratings (MTO 2013)				
Barrel Material (0-4)	Shape (0-4)	Capacity (0-2)	Erosion and Scour (0-2)	US/DS Channel (0-2)
0	0	0	0	0

Recommended Action(s):	No Action	Priority:	Low
------------------------	-----------	-----------	-----

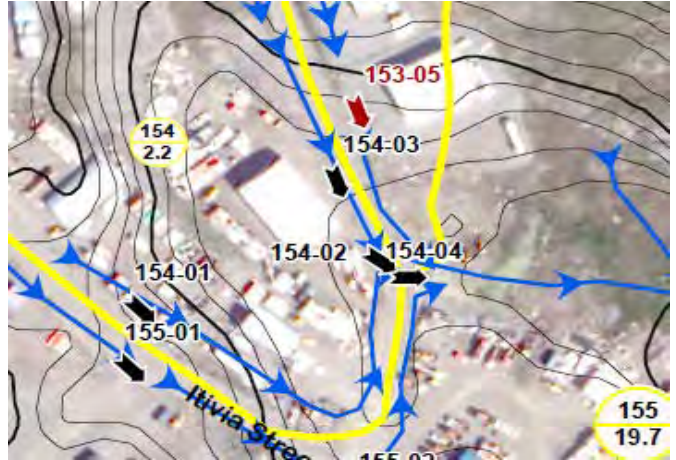
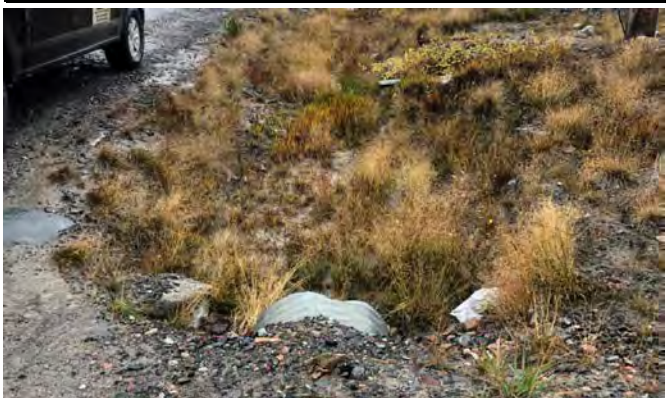
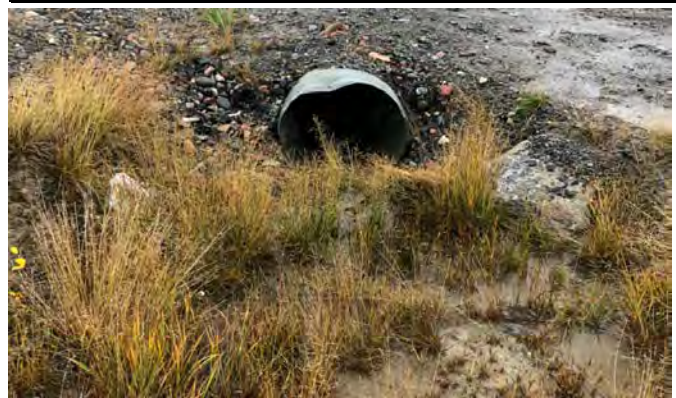
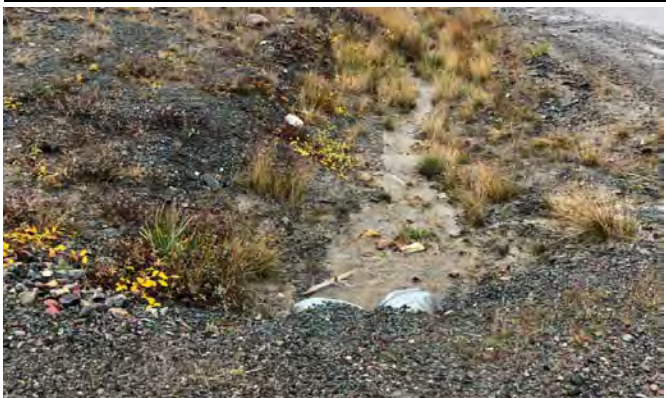
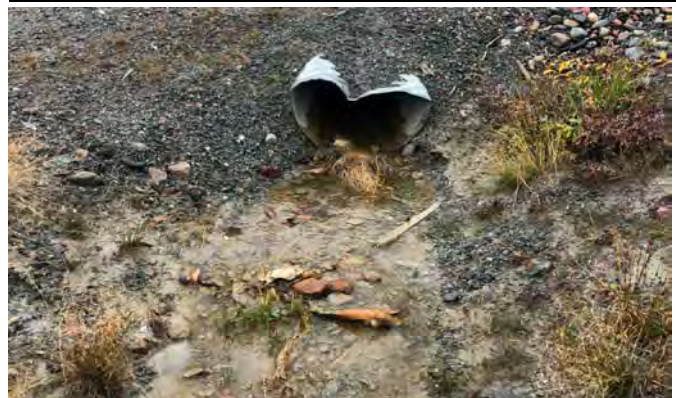
Culvert Condition Ratings (MTO 2013)				
Barrel Material (0-4)	Shape (0-4)	Capacity (0-2)	Erosion and Scour (0-2)	US/DS Channel (0-2)
1	3	0	0	0

Recommended Action(s):	Repair culvert end	Priority:	High
------------------------	--------------------	-----------	------

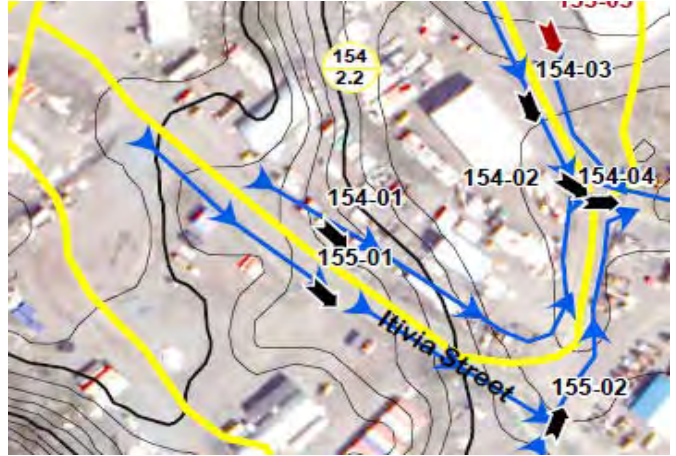
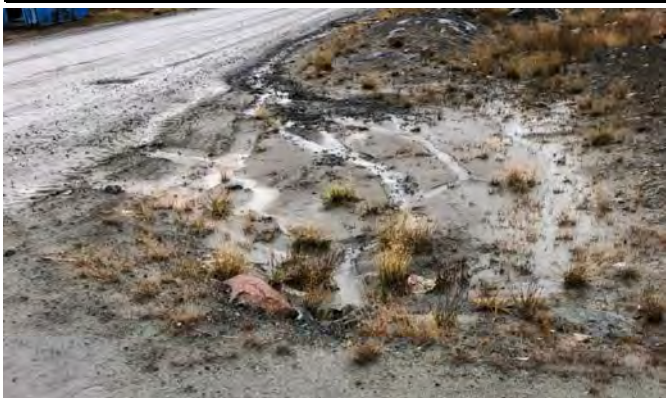
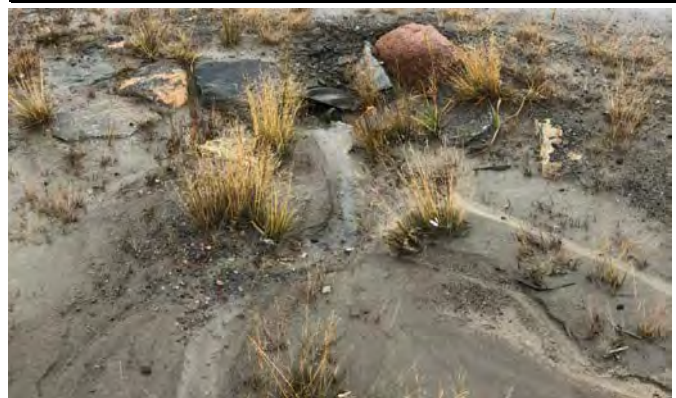
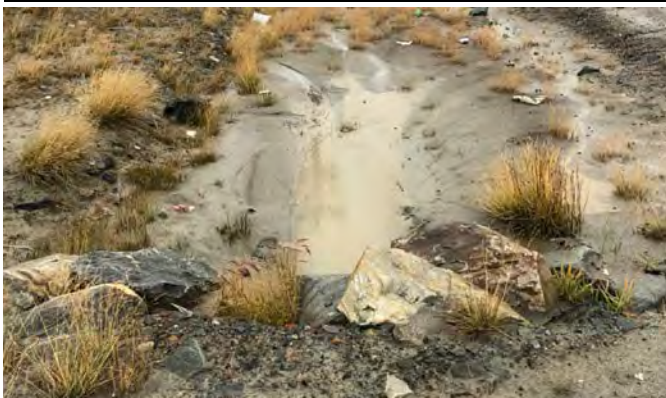
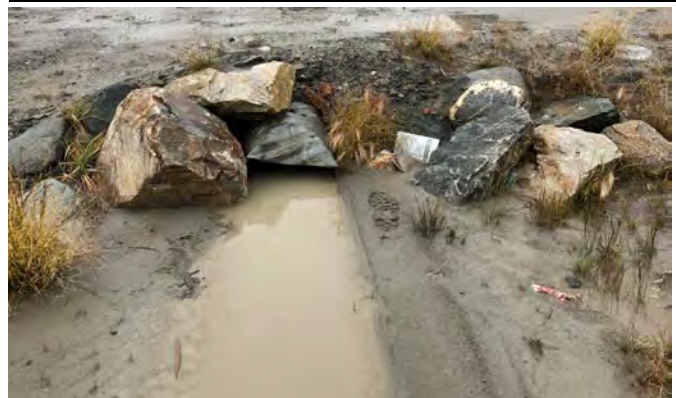
Culvert Condition Ratings (MTO 2013)				
Barrel Material (0-4)	Shape (0-4)	Capacity (0-2)	Erosion and Scour (0-2)	US/DS Channel (0-2)
0	3	2	0	1

Recommended Action(s):	Clear blockage, repair culvert end	Priority:	High
------------------------	------------------------------------	-----------	------

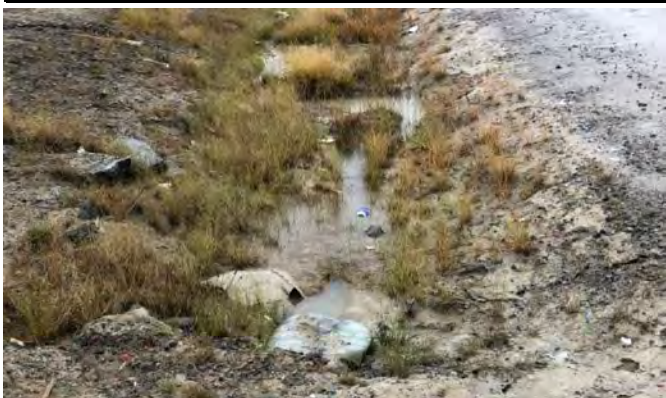
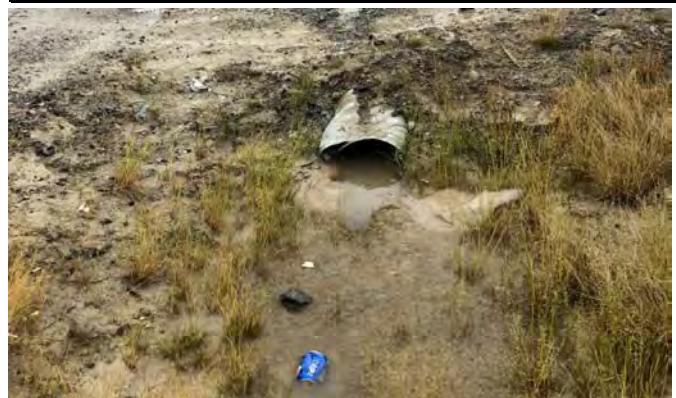
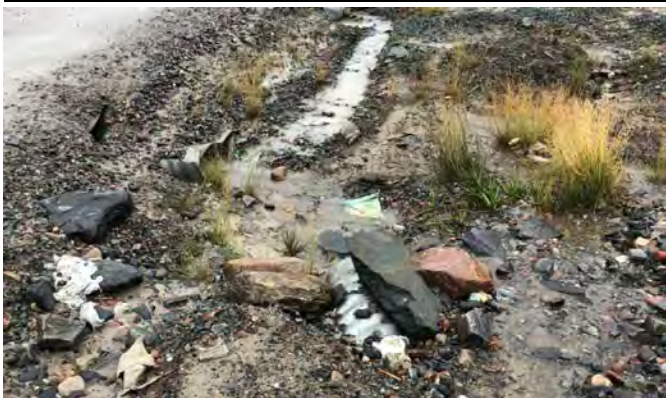
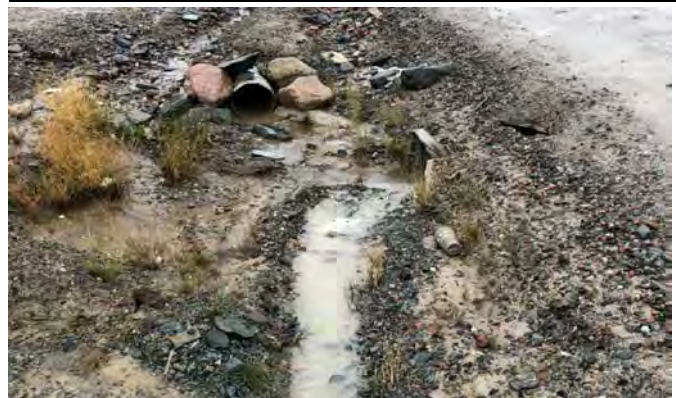
Culvert Condition Ratings (MTO 2013)				
Barrel Material (0-4)	Shape (0-4)	Capacity (0-2)	Erosion and Scour (0-2)	US/DS Channel (0-2)
1	2	0	0	1

Recommended Action(s):	Repair culvert end	Priority:	Low
------------------------	--------------------	-----------	-----

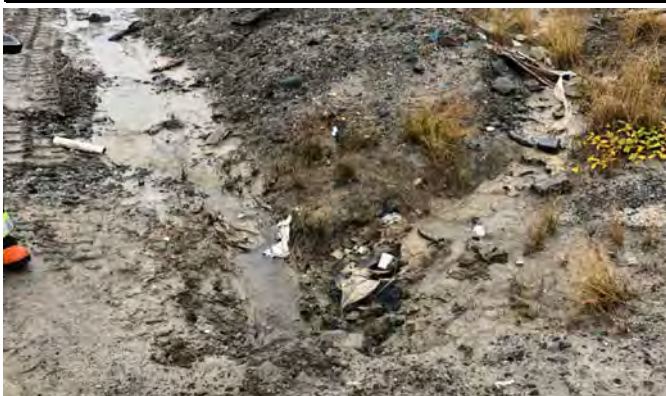
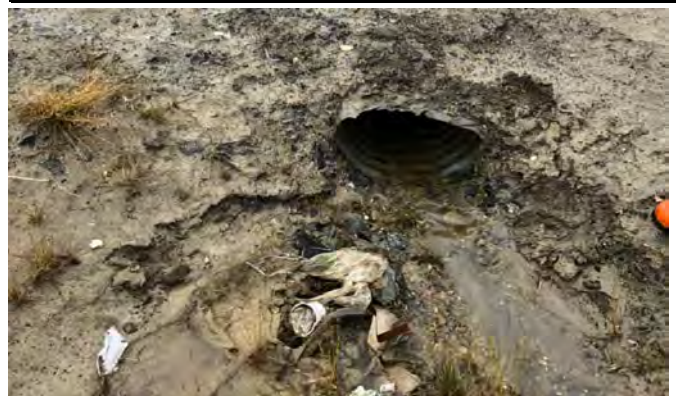
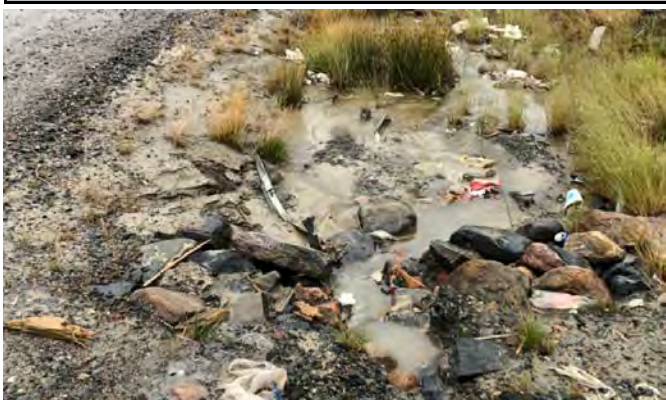
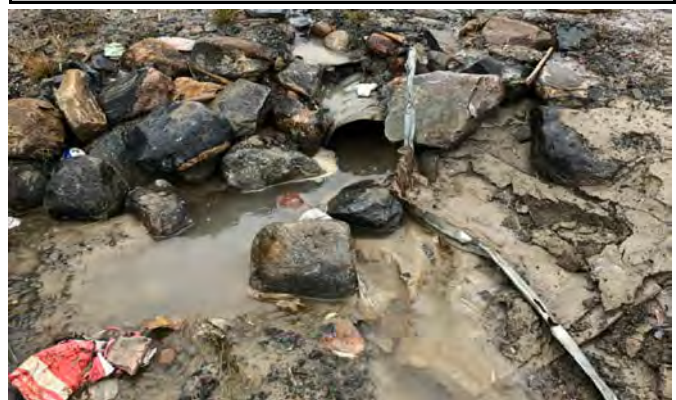
Culvert Condition Ratings (MTO 2013)				
Barrel Material (0-4)	Shape (0-4)	Capacity (0-2)	Erosion and Scour (0-2)	US/DS Channel (0-2)
0	2	2	1	1

Recommended Action(s):	Clear blockage, repair culvert end	Priority:	High
------------------------	------------------------------------	-----------	------

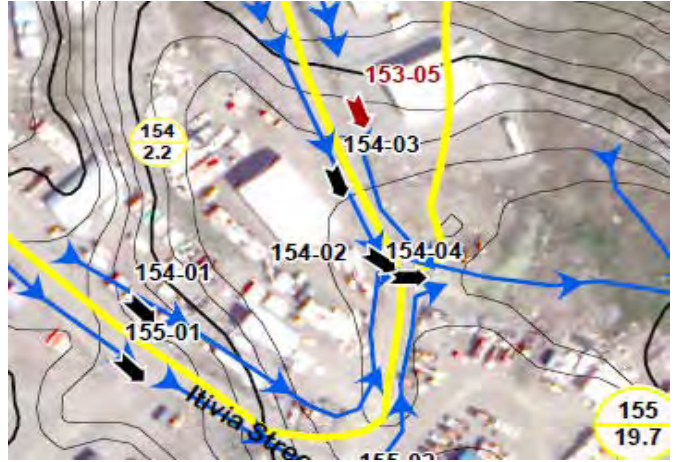
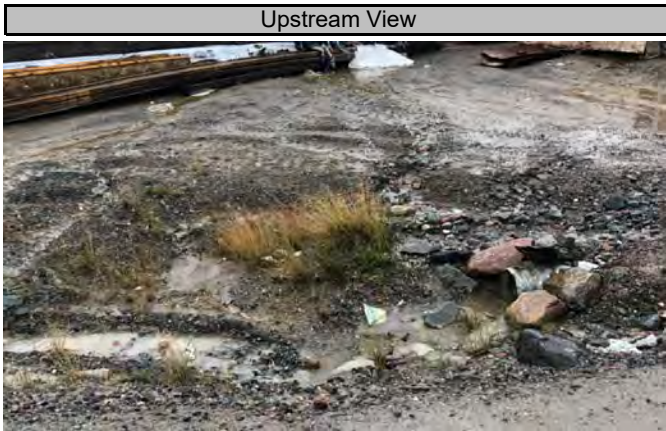
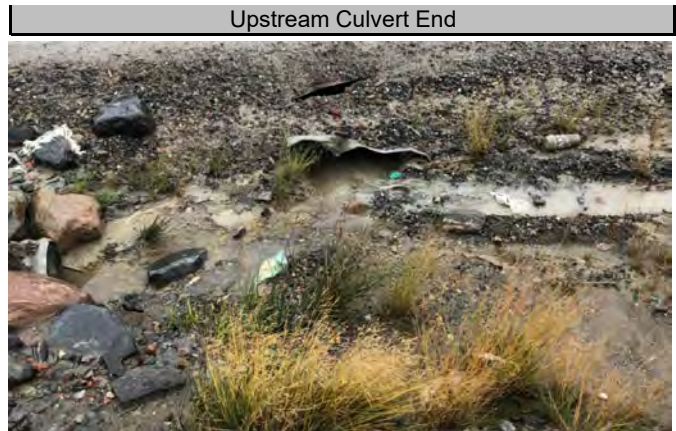
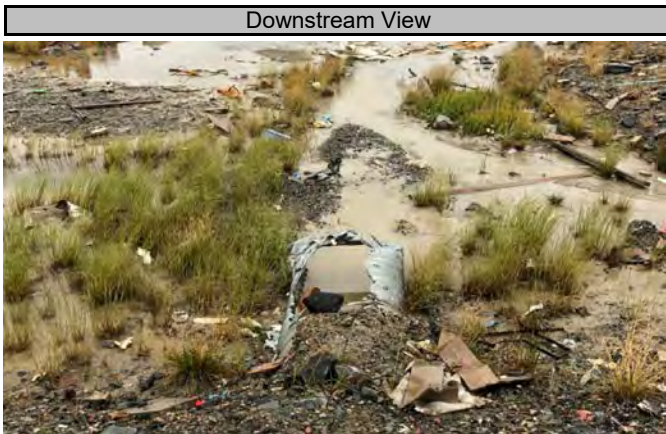
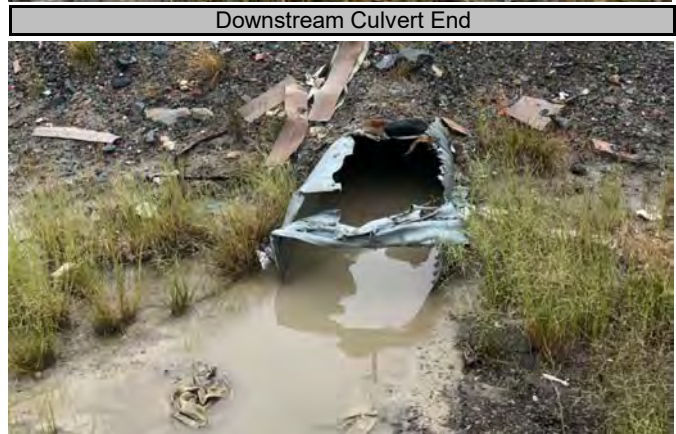
Culvert Condition Ratings (MTO 2013)				
Barrel Material (0-4)	Shape (0-4)	Capacity (0-2)	Erosion and Scour (0-2)	US/DS Channel (0-2)
1	4	1	0	0

Recommended Action(s):	Replace culvert	Priority:	High
------------------------	-----------------	-----------	------

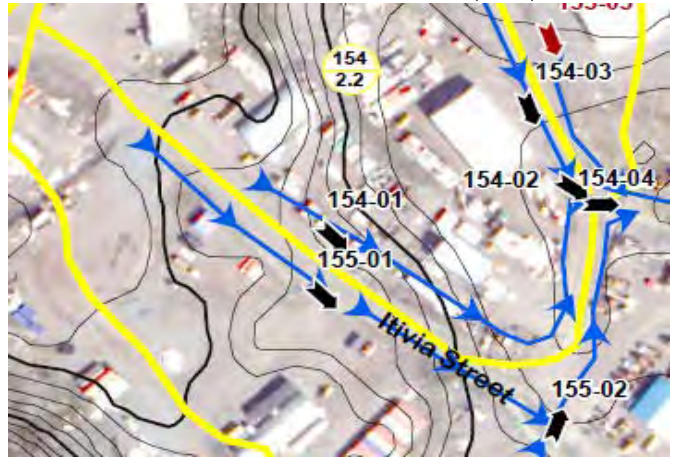
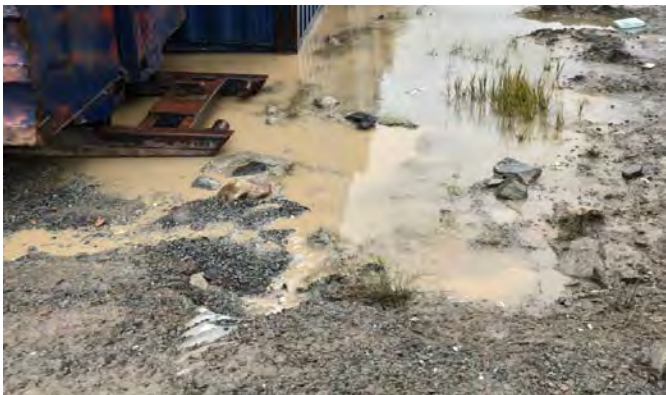
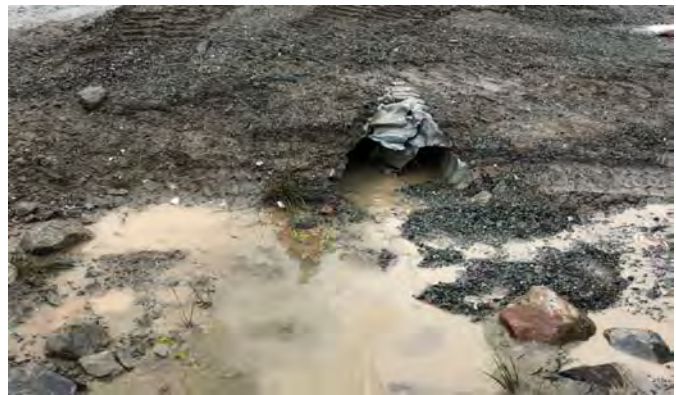
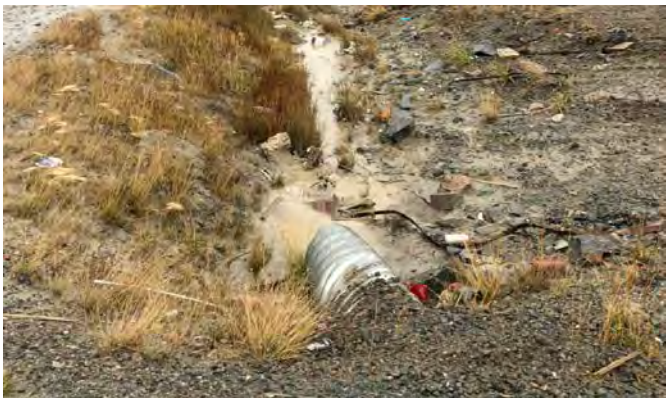
Culvert Condition Ratings (MTO 2013)				
Barrel Material (0-4)	Shape (0-4)	Capacity (0-2)	Erosion and Scour (0-2)	US/DS Channel (0-2)
1	3	1	0	1

Recommended Action(s):	Clear blockage, repair culvert end	Priority:	High
------------------------	------------------------------------	-----------	------

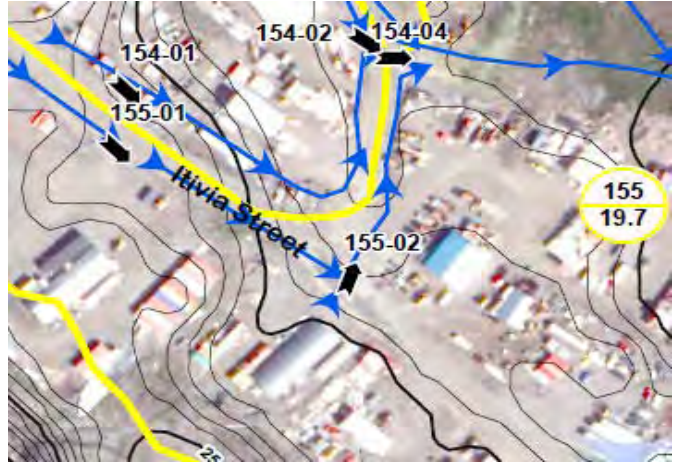
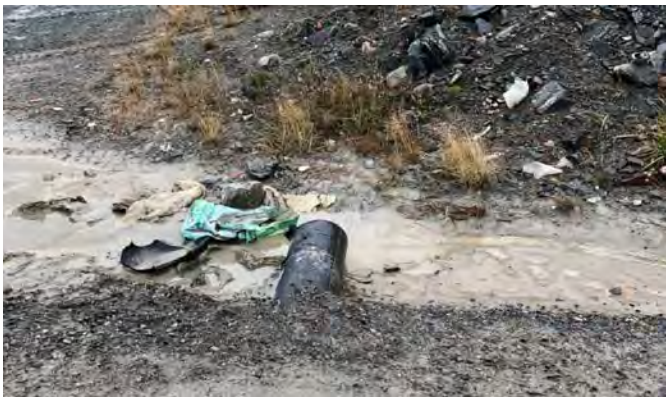
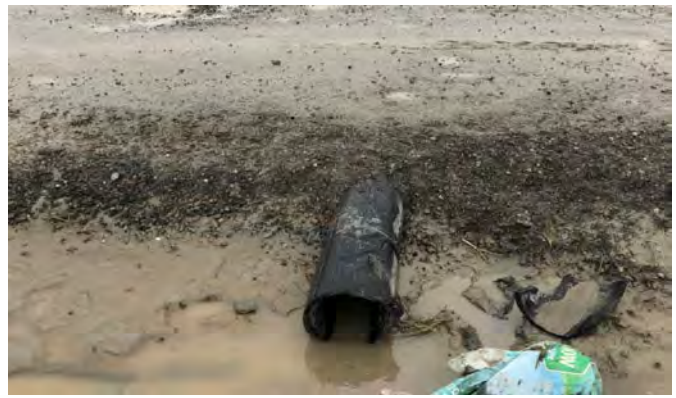
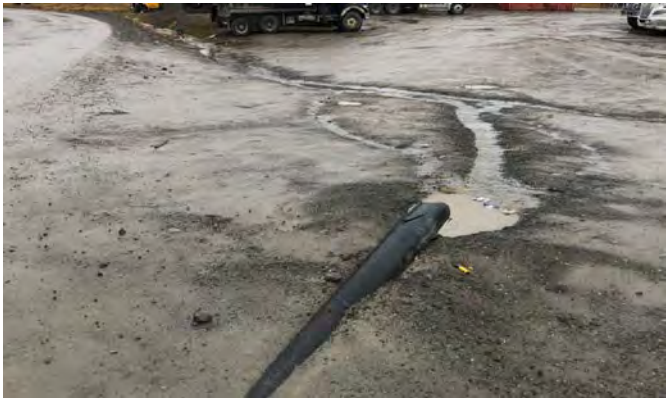
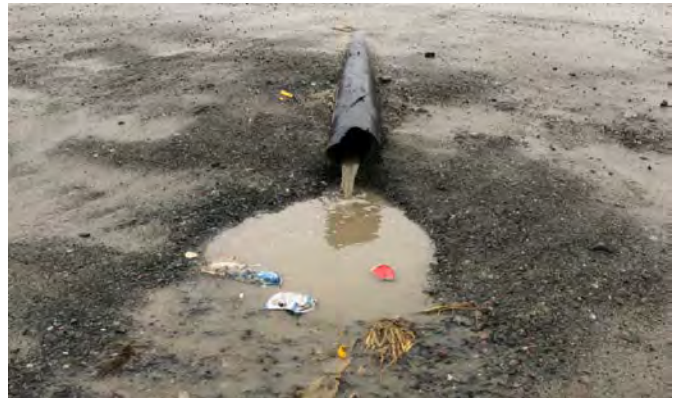
Culvert Information				
Culvert ID	155-02			
Type	Cross			
Shape	Circular			
Material	PVC			
Diameter or Dimensions (mm)	250			
Marker Post Present	N			
Barrel Length (m)	15.5			
Approx. Barrel Slope (%)	4.0%			
Approx. Depth of Cover (m)	320			
End	Upstream			
Crushing	Downstream			
Infill Depth (mm)	Upstream			
	Downstream			
Other Comments	Perched DS end			
Culvert Elevations (masl) ²				
Upstream		Downstream		Road Crown
Invert	Obvert	Invert	Obvert	
18.21	18.44	17.59	17.82

Culvert Condition Ratings (MTO 2013)				
Barrel Material (0-4)	Shape (0-4)	Capacity (0-2)	Erosion and Scour (0-2)	US/DS Channel (0-2)
2	1	0	2	1

Recommended Action(s):	Monitor Rusting, Investigate embankment scour/erosion	Priority:	High
------------------------	-------------------------------------------------------	-----------	------

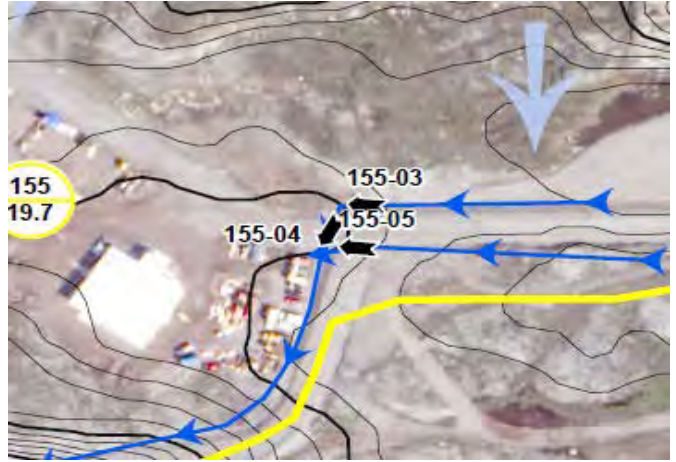
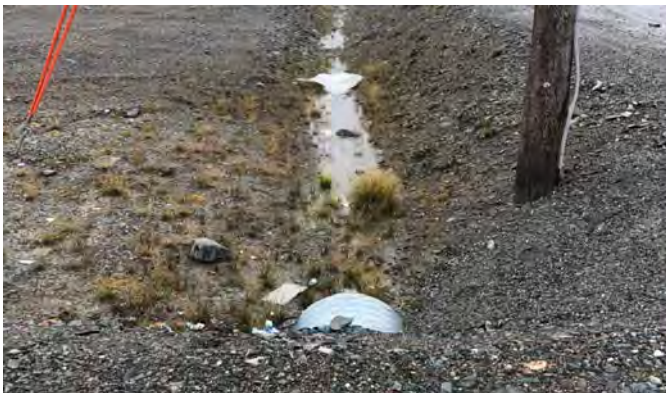
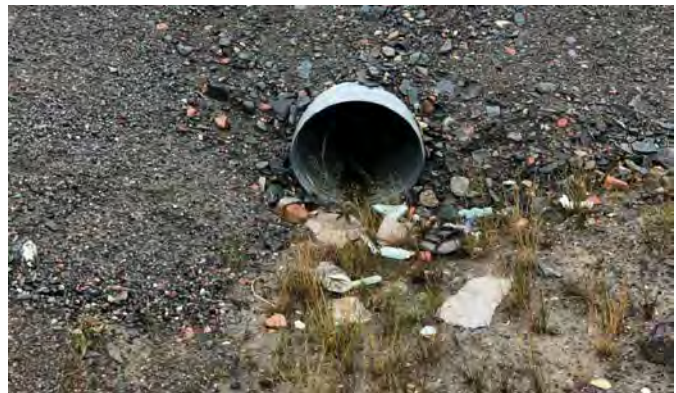
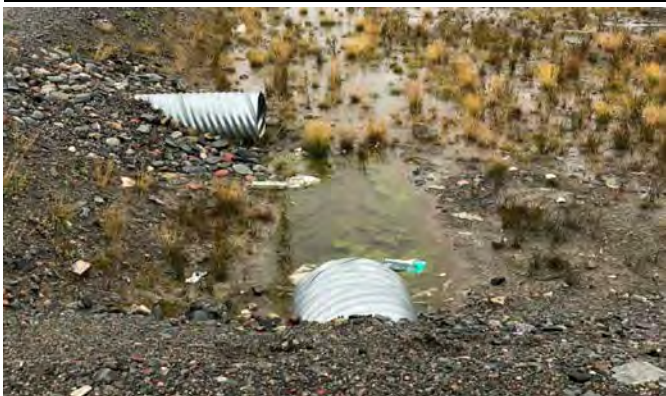
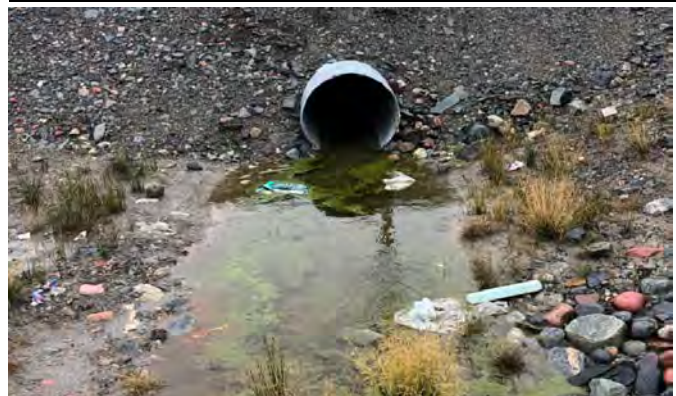
Culvert Information				
Culvert ID	155-03			
Type	Cross			
Shape	Circular			
Material	CSP			
Diameter or Dimensions (mm)	600			
Marker Post Present	N			
Barrel Length (m)	12.0			
Approx. Barrel Slope (%)	0.6%			
Approx. Depth of Cover (m)	525			
End	Upstream	N		
	Downstream	N		
Infill Depth (mm)	Upstream	0		
	Downstream	0		
Other Comments	0			
Culvert Elevations (masl) ²				
Upstream		Downstream	Road Crown	
Invert	Obvert	Invert		Obvert
30.67	31.31	30.6	31.24	31.8

Culvert Condition Ratings (MTO 2013)				
Barrel Material (0-4)	Shape (0-4)	Capacity (0-2)	Erosion and Scour (0-2)	US/DS Channel (0-2)
0	0	0	0	0

Recommended Action(s):	No Action	Priority:	Low
------------------------	-----------	-----------	-----

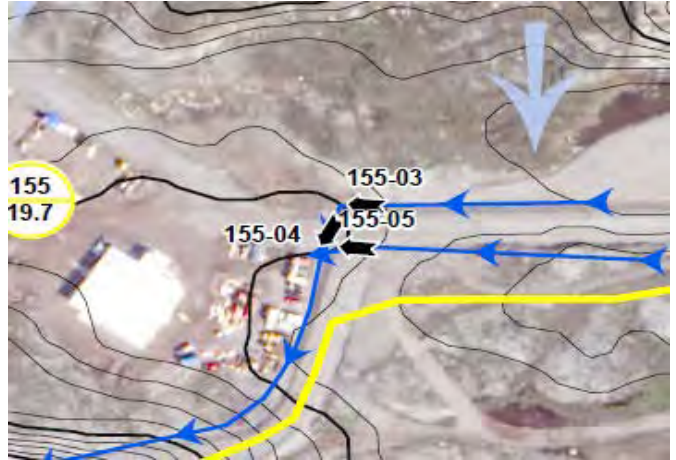
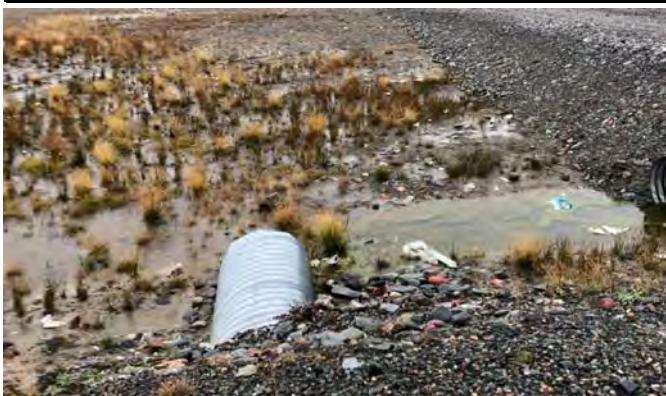
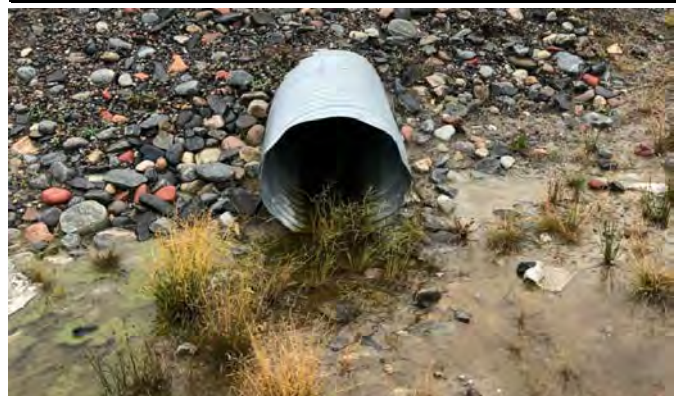
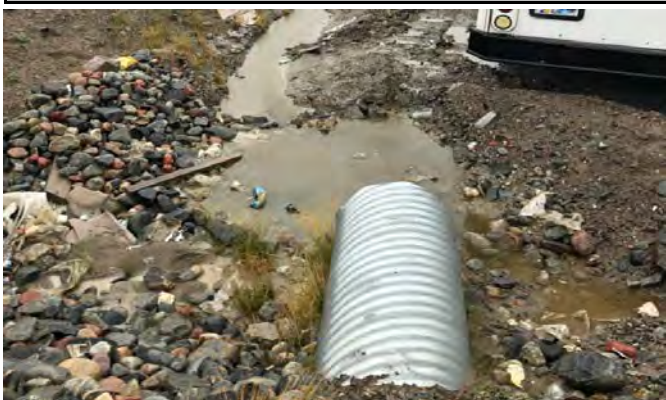
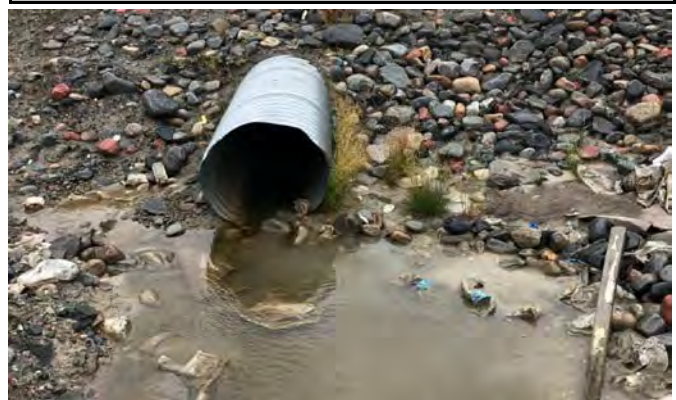
Culvert Information				
Culvert ID	155-04			
Type	Cross			
Shape	Circular			
Material	CSP			
Diameter or Dimensions (mm)	600			
Marker Post Present	N			
Barrel Length (m)	14.3			
Approx. Barrel Slope (%)	0.4%			
Approx. Depth of Cover (m)	665			
End	Upstream	N		
Crushing	Downstream	N		
Infill Depth (mm)	Upstream	0		
	Downstream	0		
Other Comments	0			
Culvert Elevations (masl) ²				
Upstream		Downstream	Road Crown	
Invert	Obvert	Invert		Obvert
30.59	31.2	30.53	31.13	31.83

Culvert Condition Ratings (MTO 2013)				
Barrel Material (0-4)	Shape (0-4)	Capacity (0-2)	Erosion and Scour (0-2)	US/DS Channel (0-2)
1	0	0	0	0

Recommended Action(s):	No Action	Priority:	Low
------------------------	-----------	-----------	-----

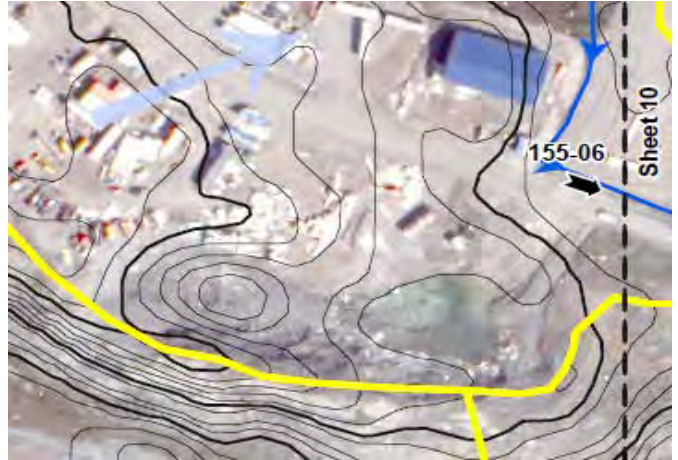
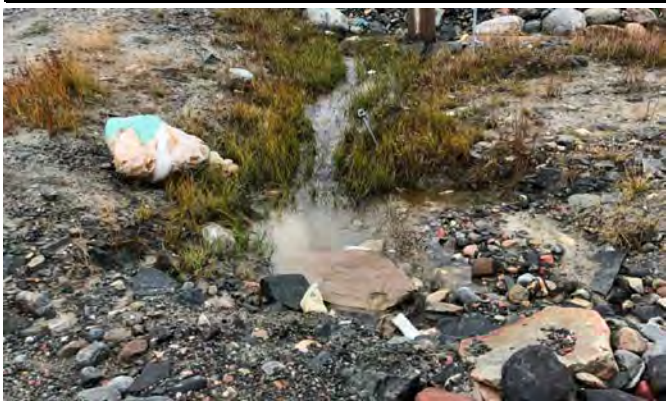
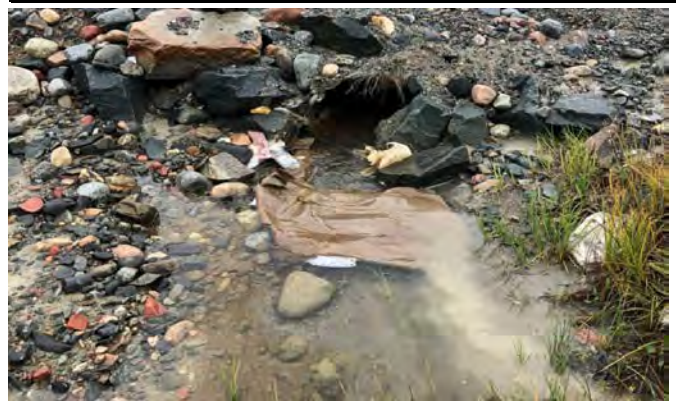
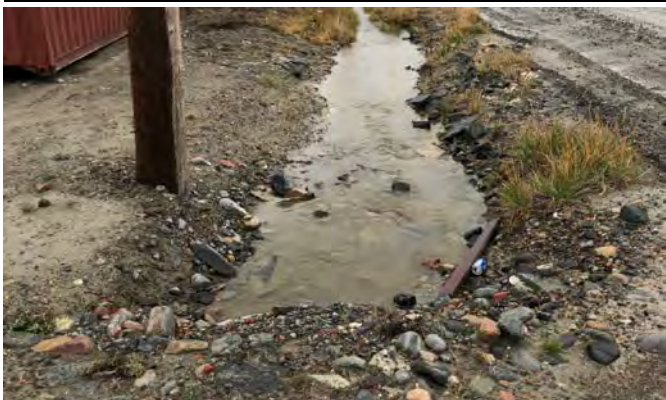
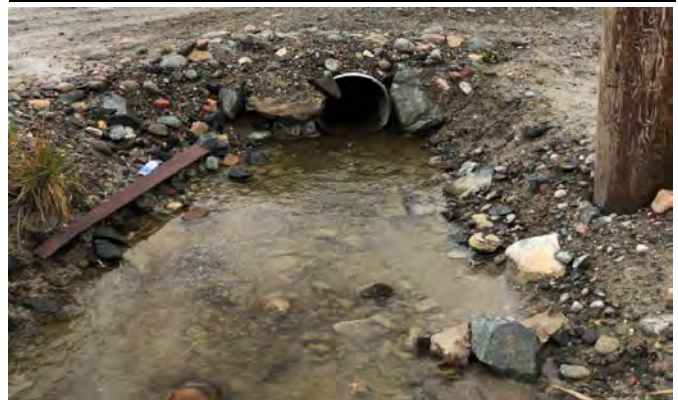
Culvert Information	
Culvert ID	155-06
Type	Cross
Shape	Circular
Material	CSP
Diameter or Dimensions (mm)	500
Marker Post Present	N
Barrel Length (m)	13.1
Approx. Barrel Slope (%)	1.1%
Approx. Depth of Cover (m)	320
End	Upstream
Crushing	Downstream
Infill Depth (mm)	Upstream
	Downstream
Other Comments	Debris blocking US end

Culvert Condition Ratings (MTO 2013)				
Barrel Material (0-4)	Shape (0-4)	Capacity (0-2)	Erosion and Scour (0-2)	US/DS Channel (0-2)
1	0	0	1	0

Recommended Action(s):	No Action	Priority:	Low
------------------------	-----------	-----------	-----

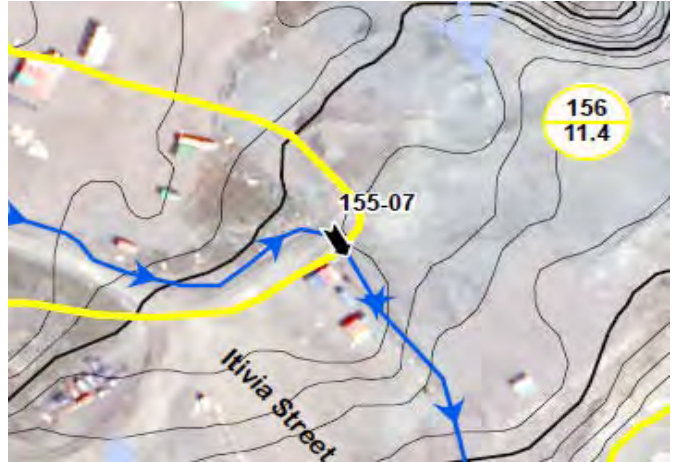
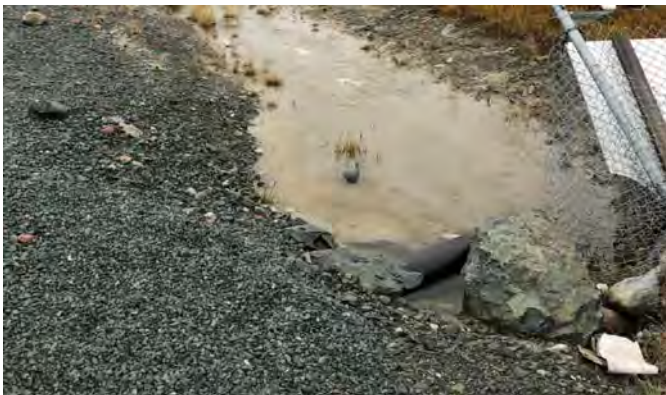
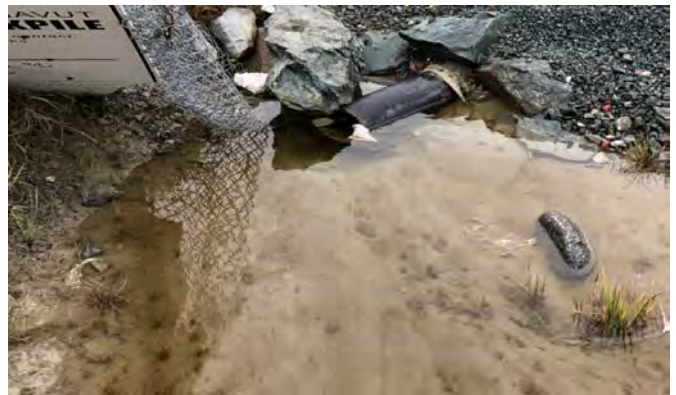
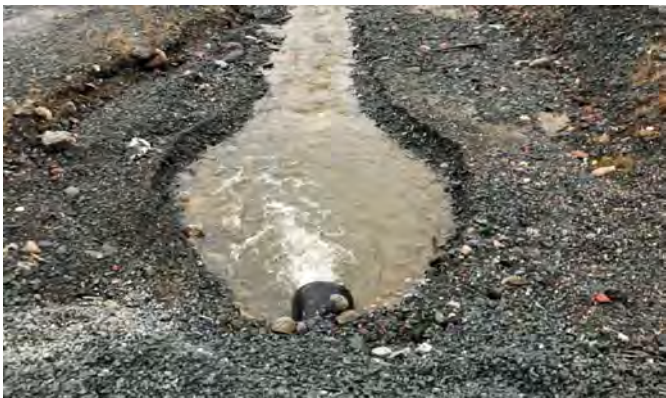
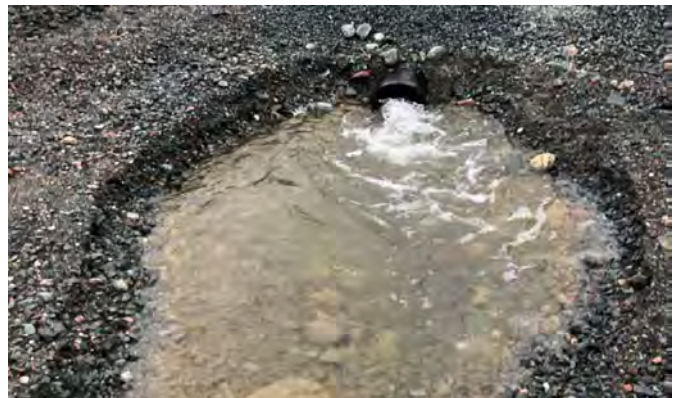
Culvert Information				
Culvert ID	155-07			
Type	Entrance			
Shape	Circular			
Material	PVC			
Diameter or Dimensions (mm)	250			
Marker Post Present	N			
Barrel Length (m)	15.1			
Approx. Barrel Slope (%)	4.2%			
Approx. Depth of Cover (m)	455			
End	Upstream			
Crushing	Downstream			
Infill Depth (mm)	Upstream			
	Downstream			
Other Comments	Scouring on DS end			
Culvert Elevations (masl) ²				
Upstream		Downstream		Road Crown
Invert	Obvert	Invert	Obvert	
8.9	9.13	8.27	8.52

Culvert Condition Ratings (MTO 2013)				
Barrel Material (0-4)	Shape (0-4)	Capacity (0-2)	Erosion and Scour (0-2)	US/DS Channel (0-2)
0	0	0	2	2

Recommended Action(s):	gate embankment scour/erosion, Remediate channel	Priority:	High
------------------------	--------------------------------------------------	-----------	------

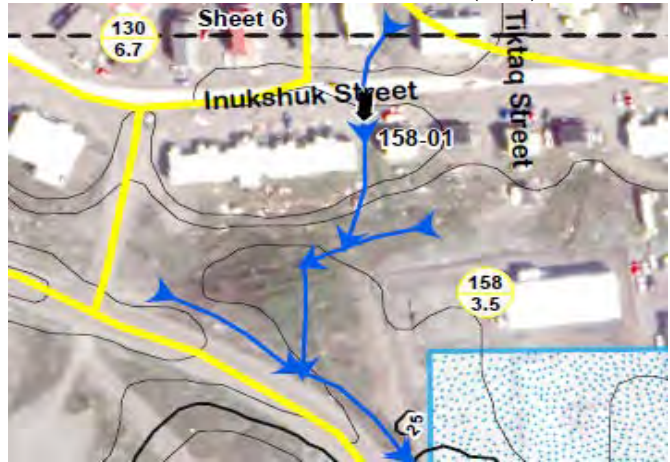
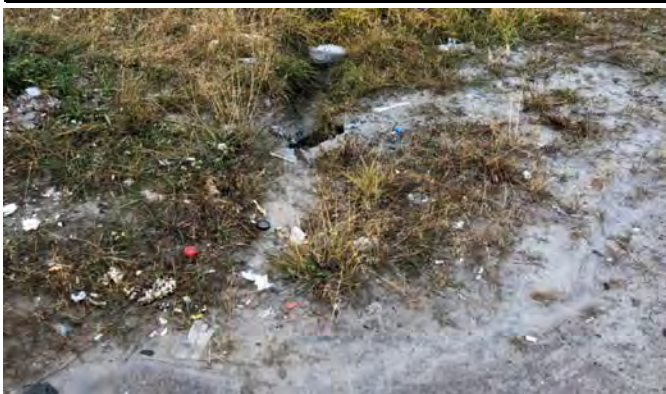
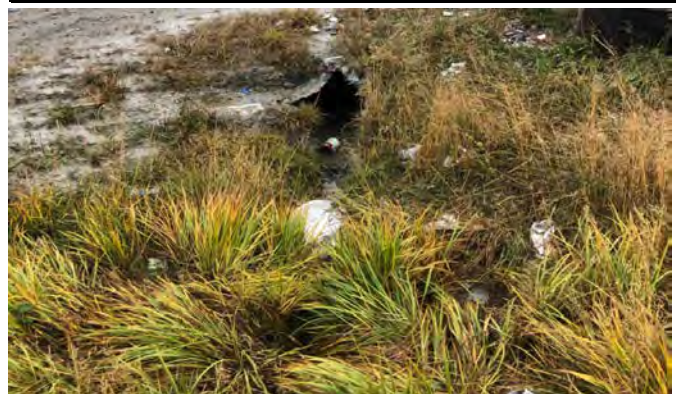
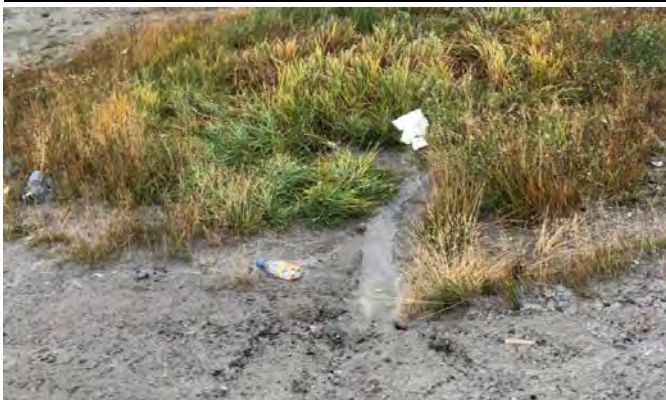
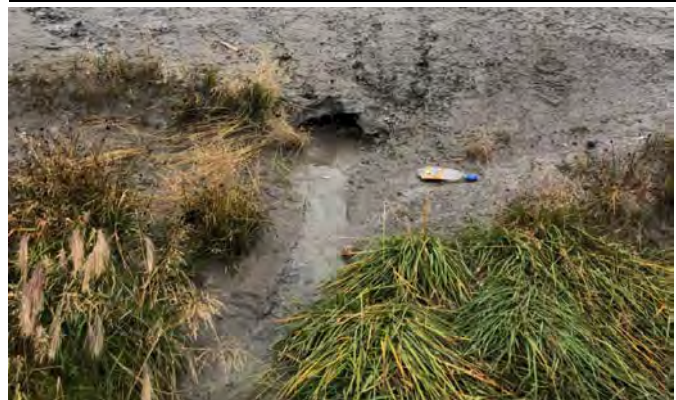
Culvert Information				
Culvert ID	158-01			
Type	Cross			
Shape	Circular			
Material	CSP			
Diameter or Dimensions (mm)	400			
Marker Post Present	N			
Barrel Length (m)	11.1			
Approx. Barrel Slope (%)	1.2%			
Approx. Depth of Cover (m)	465			
End	Upstream			
Crushing	Downstream			
Infill Depth (mm)	Upstream			
	Downstream			
Other Comments	cross culvert connecting 2 swales. Eventually discharges to the humanmade right angle swale			
Culvert Elevations (masl) ²				
Upstream		Downstream		Road Crown
Invert	Obvert	Invert	Obvert	
27.26	27.63	27.13	27.36	27.96

Culvert Condition Ratings (MTO 2013)				
Barrel Material (0-4)	Shape (0-4)	Capacity (0-2)	Erosion and Scour (0-2)	US/DS Channel (0-2)
1	2	2	0	0

Recommended Action(s):	Clear blockage, repair culvert end	Priority:	High
------------------------	------------------------------------	-----------	------

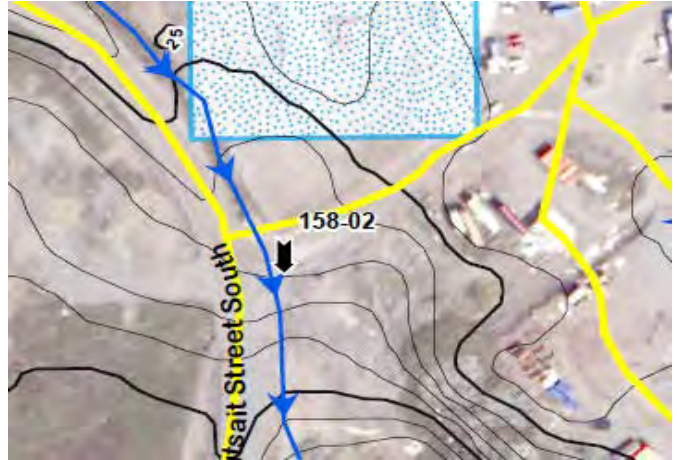
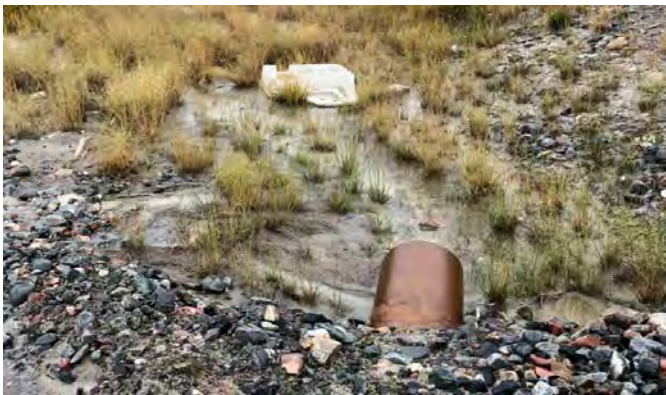
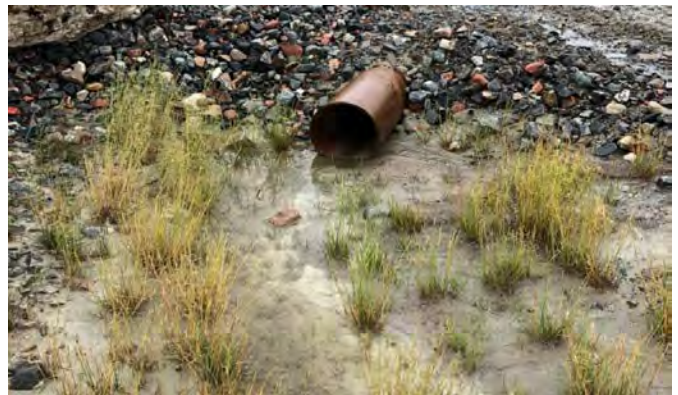
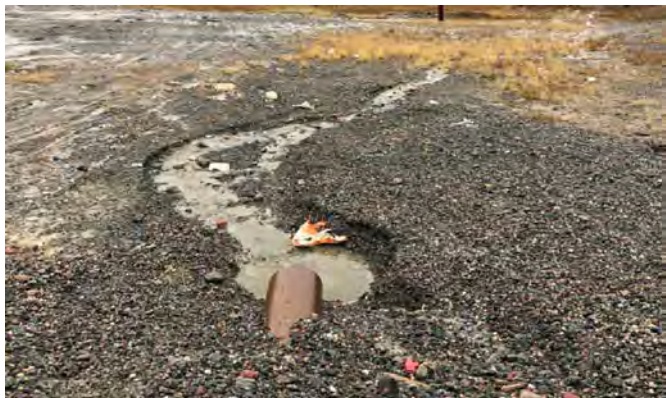
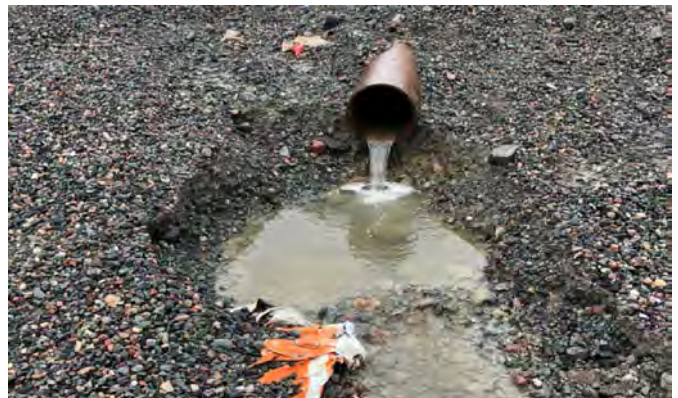
Culvert Information	
Culvert ID	158-02
Type	Cross
Shape	Circular
Material	SWSP
Diameter or Dimensions (mm)	300
Marker Post Present	N
Barrel Length (m)	18.3
Approx. Barrel Slope (%)	2.4%
Approx. Depth of Cover (m)	350
End	Upstream
Crushing	Downstream
Infill Depth (mm)	Upstream
	Downstream
Other Comments	Perched outlet. Scouring

Culvert Condition Ratings (MTO 2013)				
Barrel Material (0-4)	Shape (0-4)	Capacity (0-2)	Erosion and Scour (0-2)	US/DS Channel (0-2)
0	0	0	2	1

Recommended Action(s):	Investigate embankment scour/erosion	Priority:	High
------------------------	--------------------------------------	-----------	------

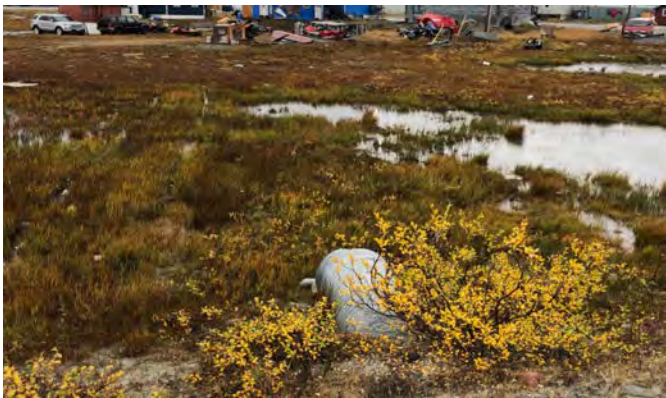
Upstream View

Culvert Condition Ratings (MTO 2013)				
Barrel Material (0-4)	Shape (0-4)	Capacity (0-2)	Erosion and Scour (0-2)	US/DS Channel (0-2)
0	0	0	0	0

Recommended Action(s):	No Action	Priority:	Low
------------------------	-----------	-----------	-----
