Drainage Report

Government of Nunavut

Final Report

Geotechnical Investigation and Drainage Planning Services in Sanikiluaq, NU

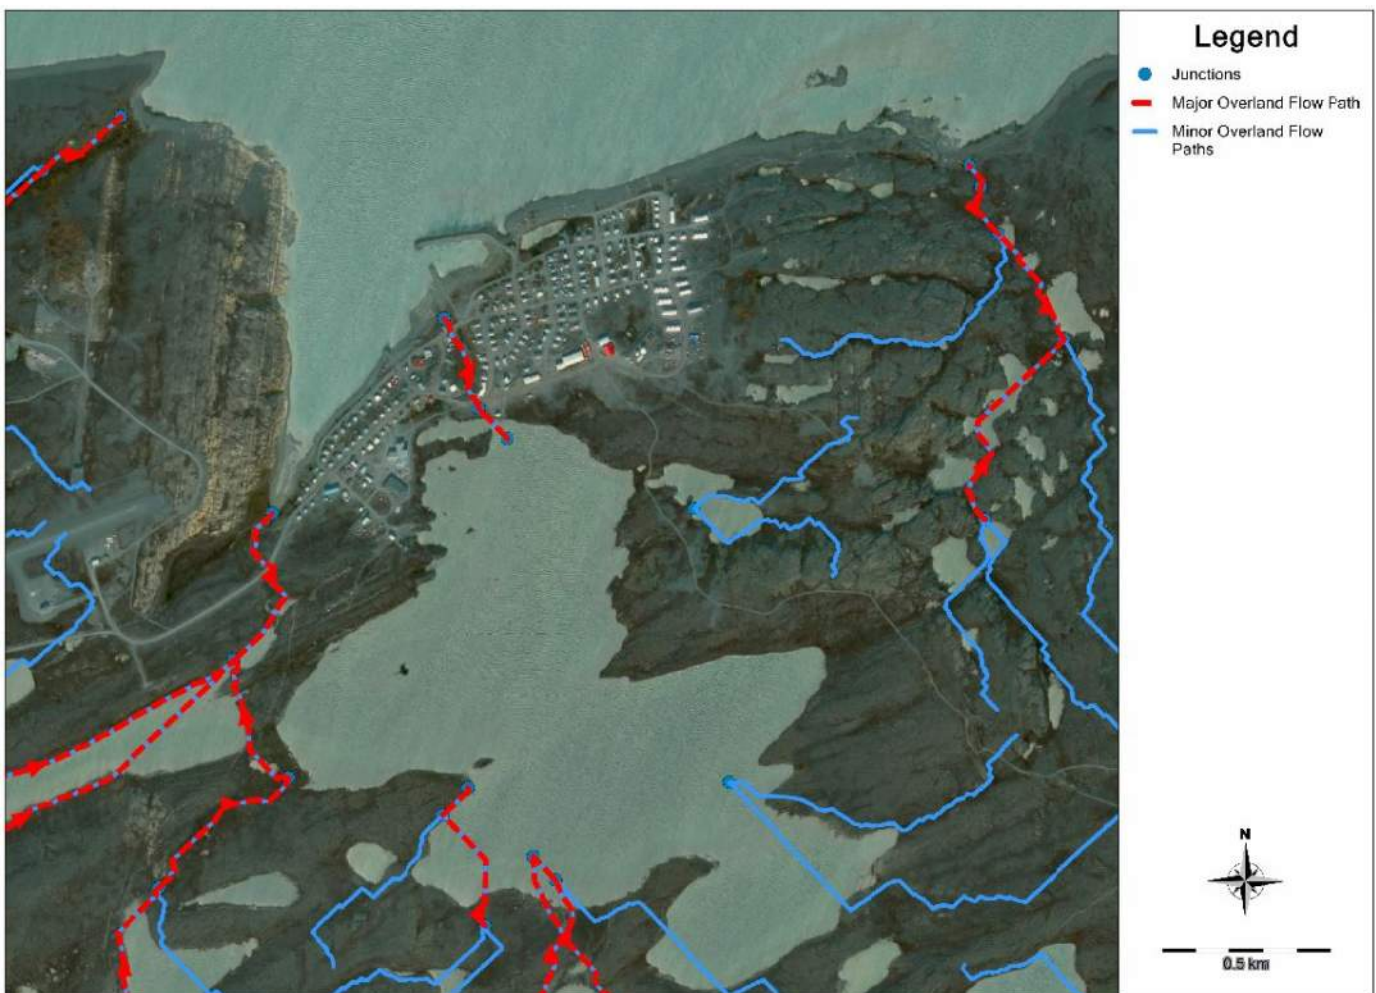
Figure 2. Existing major overland flow paths in and around Sanikiluaq.

As seen in this figure, Sanikilliaq Lake drains through the Hamlet out into the ocean. The other two major overland flow paths occur to the west of Area 1, and the east of the new development area. No major flow paths are travelling through the new development area. Figure 3 below is a closer view of the area which shows the locations of minor overland flow routes through Area 5.

As seen above in Figure 1 in Section 3.2 some of the major concerns noted during the site visit and described by local Hamlet staff were the major drainage courses traversing through the community, specifically in Area 1. Figure 2 in Section 3.2 shows a significant portion of the southern overland flow route drains northerly through the Hamlet of through crossings X-01, X-03 and X-04. Due to the extent of the drainage area, it is critical to maintain adequate flow through these culvert crossings at all times, and most importantly during the seasonal spring melt. From discussions with Hamlet staff, it is EXP's understanding that during these melting periods with increased flow, large masses of ice and snow tend to build up around the crossing X-03, resulting in increased lake water levels and minor to moderate flooding of adjacent properties. Crossing locations are shown in on the Site Plan in Appendix B. By reviewing the contour data provided by GN sources, there appears to be less than one meter of elevation difference between the typical lake water level, and the airport road surface (i.e. the highest elevation in Area 1). That is, if the lake drainage outlet is blocked and water levels rise, it is more than likely that water will begin to drain westerly through the Hamlet. The results of this will vary in severity depending on the duration of the blockage and peak flow rates, but can range from standing water and minor erosion along roadsides and residential properties, to major erosion and washouts of road surfaces and building block footings.

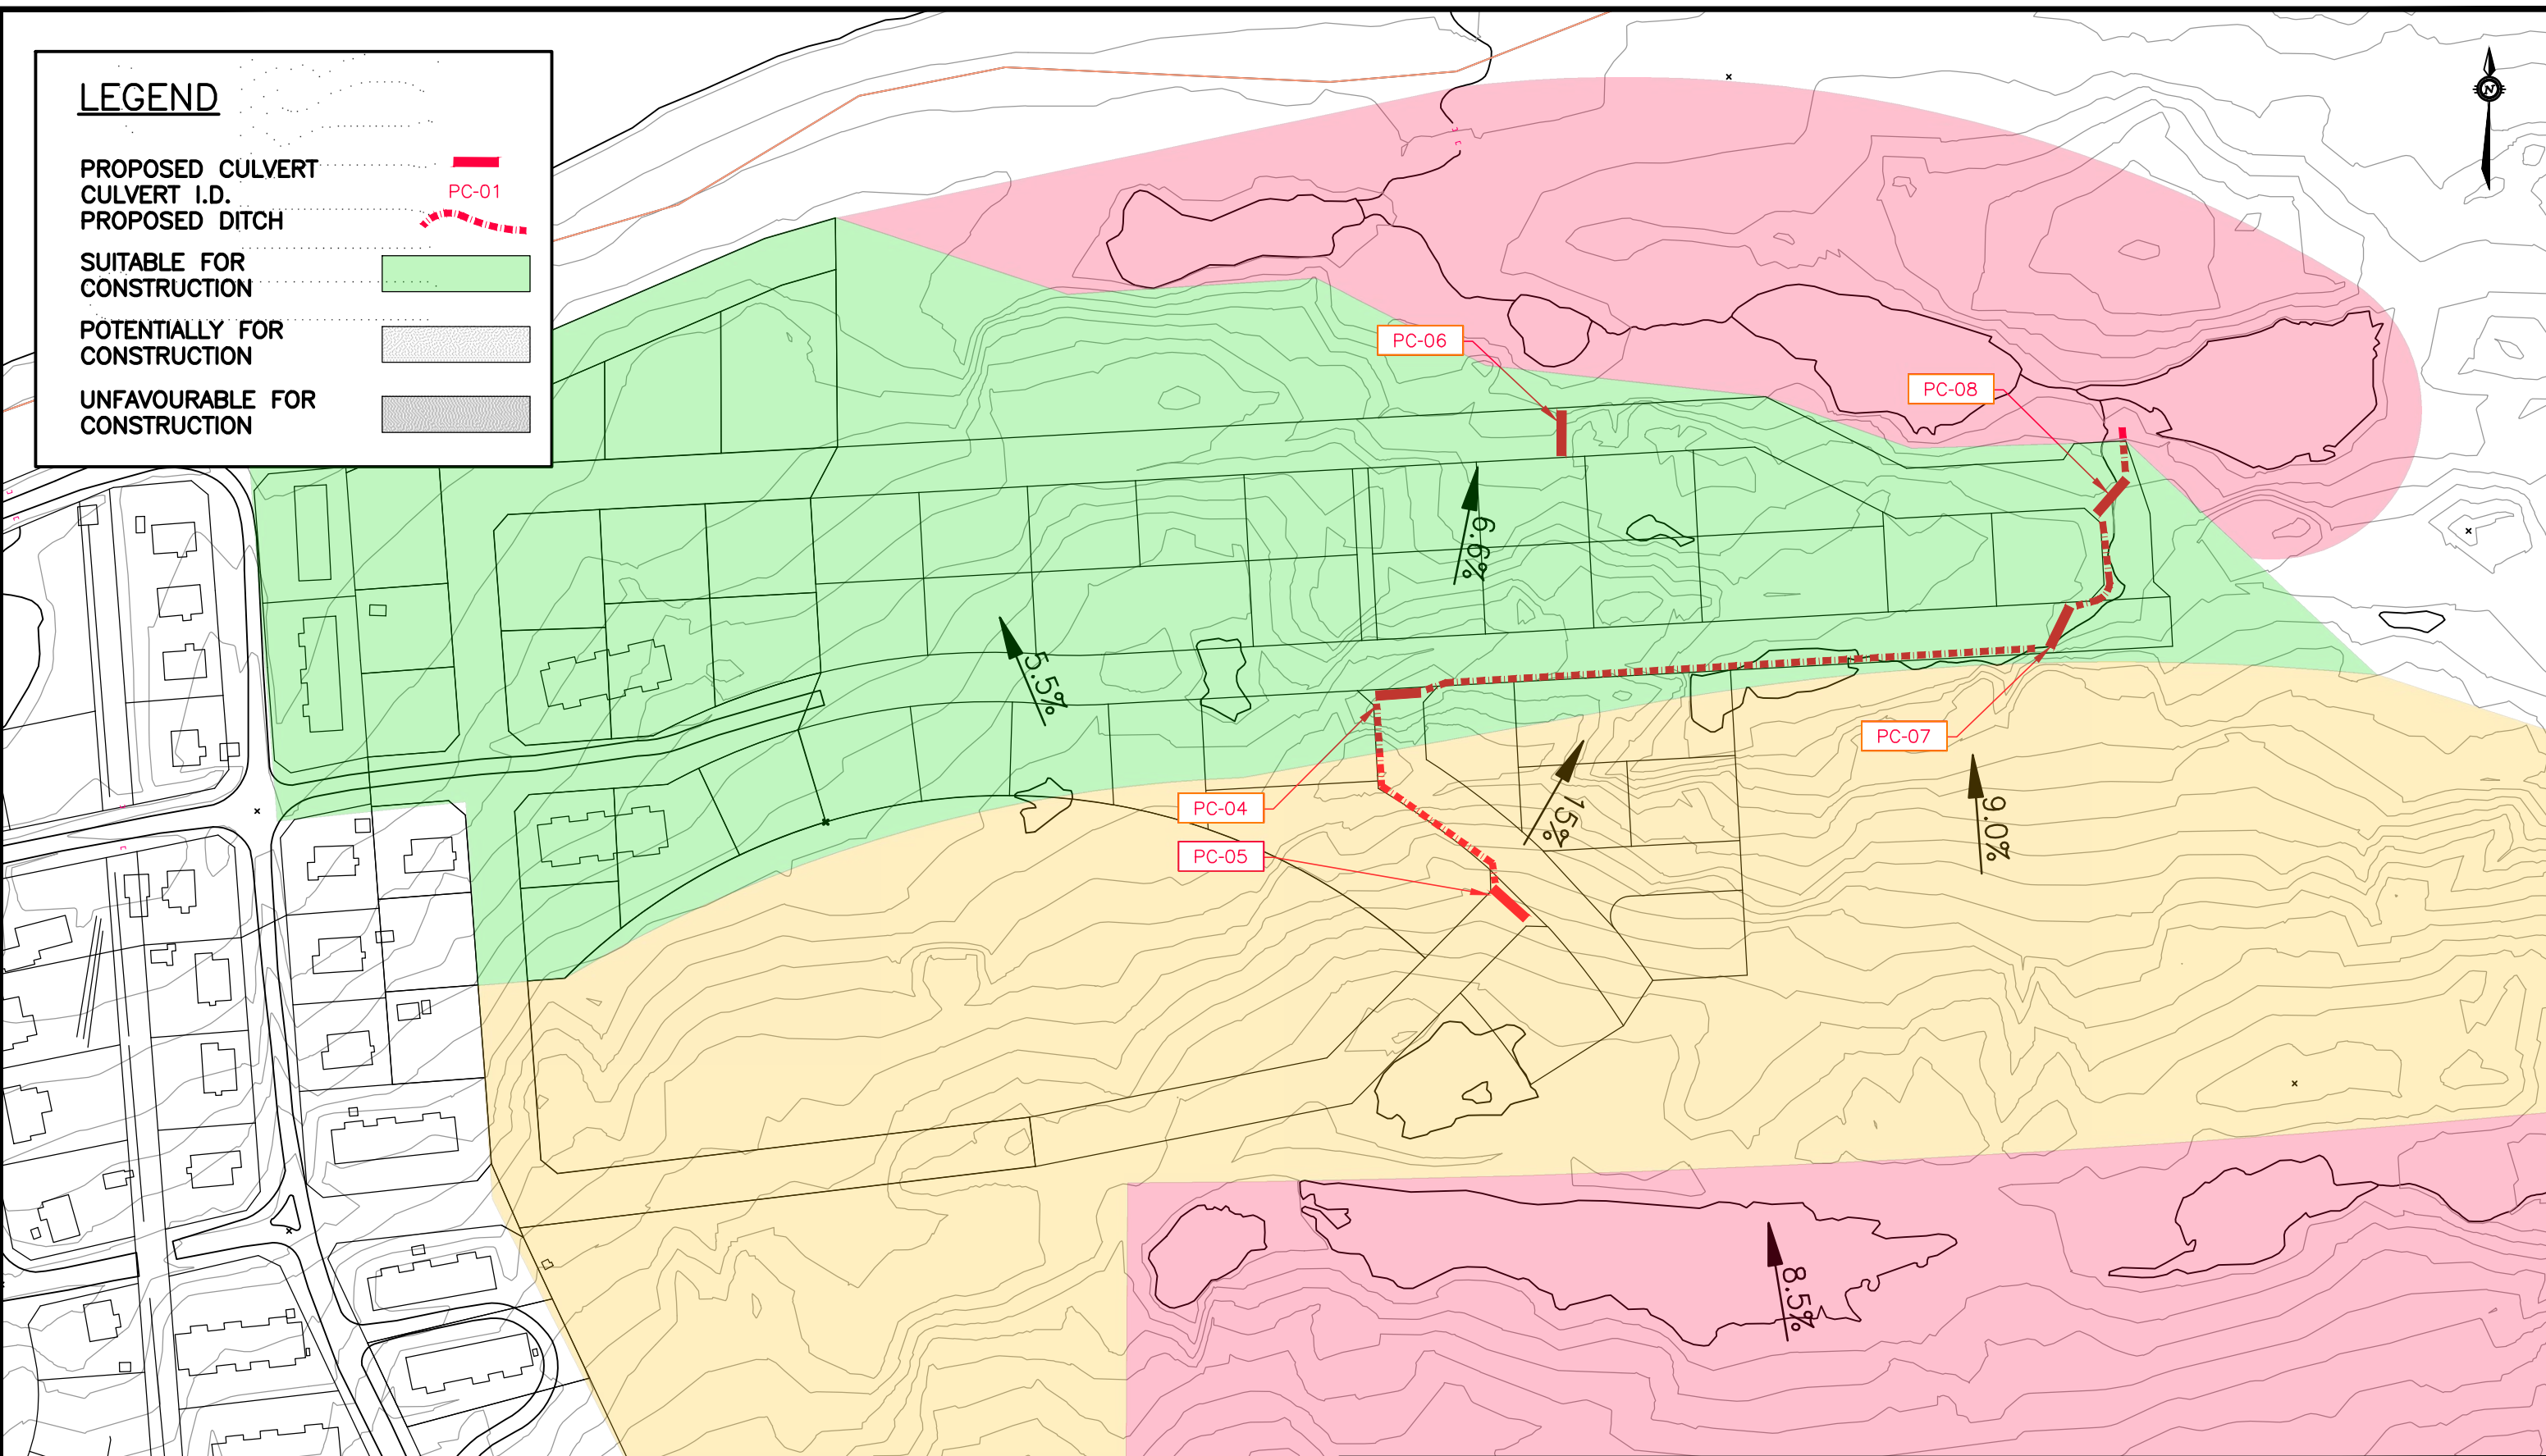
<p>exp Services Inc. 100-2650 Queensview Drive Ottawa, ON K2B 8H6 www.exp.com</p>		DESIGN	EXP	<p>SANIKILUAQ DRAINAGE PLANNING SANIKILUAQ, NU</p> <p>PROPOSED IMPROVEMENTS & CONSTRUCTION SUITABILITY - AREA 5</p>	SCALE	1:2000
		DRAWN	JH		<p>A02</p>	
		DATE	FEB 2020			
		FILE NO	255134-A0
